## Vendors Report

Inspection Date: 8 Apr 2020

Report Type: Property Inspection Report

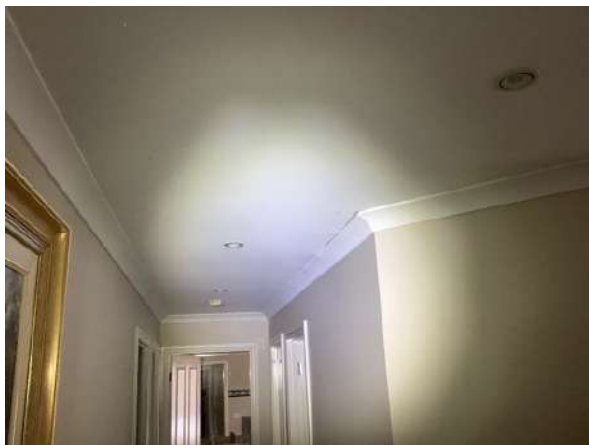
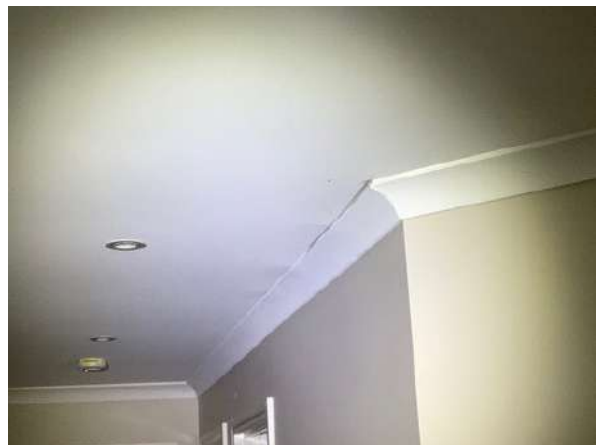
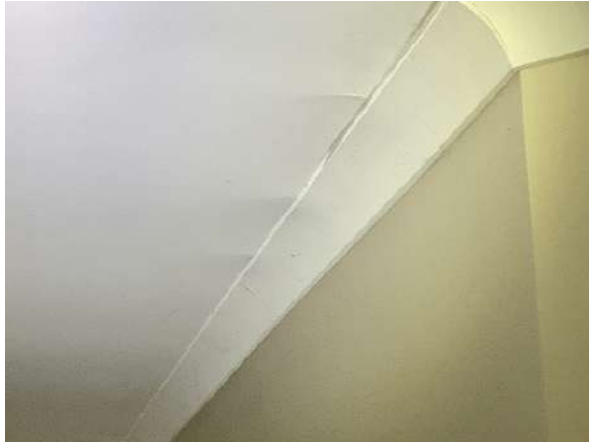
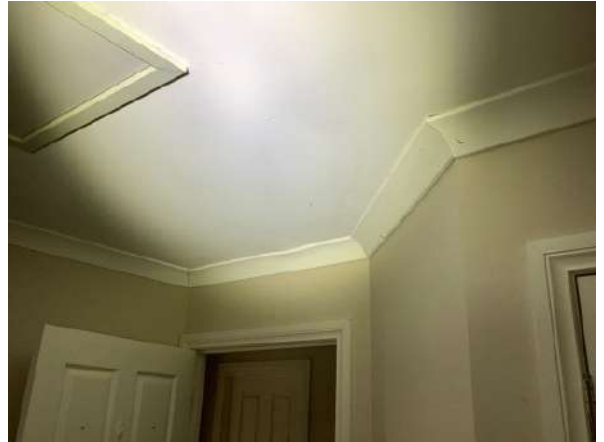
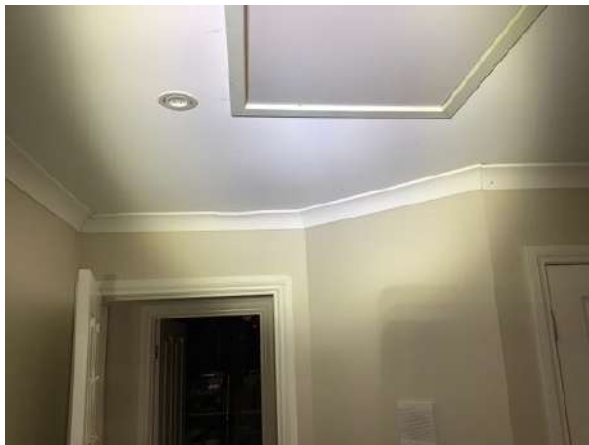
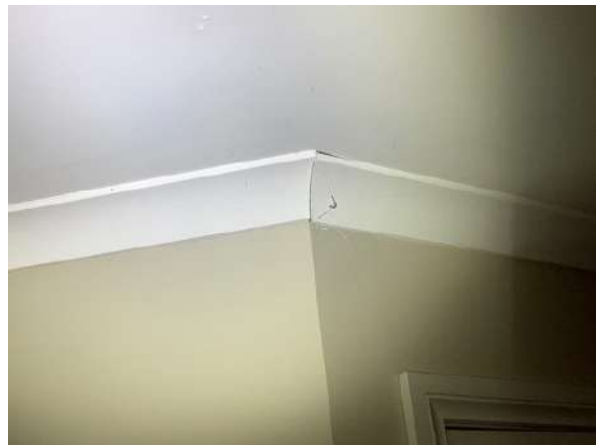
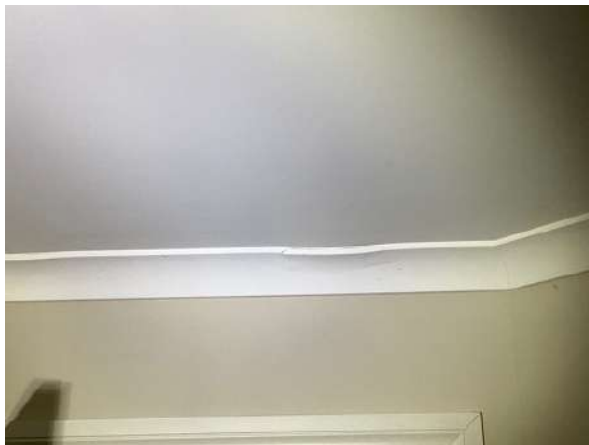
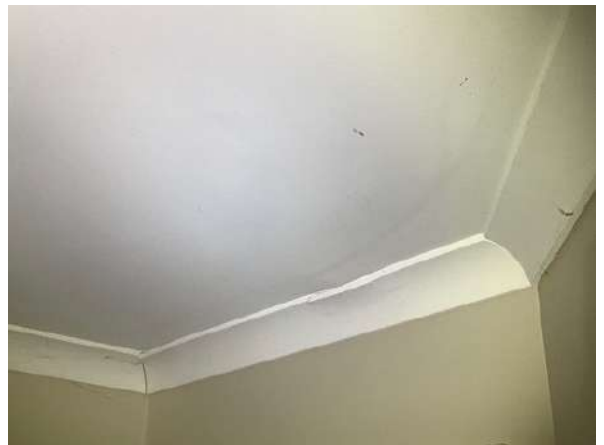
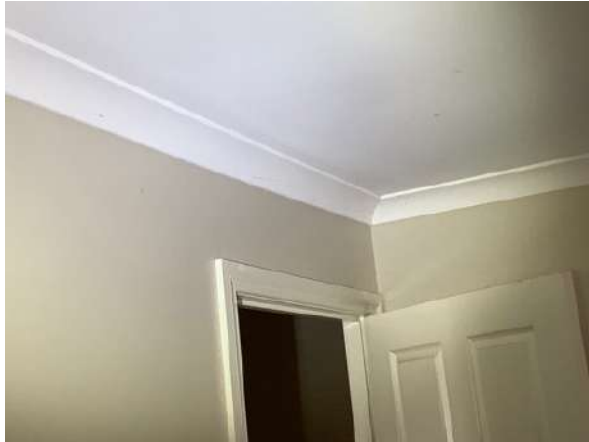
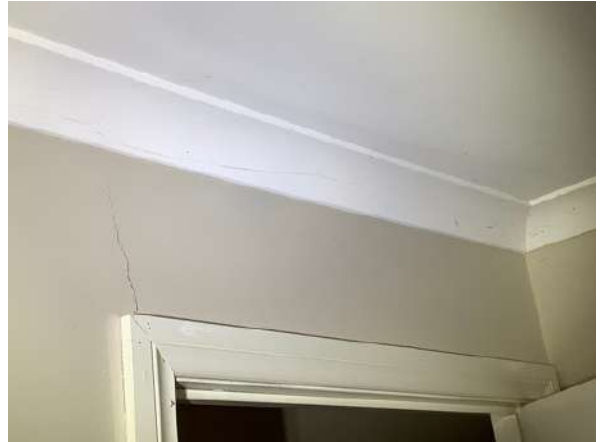
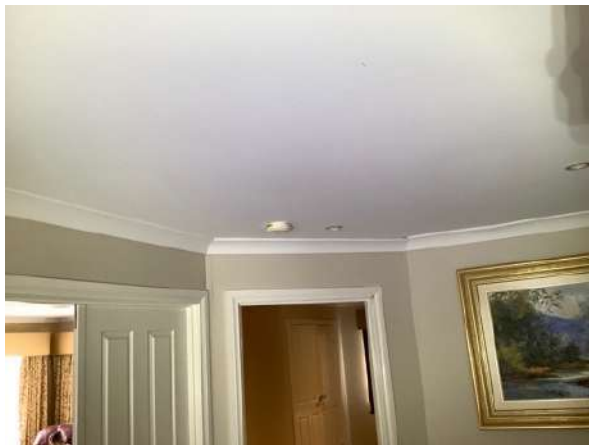
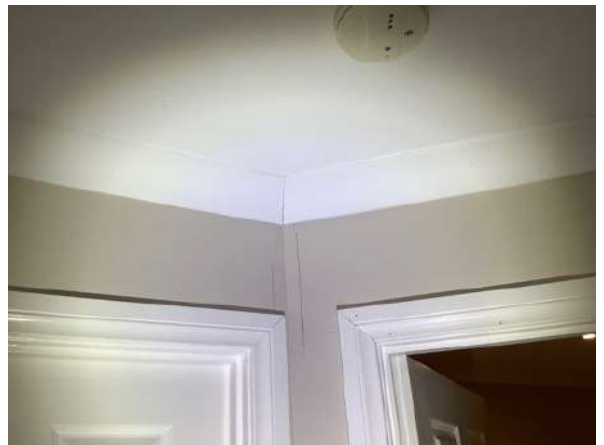
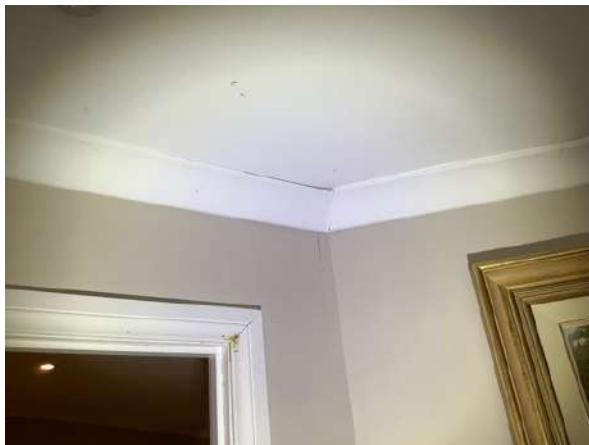
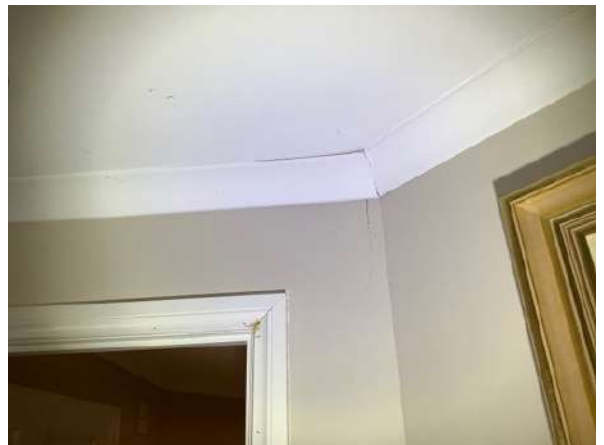
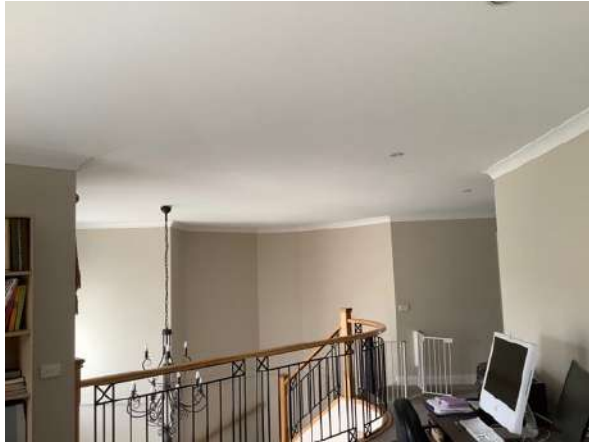
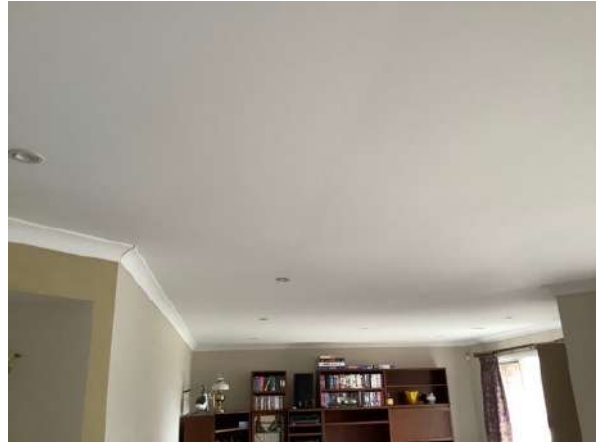
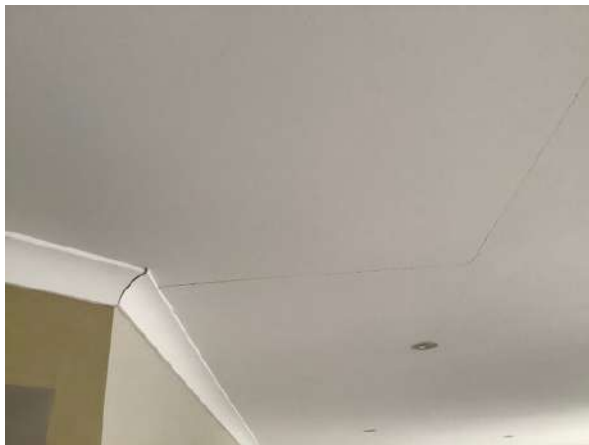
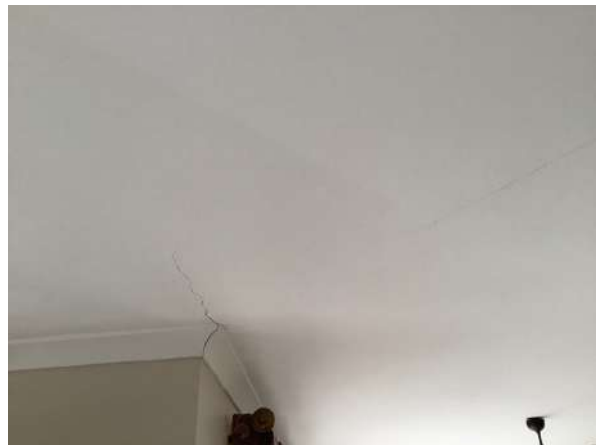
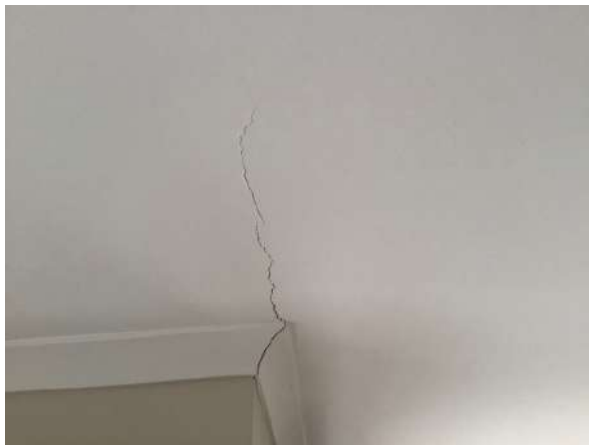
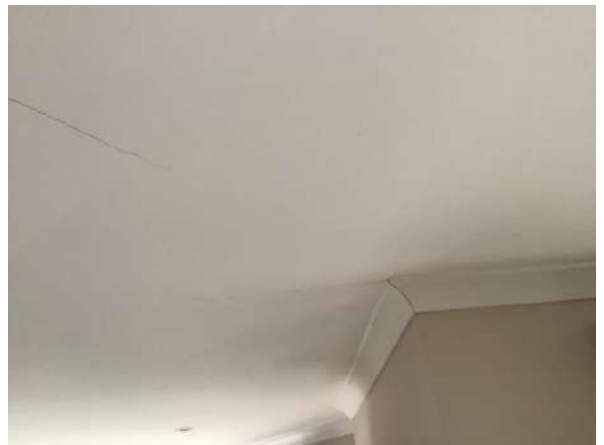
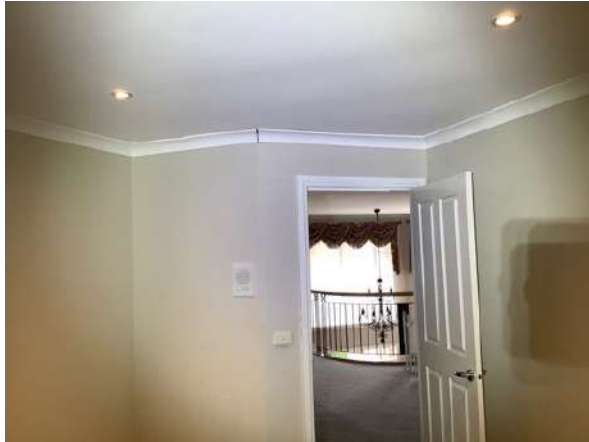
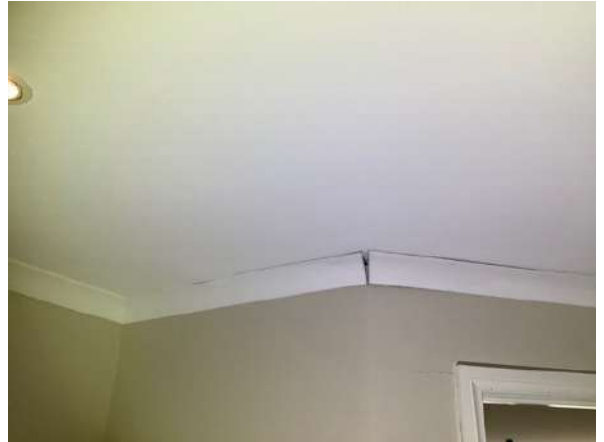
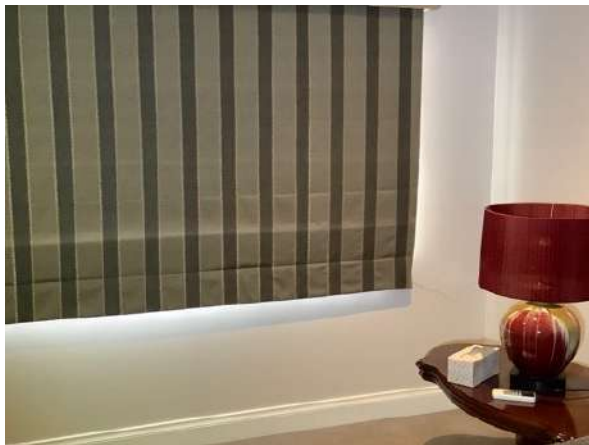
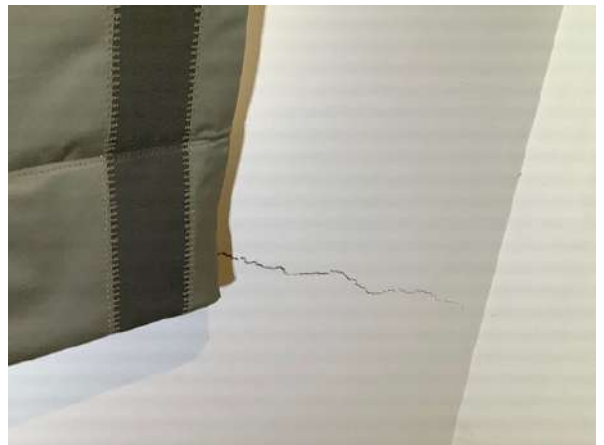
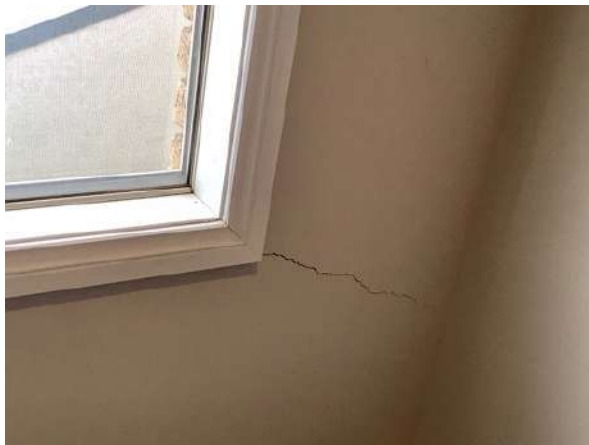
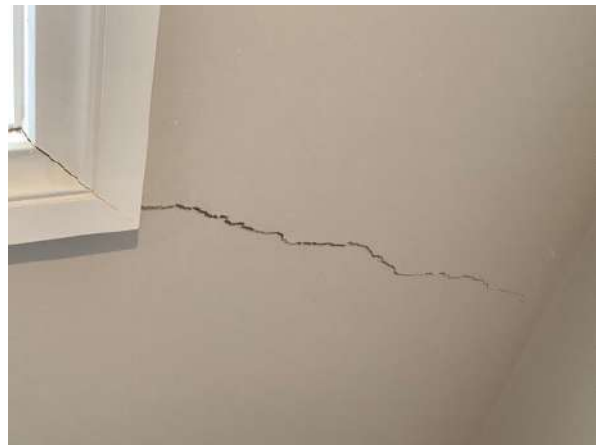
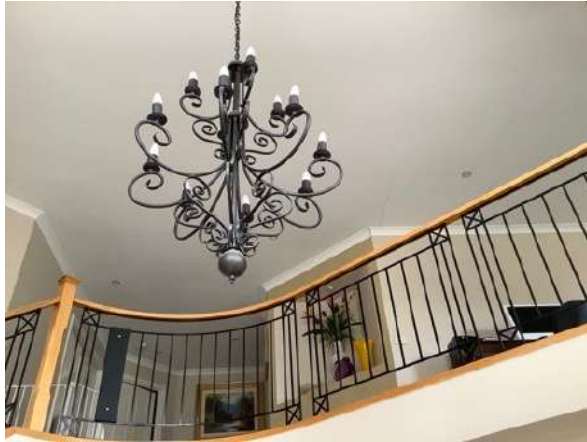
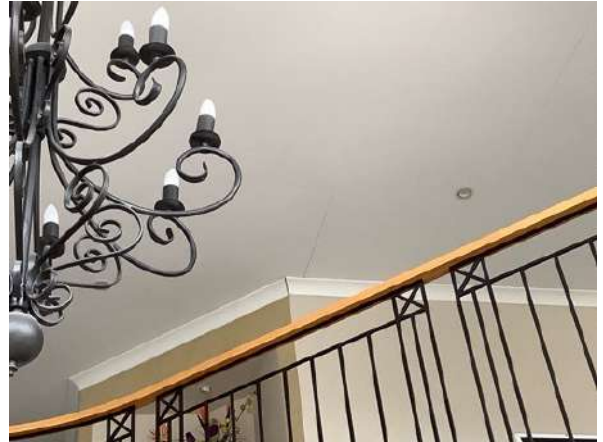
## Major Defect 2.01

Finding: Plaster Movement & Cracking.

There are various areas of plaster cracking, cornice cracking, plaster joints cracking, plaster movement and compressed plaster in areas on the cornices or junctions where the ceilings and walls meet.

There are various reasons why the above defects can occur, one of them is timber shrinkage, the next is under engineered roofing and wall supports, the next one is not enough supports in the roof. Further to this as tiles age they absorb more water in them and the additional weight of the roof tiles can create such problems.

I highly recommend a structural engineer assess the roofing to determine if further additional supports are required in the roof.

In relation to the plaster repair, there are various options in which a qualified plasterer can assess and make the options for repair.

1/ One of the methods would be to take out all the plaster and suspend batons or fix batons to the trusses and install new plaster and cornices.

2/ Another option would be to fix batons to the existing plaster ceiling and install new plaster sheets.

3/ Or leave the existing plaster and make holes to install hangers through the plaster to install new batons for the new plaster sheeting.

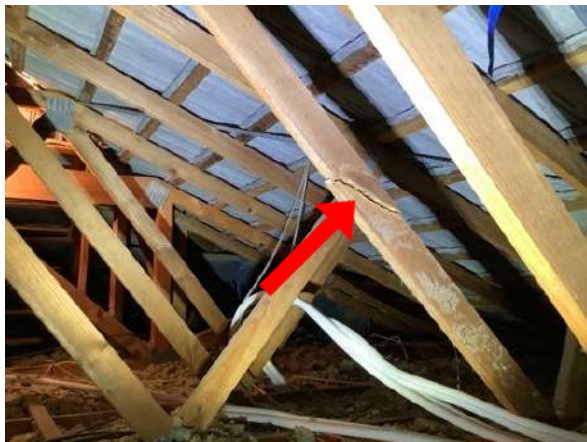
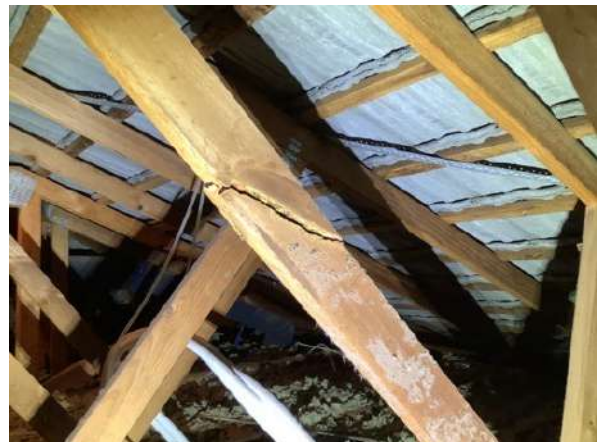
## Major Defect 2.02

Finding: Truss - Damaged

The truss in the roof space area appears to be structurally compromised, this will require a minimum of a double lamination from the top of the truss to the bottom to enhance the structural integrity.

A registered builder or a qualified carpenter should be engaged to assess the damage and do the repairs.

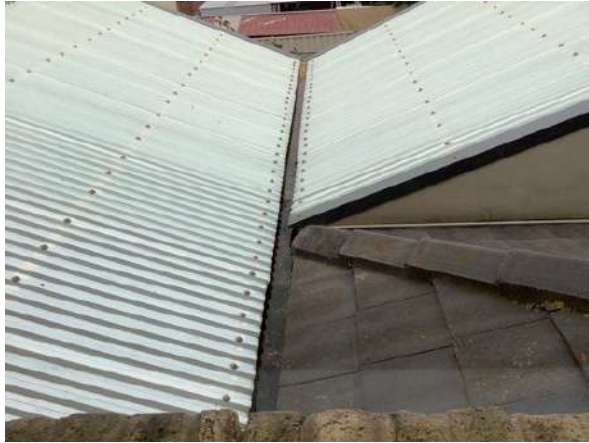
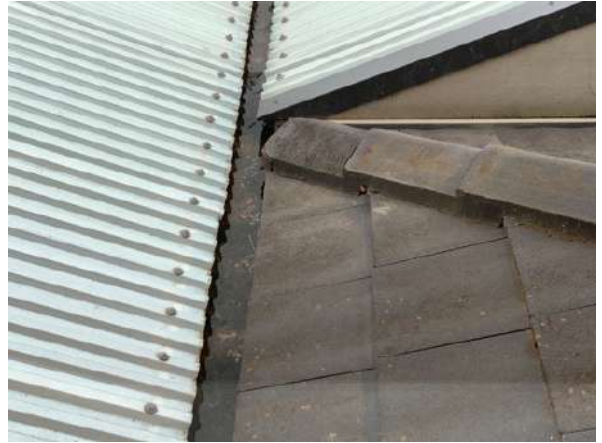
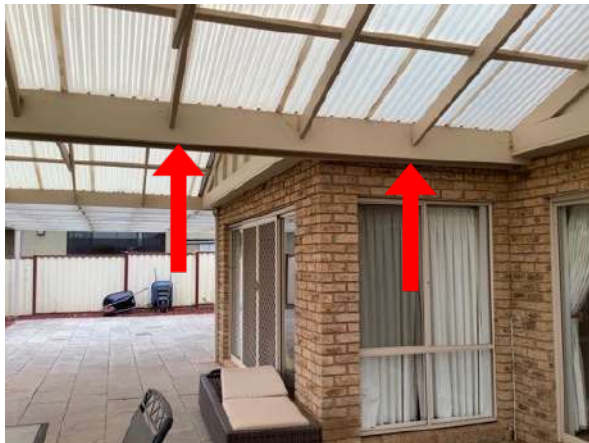
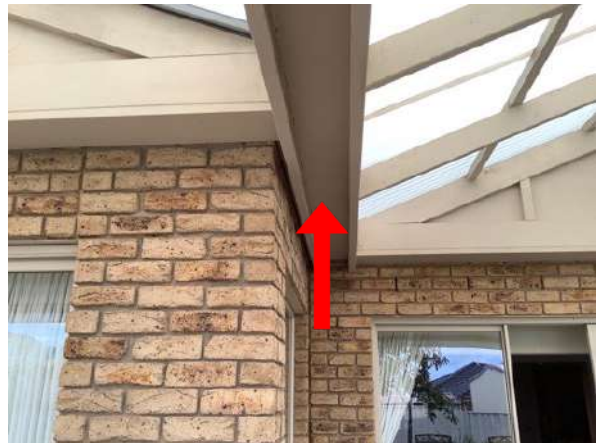
## Minor Defect 3.03

Finding: Guttering Roof Plumbing - Insufficient Capacity & Defective Gutters/Box Gutters.  
 There is water pooling in the gutter which exceeds the acceptable level of 10 mm. There is really 3 ways to do the repair, one would be to add more fall to the gutter, which may not be so easy. The second option would be to add an additional downpipe towards the end of the home approximately 1 m from the brick wall of the sliding door into the meals area. However the issue with this is where you would connect the downpipe to, there are various options in which a qualified plumber would need to further assess.  
 Third option would be to install an angle platform inside the gutter approximately 3 meters long, that would fall away from the property.

It is suspected that the roof plumbing to the exterior roof is insufficient in capacity and is not adequately managing the volume of rainwater that it is required to drain. The result is generally that the plumbing overflows during periods of heavy rainfall, creating damp conditions against external surfaces and the base of the building perimeter.

If left unmanaged, the excess moisture in this areas may allow the formation and development of an environment that is conducive to rust, corrosion and rot, creating potential for secondary defects to all associated building elements. Damp conditions are also conducive to termite and pest activity, further exacerbating the risk of the environment.

Appointment of a roofing plumber is recommended to replace any inadequate drainage systems to ensure proper drainage to this area. In the interim, it is important to ensure that all roof plumbing is free of any debris or blockages.

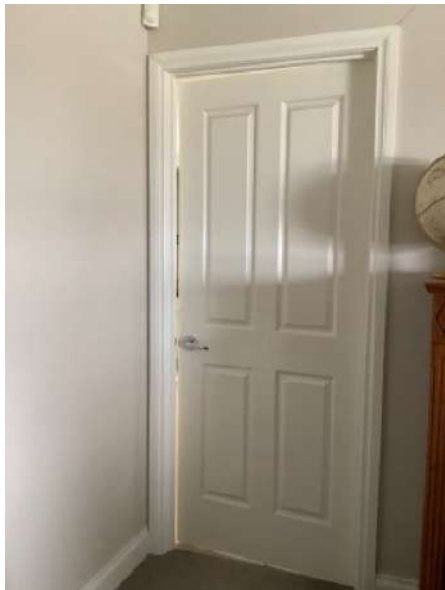
## Minor Defect 3.04

Finding: Door - Binding / Jamming / Out Of Level  
There are various doors to the upper level that are binding and jamming.

Binding, Jamming and/or Out Of Level Doors is evident during standard operation.

A door that binds to flooring or to the associated door frame may have several causes, ranging from minor defects, such as poor installation of the door or deteriorated hinges, through to major structural issues, such as damage and/or subsidence ( sinking ) to subfloor structures.

Where door binding/jamming/out of level appears to indicate major structural issues, a registered builder specialising in re-stumping / re-stumping company or concrete slab subsidence expert should be appointed to provide an estimate on the cost of rectification.

For minor causes, a qualified carpenter or general handyperson should be appointed to perform minor rectification works at client discretion.

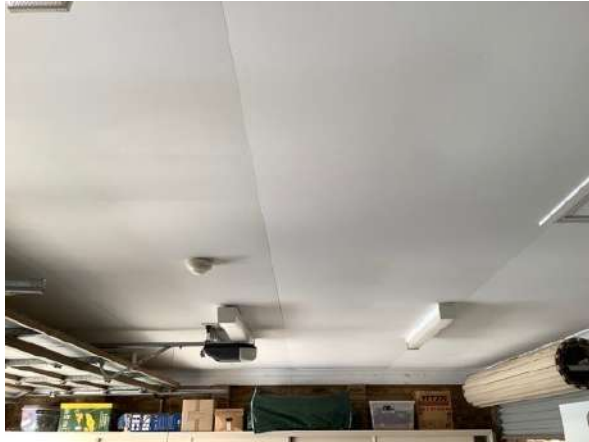
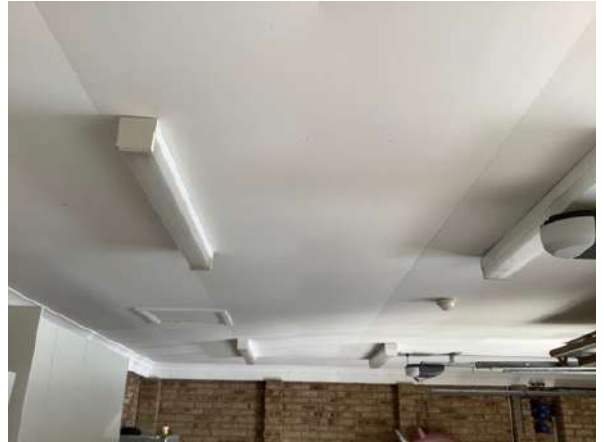
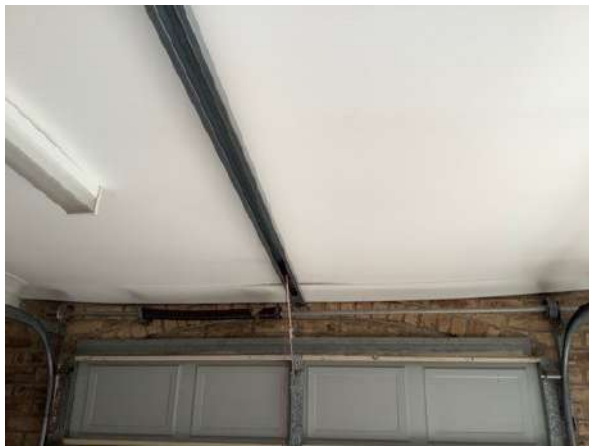
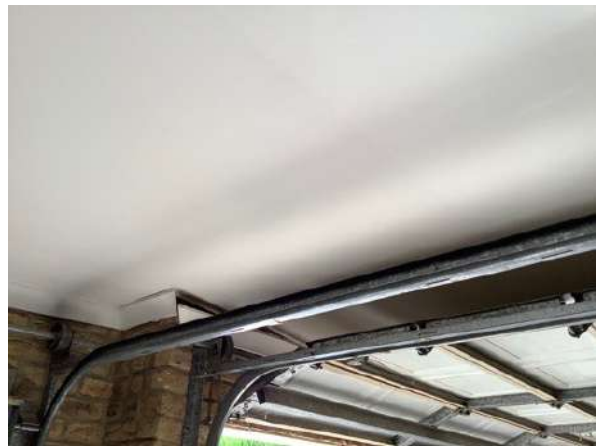
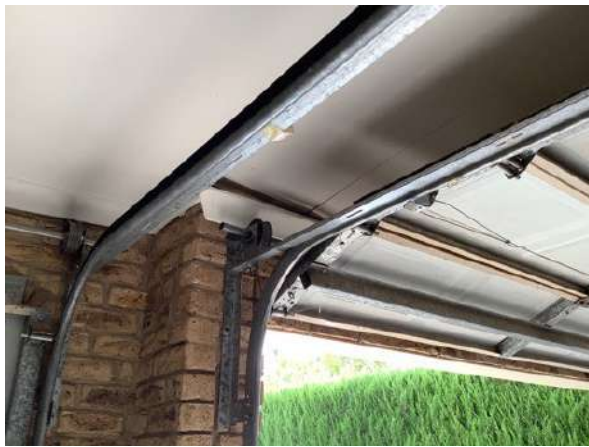
## Minor Defect 3.05

Finding: Plaster Ceiling - Drummy / Sagging

Sections of plaster sheeting in this area appear to be drummy. The term `drummy` is used to describe plaster which, whilst solid, has become detached from its original fixing, where the defect is spread wide the drummy plaster can also be a safety defect, meaning plaster ceilings can just drop in an instance, usually this is the more extreme drummy ceilings.

The most common causes of plaster failure are physical damage and moisture damage. Moisture causes plaster to swell and shrink as the humidity of the air changes, or as a consequence of leaks, which can be enough to create drumminess or cracking.

Drummy plaster generally needs chemical re-adhesion ( glue ) or to be screwed back to the substrate, with minor consequent patching and painting required but sometimes drummy plaster can be permanently deformed in shape so therefore will sometimes need to be replaced.

Ensure that the general environment is free of moisture and humidity to aid in the prevention of drummy plaster and plaster damage. Appointment of a qualified plasterer and/or builder is advised in order to complete remedial works as necessary.

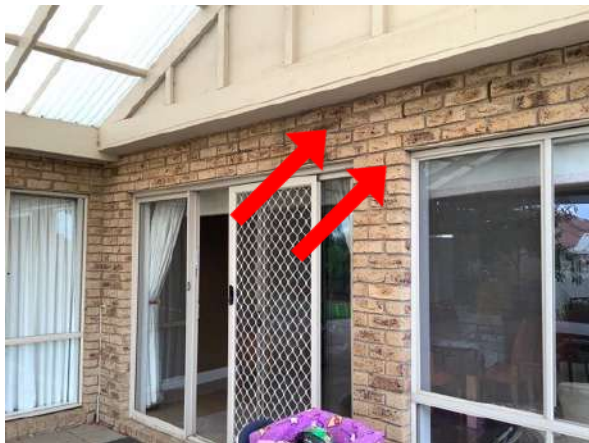
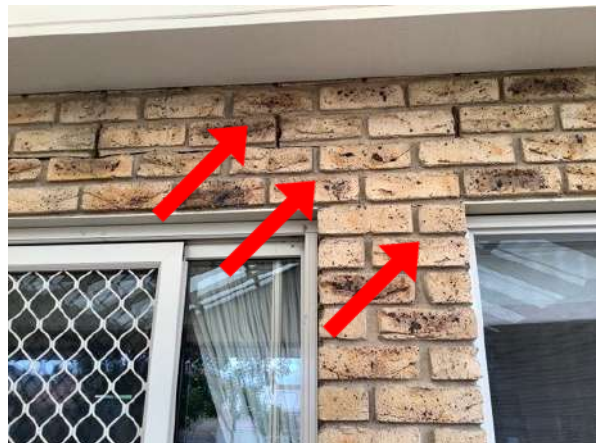
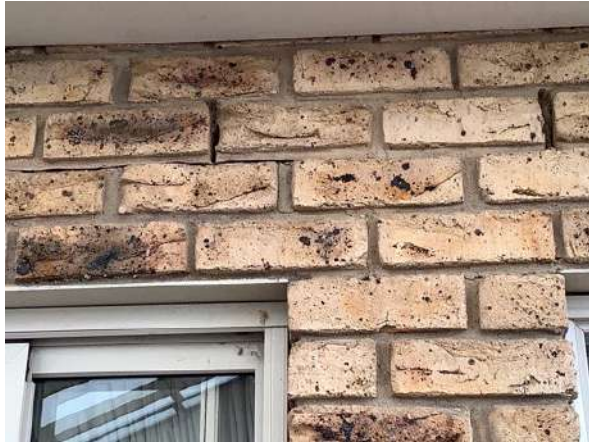
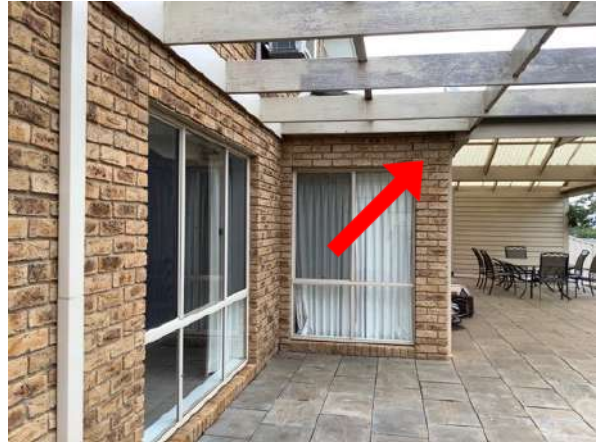
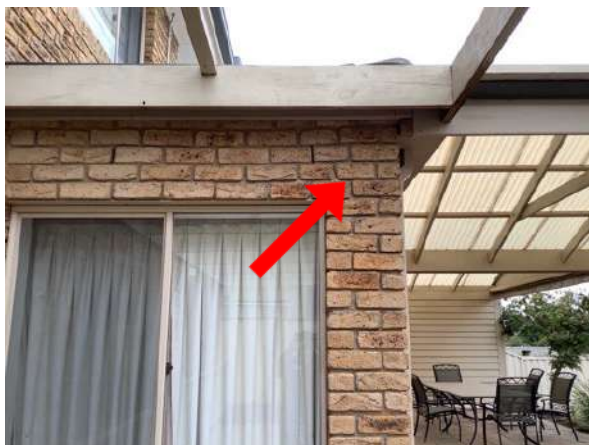
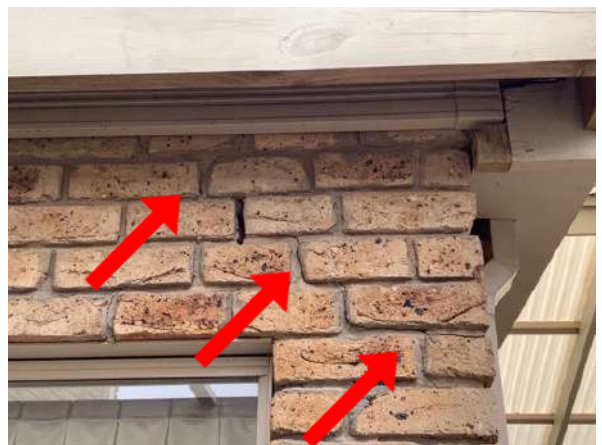
### Minor Defect 3.06

Finding: Brickwork / Masonary - Step cracking and minor cracking  
There are several cracks and/or step cracking evident throughout the exterior of the property . These cracks are commonly less than 5mm in width.

Although fine cracks are quite noticeable, they are often only considered to be an appearance defect and usually do not indicate any structural damage most of the time. Generally, the cause of a fine crack is indicative of a separation between brickwork and mortar throughout the structure, but single bricks may also show cracks of this nature.

Step cracking, which is similar to other forms of cracking, has a variety of possible causes. However, the most common is the subsidence of adjacent footings.

Cracking of this nature can generally be repaired with minor filling and should be conducted by a qualified bricklayer and/or registered builder.

Where step cracking is extensive or severe, the client is advised to consult a structural engineer.

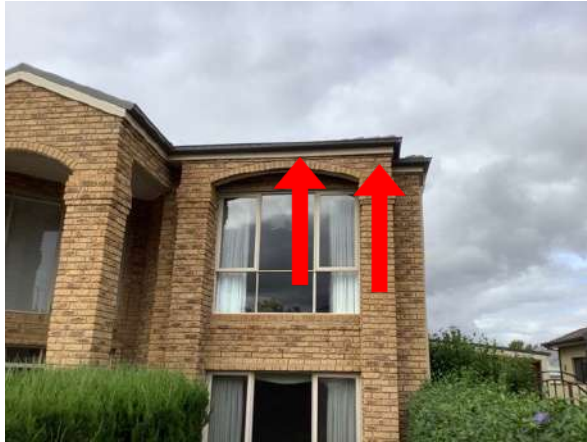
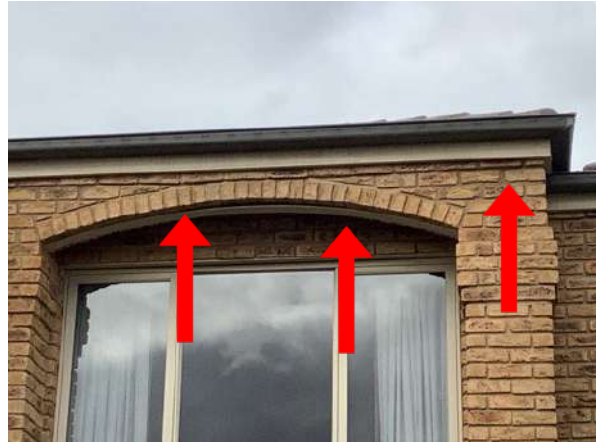
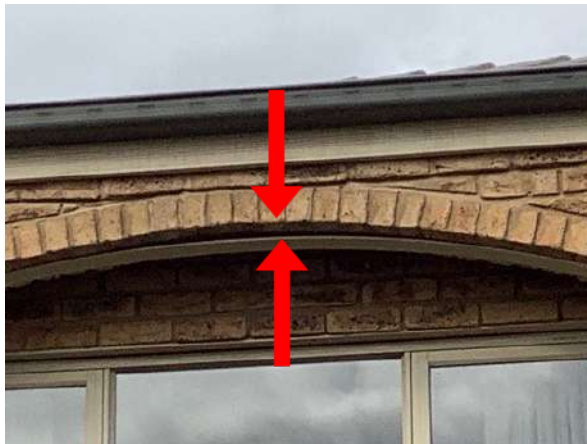
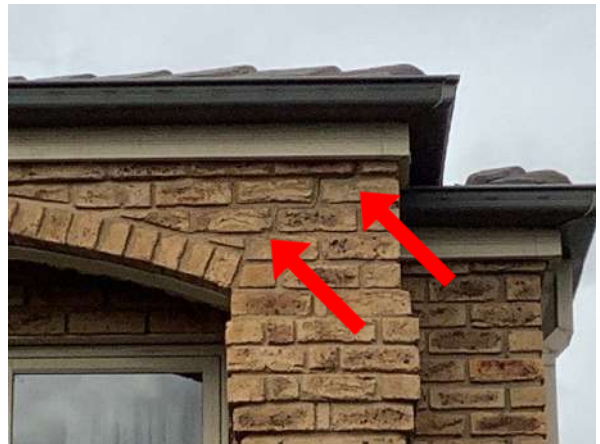
## Observation 4.08

Finding: Front lintel – movement.

The front lintel archway supporting the brickwork archway appears to have moved, possibly shrinkage and expansion. The brickwork appears to have minor cracking to one side of the archway. I highly recommend that this gets monitored by an appropriate qualified person over time to assess whether things worse and I remain the same.
