Building, Electrical, Digital Floor Assessment & Termite, Timber Pest Report

Inspection Date: 14 Apr 2020

Property Address: Prahran Area, Melbourne

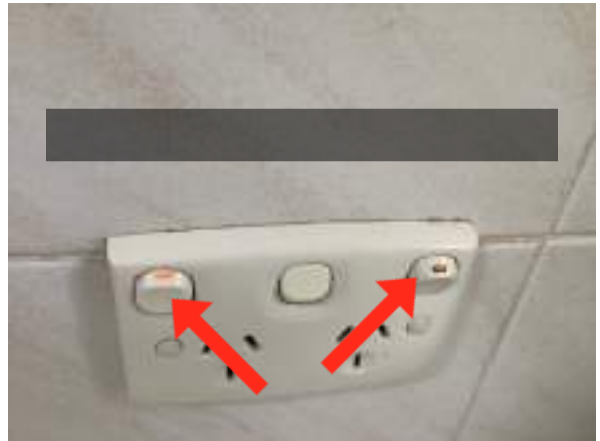
Serious Safety Hazard 1.01

Finding: Electrical - Switches / Power Points - Damaged/Faulty

The switches / power points in areas were found to be damaged or faulty at the time of inspection. This occurs generally when the building materials have either aged and decayed or as a result of impact damage (accidental or deliberate).

Repair and/or replacement of the switches/power points is advised to ensure the fixture and it's associated structures are safe and fully operational. A licensed electrician should be appointed to repair/replace the light switches/power points as soon as possible.

Please engage a licensed electrician to further inspect the property for the repairs and replacements as required.

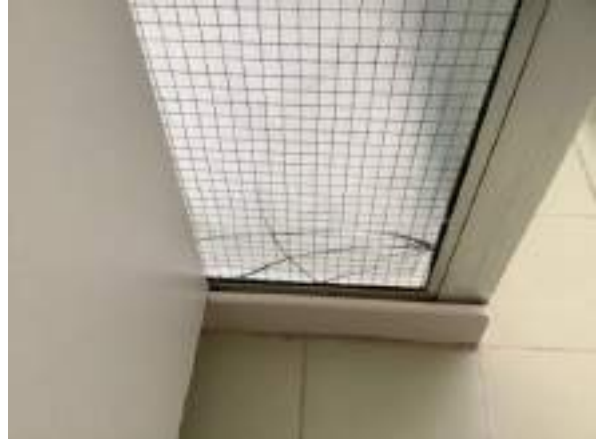
Serious Safety Hazard 1.02

Location: Bathroom

Finding: Shower Screen Cracked

The shower screen glass is cracked and requires replacement. A shower screen specialist or installer is generally the right trades person to do the job.

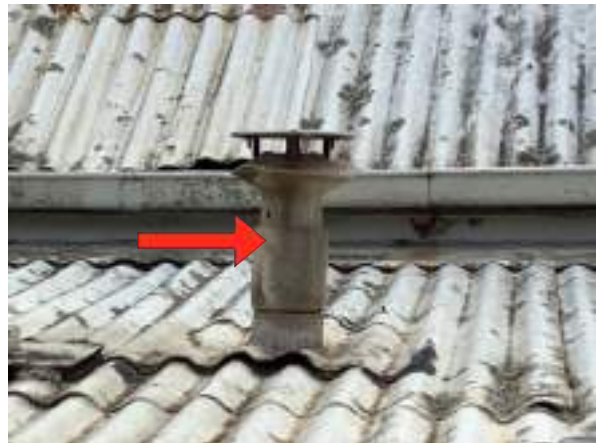
Serious Safety Hazard 1.04

Finding: Asbestos - Suspected ACM Identified On Site.
Reporting on Asbestos is outside the Scope of this Report. This suspected defect is highlighted as a caution ONLY and is ONLY a guide as asbestos inspections are outside the scope of pre-purchase inspection and reports.

As Asbestos Reporting is outside the scope of this report, we advise that you consider a separate Asbestos Inspection and Condition Audit, which can include the taking of samples for definitive confirmation of the presence of Asbestos.

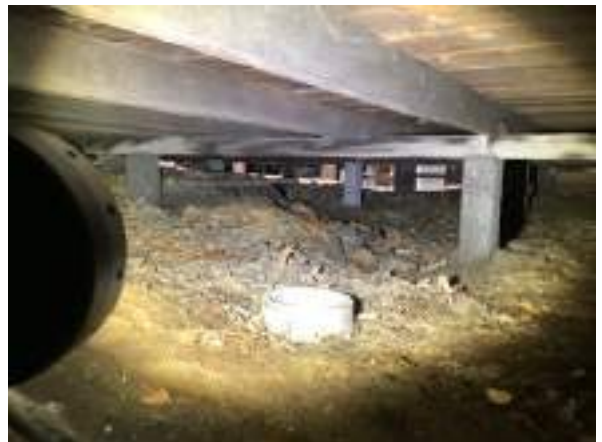
Serious Safety Hazard 1.05

Location: Subfloor

Where evidence of mould growth was noted, there may be environmental, biological or health issues associated with the report. A specialist inspection by a suitably qualified environmental health inspector may be warranted where mould is extensive or where any queries regarding air quality spores or other related issues apply.

Generally, the client is advised to ensure that the general environment is free of moisture and humidity to aid in the prevention of mould formation and development. Any mould found during the inspection should be cleaned immediately and/or taken out, particularly where the mould is in the silicon / caulking.

Finally the cause or source of the mould MUST BE TAKEN CARE OF URGENTLY.

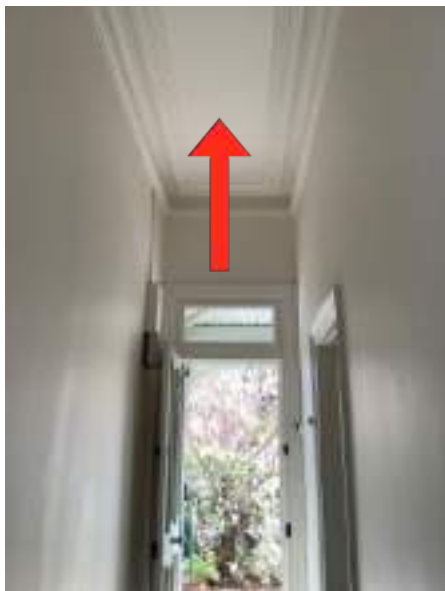
Serious Safety Hazard 1.06

Please note that this defect is highlighted as a caution only. We suspect, based on our experience in the building industry, that the absence of smoke detectors should be addressed as a matter of urgency to improve occupant safety.

A qualified electrician is required do these works for hard wiring.

Upon completion a safety certificate is required to be supplied to the owner of the building.

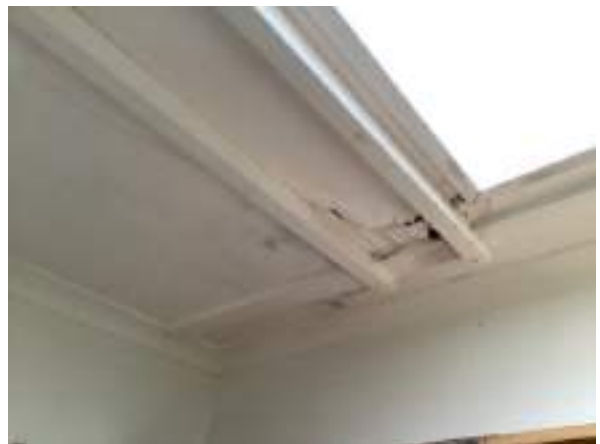
Serious Safety Hazard 1.07

Location: Studio House

Where evidence of mould growth was noted, there may be environmental, biological or health issues associated with the report. A specialist inspection by a suitably qualified environmental health inspector may be warranted where mould is extensive or where any queries regarding air quality spores or other related issues apply.

Generally, the client is advised to ensure that the general environment is free of moisture and humidity to aid in the prevention of mould formation and development. Any mould found during the inspection should be cleaned immediately and/or taken out, particularly where the mould is in the silicon / caulking.

Finally the cause or source of the mould MUST BE TAKEN CARE OF URGENTLY.

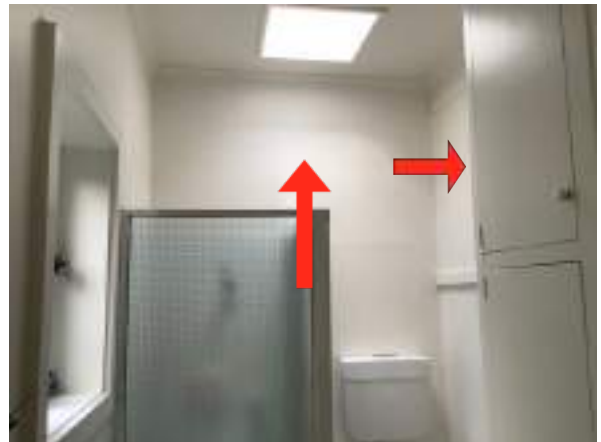
Serious Safety Hazard 1.08

Location: Internal Areas
Finding: Asbestos - Suspected ACM Identified On Site.
Bathroom & Kitchen

In the interim, the client is advised to act with caution, especially when considering any damage to building materials general wear and tear renovations extensions demolition and general maintenance activities due to the suspected presence of Asbestos.

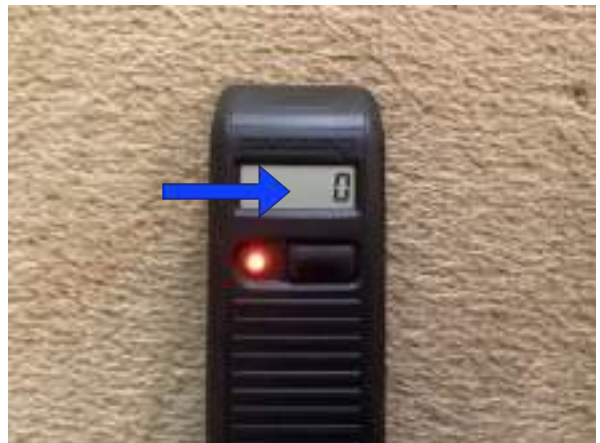
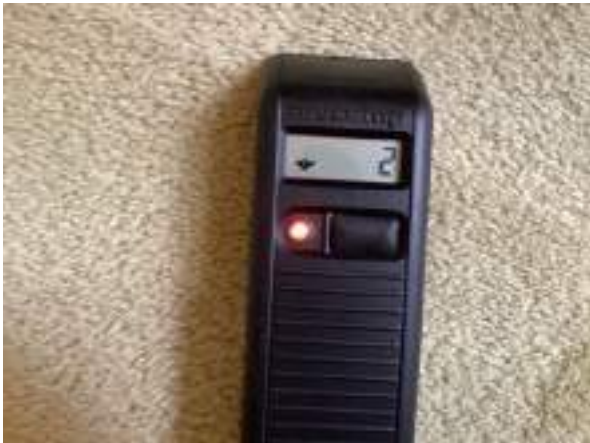
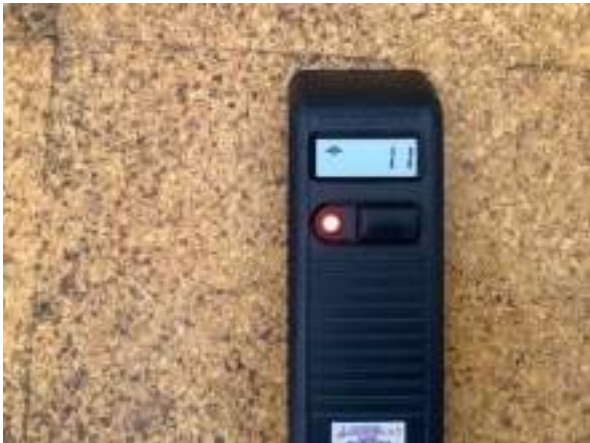
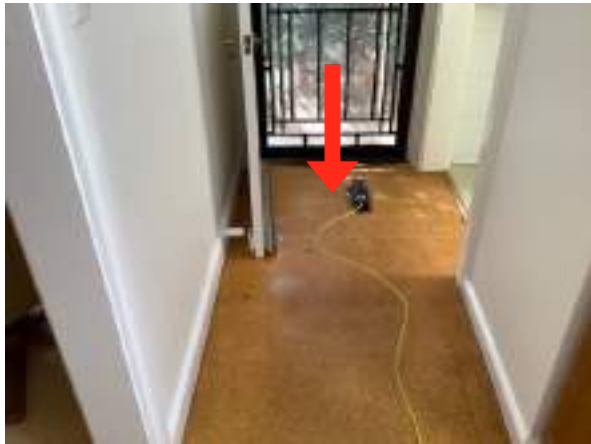
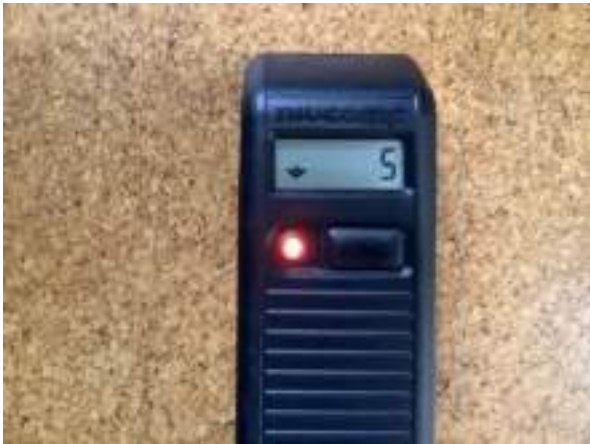
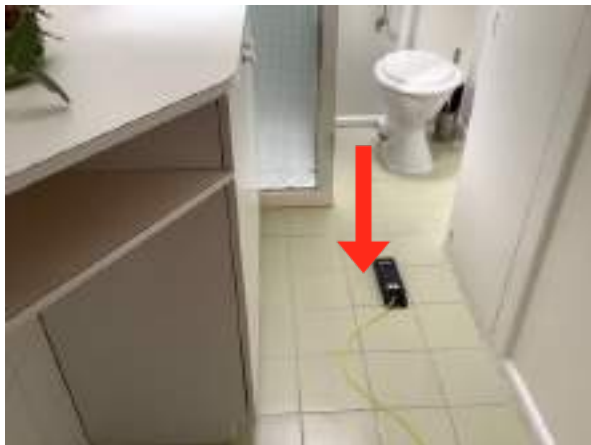
Major Defect 2.10

foundations of the property.

IMPORTANT TO NOTE : It will be important to note that the likely hood of cracking and movement to plaster, floor and wall tiles, doors requiring re-working, windows requiring re-working, kitchen cupboards, etc will be high once the home is jacked up and re-leveled to the correct height, the amount of repairs can be nothing to many areas. There will more then likely be the repairs of plaster, paint and the other repair concerns mentioned.

A Registered Builder who is experienced in flooring, stumps and re-stumping would then generally carry out works or be associated with re-stumpers as advised by a Structural Engineer and/or a geotechnical engineer, if required.

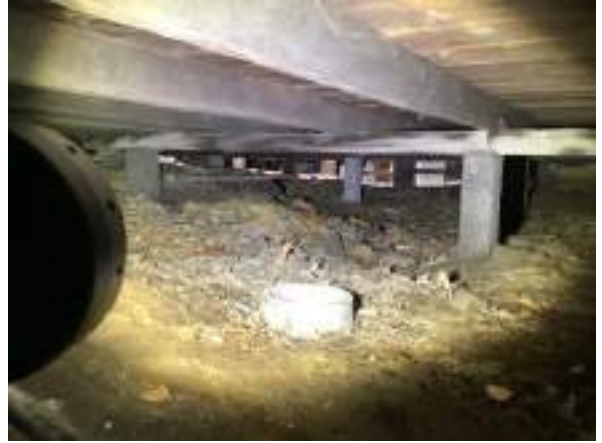
Major Defect 2.11

Location: Subfloor

It is important to note that the subfloor timbers may also be structurally compromised in areas. A registered builder will need to perform further invasive investigations.

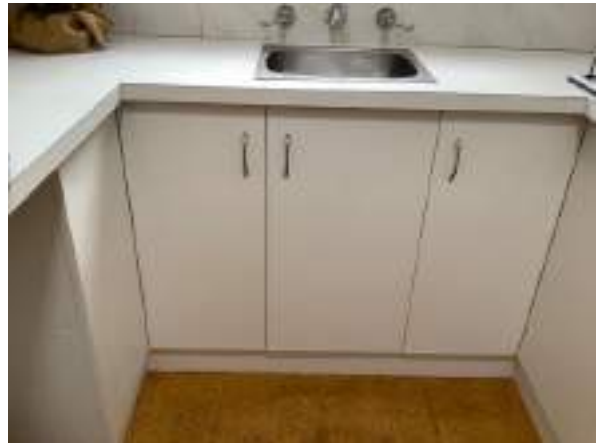
Minor Defect 3.12

Items like cracked glass mirrors, cracked glass windows and windows not operation smoothly are defects that should be repaired by the appropriate trades.

It is IMPERATIVE that you engage registered and qualified trades and at the end of there works they must supply certificates, such as an electrical safety certificate, plumbing and gas certificate if the works are electrical or plumbing, but for items such as damaged door handles, painting an experienced carpenter or handyman can sometimes be engaged.

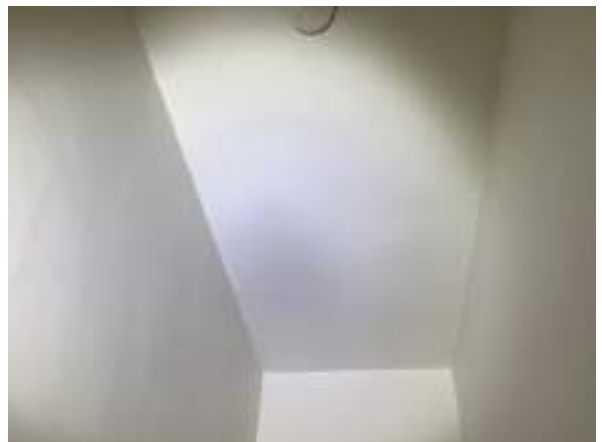
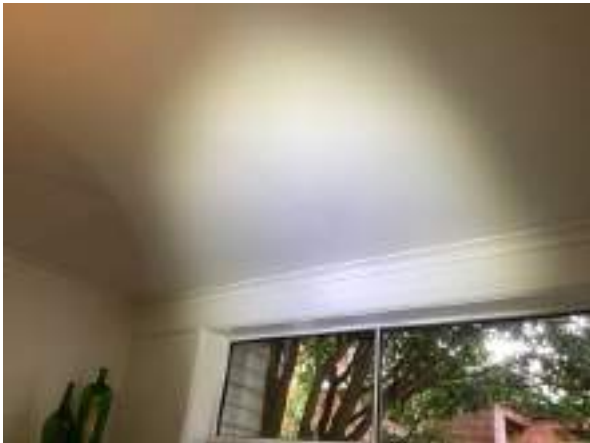
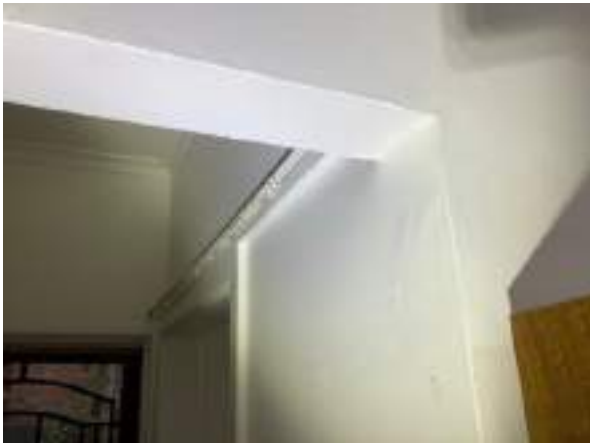
Minor Defect 3.14

Location: Paint Internal Areas

Finishes to (lath and plaster walls & hair line plaster walls or ceilings) generally have many imperfections.

Ultimately an experienced professional can generally put you on the right direction before spending a lot of money on repairing (lath and plaster walls & hair line plaster walls or ceilings)

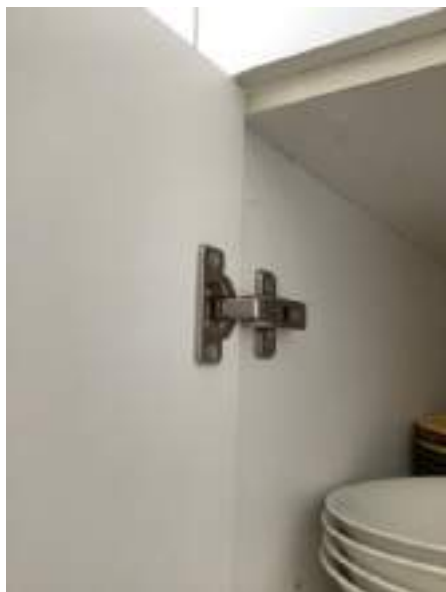
Minor Defect 3.16

Location: Cabinetry / Wardrobe Doors Internal Areas

Such works should be completed at the discretion of the client, but we do recommend repairs so that there is no further damages to the existing cabinets or cupboards.

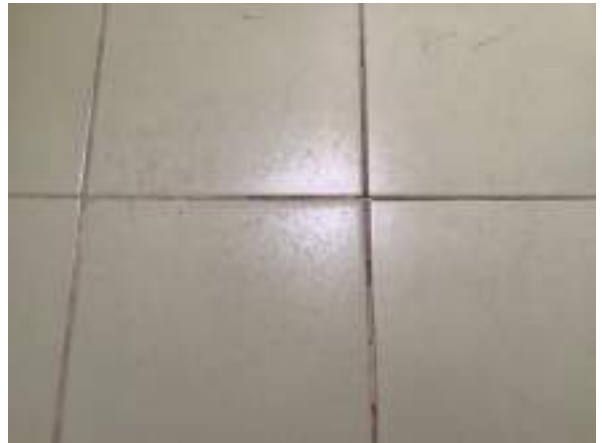
Minor Defect 3.17

Location: Bathroom

Where water penetration has led to water damage, appointment of a relevant tradesperson may be required to repair damaged building elements.

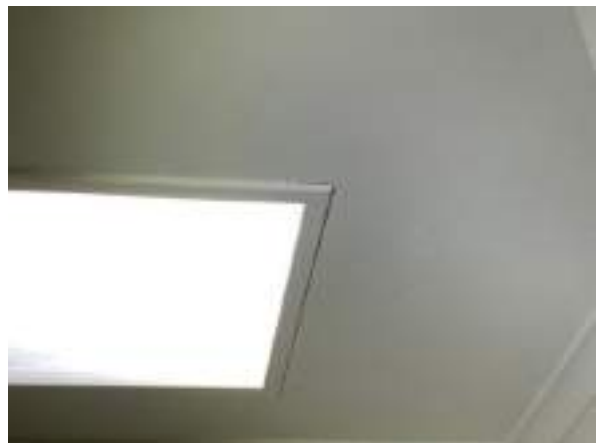
Minor Defect 3.18

The presence of excessive moisture can have major implications on associated building elements if left unattended. While only seemingly minor at this stage, the damage cannot be determined due to the paint obstructing any further inspection of the damage.

It is highly advised that the affected paint be cleaned to allow a further, more invasive inspection by a licensed plumber. Failure to act on this defect may necessitate major works in the future.

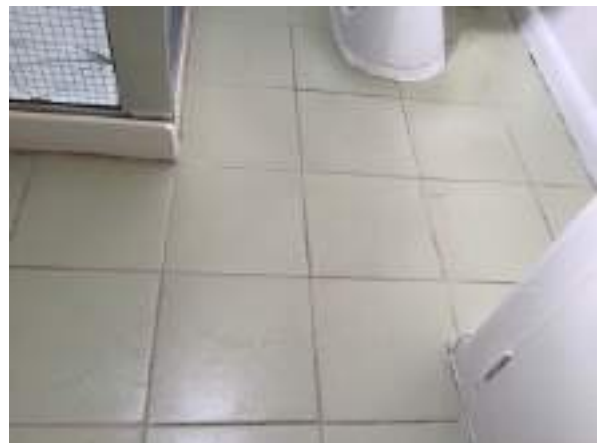
Minor Defect 3.19

Location: Bathroom

If left unmanaged, water penetration to these areas may lead to subsequent water damage, which is likely necessitate repair work to affected building elements.

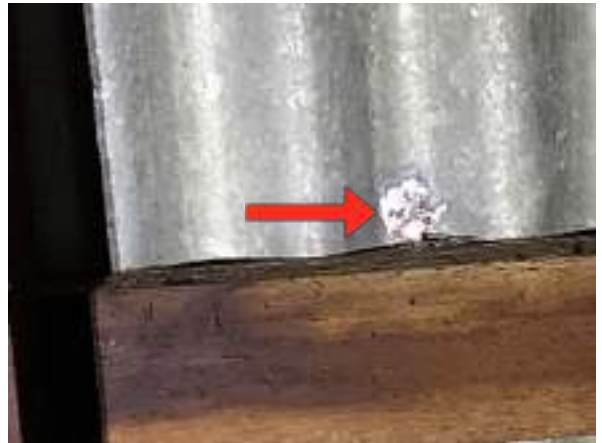
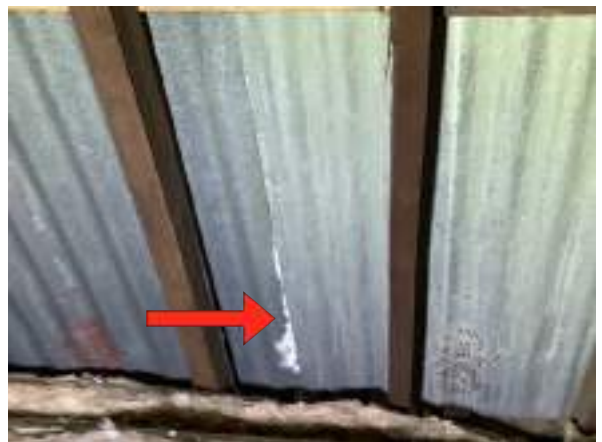
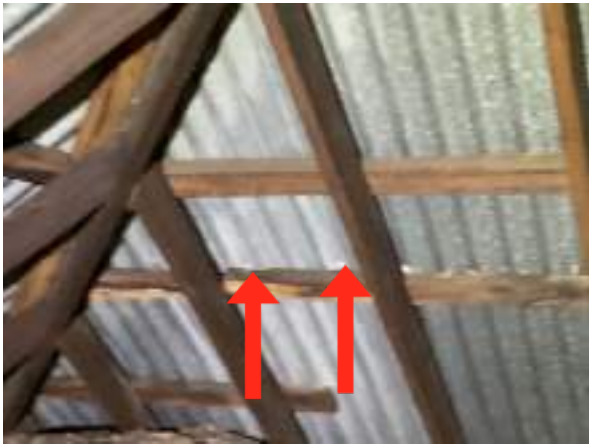
Minor Defect 3.20

Location: Bathroom

A roofing contractor should be appointed immediately to assess the damage to the roofing sheets and to perform remedial works as necessary. Works may include replacement of severely affected roofing sheets or minor works such as the application of rust-retardant surface protectors.

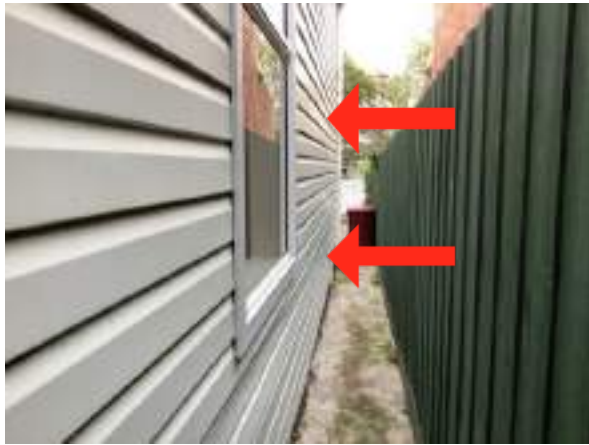
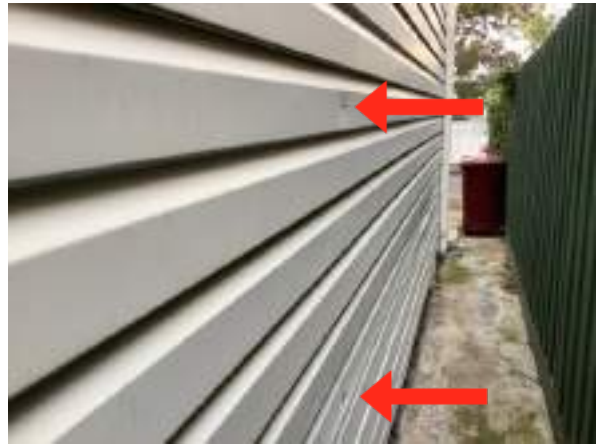
Minor Defect 3.23

Location: Perimeter Of Building - Exterior

An external hole was located at the time of inspection. This hole appears to be large enough to allow bird, rodent or other pest ingress creating the potential for nesting or infestation of live animals.

To ensure no such infestation occurs this hole should be adequately covered. Holes such as these are also likely to attract rain penetration which may lead to subsequent water damage to associated structures if left unmanaged.

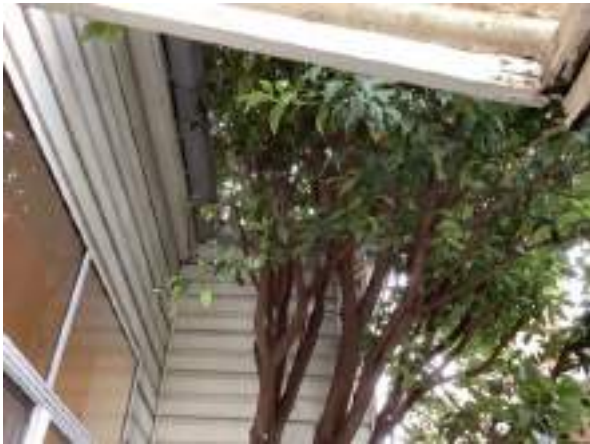
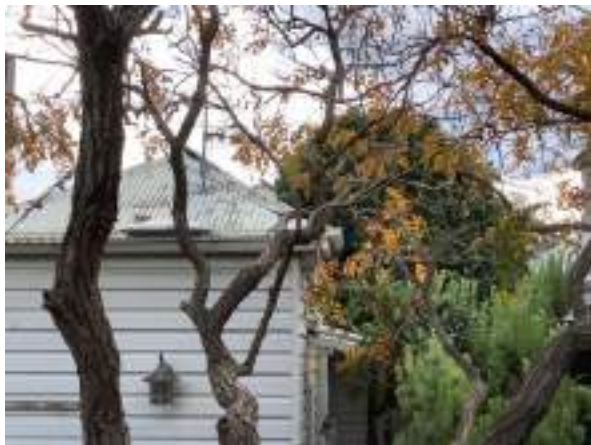
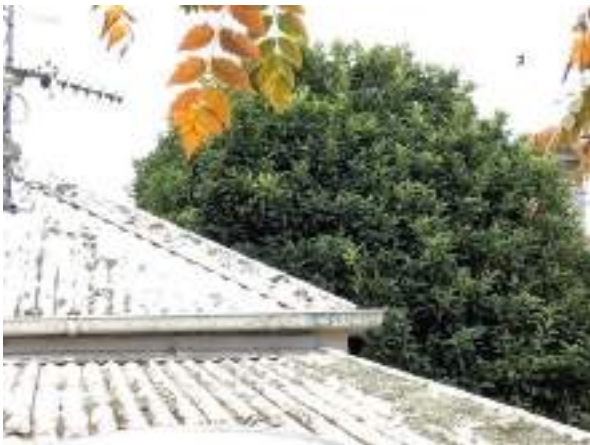
Minor Defect 3.24

Location: Garden Areas - All Areas

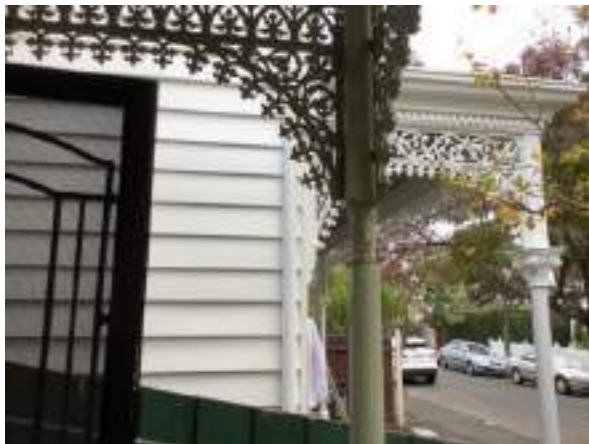
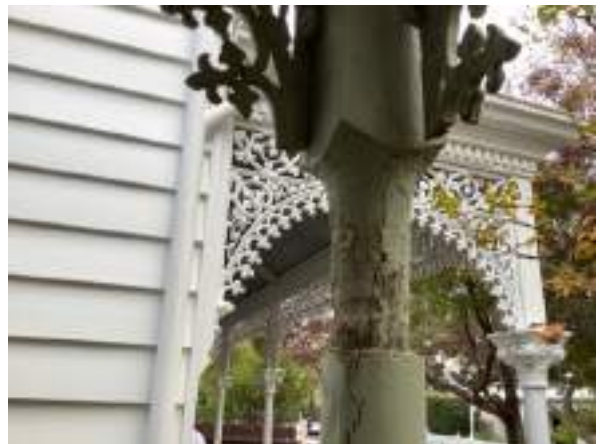
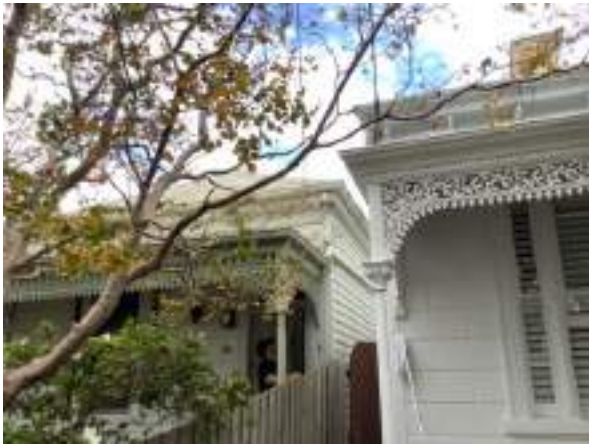
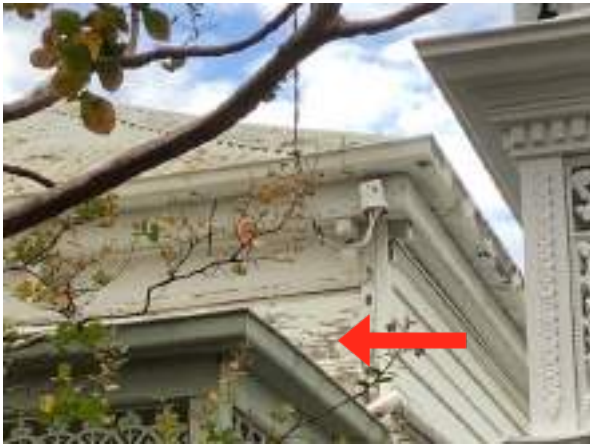
Minor Defect 3.25

Location: Timber Work - All External Areas

The property is a very high risk for termites as the environments to the property are very conducive with many susceptible areas.

Please read the report carefully and Maintenance to all susceptible and conducive areas is a MUST to minimise the risk of termite and timber pest existence and timber damage.

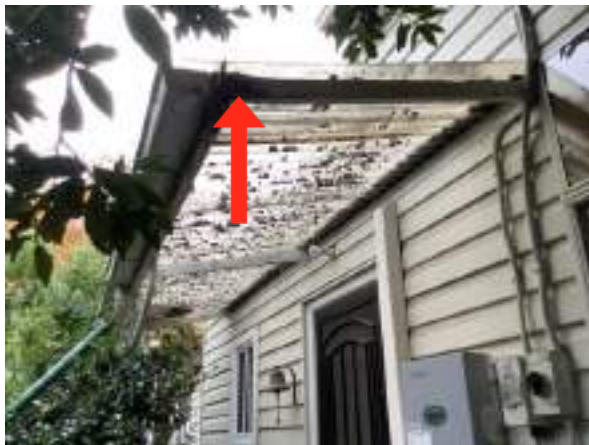
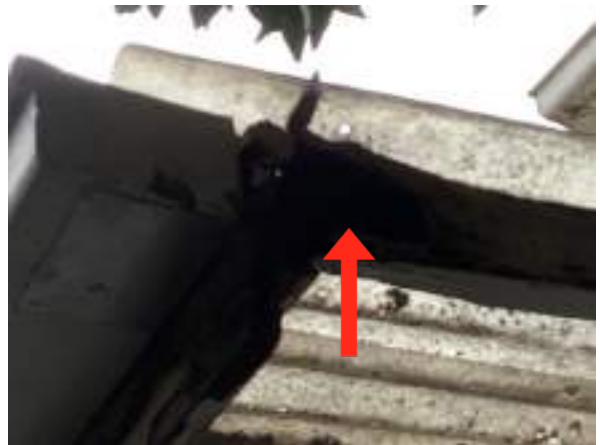
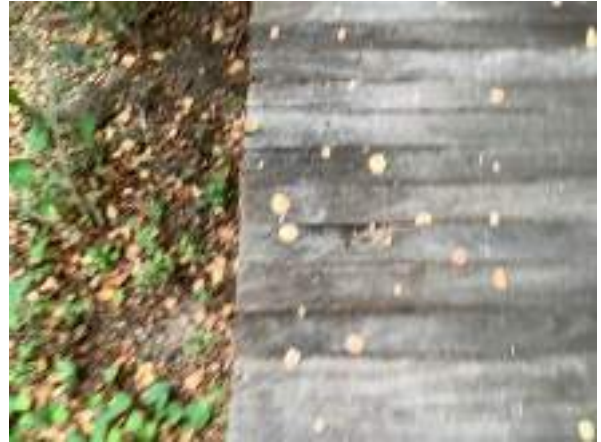
Minor Defect 3.26

Location: Timber Work - All External Areas

The property is a very high risk for termites as the environments to the property are very conducive with many susceptible areas.

Please read the report carefully and Maintenance to all susceptible and conducive areas is a MUST to minimise the risk of termite and timber pest existence and timber damage.

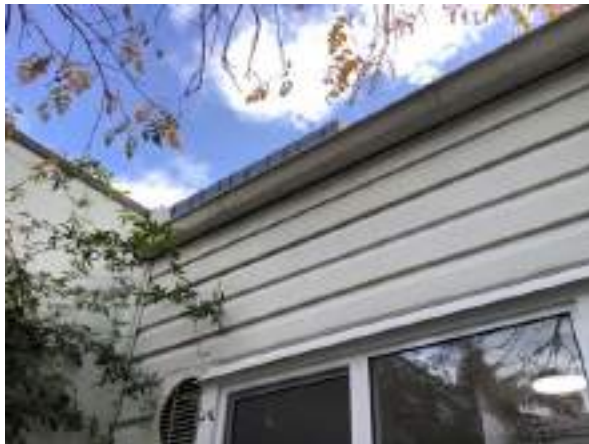
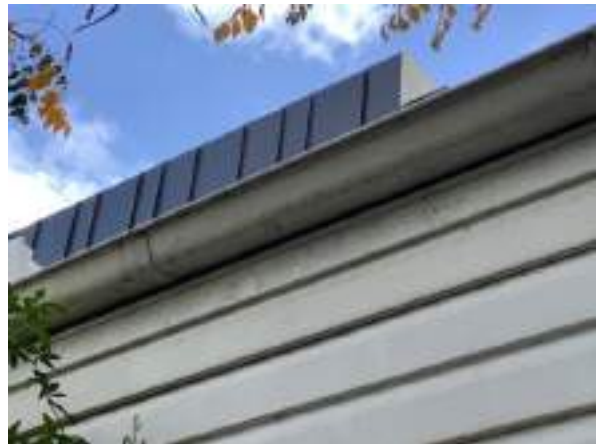
Minor Defect 3.28

Location: Roof Areas & Stormwater

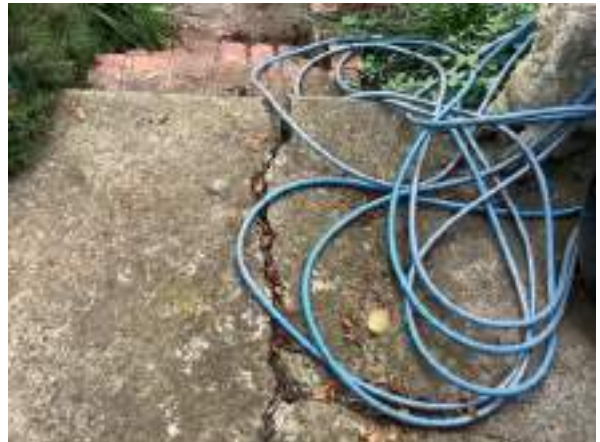
Minor Defect 3.29

Location: Concrete - All Areas

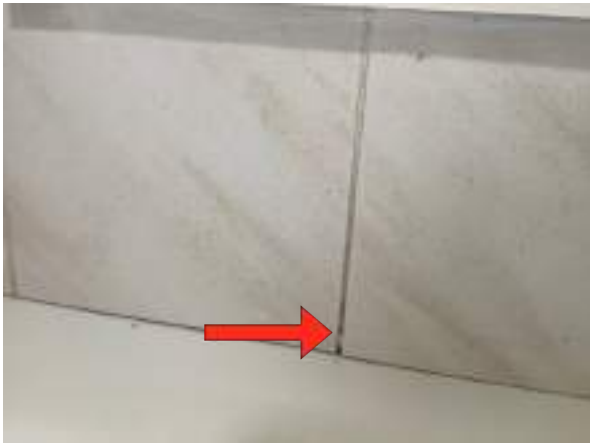
Minor Defect 3.30

Location: Kitchen & Bathroom

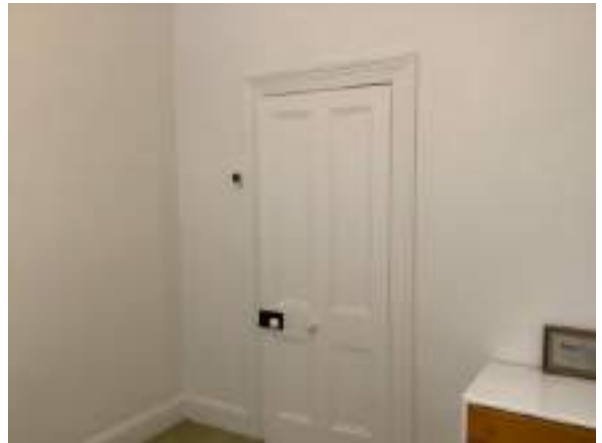
Minor Defect 3.32

Location: Entry, Bedroom 2
Finding: Door - Binding / Jamming / Out Of Level

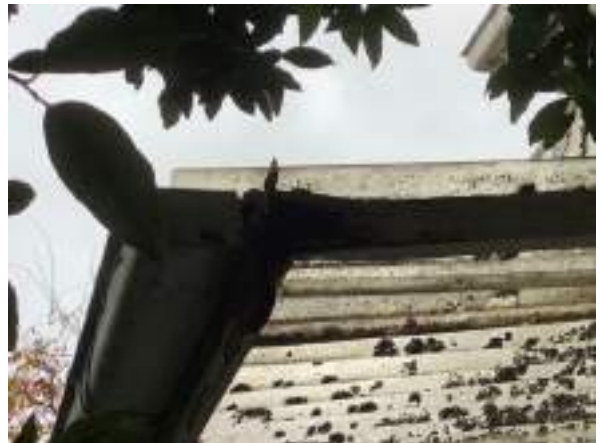
Item 2.05

Location: External Areas

It is highly recommended that all plumbing and drainage fixtures and fittings be maintained regularly in order to prevent excessive moisture being present in the external / internal property.
