Post Pour Concrete Slab Report

Inspection Date: 9 Apr 2020

Property Address: Rockbank Area - Melbourne

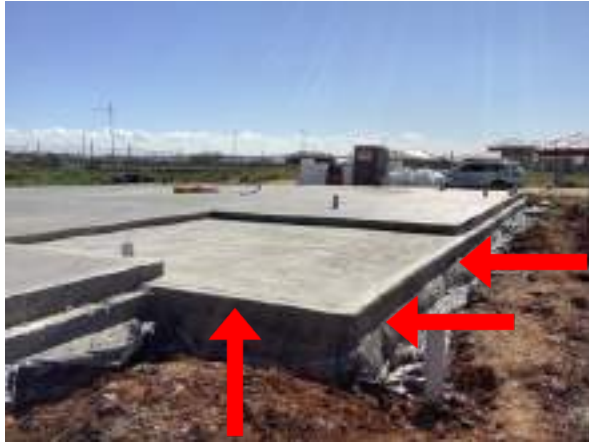
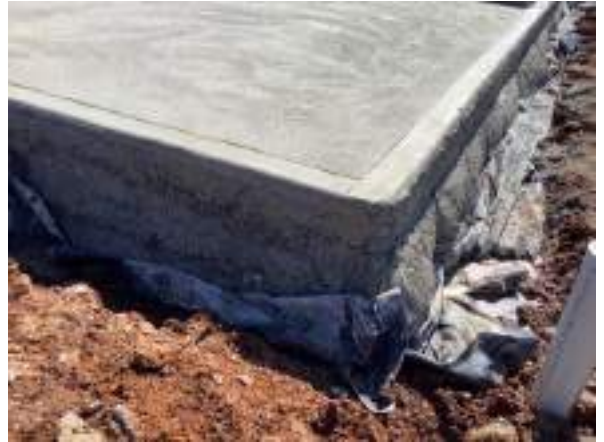
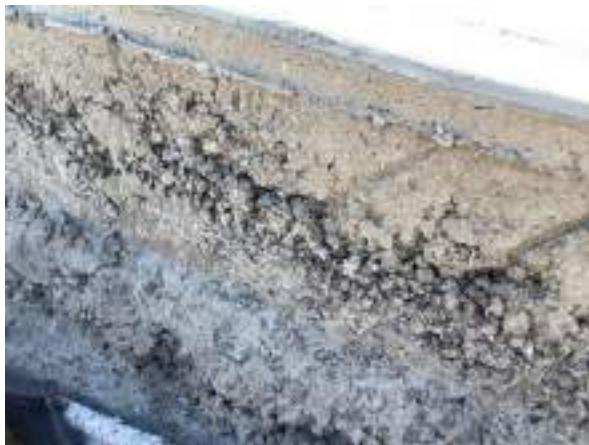
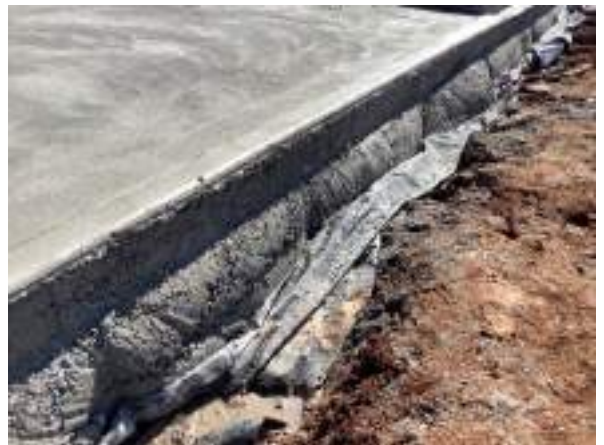
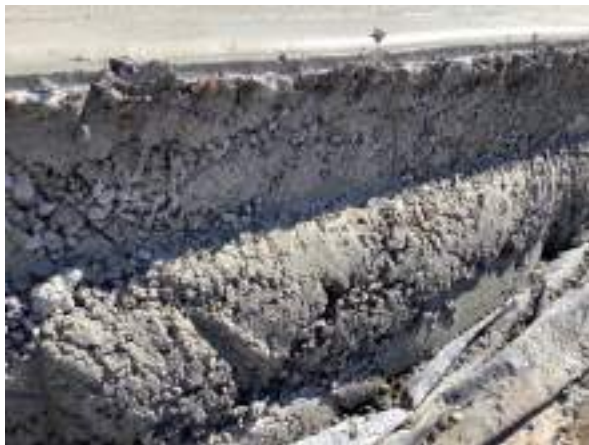
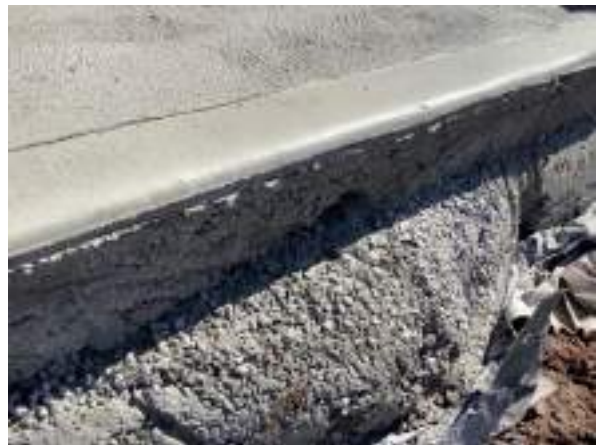
Non Compliant 2.01

Location: Post Pour Slab - All Areas

Finding: Compaction Of The Slab.(Honeycomb Evident)
At the time of the inspection it appears that the slab has not been mechanically compacted as per the requirements of AS 2870. I refer the builder to:

Looking at the side of the slab, it appears evident that the slab has not been vibrated to all parts. The honeycomb effect that is made up of hundreds of air pockets is what should not be present.

Had this slab been vibrated to all parts, then this honeycomb effect would not be present and the concrete would have a smooth like finish.

The defect is that if it has not been done to the outer skin of the exposed areas, then the likely

hood is that the internal of the slab has the same honeycomb effects as well and if this is the case then the density of the concrete will be compromised.

It is highly recommended that you :

-/ Seek engineering advice.

-/ Seek a Compressive Strength Test to check the MPA strength after a certain period of cure time.

-/ Sample the slab via a core hole or several core holes that are taken by a NATA accredited testing agency. Note the NATA testing agency must take the samples to ensure a reliable chain of evidence.

-/ Share the results with my client and the engineer.

-/ Upon all the results a conclusion that meets the AS 2870.

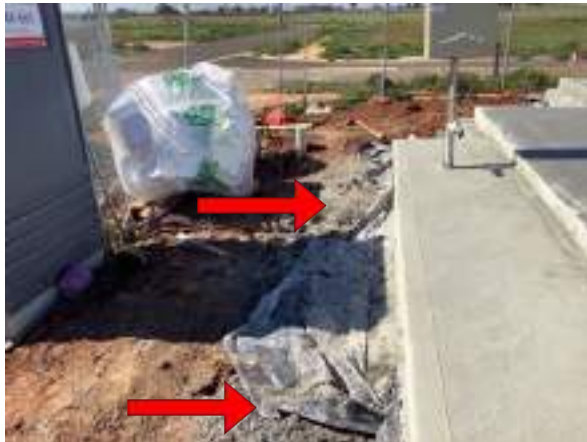
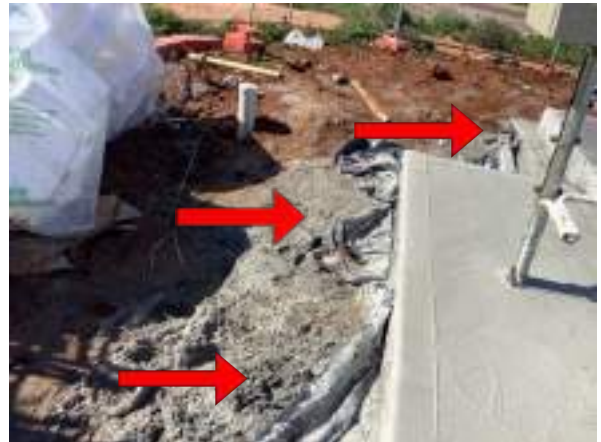
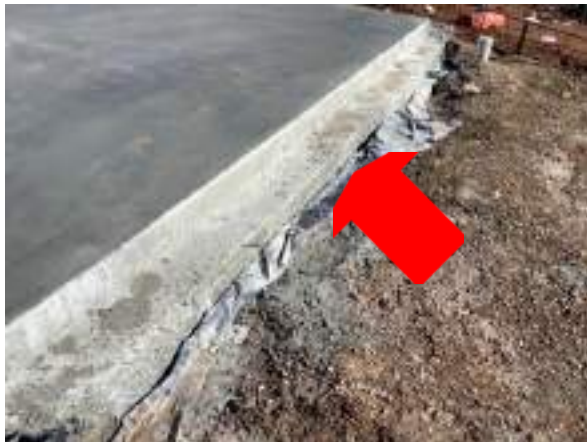
Non Compliant 2.02

Location: Post Pour Slab - All Areas

Finding: Builder Concrete Waste - Remaining

It was noted that there is excessive amount of concrete (builder waste) on the site in various areas. All builders waste must be removed as per the contract.

The builder must use all endeavours to ensure that the site is safe and left clean whilst in construction and a clean, builders waste free site prior to final handover as per the building act and contractual agreements.

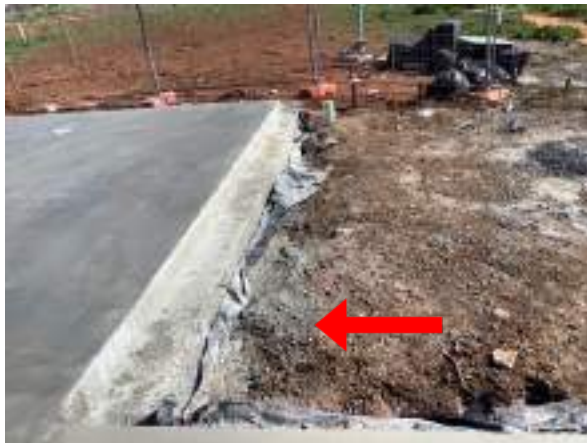
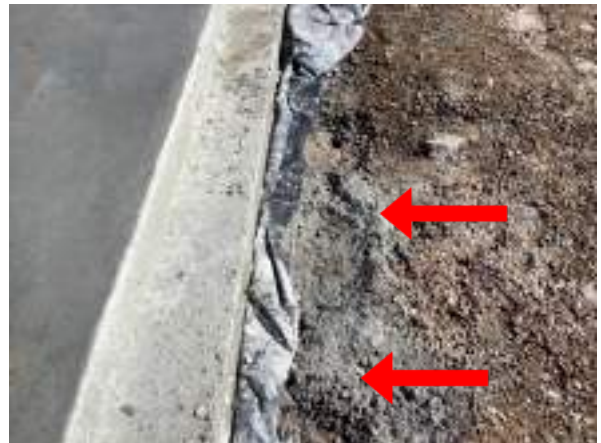
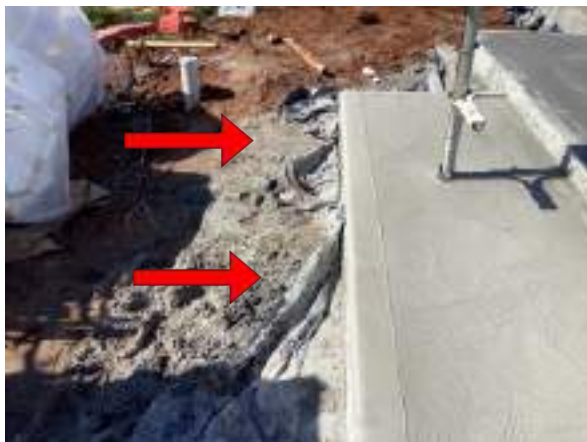
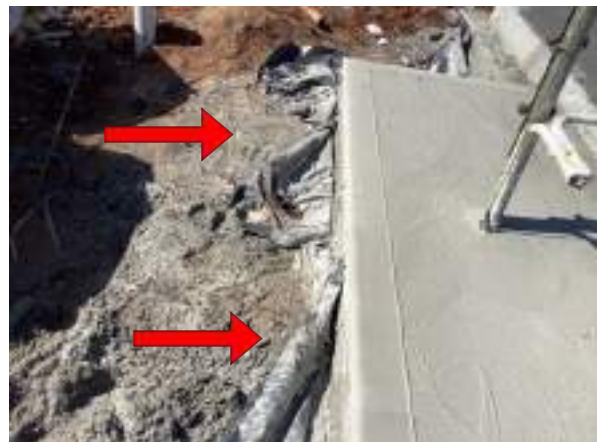
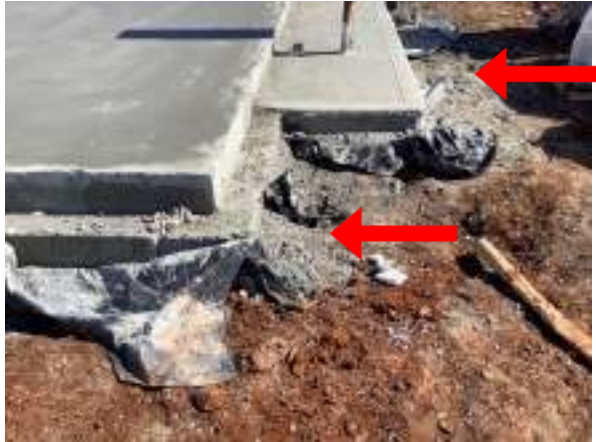
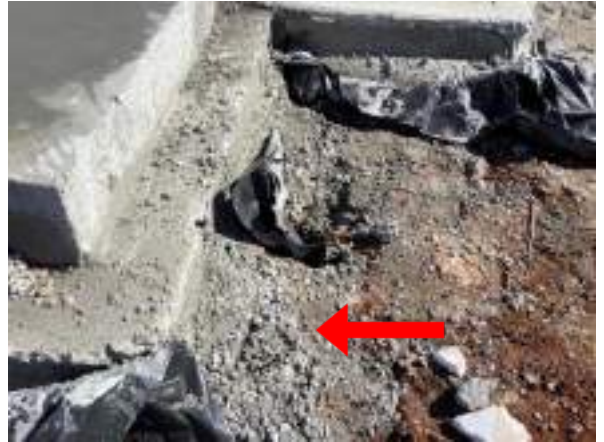
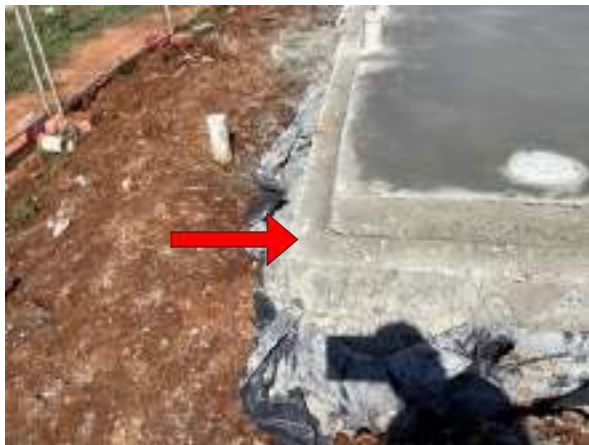
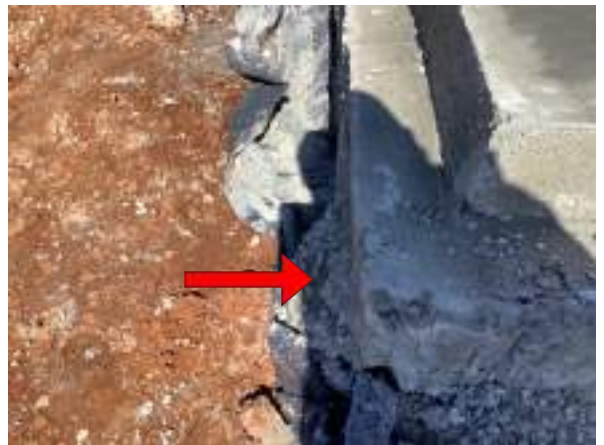
Non Compliant 2.03

Location: Post Pour Slab - All Areas

Finding: Slab Over Pour - Not Acceptable.

The slab has been installed with what is known as over pour.

The over pour will affect the home owner's ability to install paving and other landscaping.

The over pour will need to be removed. This will require:

-/ Seek engineering process and design for rectification of this defect.

-/ Document same.

-/ Send the engineering to the site surveyor for approval.

-/ Have the site surveyor witness the repair of the slab to ensure that the builder has carried out the works in accordance with the process's and rectification statements in the engineering documentation.

-/ Supply a copy of all to my client as per section 26 of the Domestic building contracts Act 1995.

-/ Satisfy the defect has not been hidden by placing soil over the edge beam of the over poured slab.

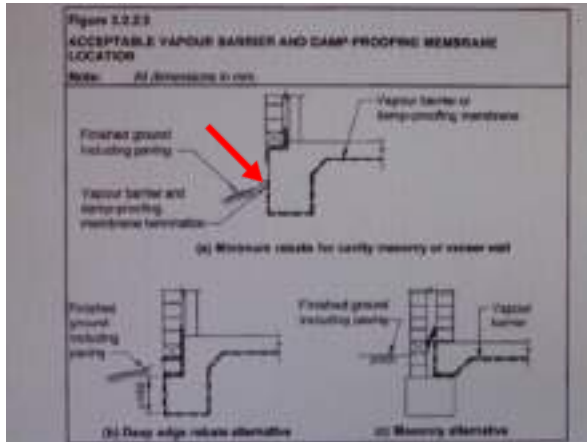
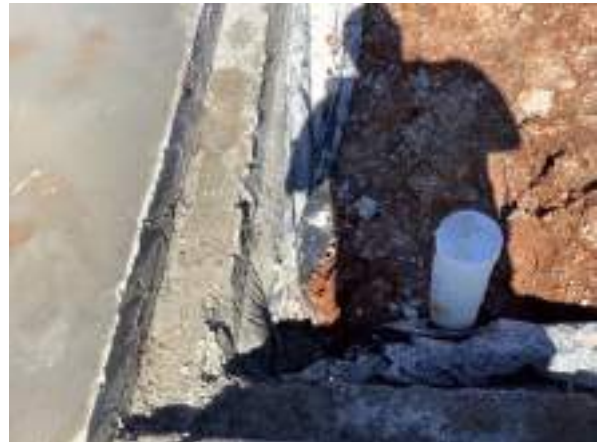
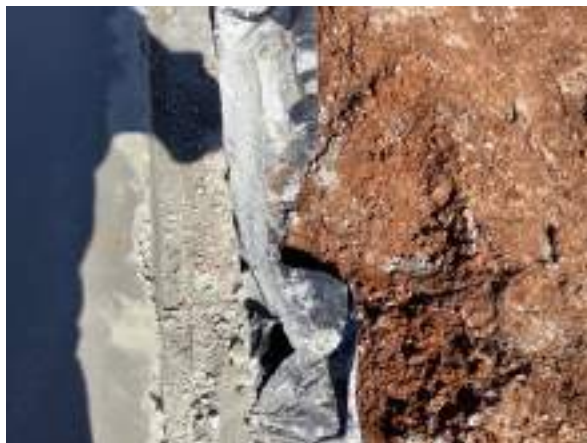
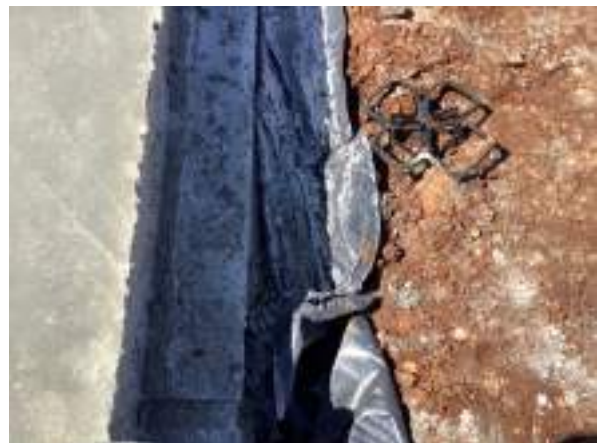
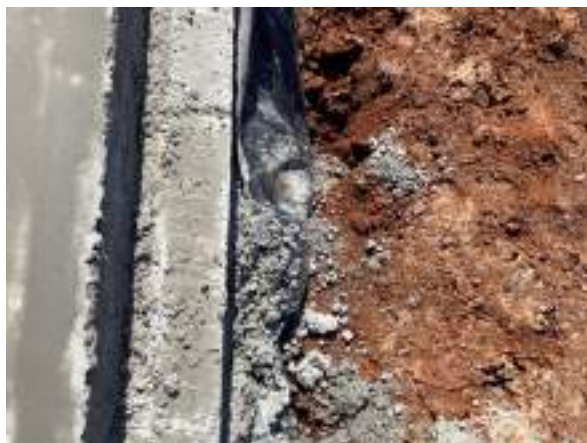
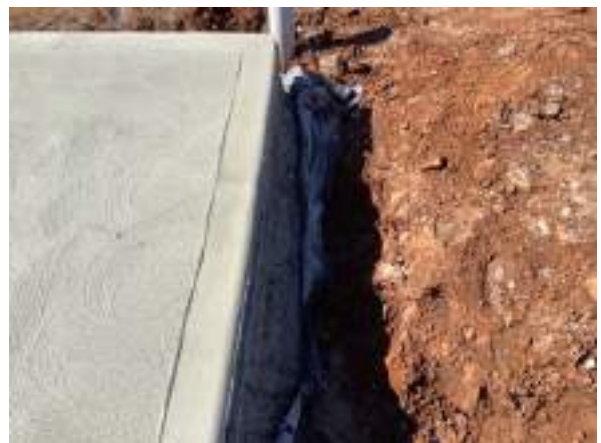
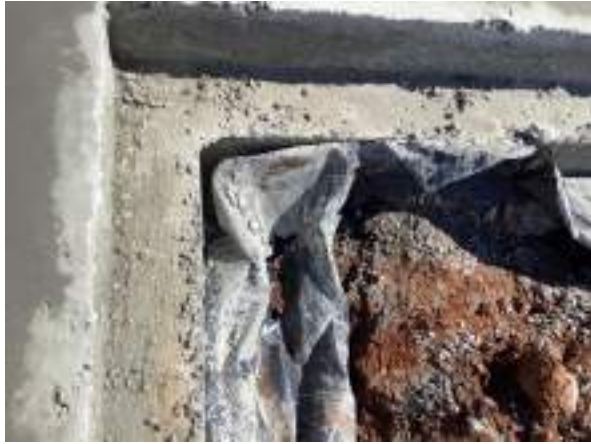
Non Compliant 2.04

Location: Post Pour Slab - All Areas

Finding: Polyethylene vapour barrier not installed as per BCA - Part 3.2.2.6

It was noted at the time of inspection that a vapour barrier had not be installed in accordance with AS2870 and BCA Part 3.2.2.6.

All of the vapour barrier system has NOT been done correctly and ALL areas of non compliance is required to be repaired.

- 1/ All over laps are not taped as described below.
- 2/ All the rips and/or damaged area needs to be taped.
- 3/ ALL areas are not up to future ground and/or finished paving or concrete heights and must be extended with 200mm overlay and taped.
- 4/ Somes areas whilst listed above are Damaged / Ripped / Not Consistent And Sealed with 200mm Overlay And Taped / Not High Enough / Non Existent must ALL be repaired.

The polyethylene vapour barrier from beneath the concrete floor slab must be turned up the external side faces of its edge beams. Failing to install the vapour barrier correctly will allow moisture ingress via slab edge dampness into the internal timber wall skins and/or the floor coverings if not done.

Without a vapour barrier installed, these areas are non-compliant with Australian Standards and are susceptible to excessive moisture, which may create major secondary defects as the building ages. Rectification works are necessary as soon as possible to ensure all standards are met.

The polyethylene vapour barrier must properly extended up the external side faces of the edge beams to at least 600mm above the height of the slab for now and then at future finished ground level of the solid, concrete , etc.

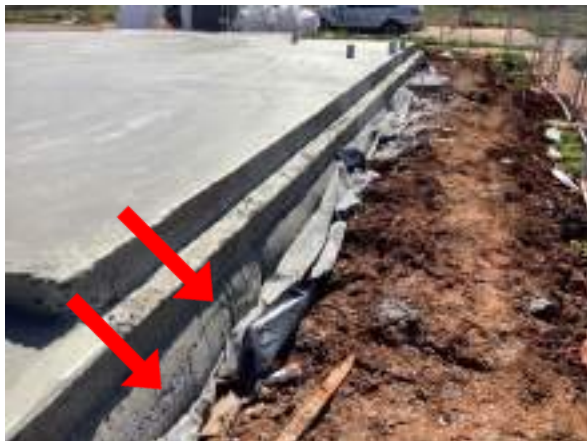
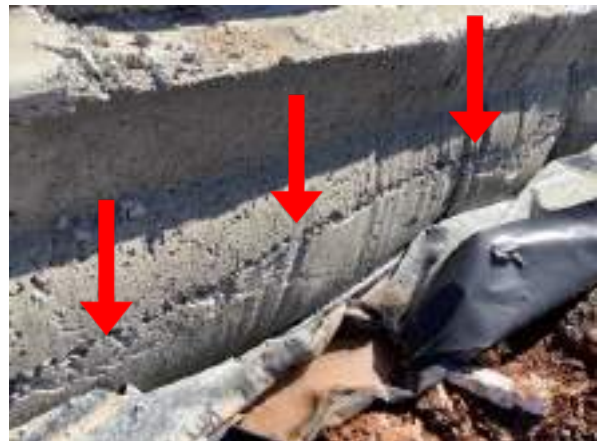
Non Compliant 2.05

Location: Post Pour Slab - All Areas

Finding: Cold Joint - Rebate Defective, Works not in a proper and workmanlike manner
Evidence is identified generally that works have been completed in a manner which is not considered to be proper and workmanlike.

It is obvious that that the brick rebate has had concrete added at a later stage when the original concrete was drying and/or dry as there is a cold joint between the two surface areas.

Cold Pour Joints in concrete foundations which leave visible lines in the concrete foundation wall are not usually a structural problem but may in some cases form a dry joint which permits water leakage through the foundation wall.

This remedial works requires a structural engineer to determine the repair method prior to any further works advancing over the rebate.

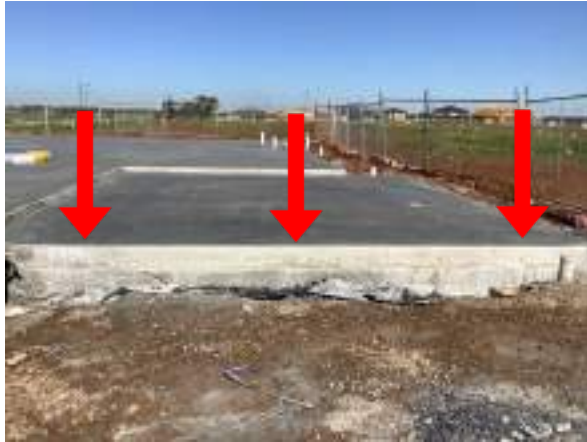
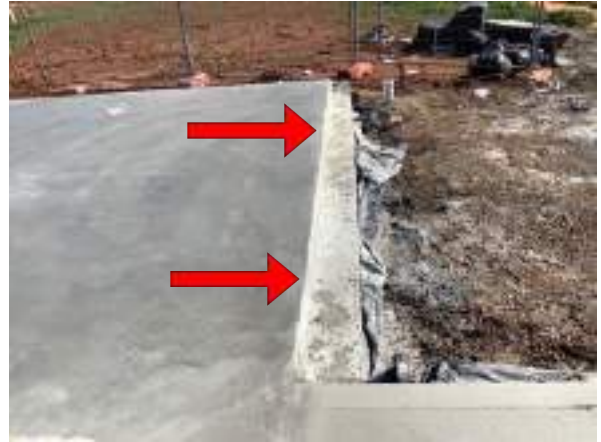
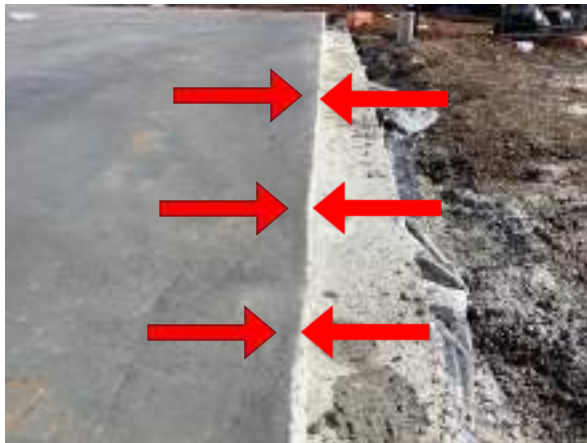
Non Compliant 2.06

Location: Front Garage

Finding: Re Bate - Defective

The front of the garage requires a rebate. The builder has not installed a rebate to the width and front of the garage which is a standard requirement. The builder is required to repair to a tradesman's like level the front rebate required as per the Australian standards.

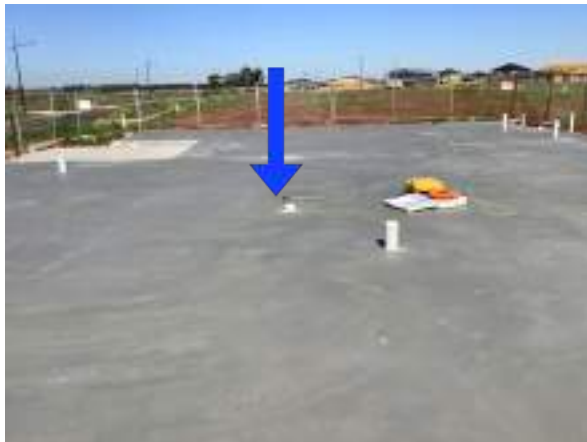
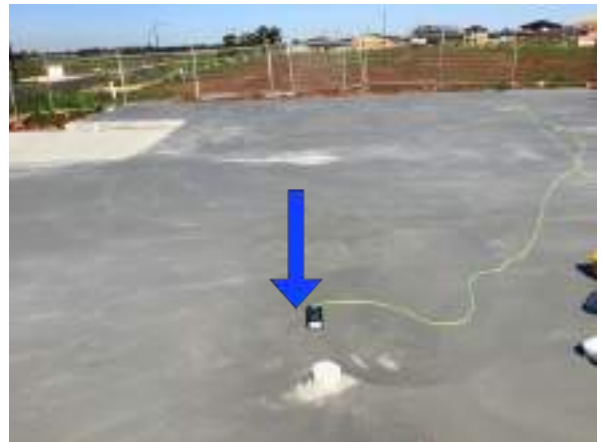
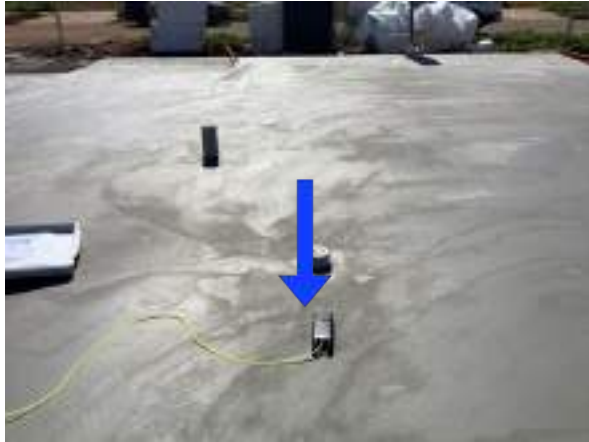
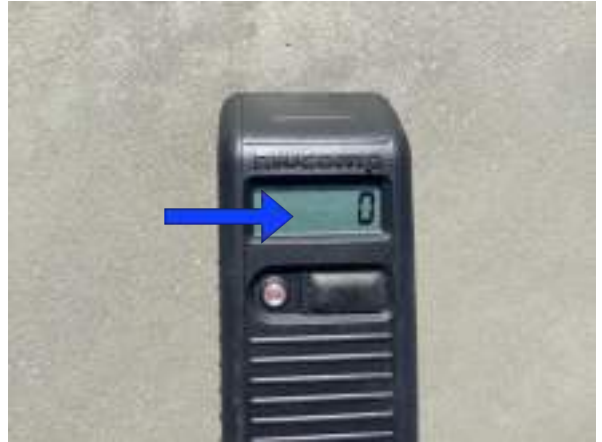
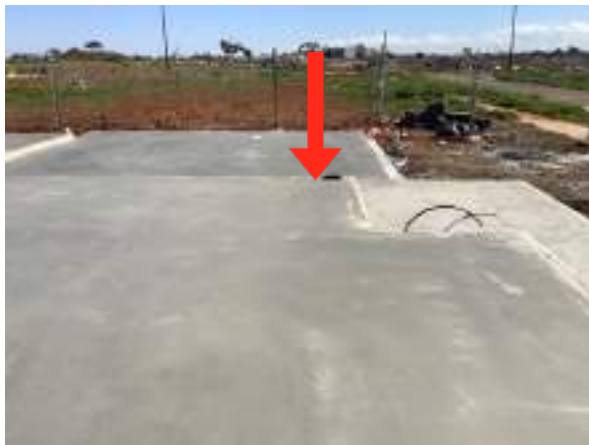
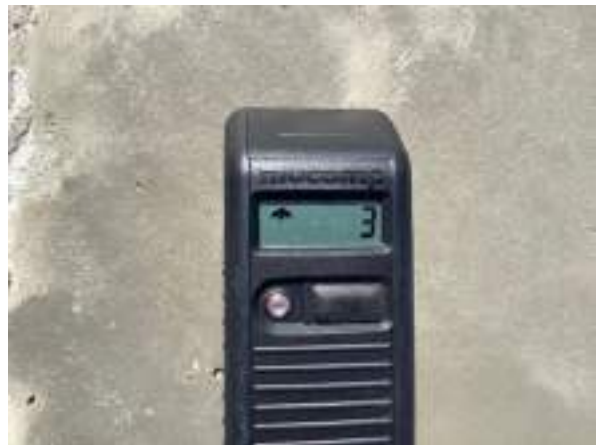
For Your Information 5.07

Location: For Your Information
Finding: Finished Concrete Floor Levels - Acceptable
LIQUID DIGITAL ELECTRONIC FLOOR LEVELLING

NOTE :
THE PHOTOS WITH THE BLUE ARROWS INDICATE THE REFERENCE POINTS, WHICH DETERMINES IN MILLIMETRES IF THE OTHER LOCATIONS ARE HIGHER OR LOWER THEN THE REFERANCE POINTS WITH THE BLUE ARROWS.
THIS PROPERTY INDICATES THAT THE FLOORING IS WITHIN TOLERANCES & IS WITHIN THE ACCEPTABLE AUSTRALIAN STANDARDS .

The photos will demonstrate that the floor levels are within Guide To Standards And Tolerances 2015, Footings, Slabs And Setting Out, 2.08 and Australian Standards (AS 1684)

The overall deviation of floor level (concrete slab) to the entire building footprint shall not exceed 20 mm, as per the `Guide to Standards and Tolerances` Section 2.08 and AS 1684.

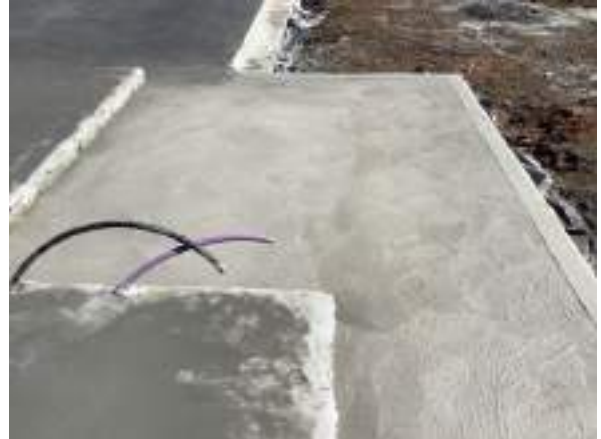
For Your Information 5.13

Location: Post Pour Slab - All Areas

Finding: Concrete Surface Finish - Acceptable
Additional photos are provided for your general reference to show that the concrete surface finish is acceptable and well within Standards & Tolerances 2015.
