Termite & Timber Pest Report

Inspection Date: 31 Jan 2020

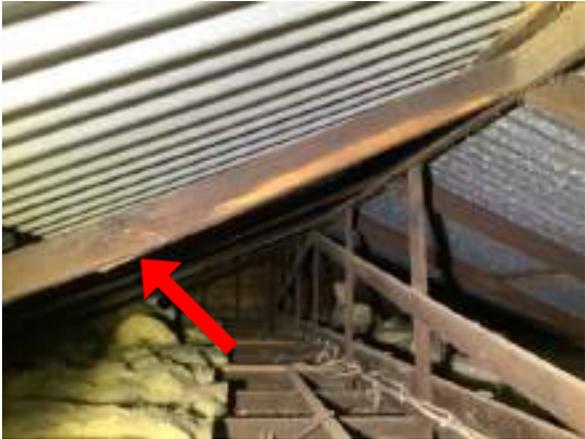
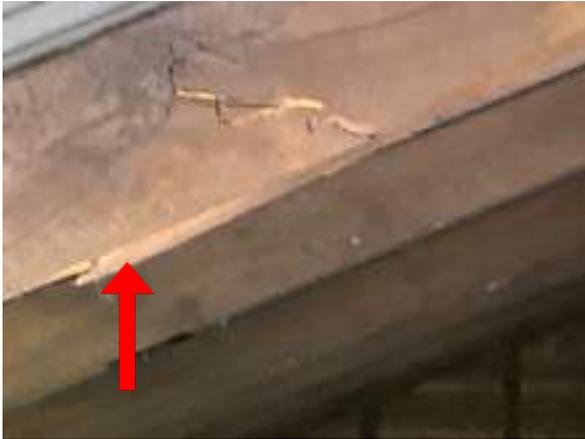
1.03

Location: Baby's Room

Finding: Timber Pest - Damage Identified.

It is suspected that timber pest (Borer) activity is occurring or has occurred as there appears to be evidence of timber pest damage.

Despite no live termite or timber pest activity being identified, previous timber pest damage was found in these areas.

Such damage creates a potential safety hazard, and is likely to worsen and cause further damage to adjoining building materials.

In addition I would like to mention, that the client has taken up the flooring in this area only as they were concerned for termite damage, it appears that the damage is borer timber damage and the damage is sustained within the area of where the timber flooring has been taken out. The subfloor area that can be visually sited has additional minor borer damage approximately 1500 mm away on the floor Joist, however from the location where I can see, it appears to be cosmetic only.

A building contractor should be appointed immediately to advise on options to prevent further damage and repair all affected building materials. Until such time, caution should be taken by all people coming into contact with these building elements and this area.

The application of a post-construction chemical termite barrier or other termite / timber pest treatments is highly recommended for all properties, particularly if live termite activity has been found on the site previously. Such barriers are highly effective in preventing termite attack on any timber building elements throughout the property.

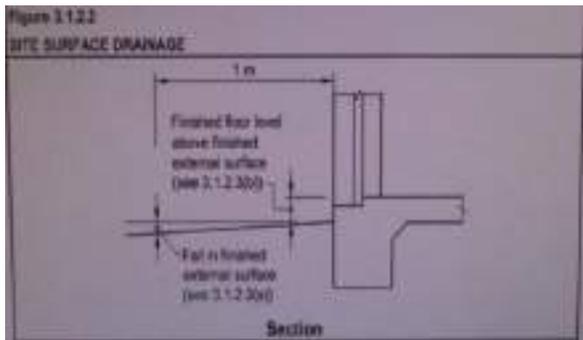
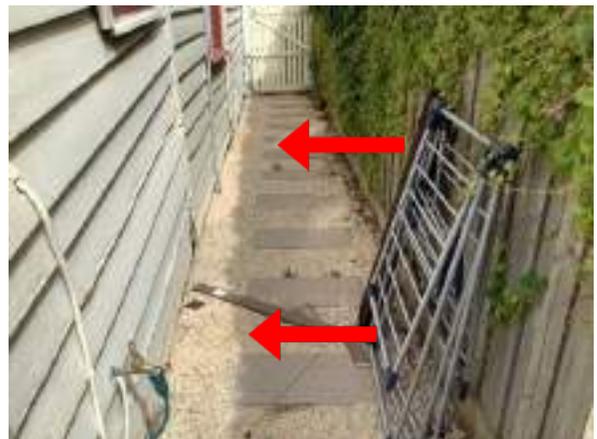
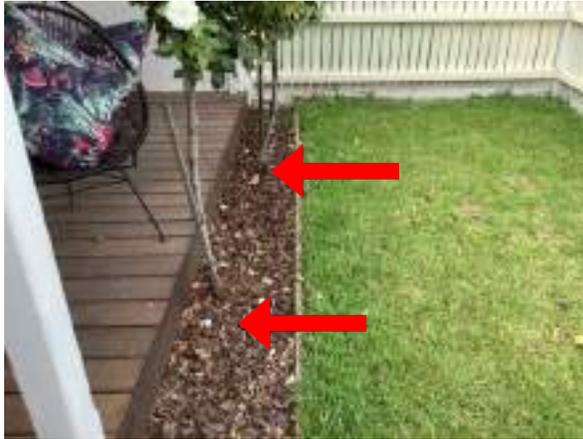
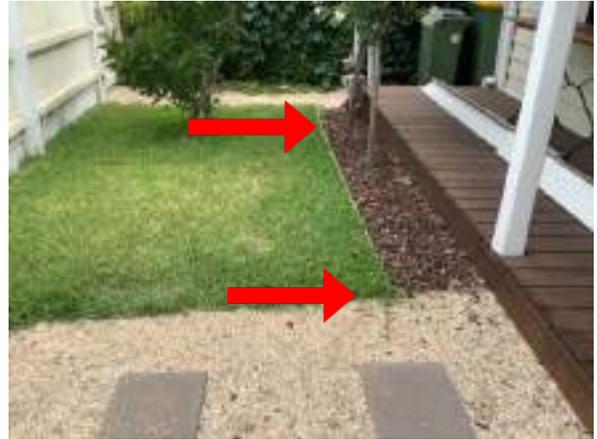
Finding: Drainage - Perimeter Building Ground Fall Defective.
At the time of the inspection it was noted that the surrounding perimeter soil does not fall away from the slab / building.

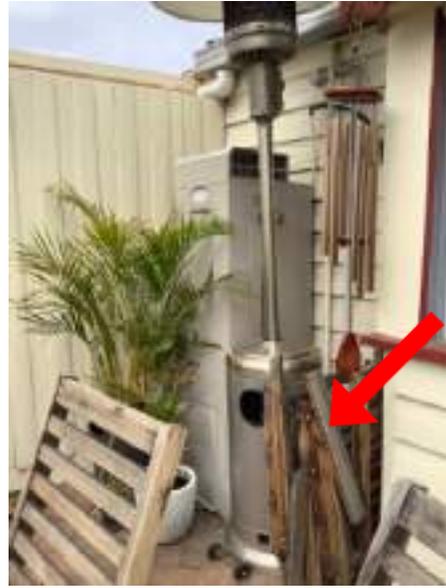
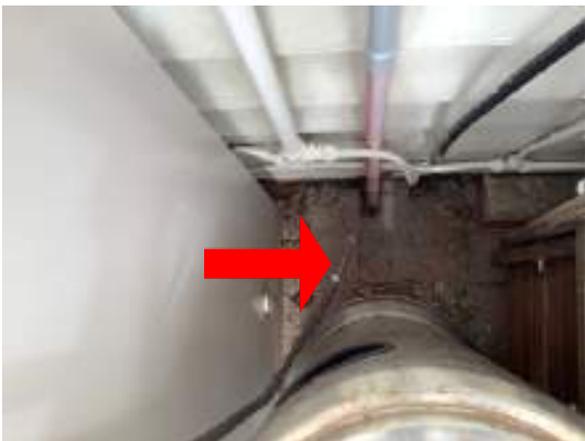
2.06

Location: Perimeter Of Building - Exterior

Finding: Air conditioner - Disconnected overflow

The Air Conditioner (A/C) overflow was found to be disconnected from storm water draining and is creating excessive moisture in the surrounding area.

Such leaking creates an environment which is conducive to an array of defects, including water damage to associated building elements and the attraction of termite or timber pest infestation.

This excessive water creates a much more conducive environment for termites as well.

It is highly recommended that a licensed plumber be appointed to connect the A/C overflow in order to prevent such an environment from being created.

These minor works should be carried out as soon as possible.

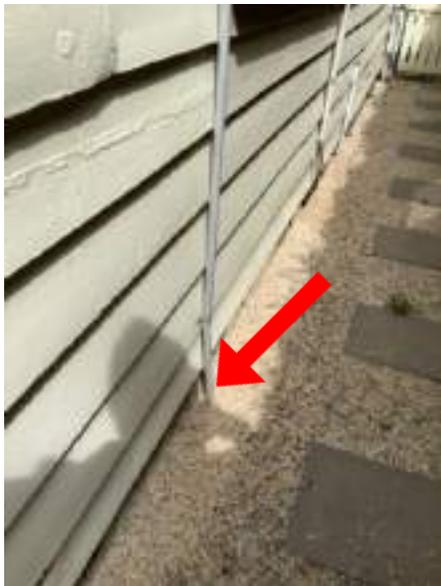
2.07

Location: Timber Work - All External Areas

Finding: Wood Rot

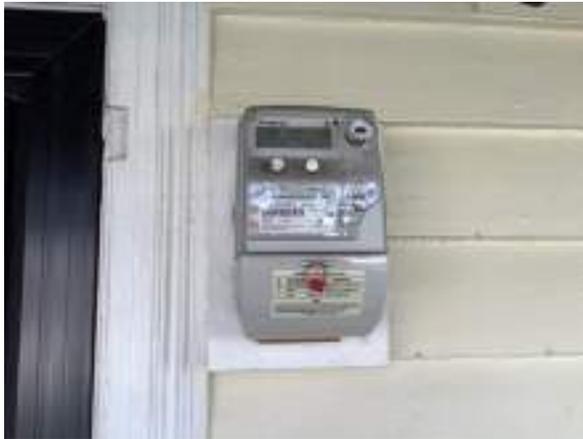
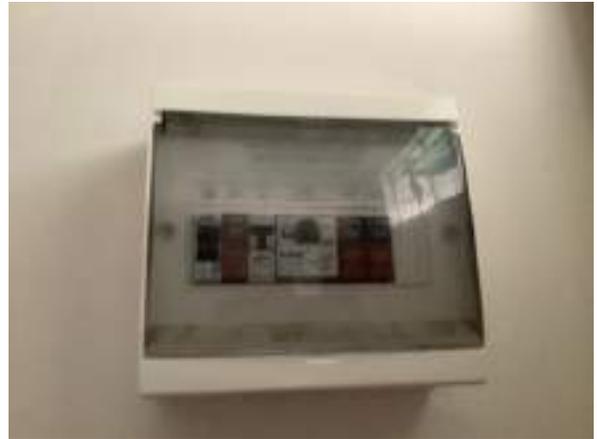
4.14

Location: The Site

Whilst we have taken many photos of the home and surroundings of the obstructions and limitations , we have just added a few photos in the report for you to understand the type of obstructions and limitations .

A re-inspection is recommended once the areas are made accessible.

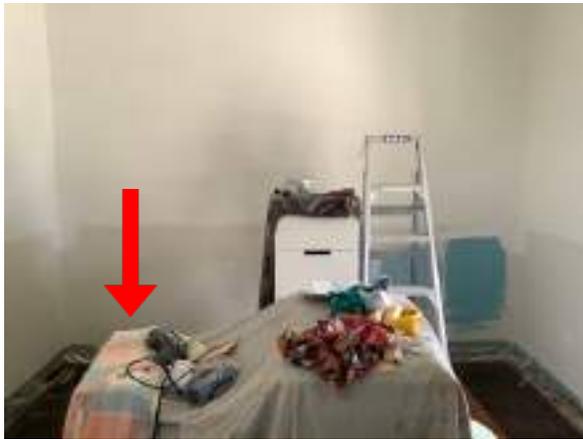
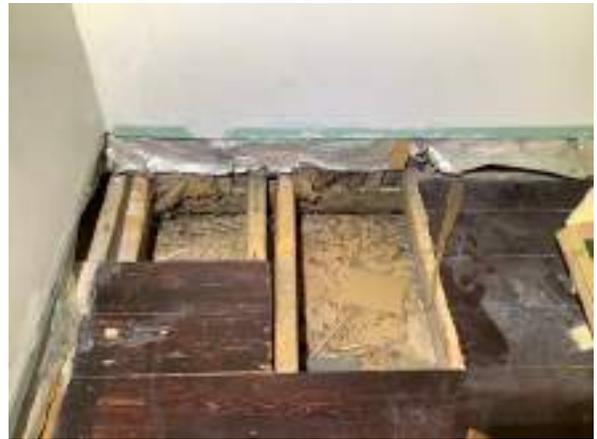
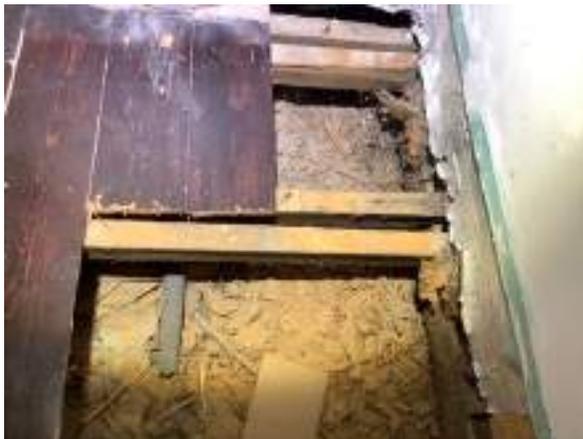
4.17

Location: Subfloor

Height 3.6 m ladder max on a ladder.

By not inspecting the sub floor area there can hide an array of defects, without inspection to the roof void area it is impossible to rule out termite activity and/or termite damage and other undetectable issues .
