## Termite / Timber Pest Report

Inspection Date: 30 Mar 2020

Property Address: Bundoora Area

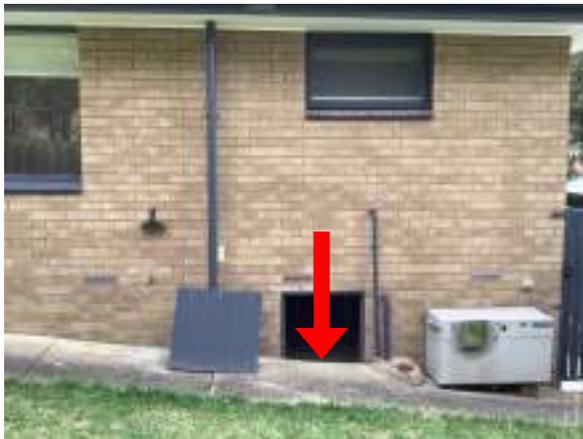
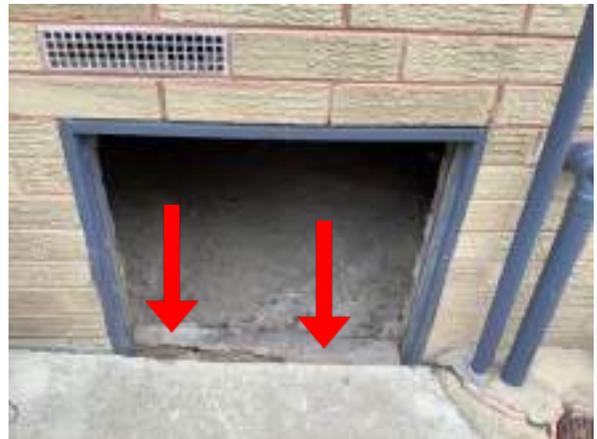
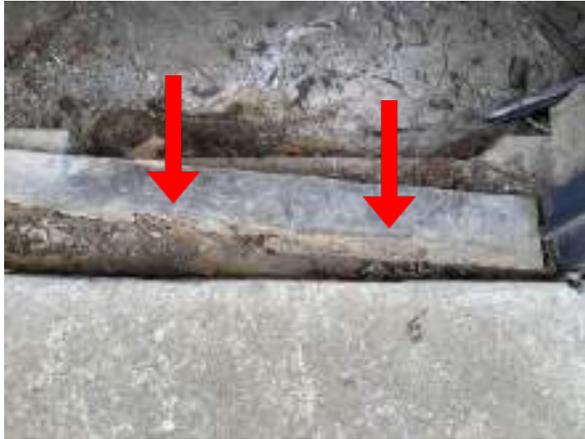
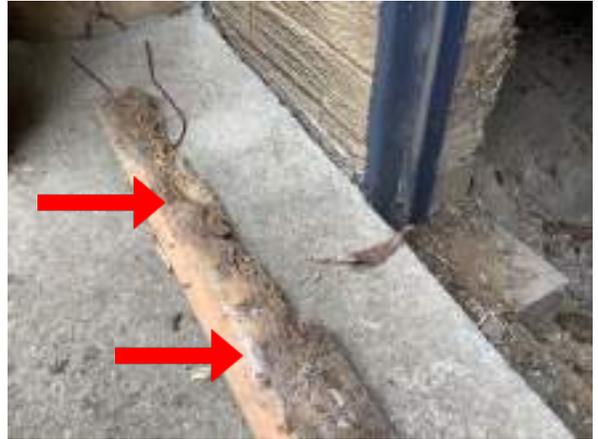
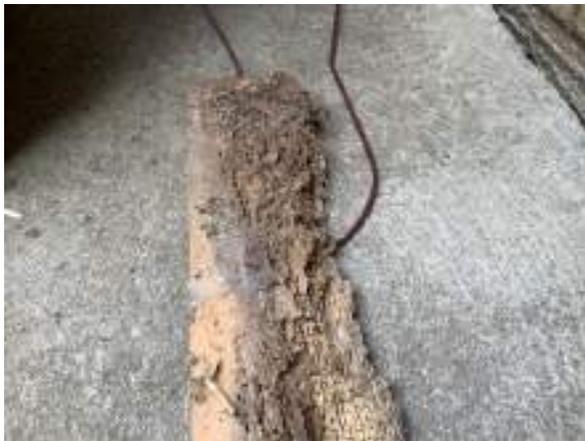
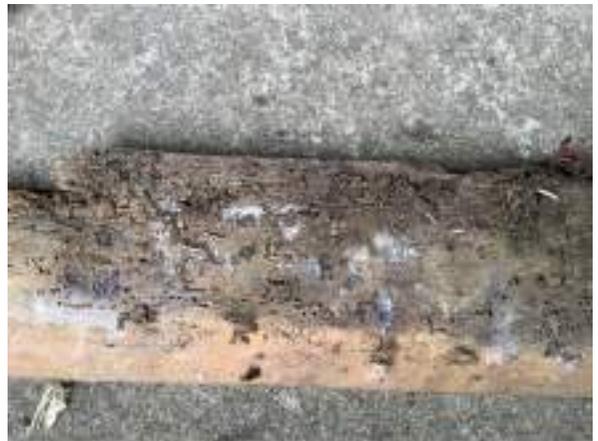
Finding: Termite - Damage Identified.

Despite no live termite or timber pest activity being identified, previous termite damage was found in this area.

Such damage creates a potential safety hazard, and is likely to worsen and cause further damage to adjoining building materials.

A building contractor should be appointed immediately to advise on options to prevent further damage and repair all affected building materials. Until such time, caution should be taken by all people coming into contact with these building elements and this area.

The application of a post-construction chemical termite barrier or other termite treatments is highly recommended for all properties, particularly if live termite activity has been found on the site previously. Such barriers are highly effective in preventing termite attack on any timber building elements throughout the property.

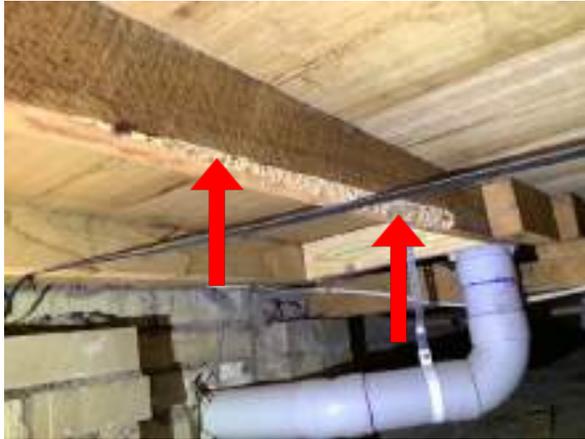
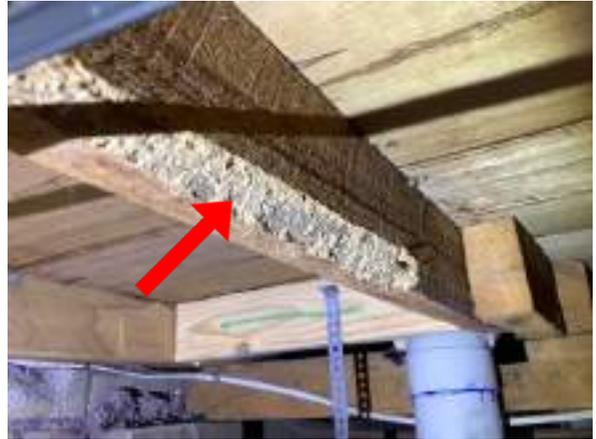
Finding: Timber Pest - Damage Identified.

Despite no live termite or timber pest activity being identified, previous timber pest damage was found in these areas.

A building contractor should be appointed immediately to advise on options to prevent further damage and repair all affected building materials. Until such time, caution should be taken by all people coming into contact with these building elements and this area.

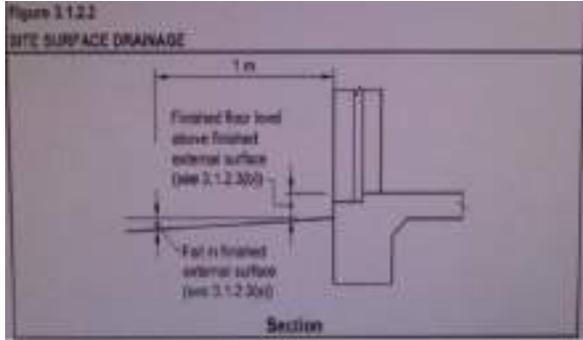
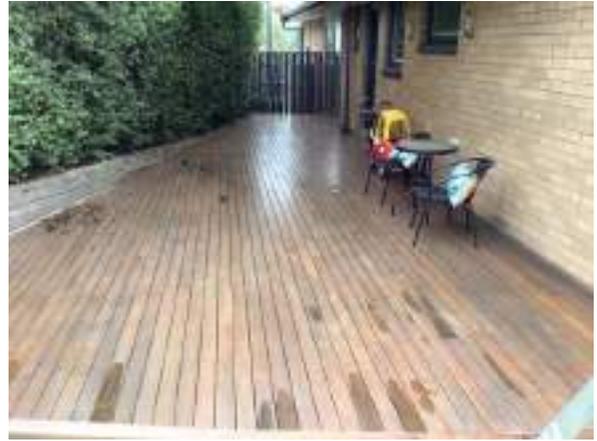
## Conditions conducive to timber pest attack 2.03

Finding: Drainage - Inadequate

Water pooling near foundations and footings is a serious concern with the potential to adversely impact on the longevity of the dwelling. The Building Code of Australia (BCA) outlines that the soil or concrete must be graded away from the dwelling at a minimum of 50mm over 1m (1:50 fall).

The site drainage in this area was found to be inadequate at the time of inspection, creating potential for subsequent water damage to associated building elements, such as foundation subsidence, brickwork cracking, windows and doors moving, concrete paths cracking, etc.

It is highly recommended that a plumber be appointed to further inspect the area and to install / repair adequate drainage equipment where necessary.

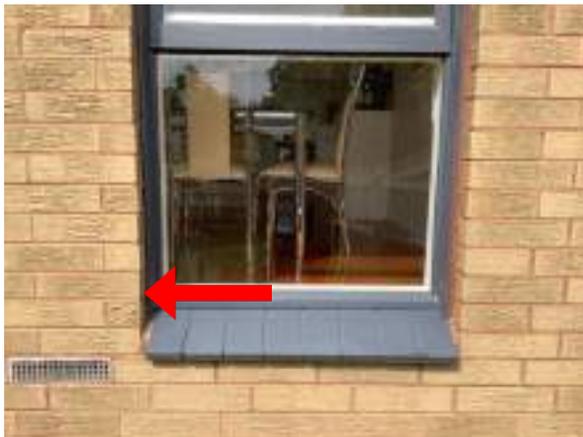
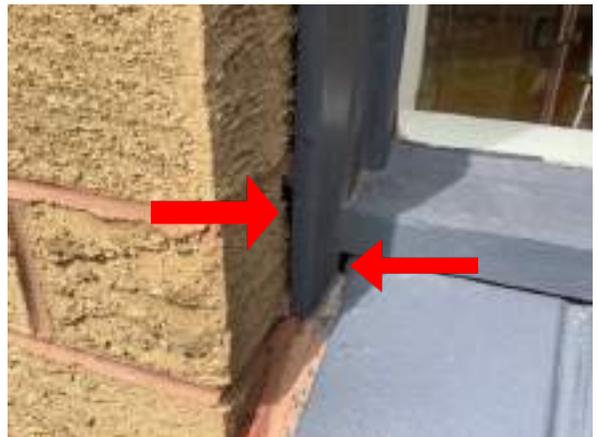
## Conditions conducive to timber pest attack 2.04

Finding: Water Leaking & Water Ingress - External Areas

Water leaks were found to be present to the exterior sides, tops and or bottoms of the windows and/or doors and other areas as per the photos attached, such as brick expansion joints and timber and cement sheet junctions above windows , eaves and other areas.

Leaks are generally caused by deterioration of silicon or rubber seals or sometimes just defective workmanship when no caulking as ever been used .

It is highly advised that a licensed plumber, handyman, builder be appointed to rectify any water leaks that may be present.

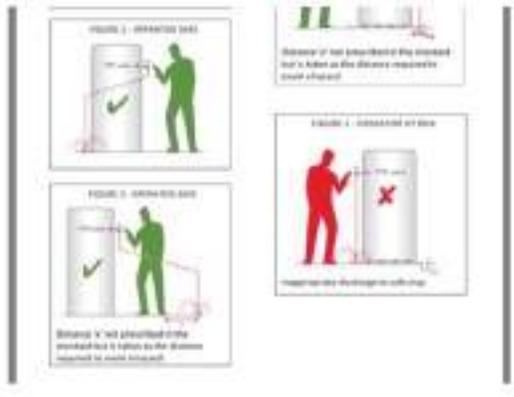
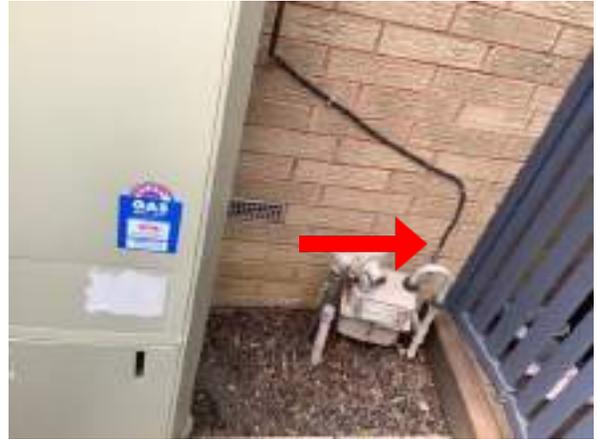
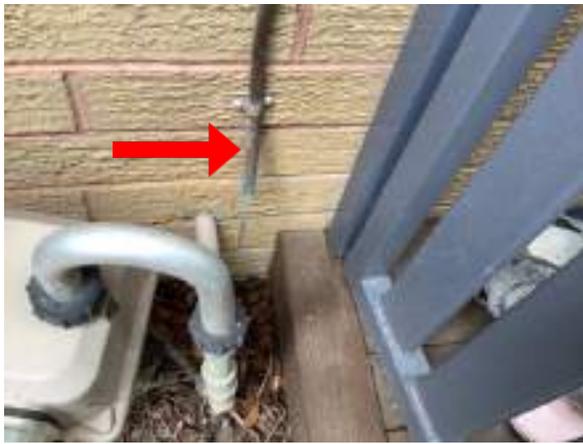
## Conditions conducive to timber pest attack 2.05

The Hot Water System (HWS) overflow was found to be disconnected from storm water draining and is creating excessive moisture in the surrounding area.

These damp conditions can lead to secondary defects such as rot, rust or corrosion of associated building elements, the formation of fungal decay, or even the creation of potential slip hazards. When coupled with poor site drainage, pooling of water may also attract termite activity to this area.

It is highly recommended that a licensed plumber be appointed to connect the HWS overflow in order to prevent such an environment from being created. These minor works should be carried out as soon as possible.

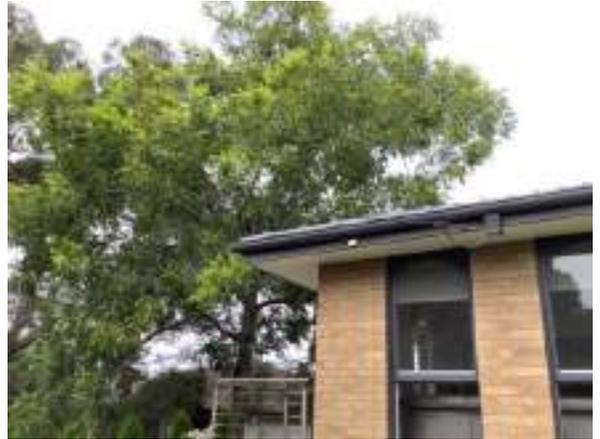
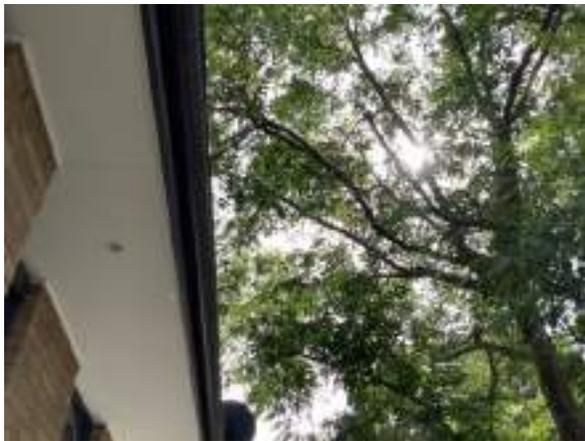
## Conditions conducive to timber pest attack 2.06

Finding: Garden trees - Overhanging and filling gutters  
 PLEASE NOTICE THE ATTACHMENT PICTURES TO THIS DEFECT STATEMENT;  
 H = the height of the tree at its full potential height, not its height today.  
 D = the distance from the tree to the building at the trees full potential height.  
 D = varies pending on one tree to 4 trees or more.

Gutters are a critical part of the building's management of storm water and rain. It is therefore important that they be kept clear to prevent secondary damage to associated building elements, including exterior and interior walls, ceiling linings and any adjoining building elements. Where gutters are blocked, pooling of rainwater is likely to occur, fast-tracking rust and corrosion of the roof plumbing elements.

It is highly advised that all overhanging tree branches be removed as soon as possible to prevent any further damage. Repair and/or replacement of sections of damaged guttering may also be required where the extent of the damage necessitates.

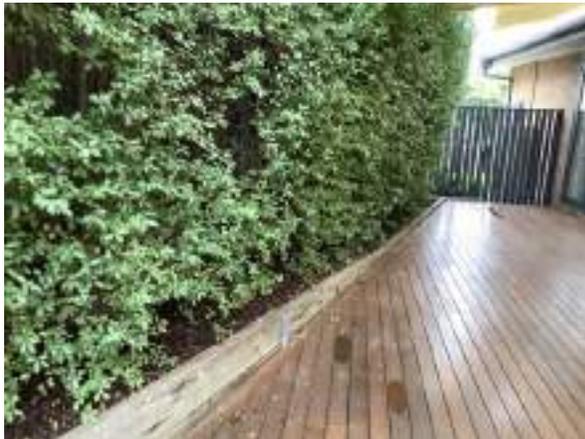
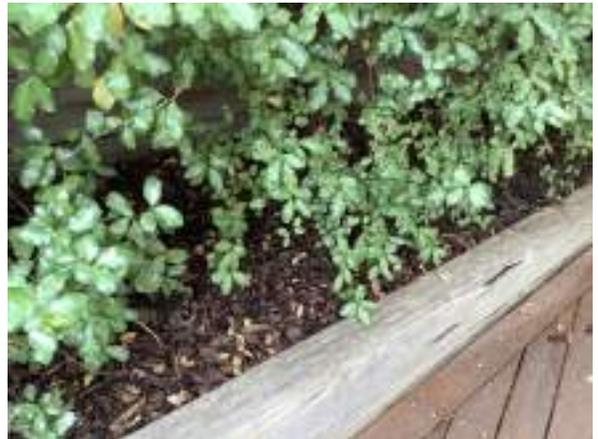
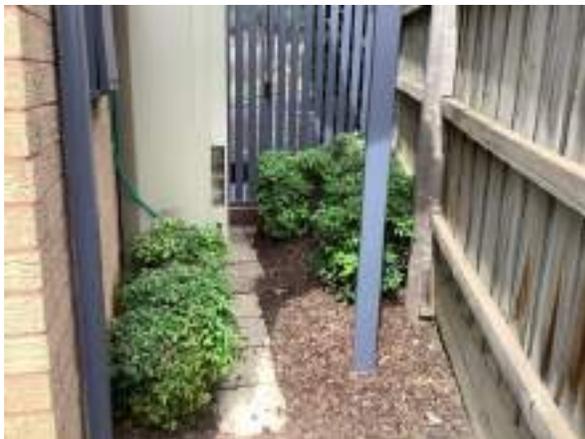
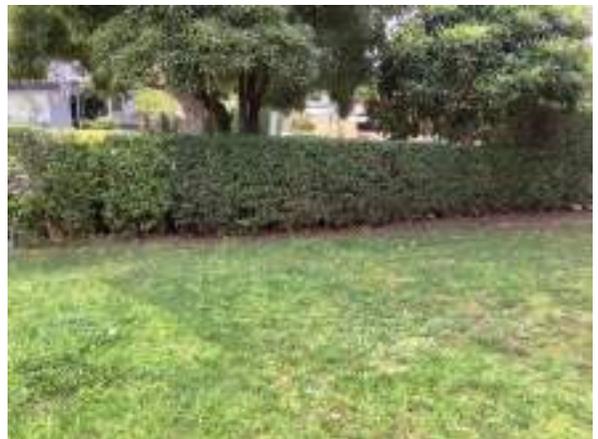
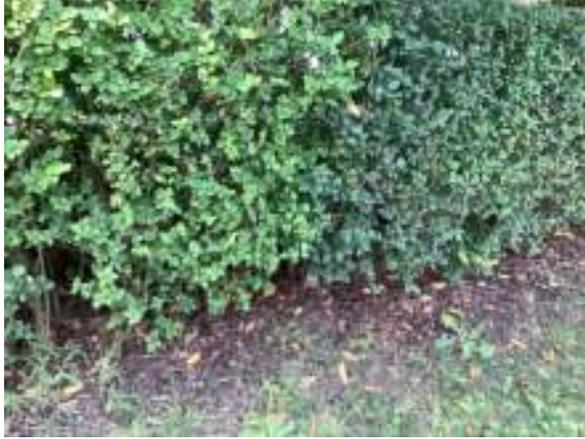
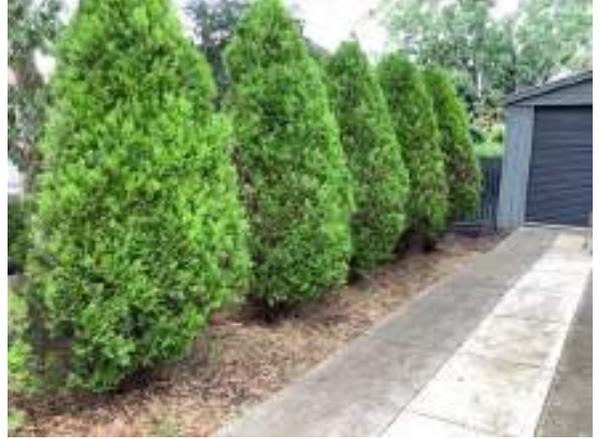
## Conditions conducive to timber pest attack 2.07

Finding: Garden Beds - Conditions Conducive to Termites  
Garden beds were found to be evident in areas of garden areas. These garden beds can include untreated timber, bark, excessive old vegetation and with a combination of moisture from watering hosing can make conditions very conducive to termite activity and termite ingress. It is always important to keep the garden beds as clean as possible and take out excess old bark from the trees, leaves and keep bark mulch to a minimum or better introduce rocks or some item that does not create an conducive environment for termites and hold excess moisture.

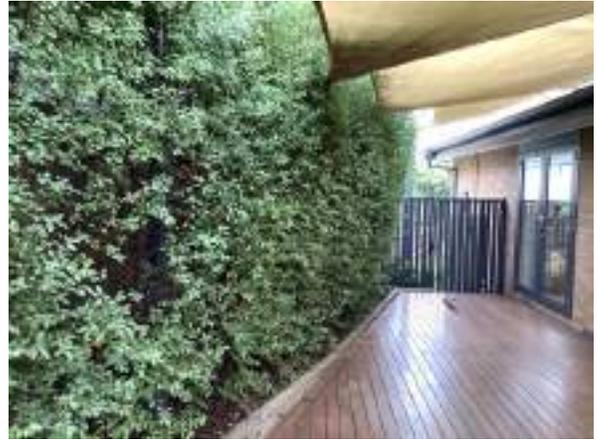
## Conditions conducive to timber pest attack 2.08

-----  
At the time of the inspection it was found that the plants are overgrown and close to the exterior building.

It is highly recommended that the plants be trimmed and/or moved away from the immediate area of the perimeter building...

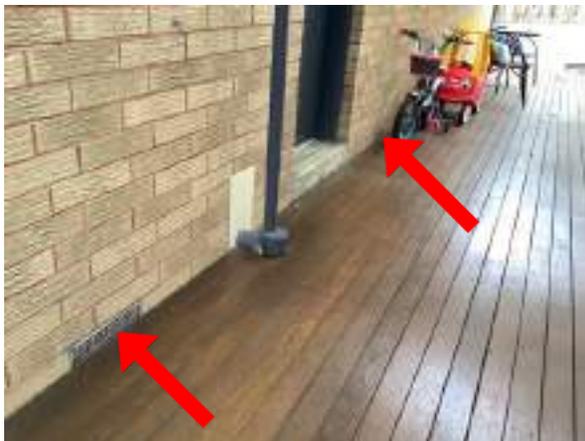
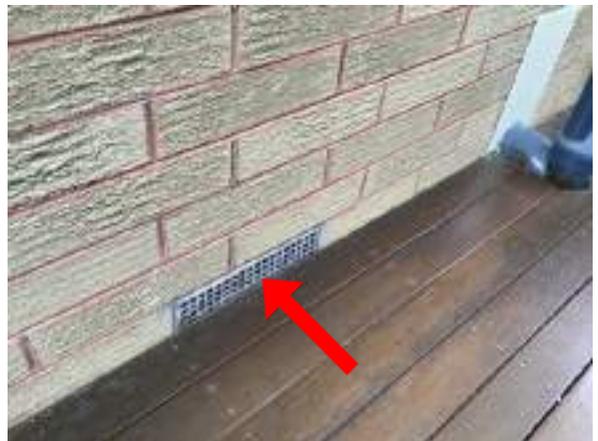
## Conditions conducive to timber pest attack 2.09

Finding: Weep Holes - Bridging Or Breaching Of Termite Barriers Defective.  
Bridging is the spanning of a termite barrier or inspection zone so that subterranean termites are provided with passage over or around that barrier.

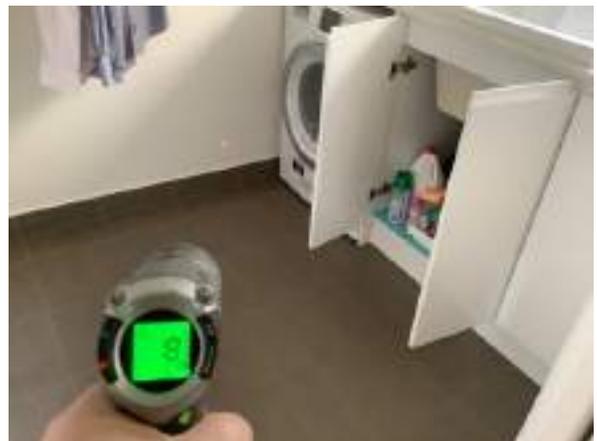
## For your information 4.15

As all areas are not able to be inspected due obstructions and limitations, we therefore can not rule out the possibility of concealed timber pest activity.

Wall paneling, wall paper, carpet and fixed cabinetry can obscure termite activity.

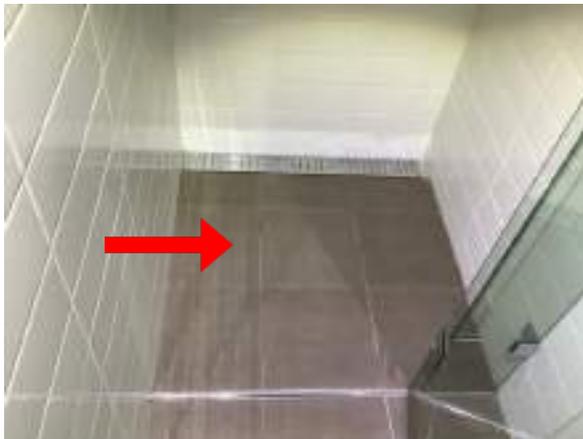
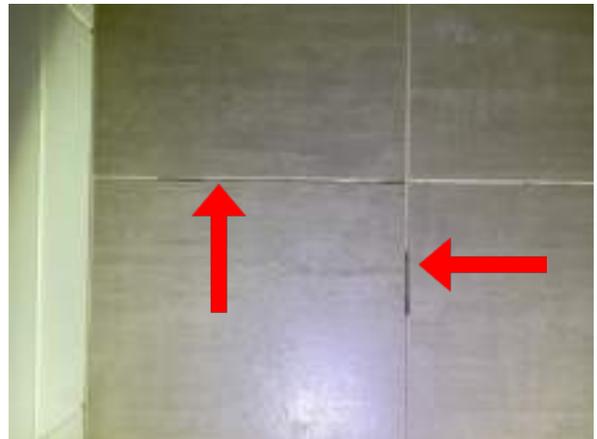
### For your information 4.16

Please note this is not a building inspection however tiled grout is missing and water ingress through the tile grout areas can create moisture.

All wet areas must be taken care of to reduce the HIGH risk of termite attraction.

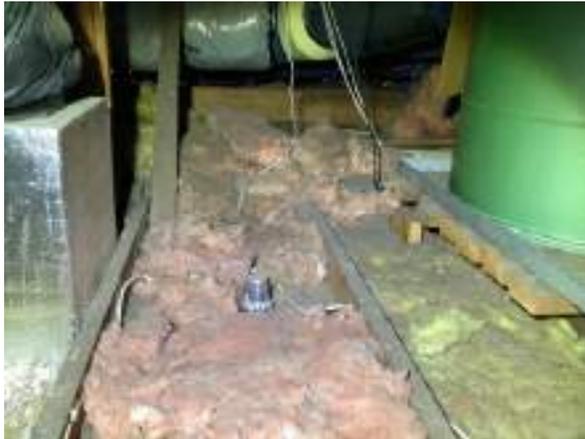
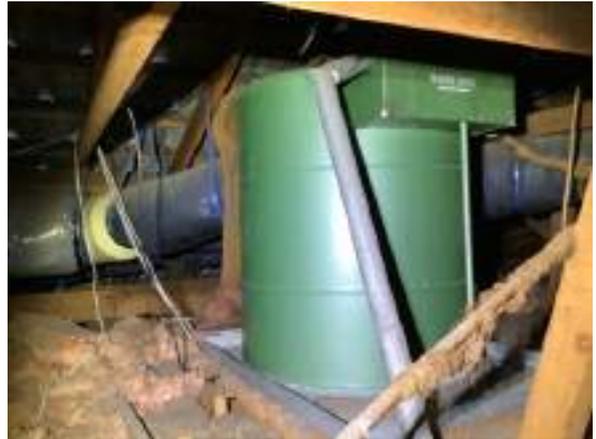
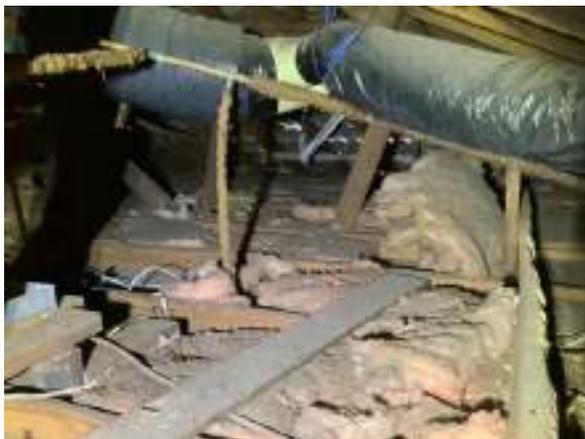
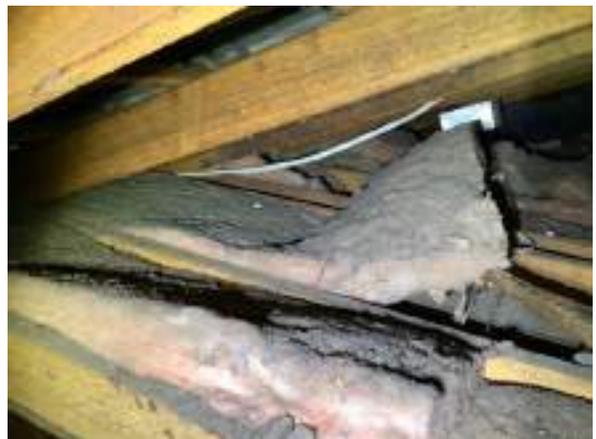
## For your information 4.17

The property is a very high risk for termites as the environments to the property are very conducive with many susceptible areas.
