Asbestos Sampling Report

Inspection Date: 30 Apr 2020

Property Address: Nothern Country Area

Report Type: Asbestos Inspection and Condition Report

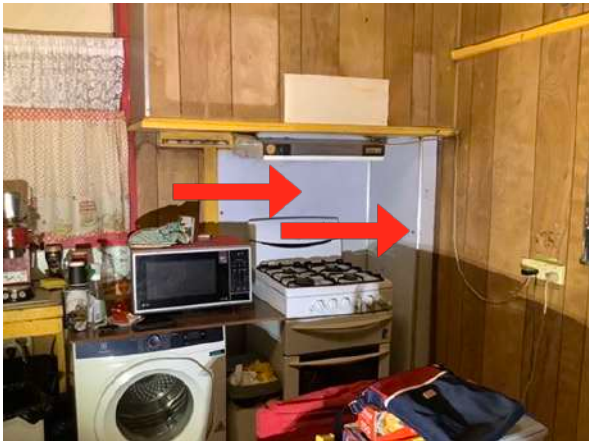
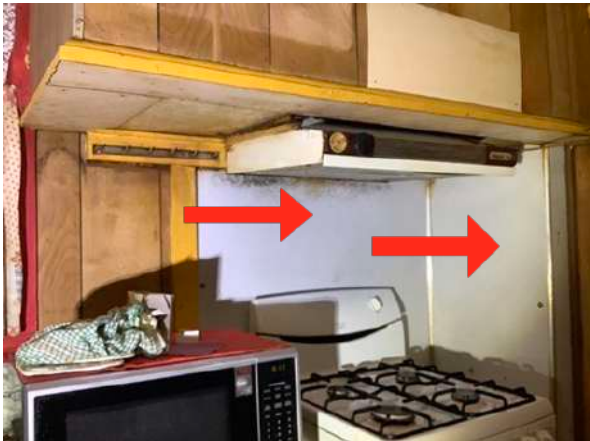
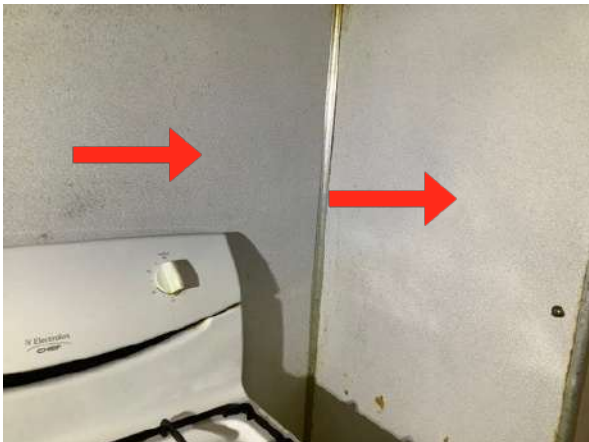
ACM Confirmed in Samples 4.01

Finding: Asbestos - ACM Confirmed - Sample 1.
A sample of the kitchen splash back was taken and sent to the Lab.

Samples of suspected Asbestos Containing Material (ACM) were removed from the building for analysis by a NATA accredited laboratory. The sample results confirmed that the material/s tested do contain Asbestos. The results indicated that the type of Asbestos is (White Chrysotile or Brown Amosite or Other).

Consequently, the client is advised to consider relevant risk reduction strategies, including removal by a licensed Asbestos Removal firm.

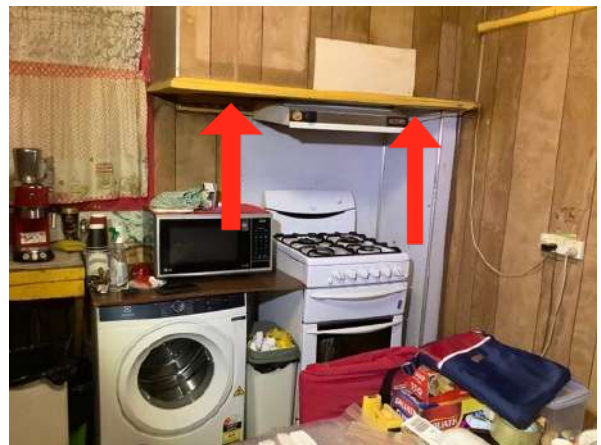
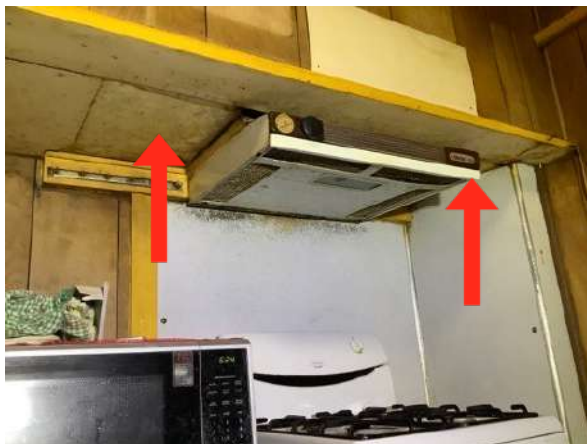
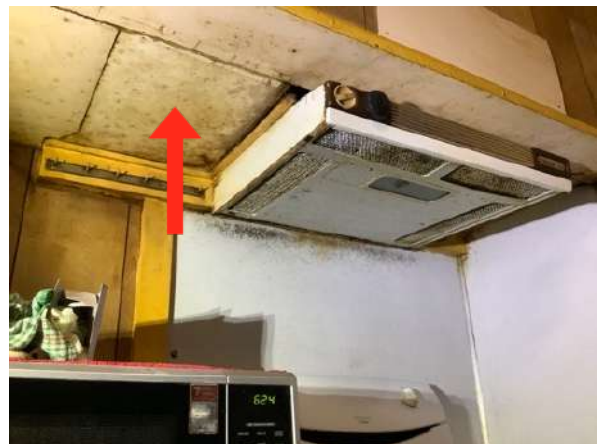
ACM Confirmed in Samples 4.02

Finding: Asbestos - ACM Confirmed - Sample 2
A sample under the cooking area canopy in the kitchen was taken and sent to the Lab.

Samples of suspected Asbestos Containing Material (ACM) were removed from the building for analysis by a NATA accredited laboratory. The sample results confirmed that the material/s tested do contain Asbestos. The results indicated that the type of Asbestos is (White Chrysotile or Brown Amosite or Other).

Consequently, the client is advised to consider relevant risk reduction strategies, including removal by a licensed Asbestos Removal firm.

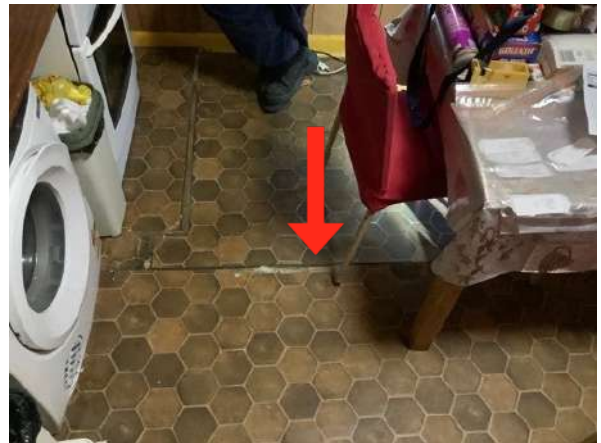
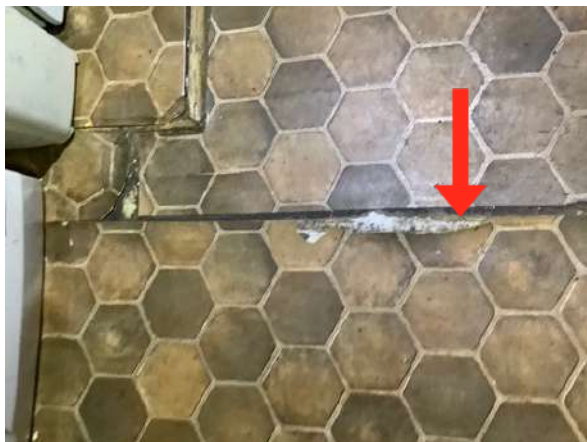
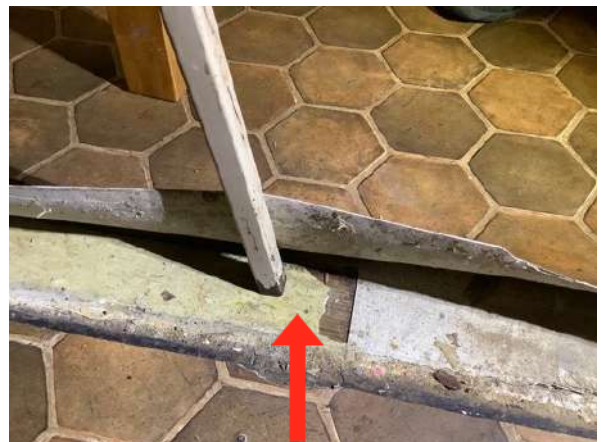
ACM Confirmed in Samples 4.03

Finding: Asbestos - ACM Confirmed - Sample 4
A sample of the underlay of the lino in the kitchen was taken and sent to the Lab.

Samples of suspected Asbestos Containing Material (ACM) were removed from the building for analysis by a NATA accredited laboratory. The sample results confirmed that the material/s tested do contain Asbestos. The results indicated that the type of Asbestos is (White Chrysotile or Brown Amosite or Other).

Consequently, the client is advised to consider relevant risk reduction strategies, including removal by a licensed Asbestos Removal firm.

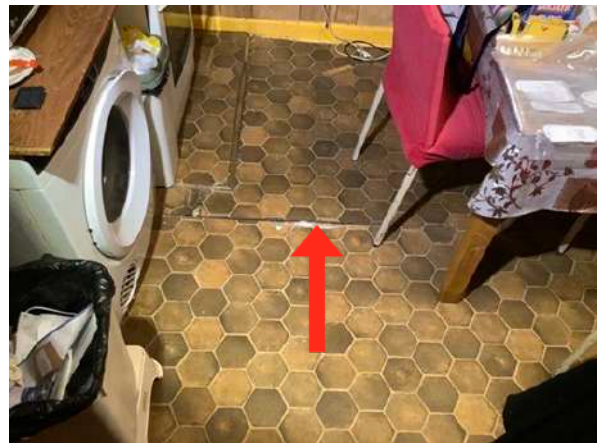
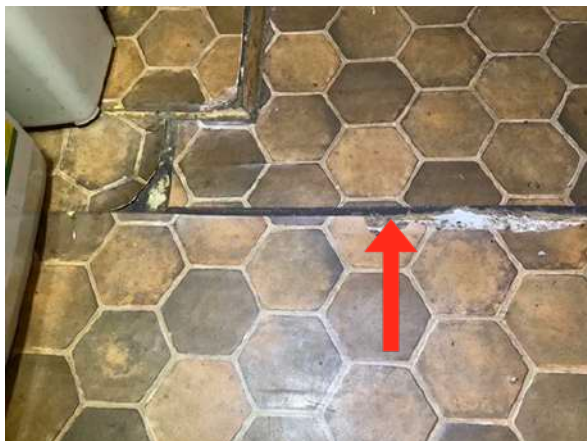
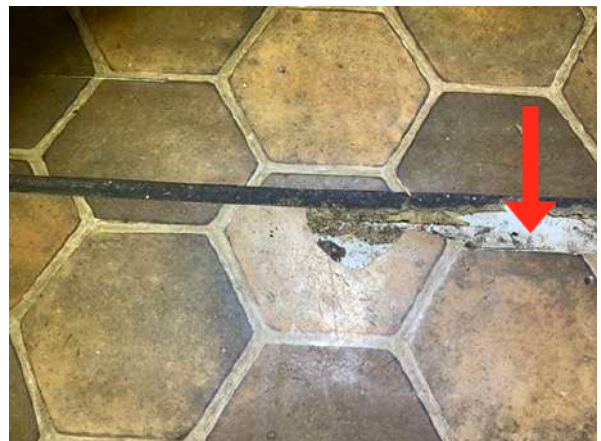
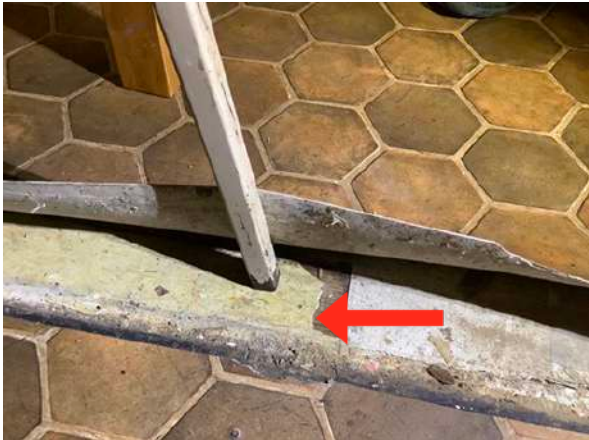
ACM Confirmed in Samples 4.04

Finding: Asbestos - ACM Confirmed - Sample 5
A sample of the glue from the lino was taken and sent to the Lab.

Samples of suspected Asbestos Containing Material (ACM) were removed from the building for analysis by a NATA accredited laboratory. The sample results confirmed that the material/s tested do contain Asbestos. The results indicated that the type of Asbestos is (White Chrysotile or Brown Amosite or Other).

Consequently, the client is advised to consider relevant risk reduction strategies, including removal by a licensed Asbestos Removal firm.

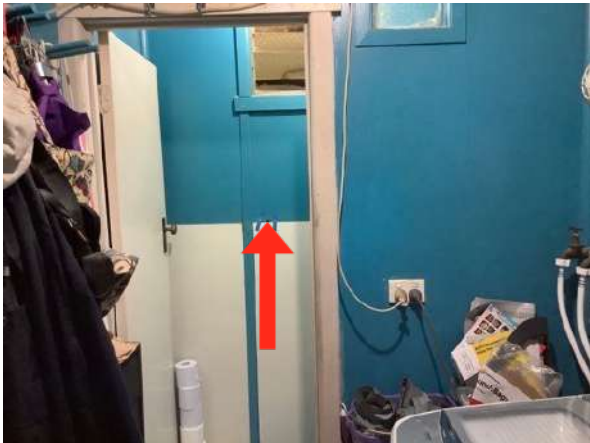
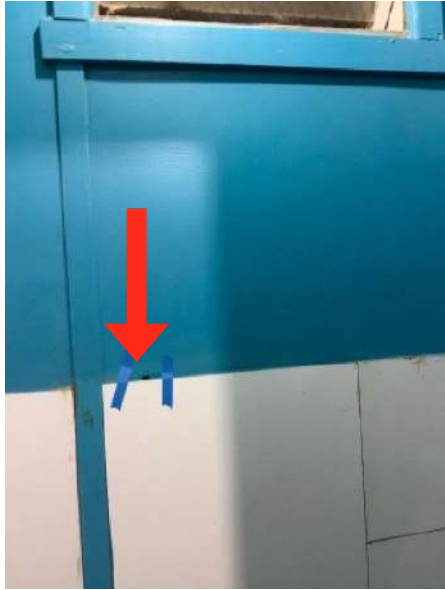
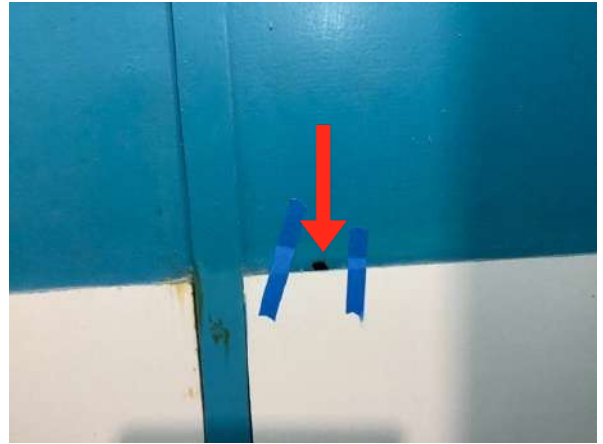
ACM Confirmed in Samples 4.05

Finding: Asbestos - ACM Confirmed - Sample 6
A sample of the toilet wall was taken and sent to the Lab.

Samples of suspected Asbestos Containing Material (ACM) were removed from the building for analysis by a NATA accredited laboratory. The sample results confirmed that the material/ s tested do contain Asbestos. The results indicated that the type of Asbestos is (White Chrysotile or Brown Amosite or Other).

6	The sample consisted of fibre plaster cement Location: Toilet wall Sample Dimensions: 4.0cm X 4.0cm X 0.3cm	Amosite Asbestos Detected Chrysotile Asbestos Detected
7	The sample consisted of fibro Location: Under canopy sheet Sample Dimensions: 4.0cm X 3.0cm X 0.1cm	No Asbestos Detected Organic Fibre Detected

Consequently, the client is advised to consider relevant risk reduction strategies, including removal by a licensed Asbestos Removal firm.

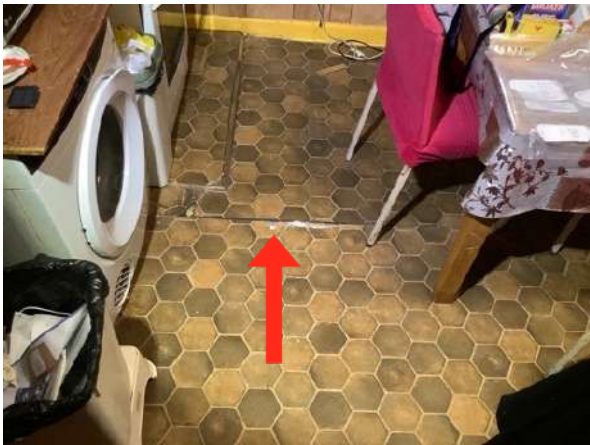
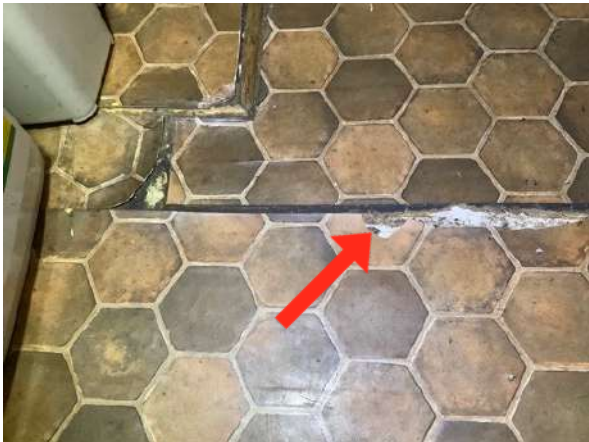
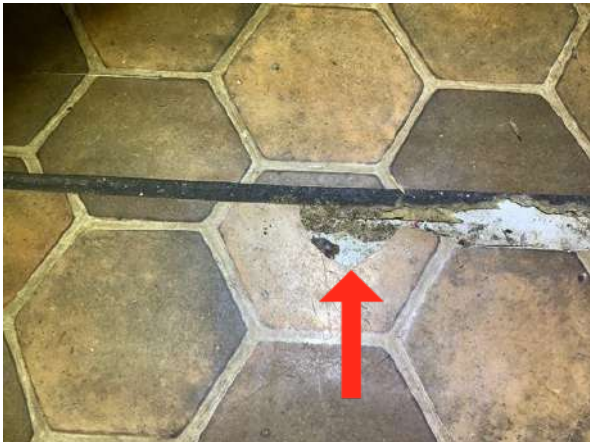
ACM Samples Negative 5.06

Finding: Asbestos - ACM Confirmed - Sample 3
A sample of the lino in the kitchen area was taken and sent to the Lab.

The samples analysed was free of Asbestos fibres.

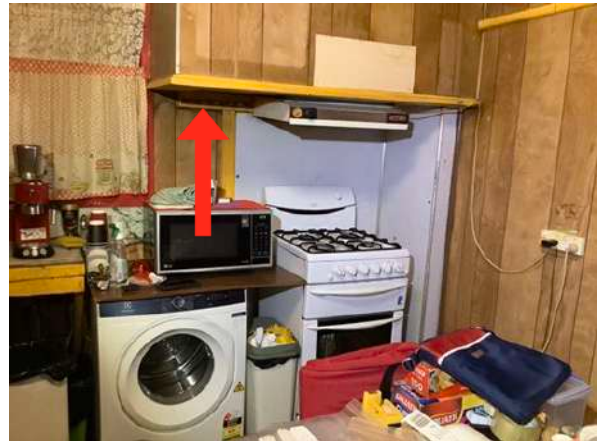
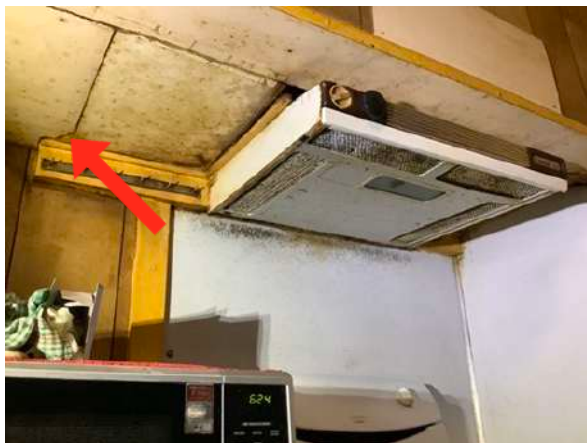
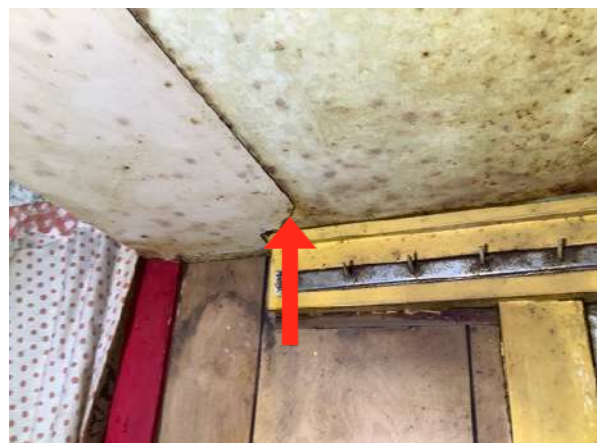
ACM Samples Negative 5.07

Finding: Asbestos - ACM Confirmed - Sample 7
A sample of the under sheet glue, under the canopy in the kitchen area was taken and sent to the Lab.

The samples analysed was free of Asbestos fibres.

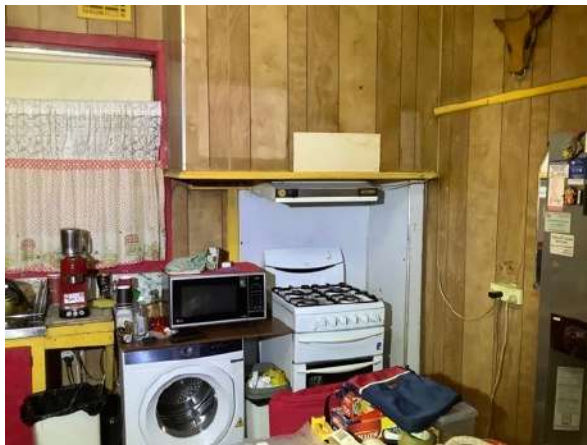
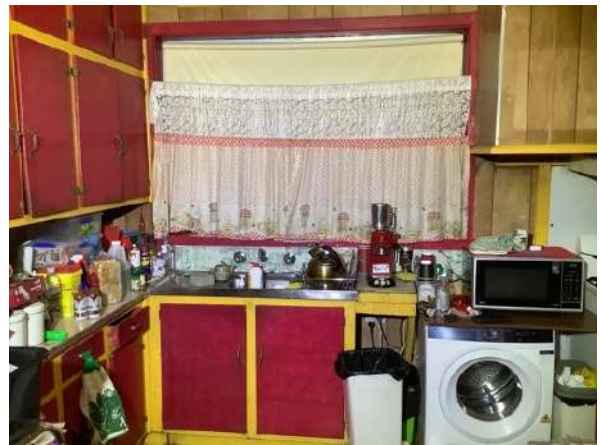
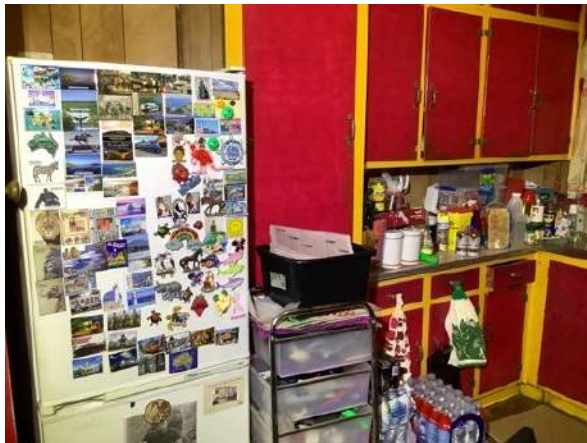
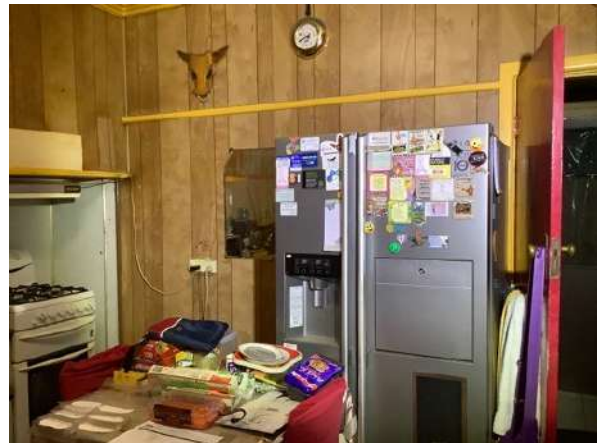
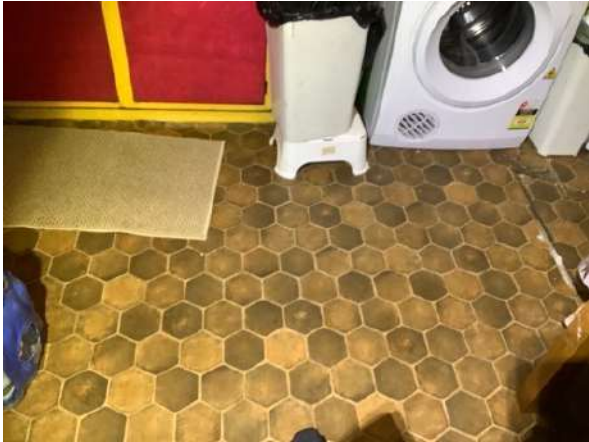
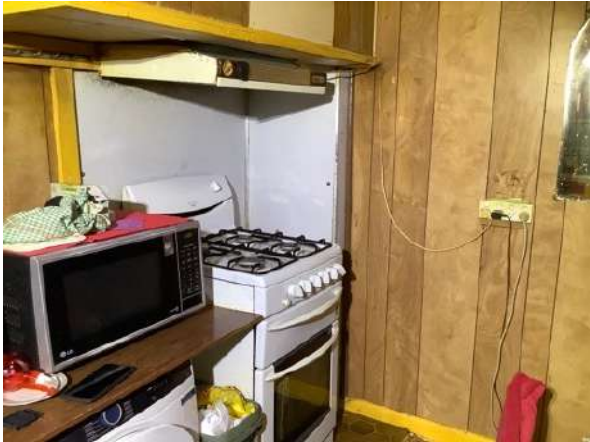
For your information 5.08

Finding: Additional Photos - Obstructions and Limitations

These photographs are an indication of the obstructions and limitations which impeded full inspection of the property at the time of inspection. These obstructions can hide an array of defects and should be removed to allow full inspection to be carried out.

A re-inspection is recommended once the areas are made accessible, if you require a further detailed inspection and report, which we do recommend.

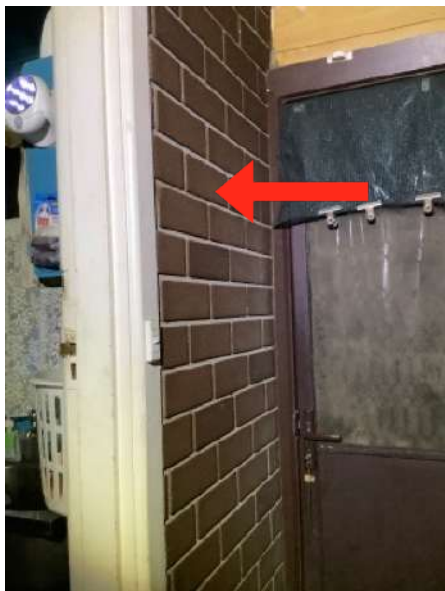
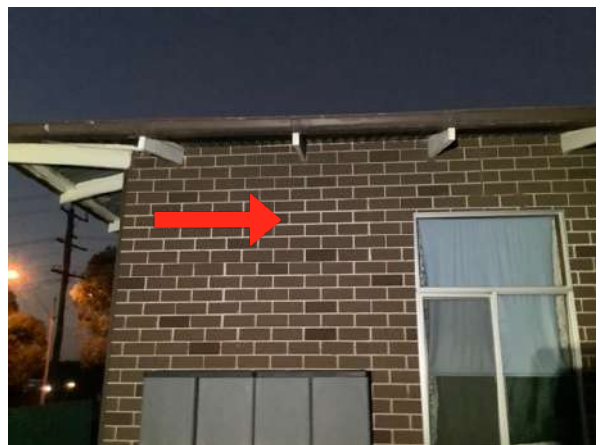
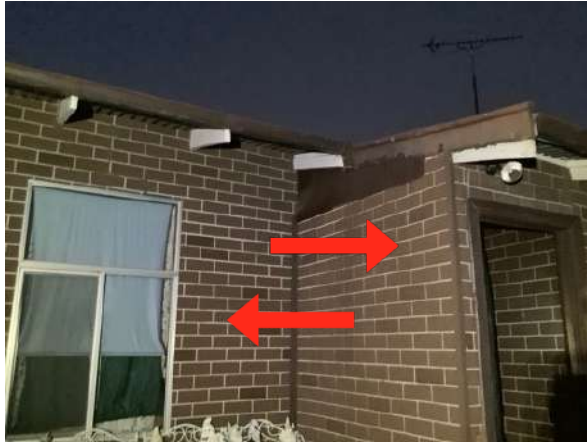
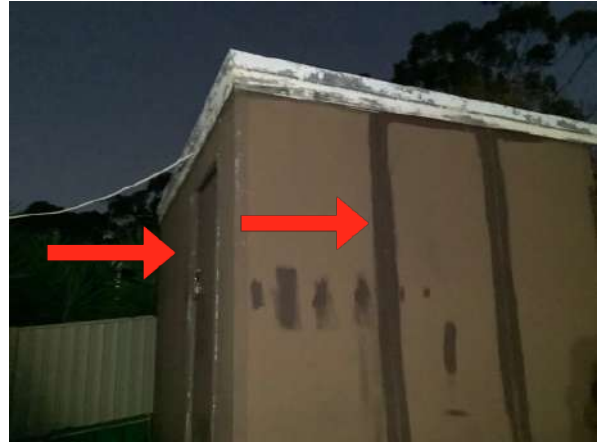
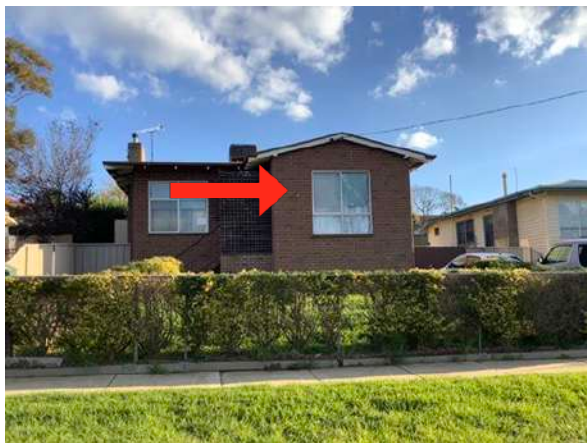
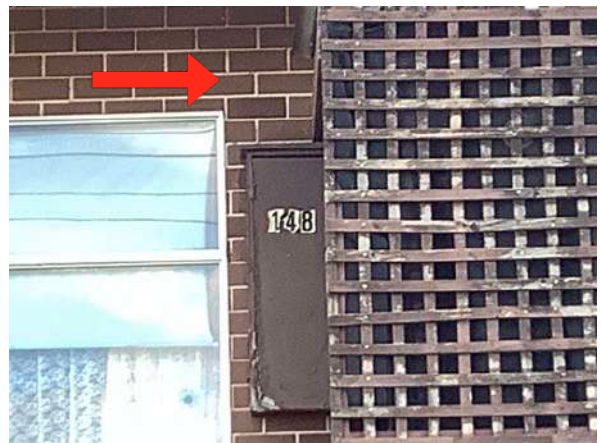
For your information 5.13

Finding: Asbestos - Suspected ACM Identified on Site (Visual Assessment Only)
This statement and photos attached to this statement are areas that we believe may be asbestos and/or contain asbestos and this is just a visual observation as requested and is a guide only.
We strongly believe we should take samples of these areas that appear to contain asbestos to the laboratory as a visual Inspection of asbestos is only a guide and not accurate.

This suspected defect is highlighted as a caution only. We suspect, based on our experience in the building industry, that there is a higher risk of the identified building element containing asbestos.

As noted above we advise that you consider a separate Asbestos Inspection and Condition Audit of these areas as well, which can include the taking of samples for definitive confirmation of the presence of Asbestos.

In the interim, the client is advised to act with caution, especially when considering any damage to building materials general wear and tear renovations extensions demolition and general maintenance activities due to the suspected presence of Asbestos.
