Bathroom & Toilet Renovation Report

Inspection Date: 8 May 2020

Property Address: Airport West Area

Report Type: New Home Construction

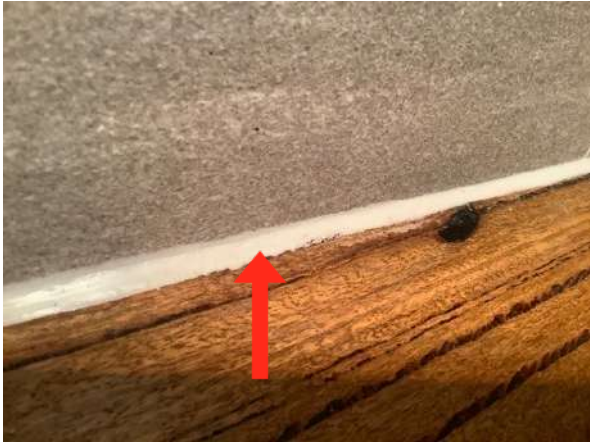
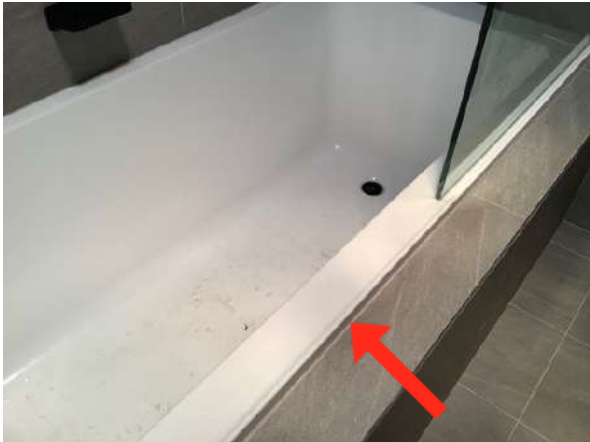
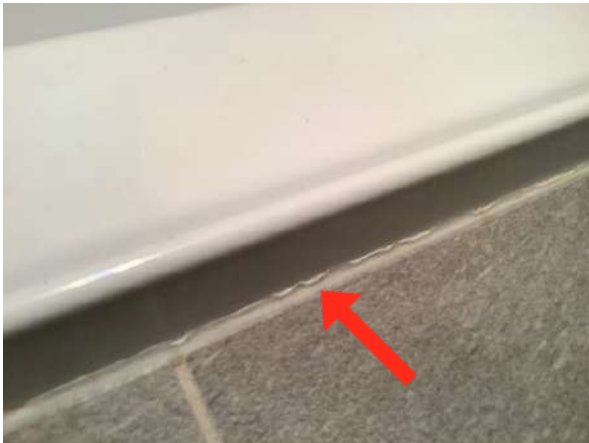
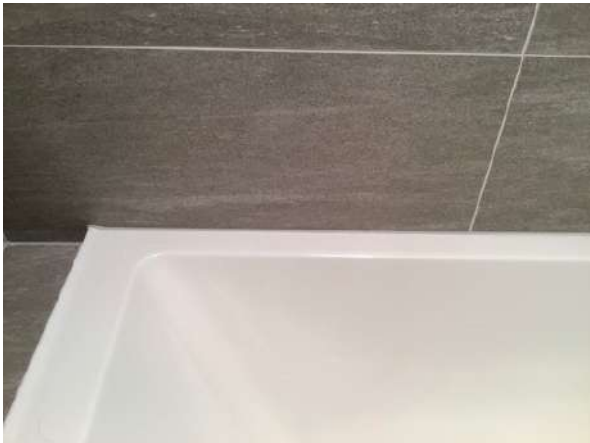
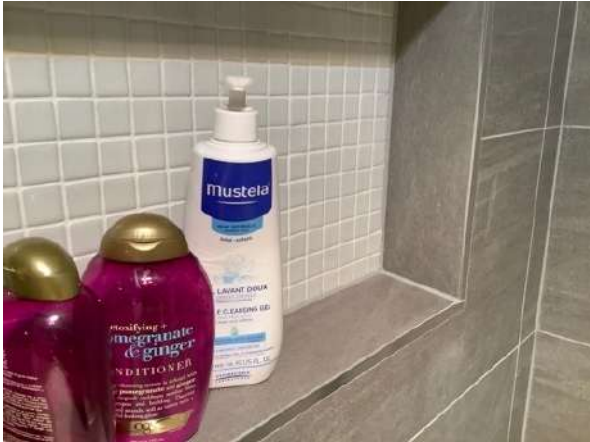
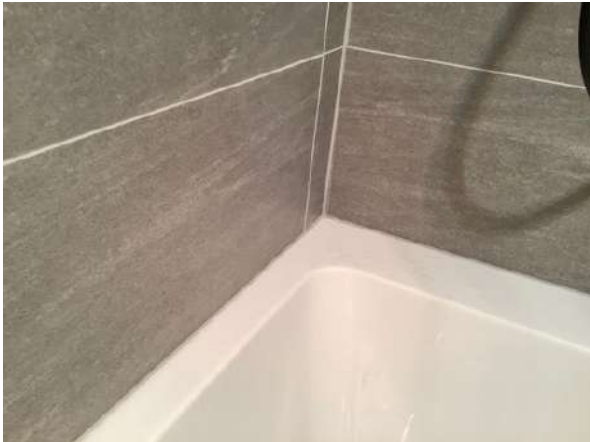
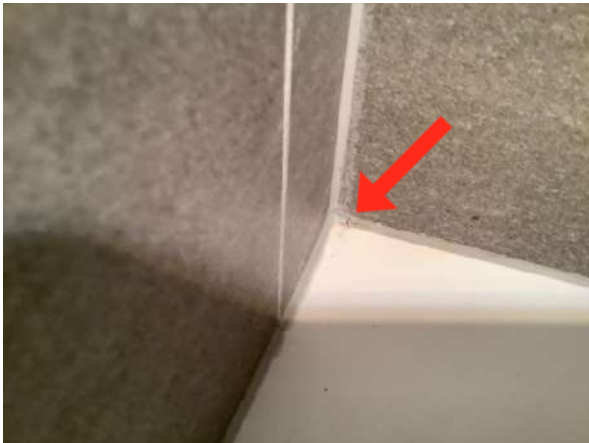
Non Compliant 2.01

Defective Caulking To Cabinetry, Bench Tops, Tile Junctions, Cabinetry/Plaster Junctions, Etc.

It was noted on inspection that sealant is missing, inadequate and/or not completed to a tradesmens like finish.

This may include floor edges, kitchen benches/splashbacks, vanities, cabinetry/plaster junctions, bath edges and shower floor/wall corners, etc.

Where required, junctions between bench tops and adjoining surfaces are defective if they are not sealed with a suitable flexible sealant of matching or agreed colour.

Seals around items such as sinks, hand basins or the like are defective if the joint leaks or they are not installed in accordance with the manufacturer's installation requirements.

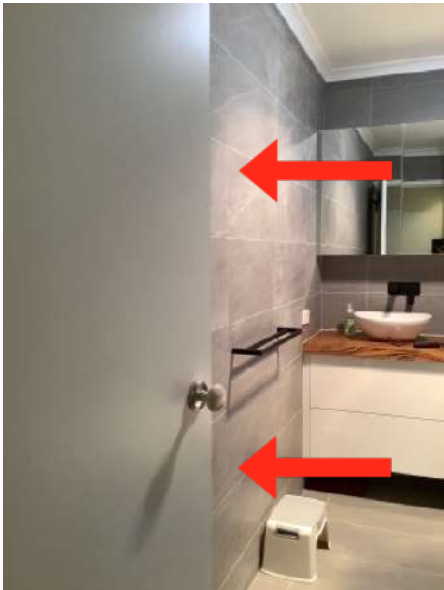
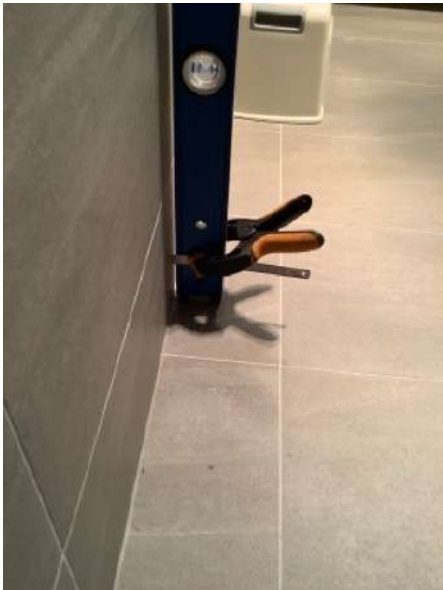
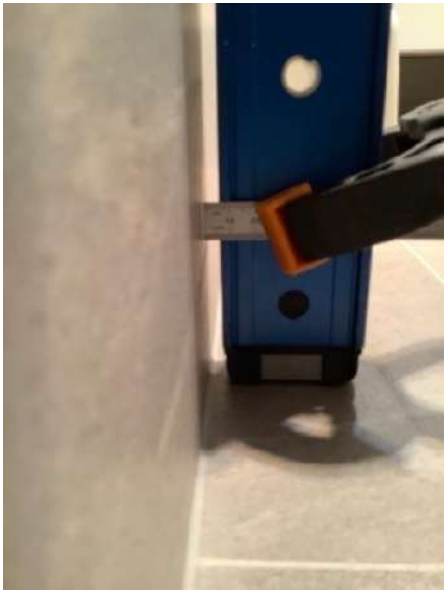
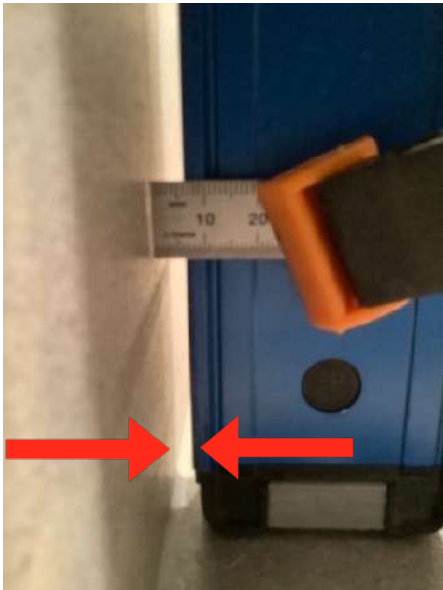
Non Compliant 2.02

Finding: Plaster wall surfaces - Vertical / Horizontal Defective to plaster, tiling and/or framing.

It is observed that the wall frame/s are defective as there is a deviation from a vertical or straight plumb line which exceeds 4mm within any 2m of height / length.

This is commonly referred to as a bow in the frame material and/or defective workman. Any bow in excess of 4mm as identified exceeds the allowable Standards and Tolerances and is considered defective.

This deviation from the verticality / horizontal or plumbness of the wall is a defect with reference to Standards and Tolerances 9.10.

Frames are defective if they deviate from plane (horizontal or vertical bow) by more than 4 mm in any 2 m length of wall.

A registered builder should be appointed to assess the defect and perform rectification works as necessary.

Considerable re working of the walls to rectify this defect in the areas specified is required. This work will consist of taking out tiles, waterproofing, cement sheet and or water resistant plaster, and re-installation and full repair of waterproofing And all items that have to be repaired.

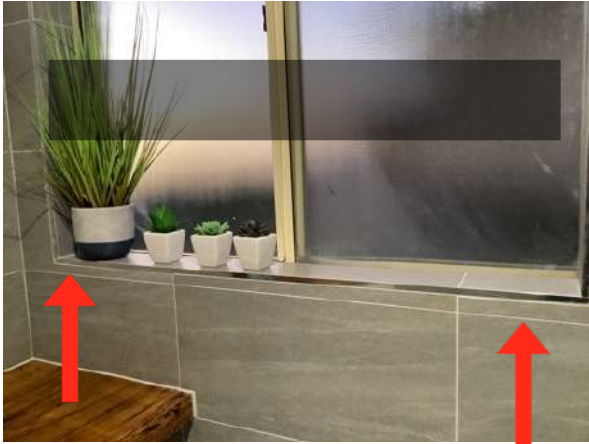
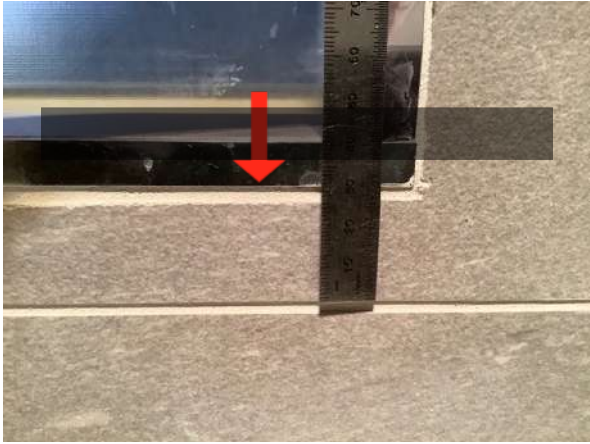
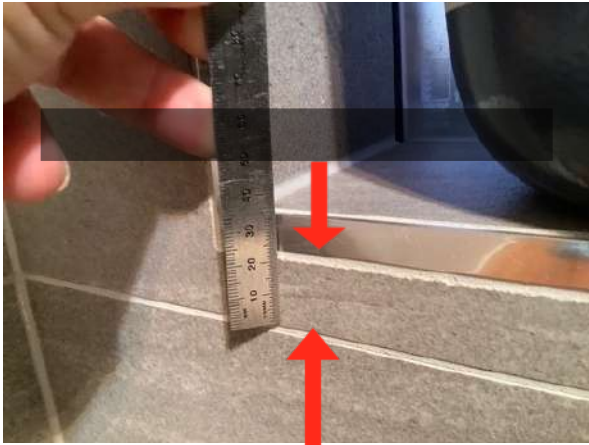
Non Compliant 2.03

This defect has come about due to misjudgement on the tile set up. Normally the tiler would calculate the tiles and the tile grout widths to determine the first tile installed on the wall or floor, meaning it to be a full tile or 3/4 tile or 1/2 tile in order not to allow this defect to happen.

Areas of grouting which are inconsistent in their width were identified. It is considered a defect with reference to AS3958.1 if grout lines are as far as practicable not consistent widths.

The relevant Australian Standard A.S. 3958.1 – 2007 Ceramic Tiles – Guide to the Installation of Ceramic Tiles, clause 5.4.6 Tile Finish and Joints also states that 'Joint widths should be consistent throughout the installation unless otherwise specified. The recommended joint widths for floors with dust-pressed tiles are 3mm, measured at the tile face' and clause 5.4.3 – Fitting, states that 'Keep all joint lines, including mitres, straight and of even width'. These tiles and the grout joint widths must be properly rectified or replaced.

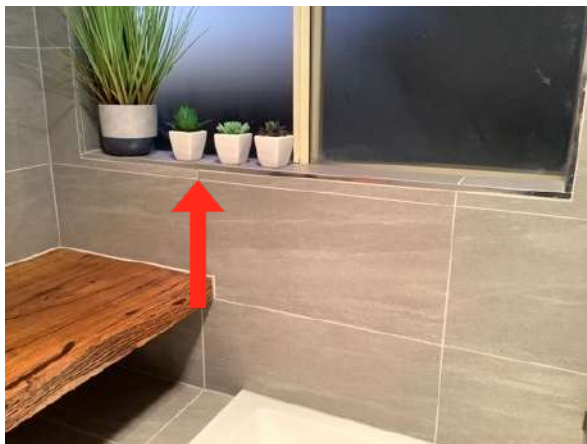
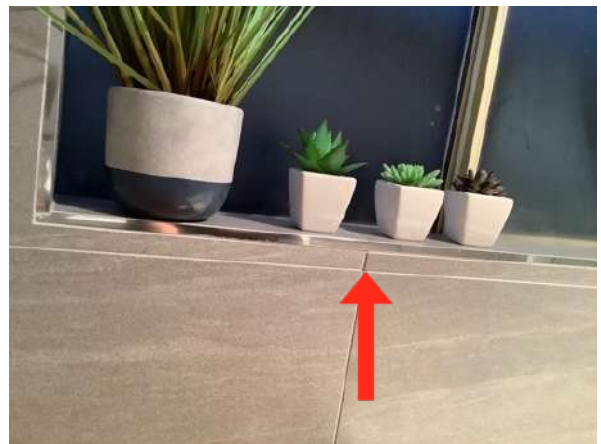
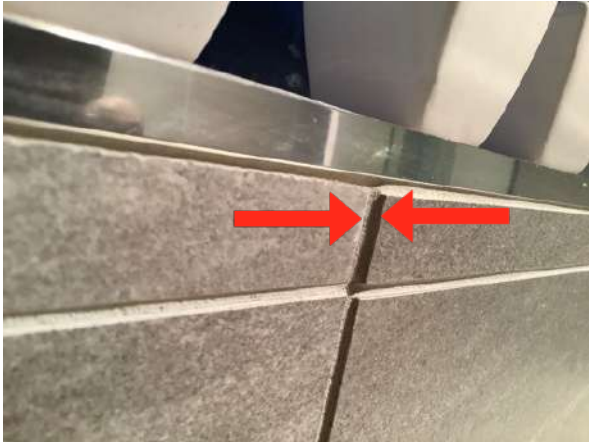
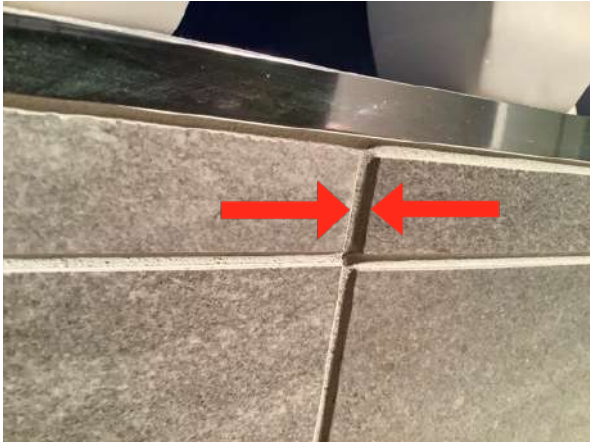
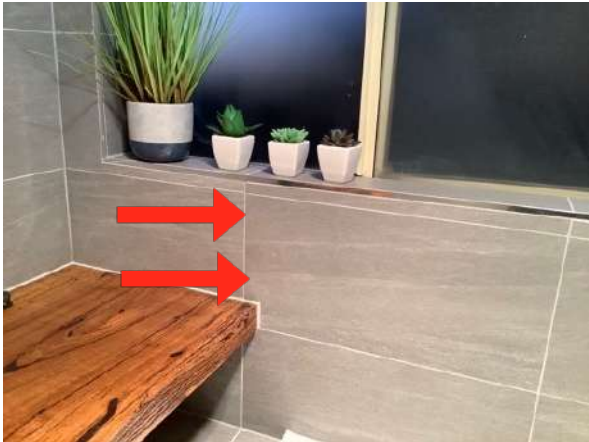
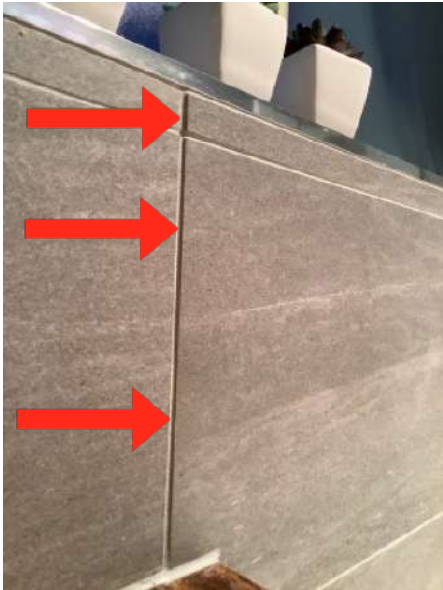
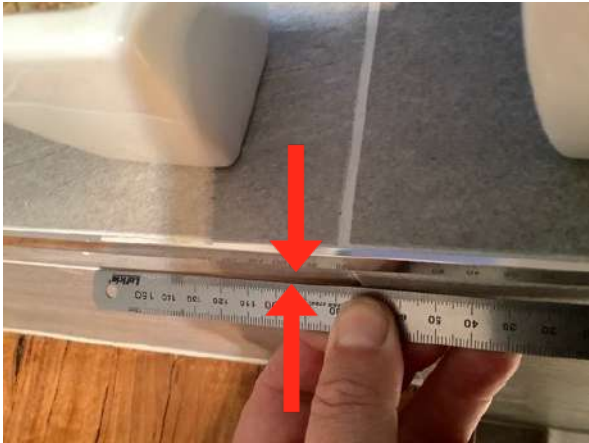
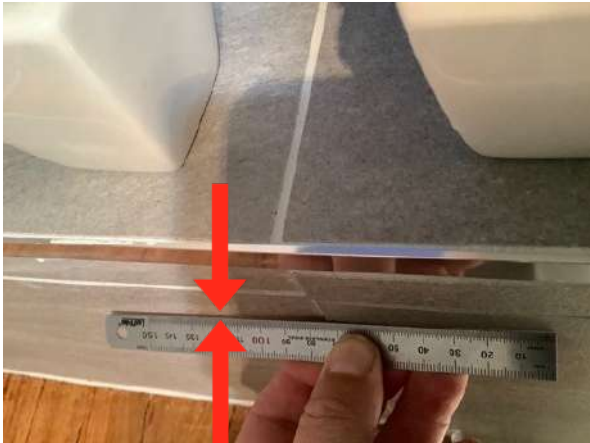
Non Compliant 2.04

When measured with a straightedge, tiling is defective if the finished surface of the tiling is not at and true to within a tolerance of ± 4 mm in 2m from the required plane.

Tiling is defective if the lippage between two adjacent tiles exceeds 2 mm. In the case of tiles where the surface has been ground at, for example polished tiles, tiling is defective if the lippage exceeds 1.5 mm; for joint widths of 3 mm or less the lippage should not exceed 1 mm.

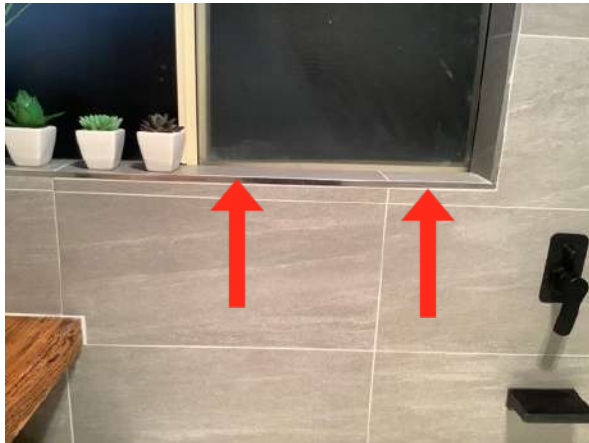
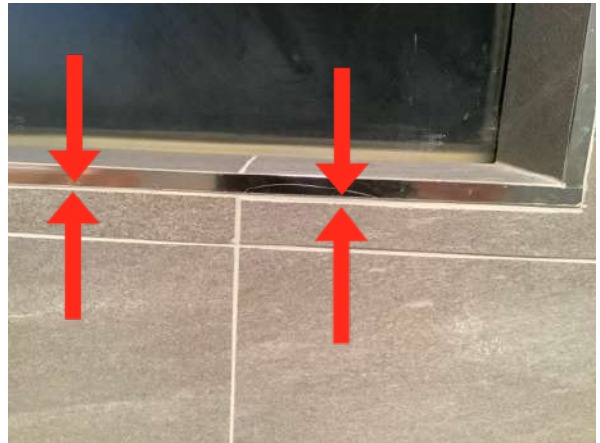
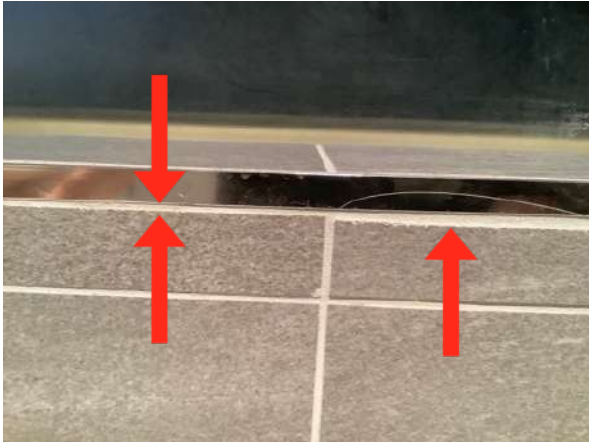
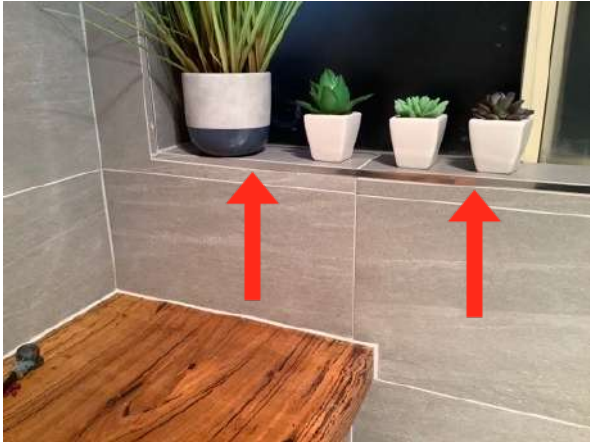
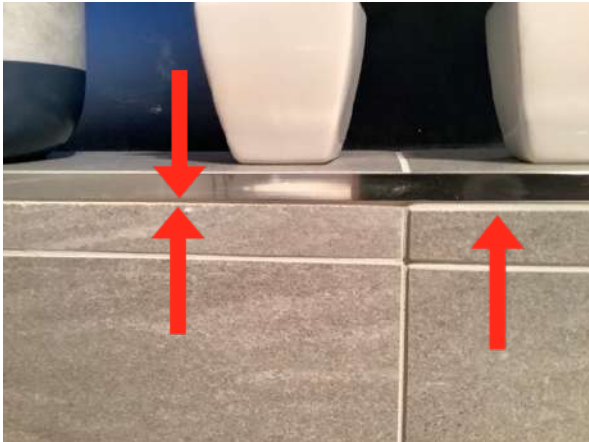
Non Compliant 2.05

Grouting is defective if it is not carried out in accordance with the requirements of Clause 5.7 of AS 3958.1.

Joints are defective if they are not, as far as is practicable, of consistent width and can be seen from a normal viewing position.

Finished grout is defective if it is not uniform in colour, smooth, without voids, pinholes or low spots.

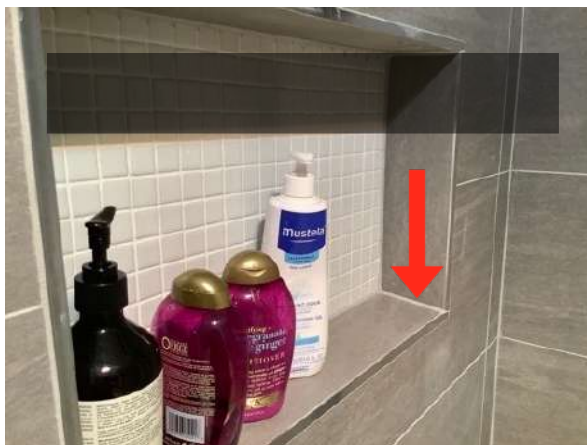
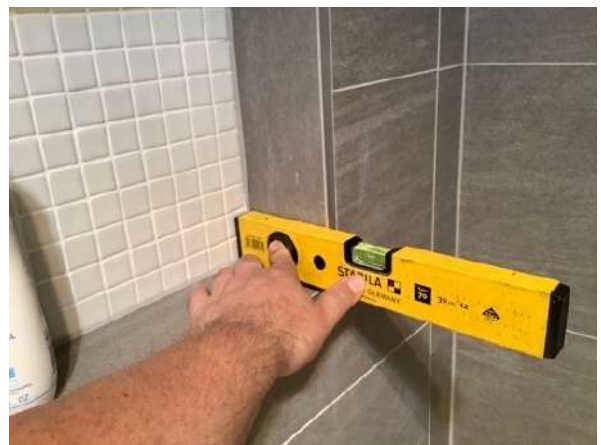
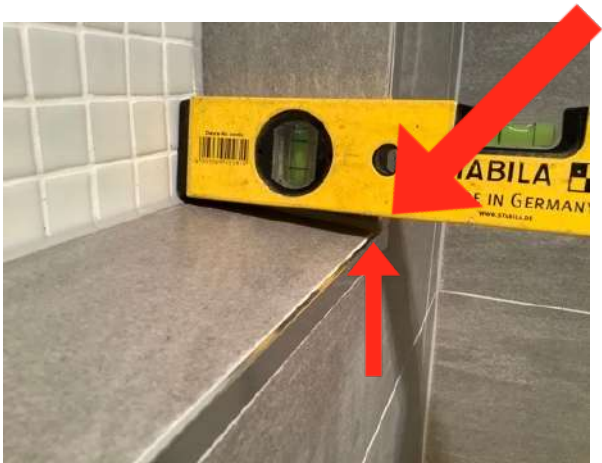
Non Compliant 2.06

The recess area to sit the shower accessories is on an excessive angle.

It is typical to have a minimal angle so that the water flows back into the shower, however The angle on the base of the recess area is not completed to a tradesmens like level of satisfaction and is visually not pleasant to look at, Particularly for a new bathroom.

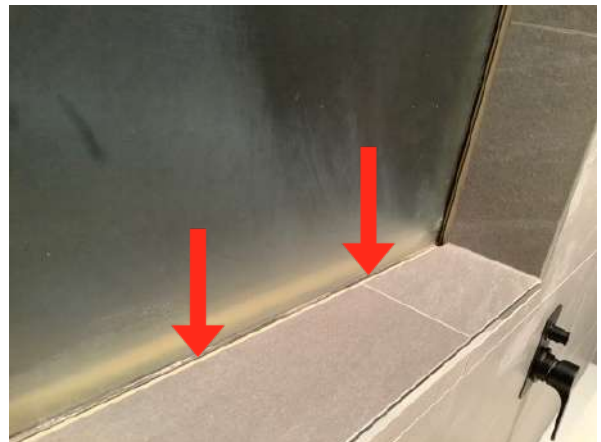
Non Compliant 2.07

The tiles to the base of the existing window should be flush with the base of the window frame, which is typical of normal for every installation of this type. In this particular case the height of the tiles far exceeds the height of the window sill, in fact you cannot visually see the bottom of the window.

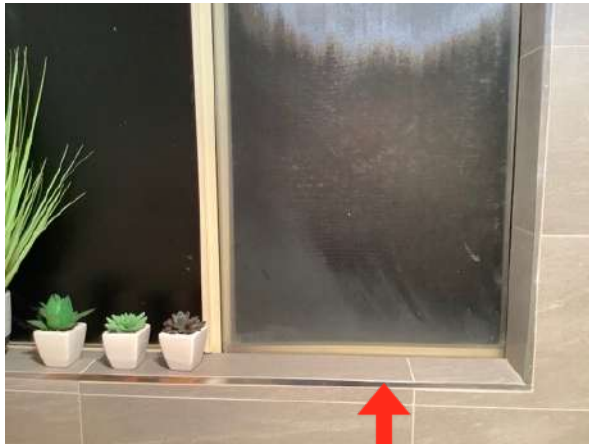
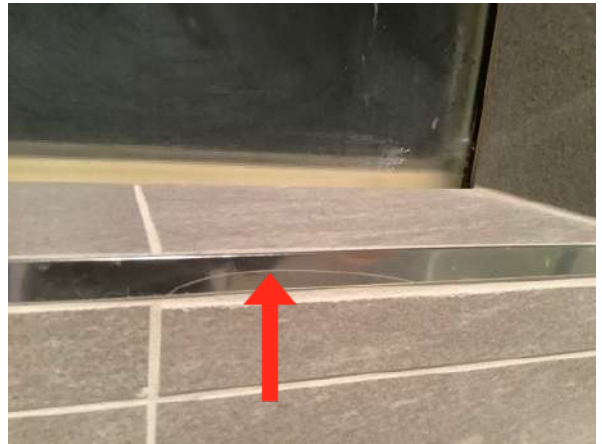
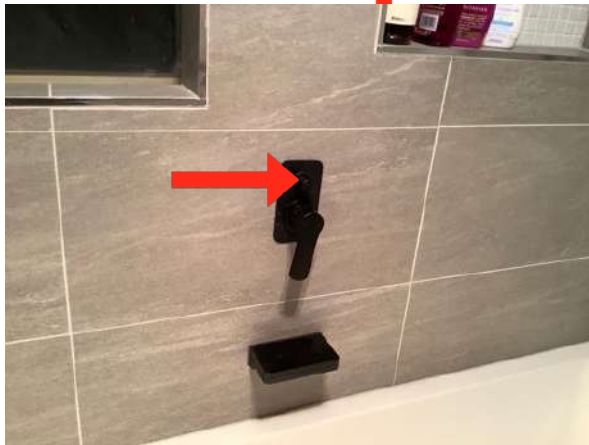
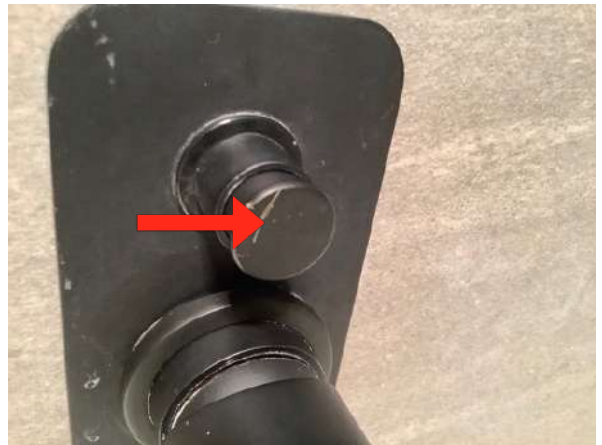
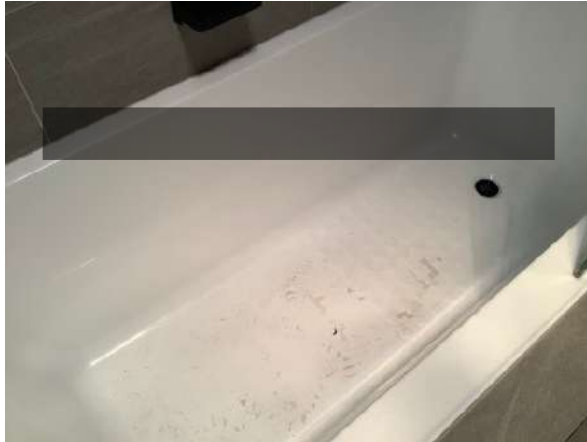
Non Compliant 2.08

Finding: Damages/ Faults - Appliances / Fittings / Tiles, Etc

It is identified that damage or faults affecting tiles, appliances and / or fittings supplied as part of the building contract have occurred. Where this is due to the builder's workmanship or damage occurring during construction it is considered a defect with respect to Standards and Tolerances - 18.02.

The builder must handover the bathroom completed as new and all damaged items that occurred during construction are required to be replaced as per the contract signed under the building act requirements.

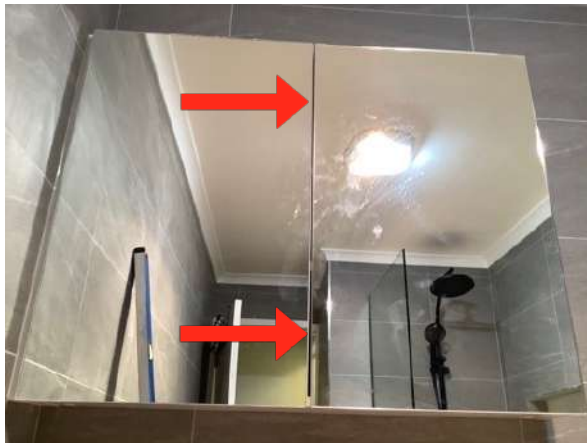
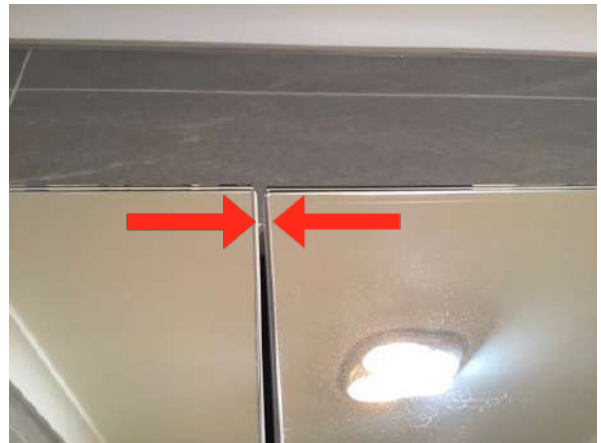
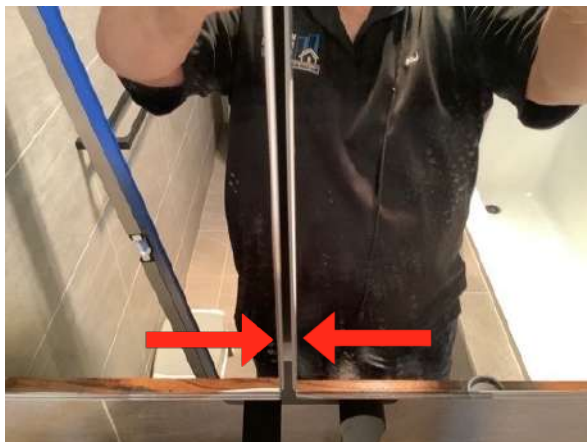
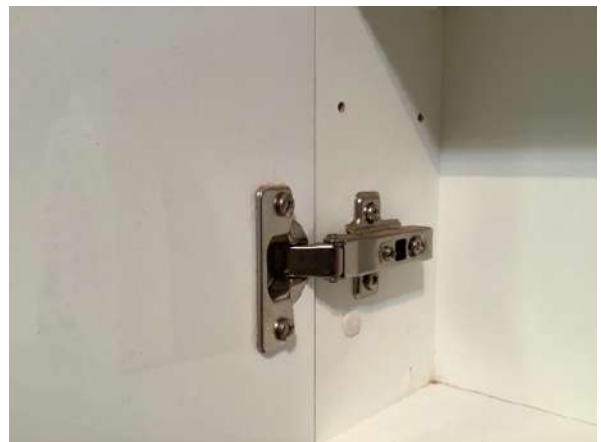
Non Compliant 2.10

It is observed that some of the cabinet doors are not aligned and / or have inconsistent gaps between the doors.

The Building Commissions, Guide to Standards and Tolerances clause 8.04 Internal Door Clearances, states- 'The installation of doors is defective if within three months of completion, clearances between door leaves and frames and between adjacent door leaves are not uniform and within 1mm. A clearance between door leaves or between a door leaf and the frame is defective if it is less than 2mm or greater than 5mm in width'

The gaps around these doors must be adjusted to comply with this tolerance.

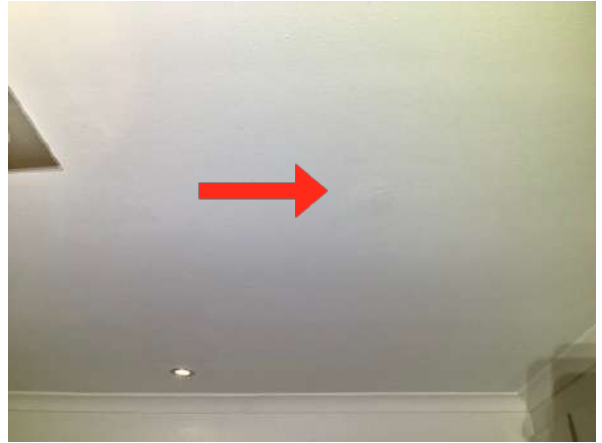
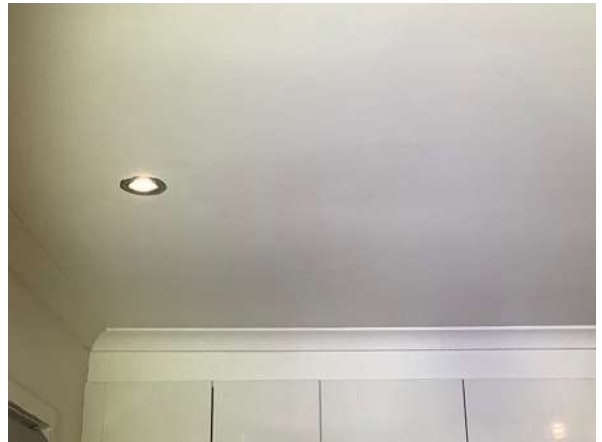
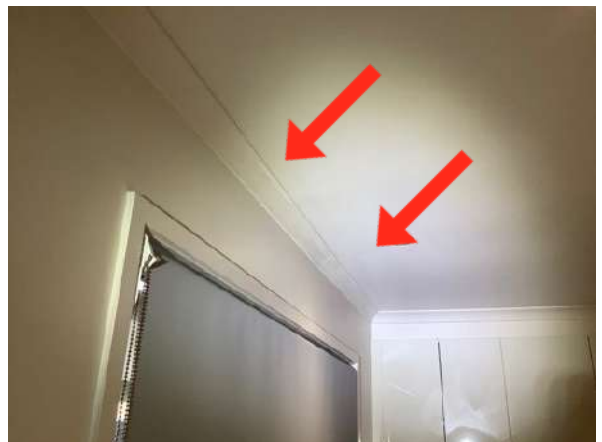
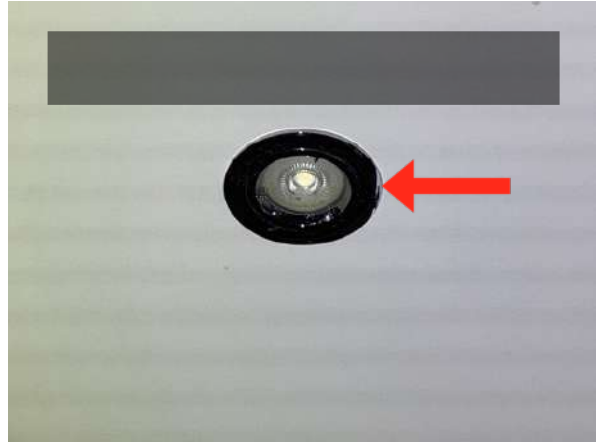
Non Compliant 2.11

Finding: Painting - Defective (AS2311)

The plaster ceiling downstairs had gotten damaged due to the builders works and whilst the builder has repaired the plaster and paint, the workmanship is well below standards.

Areas were identified where the surface finish of the painting was found to be defective. This includes areas of minor blemishes, missing painting, over-painting, paint runs, sags , lack of paint and/or wrinkling of paint finish.

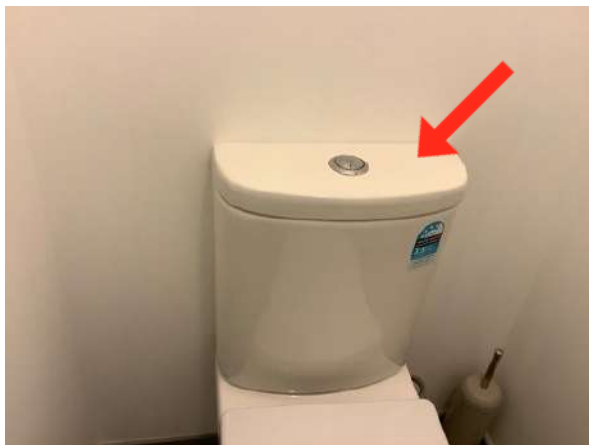
Non Compliant 2.12

Finding: Toilet Cistern - Loose Not Secured
The toilet cistern was found to be loose and relatively unstable at the time of inspection. It is suspected that this defect has developed due to defective Installation or sometimes it is just the design of the toilet, where the cistern just sits on top of the toilet pan.

If left unmanaged, the toilet cistern could deteriorate further and cause leaks and/or secondary damages.

It is recommended that the cistern be secured to the wall and if this is not possible we recommend just a couple of dabs of silicon behind the cistern and this will stabilise the cistern.

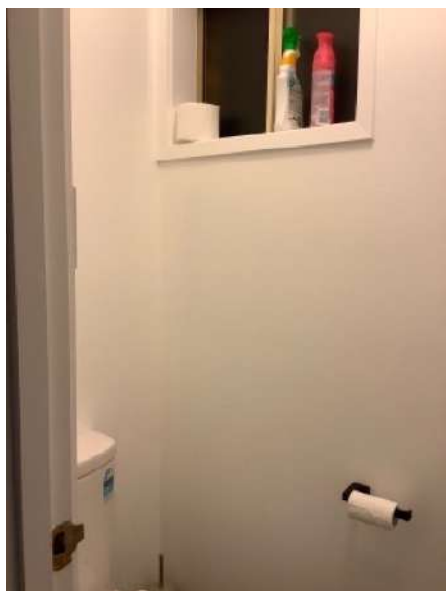
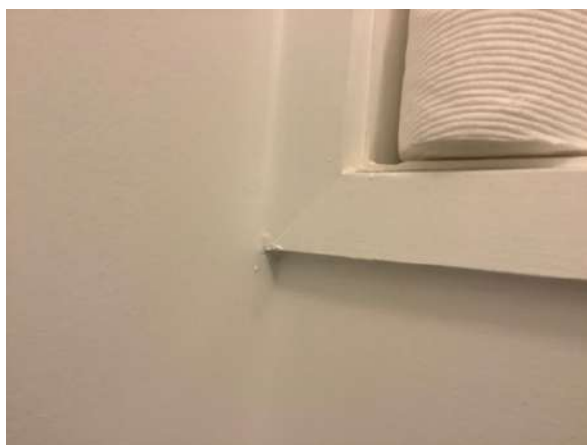
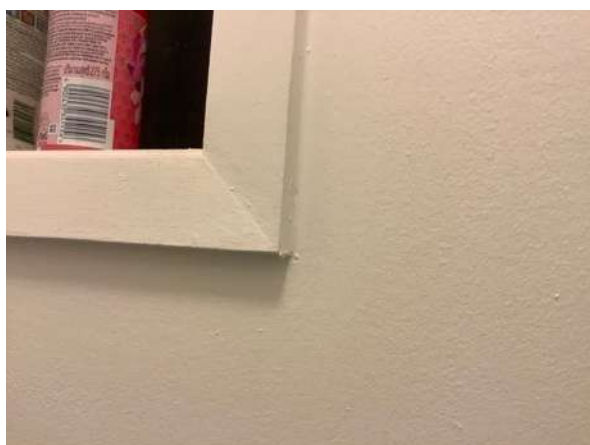
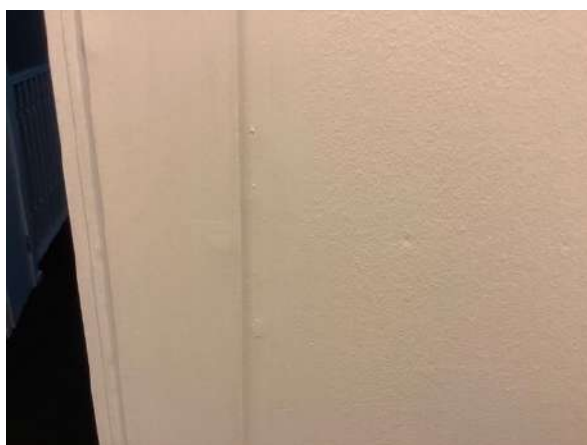
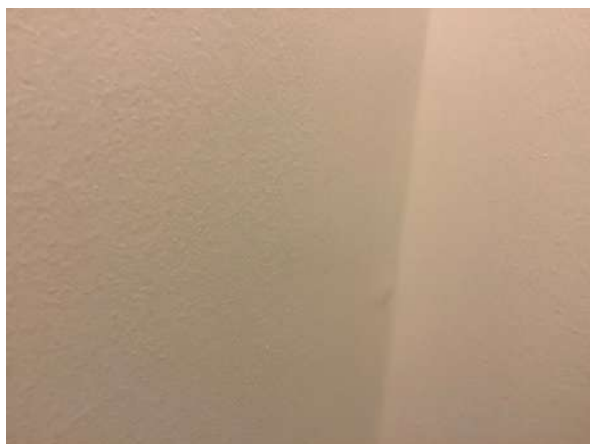
Non Compliant 2.13

Finding: Painting - Defective (AS2311)

Areas were identified where the surface finish of the painting was found to be defective. This includes areas of minor blemishes, missing painting, over-painting, paint runs, sags, lack of paint and/or wrinkling of paint finish.

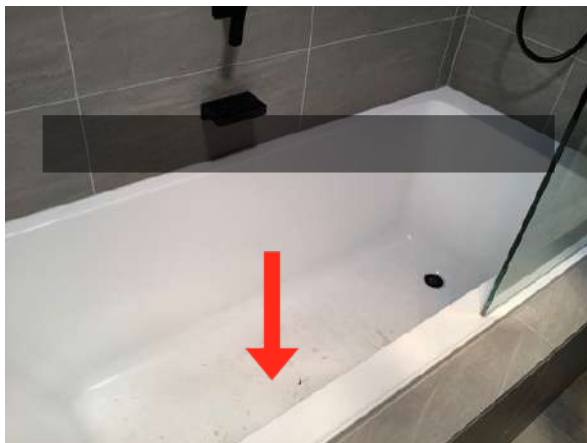
Substandard Workmanship 3.14

Drummy bath tub was identified at the time of inspection. The term `drummy` refers to bath tub that has become detached from its fixing and/or was never attached to a secure base underneath, which means that there are areas under the bath tub that have air pockets, this in fact means the structural integrity of the bath tub is compromised and in fact the client told me that the first time they used to shower the entire bath tub dropped and the builder had to come back to re-seal the bath tub. Unfortunately the bath tub is still Drummy and a repair by taking the bath tub out and reinstalling a proper base is the only way to give the bath tub it's structural integrity required.

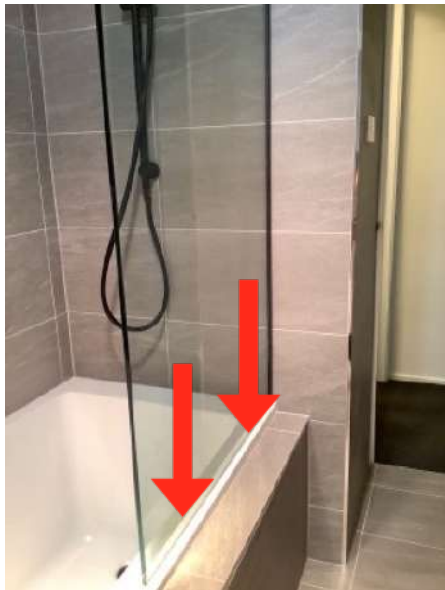
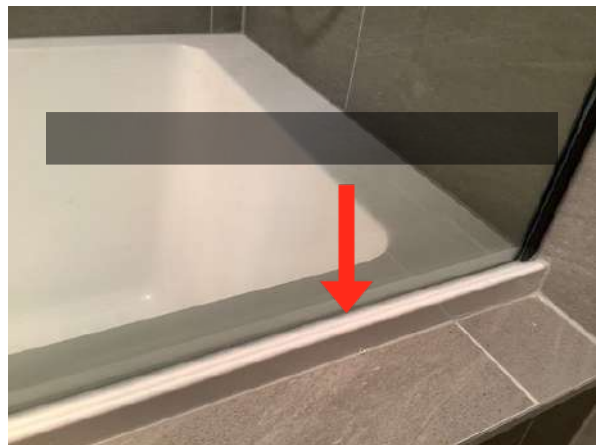
Substandard Workmanship 3.15

Finding: Shower screen installation – defective.
DOMESTIC BUILDING CONTRACTS ACT 1995, Act No. 91/1995, Part 2 - Provisions that apply to all Domestic Building Contracts.

The shower screen has no bottom bracket, which is the same normally as the wall bracket. This is so that the glass sits inside the bracket to give the glass its structural integrity required.

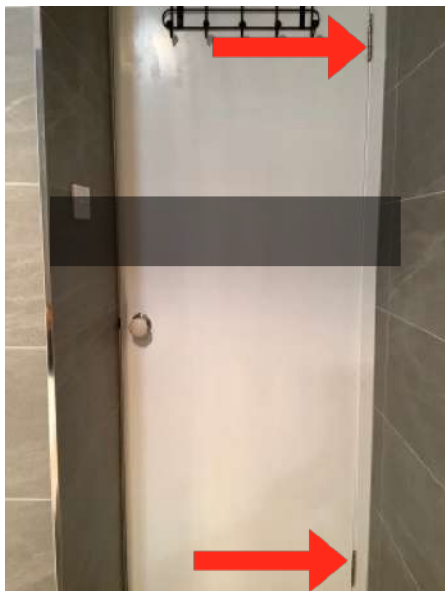
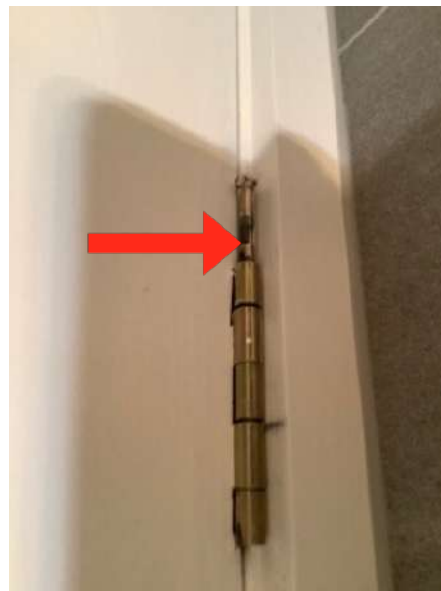
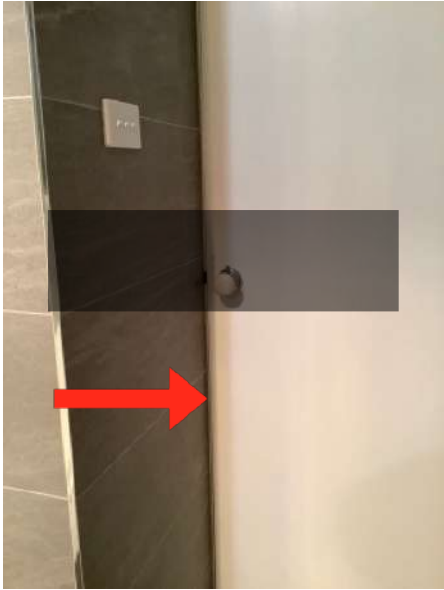
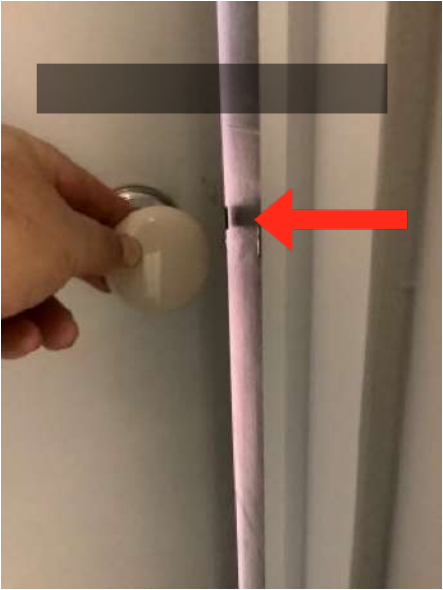
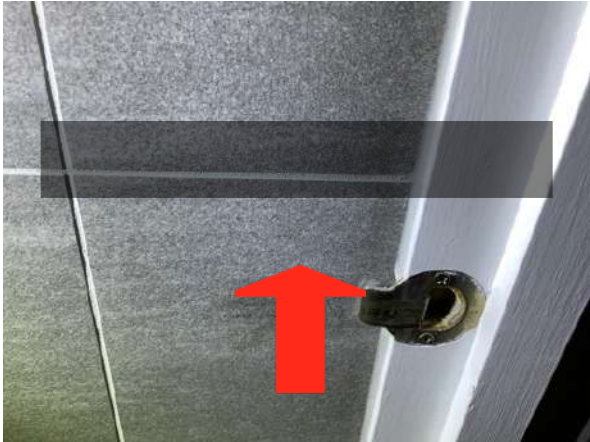
Substandard Workmanship 3.16

Finding: Door installation defective.
DOMESTIC BUILDING CONTRACTS ACT 1995, Act No. 91/1995, Part 2 - Provisions that apply to all Domestic Building Contracts.

The door hinge pins are not installed all the way through, this sometimes it's because the builder cannot get the door to operate correctly. Also the door latch, as it is closing is hitting the wall, it is obvious the builder has not installed the door frame correctly and allowed enough gap between the door frame to the wall and now the operation of the door is not functioning as intended.

In addition the door latch is hitting the tiles and damaging the tiles.

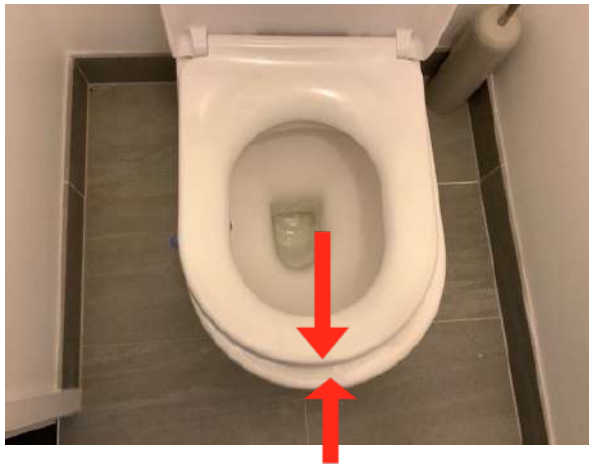
Substandard Workmanship 3.17

Finding: Toilet seat defective
DOMESTIC BUILDING CONTRACTS ACT 1995, Act No. 91/1995, Part 2 - Provisions that apply to all Domestic Building Contracts.

The toilet seat does not appear to be the right size to the toilet pan. The client has paid for a new toilet so the toilet seat must fit the toilet pan as the manufacturer intended.

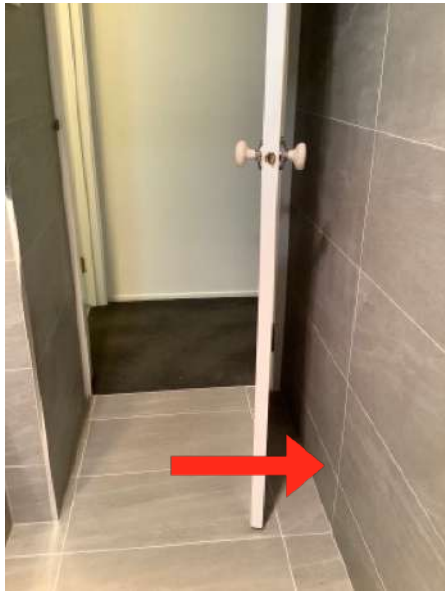
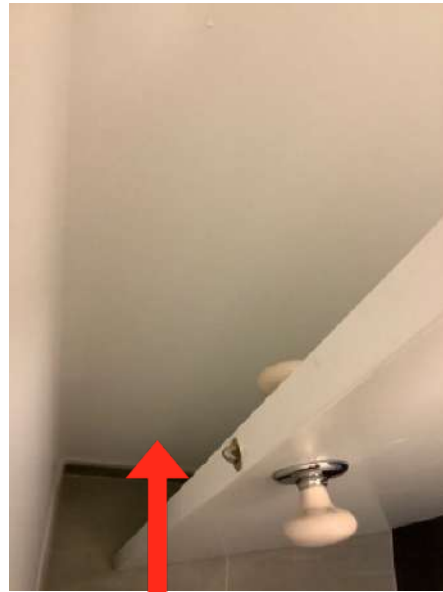
Incomplete 4.18

Finding: Door Stop - Missing.

The is no door stop to the opening door, leaving the door to swing and hit the wall, or cupboard which will damage the area the door hits and the handle.

An appropriate door stop should have been installed prior to handover .
