Building, Electrical, Asbestos & Termite, Timber Pest Report.

Inspection Date: 29 May 2020

Property Address: Ivanhoe Area

Report Type: Property and Timber Pest Report

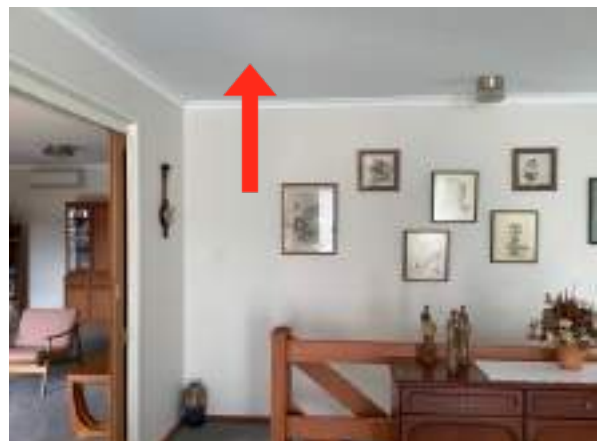
Serious Safety Hazard 1.01

Please note that this defect is highlighted as a caution only. We suspect, based on our experience in the building industry, that the absence of smoke detectors should be addressed as a matter of urgency to improve occupant safety.

A qualified electrician is required do these works for hard wiring.

Upon completion a safety certificate is required to be supplied to the owner of the building.

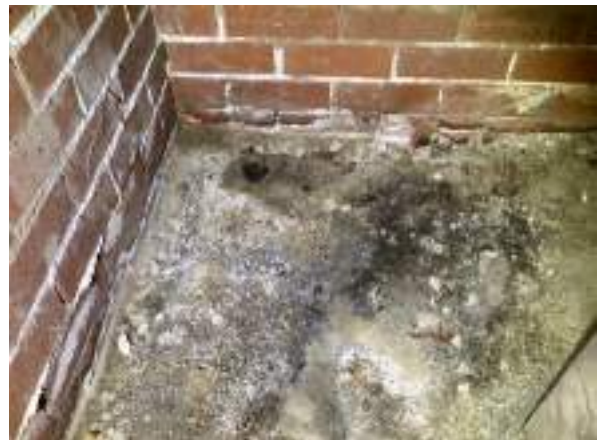
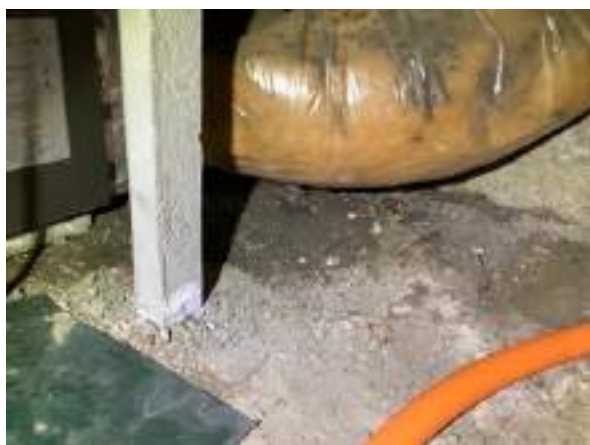
Serious Safety Hazard 1.04

Where evidence of mould growth was noted, there may be environmental, biological or health issues associated with the report. A specialist inspection by a suitably qualified environmental health inspector may be warranted where mould is extensive or where any queries regarding air quality spores or other related issues apply.

Finally the cause or source of the mould MUST BE TAKEN CARE OF URGENTLY.

Generally, the client is advised to ensure that the general environment is free of moisture and humidity to aid in the prevention of mould formation and development. Any mould found during the inspection should be cleaned immediately and/or taken out, particularly where the mould is in the silicon / caulking.

Please note that severely affected building elements may require replacement by a registered builder or qualified carpenter, however generally where mould is found in bathrooms benches, shower tile junctions, laundry sinks and all other wet area junctions you can get rid of the mould, once you take out the old caulking in most cases.

Heavy mould on walls, ceilings and under homes, generally will require professionals in this field, like hazardous material company's.

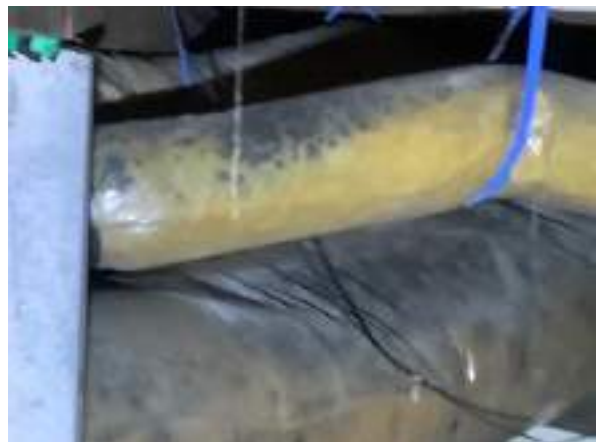
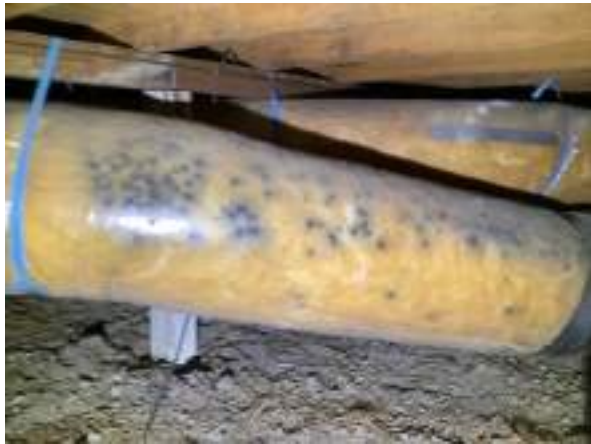
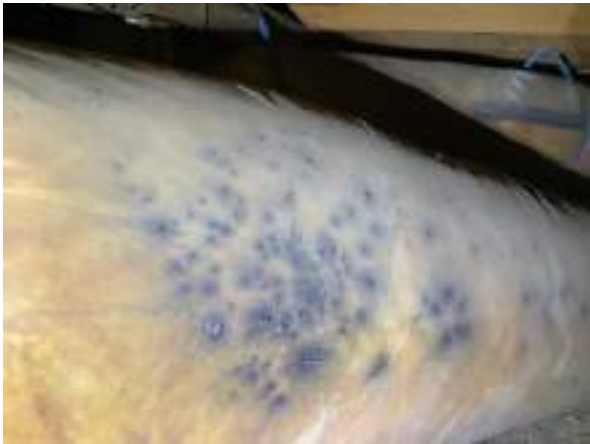
Serious Safety Hazard 1.05

Location: Subfloor

The ductwork under the house that is controlling the heating and or cooling appears to be quite compromised. I'm not sure if this is mould as visually seen with the black spots or something else however I highly recommend that you further investigate this matter as it could be a health risk.

Where evidence of mould growth was noted, there may be environmental, biological or health issues associated with the report. A specialist inspection by a suitably qualified environmental health inspector may be warranted where mould is extensive or where any queries regarding air quality spores or other related issues apply.

Generally, the client is advised to ensure that the general environment is free of moisture and humidity to aid in the prevention of mould formation and development. Any mould found during the inspection should be cleaned immediately and/or taken out, particularly where the mould is in the silicon / caulking.

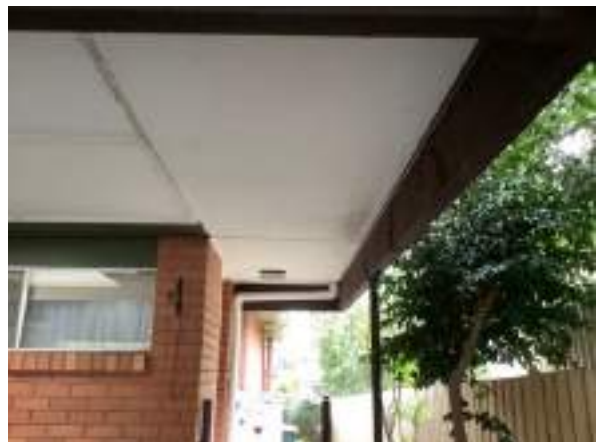
Major Defect 2.07

The damage to the eave sheeting in this area detracts from the appearance of the structure, as well as potentially compromising the structural integrity of the roofing area.

Where eaves show moderate to severe damage, remedial works may be required. Where water damage is suspected as being the underlying cause, appointment of a licensed plumber is advised as a matter of urgency to identify the source of the water leak.

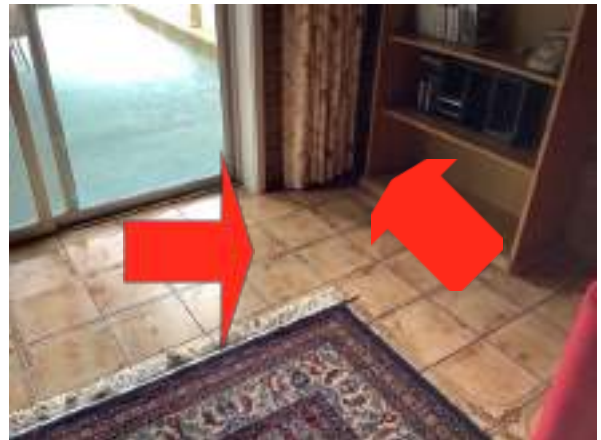
Minor Defect 3.09

If left unmanaged, water penetration to these areas may lead to subsequent water damage, which is likely necessitate repair work to affected building elements.

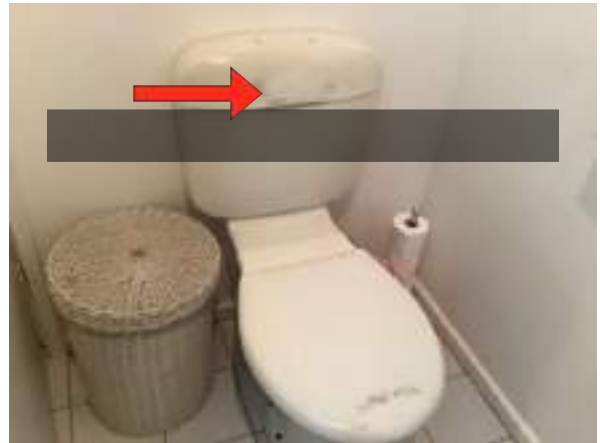
Minor Defect 3.10

Items like cracked glass mirrors, cracked glass windows and windows not operation smoothly are defects that should be repaired by the appropriate trades.

It is IMPERATIVE that you engage registered and qualified trades and at the end of there works they must supply certificates, such as an electrical safety certificate, plumbing and gas certificate if the works are electrical or plumbing, but for items such as damaged door handles, painting an experienced carpenter or handyman can sometimes be engaged.

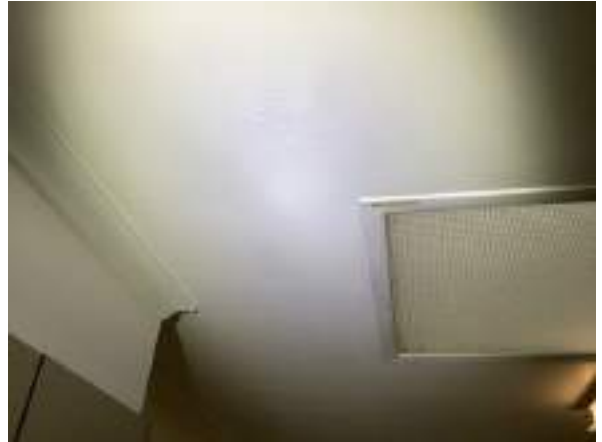
Minor Defect 3.13

Wet areas are the main areas that MUST have SUFFICIENT paint coverage to the walls, ceilings and timber work as moisture can deteriorate the areas.

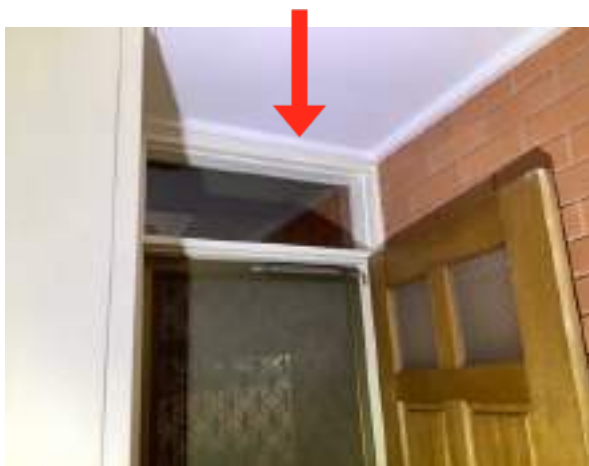
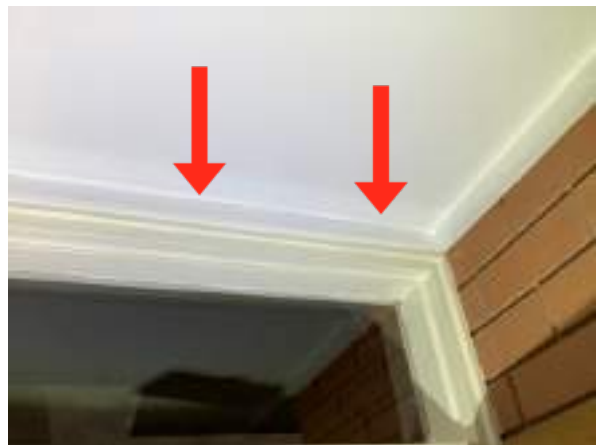
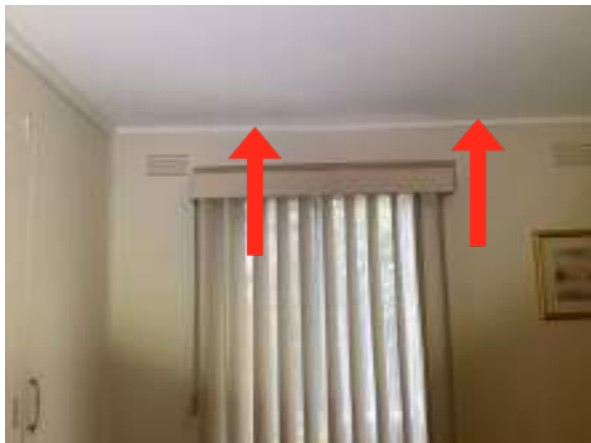
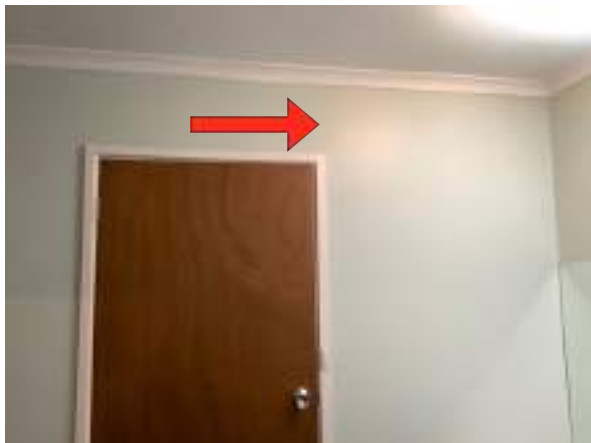
Minor Defect 3.14

Location: Entry, Hallway, Various Bedrooms, Main Bedroom

Cracking of this nature can generally be repaired with minor sanding, filling and/or repainting. Such works should be performed by a qualified painter or a general handyman.

Monitoring of all cracking should be conducted frequently. Always contact a building inspector should cracks widen, lengthen, or become more numerous.

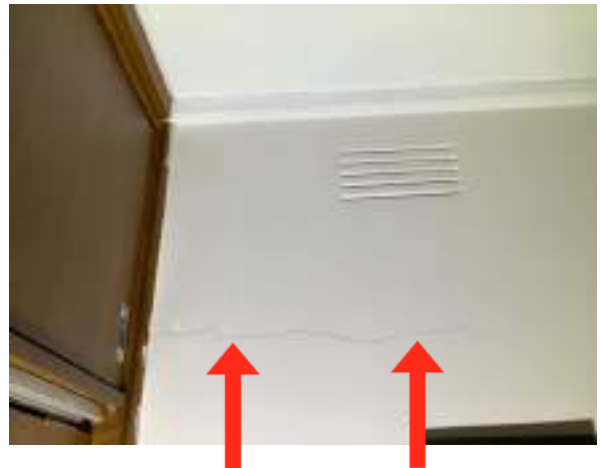
Minor Defect 3.15

Location: Front Bedroom East Side, Front Bedroom East Side, Laundry

Relevant tradespeople, such as carpenters, painters and plasterers, should be appointed to perform remedial works, as deemed necessary.

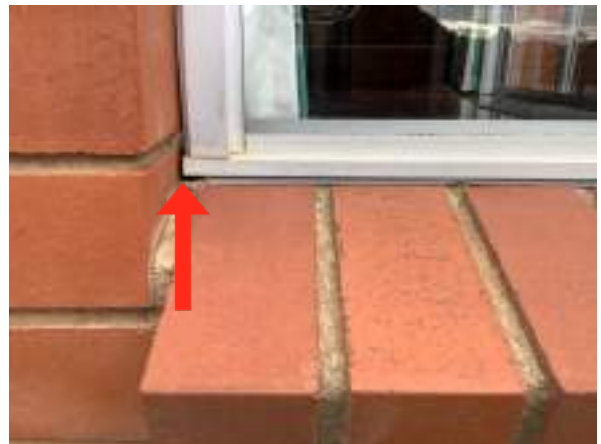
Minor Defect 3.20

Location: Perimeter Of Building - Exterior

It is important to note once caulking these areas if water damage is noticeable to windows, timbers, etc, such as wood rott, it is imperative to engage the appropriate trades for replacement or repairs.

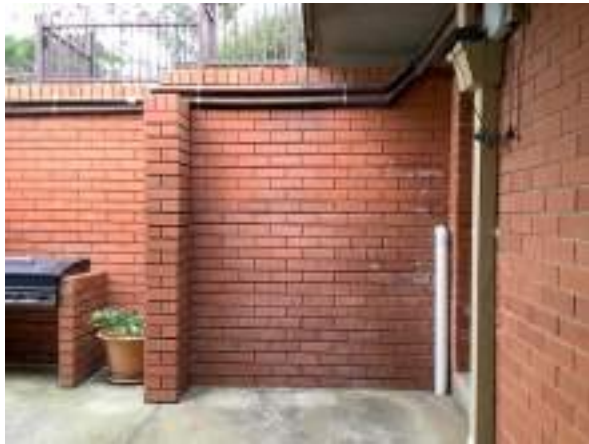
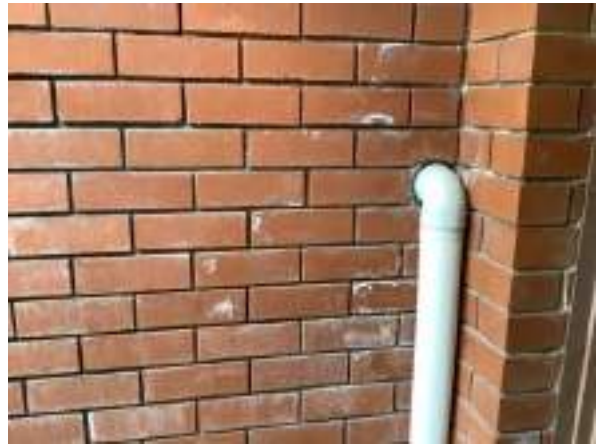
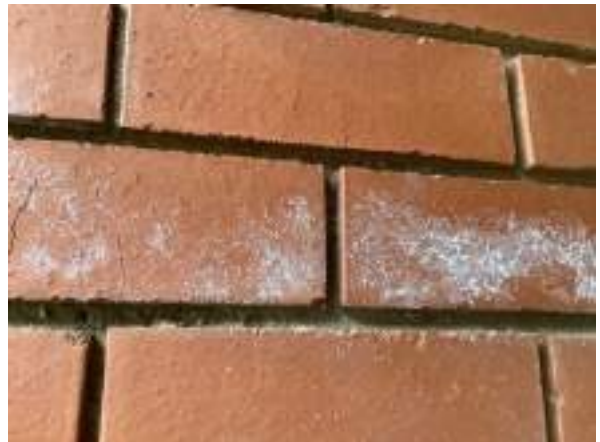
Minor Defect 3.22

Location: Brickwork

It is typically seen as white salt deposits on the surfaces of concrete pavement or mortar between bricks or tiles. While detracting from the overall appearance of the affected area, efflorescence is not likely to develop into secondary damage if left unmanaged.

Generally, soluble salt deposits can be removed by dry brushing with a stiff-bristled brush. Repeated dry brushing is an ideal treatment for eliminating this forming of efflorescence. A cleaning contractor or general handy person may be appointed to perform these works at the discretion of the client.

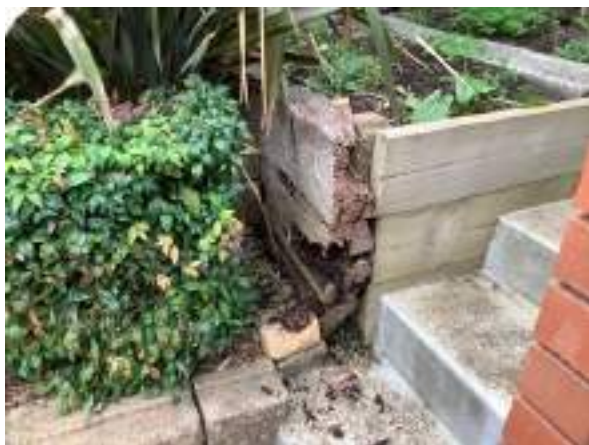
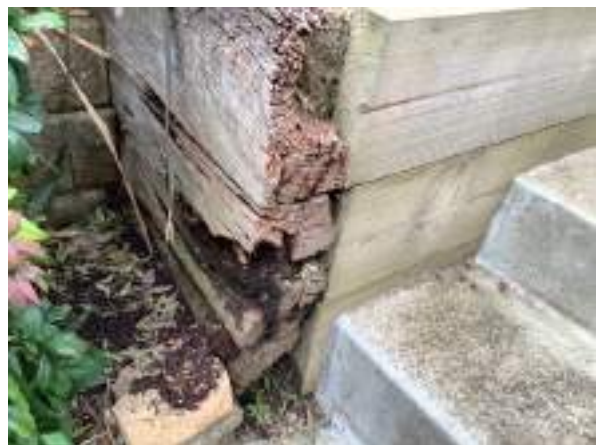
Minor Defect 3.25

The property is a very high risk for termites as the environments to the property are very conducive with many susceptible areas.

Please read the report carefully and Maintenance to all susceptible and conducive areas is a MUST to minimise the risk of termite and timber pest existence and timber damage.

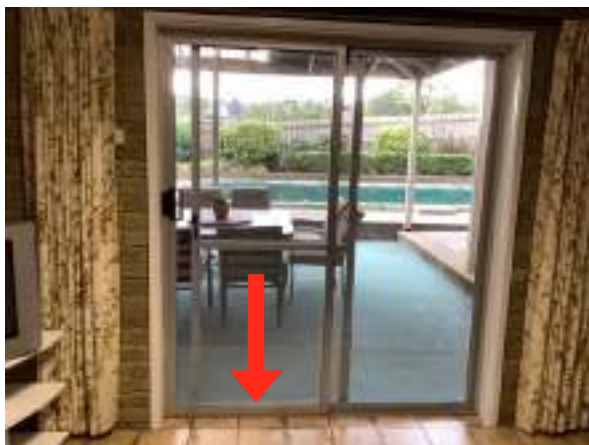
Minor Defect 3.28

Location: Downstairs rumpus Room

This may need cleaning, lubricating, adjusting or new parts.

This repair can be done by a handyman /carpenter or a window/door company.

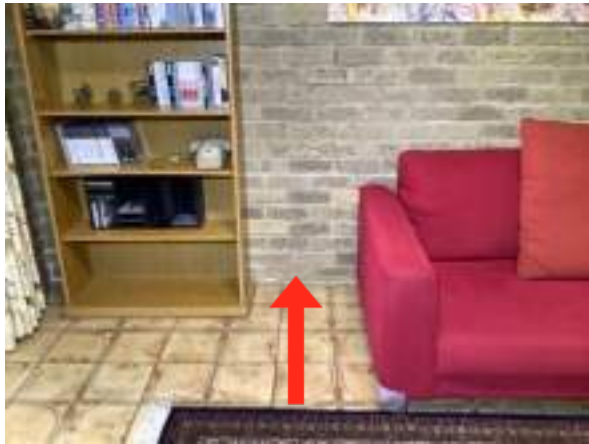
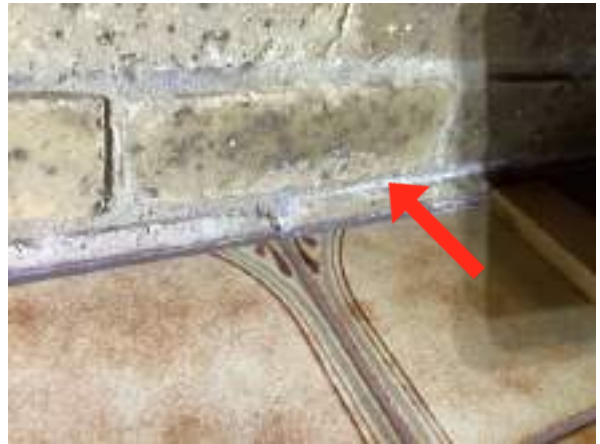
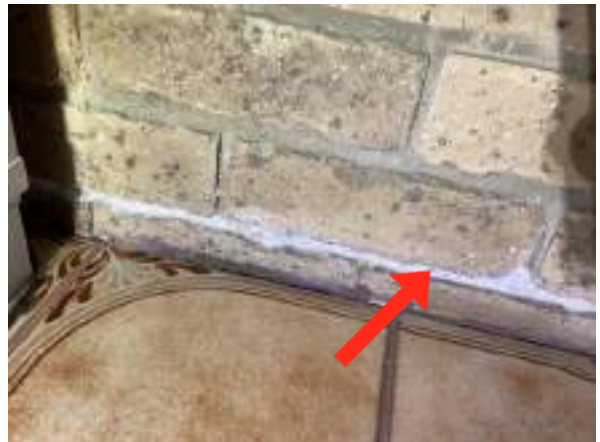
Minor Defect 3.29

Location: Downstairs Rumpus Room & Subfloor Areas

It is typically seen as white salt deposits on the surfaces of concrete pavement or mortar between bricks or tiles. While detracting from the overall appearance of the affected area, efflorescence is not likely to develop into secondary damage if left unmanaged.

Generally, soluble salt deposits can be removed by dry brushing with a stiff-bristled brush. Repeated dry brushing is an ideal treatment for eliminating this forming of efflorescence. A cleaning contractor or general handy person may be appointed to perform these works at the discretion of the client.

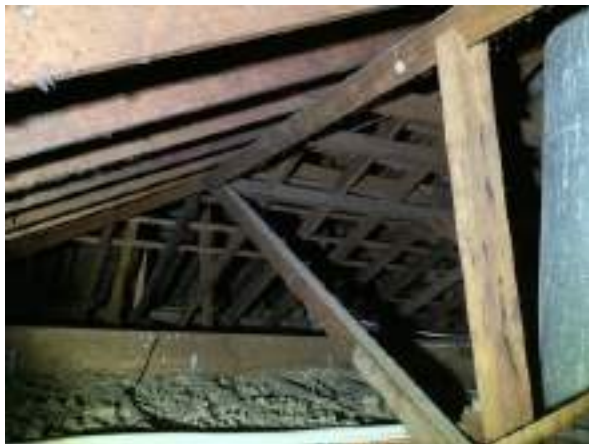
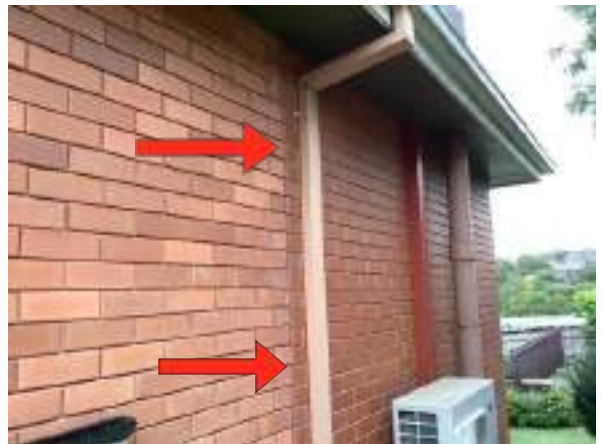
Finding: House Extension

I would like to note that this home has had an extension, as you can see by the roof space area where the original roof finishes and the new roof has started, also the exterior as shown in the photos attached.

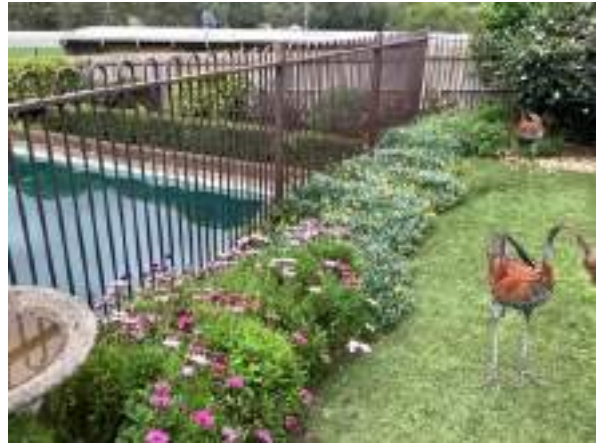
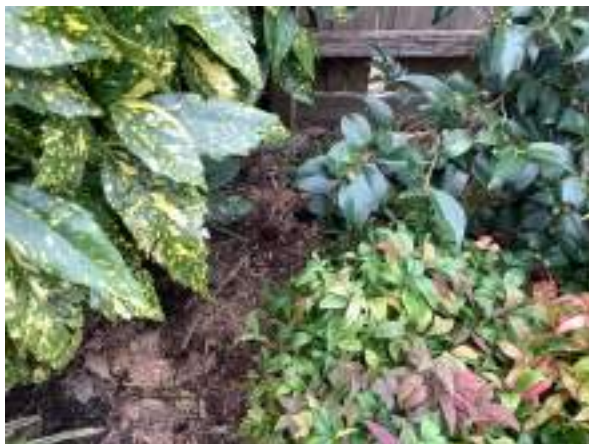
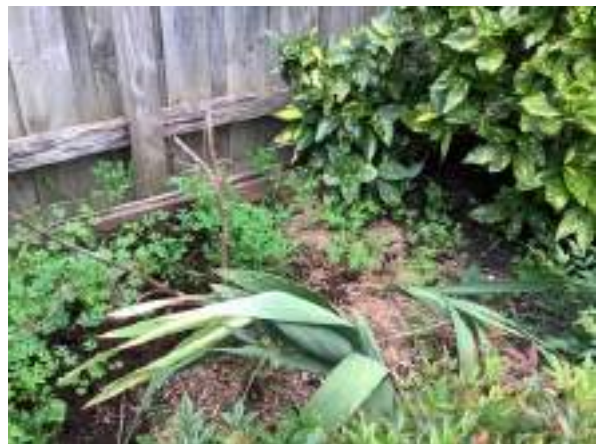
Finding: Garden Beds - Conditions Conducive to Termites
Garden beds were found to be evident in areas of garden areas.
These garden beds can include untreated timber, bark, excessive old vegetation and with a combination of moisture from watering hosing can make conditions very conducive to termite activity and termite ingress.
It is always important to keep the garden beds as clean as possible and take out excess old bark from the trees, leaves and keep bark mulch to a minimum or better introduce rocks or some item that does not create an conducive environment for termites and hold excess moisture.

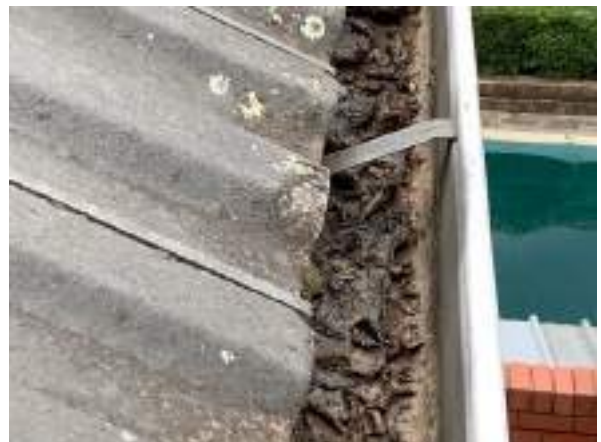
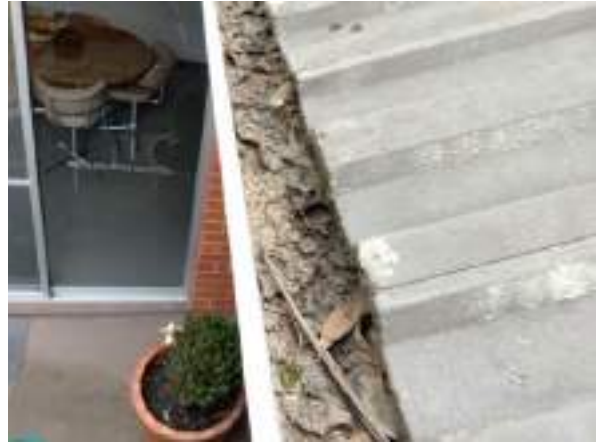
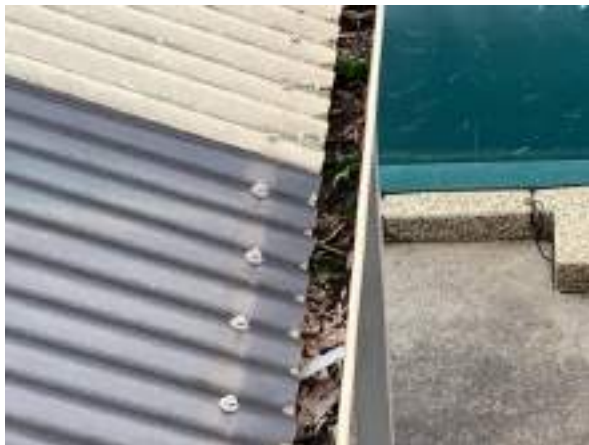
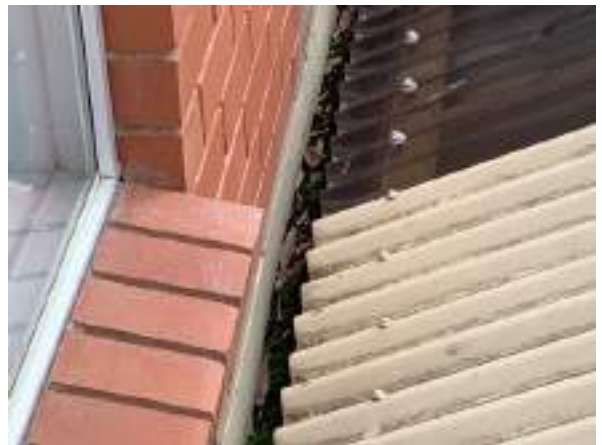
Item 2.04

Location: Roof Areas & Stormwater

Immediate clean up is required.

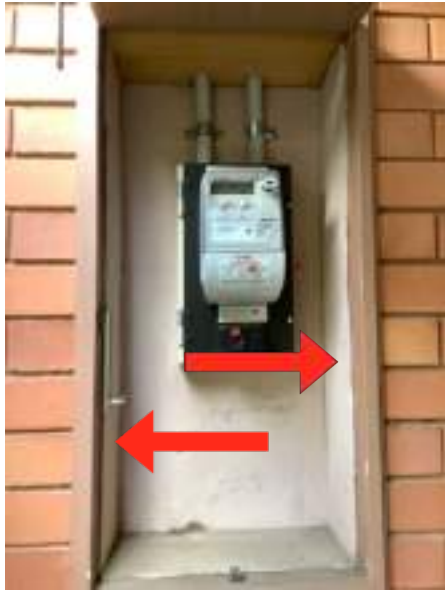
At the time of inspection, it appeared as though no termite management system has been installed, with no evidence to suggest preventative works taking place.

The client may consider gaining further advice from a pest controller as to the costs and procedures involved with this application. It is recommended that obtaining such advice be a short-term priority.
