Pre-Pour Concrete Slab

Inspection Date: 22 May 2020

Property Address: Lot 516, No 12, Mantle Street, Wollert, Vic

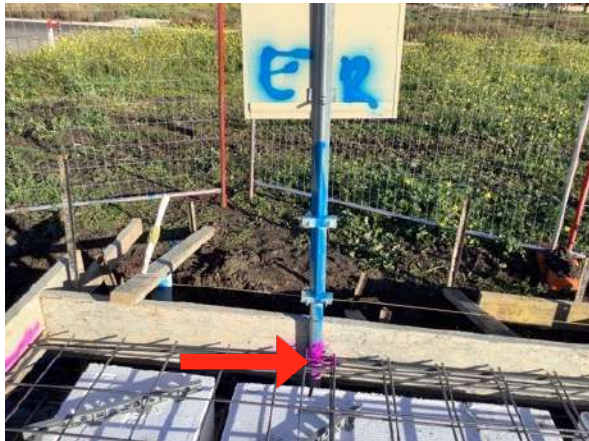
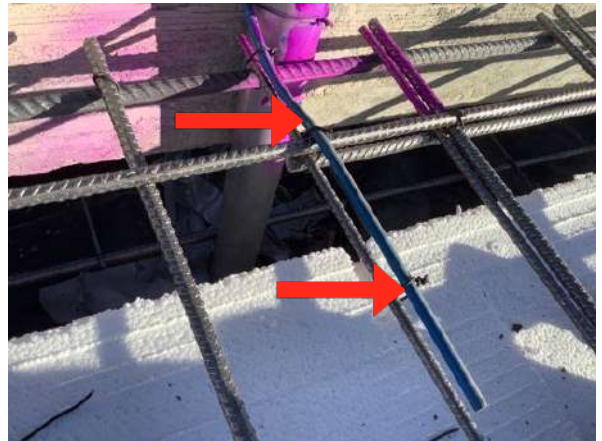
Safety Hazard 1.01

Finding: Defective Earthing To Steel Mesh.

The earthing facility installed to the dwellings slab steel as required in AS 3000 has not been completed as per AS3000.

I refer the builder to AS 3000, clause 5.6.2.5 that states "Any conductive reinforcing within a concrete floor or wall forming part of a shower or bathroom shall be bonded to the earthing system".

Whilst the earth bar is in location and tied, it needs to be tied and/or secured tight so that the bar is not loose to the steel mesh of the slab.

In this case I recommend a couple of additional ties that secure the earth bar to the steel mesh tight.

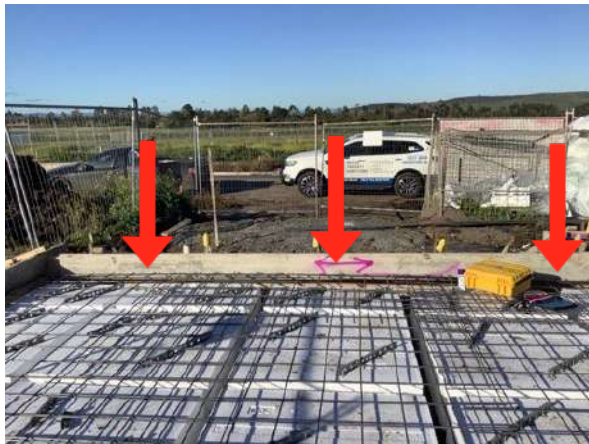
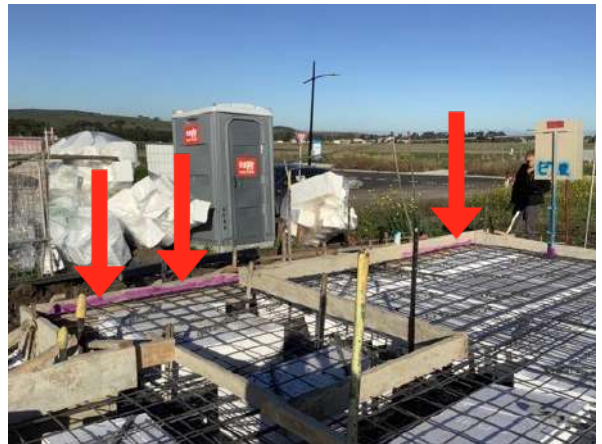
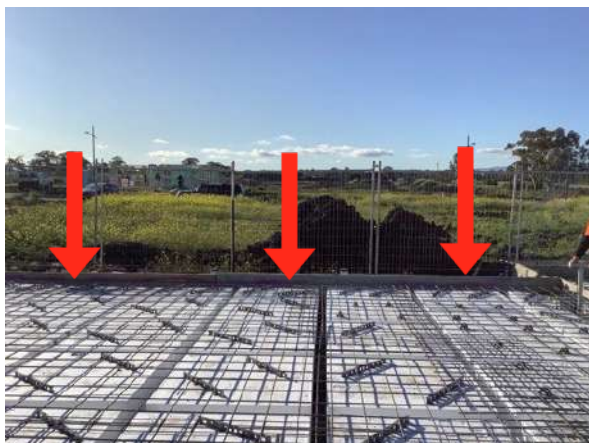
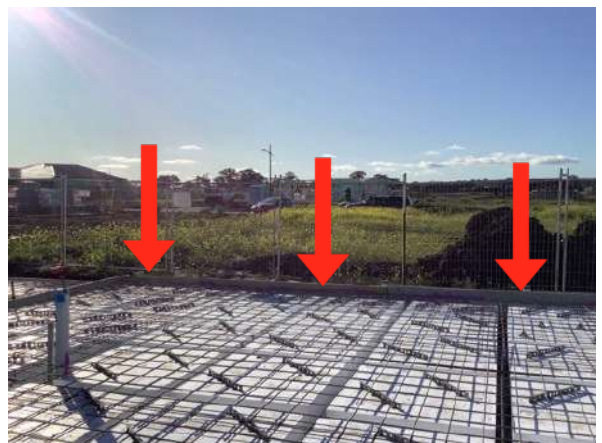
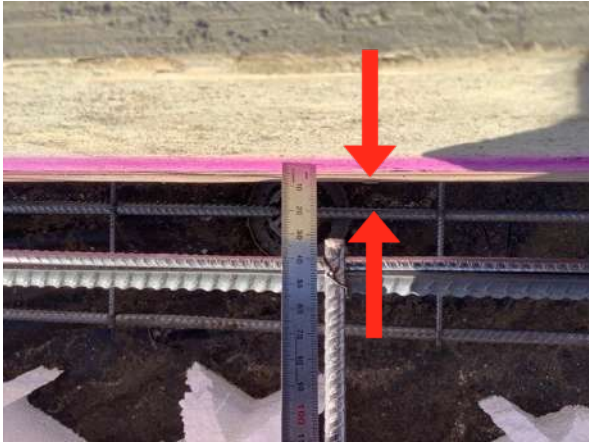
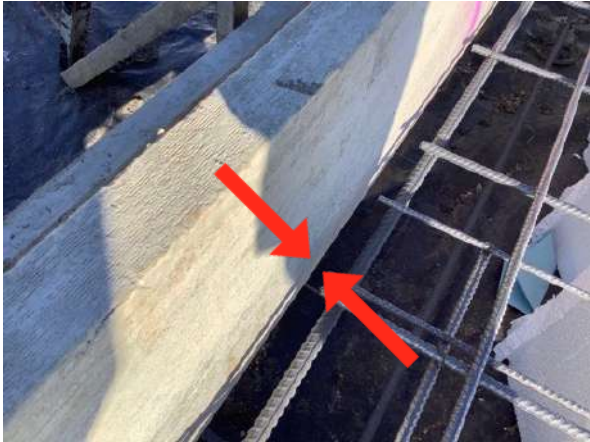
Non Compliant 2.02

Finding: Mesh Too Close To The Perimeter.

1. The reinforcement mesh is sitting too close to the perimeter boxing to sections of the dwelling. 40mm to external exposure, to the entire perimeter boxing is required.

(iv) 40mm to external exposure.

This mesh will need to be cut back or repositioned before the slab is poured to provide sufficient concrete cover to the reinforced steel.

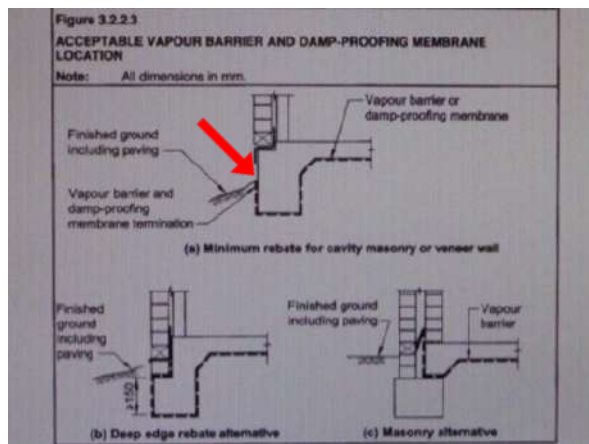
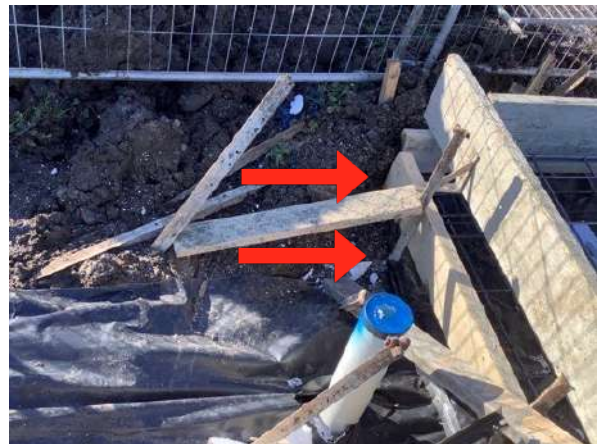
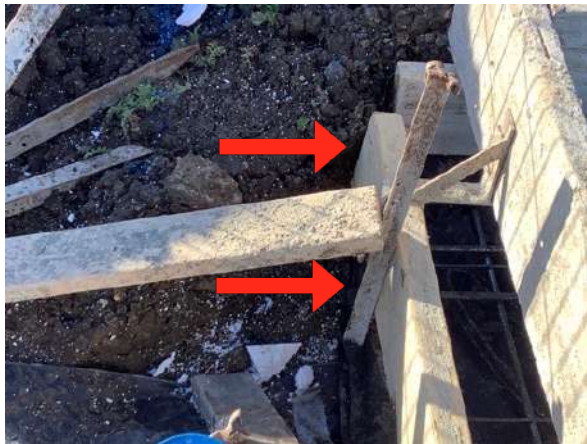
Non Compliant 2.03

Finding: polyethylene vapour barrier not installed as per BCA - Part 3.2.2.6
Defective Vapour Barrier Installation - Damaged/Punctured and/or overlapping Defective.

It was noted at the time of inspection that a vapour barrier had not be installed in accordance with AS2870 and BCA Part 3.2.2.6.

Whilst the majority of the vapour barrier system has been done correctly there are minor areas of non compliance to repair.

- 1/ All over laps are not taped as described below.
- 2/ All the ripples and/or damaged area needs to be taped.
- 3/ Some areas are not up to future ground and/or finished paving or concrete heights and must be extended with 200mm overlay and taped.
- 4/ Some areas whilst listed above are Damaged / Ripped / Not Consistent And Sealed with 200mm Overlay And Taped / Not High Enough / Non Existent must ALL be repaired.

Without a vapour barrier installed, these areas are non-compliant with Australian Standards and are susceptible to excessive moisture, which may create major secondary defects as the building ages. Rectification works are necessary as soon as possible to ensure all standards are met.

The polyethylene vapour barrier from beneath the concrete floor slab must be turned up the external side faces of its edge beams. Failing to install the vapour barrier correctly will allow moisture ingress via slab edge dampness into the internal timber wall skins and/or the floor coverings if not done.

The polyethylene vapour barrier must properly extended up the external side faces of the edge beams to at least the height of future finished ground level or paving i.e. 75mm below the damp-proof course and bottoms of the weepholes, after which any termite barriers that are in place, if required, will also need to be properly installed.

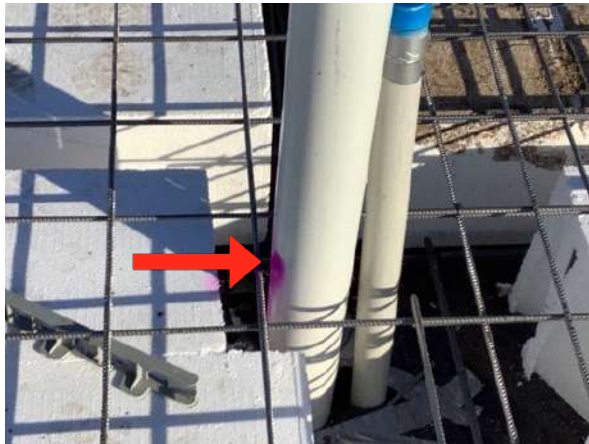
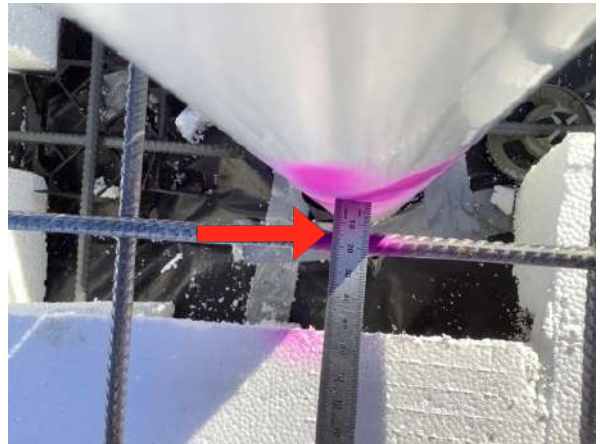
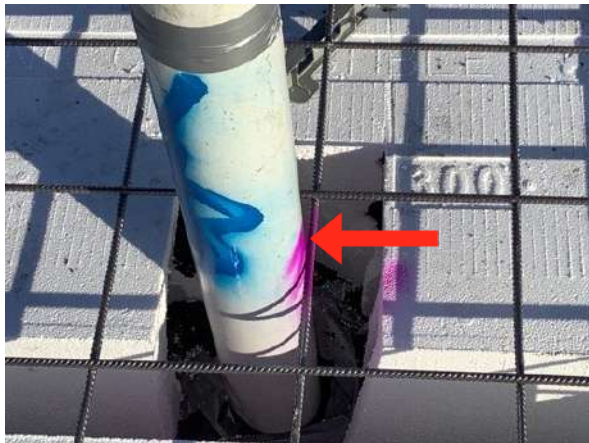
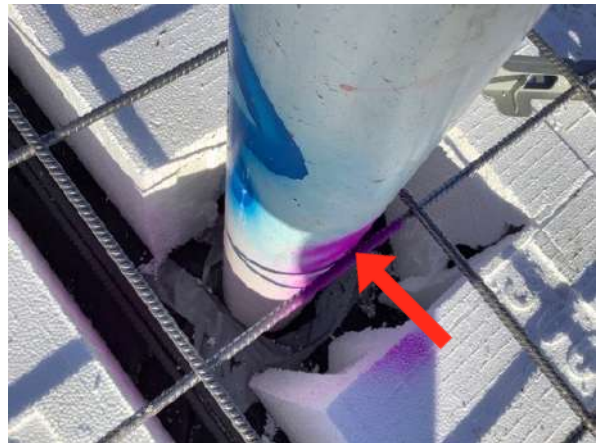
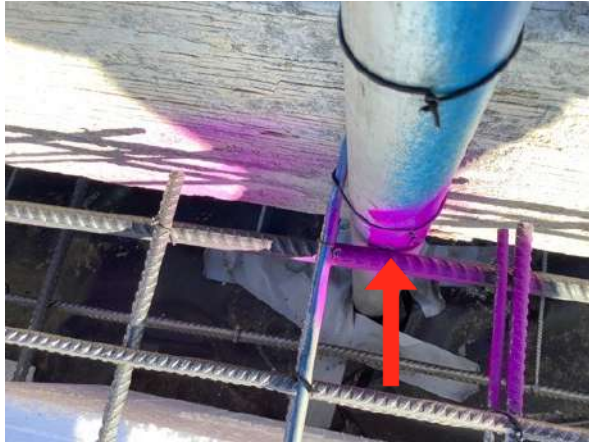
Non Compliant 2.04

Finding: Plumbing Pipe Clearance.

At the time of inspection it was found that distance between the plumbing pipes and the Mesh/Reo is NOT at a minimum clearance of 20mm.

Note all repairs required are sprayed with pink paint.

It is advised that all the Mesh/Reo that is not 20mm clearance to any plumbing be rectified before the concrete is poured.

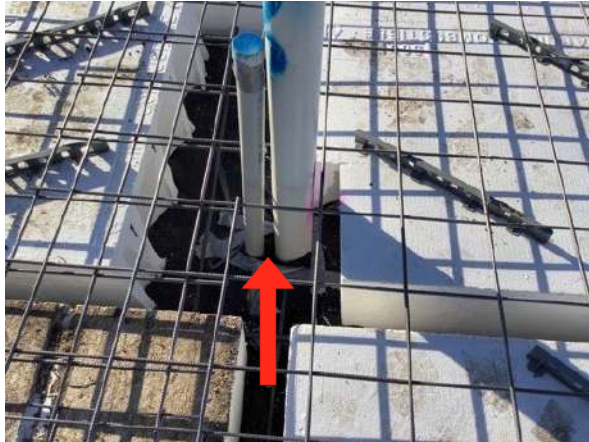
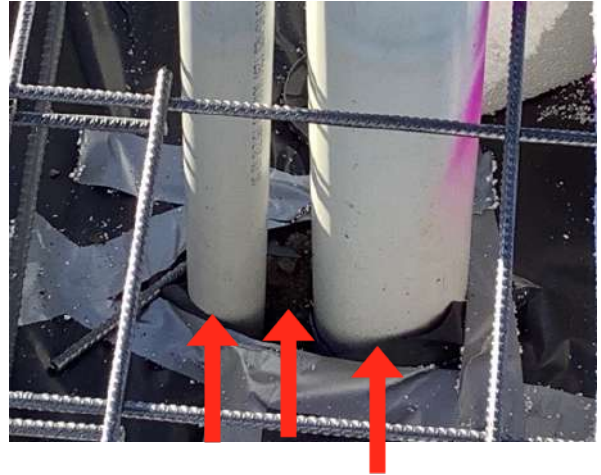
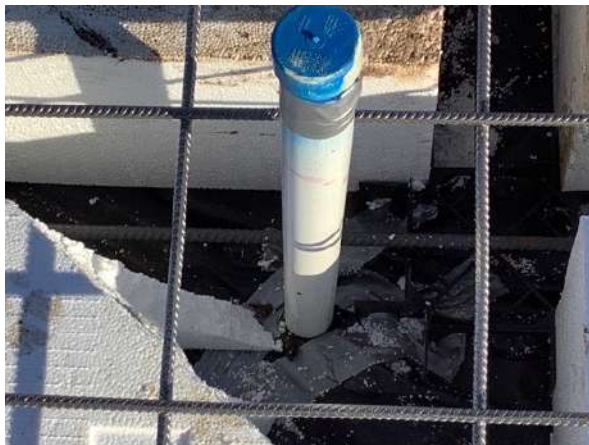
Non Compliant 2.05

Finding: Pipe penetrations through the vapour barrier.
The pipe penetrations through the vapour barrier have not been fully taped and require further works.
There are also numerous cuts and tears throughout the vapour barrier that have not been taped correctly.
These will need to be taped up and photographed before the pour is started.

- (i) lap not less then 200 mm at all joins. And
- (ii) tape or seal with a close fitting sleeve around all service penetrations.

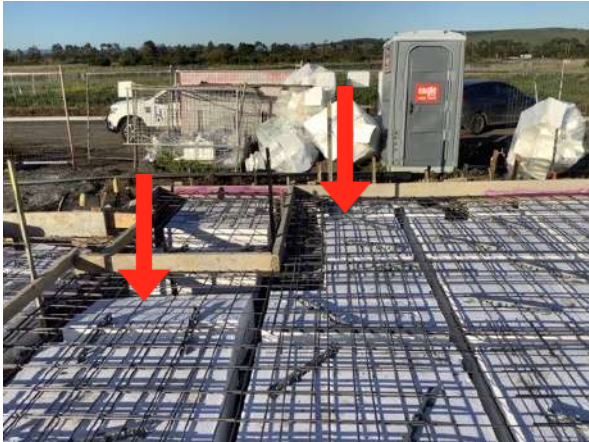
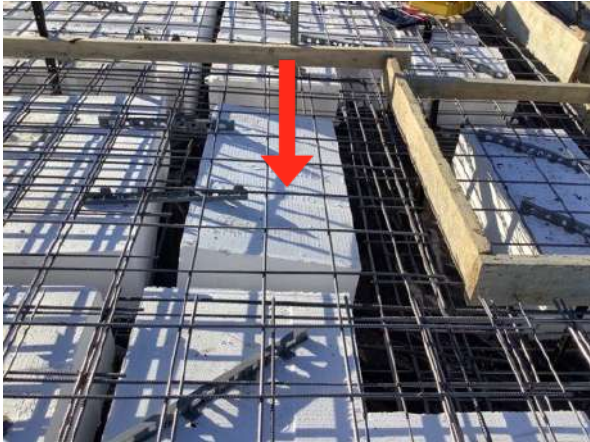
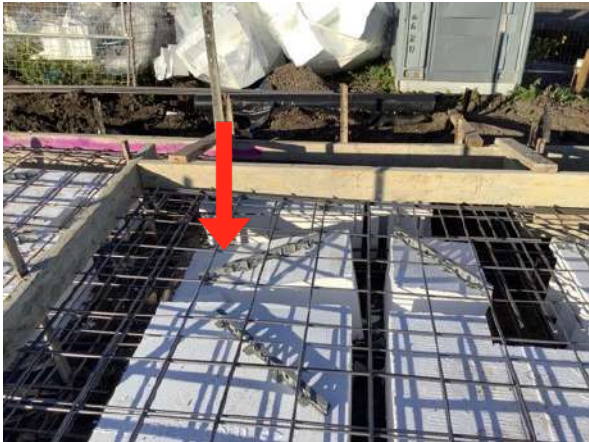
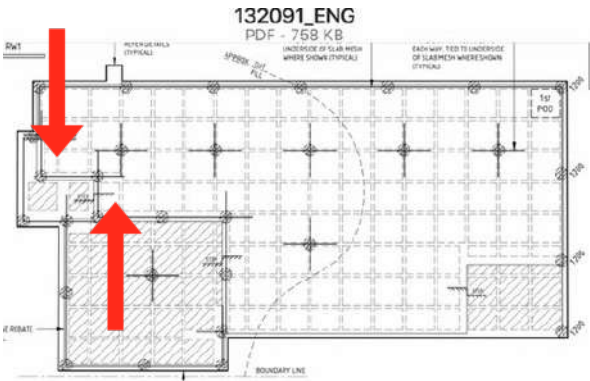
Substandard Workmanship 3.06

Finding: Completion - Not Satisfactory

The waffle slab support and steel mesh in these areas needs to be supported better.

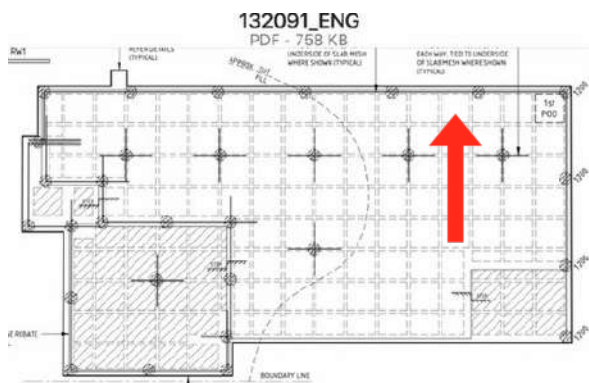
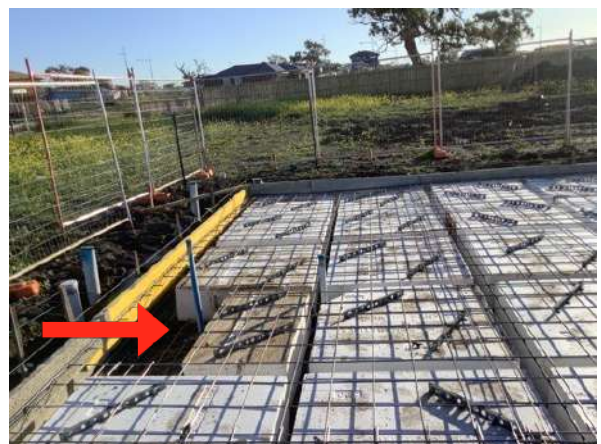
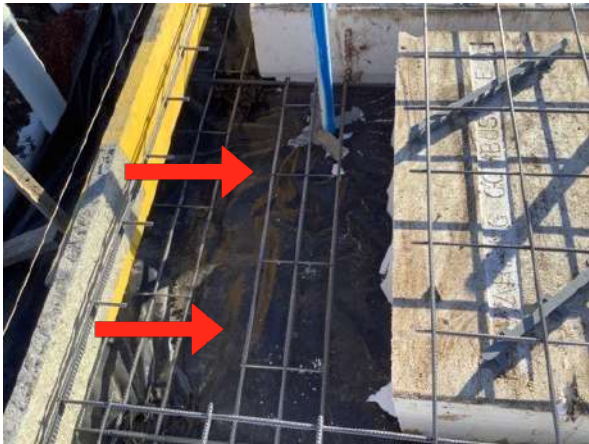
Incomplete 4.08

Finding: Slab alterations or trenching (AS2870)

It was identified that the slab steel has been cut and/or altered in this location.

The slab steel mesh and waffle does not comply or correspond with the engineering drawings in this location. This must be completed prior to concrete pour.

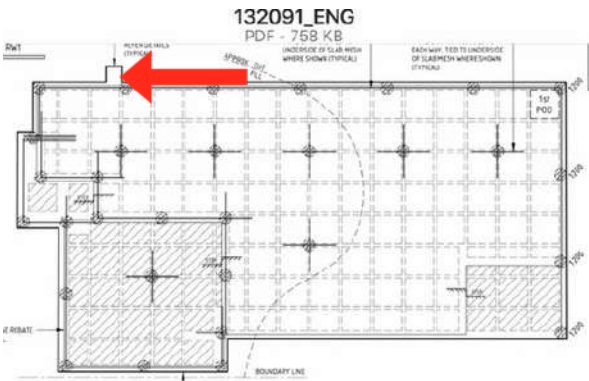
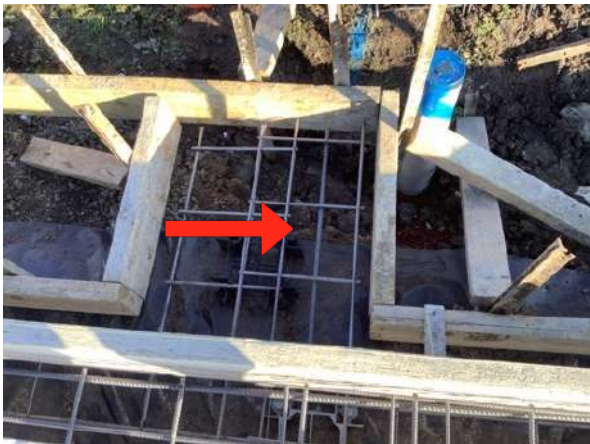
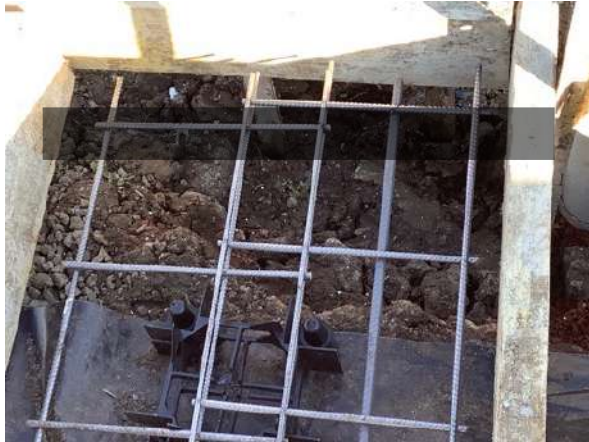
Incomplete 4.09

Finding: No Pad Installed For HWS.
The pad for the hot water service is not complete.

I recommend the vapour barrier system, be completed in this area.

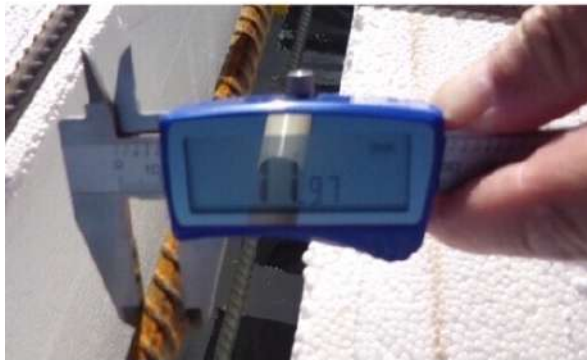
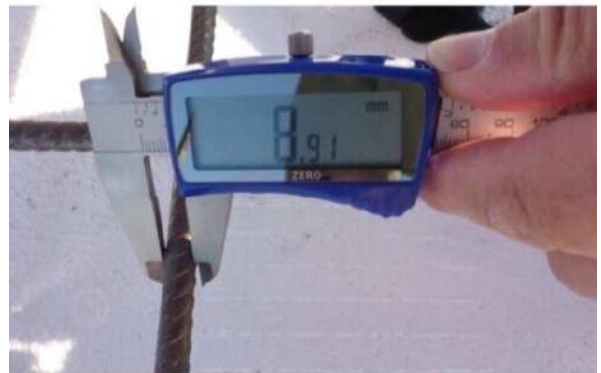
For Your Information 5.14

Finding: Thickness Of Steel Mesh.
