## Warranty Claim Report

Inspection Date: 7 May 2020

Property Address: Eastern Area Victoria

Report Type: New Home Construction

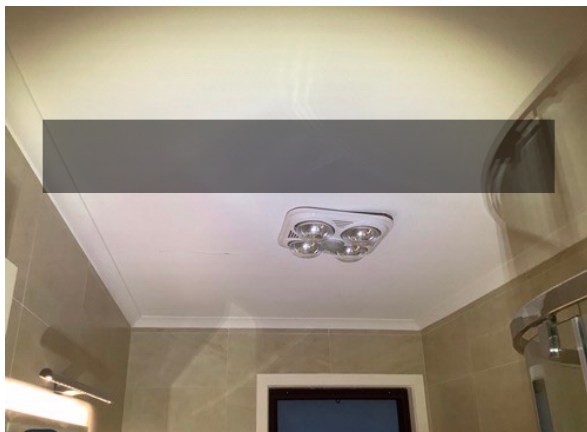
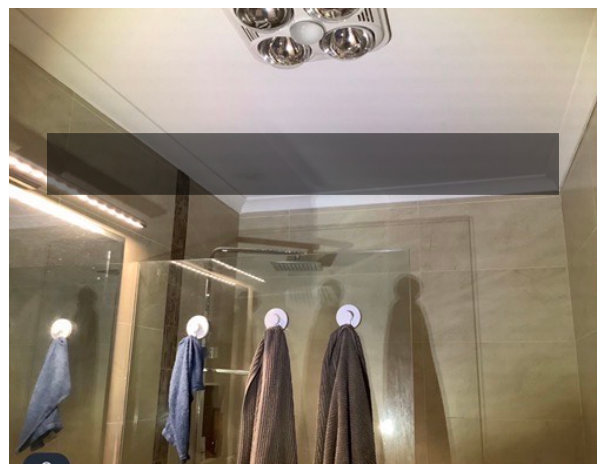
### Safety Hazard 1.01

Location: Bathroom & En-suite

Finding: Possible Mould Concerns

Generally, the client is advised to ensure that the general environment is free of moisture and humidity to aid in the prevention of mould formation and development. Any mould found during the inspection should be cleaned immediately and/or taken out.

Where mould is particularly serious cleaning or remediation works should be performed by a cleaning contractor.

Finally the cause or source of the mould MUST BE TAKEN CARE OF URGENTLY.

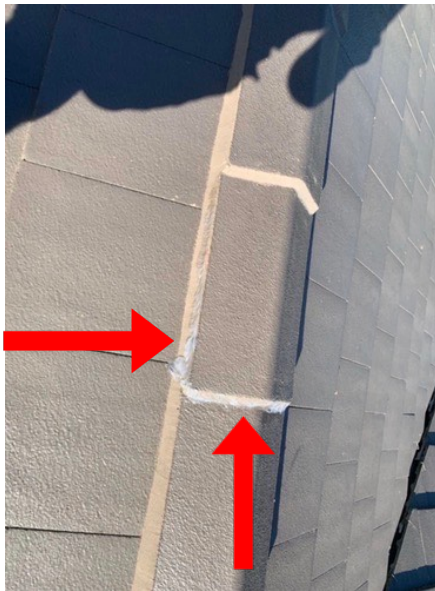
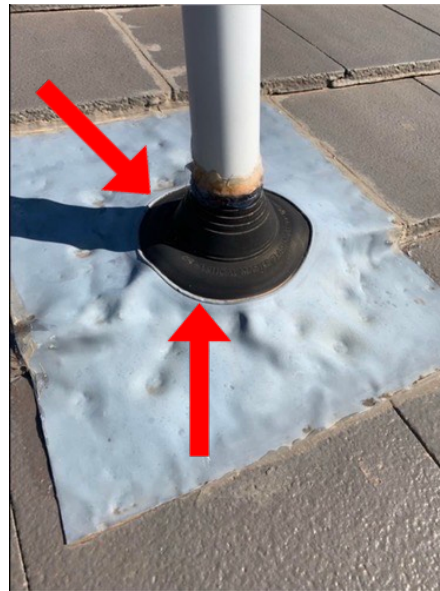
### Substandard Workmanship 3.03

Location: Exterior Roof

Finding: Photos taken from Plumbing repair company.

The client noticed water dripping through the heat light fan combination and the plaster ceiling, as per the damage shown in the photos attached. And it is gradually getting worse over time.

Photos attached from the repair company at the time of the repair.

Used silicone to seal up ridge capping, broken tile and vent.  
Recommended for the member to get a roof specialist to fix the ridge capping.

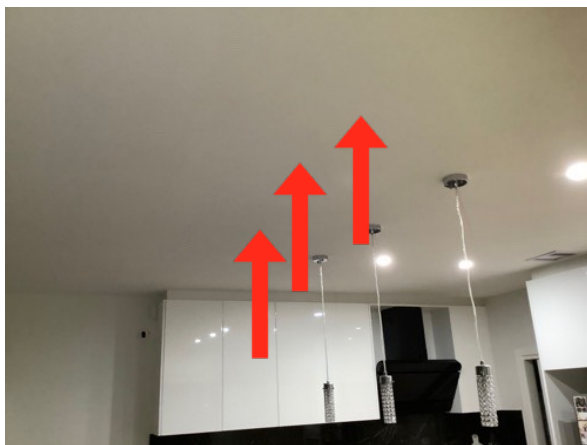
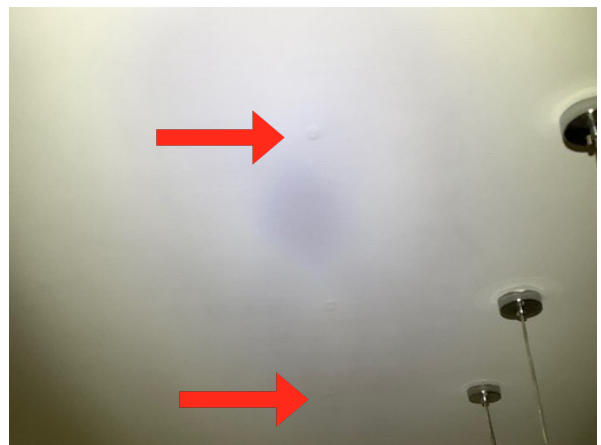
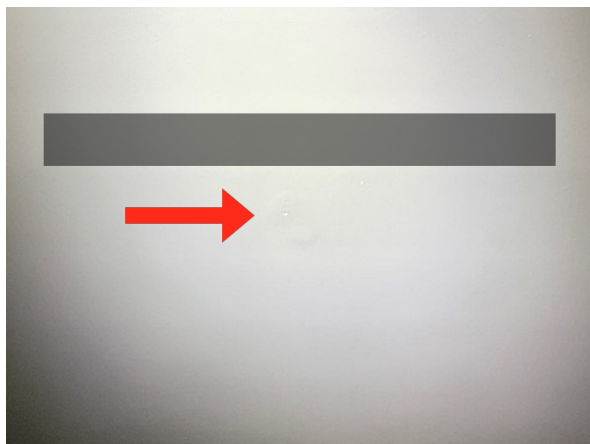
## Substandard Workmanship 3.04

Location: Kitchen / Family

Finding: Plaster Ceiling - Drummy

Sections of plaster sheeting in this area appear to be drummy. The term `drummy` is used to describe plaster which, whilst solid, has become detached from its original fixing, where the defect is spread wide the drummy plaster can also be a safety defect, meaning plaster ceilings can just drop in an instance, usually this is the more extreme drummy ceilings.

The most common causes of plaster failure are physical damage and moisture damage. Moisture causes plaster to swell and shrink as the humidity of the air changes, or as a consequence of leaks, which can be enough to create drumminess or cracking.

Drummy plaster generally needs chemical re-adhesion ( glue ) or to be screwed back to the substrate, with minor consequent patching and painting required but sometimes drummy plaster can be permanently deformed in shape so therefore will sometimes need to be replaced.

Where minor sagging is evident, comparatively minor works, such as re-gluing of ceiling sheets, may be required. Such works may be performed by relevant tradespeople, such as plasterers and painters. Where excessive moisture has caused the roofing structure to swell and sag, the source of the water leak should primarily be identified prior to any remedial works being performed.
