New Construction Lock Up Report

Inspection Date: 23 Jun 2020

Property Address: Rockbank Area

Report Type: New Home Construction

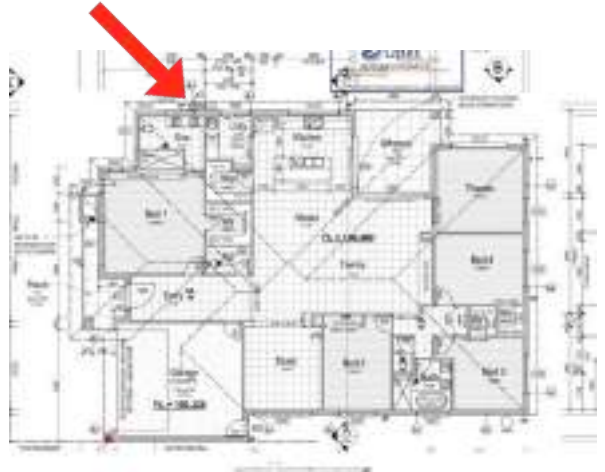
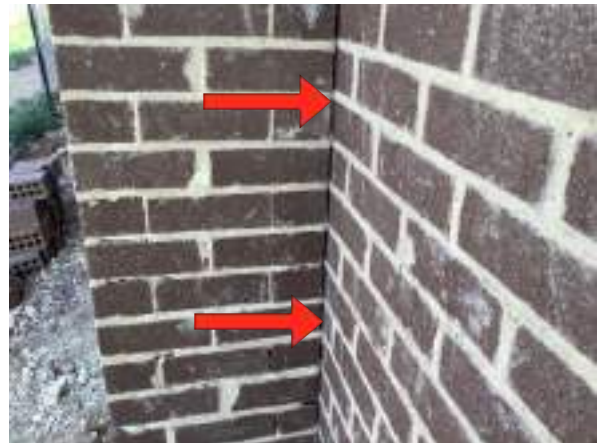
Non Compliant 2.01

Location: Articulation Joints - Exterior Perimeter Of Building

Finding: ARTICULATION JOINTS - Missing - Inadequate .

Again just as a matter of interest only, it does appear that the normal type locations for articulation joints to this building have not all been installed.

Masonry work is considered to be defective if articulation and movement control joints have not been provided for as required.

Articulation joints shall be provided in unreinforced masonry walls longer than 5 m long.

Articulation joints shall be vertical (not toothed), full-height of the masonry, and free of mortar.

Part 3.3.1.8 Vertical Articulation Joints, of the BCA requires that 'Vertical articulation joints with a width of not less than 10mm must be provided in straight, continuous un-reinforced masonry walls having no openings, at not more than 6 metre centres; and where openings more than 900 x 900mm occur, at not more than 5 metre centres.'

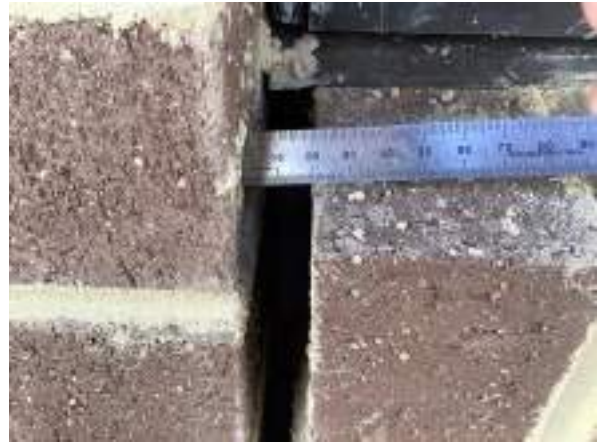
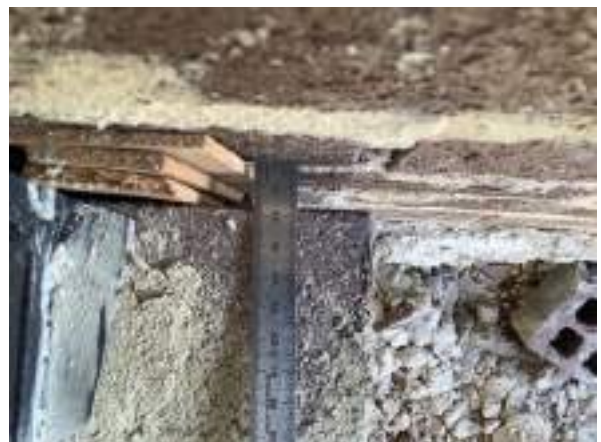
Non Compliant 2.02

Location: Articulation Joints - Exterior Perimeter Of Building

Finding: Articulation joints - Width defective .(AS3700)
To comply with AS3700 all articulation joints must be a minimum gap of 10mm wide and a max gap of 15mm.

The Masonry Structures Code AS3700 limits the amount of movement to be accommodated at a vertical joint to 15mm, and requires that a gap of at least 5mm should remain after the movement has taken place. It limits the amount of movement to be accommodated at a horizontal joint to 10mm.

The joints also must be sealed to maintain the integrity of weatherproofness, acoustic and fire isolation.

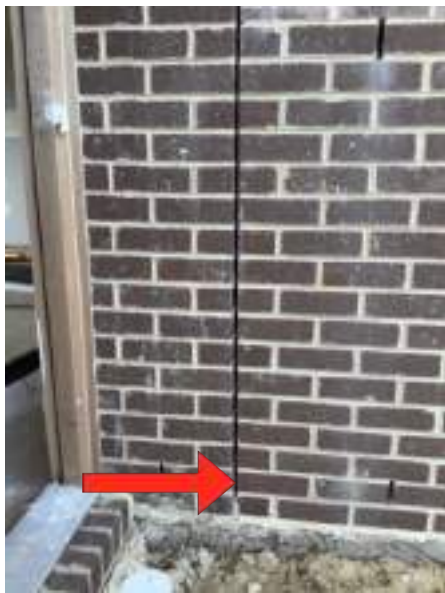
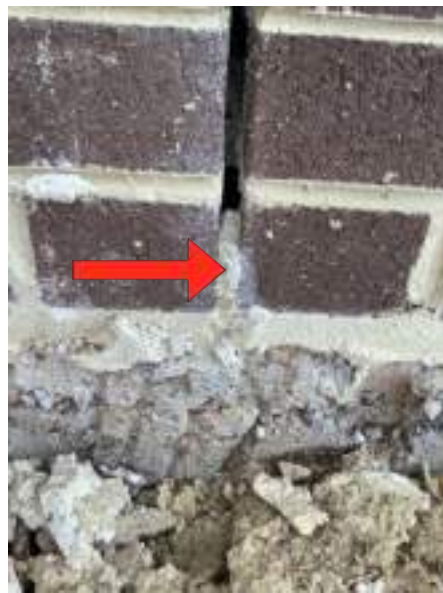
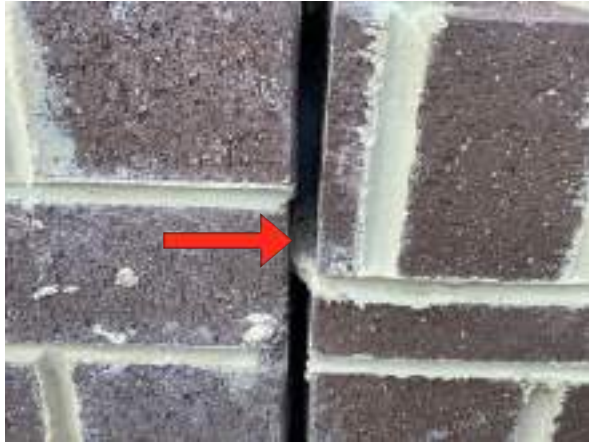
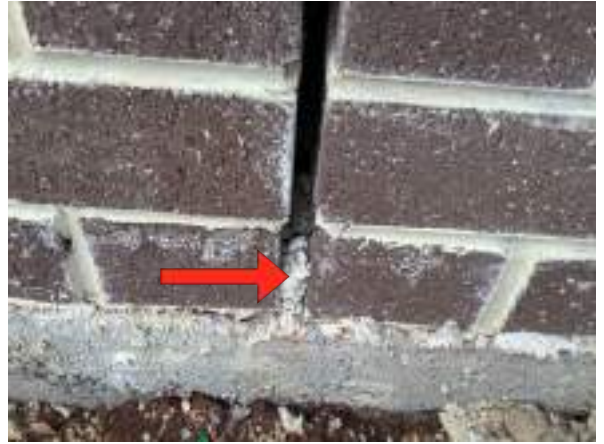
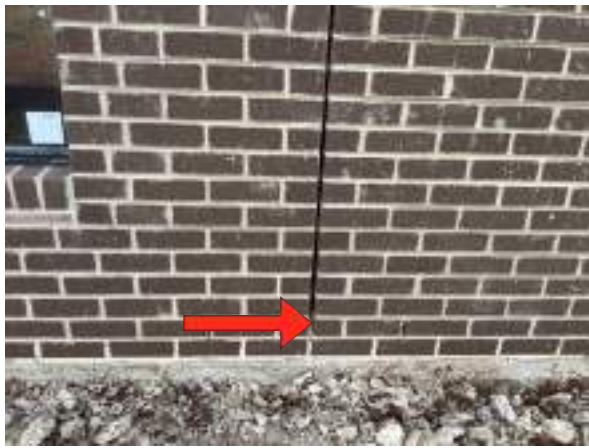
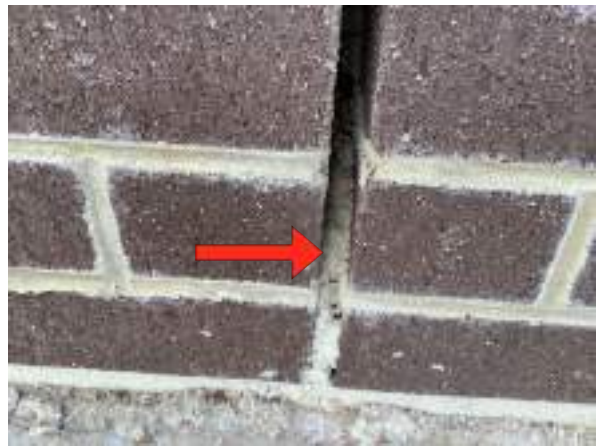
Non Compliant 2.03

Location: Articulation Joints - Exterior Perimeter Of Building

Finding: ARTICULATION JOINTS - Not Free Of Mortar
I have ONLY taken LIMITED photos of this defect and attached are LIMITED photos of this defect in SOME AREAS ONLY.
All AREAS to the entire property should be checked CAREFULLY to identify any further defects that are the same, as this defect is in other areas of the property.

Articulation joints shall be vertical (not toothed), full-height of the masonry, and free of mortar.

It was observed at the time of inspection that many of the articulation joints (AJ's) were obstructed by incompressible material (mortar)

At the time of inspection, this area does not meet the requirements of Australian Standards AS 4455 masonry for small structures or the BCA contractual requirements regarding acceptable finishes.

All AJ's need to be cleaned out and continuous for the full length of the wall.

The responsible contractor should be appointed to complete these works in order to comply with standards and regulations. Such works should be completed prior to final handover.

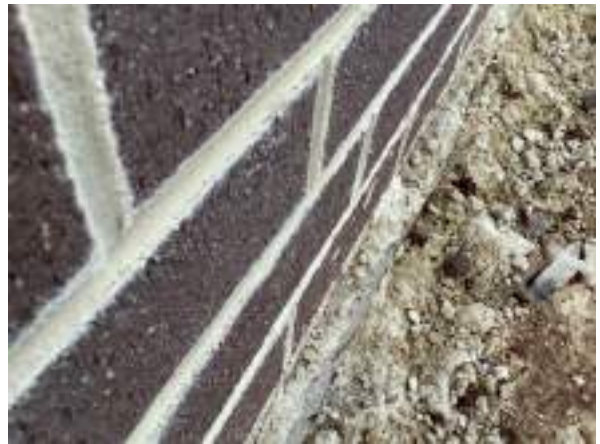
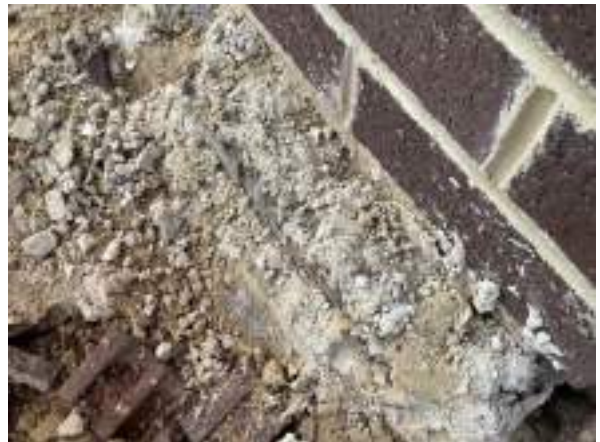
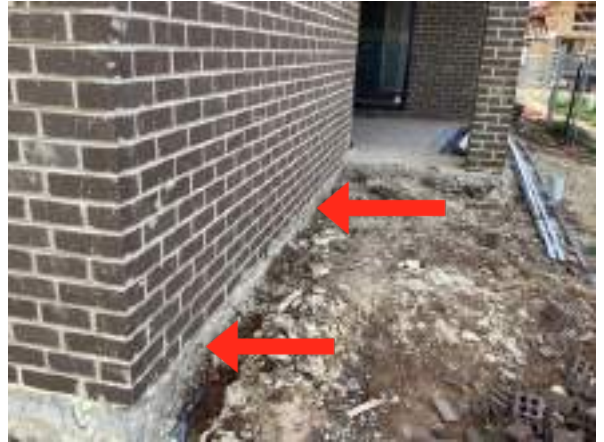
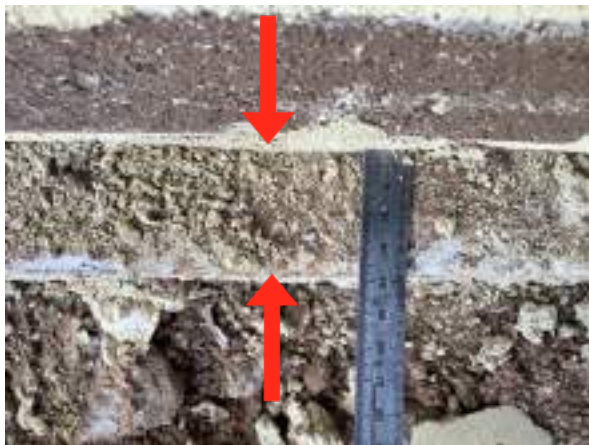
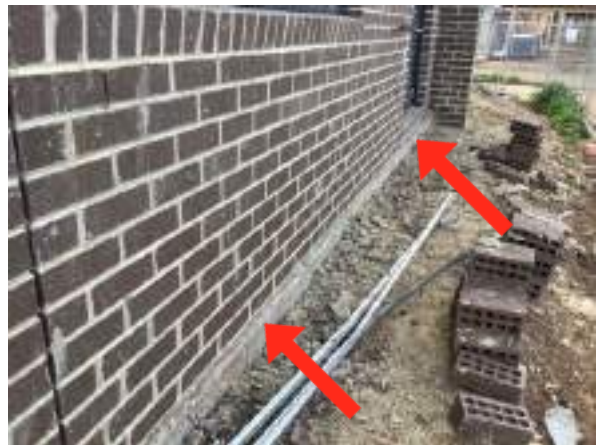
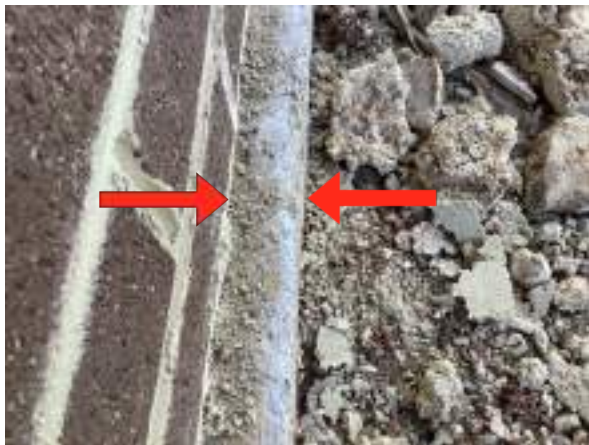
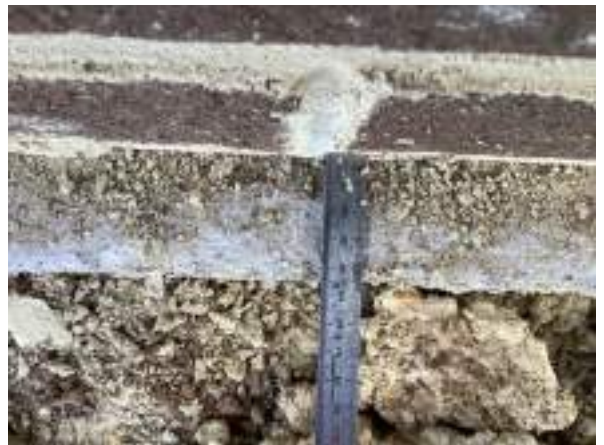
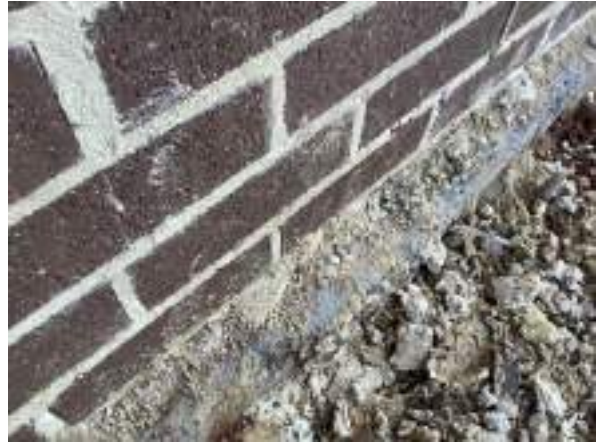
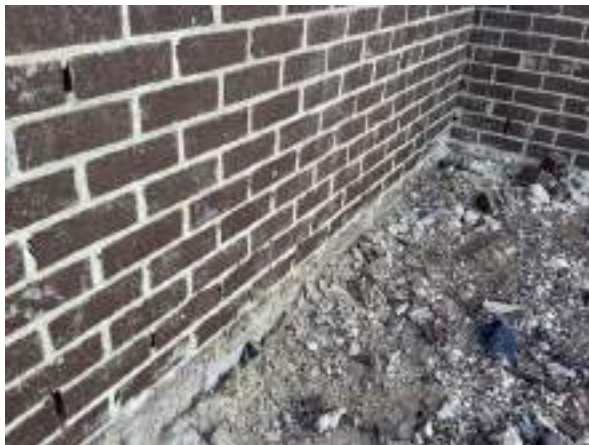
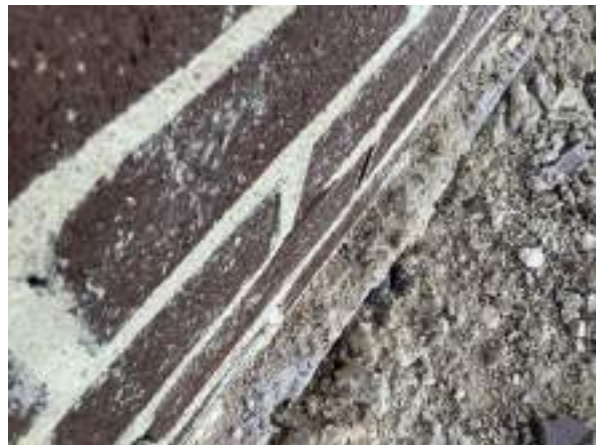
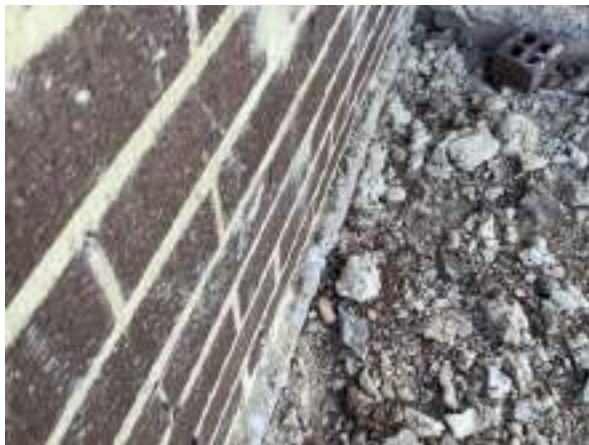
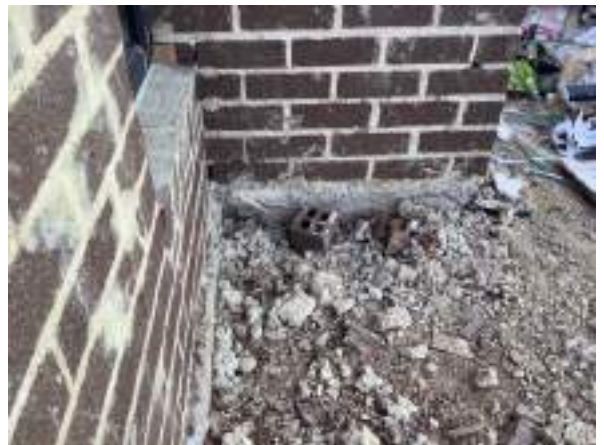
Non Compliant 2.04

Location: Brick Work - Exterior Perimeter Of Building

Finding: Bricks Base - Overhang Of Slab.

It was observed that there are areas where the edge of the slab protrudes past the document finished dimension of the slab. There are many areas to the total perimeter of the home that have EXCESSIVE concrete slab .

The edges of the slab needs to be trimmed back in line with the brickwork face edge. It appears the boxing on the slab may have bulged out which occurs when insufficient pegging and bracing is provided prior to the concrete pour.

The current overhang will affect any concrete pavement of hard material landscaping such as pavers and as such the overhang needs to be cut back.

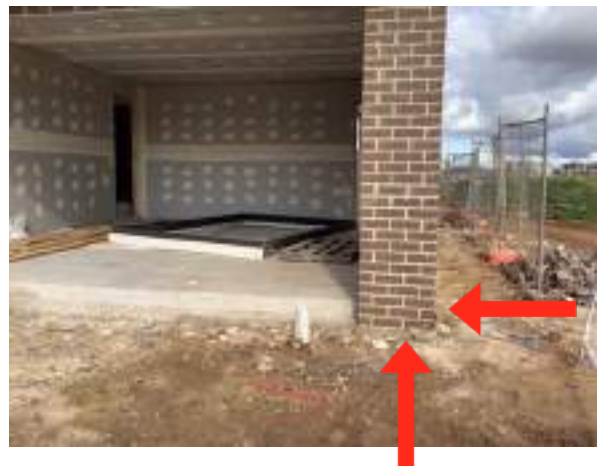
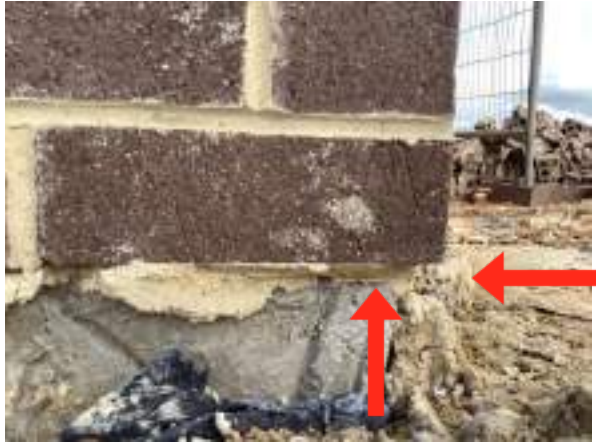
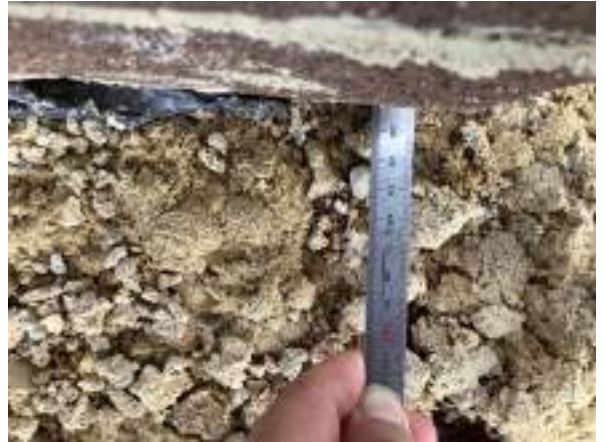
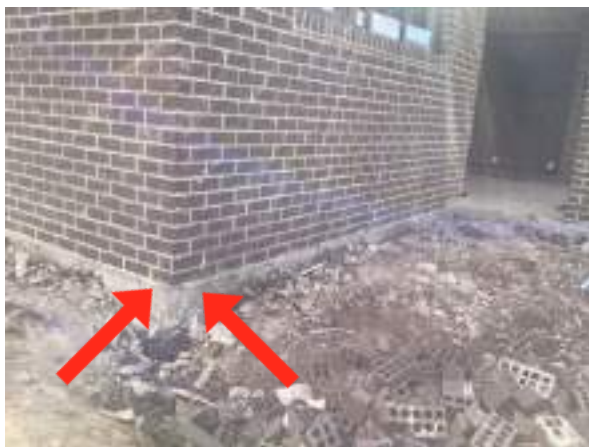
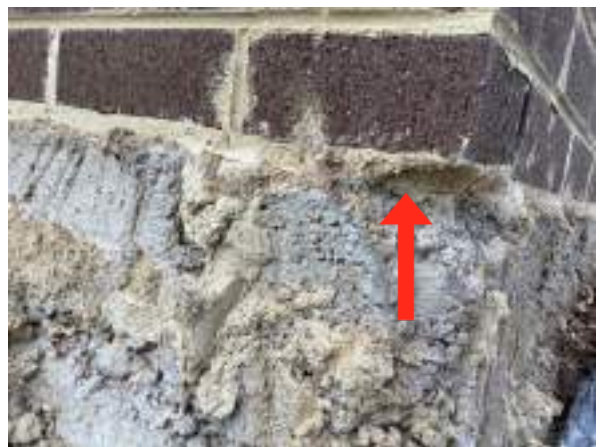
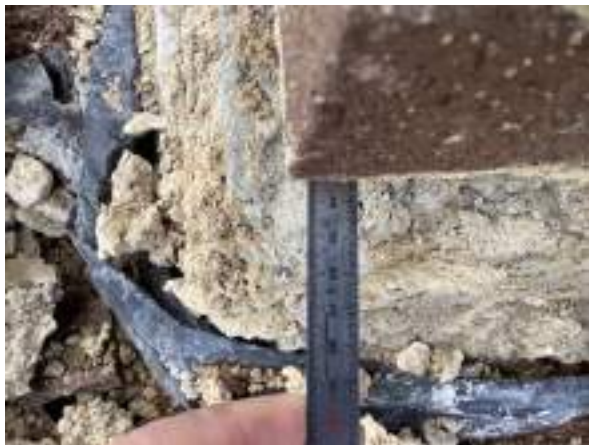
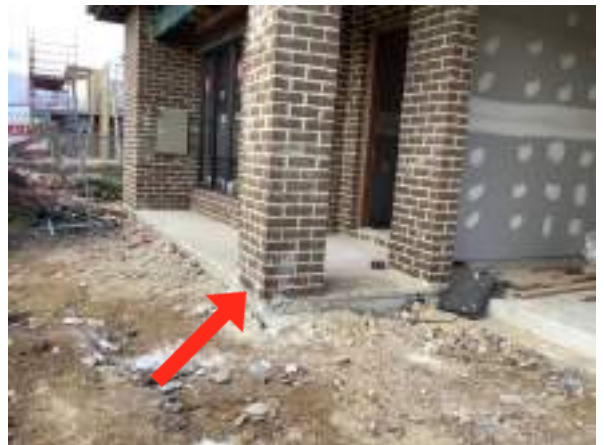
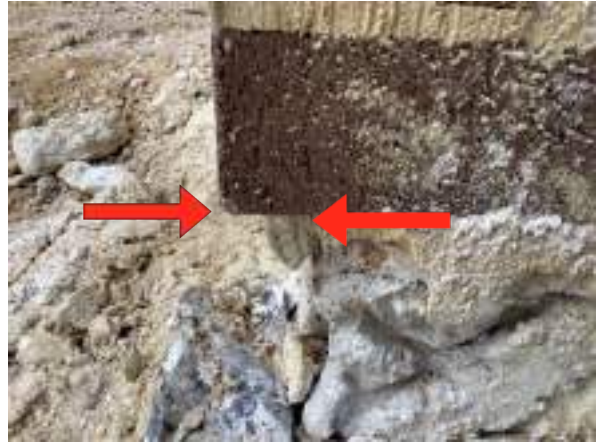
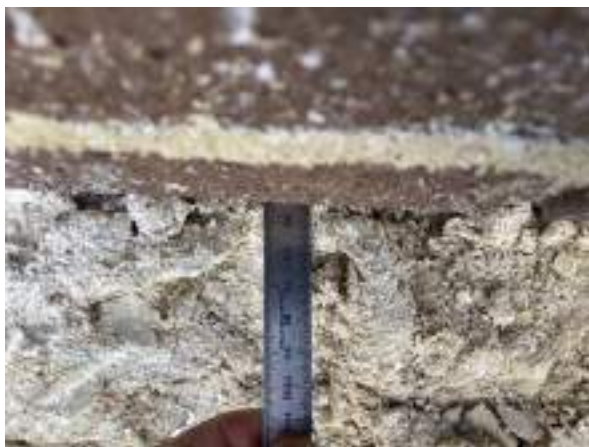
Non Compliant 2.05

Location: Brick Work - Exterior Perimeter Of Building

Finding: Brick/Wall Overhang On Slab.
 I have ONLY taken LIMITED photos of this defect and attached are LIMITED photos of this defect in SOME AREAS ONLY.
 All AREAS to the entire property should be checked CAREFULLY to identify any further defects that are the same, as this defect is in other areas of the property.

At the time of the inspection it was found that the brickwork is overhanging the slab by more than 15 mm.

Standards and Tolerances 2015 - Diagram 4.08 states that the maximum overhang of the brick work is 15 mm.

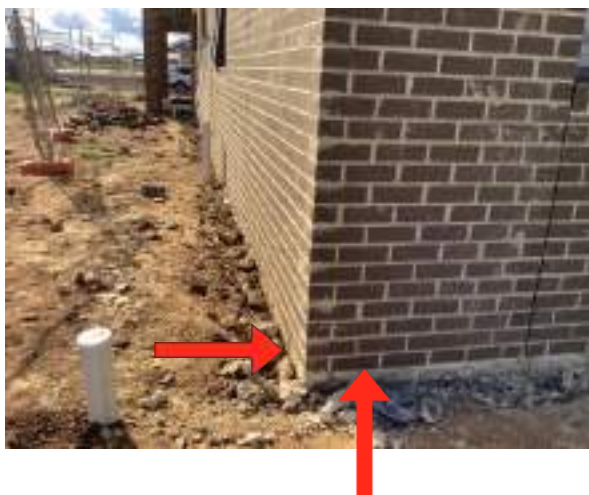
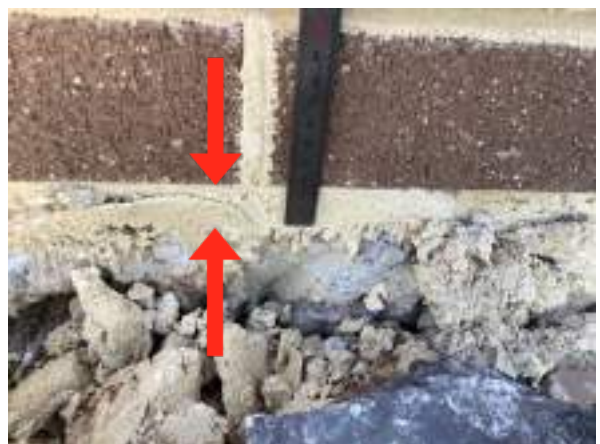
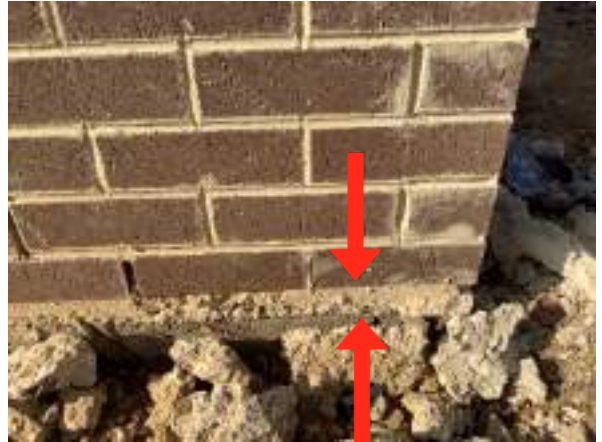
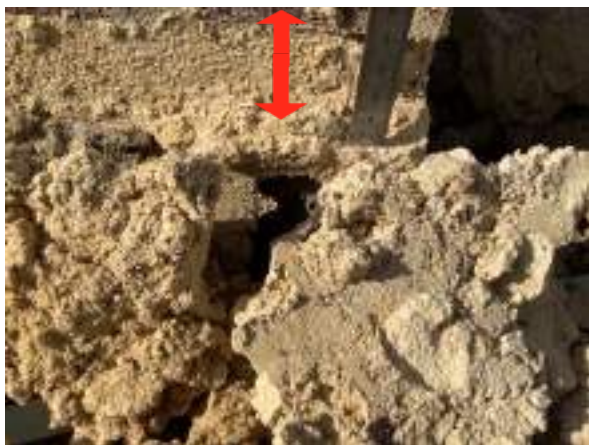
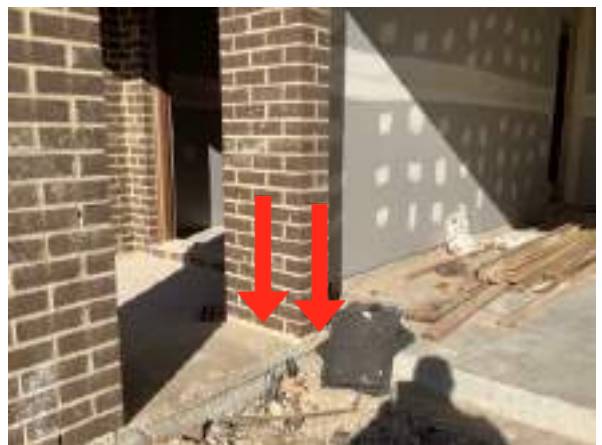
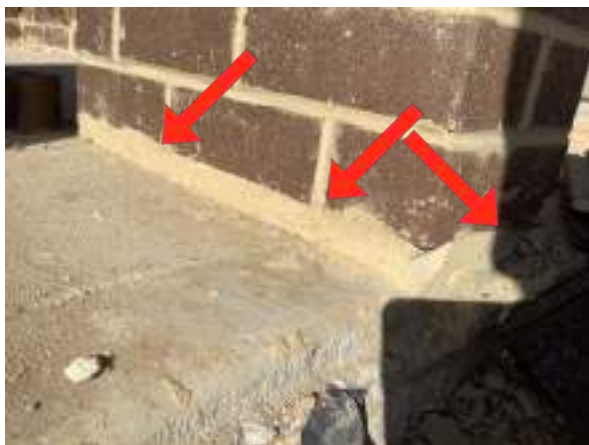
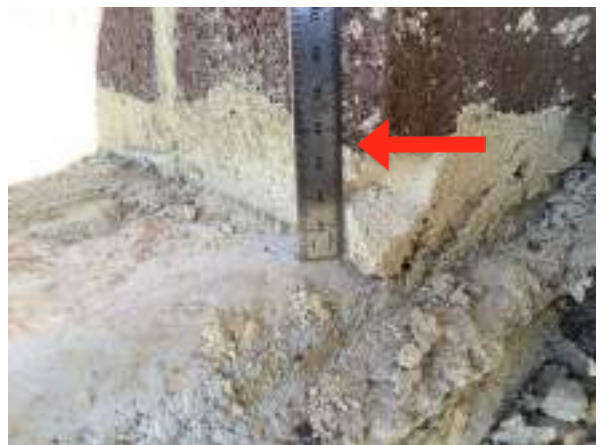
Non Compliant 2.06

Location: Brick Work - Exterior Perimeter Of Building

Finding: Brick Base bed joints (exposed)- defective
It was observed that the exposed base bed joint is defective. Exposed base bed joints in masonry walls which are above the finished ground level are considered to be defective if they exceed 20mm in thickness which is the allowable Standards and Tolerances.

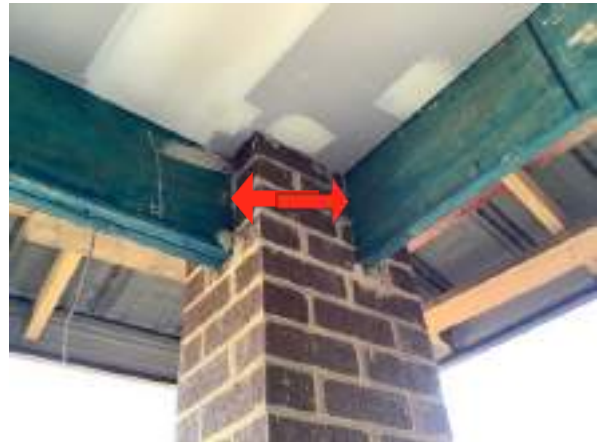
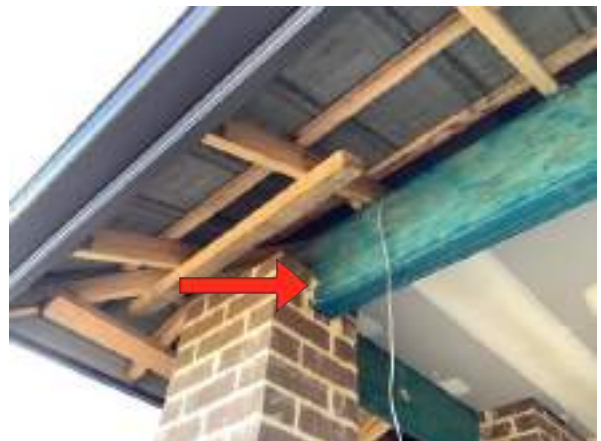
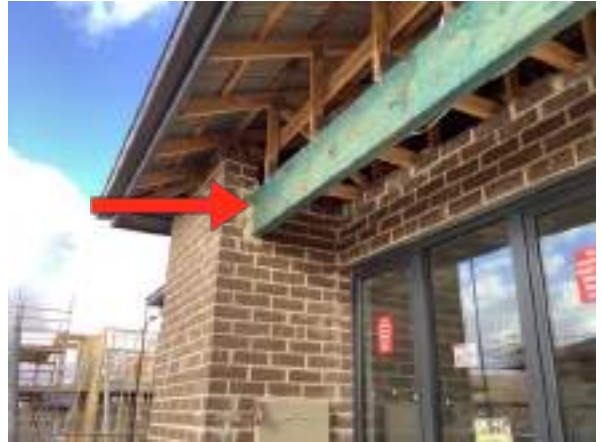
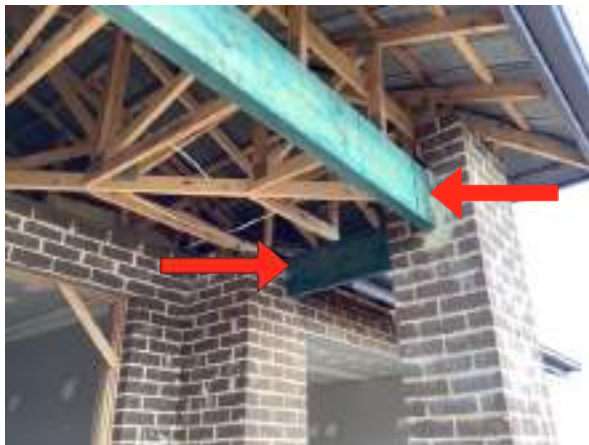
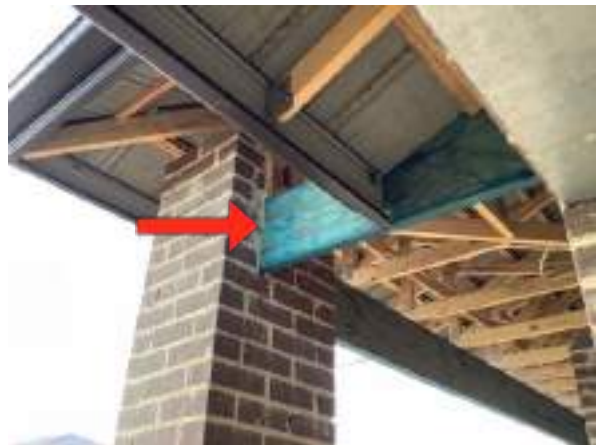
Non Compliant 2.07

Location: Brick Work - Exterior Perimeter Of Building

Finding: Brick Space Required Between Timber Beam And Brickwork.

There are insufficient expansion gaps between the brickwork and the timber beams in the alfresco.

Part 3.3.1.10 Shrinkage Allowance for Timber Framing of the BCA requires that 'In masonry veneer walls a gap must be left between the timber frame and the top of the masonry wall, including window sills ect, to allow for settlement of the timber framing caused by timber shrinkage.

These clearances must be not less than 5mm at sills of lower and single storey windows; and 8mm at roof overhangs of single storey buildings'.

The Australian Standard AS 1684.2 Timber Framed Construction and Masonry standard call for a clear gap of 8-10mm to be left to allow for expansion and contraction of timber beams due to varying moisture content.

Once the gaps have been provided the face of the opening can be concealed with a timber trim if desired to finish the installation of neatly.

The bricklayer needs to rework these junctions to achieve the 8mm minimum gap.

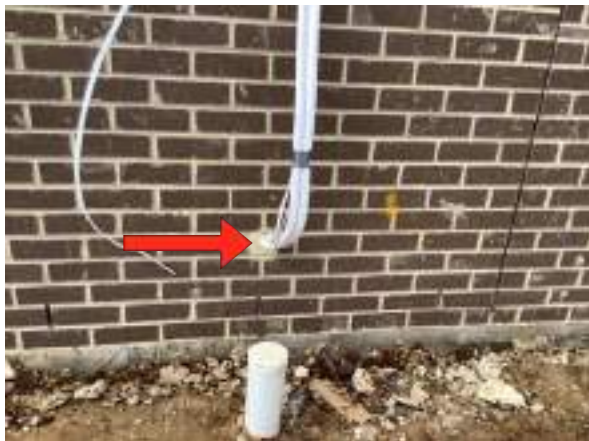
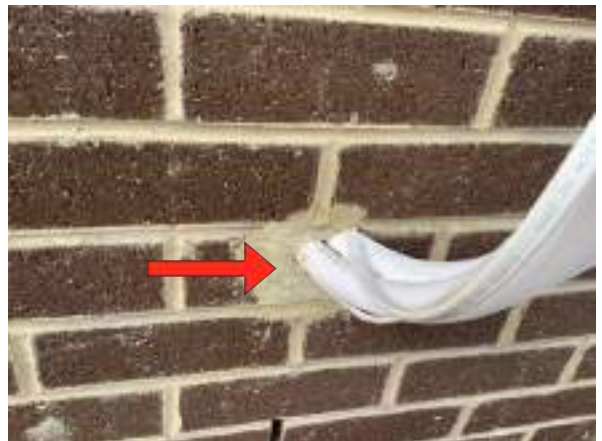
Non Compliant 2.08

Location: Brick Work - Exterior Perimeter Of Building

Finding: Brick Pipe penetrations (walls) - defective
Examples of pipe penetrations or plumbing holes which are penetrating external walls being defective were identified. Generally this means that the penetrations have not been finished neatly grouted as appropriate or kept to the smallest practicable size.

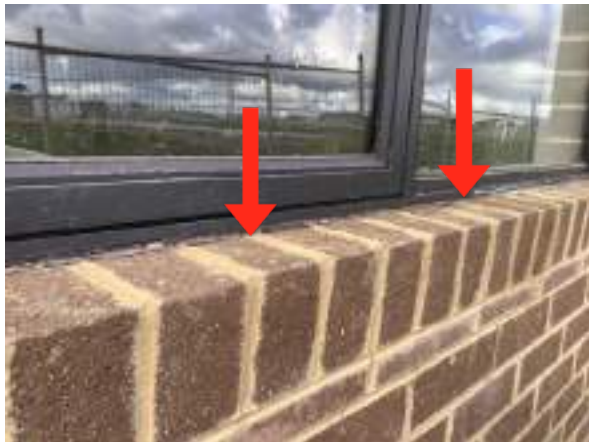
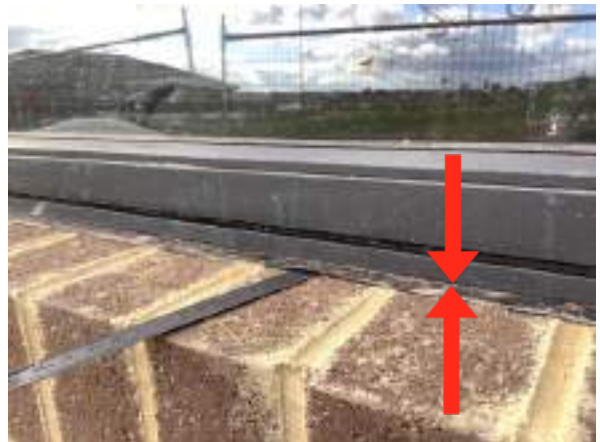
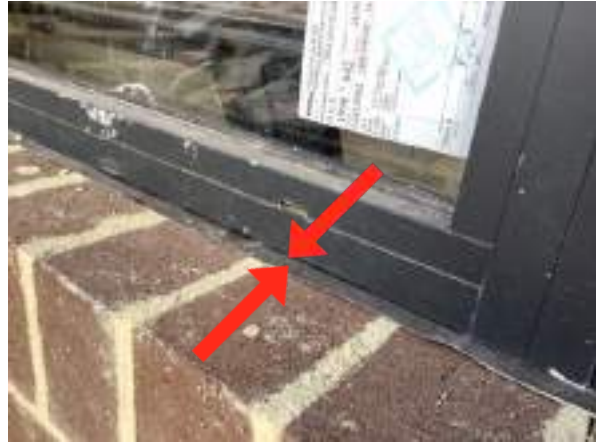
Non Compliant 2.09

Location: Windows-All Areas

Finding: Insufficient-Gap between window and brick sill.
No minimum gap under the windows. Description of this is in the Defect statement below.

This defect is of great importance and repair and re-working of the brick work, brick sills and/or window installation may be required.

A 5mm to 8 mm gap (pending on situation) between the window and the brick sill is required as a minimum as without the gap the glass can break under pressure and the window can bow and/or jam not allowing the window to open at all.

The windows should all be re-worked that do not have the gap.

The base of the window frame must be reworked to allow a gap for shrinkage.
I refer the builder to the BCA, part 3.3.1.10,

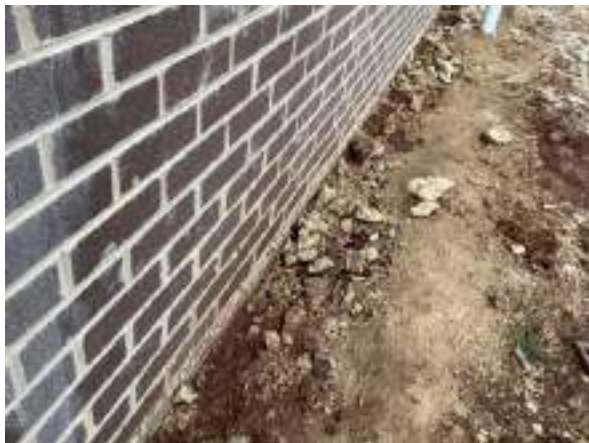
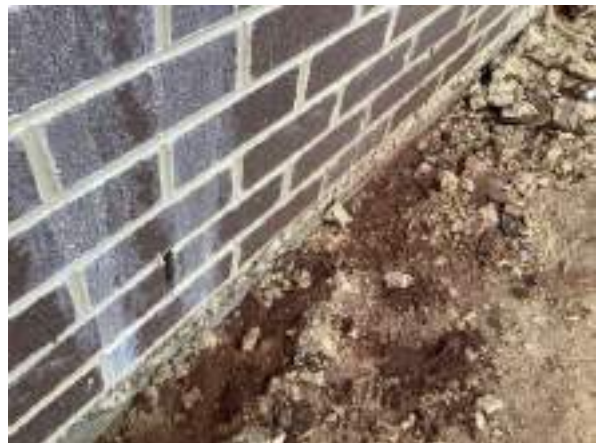
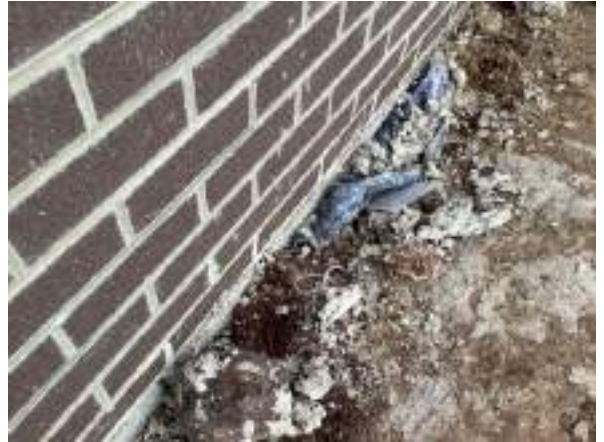
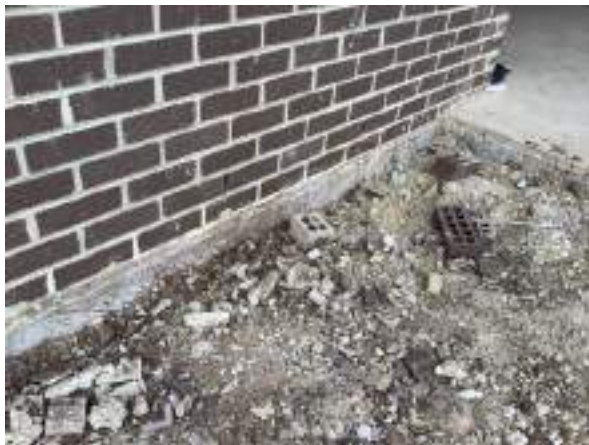
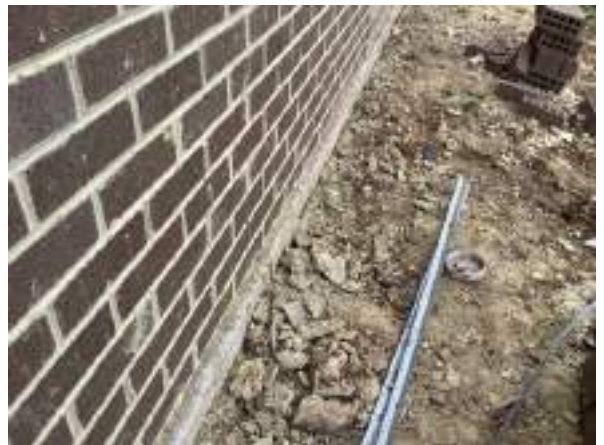
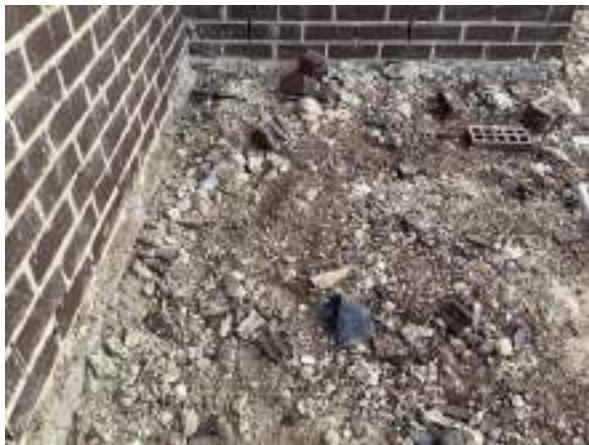
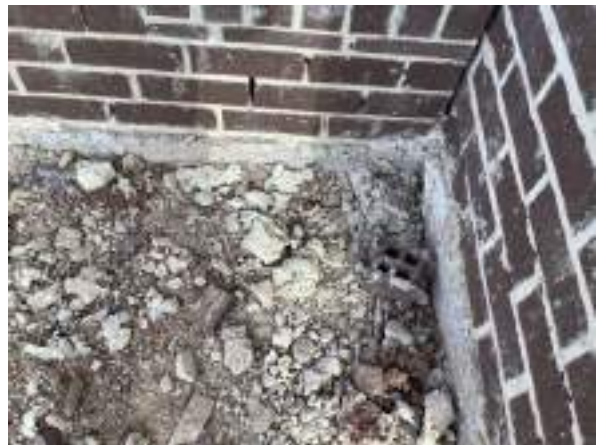
Non Compliant 2.10

Location: Concrete Slab - Perimeter To All Areas

Finding: Vapour barrier - Defective (AS2870- 2011)

The functionality of the vapour barrier to the entire perimeter of the building including, between the the buildings each side of the house is being compromised due to poor workmanship during the installation/construction process.

It is a requirement of AS 2870-2011 5.3.3.4 that vapour barriers are turned up and terminated at ground level above pavement adjacent footing. The vapour barrier is defective if building materials and fill has been left on top of the membrane, as this prevents it from being pulled up against the slab when installing perimeter paving as it is intended to be.

This must be remedied immediately to prevent slab edge dampness.

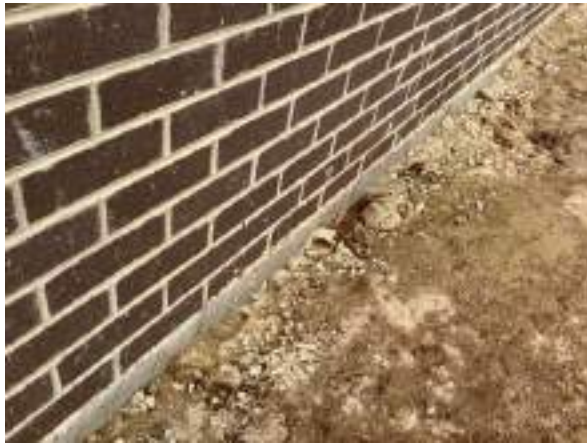
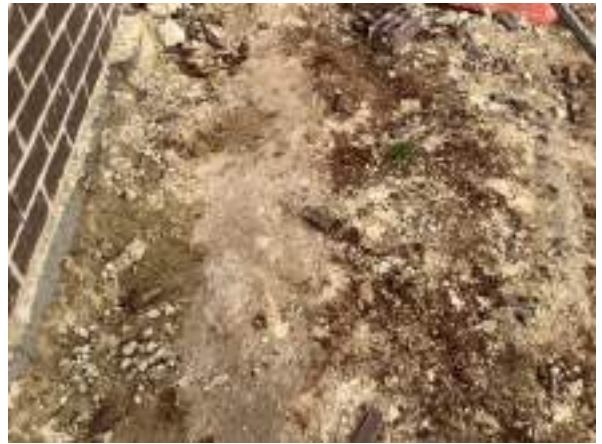
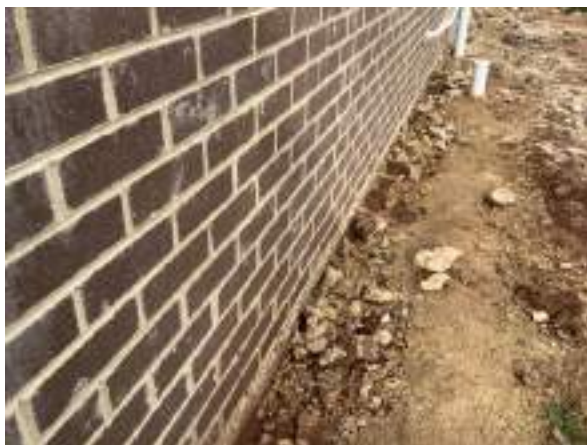
Non Compliant 2.11

Location: Concrete Slab - Perimeter To All Areas

Finding: Vapour Barrier - Cleaning Perimeter - Builders Excessive Debris.
It is very hard to determine the vapour barrier system and the Brick/Wall Overhang & the Concrete Slab Overhang On Slab with so much excessive brick mortar, render on the ground and other builders debris of excessive rock, small rocks, concrete overpour, but not limited to. The exterior perimeter to the property should be carefully all cleaned up to determine the EXACT defects that require rectification works prior to handover and without all the above performed, the repairs in particular the vapour barrier system can not be determined and repaired.

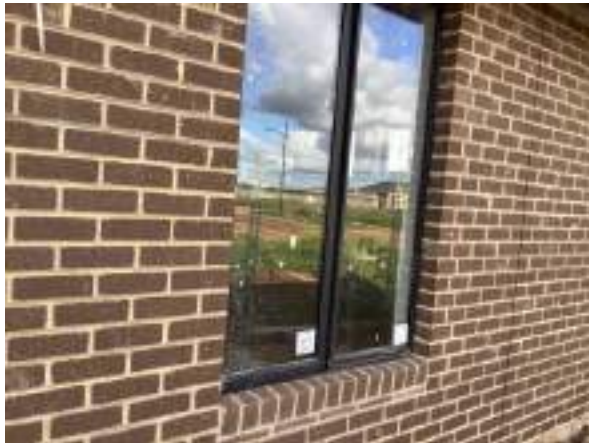
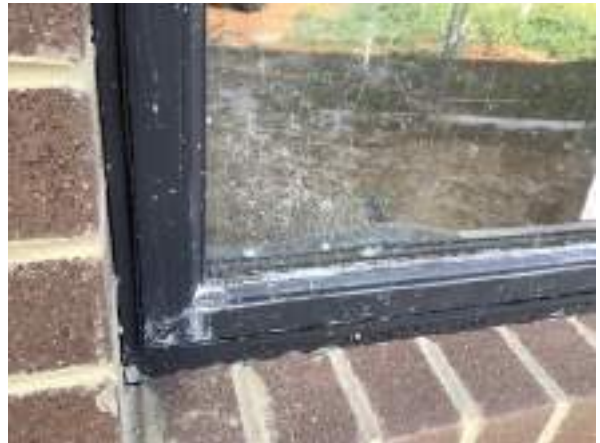
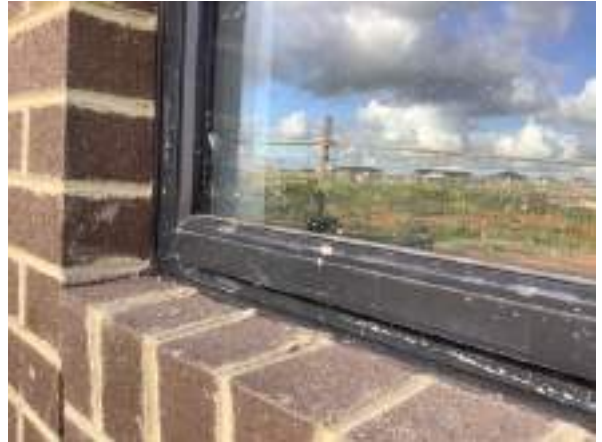
Substandard Workmanship 3.12

Location: Colourbond - All Areas

Finding: Colourbond Coating & Powder coat finish Scratched and/or Damaged.
The colorbond / powder coat is covered in brick mortar and not protected.

BlueScope Steel, the manufacturer of colorbond steel state on their web site that –'BlueScope steel does not recommend the use of touch up paints on Colorbond steel' and that 'Our recommendation is not to touch up. Minor scratching will not affect the life of the sheet and is rarely obvious to a casual observer. Should damage be substantial, replace the sheet.

All finished surfaces must be clean and free of defects at hand over to comply with the Standards and Tolerances guide.

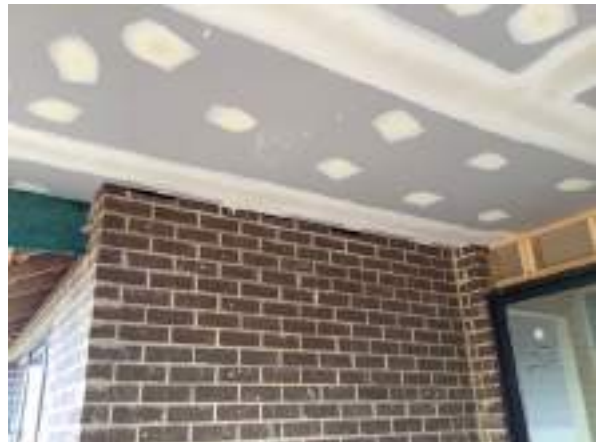
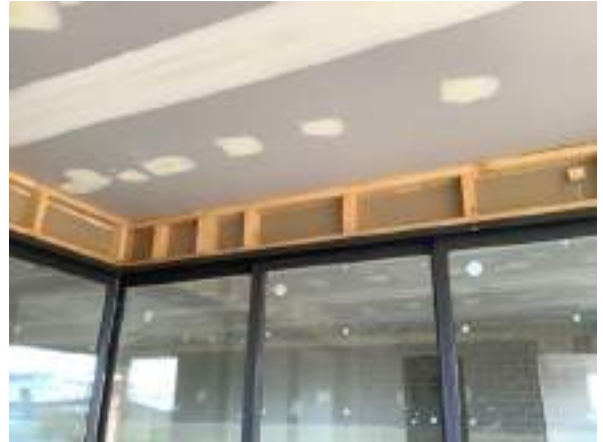
Incomplete 4.13

Location: Unfinished
Finding: External - Unfinished - Additional Photos

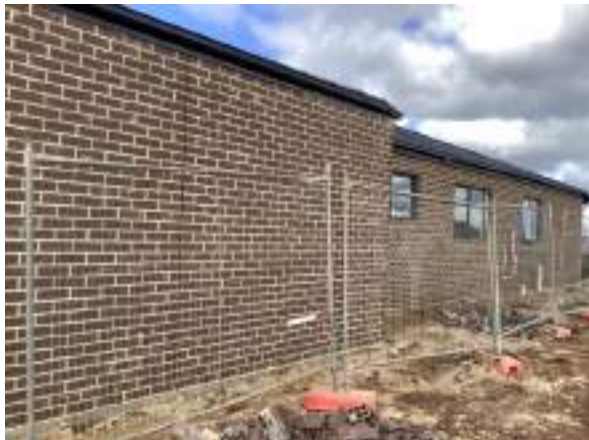
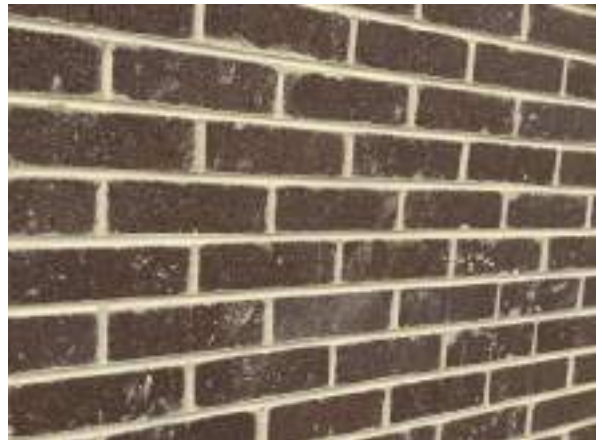
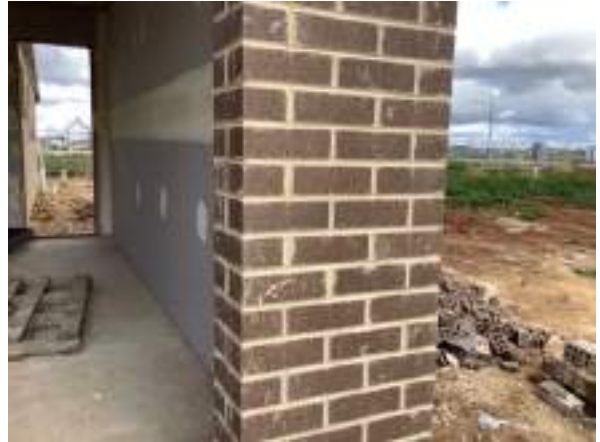
For Your Information 5.18

Location: Brick Work - Exterior Perimeter Of Building

Finding: Bricks not cleaned at the time of the inspection.
At the time of the inspection the brickwork to the exterior of the property was not cleaned by the brick cleaner.
There are various types of defects that cannot be seen until the bricks are cleaned
Such as brick holes and voids, damaged bricks, base bed Tolerances, bed joint tolerances, Brick perp tolerances and various other items.
