Commercial Report-Commercial Building Report-Public Areas (Balcony & Carpark)

Inspection Date: 19 Jul 2020

Property Address: Ascot Vale Area

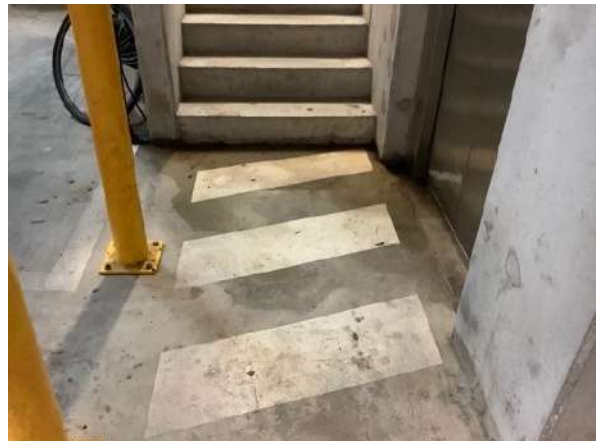
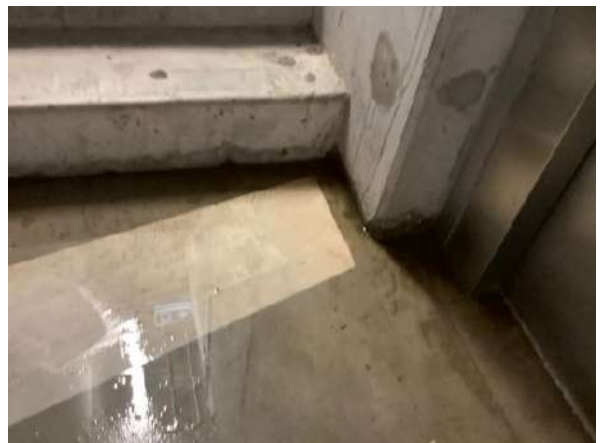
Safety Hazard 1.01

Finding: Drainage - Inadequate
Water is pooling near the steps area into the building. This is defective workmanship as the falls in the concrete, must allow the water to run away from this area.
This is a slip hazard that **MUST** be attended to.

The question as to why water is ingressing into this area is of a concern as well as water ingress via concrete and the concrete areas has the potential to damage the associated building materials and the concrete as outlined in more detail in this report.

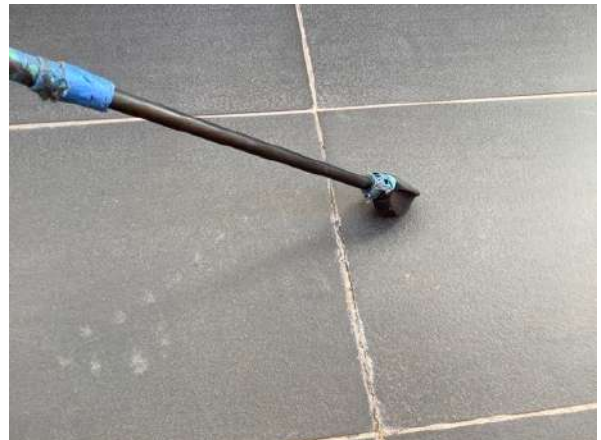
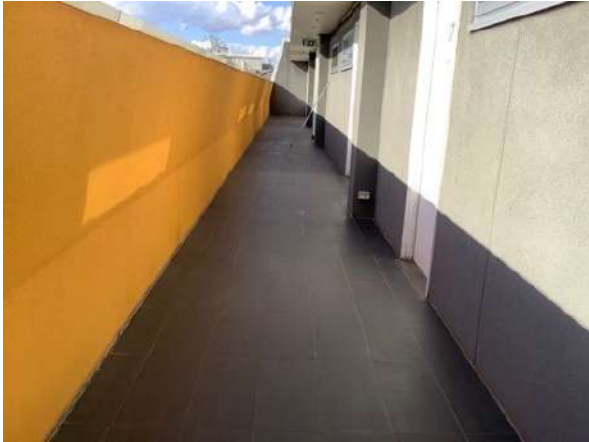
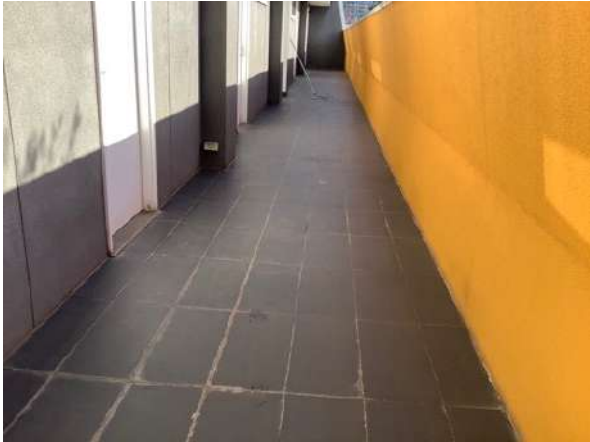
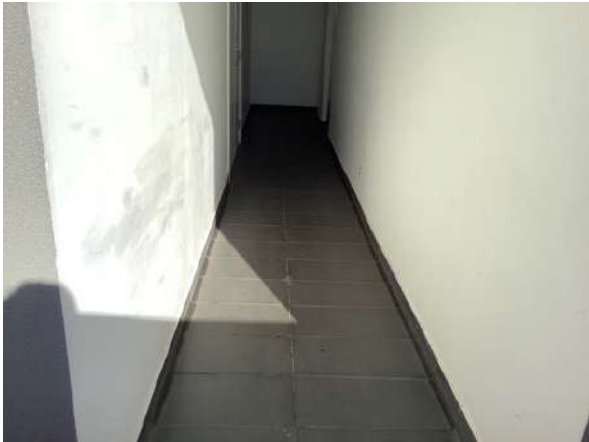
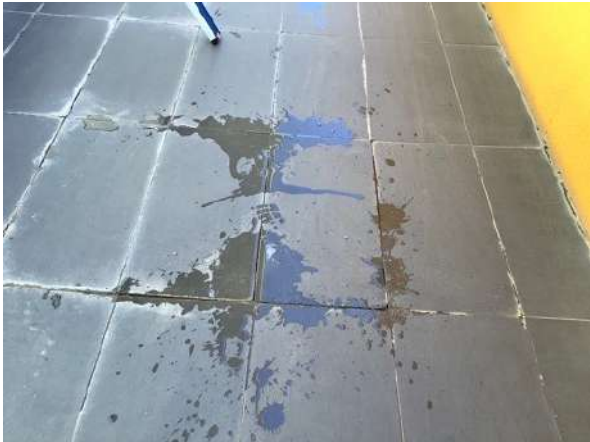
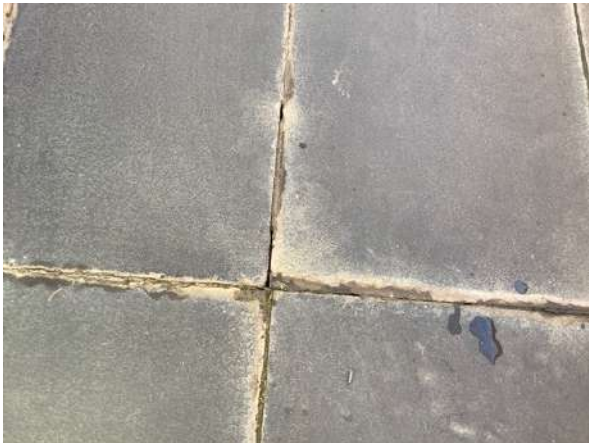
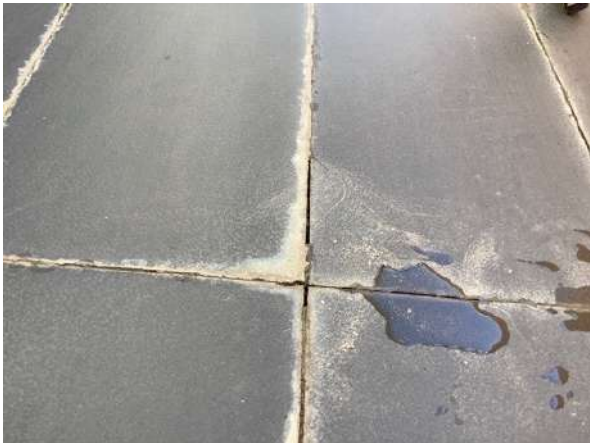
Major Defect 2.02

Drummy tiles may also be contributed to tiles cracking and what is important is to determine the cause of the cracking, which may be related to the subfloor structure, typical wear and tear and/or poor workmanship

Such defects are generally caused by physical or moisture damage to the area. Drummy tiled areas may also be a direct result of poor workmanship during the construction process.

Any exposure to moisture is capable of causing tiled areas to become drummy and/or cracked over a prolonged period of time. Drummy tiled areas generally require removal and replacement of affected tiles, with adequate sealant and grouting.

The cause of the tiles cracking must be determined and repaired otherwise the same defect will occur.

Specialist trades are available for these types of services. A registered builder may be required to undertake works if damage is extensive or if secondary building defects have resulted. Otherwise, it is advised that a tiling contractor be appointed to perform works as necessary. Immediate action is recommended to ensure that no further damage is sustained in the affected area.

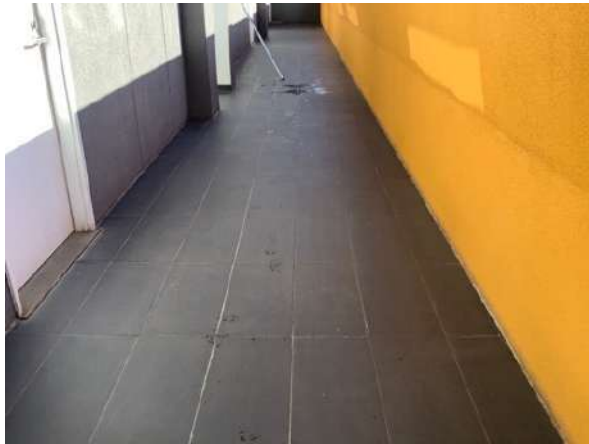
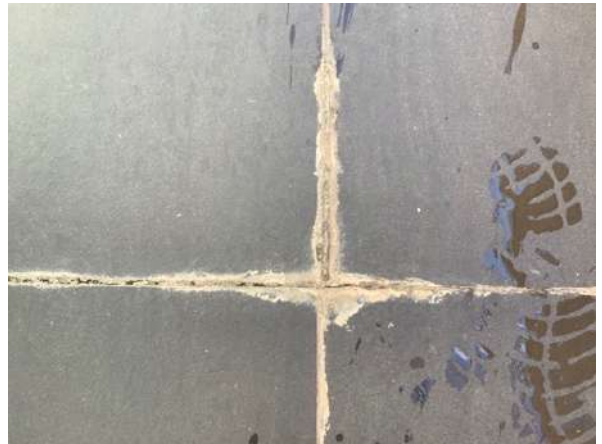
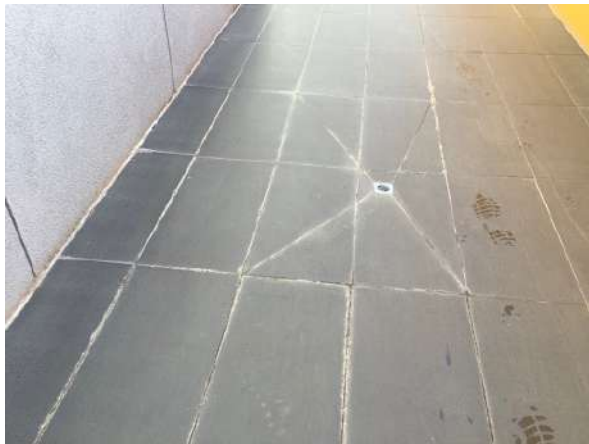
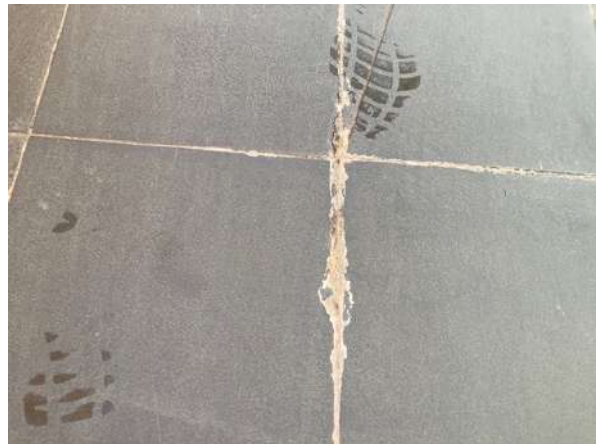
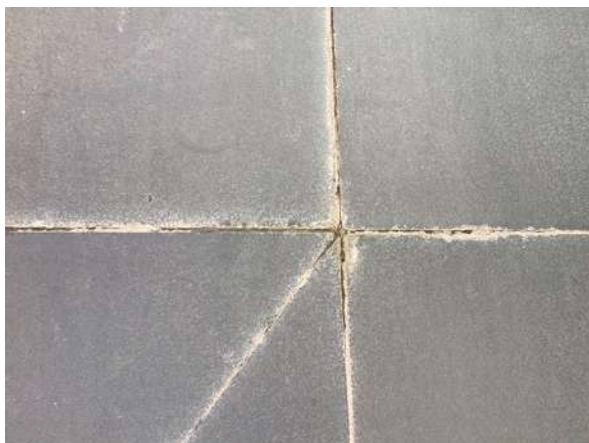
Major Defect 2.03

Location: Balcony Tiled Areas

There is evidence of calcification or efflorescence affecting the balcony area where the mortar joints of tiling are, where calcification or efflorescence is caused by water coming from under the tiles.

This is all tied in with the dated caulking and drummy tiles

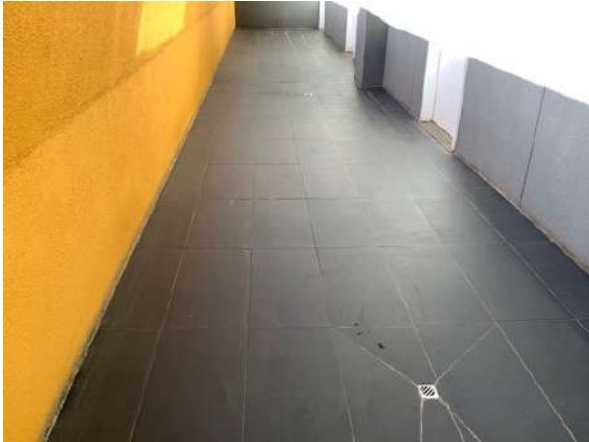
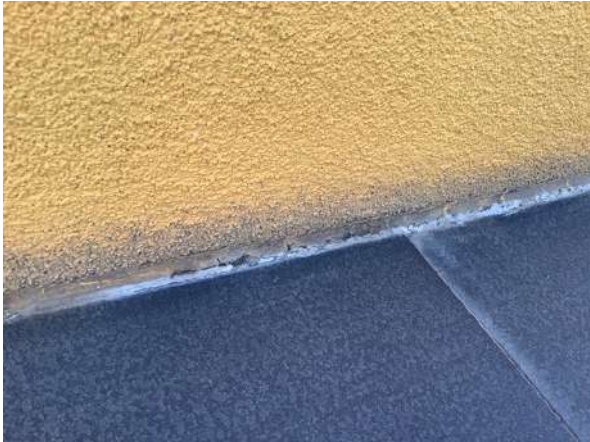
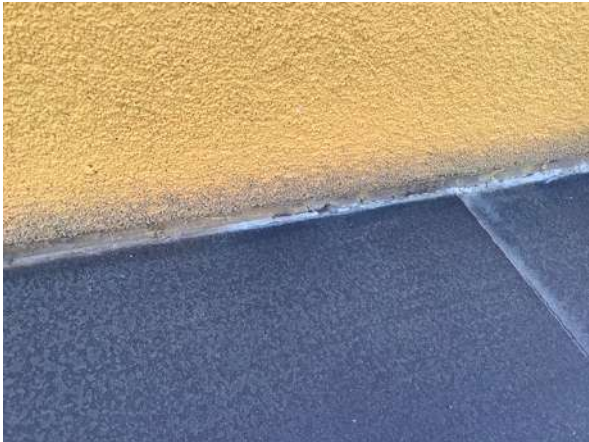
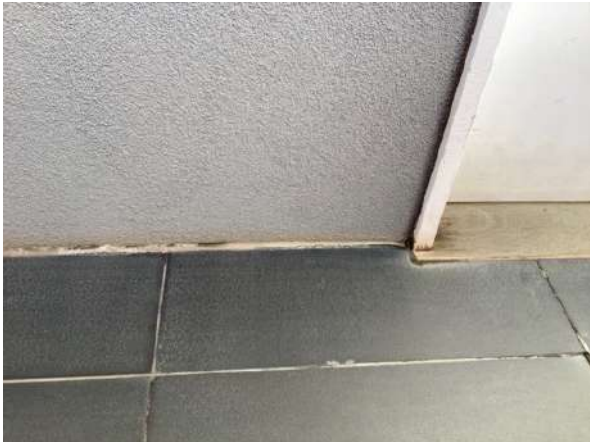
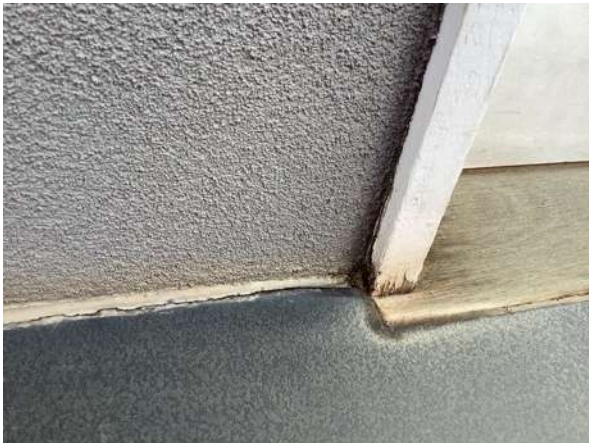
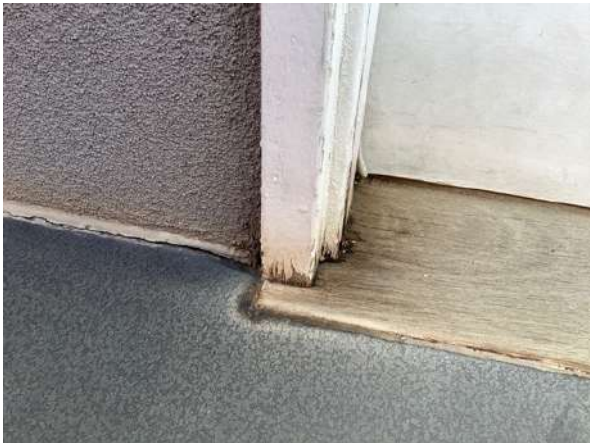
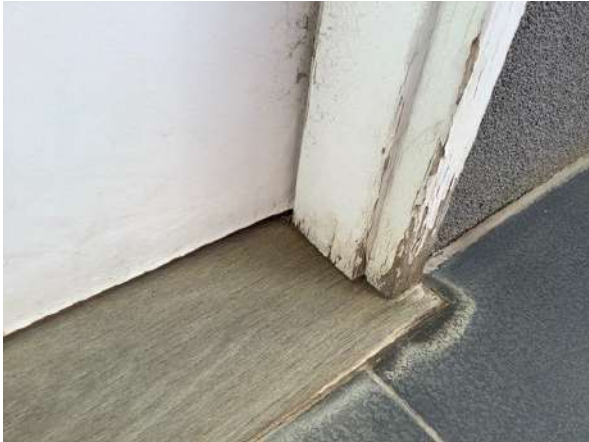
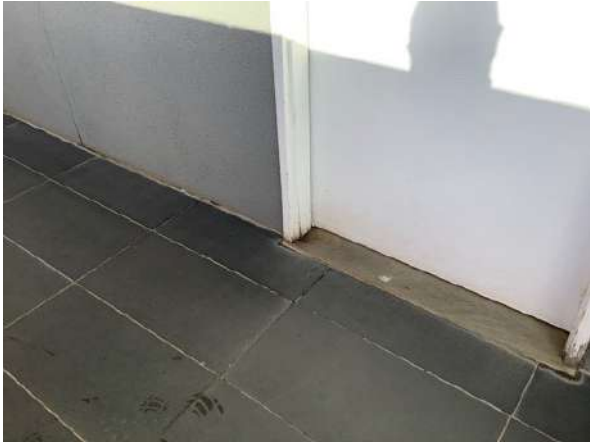
Major Defect 2.04

Location: Balcony

Finding: Balcony Silicon / Caulking To All Junctions and Tile Grouting - Missing & Damaged.
It was noted on inspection that sealant and/or tile grout is missing, damaged & inadequate to the tiled wet areas. These areas are subjected to water or moisture.

The tiles are now already drummy in many areas as detailed in another statement in this report and whilst repairing all the junctions with silicon and repairing the tile grouting will slow do the damages, it is now too late as the tiles are drummy.

Sealant and/or tile grout where missing, damaged or inadequate to the tiled wet areas allows the water to penetrate through the tiles and has the potential to cause much damage, to the affect were the damage may become a secondary defect and create a conducive environment for termites and/or cause rotting to the timber studs, floor joists and bearers or plaster etc.

Whilst in some of the areas there is sealant/silicon , it has become apparent that the sealant has deteriorated and/or is just missing.

Whilst in some of the tile mortar is perfect , it has become apparent that the tile mortar has deteriorated and/or is just missing in other areas.

A flexible sealant/silicon and tile mortar should be applied to affected areas to prevent any subsequent water damage that is likely to occur.

A sealant specialist, tiling contractor and/or registered builder should be appointed to assess any damage caused by water to the entire internal, sub-floor, walls etc of the building and clean, take off old sealant and tile mortar, then re-seal and re-mortar these works as soon as possible.

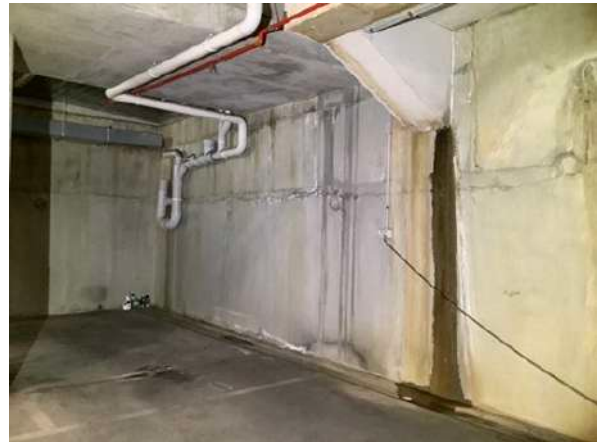
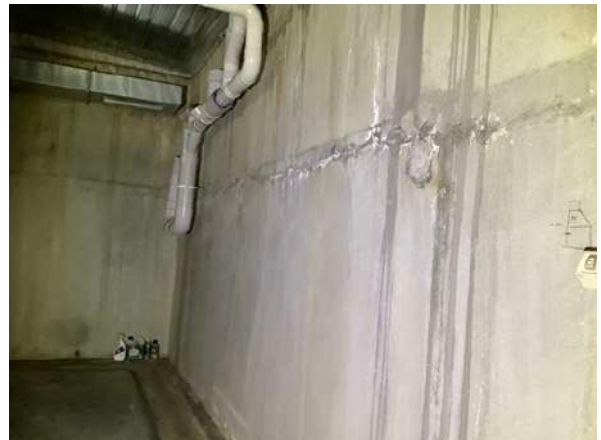
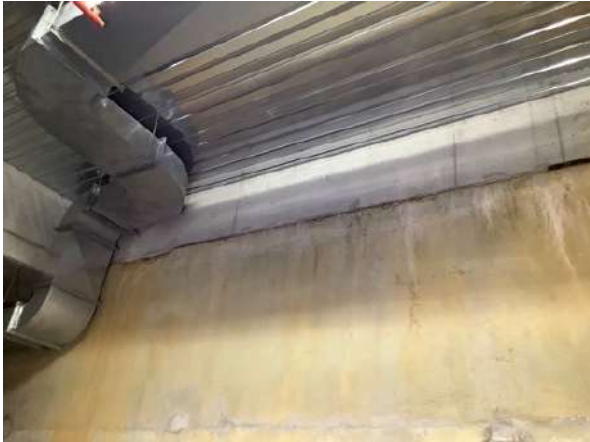
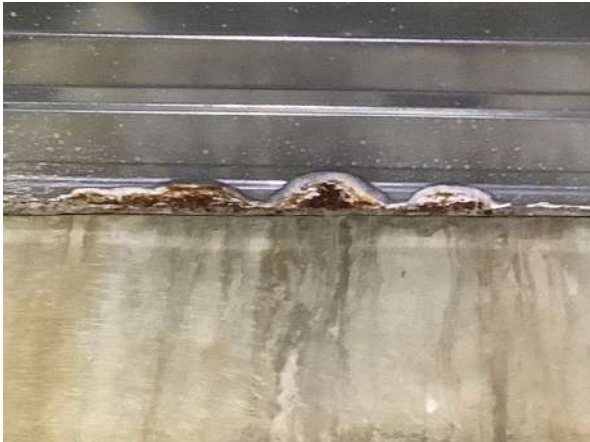
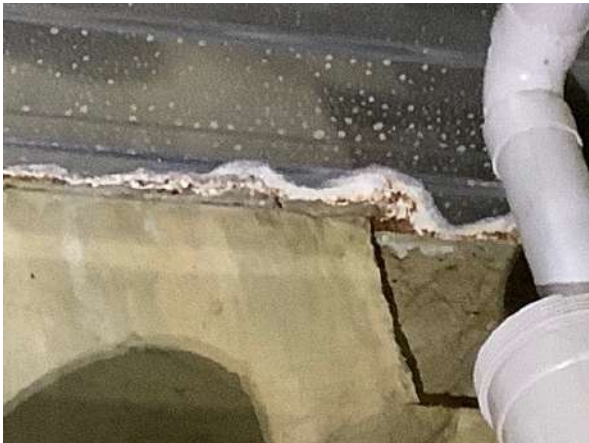
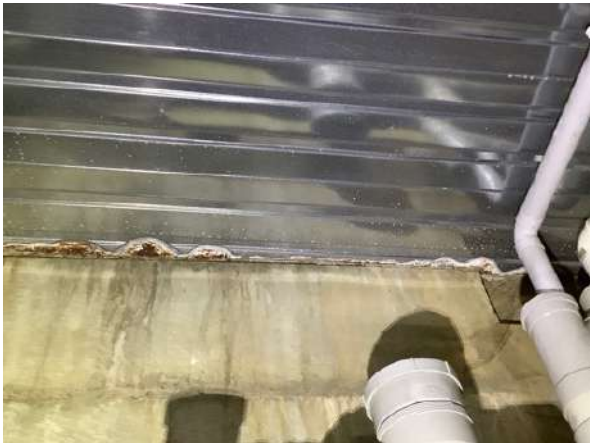
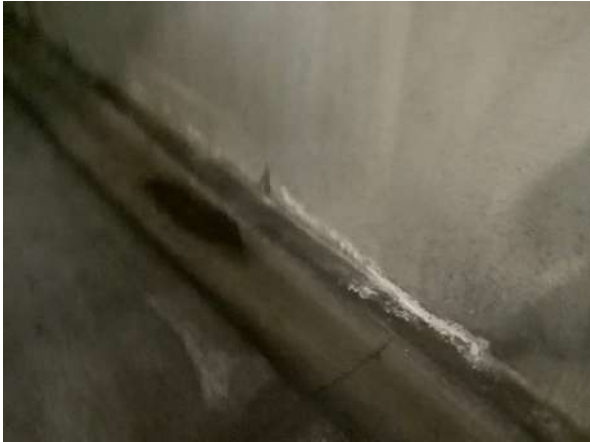
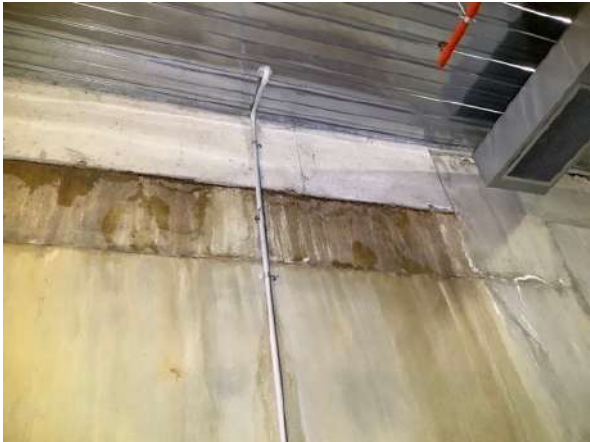
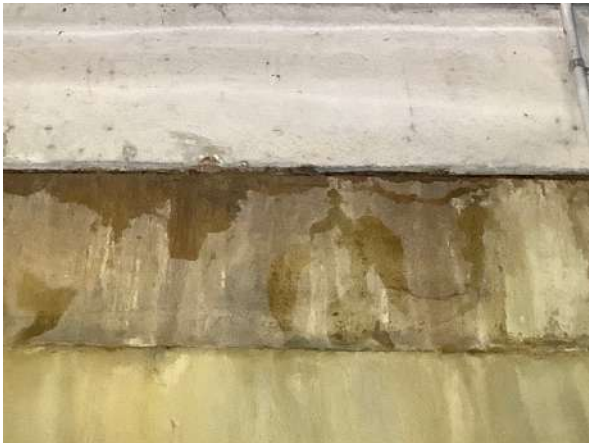
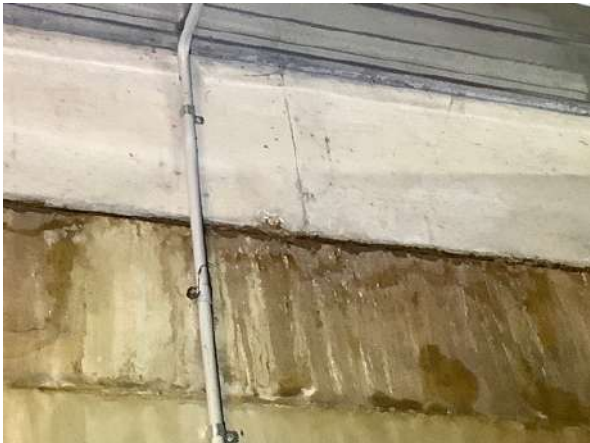
Major Defect 2.05

Location: Carpark & Surrounding Areas

Finding: Concrete - Water / Moisture Ingress
THERE ARE 3 MAIN CATEGORIES OF DAMPNESS:

Underground car parks are also exposed to water vapour penetration. A suitable waterproofing membrane must be applied and/or installed to make the concrete vapour-tight. If not fixed it could result to blistering, delamination and concrete spalling.

Once the cause is rectified further determinations may be required by a BUILDER AND OR STRUCTURAL ENGINEER AND SOMETIMES A GEOTECHNICAL ENGINEER before and after.

An assessment by a Structural Engineer is being organised to help assist with the plan documentation, for further investigations and to identify the cause or source.

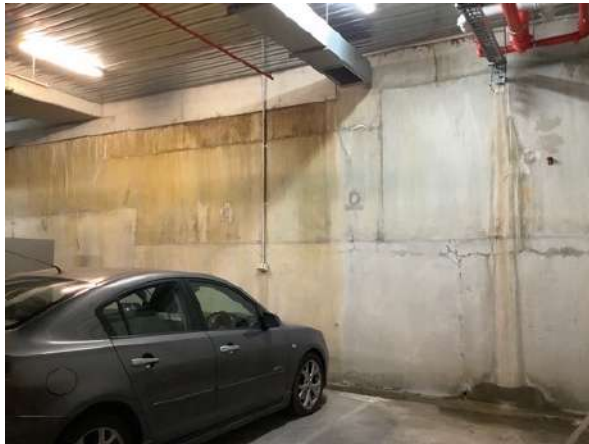
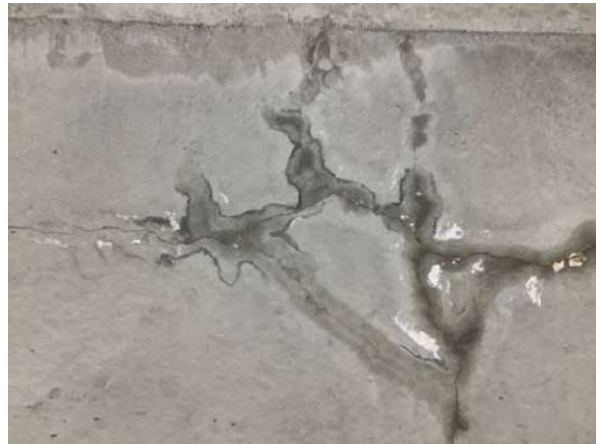
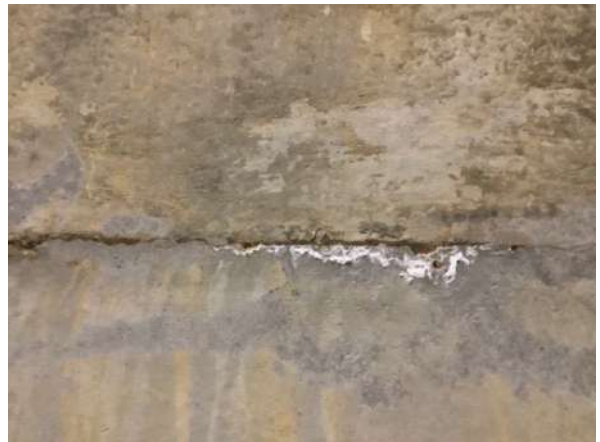
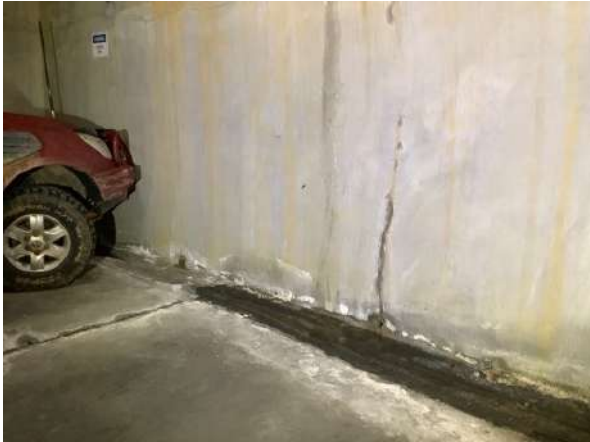
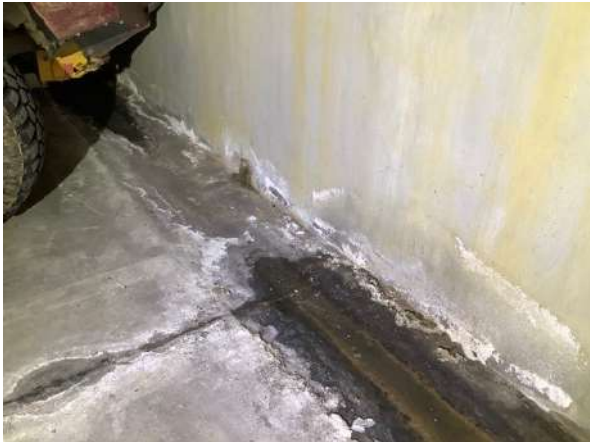
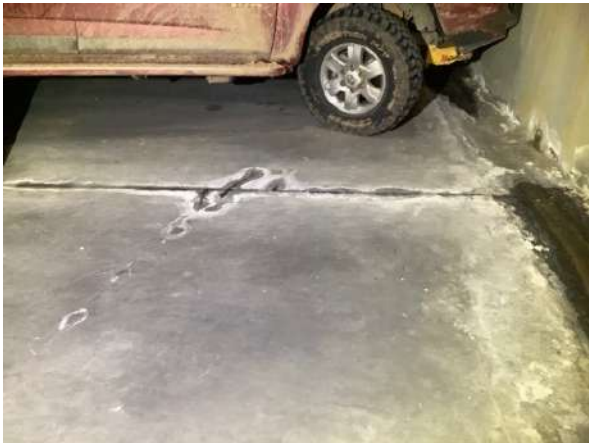
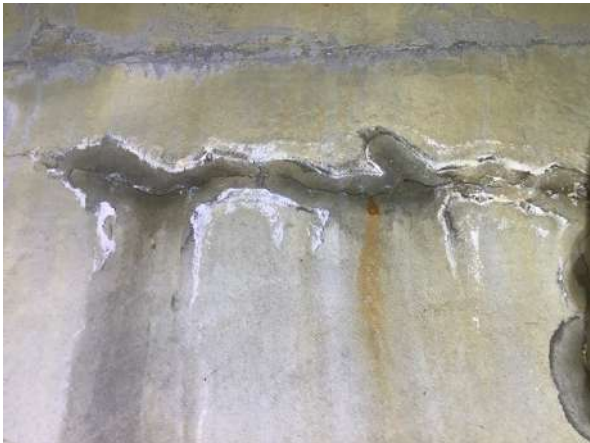
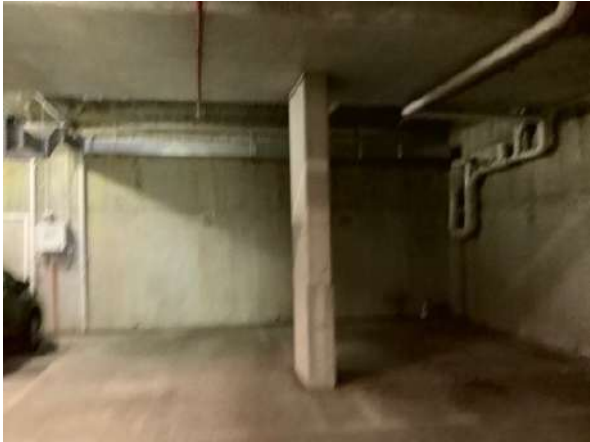
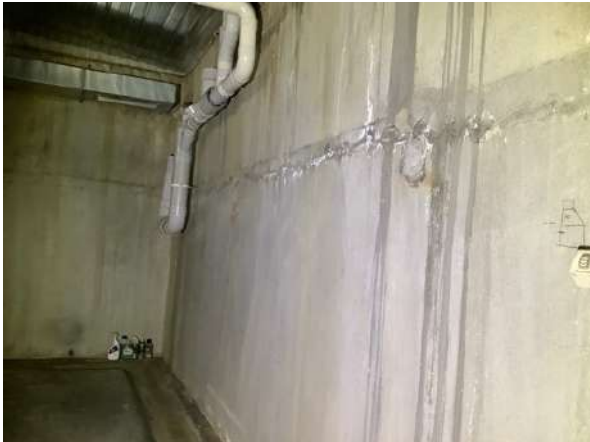
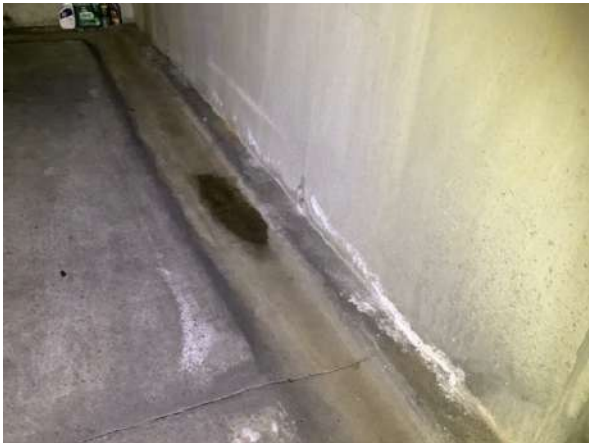
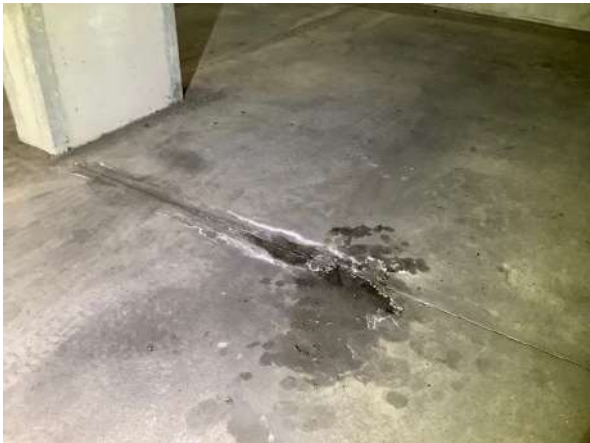
Major Defect 2.06

It is important to note that unless the cause / source is determined and repaired efflorescence will return.

A cleaning contractor should be appointed who is experienced in this field of works.

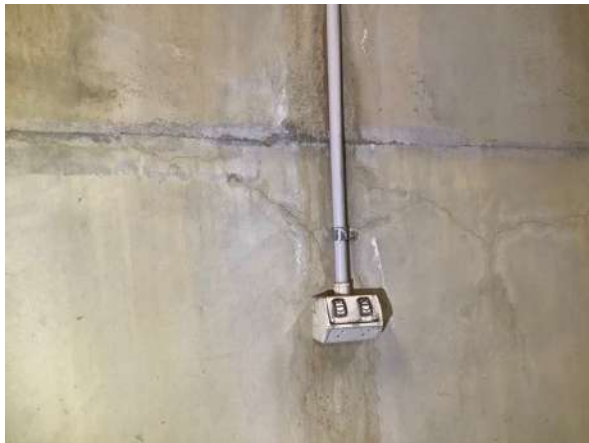
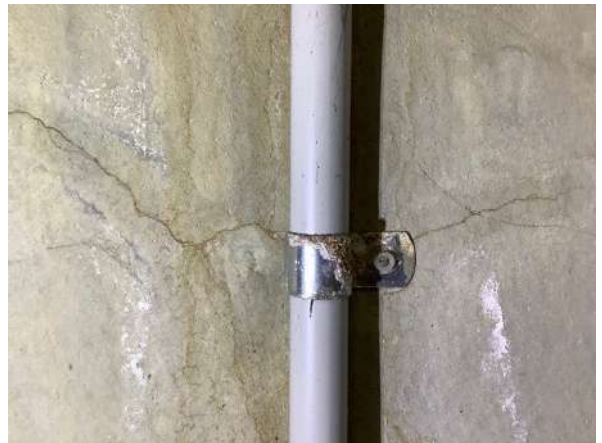
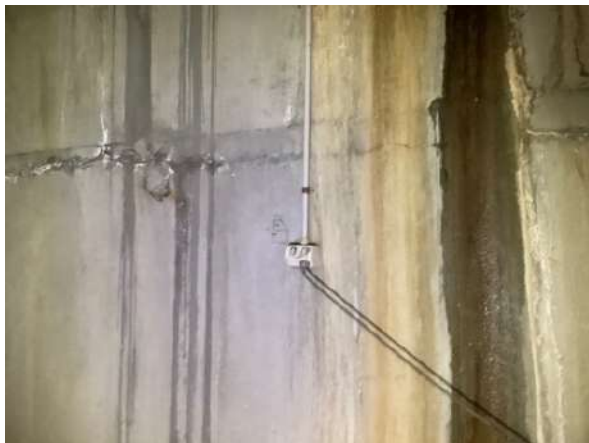
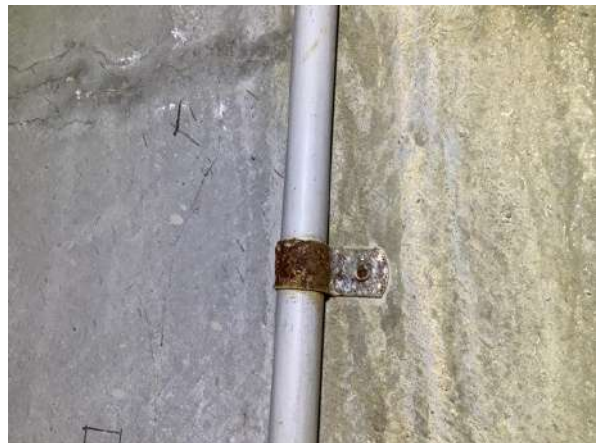
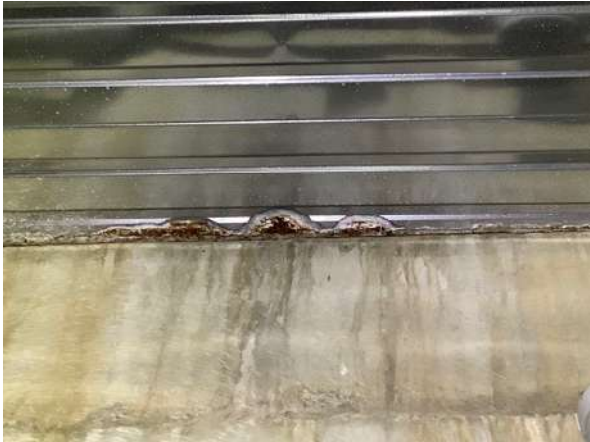
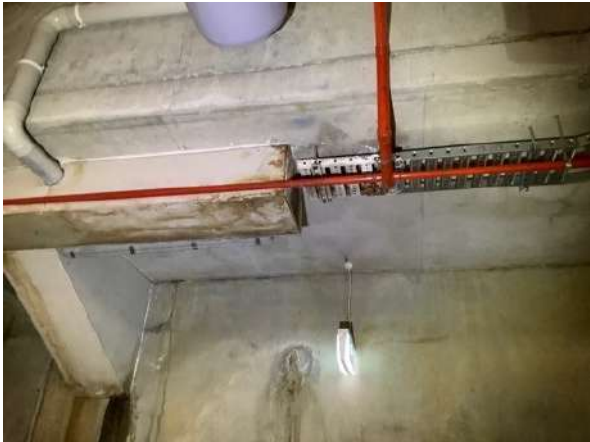
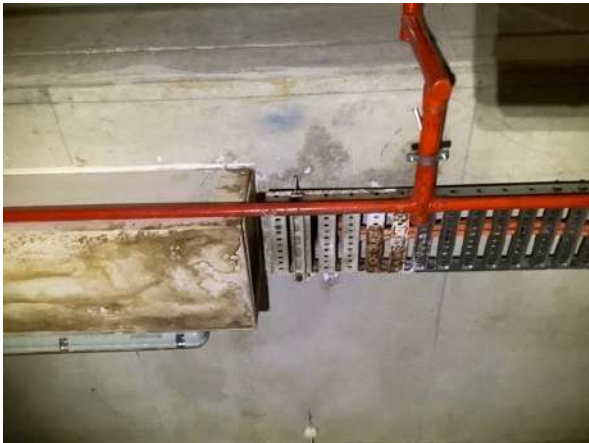
Major Defect 2.07

Location: Carpark & Surrounding Areas

Finding: Rusted / Corroded - Building Materials

This building element shows evidence of rusting and corrosion, which is likely to have developed as a result of excessive exposure to moisture, due to the water ingress and high moisture levels in the concrete.

As surface rust provides no protection to the underlying iron, the deteriorating condition is likely to worsen if not addressed in the short-term future.

Where possible, the use of galvanised (treated) metals or aluminium coated metals aid in rust prevention, as does regular general maintenance. Rust formation can be controlled with coatings, such as paint, that isolate the iron from the environment.

Rusting and corrosion should be managed by ideally removing or limiting the affected surface from exposure to moisture.

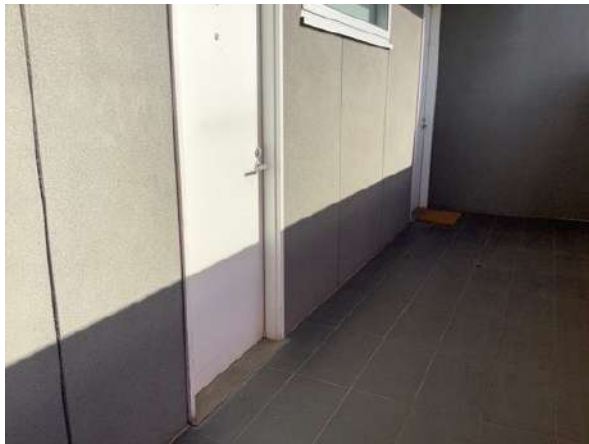
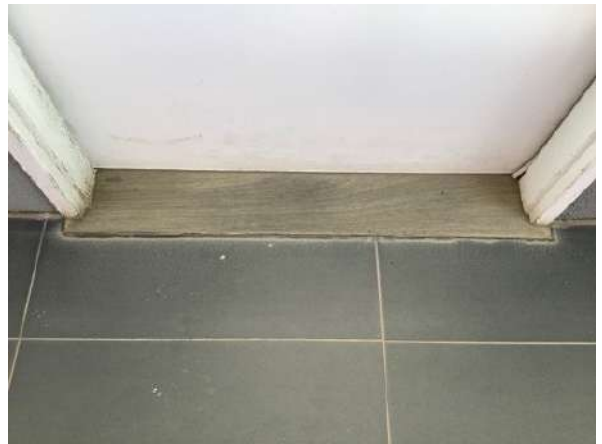
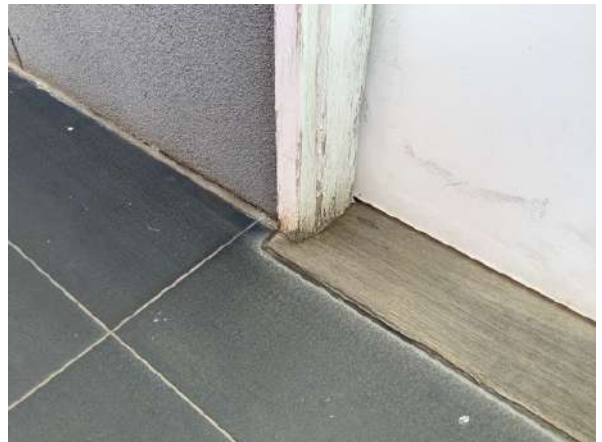
Minor Defect 3.08

Finding: Timber, exposed to weather / External painting deteriorated
Whilst incomplete or missing paint finish is generally an appearance defect, it can also lead to the development of secondary building defects over time. Incomplete areas of paint finish exposes the area to moisture, potentially accelerating the deterioration of underlying building materials.

Degraded paint finishes should be sanded back, filled, leveled and painted, as applicable. Where inadequate or missing paint protection has led to the deterioration of the associated building element, repair and/or replacement of this building element may be required.

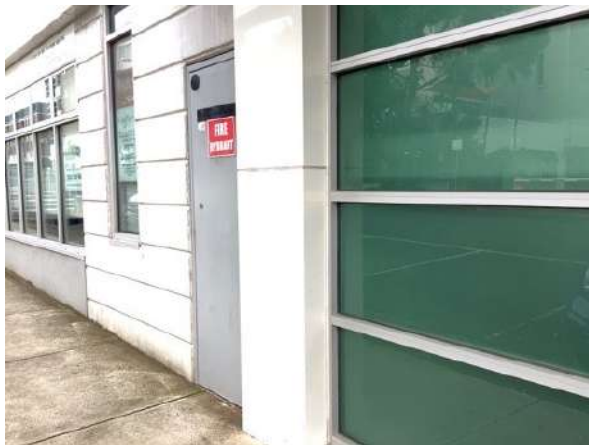
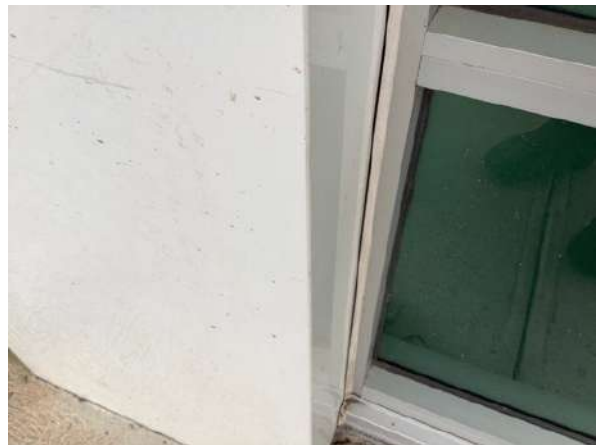
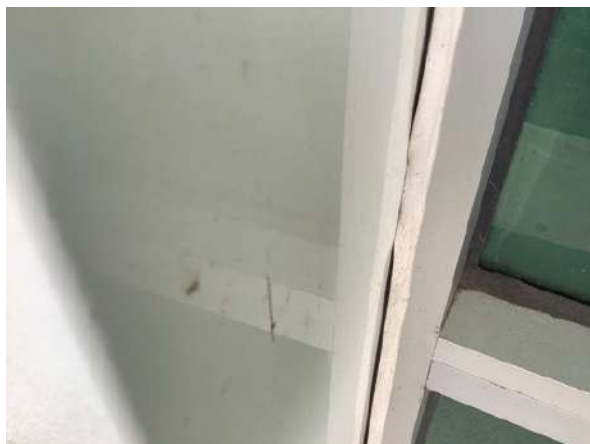
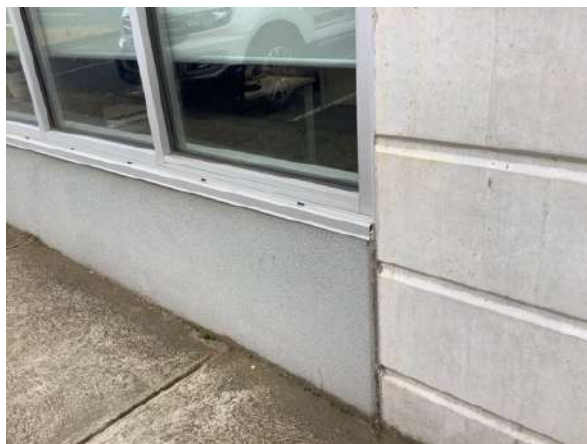
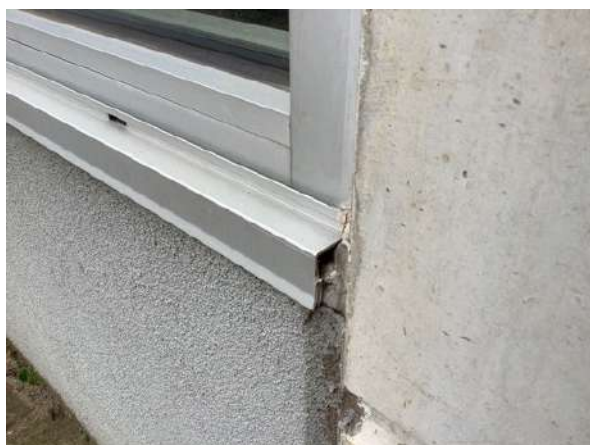
Minor Defect 3.09

Location: Perimeter Of Building - Exterior

Finding: Water Leaking & Water Ingress - External Areas

Water leaks were found to be present to the exterior sides, tops and or bottoms of the windows and/or doors and other areas as per the photos attached.

Leaks are generally caused by deterioration of silicon or rubber seals or sometimes just defective workmanship when no caulking as ever been used .

It is highly advised that a licensed plumber, handyman, builder be appointed to rectify any water leaks that may be present.

It is important to note once caulking these areas if water damage is noticeable to windows, timbers, etc, such as wood rott, it is imperative to engage the appropriate trades for replacement or repairs.

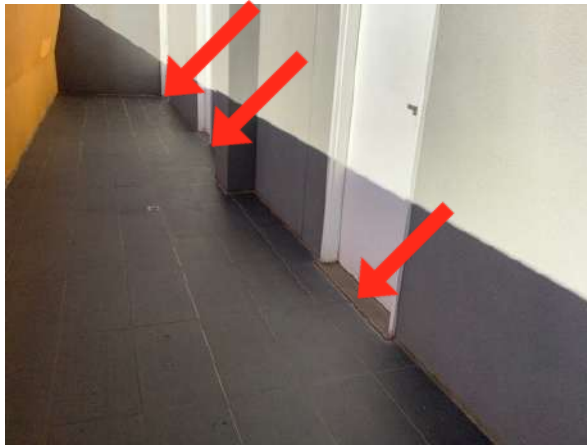
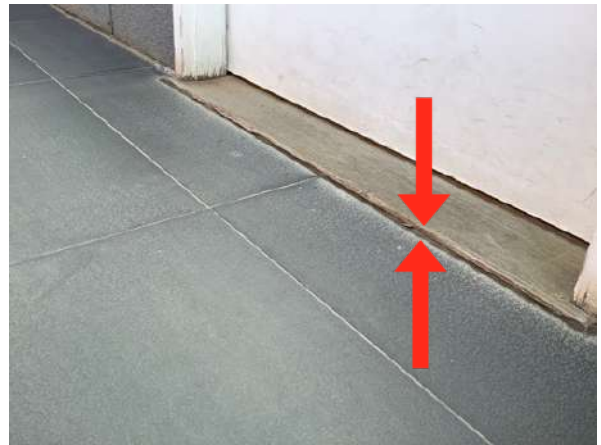
Finding: Balcony - Step defective

It was observed that the drainage system is not sufficient to withstand wind driven water surging from the deck or balcony into adjacent doors. The area should have a water proofed freeboard or step down. Where such a system is not in place the area is considered defective.

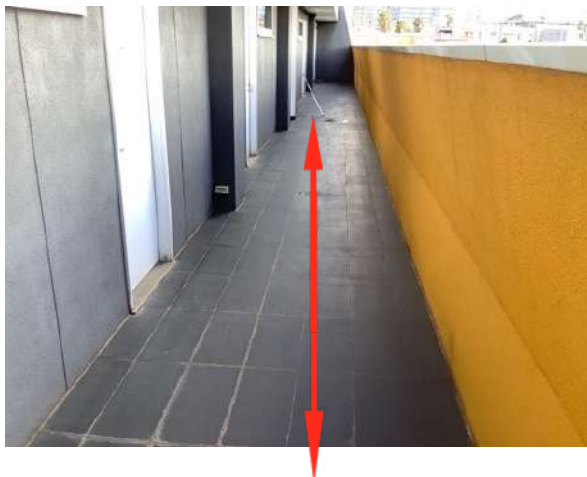
Observation 4.13

Location: Balcony Tiled Areas

Finding: Tiling (floor) - Movement or control joints missing or substandard.

There is no allowance for movement joints in the finished floor tiles. The grout to several lines needs to be fully removed and flexible similar coloured silicon installed to the opened up grout lines. We refer the builder to AS 3958.1 section 5.4.5.1. and section 5.4.5.2 (b) which require that movement resulting from separation of the tiled elements from fixed structures like columns and for large surface area stress management be provided for.

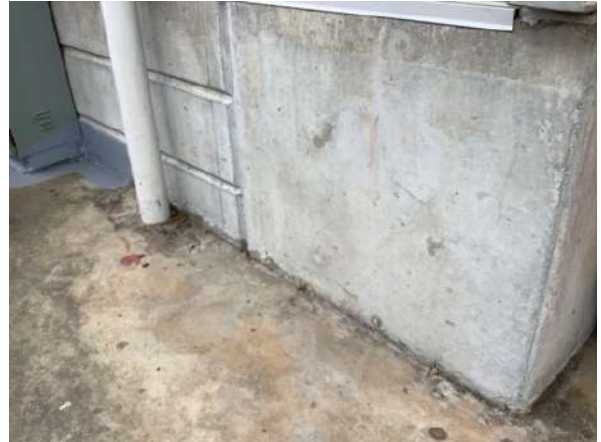
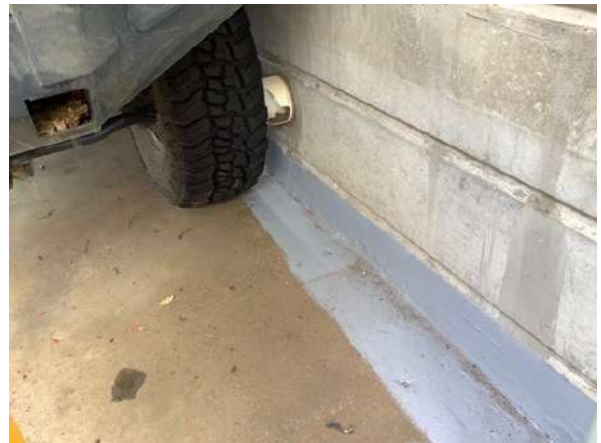
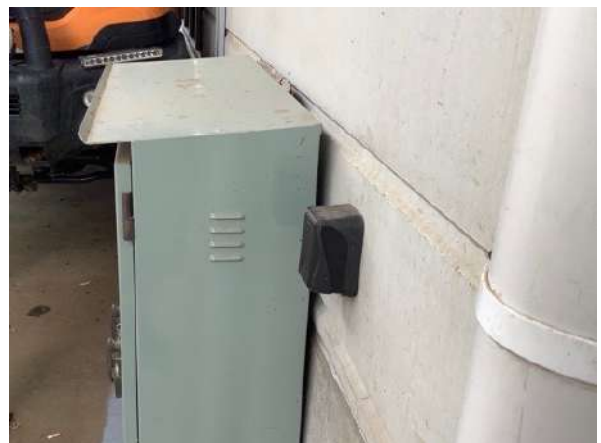
Finding: Area Of Repair

It appears as though works to this area in relation to stopping or reducing water ingress into the carpark has taken place. Whilst this may help this area of the carpark, it is not the overwhelming concern to the water and moisture ingress into the areas of concern.

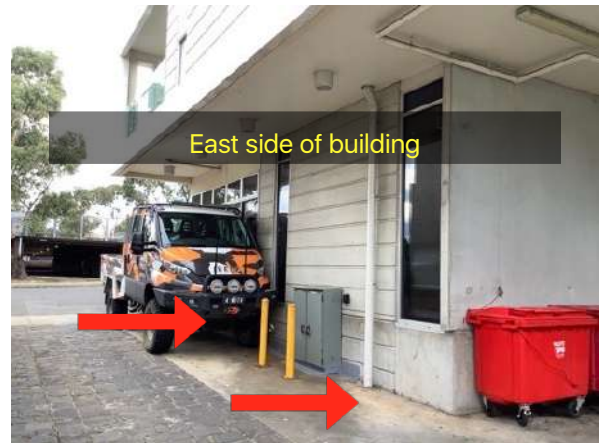
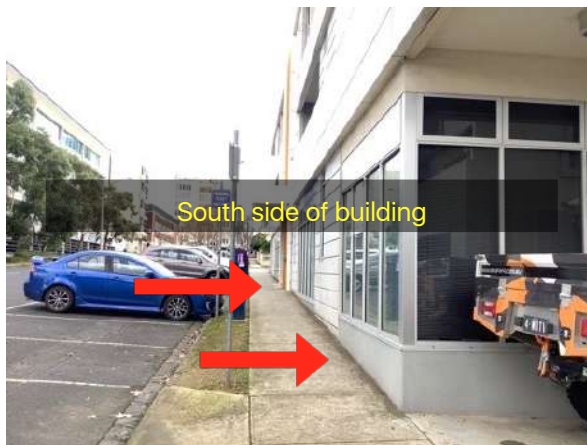
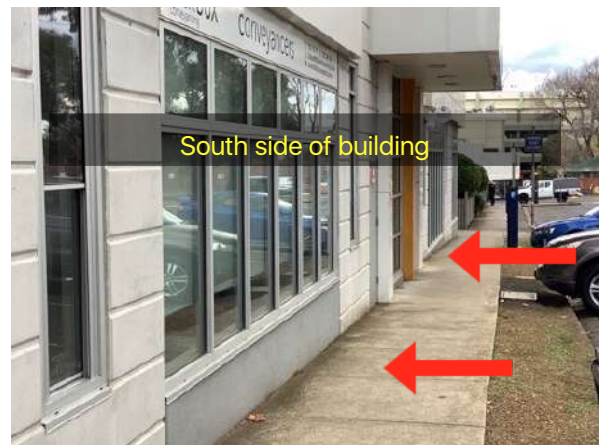
Observation 4.16

Location: Perimeter Of Building - Exterior
Finding: Areas where water is seeping through
XXXXXX

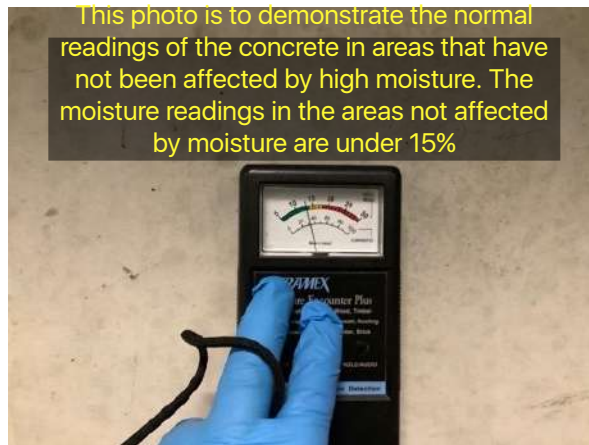
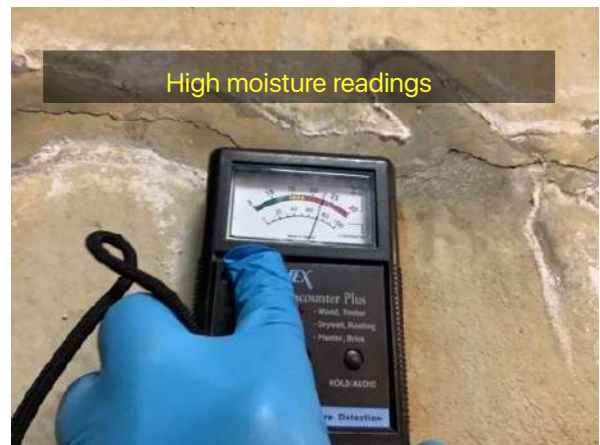
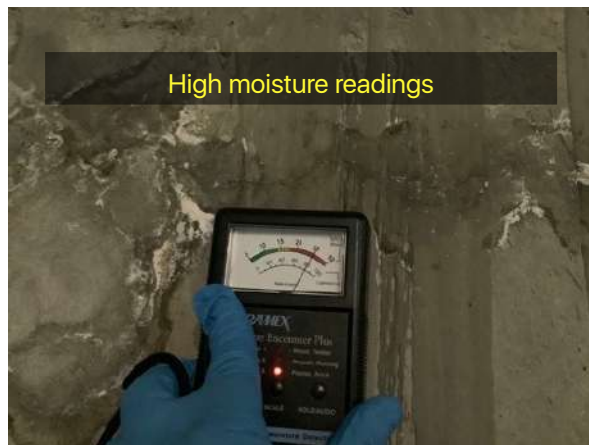
Observation 4.17

Location: Carpark & Surrounding Areas
Finding: Moisture readings
Concrete with high moisture readings in the areas of concern.
