(This is a 7 month old building) Methamphetamine Laboratory Results Report

Inspection Date: 25 Nov 2020

Property Address: Pascoe Vale Area

Report Type: Methamphetamine Screening Assessment

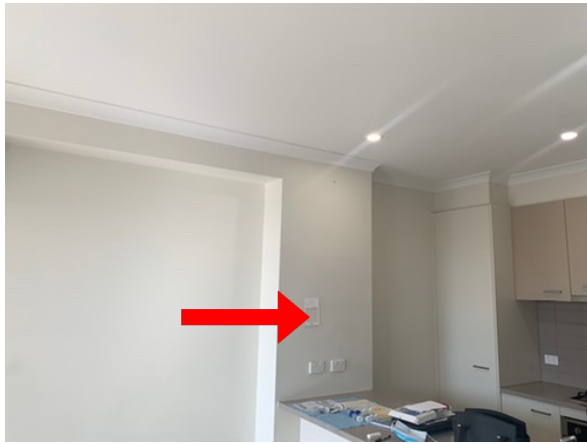
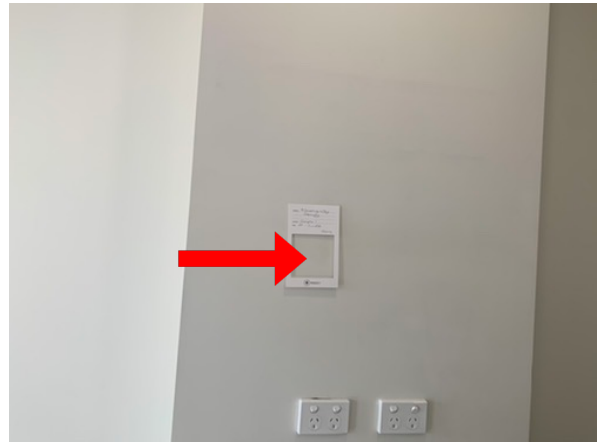
Location: Sample 1 - Kitchen

Finding: Detected Methamphetamine Sample Result - Above Allowable Levels

The levels found in this sample is 44/100cm².

Consequently the property is considered contaminated by toxic residues from Meth which could indicate its use or manufacture.

Once Remediation has been completed a further Detailed Screening Assessment is required to act as a Clearance Certificate for occupation.

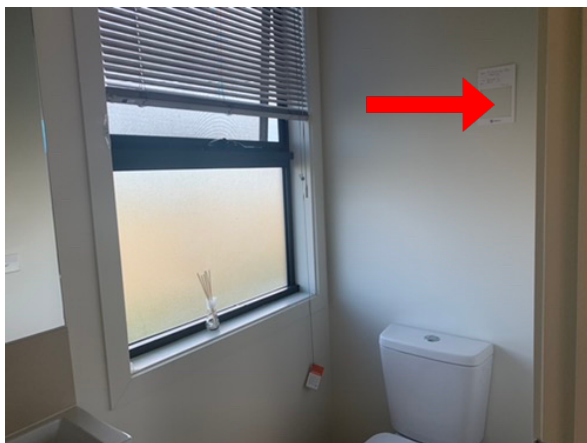
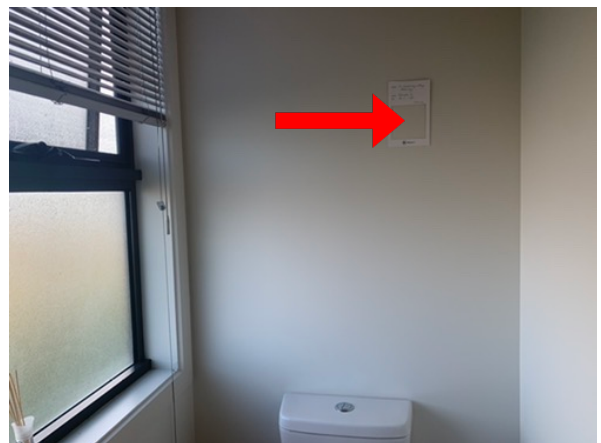
Location: Sample 2 - Powder Room

Finding: Detected Methamphetamine Sample Result - Above Allowable Levels

The levels found in this sample is 5.2/100cm².

Consequently the property is considered contaminated by toxic residues from Meth which could indicate its use or manufacture.

Once Remediation has been completed a further Detailed Screening Assessment is required to act as a Clearance Certificate for occupation.

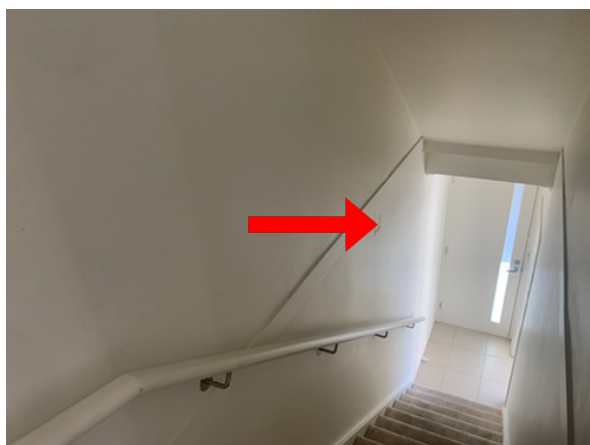
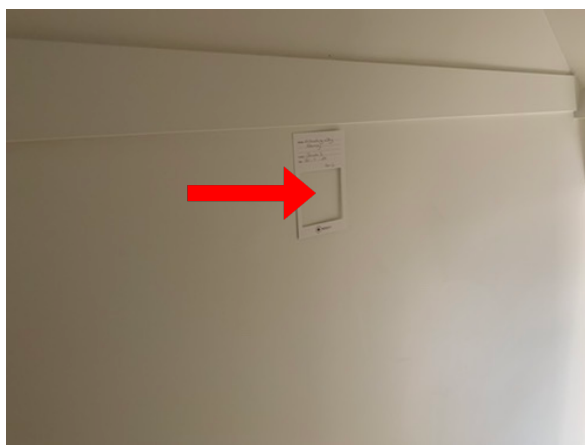
Location: Sample 3 - Staircase Entry

Finding: Detected Methamphetamine Sample Result - Above Allowable Levels

The levels found in this sample is 2.0ug/100cm².

Consequently the property is considered contaminated by toxic residues from Meth which could indicate its use or manufacture.

Once Remediation has been completed a further Detailed Screening Assessment is required to act as a Clearance Certificate for occupation.

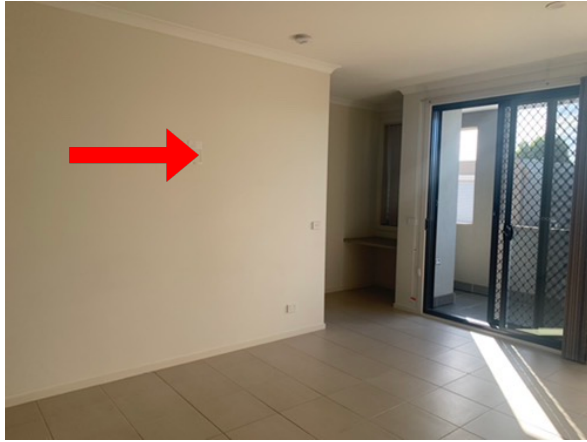
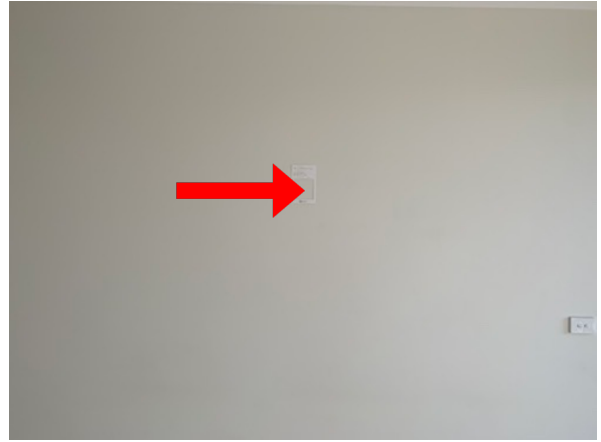
Location: Sample 4 - Family Room

Finding: Detected Methamphetamine Sample Result - Above Allowable Levels

The levels found in this sample is 3.0ug/100cm².

Consequently the property is considered contaminated by toxic residues from Meth which could indicate its use or manufacture.

Once Remediation has been completed a further Detailed Screening Assessment is required to act as a Clearance Certificate for occupation.

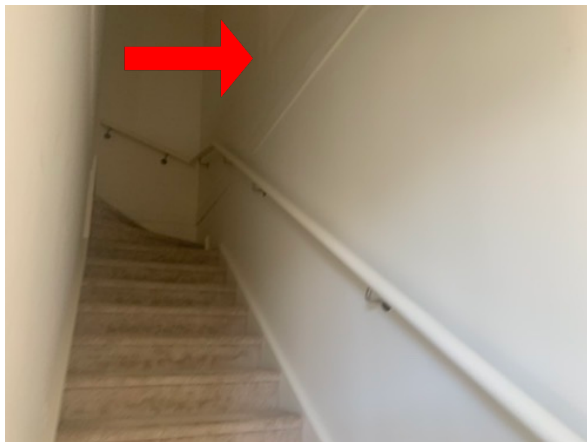
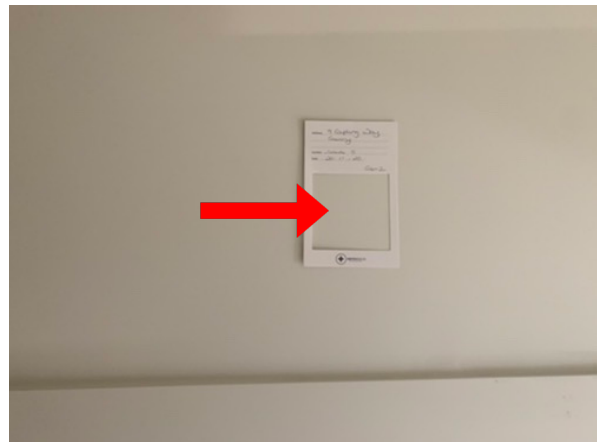
Location: Sample 5 - Stairs 2nd To 3rd Level

Finding: Detected Methamphetamine Sample Result - Above Allowable Levels

The levels found in this sample is 10ug/100cm².

Consequently the property is considered contaminated by toxic residues from Meth which could indicate its use or manufacture.

Once Remediation has been completed a further Detailed Screening Assessment is required to act as a Clearance Certificate for occupation.

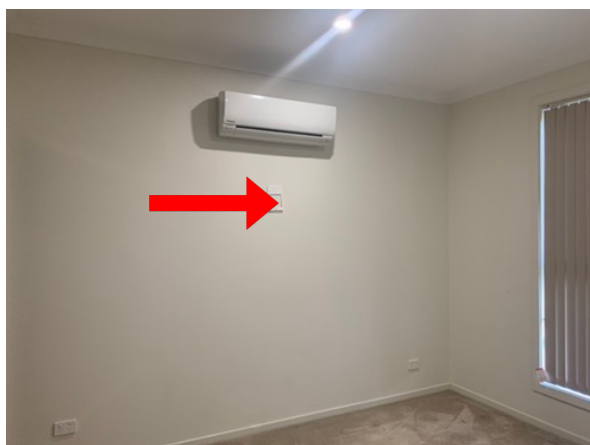
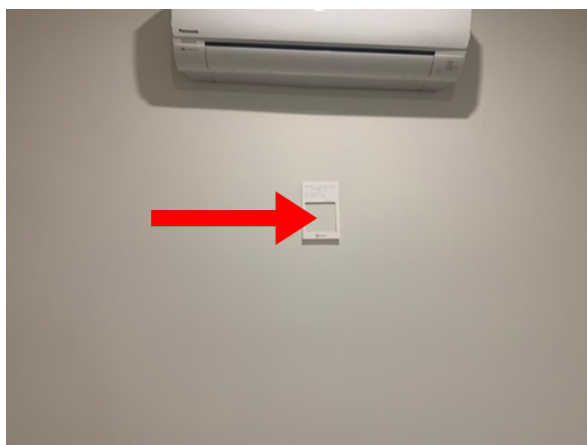
Location: Sample 6 - Bedroom 1

Finding: Detected Methamphetamine Sample Result - Above Allowable Levels

The levels found in this sample is 7.4ug/100cm².

Consequently the property is considered contaminated by toxic residues from Meth which could indicate its use or manufacture.

Once Remediation has been completed a further Detailed Screening Assessment is required to act as a Clearance Certificate for occupation.

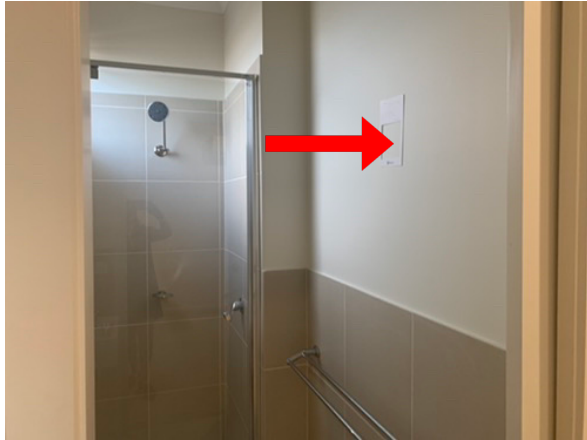
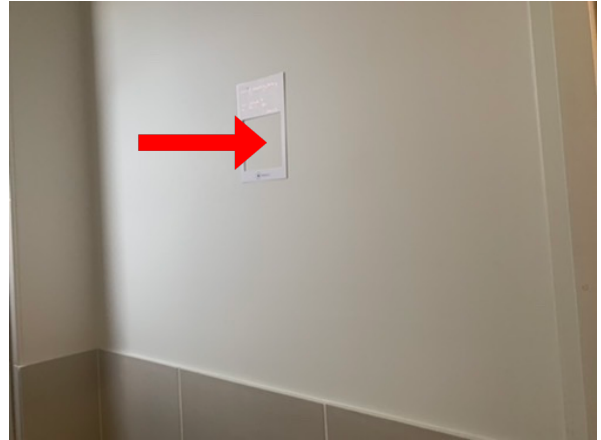
Location: Sample 7 - Ensuite

Finding: Detected Methamphetamine Sample Result - Above Allowable Levels

The levels found in this sample is 4.9ug/100cm².

Consequently the property is considered contaminated by toxic residues from Meth which could indicate its use or manufacture.

Once Remediation has been completed a further Detailed Screening Assessment is required to act as a Clearance Certificate for occupation.

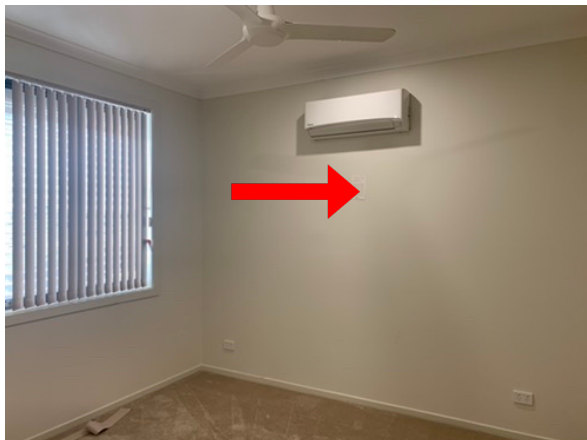
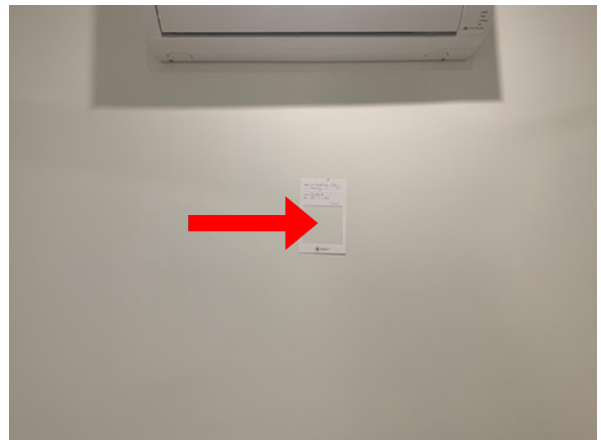
Location: Sample 8 - Bedroom 2

The levels found in this sample is 5.0ug/100cm².

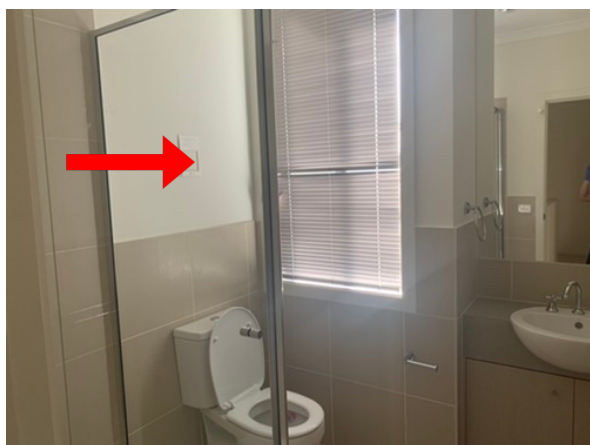
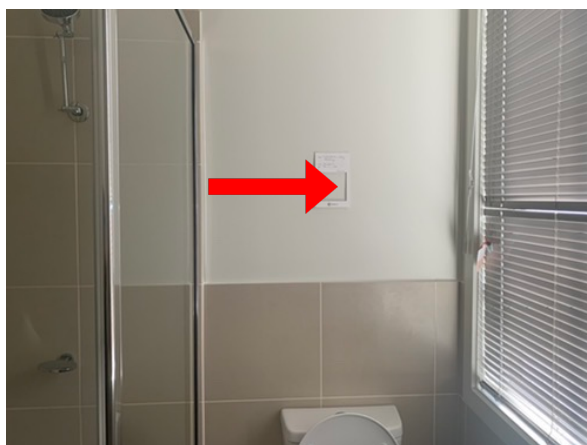
Location: Sample 9 - Bathroom

The levels found in this sample is 2.0ug/100cm².

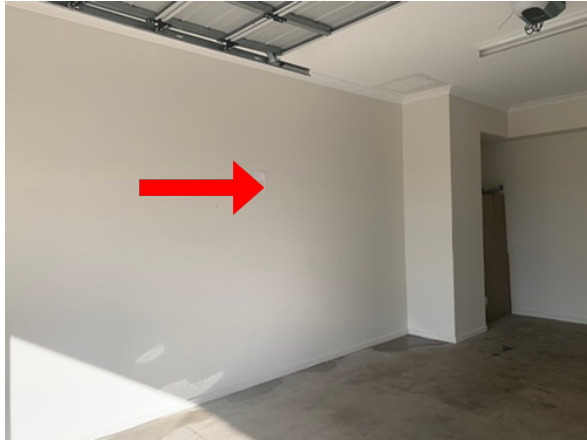
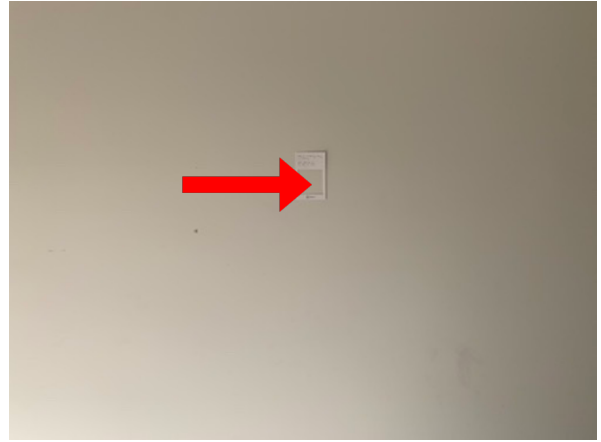
Location: Sample 10 - Garage

The levels found in this sample is 1.0ug/100cm².
