Building & Termite/Timber Pest Report (3 Star)

Inspection Date: 16 Jun 2021 Property Address: Northcote Area

Complies with Australian Standard AS 4349.1 – 2007 Inspection of Buildings Part 1: Pre-Purchase Inspections – Residential Buildings and AS 4349.3 – 2010 Inspection of buildings - Timber Pest Inspections.

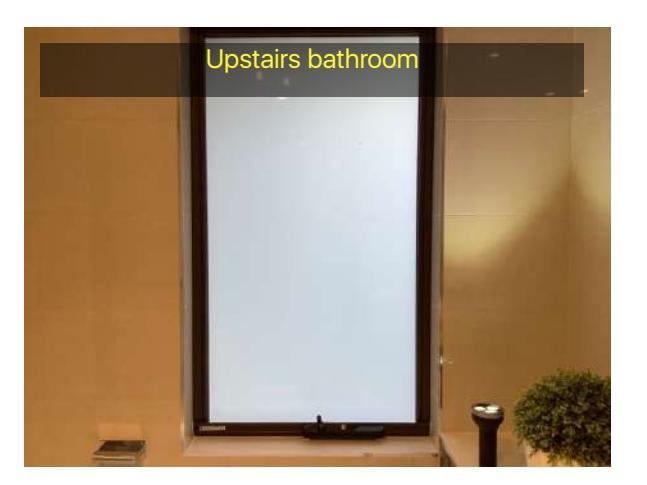
Serious Safety Hazard 1.01

Several windows throughout the property were jammed and difficult to operate at the time of the inspection. Windows provide ventilation to the adjoining area and should be at a fully operational level to ensure user comfort. Restricted function of the window may also pose as a potential safety hazard if required for emergency egress from the building.

Generally, factors such as general age of the building element and a lack of maintenance are the usual causes for this type of defect.

The windows may have several causes, ranging from minor defects as outlined above through to major structural issues, such as damage and/or subsidence (sinking) to subfloor structures or concrete slabs.

For minor causes of repair, replacement where window hardware or frame may be required, as well as minor repairs and cleaning, a qualified carpenter, registered builder, window specialist/ company or general handy person will be required to repair the affected windows.

Windows MUST function as a safety requirement and we HIGHLY RECOMMEND that you engage an appropriate proffesional as soon as possible to check all windows to the property.

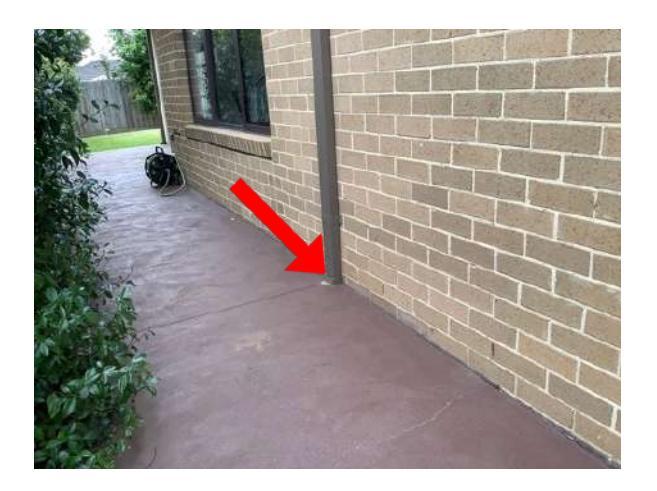
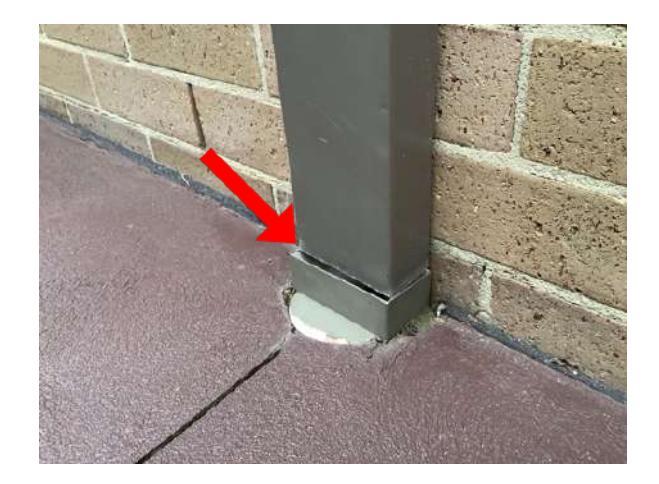
Major Defect 2.01

Stormwater drain - Not connected , Partially connected and/or Damaged.

♦ Please note that although this defect appears to be a relatively easy repair, it is still technically a major defect, as the access water spillage has the potential for the ground to gain excessive dampness & wetness, which creates added ground movement / expansion & contraction, which then follows through to potential foundation movement.

Where roof plumbing doesn't drain adequately, the area at the base perimeter can become excessively damp, potentially creating an environment that is susceptible to rust and corrosion of surrounding building elements, as well as attracting termites and other pests.

This has the potential for foundation subsidence and/or secondary damages such as structural defects such as brick movement / cracking.

It is highly recommended that a plumber be appointed to further inspect the area and to install / repair adequate drainage equipment where necessary.

If secondary damages have accrued we highly recommend that you engage a structural engineer and/or a registered builder for remedial works.

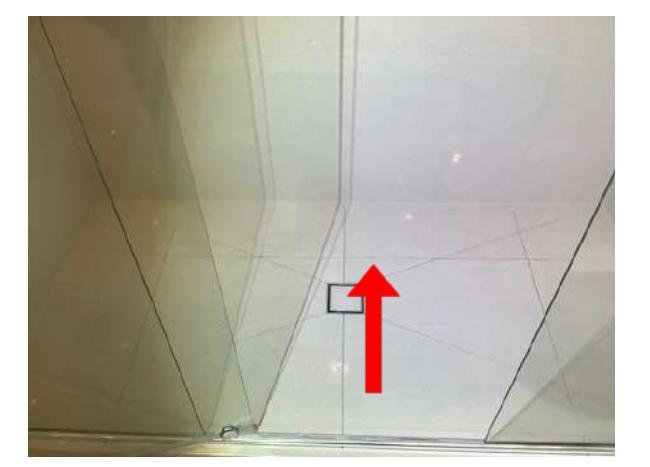
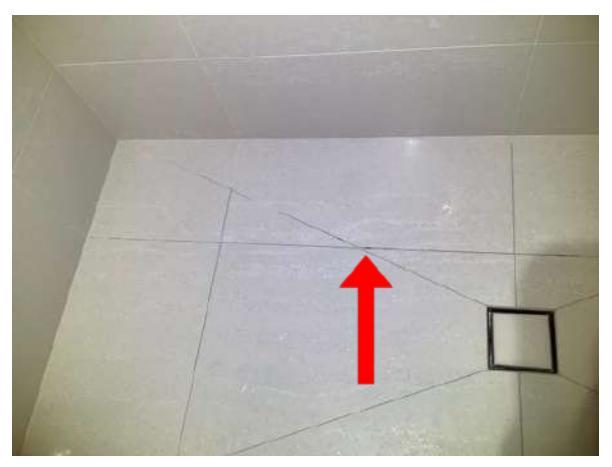
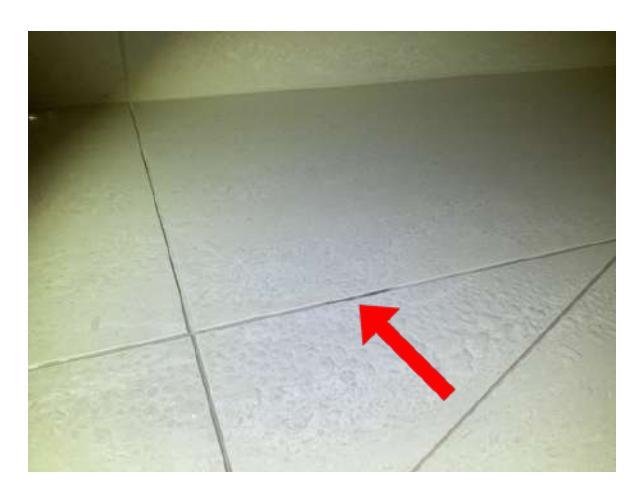
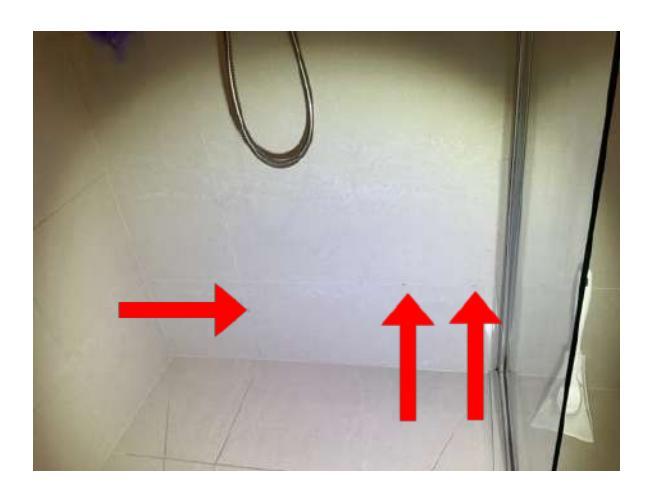
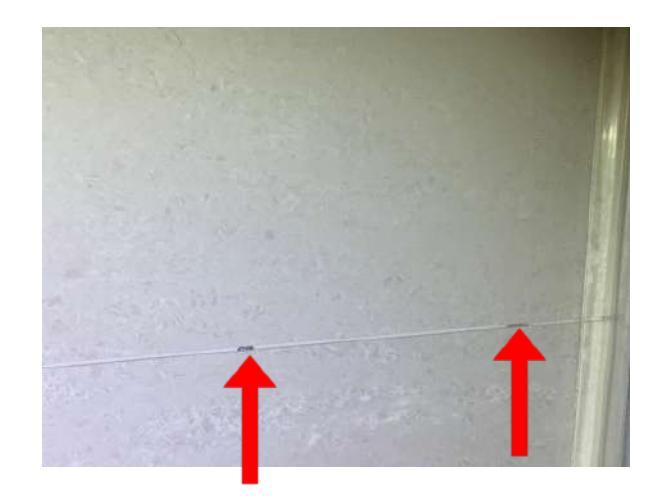
Major Defect 2.02

Silicone / Caulking To All Wet Area Junctions & Tile Grouting - Missing/Damaged or Poorly Installed

It was noted on inspection that sealant and/or tile grout is missing/damaged or inadequate to the tiled wet areas.

Whilst in some of the areas there is sealant/silicon, it has become apparent that the sealant has deteriorated and/or is just missing or just installed defectively/messy.

Whilst in some of the tile mortar is perfect, it has become apparent that the tile mortar has deteriorated and/or is just missing in other areas.

A flexible sealant/silicon and tile mortar should be applied to affected areas to prevent any subsequent water damage that is likely to occur.

A sealant specialist, tiling contractor and/or registered builder in some serious cases, should be appointed to assess any damage caused by water to the entire internal, sub-floor where applicable, walls, etc of the building and clean, take off old sealant and tile mortar, then re-seal and re-mortar these areas as soon as possible.

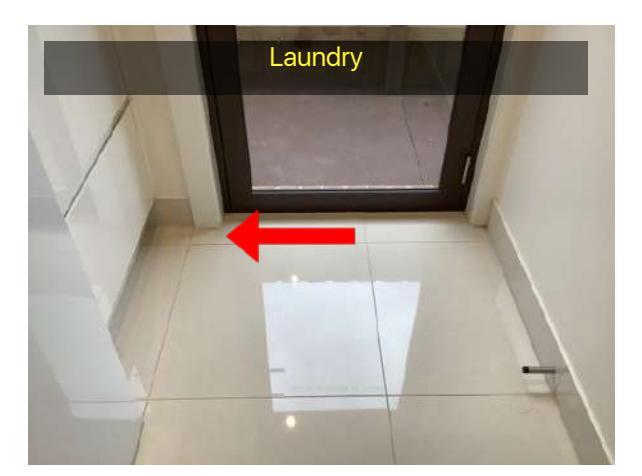
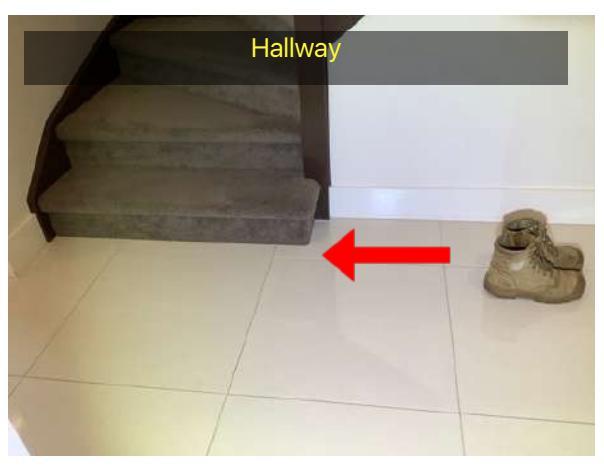
Minor Defect 3.01

Tiles - Cracked or damaged

Cracking was evident to the tiling at the time of inspection. While the cracking appears to be minor, these areas are frequently exposed to water, allowing potential for water penetration into adjoining sections of walls or flooring.

If left unmanaged, water penetration to these areas may lead to subsequent water damage, which is likely necessitate repair work to affected building elements.

A tiling contractor should be appointed to ensure that no further water damage occurs. The reapplication of silicone and grouting throughout remaining tile work is also advised, to further protect the area against water penetration.

Where water penetration has led to water damage, appointment of a relevant tradesperson may be required to repair damaged building elements.

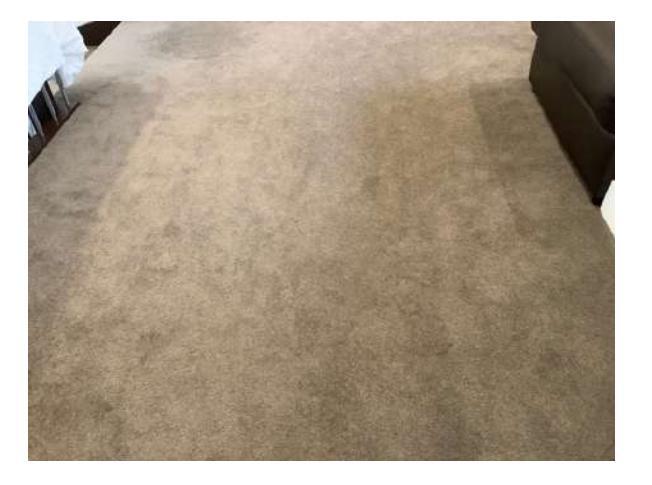
Location: Finding: Flooring - All Areas

Upstairs Flooring - Bouncy / Squeaking

Bouncy floors generally indicate that the floorboards or the subfloor structures are coming loose from the joists that they are installed on. Bouncy flooring may also be the result of gaps between flooring and stumps or joist structures, which require packing.

Bouncy flooring may also be the result of gaps between flooring or joist structures, which require packing and/or addition adhesive and in addition, additional screw fixings.

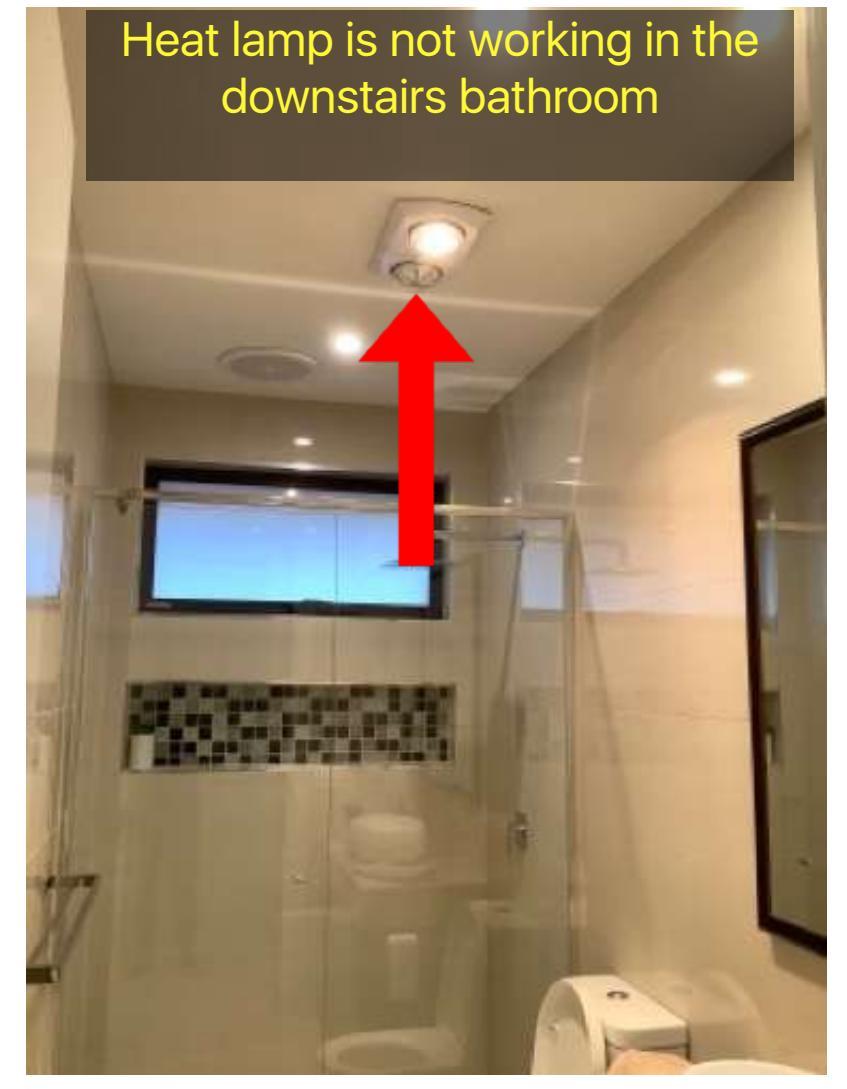
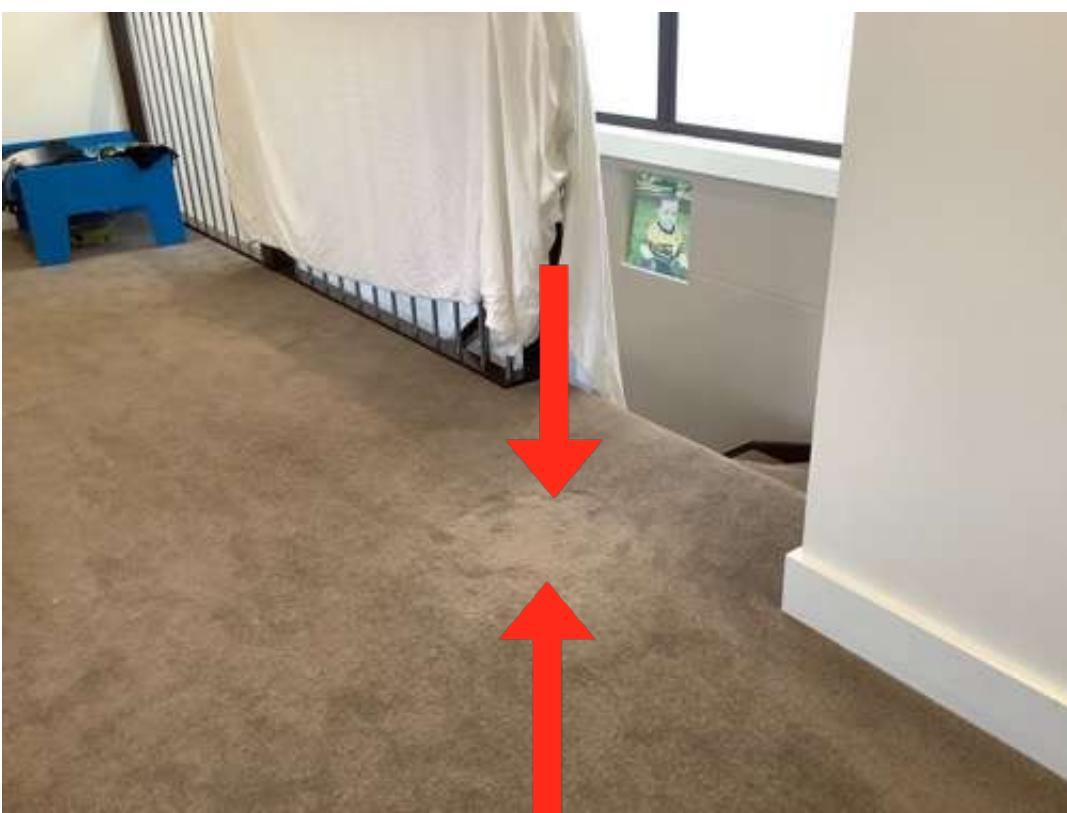
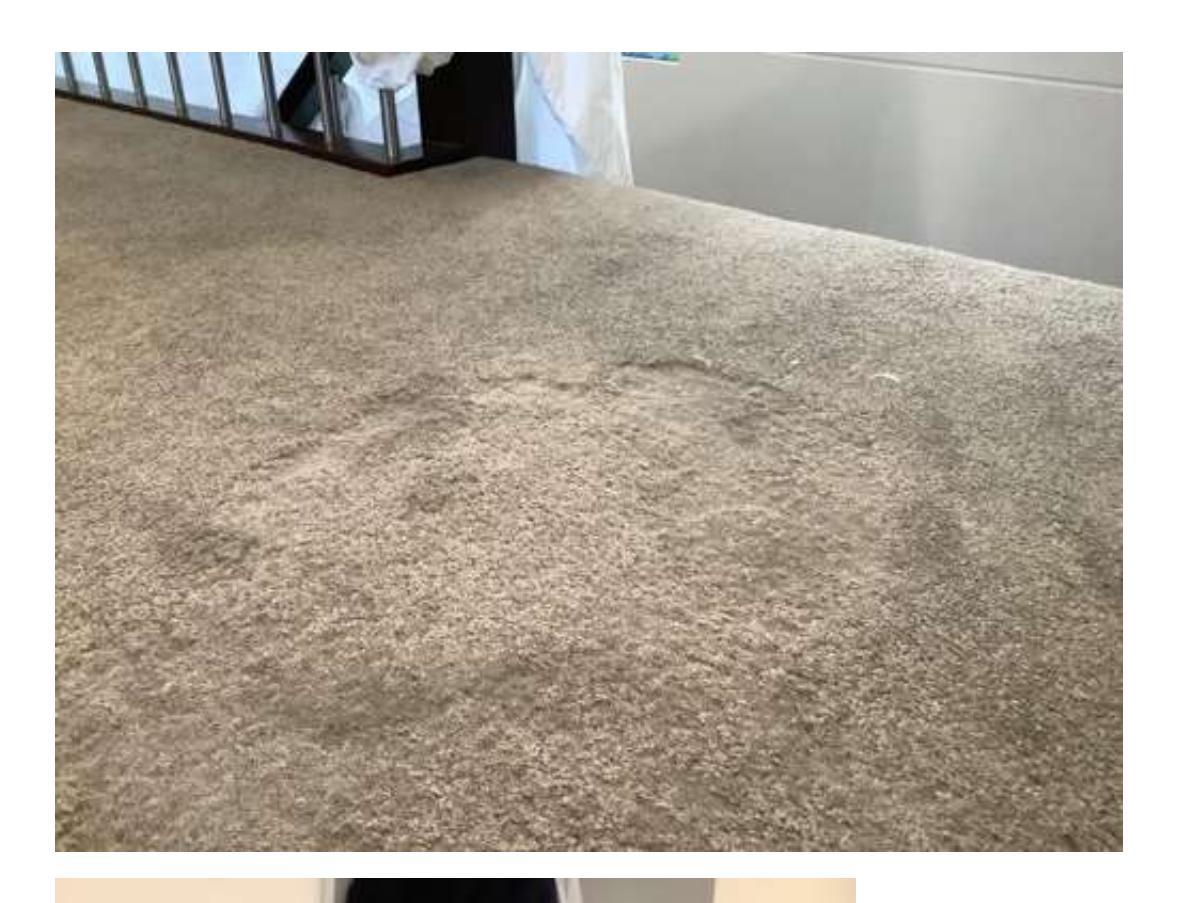
Location: Finding: Worn/Aged and/or Damaged-All Areas

Worn/Aged and/or Damaged.

Items like cracked glass mirrors, cracked glass windows and windows not operation smoothly are defects that should be repaired by the appropriate trades.

Plaster damage caused from wardrobe sliding door

It is IMPERATIVE that you engage registered and qualified trades and at the end of there works they must supply certificates, such as an electrical safety certificate, plumbing and gas certificate if the works are electrical or plumbing, but for items such as damaged door handles, painting an experienced carpenter or handyman can sometimes be engaged.

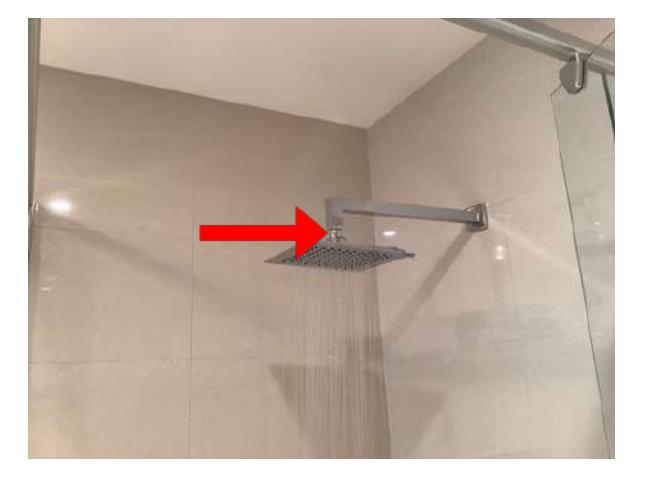
This shower head leaking creates potential for subsequent water damage to the surrounding area and materials.

Where shower heads are loose & leaking, a qualified plumber should be appointed to re-fix the plumbing fitting to prevent further secondary damages that may not be seen, creating water damage unseen.

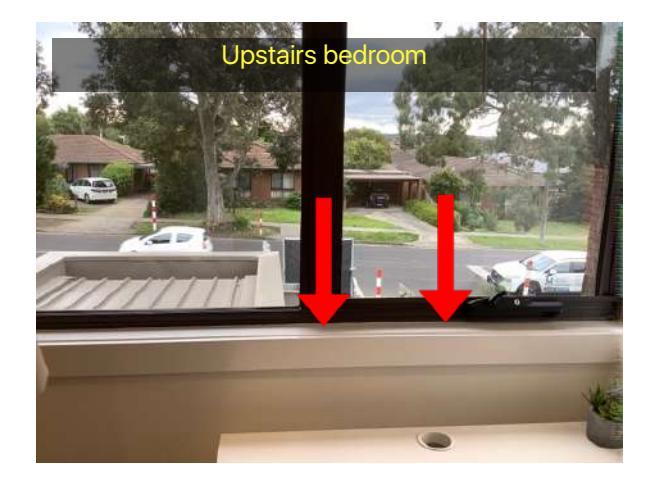
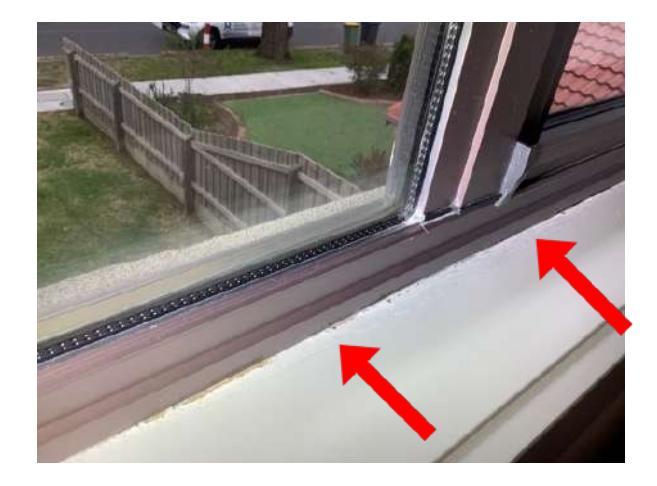
Location:	Windows - Internal Areas
Finding:	Windows - Water Staining
	Water staining was evident to various window frames.

Generally water staining to window frames, may be due to the window seals to the perimeter of the glass edges, have deteriorated. This may be due to damaged rubbers, particularly to metal window frames or may be due to deteriorated silicon and/or may be due to timber rott. In addition water staining may be a combination of damaged silicon, damaged rubber seals and wood rott.

Replacement of any broken or damaged structures is advised in particular if the damage has caused secondary defects that have compromised the building structure or safety of any persons.

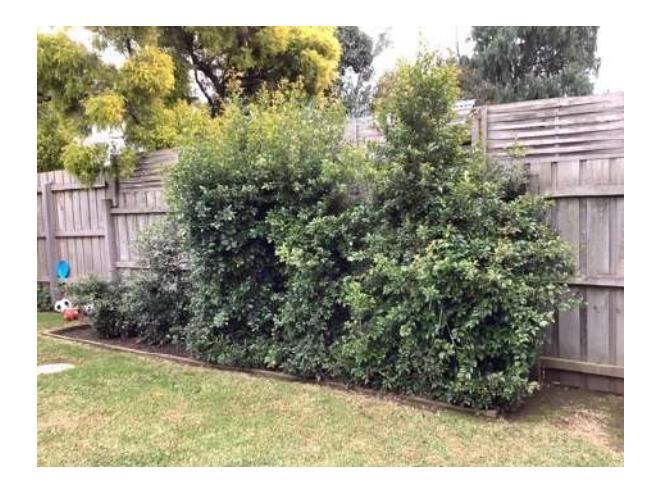
Conditions conducive to timber pest attack 4.10

Location: Garden Areas - All Areas Finding: Garden Plants - Overgrown . PLEASE NOTICE THE ATTACHMENT PICTURES TO THIS DEFECT STATEMENT; At the time of the inspection it was found that the plants are overgrown and close to the exterior building. This has the effect to create a conducive environment for termites and restricts visual contact to the weep holes in the event that termites create a barrier into the property. It is highly recommended that the plants be trimmed and/or moved away from the immediate area of the perimeter building... The property is a high risk for termites as the environments to the property are very conducive with many susceptible areas. As noted above, I can not stress how important it is to severely reduce the trees, vegetation,

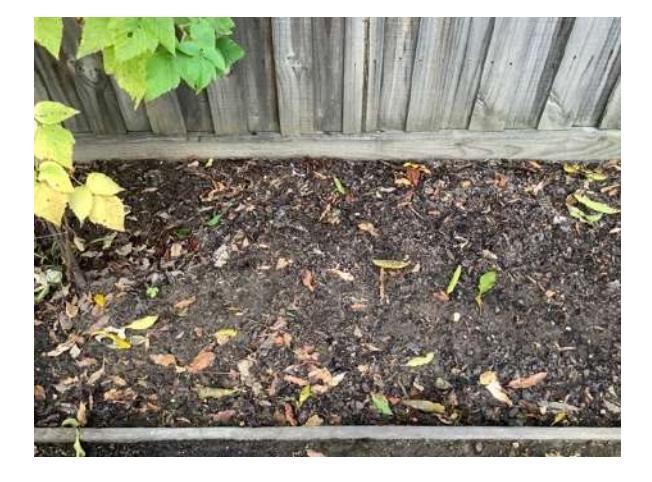
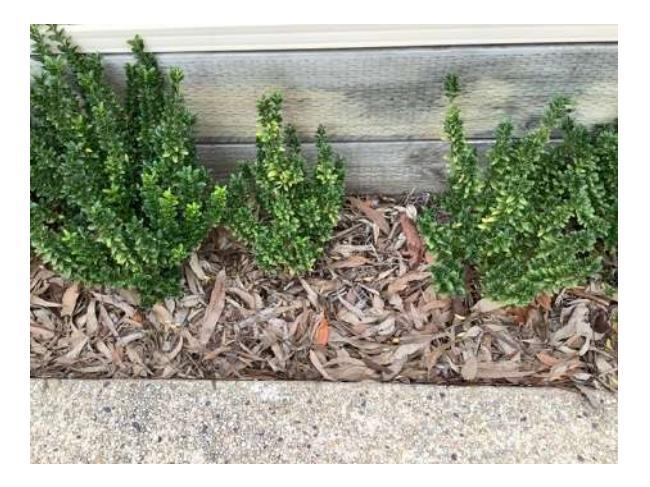
Conditions conducive to timber pest attack 4.11

Garden beds were found to be evident in areas of garden areas. These garden beds can include untreated timber, bark, excessive old vegetation and with a combination of moisutre from watering hosing can make conditions very conducive to termite activity and termite ingress.

It is always important to keep the garden beds as clean as possible and take out excess old bark from the trees, leaves and keep bark mulch to a minimum or better introduce rocks or some item that does not create an conducive environment for termites and hold excess. moisture.

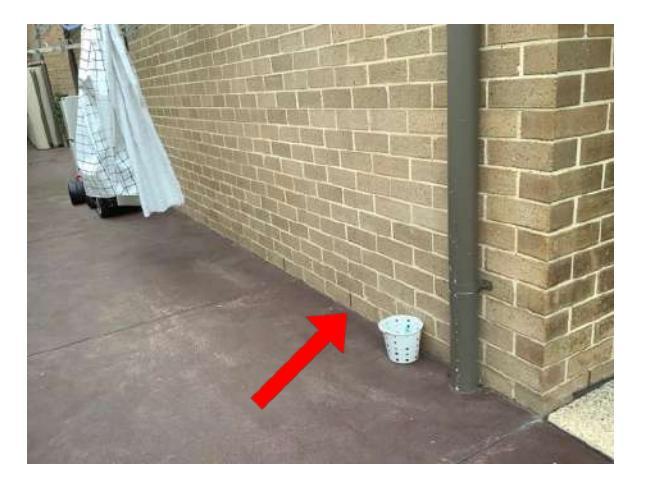
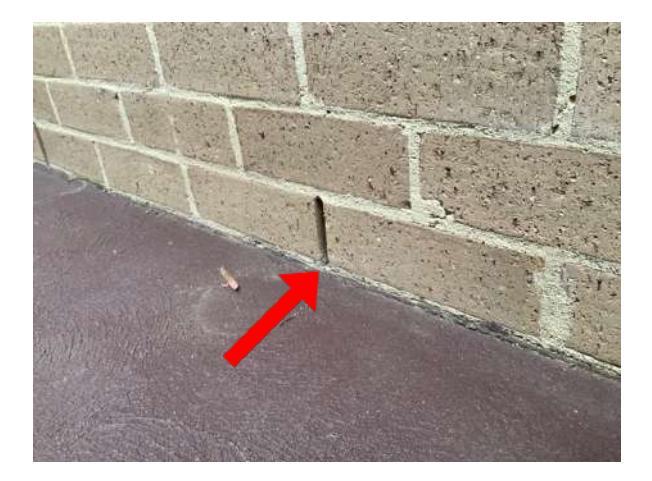
Conditions conducive to timber pest attack 4.12

BRIDGING OR BREACHING OF TERMITE MANAGEMENT SYSTEMS AND INSPECTION ZONES

It is highly recommended that Weep Holes or Ventilation Areas are left exposed 150mm from the bottom of the Weep Holes or Ventilation Areas to the ground level and 75mm from the bottom of the Weep Holes or Ventilation Areas to the top off concrete paving in all areas throughout the external property.

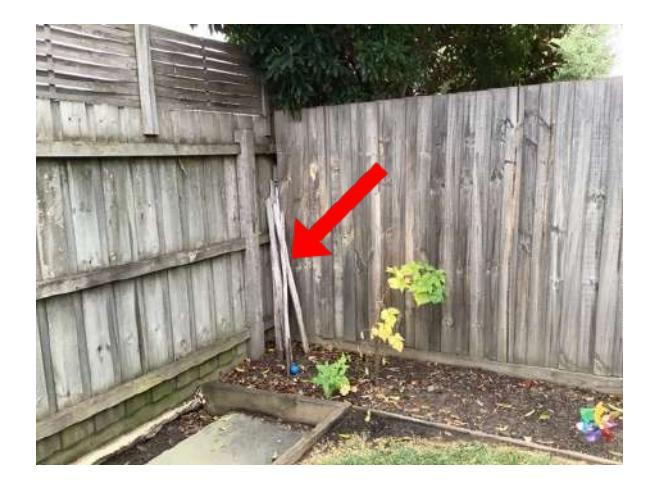
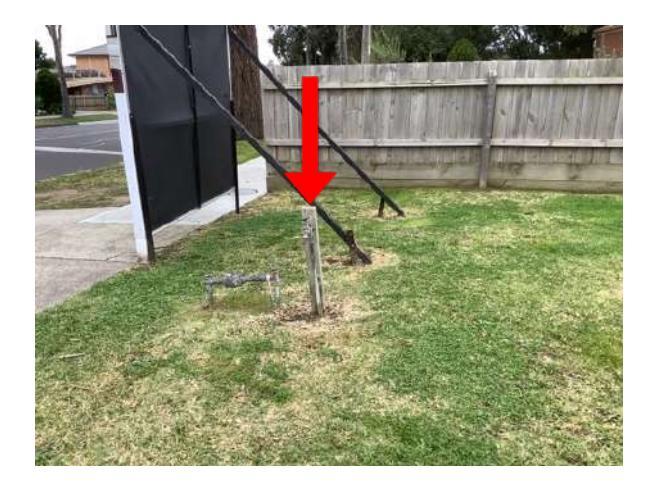
Conditions conducive to timber pest attack 4.13

UNTREATED OR NON-DURABLE TIMBER USED IN A HAZARDOUS ENVIRONMENT

Remove untreated timber that is in direct contact with external grounds. Consider replacement with more durable materials i.e. treated timber or non timber elements.

Frequent pest inspections are advised to readily identify any termite activity in these areas.

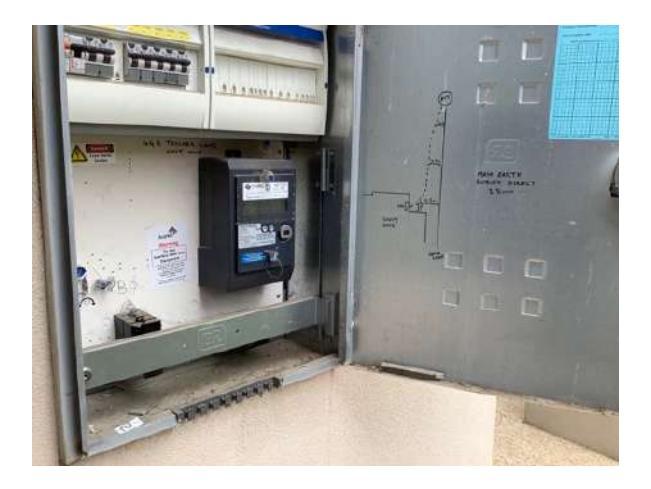
◆ Termite Management System - NO evidence of installation

At the time of inspection, it appeared as though no termite management system has been installed, with no evidence to suggest preventative works taking place.

The client may consider gaining further advice from a pest controller as to the costs and procedures involved with this application. It is recommended that obtaining such advice be a short-term priority.
