Building & Electrical Report

Inspection Date: 6 Jul 2021 Property Address: Footscray area

Complies with Australian Standard AS 4349.1 - 2007 Inspection of Buildings Part 1: Pre-Purchase Inspections - Residential Buildings

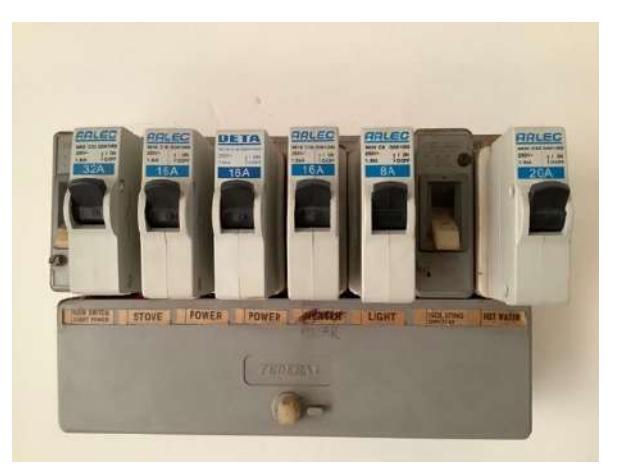
At the time of inspection it was noted that the switchboard protective devices are old fuse wire type.

Generally, the switchboard is out-dated and should be replaced with circuit breaker protective devices and fitted with a safety switch as soon as possible as a minimum to improve the safety of the property. It is advised that a qualified electrician be contacted immediately to install a new switchboard complete with a safety switch and provide any further advice on additional works that may be required in this State.

A switchboard upgrade with modern circuit breakers and safety switches is highly recommended in accordance with AS 3000.

Upon completion of electrical works a Safety Certificate (Prescribed) is required to be given to the owner of the property.

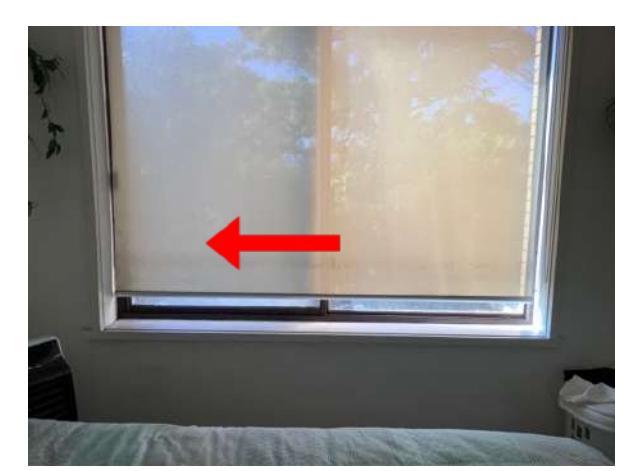
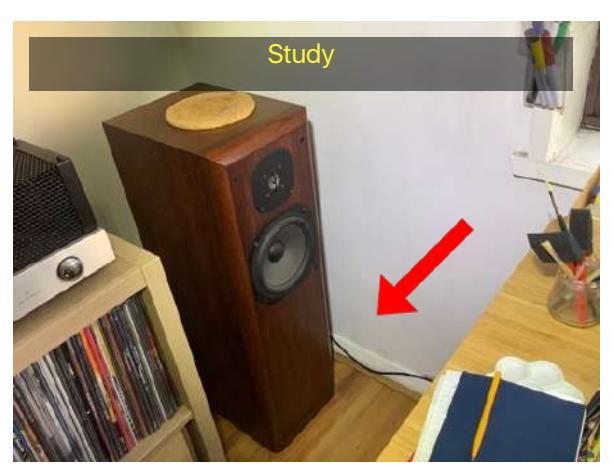
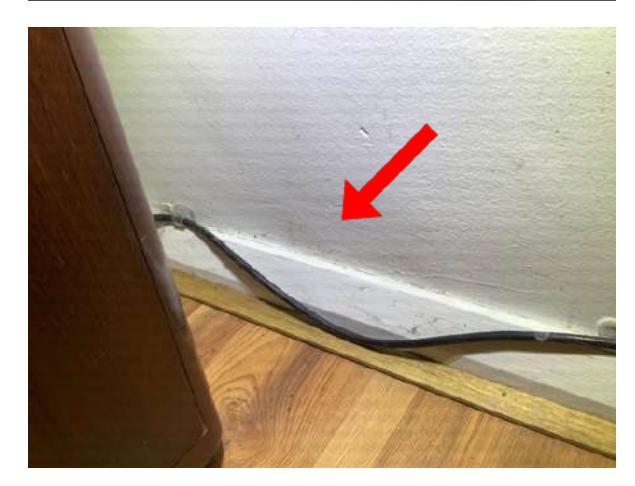
Where evidence of mould growth was noted, there may be environmental, biological or health issues associated with the report. A specialist inspection by a suitably qualified environmental health inspector may be warranted where mould is extensive or where any queries regarding air quality spores or other related issues apply.

It is important to determine the cause of mould not just to get rid of mould.

Generally, the client is advised to ensure that the general environment is free of moisture and humidity to aid in the prevention of mould formation and development. Any mould found during the inspection should be cleaned immediately and/or taken out, particularly where the mould is in the silicon / caulking.

Finally the cause or source of the mould MUST BE TAKEN CARE OF URGENTLY.

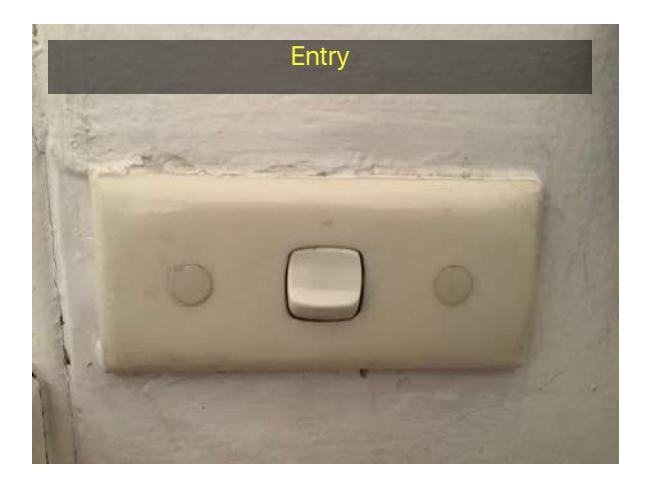
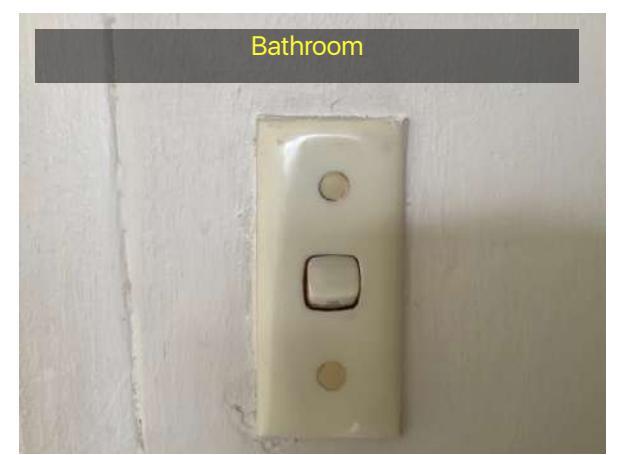
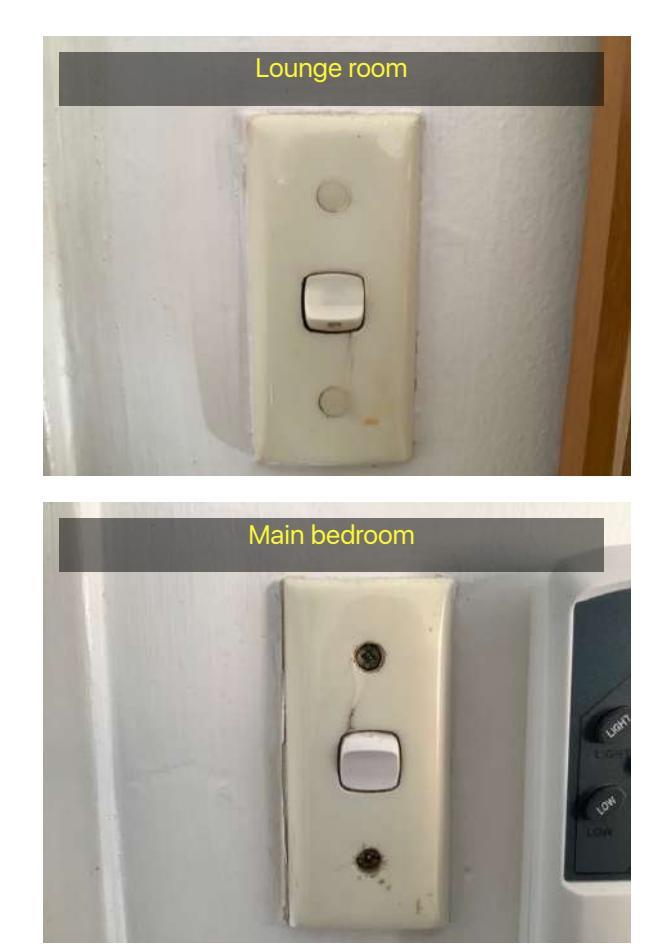
Location: Finding: Electrical - All Areas

Electrical Switch - Damaged/Faulty

The switches in areas were found to be damaged or faulty at the time of inspection. This occurs generally when the switch plate or the switch itself have either worn, decayed or burnt out as a result of electrical arching.

Repair and/or replacement of the switch is advised to ensure the fixture and it's associated structures are safe and fully operational.

A licensed electrician should be appointed to repair/replace the light switch or switches as soon as possible.

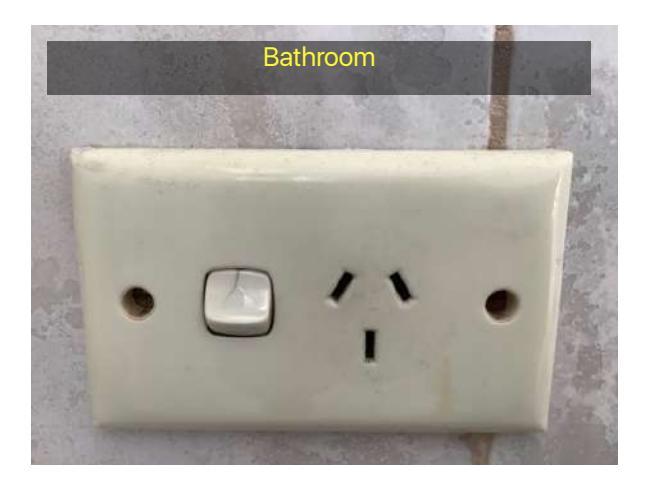
Location: Finding: Electrical - All Areas

Electrical - Power Points - Damaged/Faulty

The power points in areas were found to be damaged or faulty at the time of inspection. This occurs generally when the power point plate or the switch mechanisms have either worn, decayed or burnt out as a result of electrical arching.

Repair and/or replacement of the power points is advised to ensure the fixture and it's associated structures are safe and fully operational.

A licensed electrician should be appointed to repair/replace the power points as soon as possible.

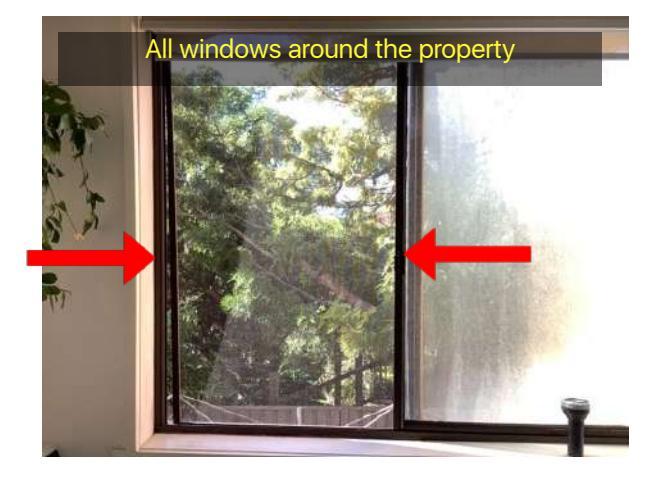
Window Opening - Not Safe/Defective

However this is a major safety concern & regardless of whether this was legal at the time of this building being built or not it is still very dangerous to have these openings that are not limited to the openings as a child, small person or somebody through accidental circumstances can fall through the window.

I highly recommend that you engage a window manufacturer or a window manufacturers technician to change the window mechanisms so that they limit the opening of the window as a matter of urgency.

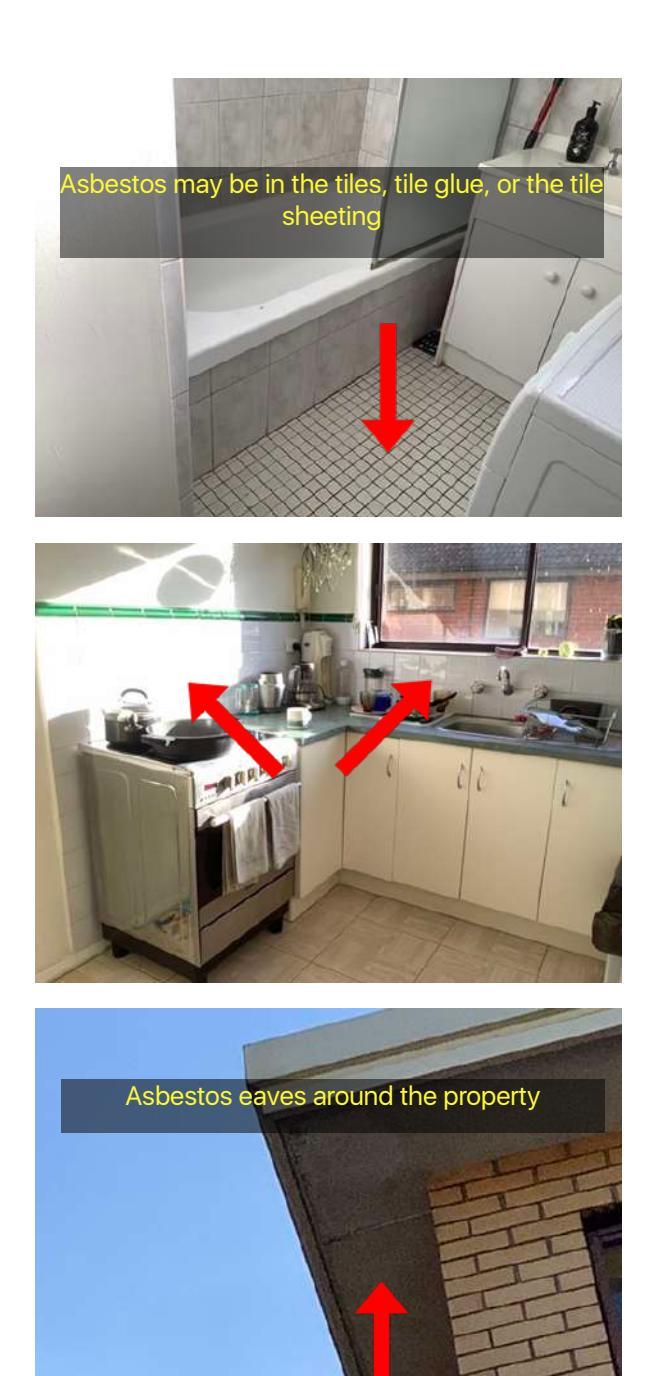
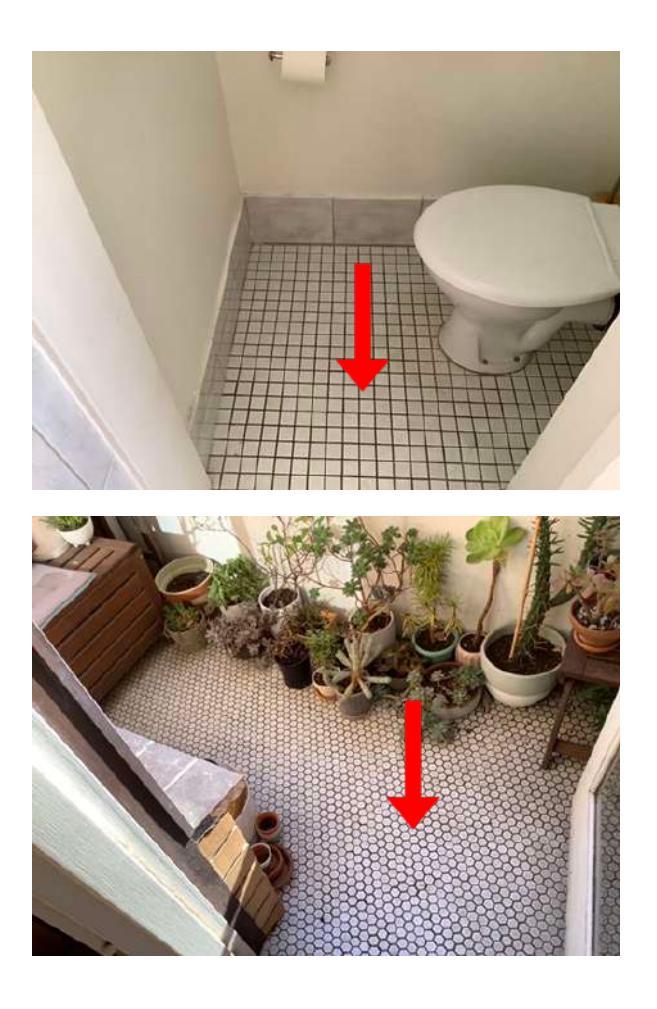
Location:	Asbestos - Various Areas
Finding:	Asbestos - Suspected ACM Identified On Site.
	We suspect, based on our experience in the building industry, that there is a higher risk of the identified building element containing asbestos (ACM).
	IMPORTANT: The Australian Standards for Pre-Purchase building inspections (AS 4349.1-2007) does not require Asbestos inspections in a report, however Master Property Inspections trained building consultants add this bonus service, as we feel that Asbestos is a very important topic that our clients should have an awareness of.
	Asbestos in the older homes can be in the glue adhesive behind the wall tiles or floor tiles, Asbestos can be behind the wall tiles and floor tiles in relation to the cement sheet backing behind the tiles
	Asbestos can be in the old wardrobes and cupboard areas, asbestos can be in the flu systems of the old hot water services or heater flu systems. Asbestos can be on the walls or ceilings. Asbestos can be in the eaves in the older homes and the exterior walls of the older homes. Asbestos can be found in the roof space areas in the floor space areas and in the old sheds. This is only the typical type scenarios in the homes up to 1990 in particular.

Whilst we are including in this report areas that we suspect is Asbestos, it is important to note that this report in relation to asbestos is a GUIDE ONLY and we do not guarantee that there are no other areas at this property that may contain Asbestos (ACM)
	Areas with the red arrows, have a high potential of containing asbestos (ACM). When a red arrow points at a tile for example, the asbestos material may be in the tile, the tile glue and/or the tile backing sheet.
	As Asbestos Reporting is outside the scope of this report, we advise that you consider a separate Asbestos Inspection and Condition Audit, which can include the taking of samples for definitive confirmation of the presence of Asbestos.
	In the interim, the client is advised to act with caution, especially when considering any damage to building materials general wear and tear renovations extensions demolition and general maintenance activities due to the suspected presence of Asbestos.

♦ PLEASE NOTE : We are able to perform an Asbestos Inspection and Condition Audit, which can include the taking of samples for definitive confirmation of the presence of Asbestos. This inspection as noted above is outside the scope of this inspection but at request of the client we can perform the necessary inspection and take the samples to the laboratory to give you a comprehensive and definitive inspection report, with laboratory results.

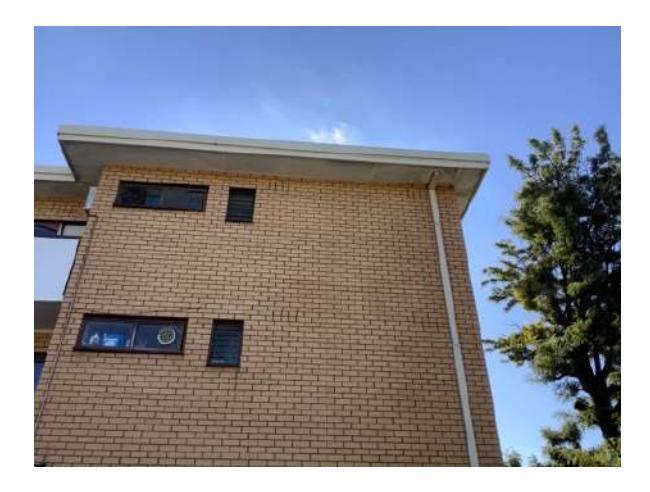
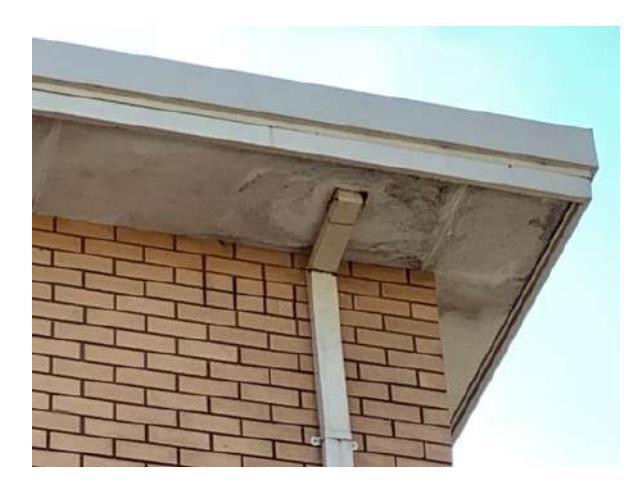
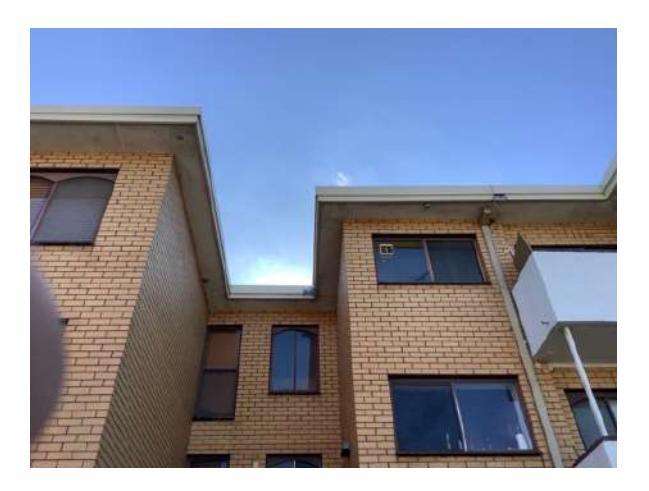
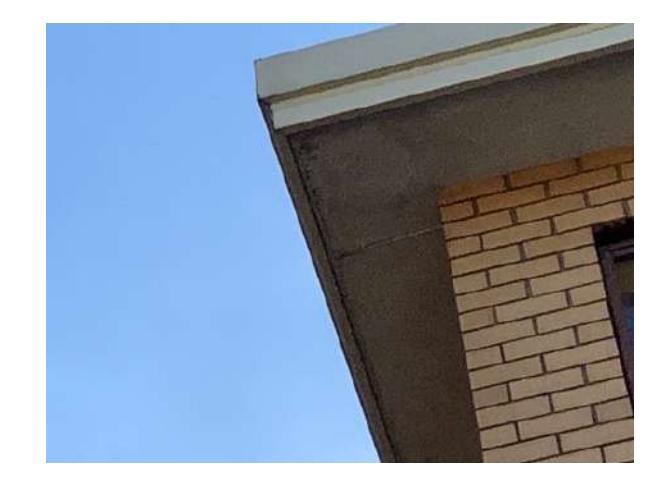
Location:	External Areas
Finding:	Eaves - Sagging / Damaged / Damp
	Please not that we would like to mention the damaged eaves are asbestos.

Sagging to the eaves was evident and visibly poor condition as stated in this report at the time of inspection. This type of defect is generally consistent with older properties, where the eave sheeting has worn over time and the damage may have been sustained as a result of a number

of possible causes, including poor roof drainage, leaking roof plumbing, blocked gutters which creates back flow of water into the roof and/or minor impact damage. . Eaves are important in preventing water ingress to associated walls by promoting adequate water run-off from roofing structures. Their secondary function is to prevent shelter to adjoining structures from excessive moisture and hence prevent water damage to these areas.

Sagging eaves are susceptible to the attraction of excessive moisture, and are therefore considered non-functional. This defect also detracts from the overall appearance and condition of the roofing structure and any associated structures.

A roofing plumbing or general handyman is recommended to perform rectification works as soon as possible. Subsequent water damage is likely to result over time if left unattended.

cause, appointment of a licensed plumber is advised as a matter of urgency to identify the source of the water leak.

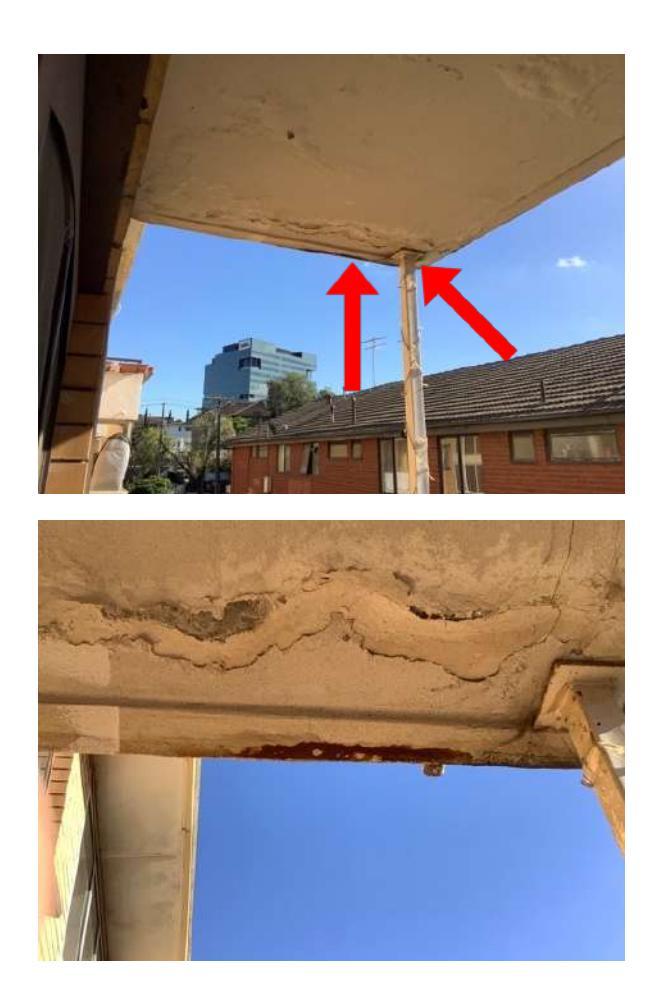
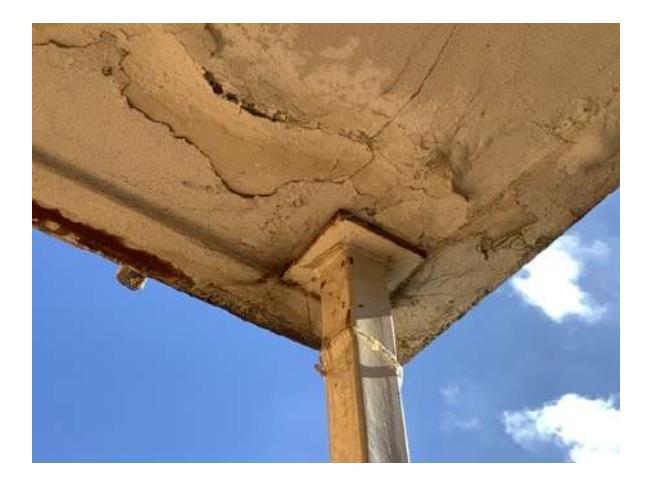
Major Defect 2.01

Balcony-Metal Damage - Unsafe

Please not this balcony is above the inspection I am performing, however there are many factors that are very important to note, number 1, as this balcony is above the possibility of the balcony collapsing is possible and number 2, whilst the balcony to the property I am inspecting does not appear to be as bad it is obvious that it has been painted and repaired over time, however the damage to the concrete is producing through.

The balcony concrete and metal in this area is weathered / compromised / damaged.

Metal framing supporting the concrete is rusted severely.

This defect creates a safety hazard and as mentioned above requires URGENT attention and until such time as the balcony has been repaired, NO PERSONS should be within the area of the balcony.

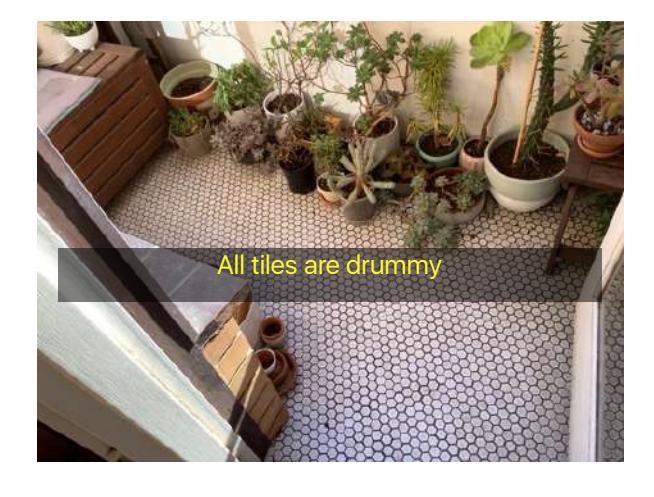
Major Defect 2.02

This defect statement is known as a major defect and a major structural defect as per the Australian Standards for prepurchase building inspections (AS 4349.1-2007)

Drummy tiles may also be contributed to tiles cracking and what is important is to determine the cause of the cracking, which may be related to the subfloor structure, typical wear and tear and/or poor workmanship

Such defects are generally caused by physical or moisture damage to the area. Drummy tiled areas may also be a direct result of poor workmanship during the construction process.

The cause of the tiles cracking must be determined and repaired otherwise the same defect will occur.

Any exposure to moisture is capable of causing tiled areas to become drummy and/or cracked over a prolonged period of time. Drummy tiled areas generally require removal and replacement of affected tiles, with adequate sealant and grouting.

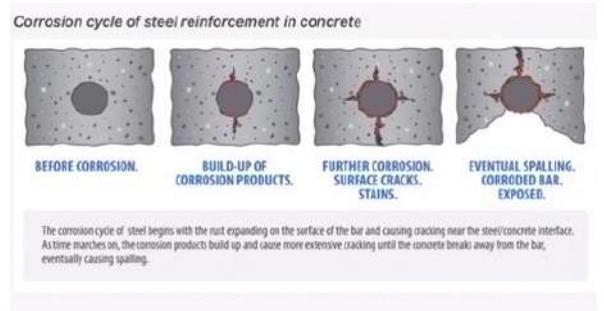
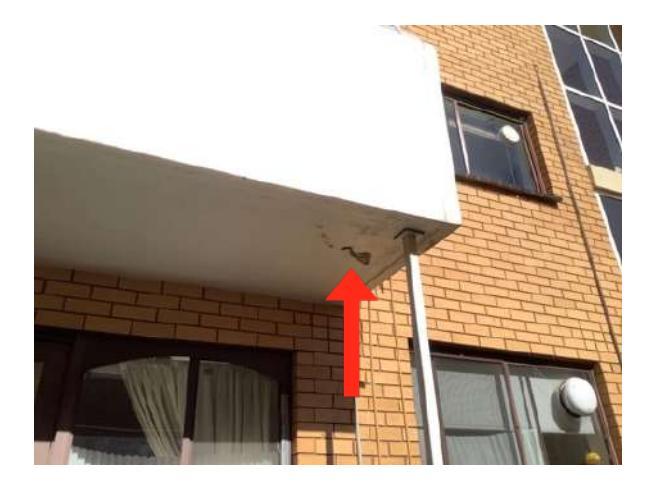
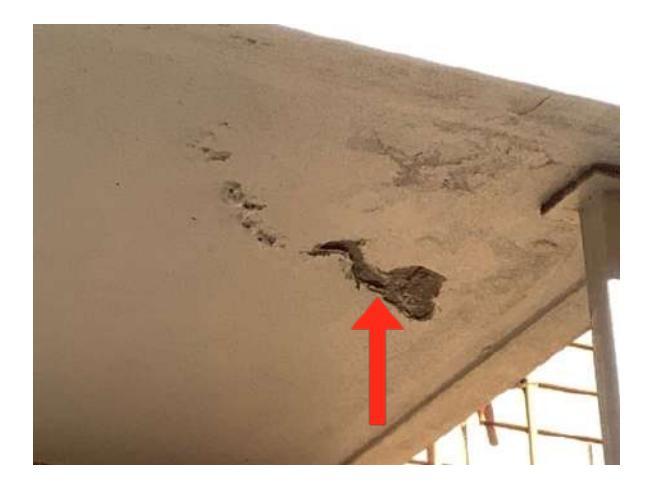
Major Defect 2.03

Location:	Concrete - All Areas
Finding:	Concrete - Cancer
	Please note the concrete cancer to the balconies is spread throughout the properties.

The structure appears to be in a state of decline. Evidence of the damage indicates that there is advanced corrosion to the metal elements and the concrete that encases the metal reinforcement is degraded.

Concrete cancer is the common term used to describe a number of factors which cause concrete construction to deteriorate. Generally, water penetration causes the concrete reinforcement to rust and expand, creating stresses on the surrounding concrete and in turn causing it to spall (or break away). Alternatively, if the cement component is too alkaline, reactions with the general atmosphere occurs and star-shaped cracks appear which allow rainwater to penetrate. Concrete cancer may also originate from poor original water proofing.

We recommend an assessment by a Structural Engineer particularly and we also strongly recommend further assessment prior to purchasing the property.

In some instances, repairs are possible; however, repair works will generally involve extensive works, including removal of affected concrete and the treatment or replacement of any exposed steel. Some injection of resins or special mortars may also be possible, however this depends on the size and extent of consequent damage.

As noted above once again a structural engineer should be appointed to provide estimates on the required works.

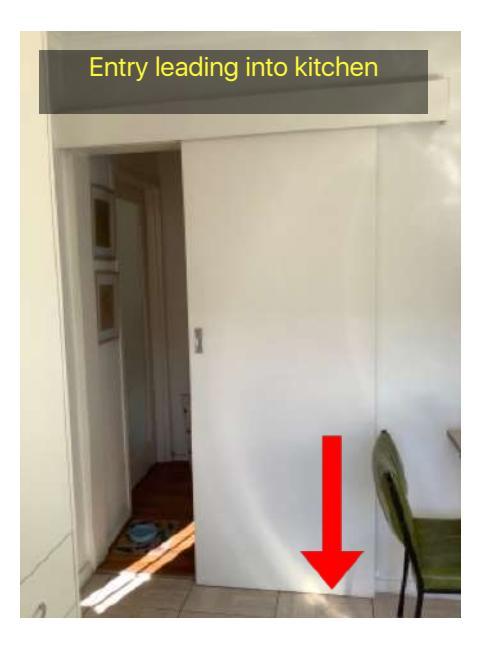
Minor Defect 3.09

Location: Finding: Doors - All Areas

The sliding cavity door is missing the bottom guide and/or the bottom guide is damaged. The guide allows the door to move freely and straight, without wobble that will damage to the side of the door paint and timber surface.

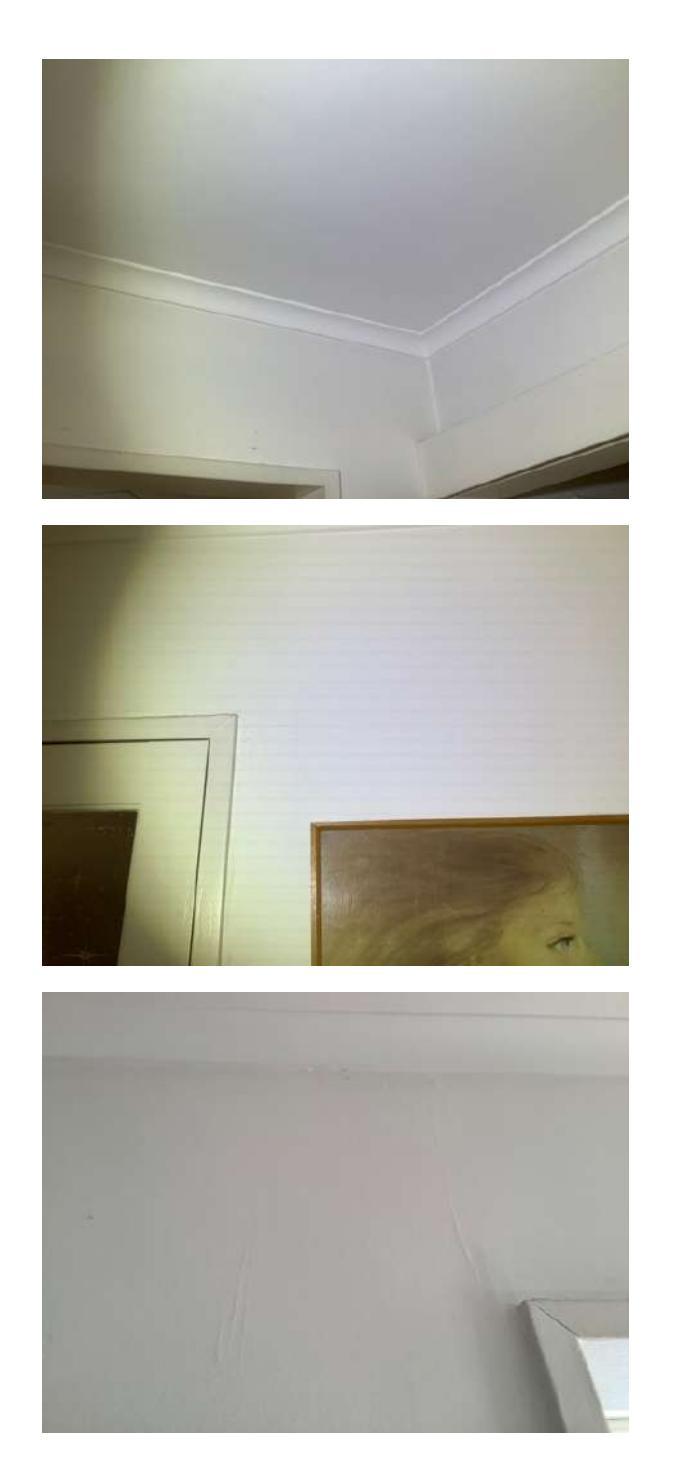
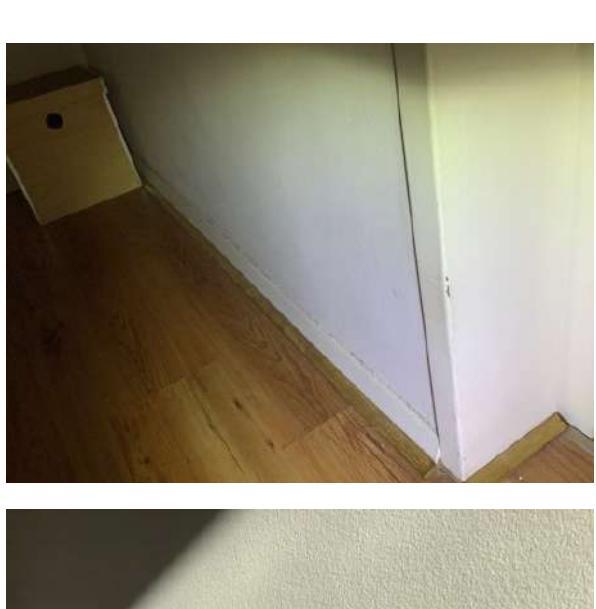
Location:	Paint & Plaster-Various Areas
Finding:	Paint & Plaster To The Doors, Various Timber's, Plaster Walls & Ceilings, ETC.
	It appears that the property has had plaster work repairs to various areas of the property.
	It appears that the property has been painted in some areas in recent times.
	There is the possibility that various plaster/solid plaster cracks may have been covered up and/ or repaired, so there is always the possibility that the cracks in part or full will come back if the repairs have not been professionally completed AND/OR the property has movement and/or continuing subsidence to the property. It is unknown how severe the cracks in the plaster work and/or solid plaster work really were, before the plaster & paint work was performed.
	Superficial scuff marks, damaged plaster, holes in walls,missing paint,sub-standard paint work were noted to the internal walls / ceilings and/or architraves as per the photos attached at the time of inspection.

While these minor defects are detracting from the overall appearance of the affected building element, they do not indicate any operational or structural damage. This degree of surface damage is consistent with general damage, accidents, movement and wear and tear.
	These type of minor defects are appearance cosmetics but they can also lead to the development of secondary building defects over time.
	Incomplete areas of paint finish, holes in plaster, exposes the area to moisture, potentially accelerating the deterioration of underlying building materials especially in wet areas such as laundrys and bathrooms.
	Superficial scuff marks, damaged plaster, holes in walls, missing paint, sub-standard paint work should be sanded back, filled, levelled and painted, as applicable. Where inadequate or missing protection has led to the deterioration of the associated building element, repair and/or replacement of this building element may be required.

A painting contractor, builder, plasterer and/or suitable handy person may be appointed to perform necessary works to aid the appearance of the affected area and to ensure the area is protected against further deterioration.
	Wet areas are the main areas that MUST have SUFFICIENT paint coverage to the walls, ceilings and timber work as moisture can deteriorate the areas.
	ALL AREAS should be checked carefully, attached are a some PHOTO EXAMPLES as a GUIDE.

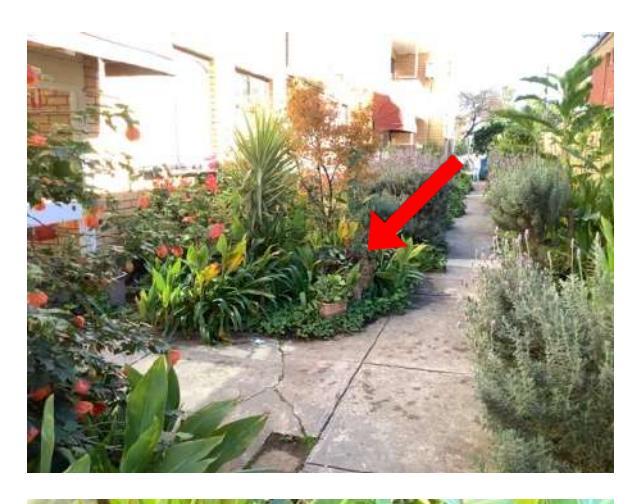
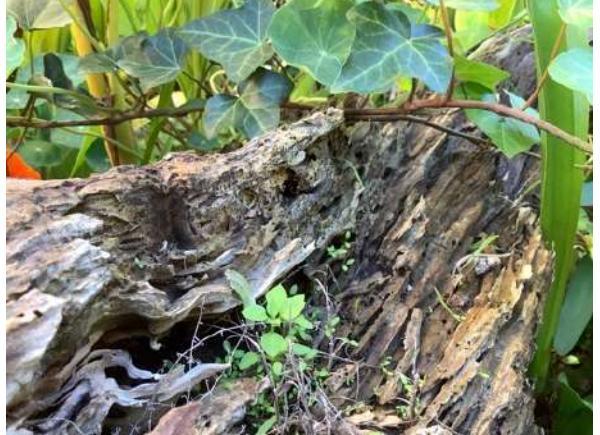
Location:	Termite - Damage Identified.
Finding:	Termite - Damage Identified.
-	It is suspected that termite activity is occurring or has occurred as there is evidence of termite damage.
	Damage caused by termites found in termite areas is considered a defect if the termite management system is not installed in accordance with the BCA / NCC and relevant Australian Standards.
	Such damage creates a potential safety hazard, and is likely to worsen and cause further damage to adjoining building materials.
	If left unattended, this damage creates an unsafe environment and is likely to lead to the need for major structural works.
	A building contractor should be appointed immediately to advise on options to prevent further damage and repair on all affected building materials, if any areas of damage are noticeable.
	The application of a post-construction chemical termite barrier or other termite treatments is ALWAYS highly recommended for all properties, particularly if live termite activity has been found on the site previously. Such barriers are highly effective in preventing termite attack on any timber building elements throughout the property.

We HIGHLY RECOMMEND the client may consider gaining further advice from a pest controller as to the costs and procedures involved with this application.
	It is recommended that obtaining such advice be treated as HIGH PRIORITY.
	ALL AREAS should be checked carefully for this defect and attached are a few PHOTO EXAMPLES as a GUIDE.
	Please Note :
	Timber pest damage WAS FOUND on the property and further information is in the report.
	The property is a HIGH risk for termites as the environments to the property are very conducive with many susceptible areas as noted in this report.
	I can not stress how important it is to reduce and keep clean the trees, vegetation, timber and/ or all other debri and all other items not only around the home but to the entire property as a matter of urgency to reduce the very high risk for termite activity and to keep the environment as low risk as possible for a conducive and susceptible area or areas for termites and timber pests.

I highly recommend you seek further professional advice from a licensed pest controller and termite management system controller in relation to any trees that have been cut on the property and what can be done overall from just the typical termite management systems to a property.
