Frame Report

Inspection Date: 7 Jul 2021 Property Address: Eastern Area

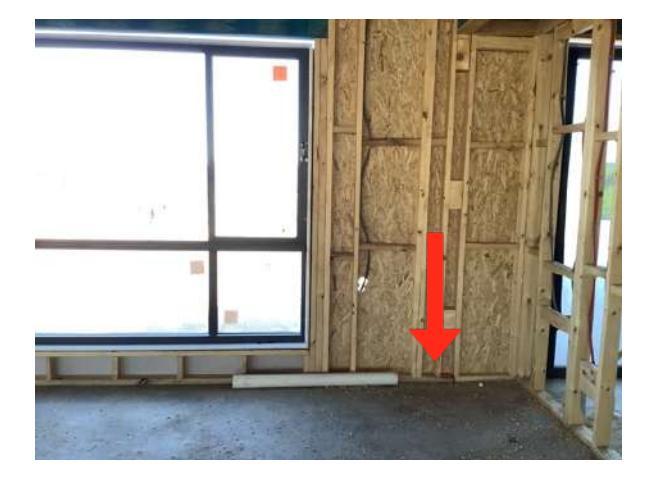
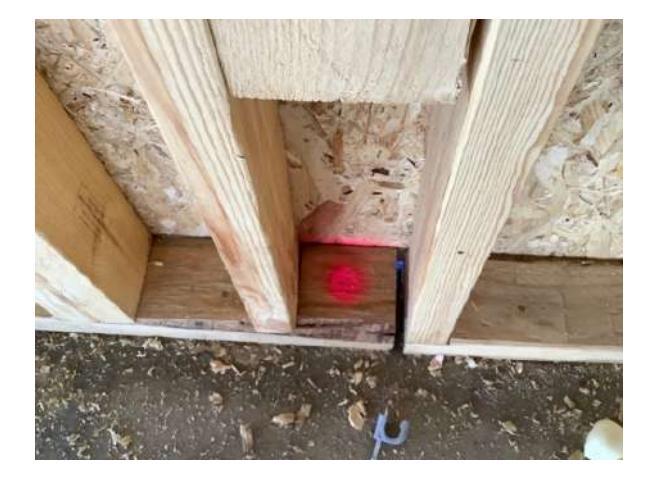
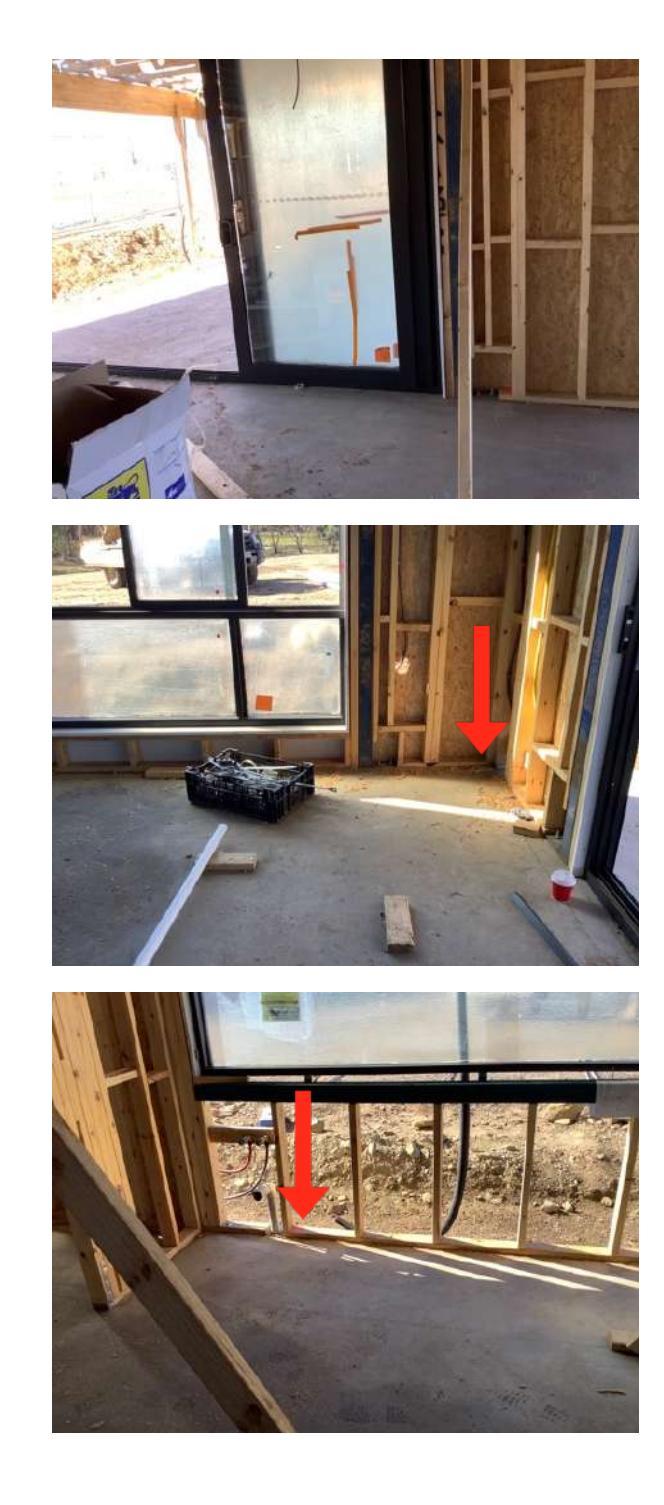
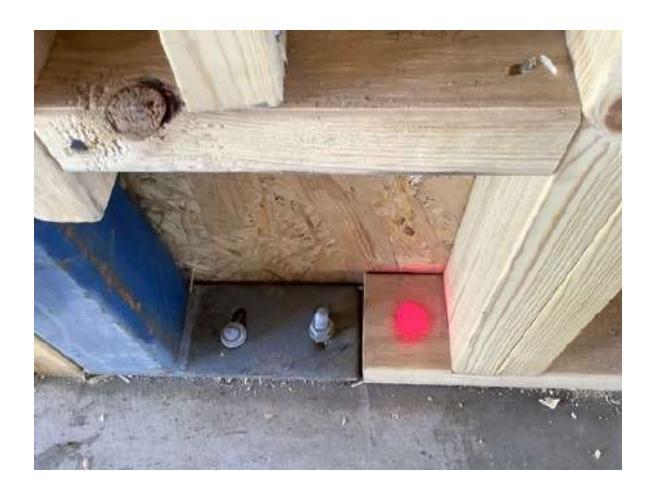
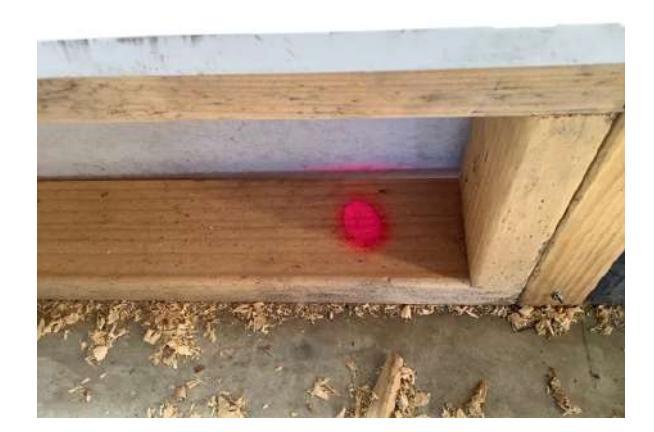
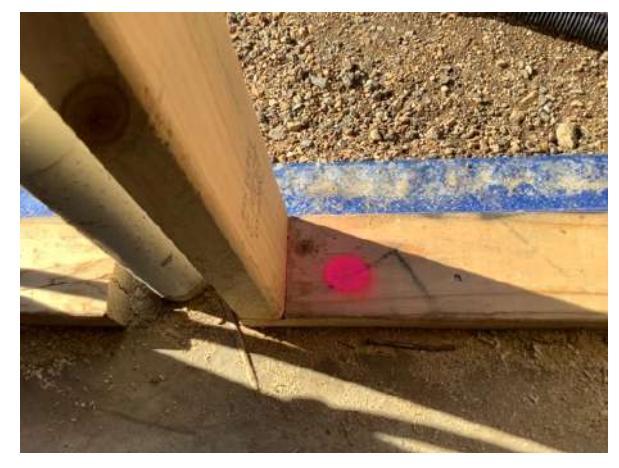
Non Compliant 2.01

Bottom plate - insufficient fixing to slab.

It was identified that there are instances where the bottom plate is not sufficiently fixed to the slab. Depending on factors like the type of concrete nail / masonry anchor used the required pull out force and wind category the distance of the fixing from the edge of the slab must be between 50 to 70mm minimum for standard 20Mpa concrete. Taking into account these factors it is considered to not meet the AS1684 Residential Timber Framed Construction.

Taking into account these factors it is considered to not meet the AS1684 Residential Timber Framed Construction.

Fixings must be placed at maximum 1200 centres and at the ends of wall plates.

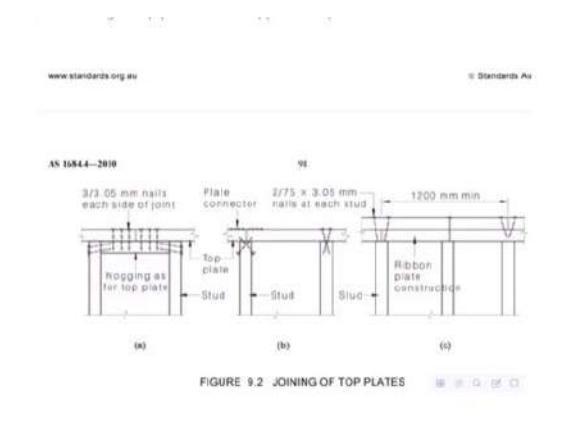
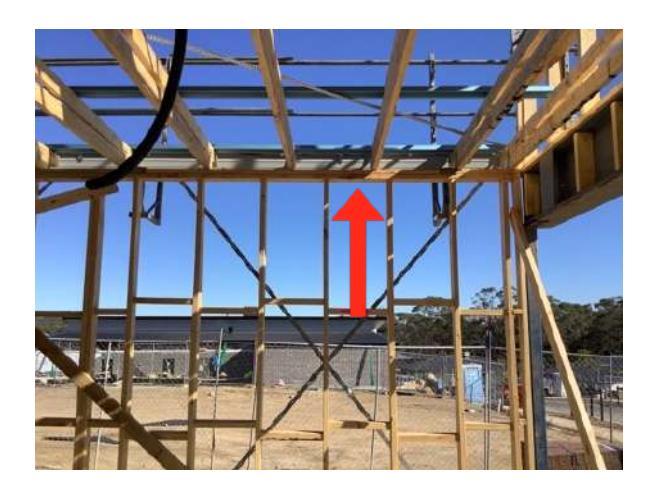
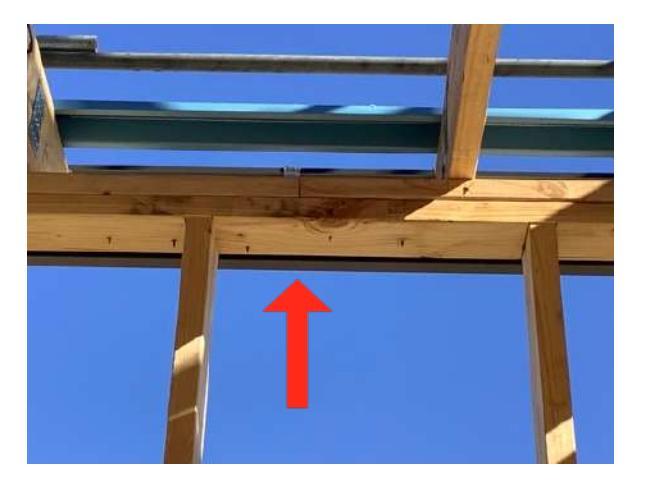
Joining of top plates /. Unsupported Top Plate Join On Double Plates.

It is a requirement of Australian Standard, A.S 1684 Residential Timber-Framed Construction, clause 2.4 Stud/Plate Lamination, that 'where joints occur in either top plate between studs, and where rafters or trusses bears onto top plates, additional blocking shall be provided (see Figure 2.9).'

The connection between the top plates and the connections of the ribbon plates do not conform to As 1684.4 section 9.2.8 outlining the correct fixings and the distance between the joint of the top plate and the joint ribbon plate

The join in this top plate must be properly rectified in accordance with the above.

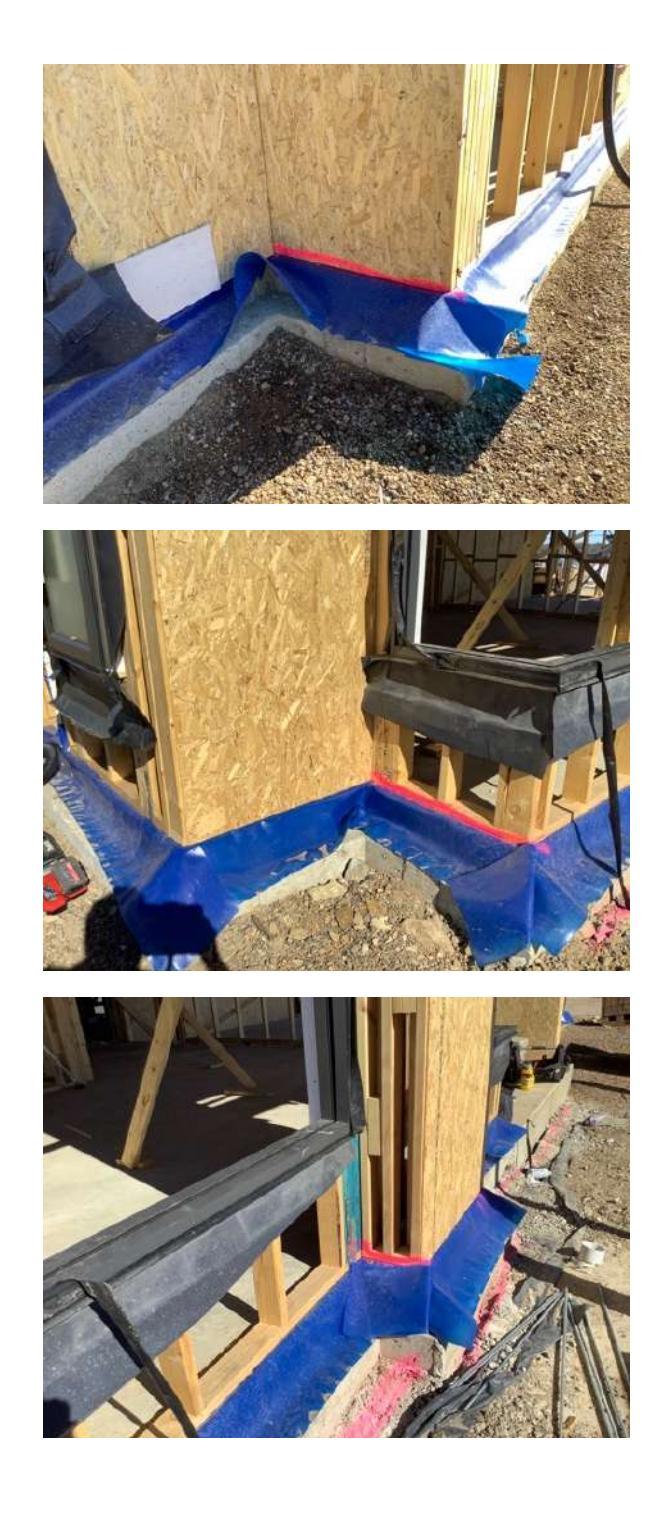
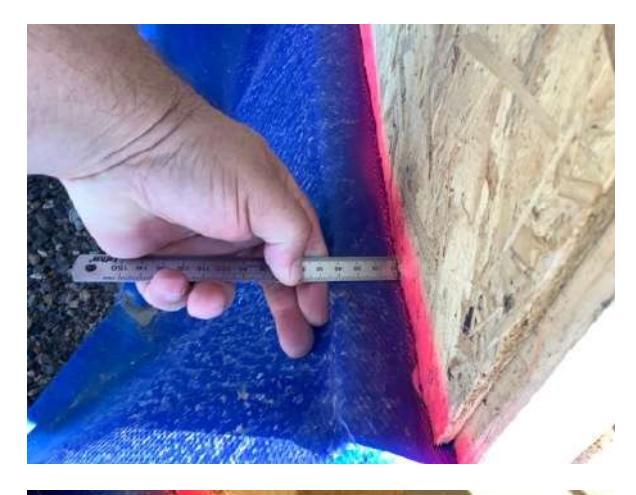
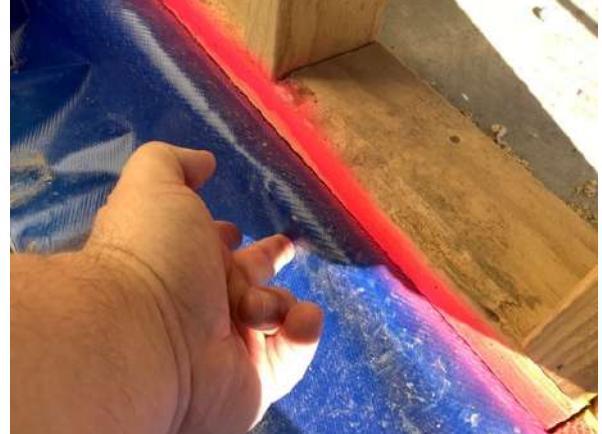
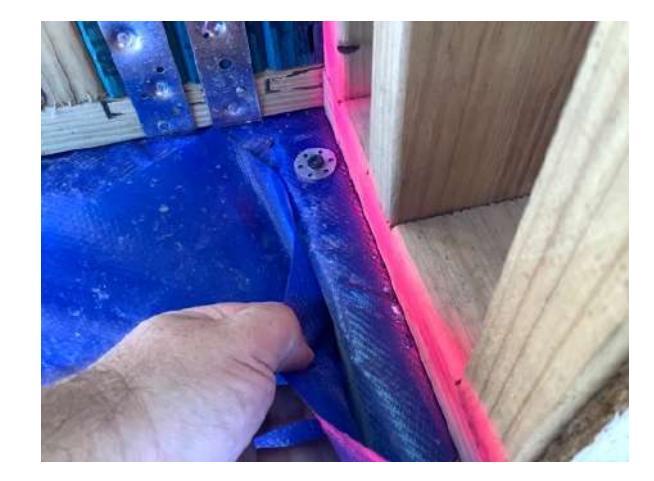
Frame Bottom Plate - With Overhang Of Slab.

It was observed that there are areas where the edge of the slab protrudes past the document finished dimension of the slab.

It appears the boxing on the slab may have bulged out which occurs when insufficient pegging and bracing is provided prior to the concrete pour or the boxing dimensions are inaccurate.

The current overhang will affect the cavity clearance and perhaps the brick base.

The edges of the slab needs to be trimmed back in line with the bottom plate face edge.

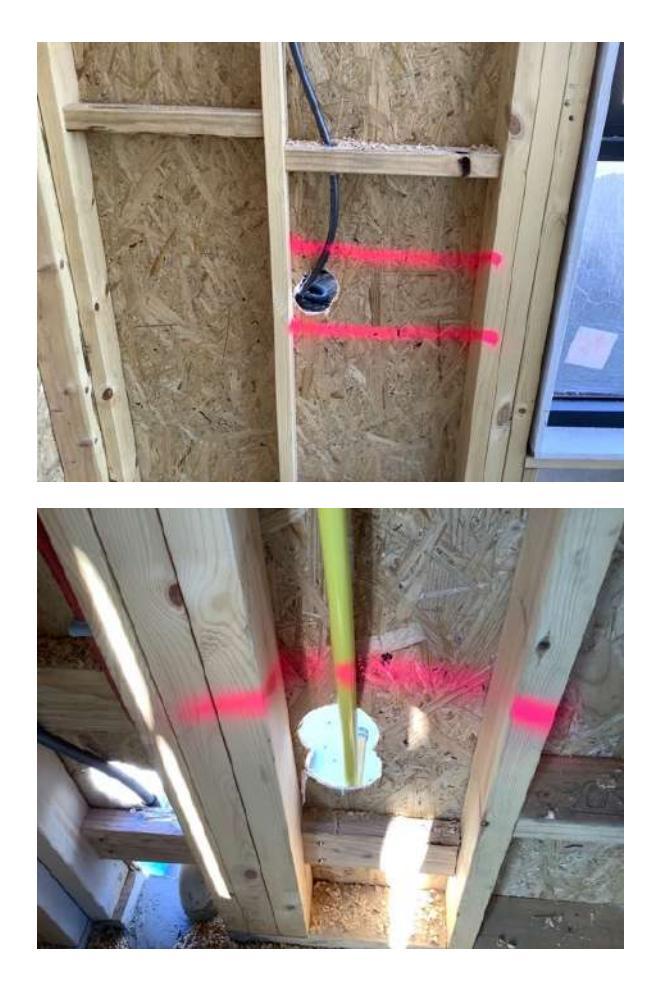
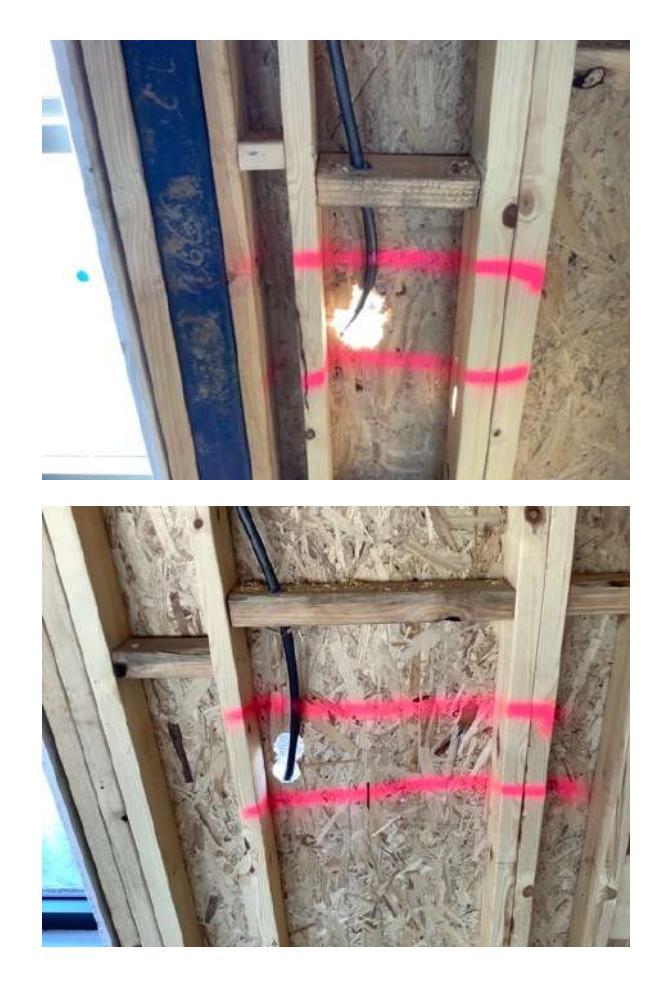
Non Compliant 2.06

Bracing Structurally Comprimised - Cut Out or Damaged.

At the time of the inspection it was found that bracing has been cut out and structurally compromised.

Whilst trades need to cut out required holes, it is clear the hole cut out is oversized.

The structual integrity of the bracing sheets has now been compromised, whilst we understand that the client would like electrical outlets or the like in this location, a preferred workman like manner would be to cut the bracing sheet the same size as the electrical braket opening and fix or secure the electrical item to the bracing sheet or cut out 5mm in addition to the electrical bracket size.

A noggin to the top and bottom of the hole with 2 galvanised nails through the studs into the edge noggins and 3 nails through the bracing into the noggins as well will bring the bracing back to its original structural integrity and strength.

Repair of the bracing sheets is required by the builder in accordance with AS1684.2 before the plaster is installed, perhaps one of the repair methods would be to install a noggin top and bottom of cut out.

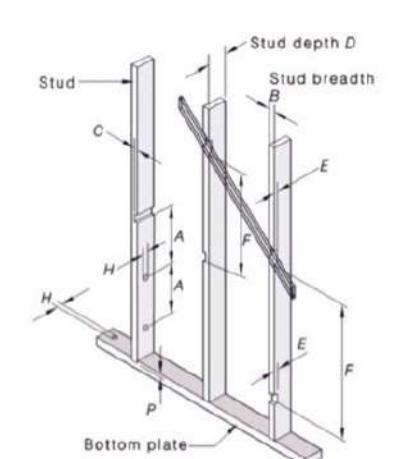
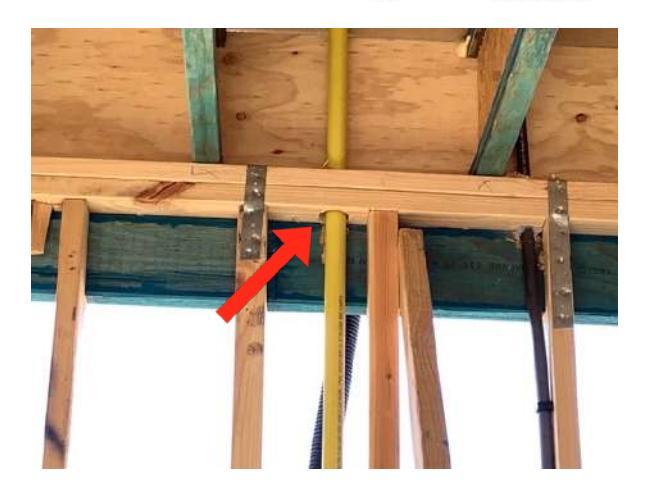
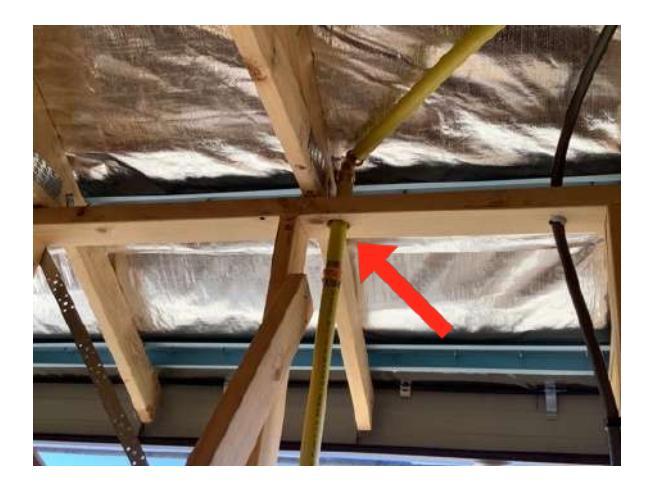
Services holes and penetrations - over sized

It was observed during inspection that the diameter/size of holes and penetrations exceeded the maximum size allowable as defined in AS1684.

AS1684 states that service penetrations to studs and plates shall not exceed 25mm and shall be placed central to the breadth or width of the member.

Generally with holes that exceed 25 mm in diameter a recommendation is just to install a noggin with two nails to each end into the studs and three nails into the top plate.

However where there are top plates, studs or timber beam structures that have been severely compromised Consultation with the building surveyor or certifier is recommended to establish the correct course of action to overcome the existing installation of services to comply with AS1684.

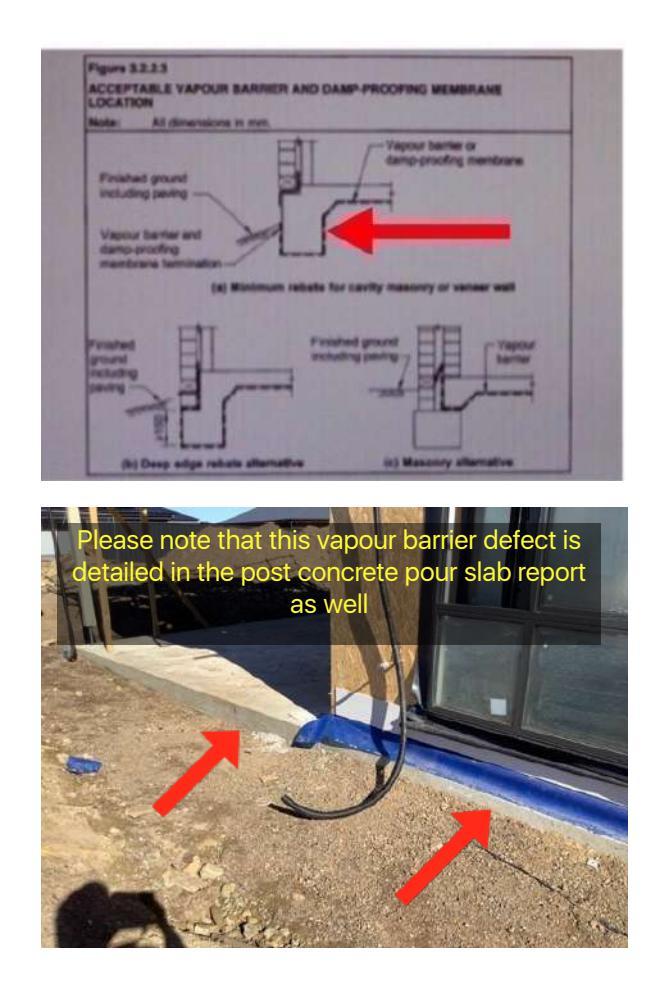
Vapour barrier - Defective (AS2870- 2011)

The builder has not completed the vapour barrier system to the porch area and the alfresco area concrete perimeters.

The functionality of the vapour barrier to the entire perimeter of the building including, between the the buildings each side of the house is being compromised due to poor workmanship during the installation/construction process.

It is a requirement of AS 2870-2011 5.3.3.4 that vapour barriers are turned up and terminated at ground level above pavement adjacent footing. The vapour barrier is defective if building materials and fill has been left on top of the membrane, as this prevents it from being pulled up against the slab when installing perimeter paving as it is intended to be.

I HIGHLY RECOMMEND that the builders digs the perimeter carefully,, sometimes the entire perimeter, pending of the severity of the vapour barrier (plastic) damage, pending on slab over pour, pending on excessive builders concrete (debri).

It is important to dig along the slab perimeter without damaging the plastic and to extend the vapour barrier plastic higher then the slab rebate as would have been in the post slab report if we performed one.

All over laps must be a minimum of 200mm and the correct tape must be used to seal the plastic.

This must be remedied immediately to prevent slab edge dampness.

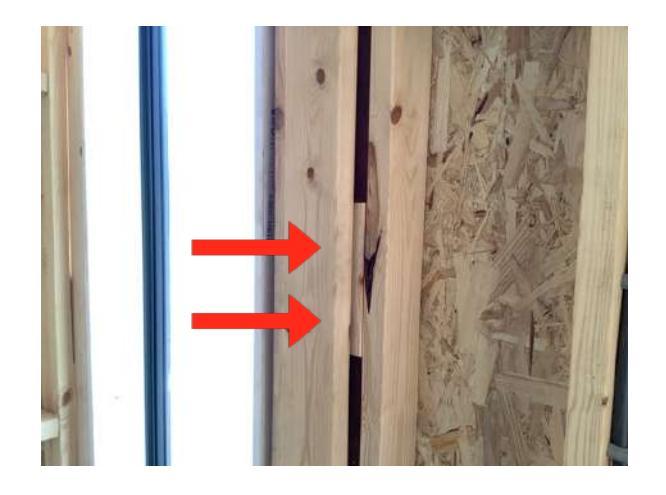
Incomplete 4.01

Location:	All Areas
Finding:	Blocking at intersecting walls - External as a minimum.
	It appears none of the external walls on the dwelling have been nailed off. Section 9.5 and table 9.4 of AS1684.2. and section 6.2.1.3 of the same document states all connecting walls must be secured and nailed in accordance with both clauses. The frame pass should not have been approved without this element being installed. The builder may claim that this will occur at pre-plaster stage or lockup stage. However this procedure fails to take into account, what holds the dwelling up in the time between now and lockup stage completion? The builder must nail off the external walls to ensure that the dwelling can resist the racking forces that AS 1684.2 mandates.

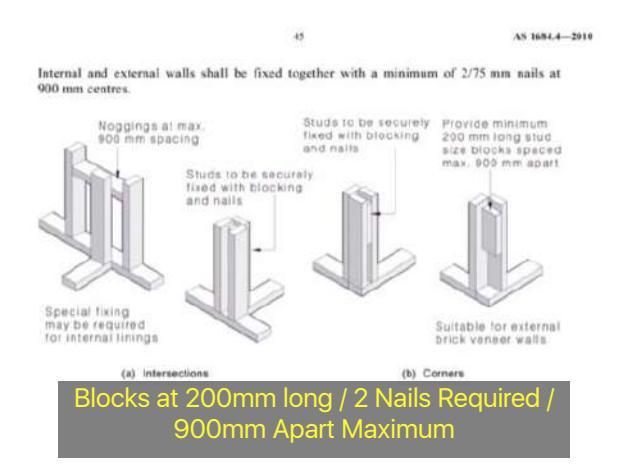
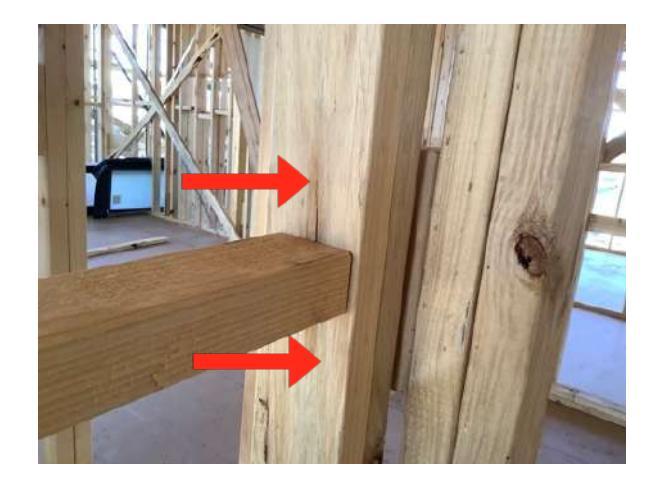
Incomplete 4.02

Blocking at intersecting walls - 1/ Missing Nails

It was observed that the blocking of intersecting walls are insufficient in the nominated locations throughout the Structure.

The AS1684.2 indicates that three blocks are required at intersecting walls (minimum length 200mm)

At spacings not exceeding 900mm and each stud must be fixed to the block with 2/75mm nails.

DEFECT 1 : Each Block - Requires 2 x 75mm nails . Check all blocks have 2 nails

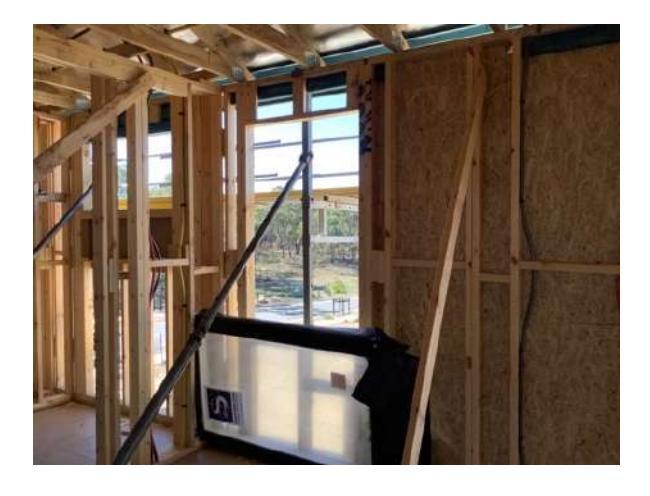
Incomplete 4.03

Upstairs Windows Windows - Not Installed

NOTE : The windows and/or not all the windows were not installed at the time of the inspection, so many defects related to window installations could not be inspected. A complete inspection was not achieved due to the above statement.

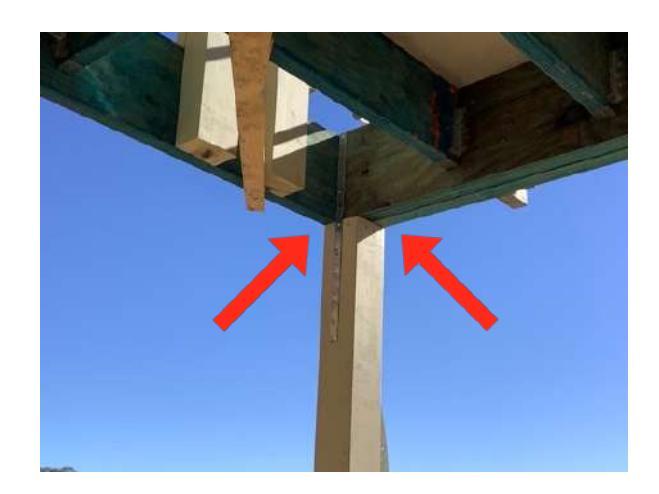
Incomplete 4.04

Mechanical Fixings & Universal Brackets - Installation / Replacement Required (Suspected)

It was identified that mechanical fixings and brackets have NOT been utilised at junctions between structural members.

At the time of inspection it was identified that mechanical fixings and brackets were inconsistent / missing with their nailing or location and further investigation is recommended to establish if the existing meet the overall design principles for the project.

Universal Bracket Required.
The beam junction requires a bracket installed in this location, a recommendation may be a LVSIA ANGLE BRACKET.

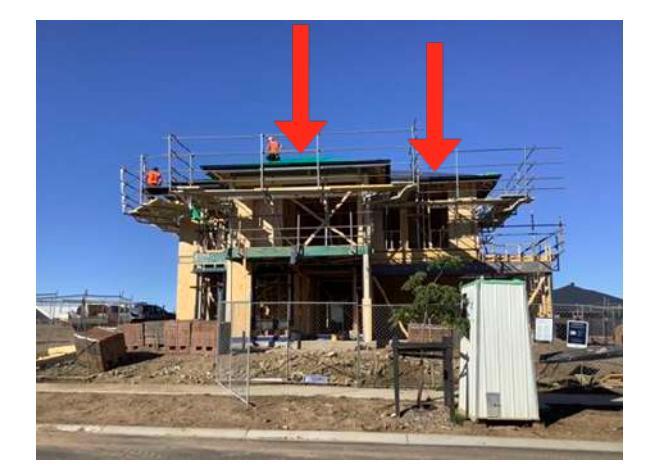
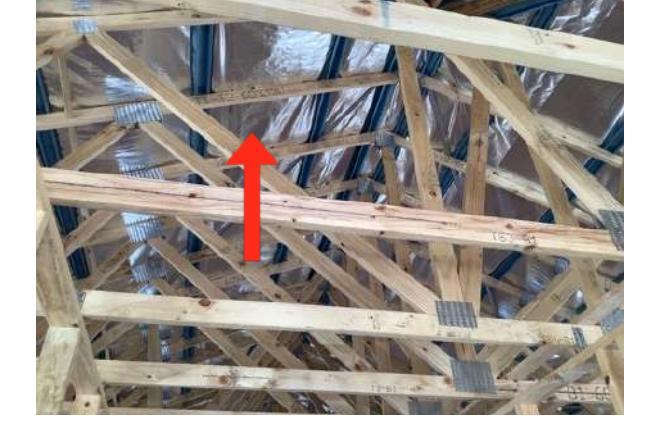
For Your Information 5.02

Roofing Installed - For Your Information

At the time of the inspection the roofing was installed as per the photo's attached.

Various defects and/or potential defects could not be inspected due to the covering of the roof.

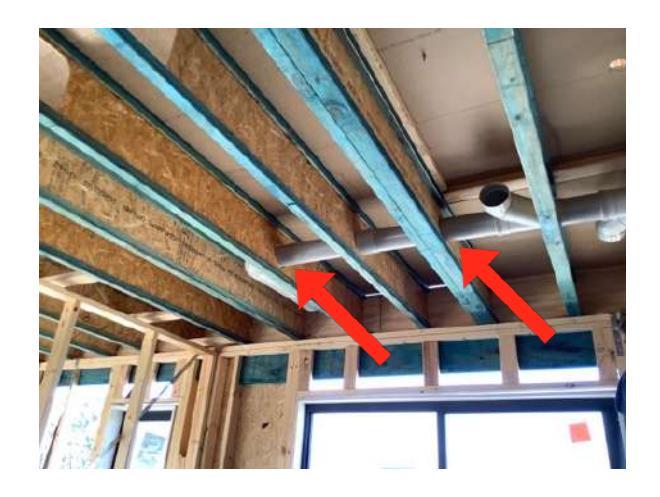
For Your Information 5.04

Whilst this may not be a defect, I would like to request the manufacturers specifications on the cut outs so that the paperwork can demonstrate that interference is acceptable and will not compromise the structural integrity of the upper flooring.
