# **Handover Report**

## Inspection Date: 10 Jul 2021 Property Address: Elwood, Vic - Area

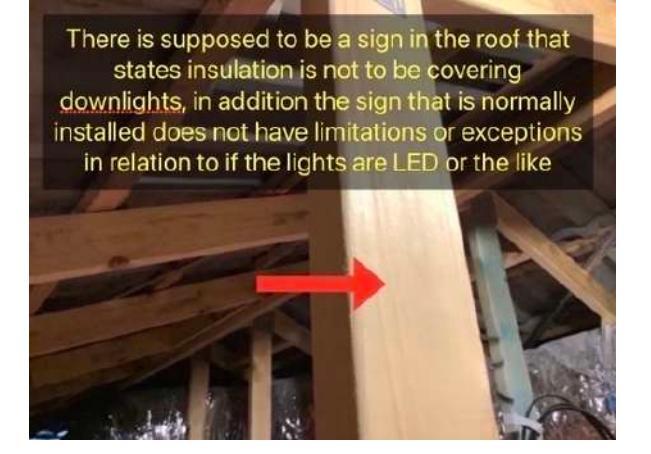
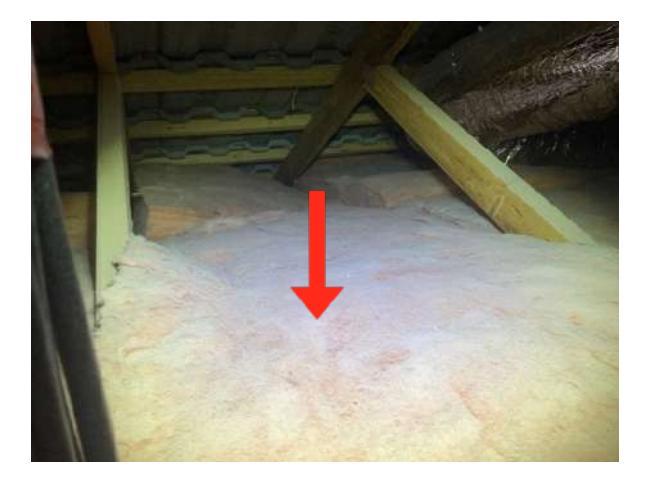
### Safety Hazard 1.01

Sections or all of the insulation in the roof void have been poorly installed and covering the downlights and / or moved from their original position and are covering down light fittings. The presence of this insulation creates a potential fire hazard and is non-compliant.

The builder may argue that LED lights can take 50° heat and it's okay to cover the downlights with insulation, However this is not the case and as an example if it is a 30 degree day or night, which is quite common, this would mean that the roof space would be 45 degrees to 75 degrees and when you also add if the light has been on for awhile as LEDs still can get quite warm, the temperature then climbs much higher, so it is very clear that the downlights must NOT be covered with insulation.

Further on this matter it is important that when the builder clears the insulation around the downlights, the builder only takes away a maximum of 200 mm around each downlight as any more than that will compromise the energy star rating on this property.

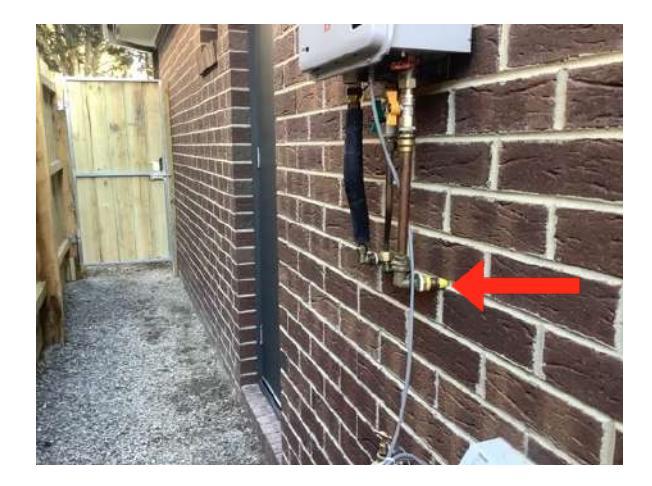
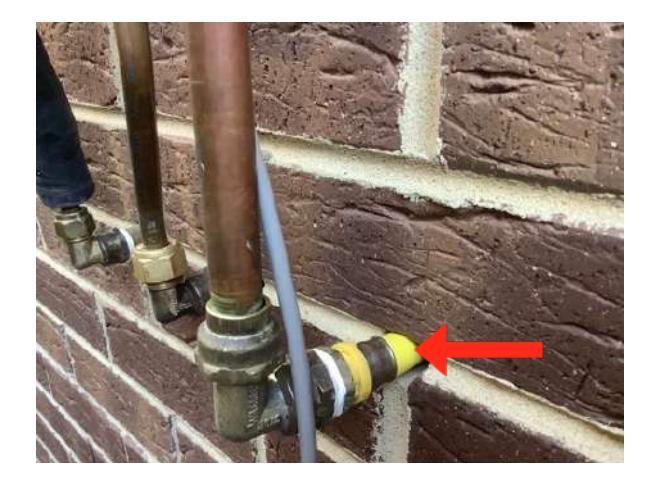
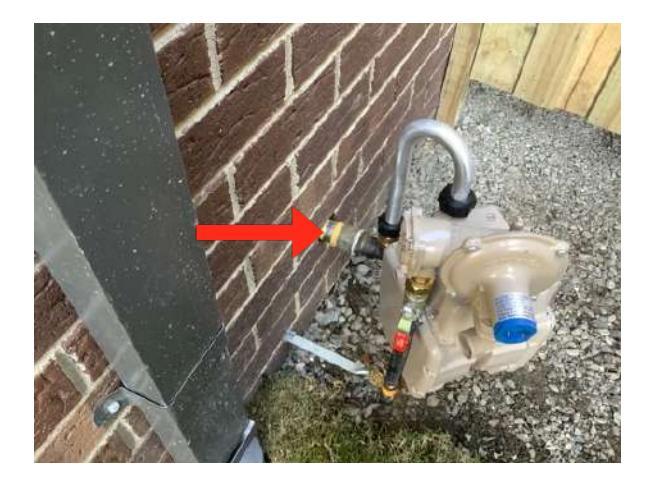
### Safety Hazard 1.02

As per AS 3559, all gas pipes on the dwelling that are exposed to the external must be metal. However, the pipes in this area were found to be plastic, despite being exposed.

It is likely that this will lead to accelerated deterioration of the pipework. Works to rectify this defect are required as a matter of urgency to ensure compliance.

For all locations where the yellow gas line is exposed to the elements, it must be wrapped or provided with protection against direct sunlight. Additional information can be located on the manufacturers website.

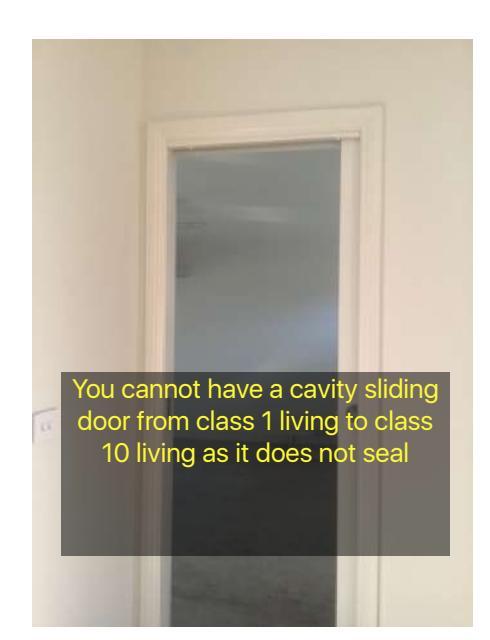
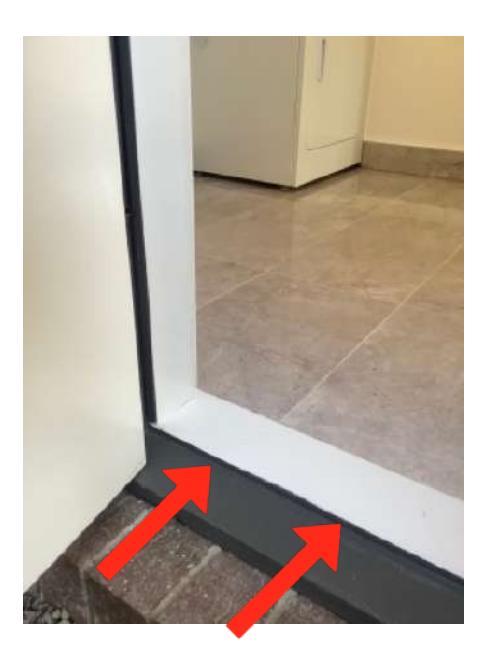
### Safety Hazard 1.03

Garage Door, Class 1 to Class 10 Door - Defective

The cavity sliding door from the living area which is class 1 to the garage which is class 10 does not appear to be appropriate and I highly recommend you take further action with the surveyor on this important non-compliant item.

As required you need to seal the door for your energy star rating and a cavity sliding door cannot be sealed as per the regulations, as the requirement is inclusive of all perimeter internal doors, including the garage door leading into the house.

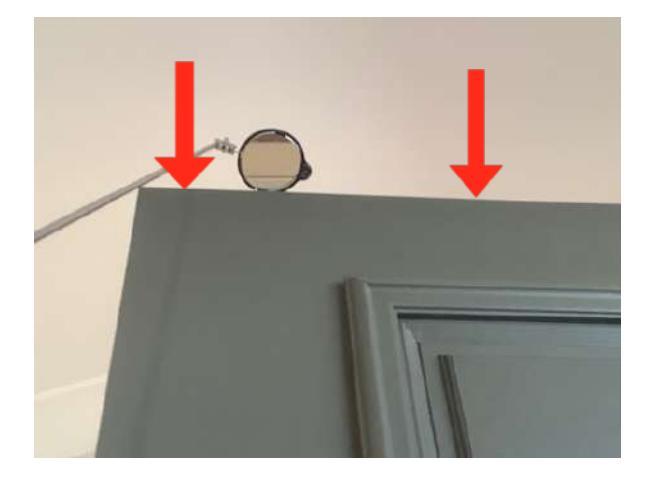
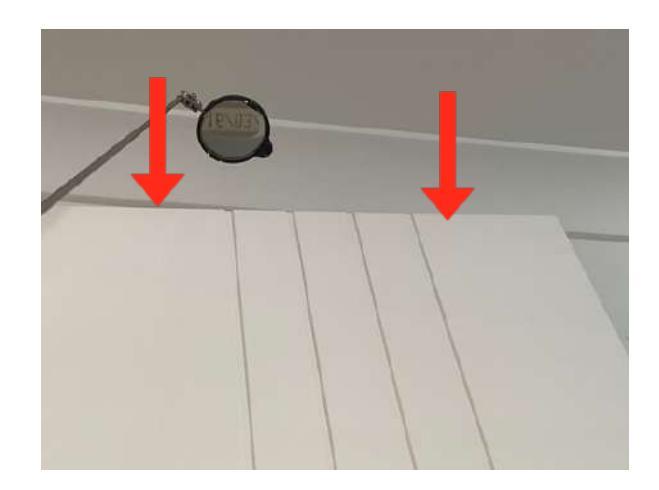
It was found at the time of inspection that the doors have not been adequately sealed.

Tops and bottoms of all external and internal doors must be sealed to uphold manufacturer warranty conditions and to comply with Section 8.06 of the Guide to Standards and Tolerances, 2015.

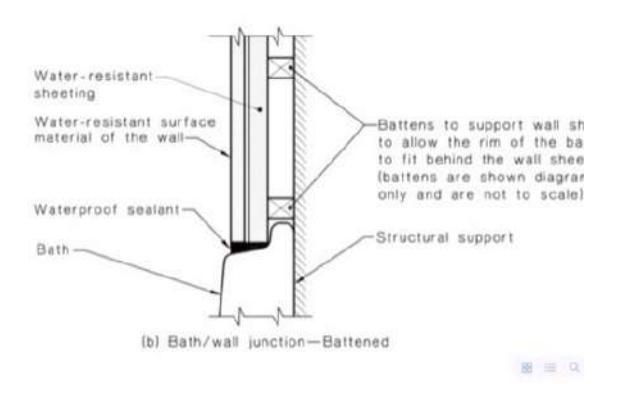
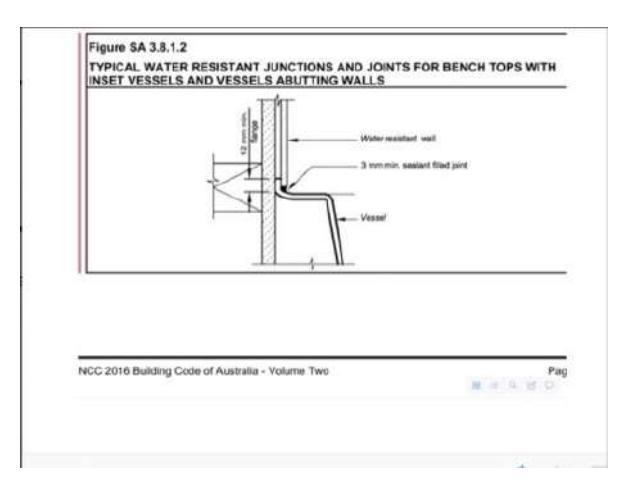
Location: Sealant / Caulking - All Areas

Defective Caulking To Cabinetry, Bench Tops, Tile Junctions, Cabinetry/Plaster Junctions, Etc.

It was noted on inspection that sealant is missing, inadequate and/or not completed to a tradesmens like finish.

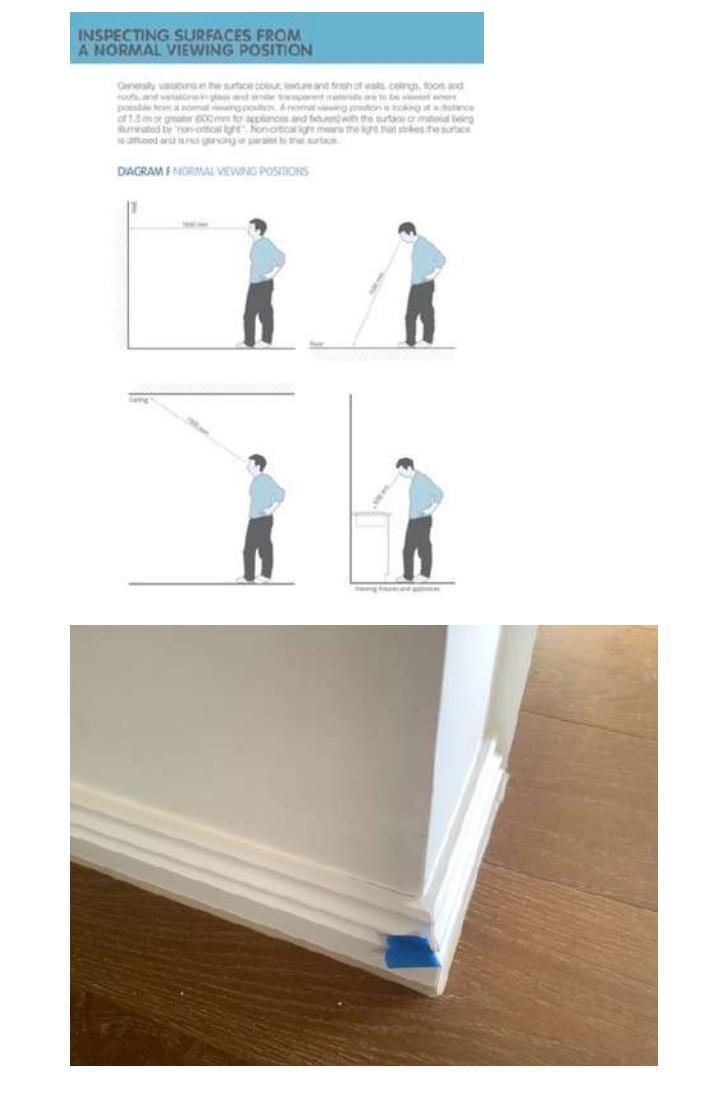
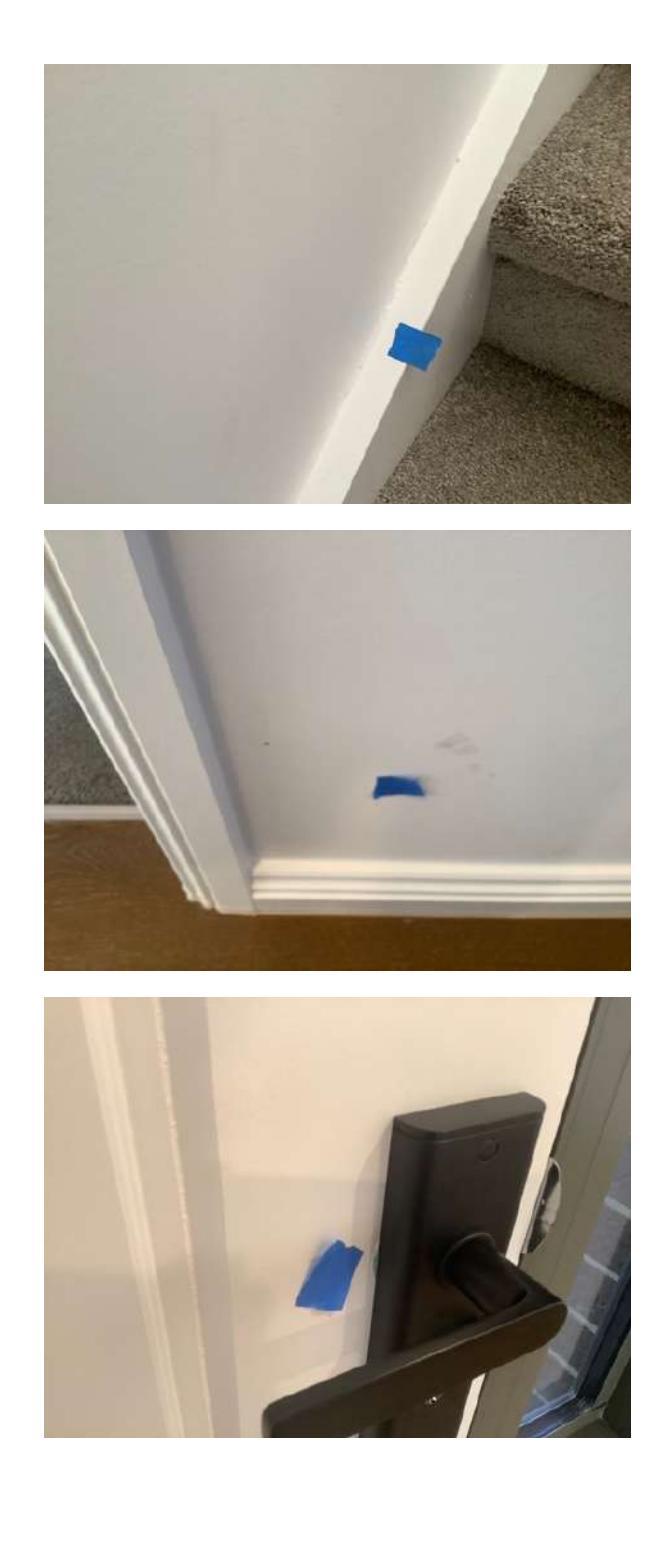
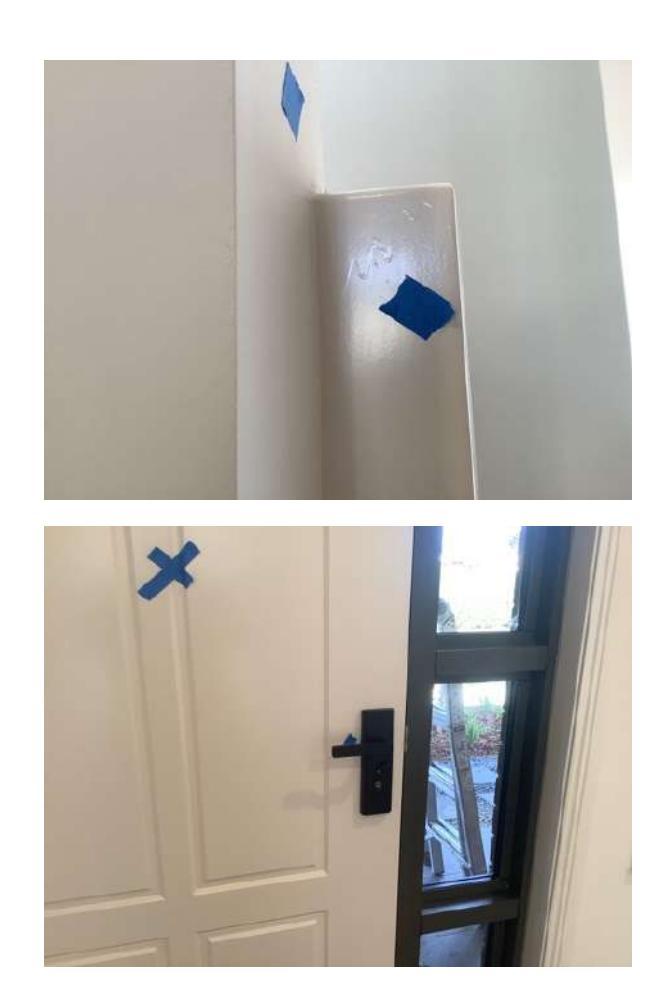
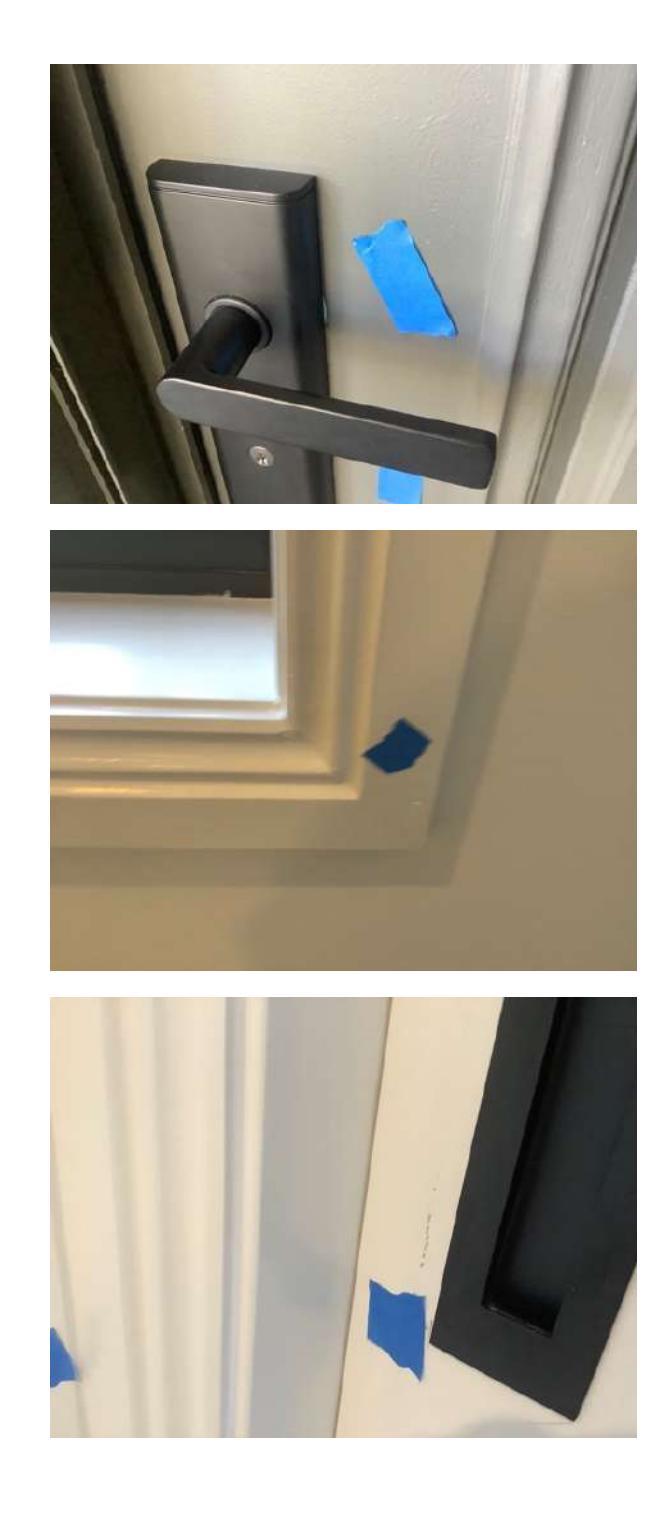
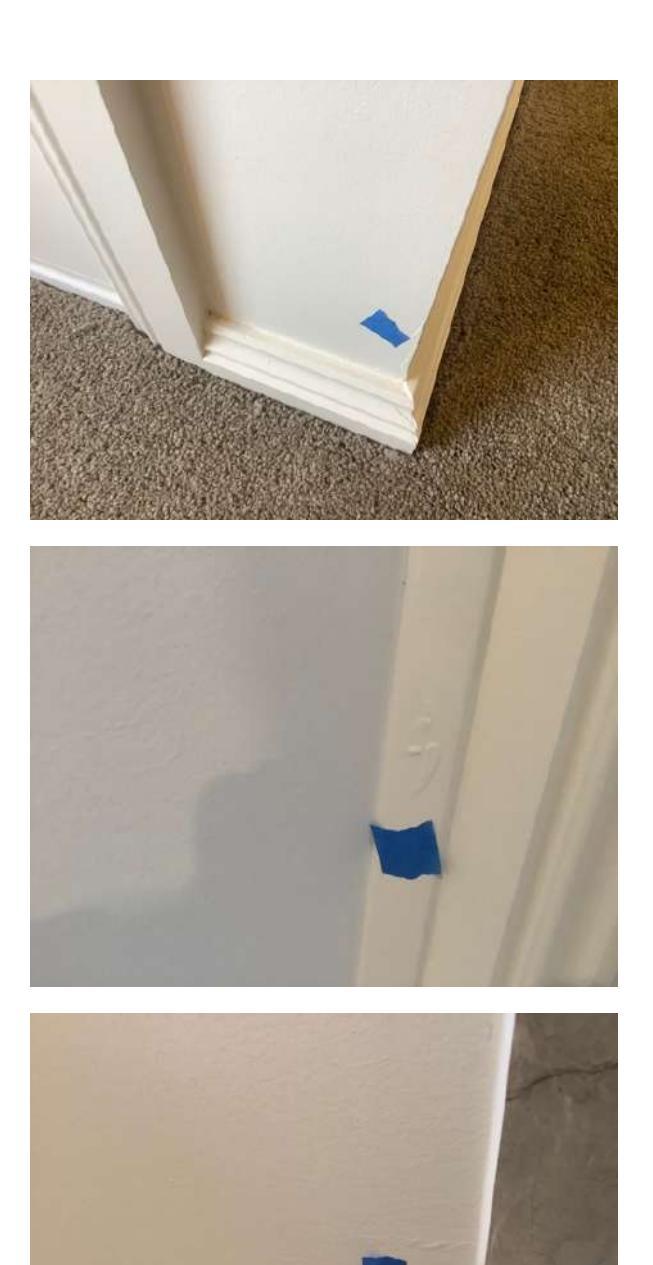
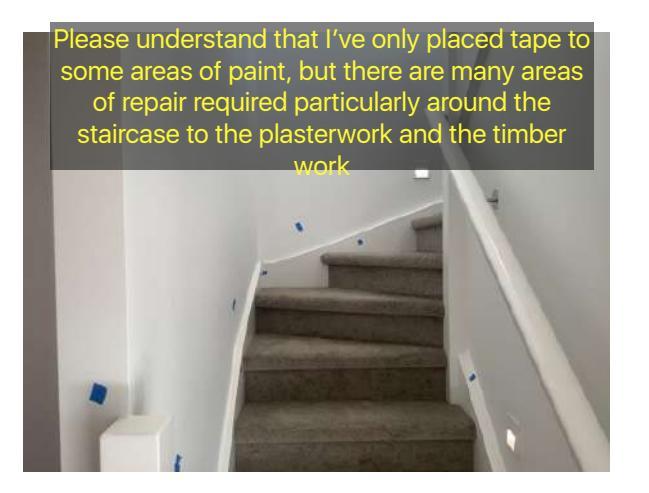
Location: Painting-Under Painted / Defective-All Areas

Paint Surface Finishes - Incomplete / Under Painted / Defective.

X in relation to the tape markings = entire sand, repair and paint edges to edges, where the X of the tape areas are.

Incomplete paint finishes should be sanded back, filled, levelled and painted as applicable. Where inadequate or missing paint protection has led to the deterioration of the associated building element, repair and/or replacement of this building element may be required.

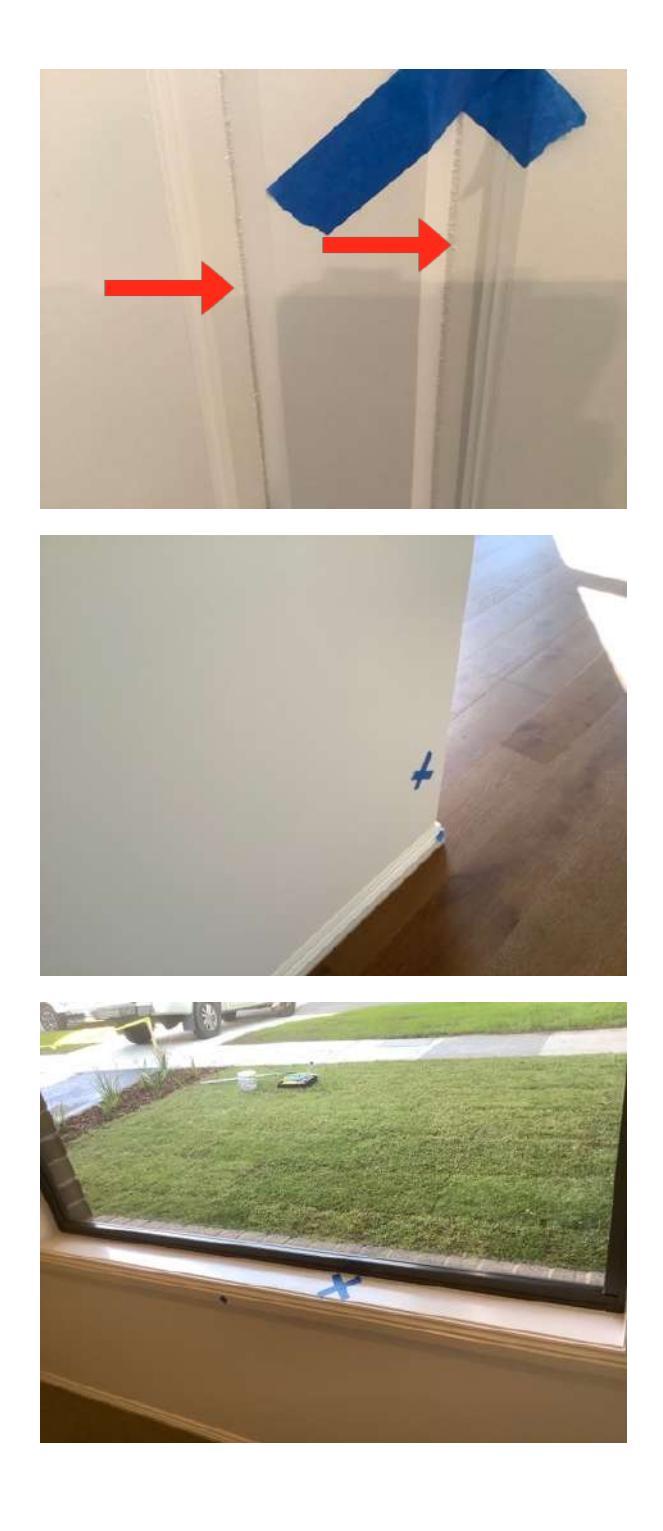
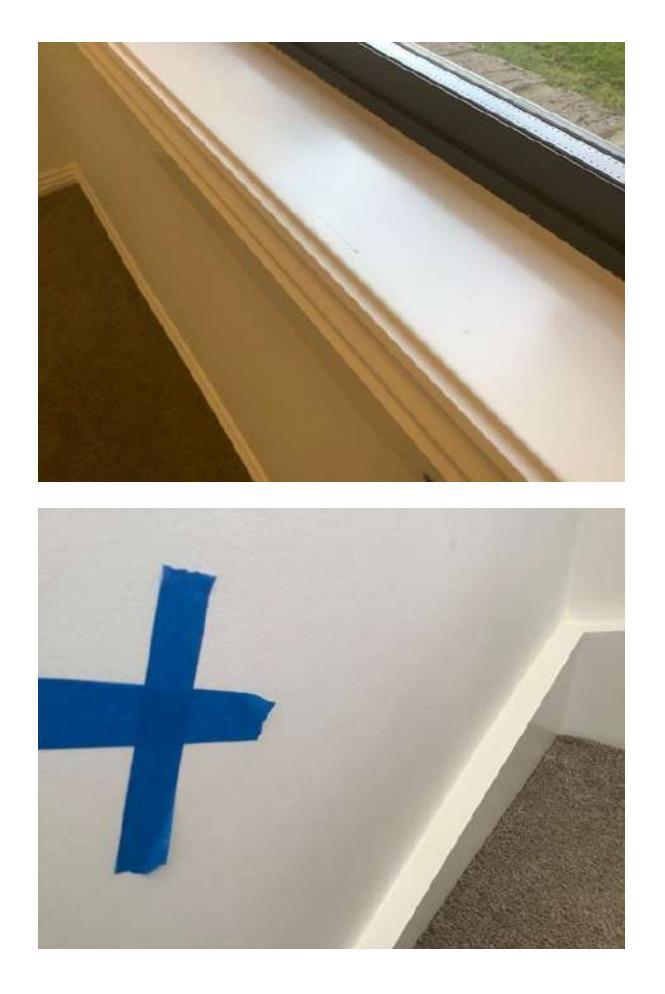
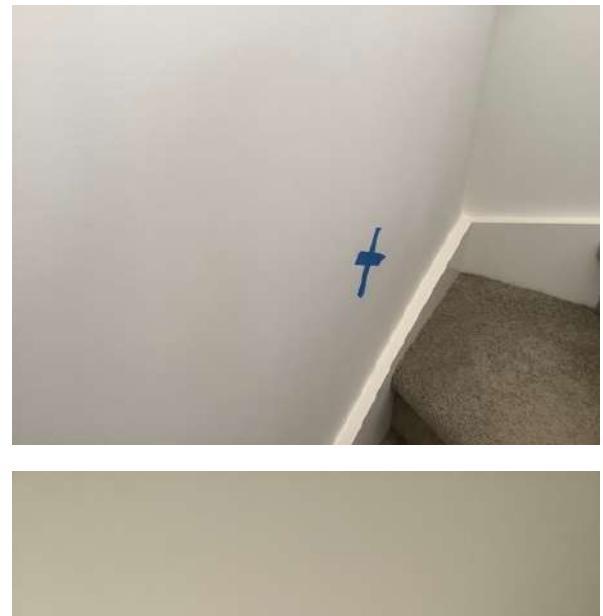
Paint finish excessive over painting - defective

Areas were identified where the surface finish and junctions of the painting is defective. This includes areas of excessive over painting of fittings, trims, skirtings, architraves, windows, cornices, junctions of colour changes and / or other finished edges and junctions.

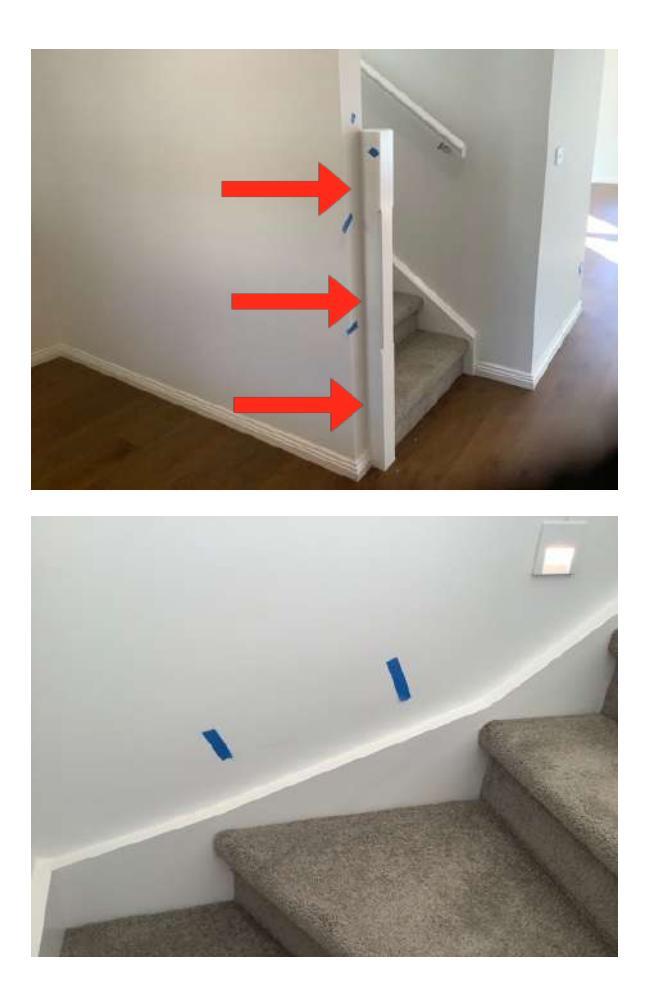
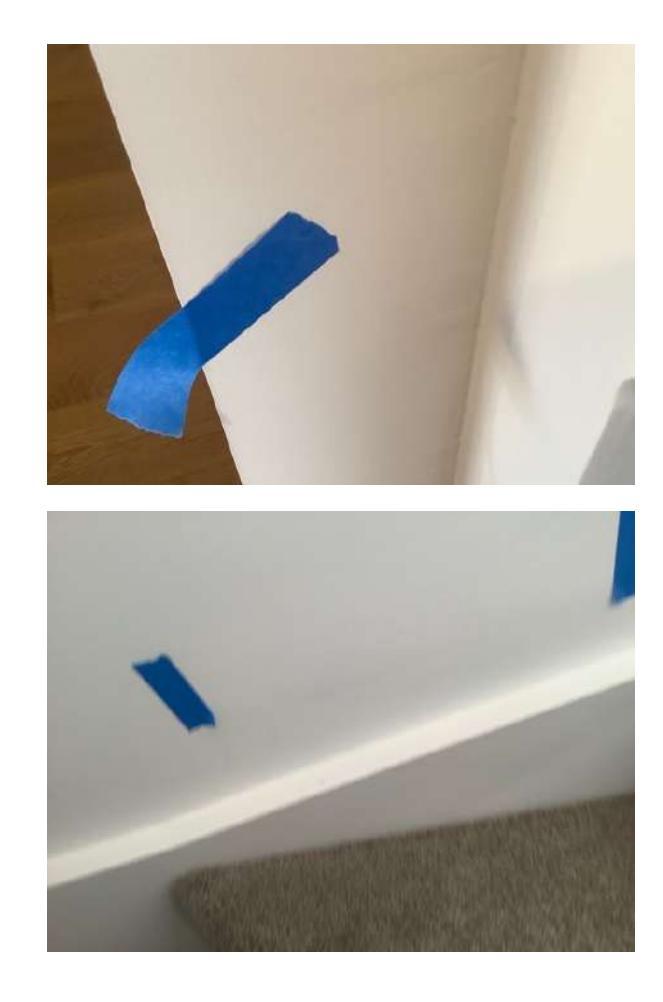
It was noted the plaster work / joints to the walls in these areas as per the photos attached are clearly visible.

The Building Commissions, Guide to Standards and Tolerances clause 9.14 Level of Finish for Plasterboard, states- 'All joint compound will be finished smooth and be free of tool marks and ridges. Additionally, clause 9.19 Peaking or Jointing in Plasterboard states- 'Plaster peaking or jointing is a defect if it is visible from a normal viewing position.'

Reworking of the plaster will need to take place and painting re-done to the areas within this report, but certainly not limited. It is the builders responsibility to make good all defective plaster work / joints within this property.

These joints will have to be properly rectified and repainted.

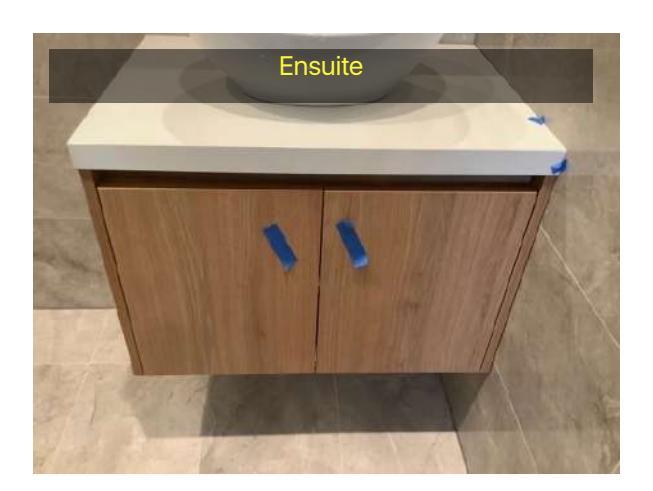
Location: Finding: Cabinet Doors - All Areas

Cabinet doors - misaligned and Cabinet drawers - misaligned.

• It is observed that some of the cabinet doors are not aligned and / or have inconsistent gaps between the doors.

• It is observed that some of the cabinet drawers are not aligned and / or have inconsistent gaps between the drawers.

The Building Commissions, Guide to Standards and Tolerances clause 8.04 Internal Door Clearances, states- 'The installation of doors is defective if within three months of completion, clearances between door leaves and frames and between adjacent door leaves are not uniform and within 1mm. A clearance between door leaves or between a door leaf and the frame is defective if it is less than 2mm or greater than 5mm in width'

The gaps around these doors must be adjusted to comply with this tolerance.

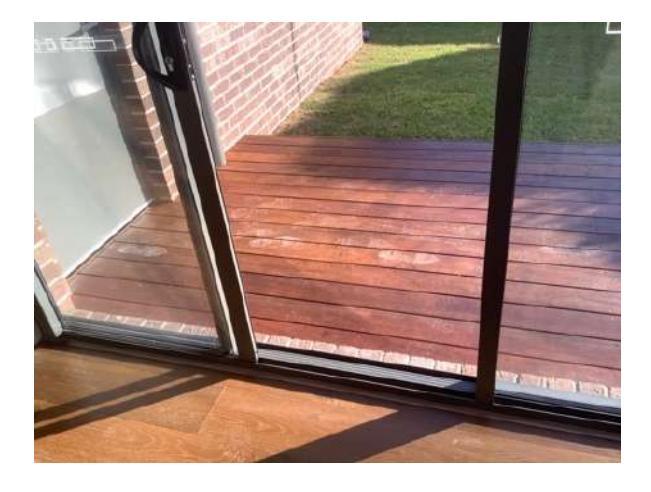
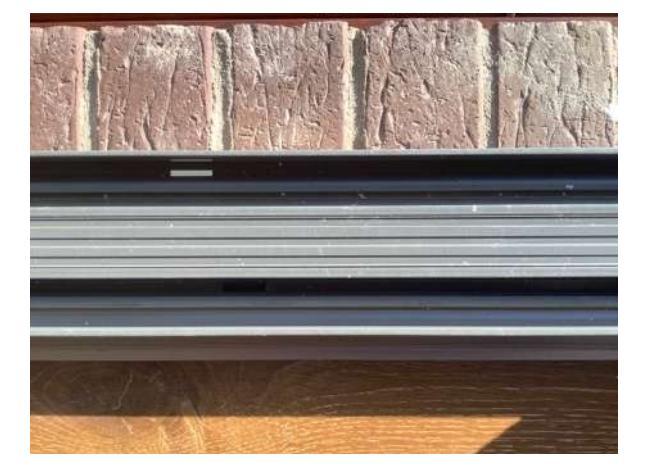
Metal Finishes-Damaged

Colourbond Coating & Powder coat finish Scratched and/or Damaged.

The affected damaged sections will need to be replaced.

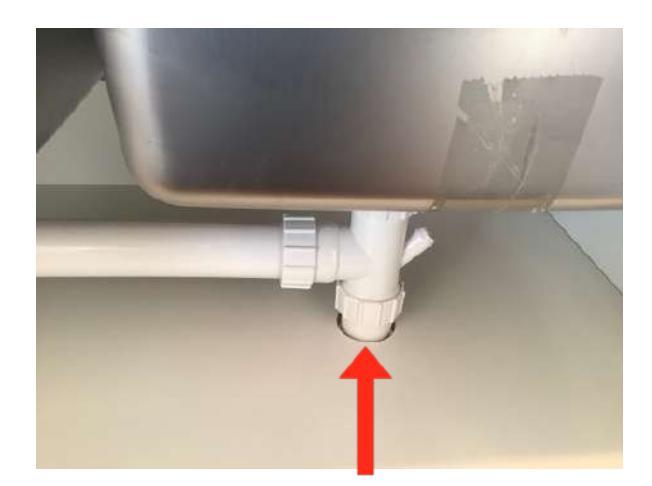
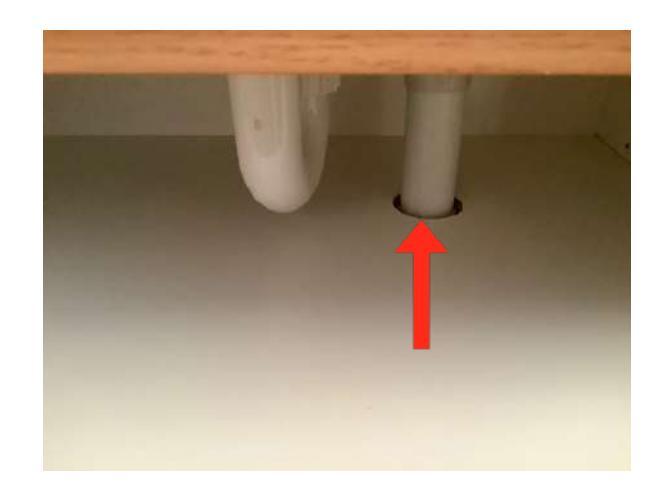
Location: Pipe penetrations (cabinetry) - All Cupboards

Finding: Pipe penetrations (cabinetry) - defective

Examples of pipe penetrations or plumbing holes which are penetrating inside cupboards or cabinetry being defective were identified. Generally this means that the penetrations have not been fitted through neat minimum size penetrations or fitted with tight fitting cover plates or collars and kept to the smallest practicable size.

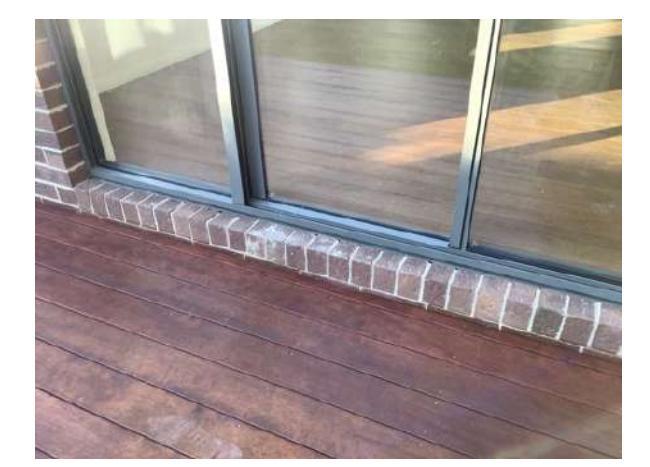
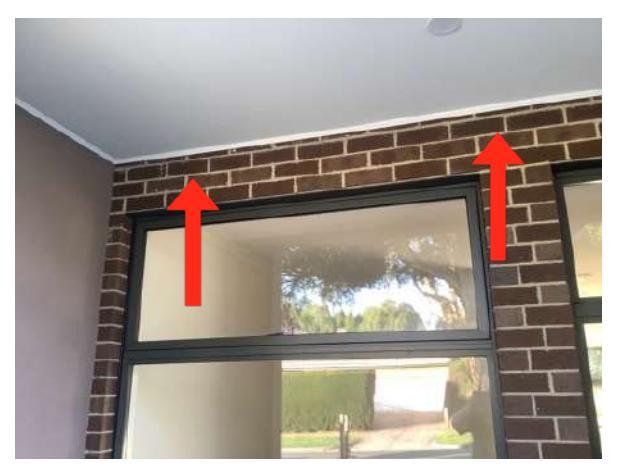
### Non Compliant 2.14

Location: Finding: Brick Work - Exterior Perimeter Of Building

At the time of inspection, this area does not meet contractual requirements regarding acceptable finishes. The responsible contractor should be appointed to complete these works in order to comply with standards and regulations. Such works should be completed prior to final handover.

The Building Commission's Guide to Standards and Tolerances clause 3.07, MasonryFacing states that:- 'Masonry faces are defective if they are not cleaned and free of excess mortar' and clause 3.11, Cleaning, Mortar Smears & Stains states that:- 'Stains, mortar smears and damage caused by cleaning are defects if they are visible from a normal viewing positioning.' The faces and edges of the bricks within the wall around this home will have to be properly recleaned to remove all traces of the mortar residue from across them.

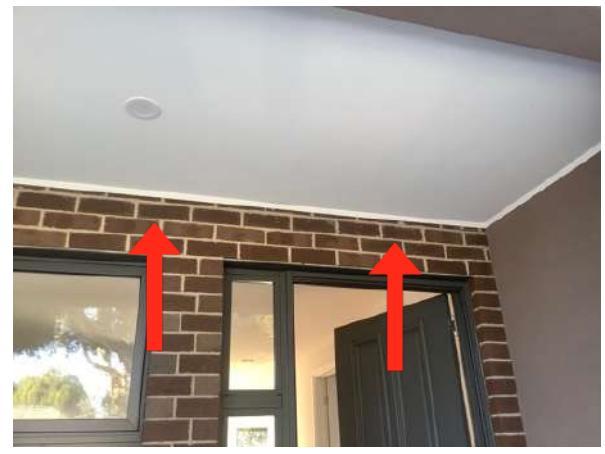
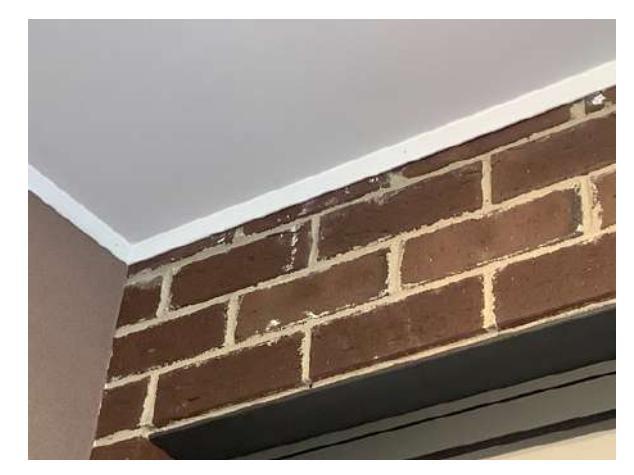
Location: Finding:	Brick Work - Exterior Perimeter Of Building Brickwork - Holes and Voids IMPORTANT — ONLY SAMPLE PHOTO'S of the Brick Holes and Voids defects. All AREAS to the entire property MUST be checked and repaired.
	There are various locations with brickwork holes and voids to the brick mortar. The brick mortar must have a consistent smooth textured finish throughout the brick mortar surface areas. There are inconsistencies with holes and voids spread throughout the property.
	Is very important that the builder repair all locations with a brick mortar match that is not noticeable, otherwise the defect will remain non-compliant.
	The brick work mortar is well below acceptable standards and the DOMESTIC BUILDING CONTRACTS ACT 1995 states that all works must completed as stated in ( A ) and ( D ) paragraph below.
	DOMESTIC BUILDING CONTRACTS ACT 1995, Act No. 91/1995, Part 2 - Provisions that apply to all Domestic Building Contracts.

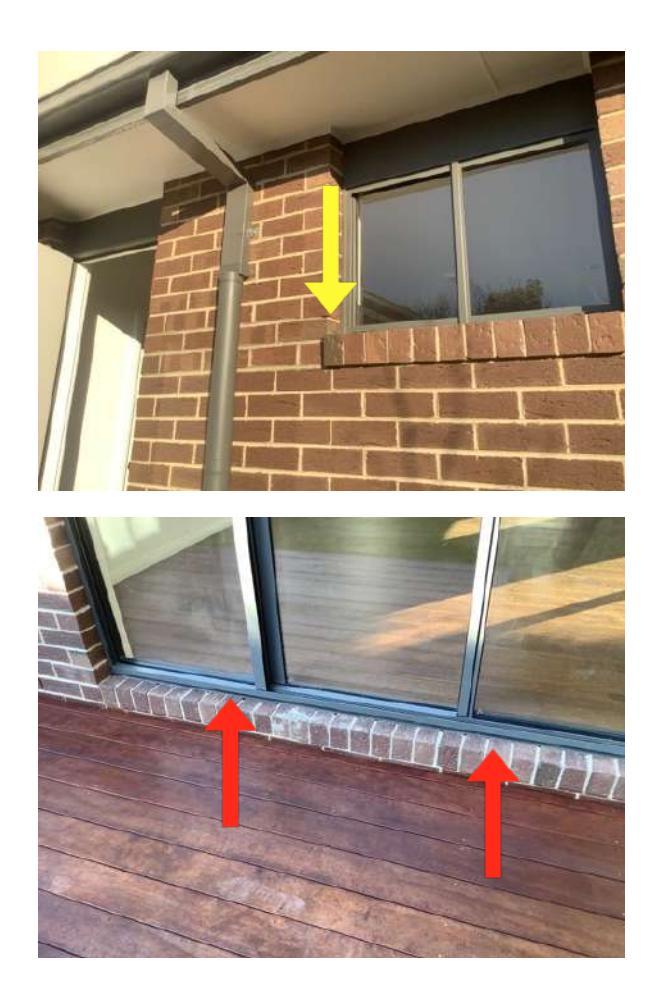
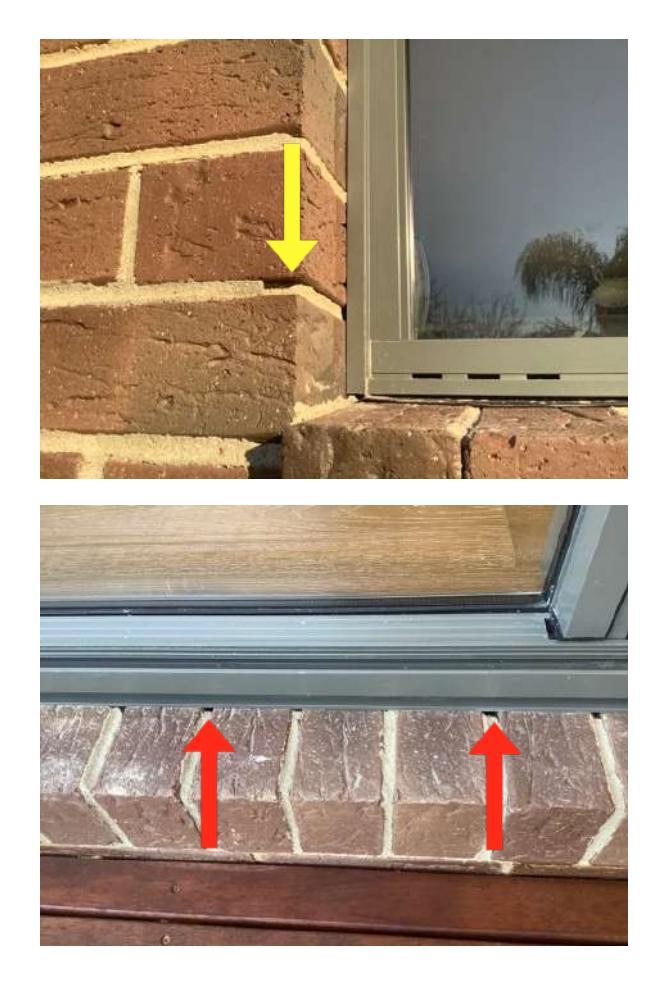
Location: Finding: Brick Work - Exterior Perimeter Of Building Brick Pipe penetrations (walls) - defective

Examples of pipe penetrations or plumbing holes which are penetrating external walls being defective were identified. Generally this means that the penetrations have not been finished neatly grouted as appropriate or kept to the smallest practicable size.

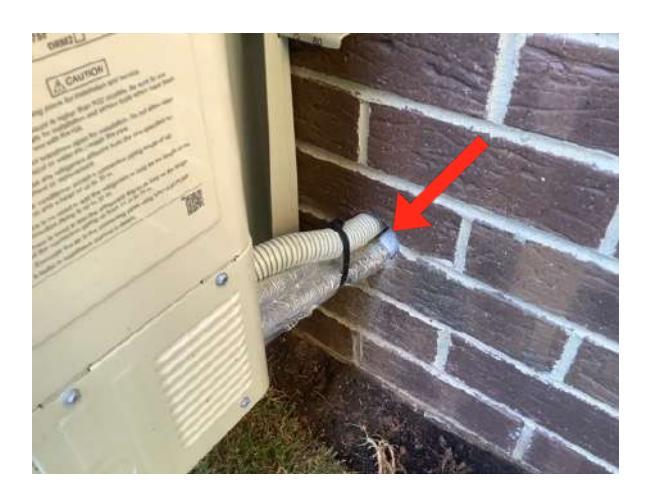
Brick Work - Exterior Perimeter Of Building

Minor Brickcleaning required of excessive builder debri remaining on the face of the brickwork. Any minor areas of builders paint, plaster, minor areas of cement, brick mortar, render and the like on the brick surfaces is a defect and the builder must hand the house to the client in as new condition at handover time.

The Building Commission's Guide to Standards and Tolerances clause 3.07, MasonryFacing states that:- 'Masonry faces are defective if they are not cleaned and free of excess mortar' and clause 3.11, Cleaning, Mortar Smears & Stains states that:- 'Stains, mortar smears and damage caused by cleaning are defects if they are visible from a normal viewing positioning.' The faces and edges of the bricks within the wall around this home will have to be properly recleaned to remove all traces of the mortar residue from across them.

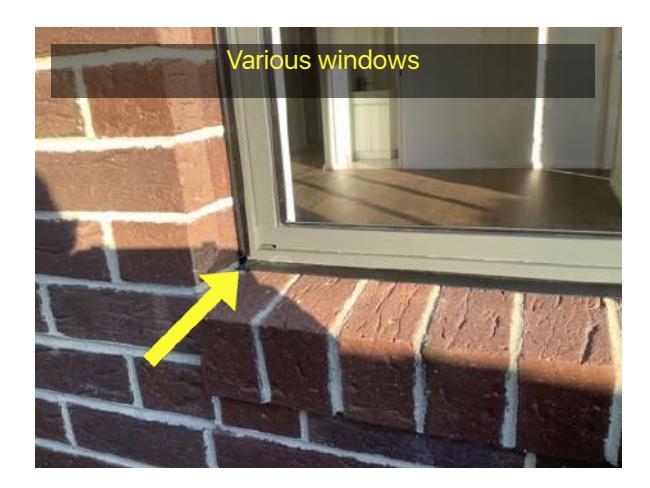
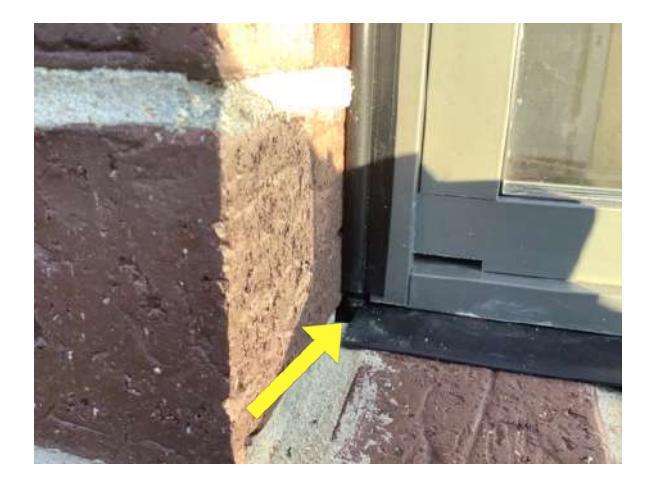
Window rubbers - Inadequate (AS2047)

It is important to note that running a line of caulking under the rubber seals is not satisfactory and will not be completed as the manufacturer has intended the window installation to be installed, re-working of the window sills may be required and it is important to note that the fall of the window sills must be incorporated in the re-working of the brick sills.

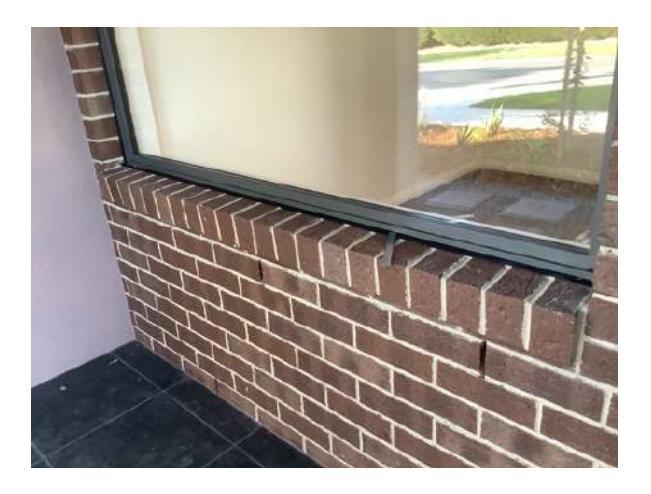
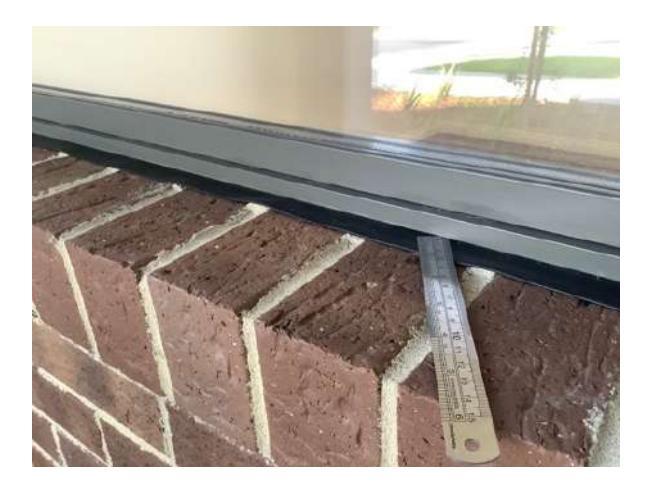
Location: Windows-All Areas

3.19 Brick sills, sill tiles and shrinkage allowance for timber framingWindow frames, sill tiles and sill bricks are defective if they are distorted or dislodged.Eaves where the soffit and the masonry meet are defective if they are not installed with the minimum clearances set out in Table 3.19.Brick sills are defective if they are not laid with a consistent slope to each elevation and adequate slope to provide drainage away from the opening.Refer also to Diagram 3.19.

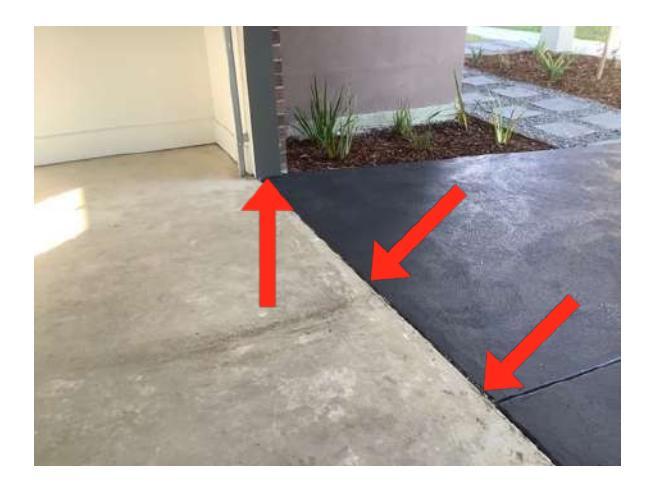
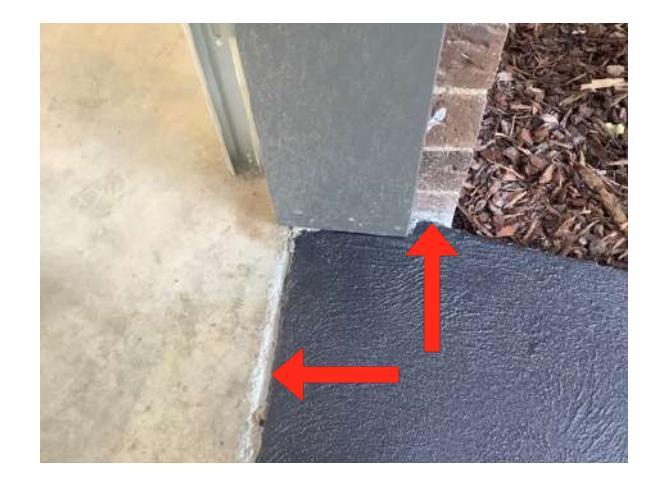
Location: Concrete - Exterior

Hydraulic pressure can have the potential to create serious movement and the builders structural warranty is likely to be void as a result of poor concrete paving by an outside contractor that the builder did not engage, if this is applicable to you.

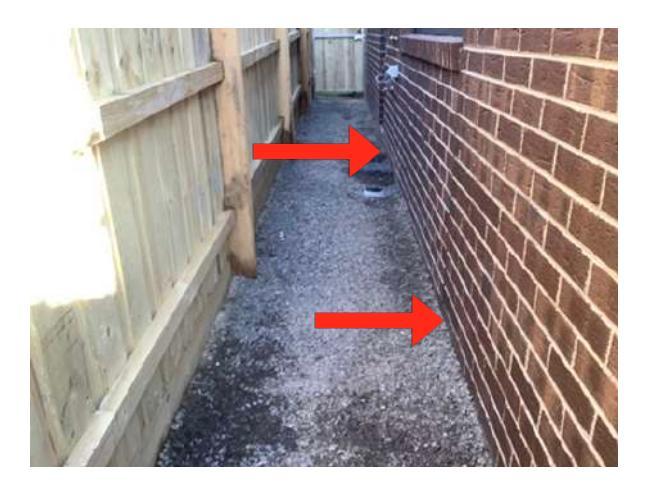
Location:	Concrete Slab - Perimeter To All Areas
Finding:	Vapour barrier - Defective (AS2870- 2011)
	IMPORTANT I IMPORTANT IN SAMPLE PHOTO'S of the vapour barrier defects. All AREAS to the entire property MUST be checked and repaired.
	The builder has not completed the vapour barrier system to the porch area concrete perimeter. These areas require the exact same requirements for a vapour barrier system without compromise as the slab of the main building area. Some builders argue that theses areas of porches, alfresco's and the like do not require the same vapour barrier system, however this is not an accurate statement and under Australian Standards the entire slab area including porches, Alfresco's and any other added areas to the main building must have the vapour barrier as well. There is no distinction in any supporting evidence of building code or australian standards to state otherwise.

I HIGHLY RECOMMEND that the builders digs the perimeter carefully,, sometimes the entire perimeter, pending of the severity of the vapour barrier (plastic) damage, pending on slab over pour, pending on excessive builders concrete (debri). It is important to dig along the slab perimeter without damaging the plastic and to extend the vapour barrier plastic higher then the slab rebate as would have been in the post slab report if we performed one. All over laps must be a minimum of 200mm and the correct tape must be used to seal the plastic.
	Repair Method : The repair method for the vapour barrier is quite complex and difficult, because the slab over pour is very severe and the builders excessive concrete waste is very severe. A structural engineer will need to be involved in this repair process with instructions for the repairs due to the severe defective workmanship of this concrete slab perimeter

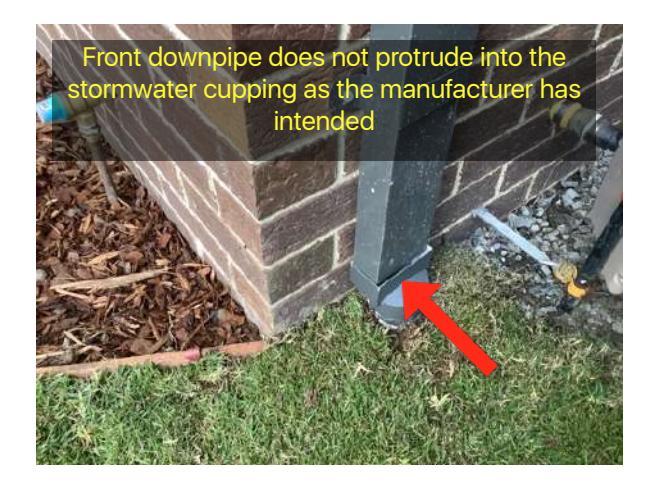
Location: Plumbing Finding: Plumbing

Plumbing work - Appears Defective.

An instance of potentially defective plumbing work was identified. Whilst we are not licensed plumbers it appears that work which is not compliant with the relevant plumbing regulations and or the contract documents has occurred. The area of suspected non-compliance or poor workmanship should be referred to the builder and or the Building Surveyor or Certifier. The builder is required to provide a Certificate of Compliance when required by the relevant regulations.

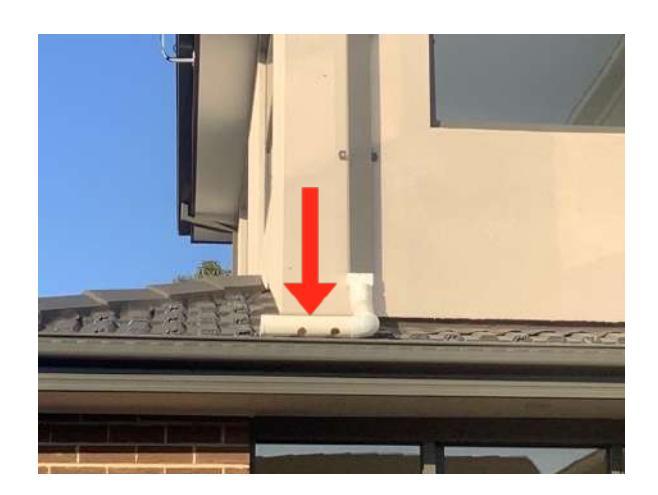
### Non Compliant 2.26

At the current time, the pipework is non-compliant. Works to rectify this must be completed prior to final handover.
