# **Handover Report**

## Inspection Date: 10 Jul 2021 Property Address: Elwood, Vic - Area

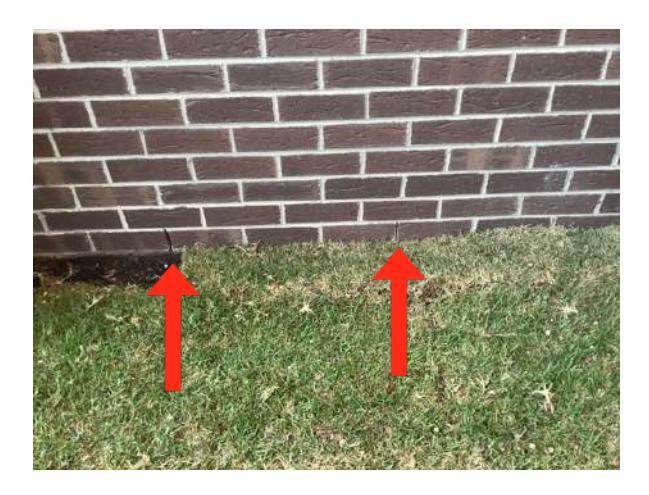
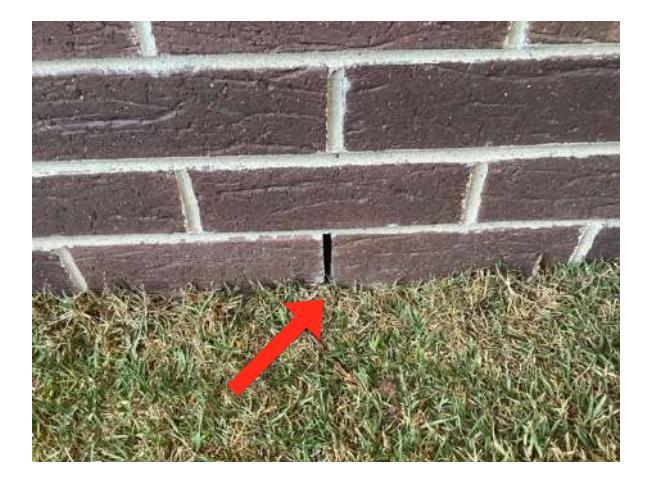
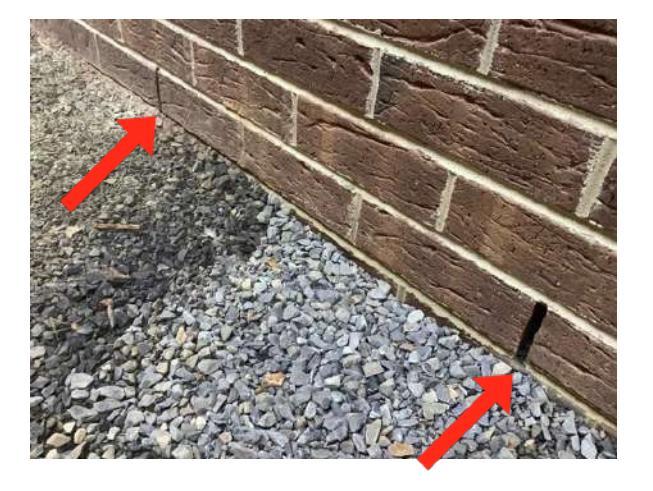
Weep Holes Height not compliant with AS requirement

It was observed that there are areas where the required Finished Ground Level (FGL) clearance to the bottom of the weepholes has not been established or maintained in accordance with AS 3700. The actual DPC position depends on the location and the requirements for this are: 150mm above the adjacent finished ground level or 100mm above sandy well drained areas or 75mm above finished paved or concrete areas or 50mm above finished paved or concrete areas which are protected from the weather such as carports or veranda's.

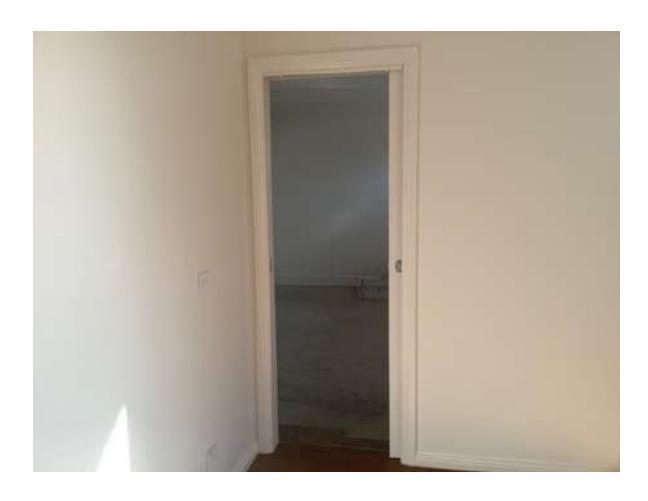
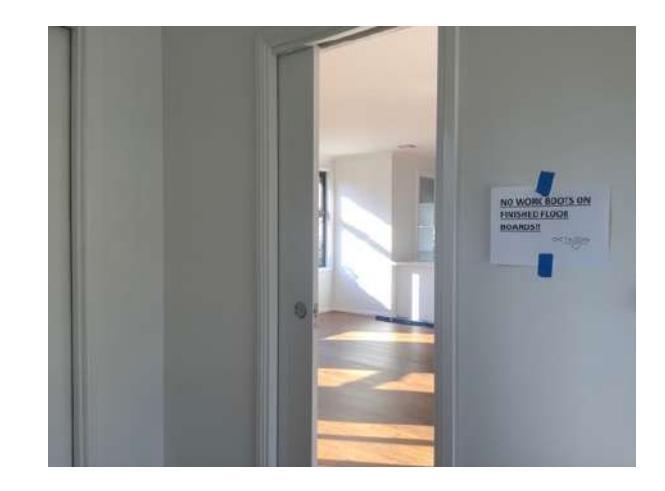
As required you need to seal the door for your energy star rating and a cavity sliding door cannot be sealed as per the regulations, as the requirement is inclusive of all perimeter internal doors, including the garage door leading into the house.

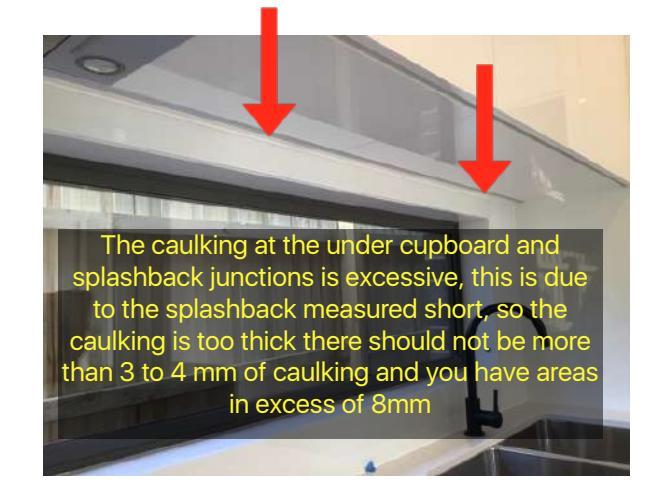
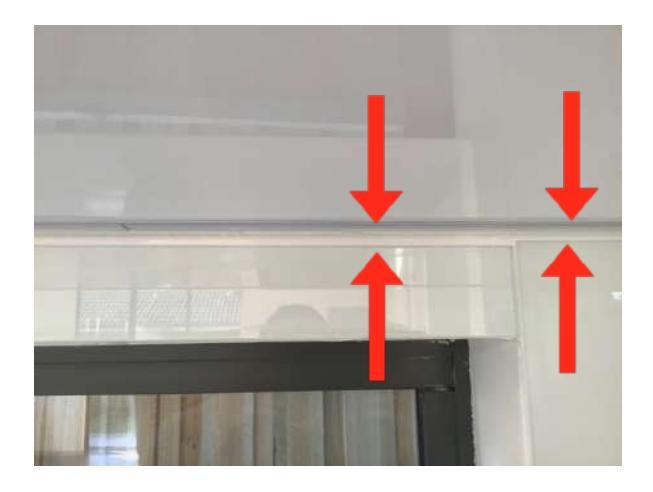
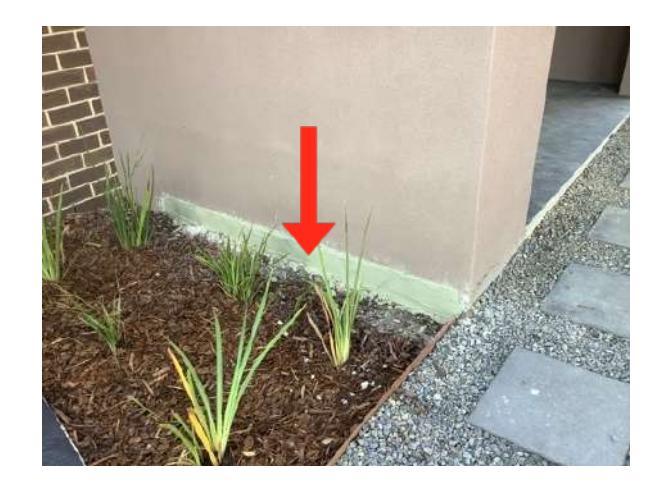
### Substandard Workmanship 3.02

Location:	Unfinished/Defective Works
Finding:	Unfinished/Defective Works
	All these photos are added, to demonstrate DEFECTIVE / SUB STANDARD and/or INCOMPLETE WORKS and they are all required to be rectified as they are ALL not satisfactory for New construction specifications of finish required as per the DOMESTIC BUILDING CONTRACT ACT 1995 as stated in the contract : (A) the builder warrants that the work will be carried out in a proper and workman like manner and in accordance with the plans and specifications set out in the contract.
	The following items will need to be completed or repaired in accordance with the Domestic Building Contracts Act 1995. We refer the builder to the implied warranties where the builder agreed to build the dwelling in a proper and workmanlike manner and with reasonable care and skill.
	DOMESTIC BUILDING CONTRACTS ACT 1995, Act No. 91/1995, Part 2 - Provisions that apply to all Domestic Building Contracts.

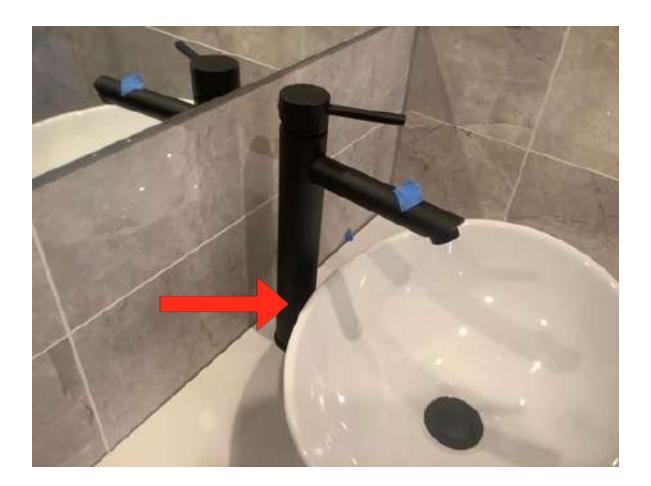
### Substandard Workmanship 3.03

Location: Finding: Ensuite

Tap - Loose

Where taps or spouts are loose, a qualified plumber should be appointed to re-fix the plumbing fitting prior to handover.

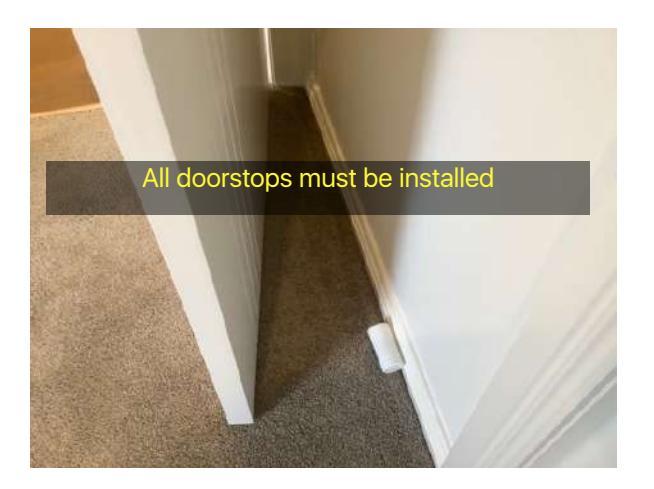
### **Incomplete 4.02**

IMPORTANT *C*ONLY SAMPLE PHOTO'S of the missing door stops. All AREAS to the entire property MUST be checked and repaired.
