# Lock Up Report

## Inspection Date: 11 Sep 2021 Property Address: Eastern Suburbs

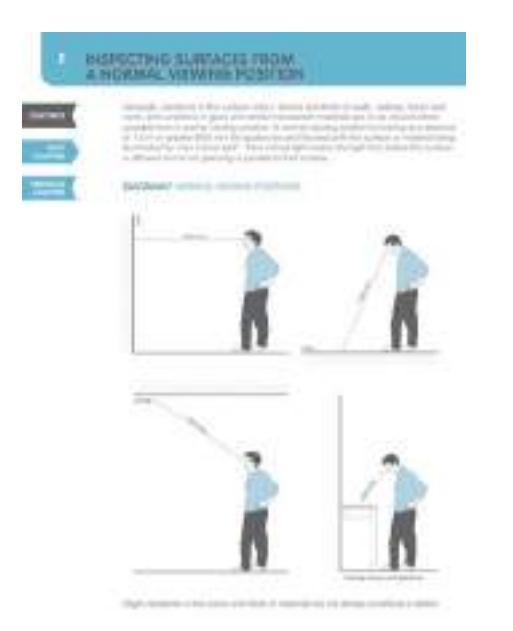
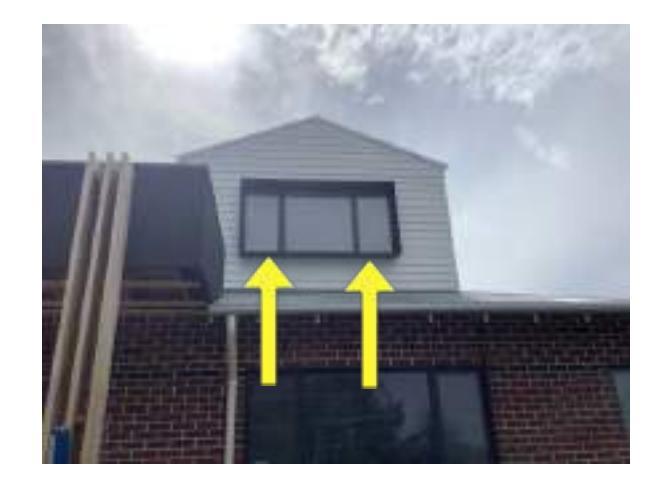
Painting-excessive over painting-All Areas Paint finish excessive over painting - defective

Paintwork is defective if the application has blemishes such as paint runs, paint sags, wrinkling, dust, bare or starved painted areas, colour variations, surface cracks, irregular and coarse brush marks, sanding marks, blistering, non-uniformity of gloss level and other irregularities in the surface that are visible from a normal viewing position. Paintwork is defective if the application results in excessive over-painting of fittings, trims, skirtings, architraves, glazing and other finished edges.

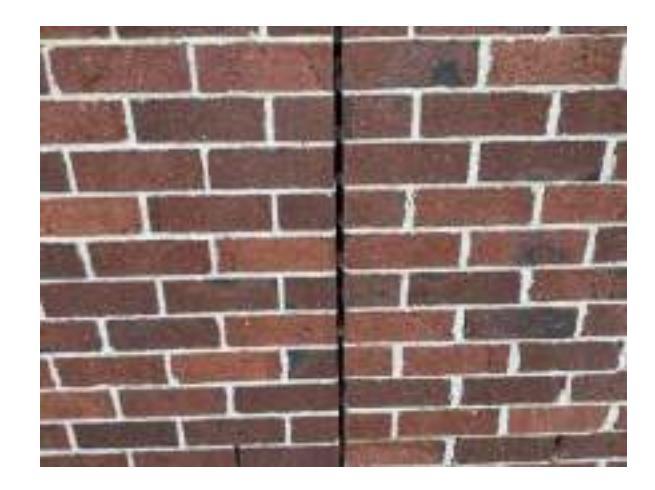
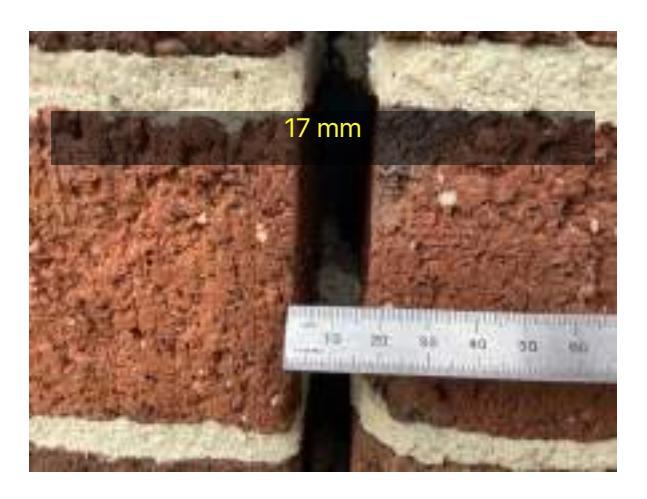
Location:	Articulation Joints - All Area's
Finding:	ARTICULATION JOINTS - Not as per plans.

Articulation joints - Width defective .(AS3700)

The Masonry Structures Code AS3700 limits the amount of movement to be accommodated at a vertical joint to 15mm, and requires that a gap of at least 5mm should remain after the movement has taken place. It limits the amount of movement to be accommodated at a horizontal joint to 10mm.

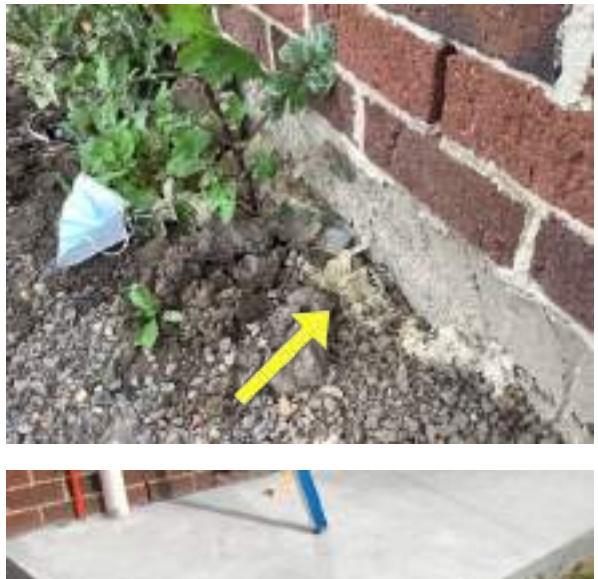
Polyethylene (plastic) vapour barrier not installed as per ( NCC ) Volume Two: 3.2.2.6 Vapour Barriers - Non-Compliant / Defective

The vapour barrier must be placed beneath the slab so that the bottom surface of the concrete slab is completely protected and extends under the edge beams to finish at ground level and It must be further noted this is also required to class 10 buildings when the slab is continuous from a class 1 slab, so the vapour barrier has failed.

Defective Vapour Barrier Installation - Damaged/Punctured and/or Overlapping Defective.

The polyethylene vapour barrier from beneath the concrete floor slab must be turned up the external side faces of its edge beams. Failing to install the vapour barrier correctly will allow moisture ingress via slab edge dampness into the internal timber wall skins and/or the floor coverings if not done.

THE ONLY TRUE REPAIR METHOD IS TO ENTIRELY DIG THE EXTERNAL PERIMETER OF THE BUILDING AT LEAST 300mm below the vapour barrier system Polyethylene (plastic) damaged areas, which will vary in areas and then overlap the existing plastic with the new plastic by a minimum of 200mm and to tape all the overlaps of the Polyethylene (plastic). The overall height of the plastic must be above the top of the slab rebate surface for now at construction stage.

The plastic must be hard against the concrete with no soil, rocks and/or builders debri in between the slab and the Polyethylene (plastic). Any over pour of concrete must be cut flush to the concrete rebate and include engineers report for alteration works and if steel mesh is visually seen, then the structural engineer must now also be notified to include the repair methods of the exposed steel mesh areas to determine the remedial works.

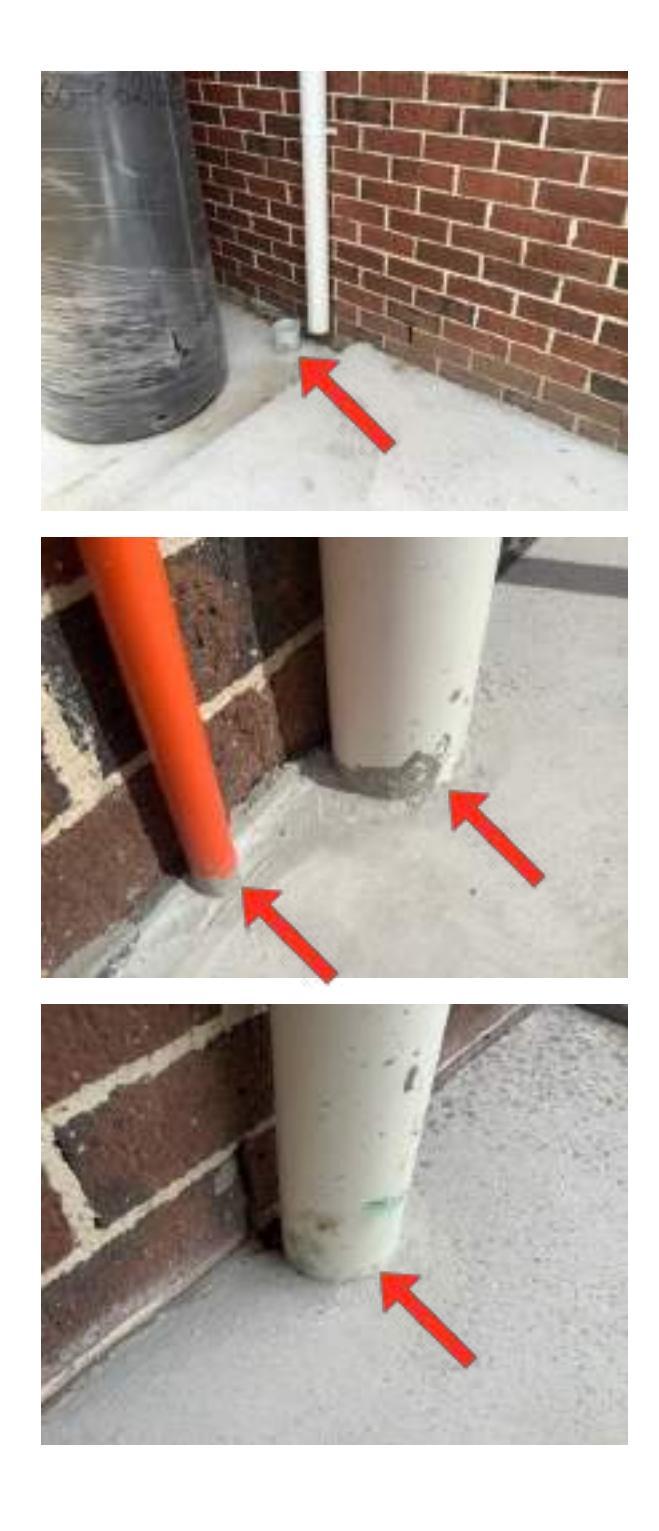
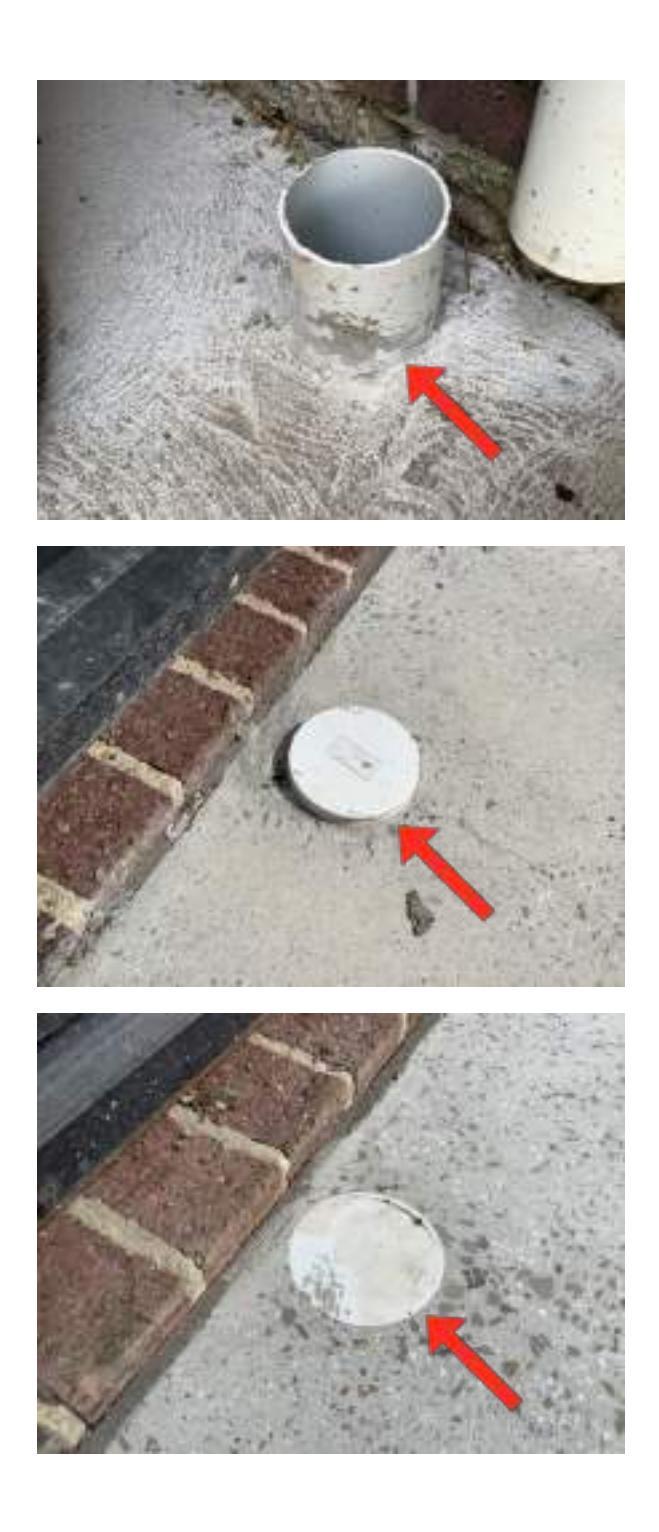
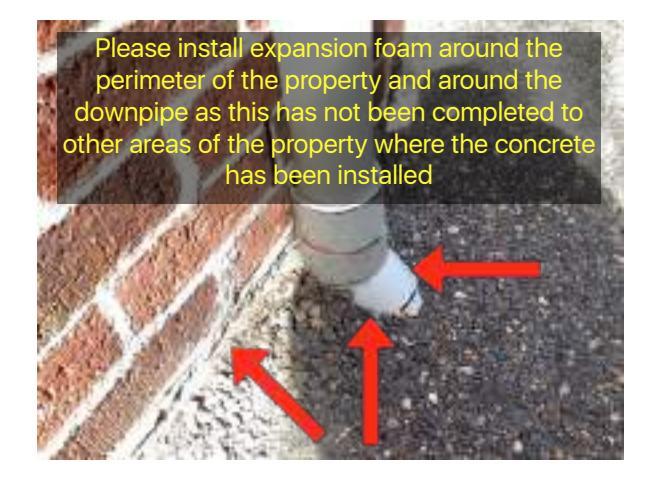
Location: Finding: Concrete - Exterior

This has the potential to crack the underground stormwater pipes, brick wall and concrete paving.

The current paving installation is incorrect and must now be properly rectified or replaced.

It is recommended that a 10mm wide cut is run all the way through the concrete, thus creating an expansion and contraction line, which is then added with the isolation joint material and caulking.

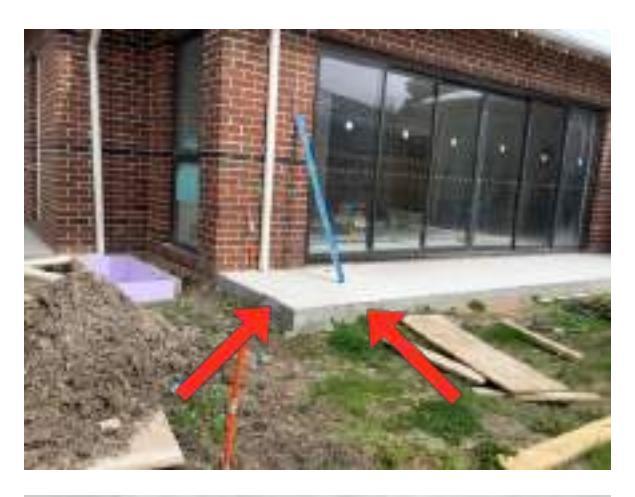
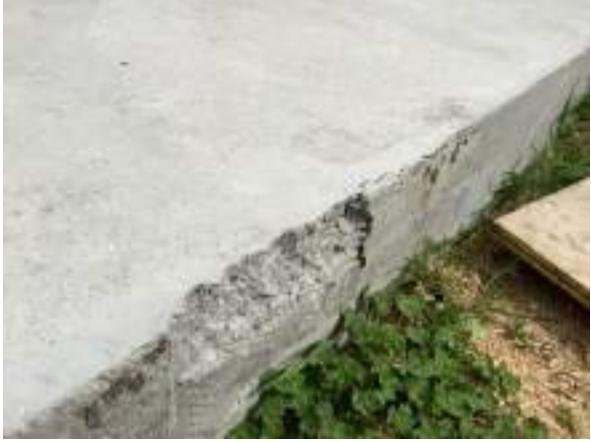
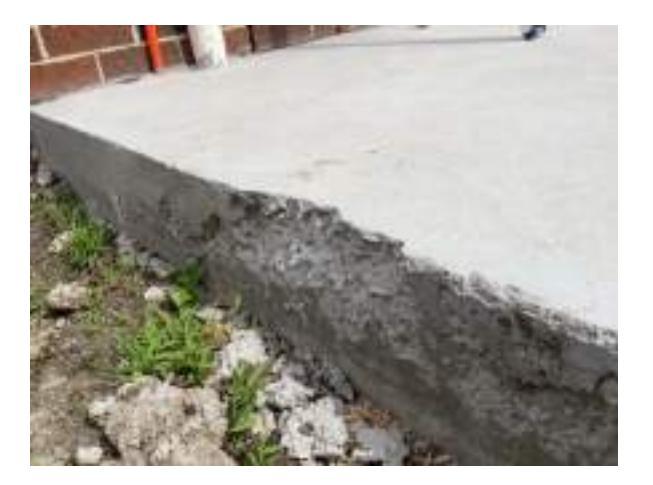
Concrete Paving - Defective Finish

Concrete paving finish is defective if it is not consistent in colour texture and general appearance. The degree of inconsistency is considered excessive and does not meet Standards and Tolerances.

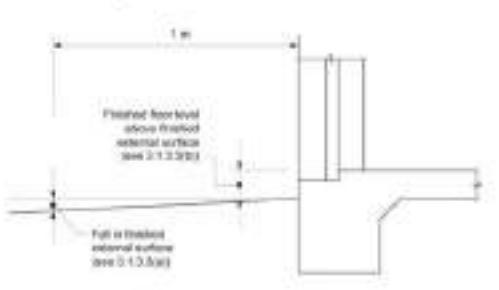
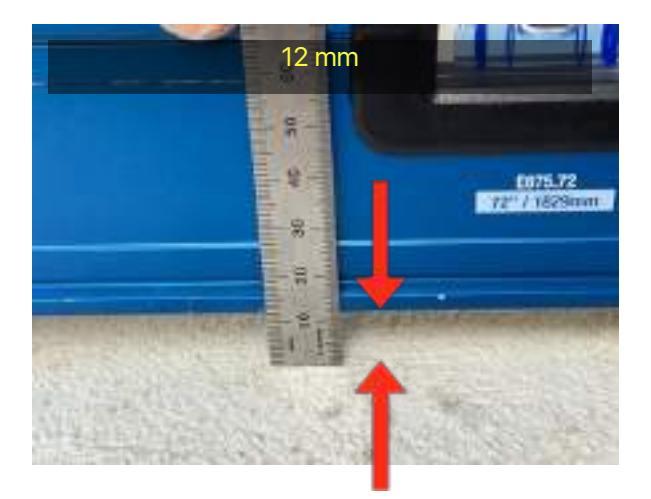
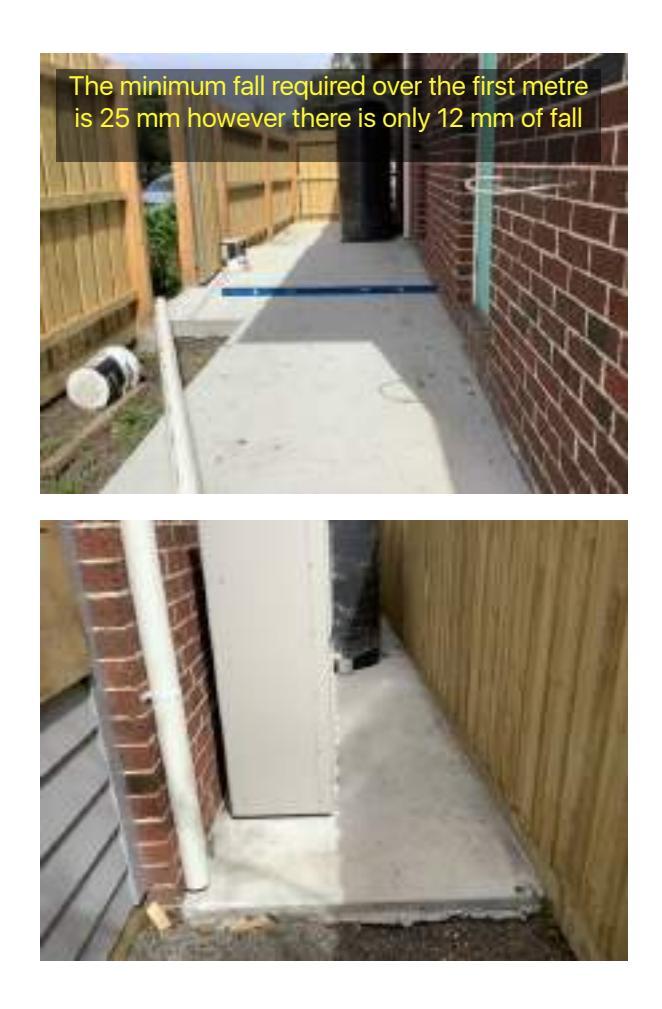
Location:	Drainage - Exterior

The perimeter paving or ground levels were found to have an inadequate slope away from the adjoining building structure, creating

Perimeter paving is required to fall from the building by a minimum of 25mm in the first metre and bare ground should fall away from the house by 50mm in the first meter. This standard ensures that excessive moisture does not pool around the base of building structures, which creates potential for water and structural damage, as well as making the area susceptible to termite and timber pest activity.

The paving/landscaping should direct surface water away from the building. Surface water drainage is defective if it is not in accordance with the requirements of the Building Code of Australia

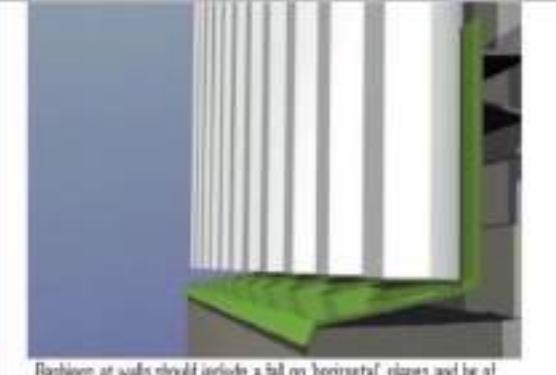
Flashing Metal Transfer - Defective

The metal transfer flashing to the garage is showing fall backwards towards the wall frame. The plumbing requirements and supplier's installation guidelines clearly mandate that the transfer flashings must have fall away from the dwelling. Note attached detail from Stramit Technical manual.

The plumber will need to rework all of the non-compliant transfer flashings to provide fall away from the dwelling. Being that the fall of the flashing is governed by its fixing height at the wall frame, the builder may need to remove the lower sections of wall cladding and rework the fixing height of the flashings.

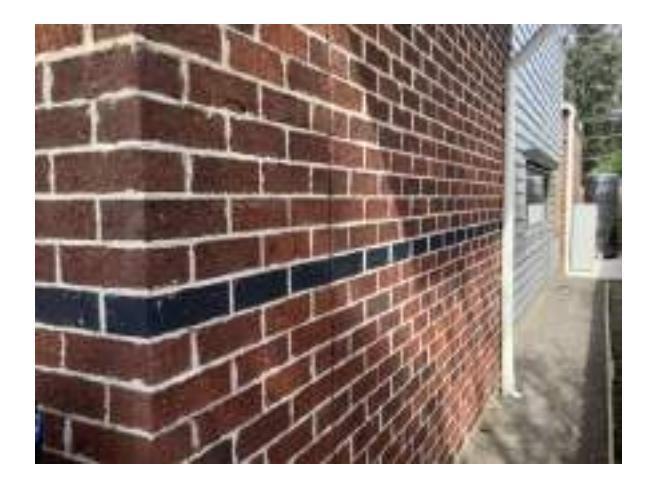
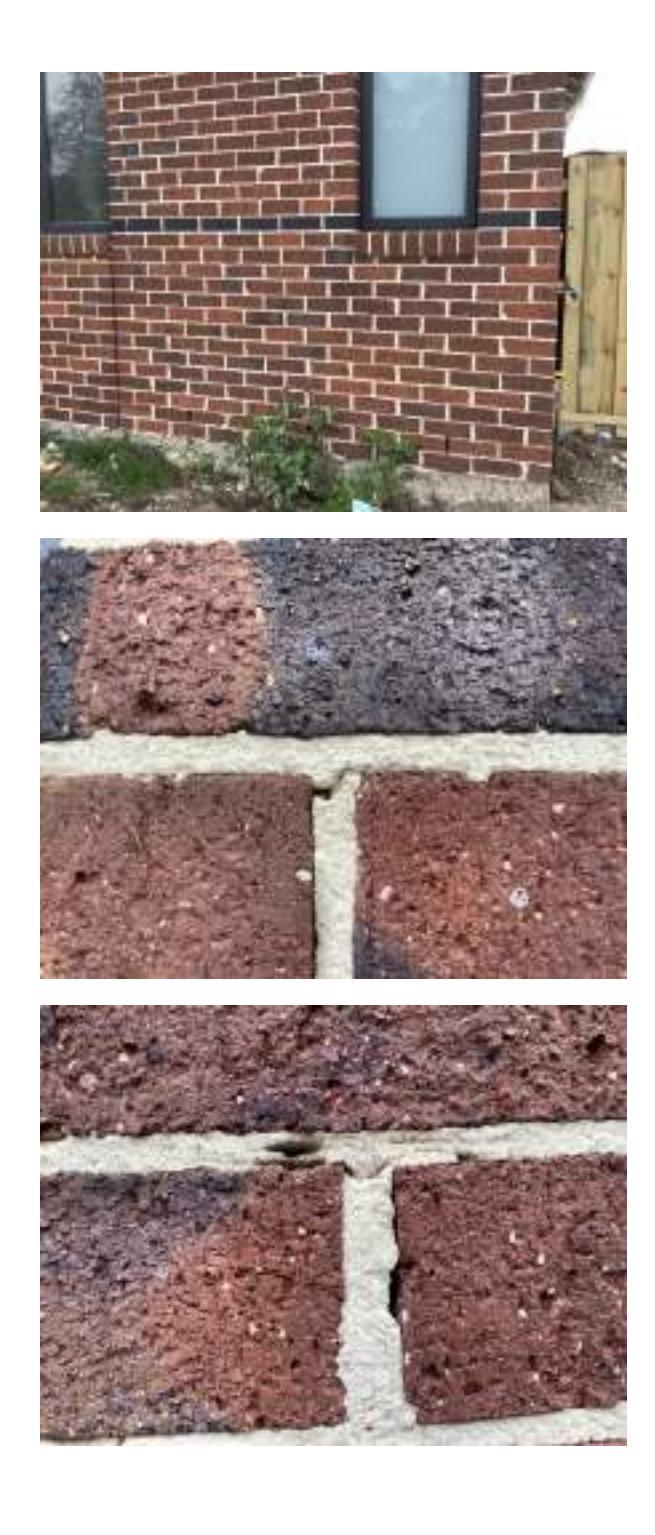
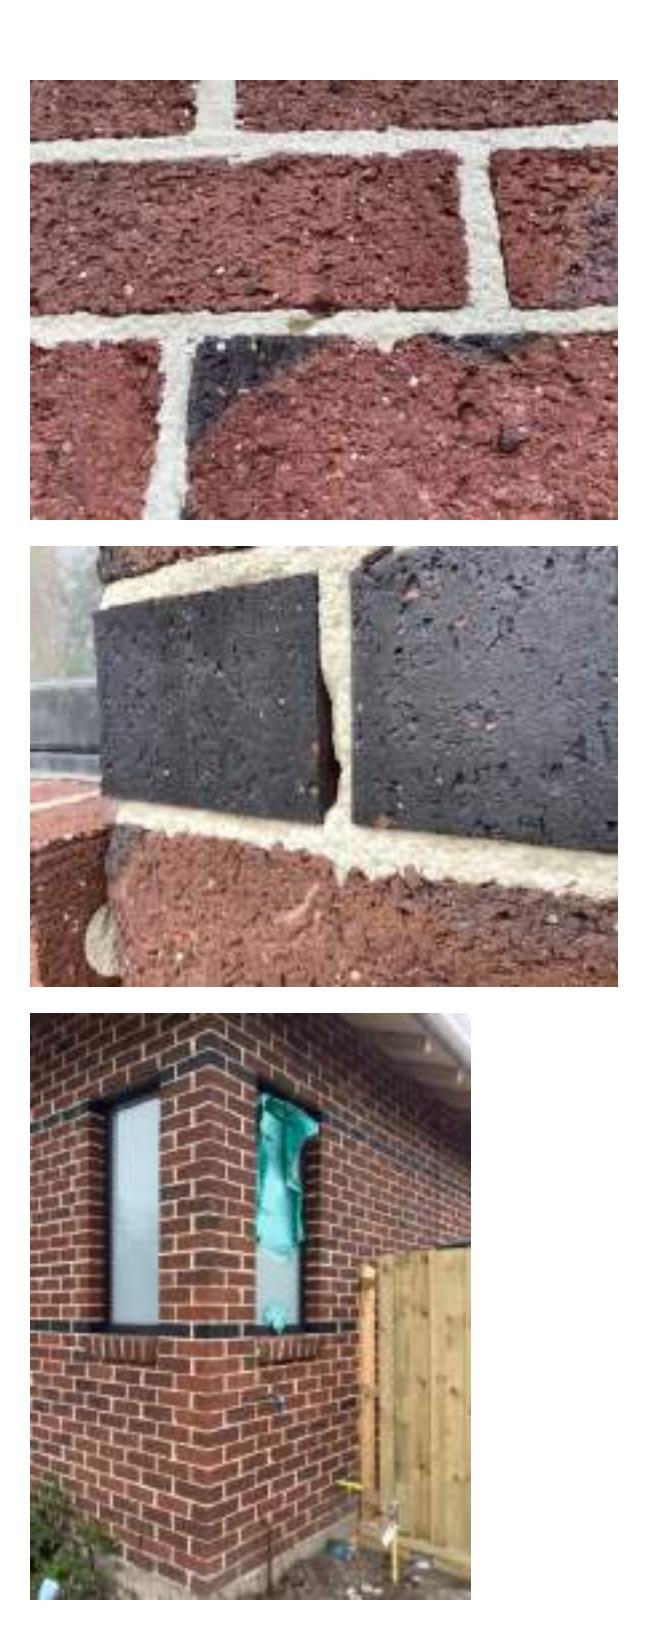
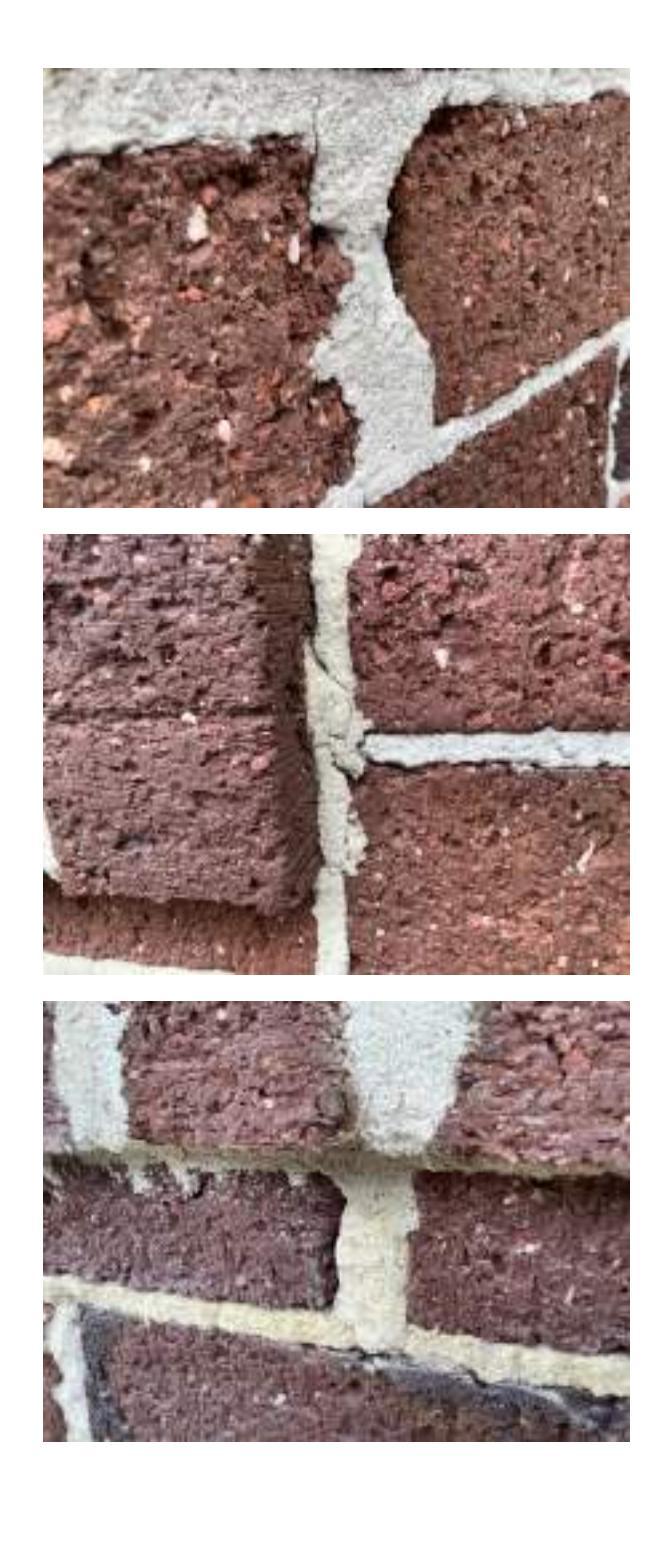
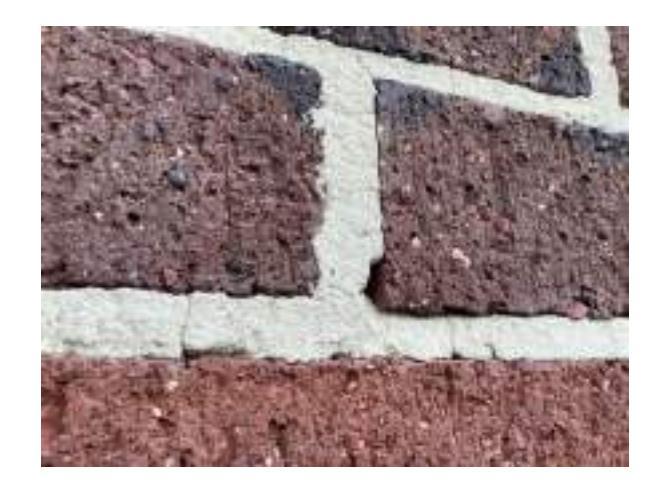
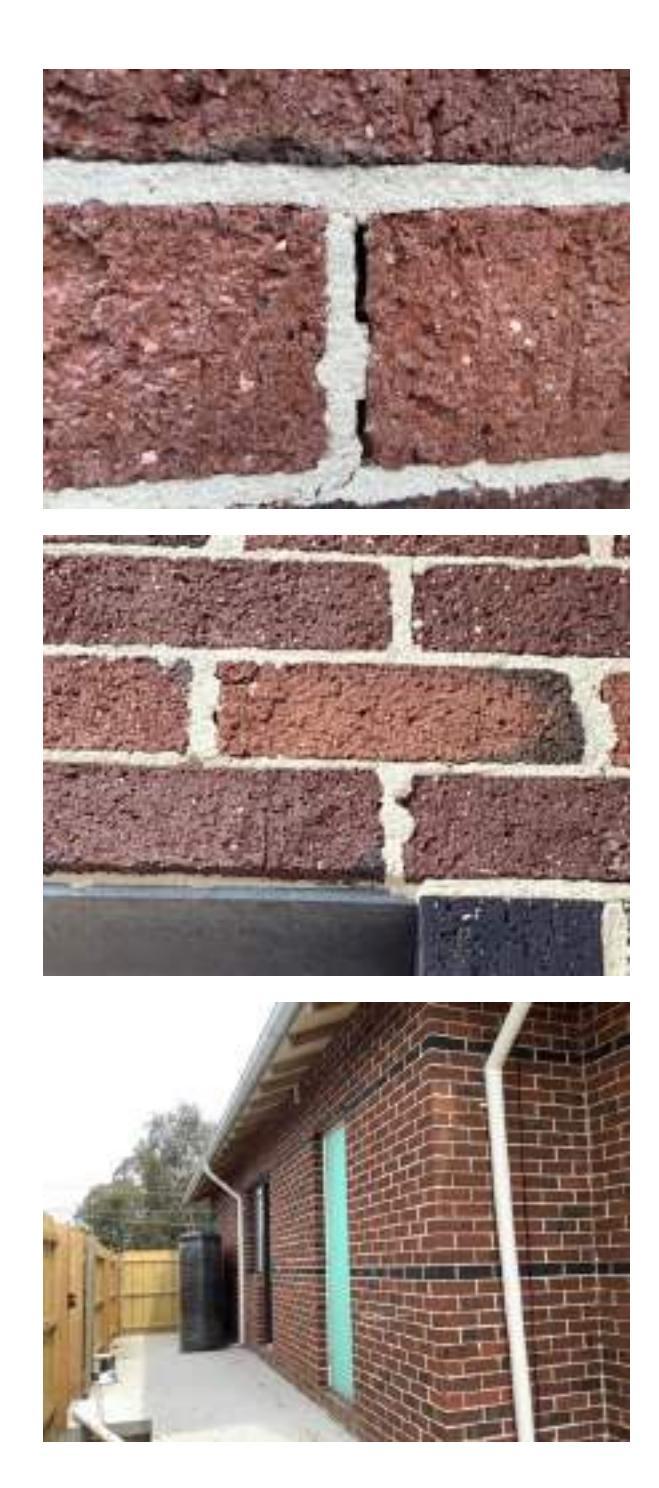
There are 2 Defects. One defect is brick mortar "holes and voids" and the other defect is "brick cleaning acid and pressure damage to the brick mortar.

I would like to make note that there are two major defects to this brickwork, one is the brick holes and brick voids in various locations to the brick mortar and the other is the damaged brick mortar due to excessive acid and pressure from the brick cleaner as the brick mortar is severely damaged in many areas.

There are many areas, in fact most areas of the brick mortar that has deteriorated, more then likely caused by excessive acid and/or pressure by the brick cleaner. All areas of the building must be consistent in finish and all areas of repairs must be consistent in finish and mortar colour.

Voids and holes in mortar in masonry walls, with the exception of weepholes and vents, are defective if they are visible from a normal viewing position.

1/ Where the brick mortar damage is excessive such as areas to this building, the builder may be required to engage a professional company that specialises in re-pointing the brick mortar which consists of grinding the brick mortar vertically and horizontally and re-install new brick mortar. Generally there is a minimum thickness of brick mortar that must be installed.

The entire building will require much more works then patching the mortar as the defect is spread throughout, re-pointing by a qualified company is highly recommended.

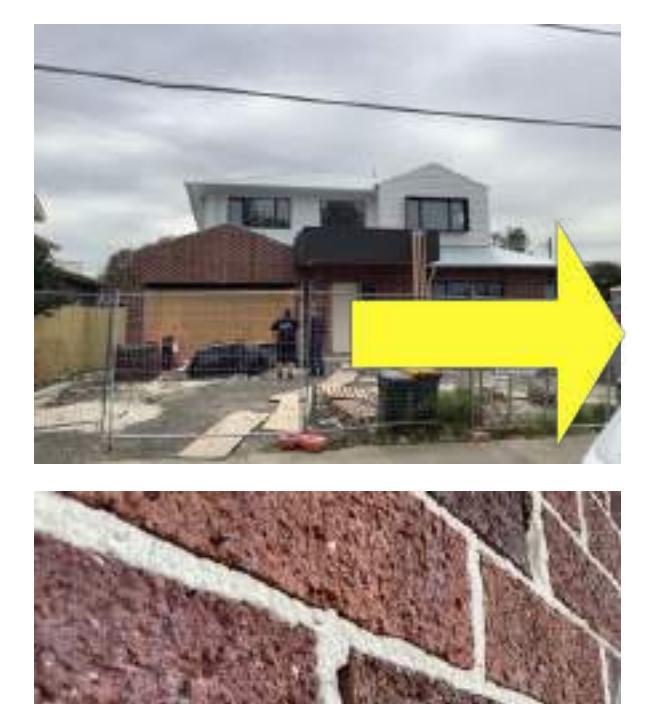
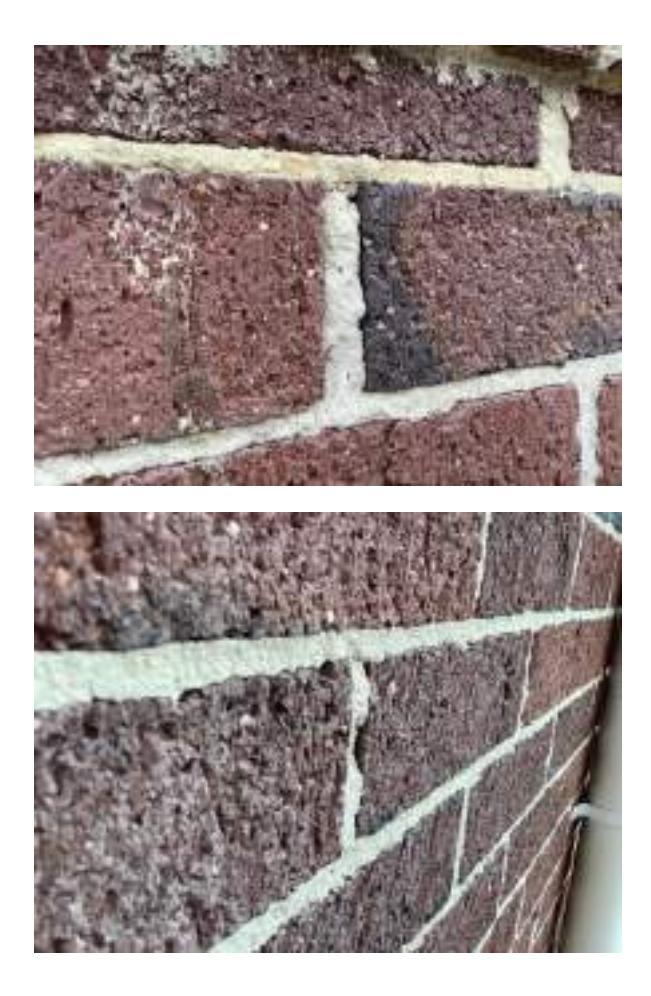
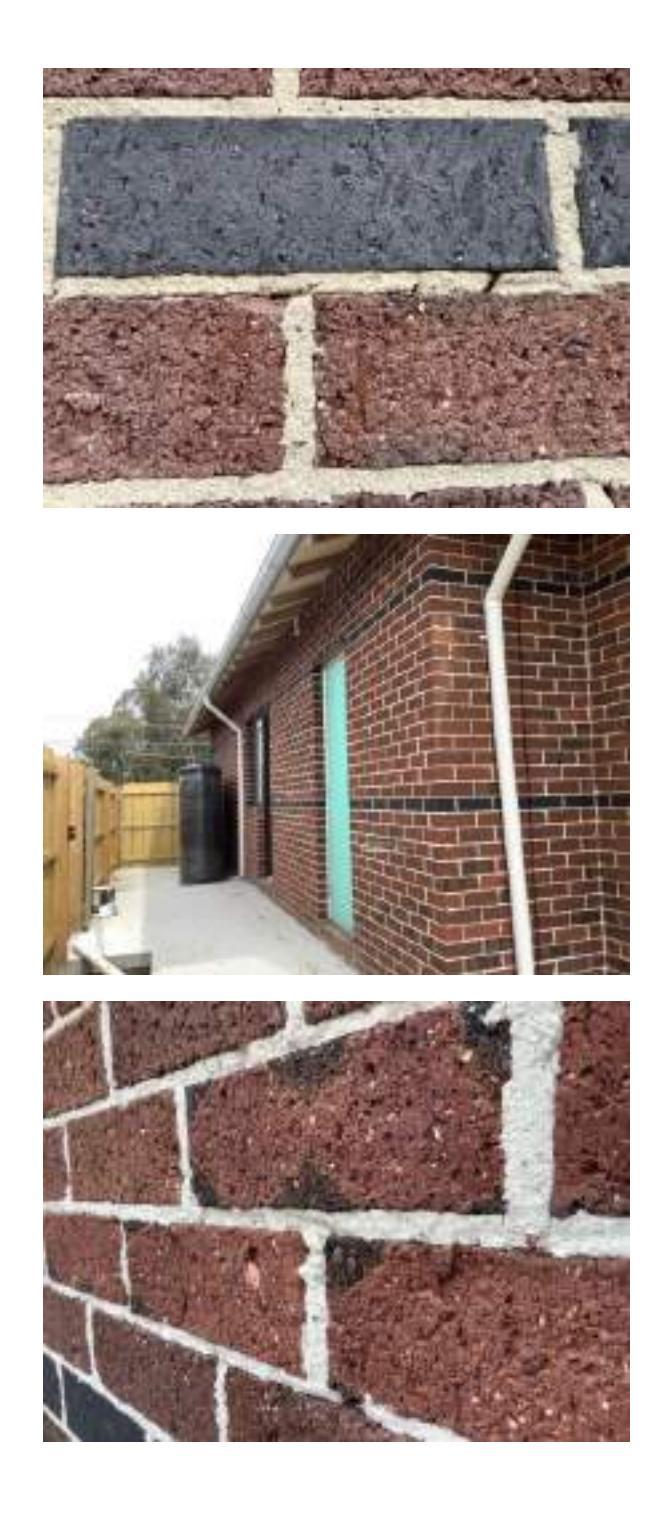
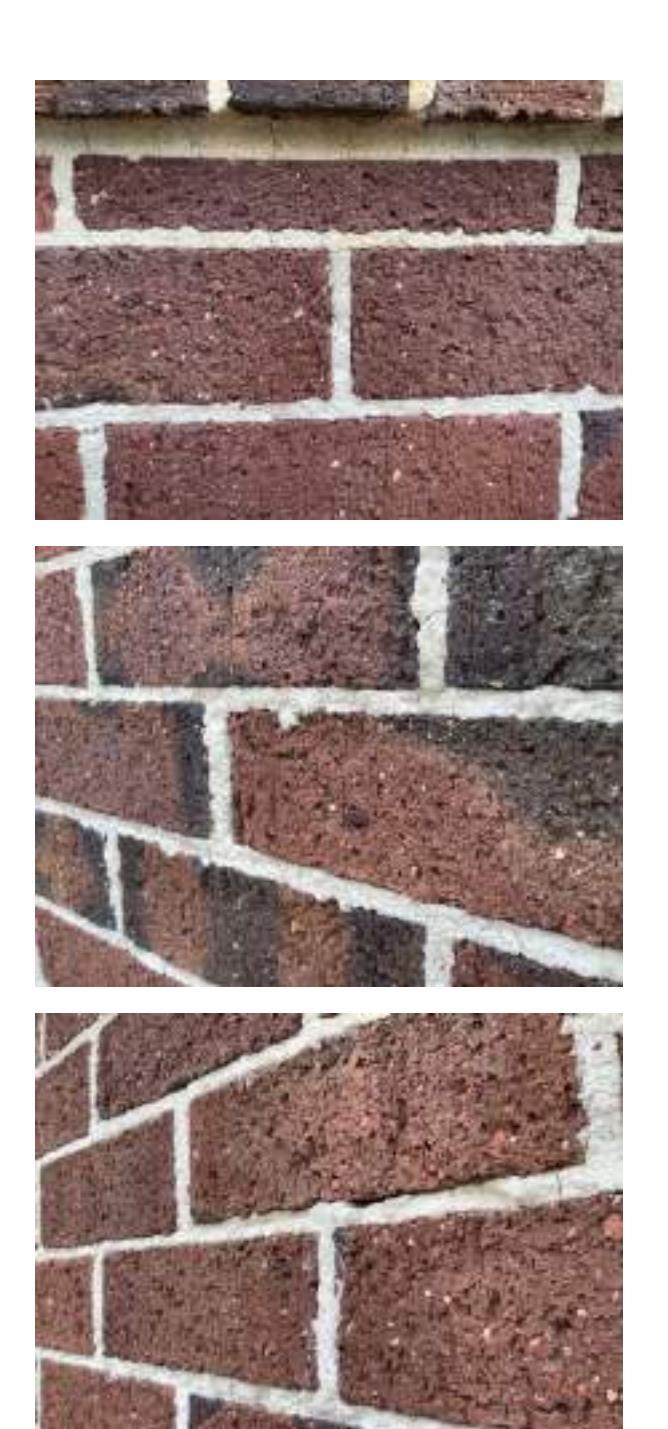
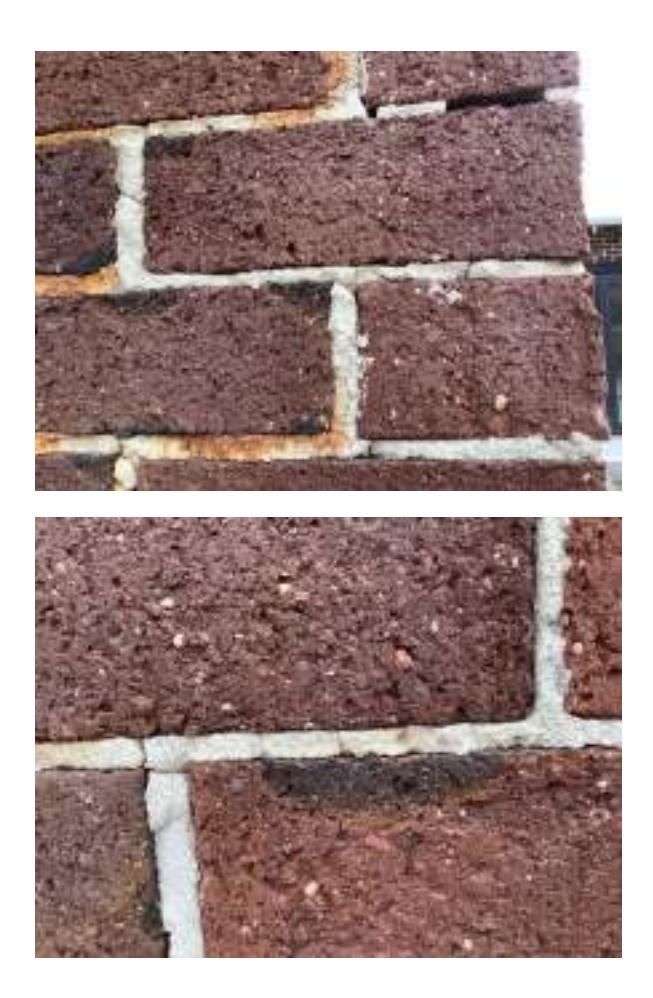
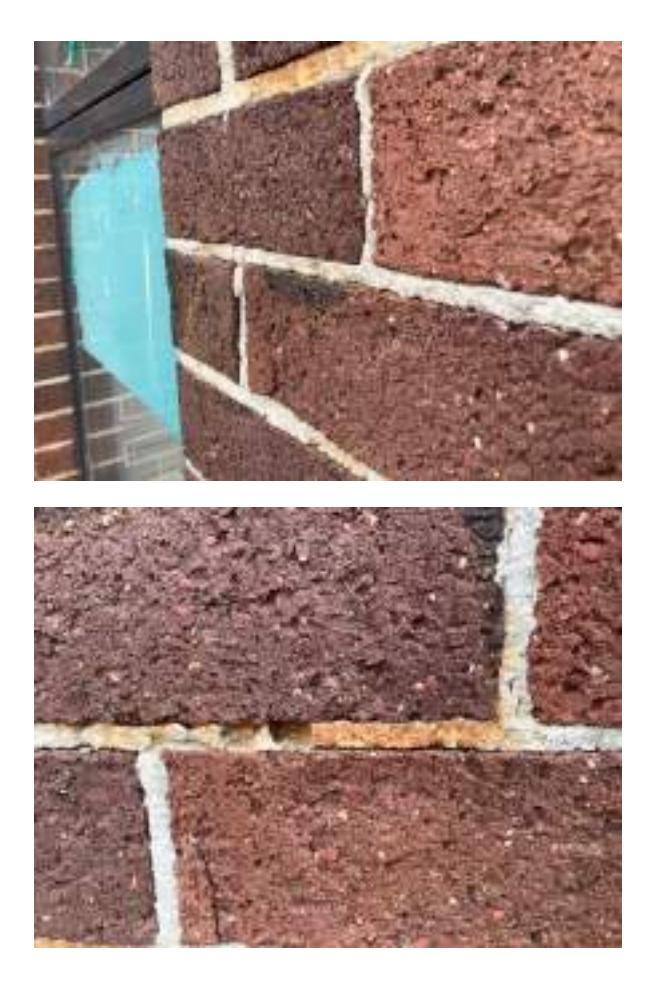
Brick Wall Mortar - Severely Damaged By The Cleaning Of The Brick Work.

I would like to make note that there are two major defects to this brickwork, one is the brick holes and brick voids in various locations to the brick mortar and the other is the damaged brick mortar due to excessive acid and pressure from the brick cleaner as the brick mortar is severely damaged in many areas.

These defects are visible from a normal viewing position.

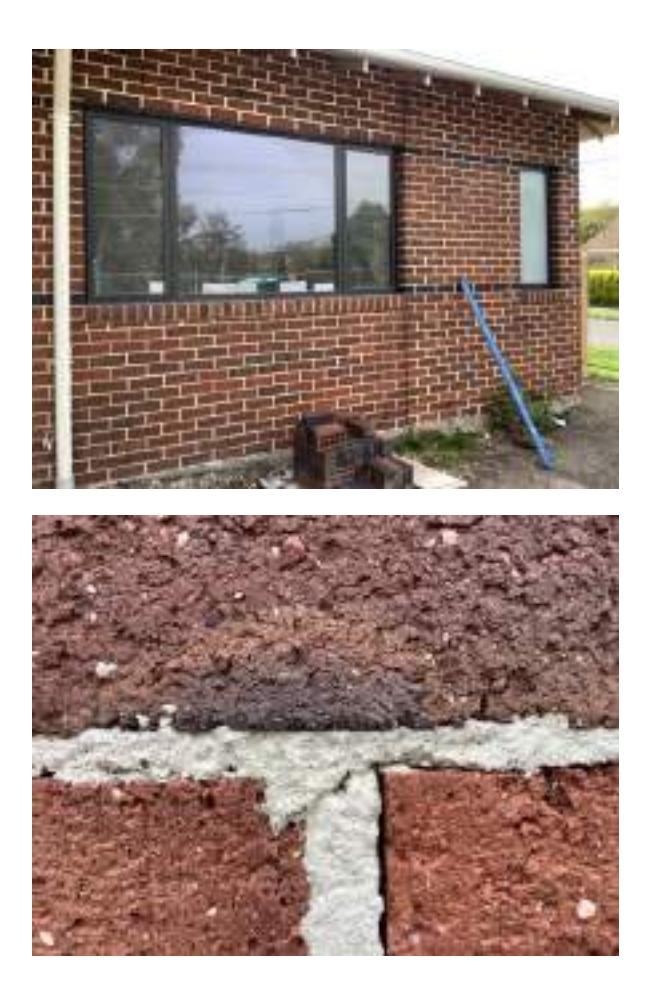
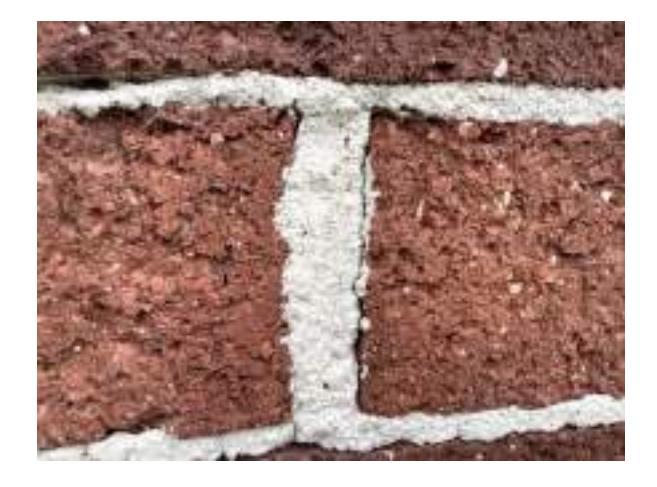
Location: Finding: Brick Work - All Area's

Bricks - Overhanging On Slab.

Standards and Tolerances 2015 - Diagram 4.08 states that the maximum overhang of the brick work is 15 mm.

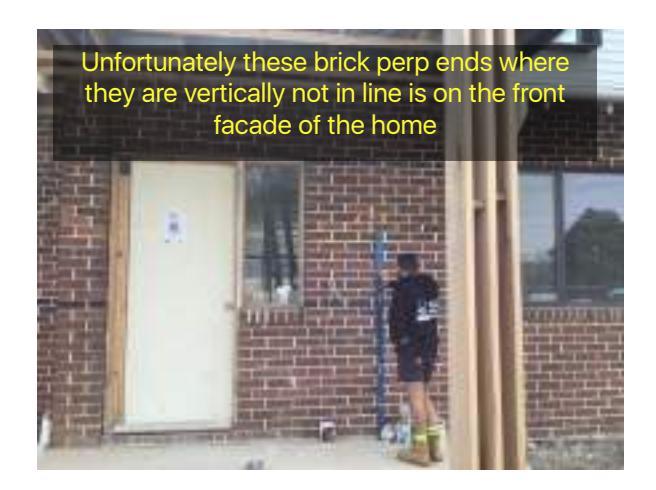
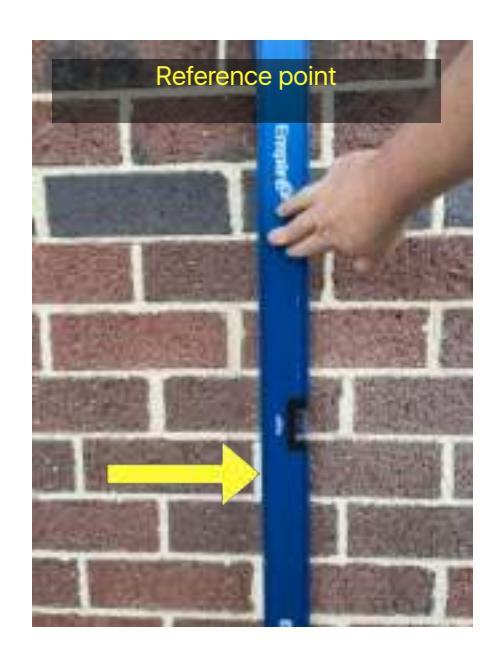
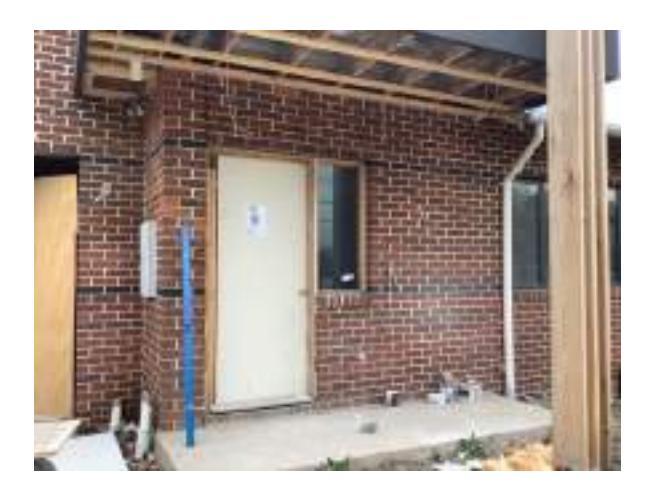
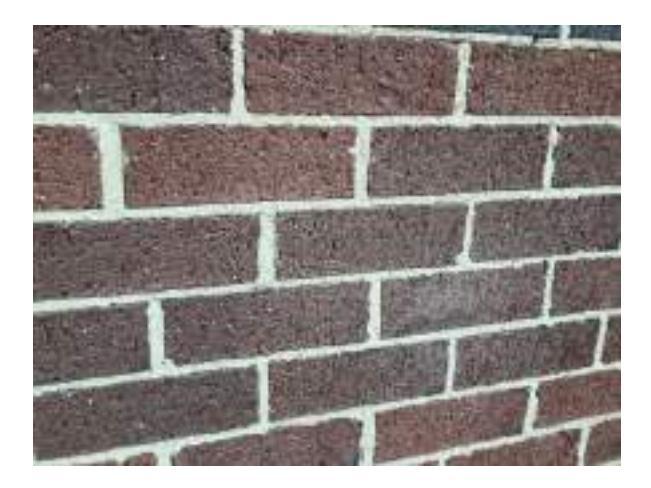
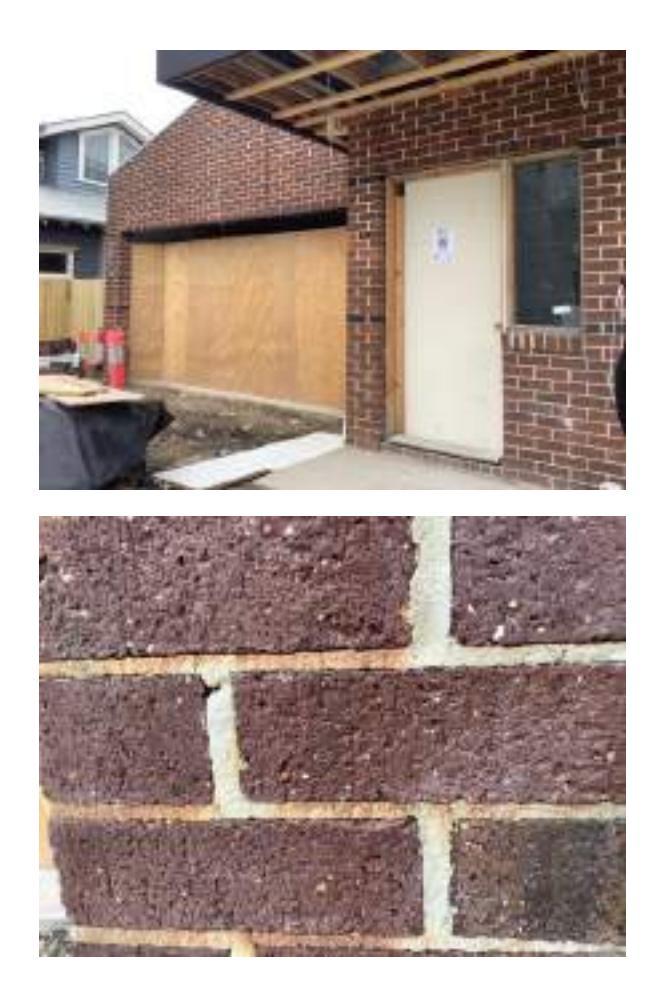
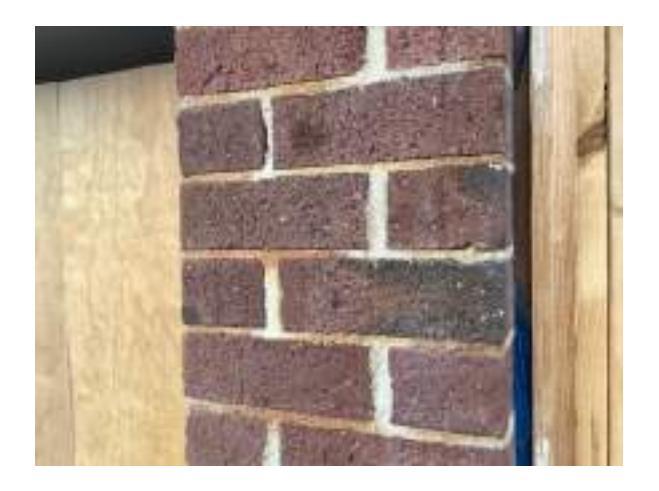
Brick wall - Perpend vertical alignment defective

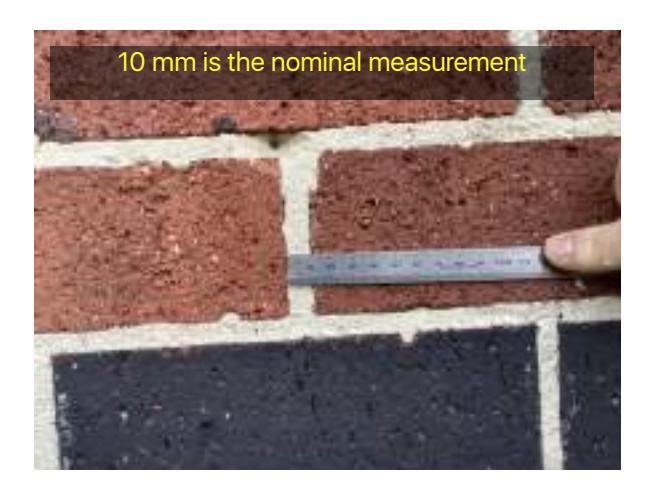
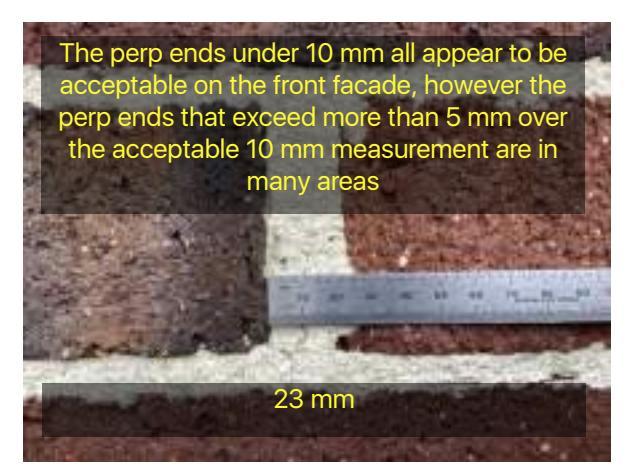
Location:	Brick Work - All Area's
Finding:	Brick Perp Ends - Variation Widths Excessive
	BRICK PERP ENDS - Non-Compliant (Defective)

NCC states that 'Unless otherwise specified masonry bed and perpend joints are to be a nominal 10mm'.

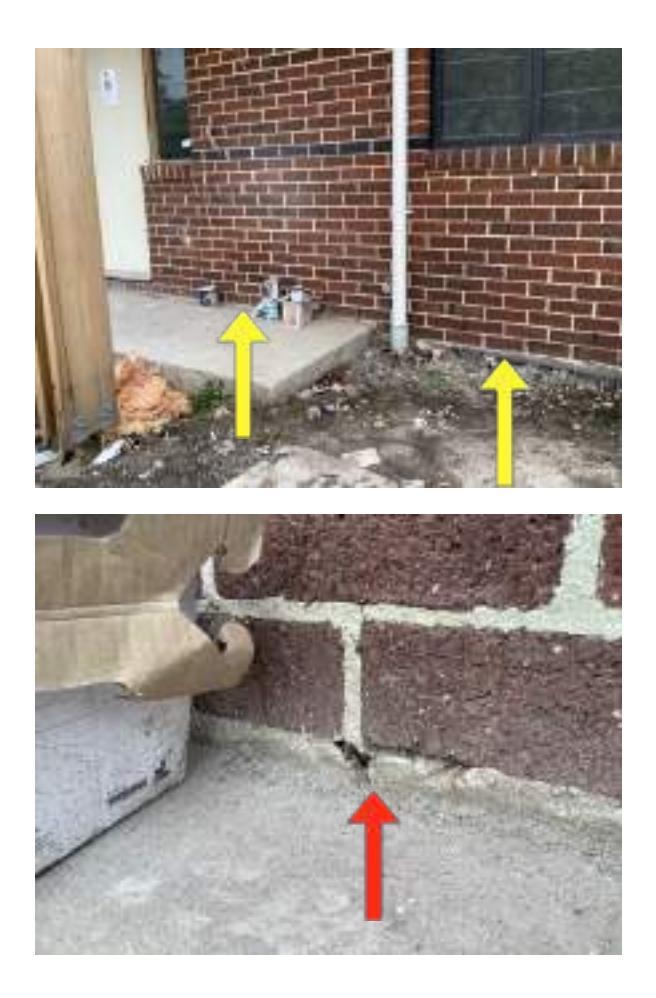
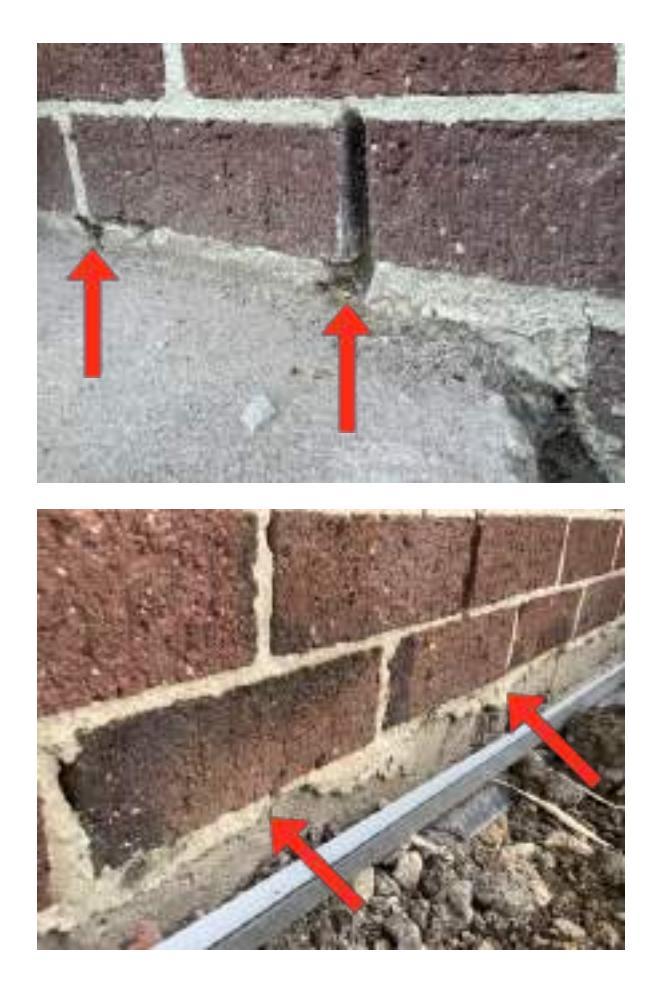
Location:	Brick Work - All Area's
Finding:	Brick Bed Joints - Variation Widths Excessive
	BRICK BED JOINTS - Non-Compliant (Defective)

NCC states that 'Unless otherwise specified masonry bed and perpend joints are to be a nominal 10mm'.
