# Lock Up Report

## Inspection Date: 11 Sep 2021 Property Address: Eastern Suburbs

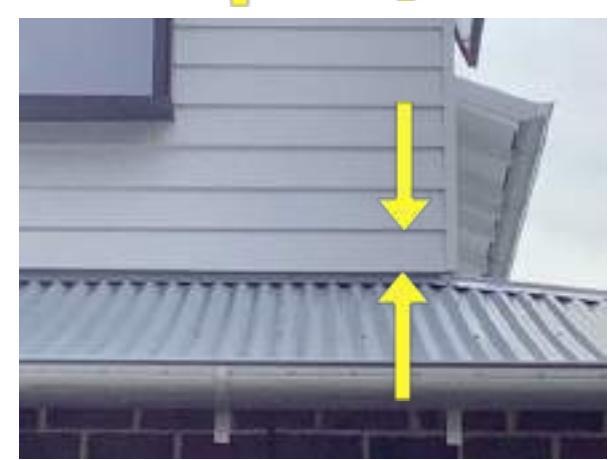
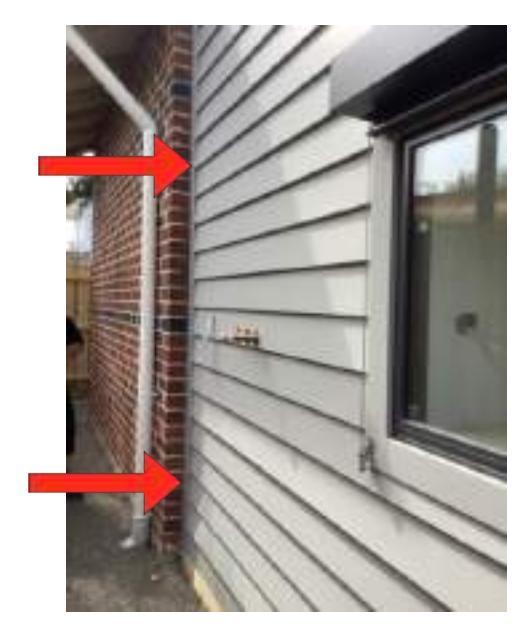
The end timbers must be painted prior to installation as it is now impossible to fully seal underneath the timbers. This is the golden rule with all situations with exterior exposed timbers
