# Methamphetamine Laboratory Assessment (Low Readings)

Inspection Date: 1 Aug 2020

Property Address: Whittlesea Area

Report Type: Methamphetamine Screening Assessment

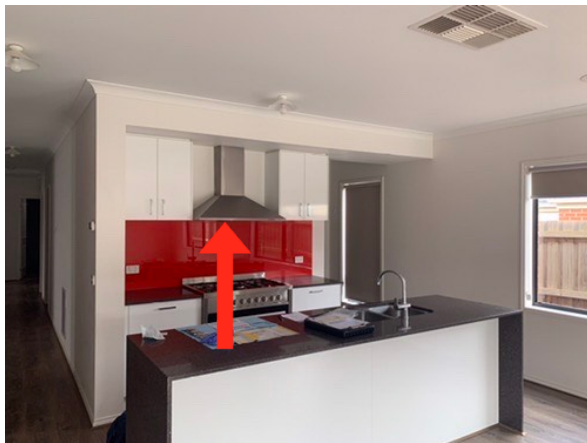
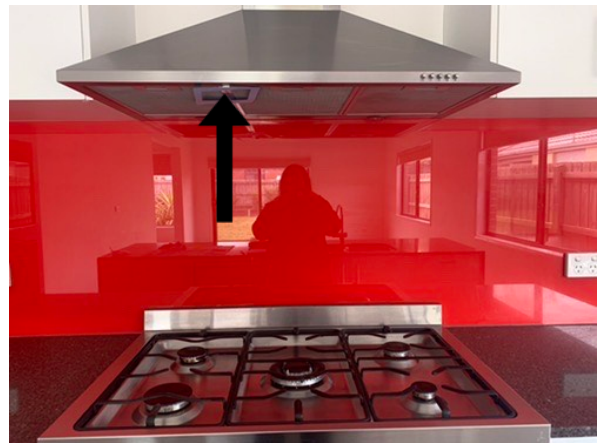
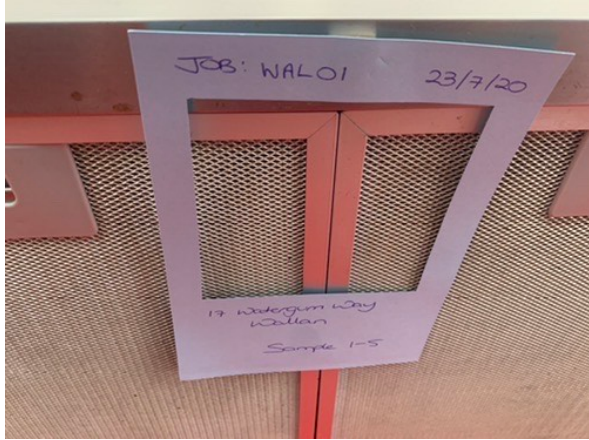
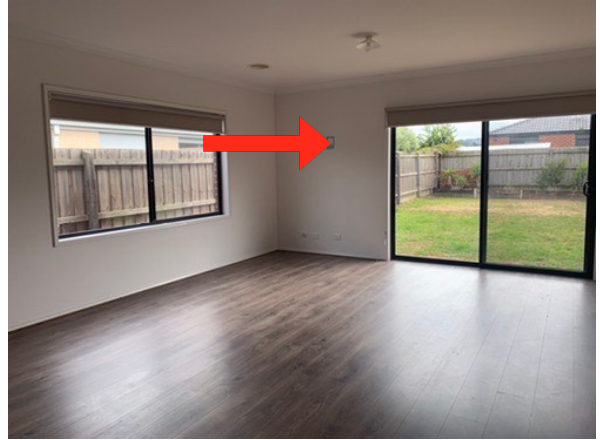
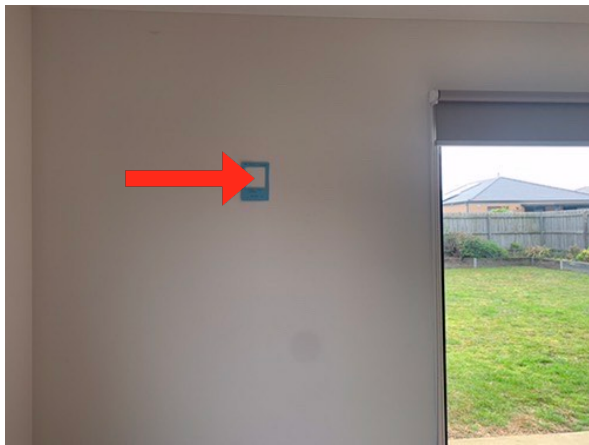
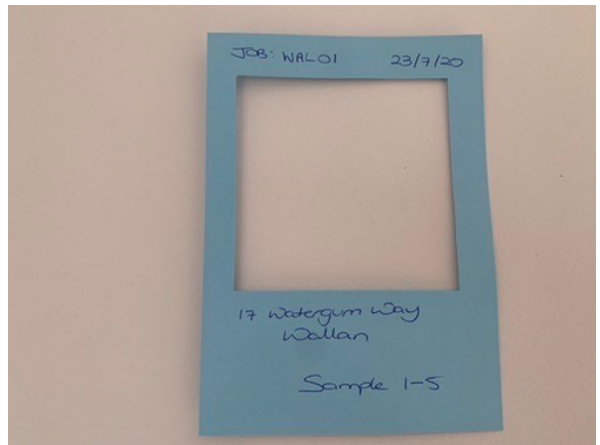
Location: Samples 1-10, Low Positive

Finding: Below Levels - Positive Methamphetamine Sample Result - Below Allowable Levels  
Samples 1 to 10

A positive screening result for the presence of Methamphetamine has been recorded in these locations in the areas tested.

The levels found in this sample are: .37ug/100cm<sup>2</sup> and is therefore below the allowable level that the CLANDESTINE DRUG LABORATORY REMEDIATION GUIDELINES have set as an acceptable level of methamphetamine in a domestic property.

However meth use has occurred at the property and therefore considered contaminated by toxic residues from Meth use or manufacture.

A Detailed Screening Assessment is now required at your discretion ONLY to aid in the development of a detailed Remediation Plan.

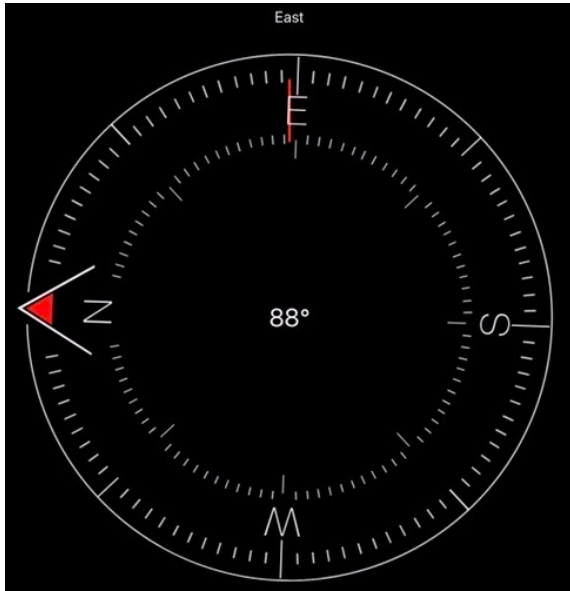
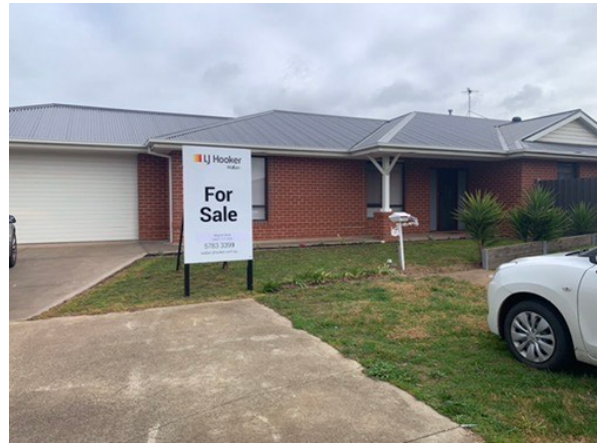
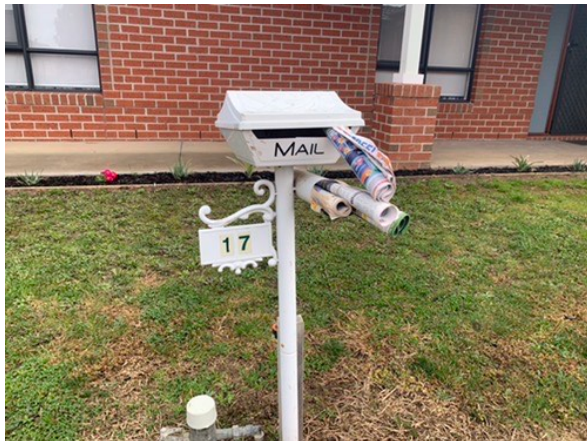
Finding: Additional Photos  
Additional photos are provided for your general reference.

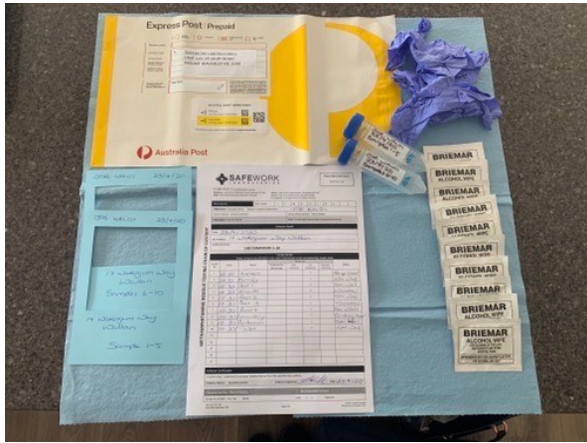
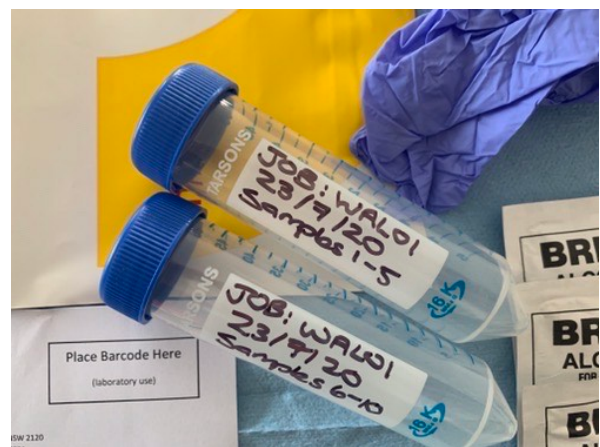
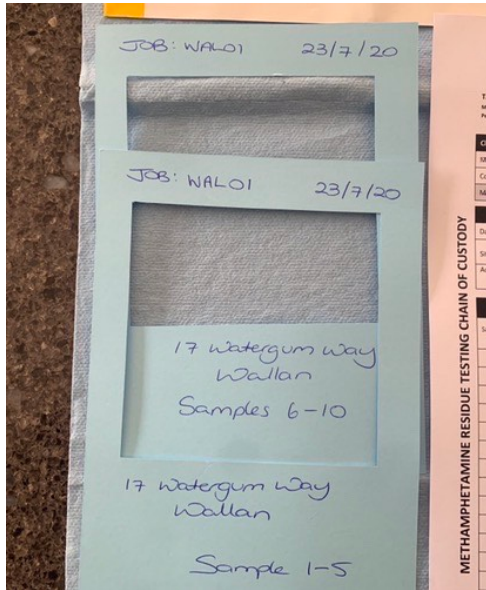
- Location: For Your Information
- Finding: Preparation Photos - Tools and Paperwork / Chain Of Custody.  
Preparation Photos, Tools and Paperwork.
- Also  
Information with Chain Of Custody.
