Methamphetamine Instant Screening Assessment

Inspection Date: 26 Nov 2020

Report Type: Methamphetamine Screening Assessment

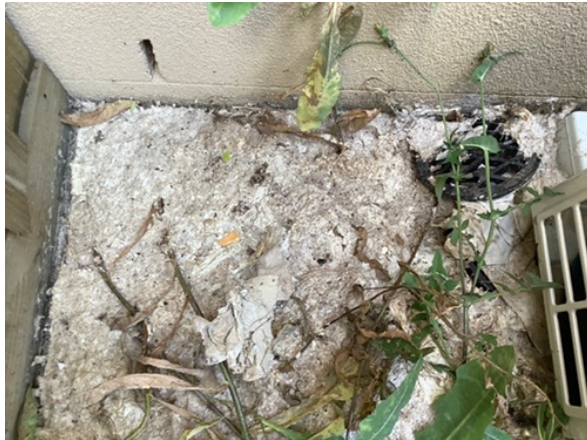
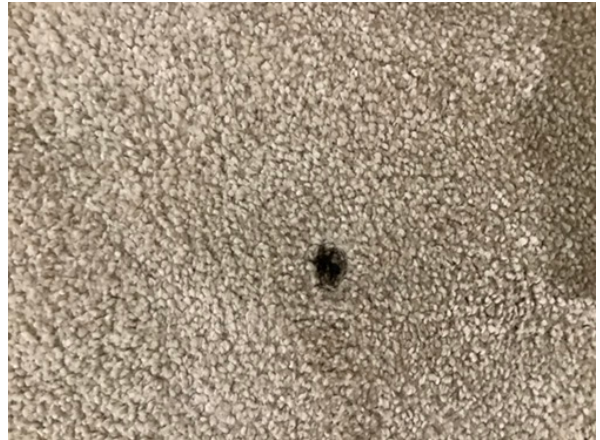
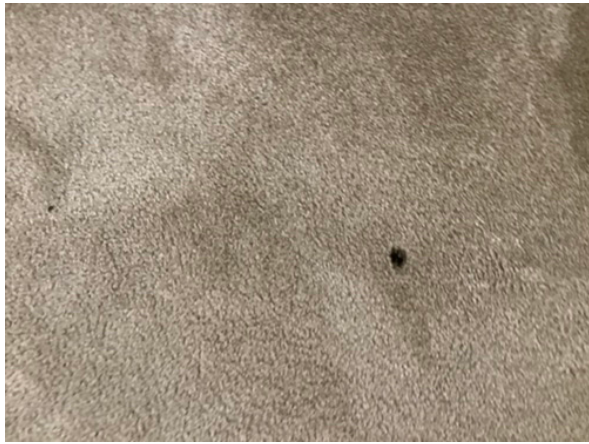
Suspected Methamphetamine Use or Manufacture 1.01

Location: The Site

Finding: Suspected Methamphetamine Manufacture - Dumping

Evidence of suspected methamphetamine manufacture was found during the inspection. The evidence identified included burning and dumping of waste materials that could be used in the manufacture of Meth. Whilst the physical removal of debris is relatively uncomplicated, the products may have specific exposure risks to those removing them and some products are flammable, noxious and dangerous.

More significant is the issue that there may be residual environmental contamination throughout the property, if Methamphetamine has been used or manufactured in the property. Residual environmental contamination caused by Methamphetamine use can have serious health implications and effects on occupants. For these two reasons we have listed this as a Safety Hazard. Remediation of methamphetamine affected properties can also be a significant investment.

We recommend a Methamphetamine Screening Assessment which includes Sampling to make an initial determination as to the presence of methamphetamine or to rule out its presence.

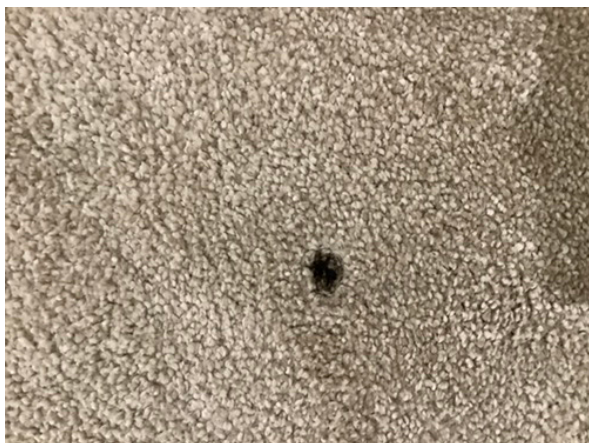
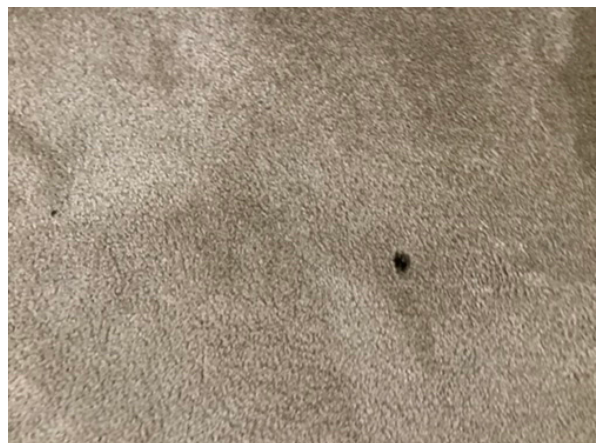
Suspected Methamphetamine Use or Manufacture 1.02

Location: The Site

Finding: Suspected Methamphetamine Use - Smoke Damage and Burns

Evidence of suspected methamphetamine use was found during the inspection. The evidence identified was staining and marking of surfaces that could be consistent with use of methamphetamine. The smoke damage and burns will discolour and create surface damage. However the more significant issue is that there may be residual environmental contamination throughout the property if Methamphetamine has been used in the property. Residual environmental contamination caused by Methamphetamine use can have serious health implications and effects on occupants.

Consequently we have listed this as a Safety Hazard. Remediation of methamphetamine affected properties can also be a significant investment.

We recommend a Methamphetamine Screening Assessment which includes Sampling to make an initial determination as to the presence of methamphetamine or to rule out its presence.

It is strongly recommended that this be completed prior to acquisition and certainly prior to occupation. A Screening Assessment will require the written permission of the property owner prior to its conduct as it may need to be invasive in nature and will most likely involve removing air conditioning and exhaust vents to gain access to areas for effective sampling.

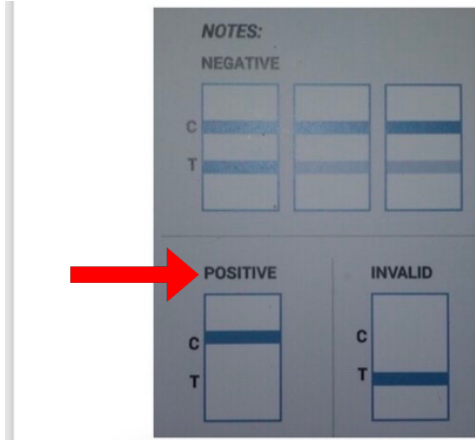
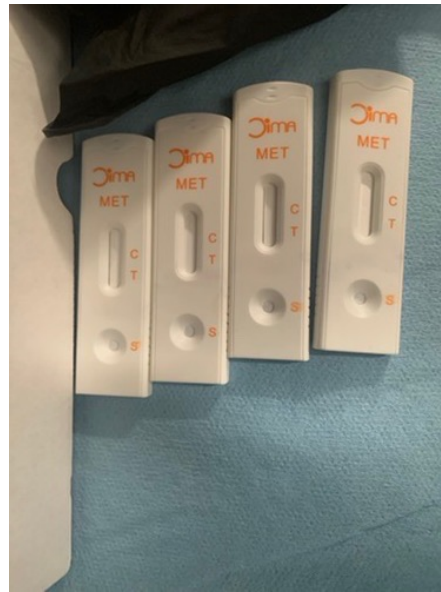
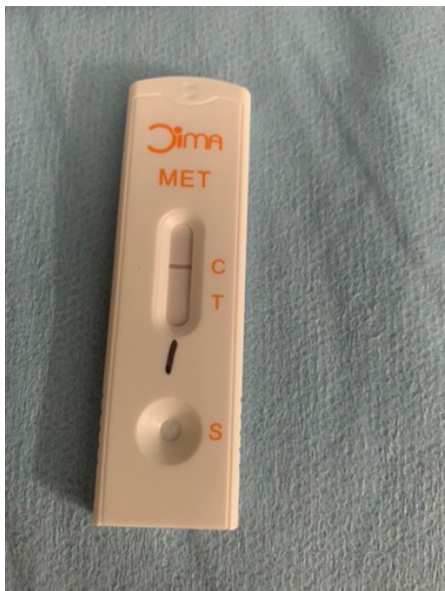
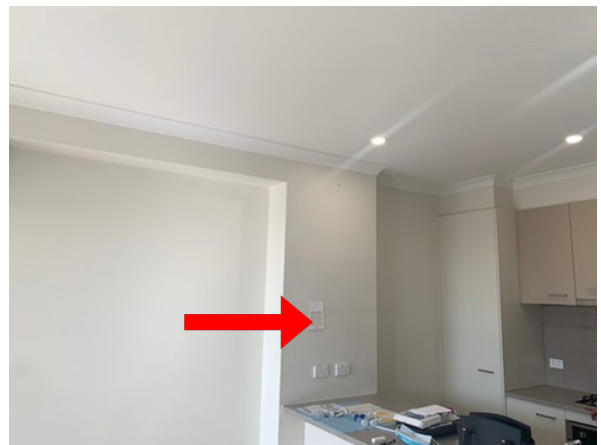
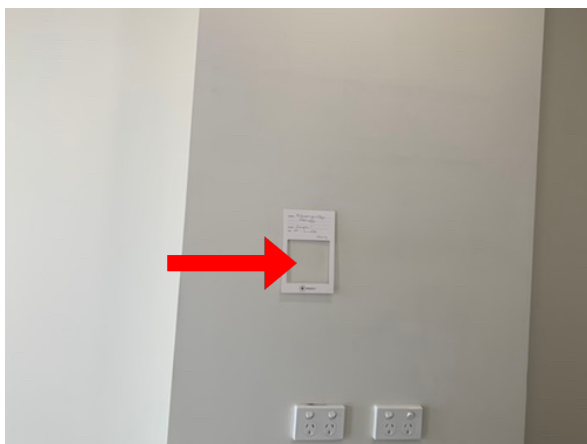
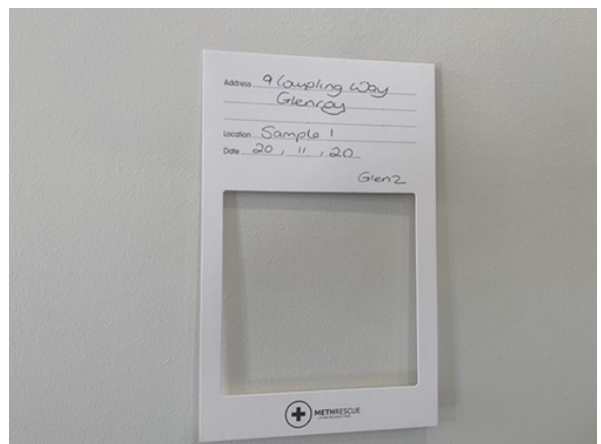
Methamphetamine Detected 2.04

Location: Kitchen
Finding: 1 - Positive Methamphetamine Sample Result - Methamphetamine Was Detected Above 0.5ug/100cm² In This Residential Property.
SAMPLE 1

A POSITIVE result for the presence of Methamphetamine has been recorded in this location.

The testing kit in this specific location ONLY, produced a POSITIVE result which clearly indicates that methamphetamine has been detected in the area tested, however it is IMPORTANT to understand that the POSITIVE result indicates that there is methamphetamine level above 0.5ug/100cm² and further testing is now required.

As Methamphetamine residue has been detected above 0.5ug/100cm², the Methamphetamine levels are highly likely to be above the safe level according to the Australian Clandestine Drug Laboratory Remediation Guidelines*

Consequently the property is considered contaminated by toxic residues from Meth Use, Cross Contamination OR Manufacture and/or a combination.

A Laboratory Composite Forensic Assessment is now required to aid in the development of a detailed Remediation Plan.

A Detailed Screening Assessment is now required to aid in the development of a detailed Remediation Plan.

Once Remediation has been completed a further Detailed Screening Assessment is required to act as a Clearance Certificate for occupation.

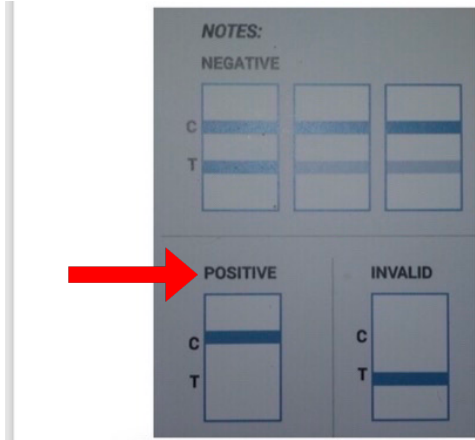
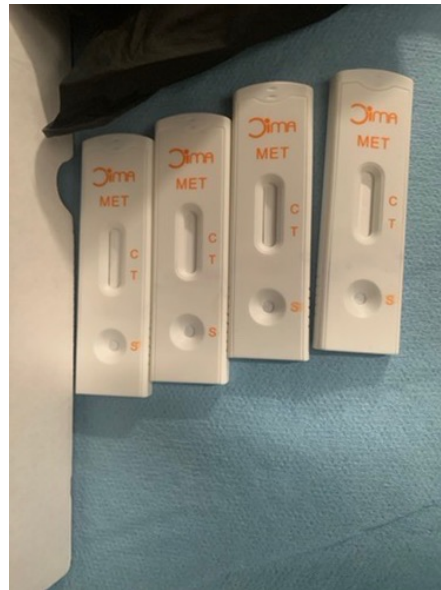
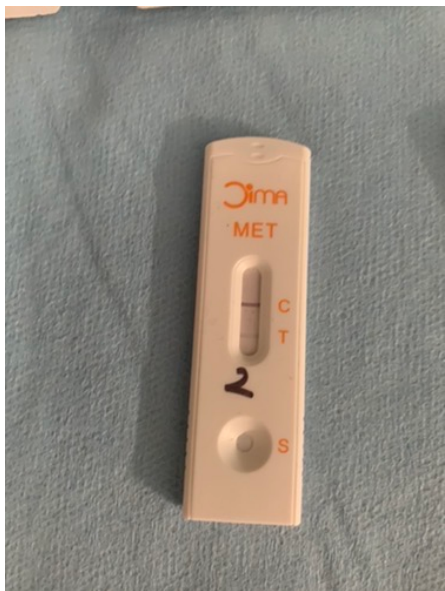
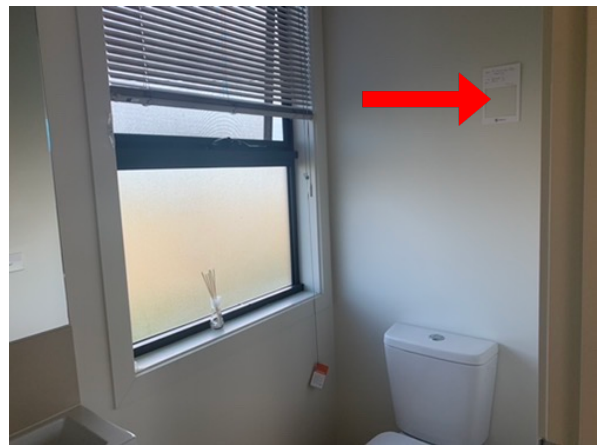
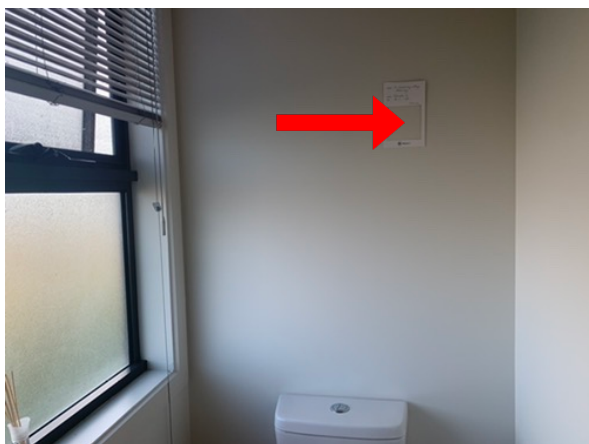
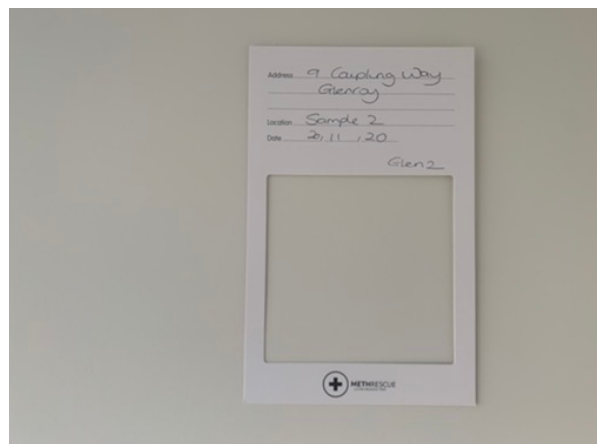
Methamphetamine Detected 2.05

Location: Powder Room

Finding: 2 - Positive Methamphetamine Sample Result - Methamphetamine Was Detected Above 0.5ug/100cm² In This Residential Property.

A POSITIVE result for the presence of Methamphetamine has been recorded in this location.

The testing kit in this specific location ONLY, produced a POSITIVE result which clearly indicates that methamphetamine has been detected in the area tested, however it is IMPORTANT to understand that the POSITIVE result indicates that there is methamphetamine level above 0.5ug/100cm² and further testing is now required.

As Methamphetamine residue has been detected above 0.5ug/100cm², the Methamphetamine levels are highly likely to be above the safe level according to the Australian Clandestine Drug Laboratory Remediation Guidelines*

Consequently the property is considered contaminated by toxic residues from Meth Use, Cross Contamination OR Manufacture and/or a combination.

A Laboratory Composite Forensic Assessment is now required to aid in the development of a detailed Remediation Plan.

A Detailed Screening Assessment is now required to aid in the development of a detailed Remediation Plan.

Once Remediation has been completed a further Detailed Screening Assessment is required to act as a Clearance Certificate for occupation.

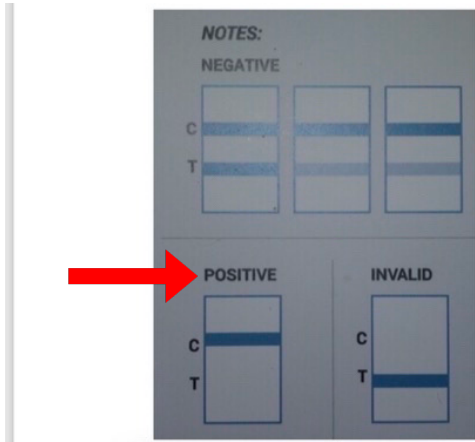
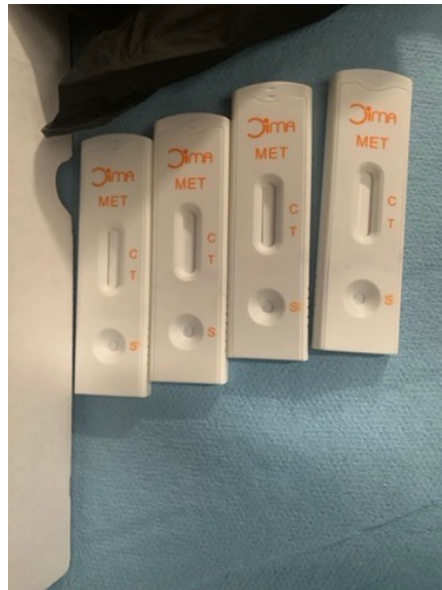
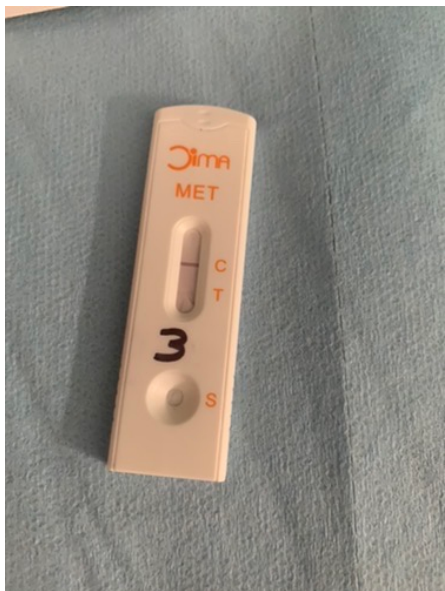
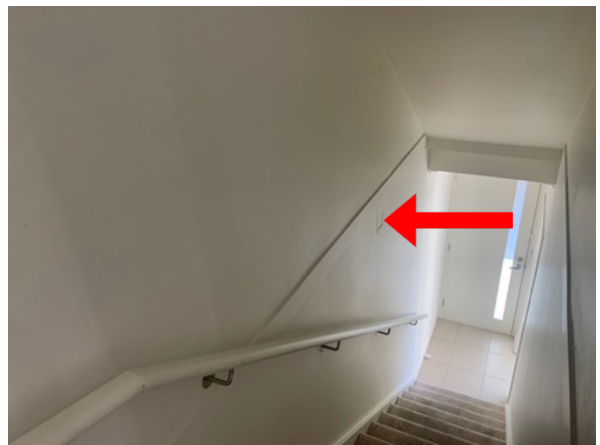
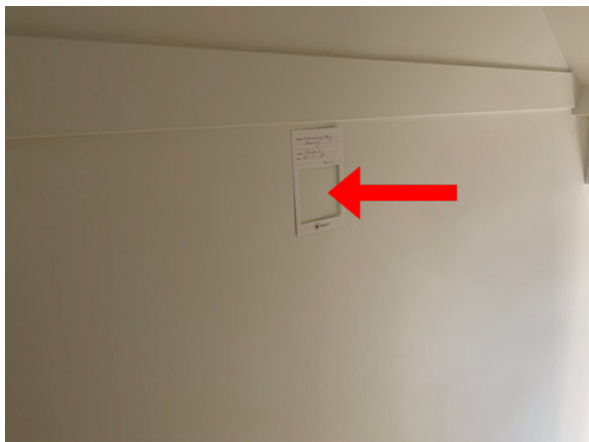
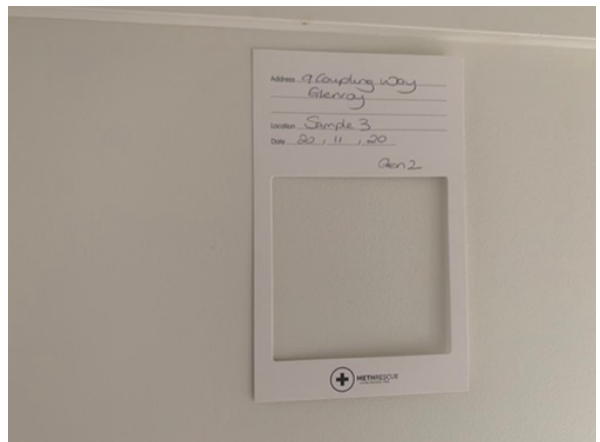
Methamphetamine Detected 2.06

Location: Stairwell
Finding: 3 - Positive Methamphetamine Sample Result - Methamphetamine Was Detected Above 0.5ug/100cm² In This Residential Property.
SAMPLE 3

A POSITIVE result for the presence of Methamphetamine has been recorded in this location.

The testing kit in this specific location ONLY, produced a POSITIVE result which clearly indicates that methamphetamine has been detected in the area tested, however it is IMPORTANT to understand that the POSITIVE result indicates that there is methamphetamine level above 0.5ug/100cm² and further testing is now required.

As Methamphetamine residue has been detected above 0.5ug/100cm², the Methamphetamine levels are highly likely to be above the safe level according to the Australian Clandestine Drug Laboratory Remediation Guidelines*

Consequently the property is considered contaminated by toxic residues from Meth Use, Cross Contamination OR Manufacture and/or a combination.

A Laboratory Composite Forensic Assessment is now required to aid in the development of a detailed Remediation Plan.

A Detailed Screening Assessment is now required to aid in the development of a detailed Remediation Plan.

Once Remediation has been completed a further Detailed Screening Assessment is required to act as a Clearance Certificate for occupation.

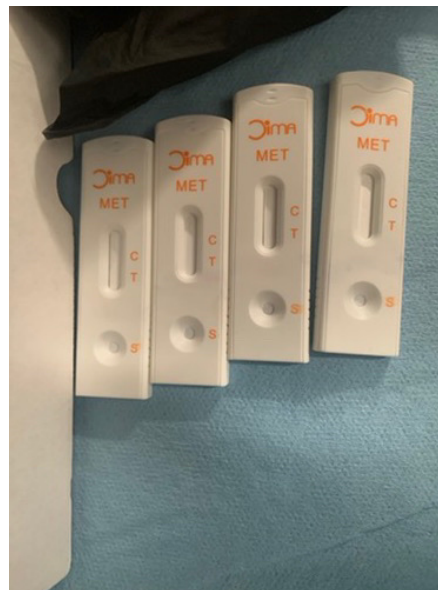
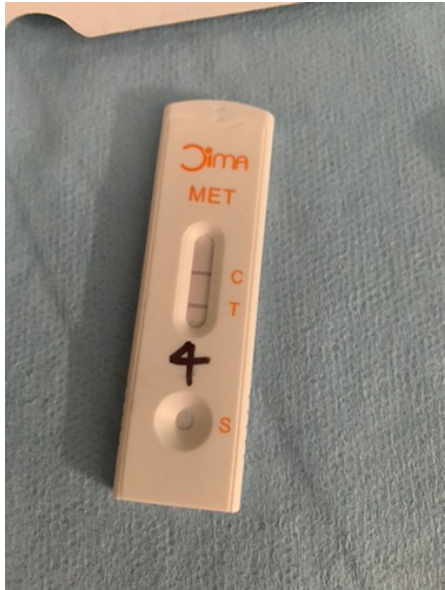
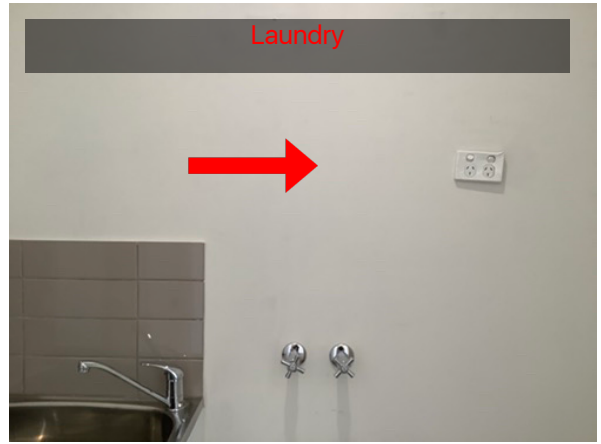
Methamphetamine Undetected 3.01

Location: Laundry

Finding: 4 - Negative Methamphetamine Sample Result - Methamphetamine Was not Detected Above 0.5ug/100cm² In This Residential Property.

A NEGATIVE result for the presence of Methamphetamine has been recorded in this location.

The testing kit in this specific location ONLY, produced a negative result which clearly indicates that methamphetamine has not been detected in the area tested, however it is IMPORTANT to understand that the negative result indicates that there is no methamphetamine level above 0.5ug/100cm but it is possible that there is methamphetamine on or below 0.5ug/100cm .

Again it is IMPORTANT to understand that whilst no levels of methamphetamine was detected , the result does have limitations, meaning that this testing kit ONLY detects levels of methamphetamine above 0.5ug/100cm and not on or below 0.5ug/100cm.

A Detailed (Forensic) Screening Assessment is optional to aid a further detailed result at the clients discretion and not required by law.

Once again a Detailed Screening Assessment is optional or you may decide that No Further Action is required.

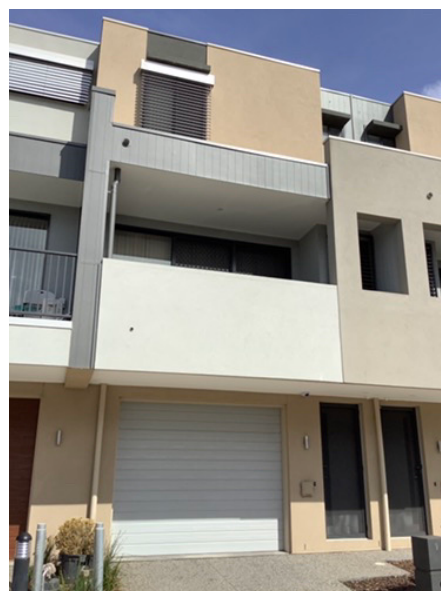
Finding: Additional Photos

Additional photos are provided for your general reference.

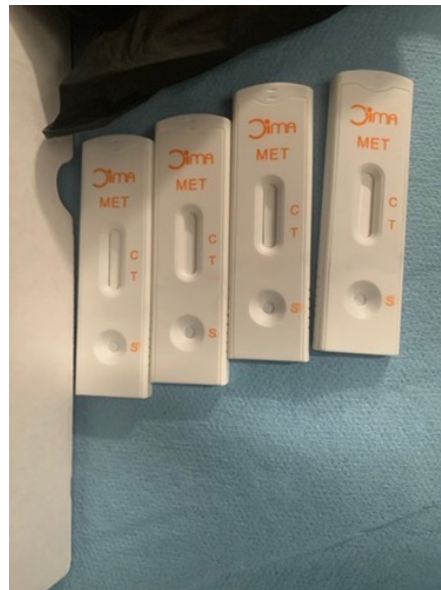
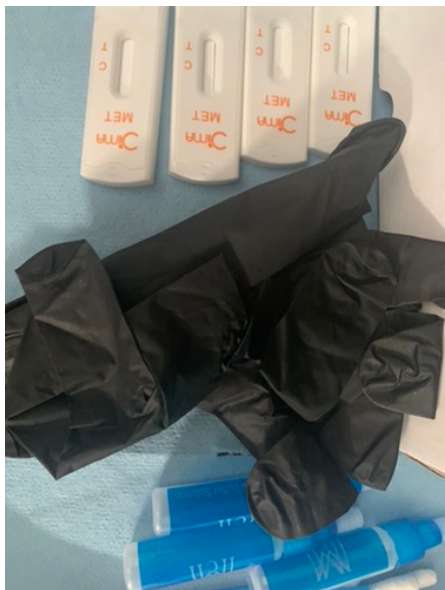
For Your Information 4.02

Location: For Your Information
 Finding: Preparation Photos - Tools and Paperwork .
 Preparation Photos, Tools and Paperwork.
