Methamphetamine Screening Assessment

Inspection Date: 8 Apr 2020

Property Address: Brunswickwick Area Report

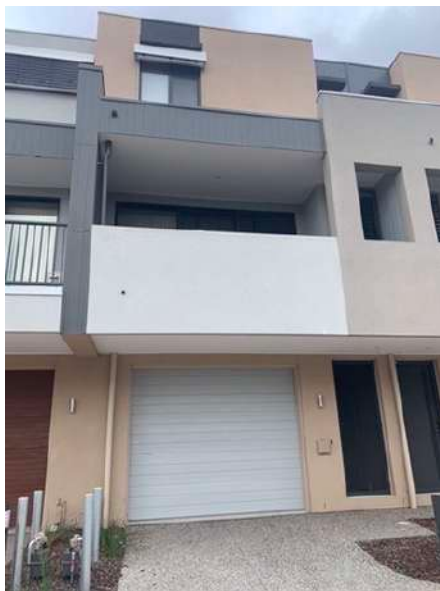
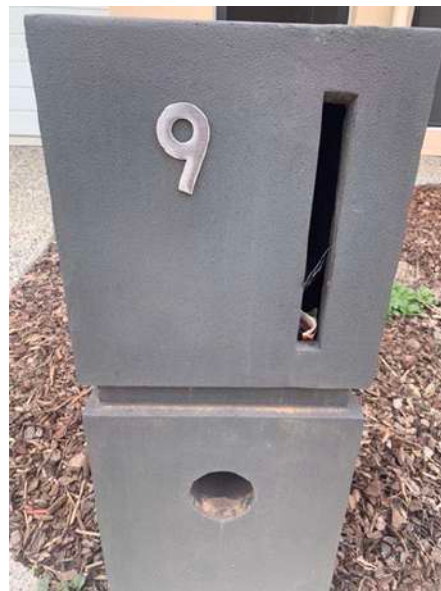
Methamphetamine Undetected 3.02

Finding: Next Action Required - Recommendation Of No further Action Required.
 Due to the results of Non Detected - There is NO FURTHER ACTIONS REQUIRED.

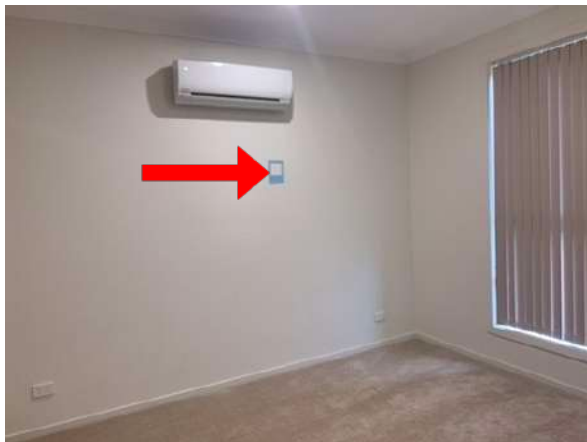
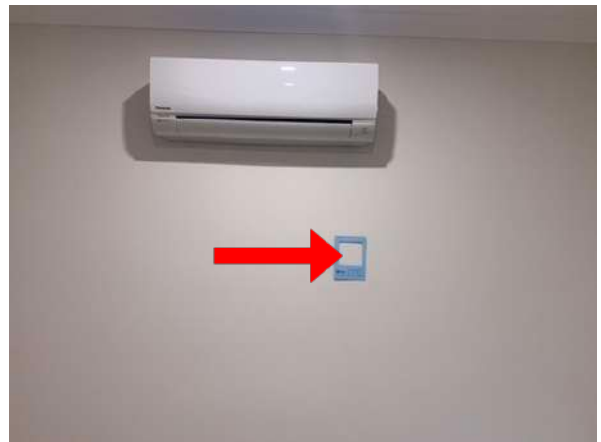
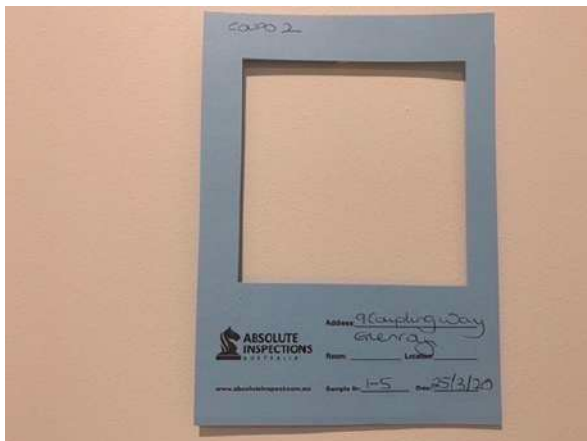
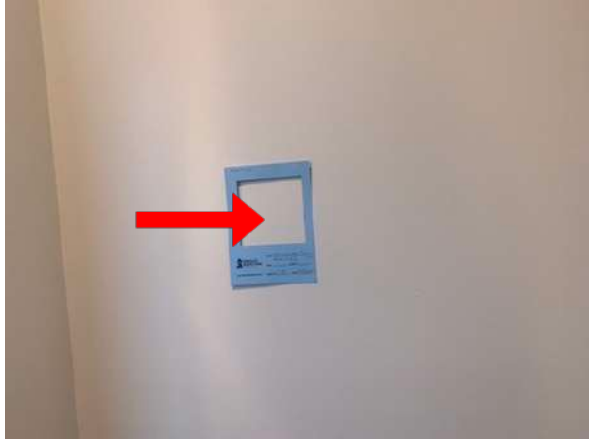
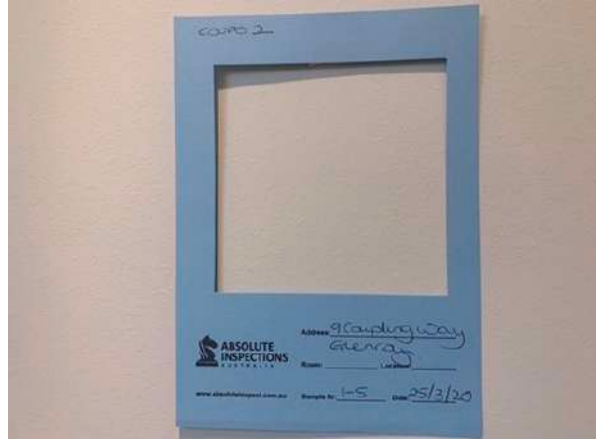
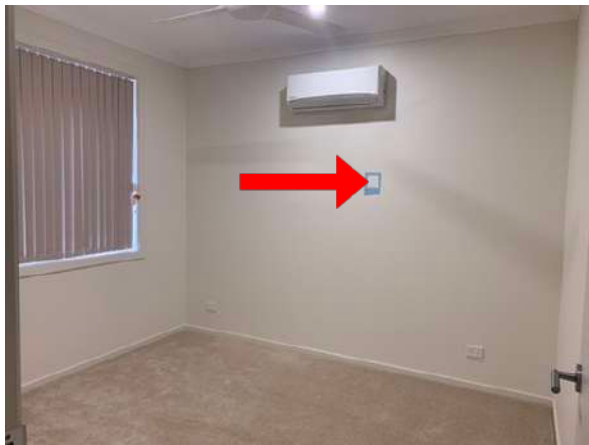
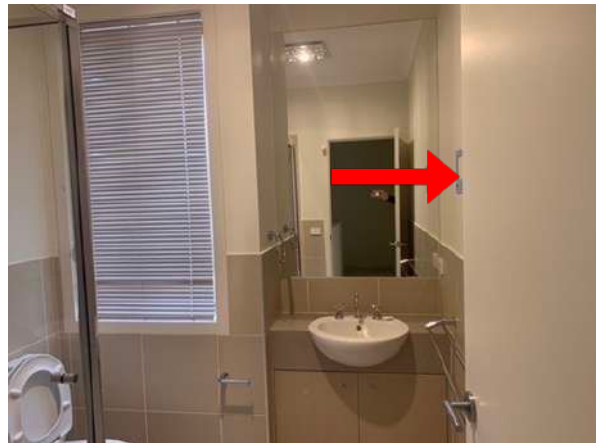
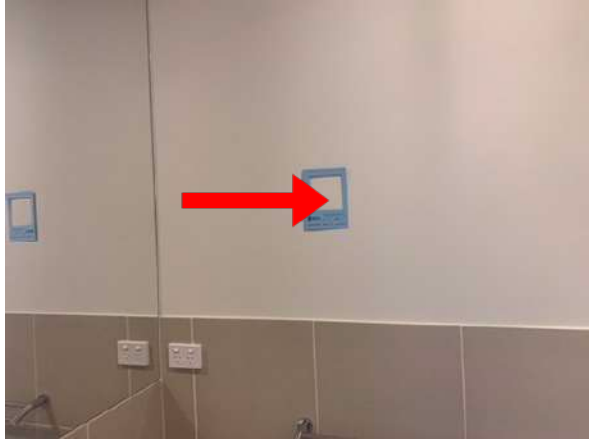
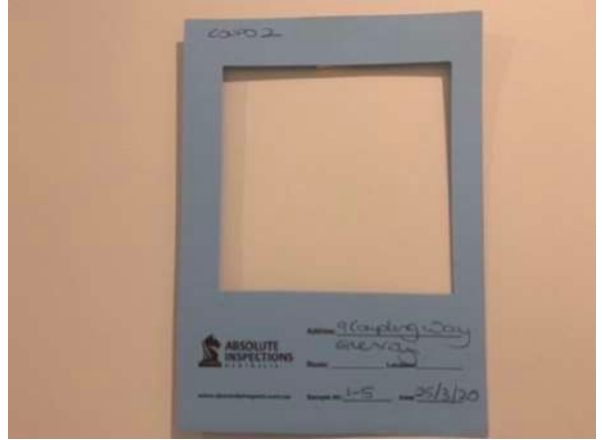
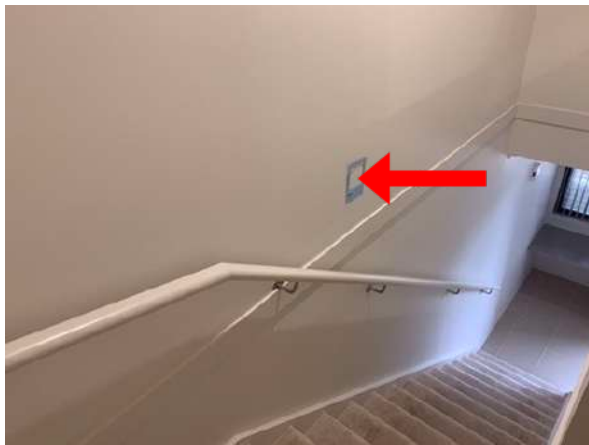
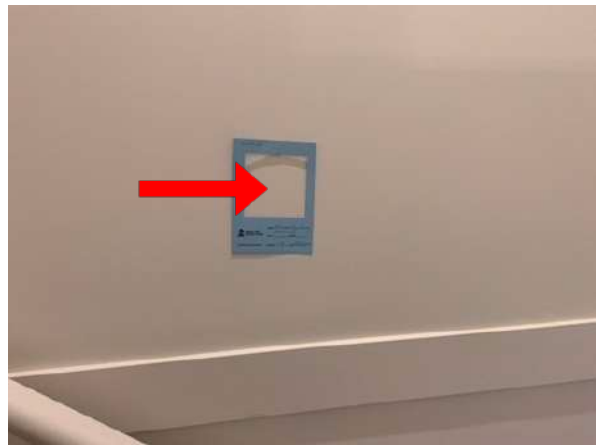
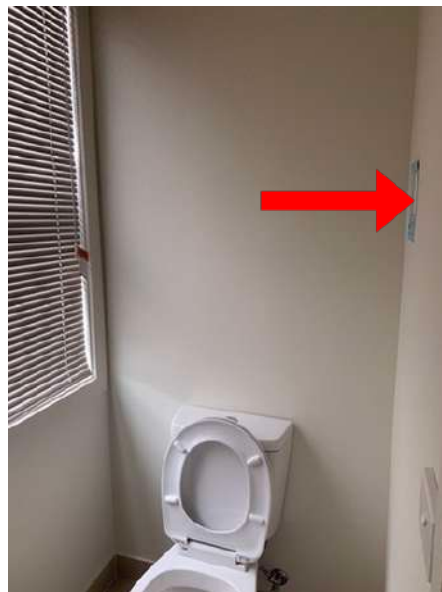
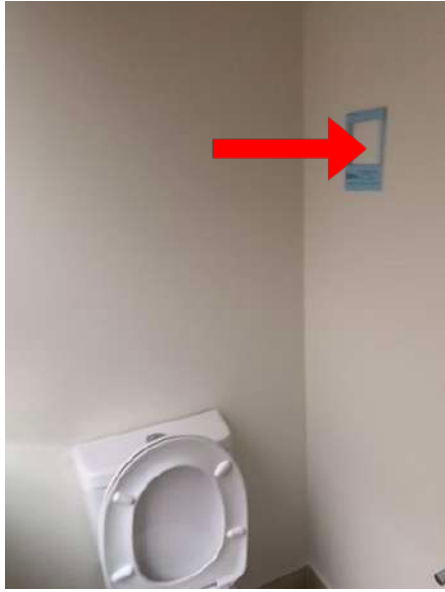
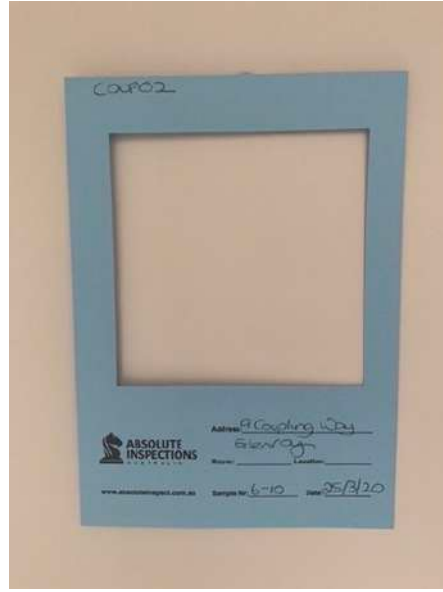
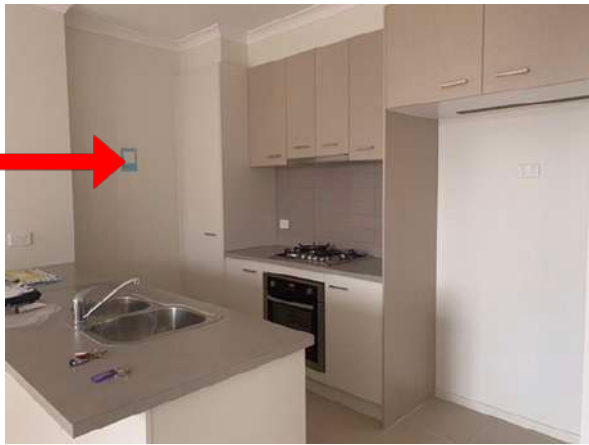
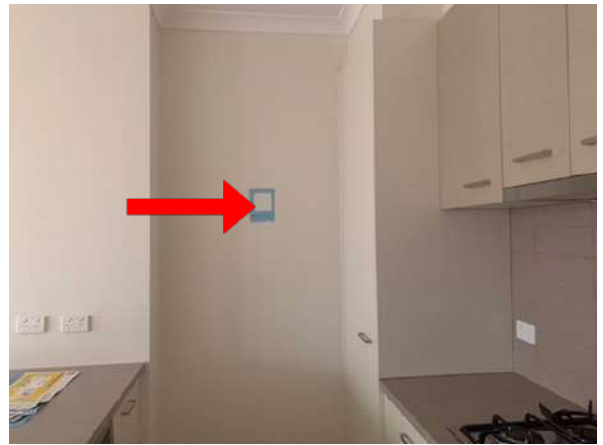
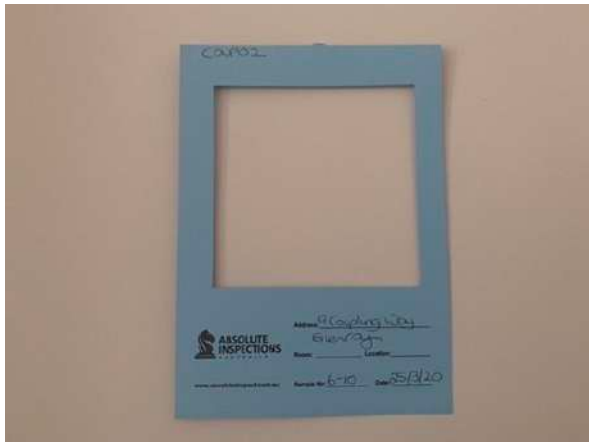
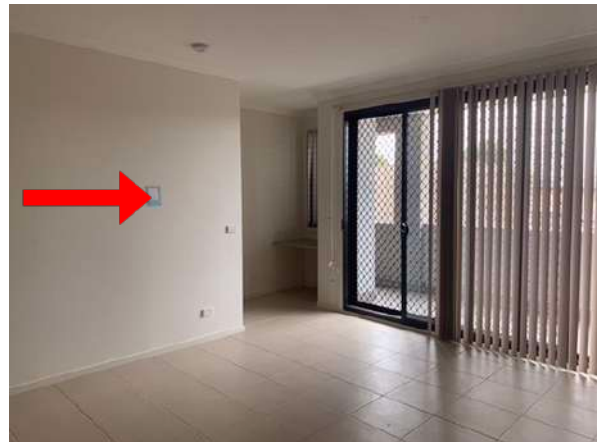
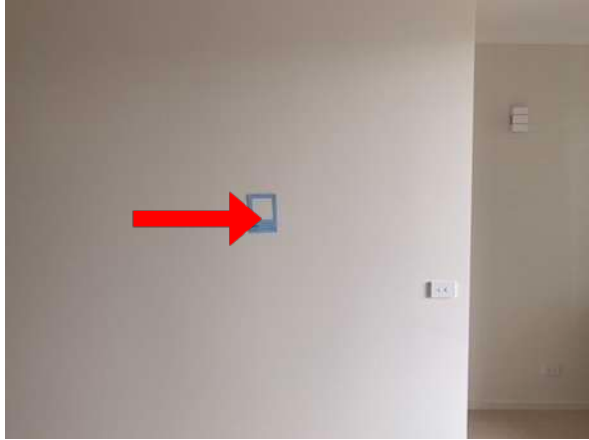
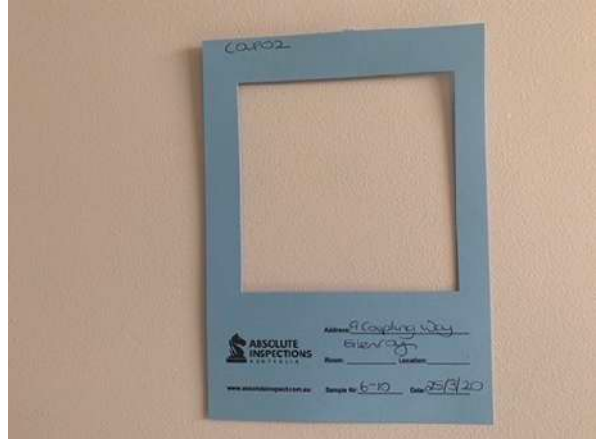
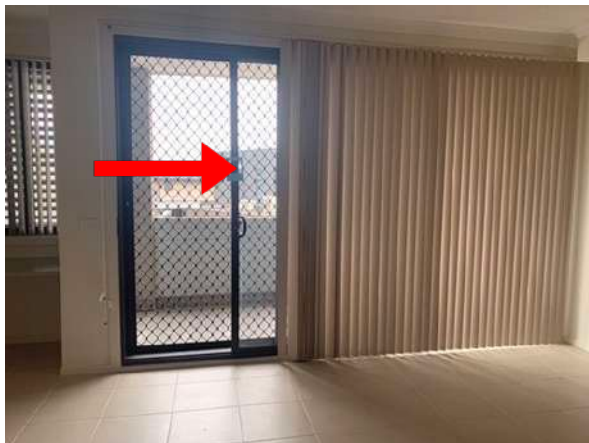
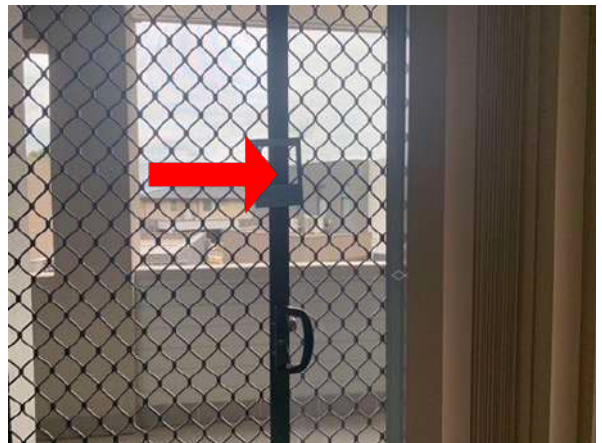
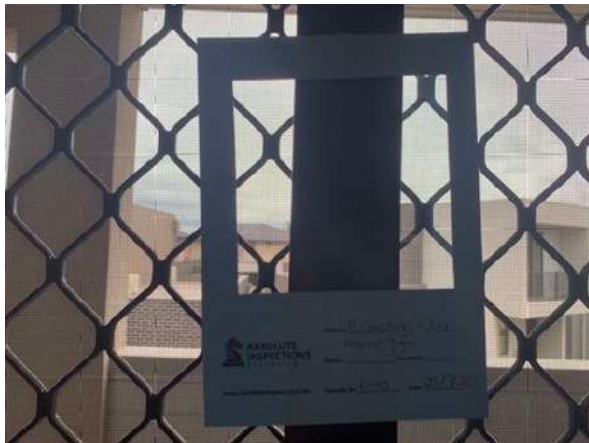
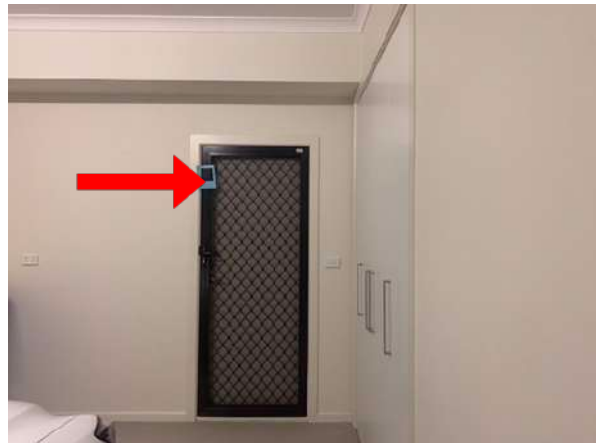
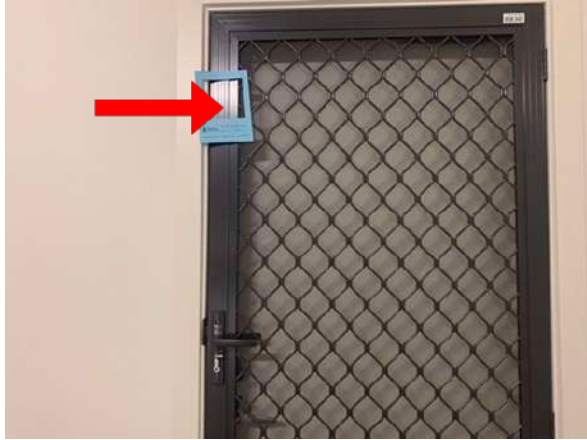
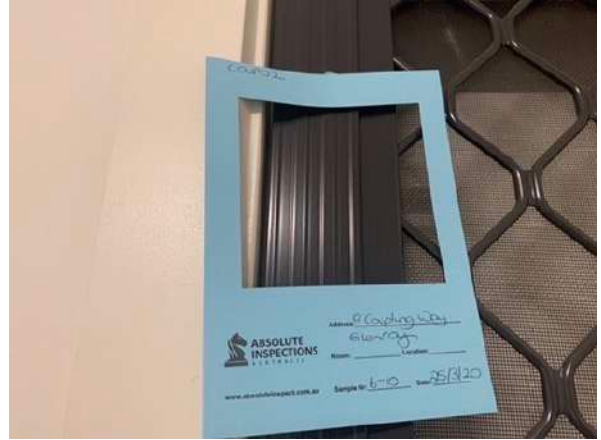
Methamphetamine Undetected 3.03

Location: Samples 1-10, Undetected
 Finding: Undetected Methamphetamine Sample Result - No Methamphetamine detected Samples 1 to 10

An undetected screening result for the presence of Methamphetamine has been recorded in these locations.

As such there is currently no detectable evidence of the presence of Methamphetamine in the areas tested.

Methamphetamine Screening Assessment; sample results indicated no detectable levels of Methamphetamine from any of the Sample locations.

A total of 10 samples with 1 sample per wipe using the NIOSH9111 method were taken from the locations listed in the report.

The presence of Methamphetamine may be obscured or limited by factors like recent renovations and painting, replacement of porous or absorbent building materials like carpet and remedial cleaning.

Please refer to the overall risk rating for undetected Methamphetamine Contamination and the Report Conclusion for further information, if any, but no more information is available on this report then - No further action is required.

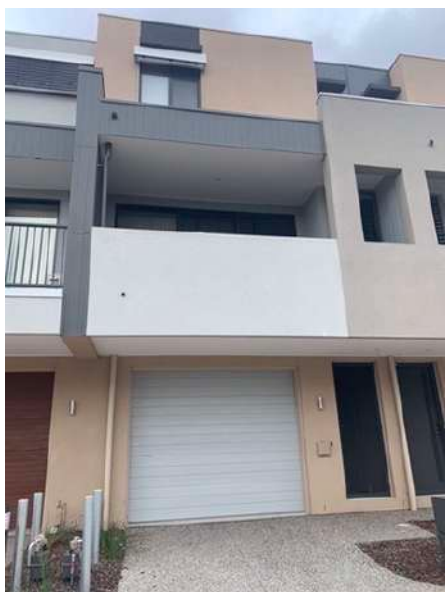
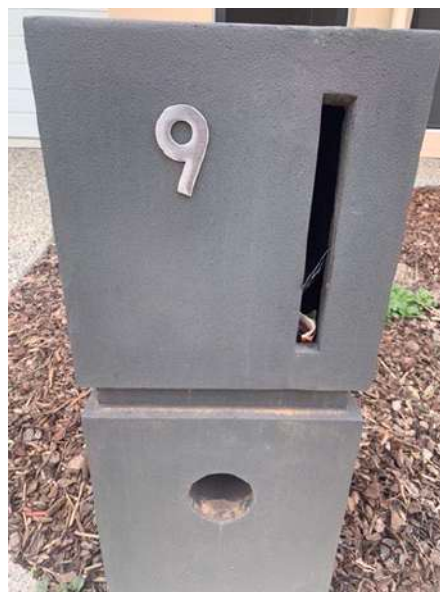
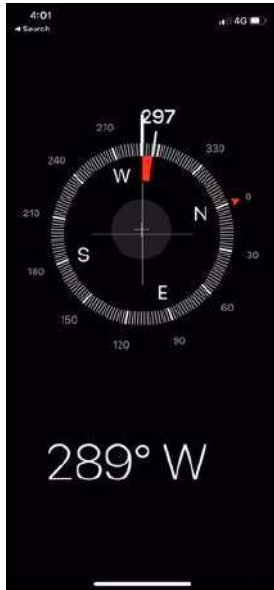
For Your Information 4.06

Finding: Additional Photos
Additional photos are provided for your general reference.
