# Apartment - Building & Electrical (Termite Not Required) Report

Inspection Date: 16 Jun 2020

Property Address: Southbank Area

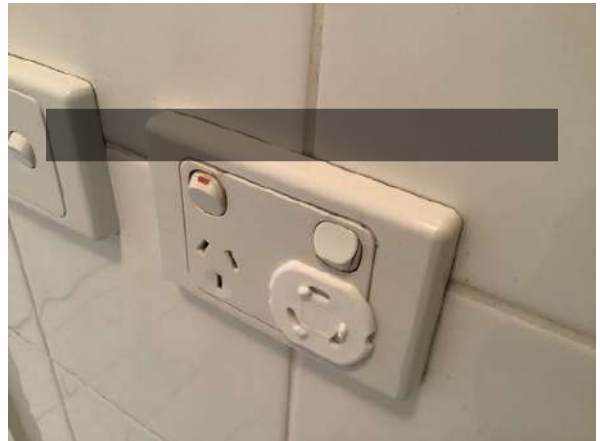
### Safety Hazard 1.01

Finding: Electrical - Power Points - Damaged/Faulty

The power points in areas were found to be damaged or faulty at the time of inspection. This occurs generally when the building materials have either aged and decayed or as a result of impact damage (accidental or deliberate).

Repair and/or replacement of the power points is advised to ensure the fixture and it's associated structures are safe and fully operational. A licensed electrician should be appointed to repair/replace the power points as soon as possible.

Please engage a licensed electrician to further inspect the property for the repairs and replacements as required.

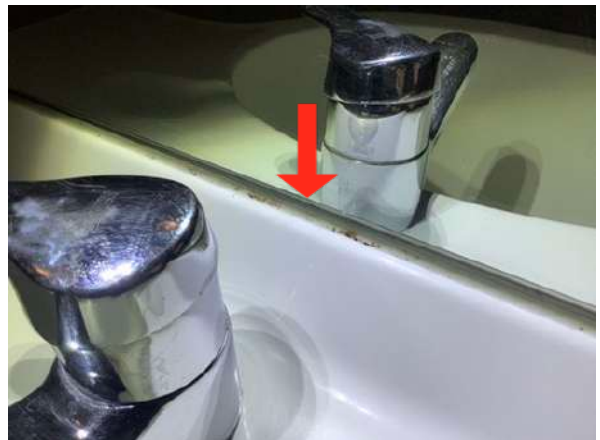
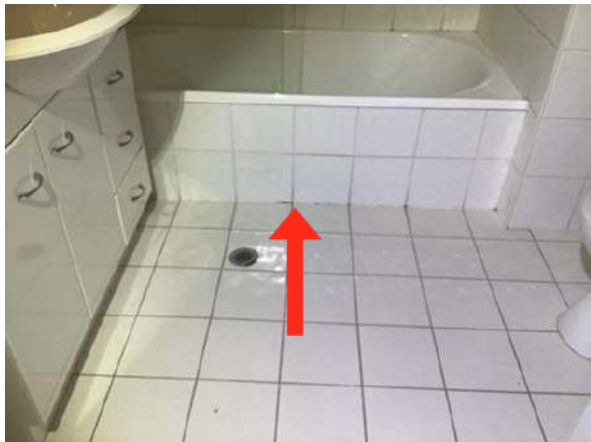
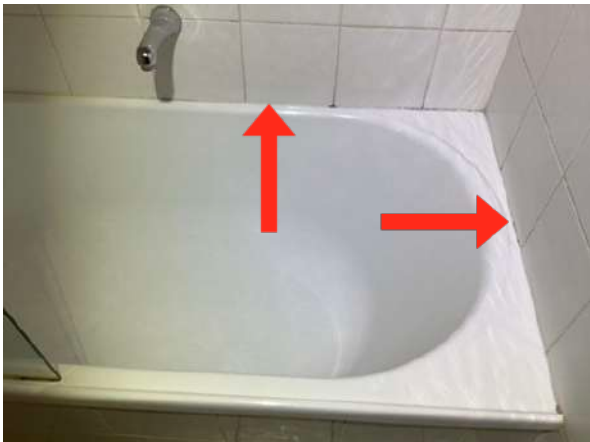
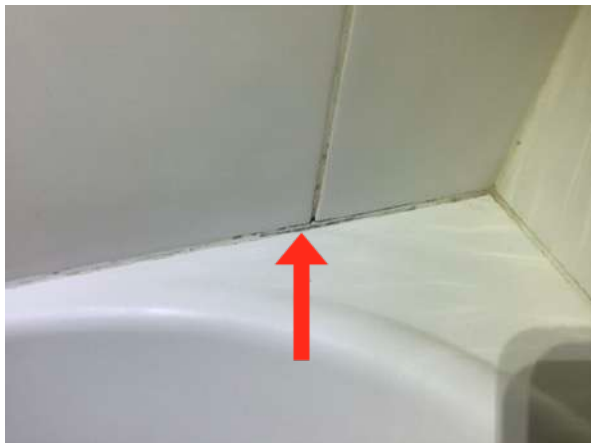
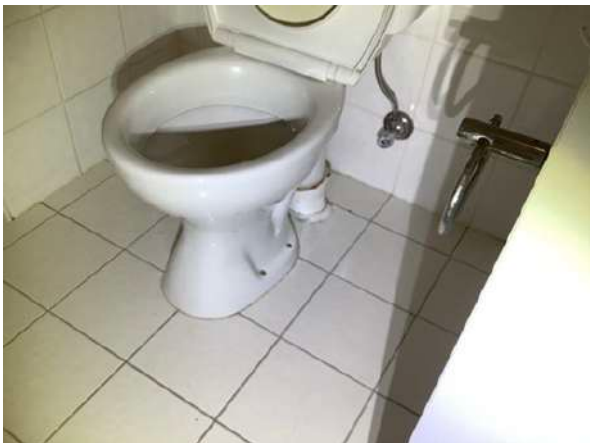
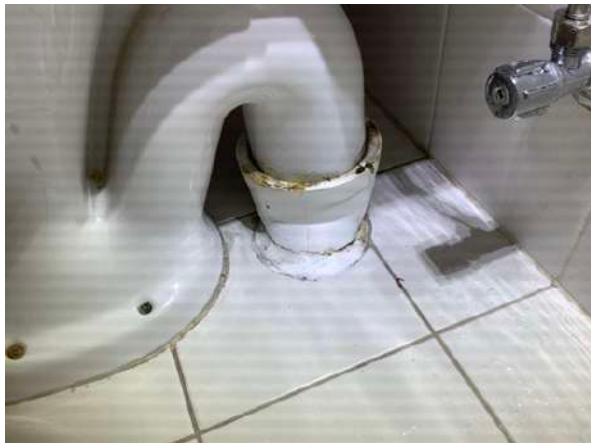
## Safety Hazard 1.02

Location: Bathroom

Where evidence of mould growth was noted, there may be environmental, biological or health issues associated with the report. A specialist inspection by a suitably qualified environmental health inspector may be warranted where mould is extensive or where any queries regarding air quality spores or other related issues apply.

Generally, the client is advised to ensure that the general environment is free of moisture and humidity to aid in the prevention of mould formation and development. Any mould found during the inspection should be cleaned immediately and/or taken out, particularly where the mould is in the silicon / caulking.

Please note that severely affected building elements may require replacement by a registered builder or qualified carpenter, however generally where mould is found in bathrooms benches, shower tile junctions, laundry sinks and all other wet area junctions you can get rid of the mould, once you take out the old caulking in most cases.

Finally the cause or source of the mould MUST BE TAKEN CARE OF URGENTLY.

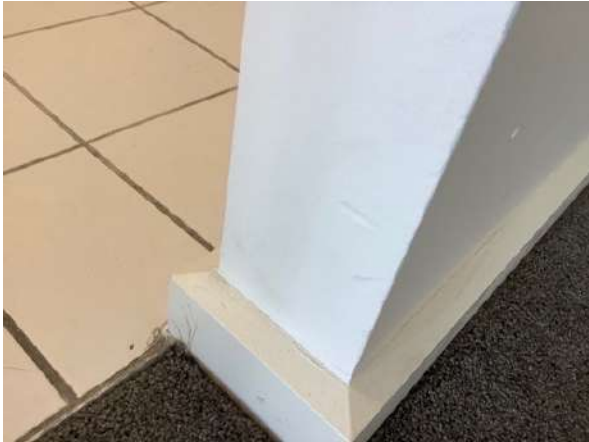
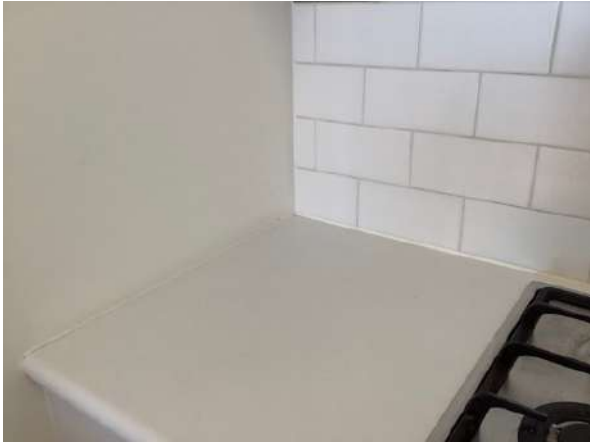
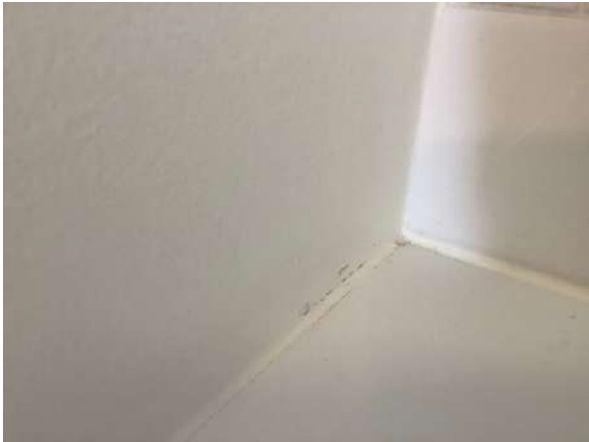
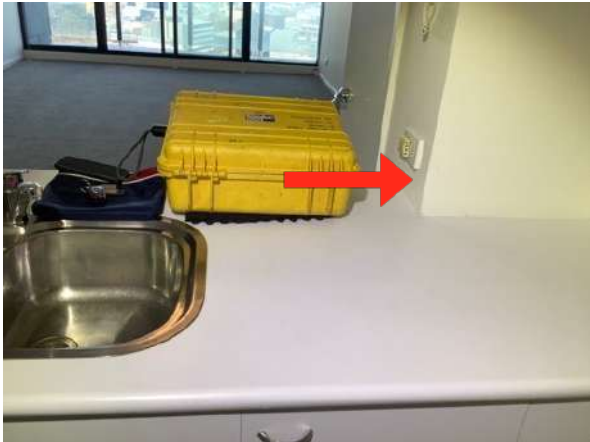
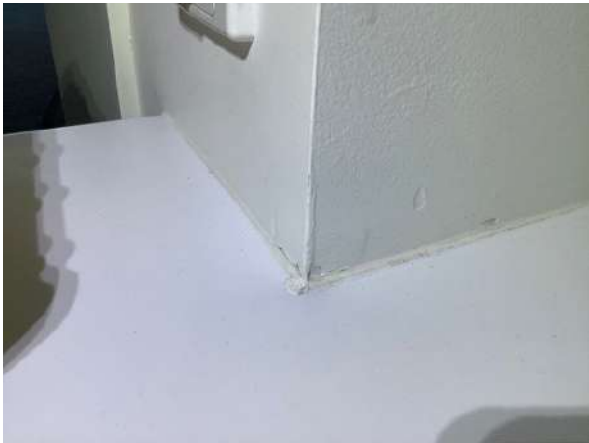
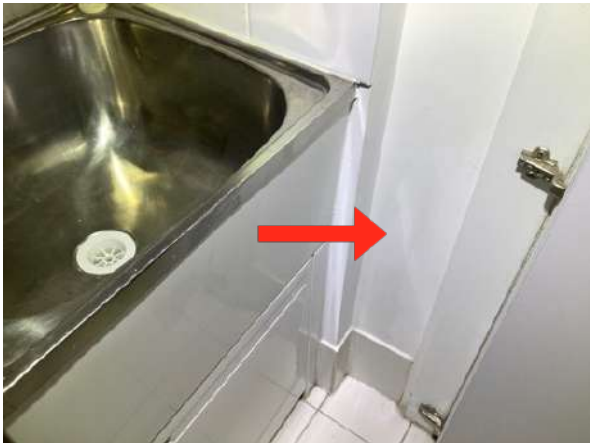
## Minor Defect 3.04

Finding: Paint & Plaster Defects To Doors, Architraves, Walls & Ceilings, ETC.  
It appears that the building has had a re paint or at least painted in areas.  
There is the possibility that some or many cracks in the plaster or solid plaster may have been covered up and/or repaired, due to the selling of the home ?  
There is always the possibility that the cracks in part or full will come back if the repairs have not been professionally done AND/OR the home has movement and/or subsidence continuing to the property.

Superficial scuff marks, damaged plaster, holes in walls,missing paint,sub-standard paint work were noted to the internal walls / ceilings and/or architraves as per the photos attached at the time of inspection.

While these minor defects are detracting from the overall appearance of the affected building element, they do not indicate any operational or structural damage.  
This degree of surface damage is consistent with general damage, accidents, movement and wear and tear.

Superficial scuff marks, damaged plaster, holes in walls,missing paint,sub-standard paint work should be sanded back, filled, levelled and painted, as applicable. Where inadequate or missing protection has led to the deterioration of the associated building element, repair and/or replacement of this building element may be required.

A painting contractor,builder, plasterer and/or suitable handy person may be appointed to perform necessary works to aid the appearance of the affected area and to ensure the area is protected against further deterioration.

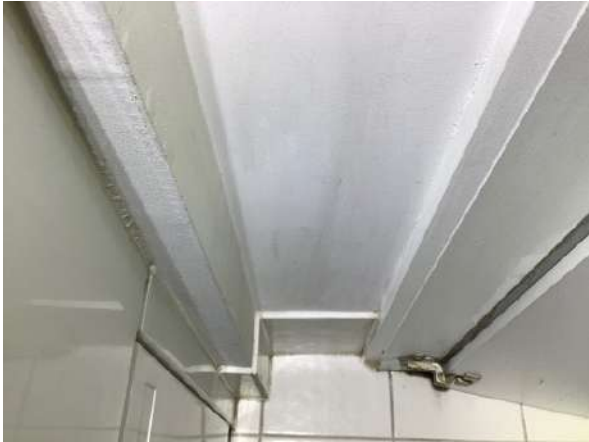
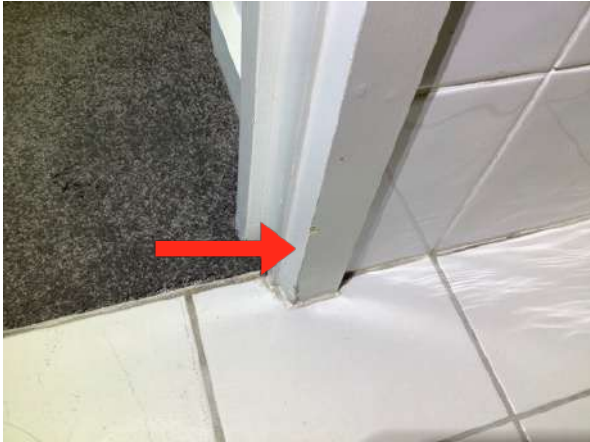
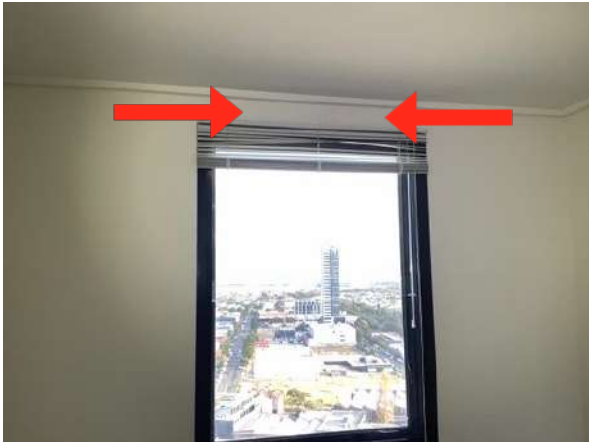
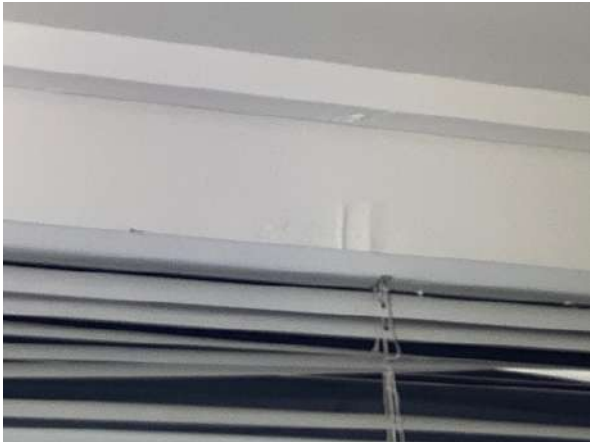
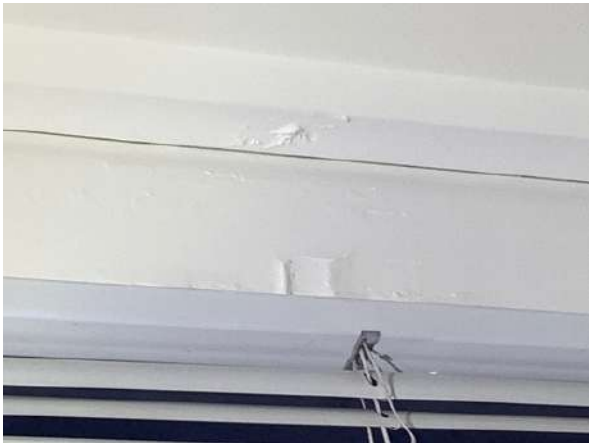
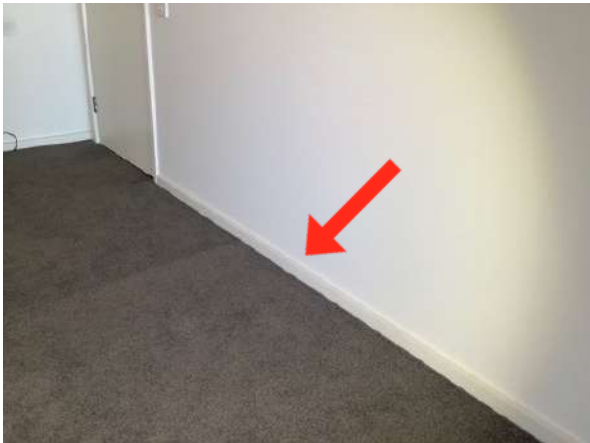
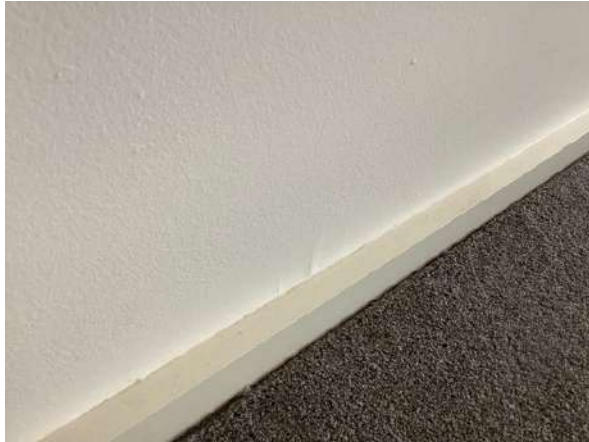
Location: Paint Internal Areas

Wet areas are the main areas that MUST have SUFFICIENT paint coverage to the walls, ceilings and timber work as moisture can deteriorate the areas.

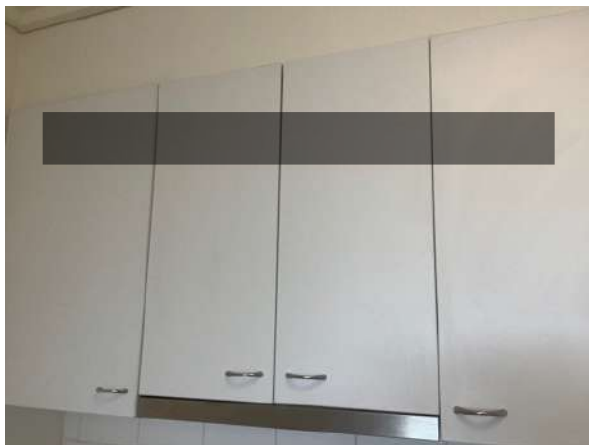
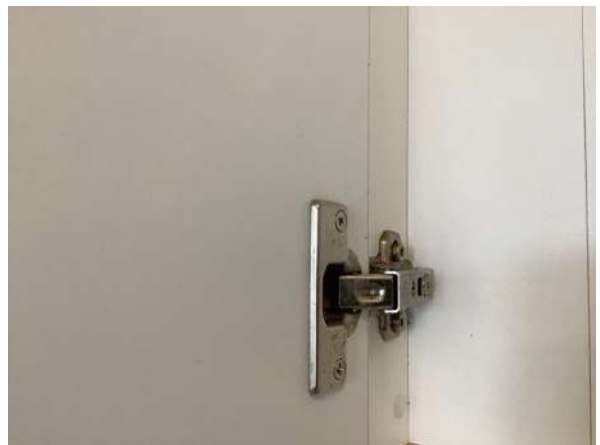
### Minor Defect 3.05

Finding: Cabinetry - Loose hinges / Re-adjustment  
Several cupboard / wardrobe doors are not level and detract from the operational state of the cabinetry and doors.  
Upon further inspection, it was noted that the hinges to the cupboard doors have deteriorated or just need adjustment. This as a result over time that they have just come loose or deteriorated from their original fixing.

To improve operation of the affected doors, a general handyman / cabinetmaker/ carpenter may be appointed to replace the faulty hinges and/or adjust .

Such works should be completed at the discretion of the client, but we do recommend repairs so that there is no further damages to the existing cabinets or cupboards.

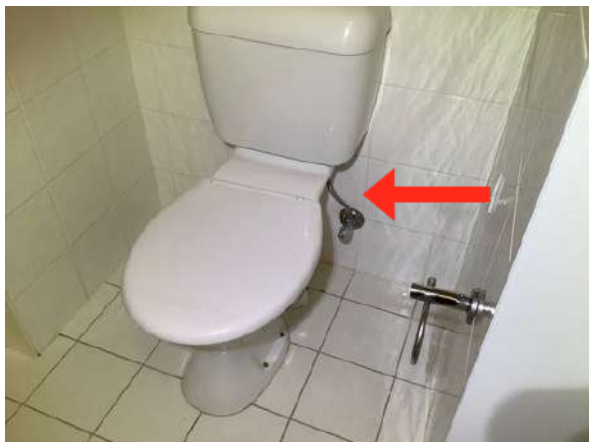
### Minor Defect 3.07

Finding: Tap - Loose

The tap in this area has not been installed correctly, or has deteriorated with age, and is consequently loose. This tap being loose creates potential for water leaks and subsequent water damage to the surrounding area.

Where taps are loose, a qualified plumber should be appointed to re-fix the plumbing fitting to prevent further secondary damages that may not be seen, creating water damage unseen.

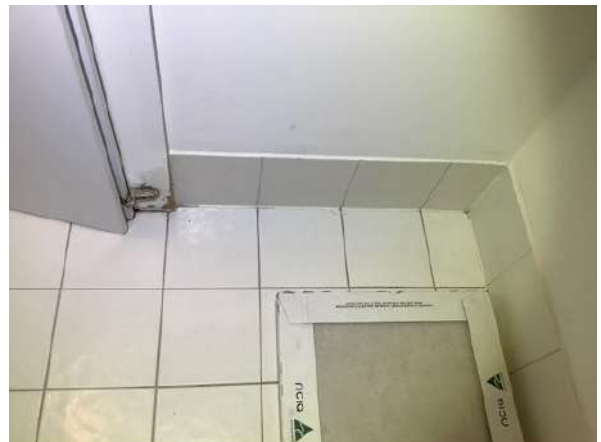
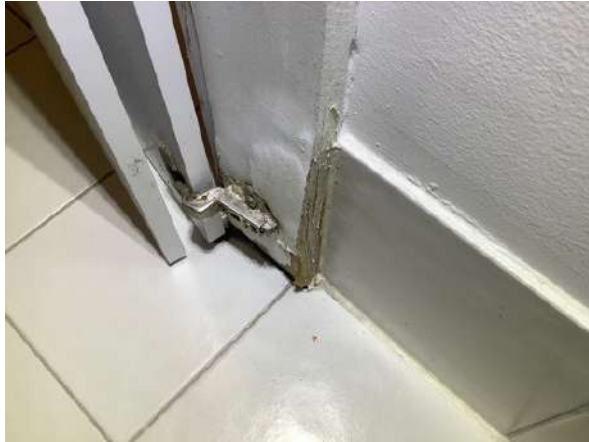
## Minor Defect 3.09

Finding: Water Staining - Damaged Materials To Door Frame  
Water staining was evident in this area or areas at the time of inspection.

Water staining indicates that surfaces have been exposed to excessive moisture / water over time. The minerals and other elements in the water lead to staining, which may graduate to corrosion and deterioration if left unmanaged.

It is important to identify the cause of water staining and STOP FURTHER DETERIORATION by the appropriate tradesperson.

Where water staining is active, a licensed plumber or appropriate trade must be consulted to identify the cause of the staining and to provide advice on any reparation works that may be required.

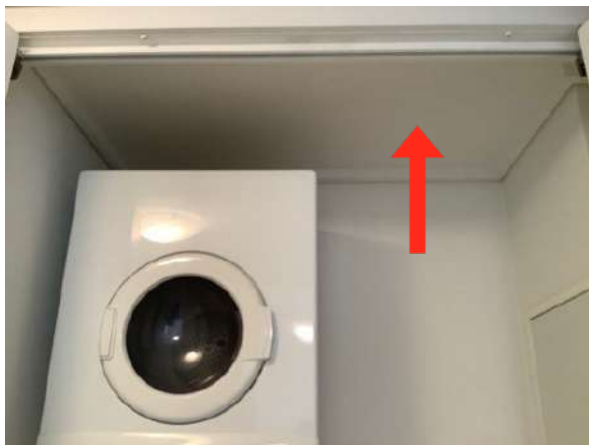
### Minor Defect 3.10

By not having an exhaust fan in this area, you increase the chance of mould growth, paint damage or blistering or even plaster damage.

A Licensed electrician should be appointed to wire and install the fan at the client's discretion, however where there is no window access an exhaust fan may be required by council regulations.

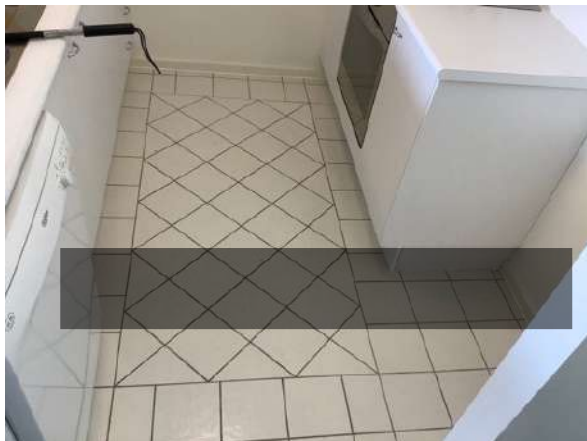
If left unmanaged, water penetration to these areas may lead to subsequent water damage, which is likely necessitate repair work to affected building elements.

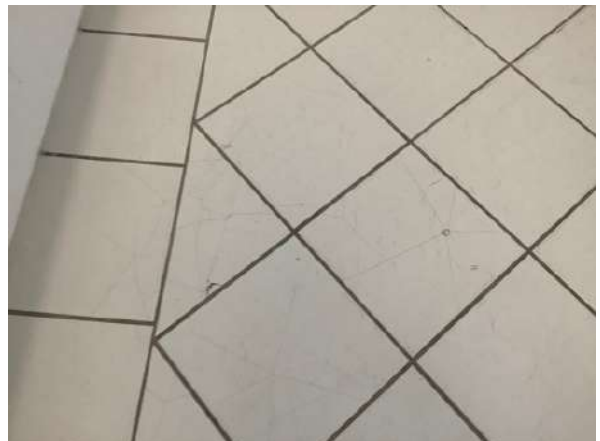
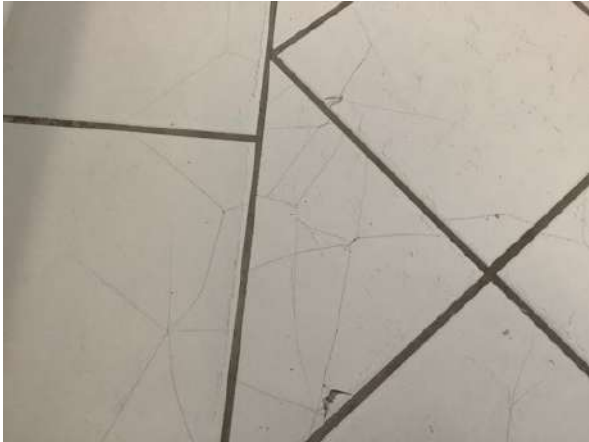
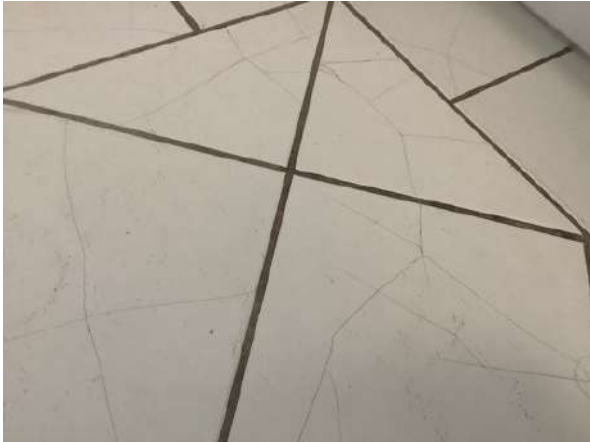
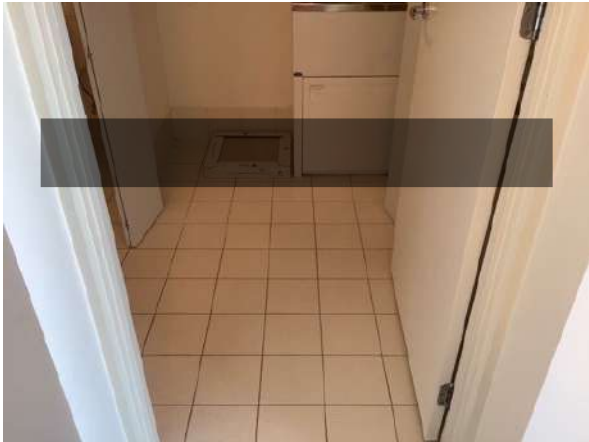
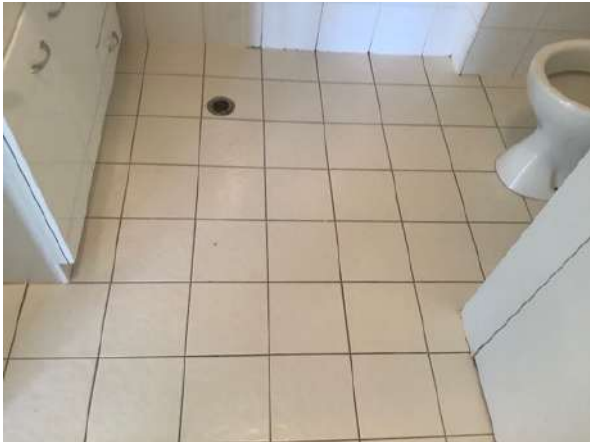
## Minor Defect 3.11

The kitchen, bathroom and laundry floor tiles are severely drummy and can not be repaired without replacement.

Drummy tiles may also be contributed to tiles cracking and what is important is to determine the cause of the cracking, which may be related to the subfloor structure, typical wear and tear and/or poor workmanship

Such defects are generally caused by physical or moisture damage to the area. Drummy tiled areas may also be a direct result of poor workmanship during the construction process.

Any exposure to moisture is capable of causing tiled areas to become drummy and/or cracked over a prolonged period of time. Drummy tiled areas generally require removal and replacement of affected tiles, with adequate sealant and grouting.

Specialist trades are available for these types of services. A registered builder may be required to undertake works if damage is extensive or if secondary building defects have resulted. Otherwise, it is advised that a tiling contractor be appointed to perform works as necessary. Immediate action is recommended to ensure that no further damage is sustained in the affected area.

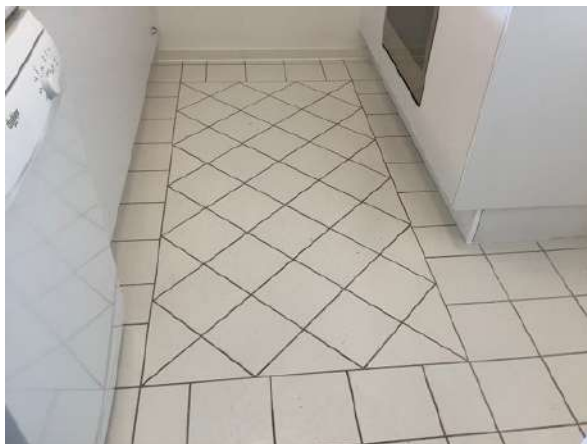
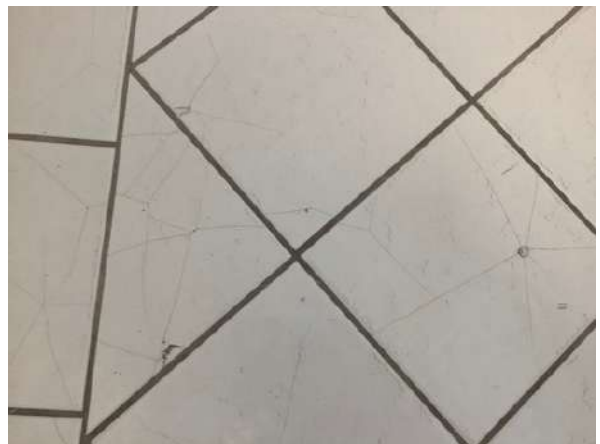
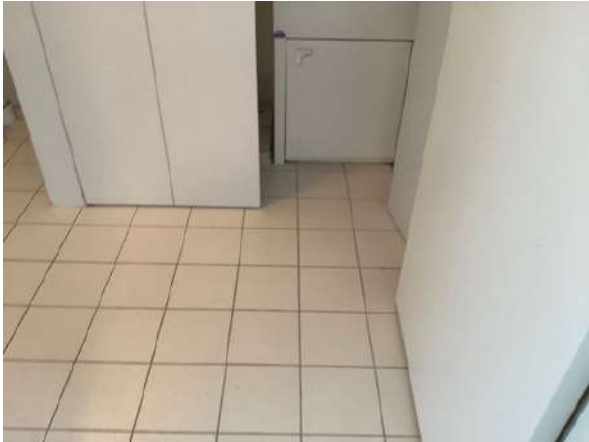
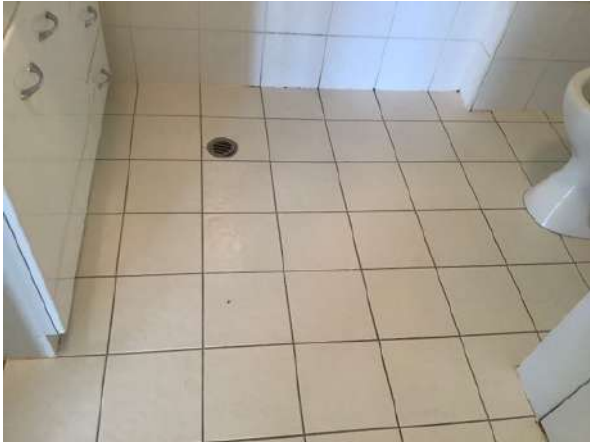
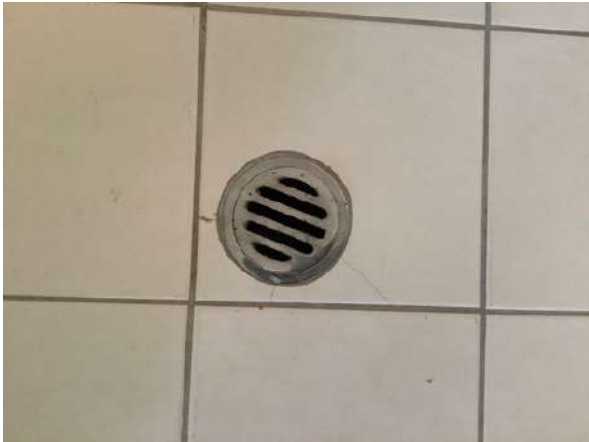
## Minor Defect 3.12

Finding: Tiles - Cracked or damaged

It is important to note that the cracked tiles are also drummy and as stated in the drummy statement in this report, these tiles cannot be saved and you cannot just replace the cracked tiles they must be all replaced and installed by a qualified tiler.

Cracking was evident to the tiling at the time of inspection. While the cracking appears to be minor, these areas are frequently exposed to water, allowing potential for water penetration into adjoining sections of walls or flooring.

A tiling contractor should be appointed to ensure that no further water damage occurs. The re-application of silicone and grouting throughout remaining tile work is also advised, to further protect the area against water penetration.

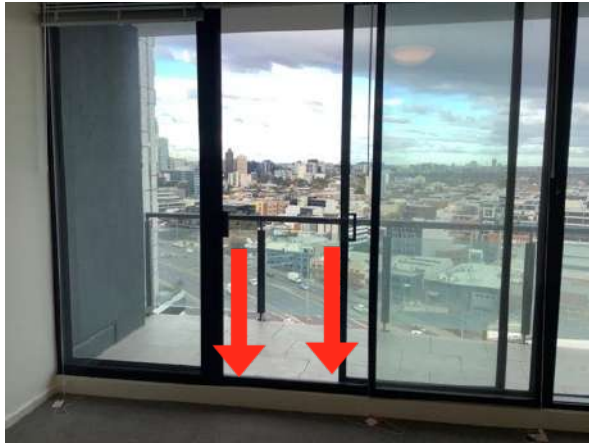
### Minor Defect 3.13

Finding: Glass Door Sliding - Defective

At the time of inspection it was noted that the sliding door was not opening or closing smoothly.

This may need cleaning, lubricating, adjusting or new parts.

This repair can be done by a handyman /carpenter or a window/door company.

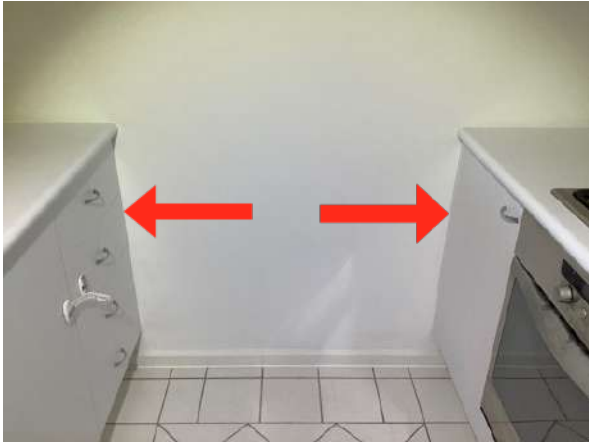
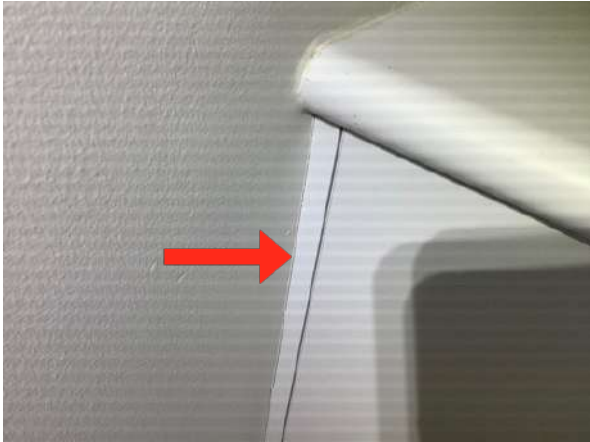
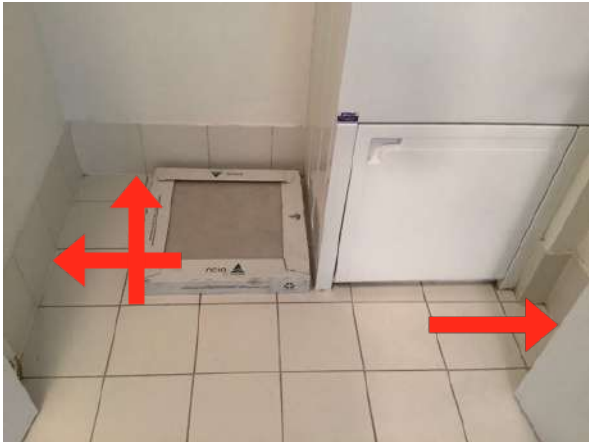
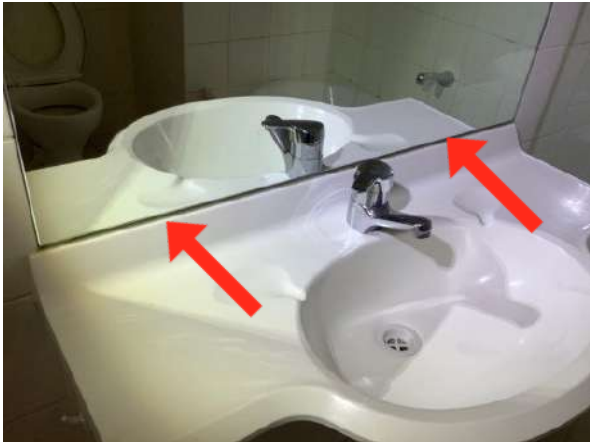
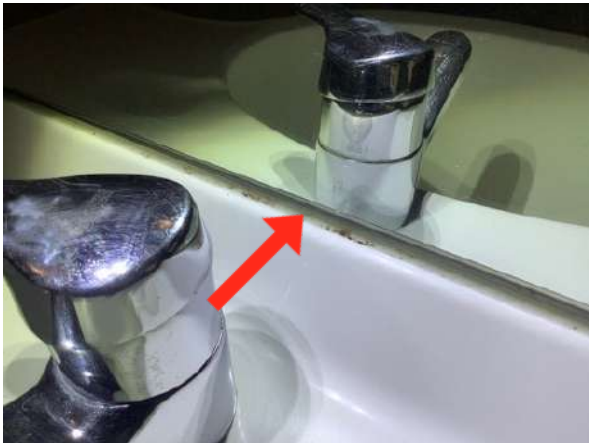
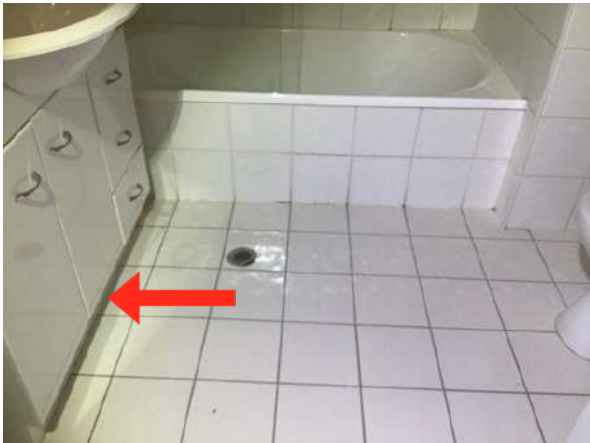
## Minor Defect 3.14

Finding: Silicon / Caulking To All Wet Area Junctions and Tile Grouting - Missing or Damaged.  
Is important to note that as the floor tiles need to be replaced, new silicon or caulking must be installed after new tiles installation.  
It was noted on inspection that sealant and/or tile grout is missing, damaged or inadequate to the tiled wet areas. This may include floor edges, kitchen benches/splashbacks, vanities, bath tub edges, shower areas to the floor and wall tiles, laundry's and all other areas subjected to water or moisture.

Whilst in some of the areas there is sealant/silicon , it has become apparent that the sealant has deteriorated and/or is just missing.

Whilst in some of the tile mortar is perfect , it has become apparent that the tile mortar has deteriorated and/or is just missing in other areas.

A flexible sealant/silicon and tile mortar should be applied to affected areas to prevent any subsequent water damage that is likely to occur.

A sealant specialist, tiling contractor and/or registered builder should be appointed to assess any damage caused by water to the entire internal, sub-floor, walls etc of the building and clean, take off old sealant and tile mortar, then re-seal and re-mortar these works as soon as possible.

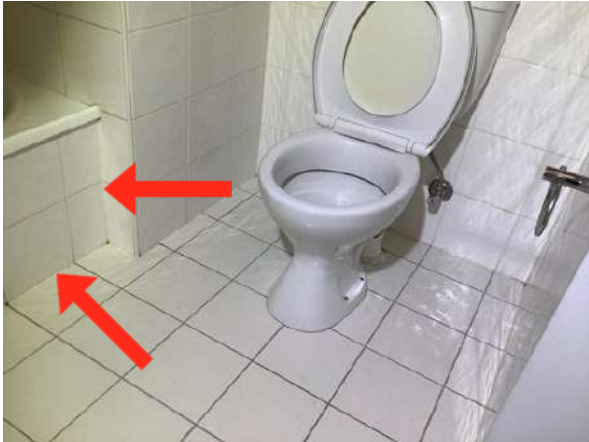
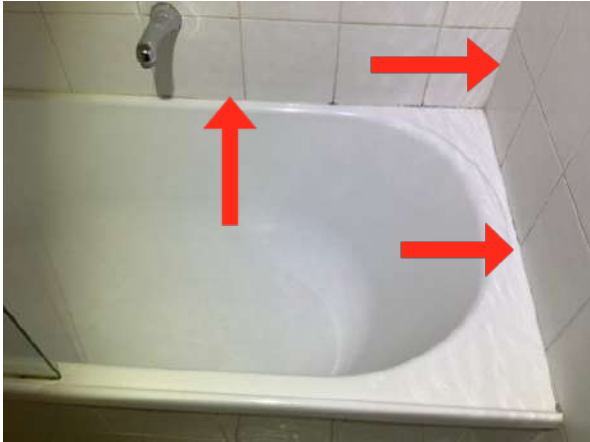
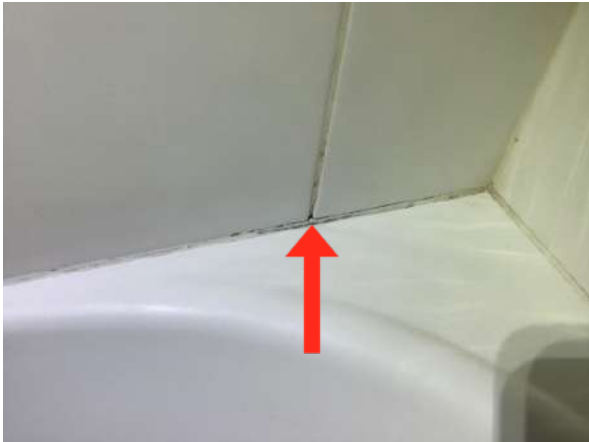
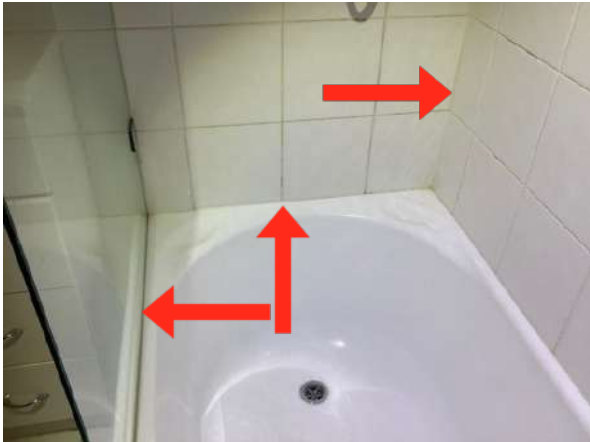
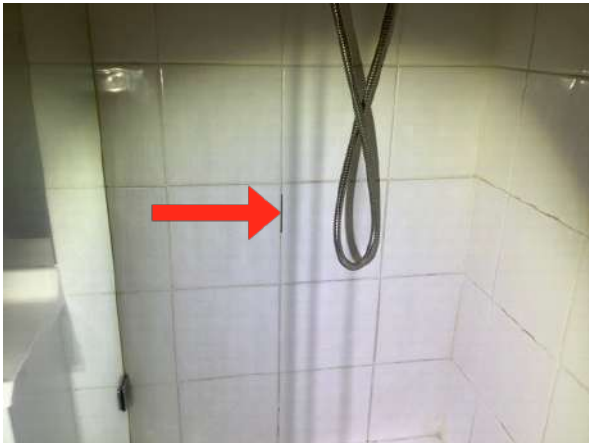
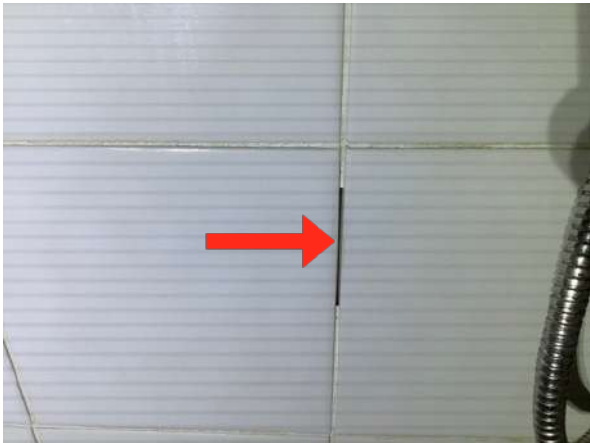
ALL AREAS should be checked carefully for this defect and attached are a few PHOTO EXAMPLES as a GUIDE.

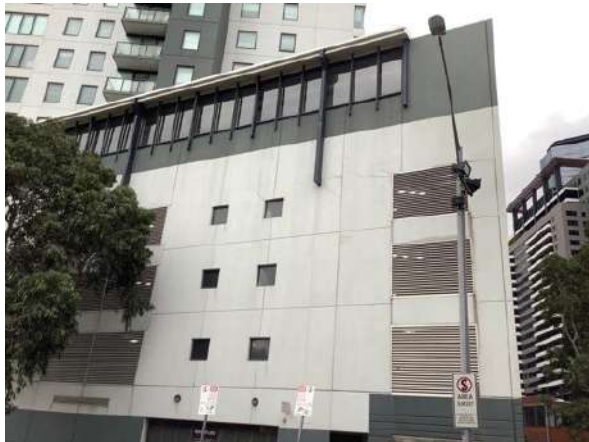
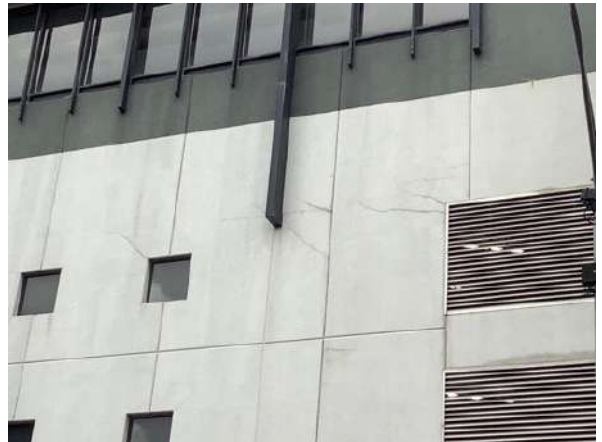
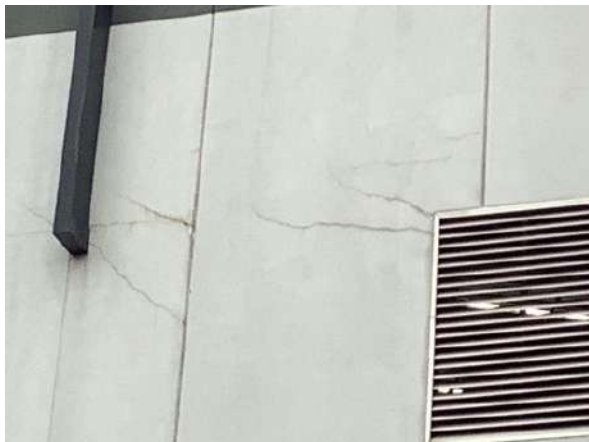
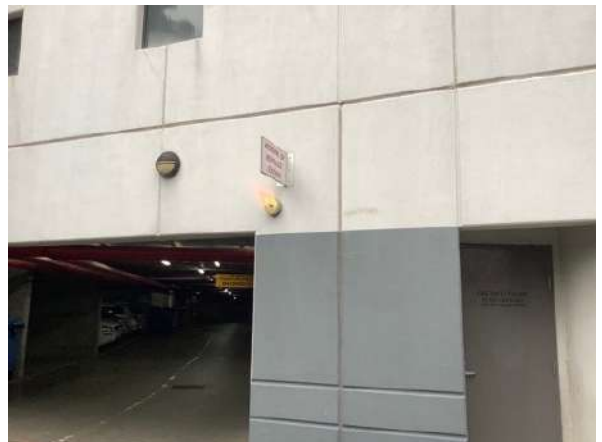
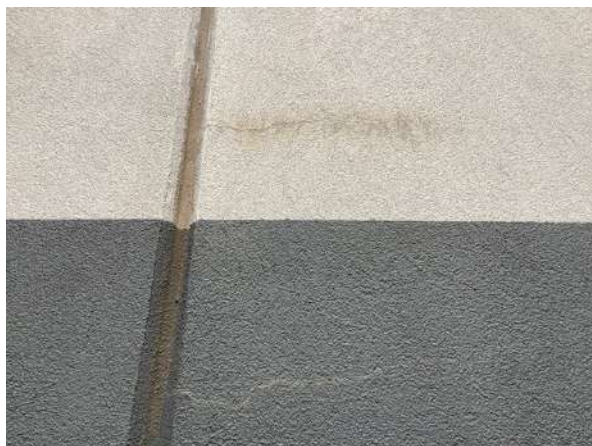
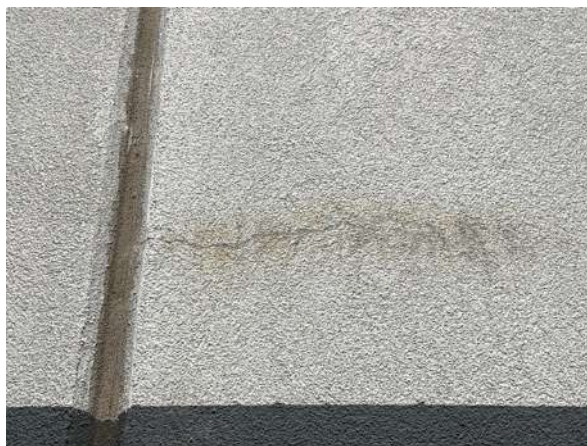
Finding: Cracking - External Concrete  
Fine cracks were identified in external concrete wall panels. Although fine cracks are quite noticeable, they are often only considered to be an appearance defect, and usually do not indicate any structural damage.

However the exterior to this building is not part of the scope of works, however I highly recommend that you notify the body corporate to the cracking so that they can investigate further, but also it does appear that minor repairs have taken place anyway.

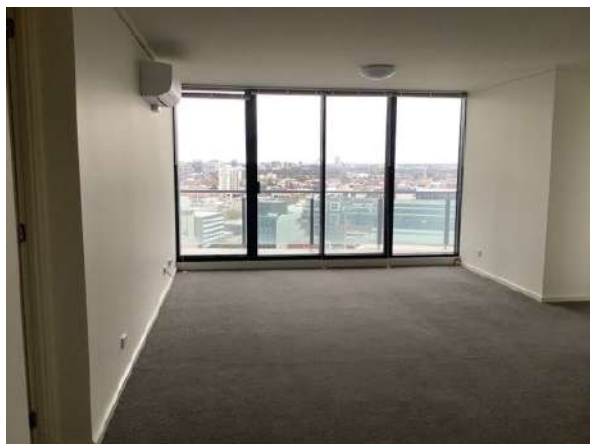
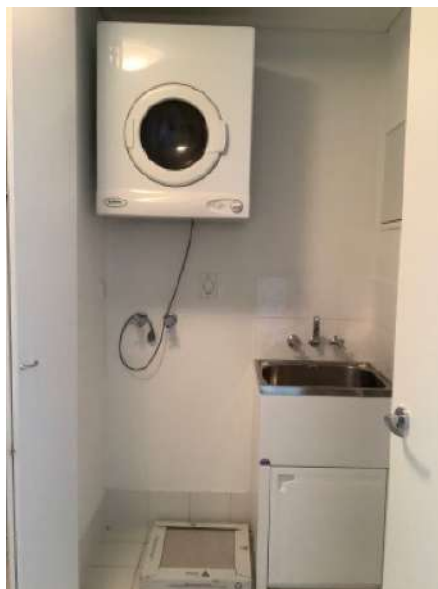
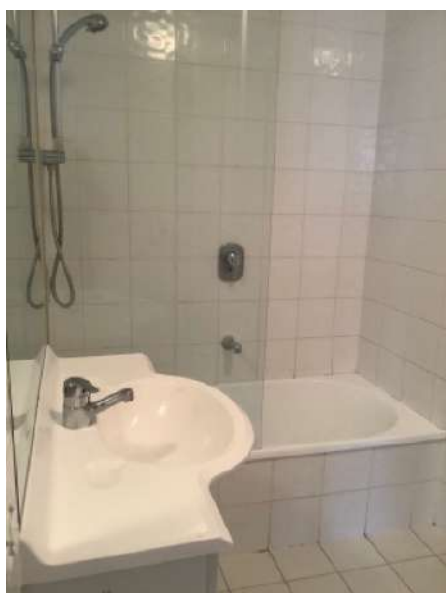
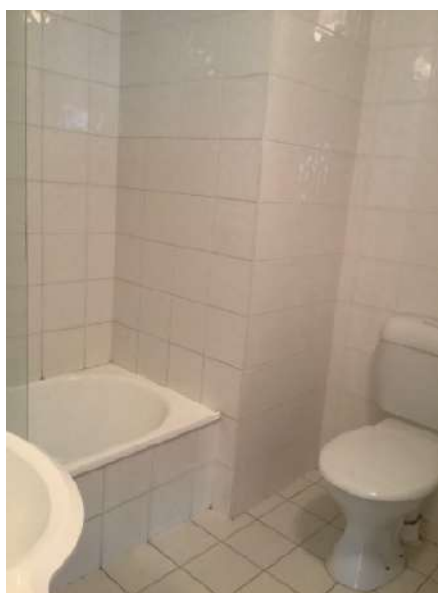
ALL AREAS should be checked carefully for this defect and attached are a few PHOTO EXAMPLES as a GUIDE.

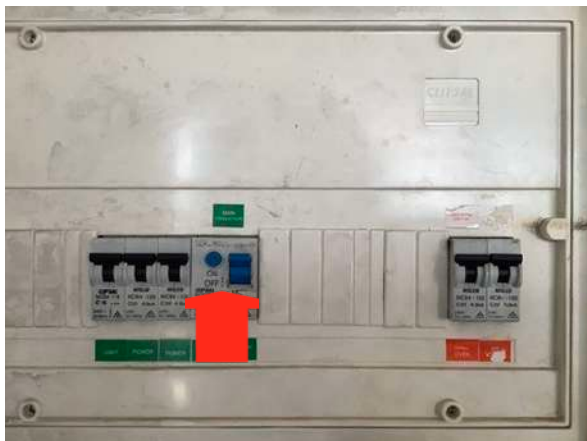
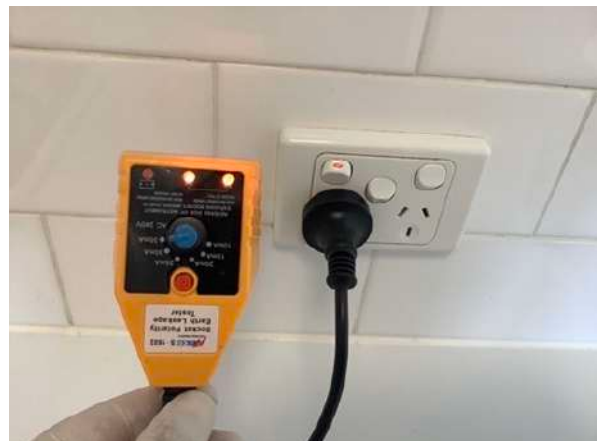
3/ Safety Switch test to trip the safety switch at less then 30 milli amps was performed.

These tests all passed the AS 3000 requirement and exceptance level.

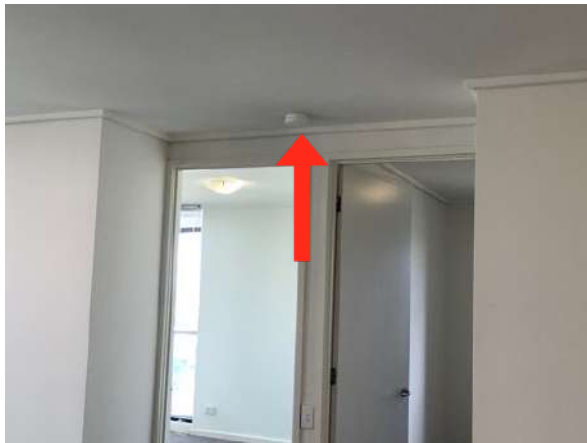
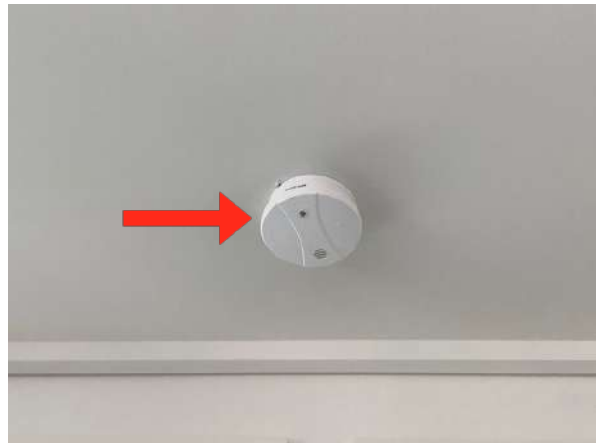
## Observation 4.21

Location: The Site

Finding: Smoke Detectors Battery Replacement.  
This inspection DOES NOT test operation of smoke detectors .

Upon moving into a new property, it is highly recommended that the batteries to the smoke detectors all get replaced instantly.

Smoke detector batteries should be replaced every 12 months at a minimum.

It is highly recommended that replacement dates of the batteries be kept in a log book.

Testing of smoke detectors is required monthly.

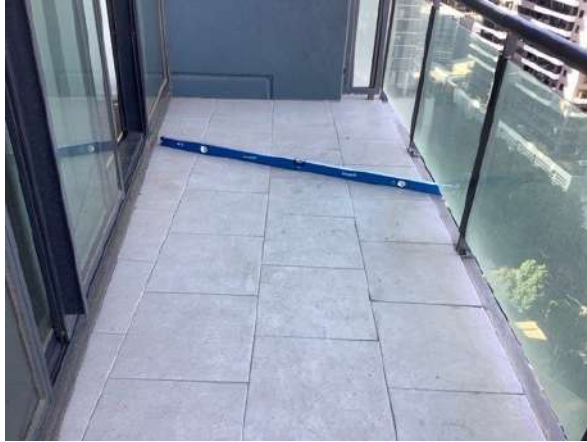
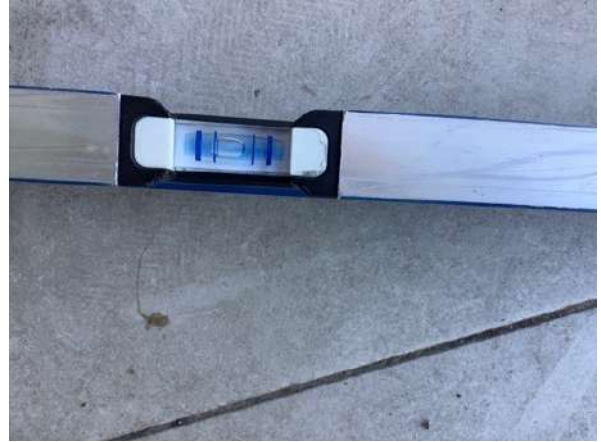
## Observation 4.22

Location: Balcony

Finding: Fall in tiles to balcony area.  
The fall in the floor tiles on the balcony all appear to be okay with the fall of the floor sloping away from the building.
