Pre-Plaster Report

Inspection Date: 30 Jul 2020

Property Address: Wollert Area

Report Type: New Home Construction

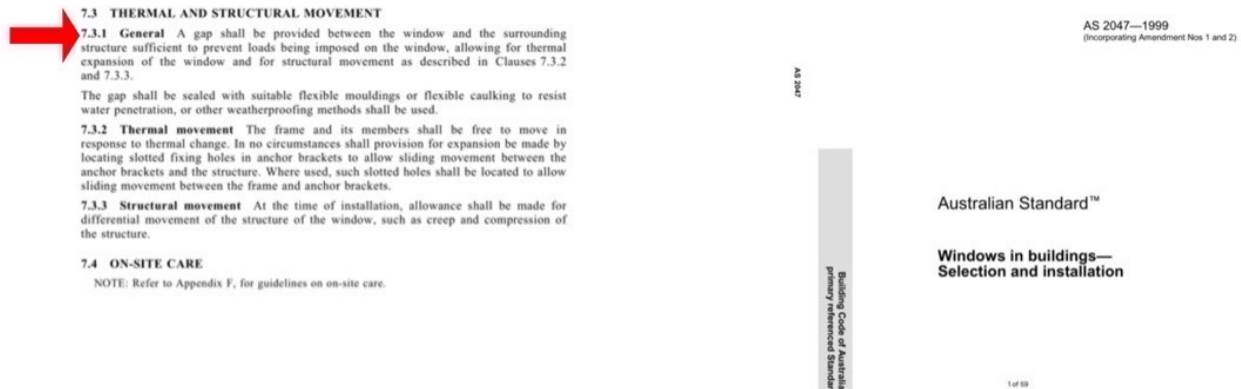
Finding: Window Installation - Gaps To Perimeter Of Windows Defective.
As per AS-2047-1999 and the defect clause is below.
All windows must have sufficient gap around them with a minimum of 15mm at the top of the window to the underside of the timber frame.
In this case the defect in discussion is the sides of the window and the bottom of the window DO NOT have a sufficient gap if any to allow for movement and compression of the frame.

ALL WINDOWS with no or insufficient gaps, also as per manufacturers standards is packing to the sides and bottom of the windows as well, must be reworked to allow a recommended of at least 15mm to 20mm of packing.

The gap shall be sealed with suitable flexible mouldings or flexible caulking to resist water penetration, or other weatherproofing methods shall be used.

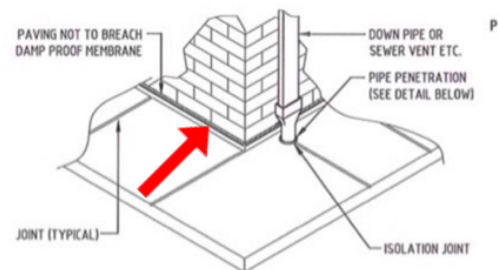
It is a requirement of AS 2870-2011 5.3.3.4 that vapour barriers are turned up and terminated at ground level above paving adjacent footing. The vapour barrier is defective is building material and fill has been left on top of the membrane as this prevents it from being pulled up against the slab when doing perimeter paving as it is intended to be.

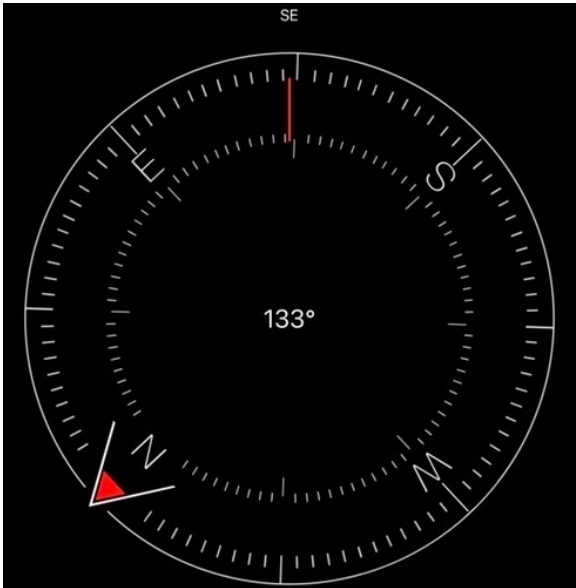
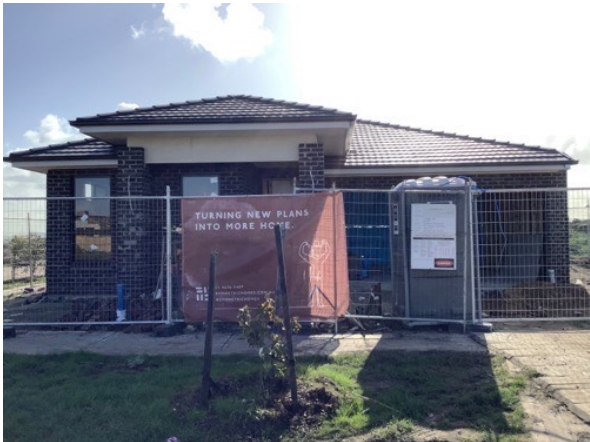
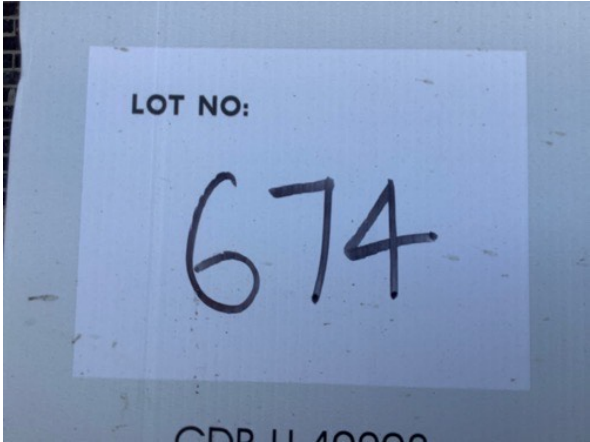
Location: The Site
Finding: Site Photos
Additional photos are provided for your general reference.
