Year-1890 Old Mansion, Building & Termite, Timber Pest

Inspection Date: 27 Jul 2020

Property Address: Ascot Vale Area

Report Type: Property and Timber Pest Report

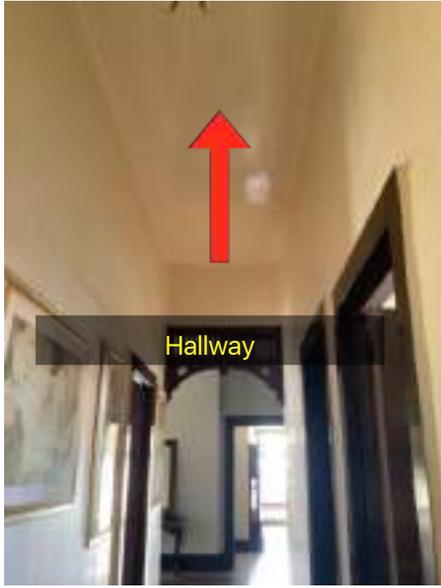
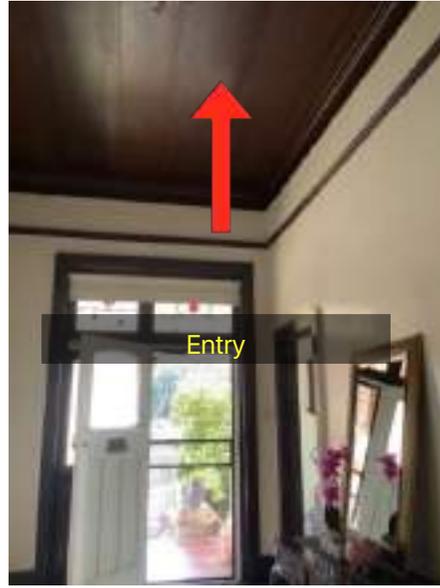
Note : Reporting on Electrical wiring and electrical installations to this property is outside the Scope of this Report as Under the Australian Standards for prepurchase building inspections (AS 4349.1-2007) does not require our inspections to cover electrical, however electrical wiring and installation is a very important safety concern and/or hazard. Master Property Inspections Building Consultants are very competent and are guided by the owner of the company, Les Camilleri as he is a registered A grade electrician with a electrical contractors license.

Upon completion a safety certificate is required to be supplied to the owner of the building.

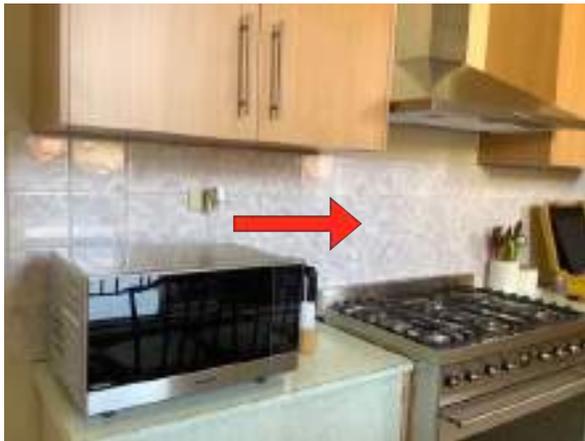
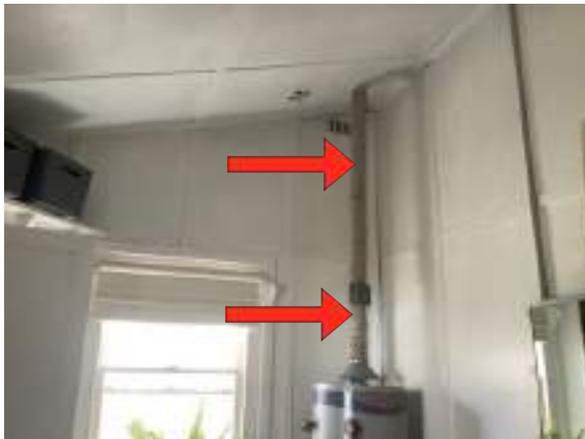
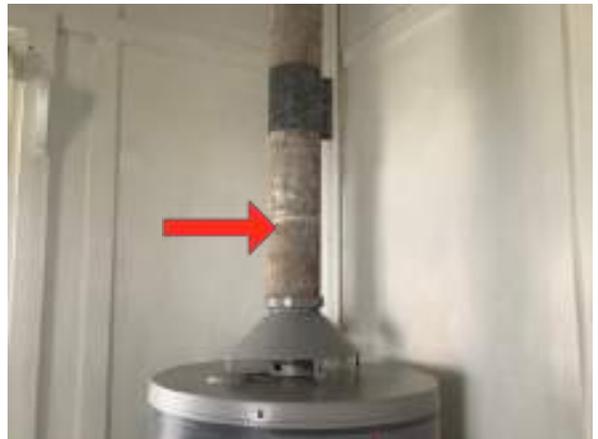
Serious Safety Hazard 1.02

Location: Internal Areas

Asbestos can be in the old wardrobes and cupboard areas, asbestos can be in the flu systems of the old hot water services or heater flu systems. Asbestos can be on the walls or ceilings. Asbestos can be in the eaves in the older homes and the exterior walls of the older homes. Asbestos can be found in the roof space areas in the floor space areas and in the old sheds.

Reporting on Asbestos is outside the Scope of this Report. This suspected defect is highlighted as a caution ONLY and is ONLY a guide as asbestos inspections are outside the scope of pre-purchase inspection and reports.

As Asbestos Reporting is outside the scope of this report, we advise that you consider a separate Asbestos Inspection and Condition Audit, which can include the taking of samples for definitive confirmation of the presence of Asbestos.

In the interim, the client is advised to act with caution, especially when considering any damage to building materials general wear and tear renovations extensions demolition and general maintenance activities due to the suspected presence of Asbestos.

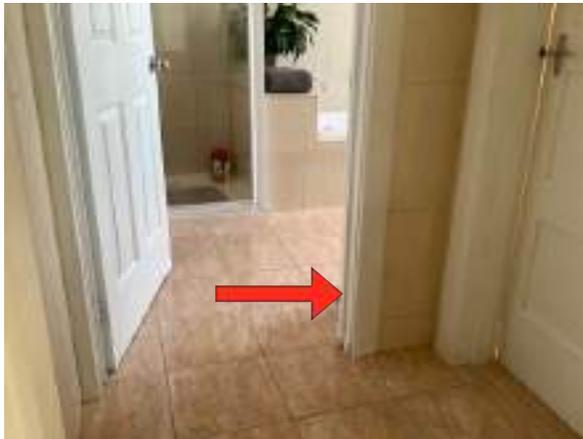
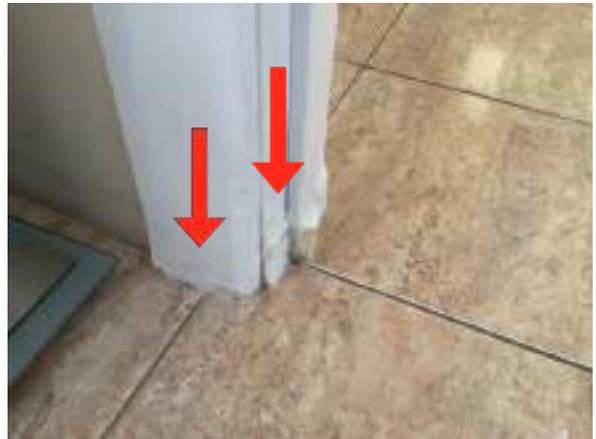
Serious Safety Hazard 1.03

Location: Internal Areas

Finding: Water Staining - Damaged Materials.
Water staining was evident in this area or areas at the time of inspection.

Water staining indicates that surfaces have been exposed to excessive moisture / water over time. The minerals and other elements in the water lead to staining, which may graduate to corrosion and deterioration if left unmanaged.

Water staining can be indicative of more serious defects, such as plaster damage that has become detached from its fixings and become dangerous not just cosmetic, wood rot, mould, conducive environment for termites and damage to other types of building materials that are concealed or not concealed by other building elements.

It is important to identify the cause of water staining and STOP FURTHER DETERIORATION by the appropriate tradesperson.

Where water staining is active, a licensed plumber or appropriate trade must be consulted to identify the cause of the staining and to provide advice on any reparation works that may be required.

Replacement of any broken or damaged structures is advised in particular if the damage has caused secondary defects that have compromised the building structure or safety of any persons.

Conversely, where water staining is old and inactive, affected building materials may be repaired or replaced at client discretion only if the damage is cosmetic though.

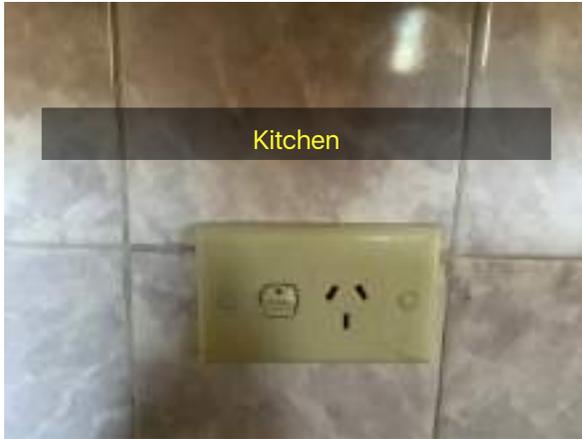
Serious Safety Hazard 1.04

Location: Electrical - All Areas

Finding: Electrical - Power Points - Damaged/Faulty

The power points in areas were found to be damaged or faulty at the time of inspection. This occurs generally when the building materials have either aged and decayed or as a result of impact damage (accidental or deliberate).

Repair and/or replacement of the power points is advised to ensure the fixture and it's associated structures are safe and fully operational. A licensed electrician should be appointed to repair/replace the power points as soon as possible.

Please engage a licensed electrician to further inspect the property for the repairs and replacements as required.

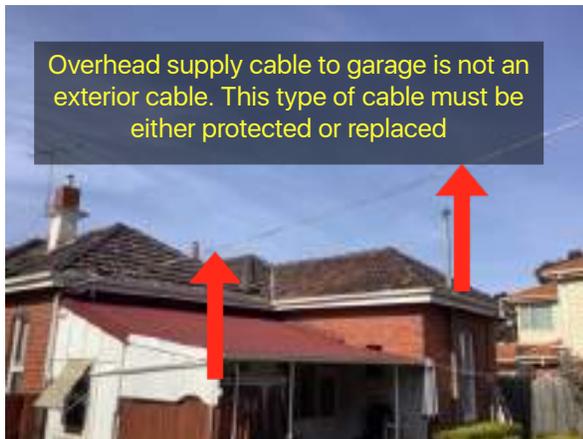
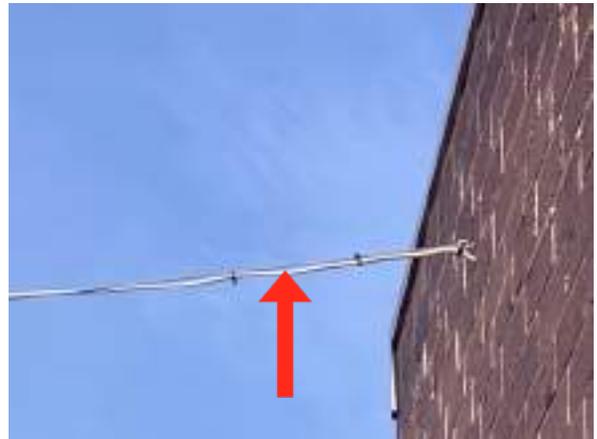
Serious Safety Hazard 1.05

Location: Electrical - All Areas

Finding: Electrical - Defective electrical wiring and/or installations.

At the time of the inspection we noted that the electrical installation appears to have items that may not be compliant with the electrical regulations AS3000-2007.

We recommend that the purchaser engages a licensed electrical contractor to check compliance and make good any defective wiring or unsafe items throughout the entire property including the outbuildings etc.

Whilst this is a limited inspection, we HIGHLY RECOMMEND further testing in accordance with the AS3000 testing procedures.

All the earthing to this property must be in accordance with AS3000 and we highly recommend further testing to the earthing system in its entirety.

We highly recommend that you engage a qualified electrician to further test the property's earthing system and that all the tests comply with AS3000 for all testing procedures of an electrical installation and its earthing components.

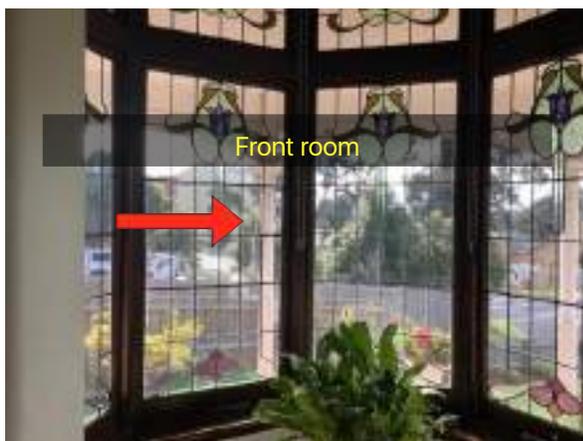
Serious Safety Hazard 1.06

Location: Windows - Internal Areas

Generally, factors such as general age of the building element and a lack of maintenance are the usual causes for this type of defect.

Windows MUST function as a safety requirement and we HIGHLY RECOMMEND that you engage an appropriate professional as soon as possible to check all windows to the property.

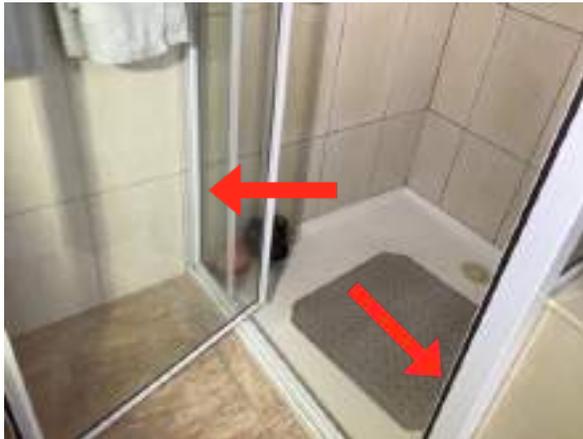
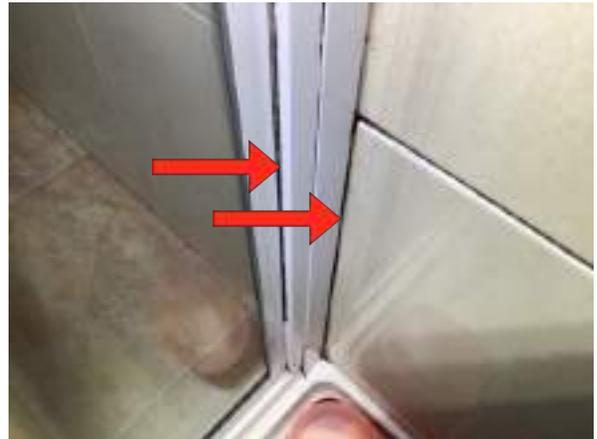
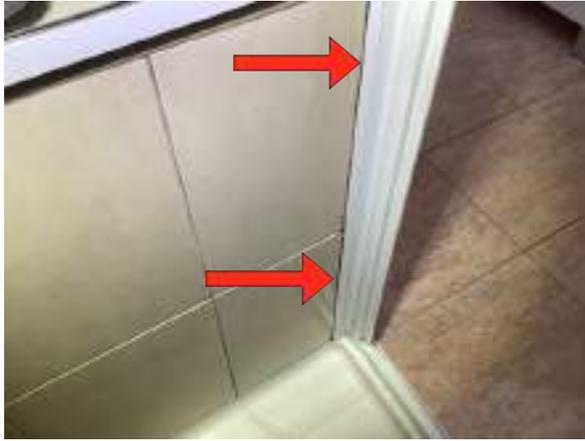
Serious Safety Hazard 1.07

Location: Bathroom

Please note that severely affected building elements may require replacement by a registered builder or qualified carpenter, however generally where mould is found in bathrooms benches, shower tile junctions, laundry sinks and all other wet area junctions you can get rid of the mould, once you take out the old caulking in most cases.

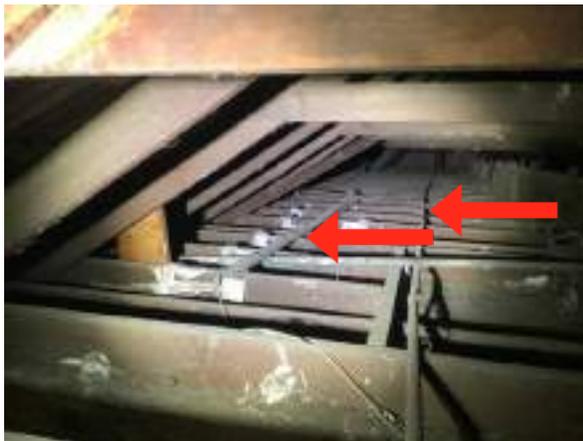
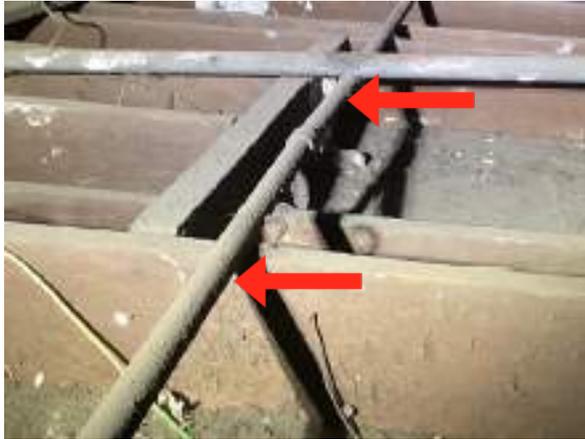
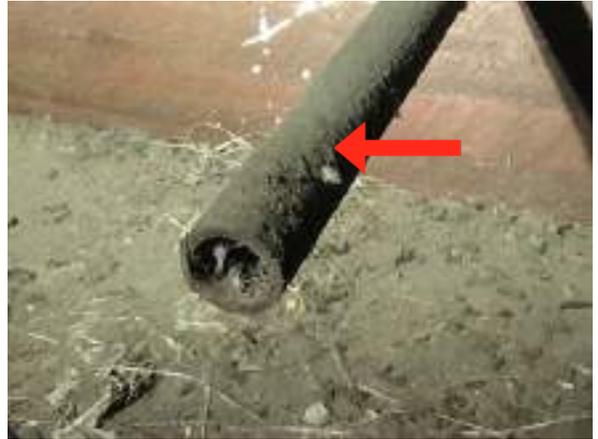
Serious Safety Hazard 1.08

Location: Roof Space

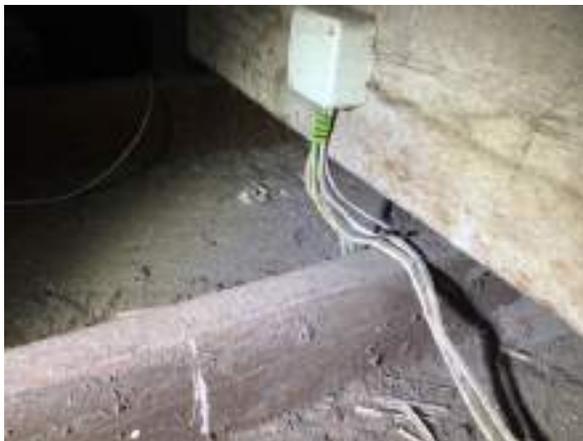
Serious Safety Hazard 1.09

Location: Roof Space

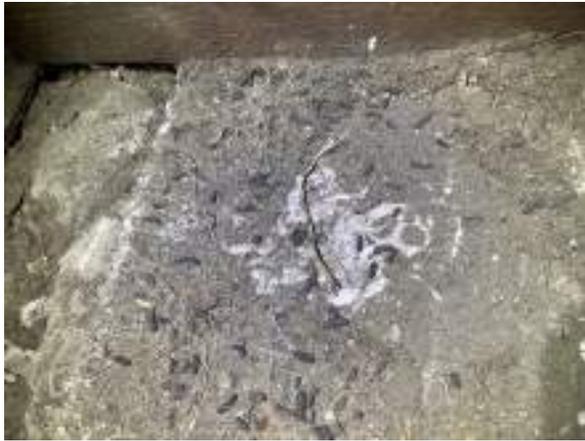
Serious Safety Hazard 1.10

Location: Roof Space

At the time of the inspection there was animal faeces spread throughout the roof space area. This is very unhygienic for obvious reasons. It's very important to seal and block any areas where, rats, possums, cats, birds and any other type of animal can get into the roof space areas or wall spaces.

This should all be cleaned for health and hygienic reasons by an appropriate professional.

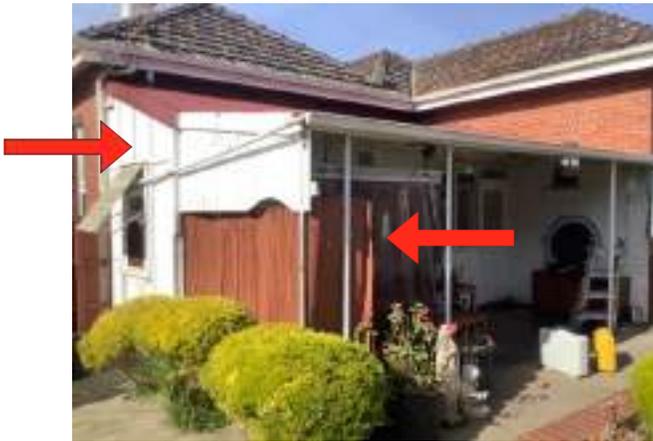
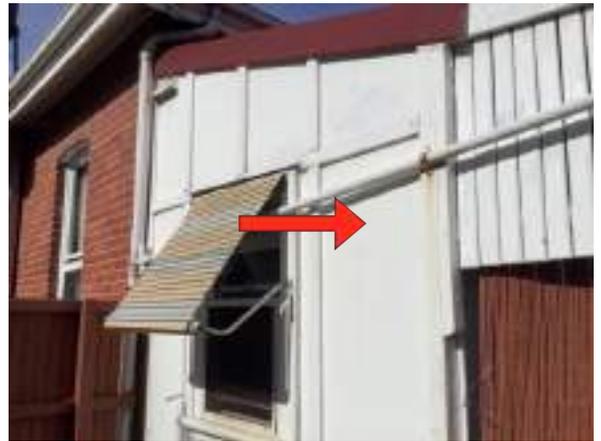
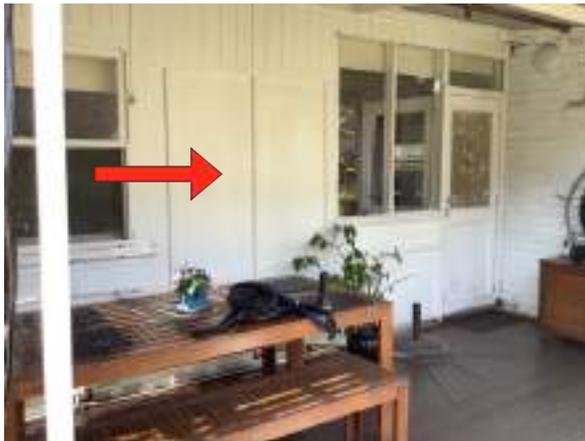
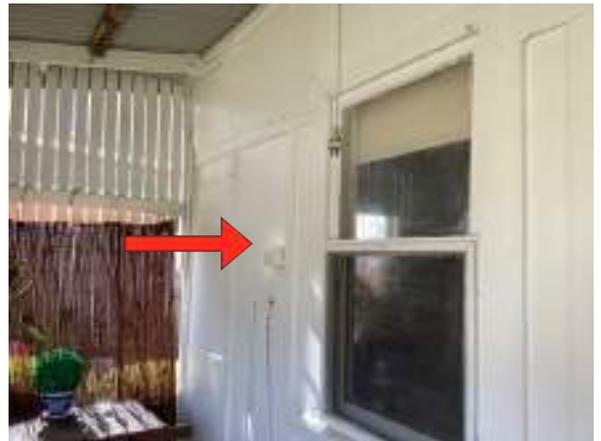
Serious Safety Hazard 1.11

Location: External Areas

In the interim, the client is advised to act with caution, especially when considering any damage to building materials general wear and tear renovations extensions demolition and general maintenance activities due to the suspected presence of Asbestos.

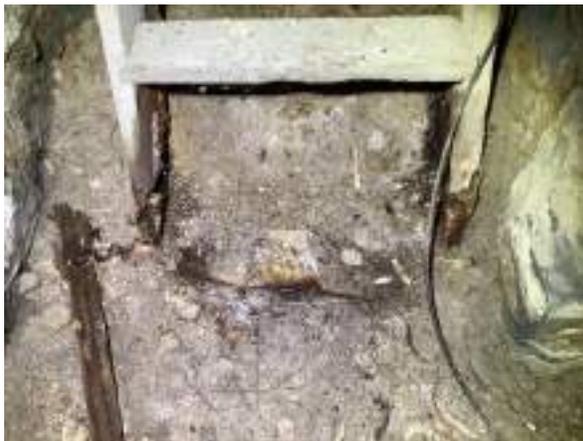
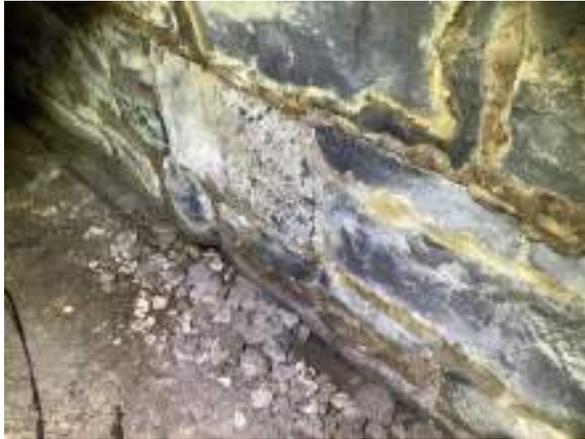
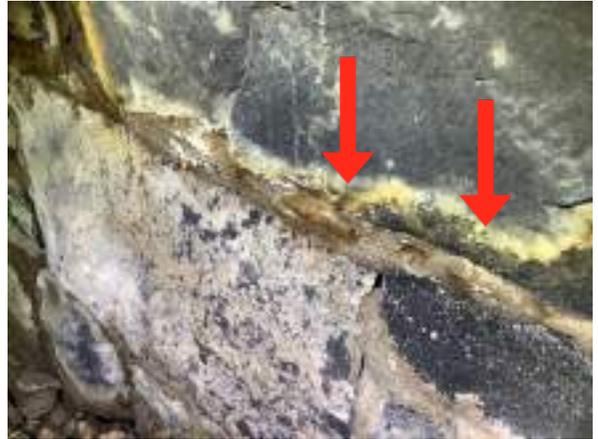
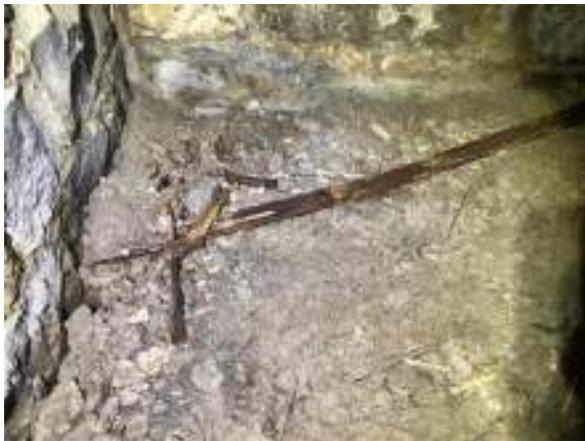
Serious Safety Hazard 1.12

Location: Subfloor

Finally the cause or source of the mould **MUST BE TAKEN CARE OF URGENTLY.**

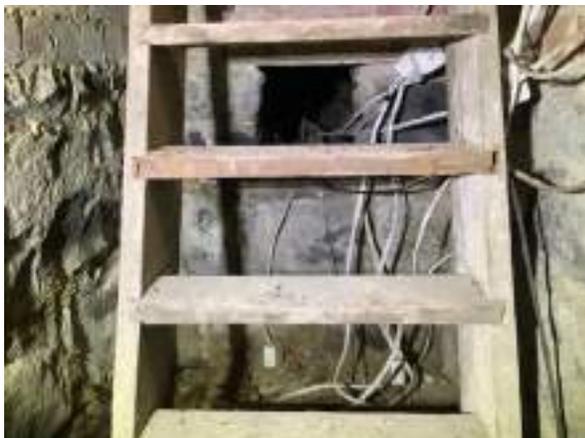
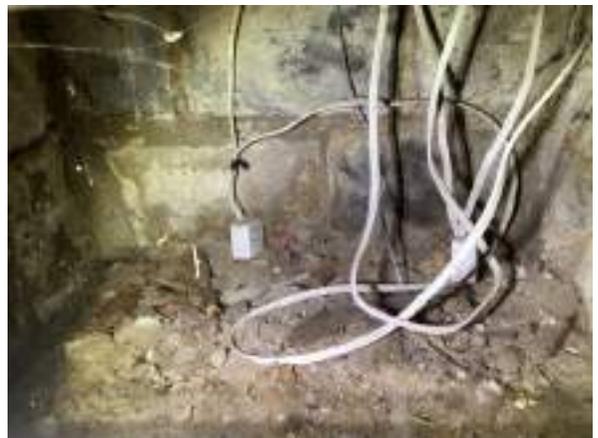
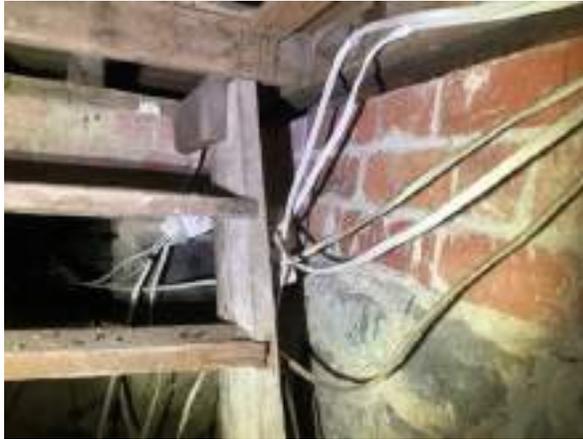
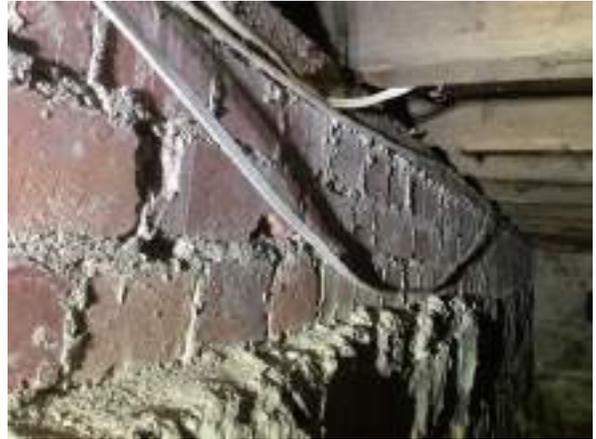
Serious Safety Hazard 1.13

Location: Subfloor

Finding: Electrical Wiring

The Electrical wiring in areas does not comply with the current electrical AS3000 regulations and should be tidied up by a qualified electrician in all areas of the subfloor that is accessible at a minimum.

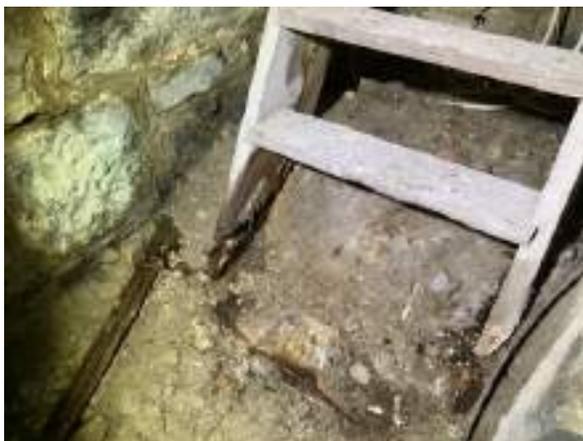
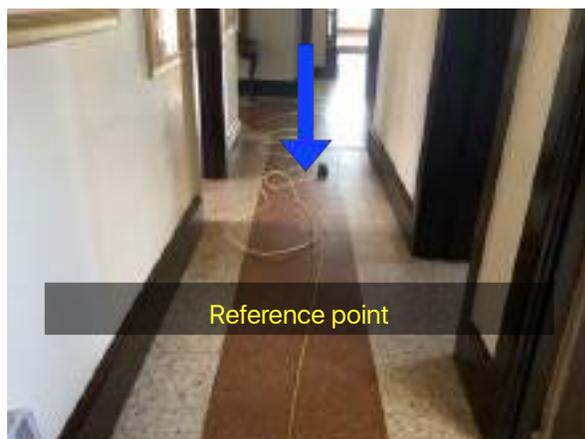
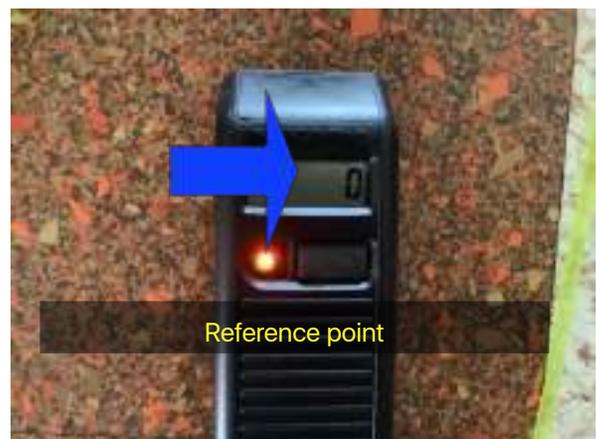
Serious Safety Hazard 1.14

Location: Subfloor

This building element shows evidence of wood rot. Wood rot, also known as Fungal Decay, occurs when timbers and other cellulose building materials are exposed to damp conditions on an ongoing basis. This could be the result of exposure to weathering over a prolonged period of time, or the attraction of excessive moisture from other abutting building materials. Contributing factors also include poor air ventilation in the area.

Wood rot is often associated with general damp problems and is evidenced by a `musty` smell or mould and mildew occurring on surfaces. If left unmanaged, damp conditions can lead to further health problems and the decay of timbers will continue.

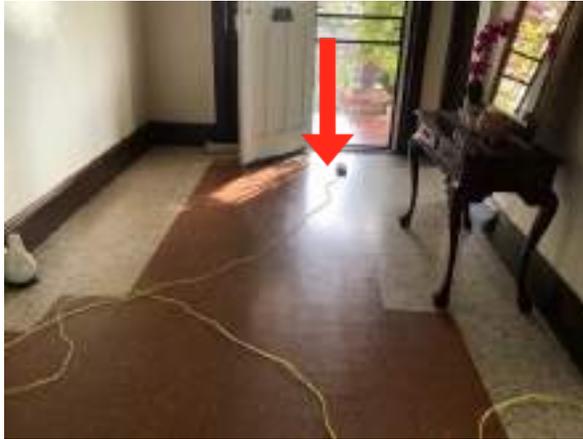
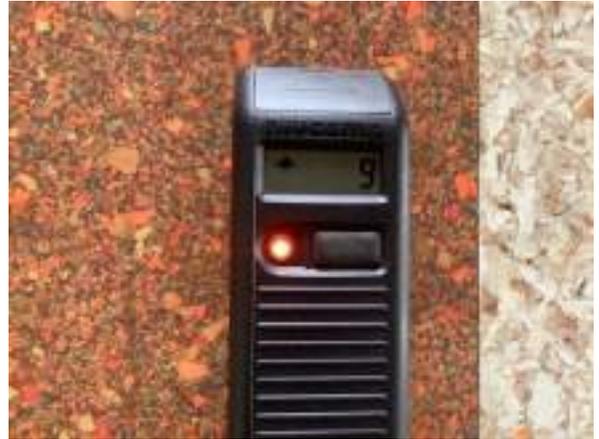
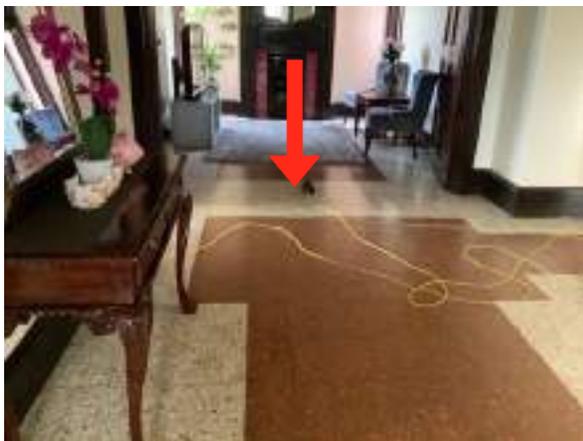
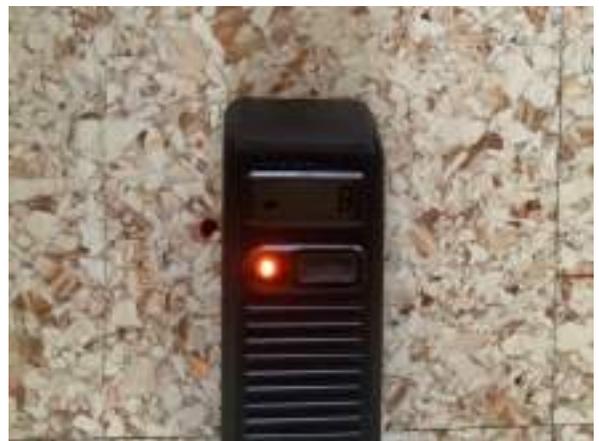
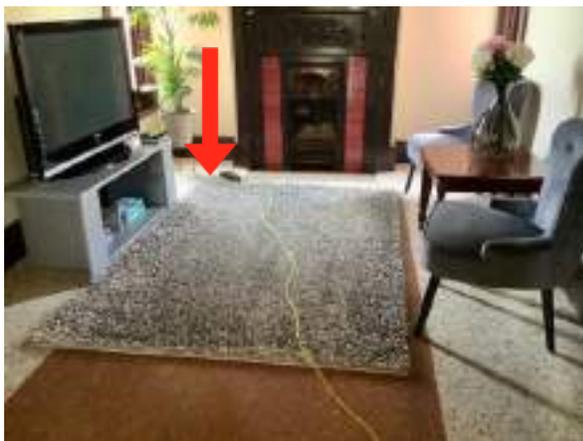
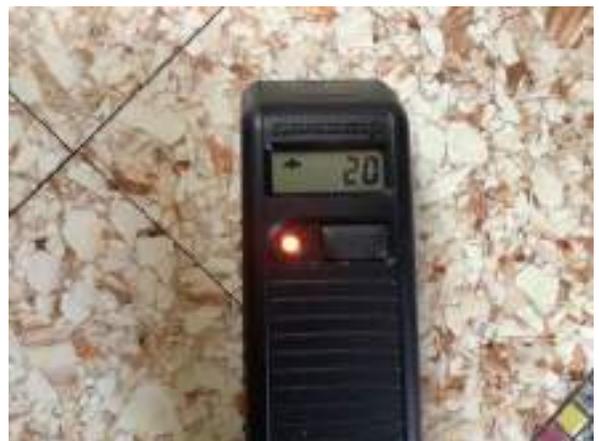
minor defects such as expected movement of the foundations of the property, but may also indicate subsidence of the associated subfloor stumps.

Whilst I have stated the above, there are other reasons why flooring can become out of level, such as wood rot, termite damage, timber shrinking, etc, however generally speaking subsidence over a home is generally related to the foundations and/or stumps moving.

It is advised that the flooring be closely monitored by a building consultant, registered builder or similar professional to identify any further movement. Where flooring remains relatively unchanged for an extended period of time (i.e. several months or seasons) it is likely that this defect has been caused by expected movement of the foundations of the property.

Where flooring has become uneven further, potentially invasive inspection of the subfloor structures and stumps in this area is required. In this case, works to repair are likely to be required, and would be carried out by a registered builder specialising or understanding the sub floor structure and the requirements of re-stumping.

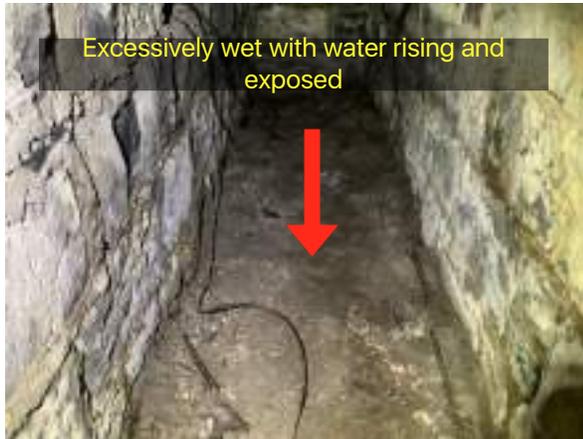
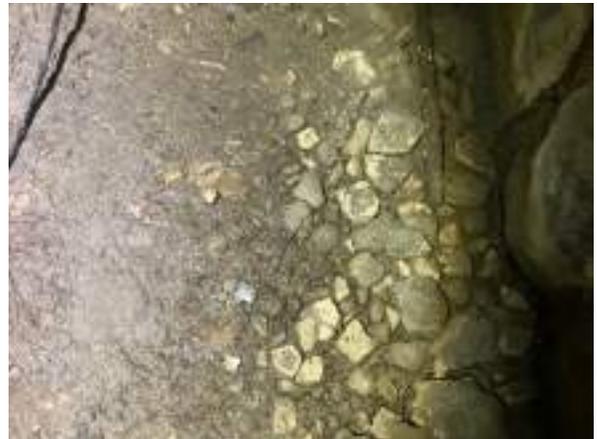
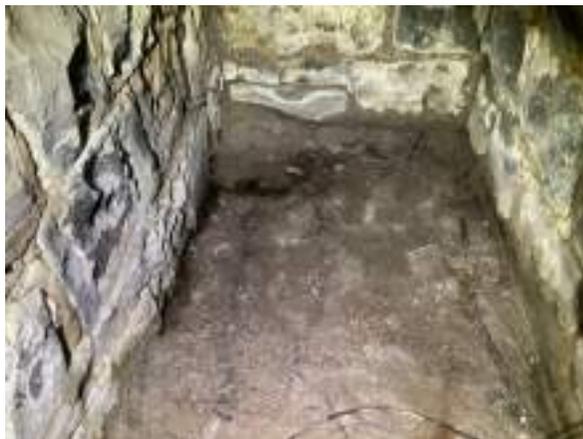
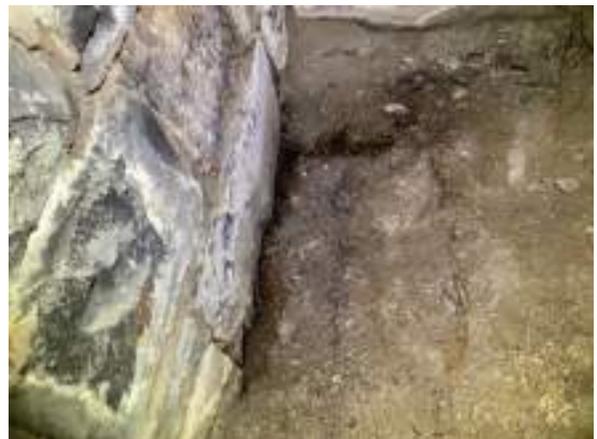
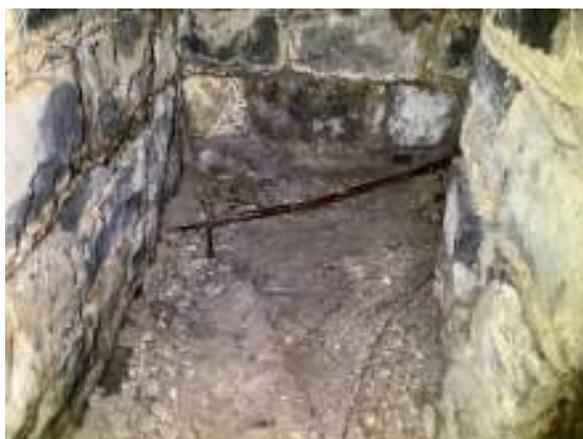
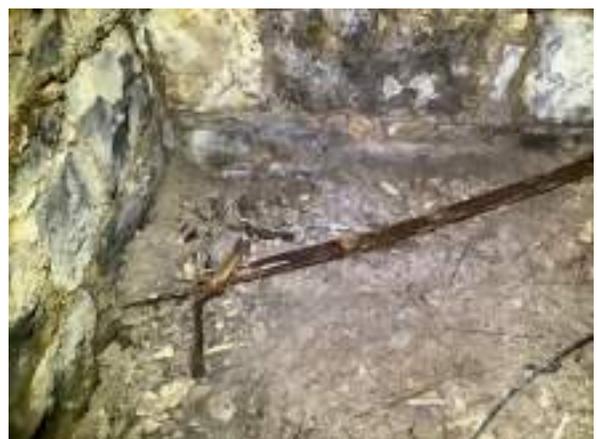
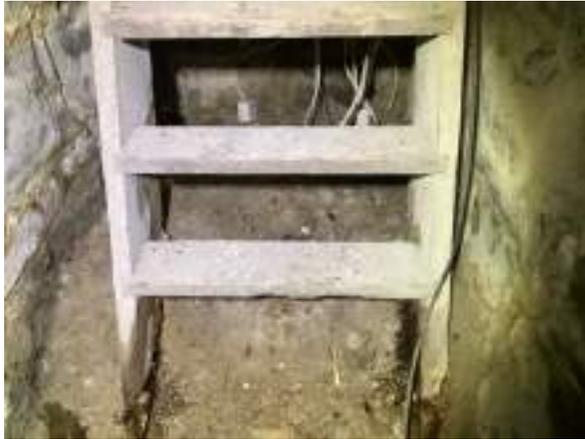
Once the cause is rectified further determinations may be required by a BUILDER AND OR STRUCTURAL ENGINEER AND SOMETIMES A GEOTECHNICAL ENGINEER.

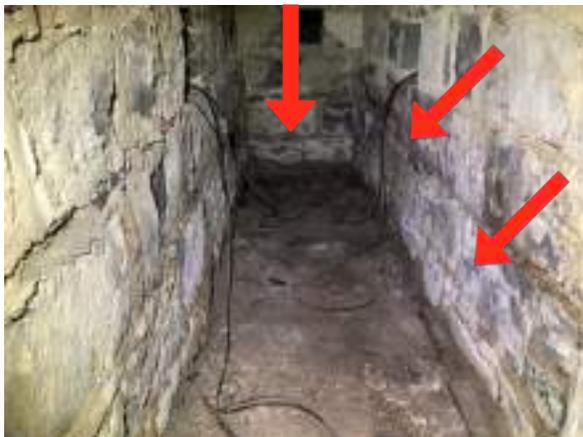
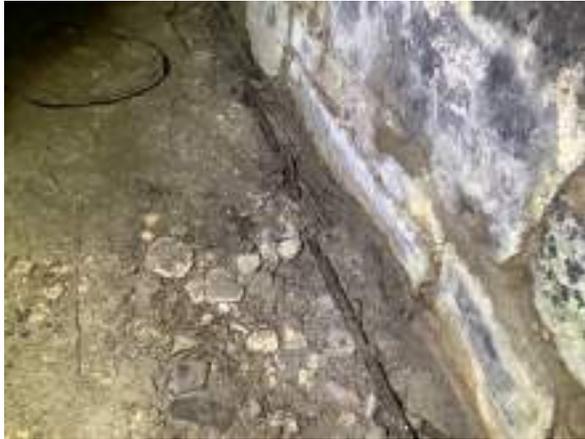
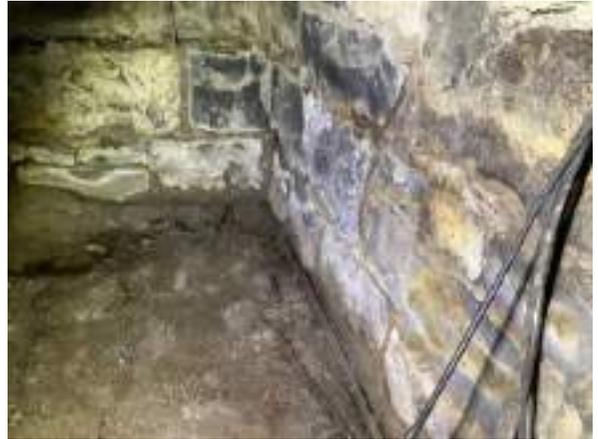
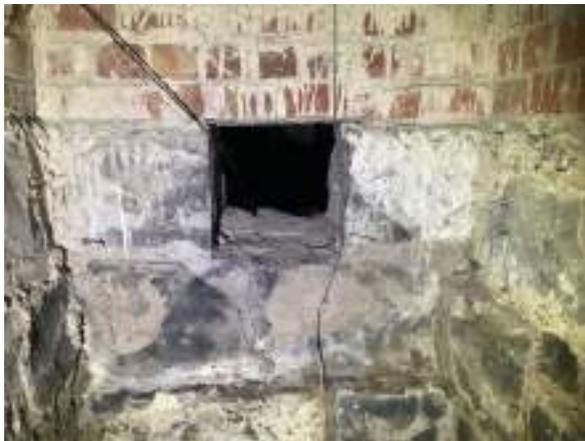
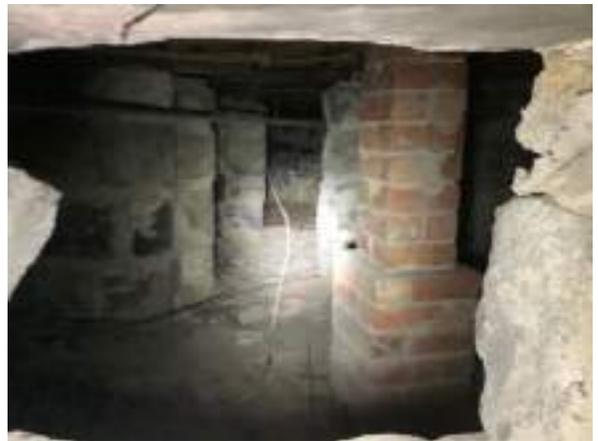
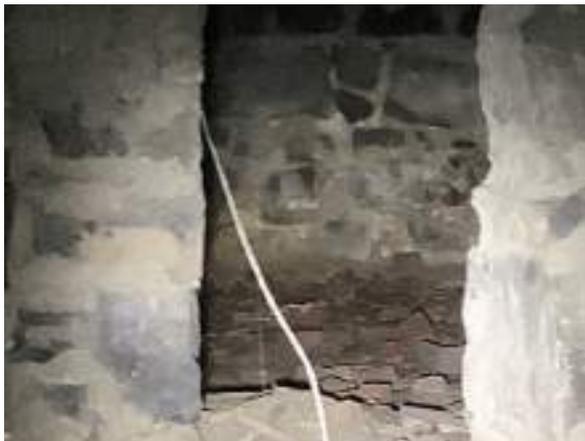
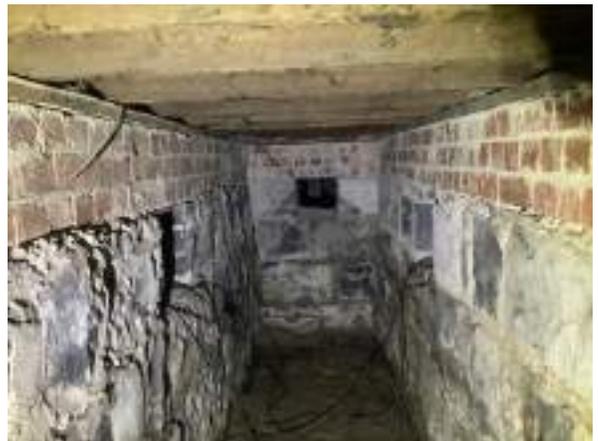
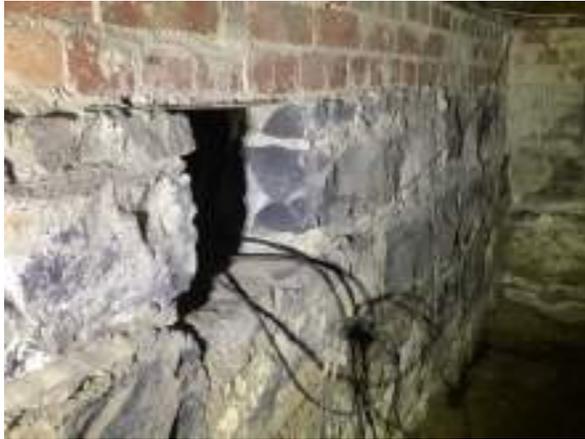
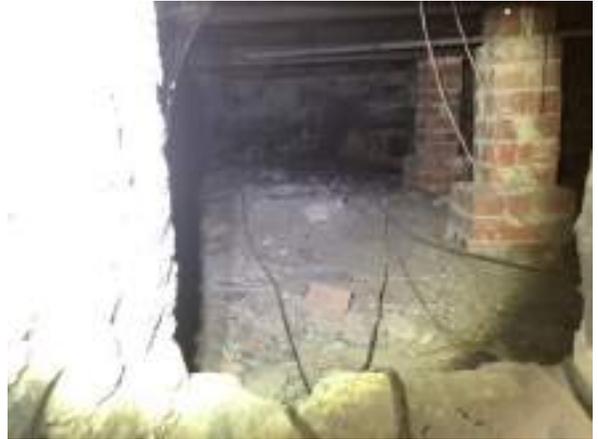
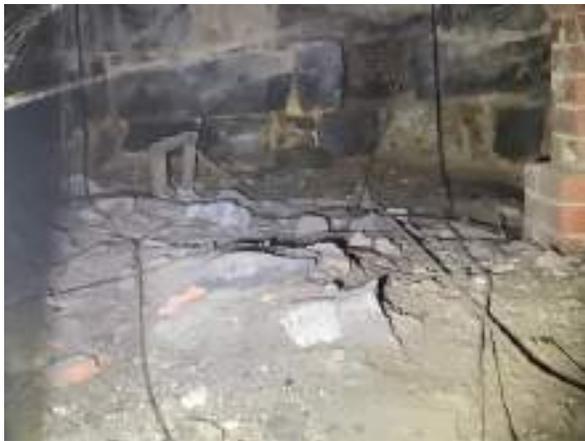
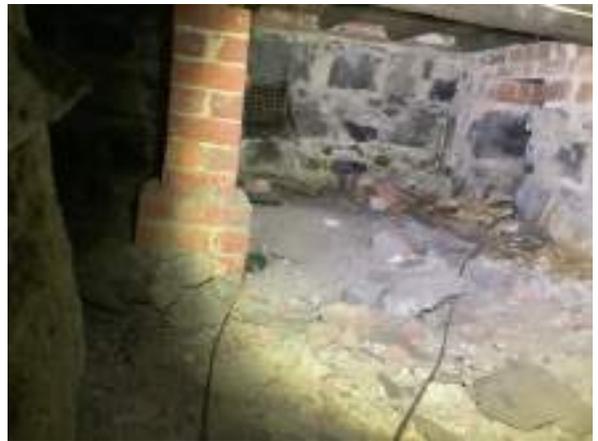
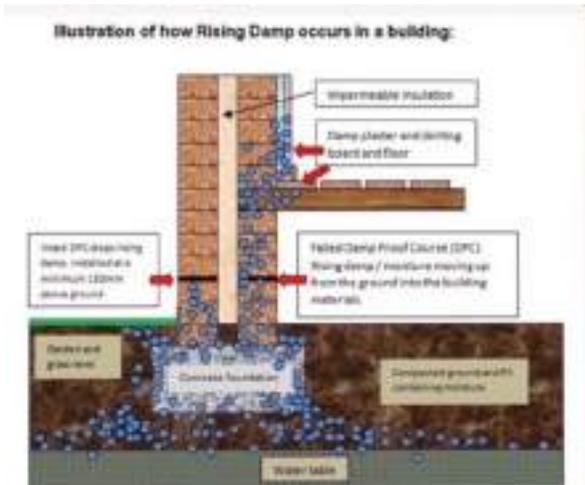
Major Defect 2.17

This defect statement is known as a major defect and a major structural defect as per the Australian Standards for prepurchase building inspections (AS 4349.1-2007)

Rising damp is generally managed by the installation of a damp proof course during construction. A Damp Proof Course (DPC) is an impermeable barrier at the base of the wall above ground level. However, many 19th Century buildings have no damp course installed, or the materials have failed. The DPC may have been omitted as a consequence of poor workmanship, or it may have been bridged where materials built up against the side of the house allow moisture ingress above the DPC level.

The first step in addressing rising damp is to diagnose the cause. The identified cause should be addressed first before addressing the appearance and other defects which have resulted from the rising damp. If the original cause is not resolved, further cases of damp are likely to ensue, resulting in secondary defects.

Consultation with a PLUMBER, BUILDER AND OR STRUCTURAL ENGINEER AND SOMETIMES A GEOTECHNICAL ENGINEER, and also more then likely a structural engineer is advised immediately to identify the cause of the damp and perform remedial works as required.

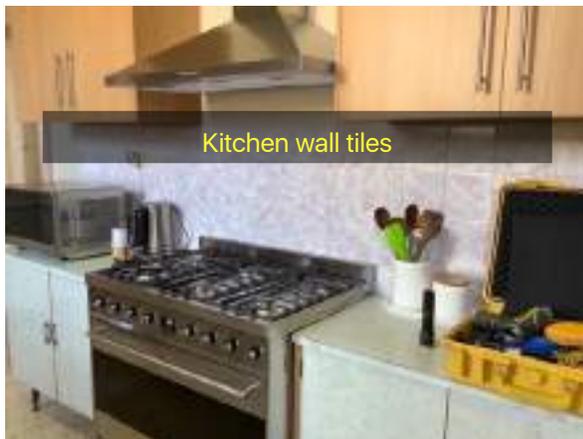
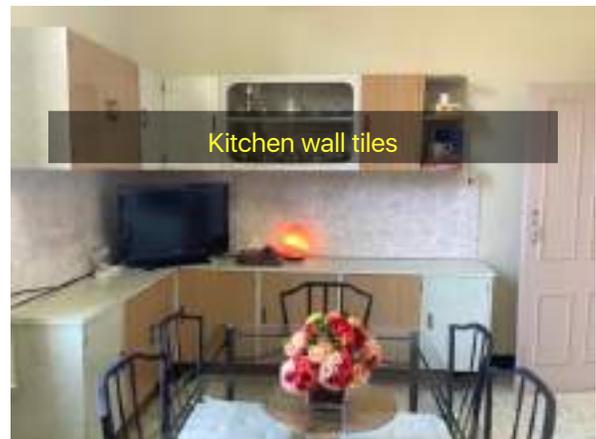
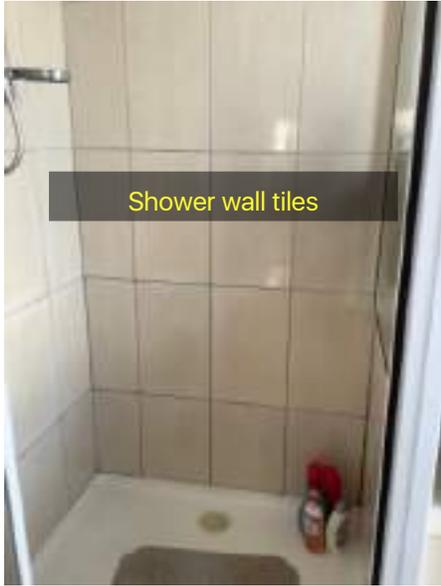
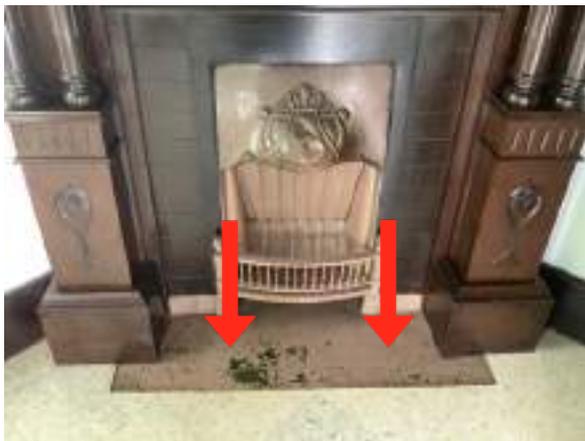
Minor Defect 3.18

Drummy tiles may also be contributed to tiles cracking and what is important is to determine the cause of the cracking, which may be related to the subfloor structure, typical wear and tear and/or poor workmanship

Such defects are generally caused by physical or moisture damage to the area. Drummy tiled areas may also be a direct result of poor workmanship during the construction process.

Any exposure to moisture is capable of causing tiled areas to become drummy and/or cracked over a prolonged period of time. Drummy tiled areas generally require removal and replacement of affected tiles, with adequate sealant and grouting.

The cause of the tiles cracking must be determined and repaired otherwise the same defect will occur.

Specialist trades are available for these types of services. A registered builder may be required to undertake works if damage is extensive or if secondary building defects have resulted. Otherwise, it is advised that a tiling contractor be appointed to perform works as necessary. Immediate action is recommended to ensure that no further damage is sustained in the affected area.

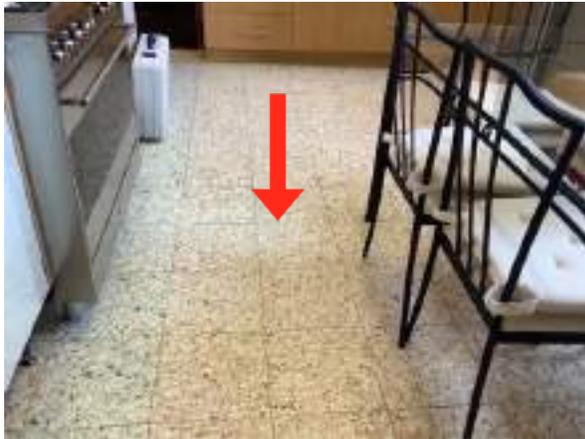
Minor Defect 3.19

Location: Floor Levels - All Areas

Bouncy floors generally indicate that the floorboards or the subfloor structures are coming loose from the joists that they are installed on. Bouncy flooring may also be the result of gaps between flooring and stumps or joist structures, which require packing.

Bouncy flooring may also be the result of gaps between flooring or joist structures, which require packing and/or addition adhesive and in addition, additional screw fixings.

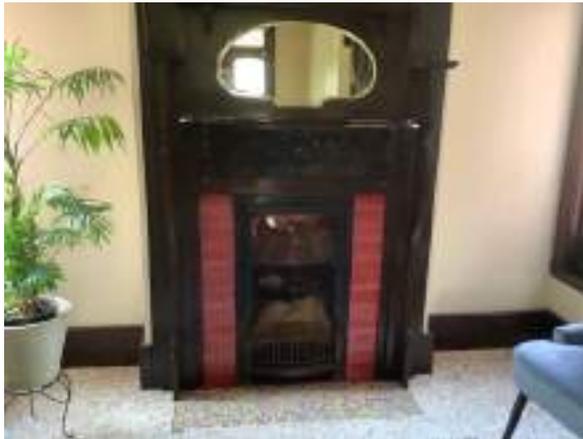
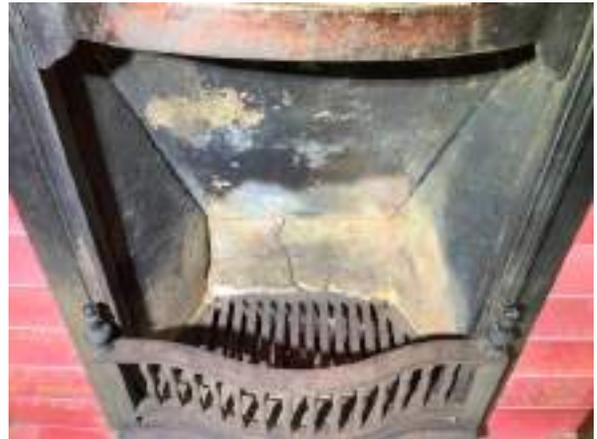
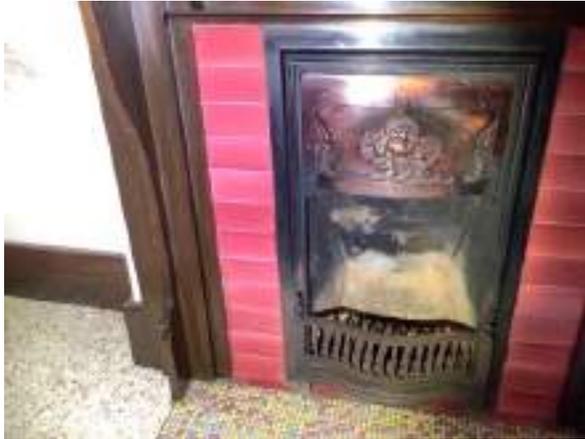
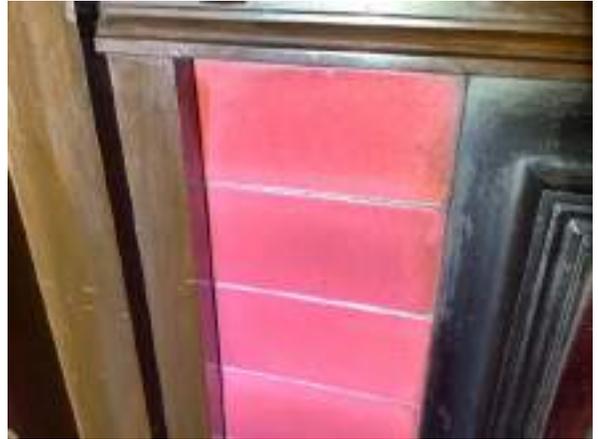
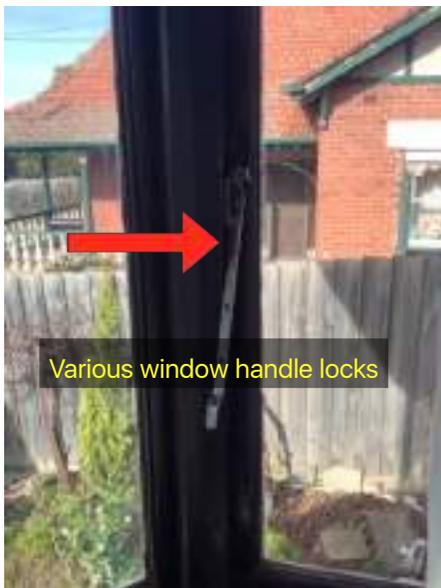
Minor Defect 3.20

Finding: Building Materials & Hardware That Is Worn / Aged and/or Damaged .

This may have been caused by water damage, moisture and/or general wear and tear. Replacement or repair (which ever is appropriate and cost effective) is up to you of the items attached.

It is IMPERATIVE that you engage registered and qualified trades and at the end of there works they must supply certificates, such as an electrical safety certificate, plumbing and gas certificate if the works are electrical or plumbing, but for items such as damaged door handles, painting an experienced carpenter or handyman can sometimes be engaged.

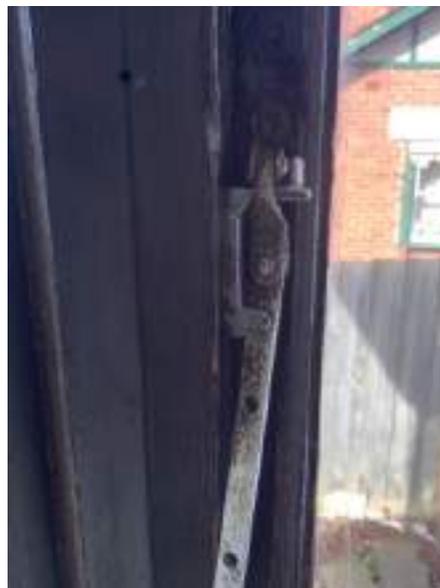
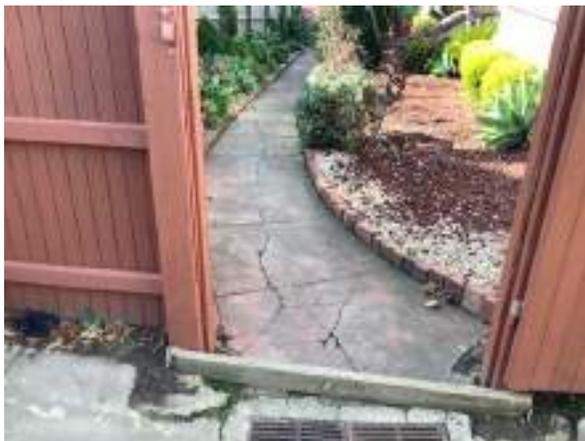
Various window handle locks

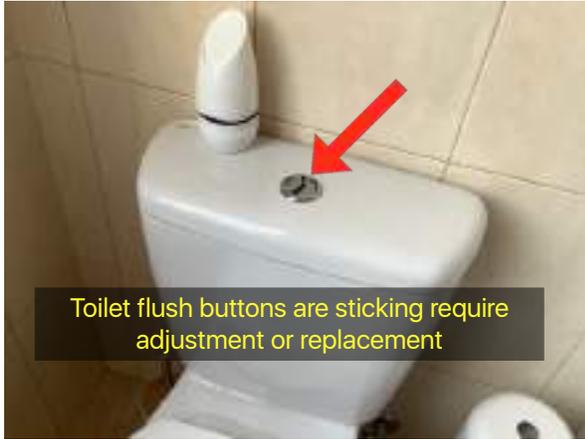
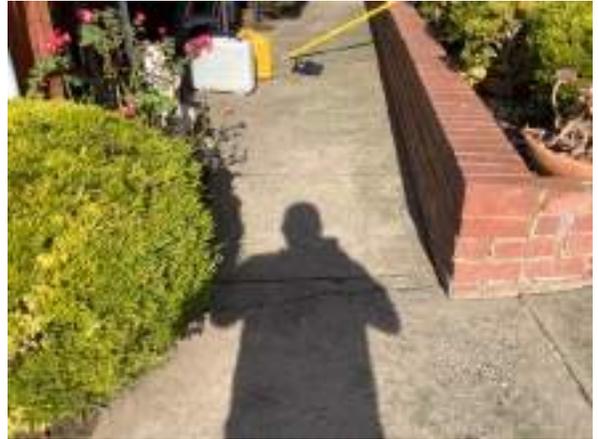
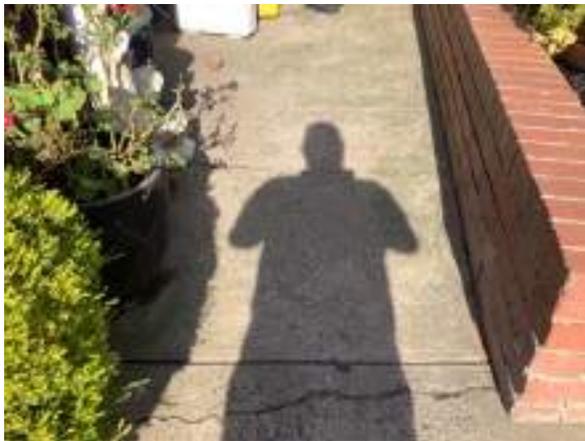
Toilet flush buttons are sticking require adjustment or replacement
