Year-1890 Old Mansion, Building & Termite, Timber Pest

Inspection Date: 27 Jul 2020

Property Address: Ascot Vale Area

Report Type: Property and Timber Pest Report

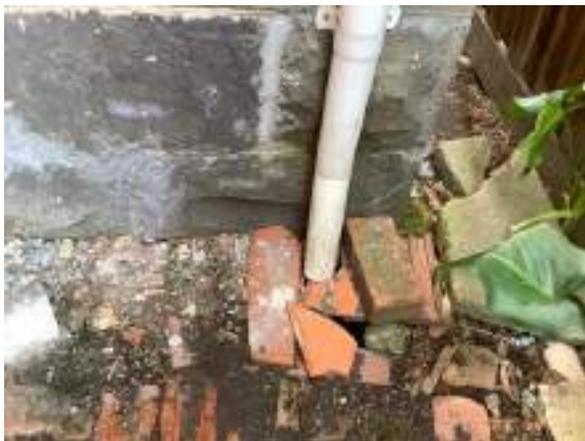
Minor Defect 3.21

These Defects are of Sub Standard Workmanship or Incomplete and not finished to a tradesmens like manner.

Unfinished and substandard building works are likely to degrade more quickly and may create potential for secondary defects to associated building elements and surrounding structures, also the workmanship is VERY displeasing to the eye.

Generally substandard repairs or installation are related to poor workmanship, the use of inappropriate materials, or a failure to complete installation to a suitable standard.

Where installation is substandard and/or incomplete, the client should contact the responsible trade to undertake rectification works, which are advised as soon as possible.

The appropriate tradesperson or specialist or handyman should be appointed to complete the various items for repair and organise the appropriate QUALIFIED trades (or not pending on job) to repair and complete the works to illiminate or reduce further deterioration / disfunction.

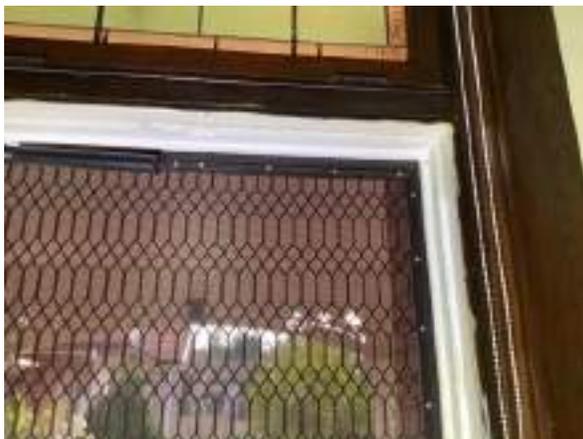
Minor Defect 3.22

Finding: Paint / Plaster - Lath and Plaster and/or Hairline - Defects To Doors, Architraves, Walls & Ceilings, ETC.

Superficial scuff marks, damaged plaster, holes in walls,missing paint,sub-standard paint work were noted to the internal walls / ceilings and/or architraves as per the photos attached at the time of inspection.

This degree of surface damage is consistent with general damage, accidents, movement and wear and tear.

Ultimately an experienced professional can generally put you on the right direction before spending a lot of money on repairing (lath and plaster walls & hair line plaster walls or ceilings)

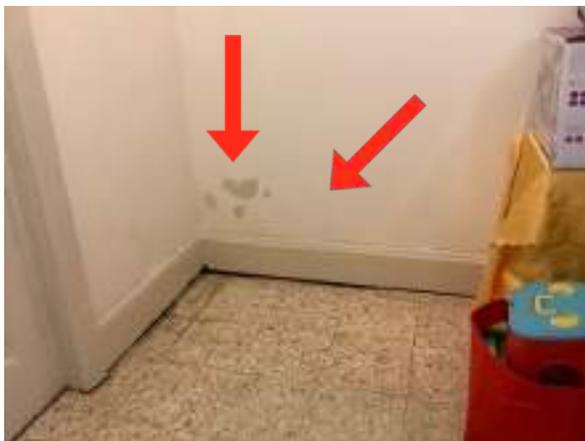
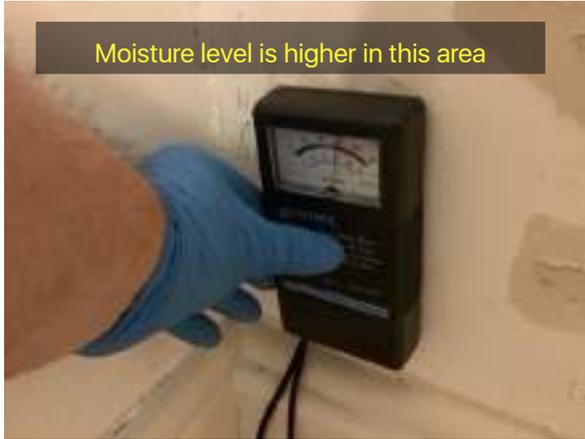
Minor Defect 3.23

Location: Paint Internal Areas
Finding: Painted surface - Bubbling
Small room at the end of the hallway

Sections of paint in this area was found to have bubbled and deteriorated. Paint bubbling is generally an indication of excessive moisture in the area, that is currently hidden by the painted surface.

The presence of excessive moisture can have major implications on associated building elements if left unattended. While only seemingly minor at this stage, the damage cannot be determined due to the paint obstructing any further inspection of the damage.

It is highly advised that the affected paint be cleaned to allow a further, more invasive inspection by a licensed plumber. Failure to act on this defect may necessitate major works in the future.

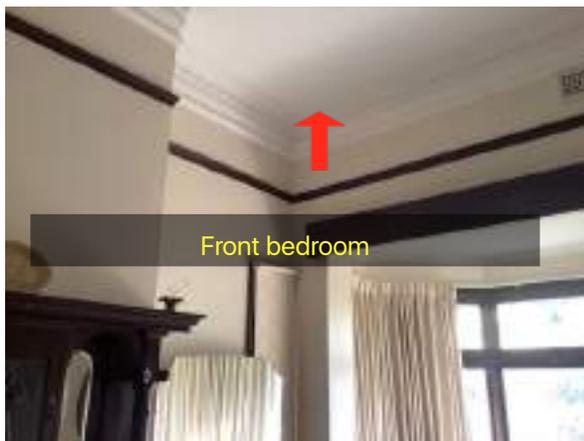
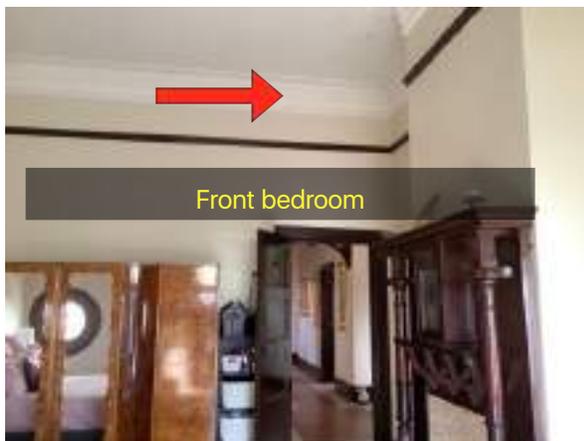
Minor Defect 3.24

Location: Plaster Internal Areas

Finding: Plaster Cracking / Timber - Damage Category 3 - Repair Required (5mm-15mm or a grouping or cluster of cracks of 3mm or more)
 Whilst we may have a photo of damaged paint, or a minor plaster cracking, etc, there may be many more paint/plaster defects and plaster cracking in many more areas throughout the property.

Cracks of this type are likely to have been caused by minor, expected movement of building elements, but may also have a structural cause that is more significant. Cracking of this degree may result in doors and windows sticking or jamming, but may have more serious implications, such as fracturing service pipes. Weather tightness (the ability to resist rain and wind) is also often impaired, creating potential for the development of secondary defects.

A crack of this size may be repaired. However, these repairs may also include further works, such as easement of associated window and door frames that are jamming, as well as more extensive filling, sanding and/or repainting.

It is highly recommended to gain quotations on repair and restoration works that are required. Always contact your building inspector should cracks widen, lengthen or become more numerous.

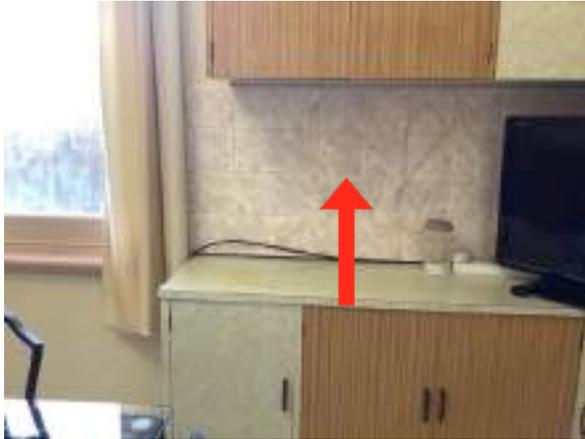
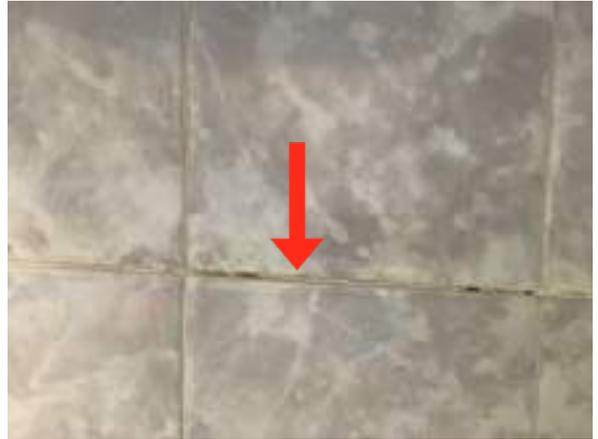
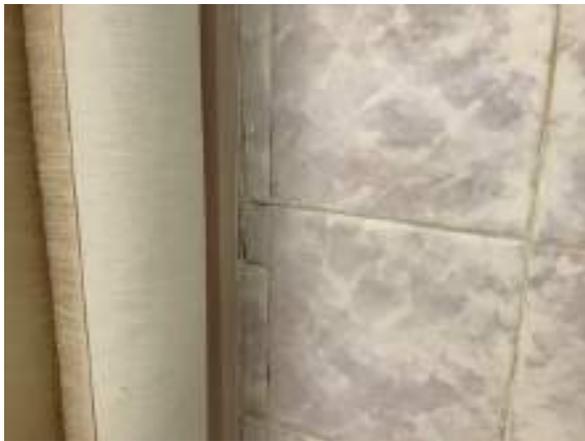
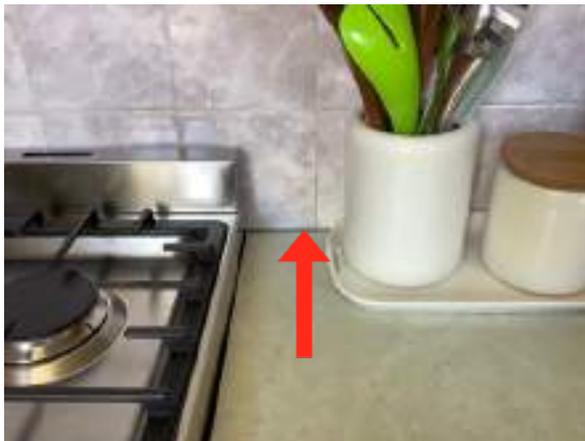
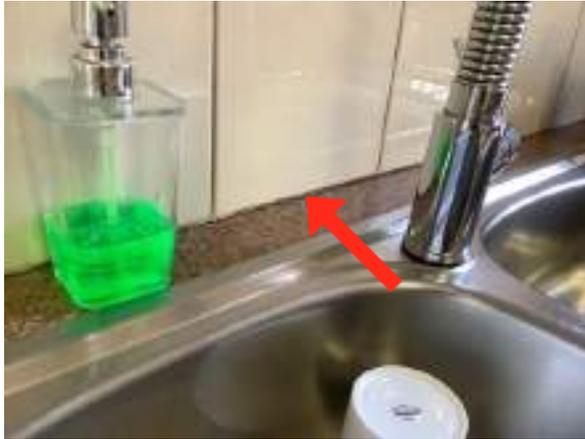
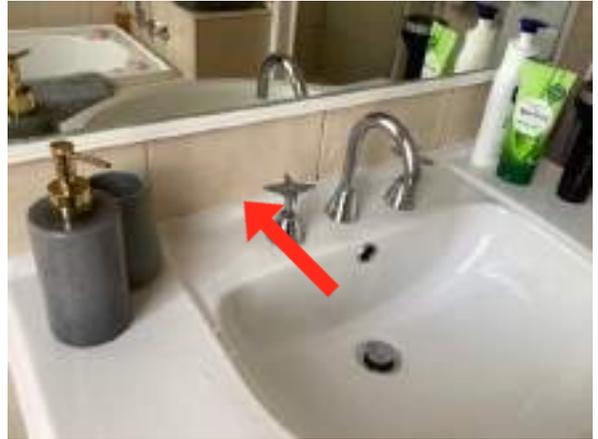
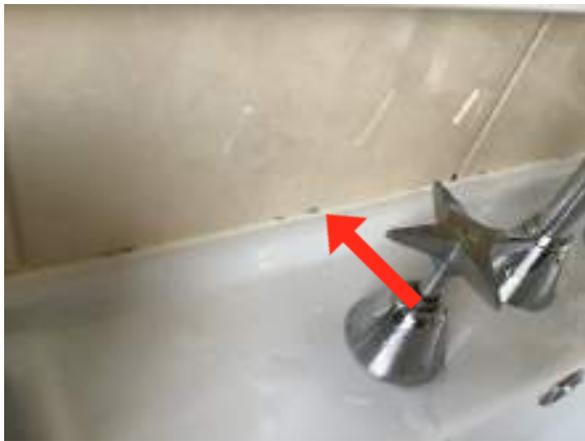
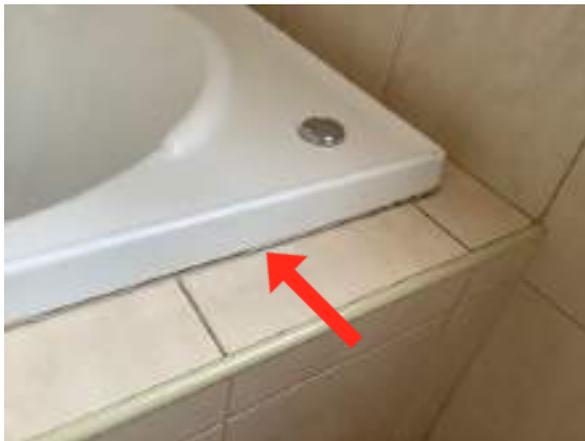
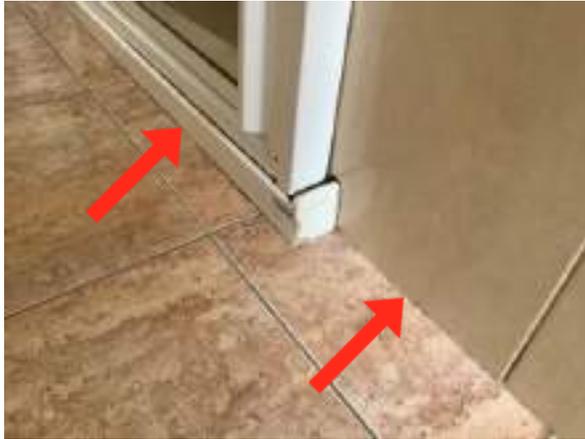
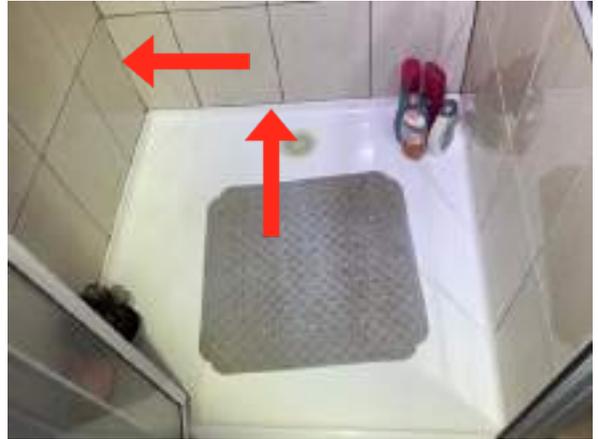
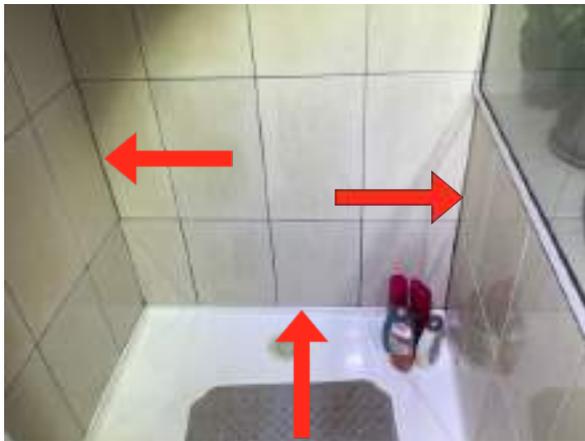
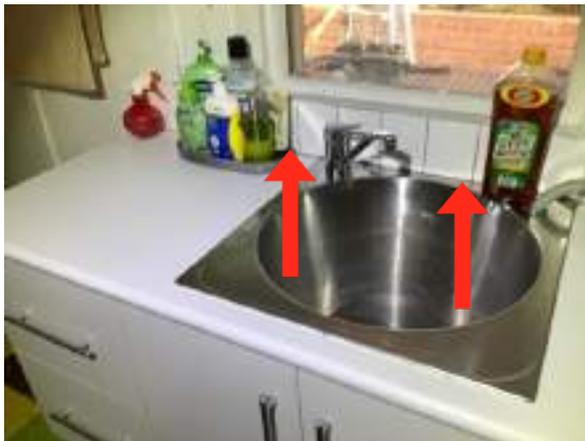
Minor Defect 3.25

Location: Caulking / Silicone-All Wet Areas

Finding: Silicon / Caulking To All Wet Area Junctions and Tile Grouting - Missing or Damaged - Internal Areas

It was noted on inspection that sealant and/or tile grout is missing, damaged or inadequate to the tiled wet areas. This may include floor edges, kitchen benches/splashbacks, vanities, bath tub edges, shower areas to the floor and wall tiles, laundry's and all other areas subjected to water or moisture.

Sealant and/or tile grout where missing, damaged or inadequate to the tiled wet areas allows the water to penetrate into the walls and floors which can cause much damage, to the affect were the damage may become a secondary defect and create a conducive environment for termites and/or cause rotting to the timber studs, floor joists and bearers or plaster etc, especially in showers, baths, laundry and the like

Whilst in some of the areas there is sealant/silicon , it has become apparent that the sealant has deteriorated and/or is just missing.

Whilst in some of the tile mortar is perfect , it has become apparent that the tile mortar has deteriorated and/or is just missing in other areas.

A flexible sealant/silicon and tile mortar should be applied to affected areas to prevent any subsequent water damage that is likely to occur.

A sealant specialist, tiling contractor and/or registered builder should be appointed to assess any damage caused by water to the entire internal, sub-floor, walls etc of the building and clean, take off old sealant and tile mortar, then re-seal and re-mortar these works as soon as possible.

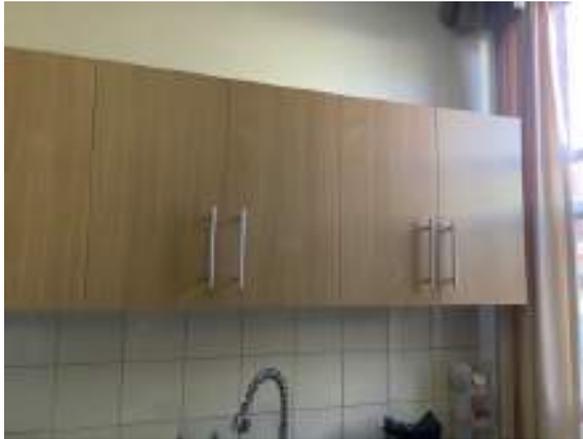
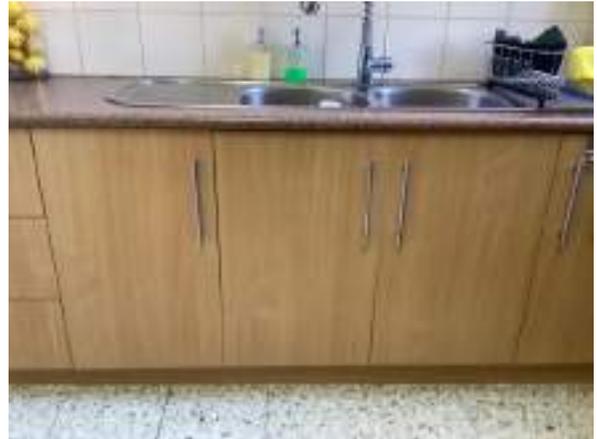
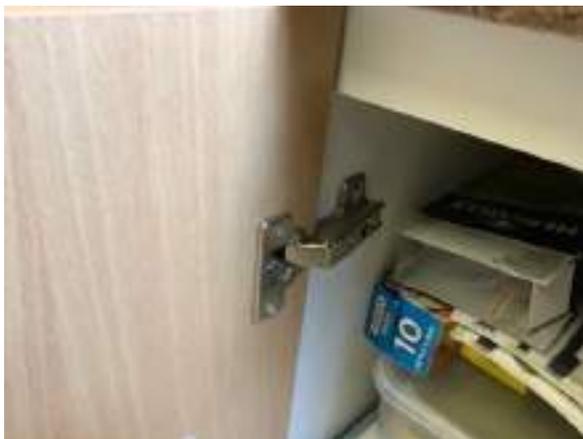
Minor Defect 3.26

Location: Cabinetry / Wardrobe Doors Internal Areas

Finding: Cabinetry - Loose hinges / Re-adjustment
Several cupboard / wardrobe doors are not level and detract from the operational state of the cabinetry and doors.
Upon further inspection, it was noted that the hinges to the cupboard doors have deteriorated or just need adjustment. This as a result over time that they have just come loose or deteriorated from their original fixing.

To improve operation of the affected doors, a general handyman / cabinetmaker/ carpenter may be appointed to replace the faulty hinges and/or adjust .

Such works should be completed at the discretion of the client, but we do recommend repairs so that there is no further damages to the existing cabinets or cupboards.

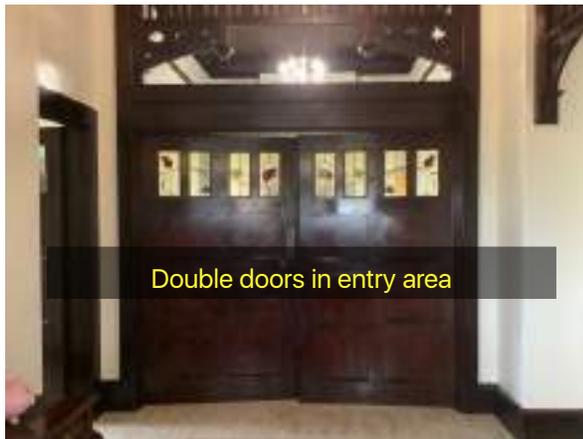
Minor Defect 3.27

Location: Doors - Internal Areas

This defect inhibits the functionality of the affected door as well as creating potential for secondary defects to associated building elements, such as damage to the floor covering.

A door that binds to flooring or to the associated door frame may have several causes, ranging from minor defects, such as poor installation of the door or deteriorated hinges, through to major structural issues, such as damage and/or subsidence (sinking) to subfloor structures.

For minor causes, a qualified carpenter or general handyperson should be appointed to perform minor rectification works at client discretion.

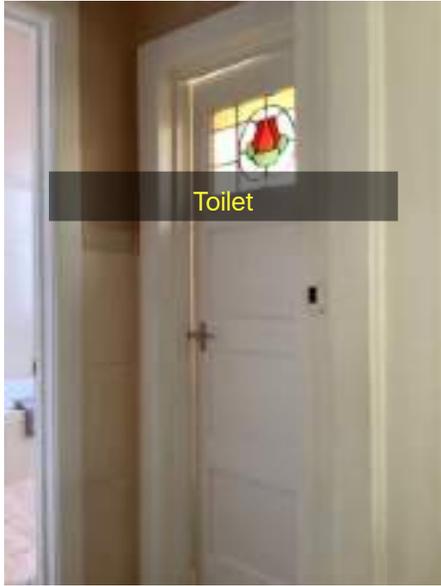
Minor Defect 3.28

Location: Doors - Internal Areas

Finding: Door stop - Missing

The door stop is missing or is inadequate to stop the door handle from damaging the wall. Although some building elements may seem irrelevant or unnecessary, all building elements play a key role in the operation and function of the overall structure and its performance.

Re-installation or replacement of the door stop is advised as soon as possible to prevent any subsequent damage to the door or associated structures.

A general handyman may be appointed to perform these works at client discretion.

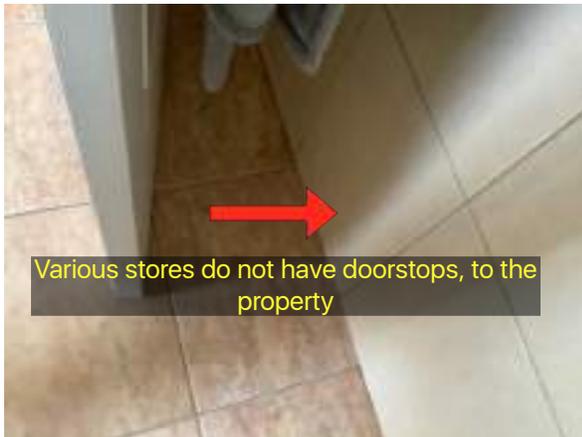
Minor Defect 3.29

Location: Doors - Internal Areas

This is a common defect and is expected in a property of this age, whether being due to substandard installation or general deterioration of the door hardware and sometimes also the associated hinges

Readjustment of the striker plate and/or hinges is recommended at client discretion.

A qualified carpenter or general handyperson may be appointed to perform rectification works as necessary, at client discretion.

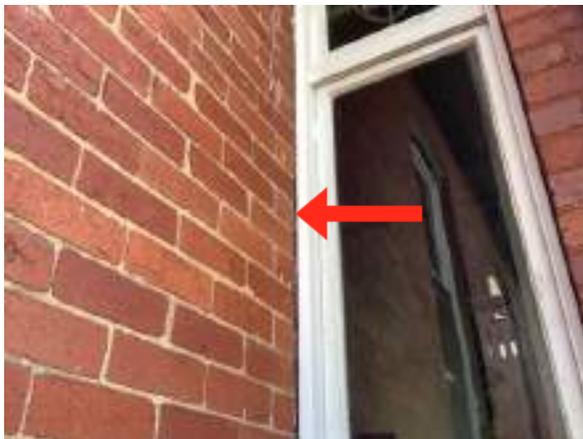
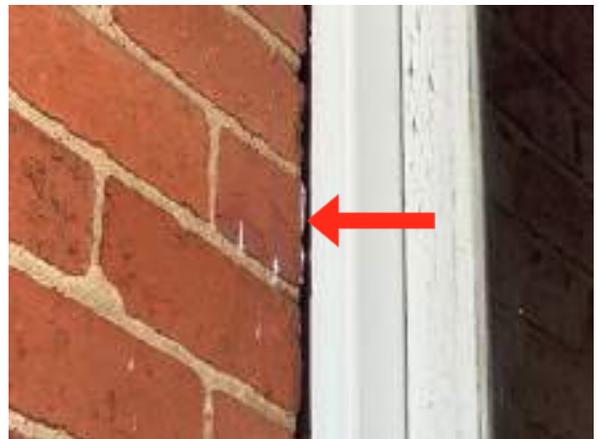
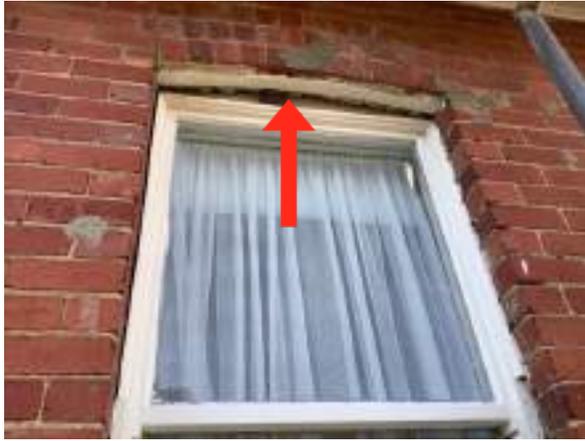
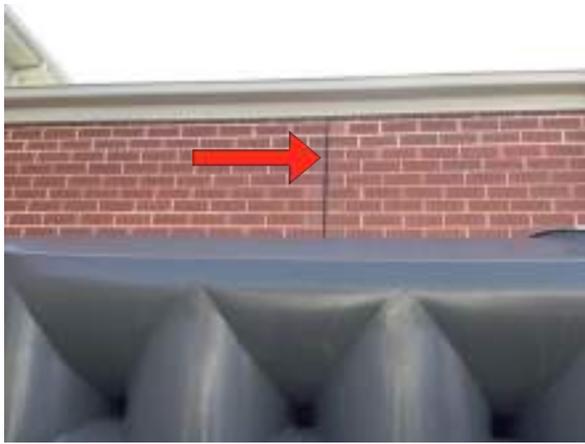
It is important to note once caulking these areas if water damage is noticeable to windows, timbers, etc, such as wood rott, it is imperative to engage the appropriate trades for replacement or repairs.

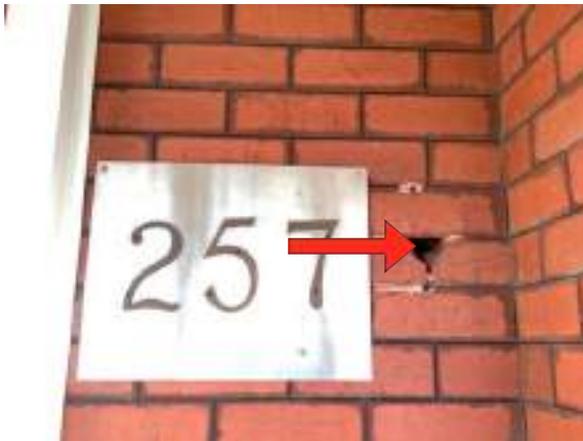
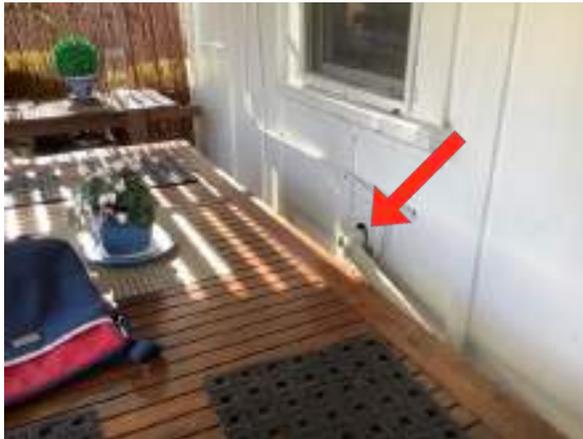
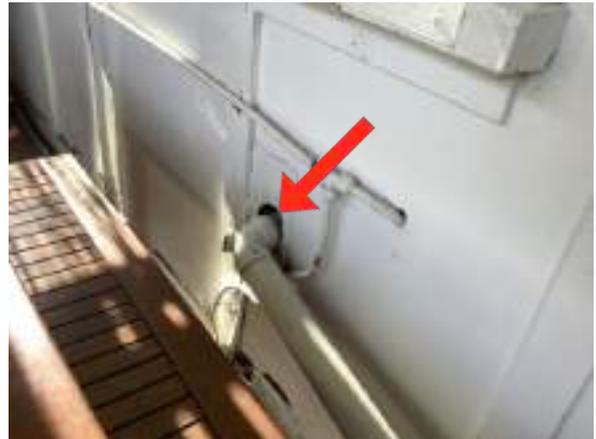
Minor Defect 3.34

An external hole was located at the time of inspection. This hole appears to be large enough to allow bird, rodent or other pest ingress creating the potential for nesting or infestation of live animals.

To ensure no such infestation occurs this hole should be adequately covered. Holes such as these are also likely to attract rain penetration which may lead to subsequent water damage to associated structures if left unmanaged.

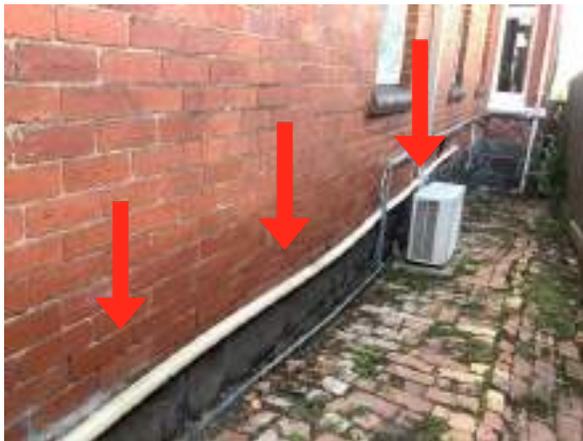
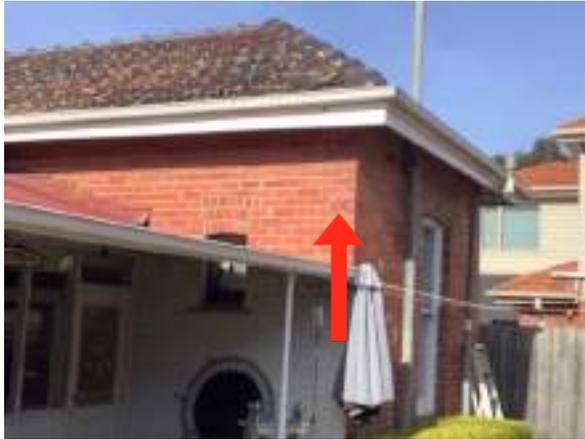
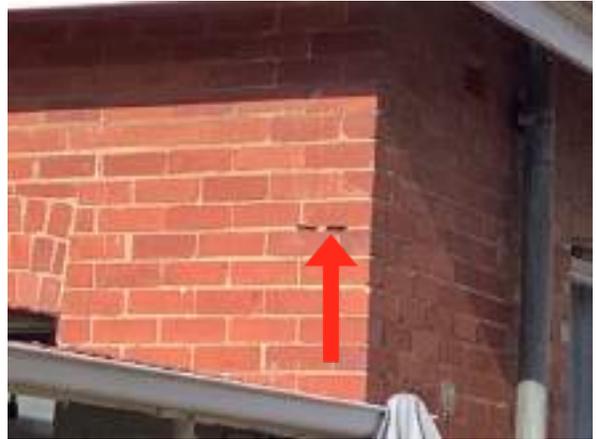
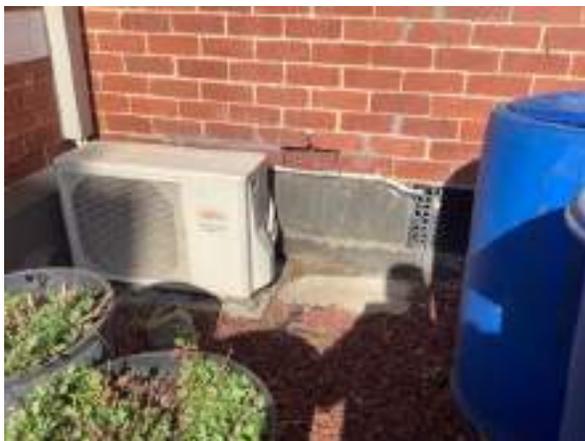
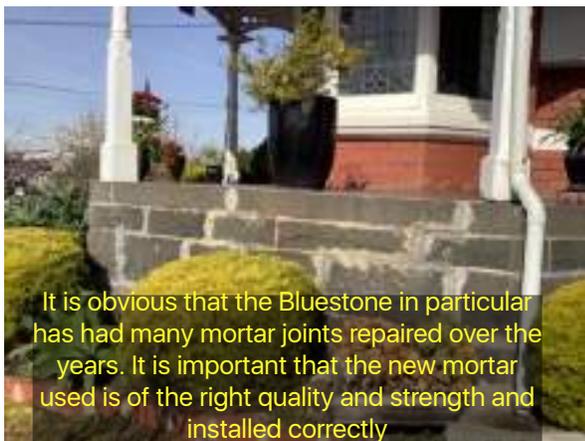
Minor Defect 3.35

Finding: Brickwork - Deteriorated mortar - Minor

The mortar is deteriorating, into the brick mortar joints, however at this stage, it does not appear to be deteriorated at a level that is a structural concern.

This generally occurs as when the building was built, the bricklayers used to put a special chemical adhesive into the brick mortar mix as a waterproof, however it is now become apparent that over time on some homes the chemicals are eating into the brick mortar and this will continue in some cases, so I highly recommend that this item be monitored over time by an appropriate and competent person.

It is obvious that the Bluestone in particular has had many mortar joints repaired over the years. It is important that the new mortar used is of the right quality and strength and installed correctly

Mortar deterioration can be addressed by a bricklayer where areas of deterioration are localised and easily accessible. Alternatively, appointment of a registered builder is advised, to repoint large areas of decaying mortar.

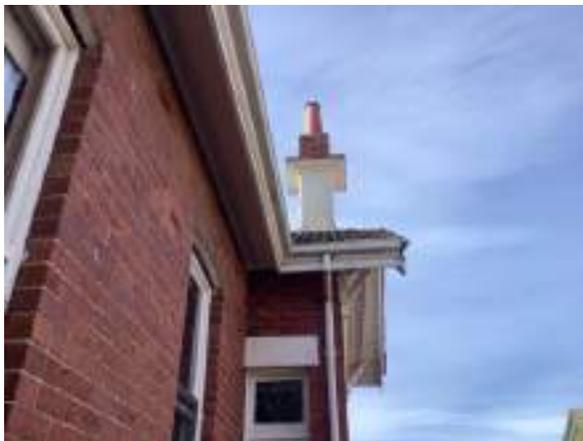
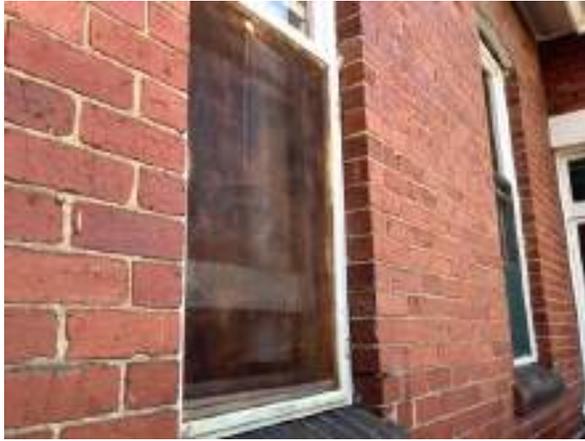
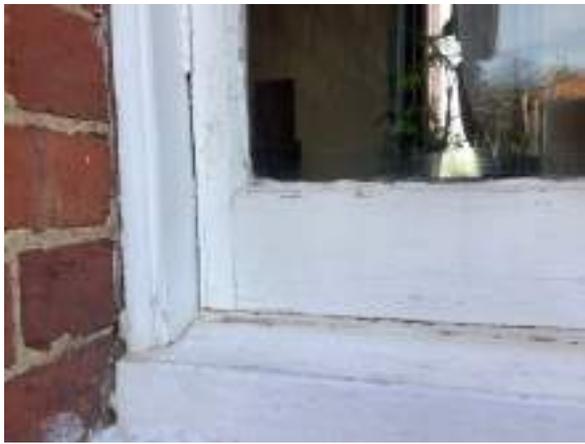
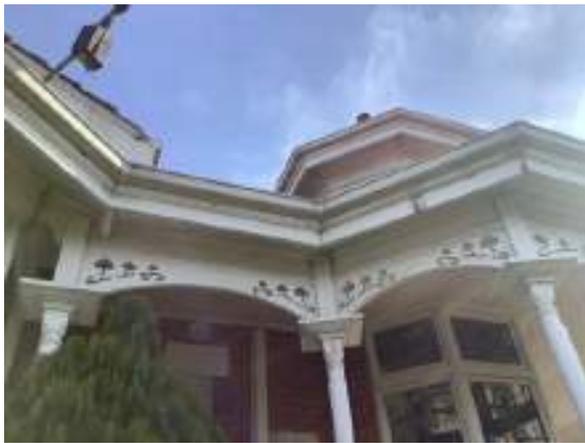
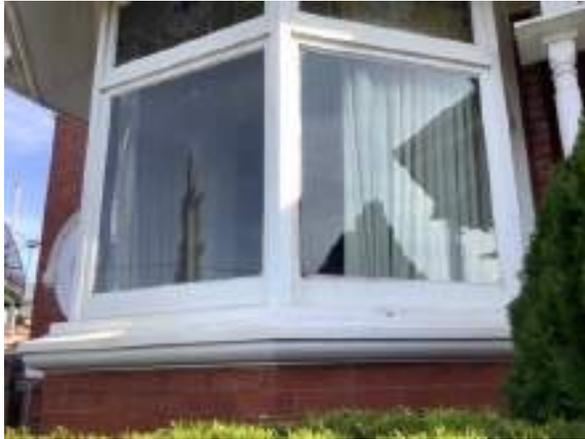
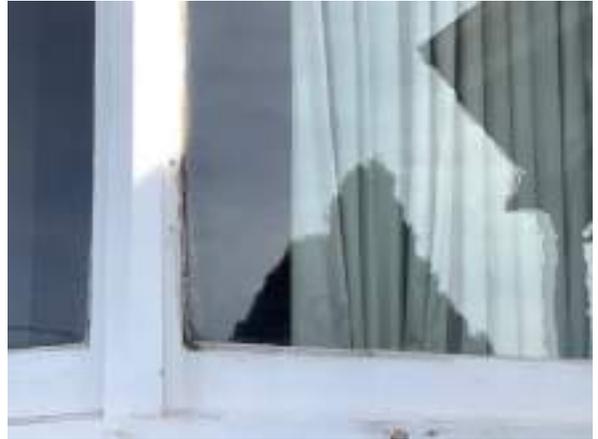
Minor Defect 3.37

Finding: Timber, exposed to weather / External painting deteriorated
Much of the external paint work including but not limited to windows, fascias, guttering, veranda and other external fitments have been neglected and require attention to prepare and re paint.
External timbers that are frequently exposed to harsh weather conditions require adequate protection (paint) in order to maintain their condition. Where timbers have not been painted or treated adequately, general deterioration is likely to occur at an accelerated rate.

Whilst incomplete or missing paint finish is generally an appearance defect, it can also lead to the development of secondary building defects over time. Incomplete areas of paint finish exposes the area to moisture, potentially accelerating the deterioration of underlying building materials.

Degraded paint finishes should be sanded back, filled, leveled and painted, as applicable. Where inadequate or missing paint protection has led to the deterioration of the associated building element, repair and/or replacement of this building element may be required.

If left unattended, replacement of these timbers is likely to be necessary in the short-term future. Adequate treatment of these timbers is required as soon as possible by a painting contractor should be appointed as soon as possible to perform necessary works to aid the appearance of the affected area and to ensure the area is protected against further deterioration. Alternatively, the homeowner following manufacturer instructions may perform these works.

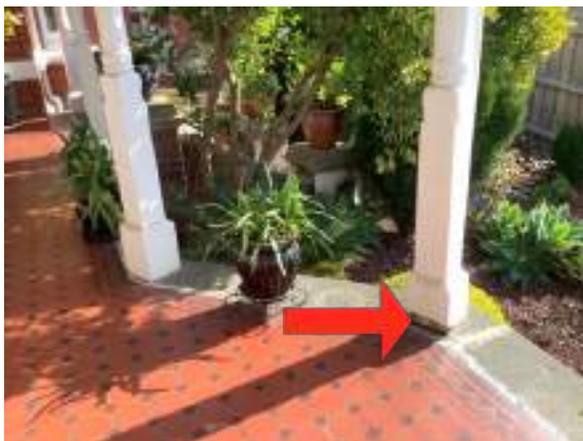
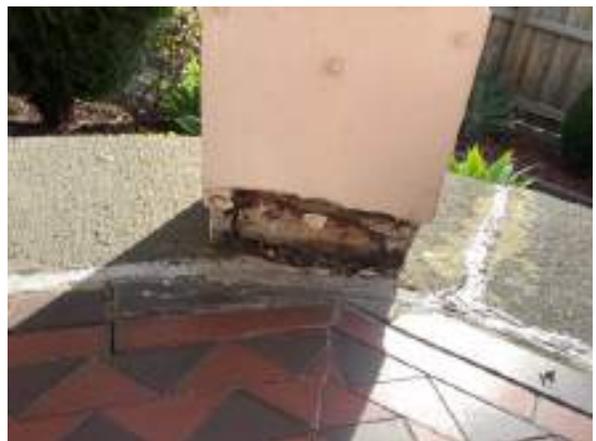
Minor Defect 3.38

Finding: Wood Rot

Wood rot is often associated with general damp problems and is evidenced by a `musty` smell or mould and mildew occurring on surfaces. If left unmanaged, damp conditions can lead to further health problems and the decay of timbers will continue.

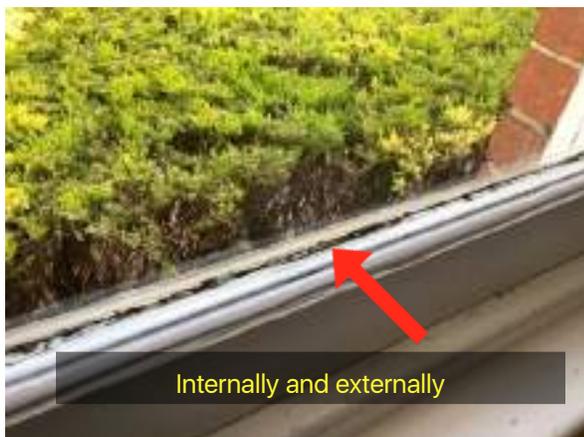
Minor Defect 3.39

Location: Windows - External

Finding: Window Seals - Deteriorated

In the case of window seals that may have also deteriorated on this building, then window seals that have deteriorated and/or are in a generally poor condition, due to frequent exposure to weather conditions and subsequent moisture, deterioration of window seals is expected in a property of this condition and age.

Where window seals have deteriorated, the window is no longer weather-tight; rain penetration and subsequent water damage is therefore likely to ensue. Insulation of the area against external weather conditions will also be compromised.

It is recommended that all deteriorated window seals be replaced by a general handyman, window technician, glazier, builder or sealant expert to prevent any further damage and to restore the window to a fully functional level. Damaged window seals can be rubber, silicon or with the old windows a special type window putty.

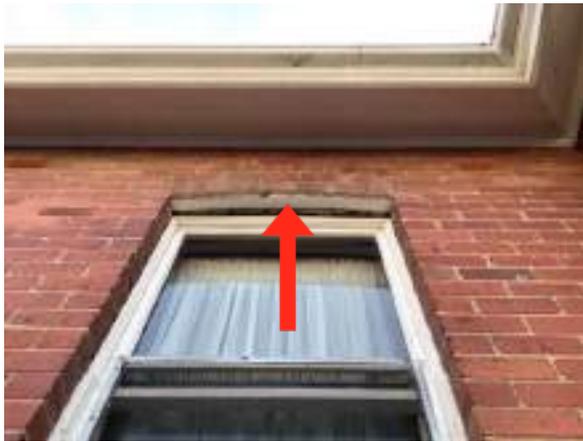
Minor Defect 3.40

Location: Lintels - Above All Exterior Openings.

Finding: Lintels - Rusted / Corroded

Severe rusting to lintels can create severe secondary defects, especially when the rust has corroded right into the lintel and in cases such as severe rust a structural engineer may be require to assess the damage.

As surface rust provides no protection to the underlying iron, the deteriorating condition is likely to worsen if not addressed in the short-term future.

Where possible, the use of galvanised (treated) metals or aluminium coated metals aid in rust prevention, as does regular general maintenance. Rust formation can be controlled with coatings, such as paint, that isolate the iron from the environment.

Rusting and corrosion should be managed by ideally removing or limiting the affected surface from exposure to moisture.

A registered builder may be appointed to replace any building elements that have been severely affected by rust or water damage.

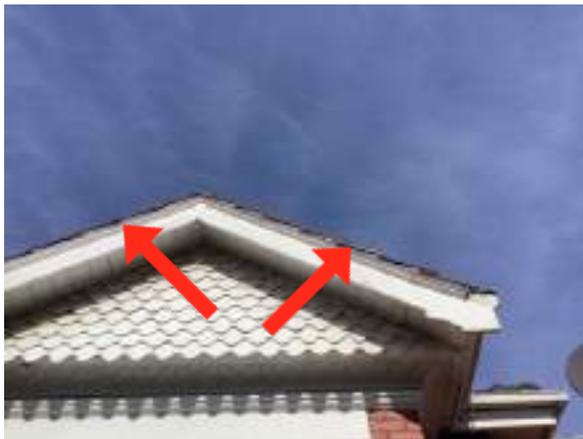
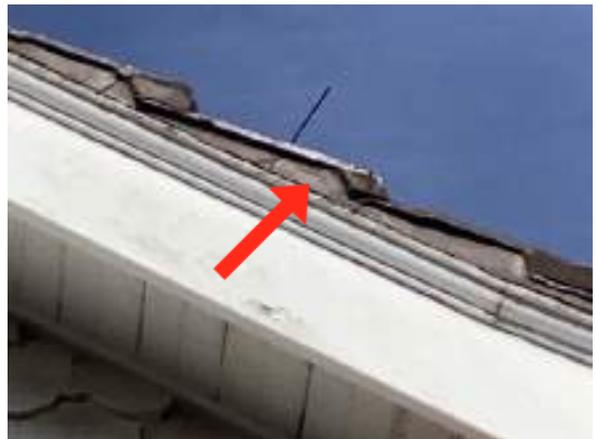
Minor Defect 3.41

Location: Roof Areas & Stormwater

Finding: Roof Capping - Mortar Deteriorated.

Upon inspection of the exterior roofing, the majority of roof tiles were considered to be in a reasonably good condition. While weathering of the tiles is consistent with the age of the property, maintenance works are required.

Upon inspection of the exterior roof, it was noted that sections of the mortar show varying levels of deterioration.

Areas of mortar have come loose in the Valleys, Hips and/or Ridges, cracking and areas of insufficient and/or no mortar is also present.

Where left unmanaged, deteriorating roof tiles are likely to lead to a number of secondary defects, including minor and/or major water leaks and weather exposure to internal roofing structures.

Remedial works are likely to increase the longevity of the exterior roofing structure.

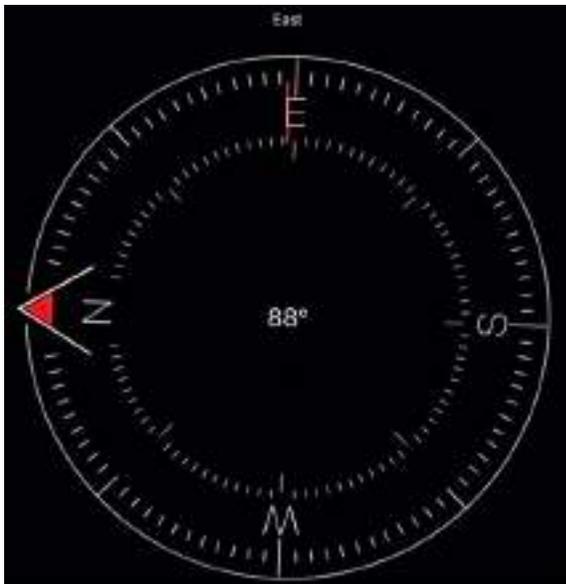
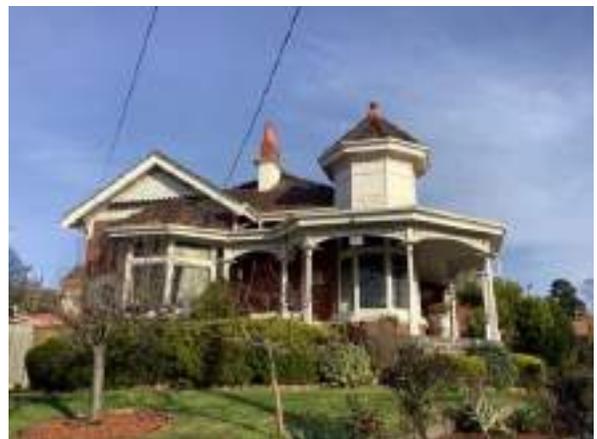
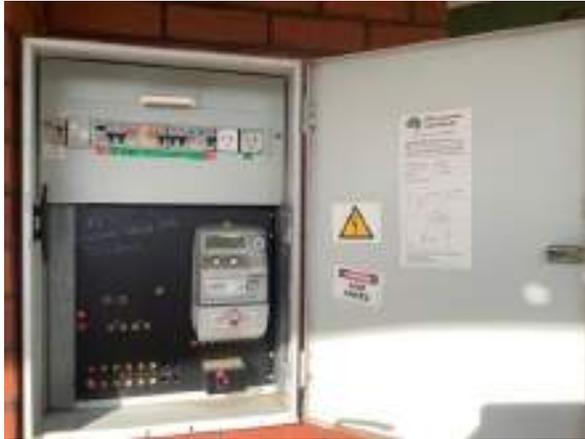
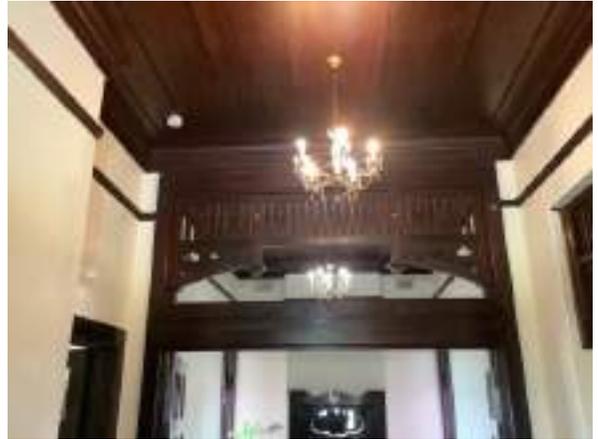
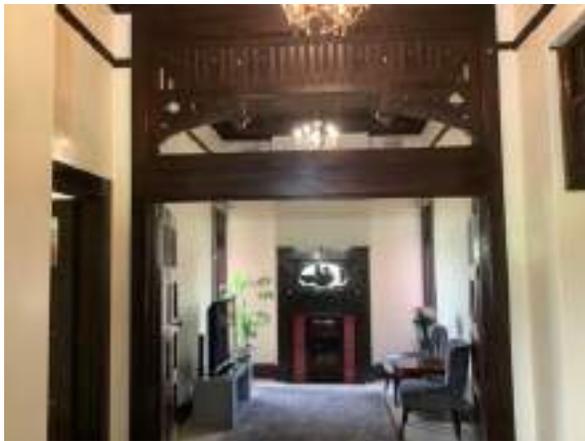
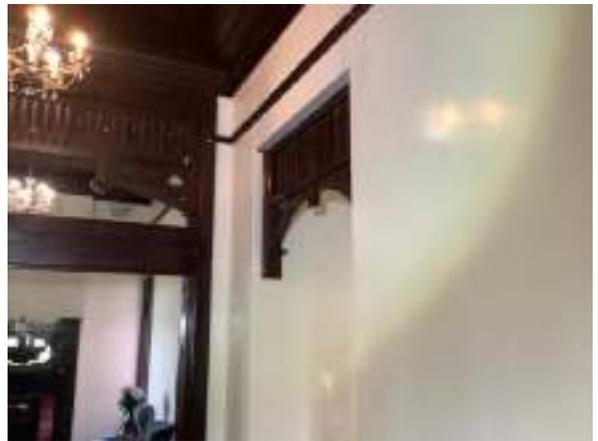
Location: For Your Information

Finding: General Site Photos
General site photos and other areas of interest are provided for your general reference.

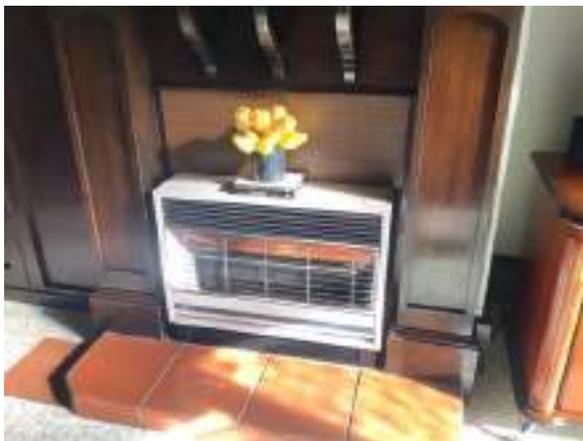
For your information 4.43

Location: For Your Information
Finding: Gas & Electrical Appliances - Inspection & Servicing
For you information

All gas appliances need to be serviced and maintained in good order. Plumbing inspections are outside the scope of the building inspection and must be conducted by a Licensed and registered Tradesperson. It is highly recommended that the client makes immediate arrangements to have the gas appliances checked by a licensed gas plumber to ensure that the appliances are working safely and efficiently.

It is highly recommended that a registered plumber is required to inspect all the gas appliances and the gas Installation for defective workmanship and for carbon monoxide leaks and/or gas leaks.

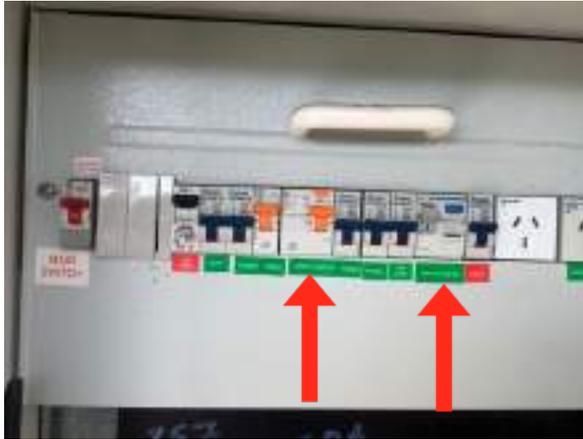
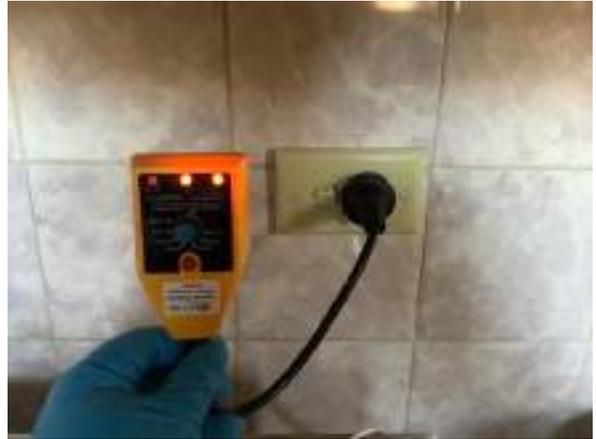
These tests all passed the AS 3000 requirement and exceptance level.

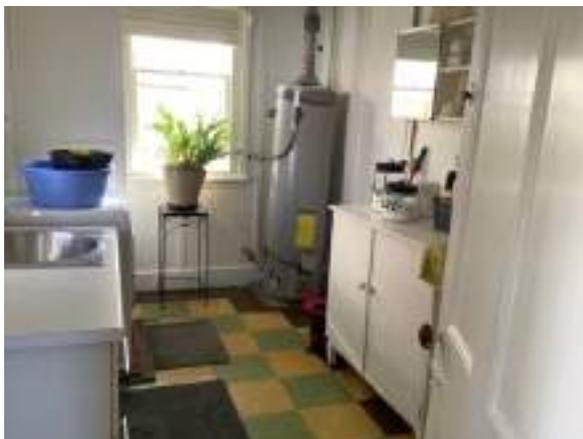
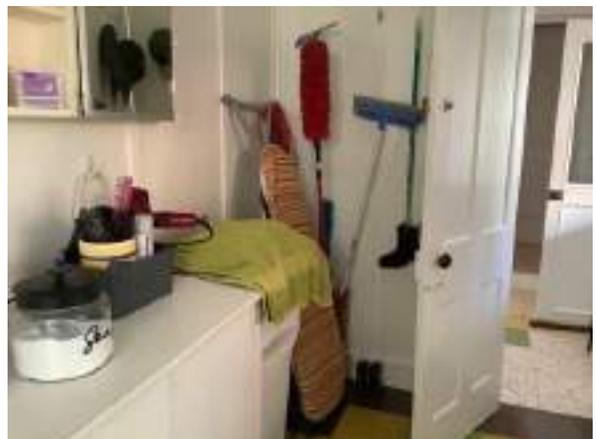
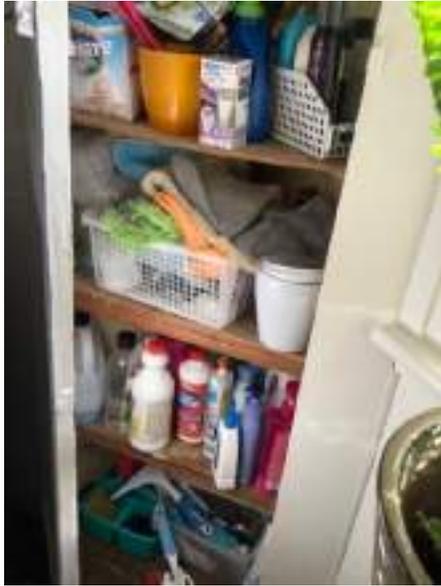
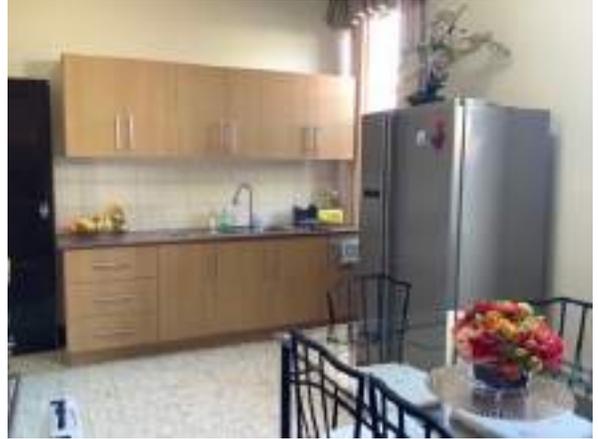
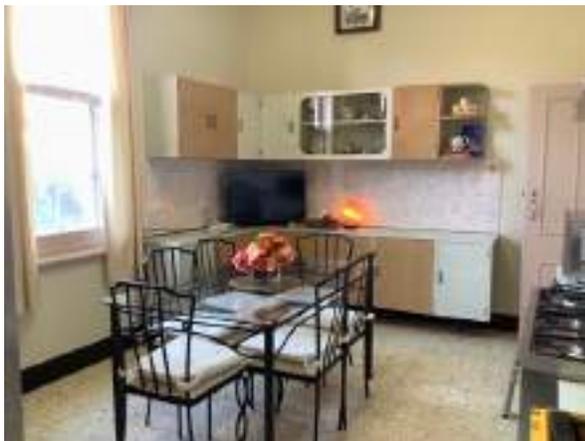
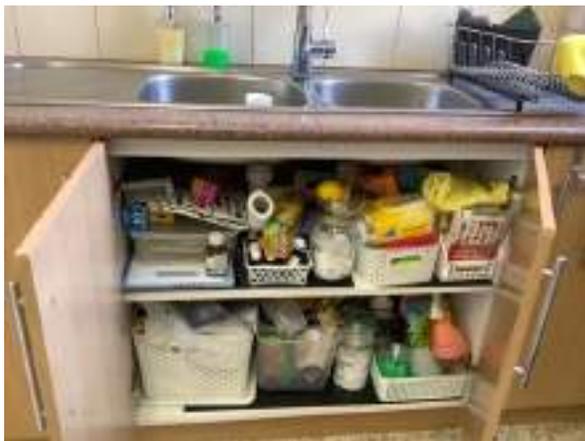
For your information 4.47

Location: The Site

Finding: Additional Photos - Obstructions and Limitations
 These photographs are an indication of the obstructions and limitations which impeded full inspection of the property at the time of inspection.
 These obstructions can hide an array of defects such as minor defects , major defects , safety hazards , termite activity and conducive environments for termites but not limited to.

A re-inspection is recommended once the areas are made accessible.

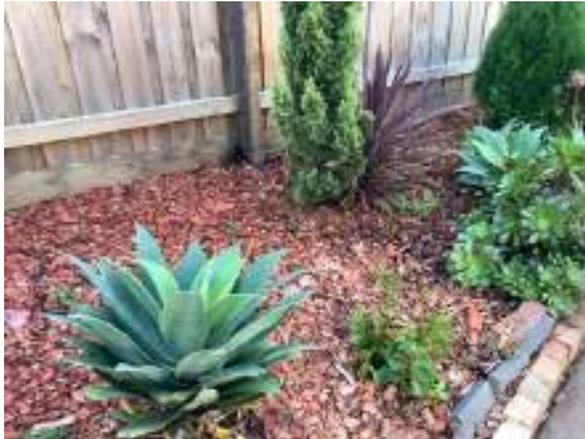
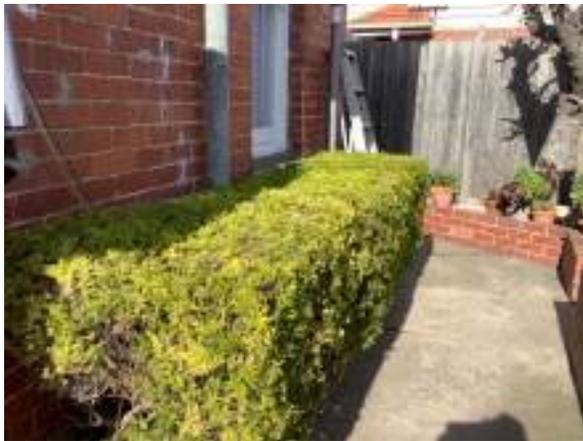
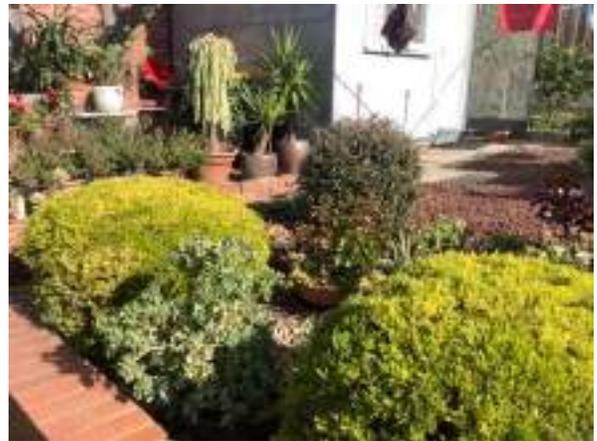
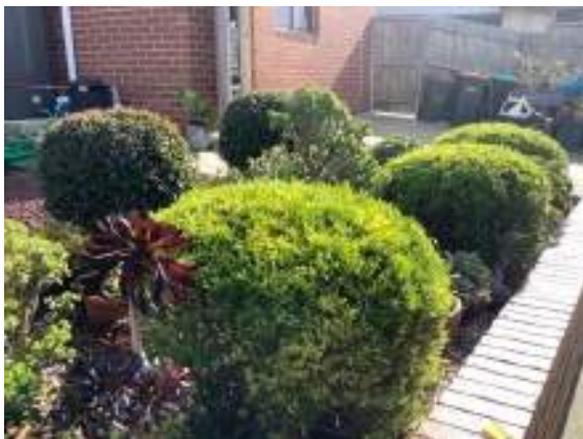
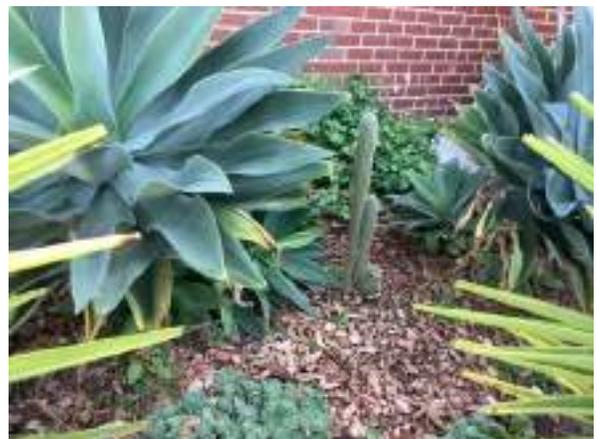
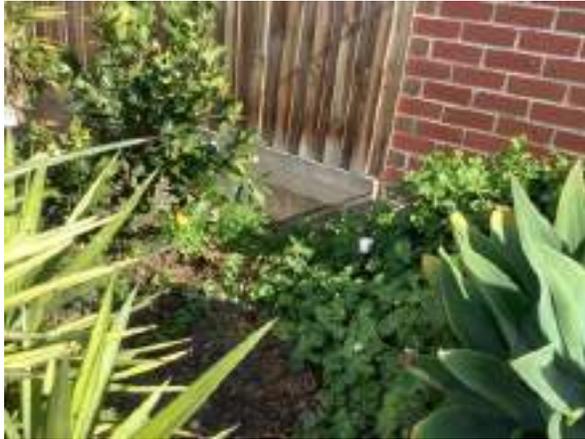
Item 2.04

Location: Garden Areas - All Areas

Finding: Garden Plants - Overgrown .
PLEASE NOTICE THE ATTACHMENT PICTURES TO THIS DEFECT STATEMENT;

At the time of the inspection it was found that the plants are overgrown and close to the exterior building.

It is highly recommended that the plants be trimmed and/or moved away from the immediate area of the perimeter building...

As noted above, I can not stress how important it is to severely reduce the trees, vegetation, timber and other debris and all other items not only around the home but to the entire property as a matter of urgency.
