Year-1890 Old Mansion, Building & Termite, Timber Pest

Inspection Date: 27 Jul 2020

Property Address: Ascot Vale Area

Report Type: Property and Timber Pest Report

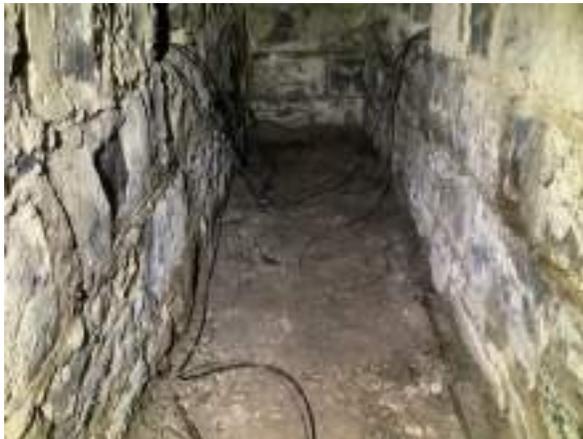
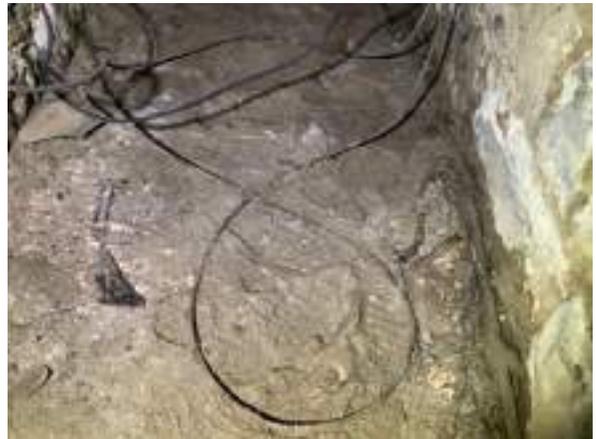
Item 2.05

Location: Subfloor

Finding: Wet Areas, Moisture Present - Attract Termites.
Excessive moisture can attract termites and produce conditions that promote termite attack fungal growth and wood decay as Termites are attracted to moisture.

Excessive moisture is generally caused by deteriorated inadequate or missing roof drainage leaking plumbing pipes or fixtures poorly plumbed HWS overflows or condenser units and poor site drainage.

It is highly recommended that all plumbing and drainage fixtures and fittings be maintained regularly in order to prevent excessive moisture being present in the external / internal property.

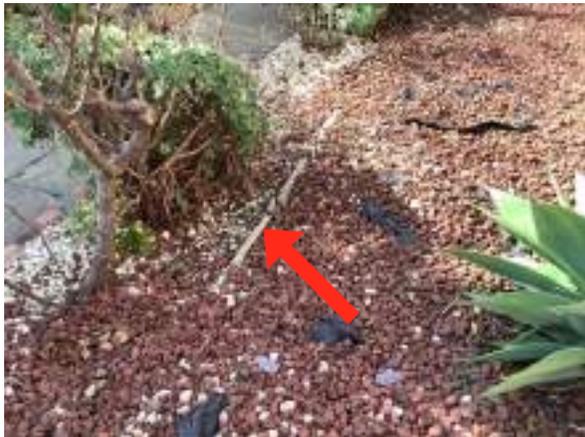
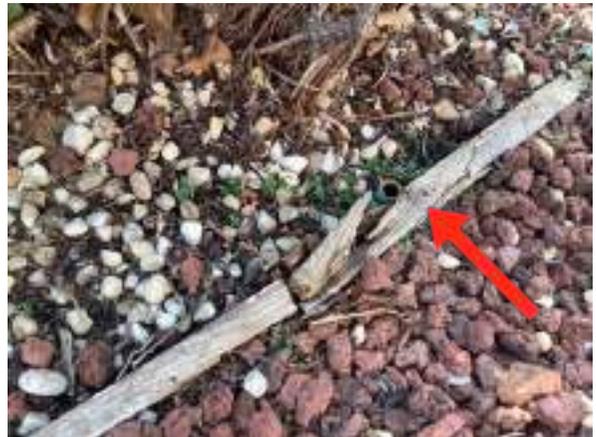
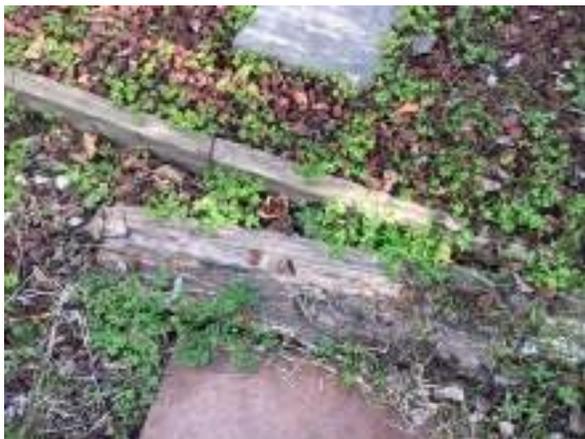
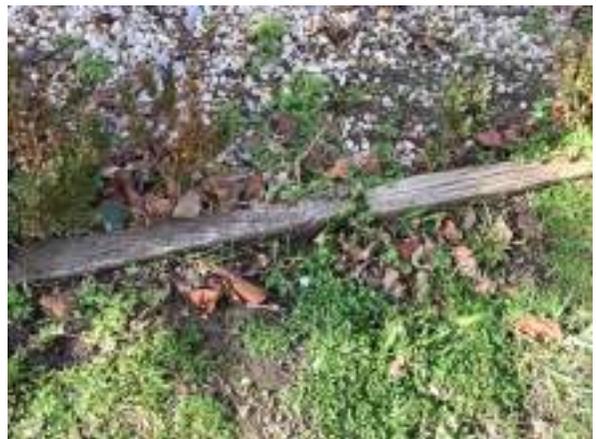
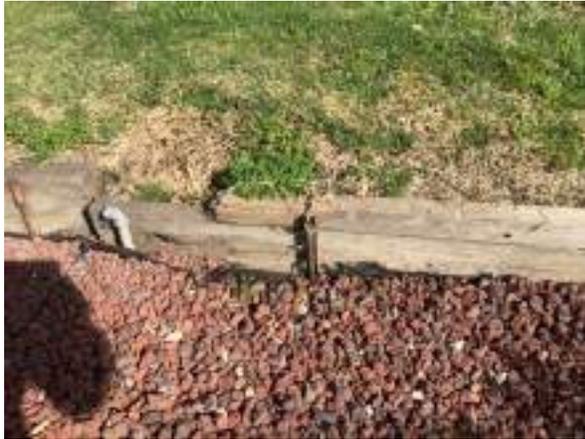
Any timbers in direct ground contact provide opportunity for concealed termite entry and are likely to be subject to premature rot and decay as the soil retains moisture or damp conditions against the timbers.

When met with excessive moisture timber begins to decay and develop wood rot. Any timbers that are in direct contact with external grounds especially if left untreated or non-durable also provide ingress for subterranean termites into that particular element.

Remove untreated timber that is in direct contact with external grounds. Consider replacement with more durable materials i.e. treated timber or non timber elements.

Frequent pest inspections are advised to readily identify any termite activity in these areas.

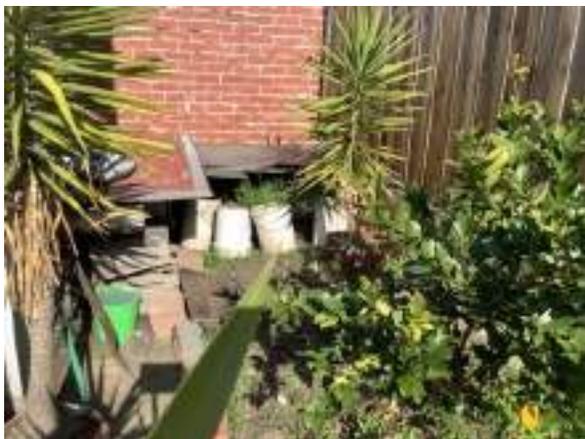
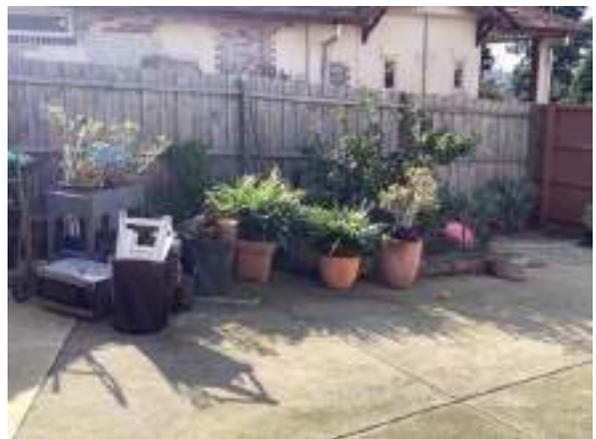
Item 2.07

Finding: Stored Timbers / Debris / Garden Areas / Sheds - All Areas, Subfloor spaces or exterior external areas.
The storing of timbers / debris / items in the subfloor space or around the external property increases the risk of termite activity being present, as they are likely to come into contact with weather conditions or excessive moisture where wood rot is likely to develop on timbers that are not treated, or where debris or items are stored

It is highly recommended that any stored timbers / debris or items be immediately removed from areas

It is highly recommended that any stored building materials or other materials be immediately removed from areas in which they may attract any termite / timber pest attack around the perimeter and/or sub floor areas of the dwelling and a re-inspection is carried out.

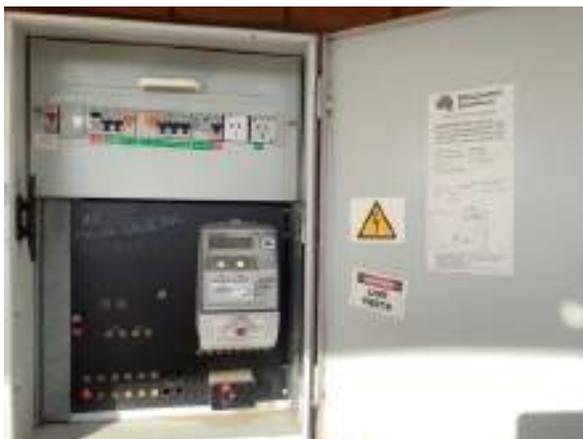
Finding: Termite Management System - NO evidence of installation
The application of a post-construction chemical termite barrier and/or baiting stations or the like is highly recommended for all properties, particularly if live termite activity has been found on the site previously. Such barriers are highly effective in preventing termite attack on any timber building elements throughout the property.

At the time of inspection, it appeared as though no termite management system has been installed, with no evidence to suggest preventative works taking place.

The client may consider gaining further advice from a pest controller as to the costs and procedures involved with this application. It is recommended that obtaining such advice be a short-term priority.
