Building & Termite Report (Termite Damage And Renovation Concerns Found)

Inspection Date: 6 Aug 2020

Property Address: Coburg Area

Report Type: Property and Timber Pest Report

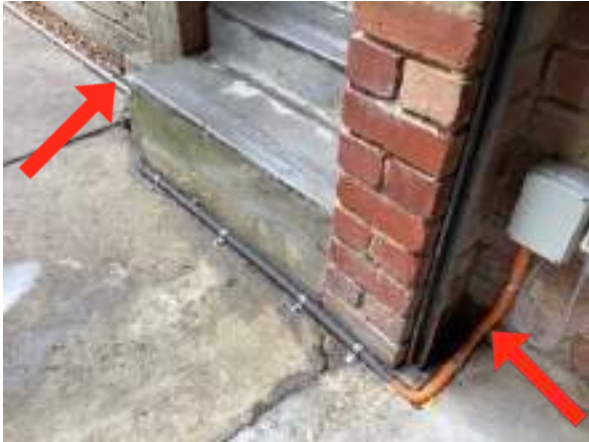
Finding: Electrical - Defective electrical wiring and/or installations.

At the time of the inspection we noted that the electrical installation appears to have items that may not be compliant with the electrical regulations AS3000-2007.

We recommend that the purchaser engages a licensed electrical contractor to check compliance and make good any defective wiring or unsafe items throughout the entire property including the outbuildings etc.

We highly recommend that you engage a qualified electrician to further test the property's earthing system and that all the tests comply with AS3000 for all testing procedures of an electrical installation and its earthing components.

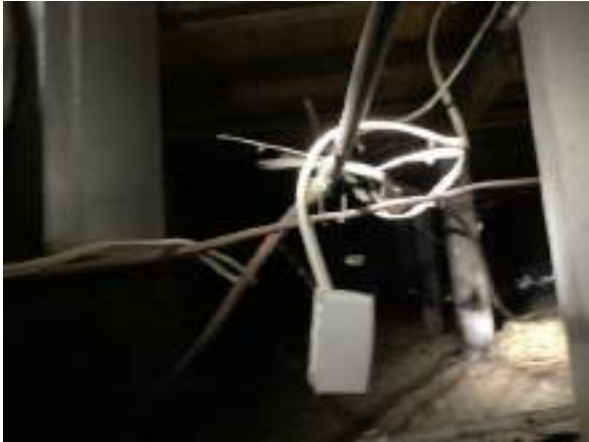
All wiring must be clipped to the timbers in accordance with AS3000 safe off the ground and/or subjected to damaged or people being in contact with them.

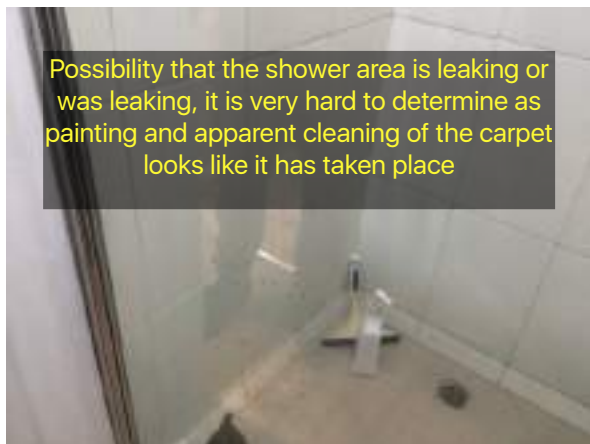
Finally the cause or source of the mould MUST BE TAKEN CARE OF URGENTLY.

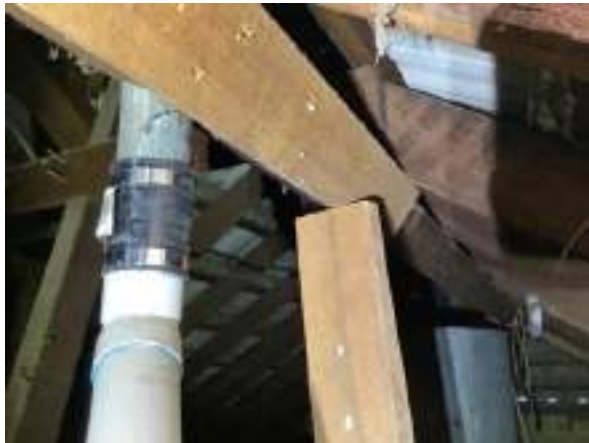
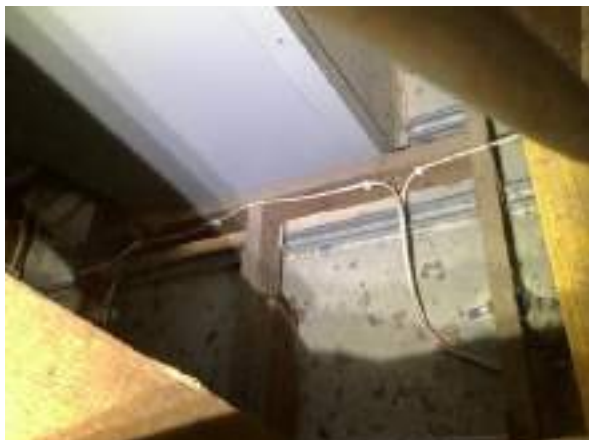
Location: Roof Space

It does appear that the work would not comply with current building codes and standards and I highly recommend you engage a registered builder and possibly a structural engineer to determine the areas that may require further investigation and repairs.

I HIGHLY RECOMMEND that you only engage a registered builder and/or a qualified carpenter for all works in order to provide you all the necessary and correct contracts and warranties.

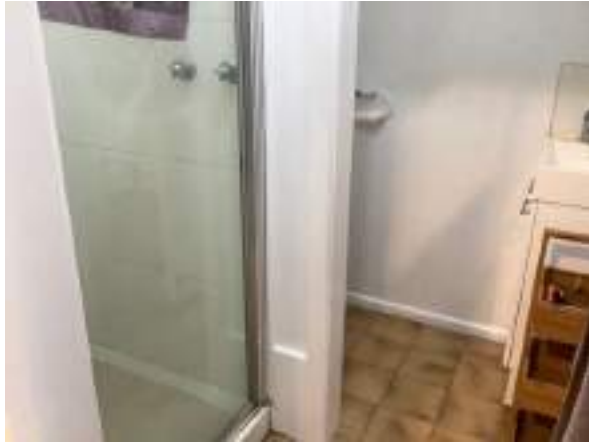
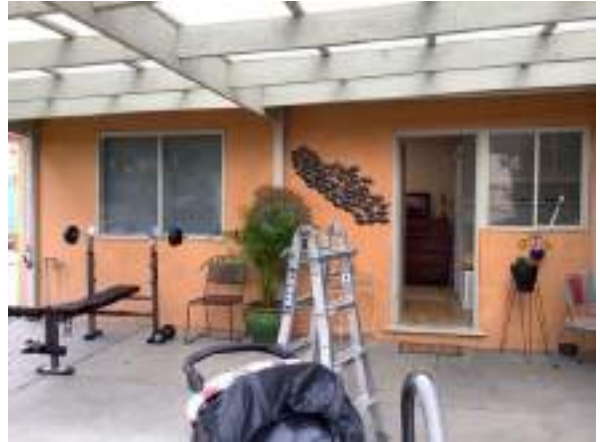
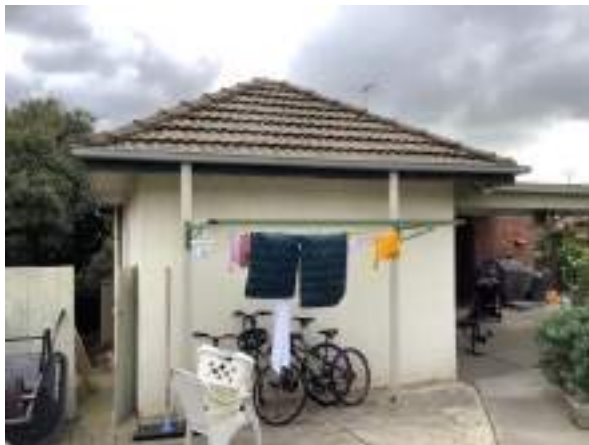
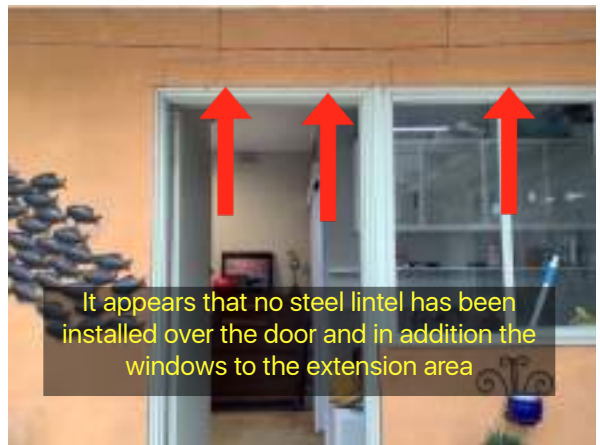
It appears that no steel lintel has been installed over the door and in addition the windows to the extension area

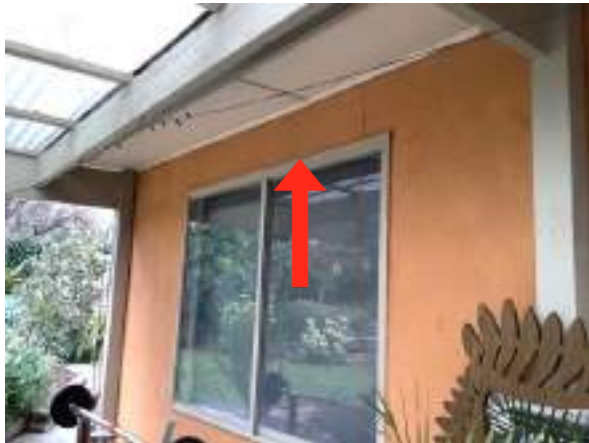
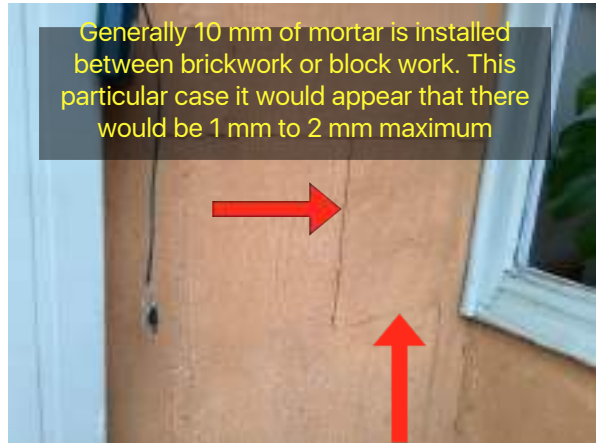
Generally 10 mm of mortar is installed between brickwork or block work. This particular case it would appear that there would be 1 mm to 2 mm maximum

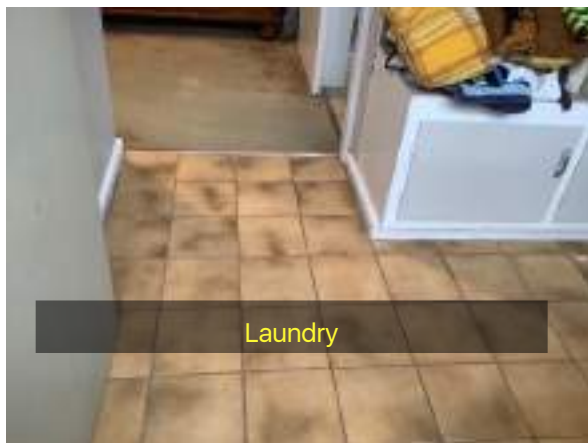
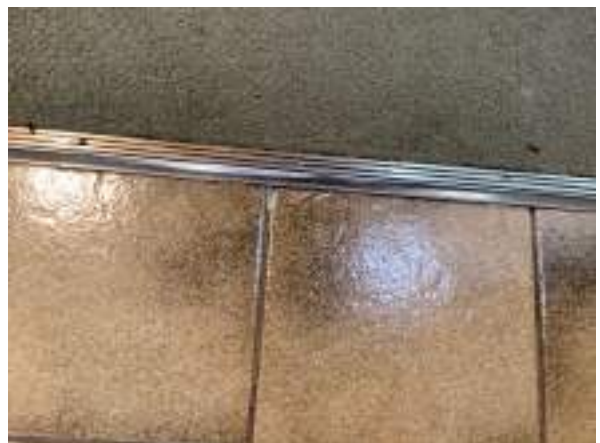
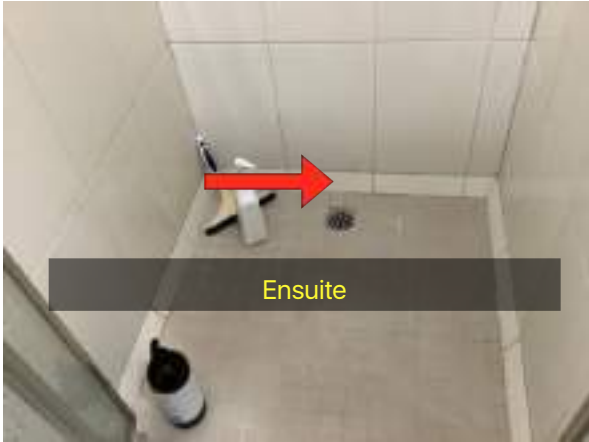
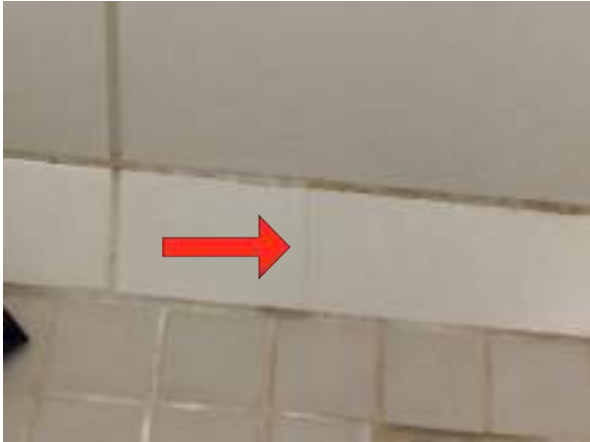
Minor Defect 3.16

Finding: Tiles - Cracked or damaged

Cracking was evident to the tiling at the time of inspection. While the cracking appears to be minor, these areas are frequently exposed to water, allowing potential for water penetration into adjoining sections of walls or flooring.

What is important when tiles are cracking is to determine the cause of the cracking, which may be related to the subfloor structure, typical wear and tear and/or poor workmanship. The cause of the tiles cracking must be determined and repaired otherwise the same defect will occur.

A tiling contractor should be appointed to ensure that no further water damage occurs. The re-application of silicone and grouting throughout remaining tile work is also advised, to further protect the area against water penetration.

Where water penetration has led to water damage, appointment of a relevant tradesperson may be required to repair damaged building elements.

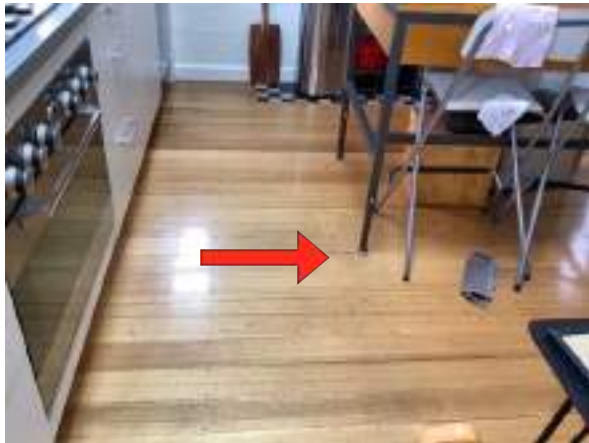
Minor Defect 3.17

Finding: Building Materials & Hardware That Is Worn / Aged and/or Damaged .

This may have been caused by water damage, moisture and/or general wear and tear. Replacement or repair (which ever is appropriate and cost effective) is up to you of the items attached.

Items like cracked glass mirrors, cracked glass windows and windows not operation smoothly are defects that should be repaired by the appropriate trades.

It is IMPERATIVE that you engage registered and qualified trades and at the end of there works they must supply certificates, such as an electrical safety certificate, plumbing and gas certificate if the works are electrical or plumbing, but for items such as damaged door handles, painting an experienced carpenter or handyman can sometimes be engaged.

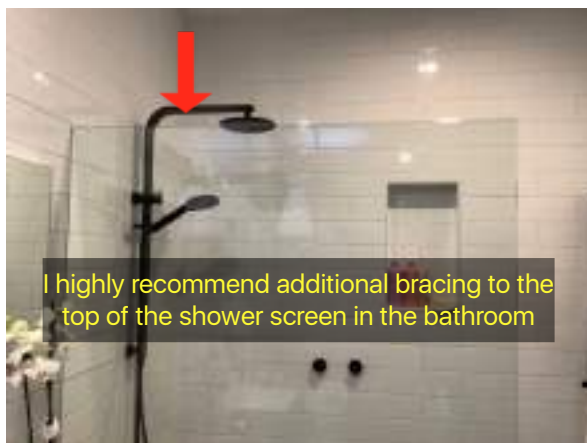
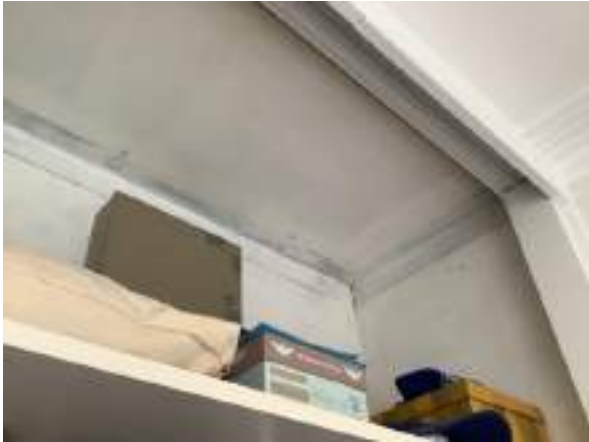
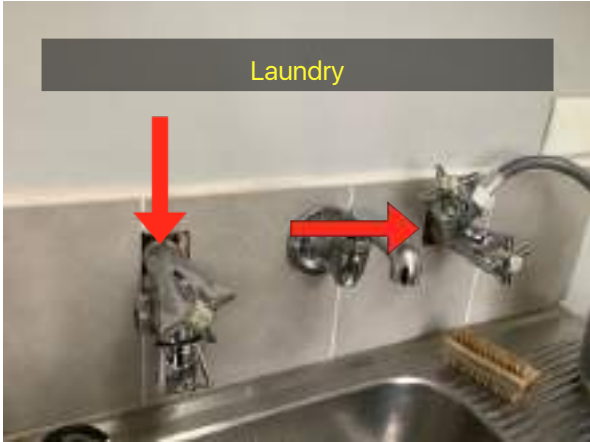
Minor Defect 3.18

These Defects are of Sub Standard Workmanship or Incomplete and not finished to a tradesmens like manner.

Unfinished and substandard building works are likely to degrade more quickly and may create potential for secondary defects to associated building elements and surrounding structures, also the workmanship is VERY displeasing to the eye.

Generally substandard repairs or installation are related to poor workmanship, the use of inappropriate materials, or a failure to complete installation to a suitable standard.

Where installation is substandard and/or incomplete, the client should contact the responsible trade to undertake rectification works, which are advised as soon as possible.

The appropriate tradesperson or specialist or handyman should be appointed to complete the various items for repair and organise the appropriate QUALIFIED trades (or not pending on job) to repair and complete the works to illiminate or reduce further deterioration / disfunction.

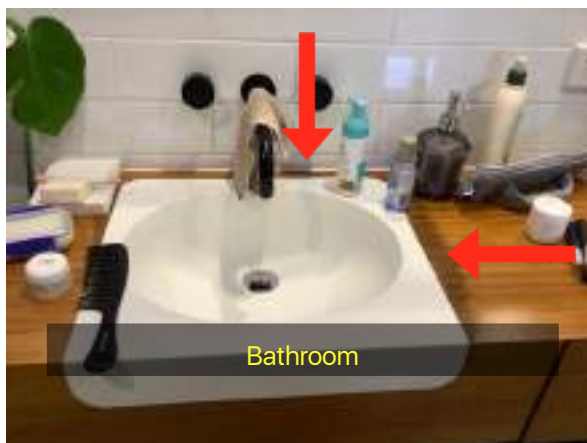
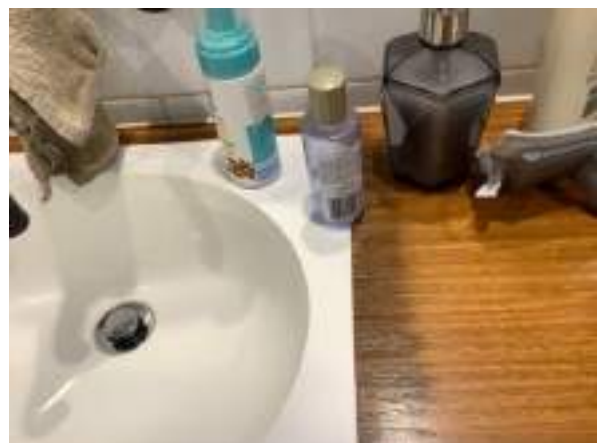
Minor Defect 3.19

Finding: Water Staining / Wood Rott - Damaged Materials.
Water Staining / Wood Rott was evident in this area or areas at the time of inspection.

Water Staining / Wood Rott indicates that surfaces have been exposed to excessive moisture / water over time. The minerals and other elements in the water lead to staining, which may graduate to corrosion and deterioration if left unmanaged.

Water Staining / Wood Rott can cause minor damages such as paint staining, timber discolouration, etc or water staining can lead to more serious major structural defects.

It is important to identify the cause of water staining and STOP FURTHER DETERIORATION by the appropriate tradesperson.

Conversely, where water staining is old and inactive, affected building materials may be repaired or replaced at client discretion only if the damage is cosmetic though.

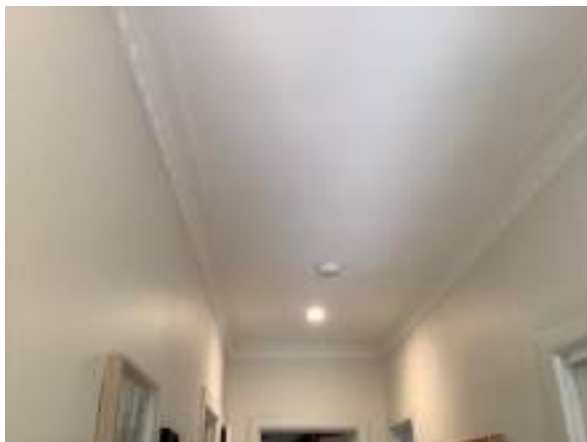
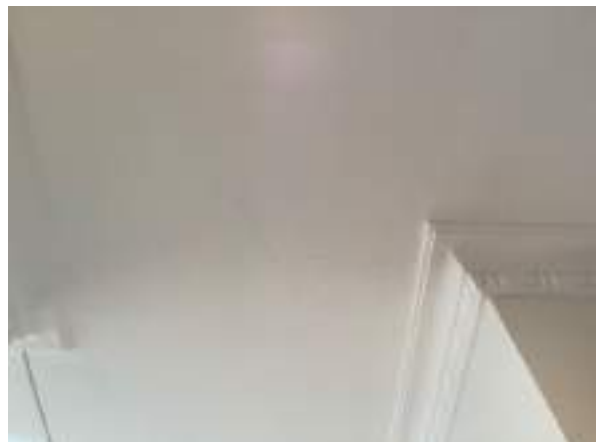
Minor Defect 3.21

Finishes to (lath and plaster walls & hair line plaster walls or ceilings) generally have many imperfections.

Ultimately an experienced professional can generally put you on the right direction before spending a lot of money on repairing (lath and plaster walls & hair line plaster walls or ceilings)

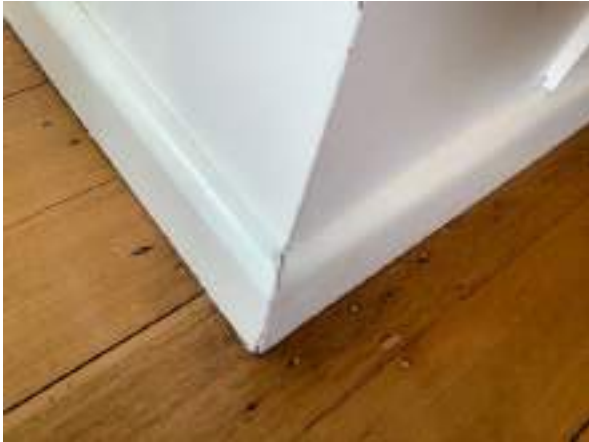
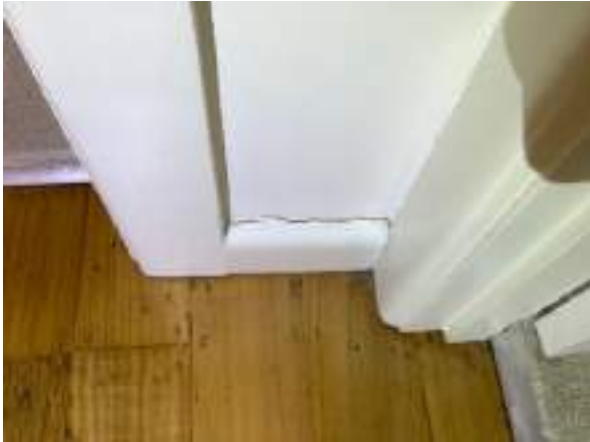
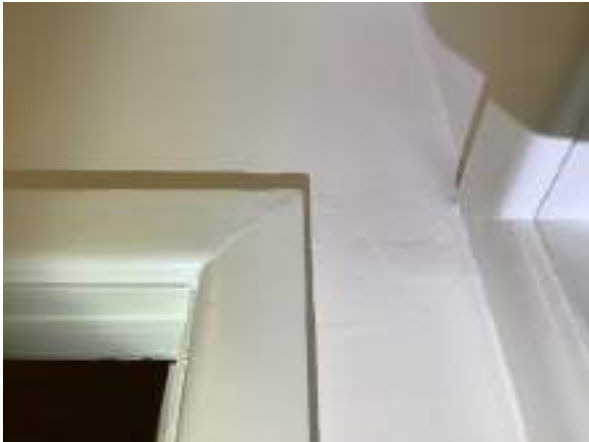
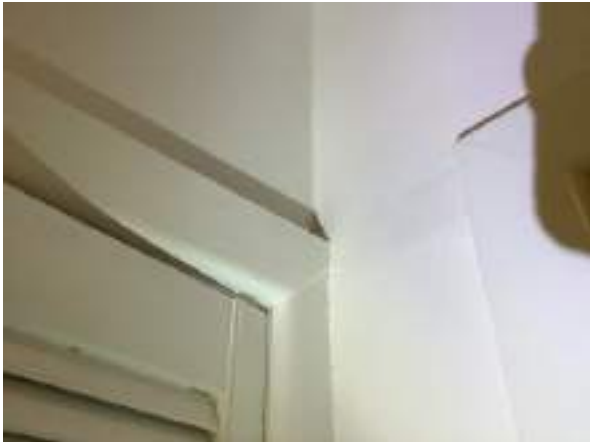
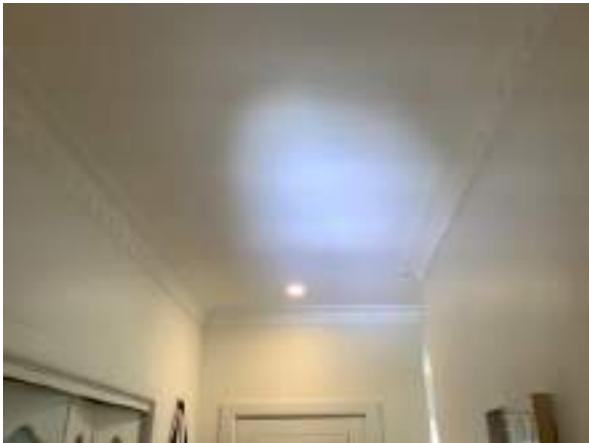
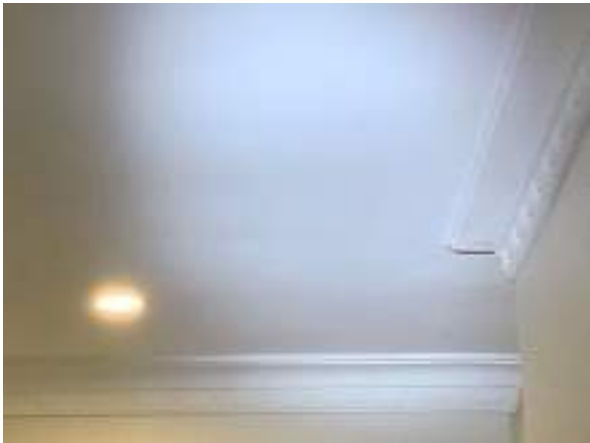
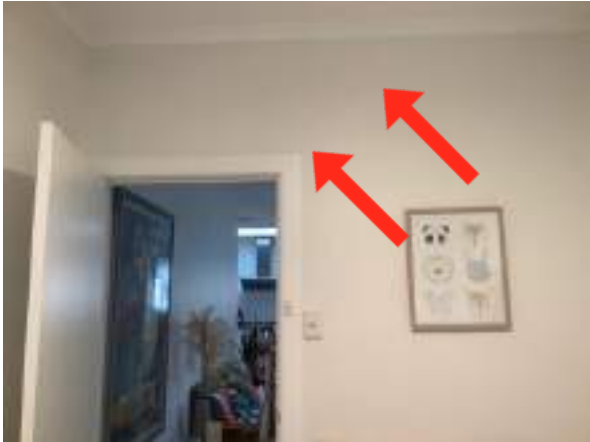
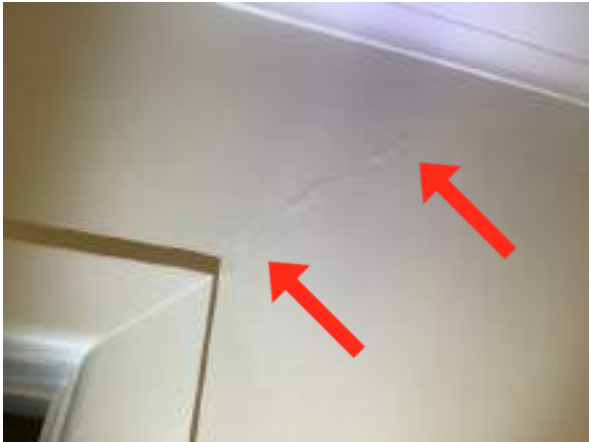
Minor Defect 3.22

Location: Plaster Internal Areas

Finding: Plaster & Timber Cracking - Damage Category 1 - Fine (up to 1mm)

Although fine cracks are quite noticeable, they are often only considered to be an appearance defect, and usually do not indicate any structural damage. Generally, the cause of a fine crack is indicative of a separation between building materials and finishes (e.g. paint, plaster, etc.) along joins.

Cracking of this nature can generally be repaired with minor sanding, filling and/or repainting. Such works should be performed by a qualified painter or a general handyman. Monitoring of all cracking should be conducted frequently. Always contact a building inspector should cracks widen, lengthen, or become more numerous.

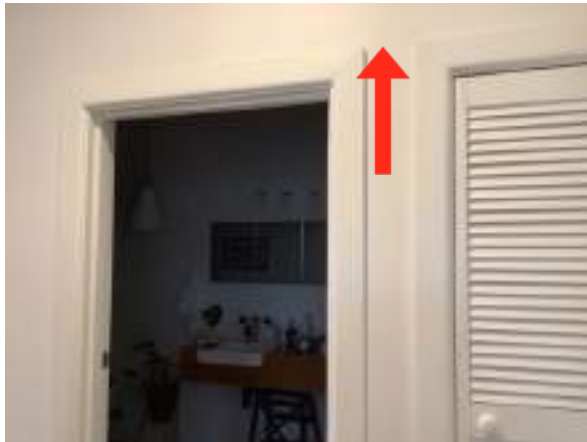
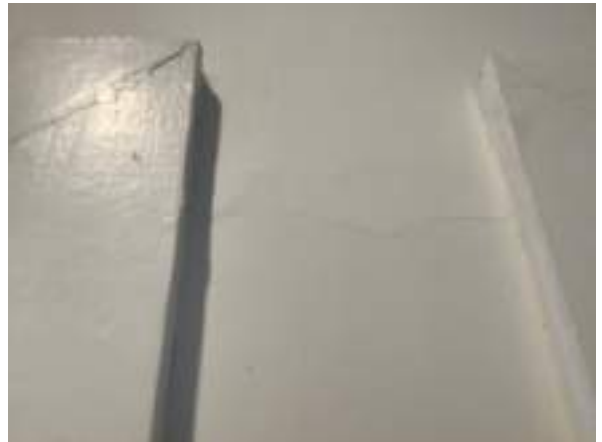
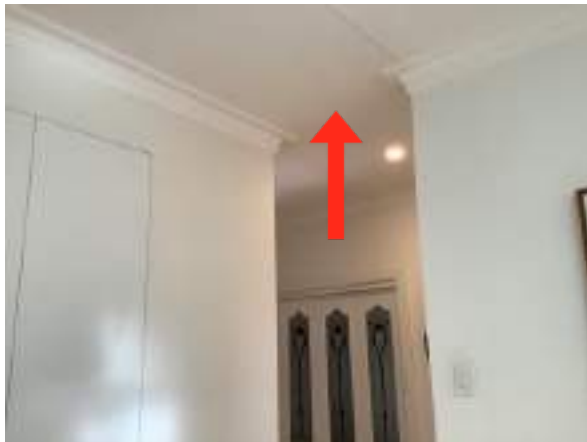
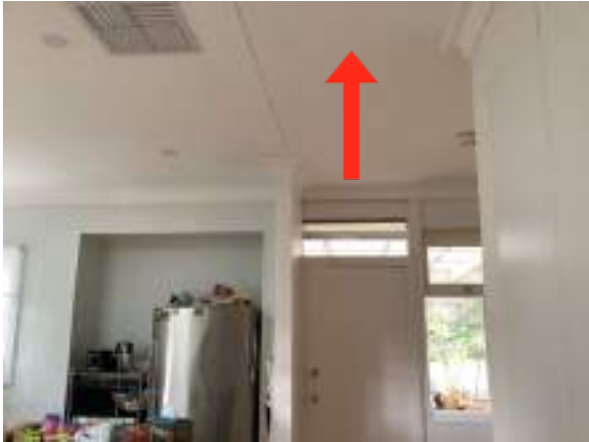
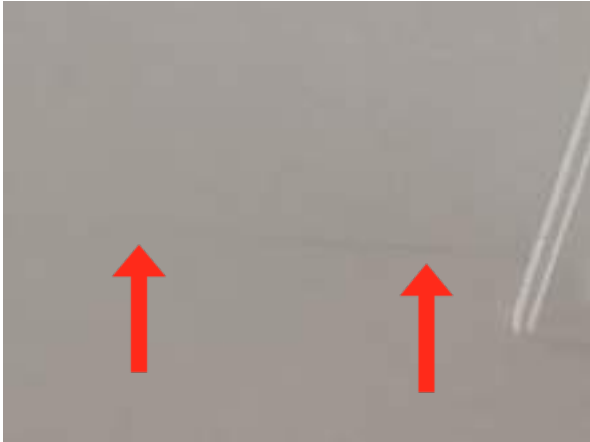
Minor Defect 3.23

Location: Plaster Internal Areas

Finding: Plaster & Timber Cracking - Damage Category 2 - Noticeable (up to 5mm)
Whilst we may have a photo of damaged paint, or a minor plaster cracking, etc, there may be many more paint/plaster defects and plaster cracking in other areas throughout the property.

Noticeable cracks are a common occurrence as a result of many primary defects. Such causes may include age, general wear and tear, expected building movement, general expansion/contraction of building materials in different weather conditions, and/or minor failings in the installation or application of building materials.

Noticeable cracks may result in minor sticking or jamming of associated doors and windows, which require easement. However, noticeable cracks are easily filled and repaired. A plasterer can be consulted to install an expansion joint at this point to allow for this movement during different weather conditions.

Monitoring of all cracking should be conducted frequently. Always contact a building inspector should cracks widen, lengthen, or become more numerous. Additionally, your building inspector should also be contacted if associated building elements such as doors and windows become more difficult to operate over time.

Relevant tradespeople, such as carpenters, painters and plasterers, should be appointed to perform remedial works, as deemed necessary.

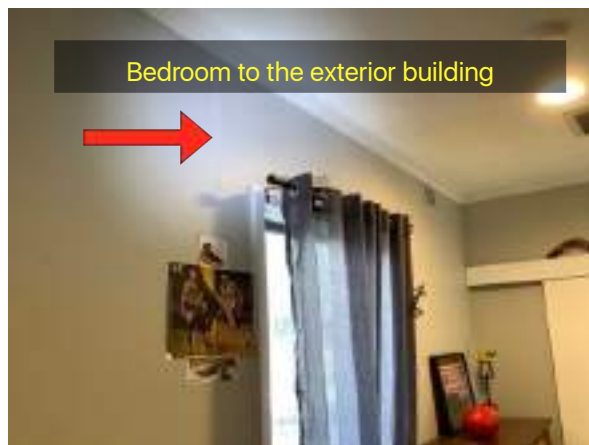
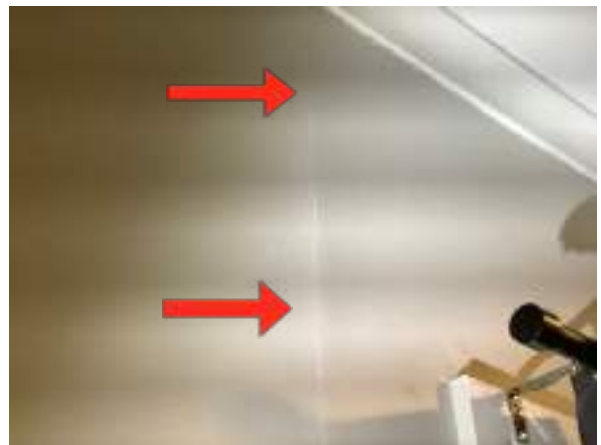
Minor Defect 3.24

Location: Plaster Internal Areas

Sections of plaster sheeting in this area appear to be drummy. The term `drummy` is used to describe plaster which, whilst solid, has become detached from its original fixing, where the defect is spread wide the drummy plaster can also be a safety defect, meaning plaster ceilings can just drop in an instance, usually this is the more extreme drummy ceilings.

The most common causes of plaster failure are physical damage and moisture damage. Moisture causes plaster to swell and shrink as the humidity of the air changes, or as a consequence of leaks, which can be enough to create drumminess or cracking.

Drummy plaster generally needs chemical re-adhesion (glue) or to be screwed back to the substrate, with minor consequent patching and painting required but sometimes drummy plaster can be permanently deformed in shape so therefore will sometimes need to be replaced.

Where minor sagging is evident, comparatively minor works, such as re-gluing of ceiling sheets, may be required. Such works may be performed by relevant tradespeople, such as plasterers and painters. Where excessive moisture has caused the roofing structure to swell and sag, the source of the water leak should primarily be identified prior to any remedial works being performed.

Ensure that the general environment is free of moisture and humidity to aid in the prevention of drummy plaster and plaster damage. Appointment of a qualified plasterer and/or builder is advised in order to complete remedial works as necessary.

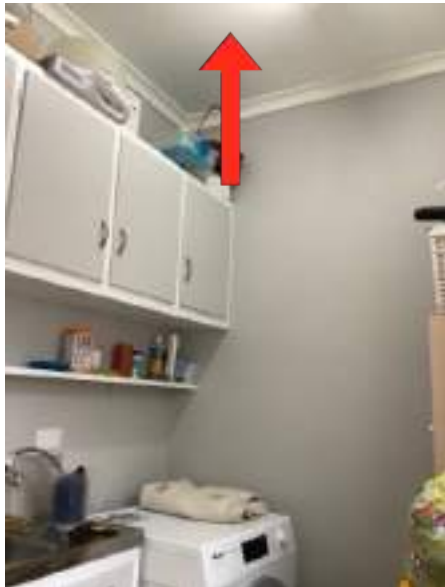
Minor Defect 3.28

Location: Roof Space

Finding: Insulation - Inadequate / Missing

Upon inspection of the roof void it was noted that there is a lack of adequate insulation and/or missing insulation.

Installation of adequate insulation is required according to Australian Standards and should be conducted as soon as possible.

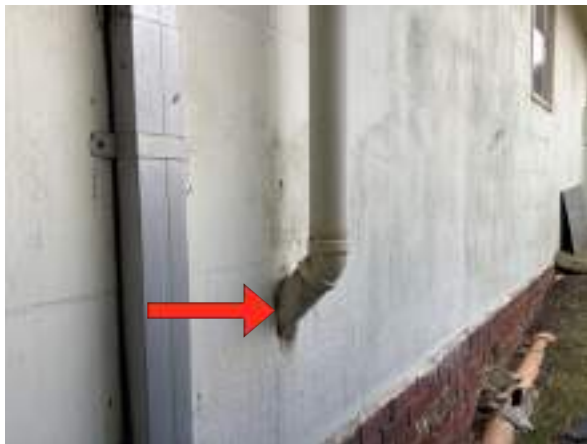
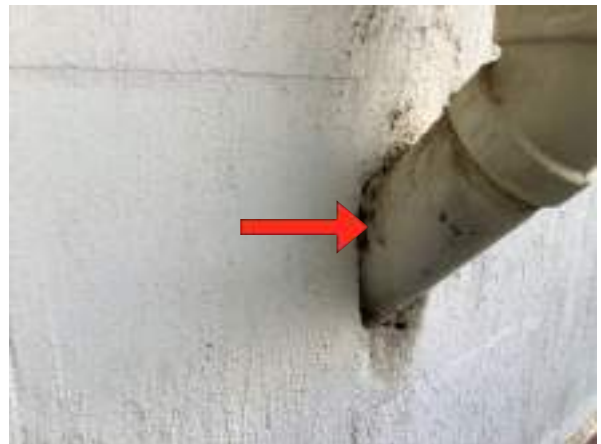
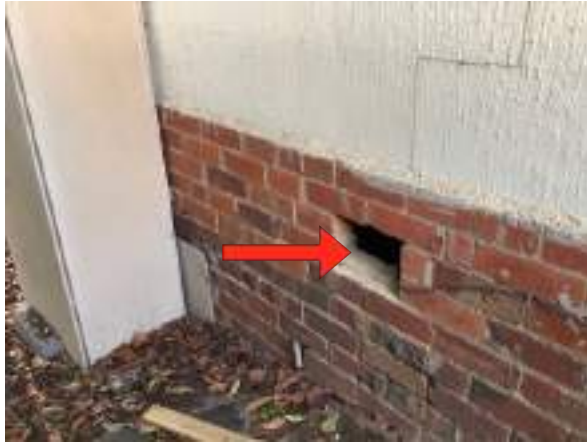
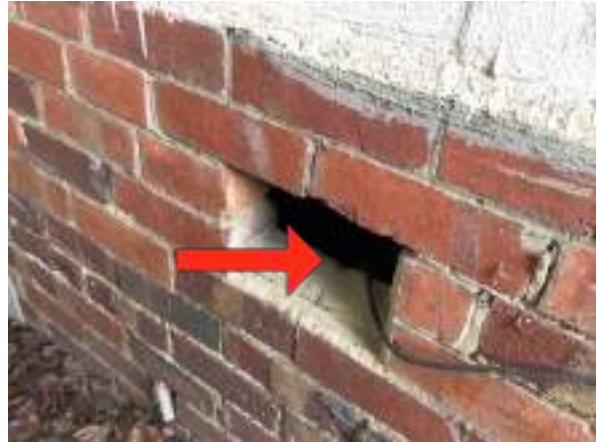
Minor Defect 3.30

Location: Perimeter Of Building - Exterior

An external hole was located at the time of inspection. This hole appears to be large enough to allow bird, rodent or other pest ingress creating the potential for nesting or infestation of live animals.

To ensure no such infestation occurs this hole should be adequately covered. Holes such as these are also likely to attract rain penetration which may lead to subsequent water damage to associated structures if left unmanaged.

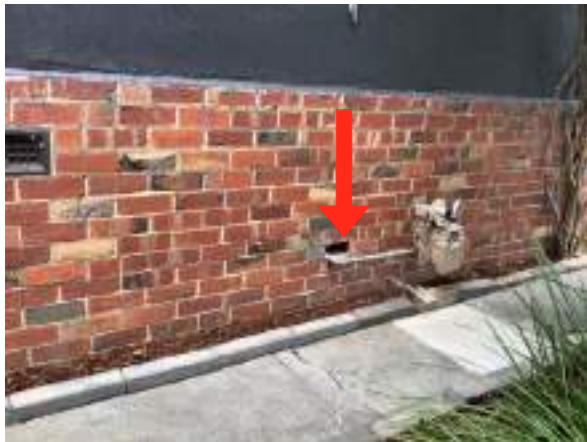
Minor Defect 3.31

Location: Brickwork

Where step cracking is extensive or severe, the client is advised to consult a structural engineer.

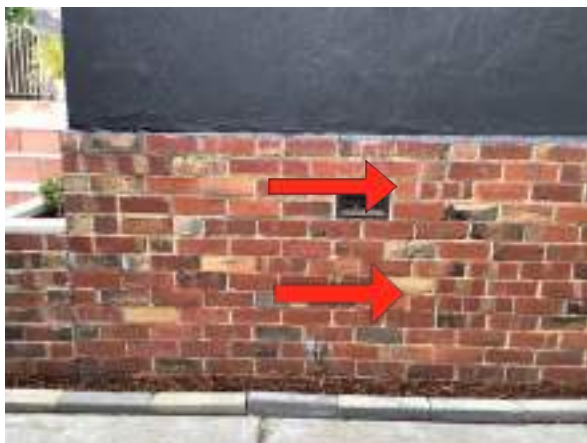
Minor Defect 3.32

Location: Garden Areas - All Areas

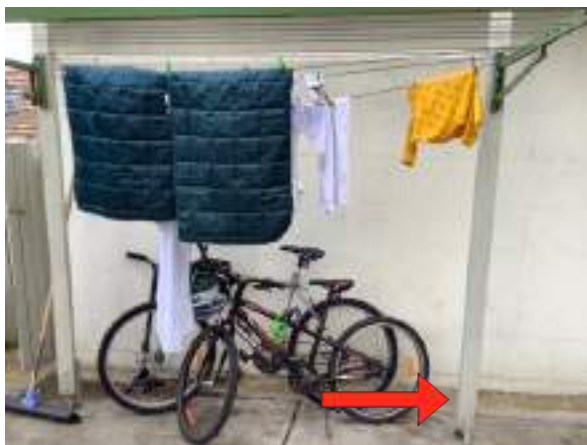
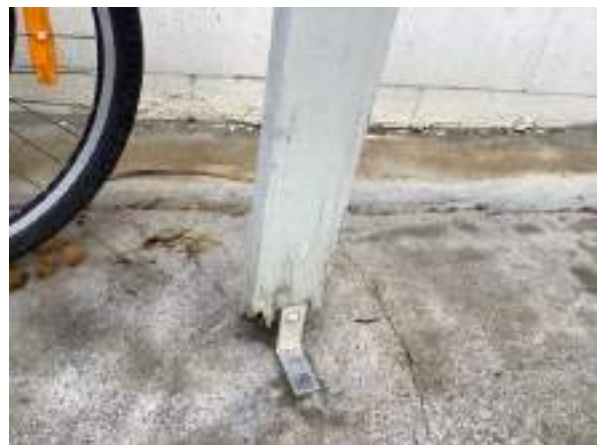
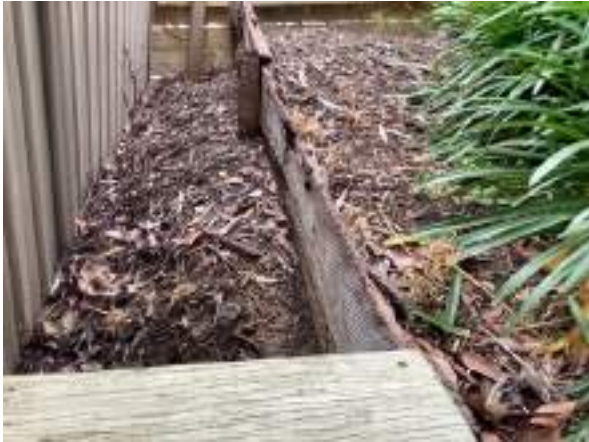
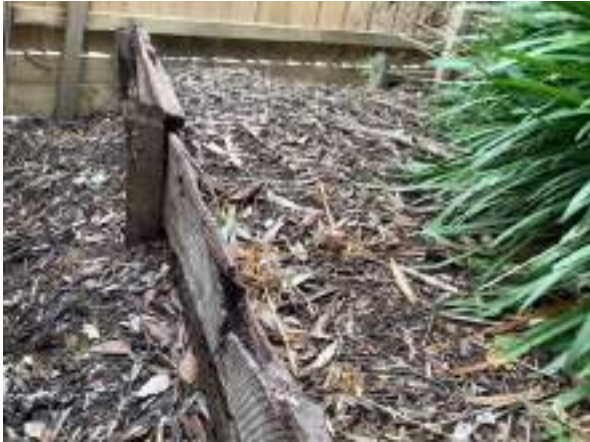
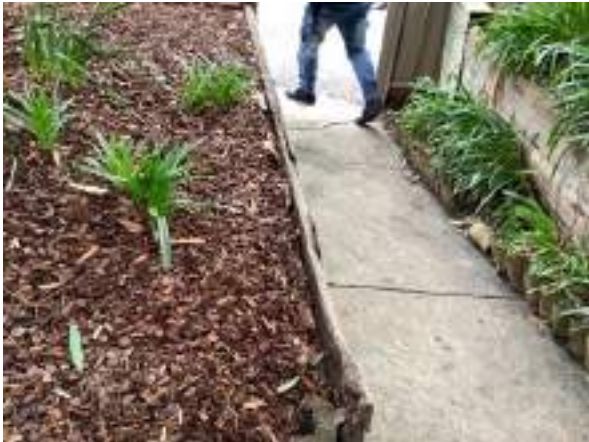
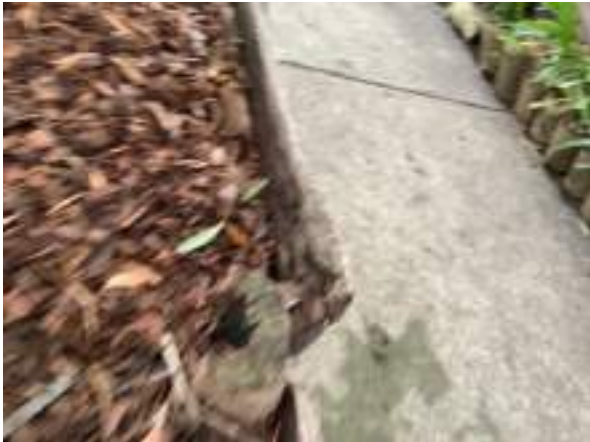
Minor Defect 3.34

Location: Timber Work - All External Areas

Finding: Wood Rot

This building element shows evidence of wood rot. Wood rot, also known as Fungal Decay, occurs when timbers and other cellulose building materials are exposed to damp conditions on an ongoing basis. This could be the result of exposure to weathering over a prolonged period of time, or the attraction of excessive moisture from other abutting building materials. Contributing factors also include poor air ventilation in the area.

A qualified plumber / builder may be appointed to assess the cause of excessive moisture and to provide advice on any remedial works as required.

A qualified carpenter and/or registered builder may also be required to replace affected building materials.

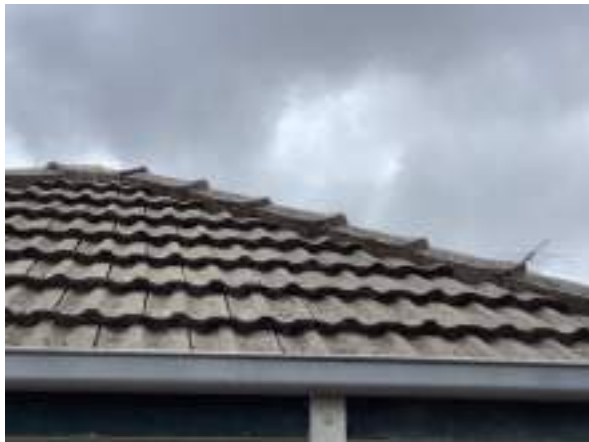
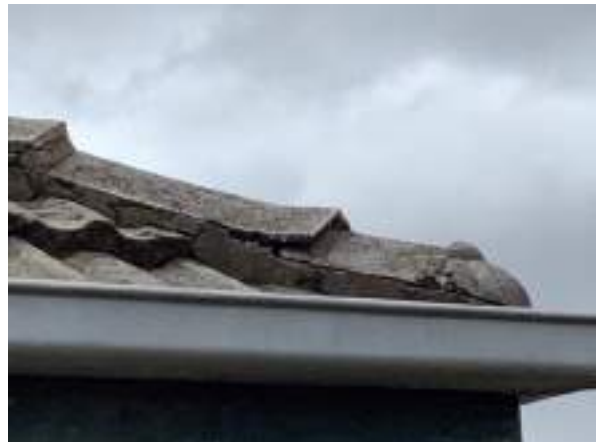
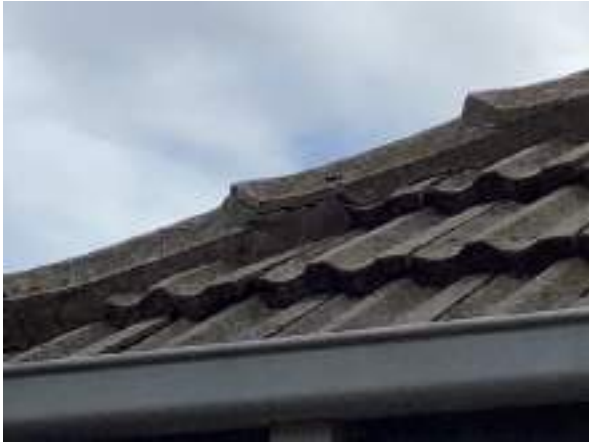
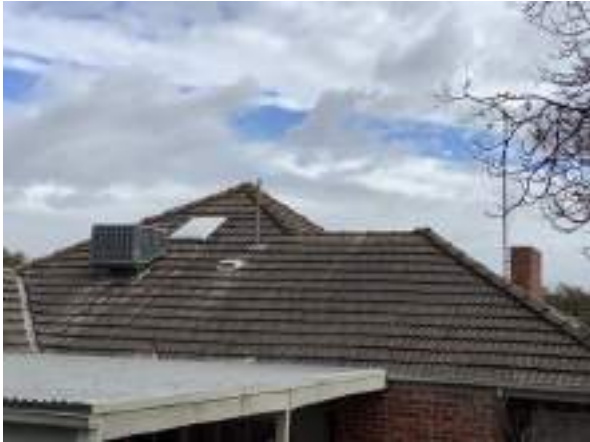
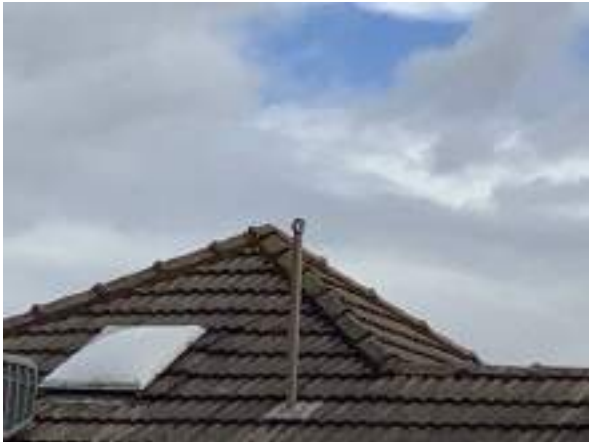
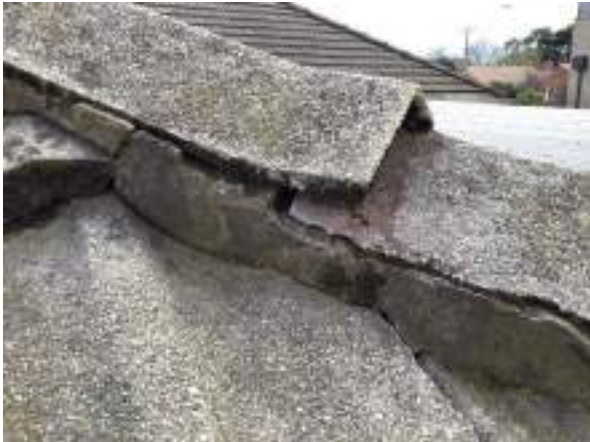
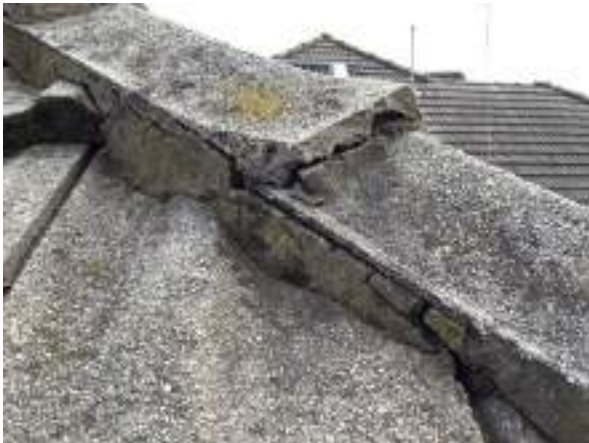
Minor Defect 3.35

Location: Roof Areas & Stormwater

Finding: Roof Capping - Mortar Deteriorated.

Upon inspection of the exterior roof, it was noted that sections of the mortar show varying levels of deterioration.

Areas of mortar have come loose in the Valleys, Hips and/or Ridges, cracking and areas of insufficient and/or no mortar is also present.

Remedial works are likely to increase the longevity of the exterior roofing structure.

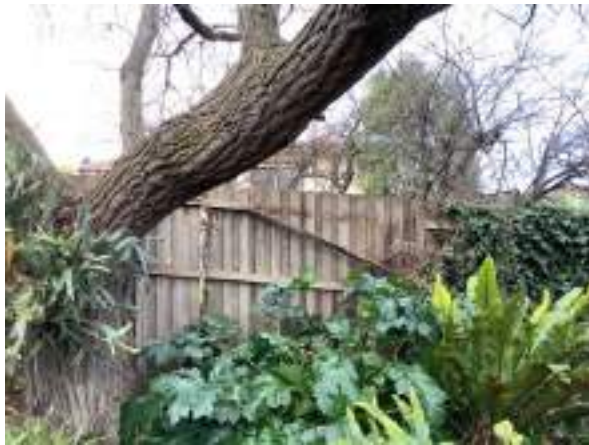
Minor Defect 3.36

Location: Fencing

Finding: Fencing - Deteriorated

It was noted at the time of inspection that sections of the fencing throughout the property have deteriorated. Typically fencing deteriorates due to age or rot which is generally expected for a structure of this age, due to prolonged exposure to weather conditions. A licensed fencing contractor should be appointed to provide further advice and perform rectification works as necessary.

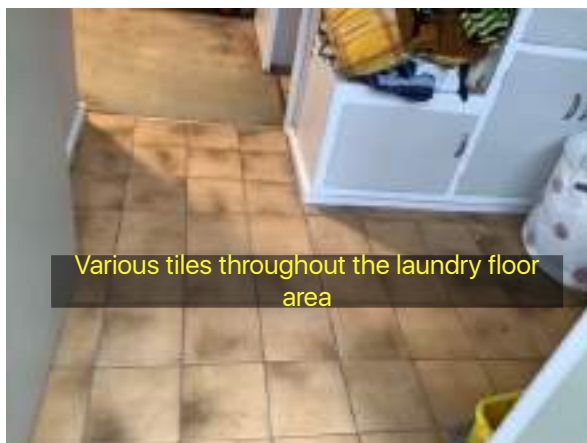
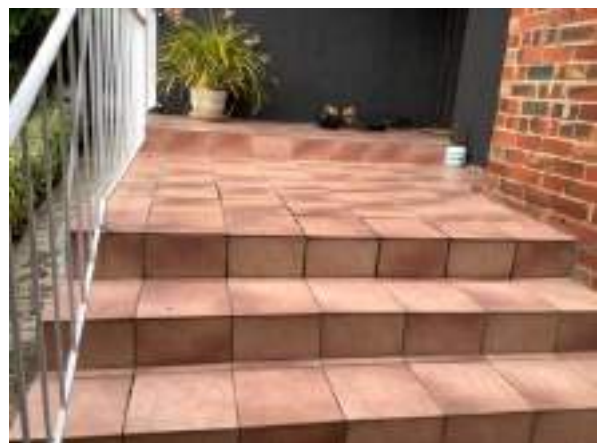
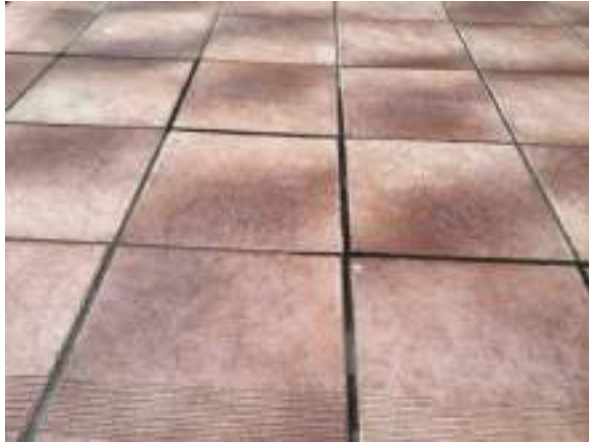
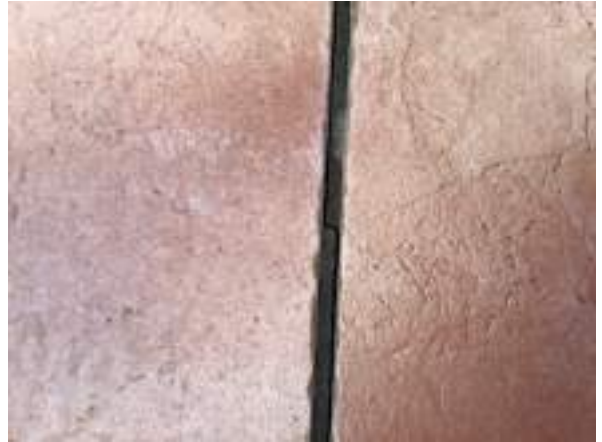
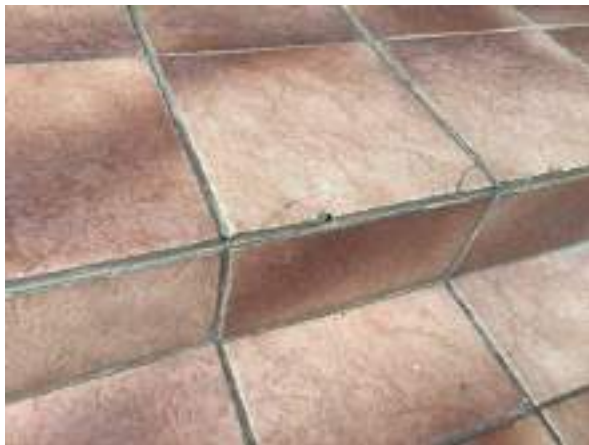
Minor Defect 3.37

Location: Laundry And Porch Area

Drummy tiles may also be contributed to tiles cracking and what is important is to determine the cause of the cracking, which may be related to the subfloor structure, typical wear and tear and/or poor workmanship

Such defects are generally caused by physical or moisture damage to the area. Drummy tiled areas may also be a direct result of poor workmanship during the construction process.

Various tiles throughout the laundry floor area

Any exposure to moisture is capable of causing tiled areas to become drummy and/or cracked over a prolonged period of time. Drummy tiled areas generally require removal and replacement of affected tiles, with adequate sealant and grouting.

Specialist trades are available for these types of services. A registered builder may be required to undertake works if damage is extensive or if secondary building defects have resulted. Otherwise, it is advised that a tiling contractor be appointed to perform works as necessary. Immediate action is recommended to ensure that no further damage is sustained in the affected area.

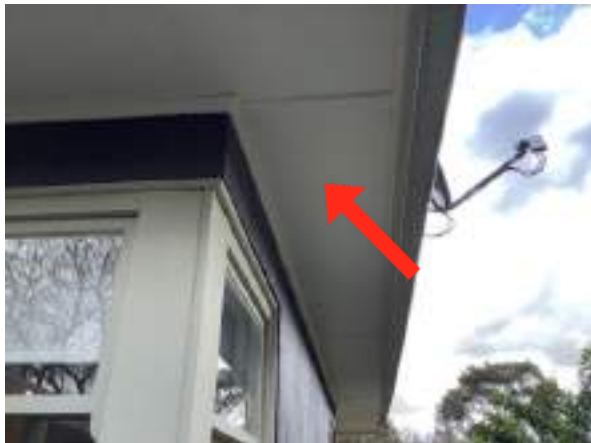
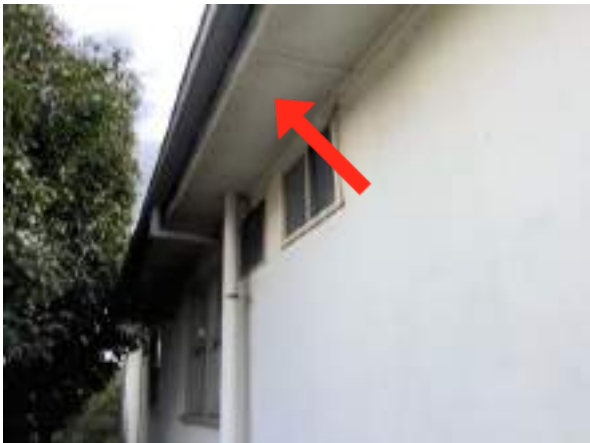
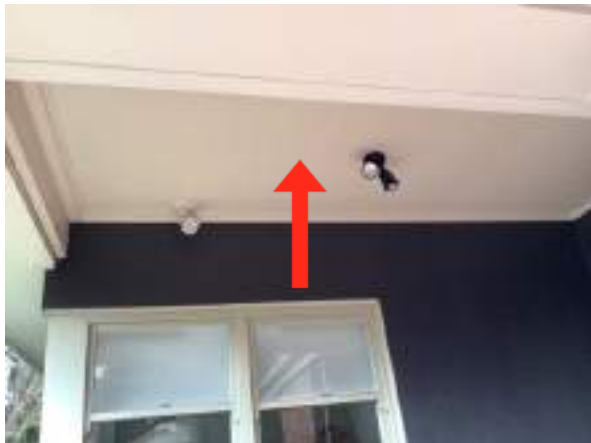
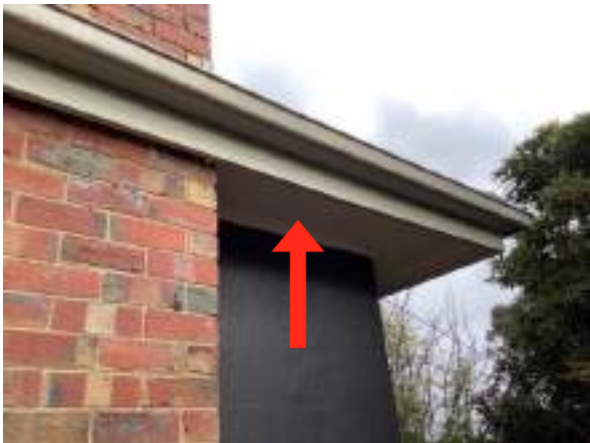
Asbestos can be in the old wardrobes and cupboard areas, asbestos can be in the flu systems of the old hot water services or heater flu systems. Asbestos can be on the walls or ceilings. Asbestos can be in the eaves in the older homes and the exterior walls of the older homes. Asbestos can be found in the roof space areas in the floor space areas and in the old sheds.

Reporting on Asbestos is outside the Scope of this Report. This suspected defect is highlighted as a caution ONLY and is ONLY a guide as asbestos inspections are outside the scope of pre-purchase inspection and reports.

As Asbestos Reporting is outside the scope of this report, we advise that you consider a separate Asbestos Inspection and Condition Audit, which can include the taking of samples for definitive confirmation of the presence of Asbestos.

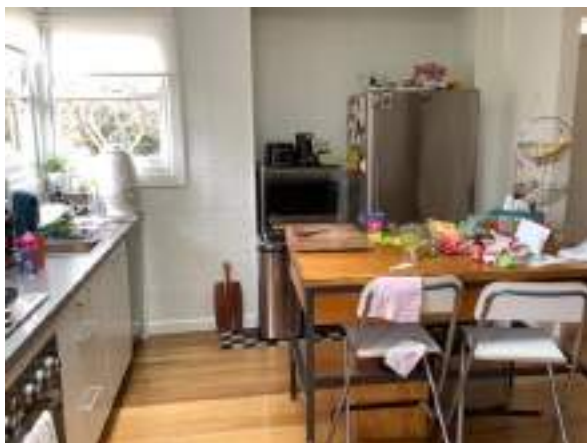
For your information 4.44

Location: The Site

Whilst we have taken many photos of the home and surroundings of the obstructions and limitations , we have just added a few photos in the report for you to understand the type of obstructions and limitations .

A re-inspection is recommended once the areas are made accessible.
