Building & Termite Report (Termite Damage And Renovation Concerns Found)

Inspection Date: 6 Aug 2020

Property Address: Coburg Area

Report Type: Property and Timber Pest Report

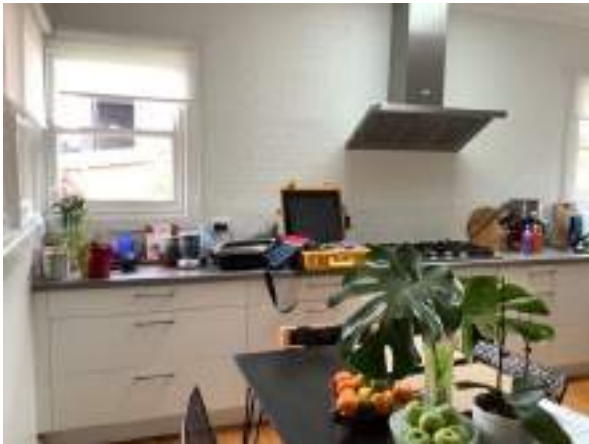
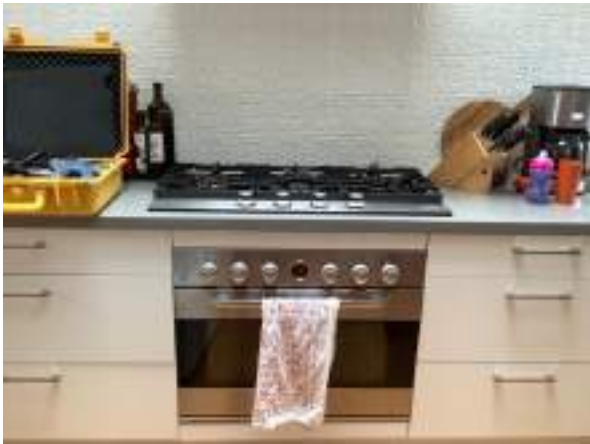
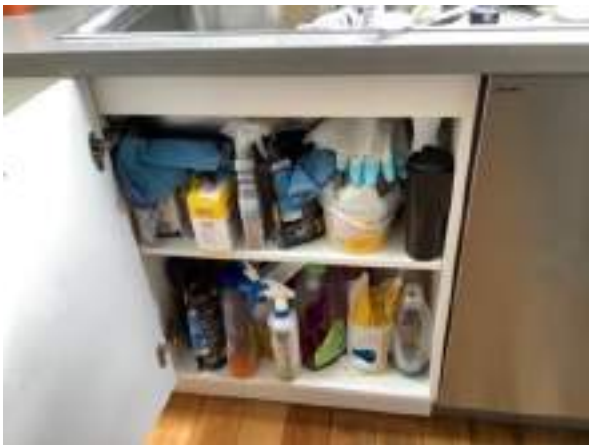
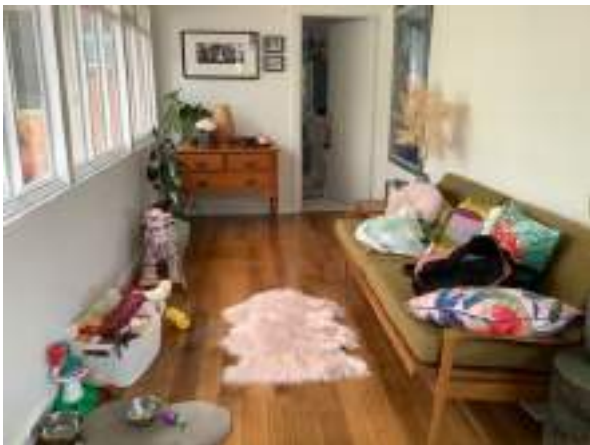
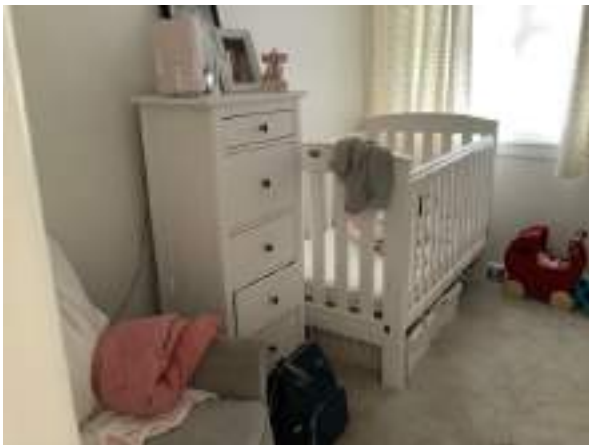
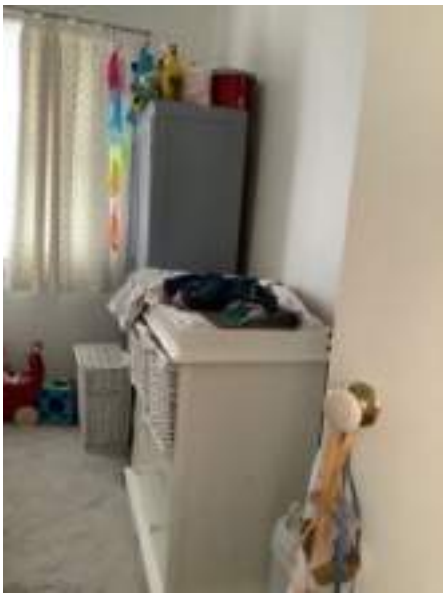
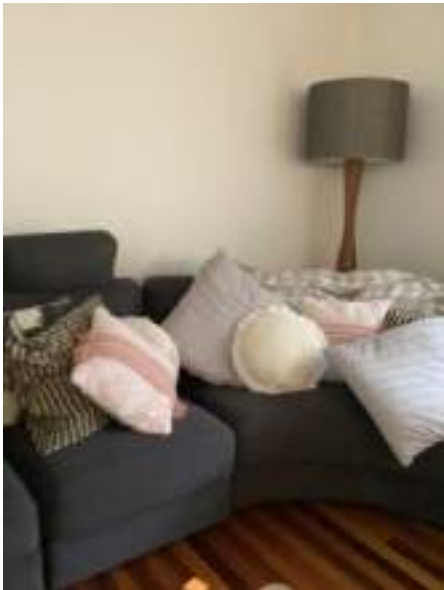
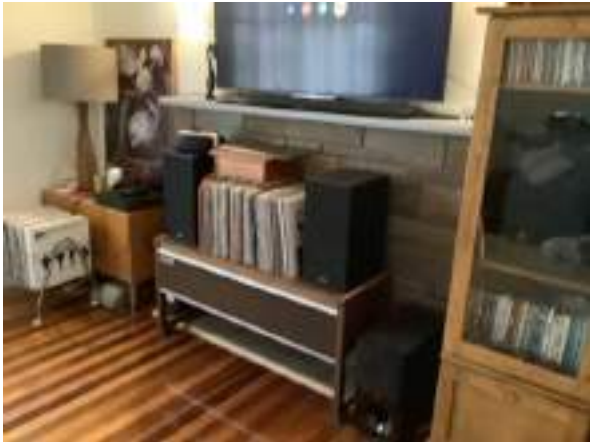
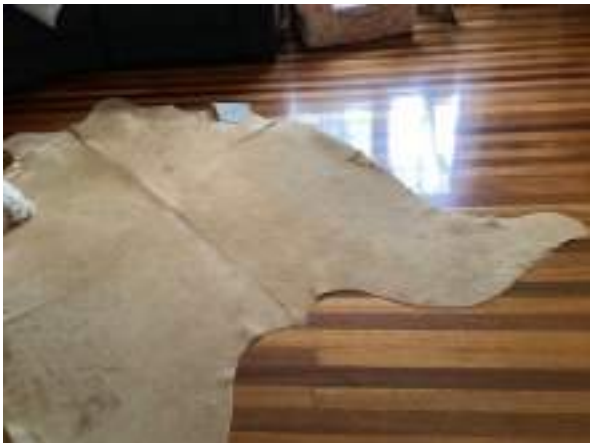
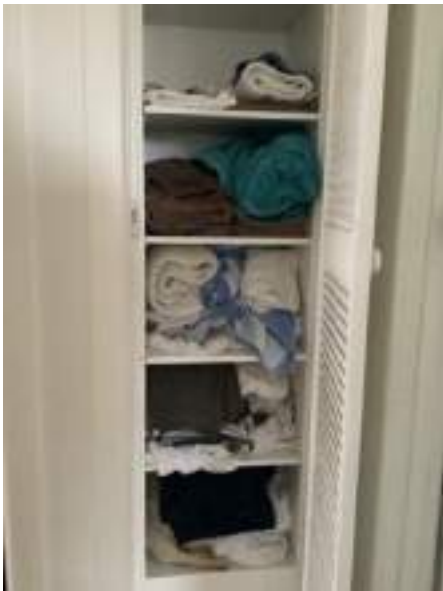
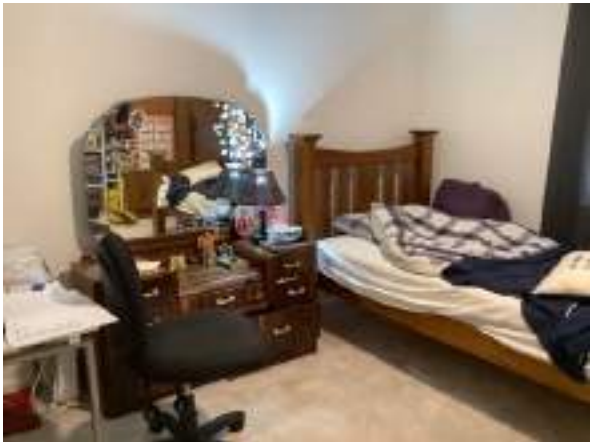
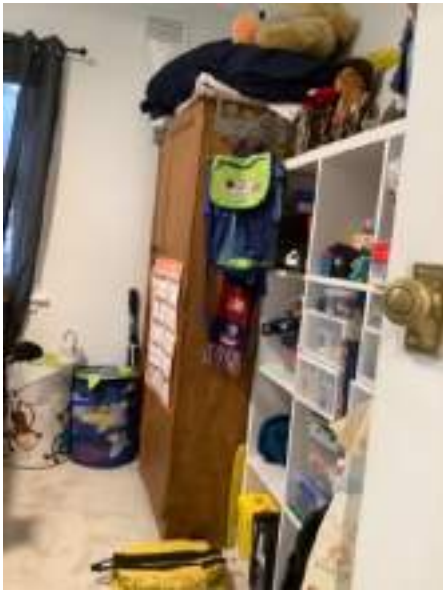
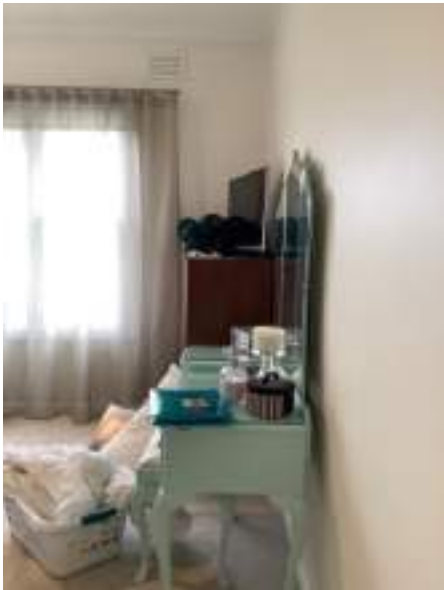
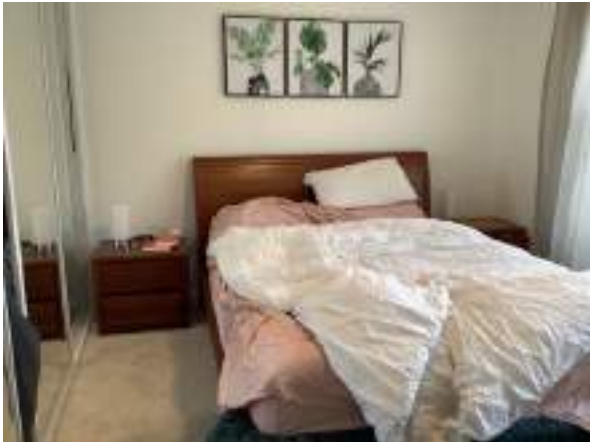
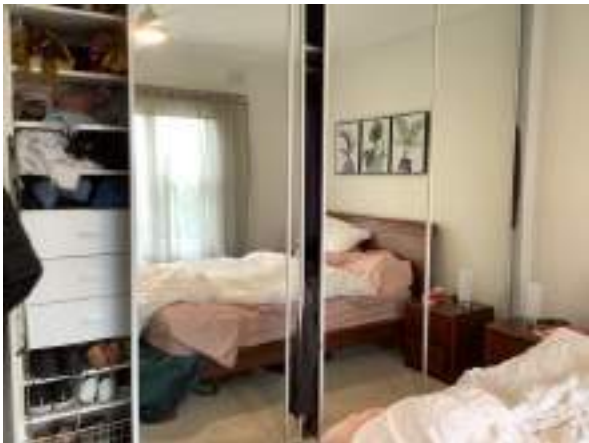
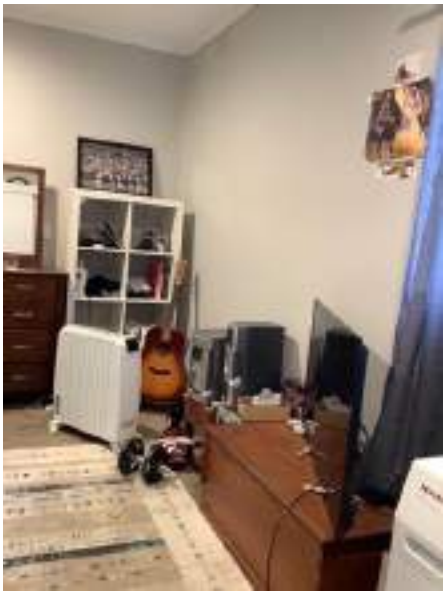
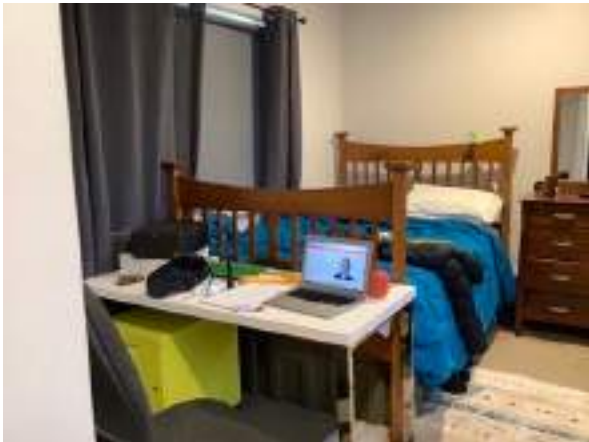
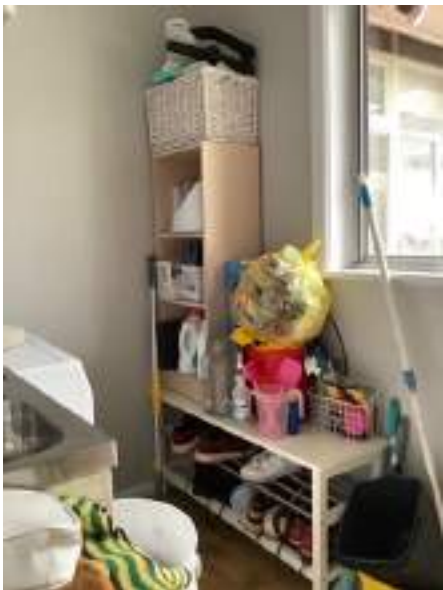
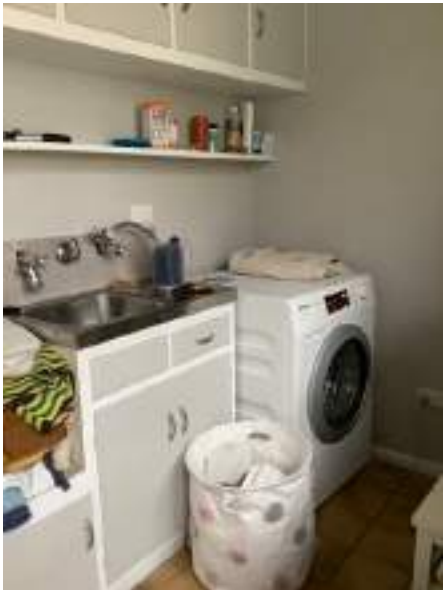
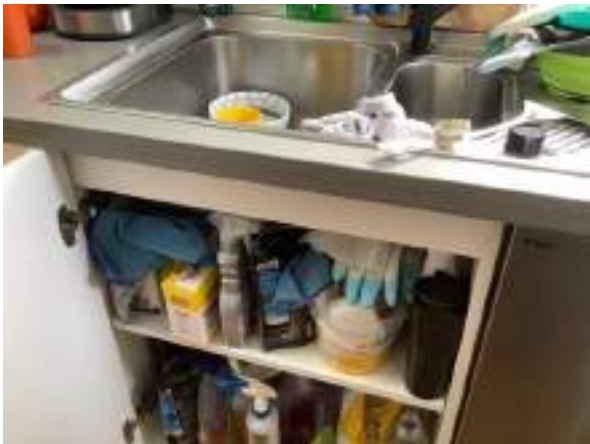
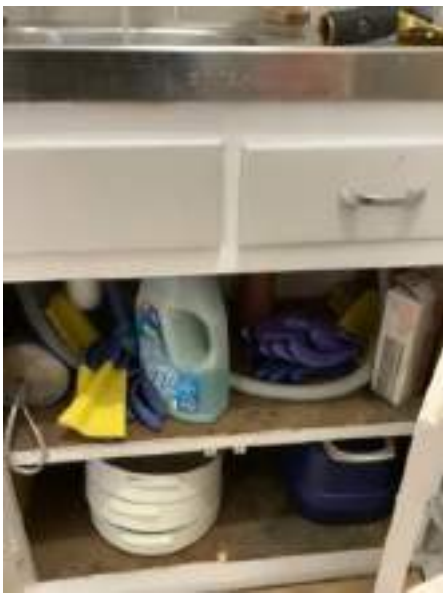
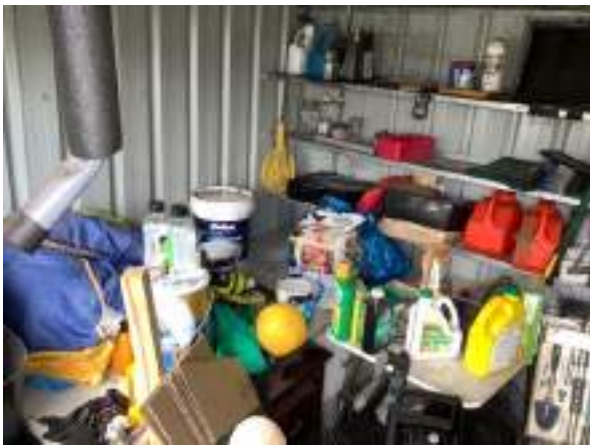
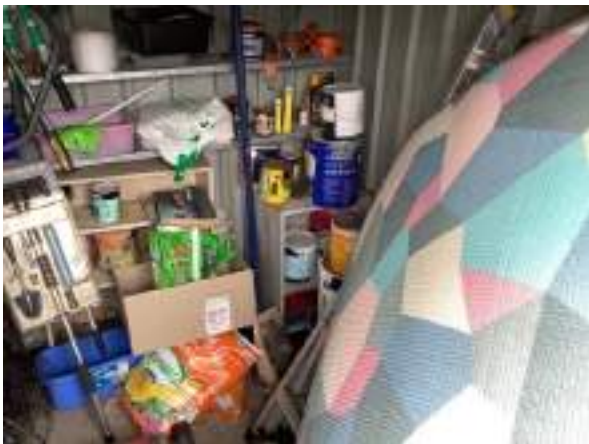
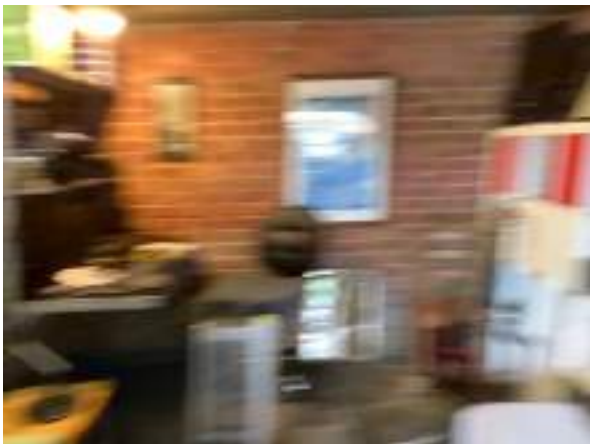
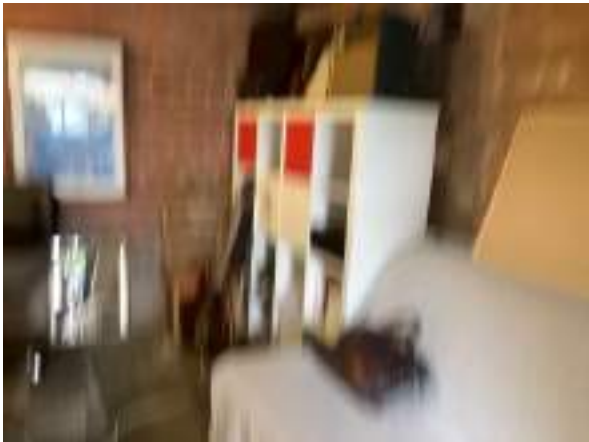
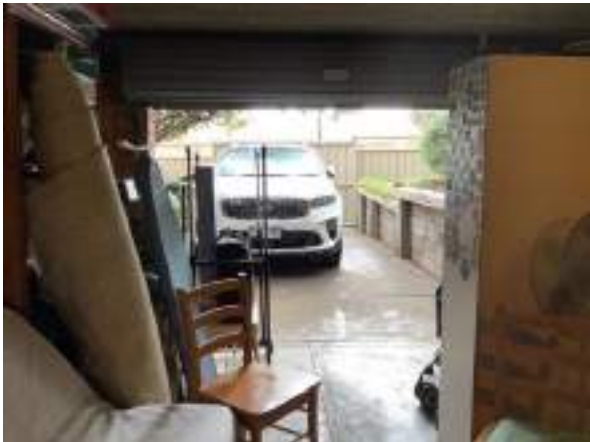
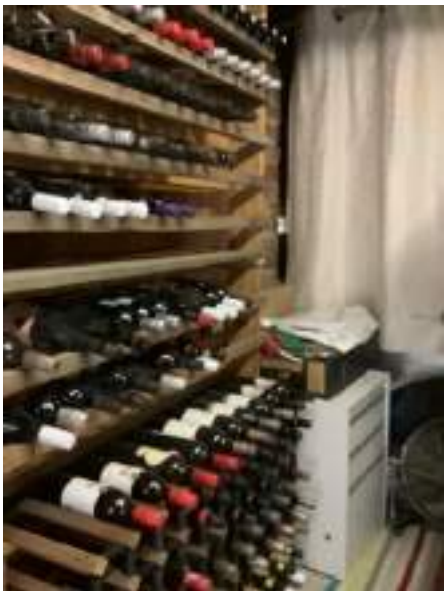
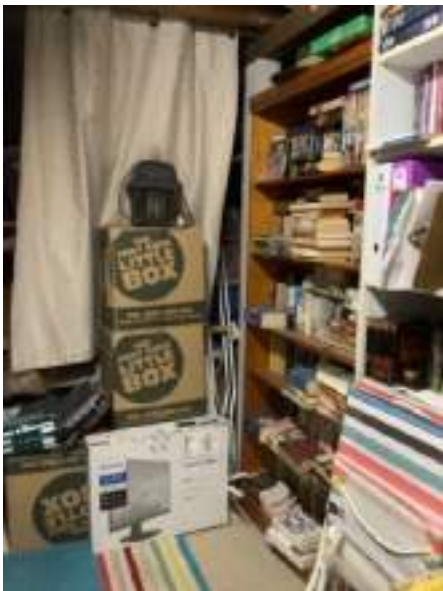
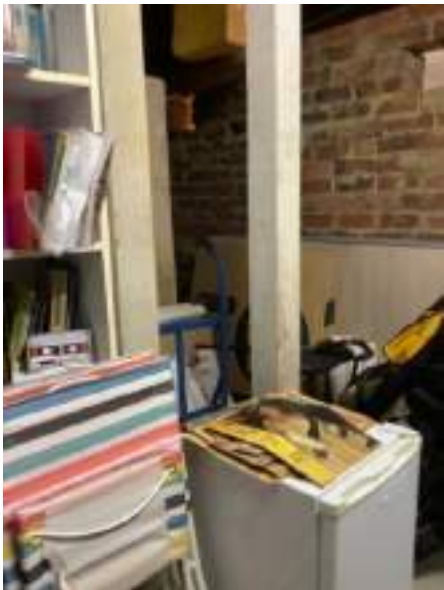
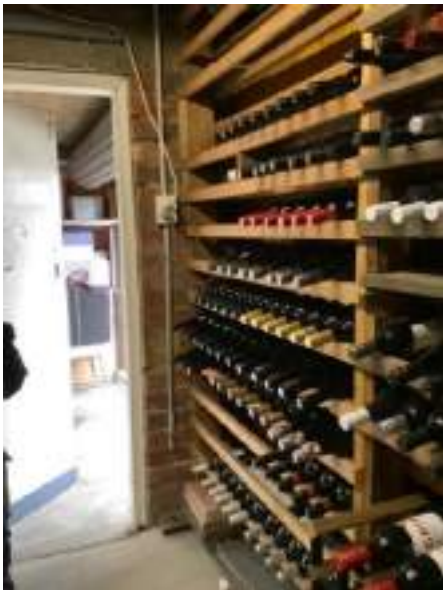
Finding: Additional Photos - Obstructions and Limitations
 These photographs are an indication of the obstructions and limitations which impeded full inspection of the property at the time of inspection.
 These obstructions can hide an array of defects such as minor defects , major defects , safety hazards , termite activity and conducive environments for termites but not limited to.

A re-inspection is recommended once the areas are made accessible.

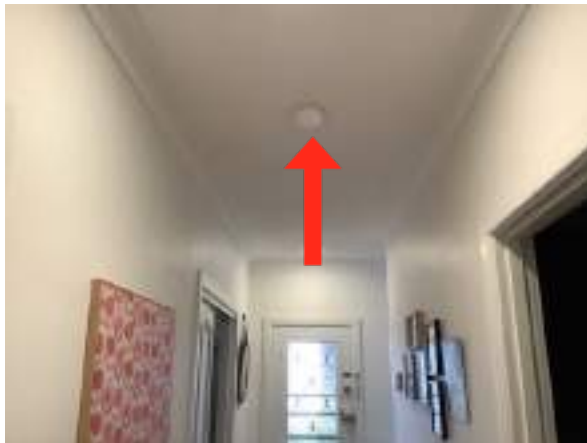
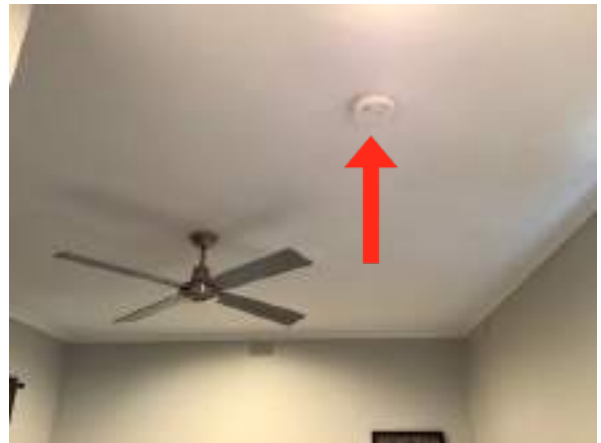
For your information 4.45

Finding: Smoke Detectors Battery Replacement.
This inspection DOES NOT test operation of smoke detectors .

Upon moving into a new property, it is highly recommended that the batteries to the smoke detectors all get replaced instantly.

Smoke detector batteries should be replaced every 12 months at a minimum.

It is highly recommended that replacement dates of the batteries be kept in a log book.

Testing of smoke detectors is required monthly.

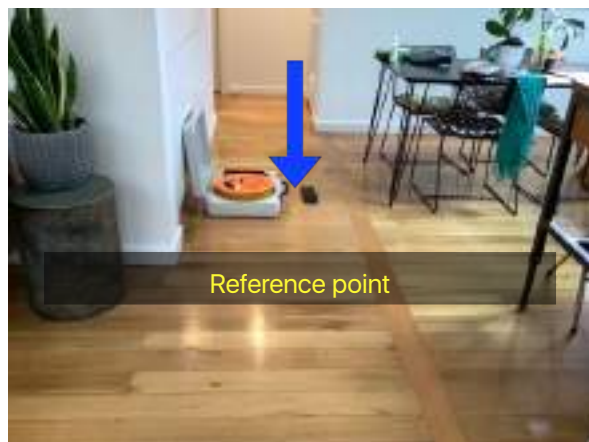
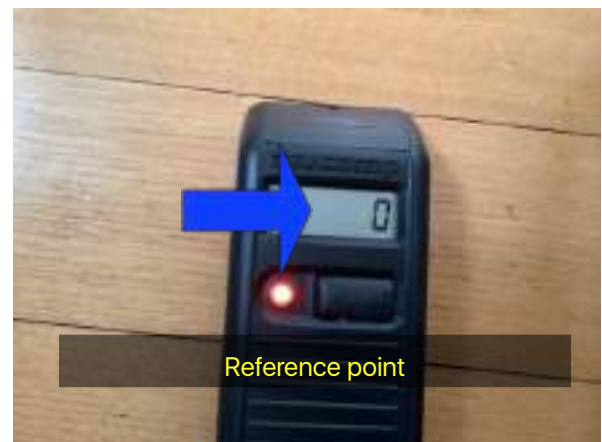
For your information 4.46

Location: Flooring - All Areas
Finding: Flooring - Within Levels Of Acceptance
DIGITAL ELECTRONIC FLOOR LEVELLING ASSESSMENT.

At the time of the inspection it appears that the subfloor structure flooring is within standards and tolerances.

We advise that the flooring be closely monitored to identify any movement over time. Where flooring remains relatively unchanged for an extended period of time (i.e. several months or seasons) it is likely that the flooring is relatively stable, however unexpected movement of the foundations of the property can happen at any time.

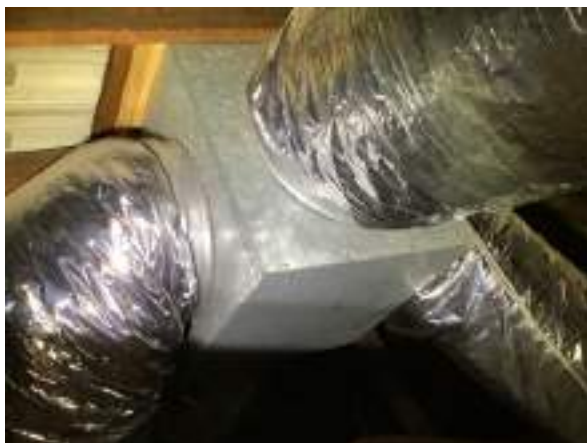
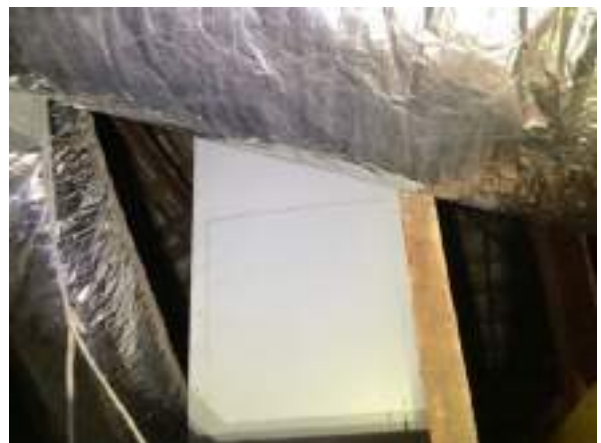
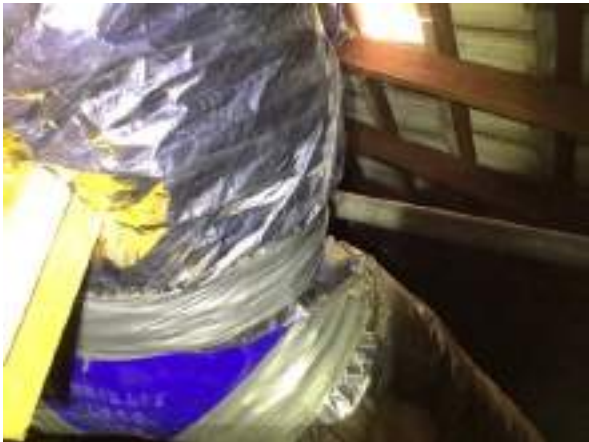
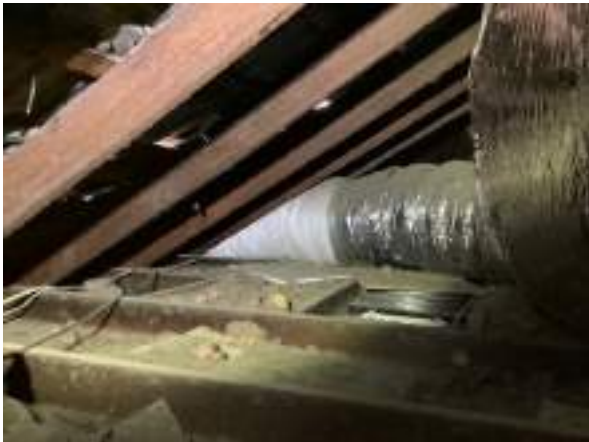
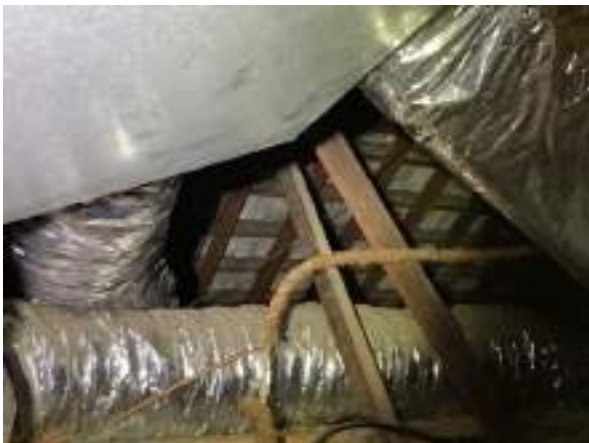
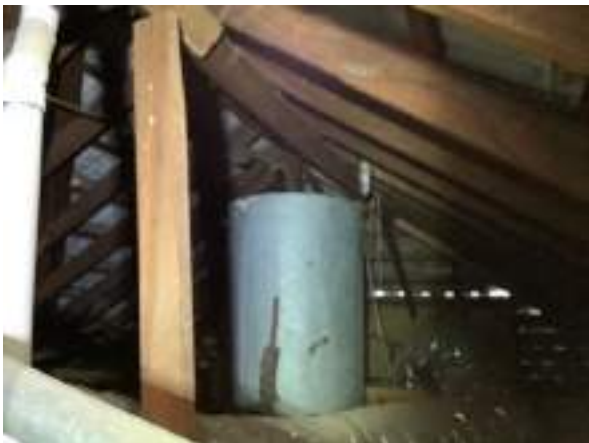
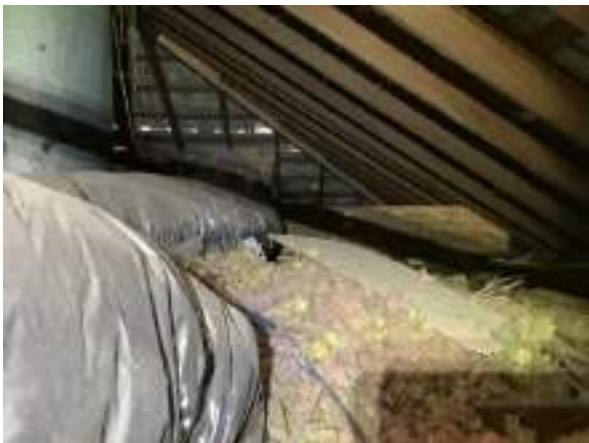
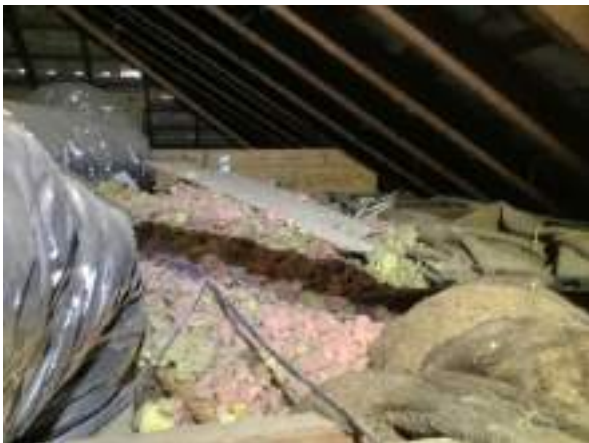
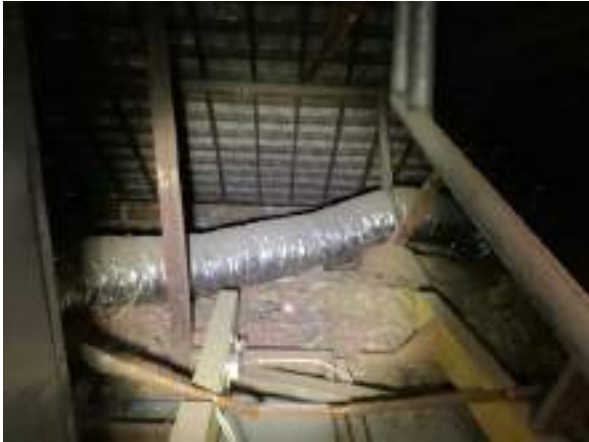
For your information 4.47

Location: Roof Space

These obstructions can hide an array of defects, without removing the insulation it is impossible to rule out termite activity and/or termite damage and other undetectable issues.

The property is a very high risk for termites as the environments to the property are very conducive with many susceptible areas.

Please read the report carefully and Maintenance to all susceptible and conducive areas is a MUST to minimise the risk of termite and timber pest existence and timber damage.

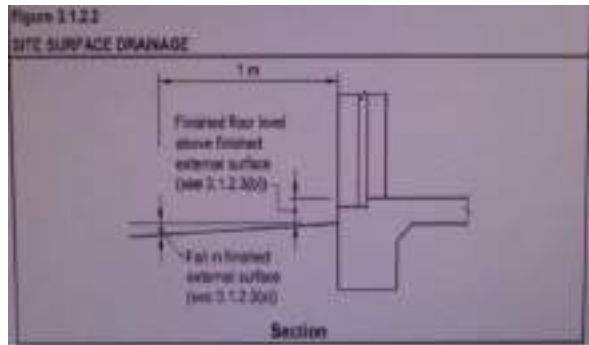
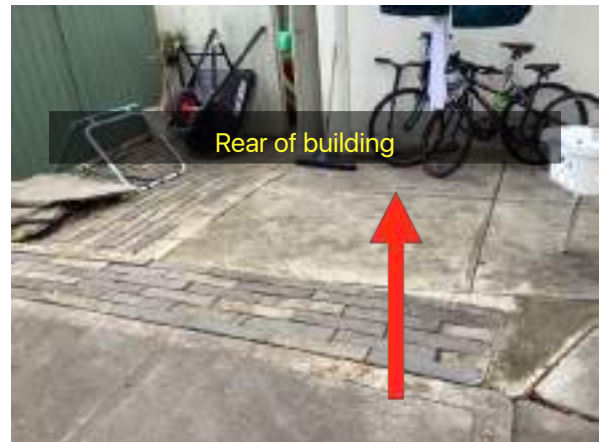
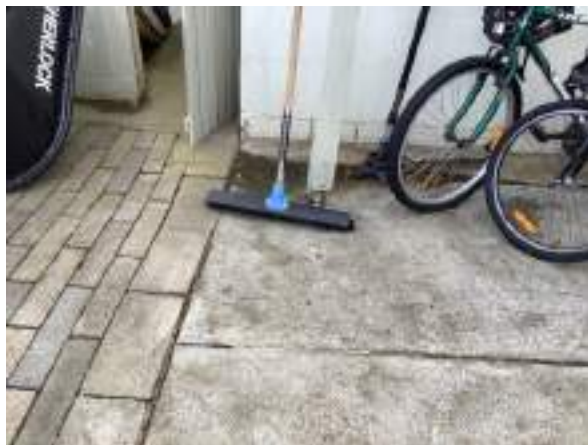
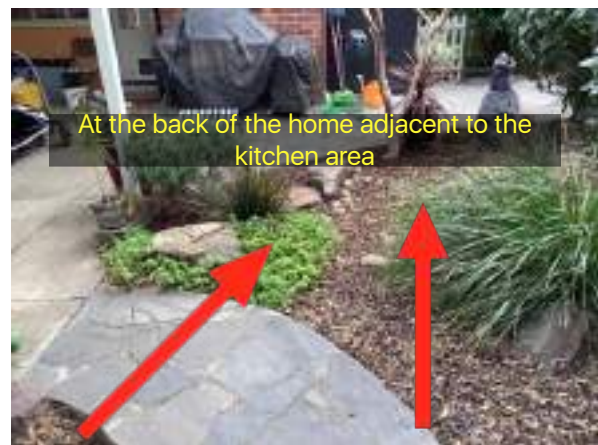
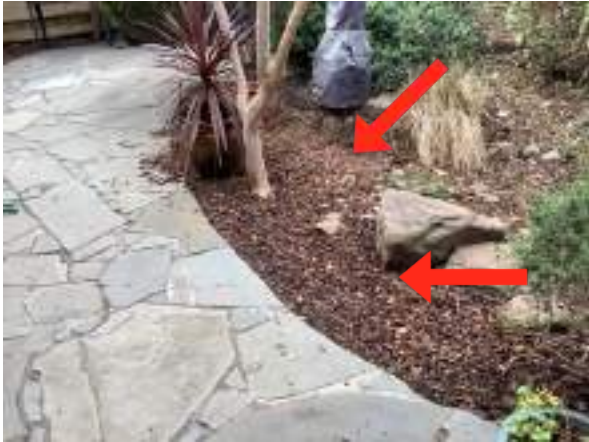
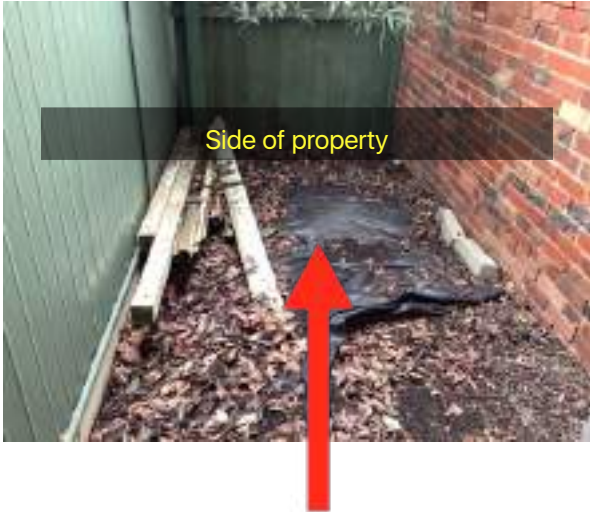
For your information 4.48

Location: Perimeter Of Building - Exterior

Finding: Drainage - Inadequate and/or Perimeter Building Ground Fall Defective.
At the time of the inspection it was noted that the surrounding perimeter soil does not fall away from the slab / building.

Water pooling near foundations and footings is a serious concern with the potential to adversely impact on the longevity of the dwelling. The Building Code of Australia (BCA) outlines that the soil or concrete must be graded away from the dwelling at a minimum of 50mm over 1m (1:50 fall).

The site drainage in this report was found to be inadequate at the time of inspection, creating potential for subsequent water damage to associated building elements, such as foundation subsidence, brickwork cracking, windows and doors moving, concrete paths cracking, etc.

These drainage concerns in this report can have grave potential for foundation subsidence and/or secondary damages such as structural defects such as brick movement / cracking as already mentioned above.

Where site drainage is inadequate, another option can be installation of an Agricultural (Aggie) Drain may be required or more serious remedial works.

It is highly recommended that a plumber, builder and other forms of professionals be appointed to further inspect the area and to install / repair adequate drainage equipment where necessary.

If secondary damages have ALREADY accrued we highly recommend that you engage a structural engineer, geotechnical engineer to start with to then engage a registered builder, qualified plumber to further inspect the property and perform any remedial works as necessary.

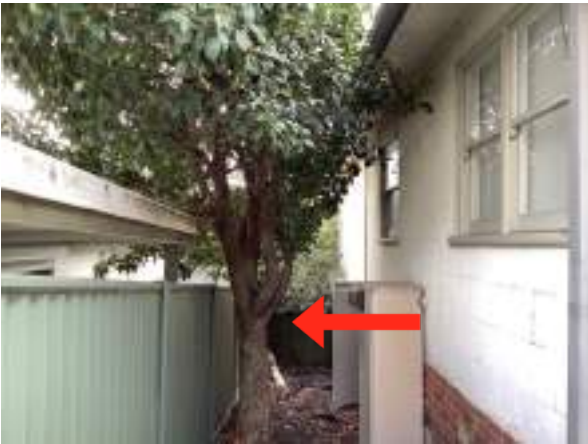
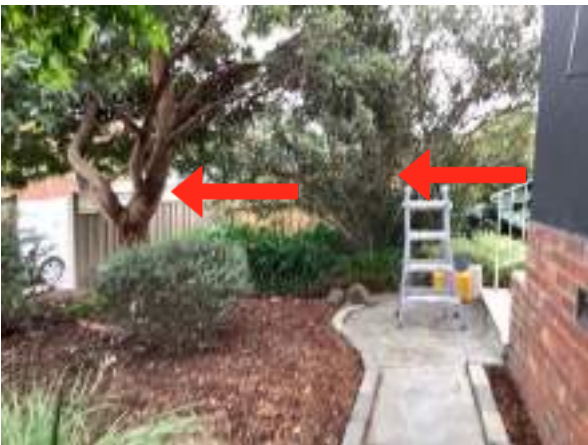
For your information 4.49

Location: Garden Areas - All Areas

Finding: Garden trees and vegetation / Yakka Trees - Subsidence - Close To Buildings
PLEASE NOTICE THE ATTACHMENT PICTURES TO THIS DEFECT STATEMENT;
H = the height of the tree at its full potential height, not its height today.
D = the distance from the tree to the building at the trees full potential height.
D = varies pending on one tree to 4 trees or more.

Trees and other vegetation can have a significant local effect on drying of soils. Over a number of years, especially during drought conditions, adjacent trees and vegetation may draw excessive moisture from the soils. The opposite may also occur, where swelling of the soil results when the trees decline or are removed.

As the cumulative moisture deficient is reversed, the surface level around the tree (and adjoining subfloor or concrete slab) will rise and expand laterally. This is often damaging to buildings unless the foundations have been strengthened or designed to cope with the effect.

Subsidence can have complex and varying causes, which will influence the required remedial works. It is advised to begin by consulting a structural engineer to determine the required scope of works. This generally includes some form of underpinning, as well as addressing the underlying cause. Consultation with a geotechnical engineer may also be necessary.

A registered builder specialising in re-stumping / structural damage such as major brick cracking would then generally carry out works as advised by an Engineer and/or Geotechnical Engineer.

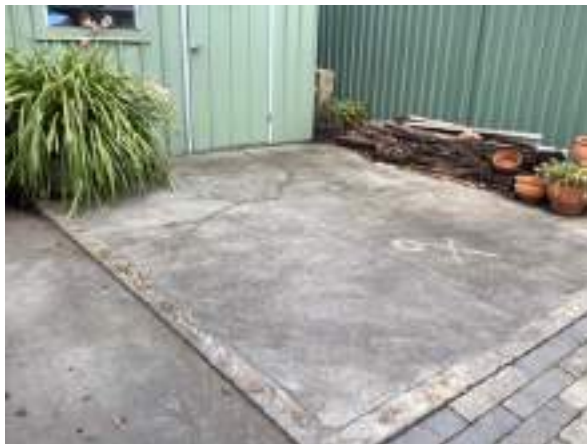
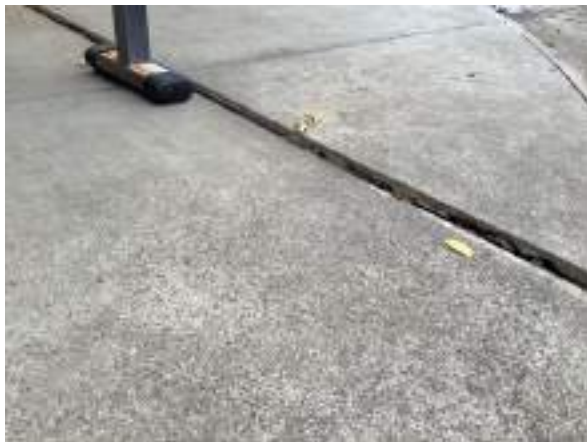
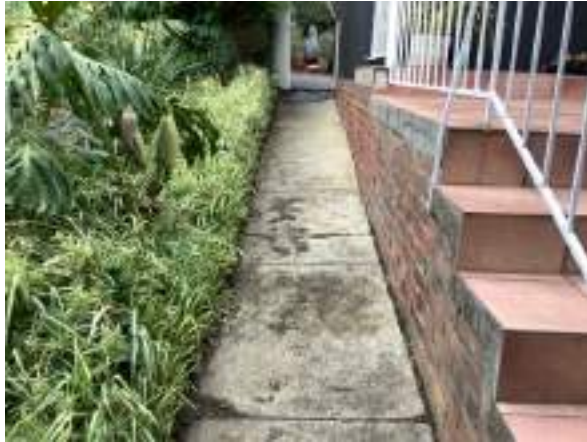
For your information 4.50

Location: Concrete - All Areas

Finding: Cracking - External Concrete Paving Damage Category 4 - Gaps in Slab (4mm - 10mm +)
Gaps in the slab were identified in external concrete paving. Gaps in the slab are significant and are likely to lead to the development of safety hazards and secondary defects if left unmanaged, such as the creation of a trip hazard.

General age and expected deterioration of the paved areas is a common cause of this type of cracking. However, expansion and contraction of the slab may also have occurred due to environmental factors. Such factors include variable moisture and weather conditions, the presence of trees and their roots having a settling or lifting affect on the soil, or the effect of load bearing, e.g. heavy vehicles over a sustained period of time.

Cracking to this degree may also be due to poor original installation of the concrete. Factors such as poor compaction of the sub surface and/or inadequate reinforcing of the slab may create cracking and other secondary defects. Gaps in the concrete paving may also have a more significant structural cause, such as subsidence of soils.

Where gaps in the concrete paving are adjacent to structural elements of the building, the advice of a Structural Engineer is advisable before undertaking repairs. Significant repair and likely replacement of the concrete paving is probable.

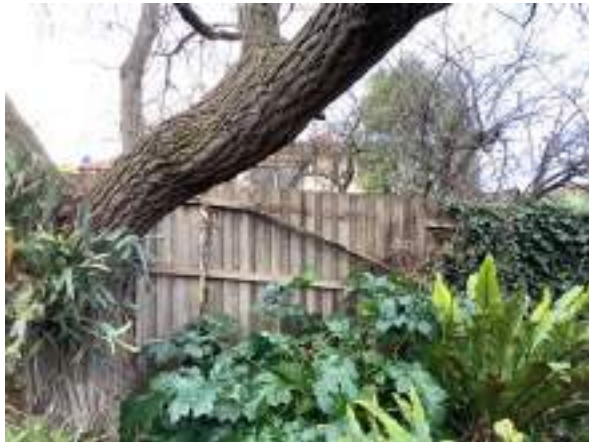
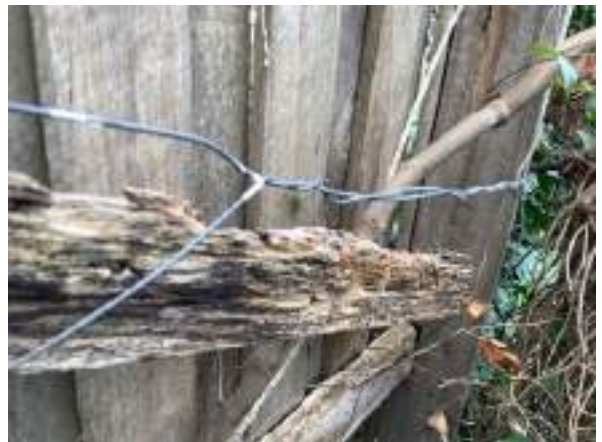
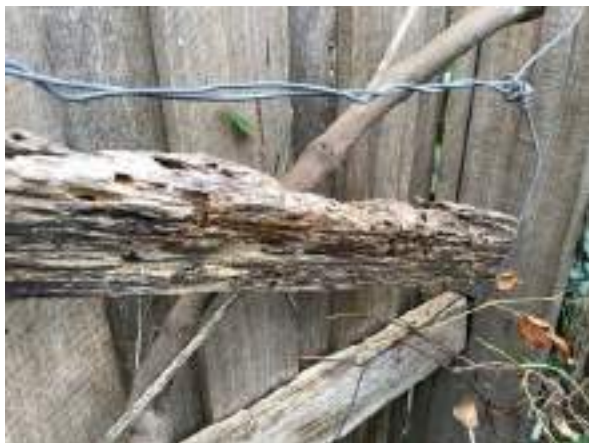
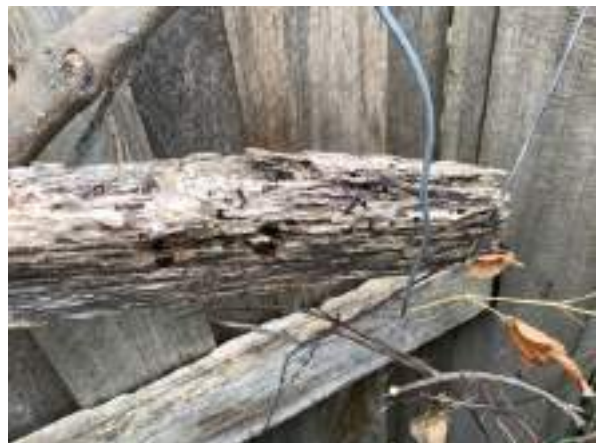
TERMITE WORKINGS AND/OR DAMAGE

The client IS HIGHLY RECOMMEND gaining further advice from a licensed pest controller as to the costs and procedures involved with application of a termite management system and/or eradication, which should be treated as HIGH PRIORITY.

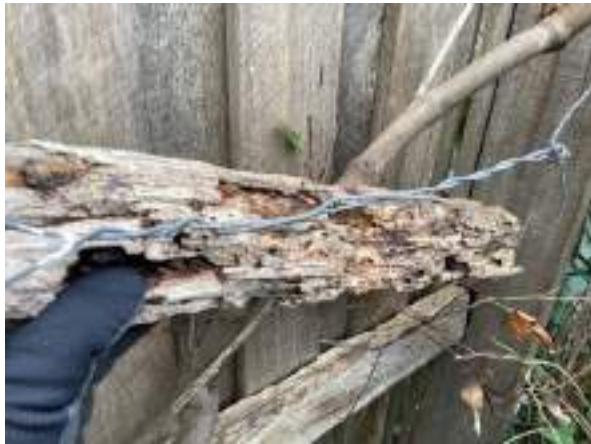
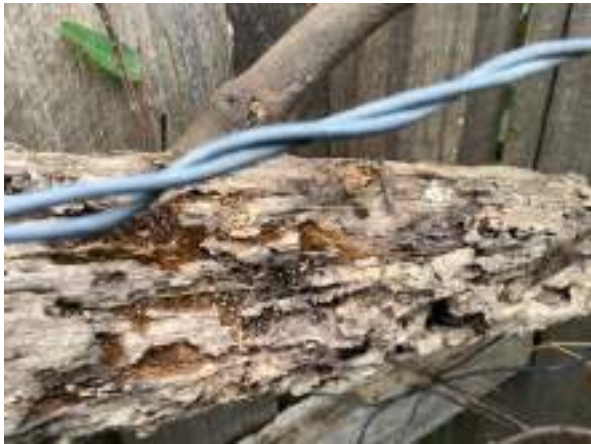
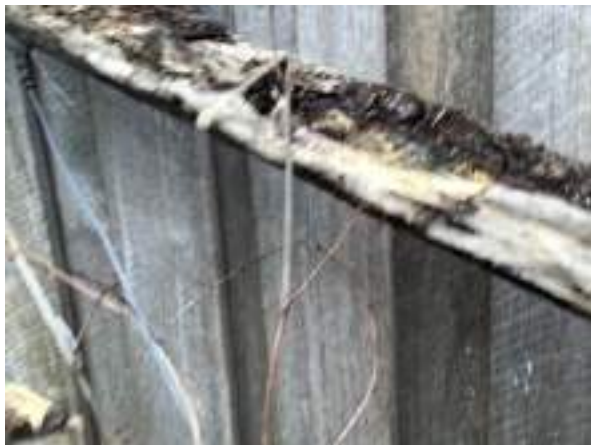
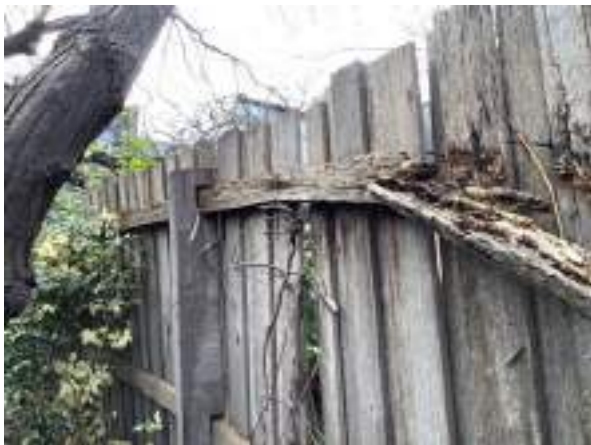
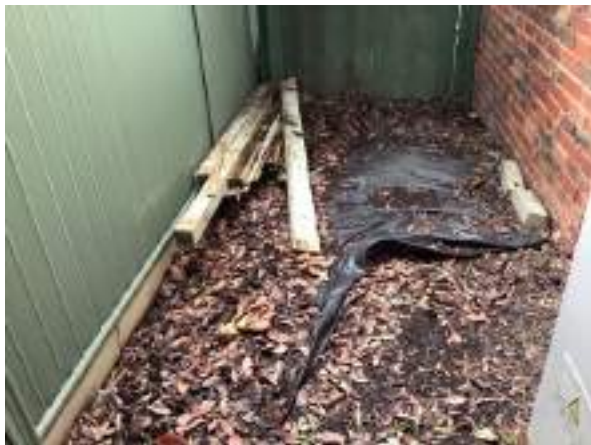
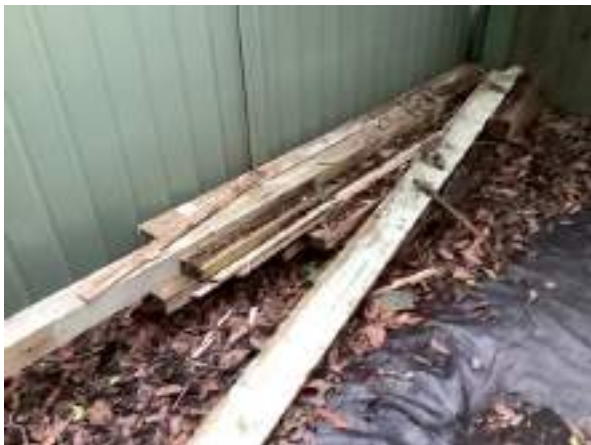
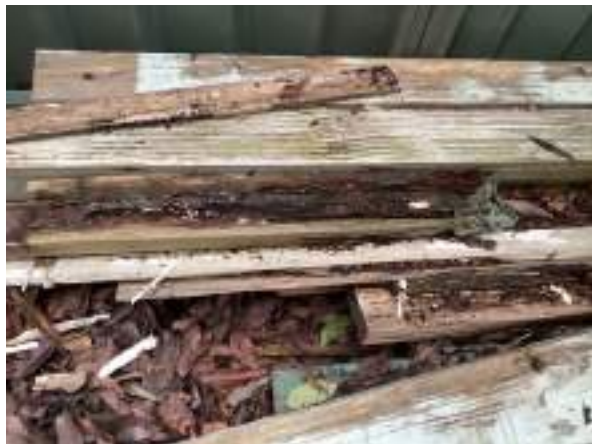
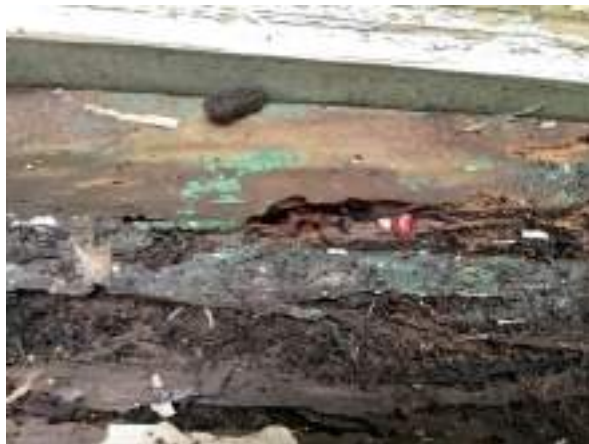
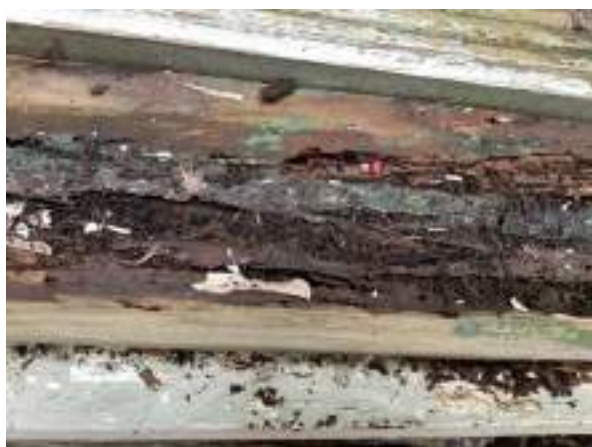
Finding: Timber Pest - Damage Identified.

It is suspected that timber pest activity is occurring or has occurred as there appears to be evidence of timber pest damage.

Despite no live termite or timber pest activity being identified, previous timber pest damage was found in these areas.

Such damage creates a potential safety hazard, and is likely to worsen and cause further damage to adjoining building materials.

If left unattended, this damage creates an unsafe environment and is likely to lead to the need for major structural works.

A building contractor should be appointed immediately to advise on options to prevent further damage and repair all affected building materials. Until such time, caution should be taken by all people coming into contact with these building elements and this area.

We HIGHLY RECOMMEND the client may consider gaining further advice from a pest controller as to the costs and procedures involved with this application.

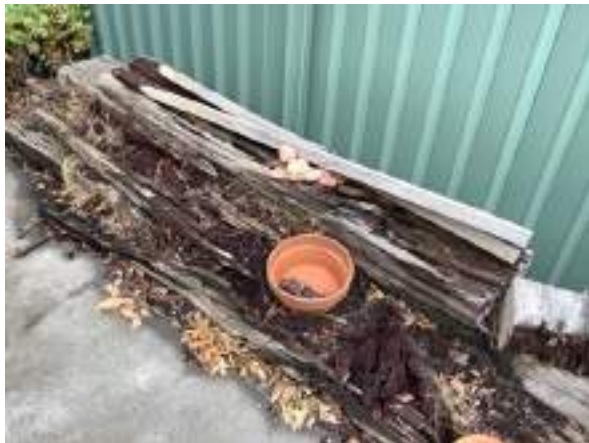
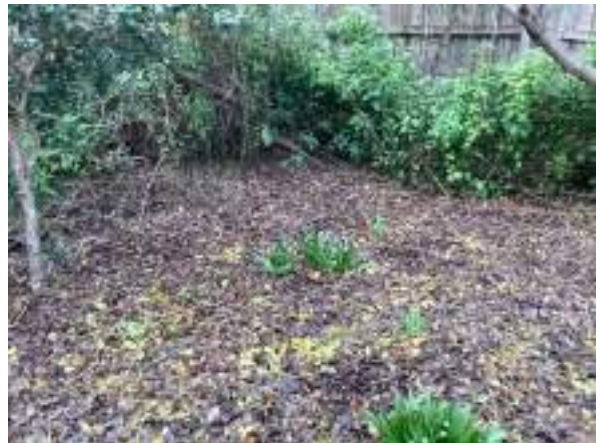
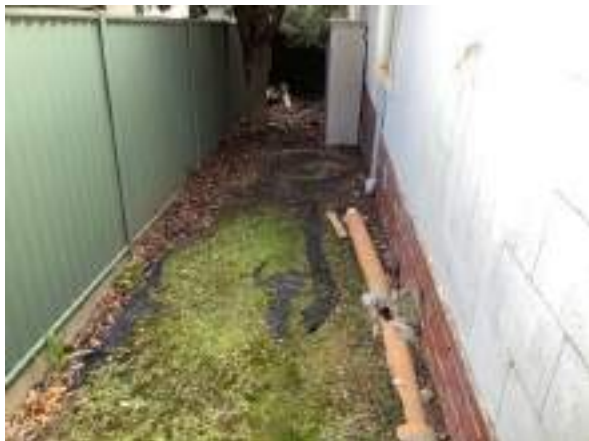
Finding: Wet Areas, Moisture Present - Attract Termites.
Excessive moisture can attract termites and produce conditions that promote termite attack fungal growth and wood decay as Termites are attracted to moisture.

Excessive moisture is generally caused by deteriorated inadequate or missing roof drainage leaking plumbing pipes or fixtures poorly plumbed HWS overflows or condenser units and poor site drainage.

It is highly recommended that all plumbing and drainage fixtures and fittings be maintained regularly in order to prevent excessive moisture being present in the external / internal property.

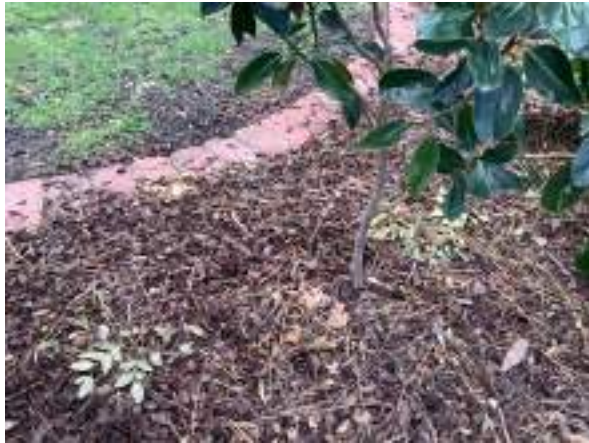
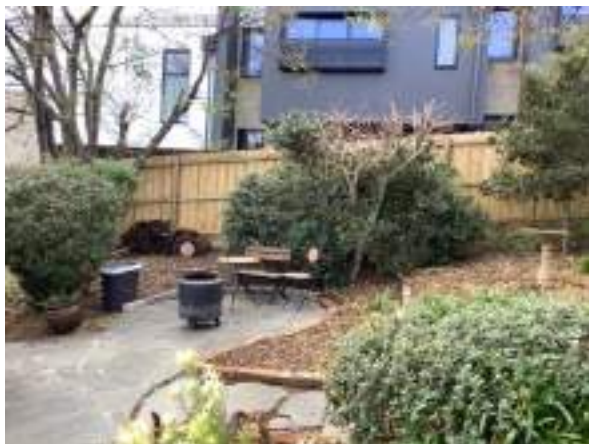
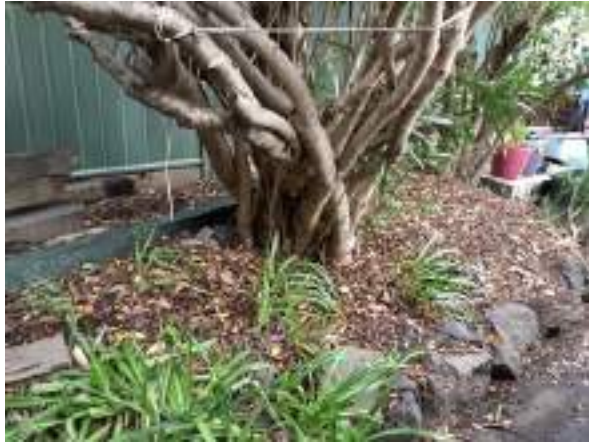
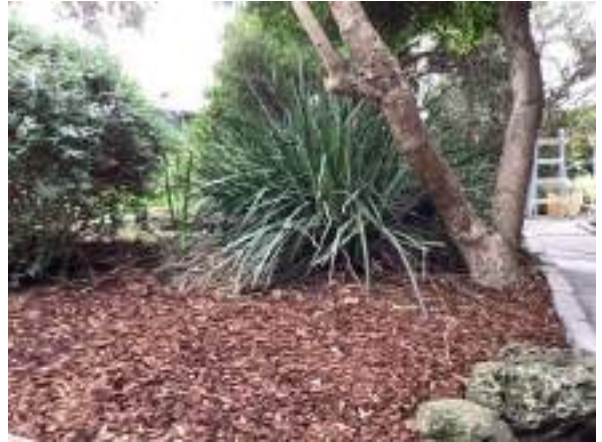
Item 2.05

Finding: Garden Beds - Conditions Conducive to Termites
Garden beds were found to be evident in areas of garden areas.
These garden beds can include untreated timber, bark, excessive old vegetation and with a combination of moisture from watering hosing can make conditions very conducive to termite activity and termite ingress.
It is always important to keep the garden beds as clean as possible and take out excess old bark from the trees, leaves and keep bark mulch to a minimum or better introduce rocks or some item that does not create an conducive environment for termites and hold excess moisture.

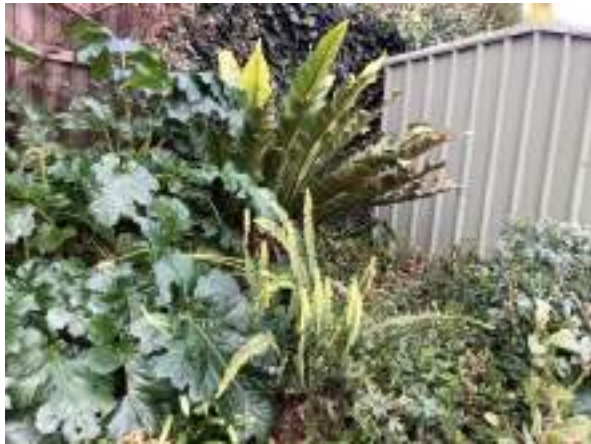
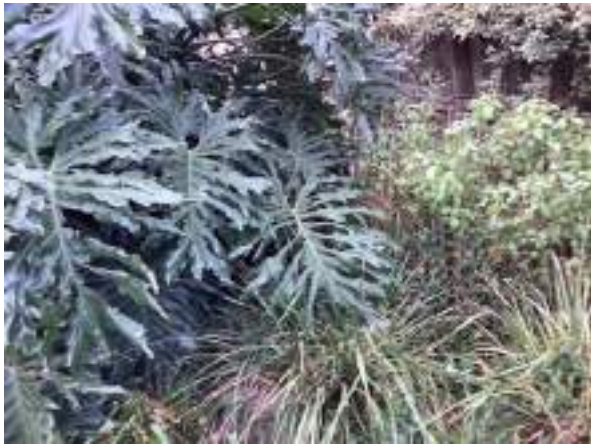
Item 2.06

Finding: Garden Plants - Overgrown .
PLEASE NOTICE THE ATTACHMENT PICTURES TO THIS DEFECT STATEMENT;

At the time of the inspection it was found that the plants are overgrown and close to the exterior building.

It is highly recommended that the plants be trimmed and/or moved away from the immediate area of the perimeter building...
