Building & Termite Report (Termite Damage And Renovation Concerns Found)

Inspection Date: 6 Aug 2020

Property Address: Coburg Area

Report Type: Property and Timber Pest Report

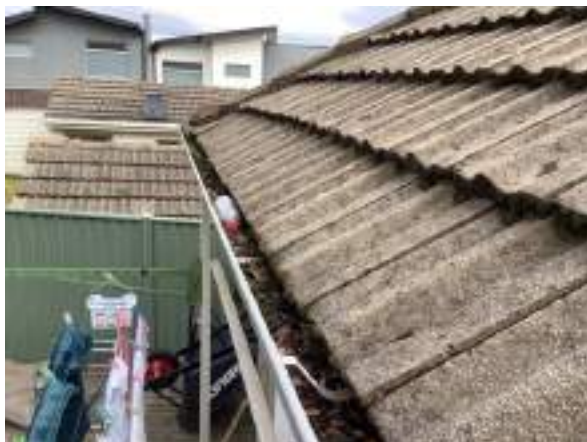
Item 2.07

Finding: Gutters - Requiring Clean Up And Removal Of Vegetation.
Gutters are a critical part of the building's management of storm water and rain. It is therefore important that they be kept clear to prevent secondary damage to associated building elements, including exterior and interior walls, ceiling linings and any adjoining building elements. Where gutters are blocked, pooling of rainwater is likely to occur, fast-tracking rust and corrosion of the roof plumbing elements.

Unclean Gutters prevent building elements from operating as intended, detracting from the overall function of the affected building elements. Additionally, the lack of general maintenance may lead to the development of more significant defects, such as damage to surrounding building materials.

Blockages should be removed and addressed promptly, as they will lead to the development of secondary building defects. The blockage should be removed as the primary rectification works. Secondly, check for any secondary or concealed damage, and then attempt to address the cause of the blockage to prevent recurrence or any water damage to associated structures.

Immediate clean up is required.

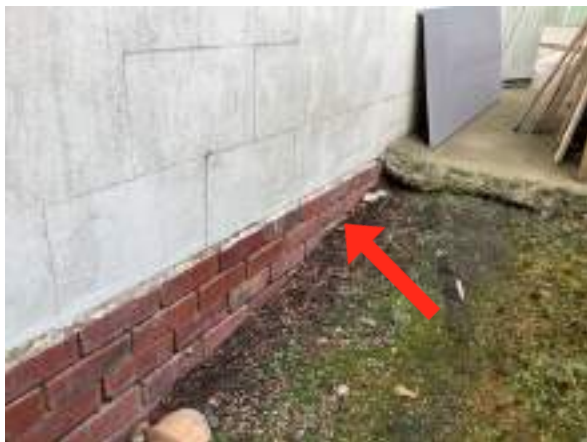
Item 2.08

Finding: Weep Holes - Bridging Or Breaching Of Termite Barriers Defective.
Bridging is the spanning of a termite barrier or inspection zone so that subterranean termites are provided with passage over or around that barrier.

Additionally build-up of moisture is likely to occur if weep holes are covered further attracting termite activity to these areas.

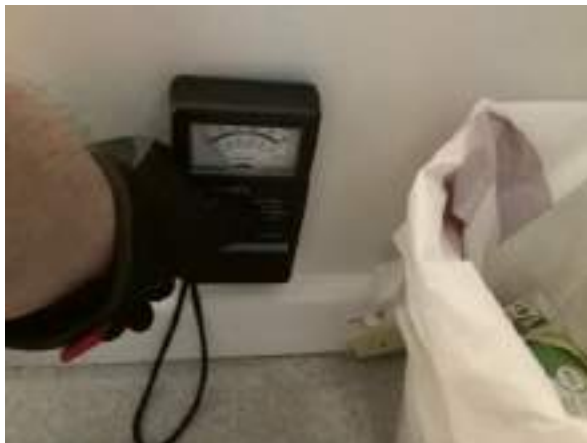
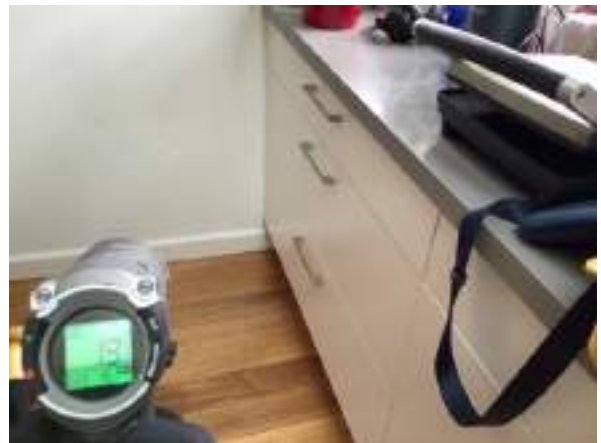
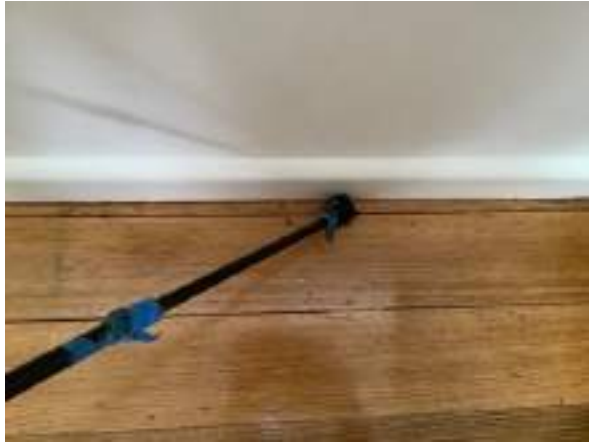
Finding: Identification Procedures Designed To Help Identify Termite Activity
All areas accessible of the dwelling are checked with particular attention paid to the wet areas which were closely assessed to check for excessive levels of moisture and temperature anomalies.

The moisture content variation was within the acceptable range of 5% to 20%.

Temperature variations were all identified under 25 degrees which is consistent with normal range for building elements in these conditions.

At the time of the inspection there was evidence of (timber pest) damage / activity and visually accessible timber damage caused by termites and / or timber pest.

The levels of moisture in all areas were found to be in the normal range.
