New Construction-Specific Exterior Roof Report (Builder Warranty Claim, Whilst Construction Is In Progress)

Inspection Date: 2 Aug 2020

Property Address:	Country Area
Date:	2 Aug 2020
Report Type:	New Home Construction

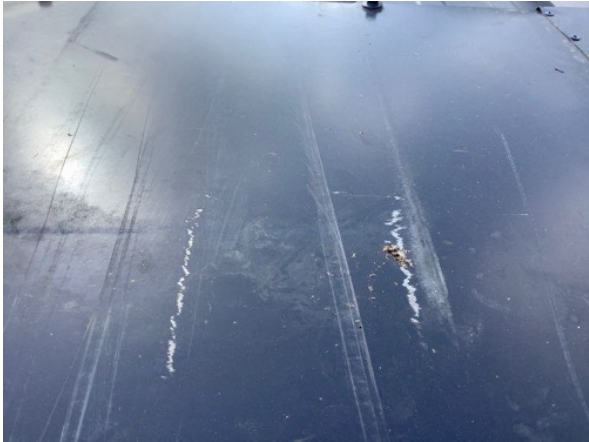
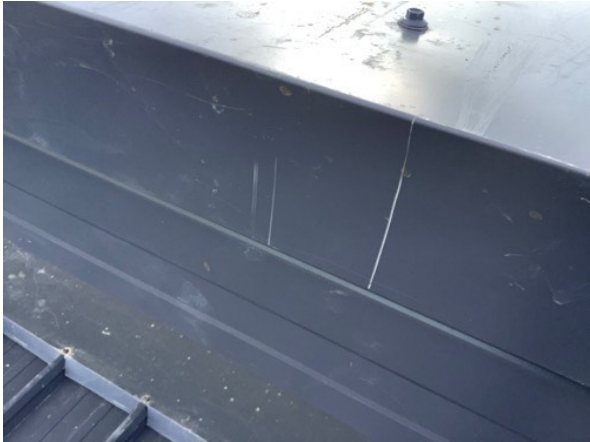
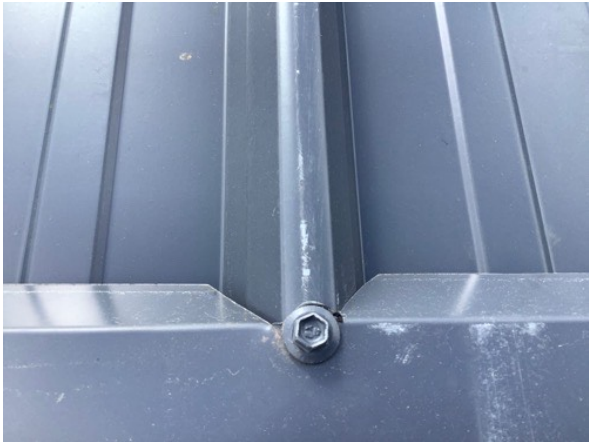
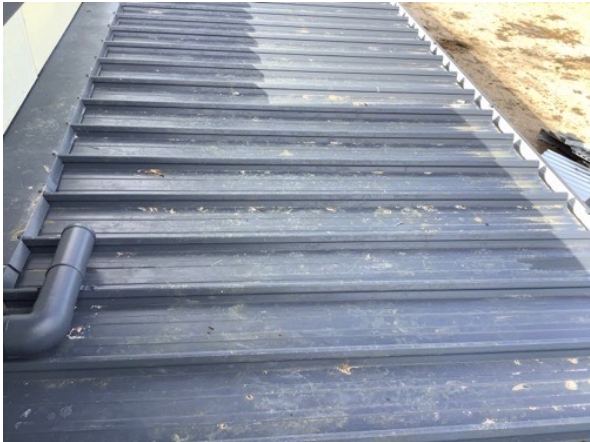
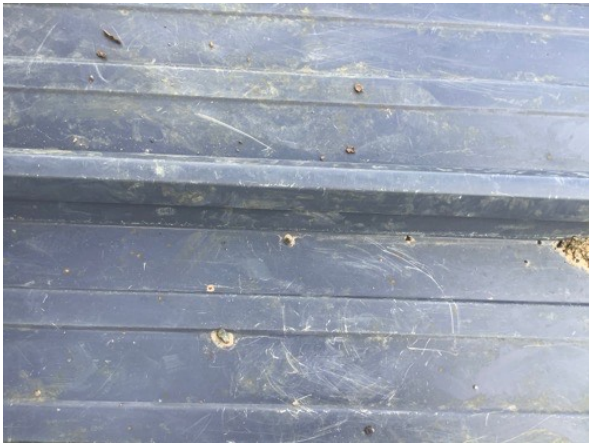
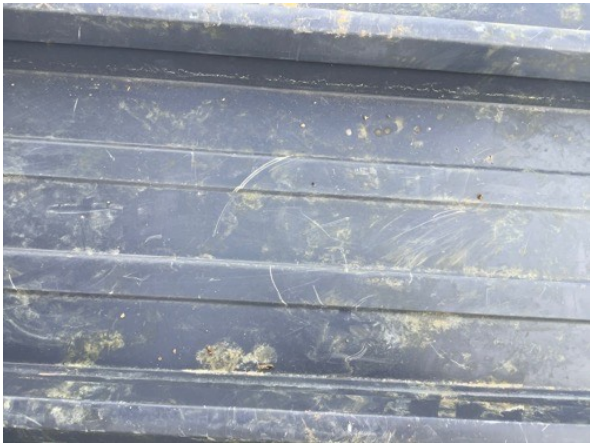
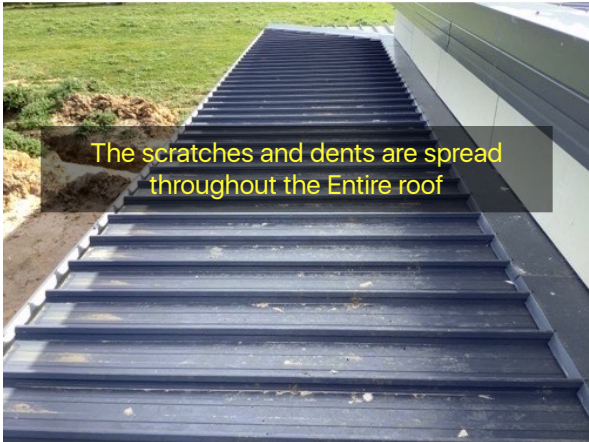
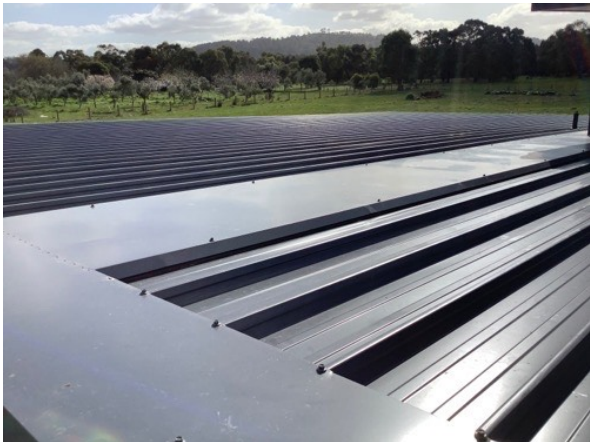
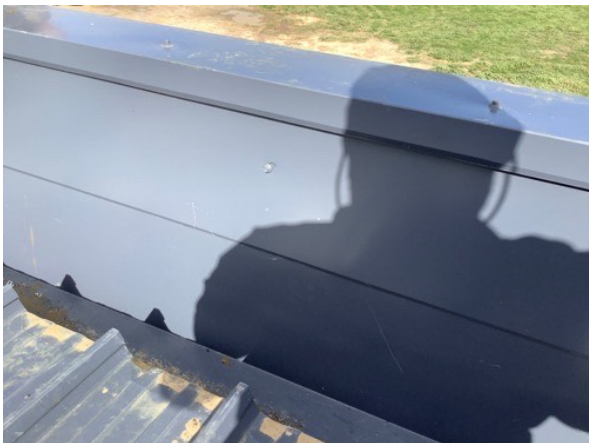
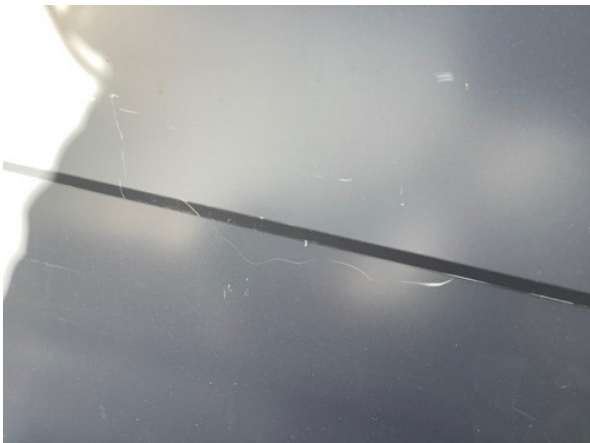
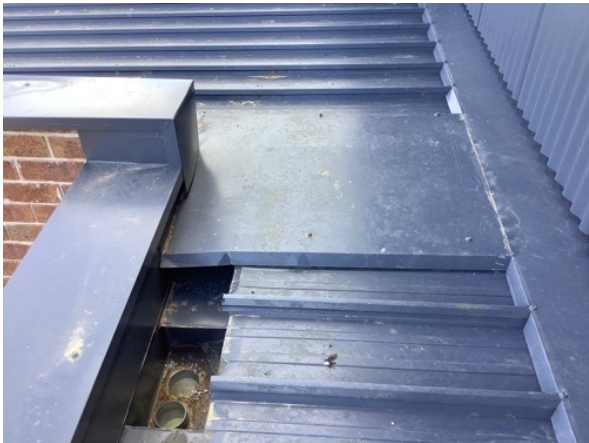
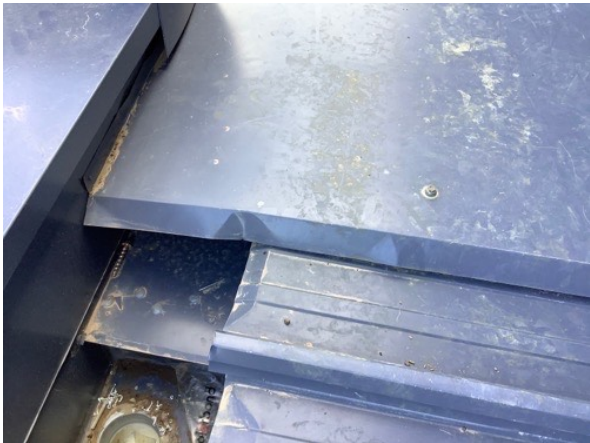
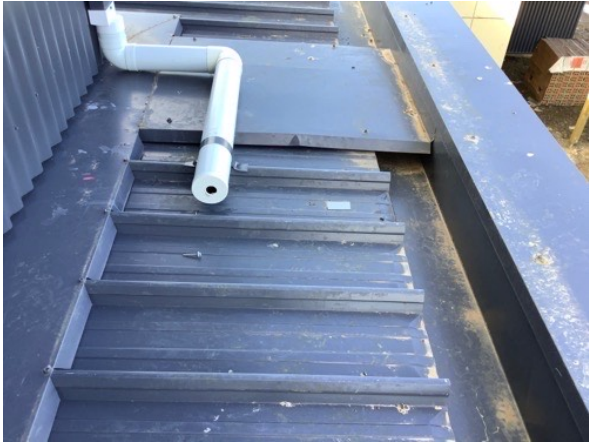
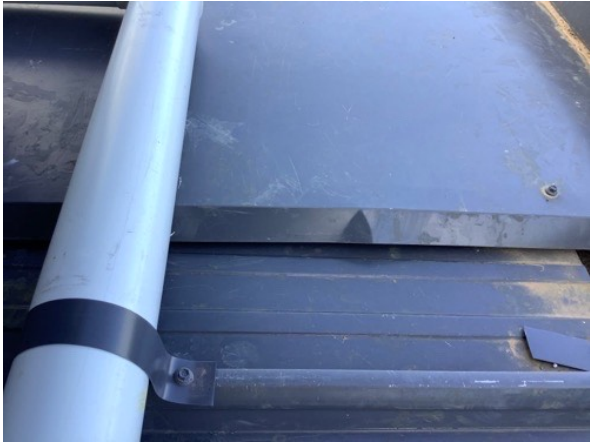
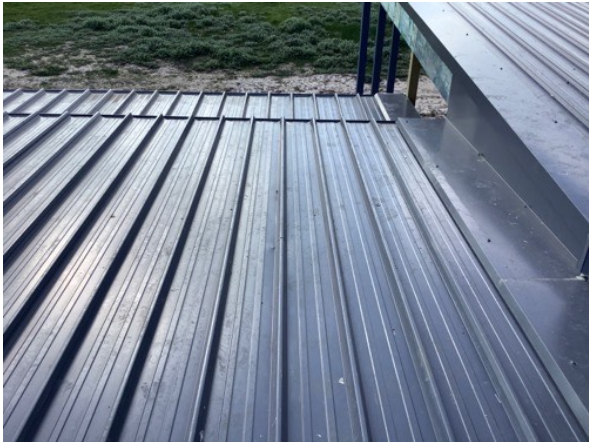
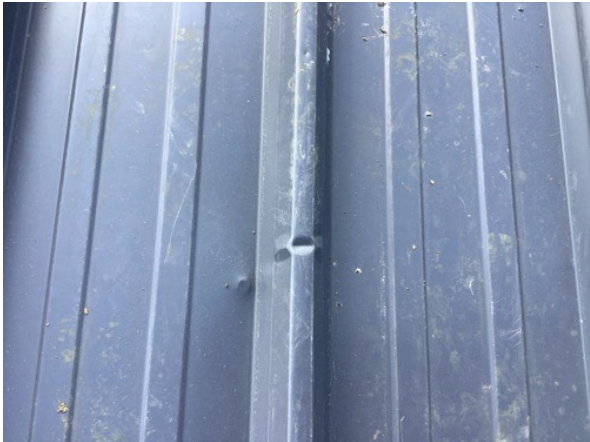
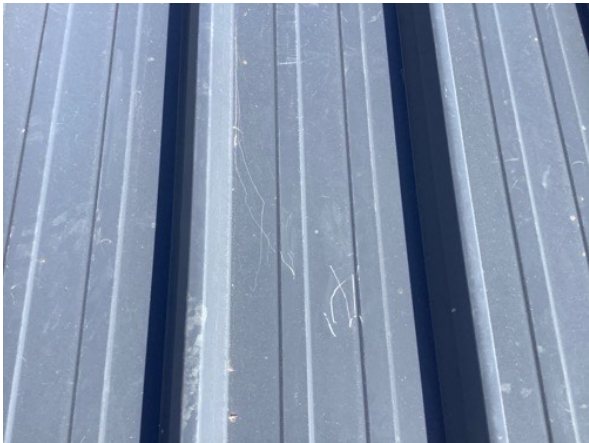
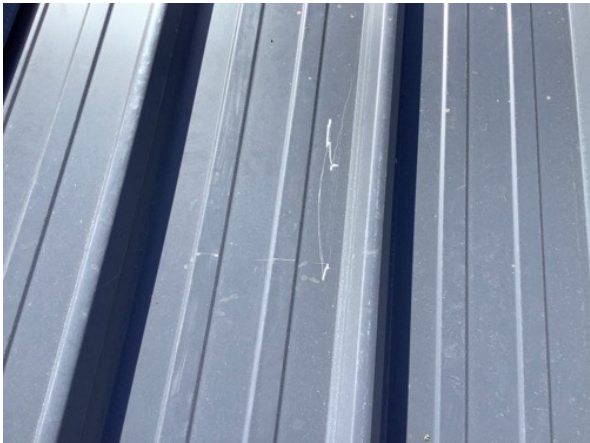
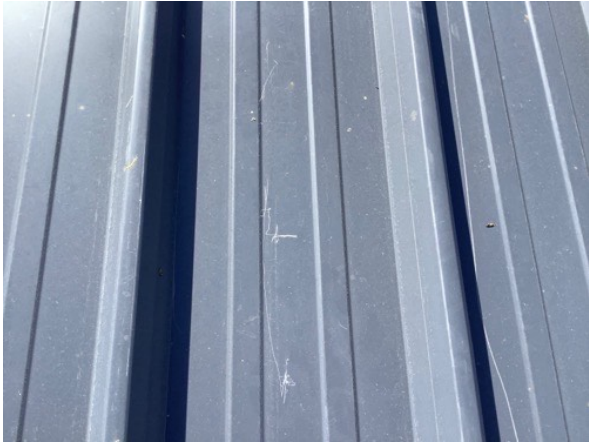
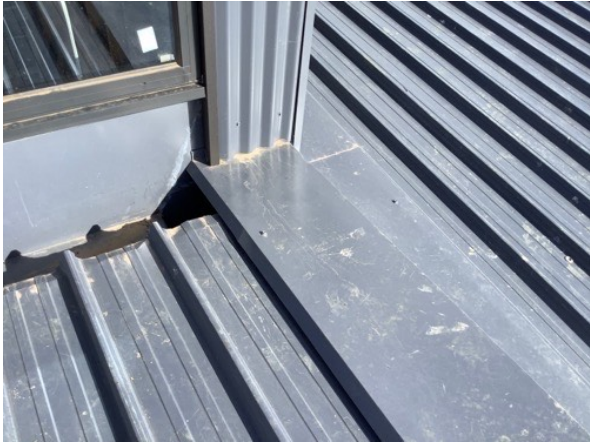
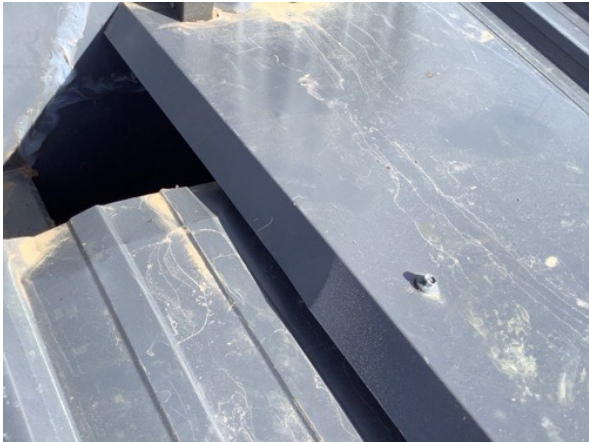
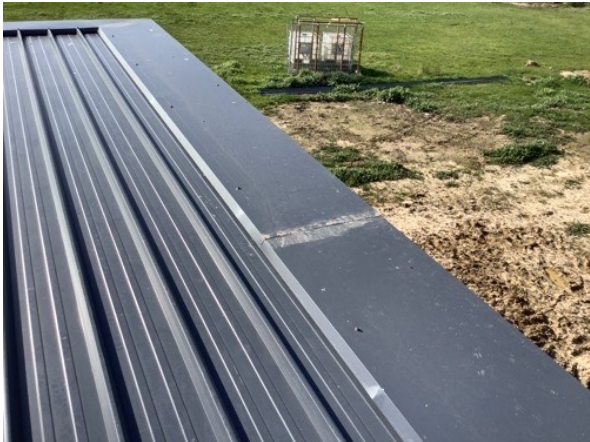
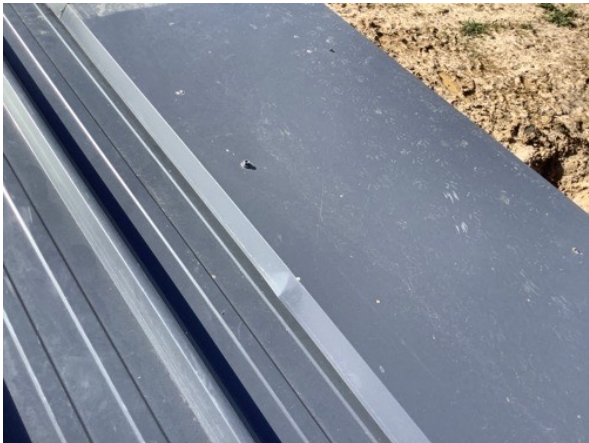
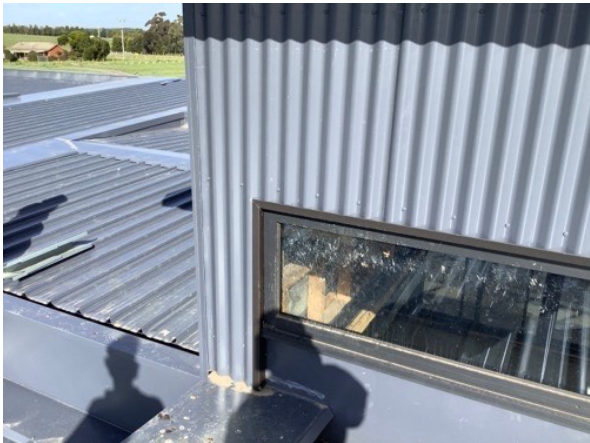
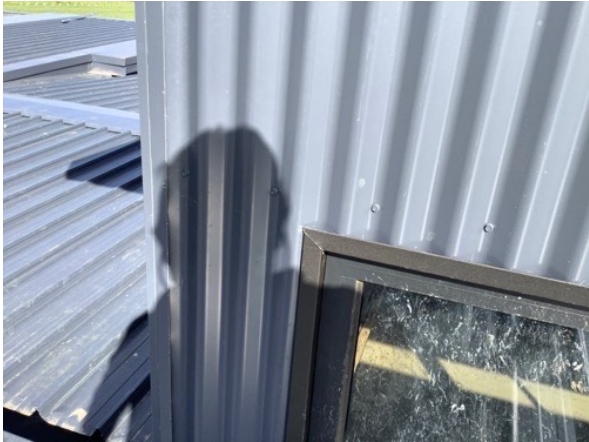
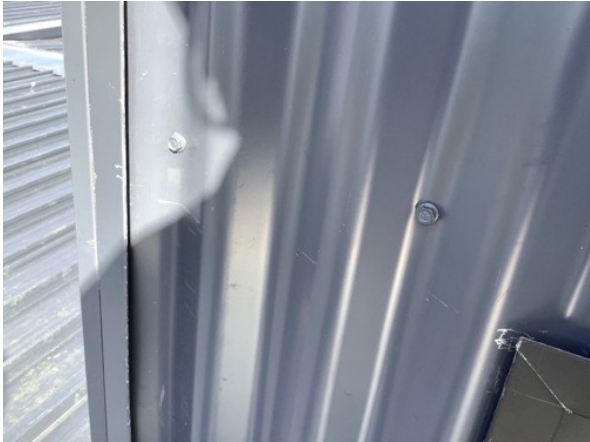
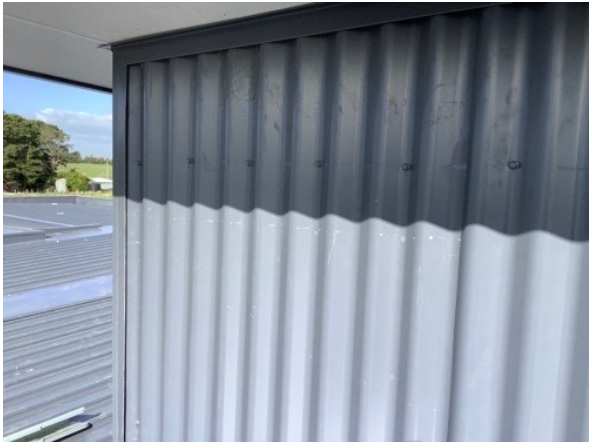
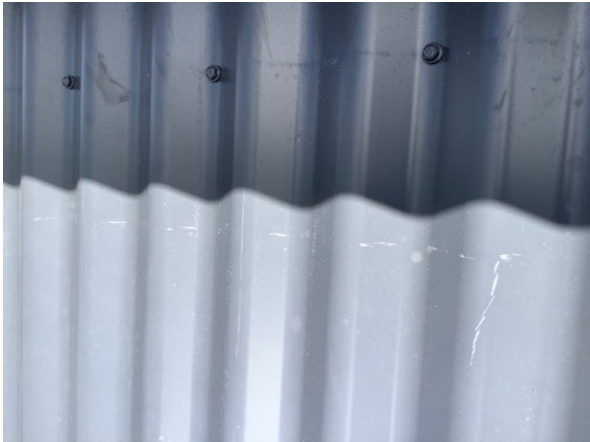
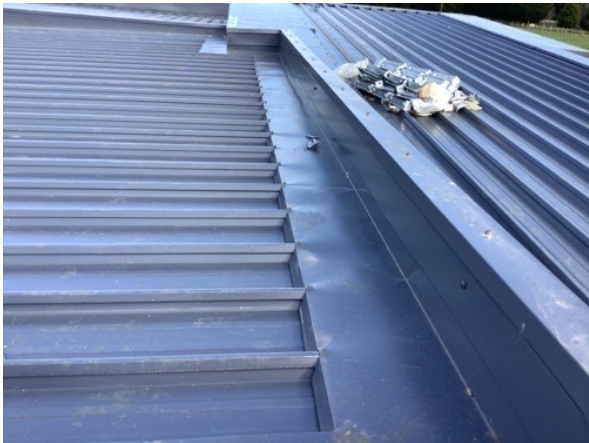
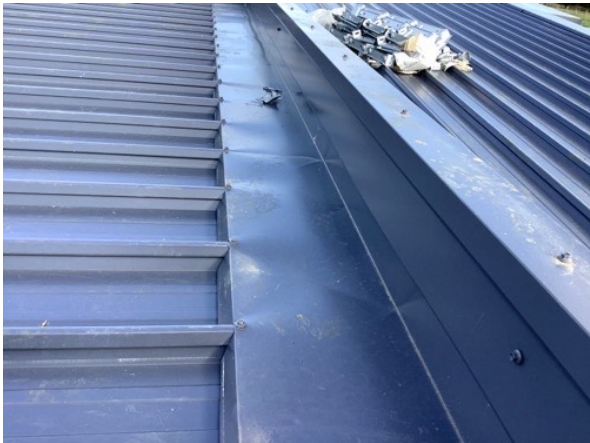
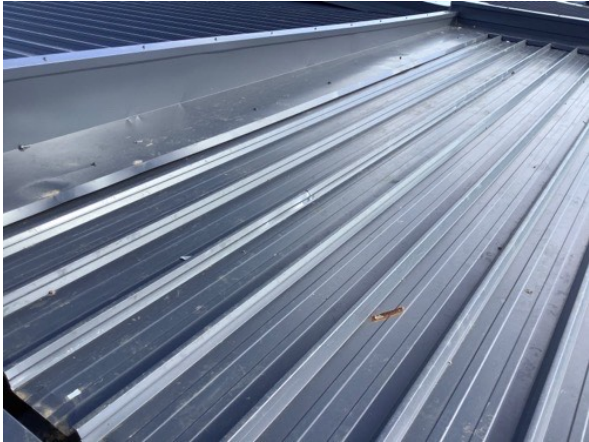
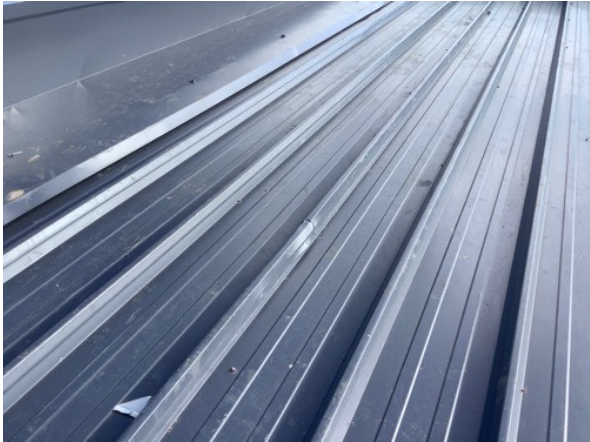
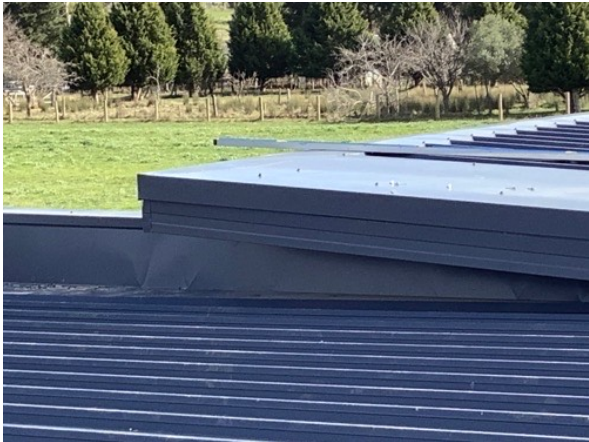
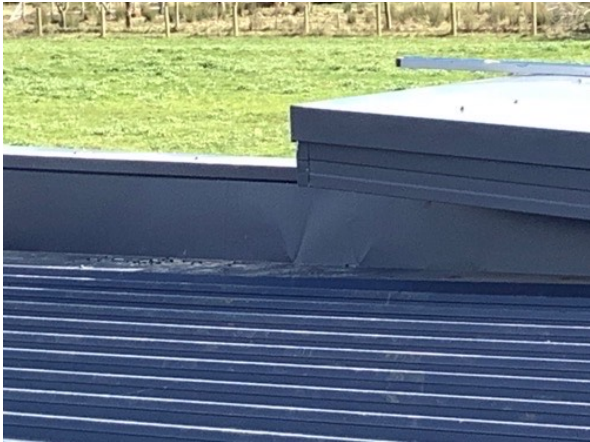
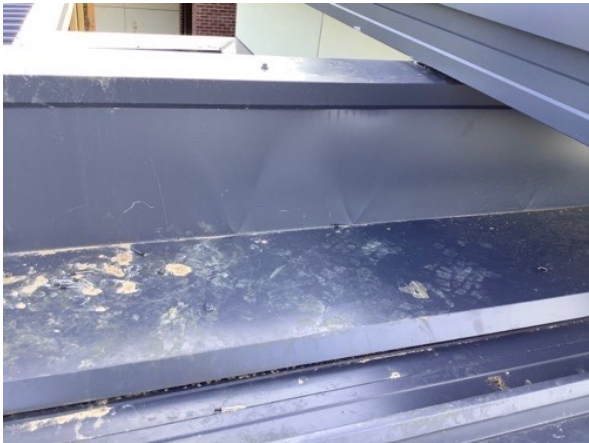
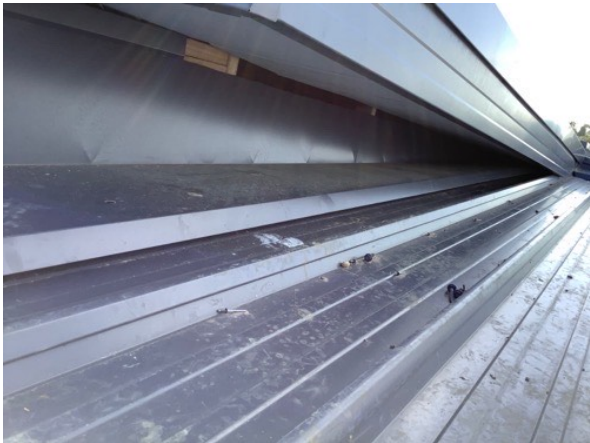
Finding: Colourbond Coating & Powder coat finishes Scratched and Damaged
The entire roof area has Colourbond Coating & Powder coat finishes Scratches and Damages spread throughout the roof area

Where this is due to the builder's workmanship or damage occurring during construction it is considered a defect with respect to Standards and Tolerances - 18.02.

The colorbond / powder coat finish has had its prefinished painted coating scratched, exposing the base metal, which cannot be correctly repaired on site.

The photos attached are just a guide to the type of repairs required and are NOT all the defects related to this topic on the property.

BlueScope Steel, the manufacturer of colorbond steel state on their web site that –'BlueScope steel does not recommend the use of touch up paints on Colorbond steel' and that 'Our recommendation is not to touch up. Minor scratching will not affect the life of the sheet and is rarely obvious to a casual observer. Should damage be substantial, replace the sheet.

We particularly recommend against the use of spray cans, as these can result in overspraying of surrounding areas. The problem might not be immediately obvious, but since overspray paint weathers at a different rate to the oven dried paint on Colorbond steel you'll eventually be left with an unsightly blemish on the sheet'.

The affected damaged sections will need to be replaced.

All finished surfaces must be clean and free of defects at hand over to comply with the Standards and Tolerances guide.

All areas to the entire property should be checked carefully to identify any further defects of the same type.

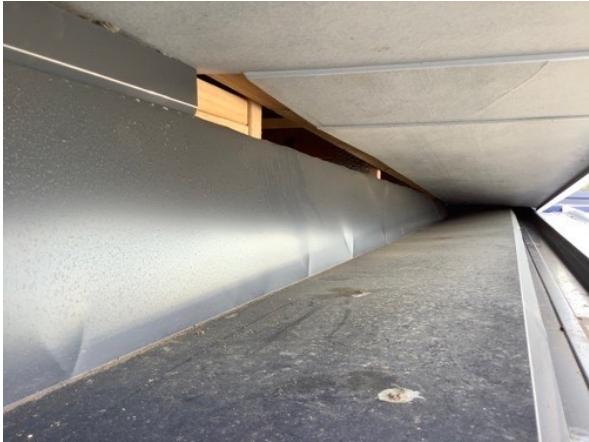
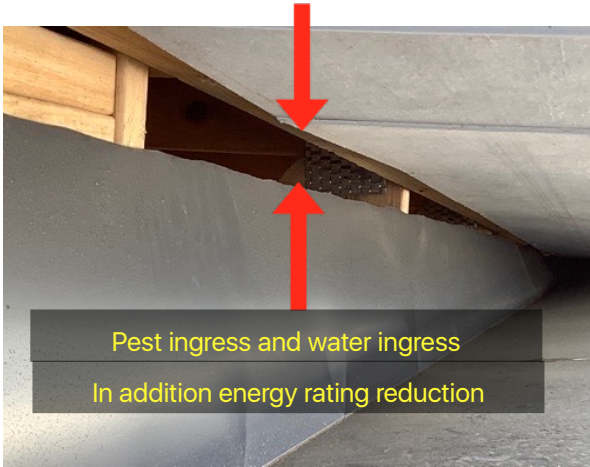
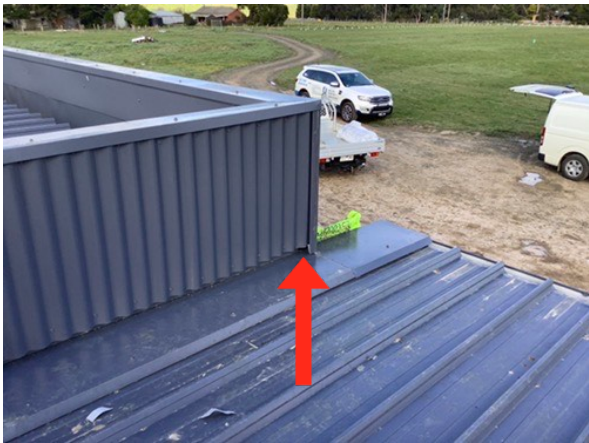
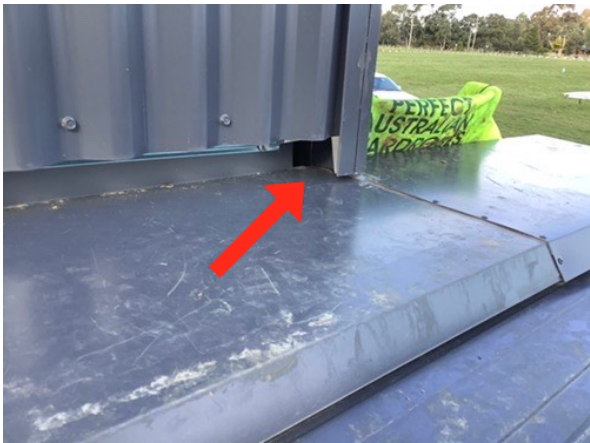
Non Compliant 2.03

Location: Roof Exterior

Finding: Overhang of sheet roofing - less than allowed
It is observed that there is or are many instance/s of sheet roofing which is overhanging the inside face of the guttering by less than 50mm. This is considered a defect with reference to Standards and Tolerances.

Extension of roof sheeting is not an option.

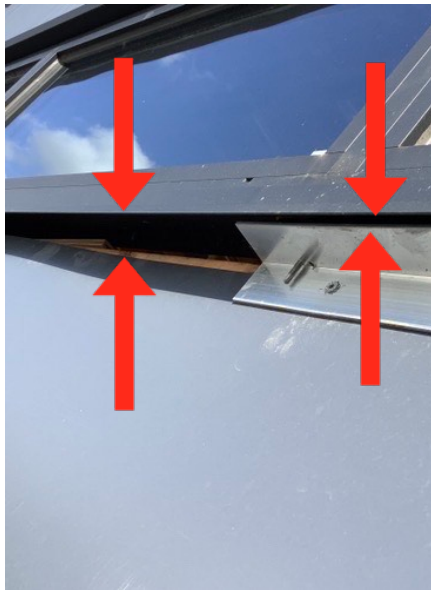
Non Compliant 2.05

Location: Roof Exterior

Finding: Flashing will water pool
The flashings are not supported and secured accurately in all areas, leaving potential for water pooling, noisy flashings and secondary building defects.

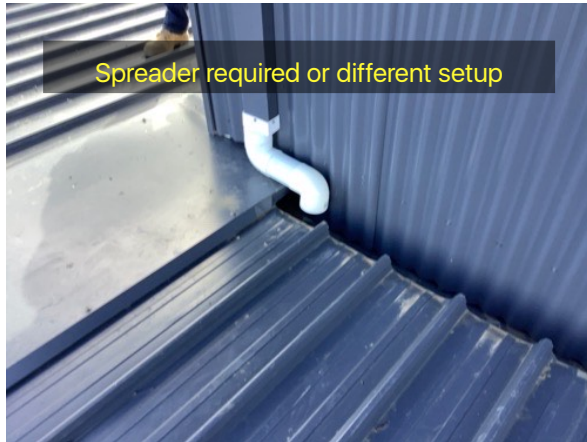
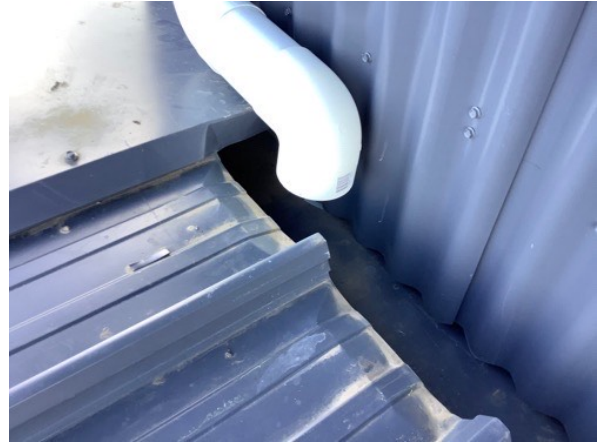
Finding: Spreader required

The volume of water from the down pipes into box gutter areas must not be concentrated into one small area. Normally a spreader or another design is installed to allow the volume of water to spread out on the box gutter area.

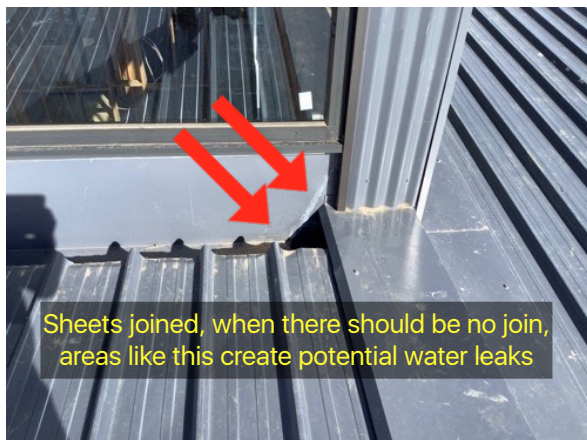
Finding: Not complete to a tradesman is like level
The following items will need to be completed or repaired in accordance with the Domestic Building Contracts Act 1995.
We refer the builder to the implied warranties where the builder agreed to build the dwelling in a proper and workmanlike manner and with reasonable care and skill.

All these photos are added in to demonstrate DEFECTIVE / SUB STANDARD and/or INCOMPLETE WORKS and they are all required to be rectified as they are ALL not satisfactory for Handover as per the DOMESTIC BUILDING CONTRACT ACT 1995 as stated above.

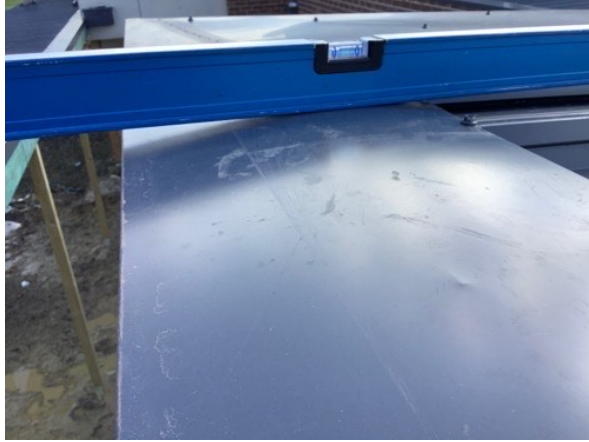
Non Compliant 2.12

Location: Roof Exterior

Finding: Inconsistency in flashing levels
The flashings have inconsistent levels , this may be due to defective timber framing and/or defective flashing installation.poor installation such as this may also have effect on the appearance of the home.

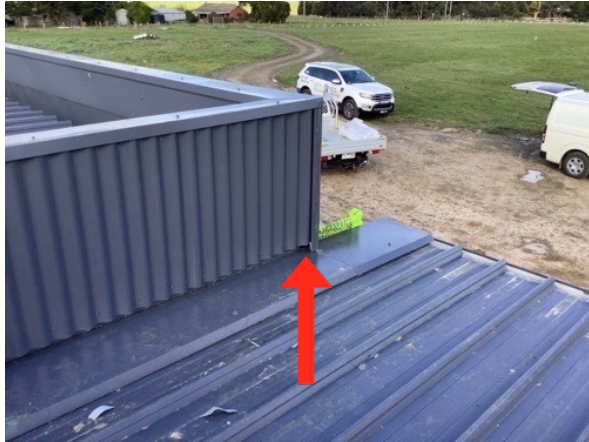
Non Compliant 2.13

Location: Roof Exterior

Finding: Pest and water ingress

The corrugated sheeting falls short and as many areas to the roof, this area and areas like this create, pest ingress, water ingress creating wood rot and further secondary building defects.

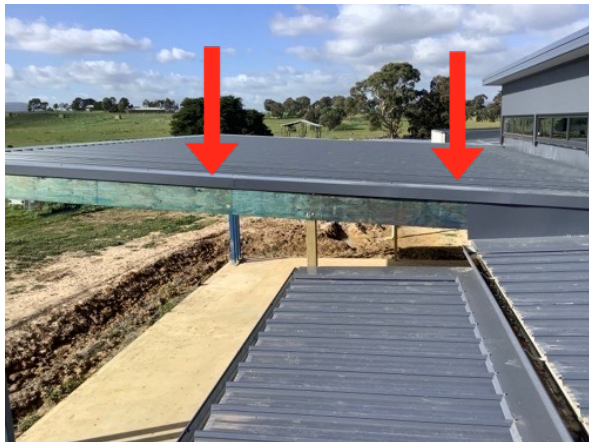
Non Compliant 2.14

Location: Roof Exterior

Finding: Flashings not secured / loose in various areas spread throughout the roof exterior
Flashing not completed and secured down. This may be due to not enough fixings and/or not enough framing built for the fixings to securely hold the flashings

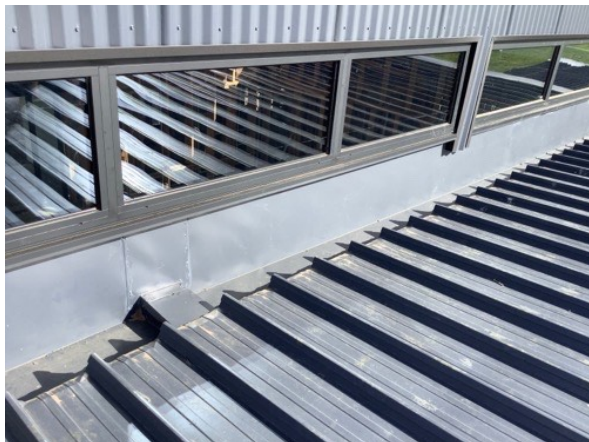
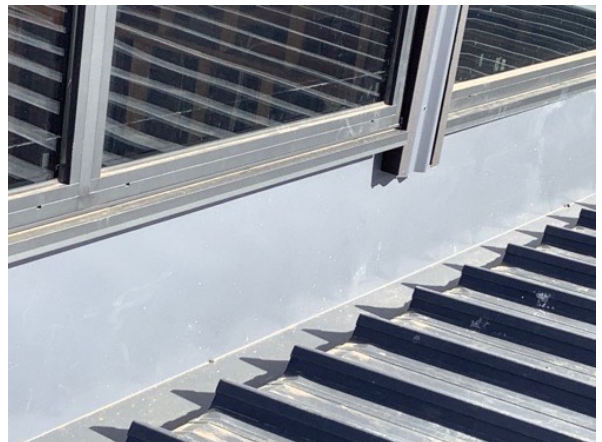
Substandard Workmanship 3.17

Location: Roof Exterior

Finding: Finishing on the windows not as per plan.
Corrugated sheeting is to continue under all the windows.

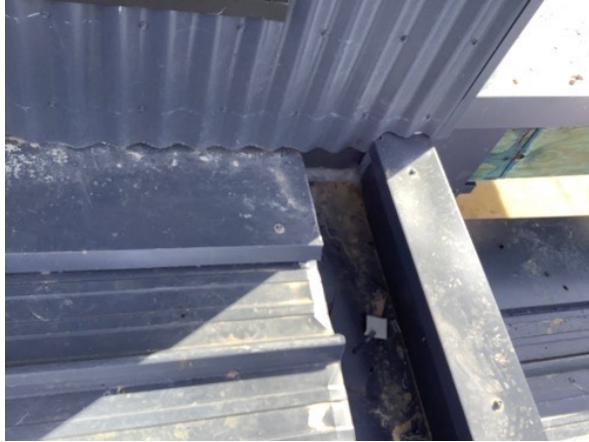
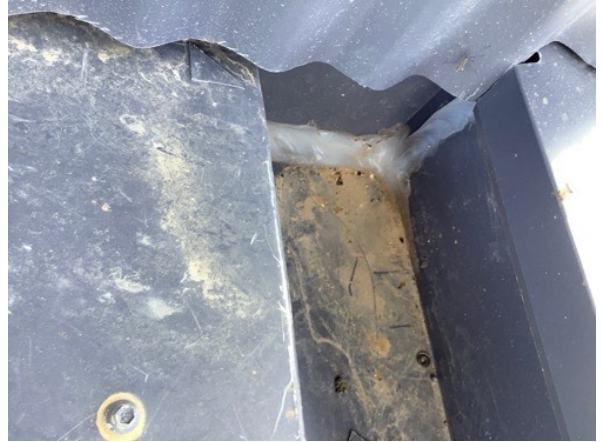
Substandard Workmanship 3.18

Location: Roof Exterior

Finding: Excessive silicon.
Excessive silicon, not complete to a tradesman's like level. It would appear that the Excessive caulking is due to the flashing falling short

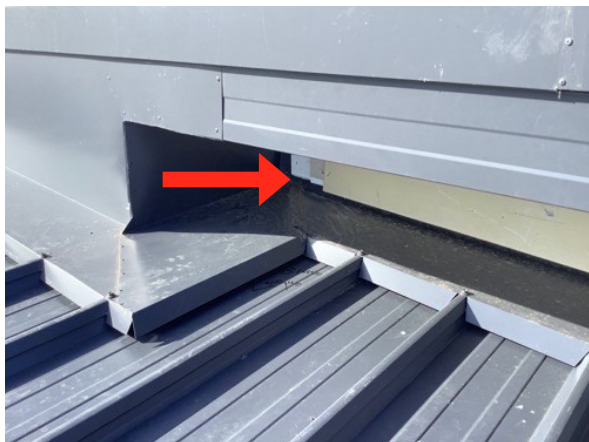
Incomplete 4.19

Location: Roof Exterior

Finding: Matrix Sheeting falls short
The Matrix Sheeting falls short and as many areas to the roof, this area and areas like this create, pest ingress, water ingress creating wood rot and further secondary building defects.
