# Post-Concrete Pour Slab Report - After Frame & Bricks Installed.

Inspection Date: 25 Aug 2020

Property Address: Craigieburn Area

Report Type: New Home Construction

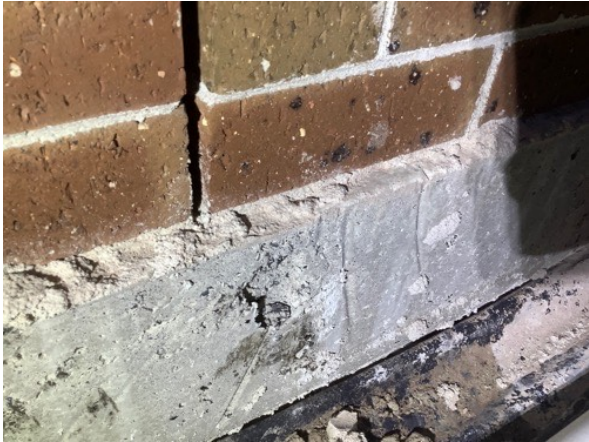
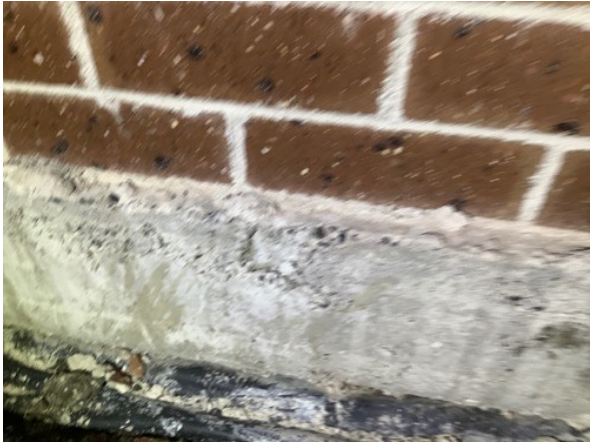
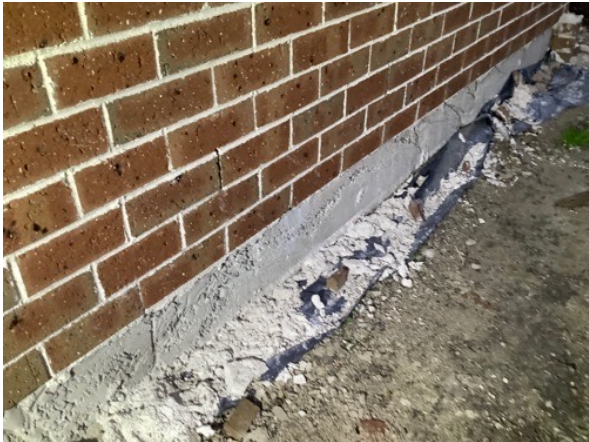
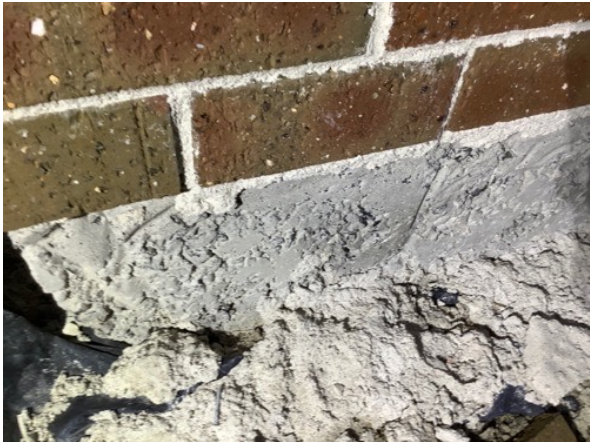
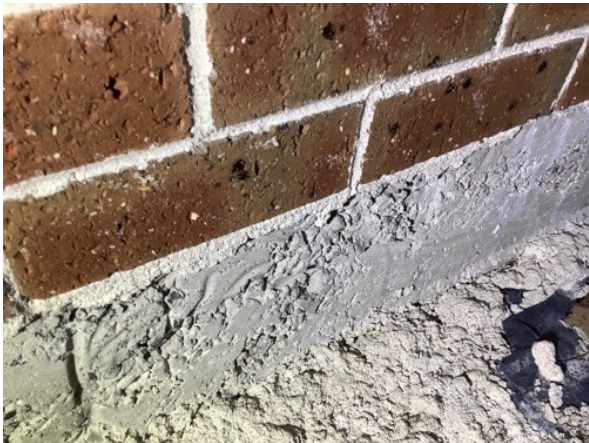
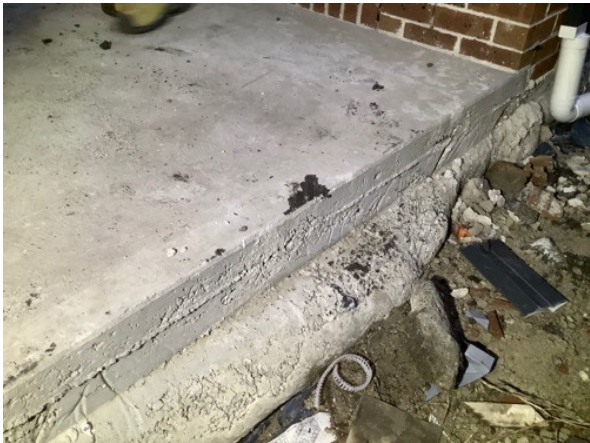
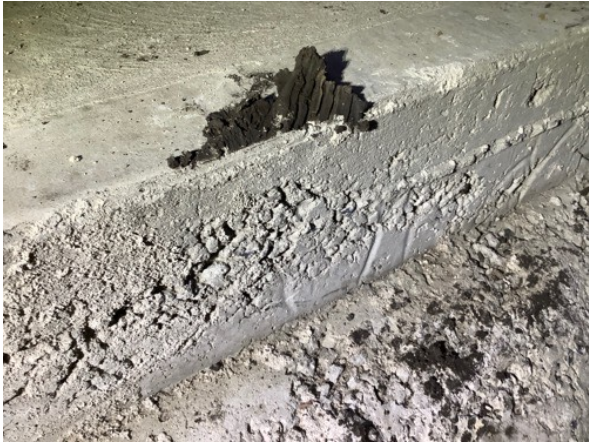
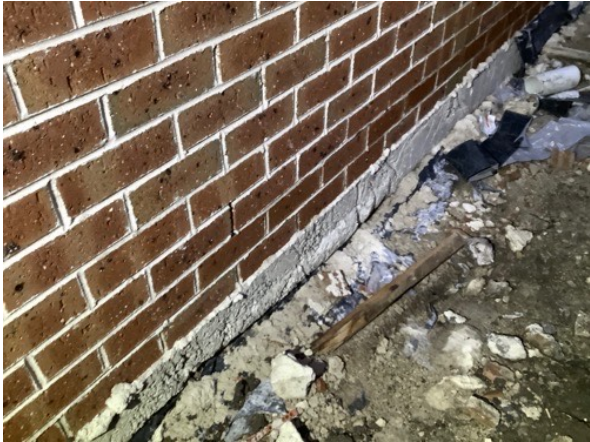
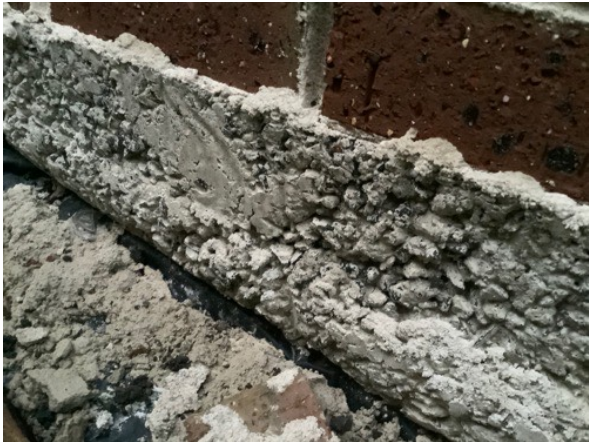
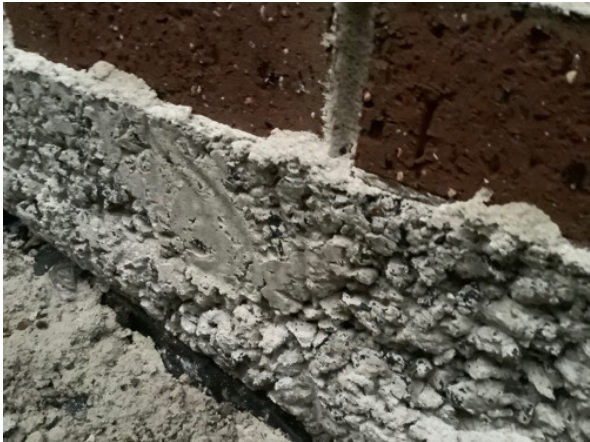
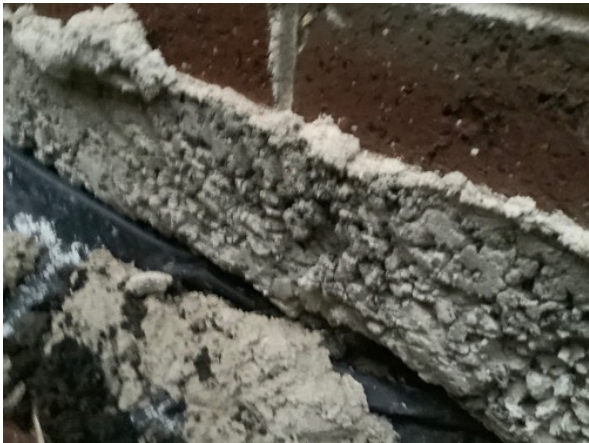
The defect is that if it has not been done to the outer skin of the exposed areas, then the likely

It is highly recommended that you :

All AREAS to the ENTIRE slab should be checked CAREFULLY to identify any further defects that are the same as this defect.

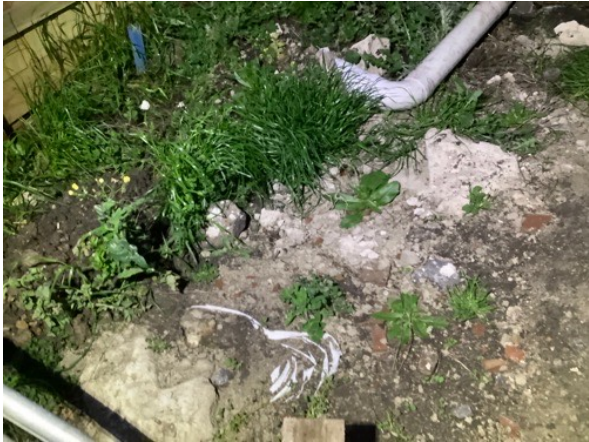
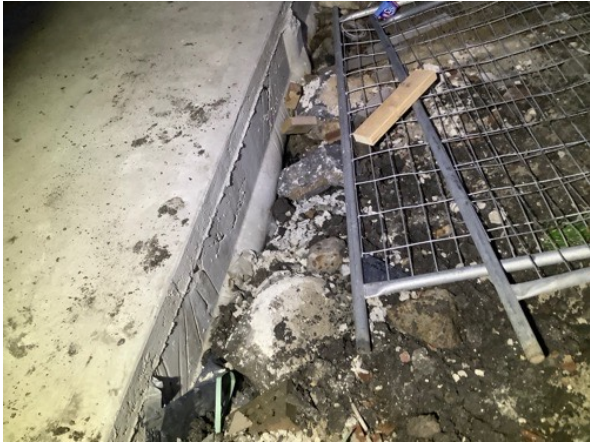
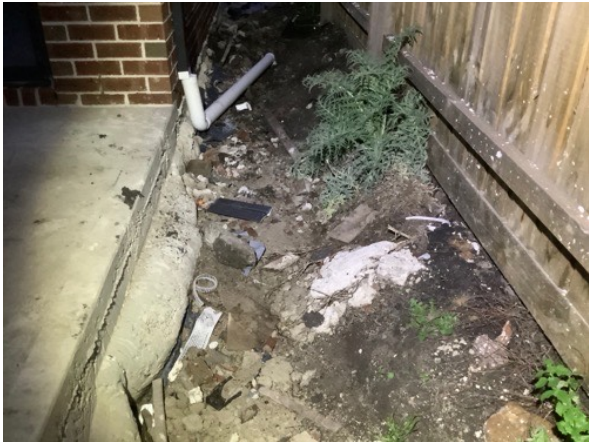
## Non Compliant 2.04

It was noted that there is excessive amount of concrete ( builder waste ) on the site in various areas. All builders waste must be removed as per the contract.

All AREAS to the ENTIRE slab should be checked CAREFULLY to identify any further defects that are the same as this defect.

I HIGHLY RECOMMEND WITHOUT ANY COMPROMISE, THAT THE BUILDER RECTIFY THE DEFECTIVE CONCRETE SLAB PERIMETER WITHOUT COVERING WITH SOIL , CRUSH ROCK, BRICK LAYERS MORTAR DEBRI OR ANYTHING ELSE.

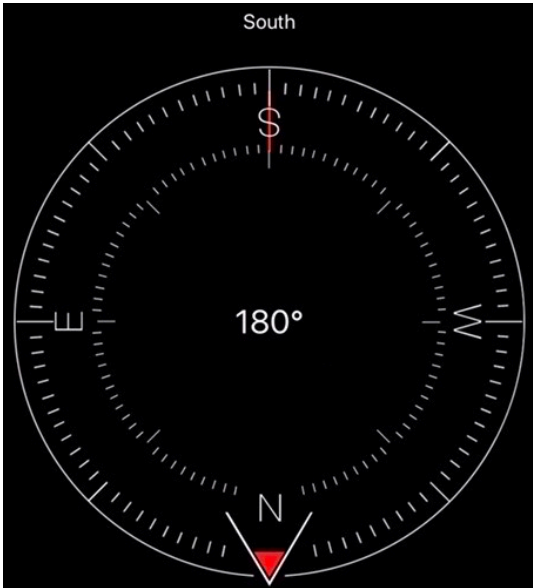
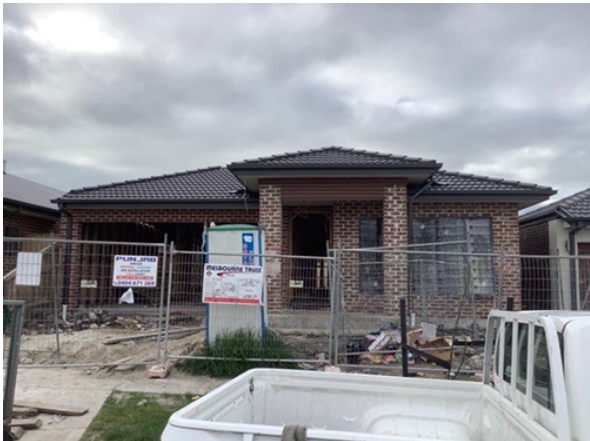
## For Your Information 5.09

Location: General Site Photos.  
Finding: Site Photos  
General site photos are provided for your general reference.
