Vendors Report - Building/Termite/ Asbestos/Electrical/Digital Floor Level Assessment

Inspection Date: 5 Aug 2020

Property Address: Sunshine Area

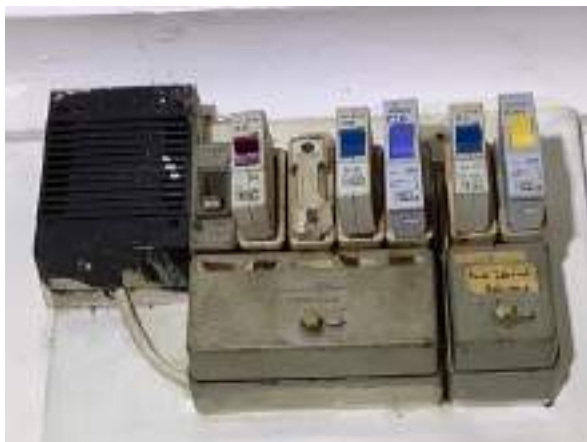
Serious Safety Hazard 1.03

At the time of inspection it was noted that the switchboard protective devices are old fuse wire type.

A switchboard upgrade with modern circuit breakers and safety switches is highly recommended in accordance with AS 3000.

Generally, the switchboard is out-dated and should be replaced with circuit breaker protective devices and fitted with a safety switch as soon as possible as a minimum to improve the safety of the property. It is advised that a qualified electrician be contacted immediately to install a new switchboard complete with a safety switch and provide any further advice on additional works that may be required in this State.

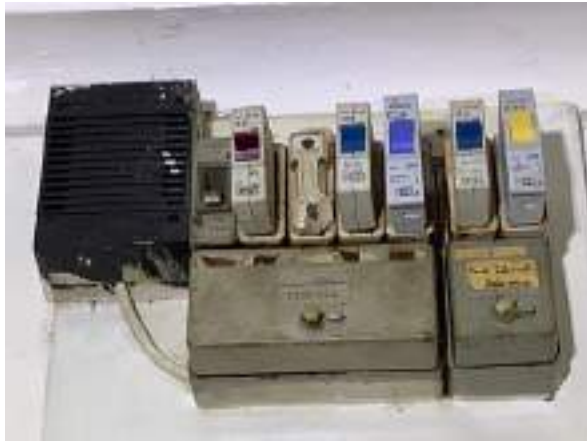
Serious Safety Hazard 1.04

Generally, the switchboard is out-dated and should be fitted with a safety switch as soon as possible as a minimum to improve the safety of the property.

It is advised that a qualified electrician be contacted immediately to install a safety switch and provide any further advice on additional works that may be required in this State.

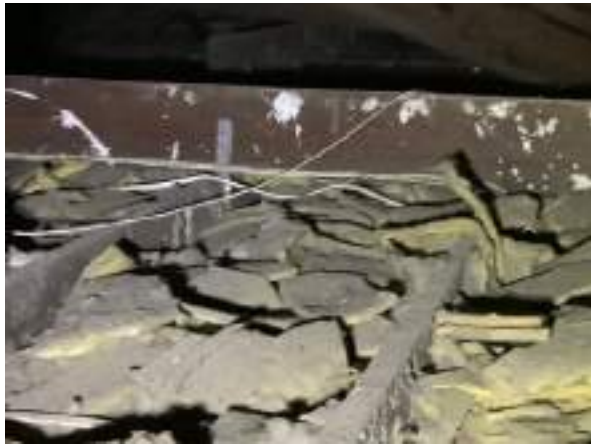
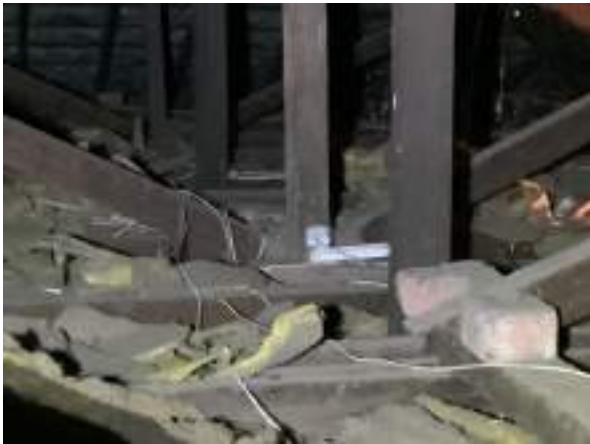
Serious Safety Hazard 1.09

At the time of the inspection we noted that electrical installation items are not compliant with the electrical regulations AS3000-2007 and each picture attached is an electrical installation defect.

We recommend that the purchaser engages a licensed electrical contractor to check compliance and make good any defective wiring or unsafe items throughout the entire property including the outbuildings etc.

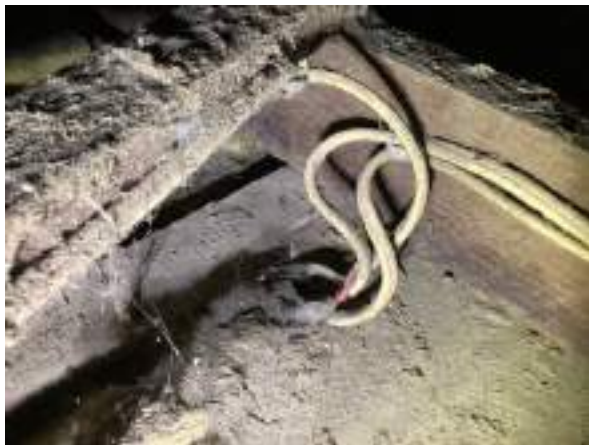
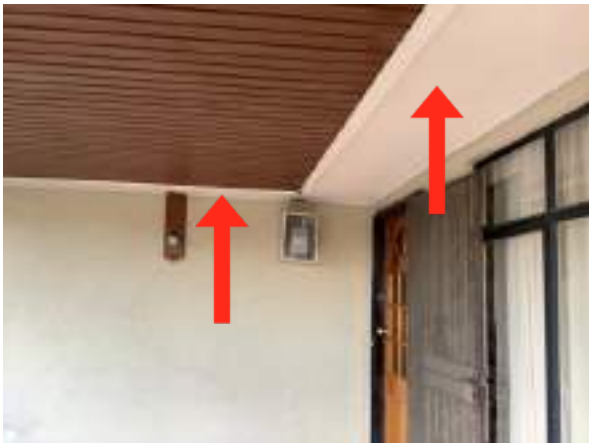
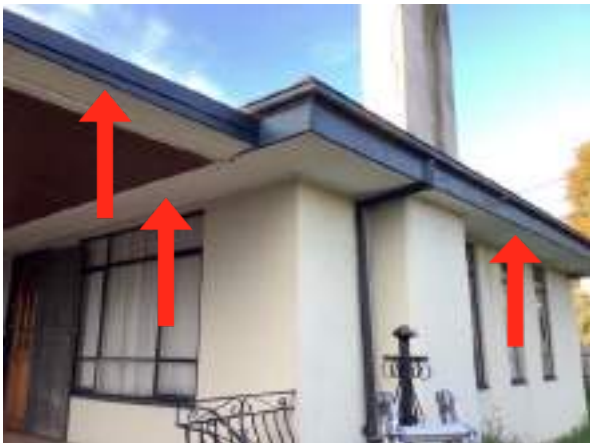
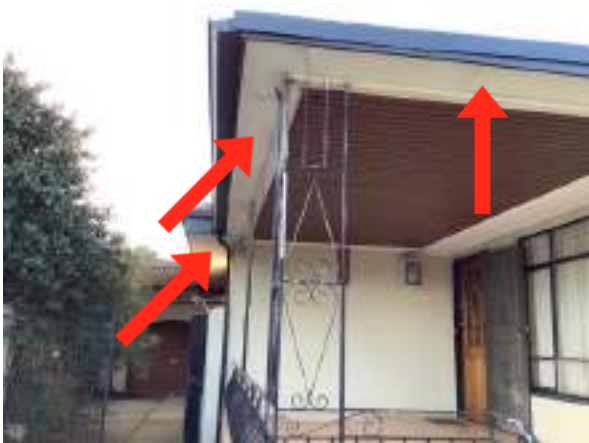
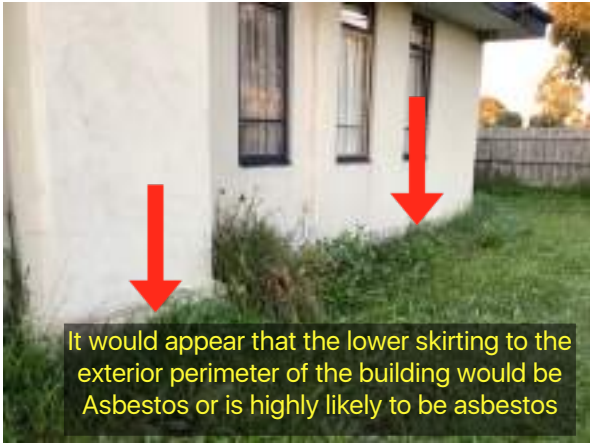
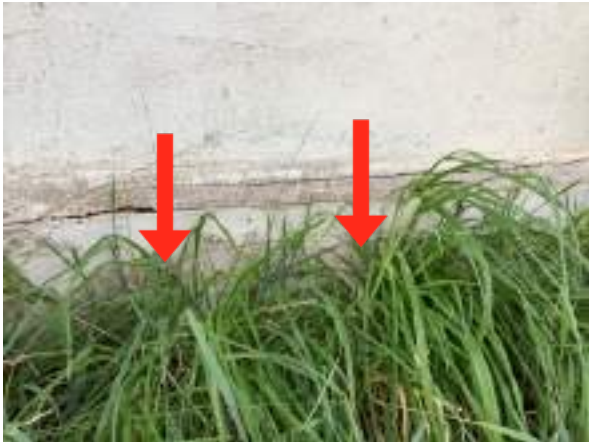
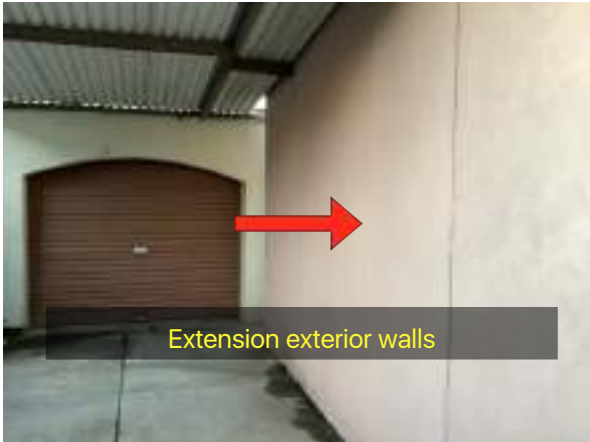
Serious Safety Hazard 1.10

Reporting on Asbestos is outside the Scope of this Report. This suspected defect is highlighted as a caution ONLY and is ONLY a guide as asbestos inspections are outside the scope of pre-purchase inspection and reports.

In the interim, the client is advised to act with caution, especially when considering any damage to building materials general wear and tear renovations extensions demolition and general maintenance activities due to the suspected presence of Asbestos.

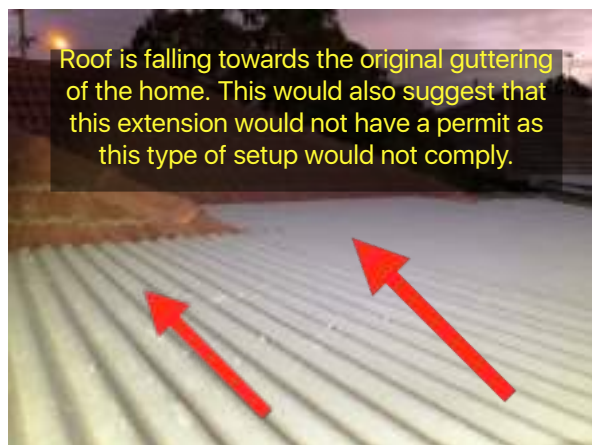
Major Defect 2.14

Location: The Extension Exterior Roof

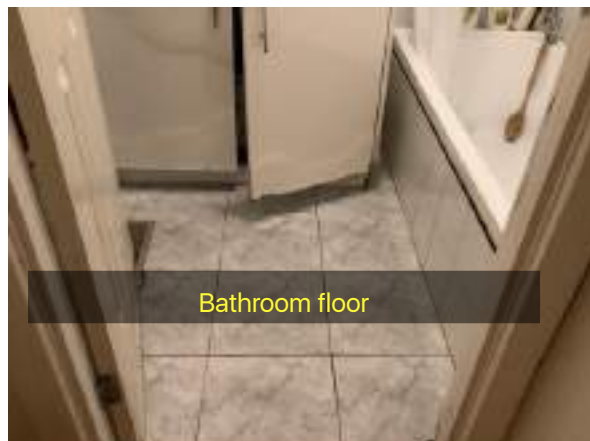
Bathroom floor

If left unmanaged, water penetration to these areas may lead to subsequent water damage, which is likely necessitate repair work to affected building elements.

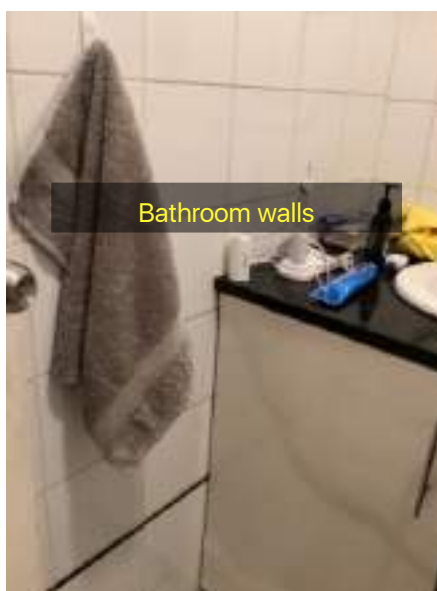
Shower walls

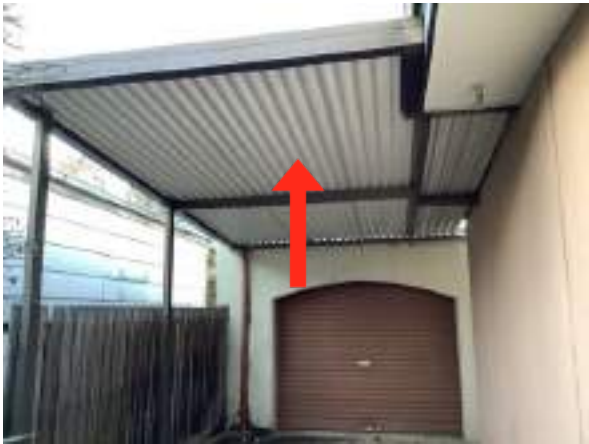
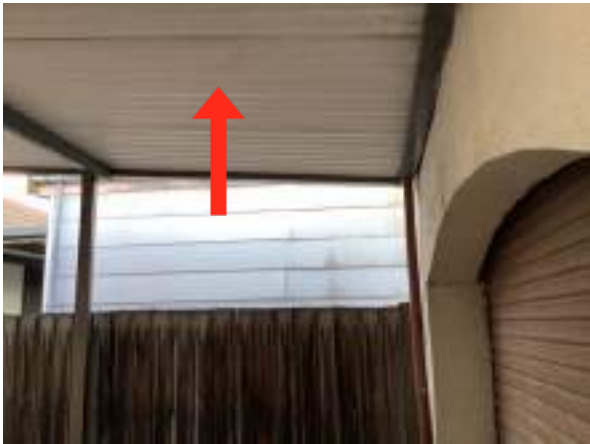
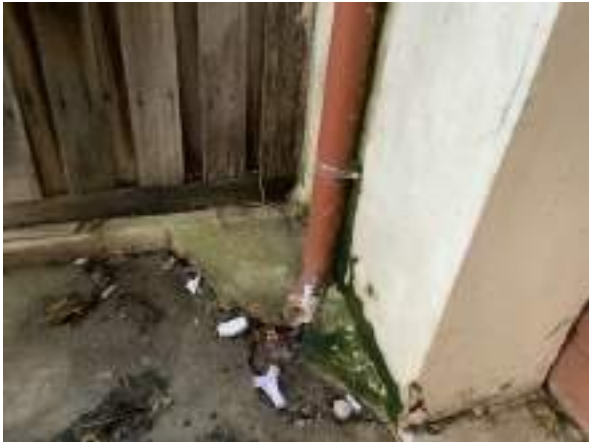
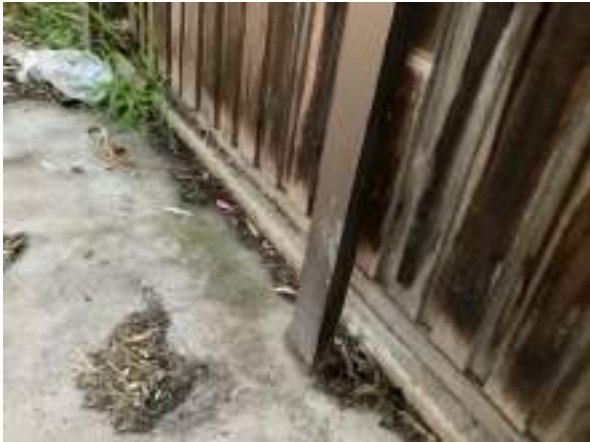
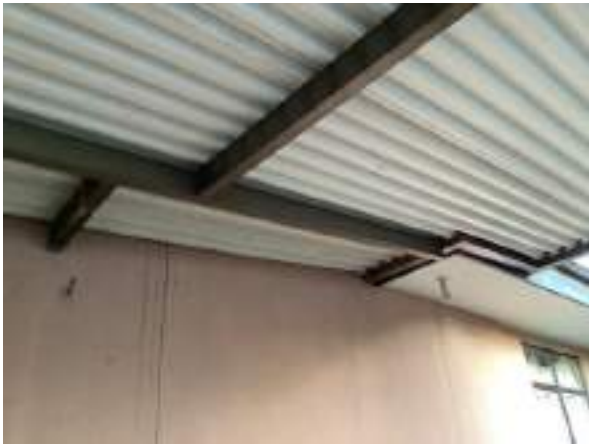
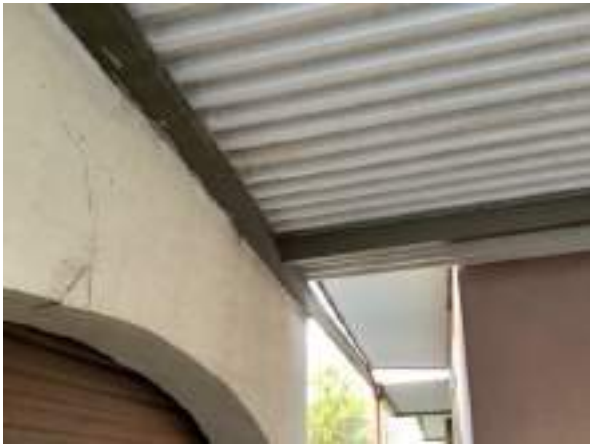
Major Defect 2.16

Finding: Carport, Two Extensions To Rear Of Home - Additional Structures - Non Compliant & Additional Structures Suspected To Be Built Without A Permit
This defect statement is known as a major defect and a major structural defect as per the Australian Standards for prepurchase building inspections (AS 4349.1-2007)

WHILST THIS DEFECT IS A MAJOR DEFECT, MORE IMPORTANTLY IT IS ALSO A SAFETY HAZARD, MEANING THAT THERE ARE SAFETY CONCERNS FOR PERSONS TO BE LOCATED IN AREAS OF THE DEFECTS MENTIONED IN THIS STATEMENT.

As building standards have not been followed, this area provides a heightened risk of the development of building defects. The structural integrity of the area may have been compromised, which creates potential for the development or presence of major safety issues.

The Carport, Two Extensions To Rear Of Home also has various elements that do not appear to comply and more importantly it also has had modifications and additions added inside that appear unsafe.

It is highly recommended that any planned repair, remodelling or demolition works be carried out by a registered builder.

I highly recommend that you further investigate this home as the Carport, Two Extensions To Rear Of Home may or may not have the correct permits / paperwork through the council, architects, engineers, etc regardless if the works have been done to a quality tradesmens like manner or not.

I HIGHLY RECOMMEND that you engage the professionals as stated above. I also highly recommend that persons keep clear of the areas until further investigations are made , repaired and cleared by the appropriate people.

It is highly advised to request that the current owner provide a Defect report (Owner Builder/ Section 137b) for this structure. This would involve a structural engineer or a licenced building surveyor conducting an inspection of the structure and advising of any defects and/ or areas of non-compliance in accordance with the current building codes. The current owner should then attend to any issues on this report prior to settlement.

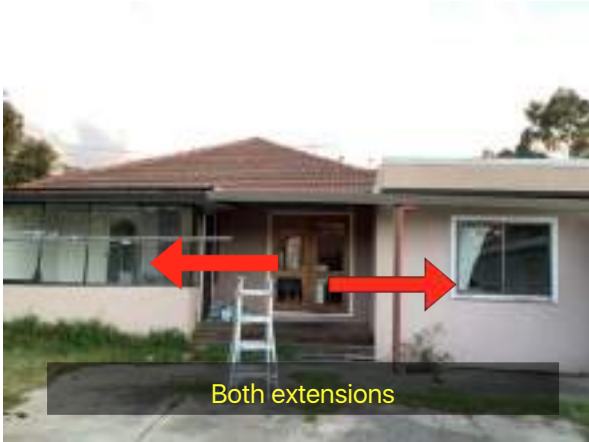
Both extensions

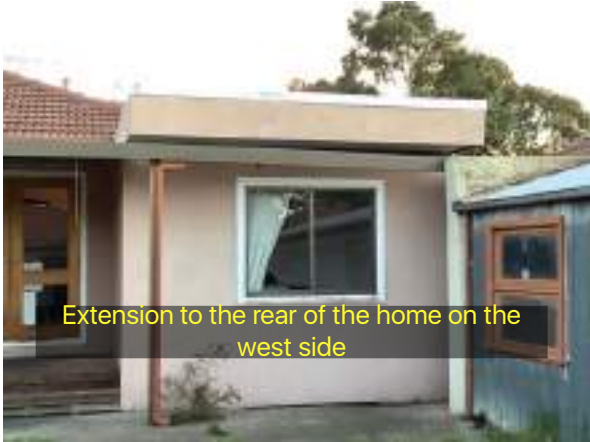
Extension to the rear of the home on the west side

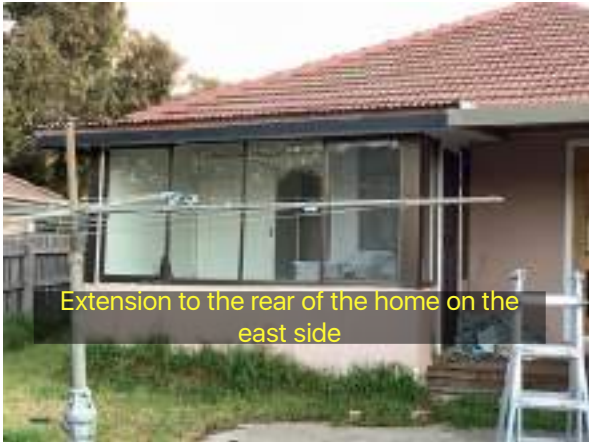
Extension to the rear of the home on the east side

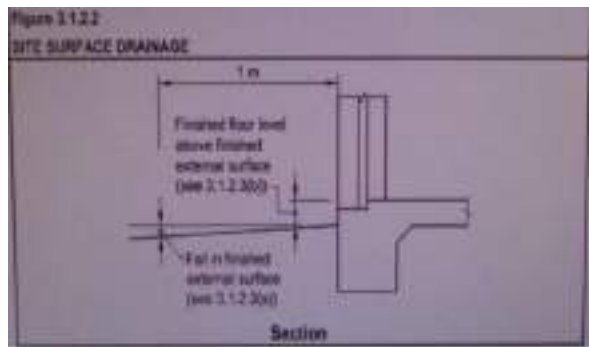
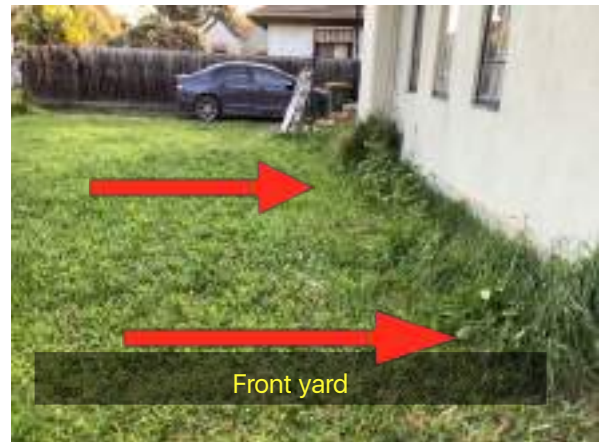
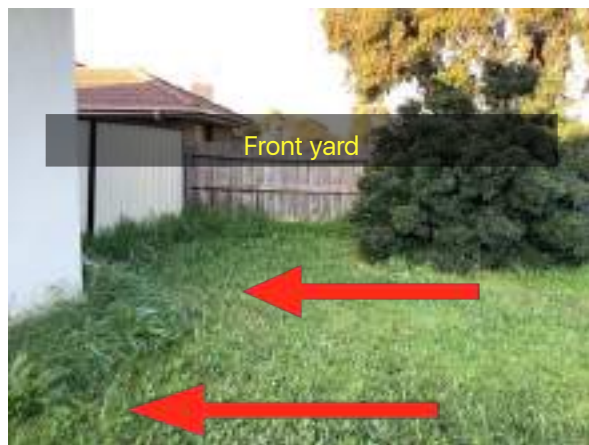
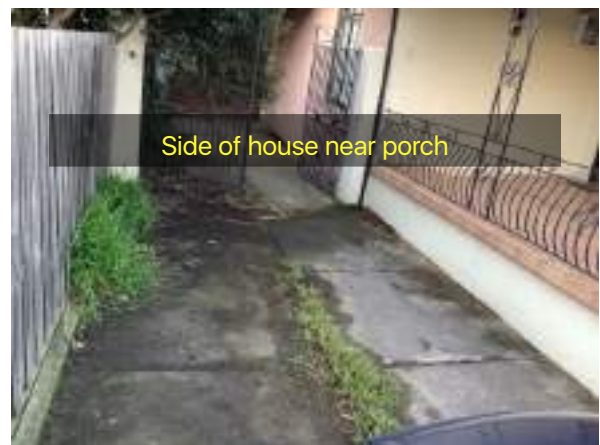
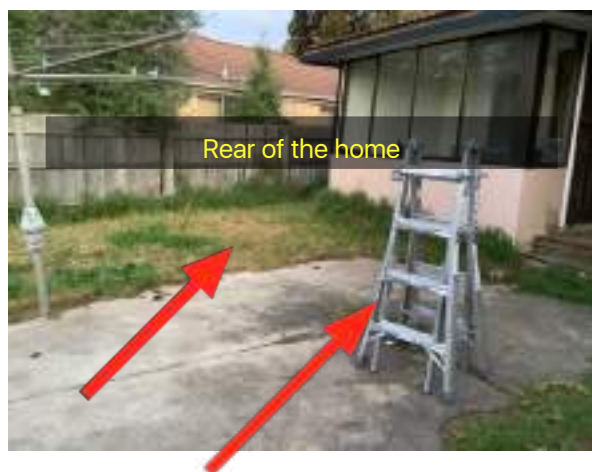
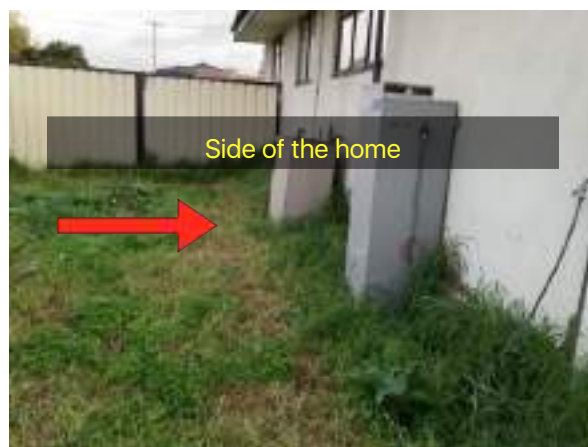
Major Defect 2.17

Finding: Drainage - Inadequate and/or Perimeter Building Ground Fall Defective.
At the time of the inspection it was noted that the surrounding perimeter soil does not fall away from the slab / building.

Water pooling near foundations and footings is a serious concern with the potential to adversely impact on the longevity of the dwelling. The Building Code of Australia (BCA) outlines that the soil or concrete must be graded away from the dwelling at a minimum of 50mm over 1m (1:50 fall).

The site drainage in this report was found to be inadequate at the time of inspection, creating potential for subsequent water damage to associated building elements, such as foundation subsidence, brickwork cracking, windows and doors moving, concrete paths cracking, etc.

These drainage concerns in this report can have grave potential for foundation subsidence and/or secondary damages such as structural defects such as brick movement / cracking as already mentioned above.

Where site drainage is inadequate, another option can be installation of an Agricultural (Aggie) Drain may be required or more serious remedial works.

It is highly recommended that a plumber, builder and other forms of professionals be appointed to further inspect the area and to install / repair adequate drainage equipment where necessary.

If secondary damages have ALREADY accrued we highly recommend that you engage a structural engineer, geotechnical engineer to start with to then engage a registered builder, qualified plumber to further inspect the property and perform any remedial works as necessary.

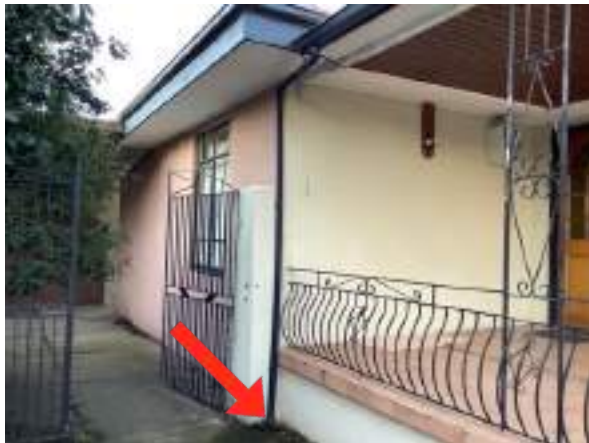
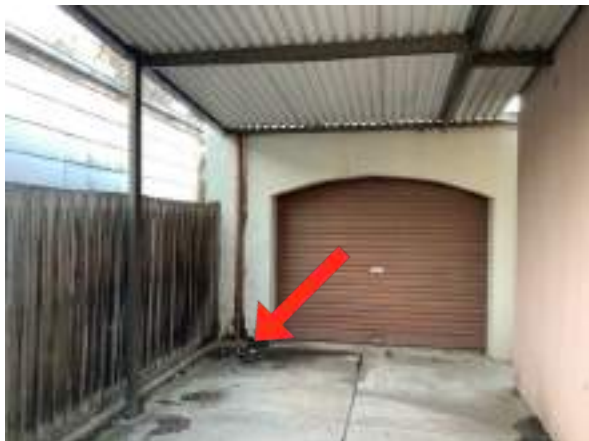
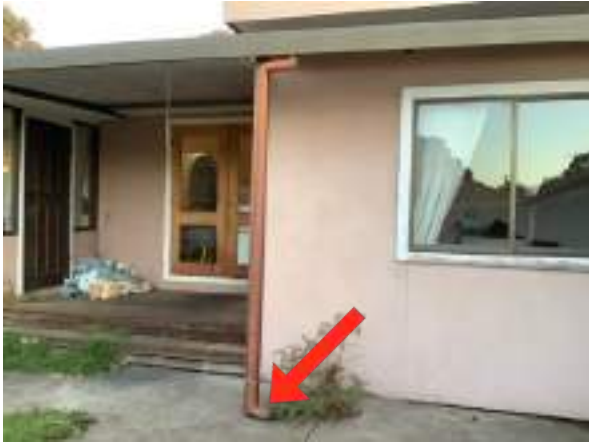
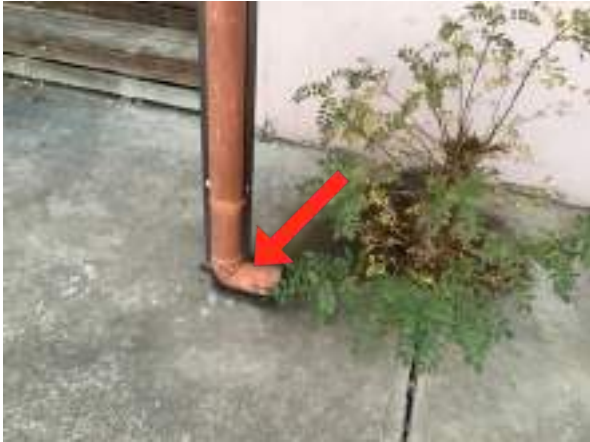
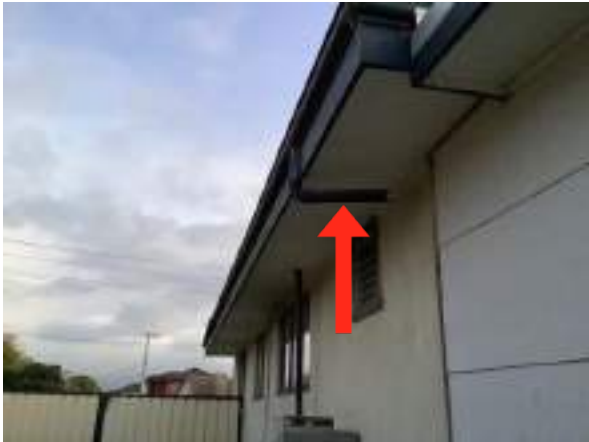
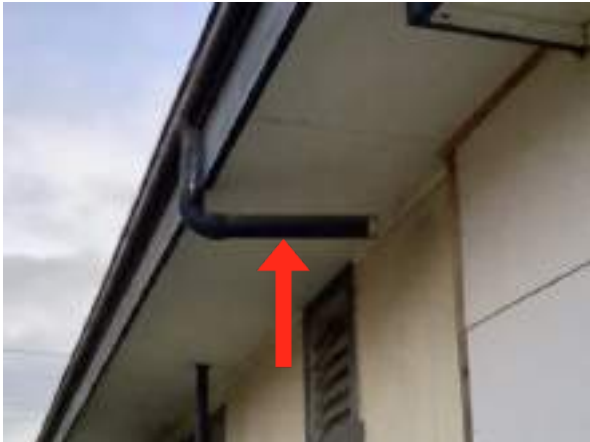
Major Defect 2.20

Finding: Stormwater drain - Not connected , Partially connected and/or Damaged.
The roof plumbing is NOT adequately connected to stormwater drainage on the site. This disconnection negatively impacts the functional capacity of the roof plumbing.

Where roof plumbing doesn't drain adequately, the area at the base perimeter can become excessively damp, potentially creating an environment that is susceptible to rust and corrosion of surrounding building elements, as well as attracting termites and other pests.

This has the potential for foundation subsidence and/or secondary damages such as structural defects such as brick movement / cracking.

It is highly recommended that a plumber be appointed to further inspect the area and to install / repair adequate drainage equipment where necessary.

If secondary damages have accrued we highly recommend that you engage a structural engineer and/or a registered builder for remedial works.

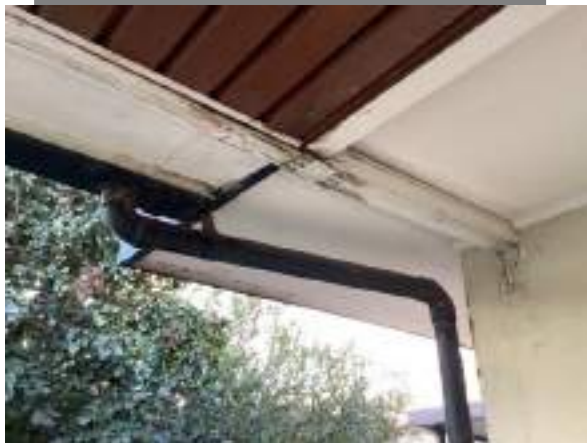
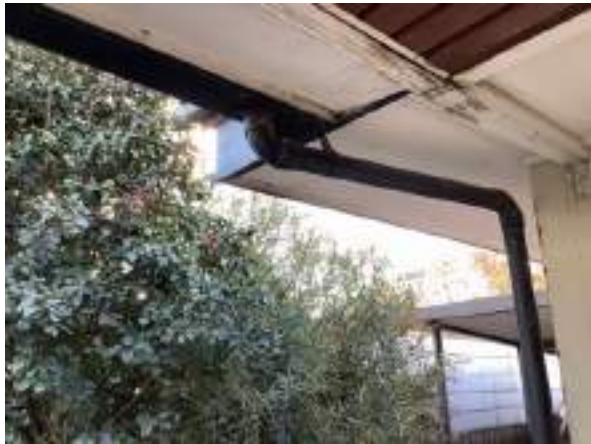
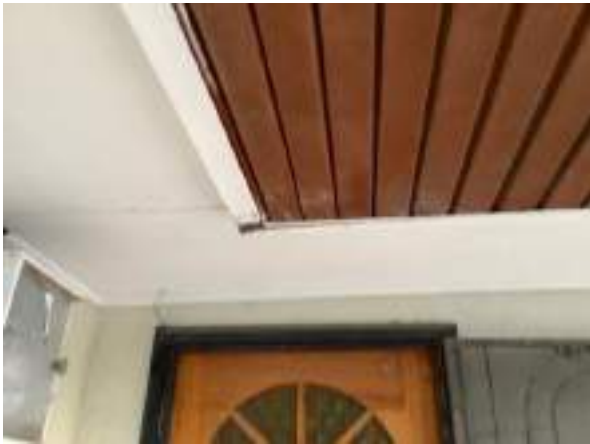
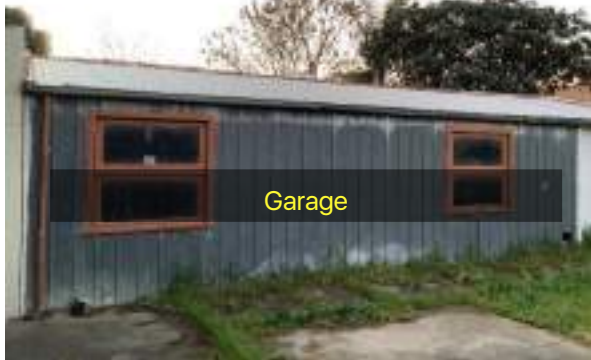
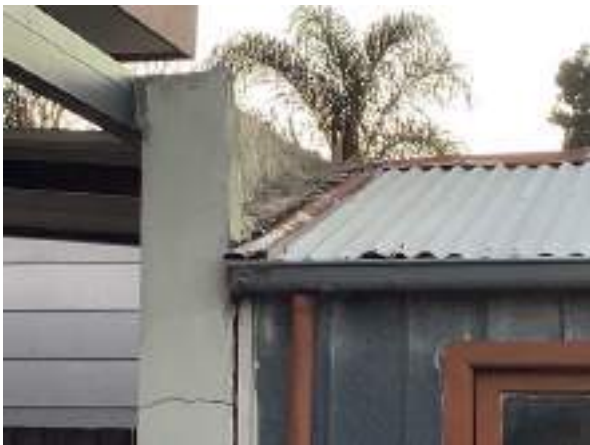
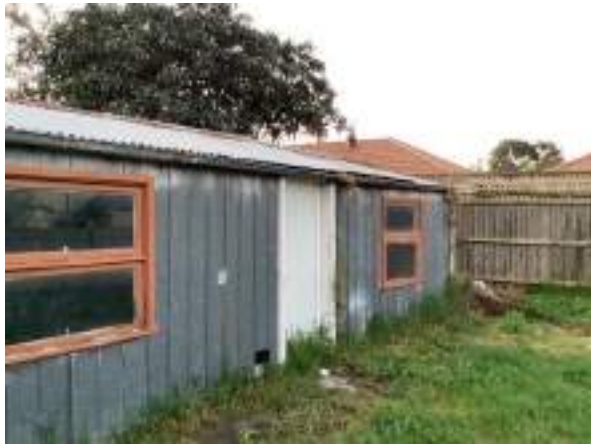
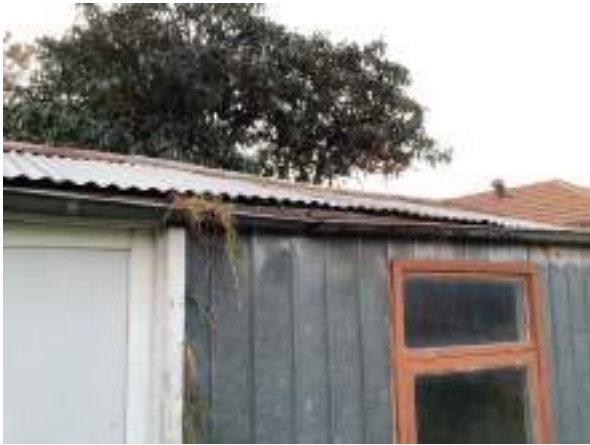
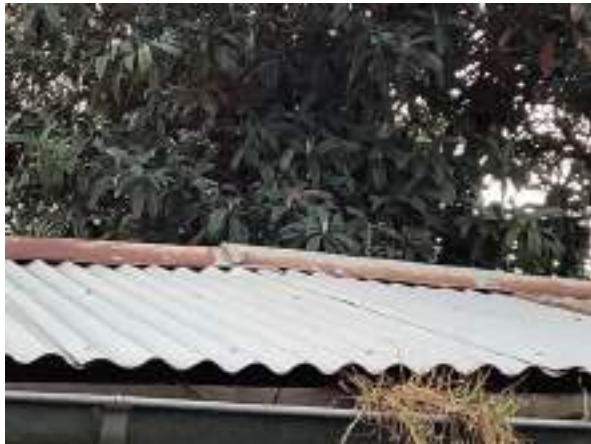
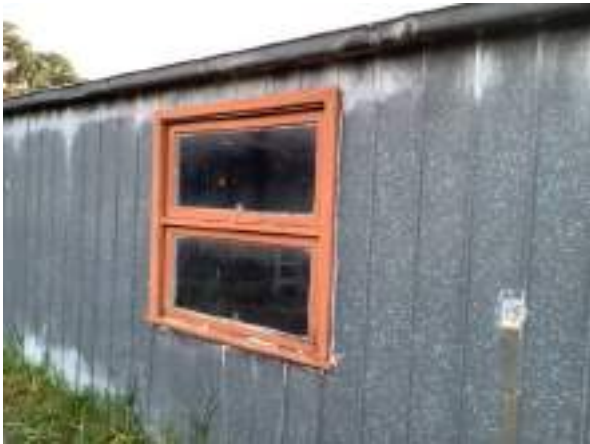
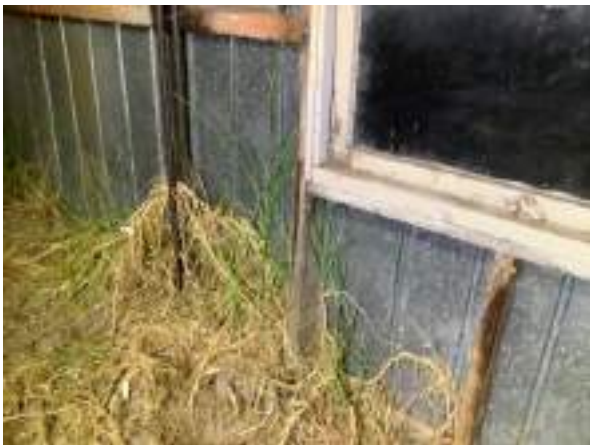
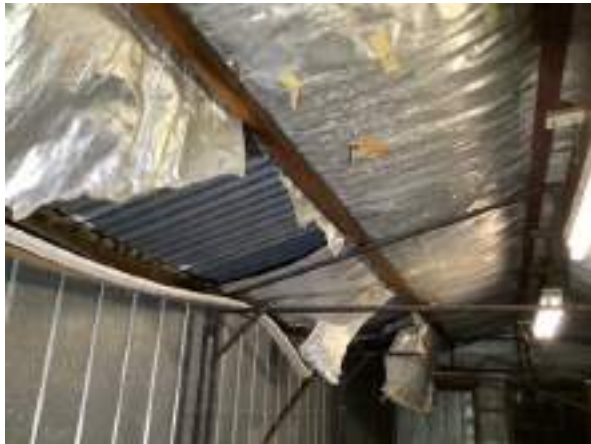
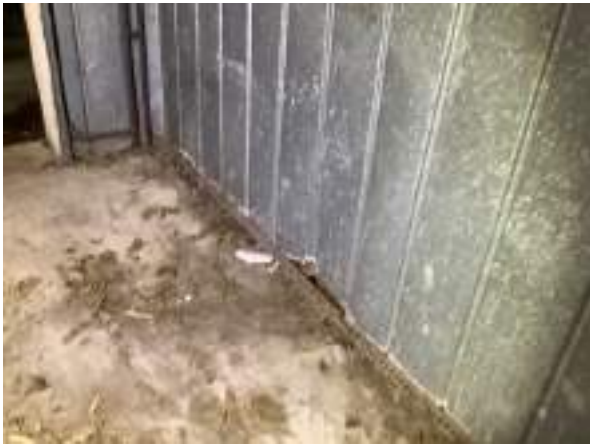
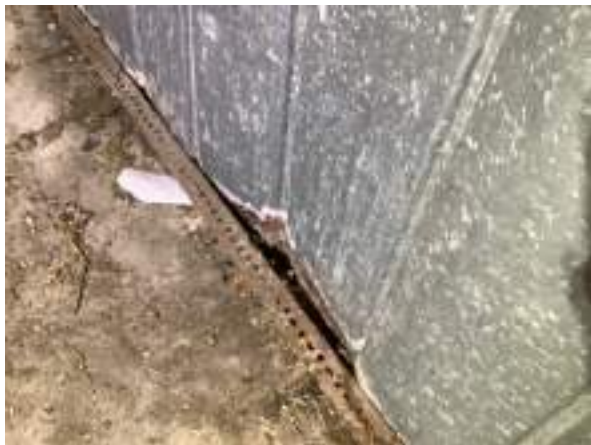
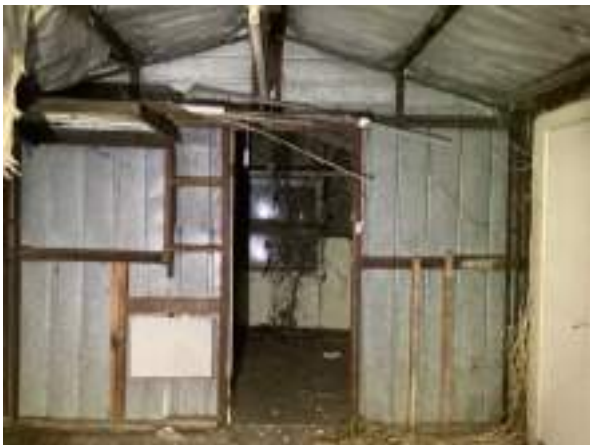
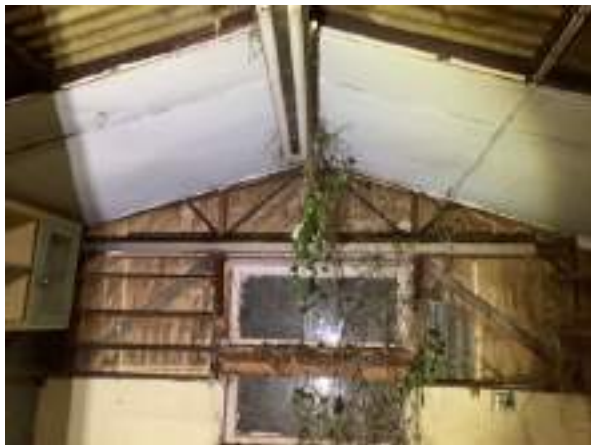
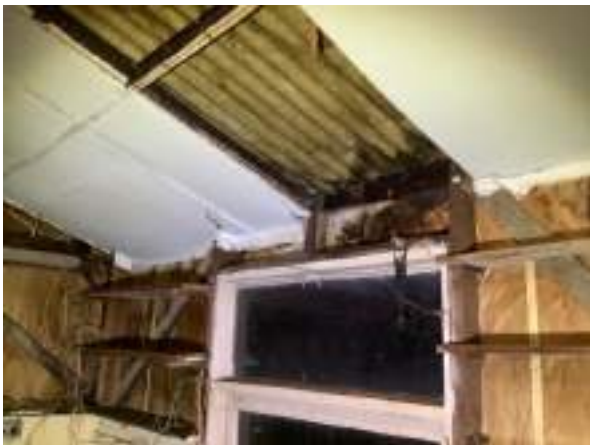
Major Defect 2.21

Location: Pergola & Garage

Finding: Unconventional Handyman Work - Demolition or Repairs Required
This handyman work appears to have been completed to a substandard level and does not comply with regular building practices. Where handyman work is not completed satisfactorily, accelerated deterioration of the associated building elements is likely to occur and secondary defects to surrounding structures may develop.

It is highly recommended that the substandard work be demolished or rectified by professional services. Works to improve this area are likely to increase the safety and the operation of the associated building elements.

The client should exercise care when coming into the immediate vicinity of the substandard works. Rectification works are advised as soon as possible by the appropriate trades.

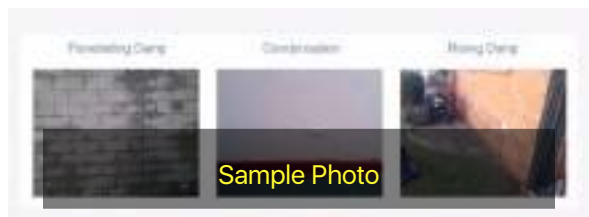
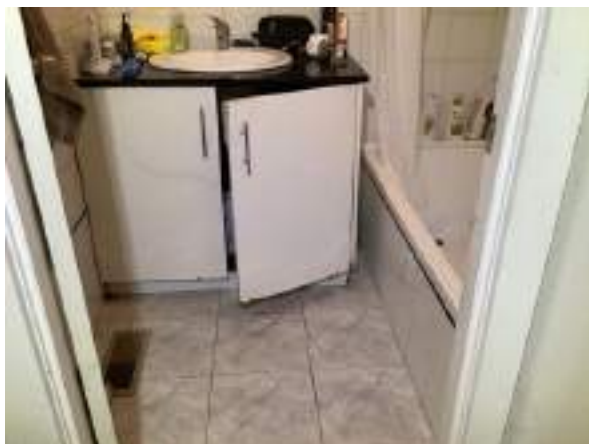
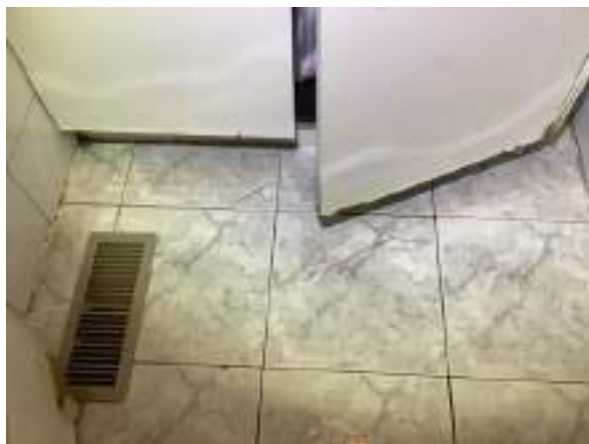
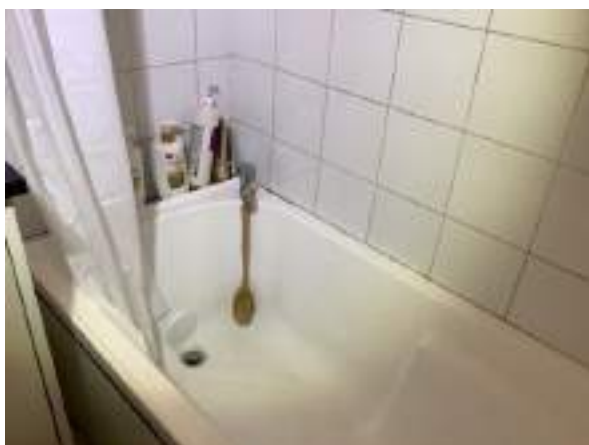
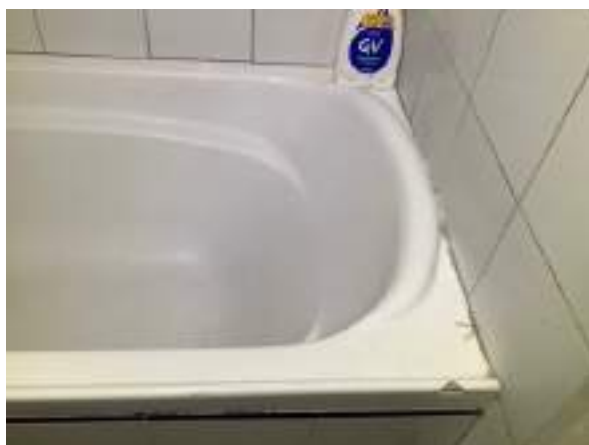
Major Defect 2.22

Location: Kitchen, Bathroom But Not Limited To

First of all it is VERY IMPORTANT to note that the subfloor was not inspected, however signs of moisture in the kitchen cupboards and bathroom was evident. An invasive inspection particularly to the subfloor area is a MUST to identify the serious of the subfloor area in relation to dampness, wood rott, mould, termites and many other serious defects as it is HIGHLY LIKELY that the bathroom area, but not limited to would be leaking.

This defect statement is known as a major defect and a safety hazard as per the Australian Standards for prepurchase building inspections (AS 4349.1-2007)

Damp (or structural damp) refers to the presence of unwanted moisture in the structure of a building, either as the result of intrusion from outside, or condensation from within the structure. Generally, structural damp is caused by rain penetration, rising damp, and leaks from plumbing pipes.

Unmanaged damp facilitates the formation and development of mould, fungi growth and wood rot, decaying associated building materials and compromising their structural integrity. Damage to finishes is also likely to occur, including lifting, bubbling, peeling and staining of paint, plaster and wallpaper.

The first step in addressing damp is to diagnose the cause. The identified cause should be addressed first prior to repairing the appearance and other defects which have resulted from the rising damp. If the original cause is not resolved, further cases of damp are likely to ensue, resulting in secondary defects.

Consultation with a qualified plumber is advised immediately to identify the cause of damp and perform remedial works as required. Where excessive mould growth is present, further inspection by a specialist environmental health inspector should also be considered.

Once the cause is rectified further determinations may be required by a BUILDER AND OR STRUCTURAL ENGINEER AND SOMETIMES A GEOTECHNICAL ENGINEER.

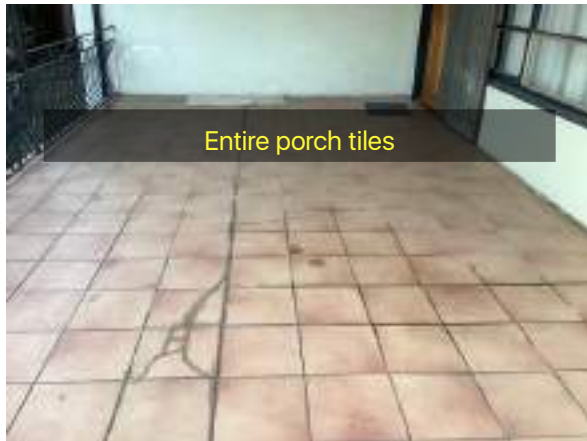
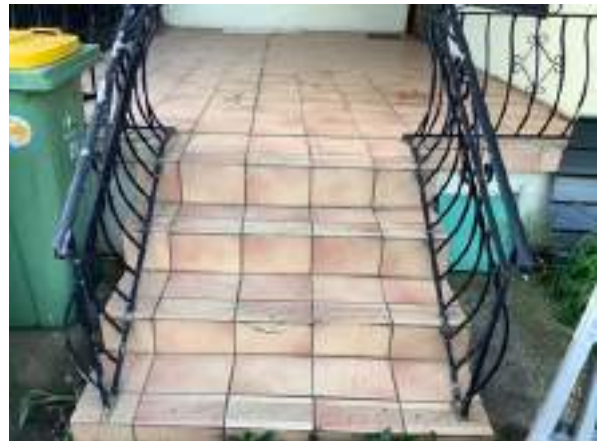
Major Defect 2.23

Location: Porch

Finding: Tiles - Cracked or damaged

If left unmanaged, water penetration to these areas may lead to subsequent water damage, which is likely necessitate repair work to affected building elements.

Where water penetration has led to water damage, appointment of a relevant tradesperson may be required to repair damaged building elements.

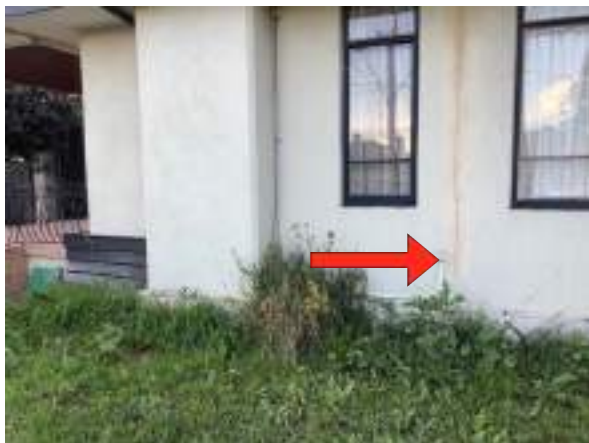
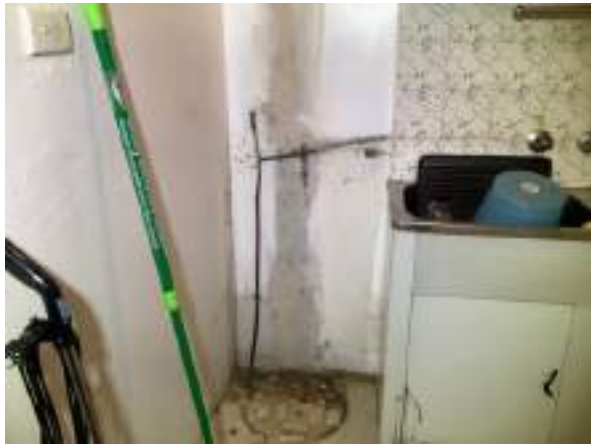
Minor Defect 3.25

Location: All Areas - Various

Where installation is substandard and/or incomplete, the client should contact the responsible trade to undertake rectification works, which are advised as soon as possible.

The appropriate tradesperson or specialist or handyman should be appointed to complete the various items for repair and organise the appropriate QUALIFIED trades (or not pending on job) to repair and complete the works to illiminate or reduce further deterioration / disfunction.

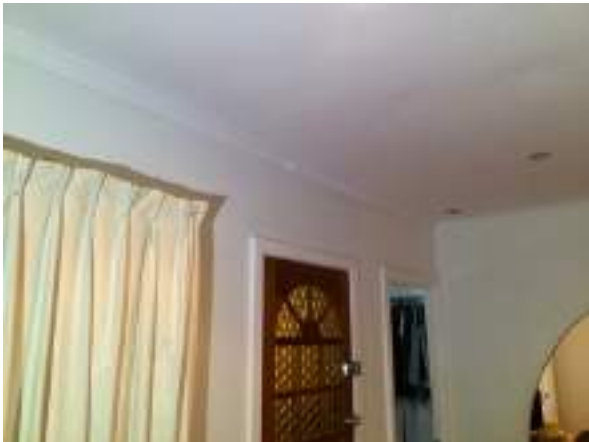
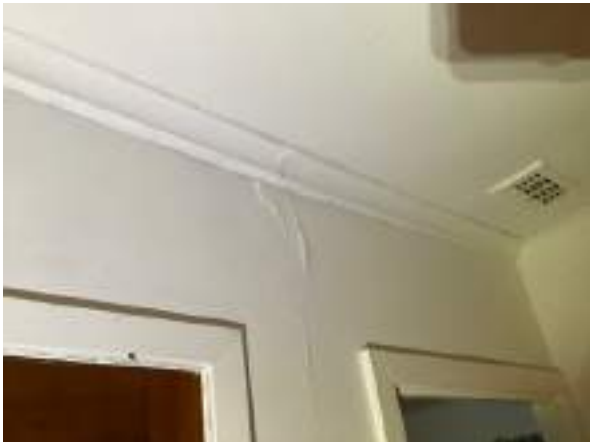
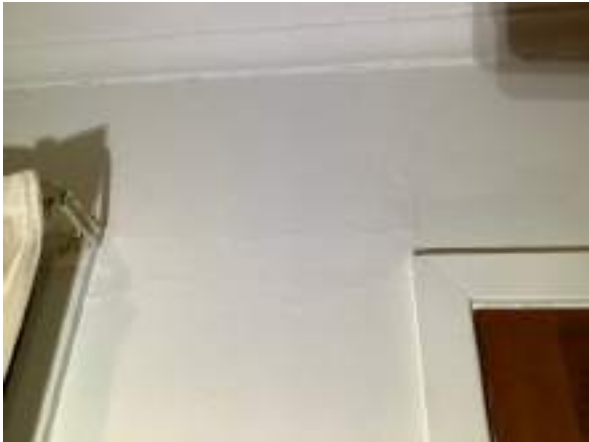
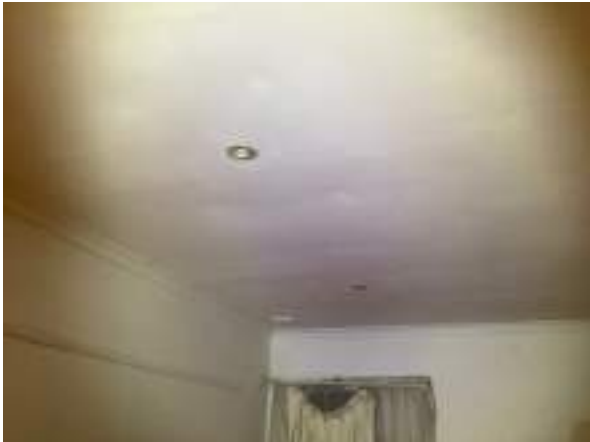
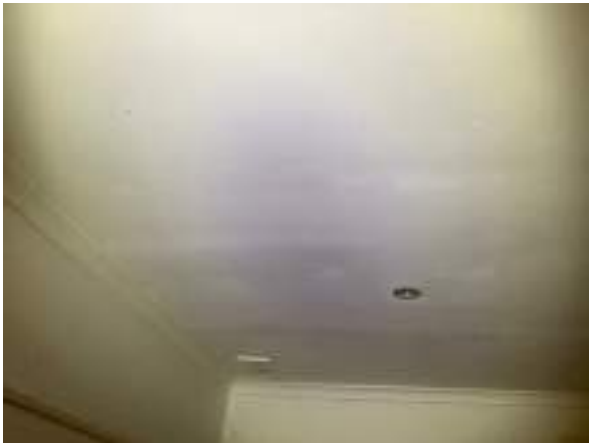
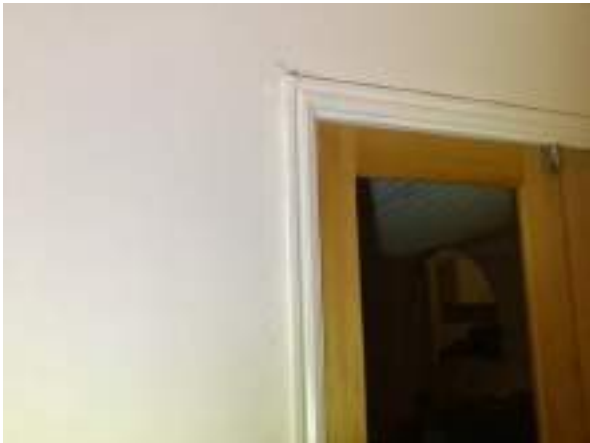
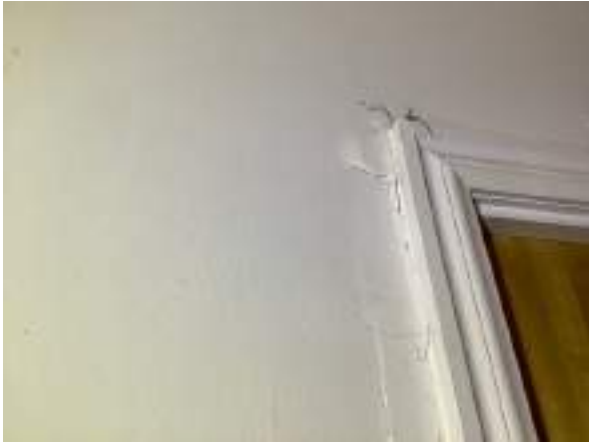
Wet areas are the main areas that MUST have SUFFICIENT paint coverage to the walls, ceilings and timber work as moisture can deteriorate the areas.

A painting contractor,builder, plasterer and/or suitable handy person may be appointed to perform necessary works to aid the appearance of the affected area and to ensure the area is protected against further deterioration.

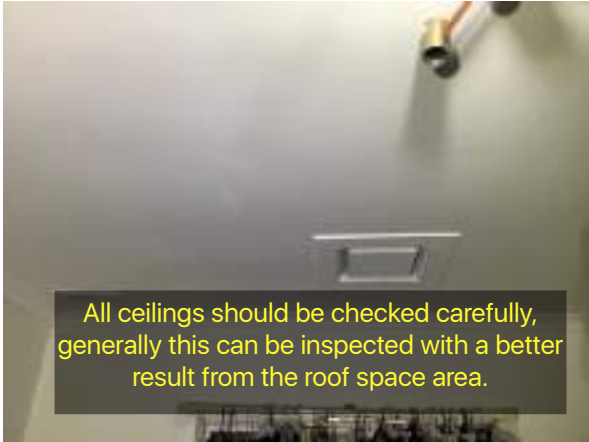
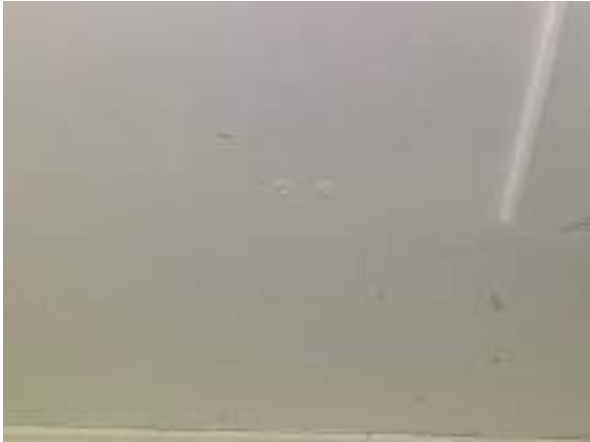
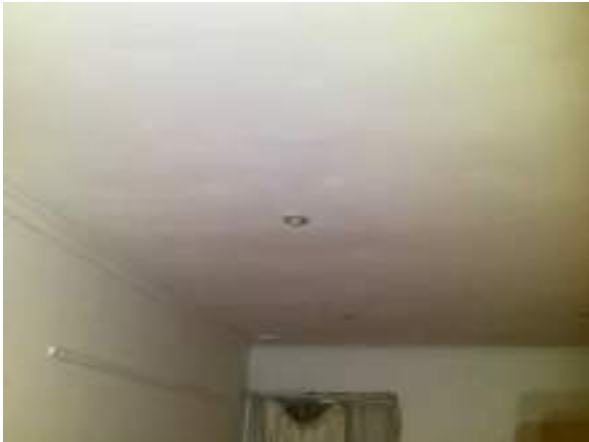
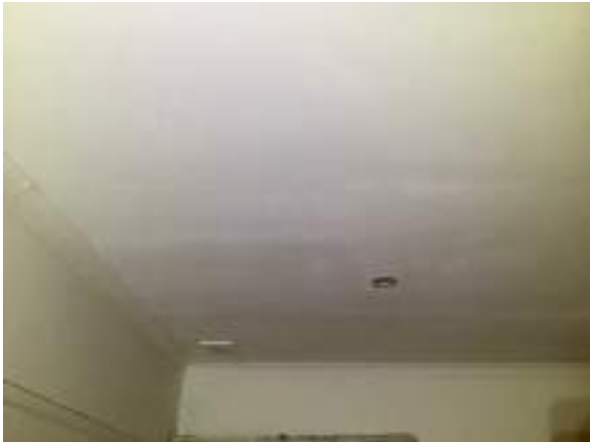
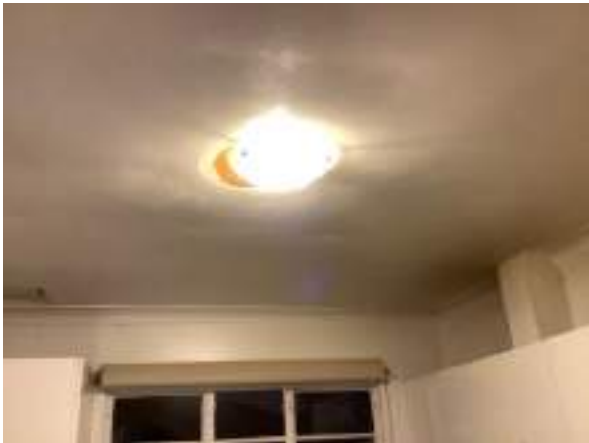
Minor Defect 3.27

Location: Plaster Internal Areas

Sections of plaster sheeting in this area appear to be drummy. The term `drummy` is used to describe plaster which, whilst solid, has become detached from its original fixing, where the defect is spread wide the drummy plaster can also be a safety defect, meaning plaster ceilings can just drop in an instance, usually this is the more extreme drummy ceilings.

The most common causes of plaster failure are physical damage and moisture damage. Moisture causes plaster to swell and shrink as the humidity of the air changes, or as a consequence of leaks, which can be enough to create drumminess or cracking.

Houses that do not have insulation can sometimes contribute to drummy plaster as many times the drummy plaster is in garages where there is no insulation in the roof so the plaster is subjected to moisture as it is not protected by the insulation, so this may be the only reason the plaster has become damaged / drummy , meaning no insulation to the garage or house or sometimes this may only be a contributing factor along with defective workmanship and/or others defects to the home, such as leaking roofs, etc.

Drummy plaster generally needs chemical re-adhesion (glue) or to be screwed back to the substrate, with minor consequent patching and painting required but sometimes drummy plaster can be permanently deformed in shape so therefore will sometimes need to be replaced.

Where minor sagging is evident, comparatively minor works, such as re-gluing of ceiling sheets, may be required. Such works may be performed by relevant tradespeople, such as plasterers and painters. Where excessive moisture has caused the roofing structure to swell and sag, the source of the water leak should primarily be identified prior to any remedial works being performed.

Ensure that the general environment is free of moisture and humidity to aid in the prevention of drummy plaster and plaster damage. Appointment of a qualified plasterer and/or builder is advised in order to complete remedial works as necessary.
