Vendors Report - Building/Termite/ Asbestos/Electrical/Digital Floor Level Assessment

Inspection Date: 5 Aug 2020

Property Address: Sunshine Area

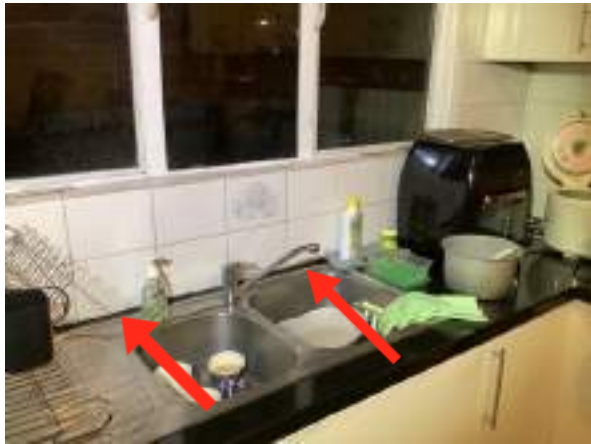
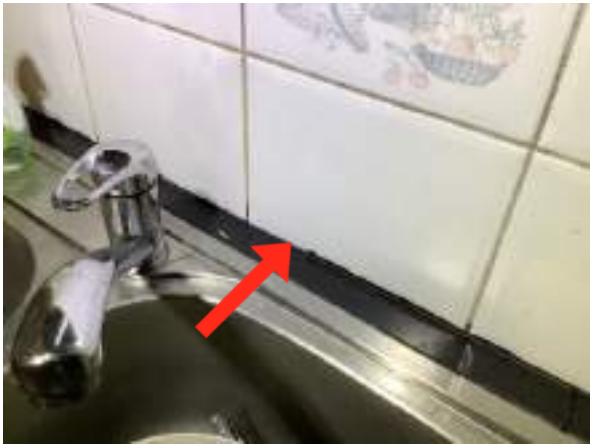
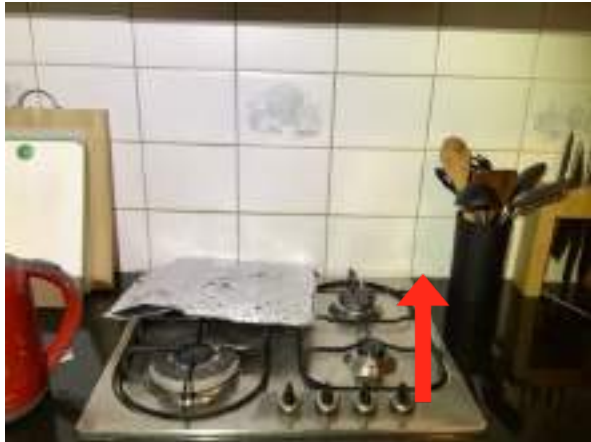
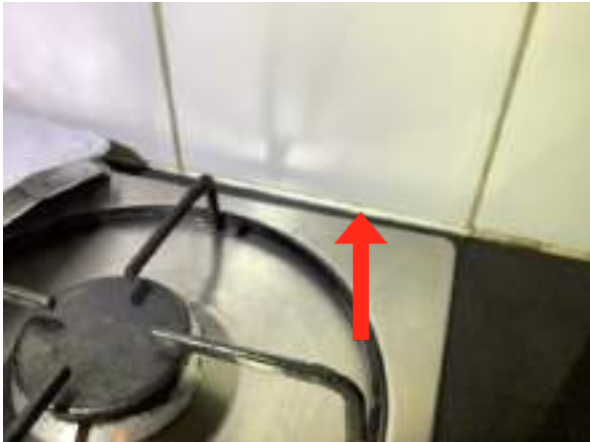
Minor Defect 3.28

Location: Caulking / Silicone-All Wet Areas

Finding: Silicon / Caulking To All Wet Area Junctions and Tile Grouting - Missing or Damaged - Internal Areas

It was noted on inspection that sealant and/or tile grout is missing, damaged or inadequate to the tiled wet areas. This may include floor edges, kitchen benches/splashbacks, vanities, bath tub edges, shower areas to the floor and wall tiles, laundry's and all other areas subjected to water or moisture.

Sealant and/or tile grout where missing, damaged or inadequate to the tiled wet areas allows the water to penetrate into the walls and floors which can cause much damage, to the affect were the damage may become a secondary defect and create a conducive environment for termites and/or cause rotting to the timber studs, floor joists and bearers or plaster etc, especially in showers, baths, laundry and the like

Whilst in some of the areas there is sealant/silicon , it has become apparent that the sealant has deteriorated and/or is just missing.

Whilst in some of the tile mortar is perfect , it has become apparent that the tile mortar has deteriorated and/or is just missing in other areas.

A flexible sealant/silicon and tile mortar should be applied to affected areas to prevent any subsequent water damage that is likely to occur.

A sealant specialist, tiling contractor and/or registered builder should be appointed to assess any damage caused by water to the entire internal, sub-floor, walls etc of the building and clean, take off old sealant and tile mortar, then re-seal and re-mortar these works as soon as possible.

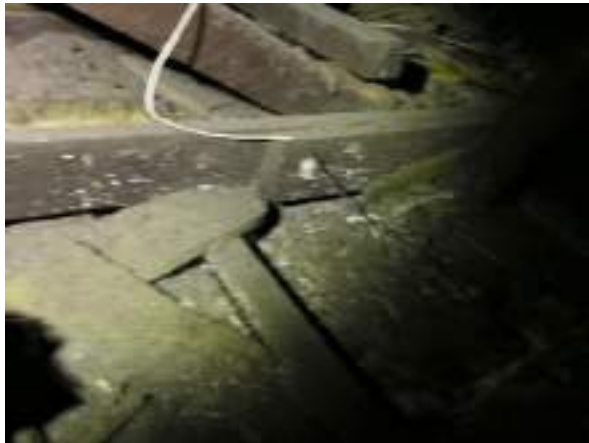
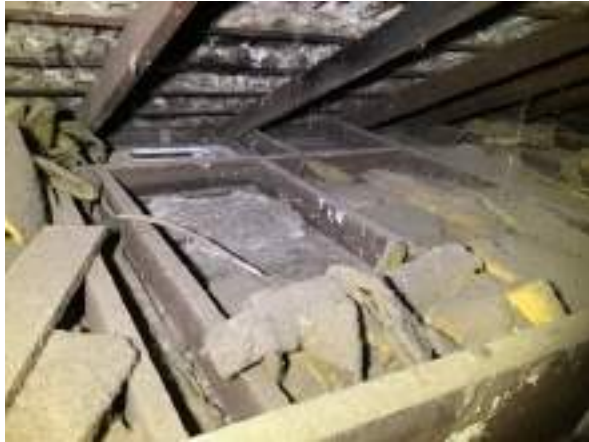
Minor Defect 3.29

Location: Roof Space

Finding: Insulation - Inadequate / Missing

Upon inspection of the roof void it was noted that there is a lack of adequate insulation and/or missing insulation.

Installation of adequate insulation is required according to Australian Standards and should be conducted as soon as possible.

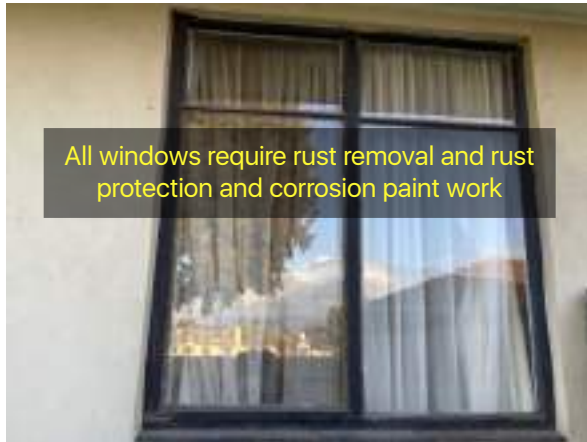
Minor Defect 3.30

Location: External Areas

Finding: Rusted / Corroded - Building Materials - Minor Repairs
This building element shows evidence of rusting and corrosion, which is likely to have developed as a result of excessive exposure to moisture.

As surface rust provides no protection to the underlying iron, the deteriorating condition is likely to worsen if not addressed in the short-term future.

Rusting and corrosion should be managed by ideally removing or limiting the affected surface from exposure to moisture.

Depending on repair, A registered builder, competent person or handyman may be appointed to replace any building elements that have been severely affected by rust or water damage.

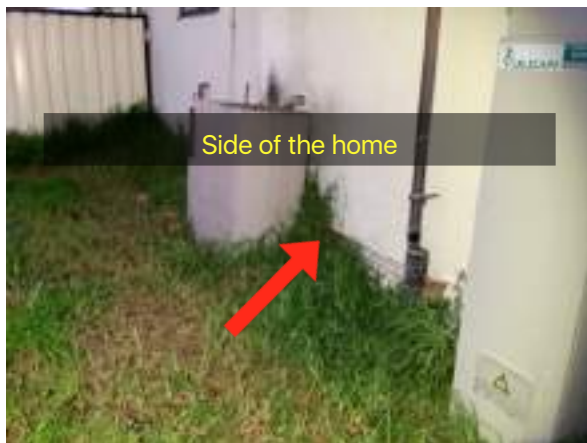
Minor Defect 3.31

Location: Perimeter Of Building - Exterior

An external hole was located at the time of inspection. This hole appears to be large enough to allow bird, rodent or other pest ingress creating the potential for nesting or infestation of live animals.

To ensure no such infestation occurs this hole should be adequately covered. Holes such as these are also likely to attract rain penetration which may lead to subsequent water damage to associated structures if left unmanaged.

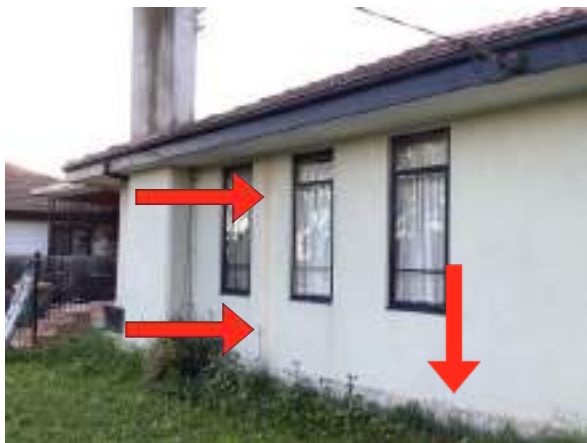
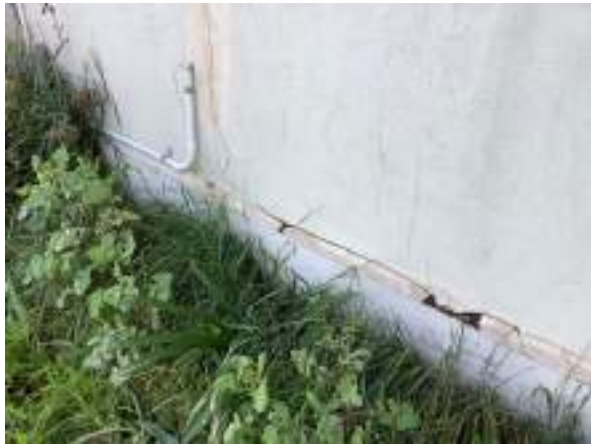
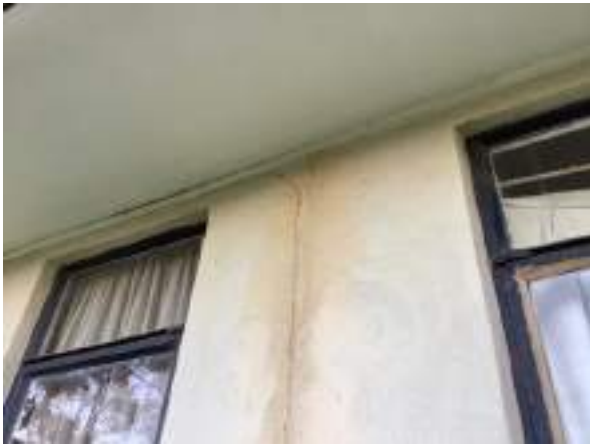
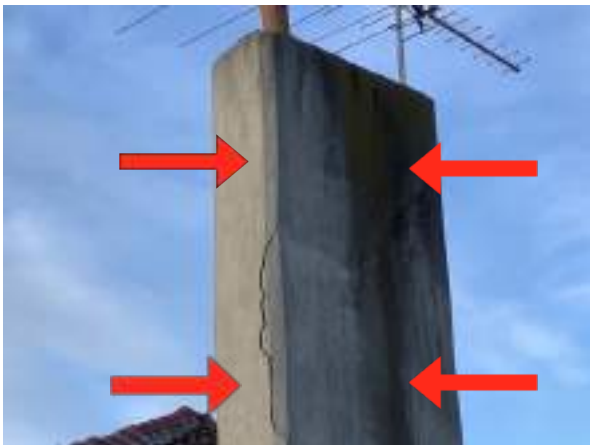
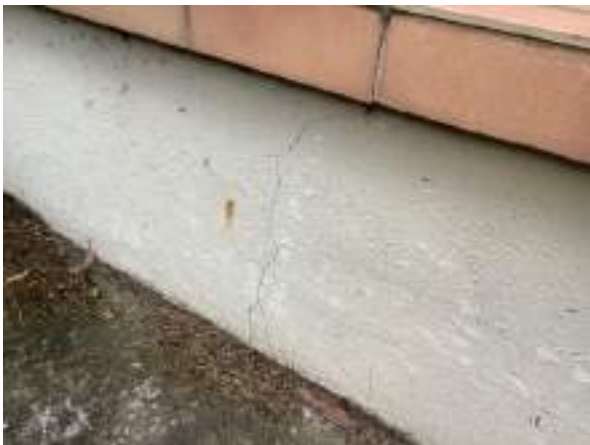
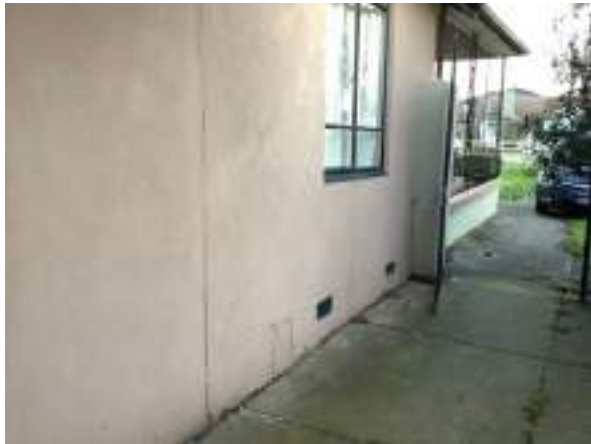
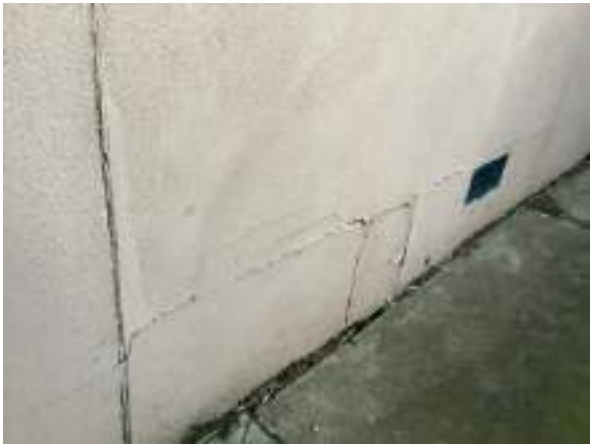
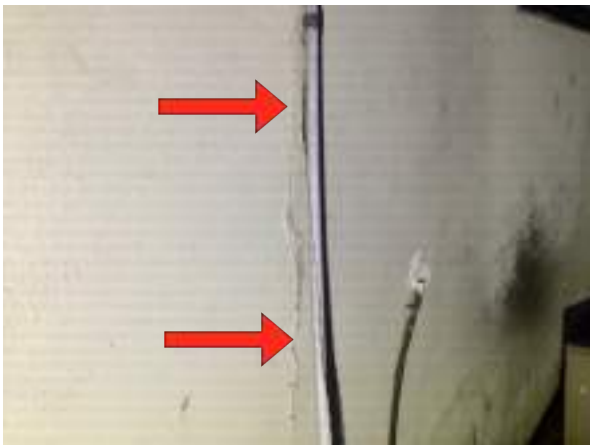
Minor Defect 3.32

Location: Brickwork

Finding: Brickwork / Masonary Rendered - Step cracking and minor cracking
RENDERED BRICKWORK OR MASONARY PRODUCTS.

There are several cracks and/or step cracking evident throughout the exterior of the property . These cracks are commonly less than 5mm in width, however as the home has been rendered the cracks are very obvious and unappealing, also it is very difficult to repair the cracks without them being noticeable, unless you render the entire wall or walls.

Although fine cracks are quite noticeable, they are often only considered to be an appearance defect and usually do not indicate any structural damage most of the time. Generally, the cause of a fine crack is indicative of a separation between brickwork and mortar throughout the structure, but single bricks may also show cracks of this nature.

Step cracking, which is similar to other forms of cracking, has a variety of possible causes. However, the most common is the subsidence of adjacent footings.

Cracking of this nature can generally be repaired with minor filling and should be conducted by a qualified bricklayer and/or registered builder.

Where step cracking is extensive or severe, the client is advised to consult a structural engineer.

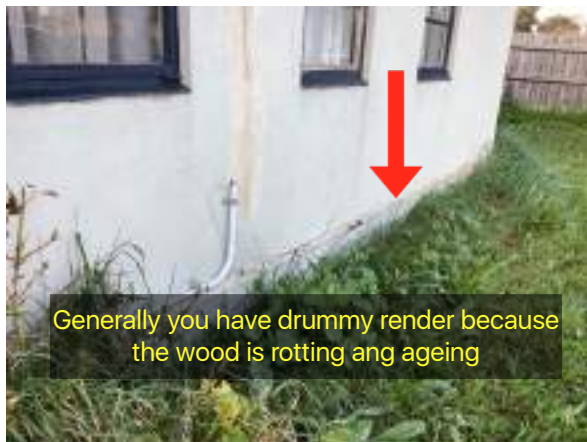
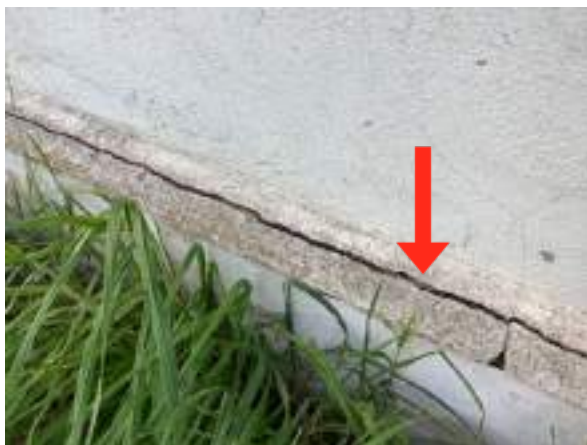
Minor Defect 3.33

Location: Brickwork

Drummy rendered areas were identified at the time of inspection. The term 'drummy' refers to render that has become detached from its fixing, despite it still being solid. Such defects are generally caused by physical or moisture damage to the area. Drummy render may also be a direct result of poor workmanship during the construction process.

Render may swell and shrink with changes in air humidity if the area has sustained moisture damage. Any exposure to moisture is capable of causing rendered areas to become drummy and/or cracked over a prolonged period of time. Drummy render generally requires chipping off and re-rendering or painting.

Specialist trades are available for these types of services. A registered builder may be required to undertake works if damage is extensive, or if secondary building defects have resulted. Immediate action is recommended to ensure that no further damage is sustained in the affected area.

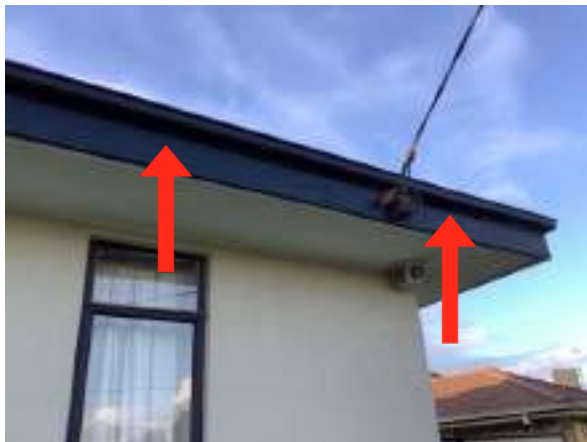
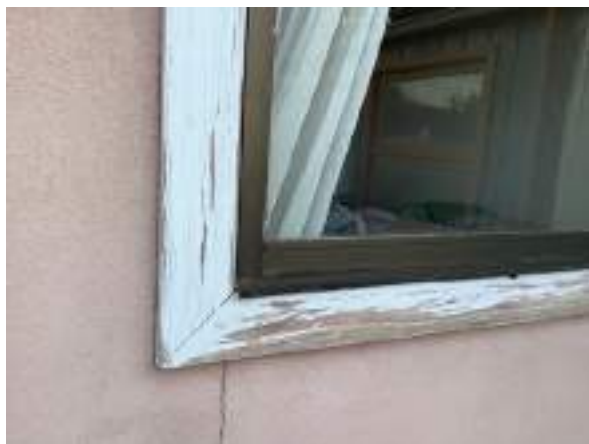
Minor Defect 3.34

Location: Timber Work - All External Areas

Finding: Timber, exposed to weather / External painting deteriorated
Much of the external paint work including but not limited to windows, fascias, guttering, veranda and other external fitments have been neglected and require attention to prepare and re paint.
External timbers that are frequently exposed to harsh weather conditions require adequate protection (paint) in order to maintain their condition. Where timbers have not been painted or treated adequately, general deterioration is likely to occur at an accelerated rate.

Whilst incomplete or missing paint finish is generally an appearance defect, it can also lead to the development of secondary building defects over time. Incomplete areas of paint finish exposes the area to moisture, potentially accelerating the deterioration of underlying building materials.

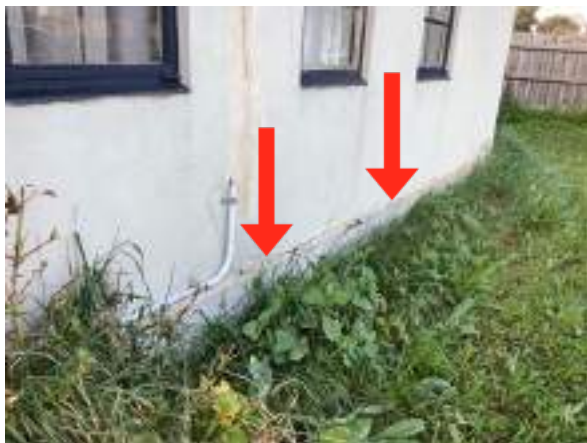
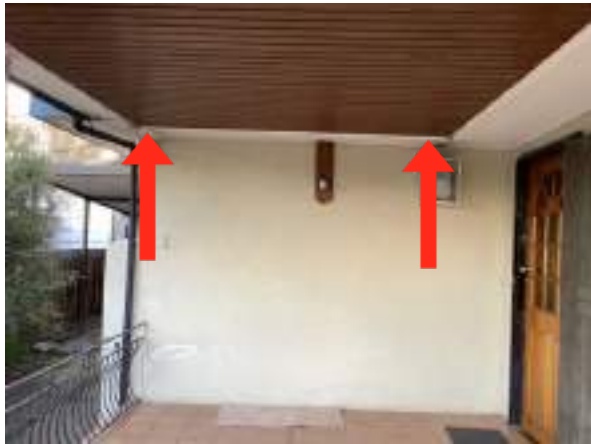
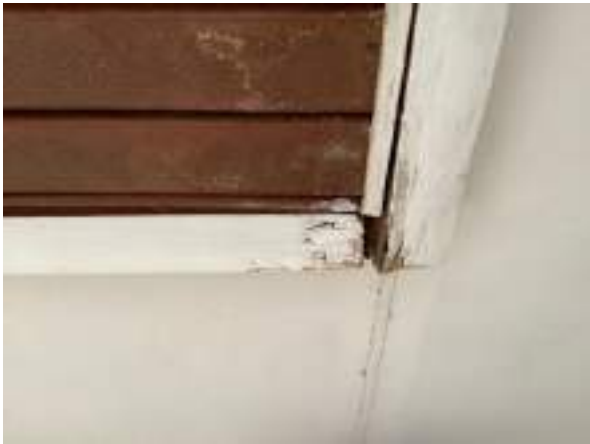
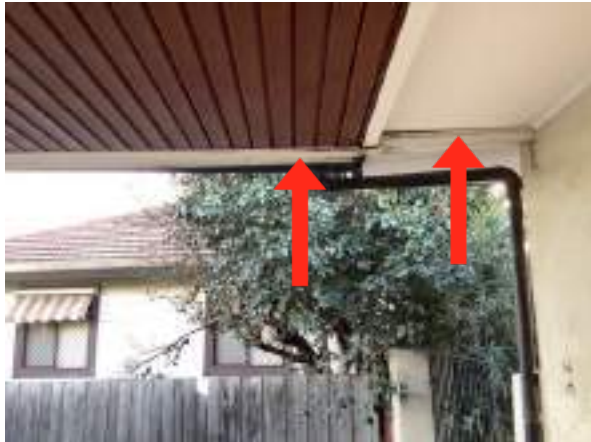
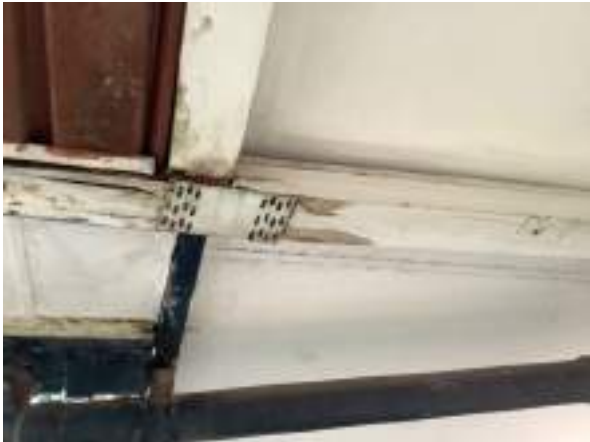
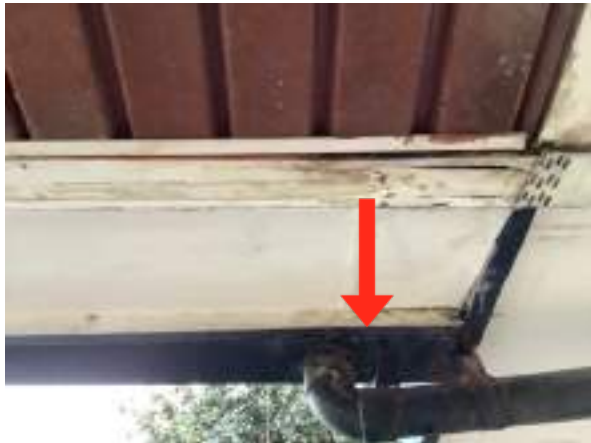
Minor Defect 3.35

Location: Timber Work - All External Areas

Finding: Wood Rot

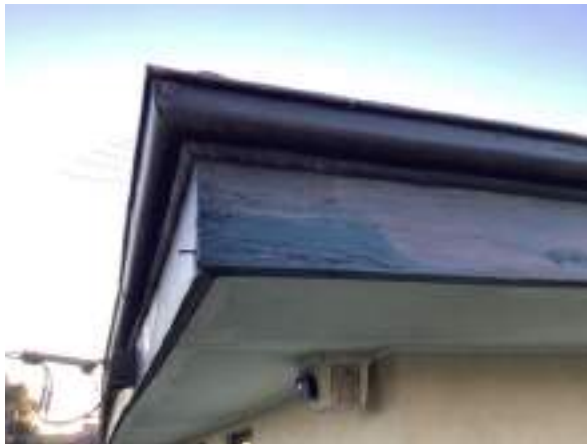
Minor Defect 3.36

Location: Timber Work - All External Areas

Replacement of affected fascias and barges may then be a necessary step in protecting surrounding building elements from such deterioration.

A qualified plumber may be appointed to assess the cause of excessive moisture and to provide advice on any remedial works as required. A qualified carpenter or registered builder may also be required to replace affected building materials.

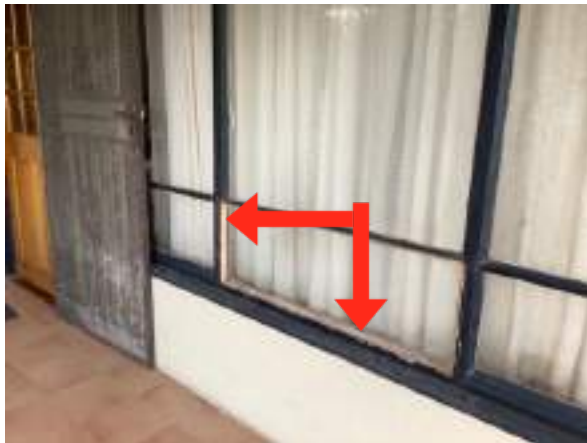
Minor Defect 3.37

Location: Windows - External

It is recommended that all deteriorated window seals be replaced by a general handyman, window technician, glazier, builder or sealant expert to prevent any further damage and to restore the window to a fully functional level. Damaged window seals can be rubber, silicon or with the old windows a special type window putty.

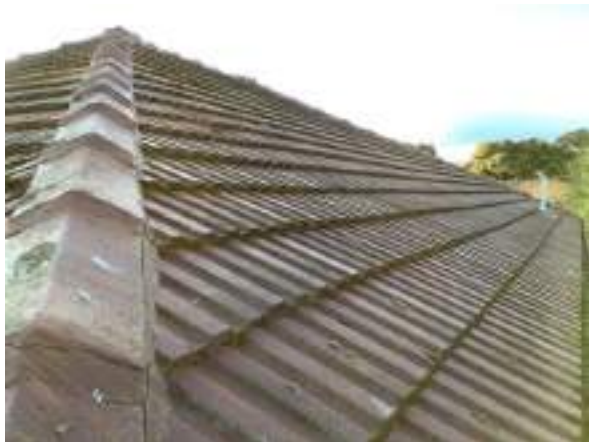
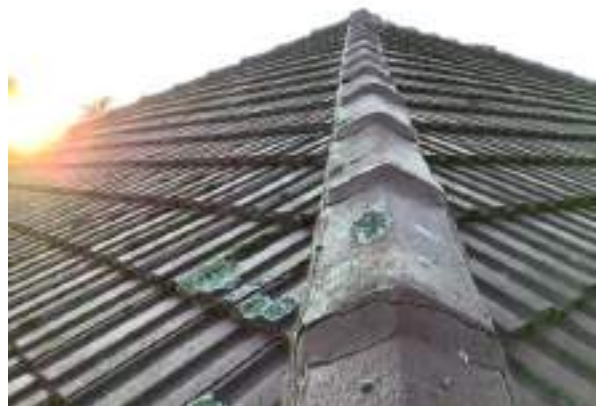
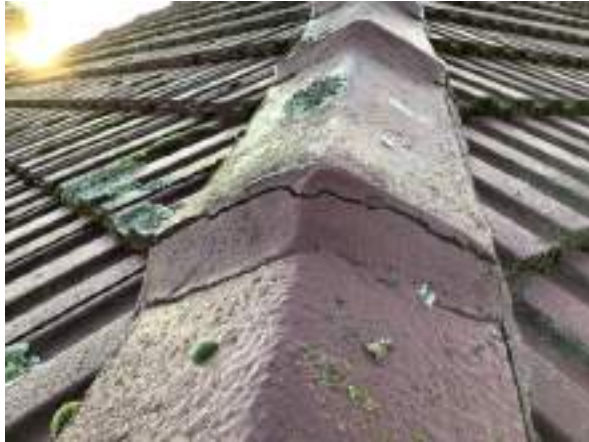
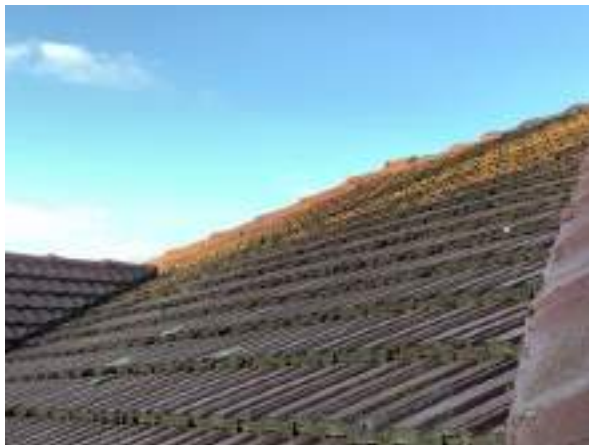
Minor Defect 3.38

Finding: Roof Capping - Mortar Deteriorated.

Remedial works are likely to increase the longevity of the exterior roofing structure.

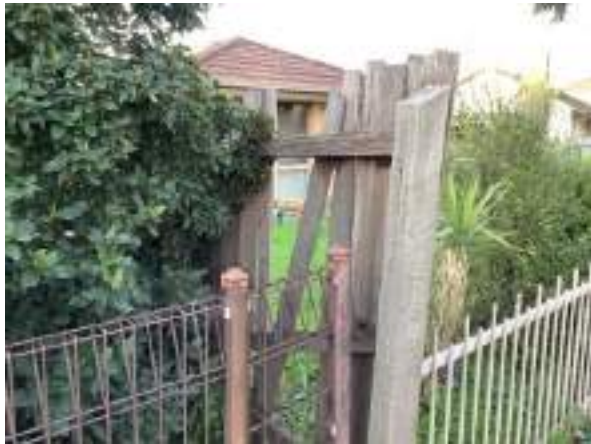
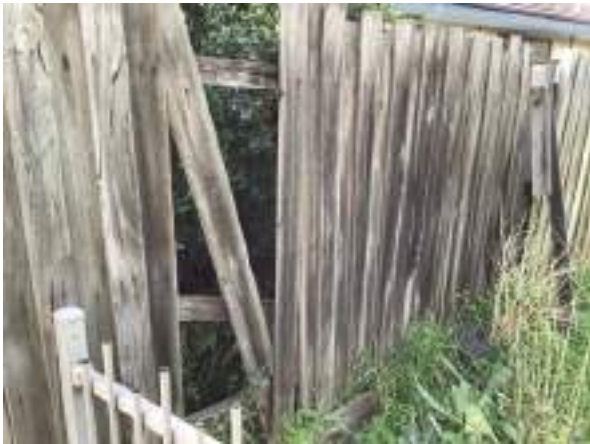
Minor Defect 3.39

Location: Fencing

Finding: Fencing - Deteriorated

It was noted at the time of inspection that sections of the fencing throughout the property have deteriorated. Typically fencing deteriorates due to age or rot which is generally expected for a structure of this age, due to prolonged exposure to weather conditions. A licensed fencing contractor should be appointed to provide further advice and perform rectification works as necessary.

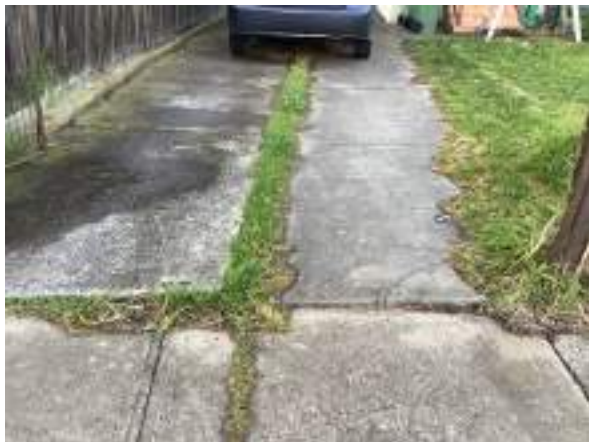
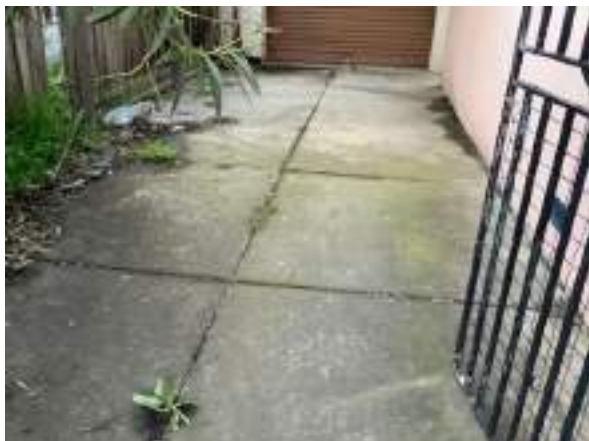
Minor Defect 3.40

Location: Concrete - All Areas

Finding: Cracking - External Concrete Paving Damage Category 3 - Wide Cracks (Over 3 to 5mm)
Wide cracks were identified in external concrete paving Wide cracks are significant and are likely to lead to the development of safety hazards and secondary defects if left unmanaged.

General age and expected deterioration of the paved areas is a common cause of this type of cracking. However, expansion and contraction of the slab may also have occurred due to environmental factors. Such factors include variable moisture and weather conditions, the presence of trees and their roots having a settling or lifting affect on the soil, or the effect of load bearing, e.g. heavy vehicles over a sustained period of time.

Cracking to this degree may also be due to poor original installation of the concrete. Factors such as poor compaction of the sub surface and/or inadequate reinforcing of the slab may create cracking and other secondary defects. Wide cracks may also have a more significant structural cause, such as subsidence of soils.

Where the crack is located adjacent to structural elements of the building, the advice of a Structural Engineer is advisable before undertaking repairs. Significant repair and likely replacement of the concrete paving is probable.

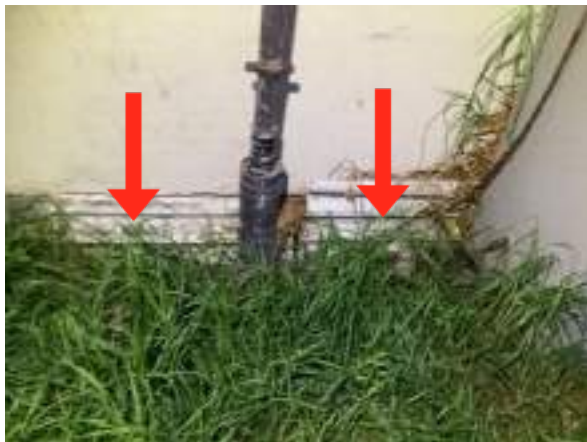
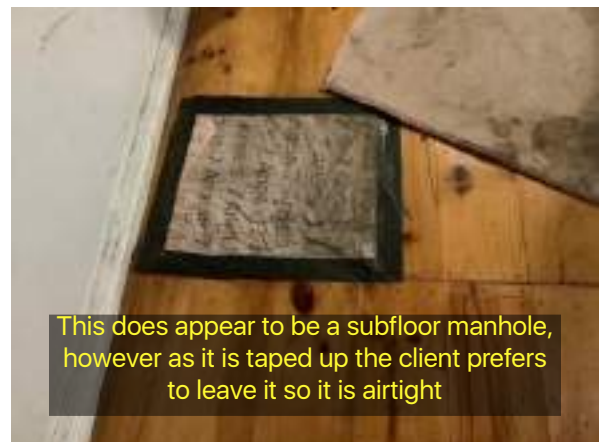
Please note that at the time of the inspection we did identify an area that appears to be possible access to under the subfloor area or at least possible access to poke my head down and have a look. Due to the severity of the bathroom kitchen and moisture areas it would be quite obvious that under the subfloor area will have dampness and witness which is quite serious and this has been discussed with the client in detail on site and they are happy at this point not to take the tape off in the area as the major structural items do currently show the severity of the situation anyway.

By not inspecting the sub floor area there can hide an array of defects, without inspection to the roof void area it is impossible to rule out termite activity and/or termite damage and other undetectable issues .

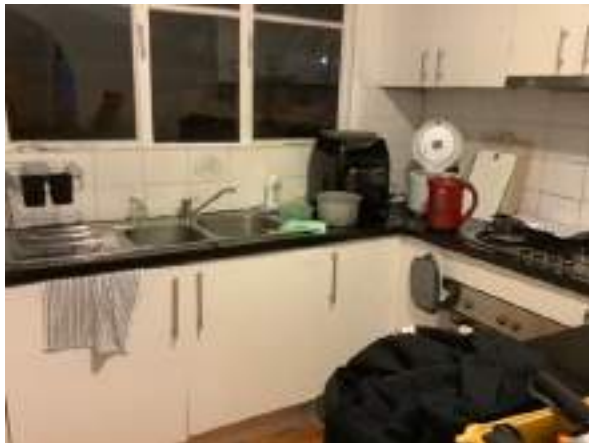
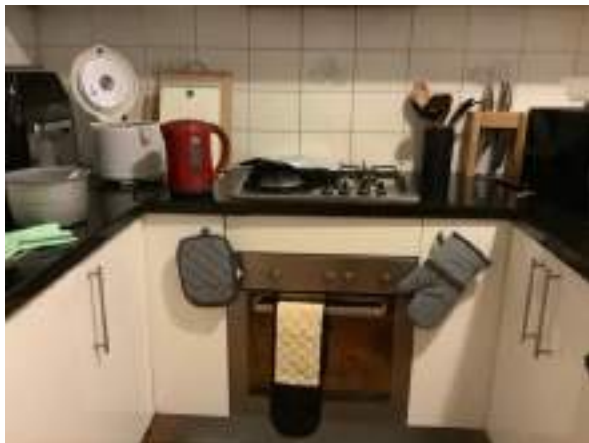
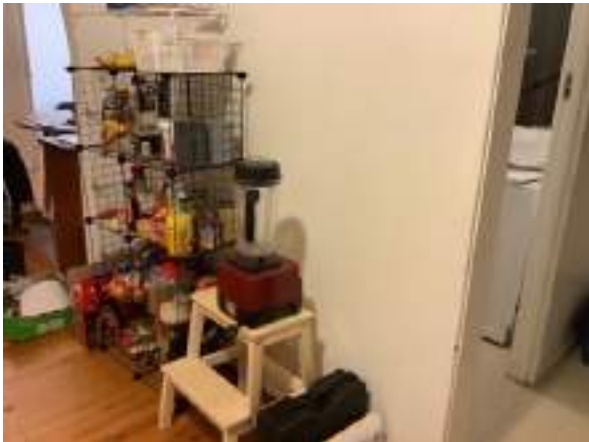
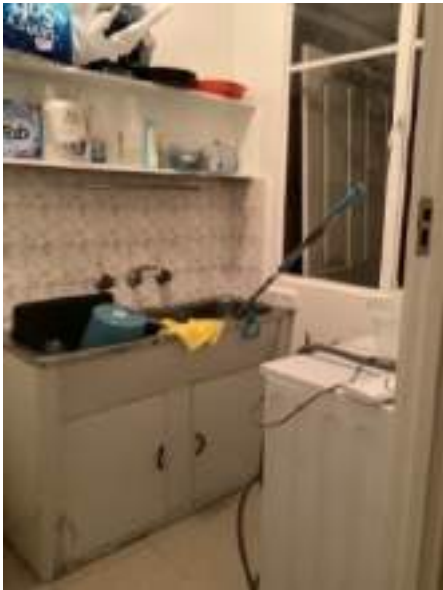
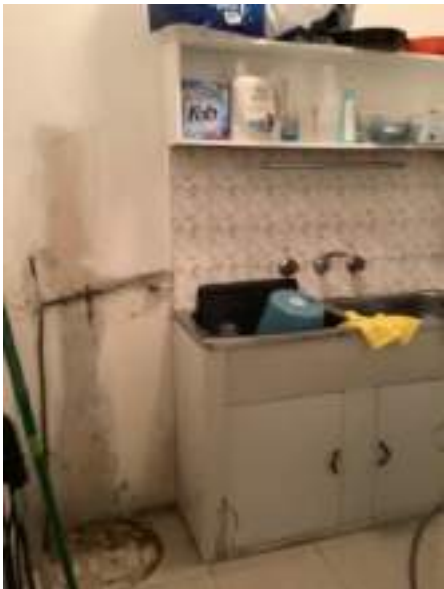
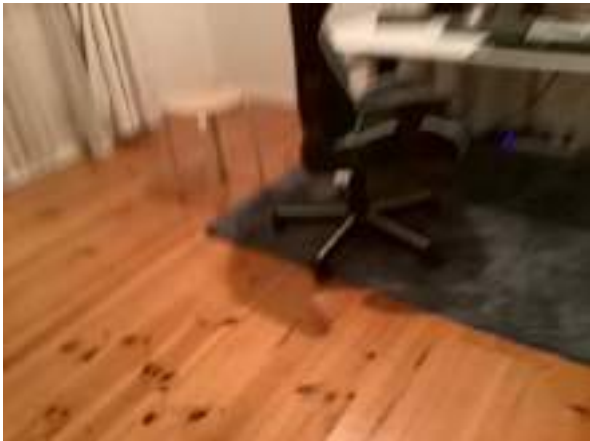
For your information 4.46

Finding: Additional Photos - Obstructions and Limitations
These photographs are an indication of the obstructions and limitations which impeded full inspection of the property at the time of inspection.
These obstructions can hide an array of defects such as minor defects , major defects , safety hazards , termite activity and conducive environments for termites but not limited to.

A re-inspection is recommended once the areas are made accessible.

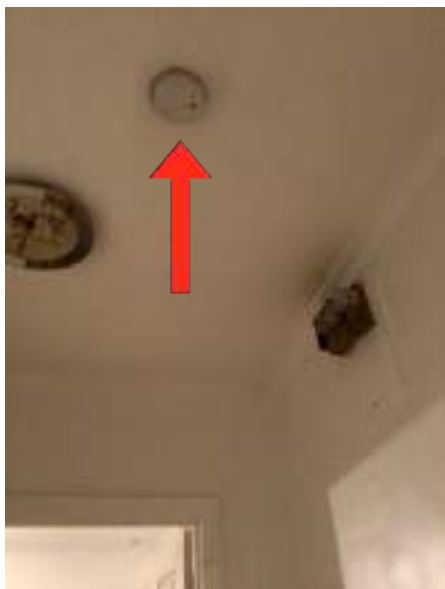
For your information 4.47

Finding: Smoke Detectors Battery Replacement.
This inspection DOES NOT test operation of smoke detectors .

Upon moving into a new property, it is highly recommended that the batteries to the smoke detectors all get replaced instantly.

Smoke detector batteries should be replaced every 12 months at a minimum.

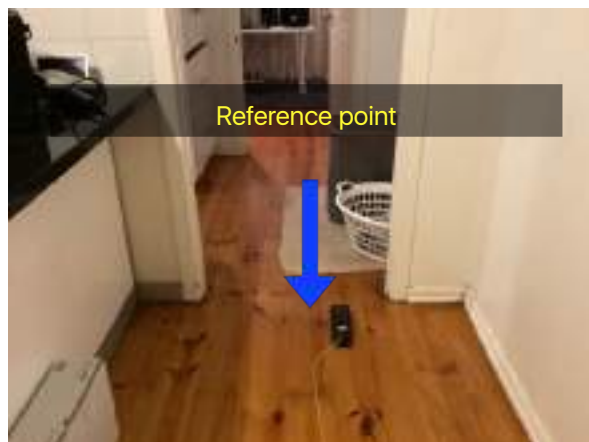
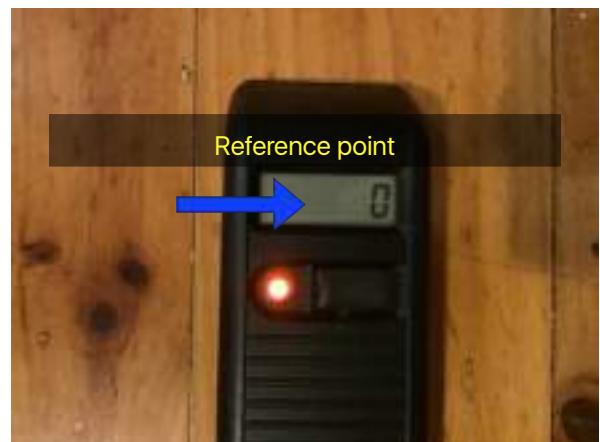
For your information 4.48

Finding: Flooring - Uneven / Defective

This defect statement is known as a major defect and a major structural defect as per the Australian Standards for prepurchase building inspections (AS 4349.1-2007)

It appears that the subfloor structure has been affected by movement of the foundations, often referred to as sinking or subsidence. a degree of movement is expected in subfloors over time, especially as environmental conditions change and buildings `settle` after construction, this degree of subfloor movement requires attention.

General subsidence is usually initiated by changes in soil moisture content. The most critical factor is identifying the specific causes, and identifying if this is a recurring or ongoing problem, or one that has been resolved by previous works in the past.

Any repairs, re-stumping and/or packing MUST be performed by qualified trades, whom take there own levels during the remedial works process.

A Registered Builder who is experienced in flooring, stumps and re-stumping would then generally carry out works or be associated with re-stumpers as advised by a Structural Engineer and/or a geotechnical engineer, if required.

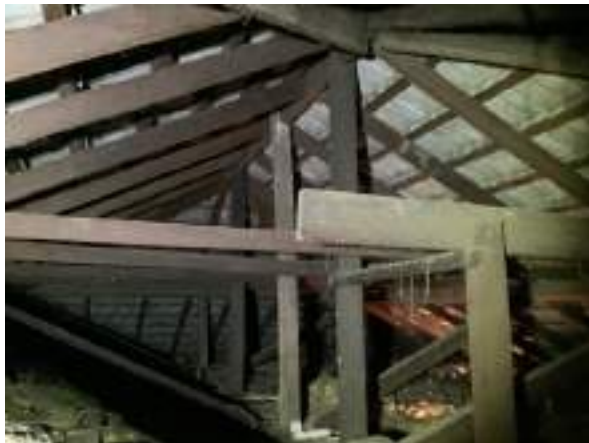
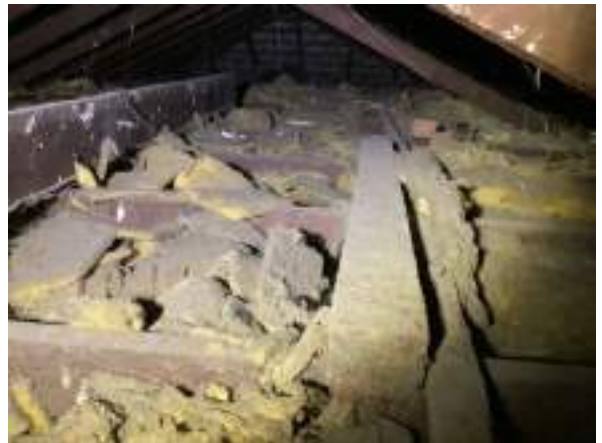
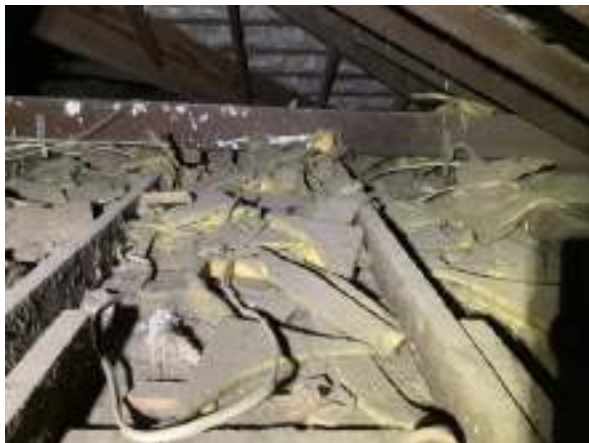
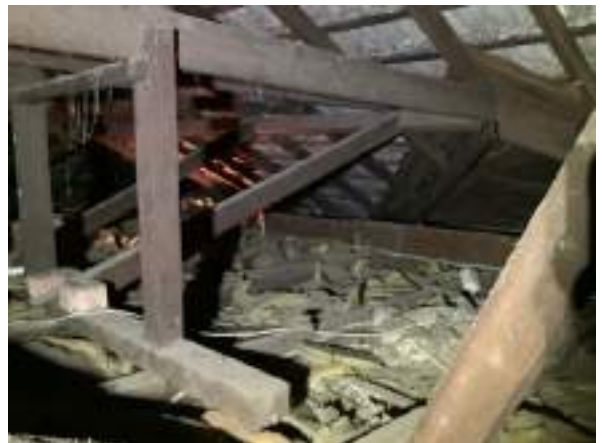
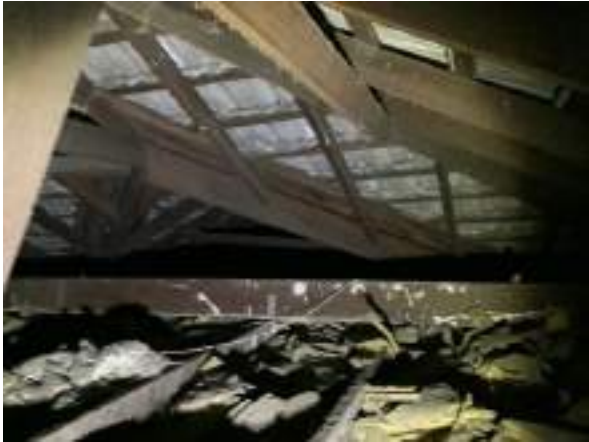
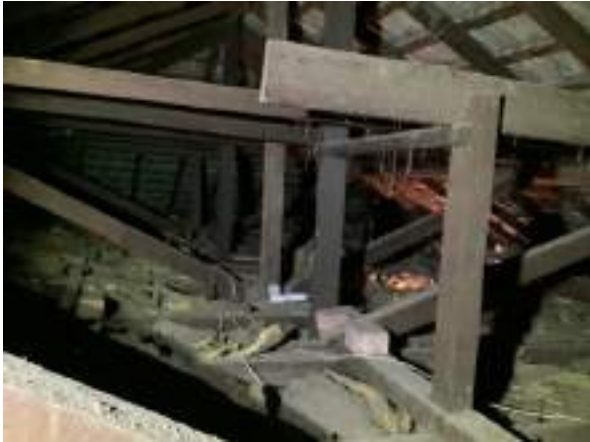
For your information 4.49

Location: Roof Space

These obstructions can hide an array of defects, without removing the insulation it is impossible to rule out termite activity and/or termite damage and other undetectable issues.

The property is a very high risk for termites as the environments to the property are very conducive with many susceptible areas.

Please read the report carefully and Maintenance to all susceptible and conducive areas is a MUST to minimise the risk of termite and timber pest existence and timber damage.

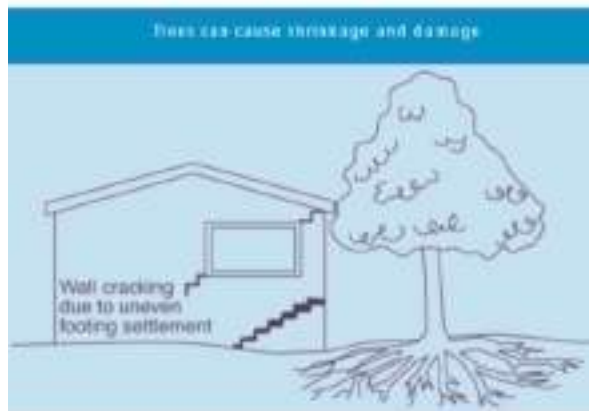
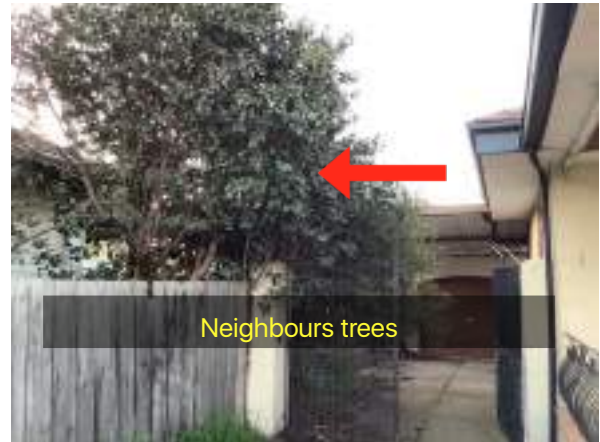
For your information 4.50

Location: Garden Areas - All Areas

Finding: Garden trees and vegetation / Yakka Trees - Subsidence - Close To Buildings
PLEASE NOTICE THE ATTACHMENT PICTURES TO THIS DEFECT STATEMENT;
H = the height of the tree at its full potential height, not its height today.
D = the distance from the tree to the building at the trees full potential height.
D = varies pending on one tree to 4 trees or more.

Trees and other vegetation can have a significant local effect on drying of soils. Over a number of years, especially during drought conditions, adjacent trees and vegetation may draw excessive moisture from the soils. The opposite may also occur, where swelling of the soil results when the trees decline or are removed.

As the cumulative moisture deficient is reversed, the surface level around the tree (and adjoining subfloor or concrete slab) will rise and expand laterally. This is often damaging to buildings unless the foundations have been strengthened or designed to cope with the effect.

Subsidence can have complex and varying causes, which will influence the required remedial works. It is advised to begin by consulting a structural engineer to determine the required scope of works. This generally includes some form of underpinning, as well as addressing the underlying cause. Consultation with a geotechnical engineer may also be necessary.

A registered builder specialising in re-stumping / structural damage such as major brick cracking would then generally carry out works as advised by an Engineer and/or Geotechnical Engineer.

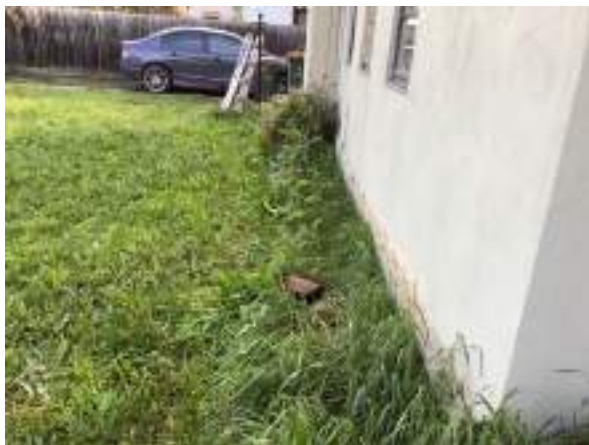
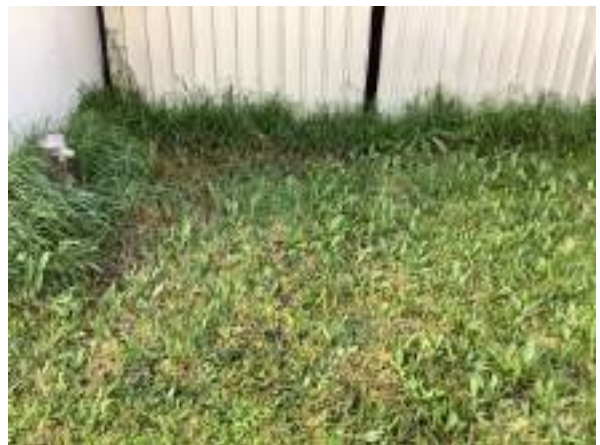
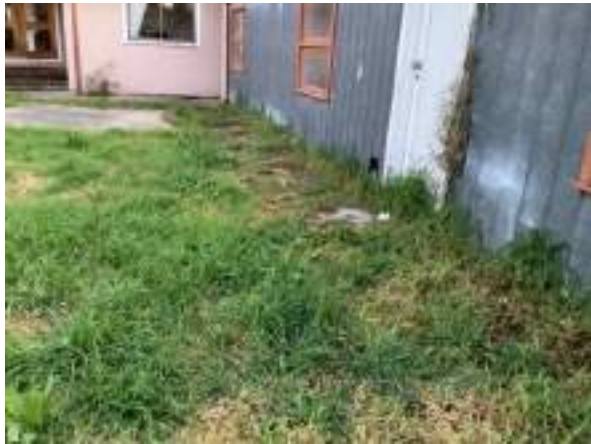
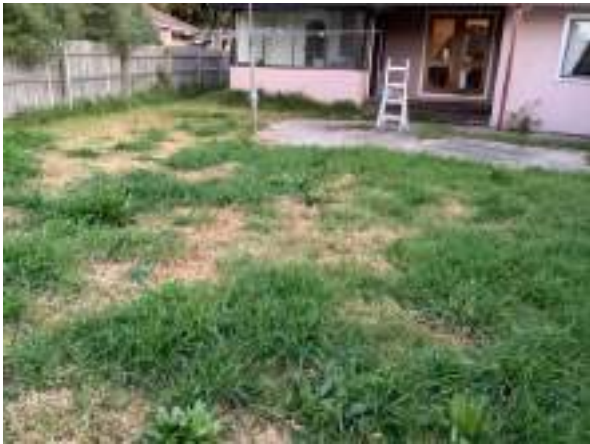
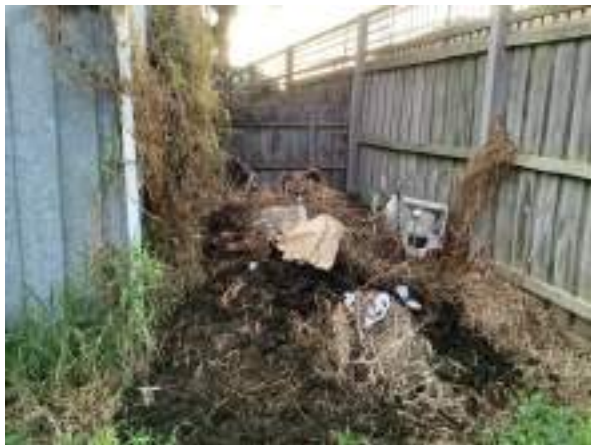
Item 2.02

Location: Garden Areas - All Areas

Finding: Garden Beds - Conditions Conducive to Termites
Garden beds were found to be evident in areas of garden areas. These garden beds can include untreated timber, bark, excessive old vegetation and with a combination of moisture from watering hosing can make conditions very conducive to termite activity and termite ingress. It is always important to keep the garden beds as clean as possible and take out excess old bark from the trees, leaves and keep bark mulch to a minimum or better introduce rocks or some item that does not create an conducive environment for termites and hold excess moisture.

ALL AREAS should be checked carefully for this defect and attached are a few PHOTO EXAMPLES as a GUIDE.

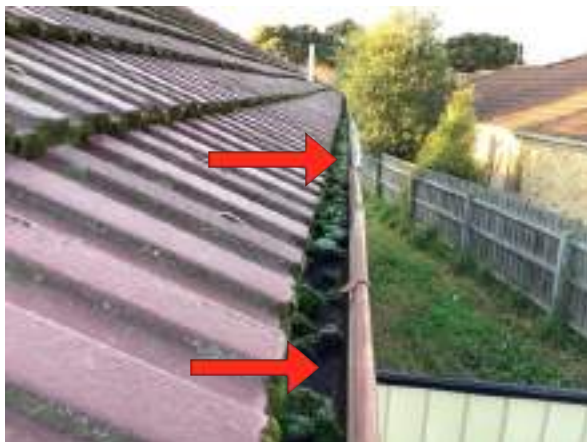
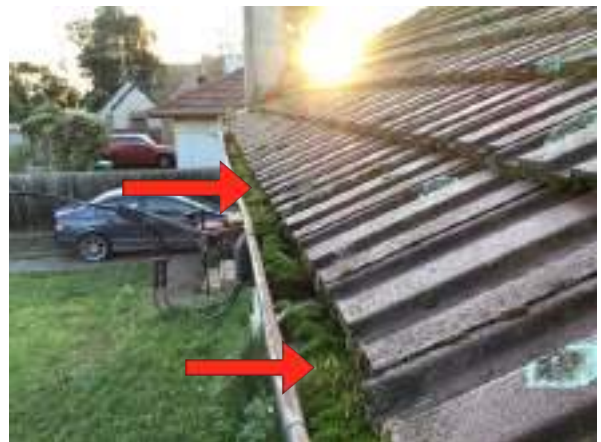
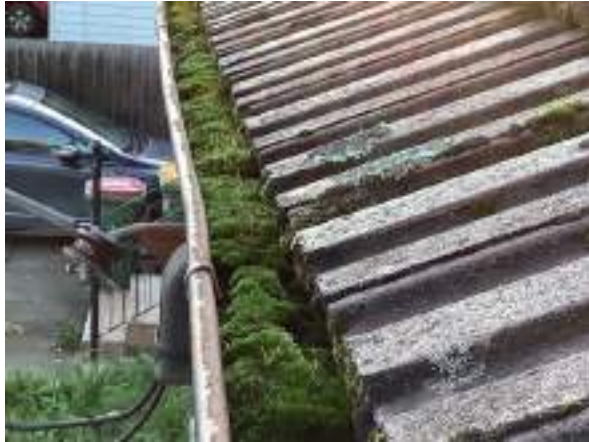
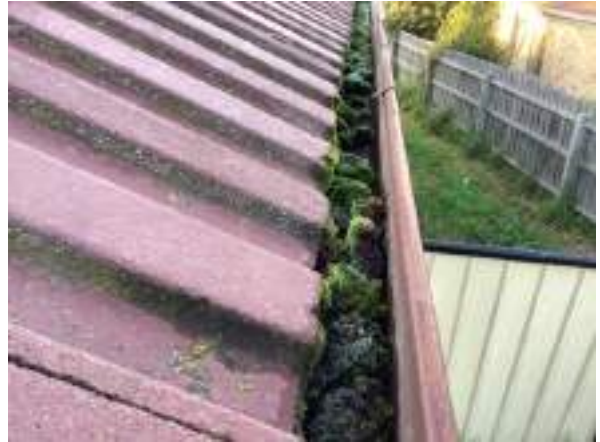
Item 2.03

Location: Roof Areas & Stormwater

ALL AREAS should be checked carefully for this defect and attached are a few PHOTO EXAMPLES as a GUIDE.

Immediate clean up is required.

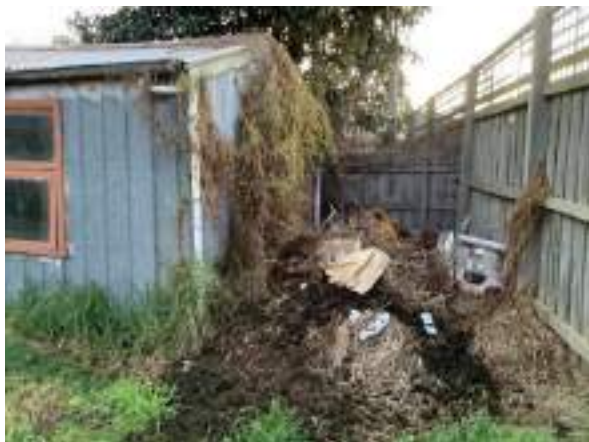
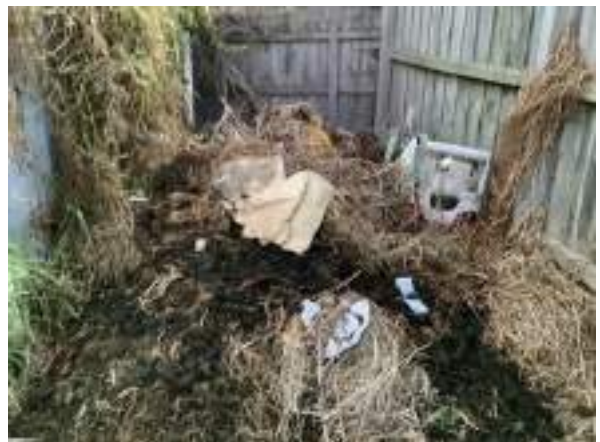
Finding: Stored Timbers / Debris / Garden Areas / Sheds - All Areas, Subfloor spaces or exterior external areas.
The storing of timbers / debris / items in the subfloor space or around the external property increases the risk of termite activity being present, as they are likely to come into contact with weather conditions or excessive moisture where wood rot is likely to develop on timbers that are not treated, or where debris or items are stored

It is highly recommended that any stored timbers / debris or items be immediately removed from areas

It is highly recommended that any stored building materials or other materials be immediately removed from areas in which they may attract any termite / timber pest attack around the perimeter and/or sub floor areas of the dwelling and a re-inspection is carried out.

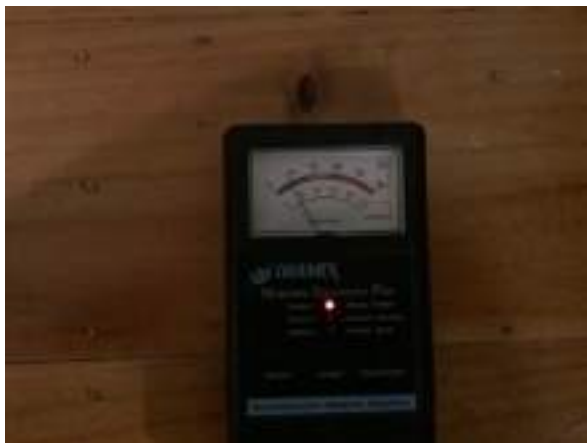
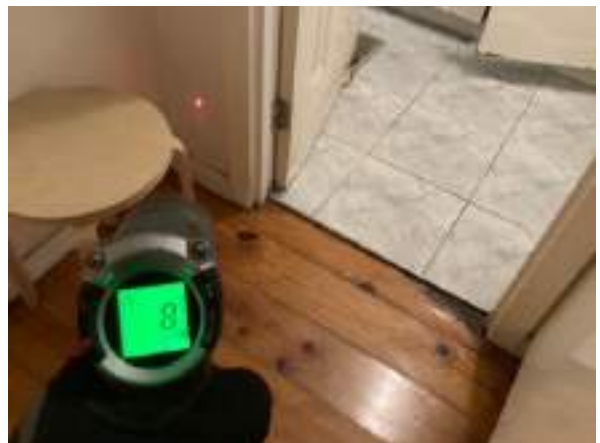
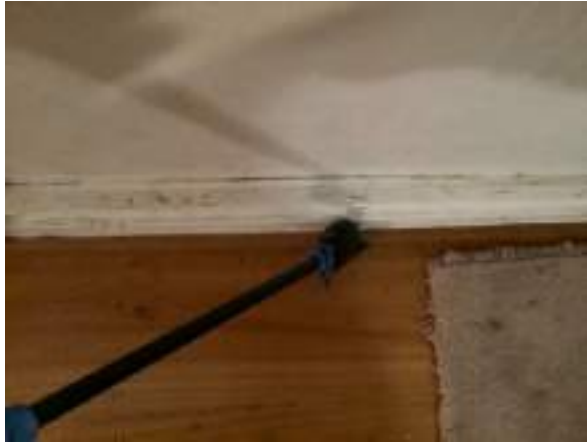
Item 4.07

Finding: Identification Procedures Designed To Help Identify Termite Activity
All areas accessible of the dwelling are checked with particular attention paid to the wet areas which were closely assessed to check for excessive levels of moisture and temperature anomalies.

The moisture content variation was within the acceptable range of 5% to 20%.

Temperature variations were all identified under as reasonable, however it is important to keep in mind hot days as temperatures for this testing procedure may be effected . The testing of temperatures was consistent with normal range for building elements in these conditions and temperatures.

At the time of the inspection there was no evidence of termite (timber pest) activity and no visually accessible timber damage caused by termites and timber pest.
The levels of moisture in all areas were found to be in the normal range.
As all areas are not able to be inspected due obstructions and limitations, we therefore can not rule out the possibility of concealed timber pest activity.
