# Final - Handover Report

Inspection Date: 7 Aug 2020

Property Address: Melbourne

Report Type: New Home Construction

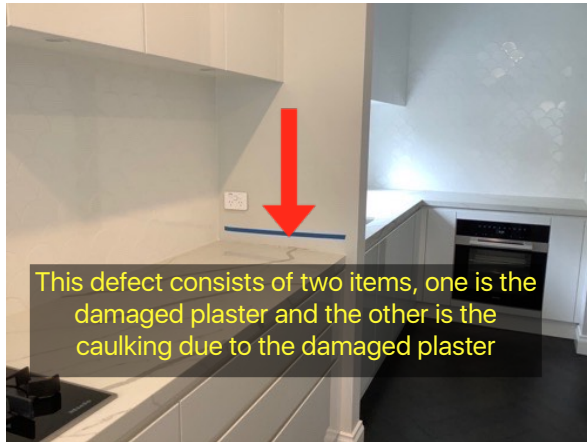
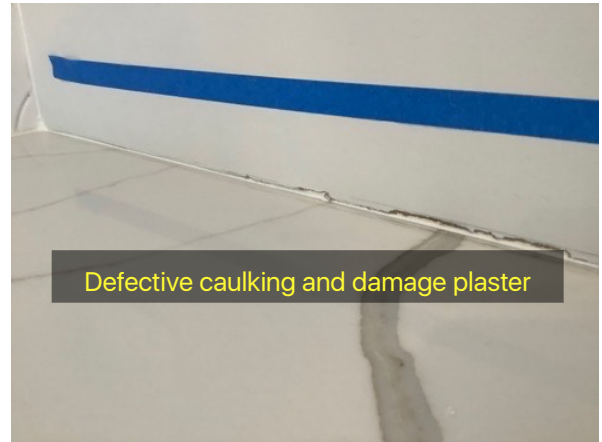
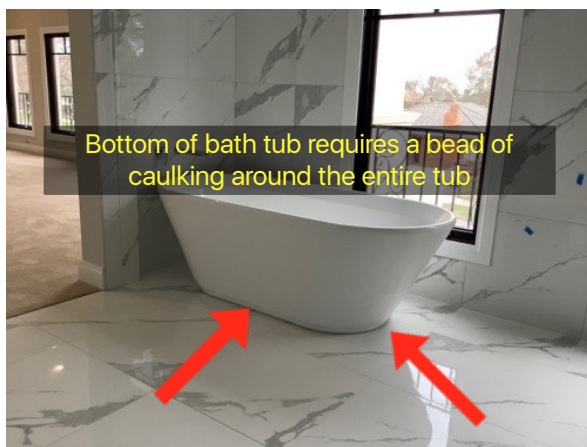
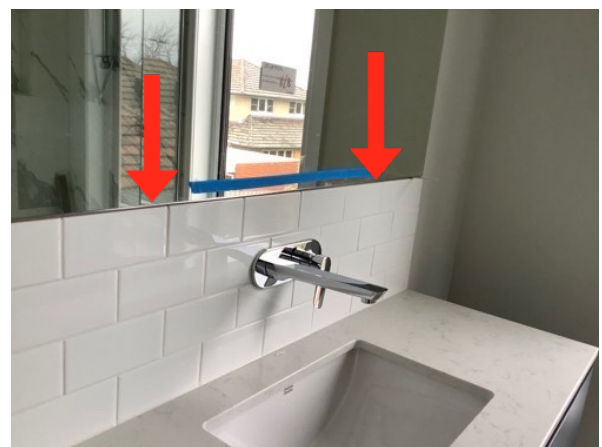
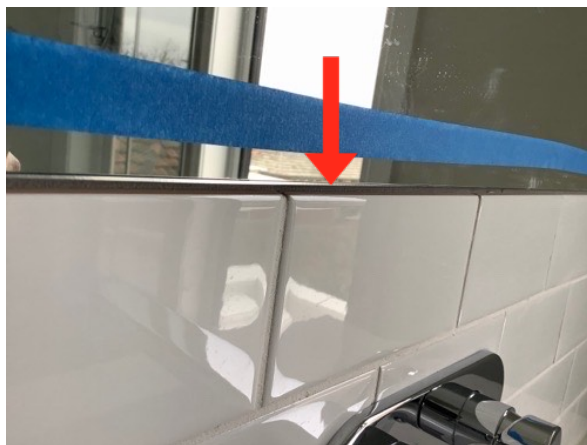
Defective Caulking To Cabinetry, Bench Tops, Tile Junctions, Cabinetry/Plaster Junctions, Etc.

It was noted on inspection that sealant is missing, inadequate and/or not completed to a tradesmens like finish.

Where required, junctions between bench tops and adjoining surfaces are defective if they are not sealed with a suitable flexible sealant of matching or agreed colour.

Seals around items such as sinks, hand basins or the like are defective if the joint leaks or they are not installed in accordance with the manufacturer's installation requirements.

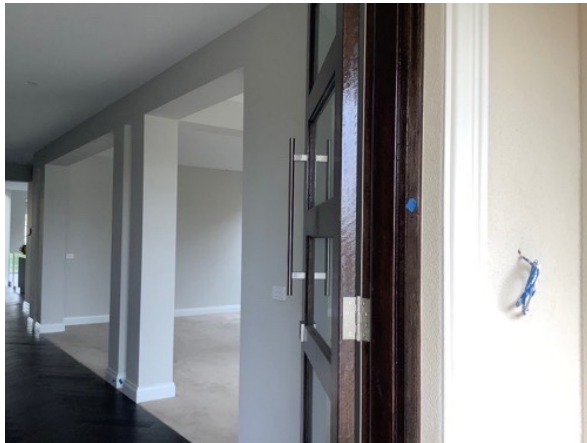
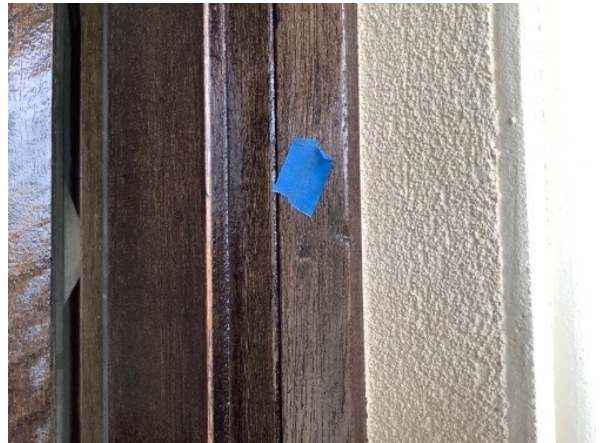
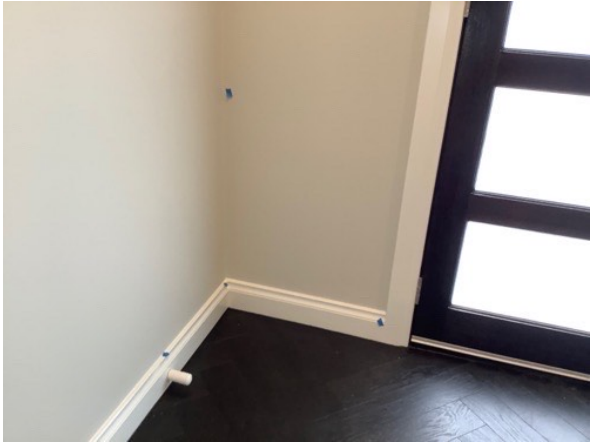
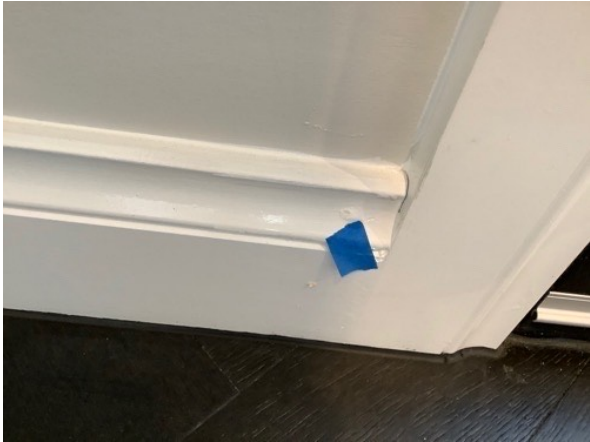
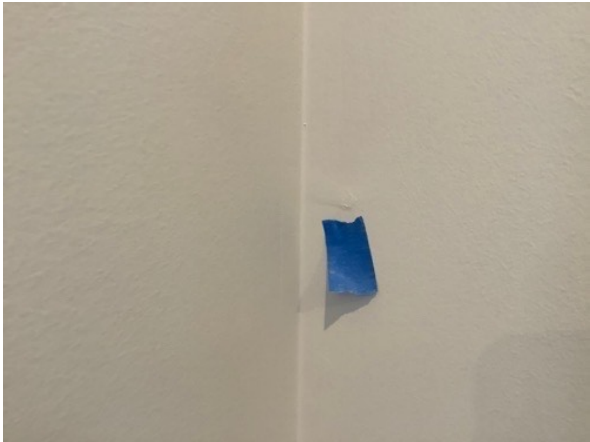
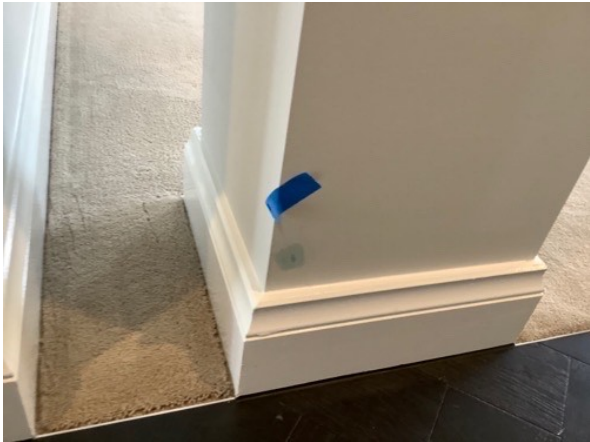
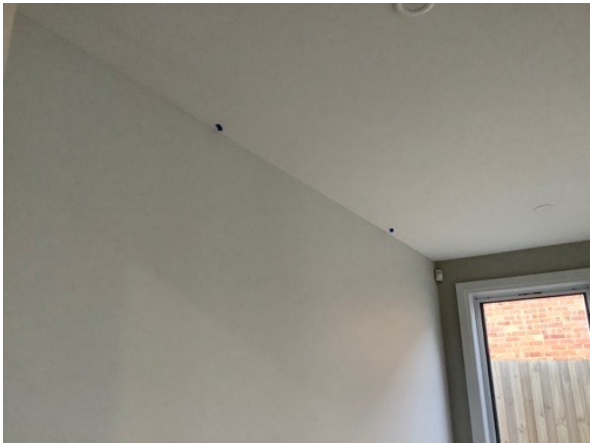
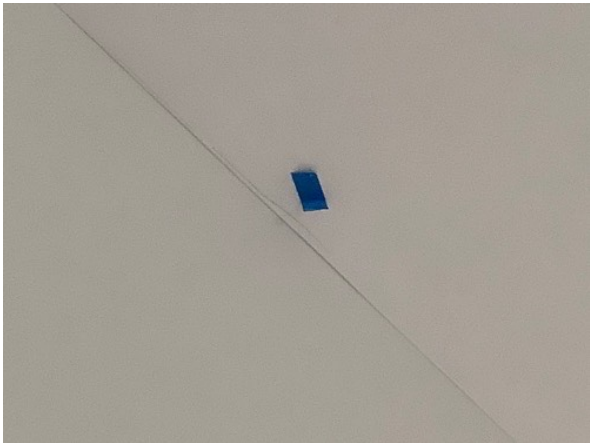
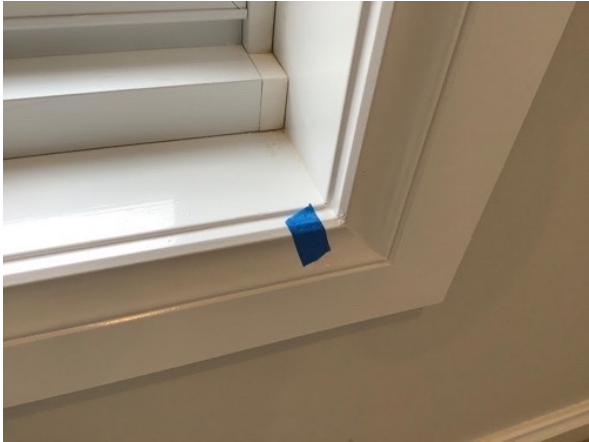
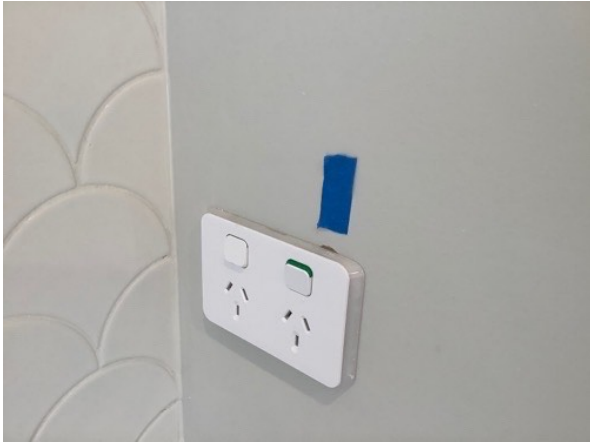
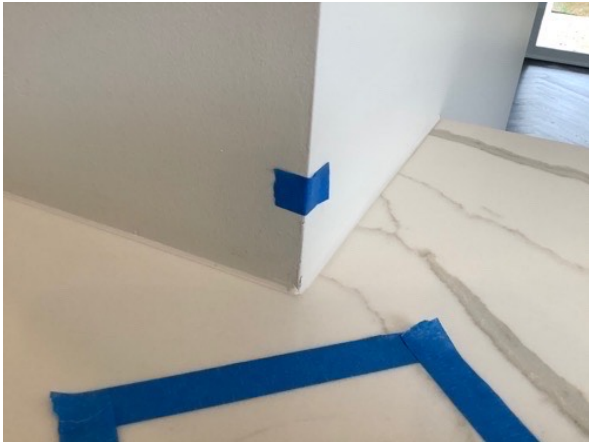
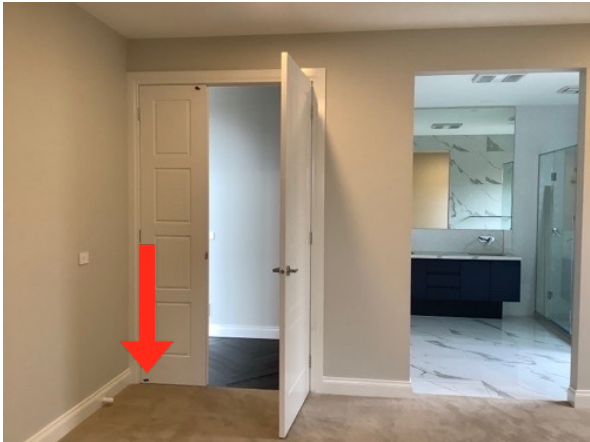
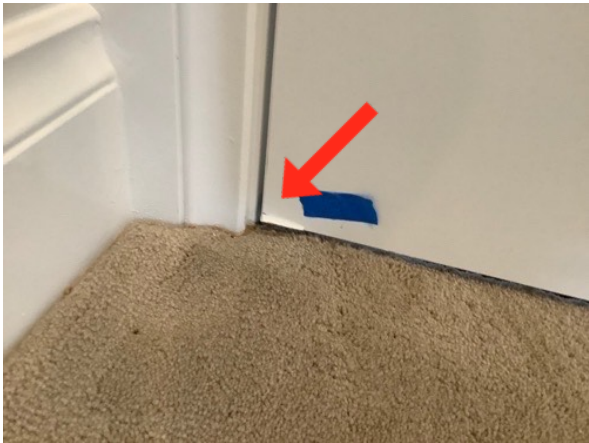
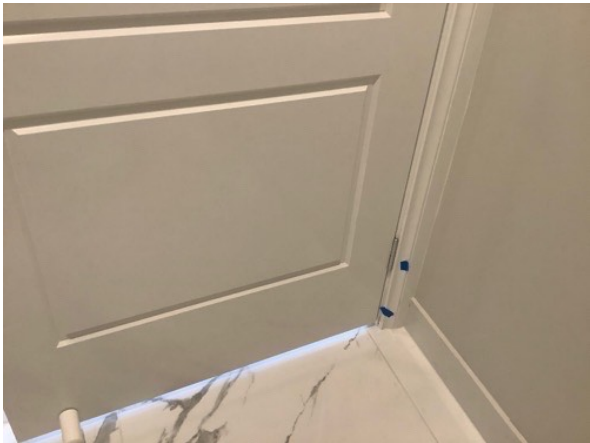
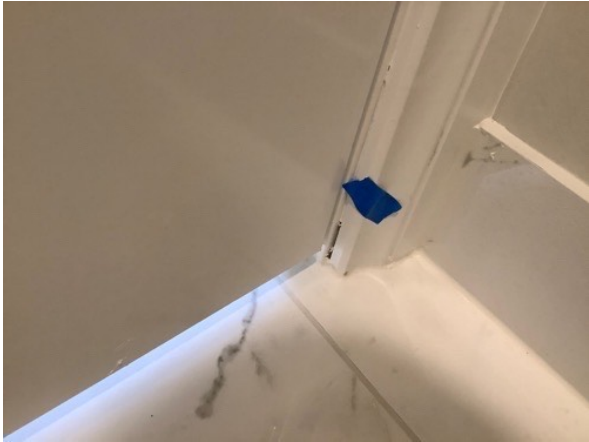
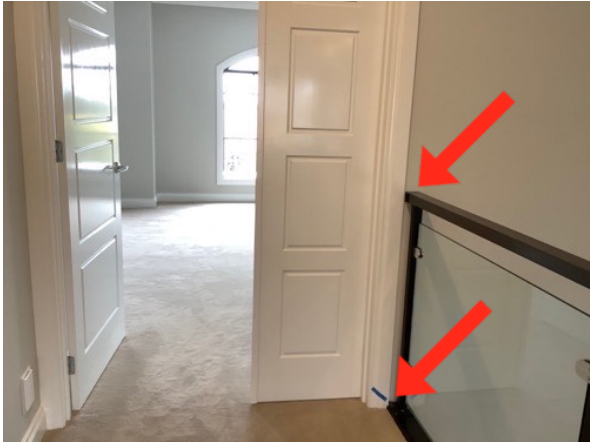
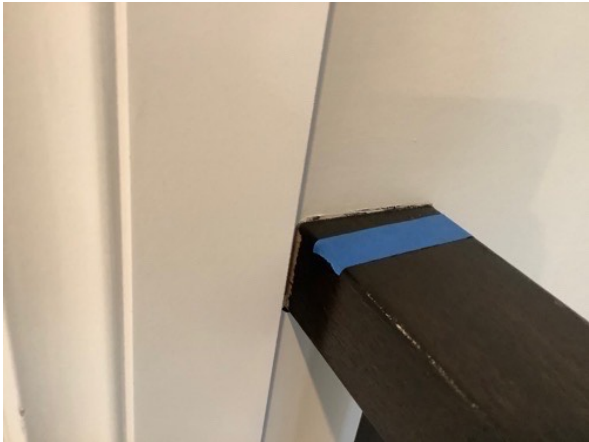
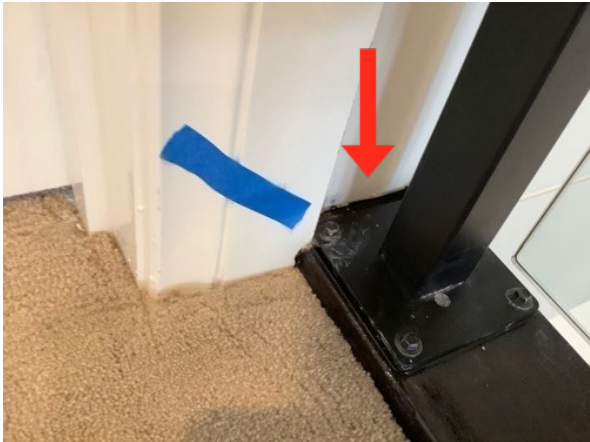
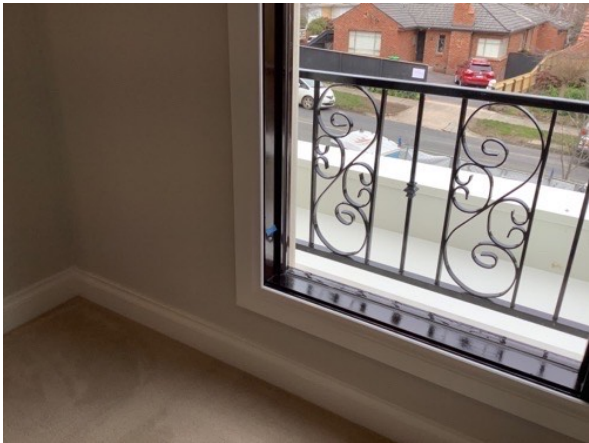
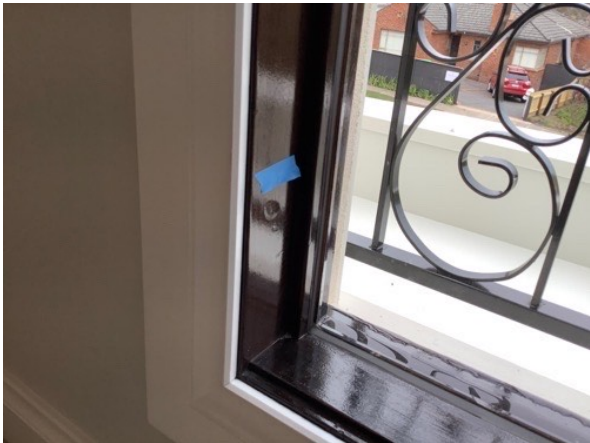
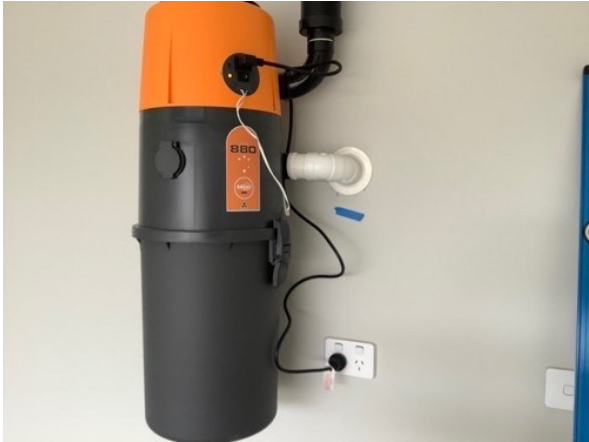
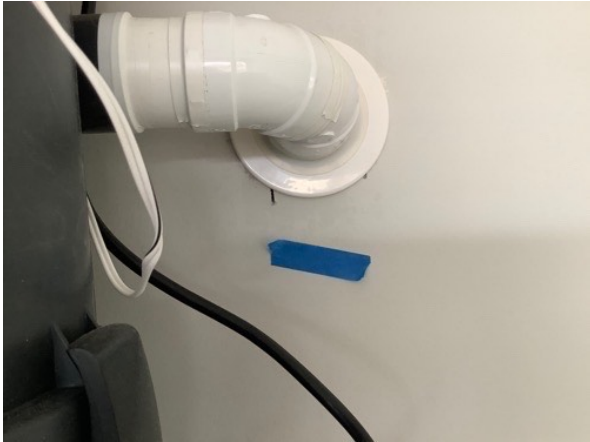
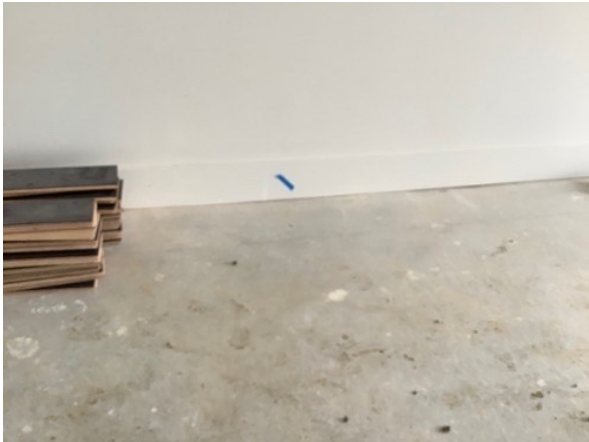
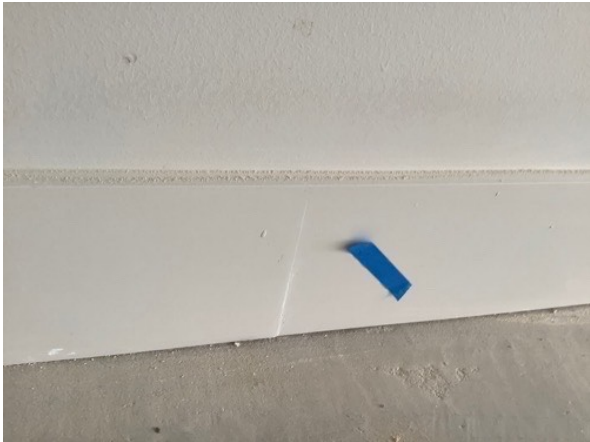
## Non Compliant 2.04

Finding: Painting - Defective (AS2311)

Areas were identified where the surface finish of the painting was found to be defective. This includes areas of minor blemishes, missing painting, over-painting, paint runs, sags , lack of paint and/or wrinkling of paint finish.

I HIGHLY RECOMMEND that the painter inspects ALL rooms and ALL areas of the building carefully to all the timber work including the skirting, architraves and doors.

I HIGHLY RECOMMEND that the painter inspects ALL rooms and ALL areas of the building carefully to all the walls and ceilings as the paint does not meet the Australian Standards and Standards and Tolerances.

All plaster work and plaster patching along with all the sanding and preparation to all the areas for repair to the plaster and timber work will require to be completed first and then the paint work.

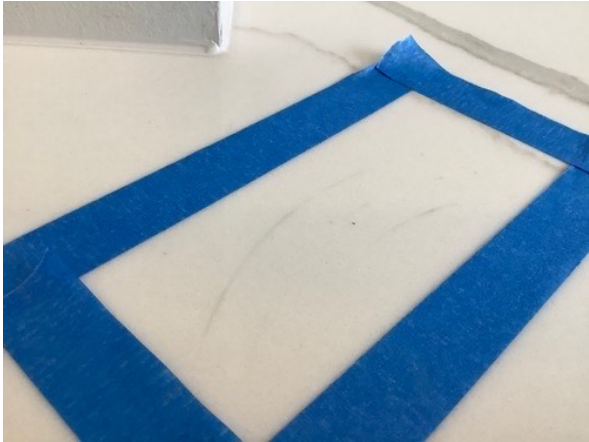
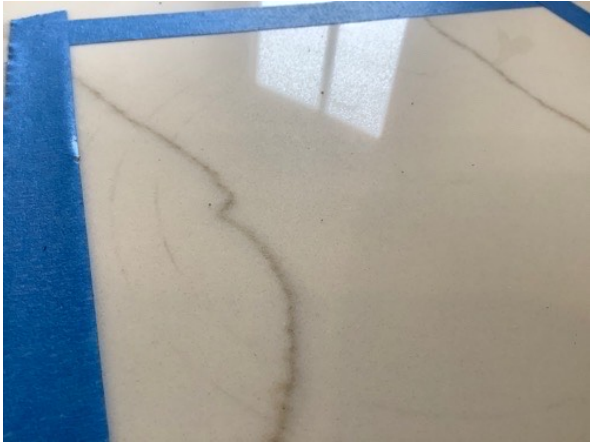
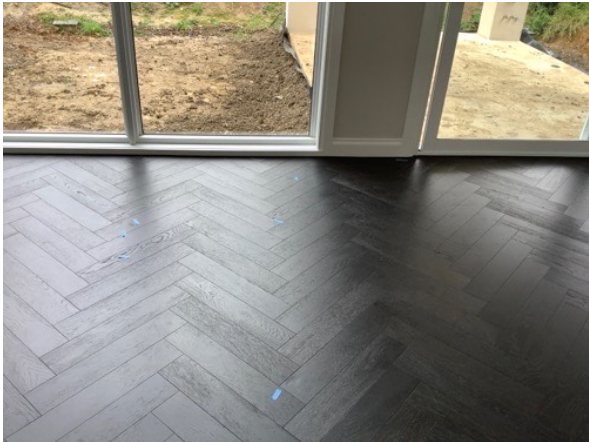
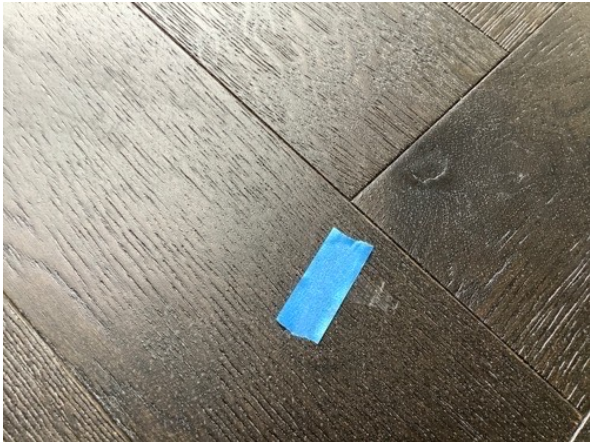
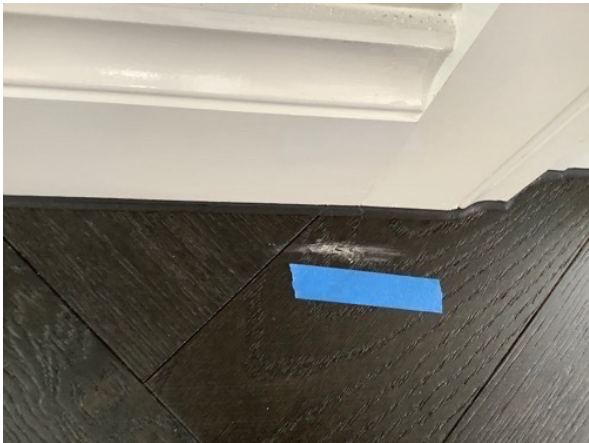
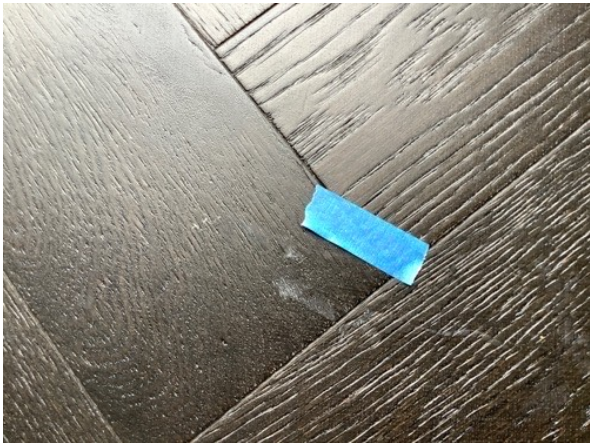
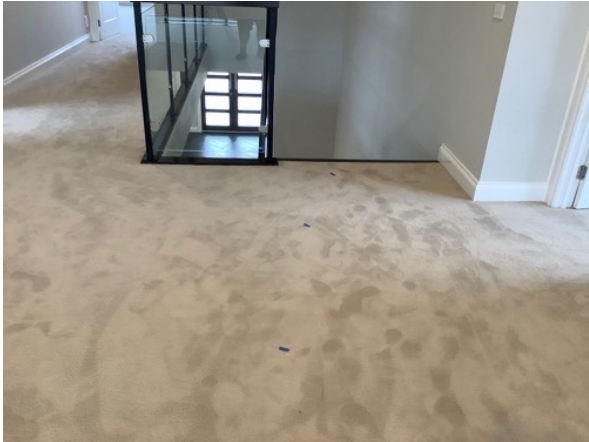
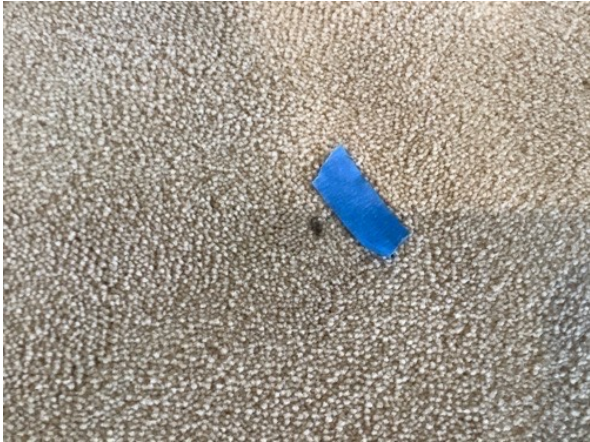
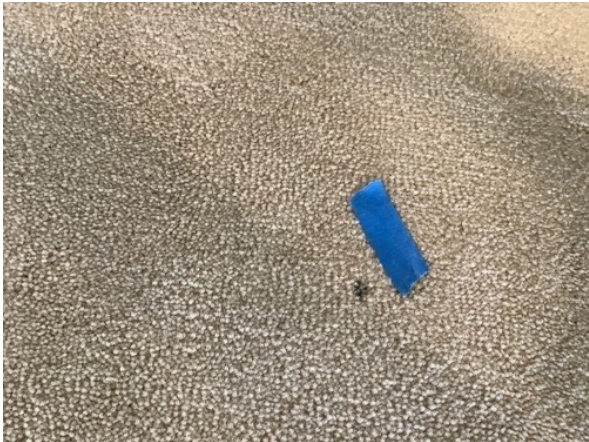
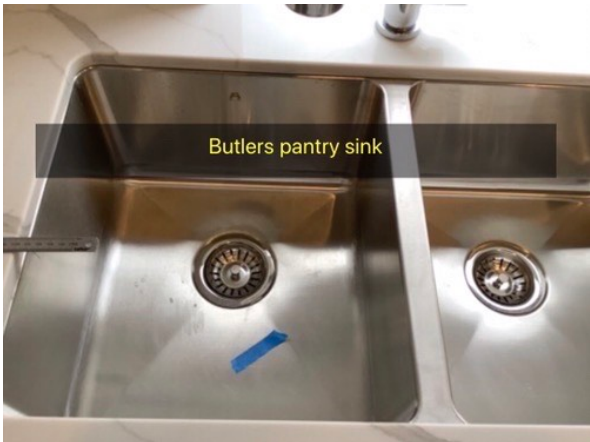
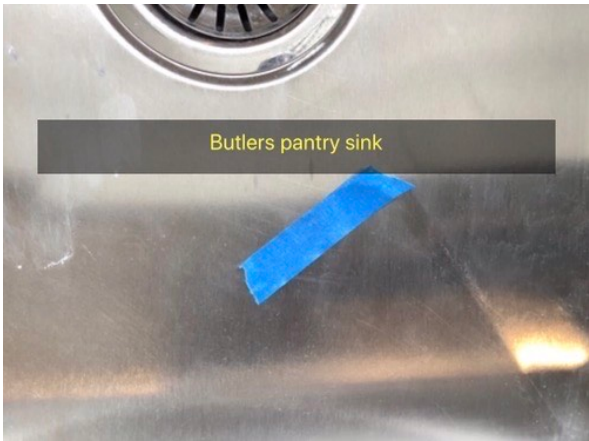
Location: Damages/ Faults - Internal

All items must be AS NEW WITHOUT COMPROMISE, prior to Handover.

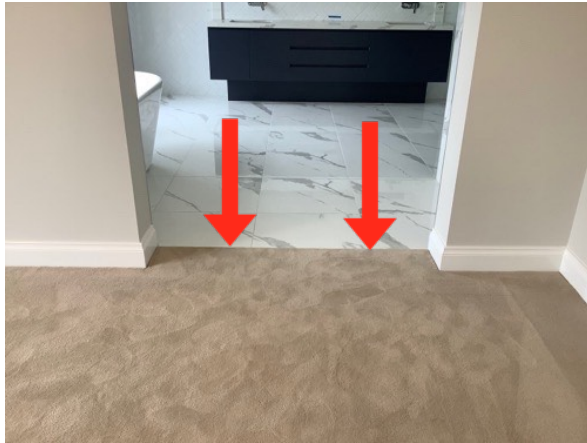
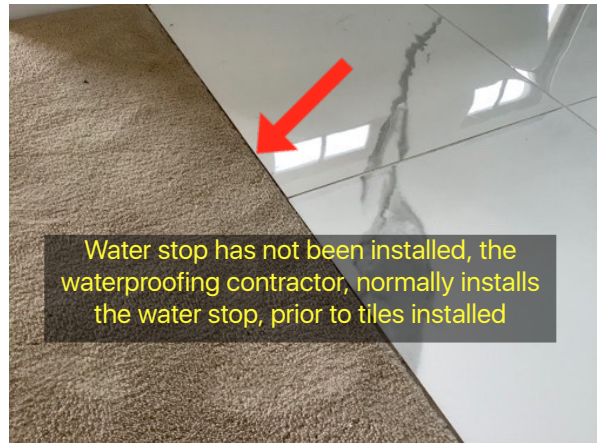
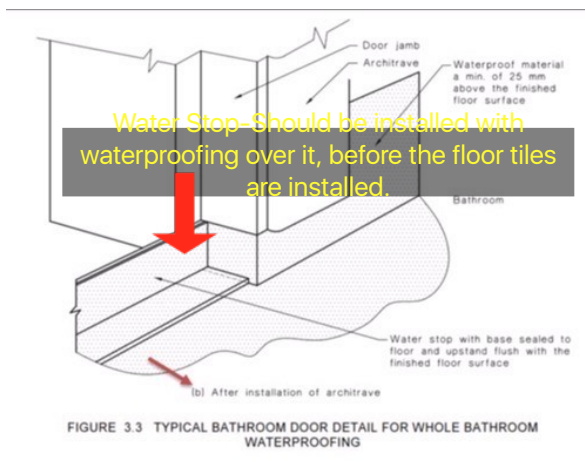
## Non Compliant 2.10

Location: All Ensuities & Bathrooms

The end of the tiles appears not to have the water stop at the end of the tiles.

The builder must install this item and complete the waterproofing, prior to Handover, in order for the water proofing to comply with the Australian Standards AS 3.9.1.2 Perimeter Flashing At Floor Level Openings.

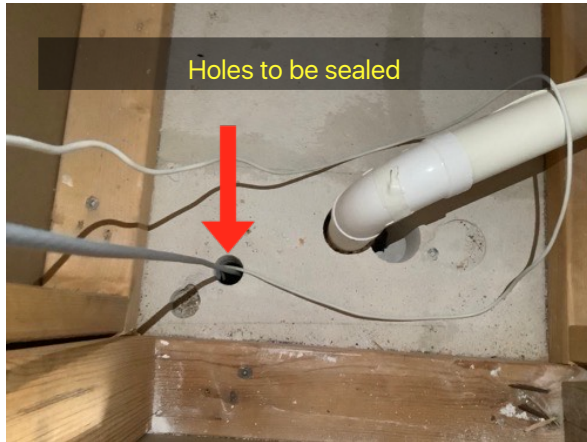
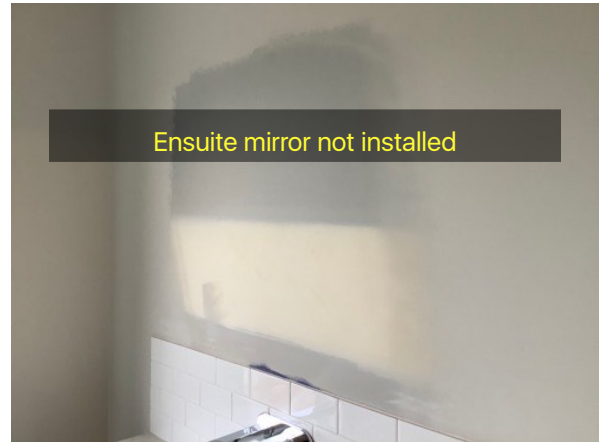
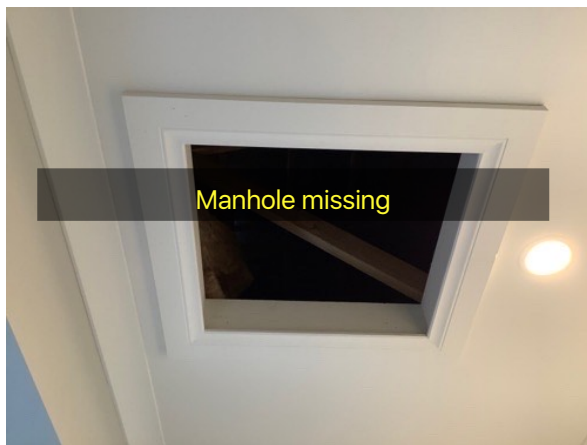
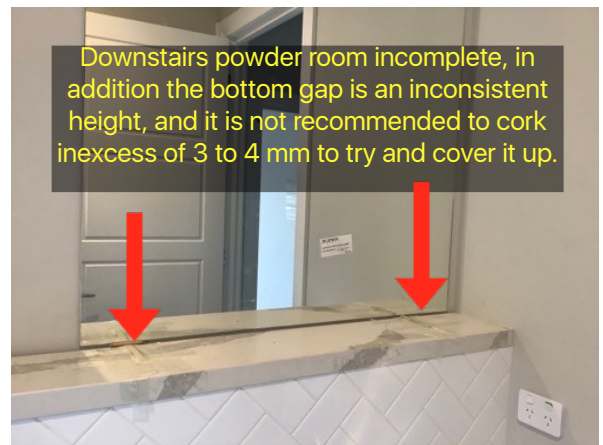
Location:	Internal-Unfinished/Defective Works
Finding:	<p>Internal - Unfinished/Defective Works - Additional Photos</p> <p>The following items will need to be completed or repaired in accordance with the Domestic Building Contracts Act 1995.</p> <p>We refer the builder to the implied warranties where the builder agreed to build the dwelling in a proper and workmanlike manner and with reasonable care and skill.</p> <p>DOMESTIC BUILDING CONTRACTS ACT 1995, Act No. 91/1995, Part 2 - Provisions that apply to all Domestic Building Contracts.</p> <p>Part 2 - Provisions That Apply To All Domestic Building Contracts.</p> <p>Division 1 - General warranties.</p> <p>8. Implied warranties concerning all domestic building work.</p> <p>The following warranties about the work to be carried out under a domestic building contract are part of every domestic building contract -</p> <p>(A) the builder warrants that the work will be carried out in a proper and workman like manner and in accordance with the plans and specifications set out in the contract.</p> <p>(D) the builder warrants that the work will be carried out with reasonable care and skill and will be completed by the date (or within the period) specified by the contract.</p> <p>ALSO</p> <p>Additional photos are provided for your general reference.</p> <p>Arrows have been included to highlight areas of importance.</p> <p>All these photos are added in to demonstrate DEFECTIVE / SUB STANDARD and/or INCOMPLETE WORKS and they are all required to be rectified as they are ALL not satisfactory for Handover as per the DOMESTIC BUILDING CONTRACT ACT 1995 as stated above.</p>

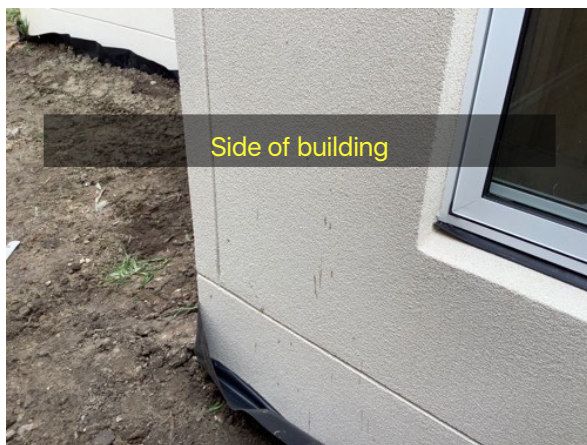
## Non Compliant 2.15

Location: Render - Exterior

Finding: Render marked - defective  
Marks caused by paint, etc due to the composition of the materials and / or any other blemish or damage which is obvious from a normal viewing position is considered a defect with reference to Standards and Tolerances.

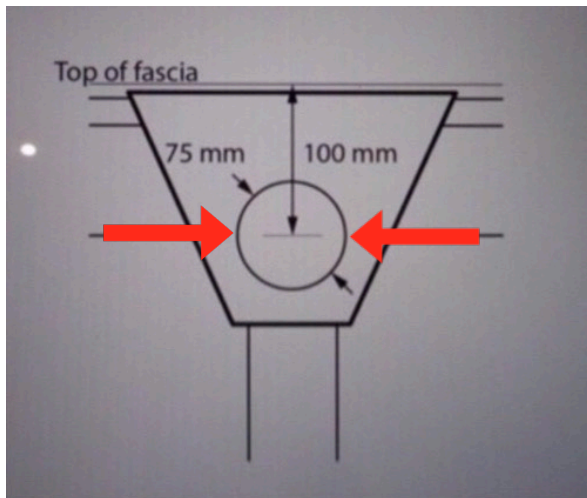
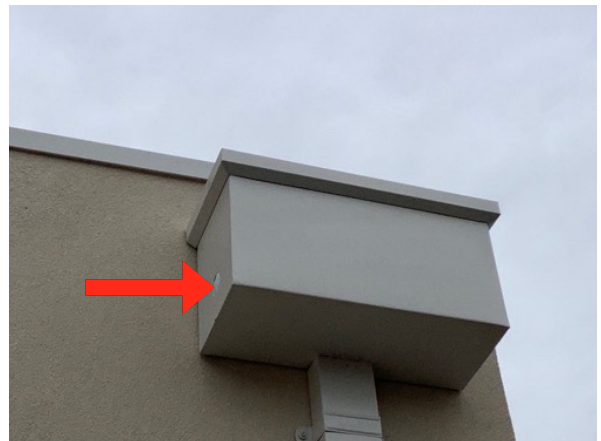
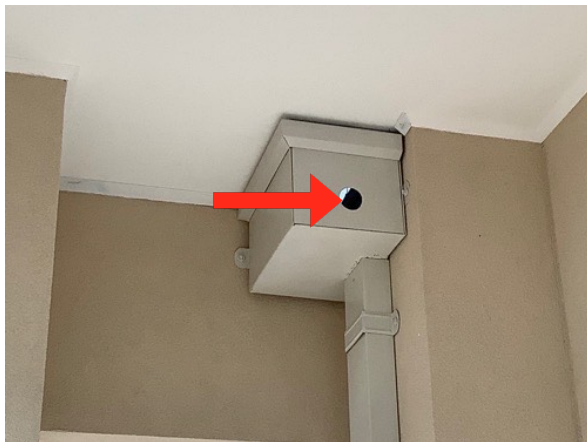
## Non Compliant 2.18

Location: Roof Exterior

Rainhead with—

- (a) a 75 mm diameter hole in the outward face of the rainhead;
- and
- (b) the centreline of the hole positioned 100 mm below the top of the fascia.

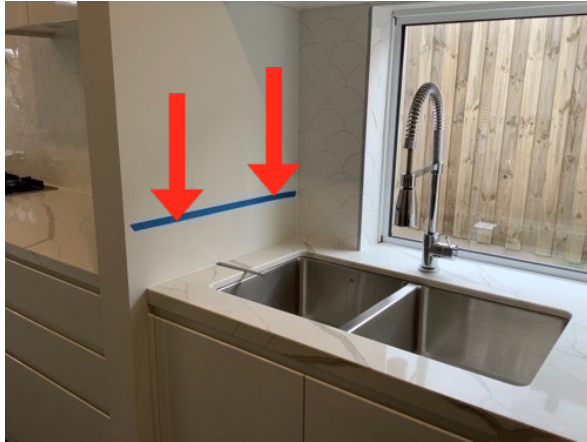
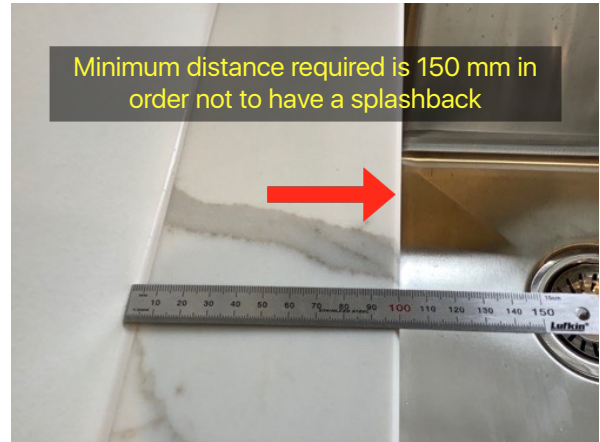
## Non Compliant 2.21

Location: Butlers Pantry

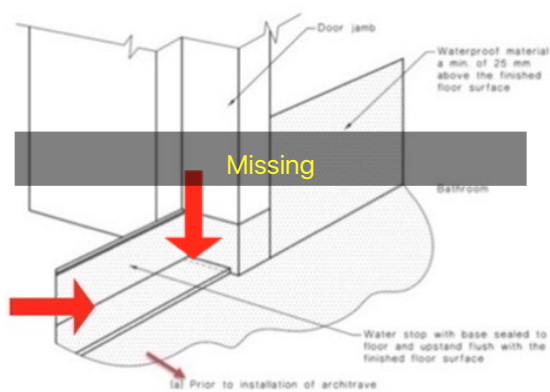
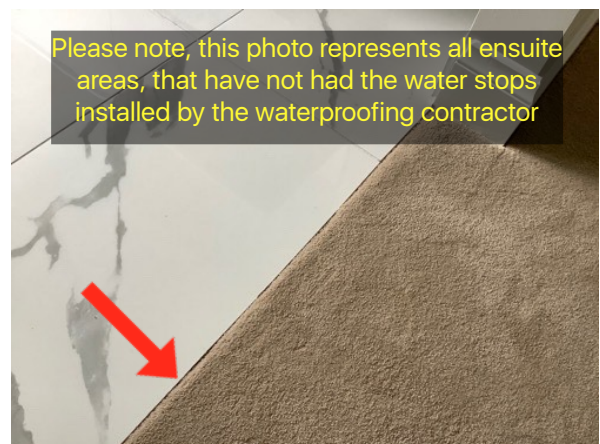
## Non Compliant 2.22

Location: All Ensuites

The end of the tiles appears not to have the water stop at the end of the tiles.

The builder must install this item and complete the waterproofing.

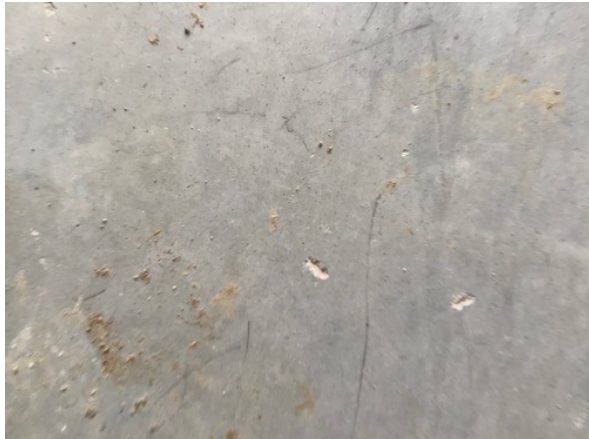
## Non Compliant 2.23

Location: Concrete Floors – Garage And Alfresco

Finding: Concrete Floor Damaged / Chipped / Marked / Paint, Etc - Non Compliant  
Areas where the concrete floor has been damaged were identified. The damage consists of deep gouges chips and scrape and associated marks.  
An acceptable finish consistent with AS 2870 Residential Slabs and Footing Construction requires the surface to be even and consistent in appearance.  
The concrete floors must be presented as new prior to handover.

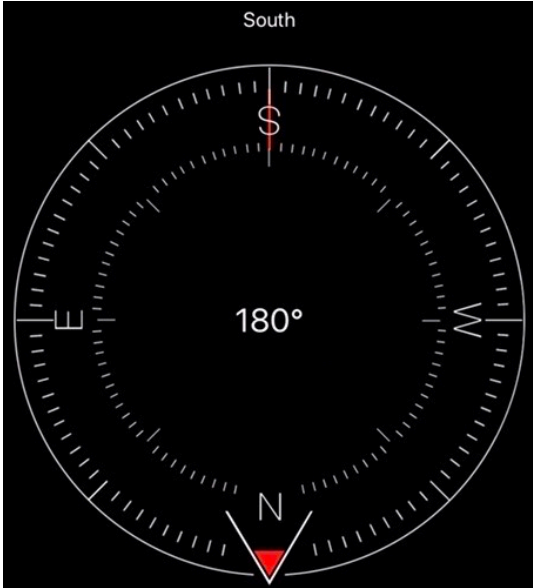
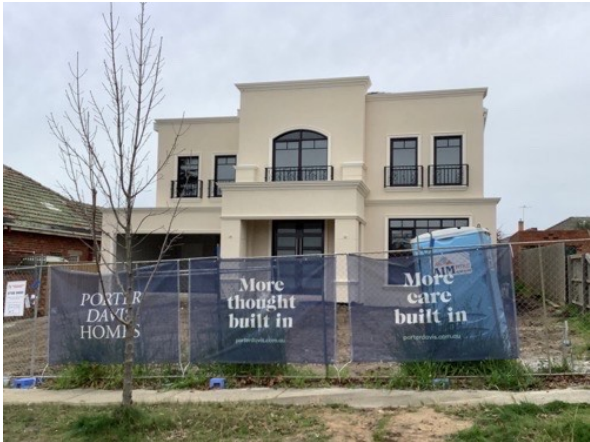
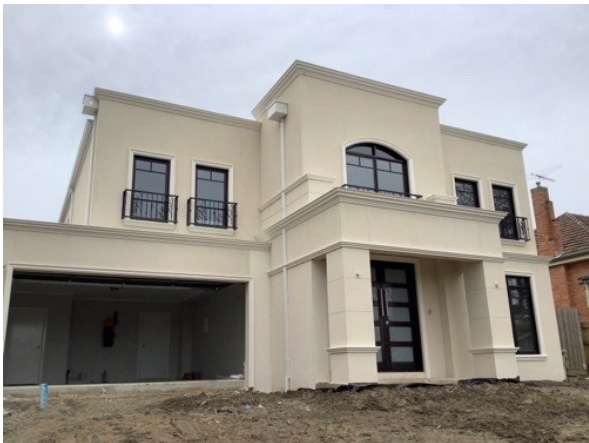
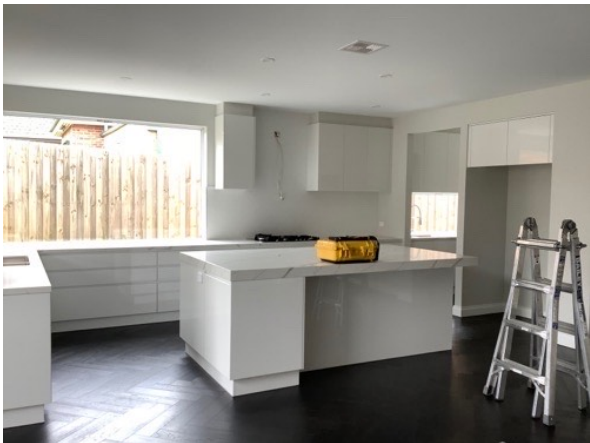
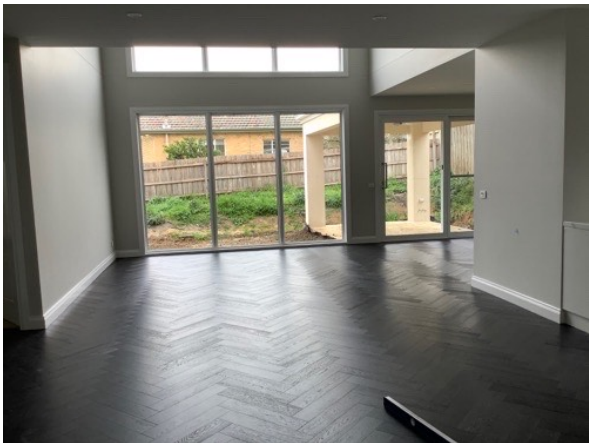
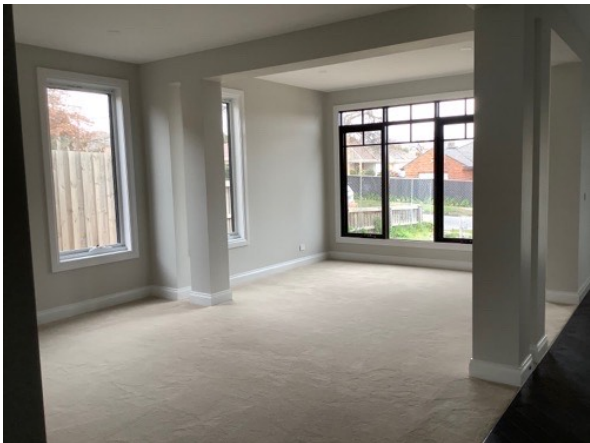
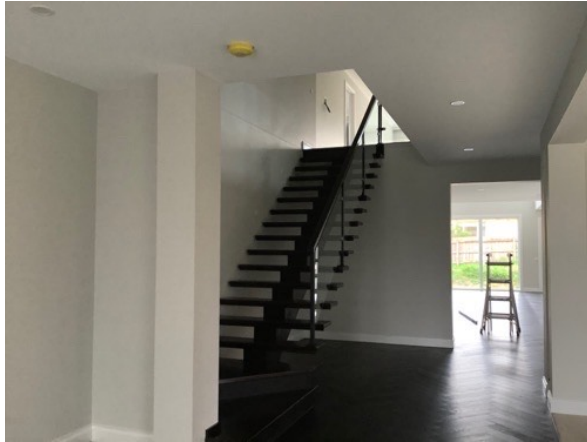
### For Your Information 5.25

Location:	Site Photos & Areas Of Interest.
Finding:	Site Photos. Additional photos are provided for your general reference.
