Dilapadation Report

Inspection Date: 4 Oct 2020

Property Address: Ascot vale area.

Report Type: Dilapidation Inspection Report

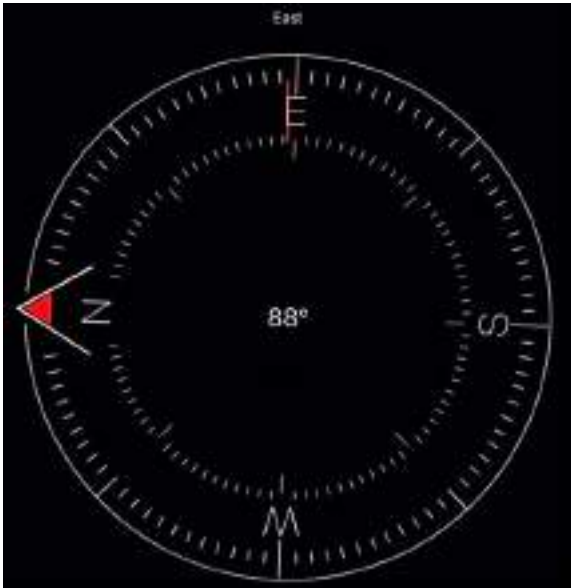
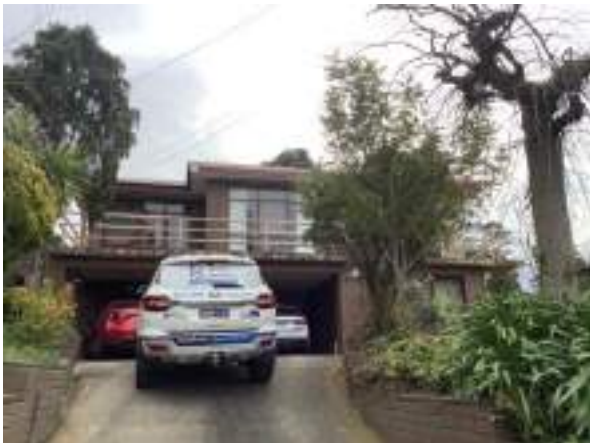
For your information 4.02

Location: The Site
Finding: Site Photos.
Site photos & Additional photos are provided for your general reference.

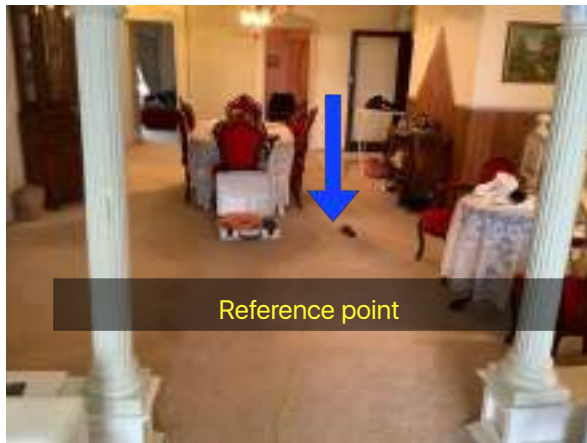
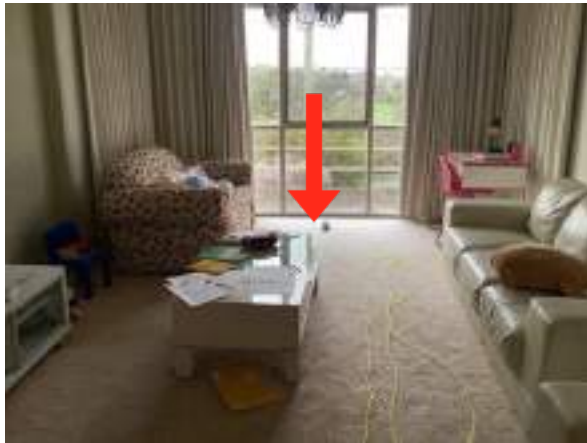
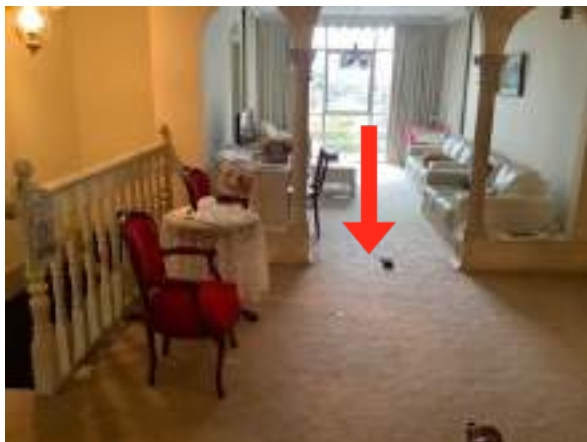
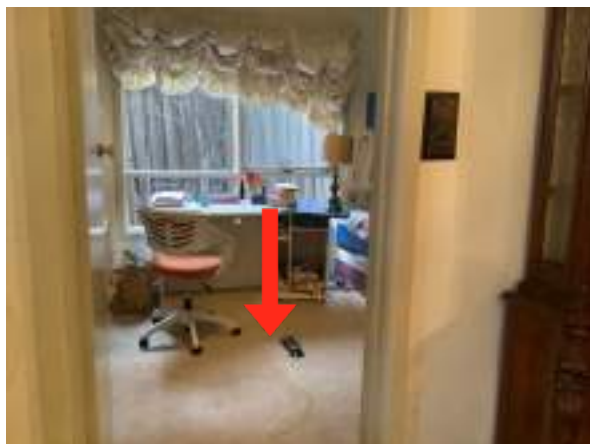
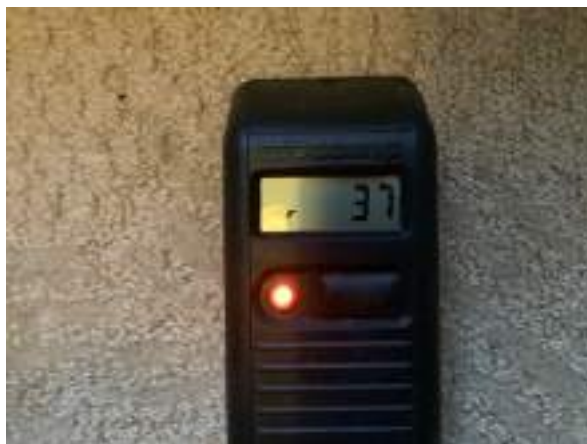
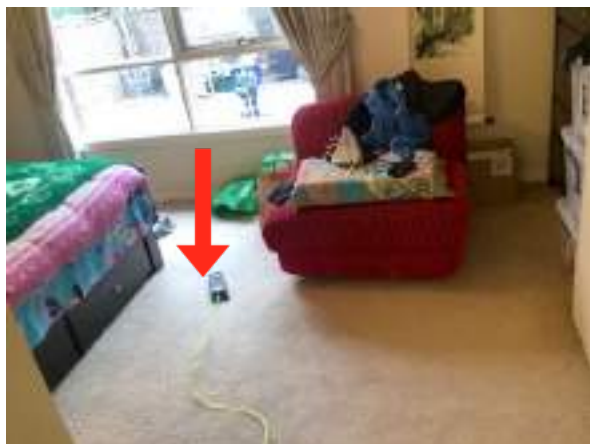
For your information 4.03

Location: Internal Floor Levels

Finding: Floor Levels - Upper Level
Attached are the floor levels in relation to a reference point to the upper level.

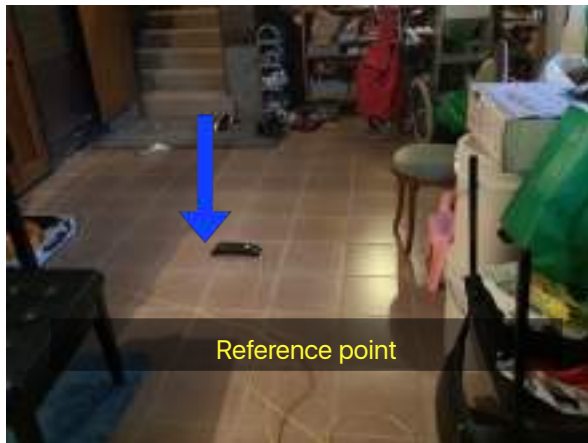
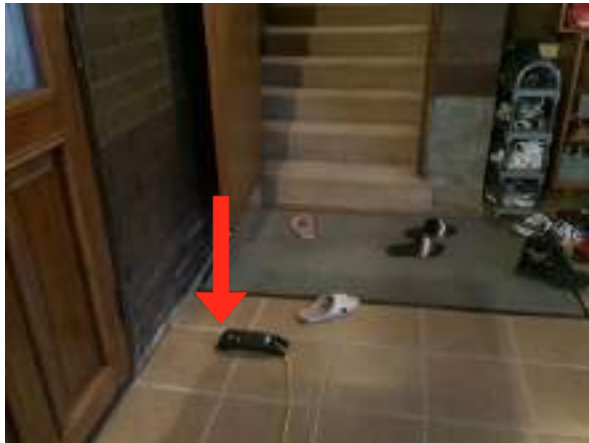
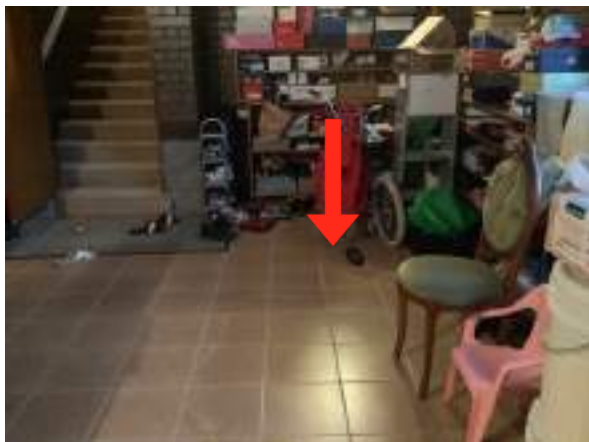
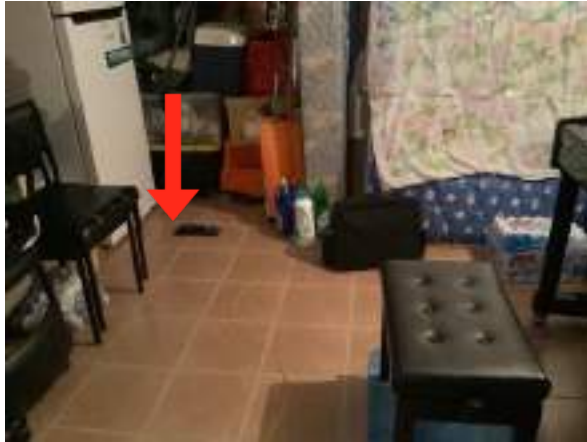
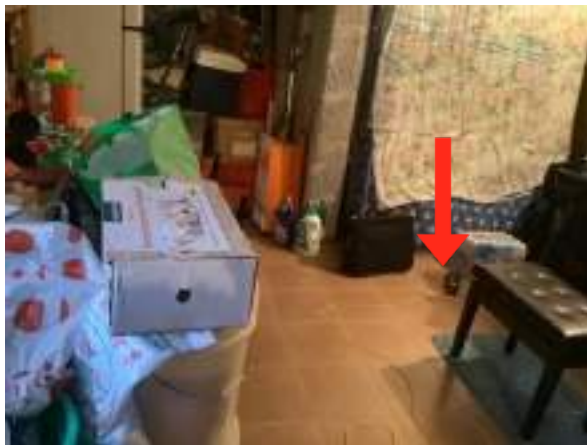
For your information 4.04

Location: Internal Floor Levels

Finding: Floor Levels - Below Storage
Attached are the floor levels in relation to a reference point to the lower level.

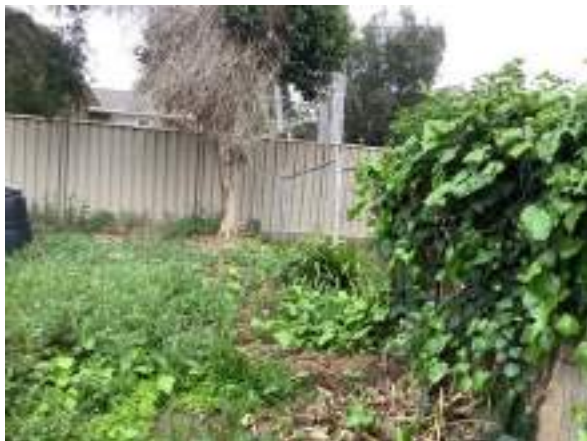
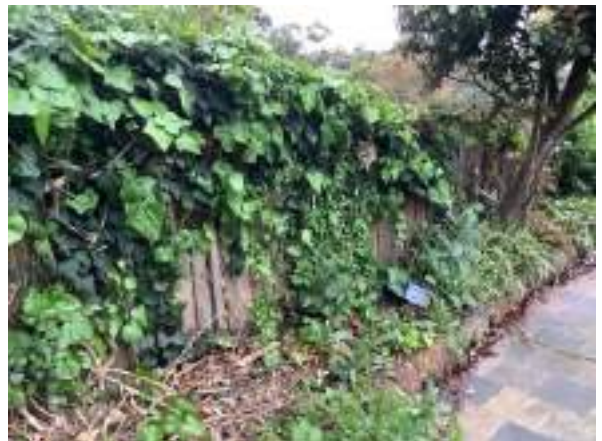
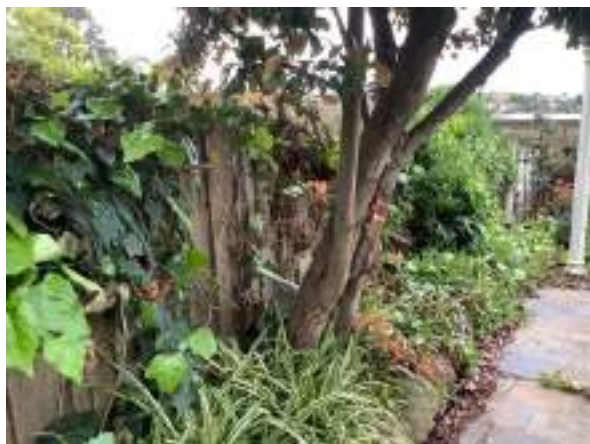
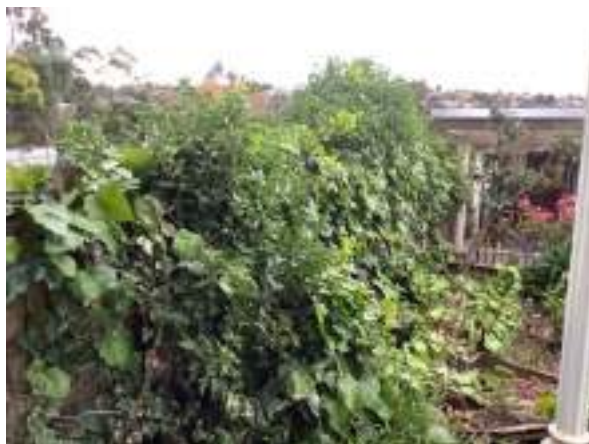
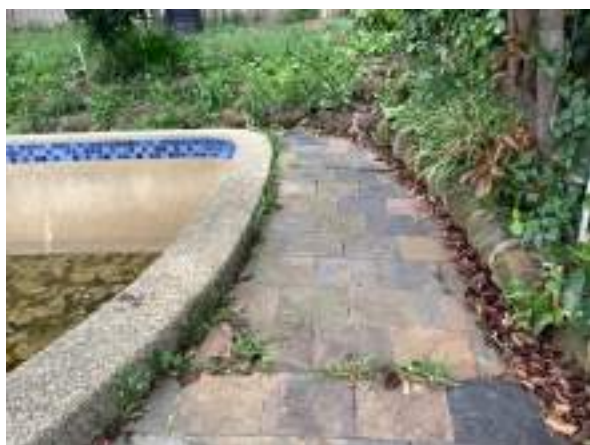
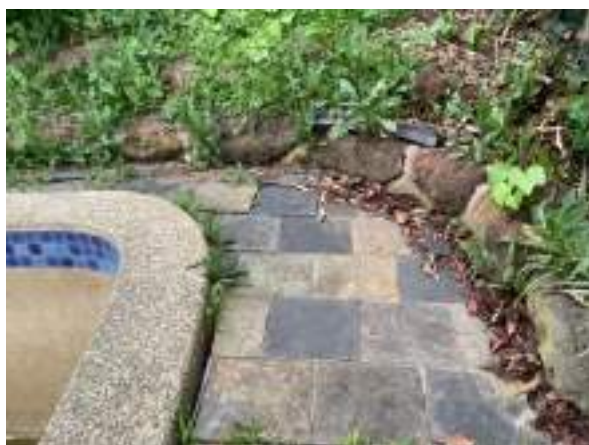
For your information 4.05

Location: Exterior North Side

Finding: For your information – site photos (back yard)
Photos of interest and the condition for this location at the time of the inspection.
In addition, various photos with a close up and/or arrows added to highlight the area of concern.

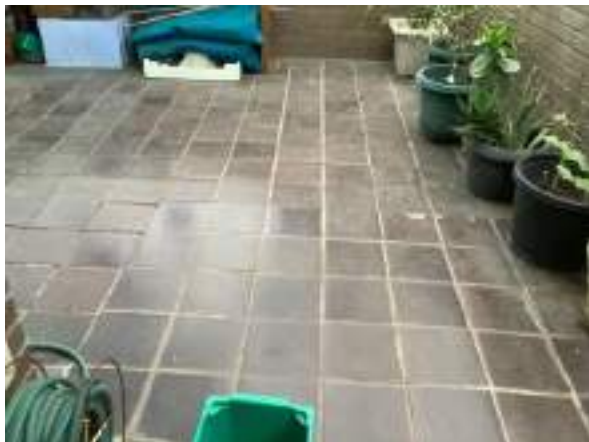
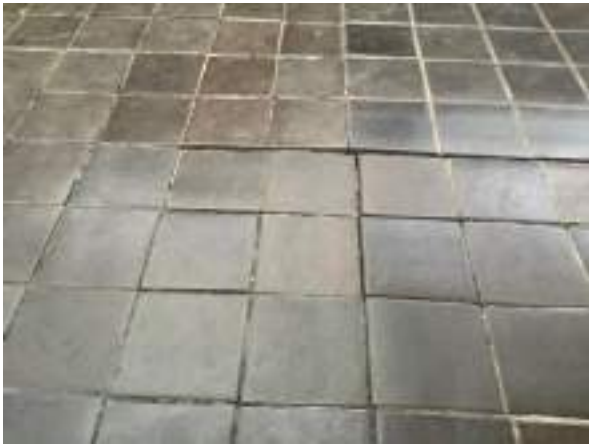
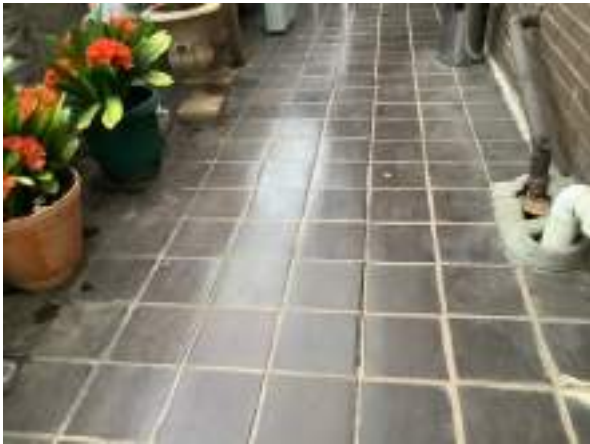
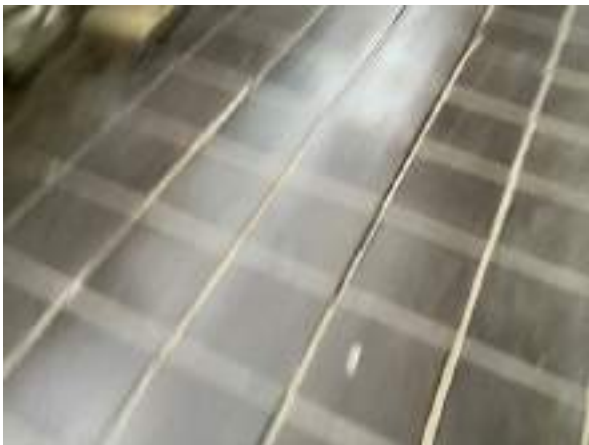
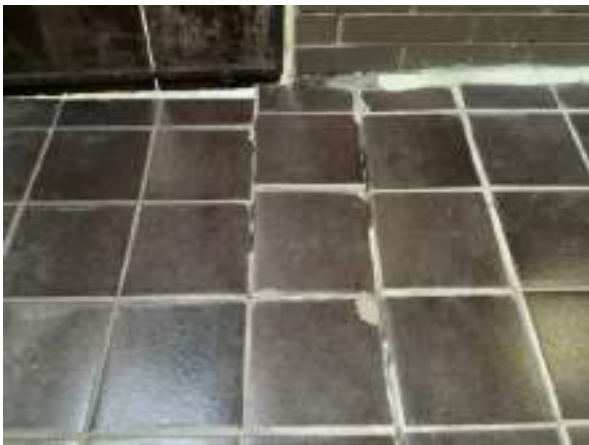
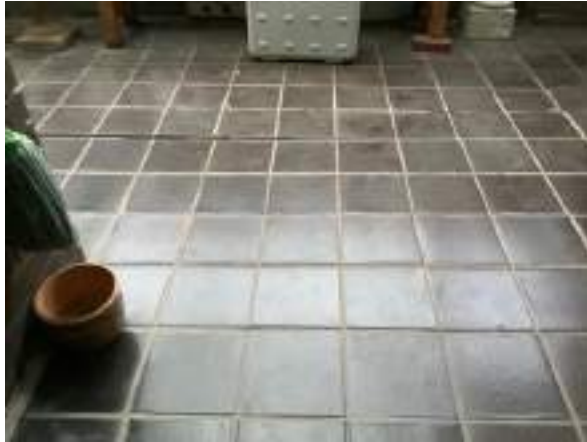
For your information 4.06

Location: Exterior North Side

Finding: Tile Paving
The tile paving is considerably compromised and drummy at the time of the inspection.

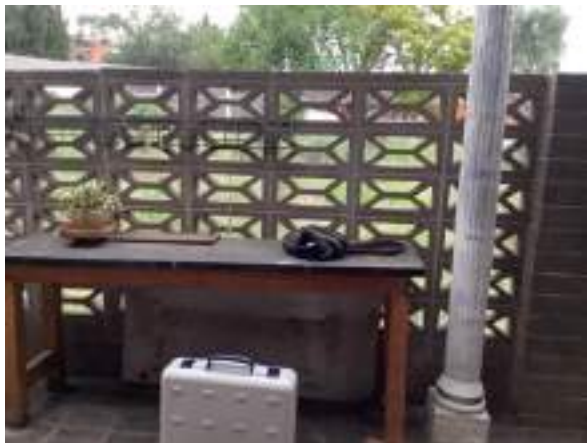
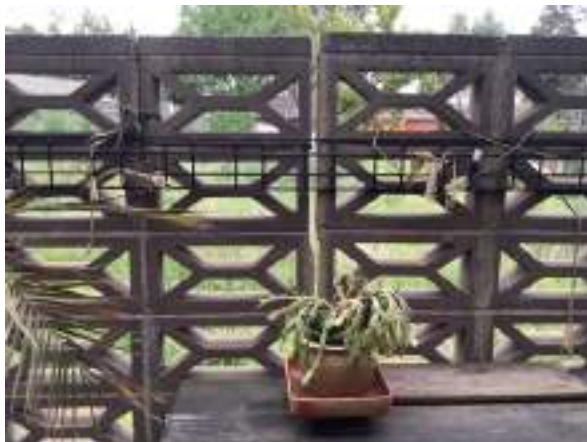
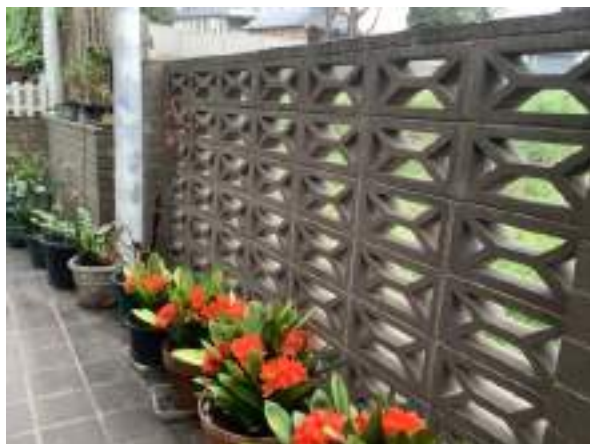
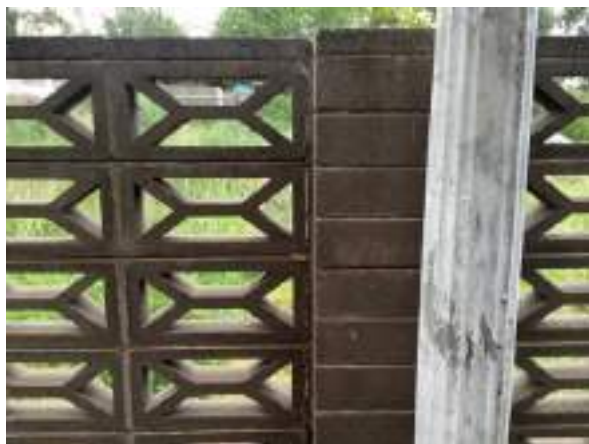
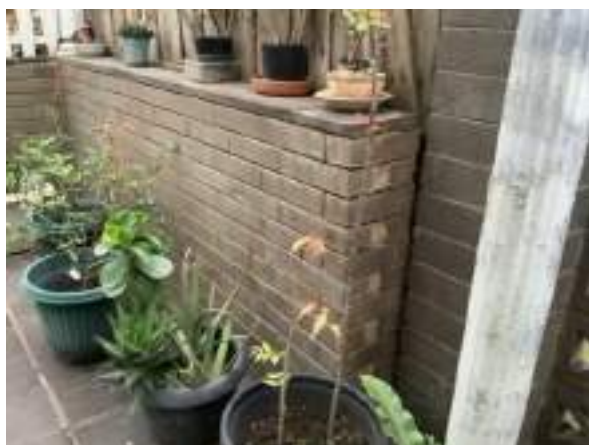
For your information 4.07

Location: Exterior North Side

Finding: Block Fencing
At the time of the inspection the block fencing has considerable movement.

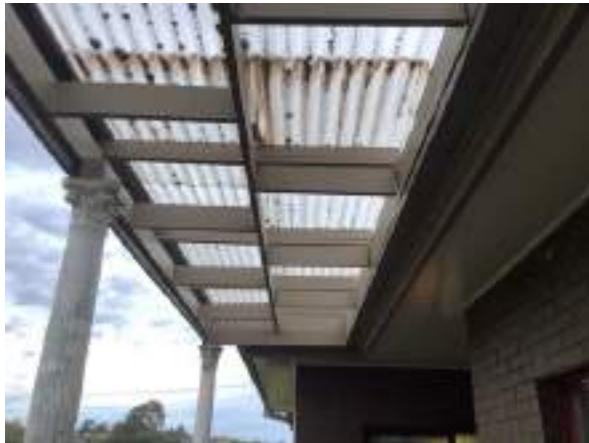
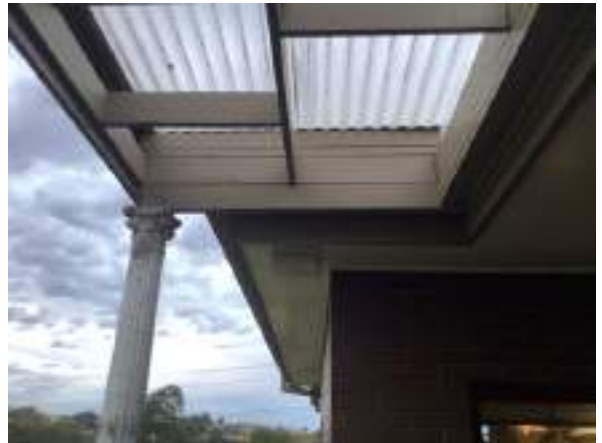
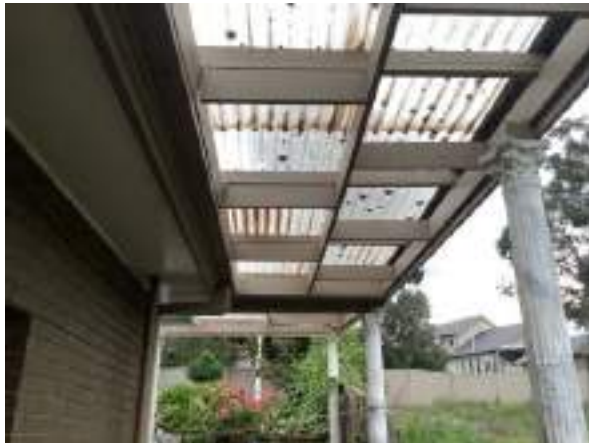
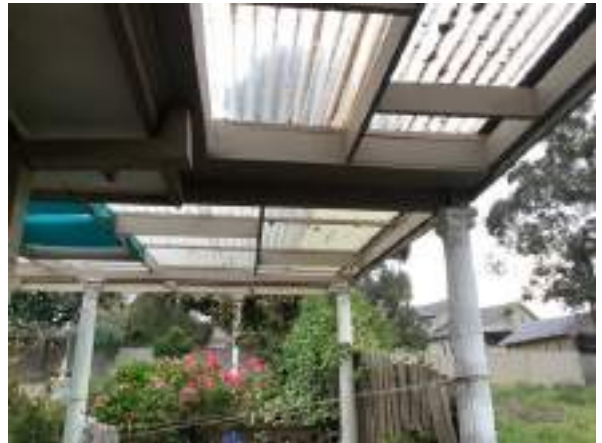
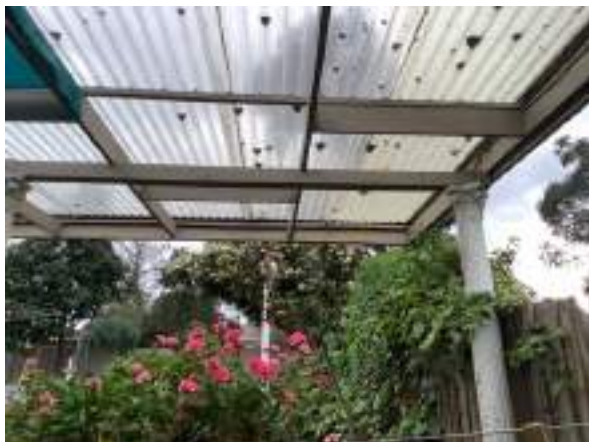
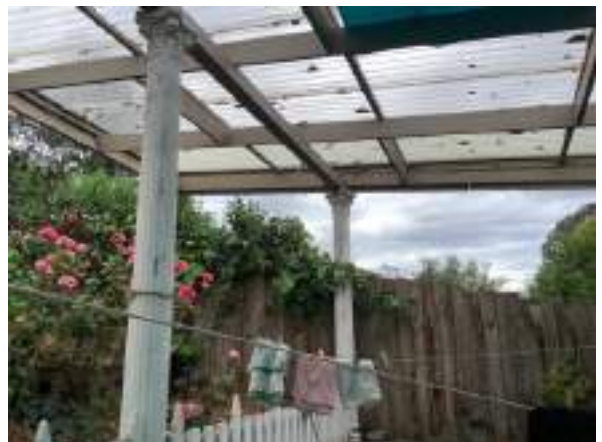
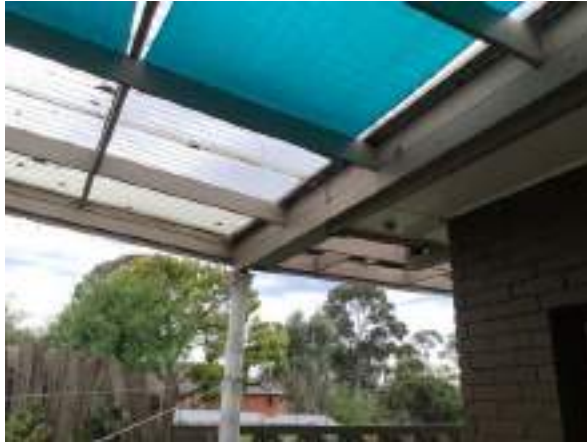
For your information 4.08

Location: Exterior North Side

Finding: Pergola roofing area
Photos of the pergola roofing at the time of the inspection.

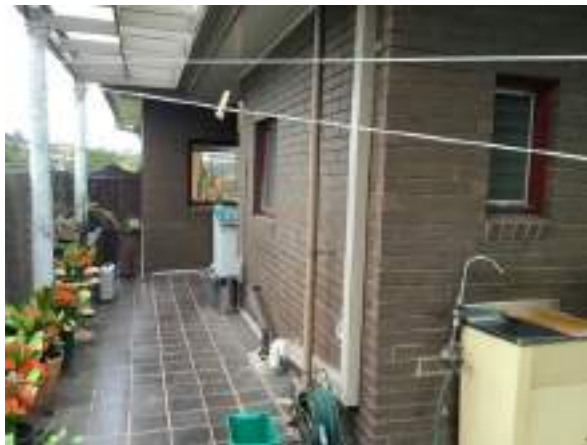
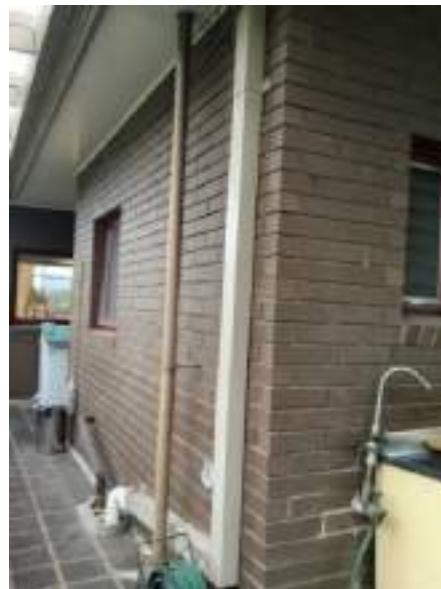
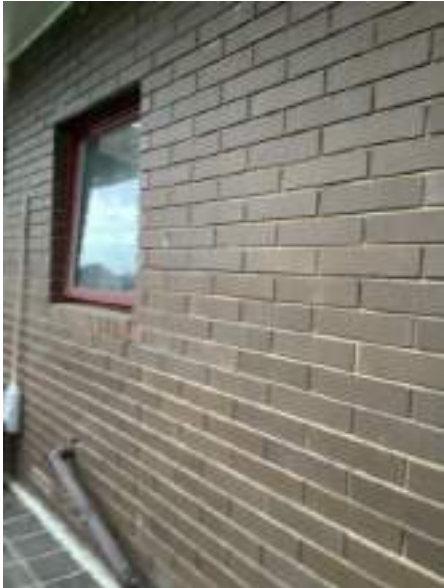
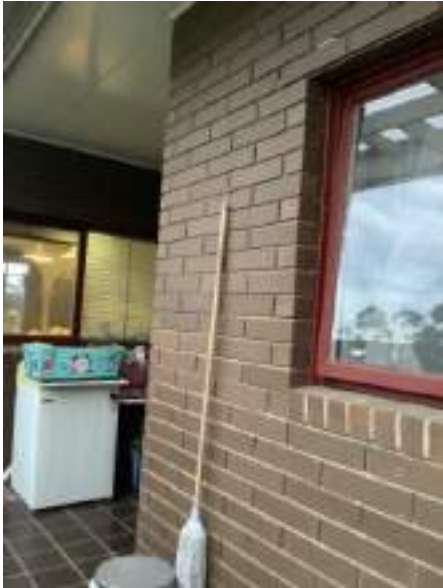
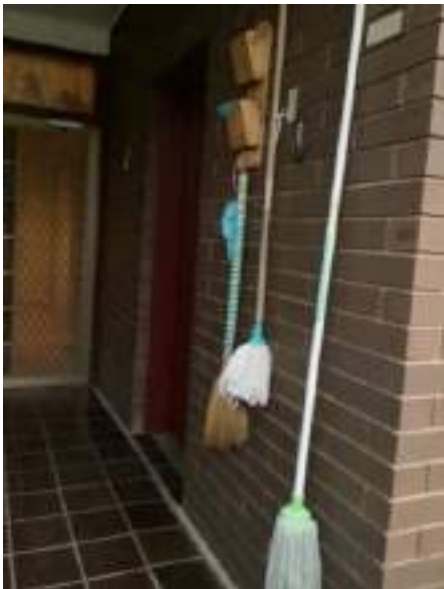
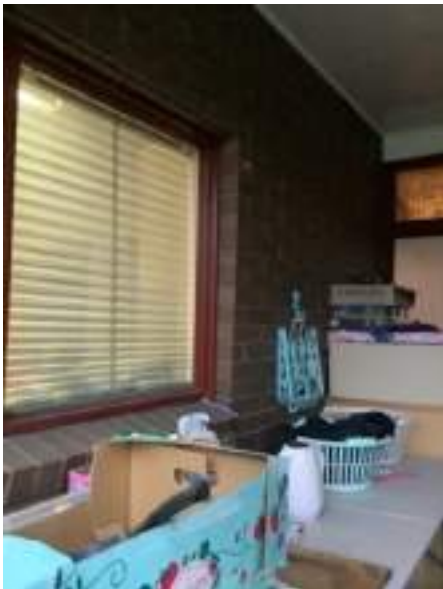
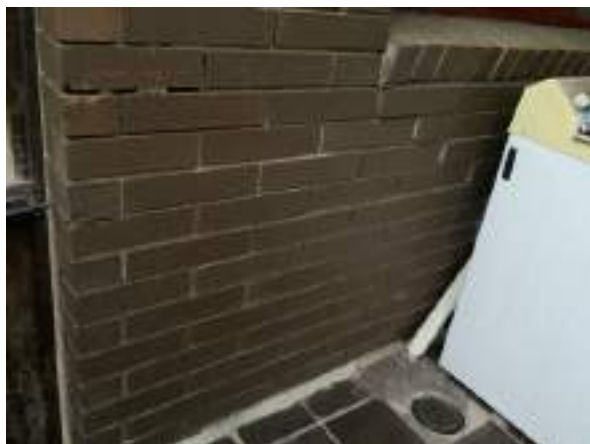
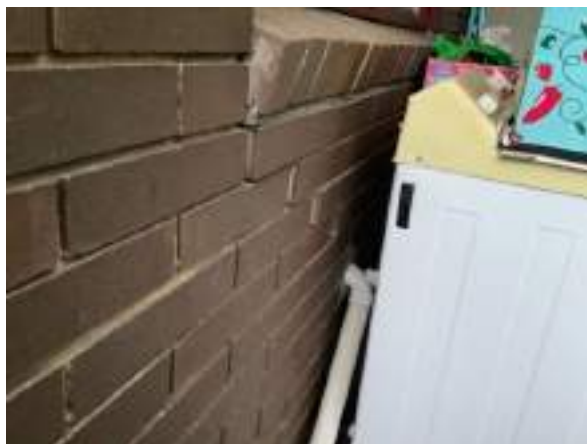
For your information 4.09

Location: Exterior North Side

Finding: Brickwork - Backyard (Behind Gate)
The photos will demonstrate that the area has movement in relation to the brickwork.

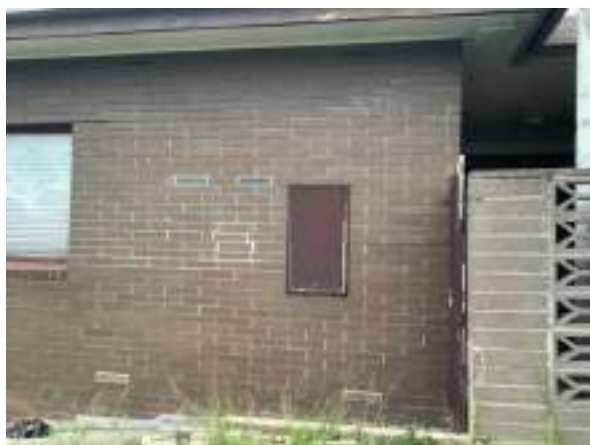
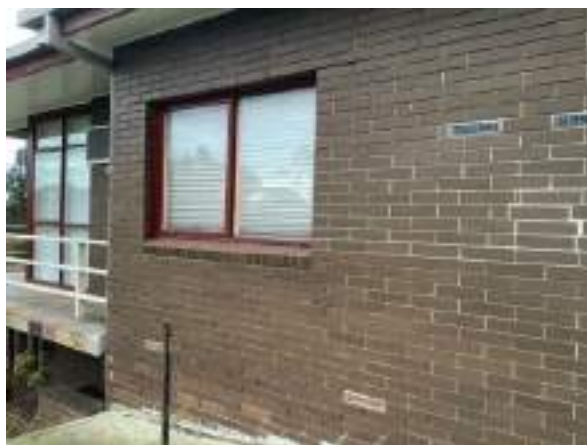
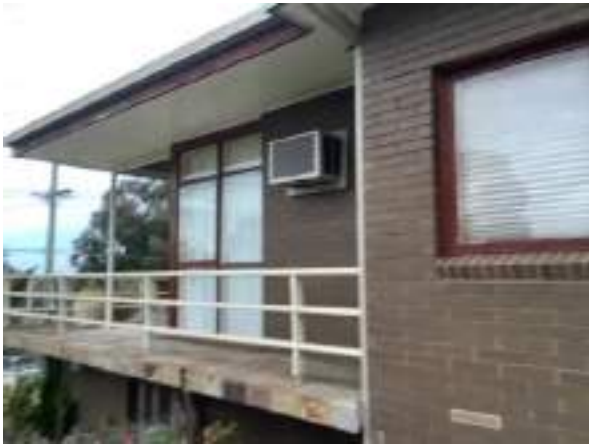
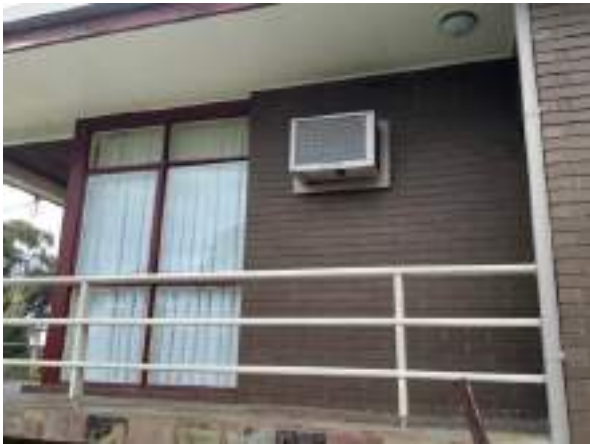
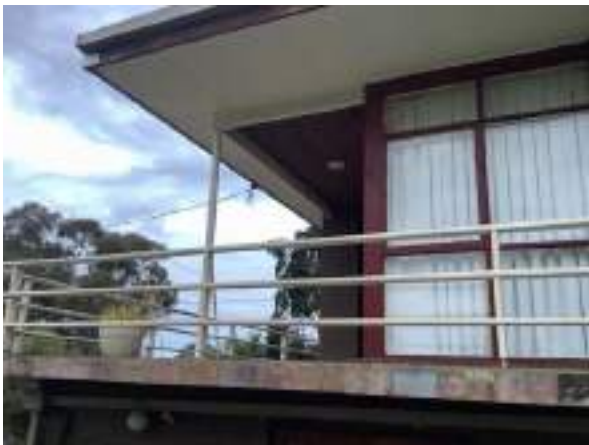
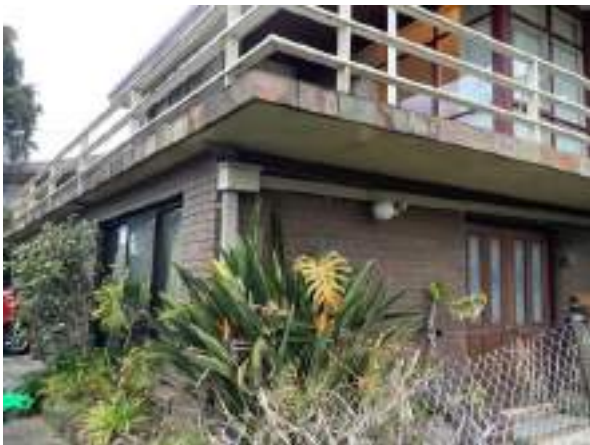
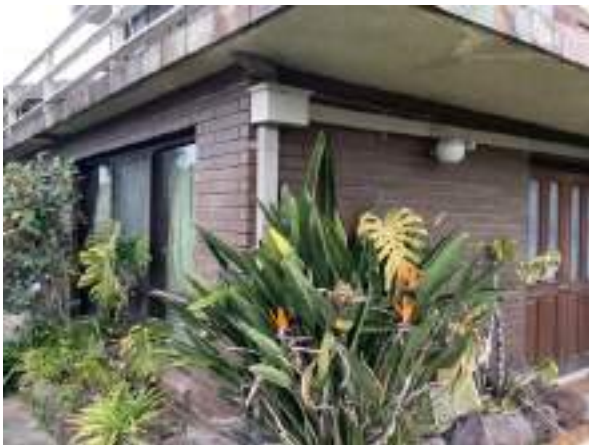
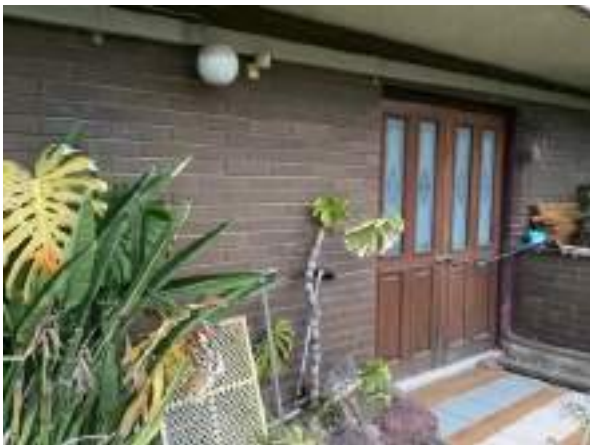
For your information 4.10

Location: Exterior North Side
Finding: Brickwork - In Front Of Gate
Brick wall photos for your information.

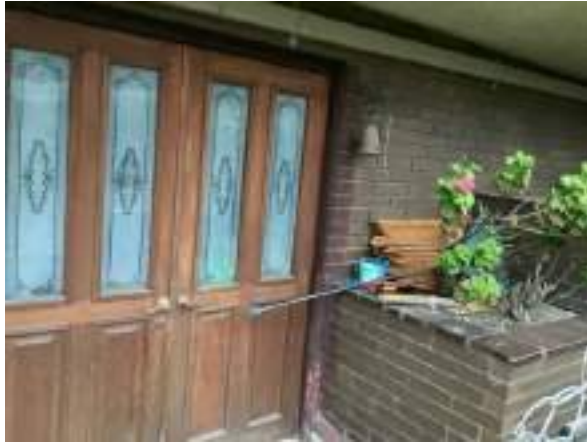
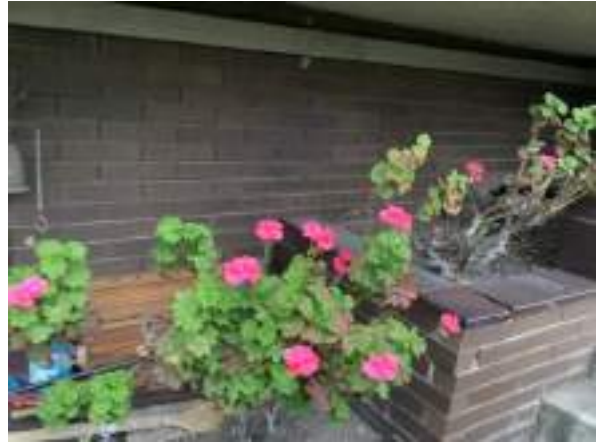
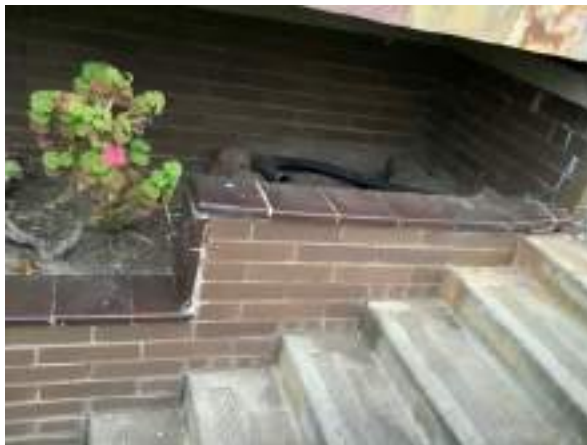
For your information 4.11

Location: Exterior North Side

Finding: Brick - Movement & Dilapidated (In Front Of Gate)
The photos will demonstrate that the brick fence is severely compromised and in a state of dilapidated which requires removal.

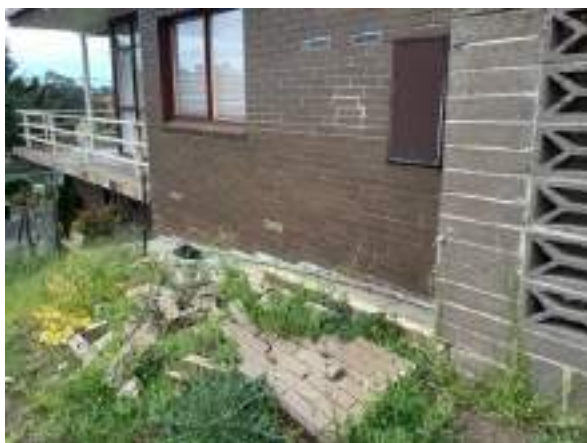
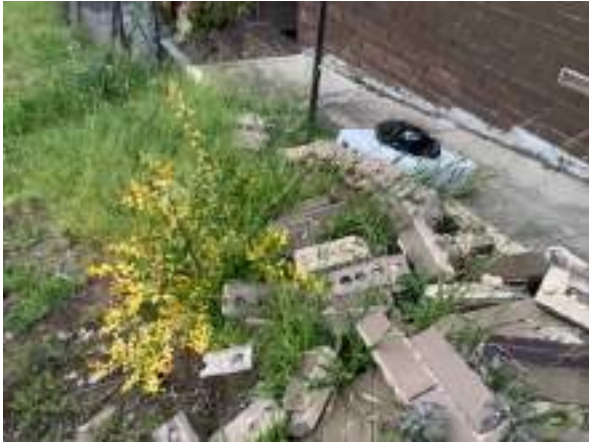
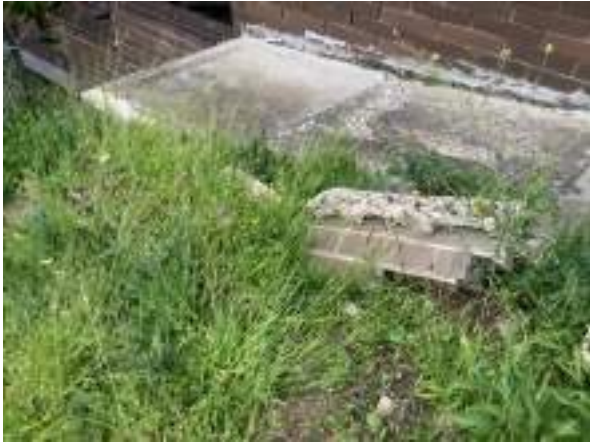
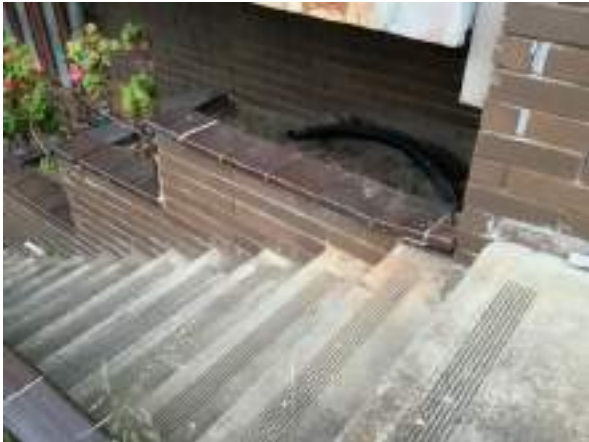
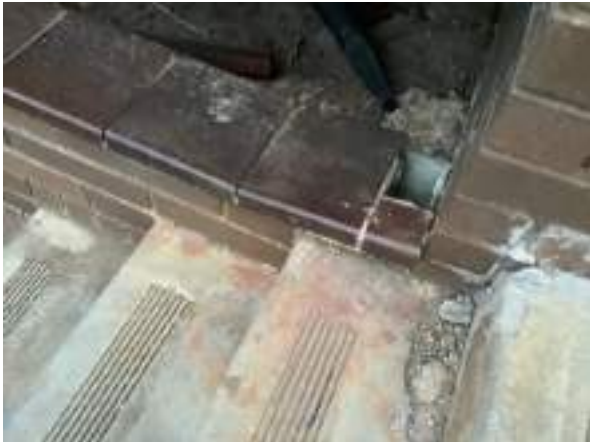
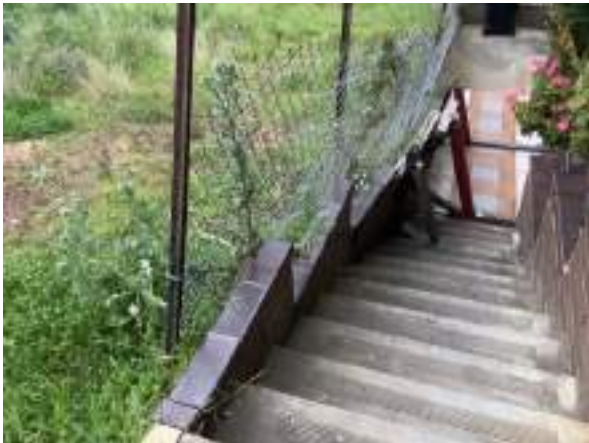
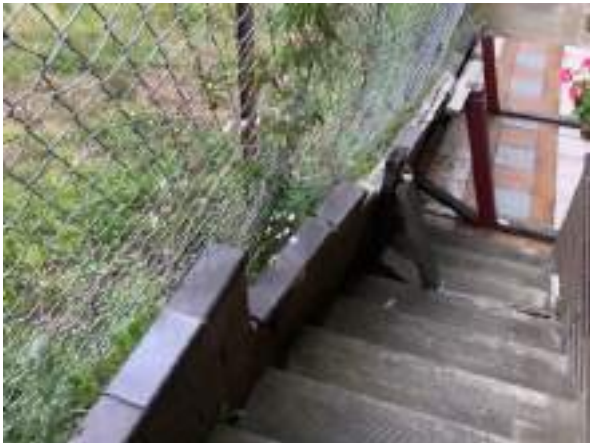
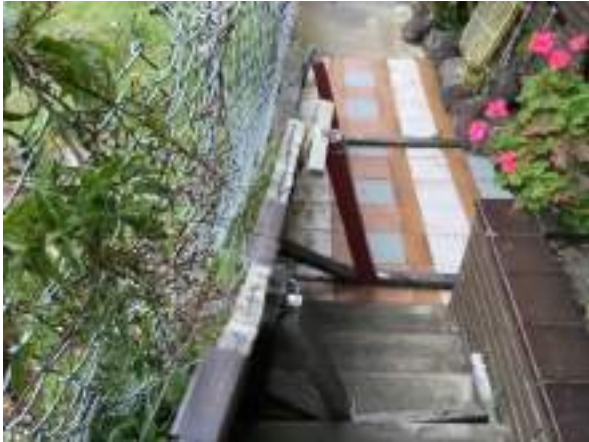
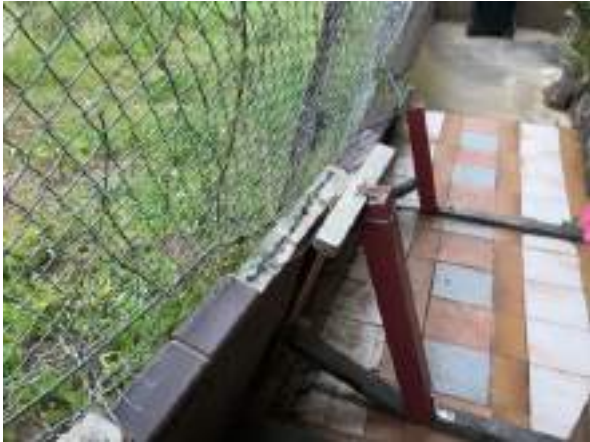
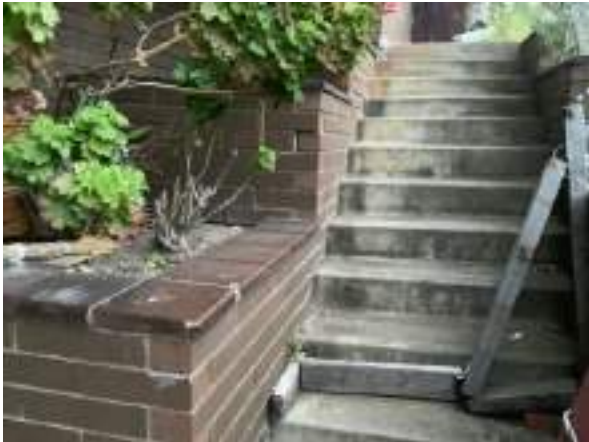
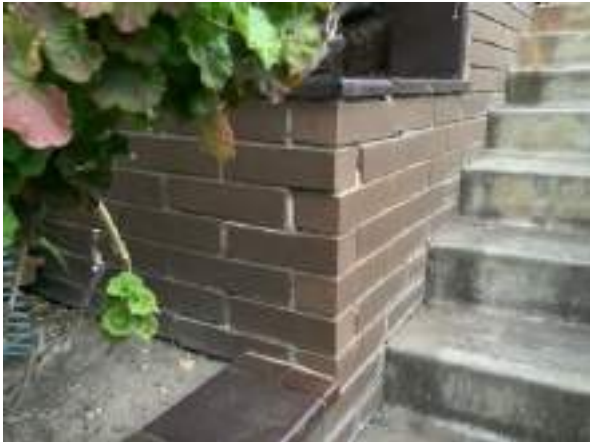
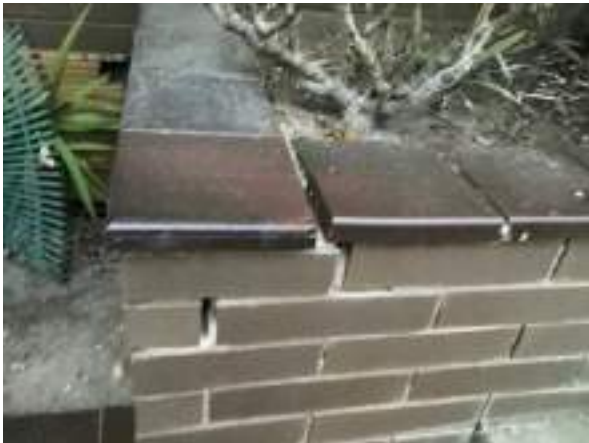
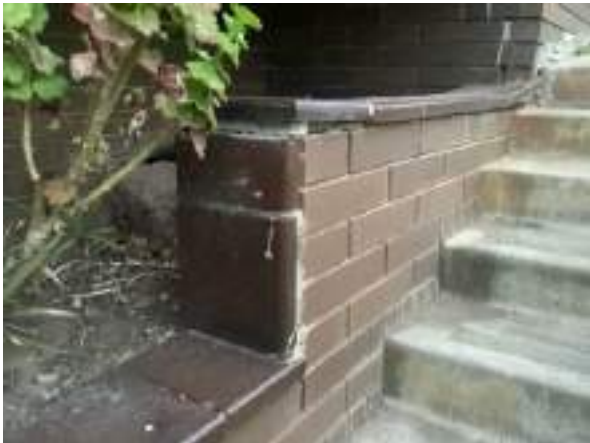
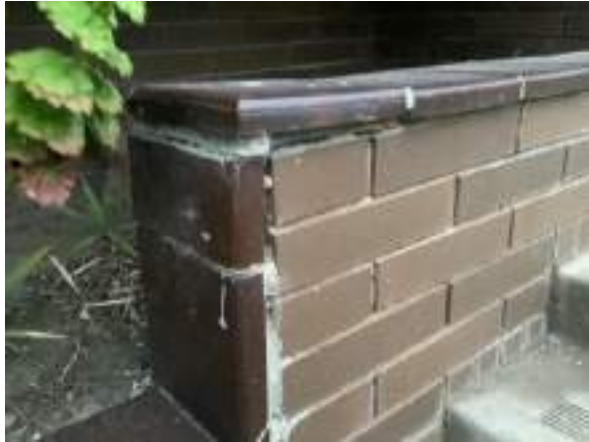
For your information 4.12

Location: Exterior North Side

Finding: Concrete Path
The photos will demonstrate that the concrete path is severely compromised and in a state of dilapidated.
