Dilapadation Report

Inspection Date: 4 Oct 2020

Property Address: Ascot vale area.

Report Type: Dilapidation Inspection Report

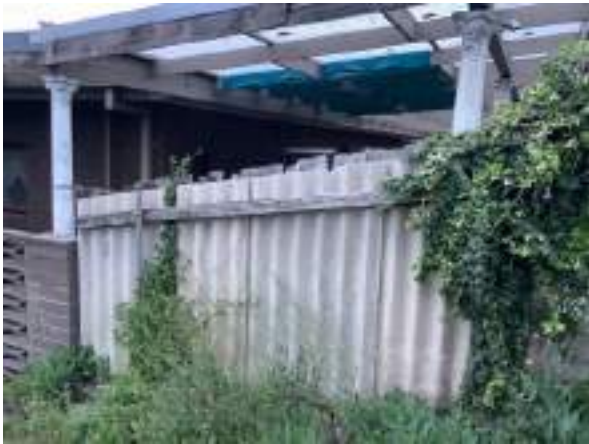
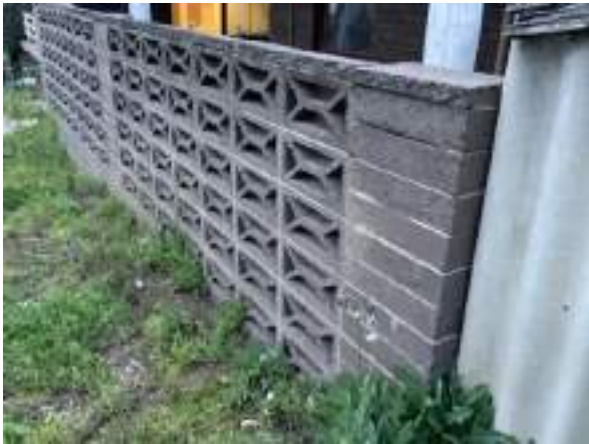
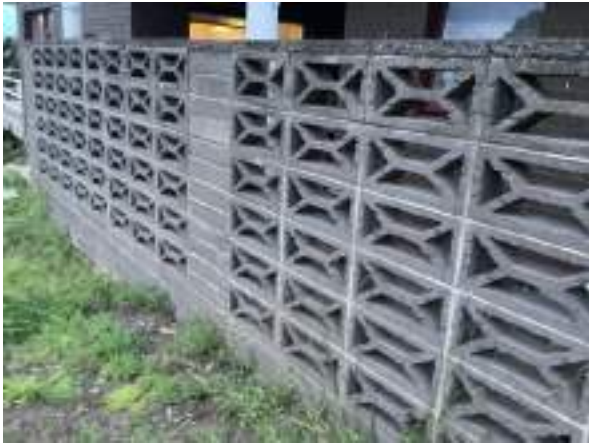
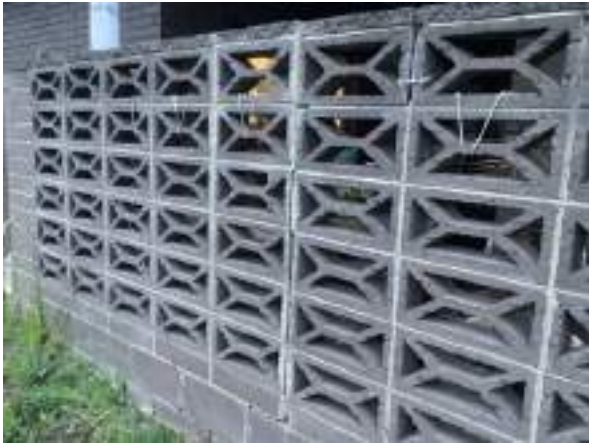
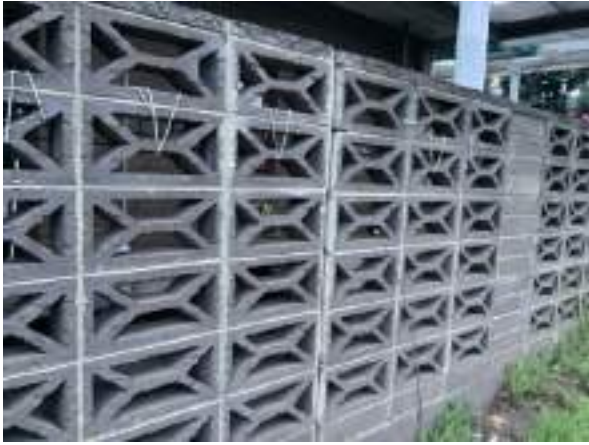
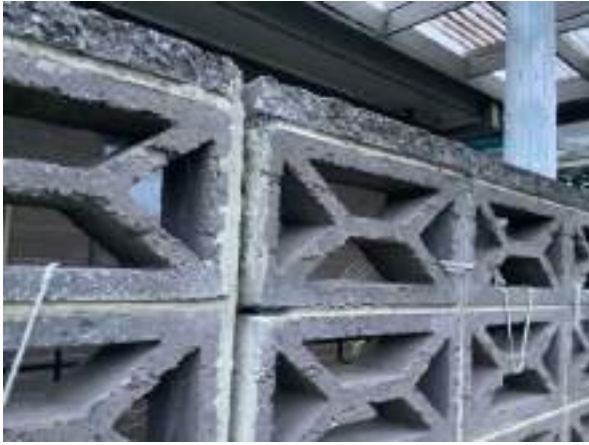
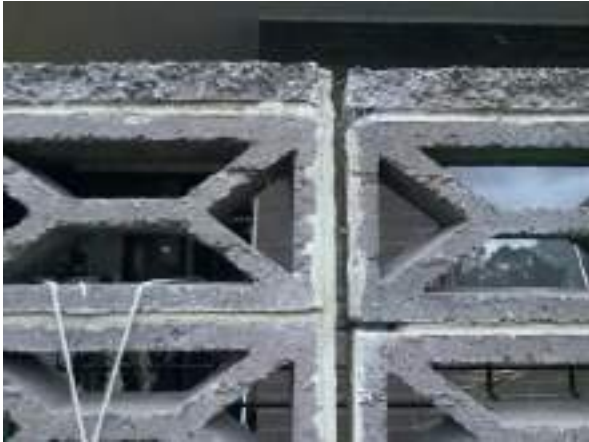
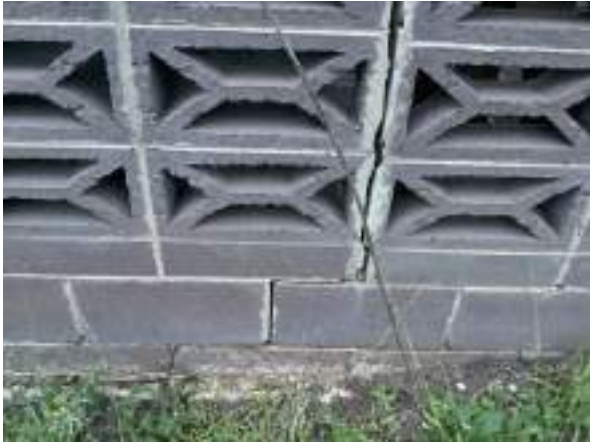
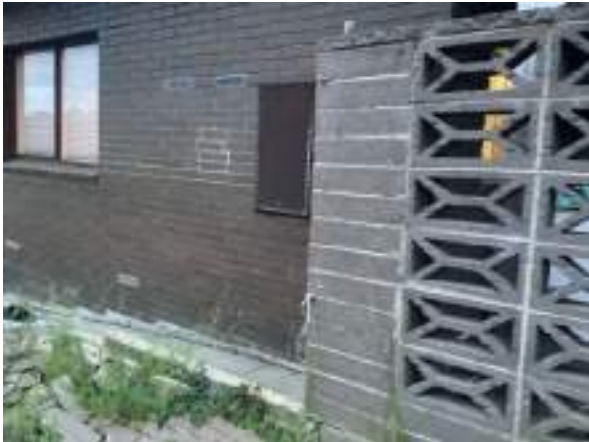
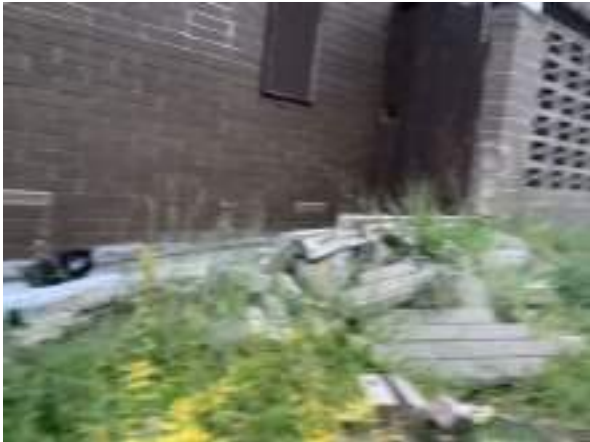
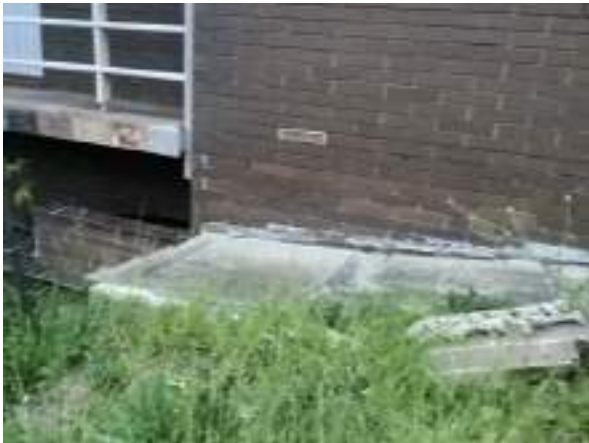
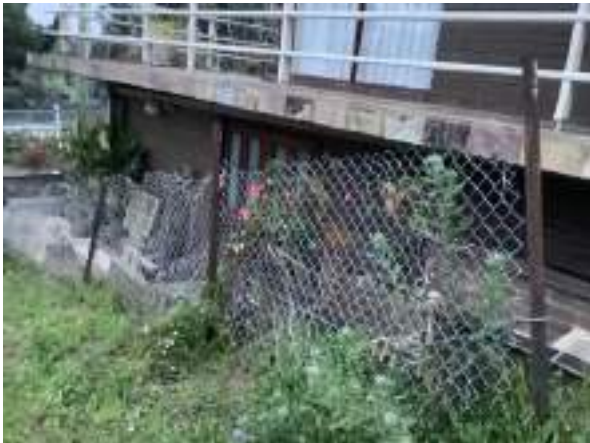
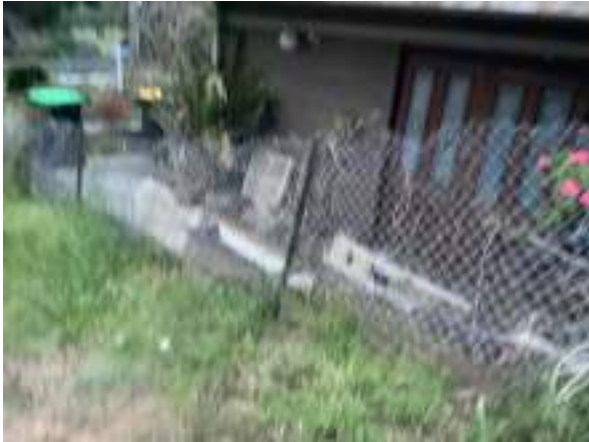
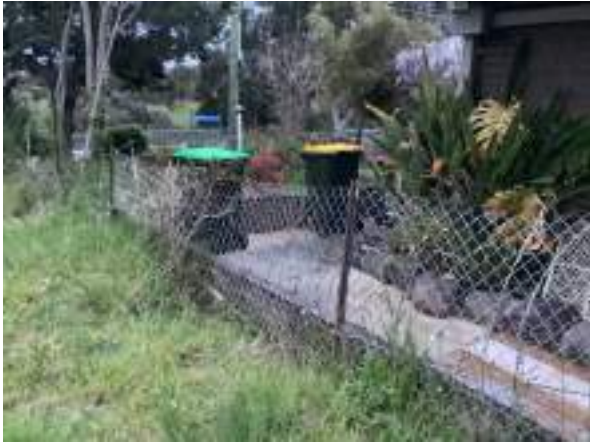
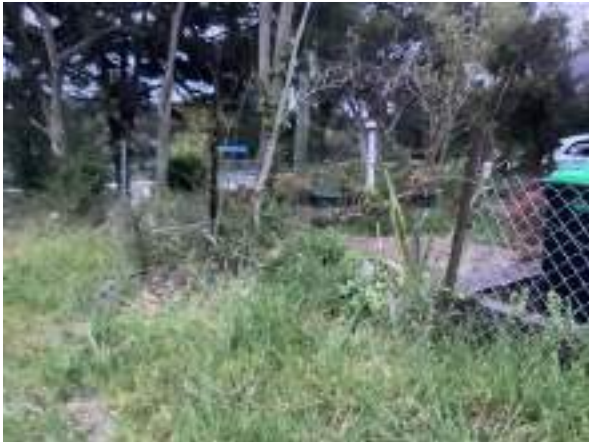
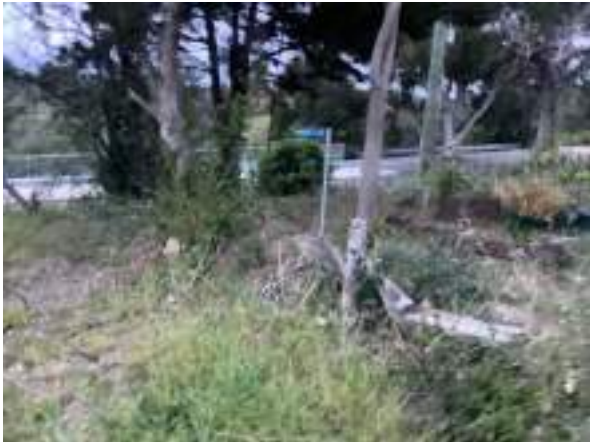
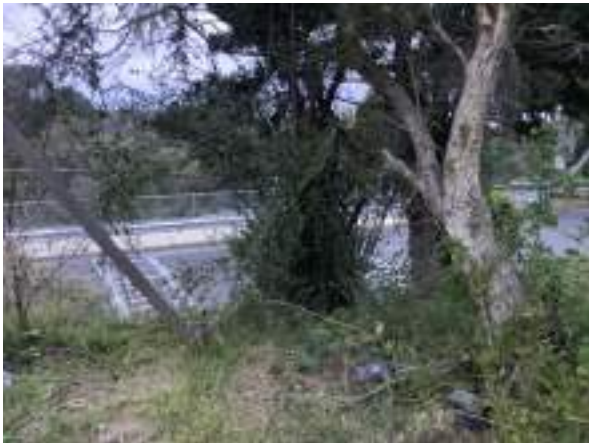
For your information 4.14

Location: Lower Story Additional Site Photos
Finding: Lower story additional site photos
Additional photos are required for your information.
