Lock Up Report

Inspection Date: 2 Oct 2020

Property Address: Dandenong Victoria

Report Type: New Home Construction

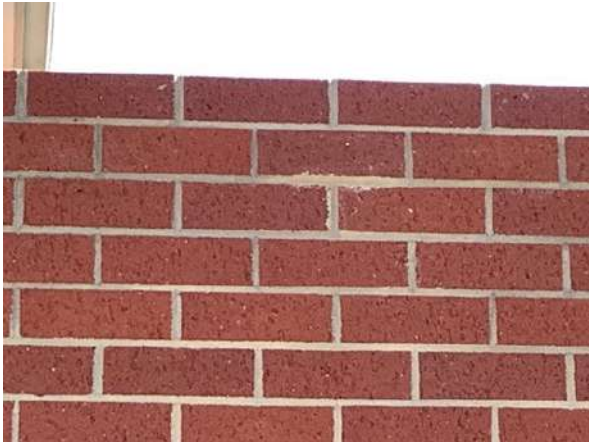
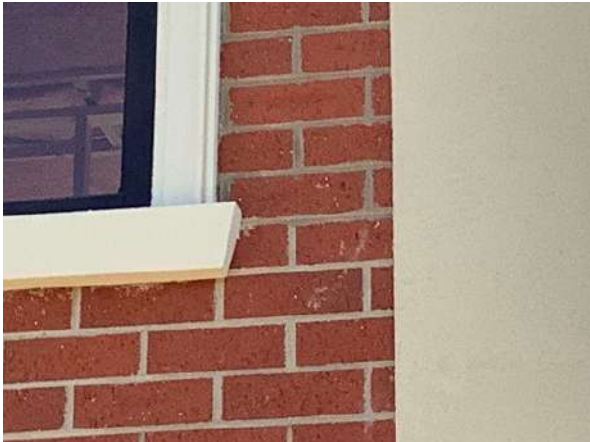
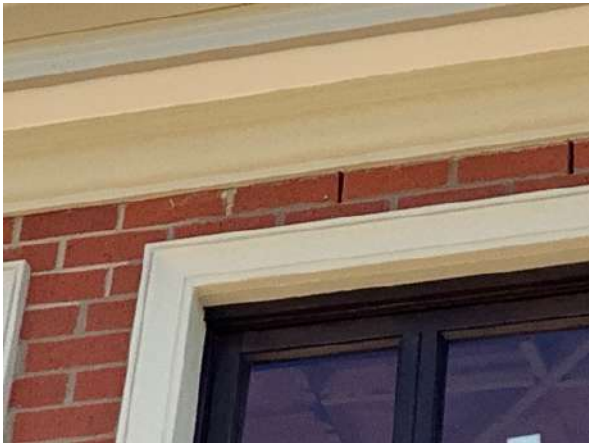
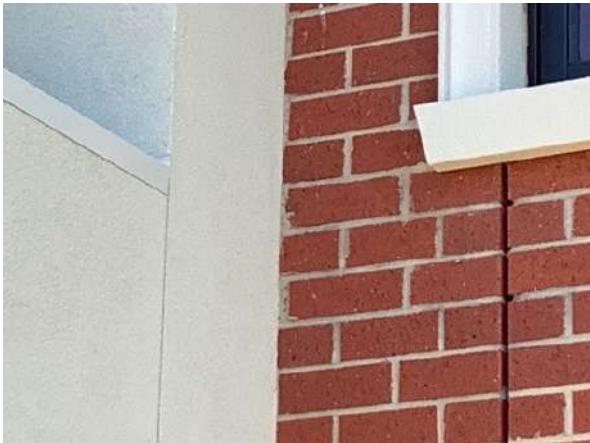
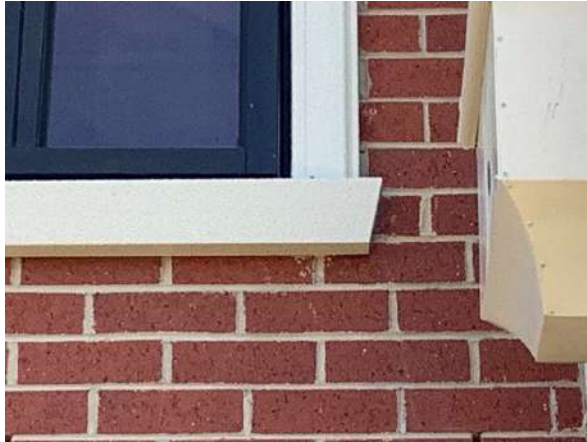
Finding: Brickwork - Excessive mortar (AS4455)
IMPORTANT 🖱️ ONLY SAMPLE PHOTO'S of the Brick Excessive mortar defects. All AREAS to the entire property MUST be checked and repaired.

The Building Commission's Guide to Standards and Tolerances clause 3.07, Masonry Facing states that:- 'Masonry faces are defective if they are not cleaned and free of excess mortar' and clause 3.11, Cleaning, Mortar Smears & Stains states that:- 'Stains, mortar smears and damage caused by cleaning are defects if they are visible from a normal viewing positioning.' The faces and edges of the bricks within the wall around this home will have to be properly re-cleaned to remove all traces of the mortar residue from across them.

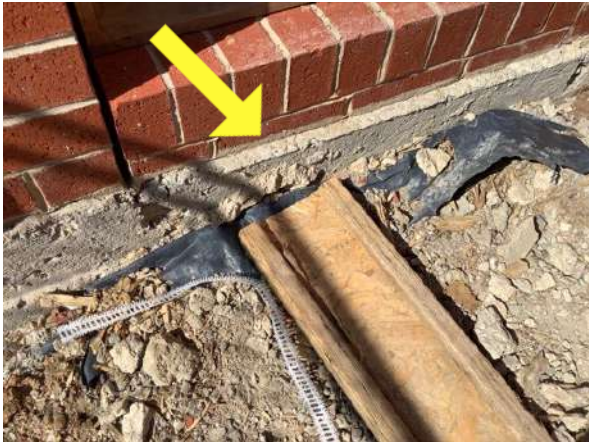
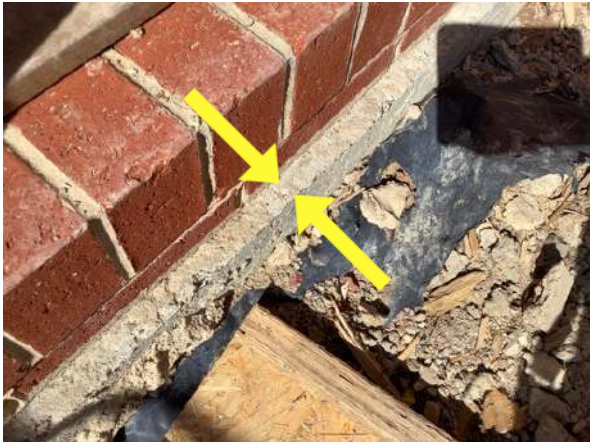
It was observed that there are areas where the edge of the slab protrudes past the document finished dimension of the slab.

The current overhang will affect any concrete pavement or hard material landscaping such as pavers and as such the overhang needs to be cut back.

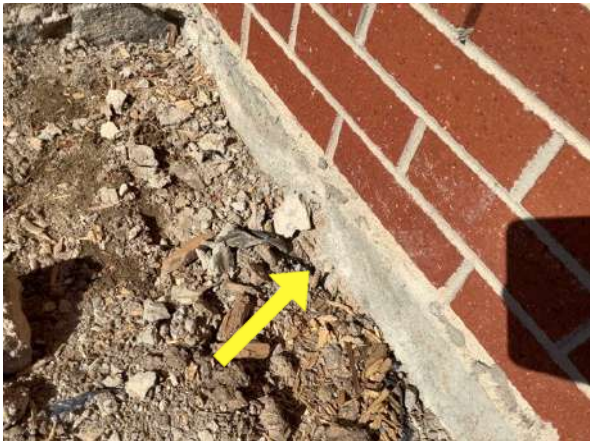
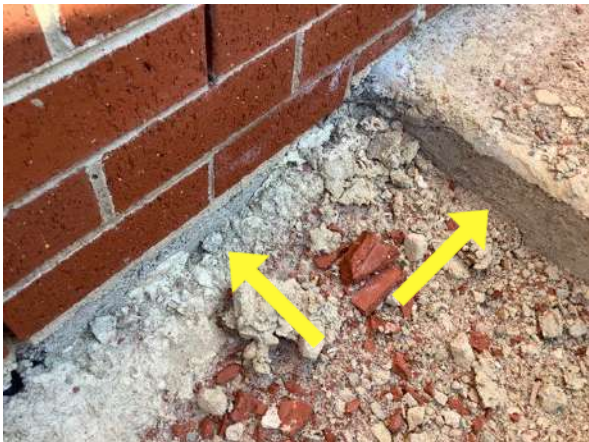
A vapour barrier must be installed as follows—

- (i) lap not less than 200 mm at all joints; and
 - (ii) tape or seal with a close fitting sleeve around all service penetrations; and
 - (iii) fully seal where punctured (unless for service penetrations) with additional polyethylene film and tape.
- (c) The vapour barrier must be placed beneath the slab so that the bottom surface of the slab is entirely underlaid and extends under edge beams to finish at ground level in accordance with Figure 3.2.2.3.

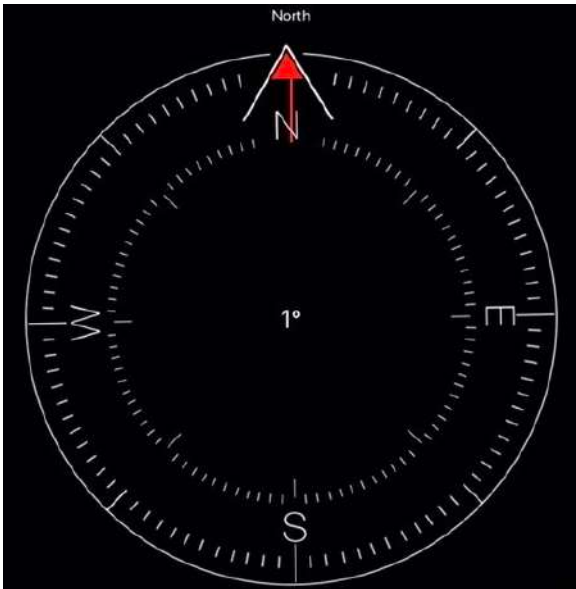
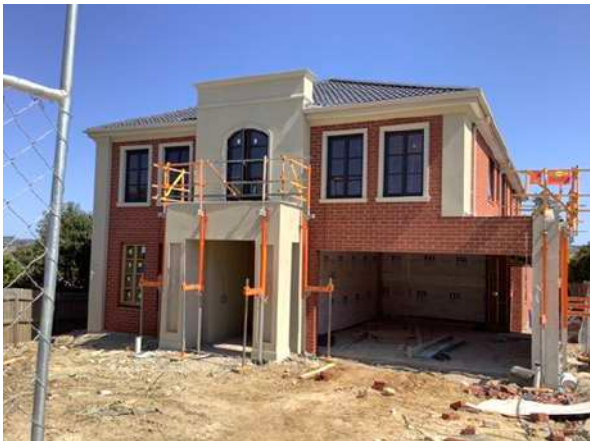
- Location:
- Site Photos & Areas Of Interest.
- Finding:
- Site Photos.
Additional photos are provided for your general reference.
