Post Concrete Pour Slab Report. (Serious Defective Works Found)

Inspection Date: 15 Oct 2020

Property Address: Taylors Lakes area

Report Type: New Home Construction

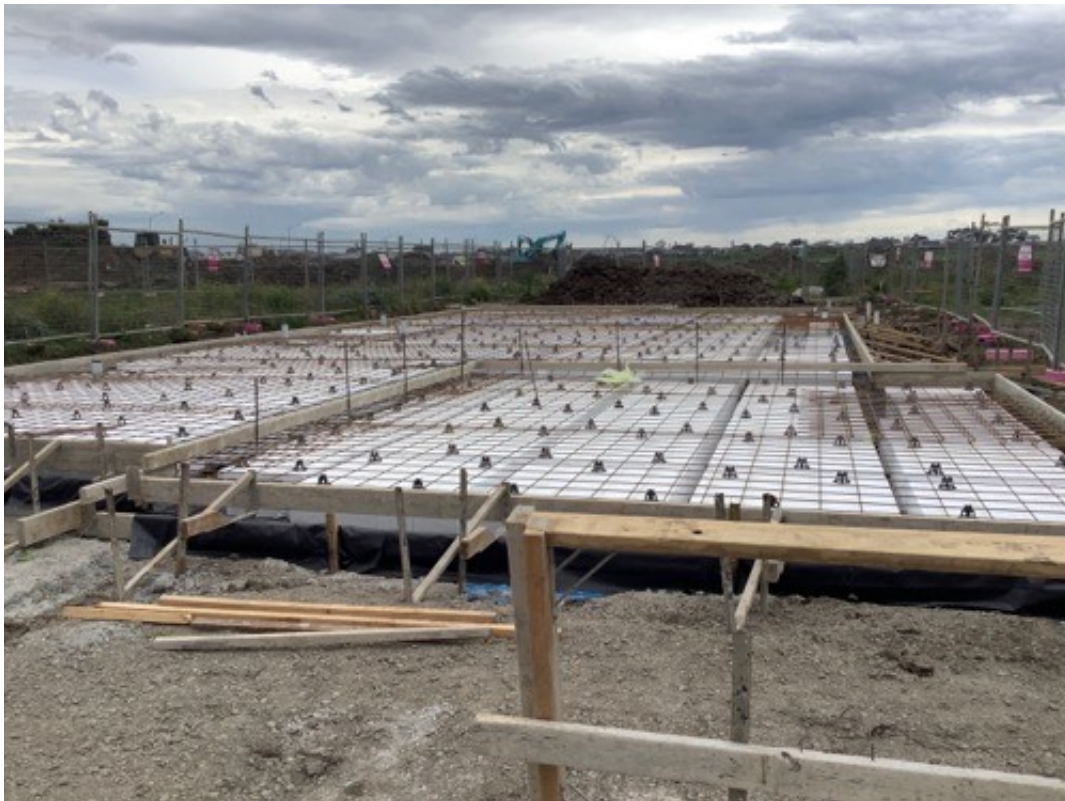
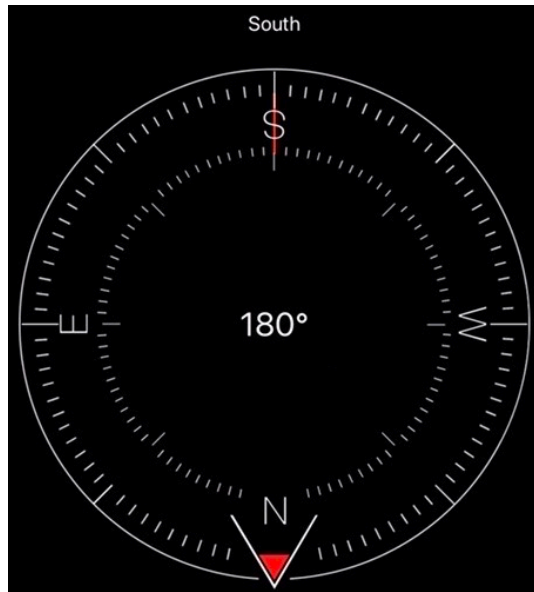
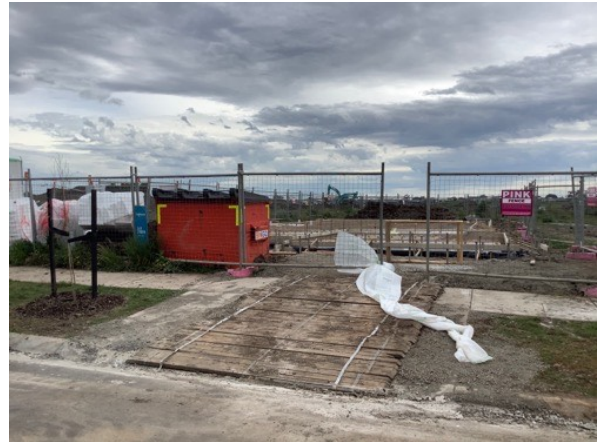
For Your Information 5.07

Location: General Site Photos
Finding: Site Photos.
Additional photos are provided for your general reference.

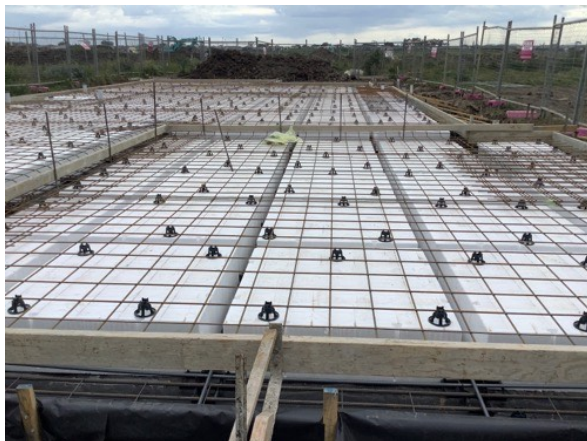
For Your Information 5.08

Concrete must comply with the following:

- (a) Concrete must be manufactured to comply with AS 3600; and —
 - (i) have a strength at 28 days of not less than 20 MPa (denoted as N20 grade); and
 - (ii) have a 20 mm maximum nominal aggregate size; and
 - (iii) have a nominal 100 mm slump.
- (b) Water must not be added to the mix to increase the slump to a value in excess of that specified.
- (c) Concrete must be placed, compacted and cured in accordance with good building practice.
