Vendors Report (Building & Termite/ Timber Pest)

Inspection Date: 1 Oct 2020

Property Address: Bundoora

Report Type: Property and Timber Pest Report

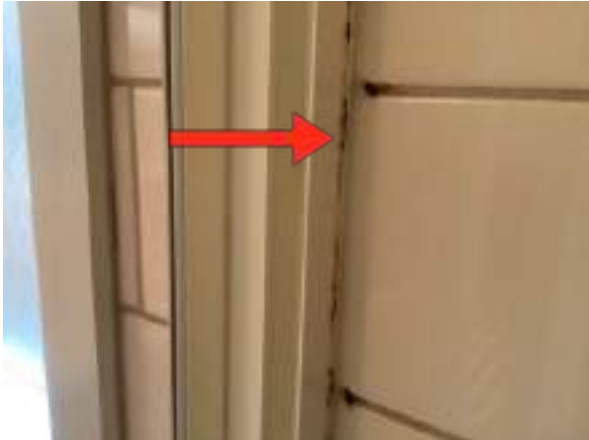
Serious Safety Hazard 1.05

Location: Mould In Caulking / Silicone-All Wet Areas

Mould in caulking or silicone is generally caused by faulty and/or damaged caulking or silicone as the moisture and water ingresses into the caulking or silicone.

The caulking or silicone must be replaced and the areas are cleaned and new caulking or silicone applied.

Generally, the client is advised to ensure that the general environment is free of moisture and humidity to aid in the prevention of mould formation and development. Any mould found during the inspection should be cleaned immediately and/or taken out, particularly where the mould is in the silicon / caulking.

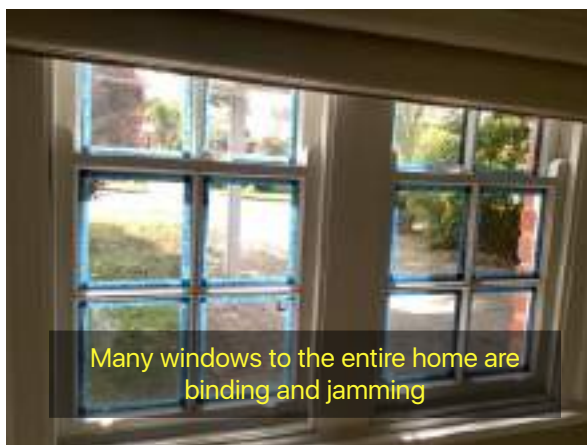
Serious Safety Hazard 1.06

Location: Windows - Internal Areas

Several windows throughout the property were jammed and difficult to operate at the time of the inspection. Windows provide ventilation to the adjoining area and should be at a fully operational level to ensure user comfort. Restricted function of the window may also pose as a potential safety hazard if required for emergency egress from the building.

Generally, factors such as general age of the building element and a lack of maintenance are the usual causes for this type of defect.

Windows MUST function as a safety requirement and we HIGHLY RECOMMEND that you engage an appropriate professional as soon as possible to check all windows to the property.

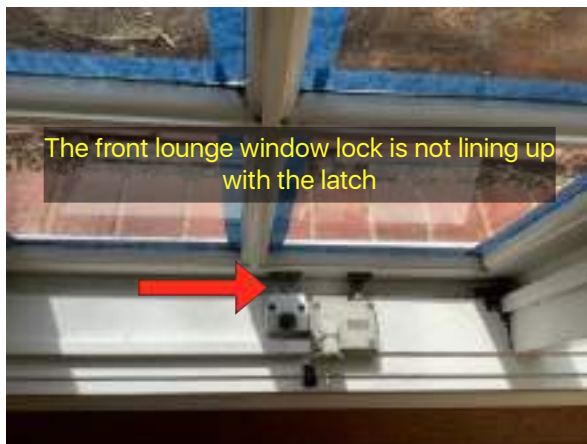
Serious Safety Hazard 1.07

Location: Windows - Internal Areas

Replacement of the handle /locks should be conducted as soon as possible. A general handy person, window manufacturer and/or service technician should be appointed to perform these works to improve the operational state of the affected window and improve the safety of the internal area.

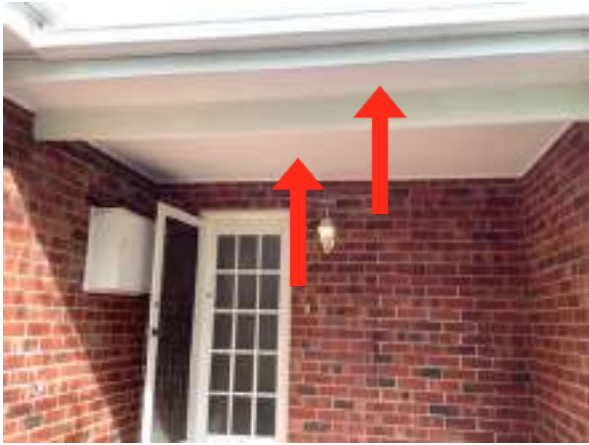
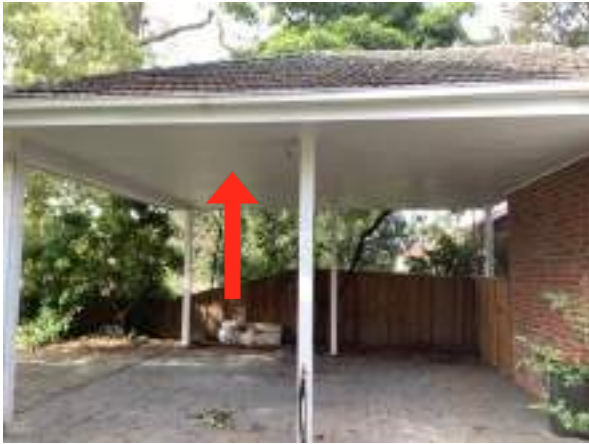
Serious Safety Hazard 1.08

Location: External Areas

In the interim, the client is advised to act with caution, especially when considering any damage to building materials general wear and tear renovations extensions demolition and general maintenance activities due to the suspected presence of Asbestos.

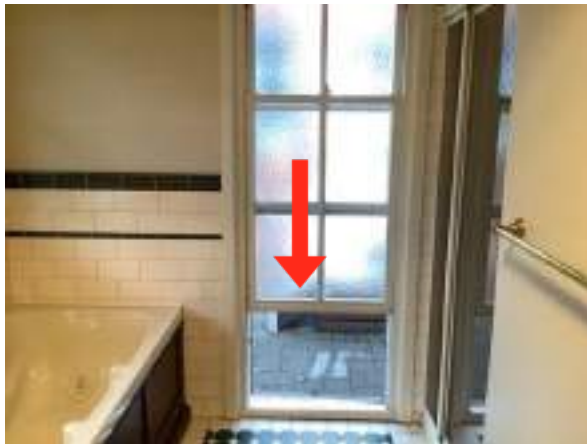
Serious Safety Hazard 1.09

Location: Ensuite

However this is a major safety concern & regardless of whether this was legal at the time of this building being built or not it is still very dangerous to have these openings that are not limited to the openings as a child, small person or somebody through accidental circumstances can fall through the window.

I highly recommend that you engage a window manufacturer or a window manufacturers technician to change the window mechanisms so that they limit the opening of the window as a matter of urgency.

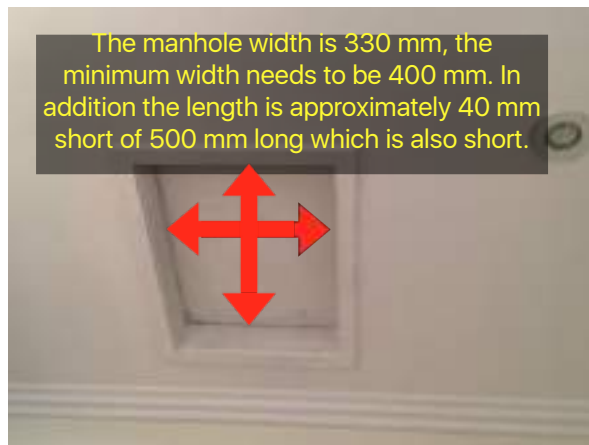
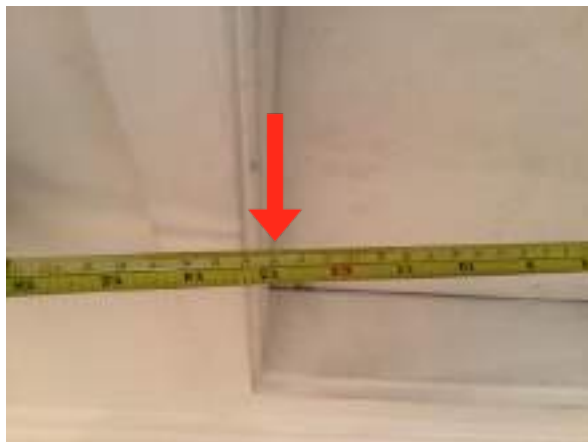
Serious Safety Hazard 1.10

Location: Manhole To Get Into The Roof Space
Finding: Roof Space Man Hole - Access NOT large enough
DIMENSIONS FOR REASONABLE ACCESS AS PER TABLE 3.2 , AS 4349.1.-2007.
Inspection of buildings - Pre-purchase Inspections - Residential buildings.

By not inspecting the roof space area there can hide an array of defects, without inspection to the roof void area it is impossible to rule out termite activity and/or termite damage and other undetectable issues .

I would treat this manhole area alteration as a matter of urgency, a carpenter or competent handyman can install a new manhole that complies.

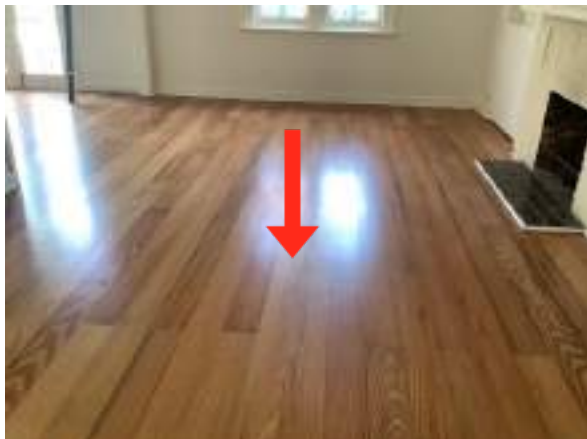
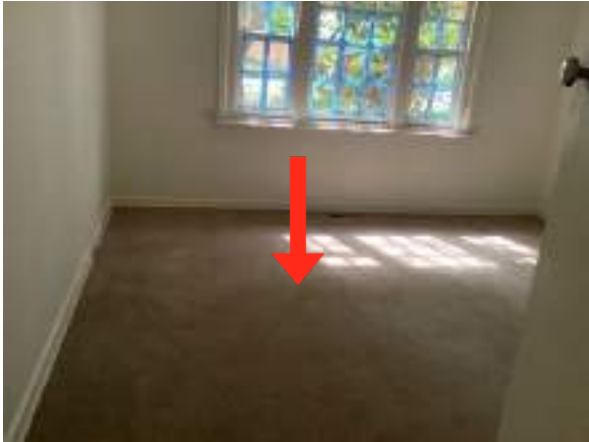
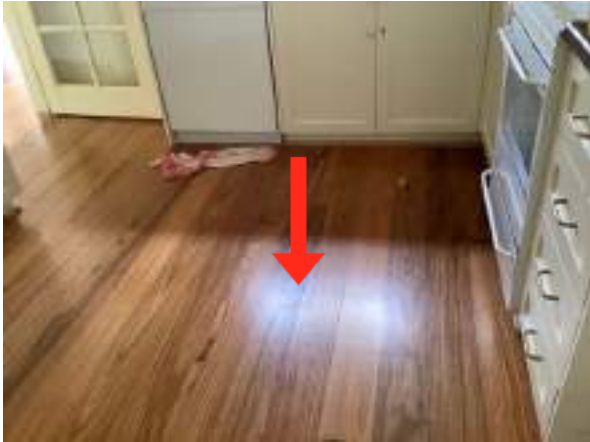
Minor Defect 3.13

Location: Flooring - All Areas

The client is advised to seek quotations for required repairs from a Registered Builder specialising in re-stumping. The potential resolution may range from packing gaps in subfloor structures through to replacement of subfloors stumps and refixing of flooring.

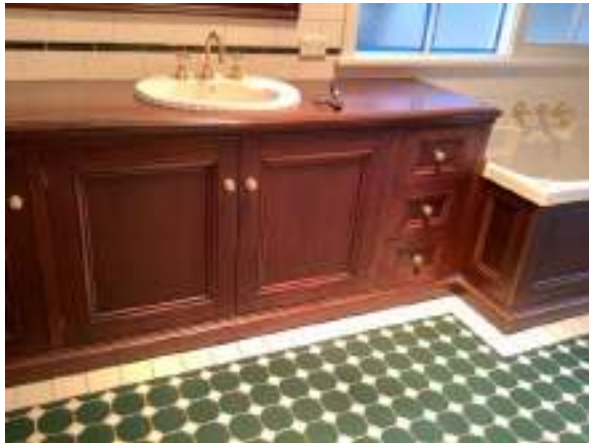
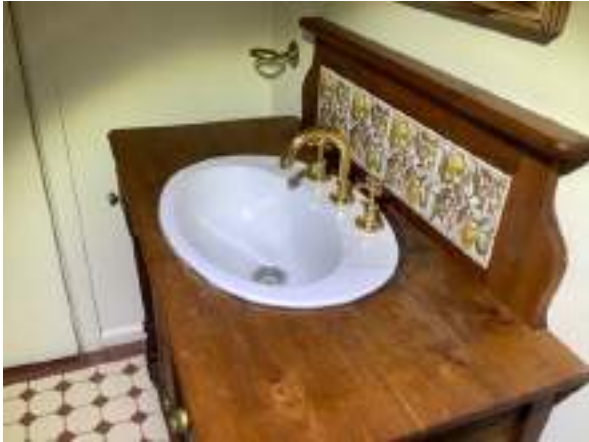
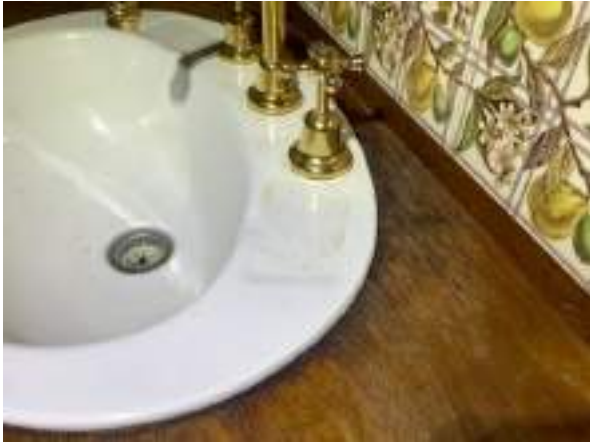
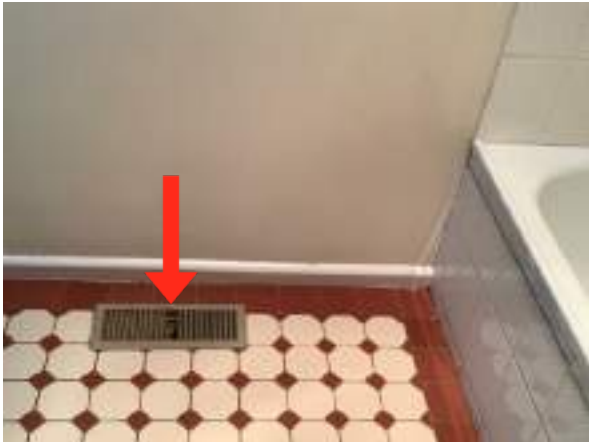
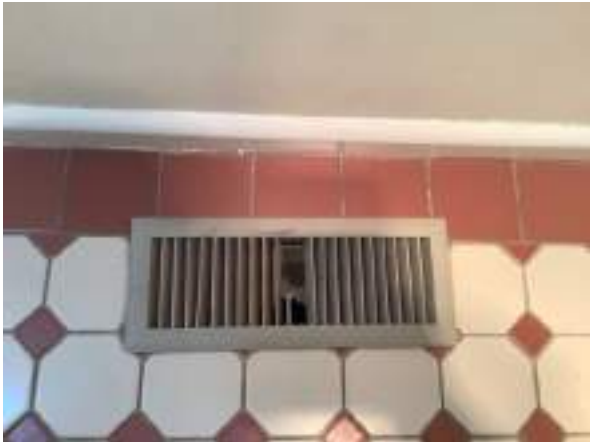
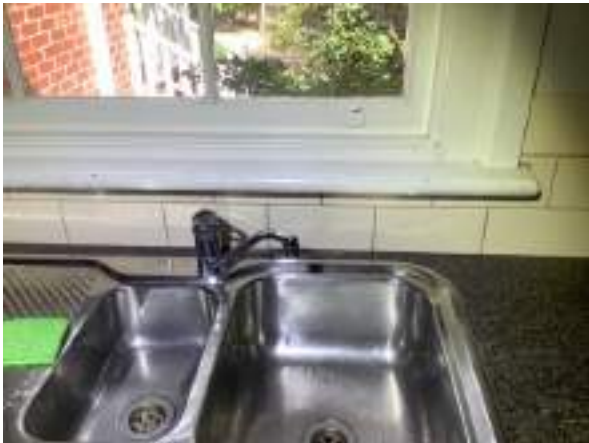
Minor Defect 3.14

Location: All Areas - Various

Items like cracked glass mirrors, cracked glass windows and windows not operation smoothly are defects that should be repaired by the appropriate trades.

It is IMPERATIVE that you engage registered and qualified trades and at the end of there works they must supply certificates, such as an electrical safety certificate, plumbing and gas certificate if the works are electrical or plumbing, but for items such as damaged door handles, painting an experienced carpenter or handyman can sometimes be engaged.

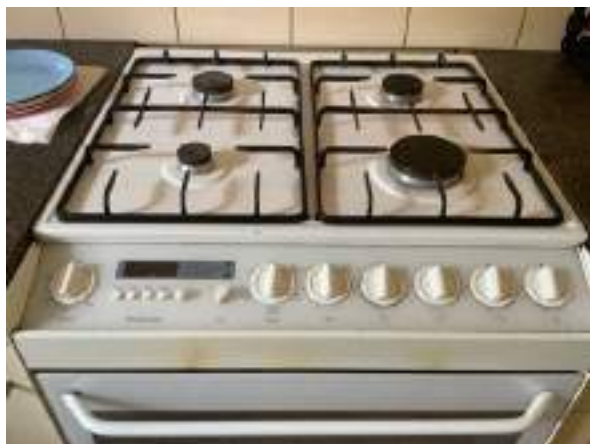
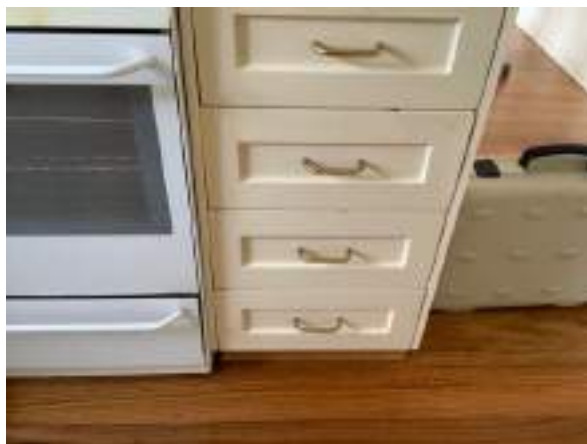
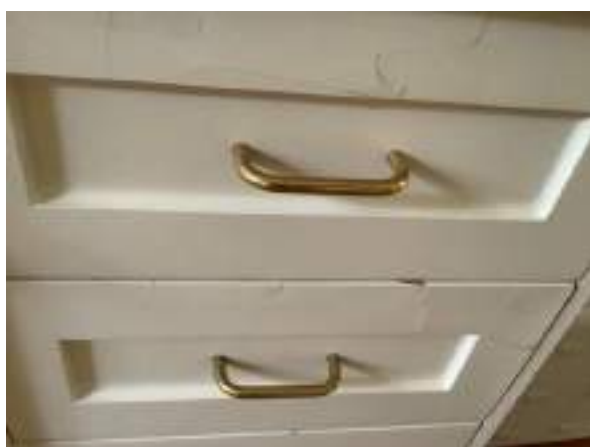
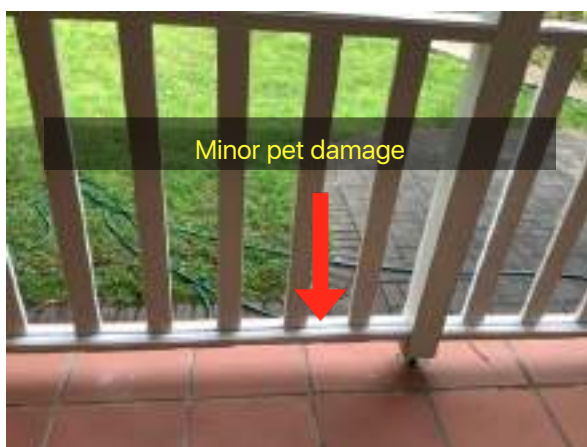
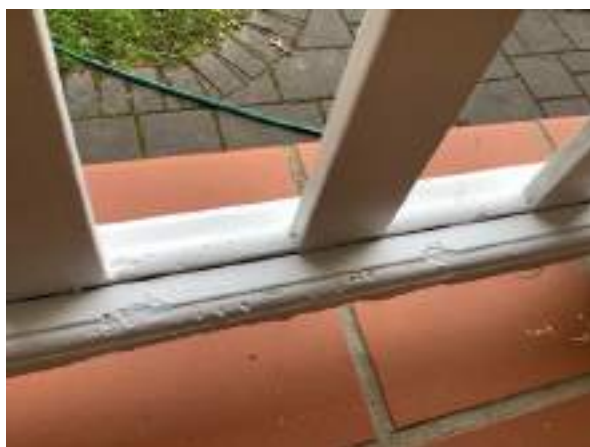
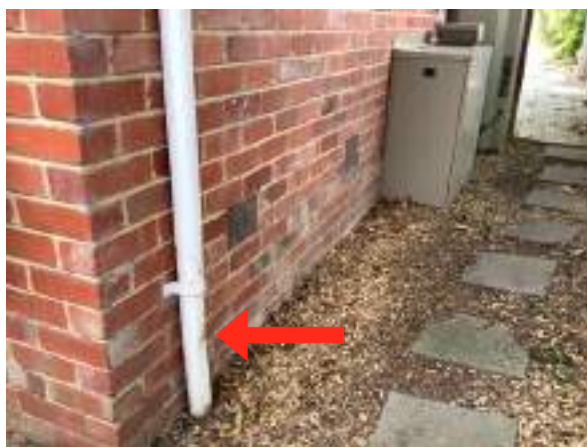
Minor Defect 3.15

Location: All Areas - Various

These Defects are of Sub Standard Workmanship or Incomplete and not finished to a tradesmens like manner.

Unfinished and substandard building works are likely to degrade more quickly and may create potential for secondary defects to associated building elements and surrounding structures, also the workmanship is VERY displeasing to the eye.

Generally substandard repairs or installation are related to poor workmanship, the use of inappropriate materials, or a failure to complete installation to a suitable standard.

Where installation is substandard and/or incomplete, the client should contact the responsible trade to undertake rectification works, which are advised as soon as possible.

The appropriate tradesperson or specialist or handyman should be appointed to complete the various items for repair and organise the appropriate QUALIFIED trades (or not pending on job) to repair and complete the works to illiminate or reduce further deterioration / disfunction.

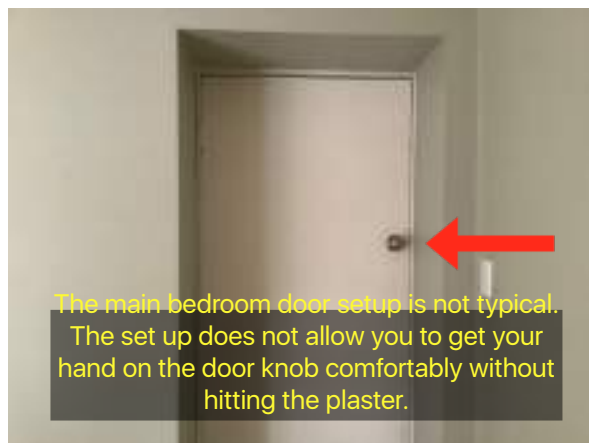
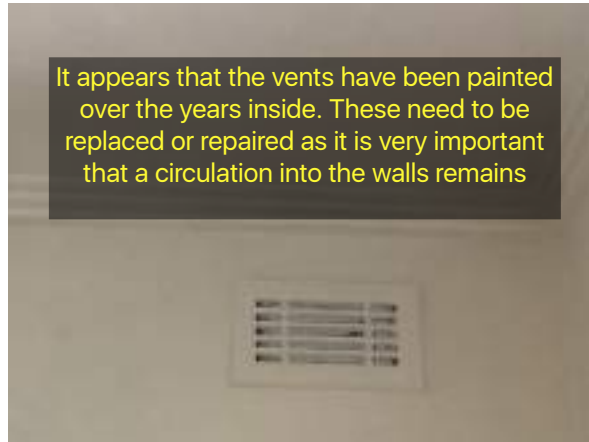
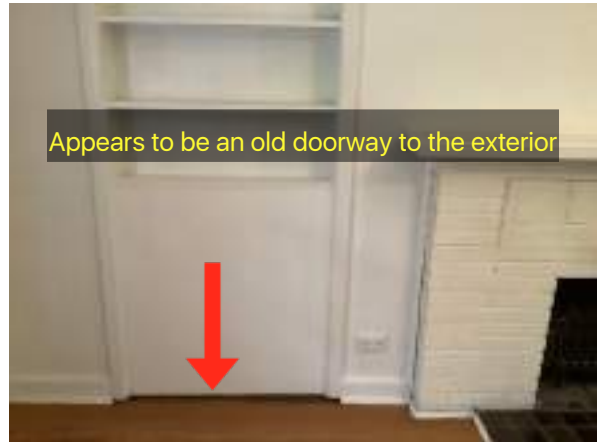
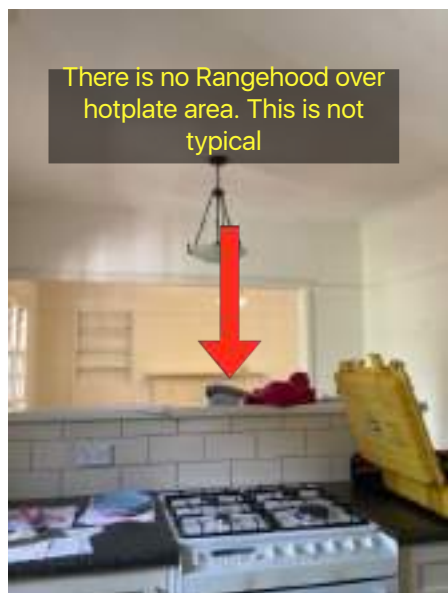
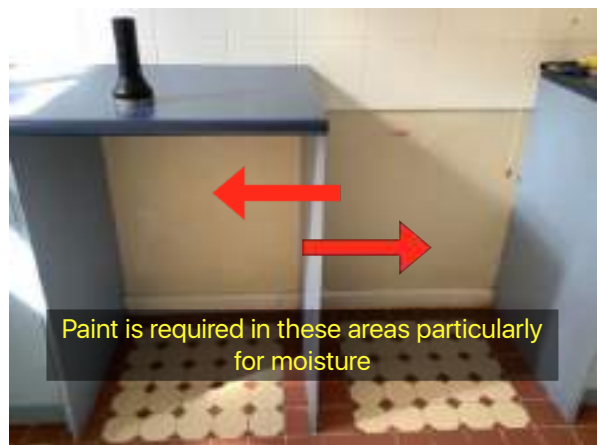
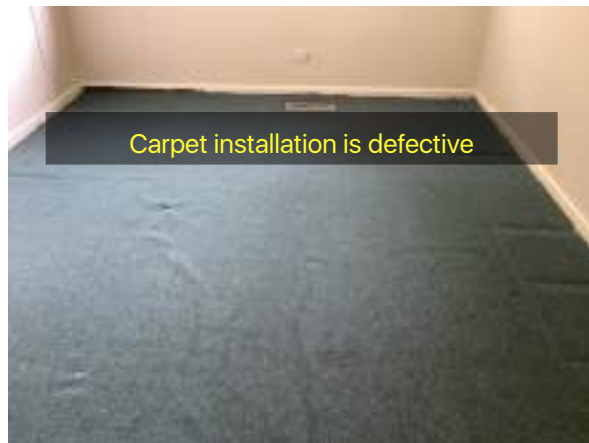
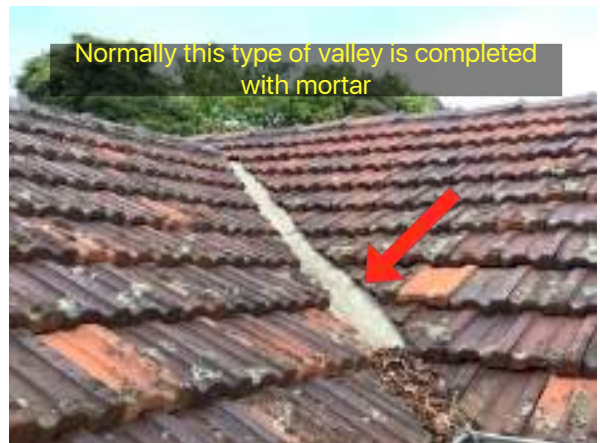
Minor Defect 3.16

Location: Paint Internal Areas

Finding: Paint / Plaster - Lath and Plaster and/or Hairline - Defects To Doors, Architraves, Walls & Ceilings, ETC.

Superficial scuff marks, damaged plaster, holes in walls,missing paint,sub-standard paint work were noted to the internal walls / ceilings and/or architraves as per the photos attached at the time of inspection.

While these minor defects are detracting from the overall appearance of the affected building element, they do not indicate any operational or structural damage.

This degree of surface damage is consistent with general damage, accidents, movement and wear and tear.

These type of minor defects are appearance cosmetics but they can also lead to the development of secondary building defects over time.

Incomplete areas of paint finish, holes in plaster, exposes the area to moisture, potentially accelerating the deterioration of underlying building materials especially in wet areas such as laundrys and bathrooms.

Superficial scuff marks, damaged plaster, holes in walls,missing paint,sub-standard paint work should be sanded back, filled, levelled and painted, as applicable. Where inadequate or missing protection has led to the deterioration of the associated building element, repair and/or replacement of this building element may be required.

A painting contractor,builder, plasterer and/or suitable handy person may be appointed to perform necessary works to aid the appearance of the affected area and to ensure the area is protected against further deterioration.

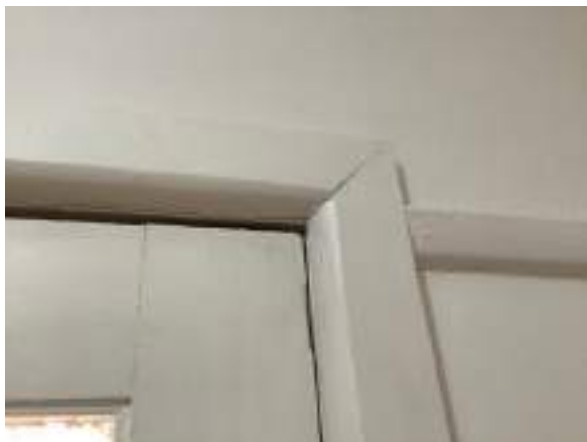
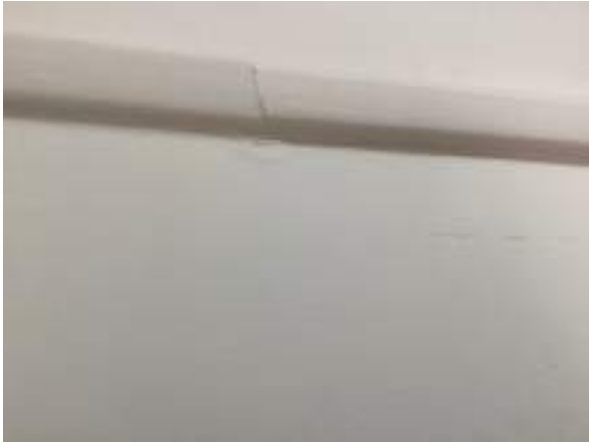
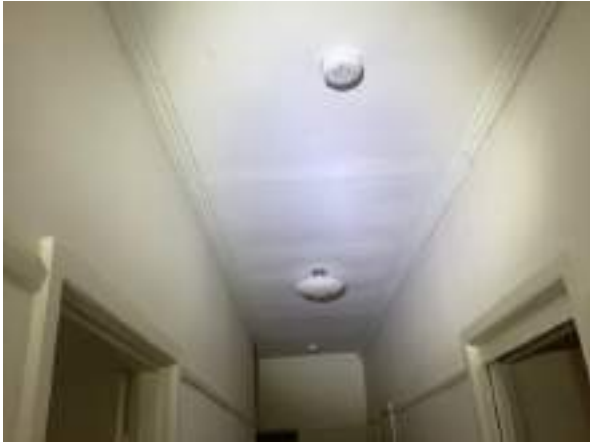
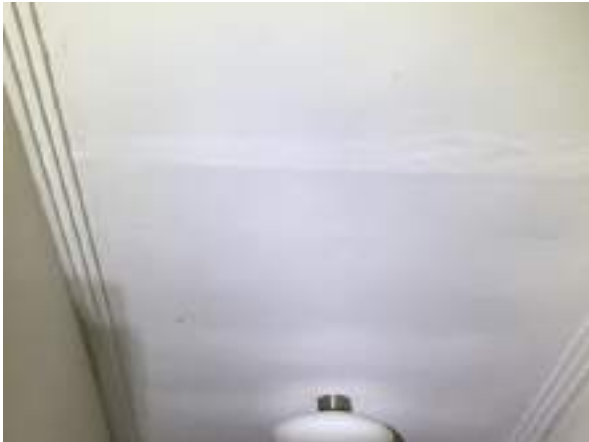
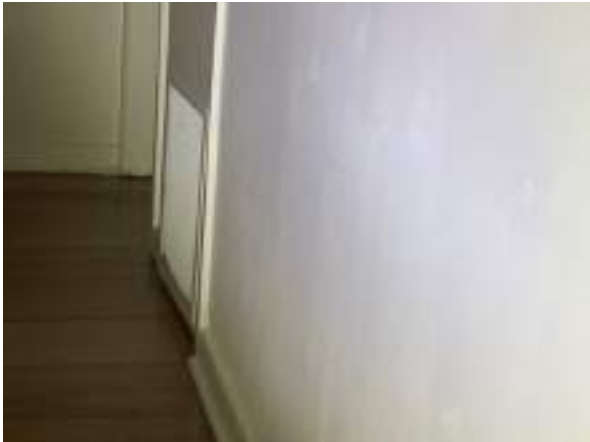
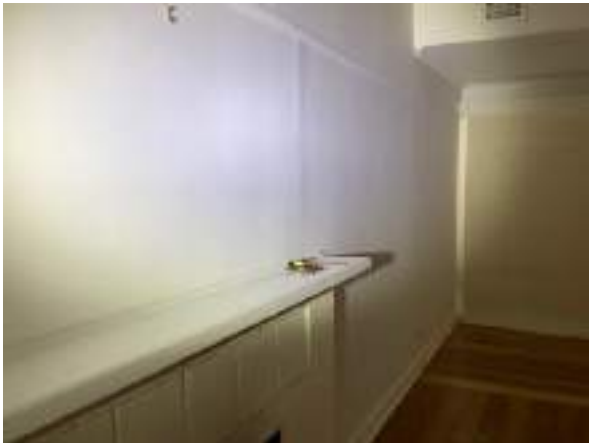
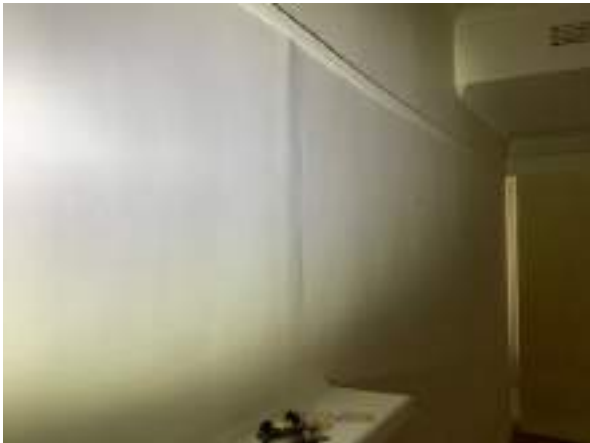
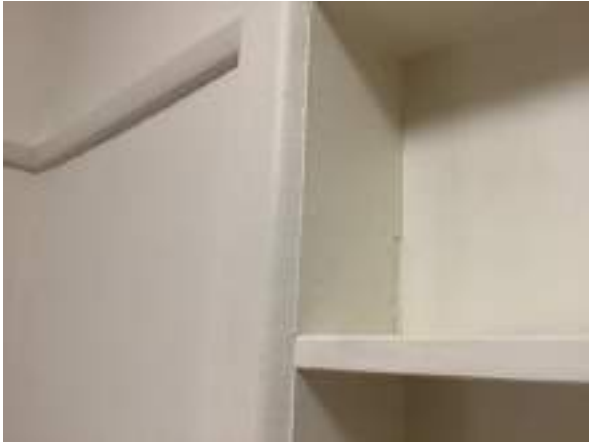
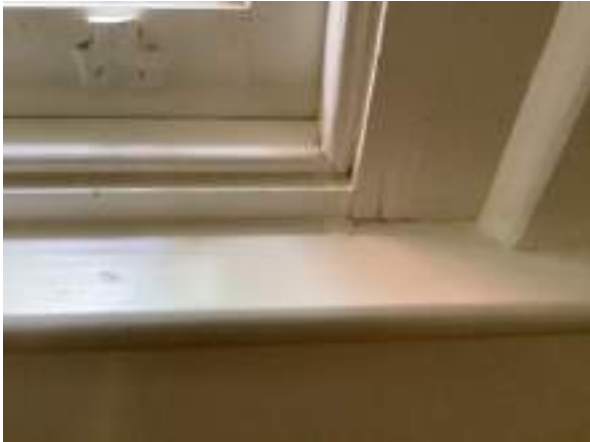
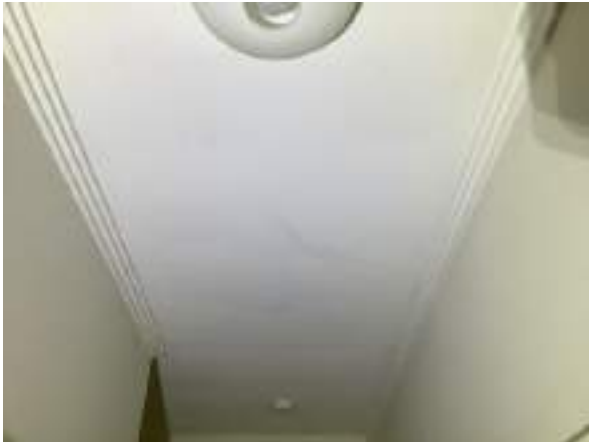
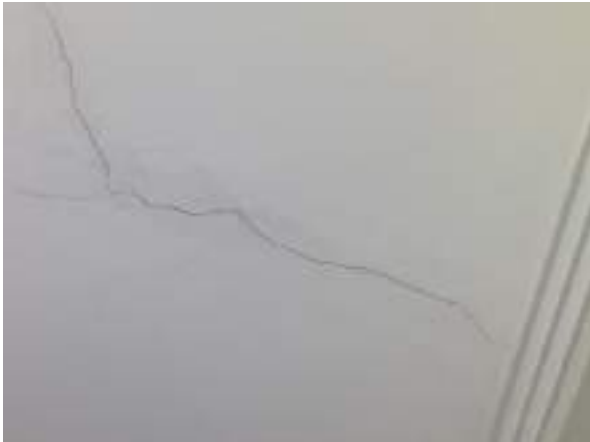
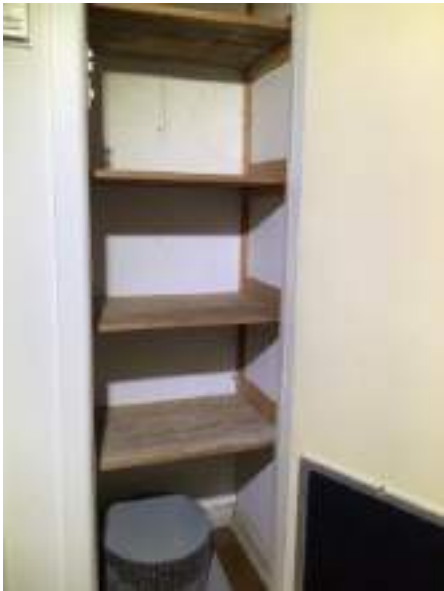
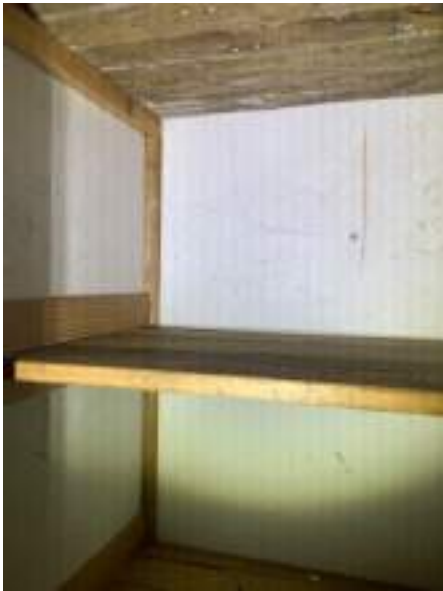
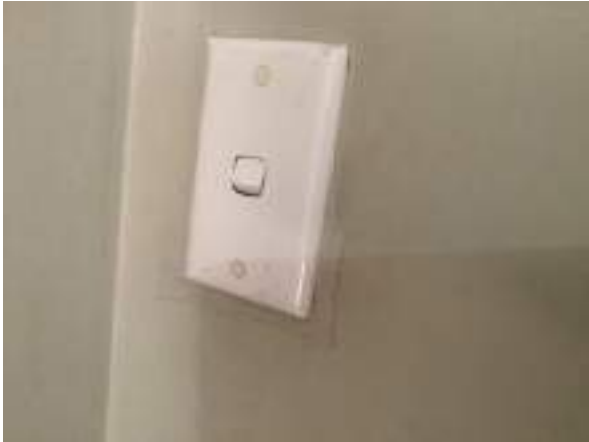
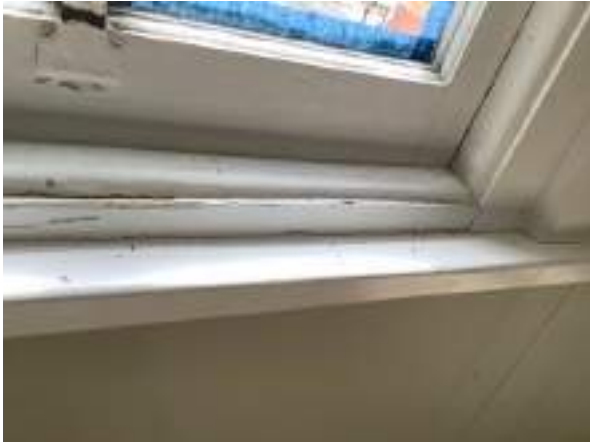
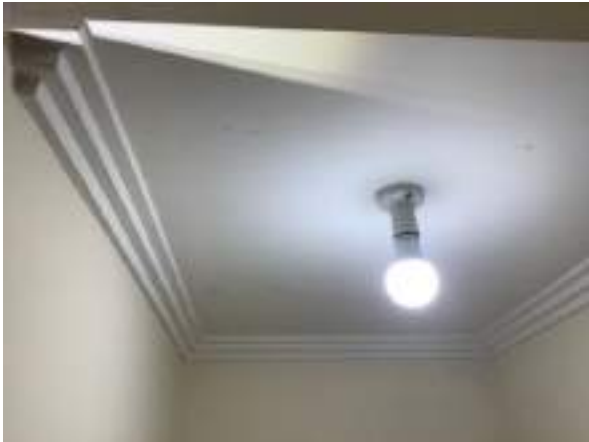
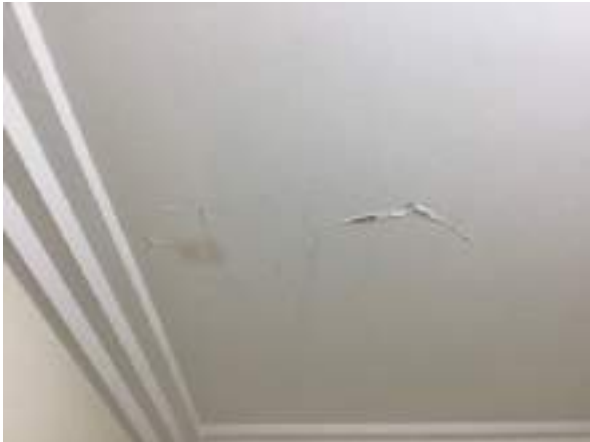
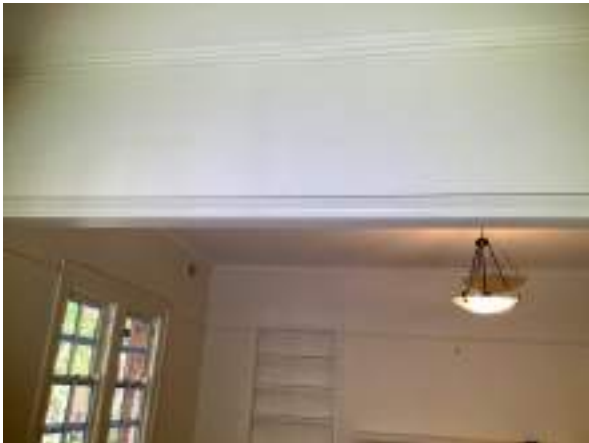
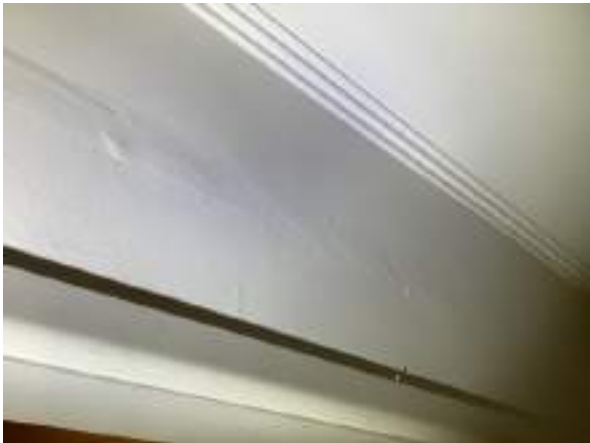
Minor Defect 3.17

Location: Plaster Internal Areas

Relevant tradespeople, such as carpenters, painters and plasterers, should be appointed to perform remedial works, as deemed necessary.

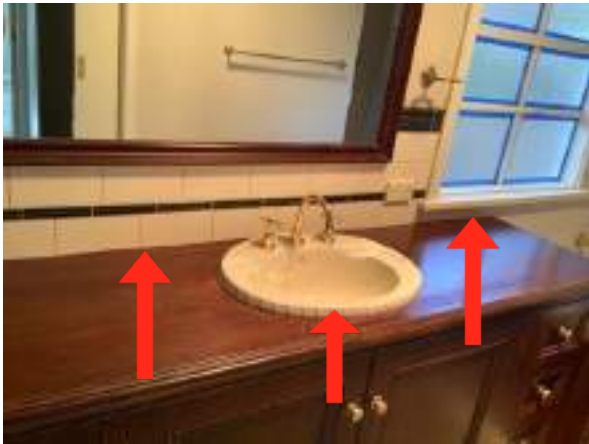
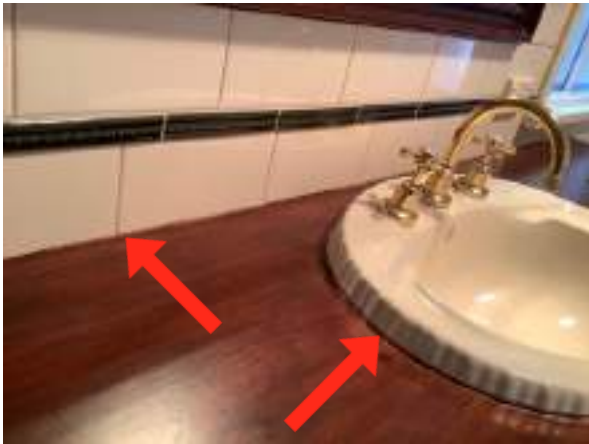
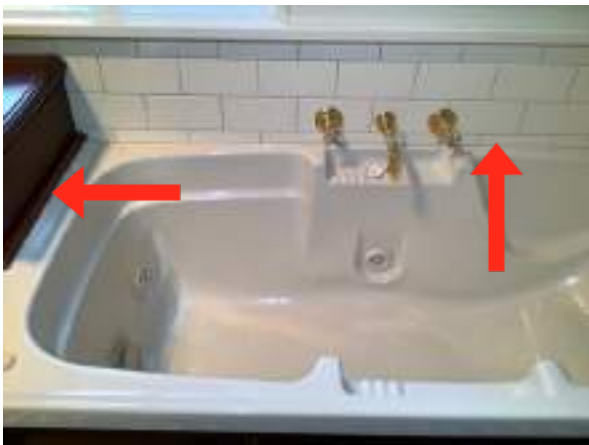
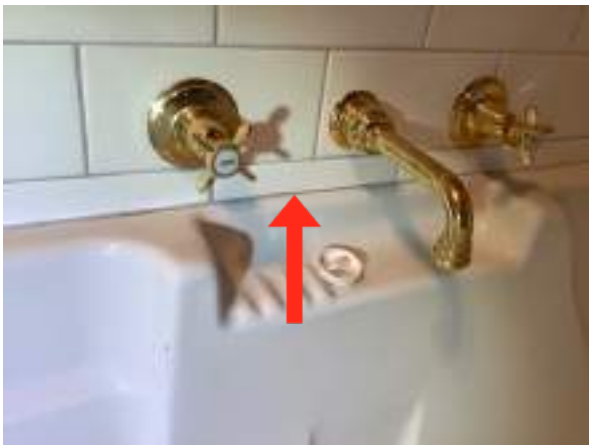
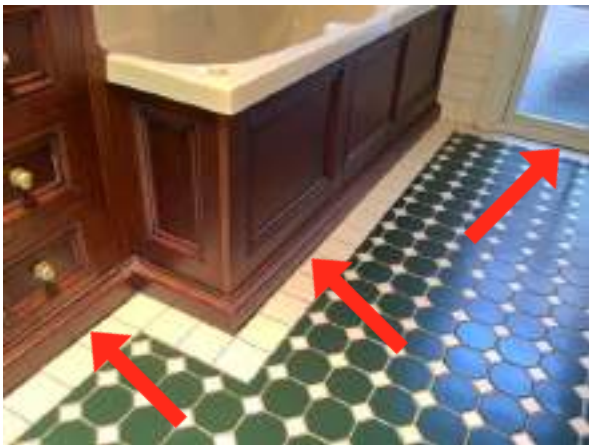
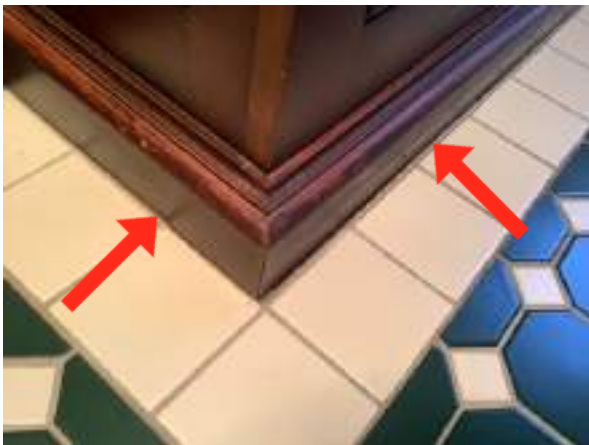
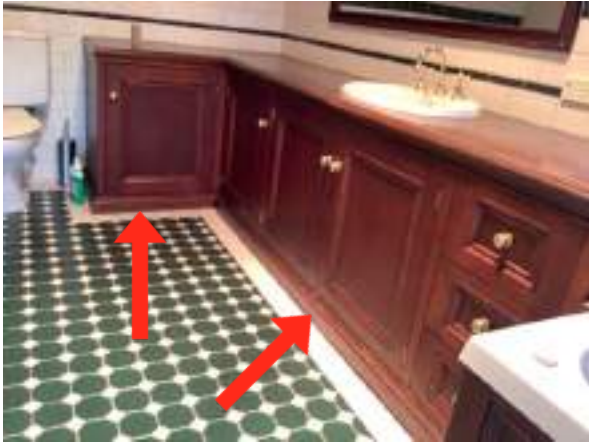
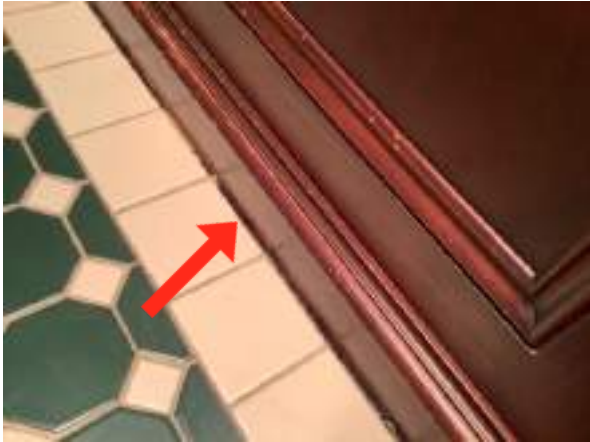
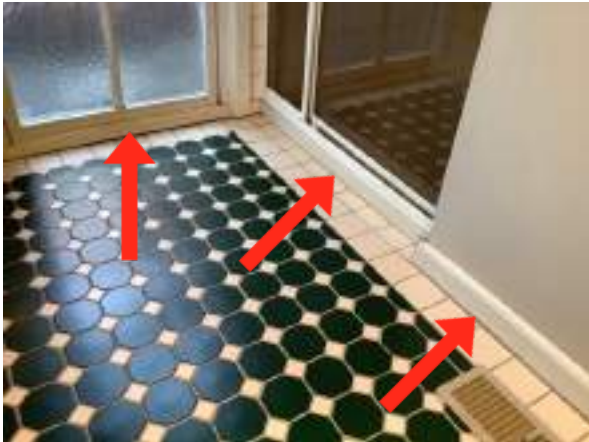
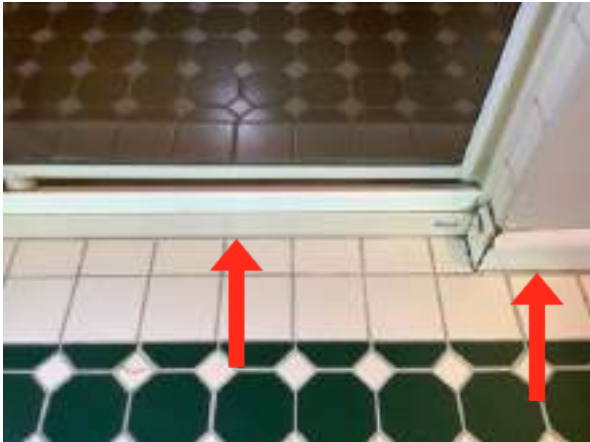
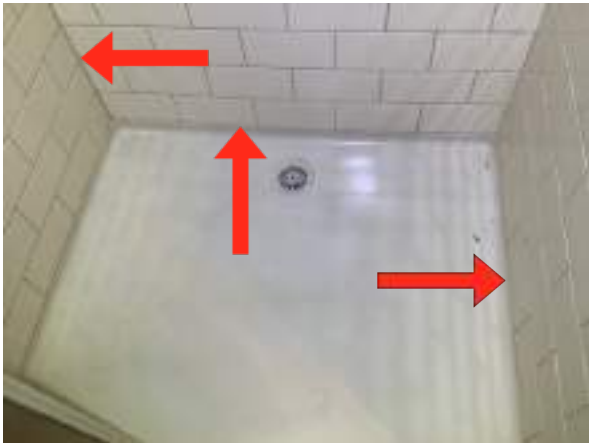
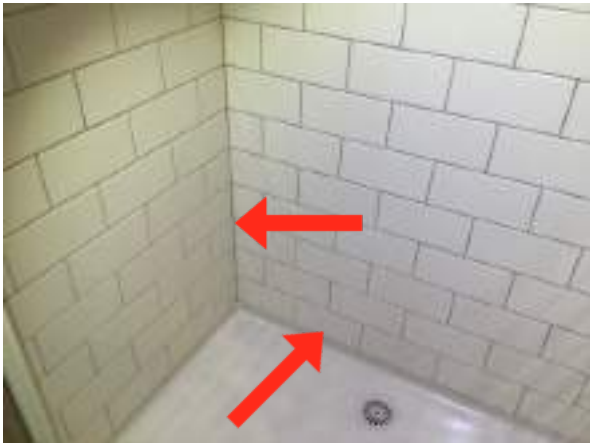
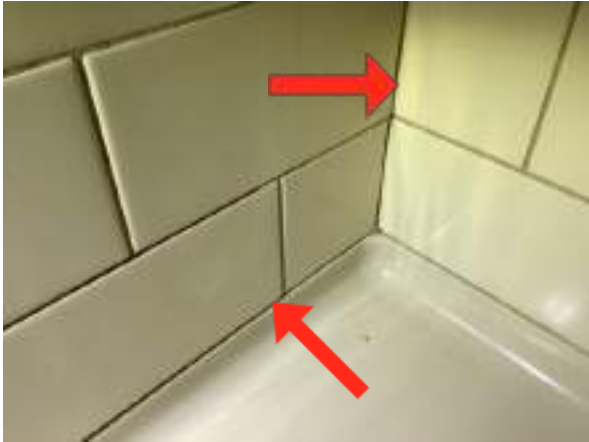
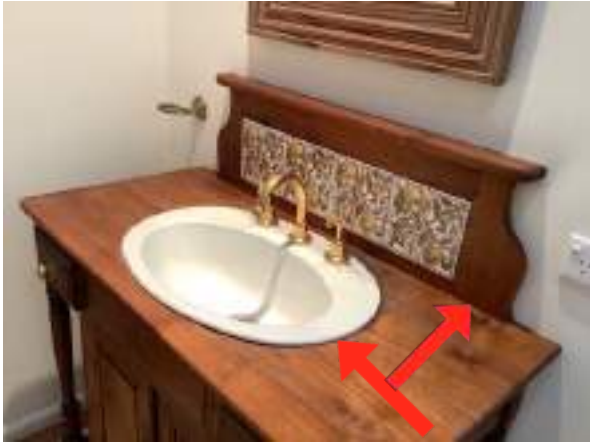
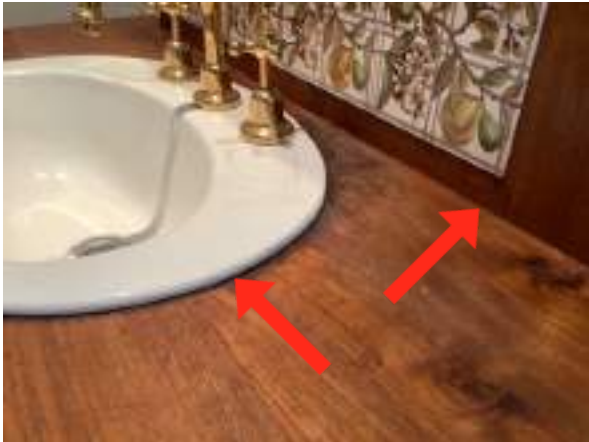
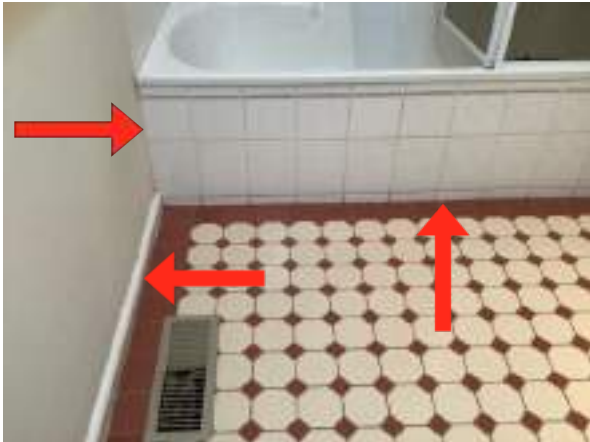
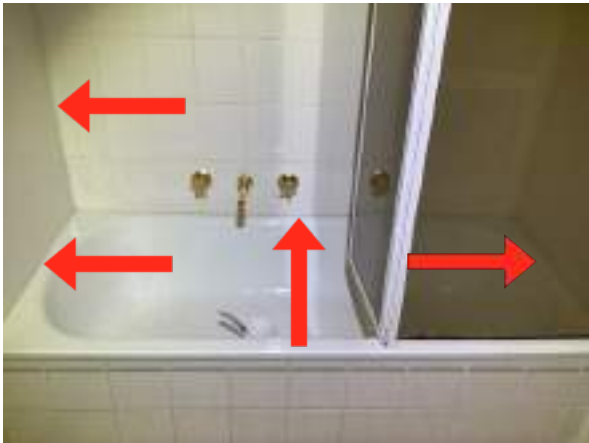
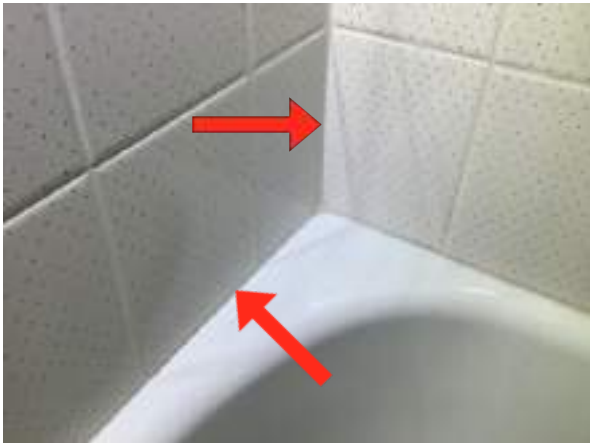
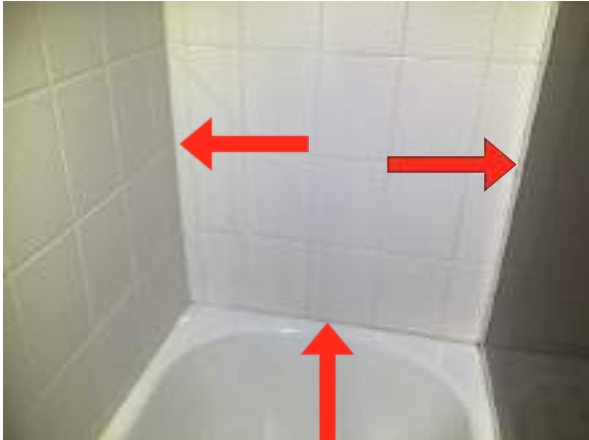
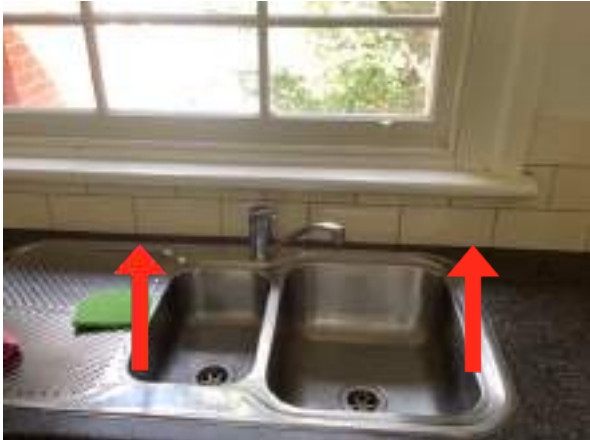
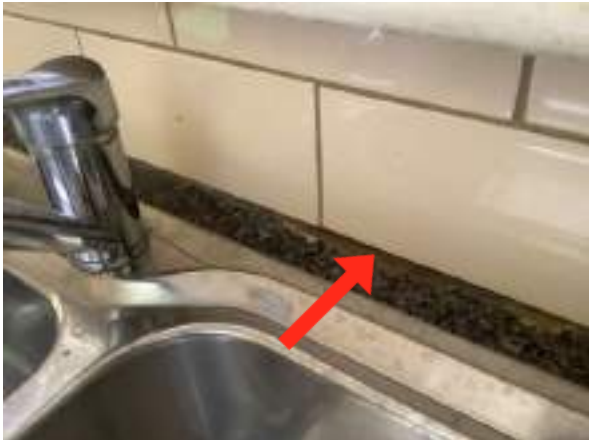
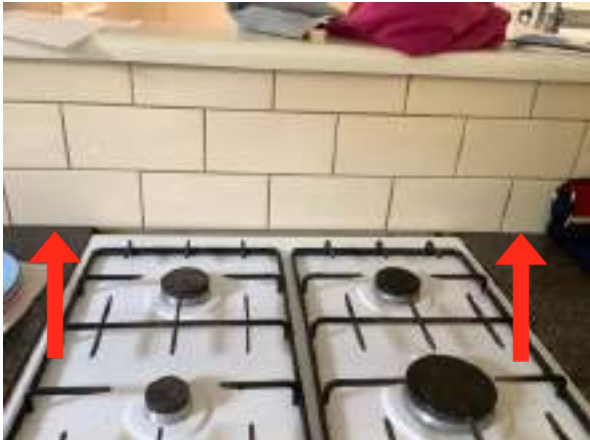
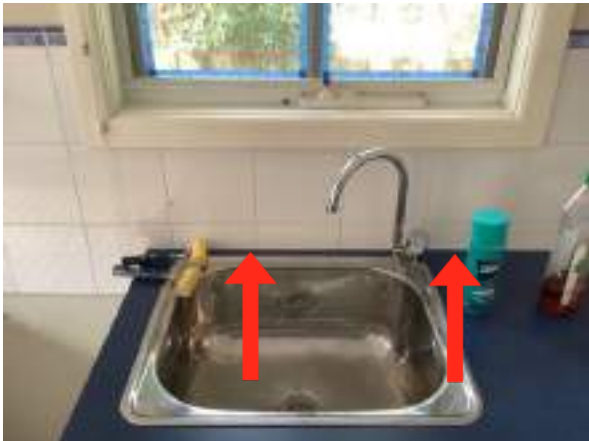
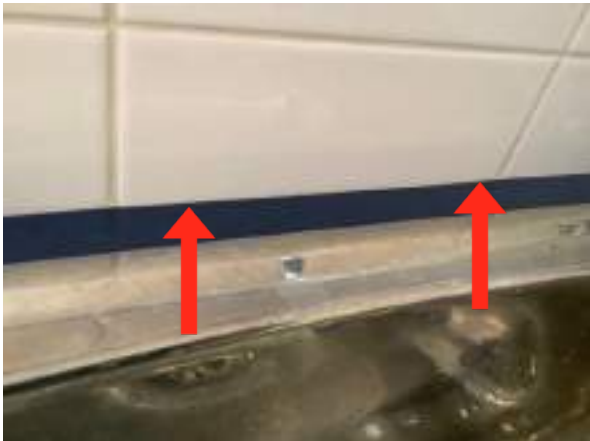
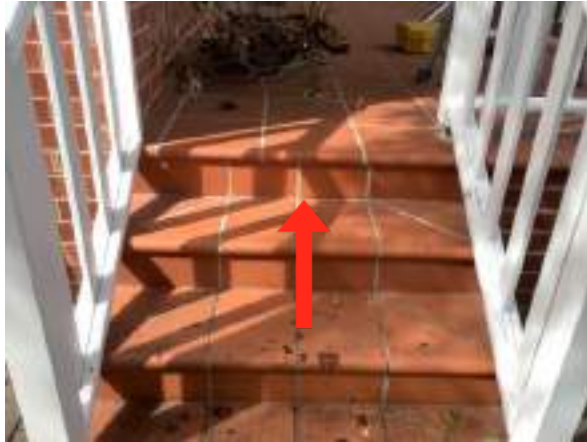
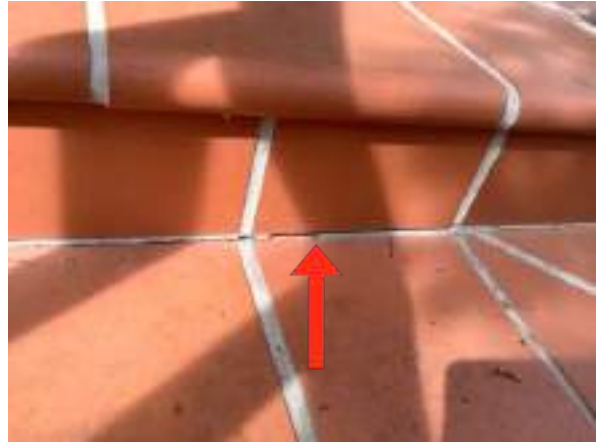
Minor Defect 3.18

Location: Caulking / Silicone-All Wet Areas

Finding: Silicon / Caulking To All Wet Area Junctions and Tile Grouting - Missing or Damaged - Internal Areas

It was noted on inspection that sealant and/or tile grout is missing, damaged or inadequate to the tiled wet areas. This may include floor edges, kitchen benches/splashbacks, vanities, bath tub edges, shower areas to the floor and wall tiles, laundry's and all other areas subjected to water or moisture.

Sealant and/or tile grout where missing, damaged or inadequate to the tiled wet areas allows the water to penetrate into the walls and floors which can cause much damage, to the affect were the damage may become a secondary defect and create a conducive environment for termites and/or cause rotting to the timber studs, floor joists and bearers or plaster etc, especially in showers, baths, laundry and the like

Different materials and floor areas move at different rates, generally causing cracking to grout at this point.

Whilst in some of the areas there is sealant/silicon , it has become apparent that the sealant has deteriorated and/or is just missing.

Whilst in some of the tile mortar is perfect , it has become apparent that the tile mortar has deteriorated and/or is just missing in other areas.

A flexible sealant/silicon and tile mortar should be applied to affected areas to prevent any subsequent water damage that is likely to occur.

Regular maintenance and replacement of damaged or missing sealant and tile mortar is highly recommended to the wet areas, as this is a regular wear and tear defect. Sealant and grouting in areas that come into regular contact with water should be maintained for the long term care of the building in the areas required as water damage is one of the main defects in a building that causes the most damage and without sealant and tile grout always being perfect, secondary defects or secondary damages can start instantly.

A sealant specialist, tiling contractor and/or registered builder should be appointed to assess any damage caused by water to the entire internal, sub-floor, walls etc of the building and clean, take off old sealant and tile mortar, then re-seal and re-mortar these works as soon as possible.

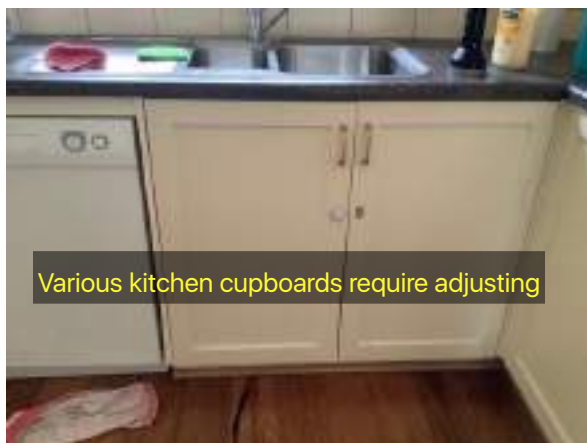
Minor Defect 3.19

Location: Cabinetry / Wardrobe Doors Internal Areas

Finding: Cabinetry - Loose hinges / Re-adjustment
Several cupboard / wardrobe doors are not level and detract from the operational state of the cabinetry and doors.
Upon further inspection, it was noted that the hinges to the cupboard doors have deteriorated or just need adjustment. This as a result over time that they have just come loose or deteriorated from their original fixing.

To improve operation of the affected doors, a general handyman / cabinetmaker/ carpenter may be appointed to replace the faulty hinges and/or adjust .

Such works should be completed at the discretion of the client, but we do recommend repairs so that there is no further damages to the existing cabinets or cupboards.
