Vendors Report (Building & Termite/ Timber Pest)

Inspection Date: 1 Oct 2020

Property Address: Bundoora

Report Type: Property and Timber Pest Report

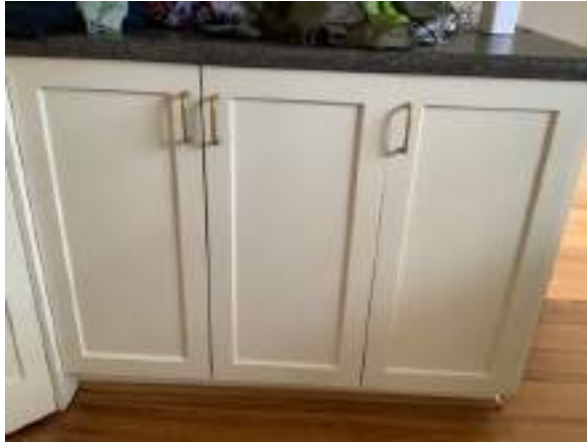
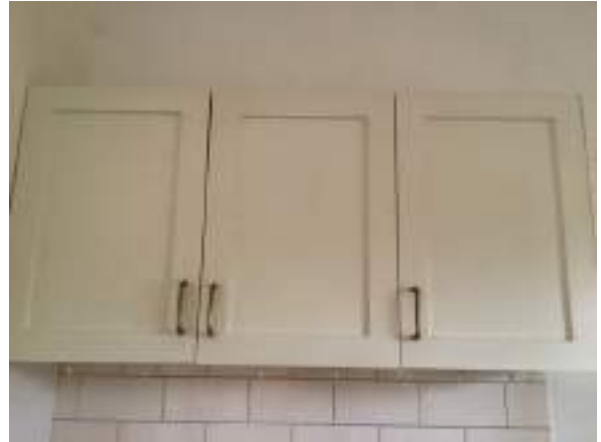
Minor Defect 3.20

Location: Doors - Internal Areas

This is a common defect and is expected in a property of this age, whether being due to substandard installation or general deterioration of the door hardware and sometimes also the associated hinges

If left unattended, further functional impairment is likely to occur.

Readjustment of the striker plate and/or hinges is recommended at client discretion.

A qualified carpenter or general handyperson may be appointed to perform rectification works as necessary, at client discretion.

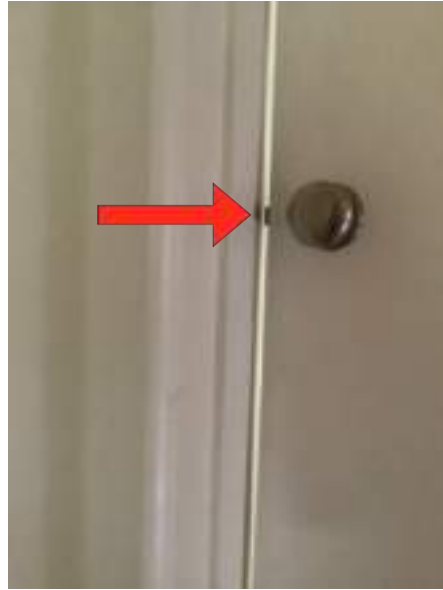
Minor Defect 3.21

Location: Doors - Internal Areas

Finding: Door stop - Missing

The door stop is missing or is inadequate to stop the door handle from damaging the wall. Although some building elements may seem irrelevant or unnecessary, all building elements play a key role in the operation and function of the overall structure and its performance.

Re-installation or replacement of the door stop is advised as soon as possible to prevent any subsequent damage to the door or associated structures.

A general handyman may be appointed to perform these works at client discretion.

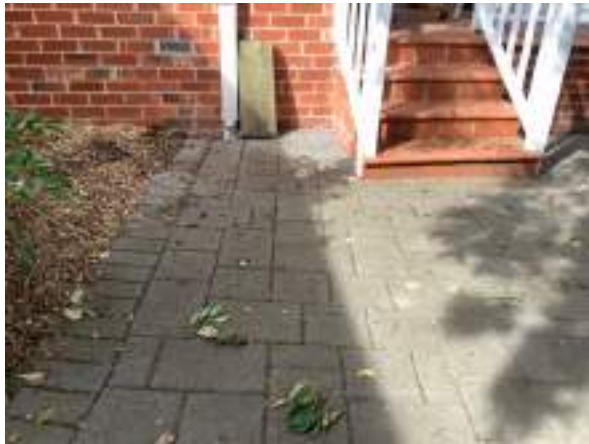
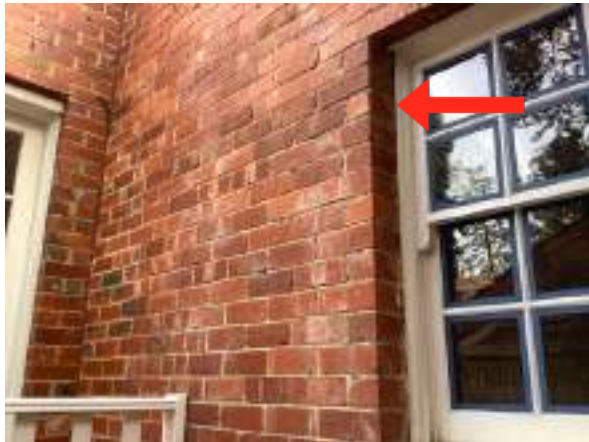
Minor Defect 3.27

Location: Perimeter Of Building - Exterior

It is important to note once caulking these areas if water damage is noticeable to windows, timbers, etc, such as wood rott, it is imperative to engage the appropriate trades for replacement or repairs.

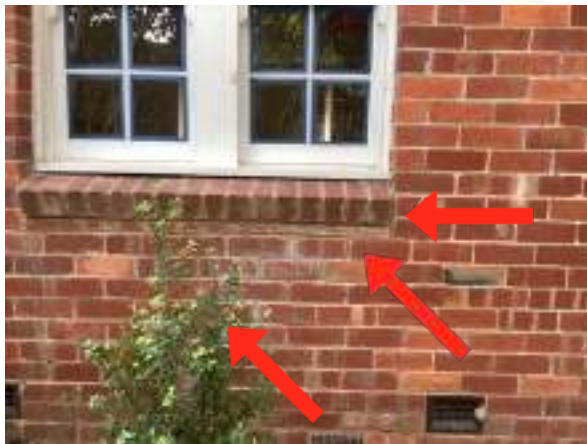
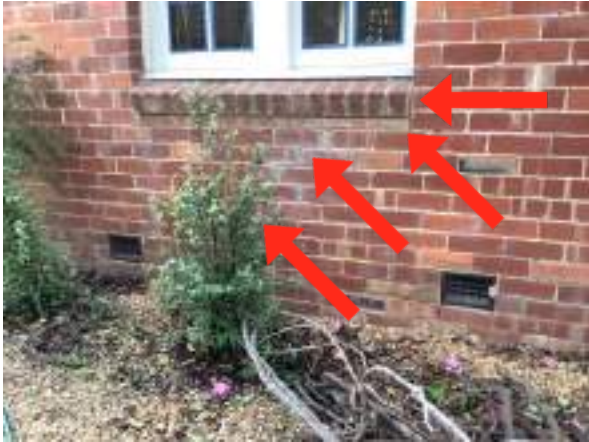
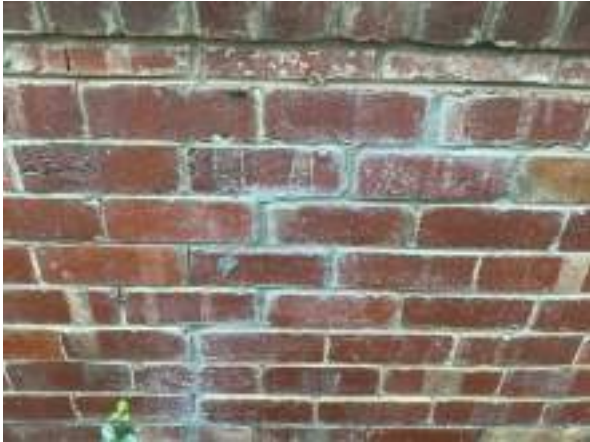
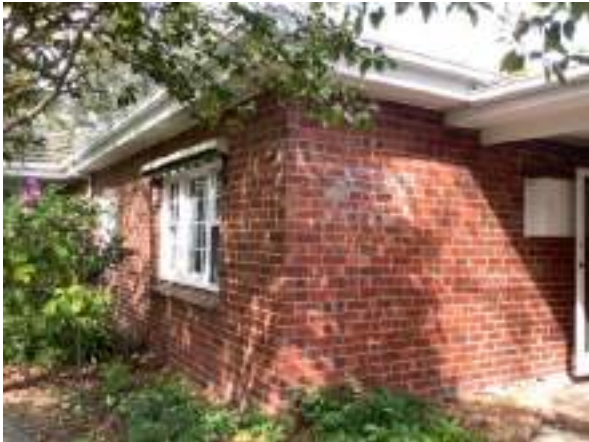
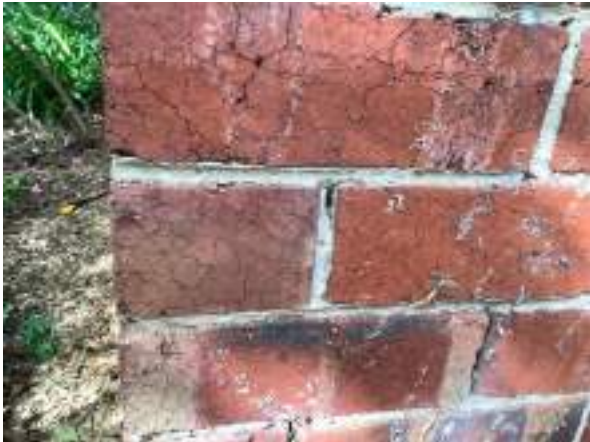
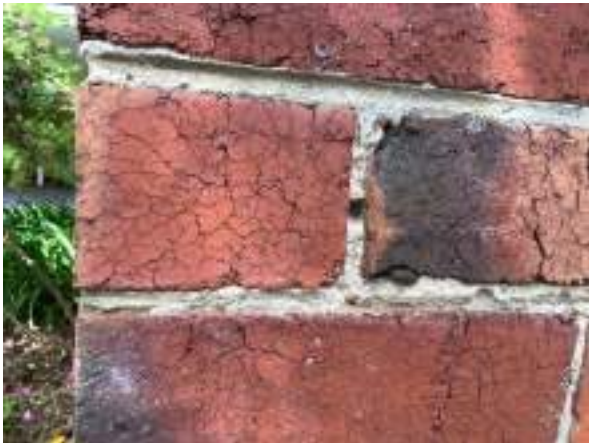
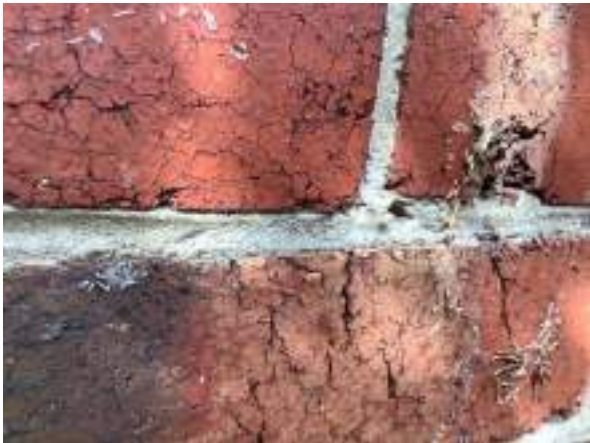
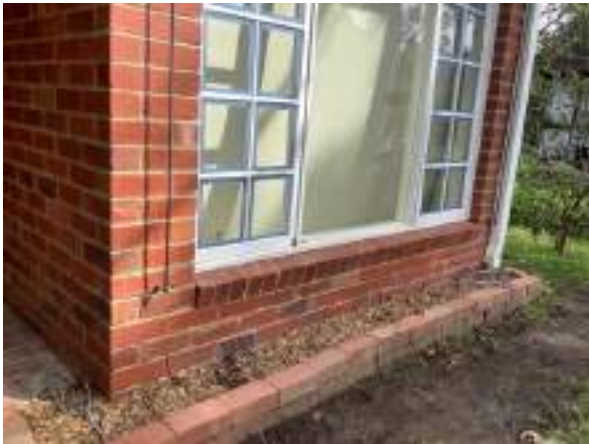
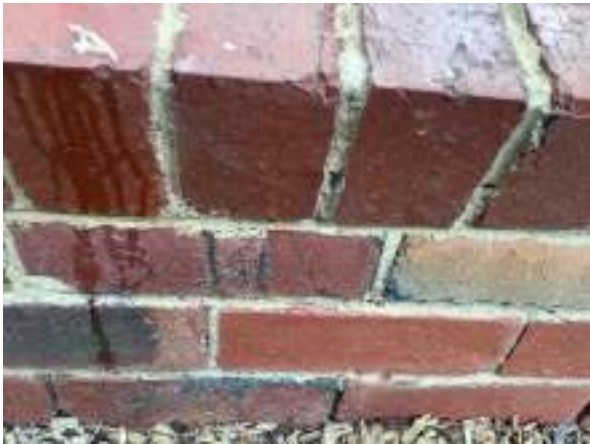
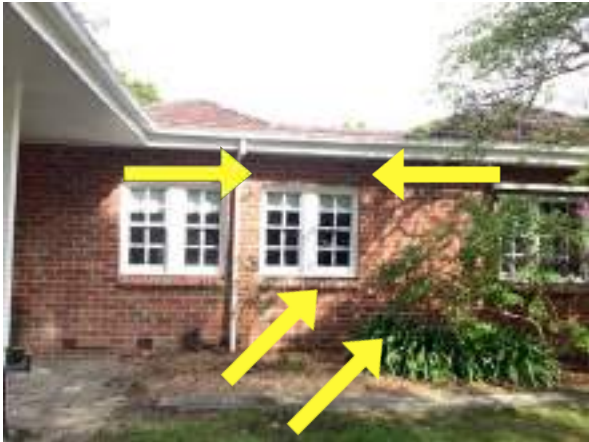
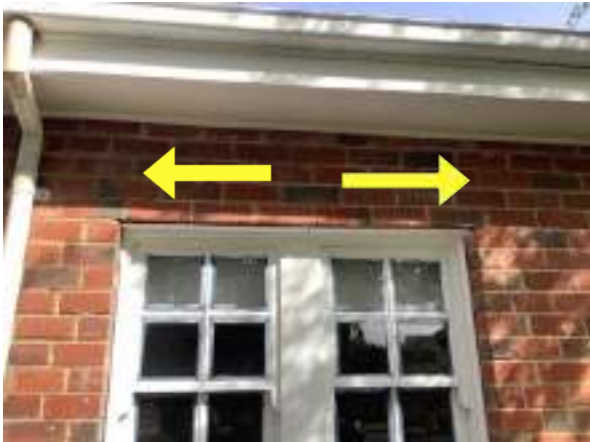
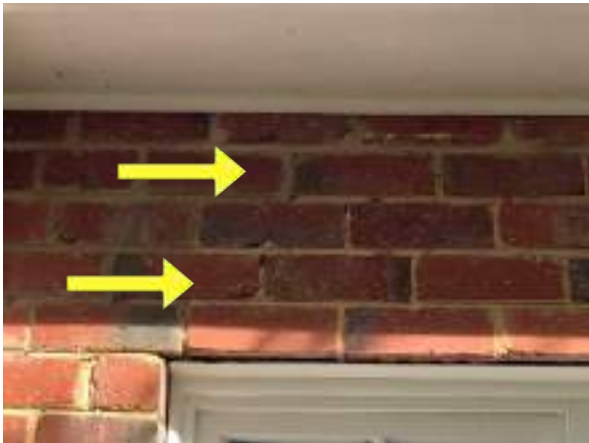
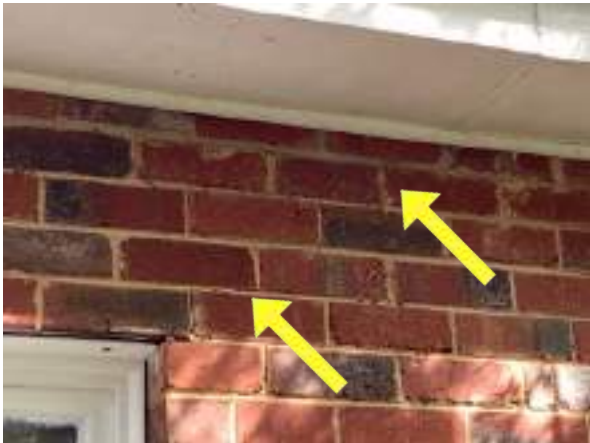
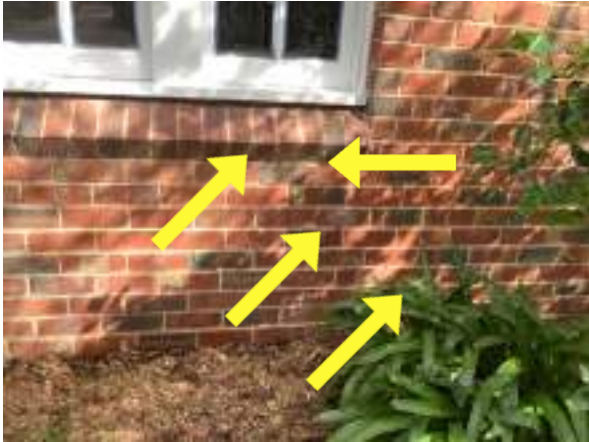
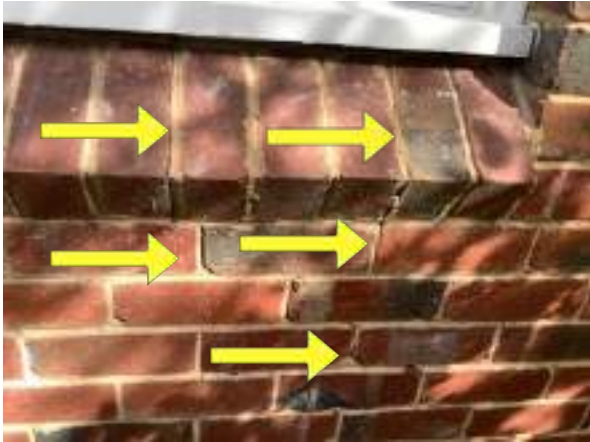
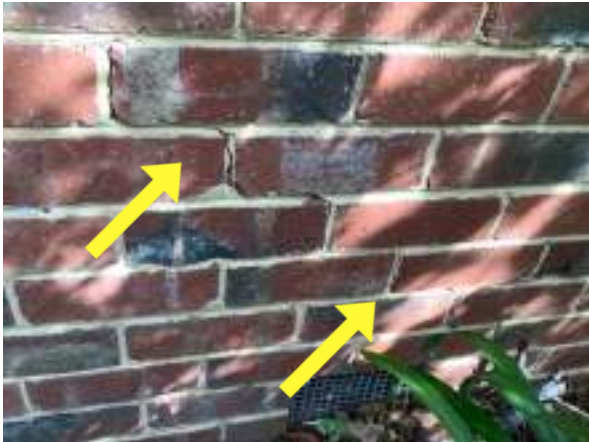
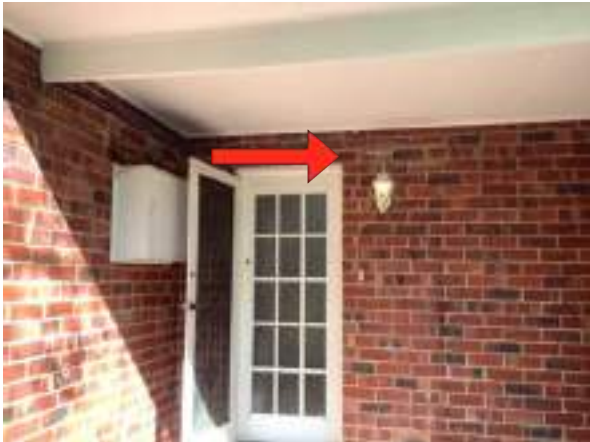
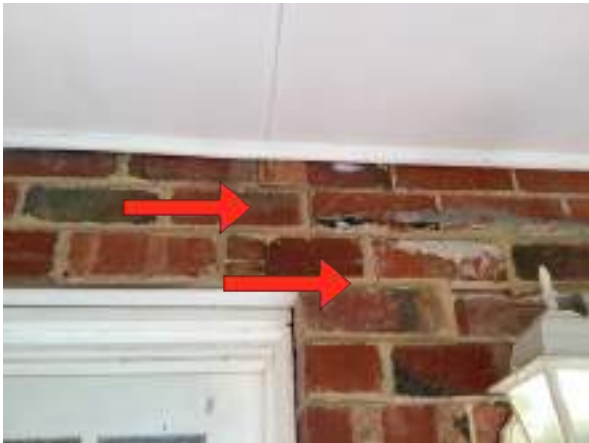
Minor Defect 3.28

Location: Brickwork

Finding: Brickwork / Masonary - Step cracking and minor cracking
There are several cracks and/or step cracking evident throughout the exterior of the property . These cracks are commonly less than 5mm in width.

Although fine cracks are quite noticeable, they are often only considered to be an appearance defect and usually do not indicate any structural damage most of the time. Generally, the cause of a fine crack is indicative of a separation between brickwork and mortar throughout the structure, but single bricks may also show cracks of this nature.

Step cracking, which is similar to other forms of cracking, has a variety of possible causes. However, the most common is the subsidence of adjacent footings.

Step cracking is a relatively common defect, and is most likely to occur adjacent to windows, doors and other openings. Mortar failure in the gaps between affected bricks indicates the stresses and tensions affecting the wall.

Cracking of this nature can generally be repaired with minor filling and should be conducted by a qualified bricklayer and/or registered builder.

Where step cracking is extensive or severe, the client is advised to consult a structural engineer.

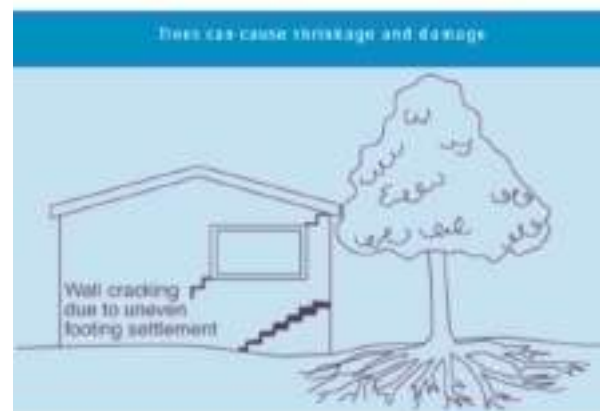
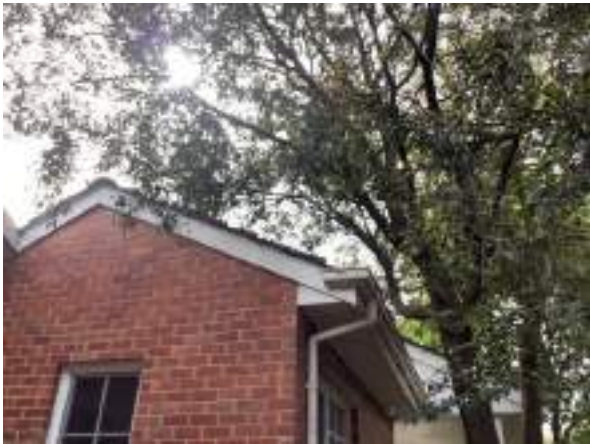
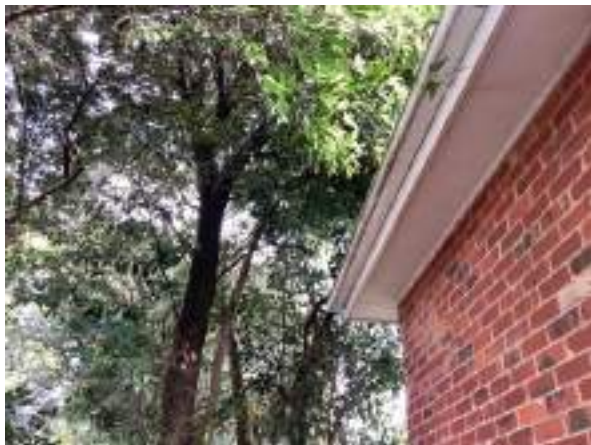
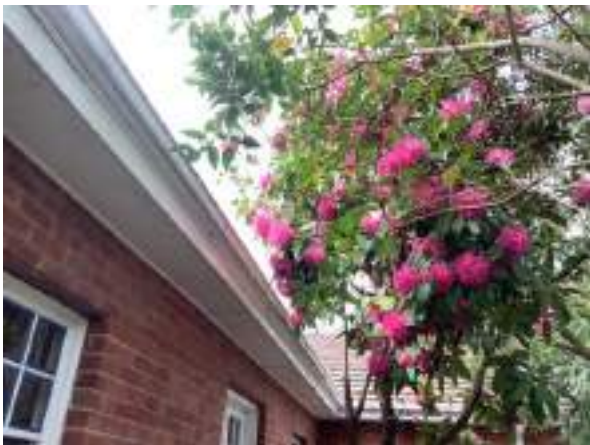
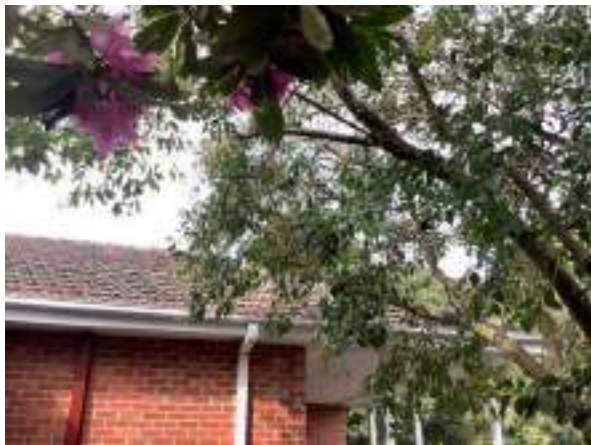
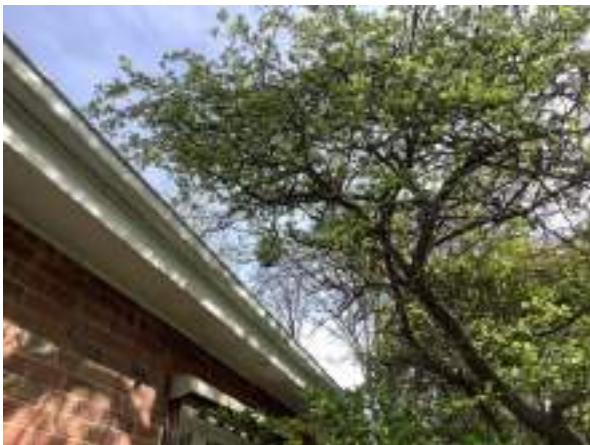
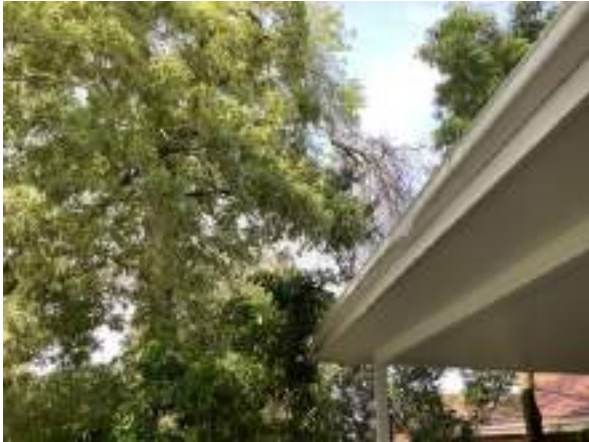
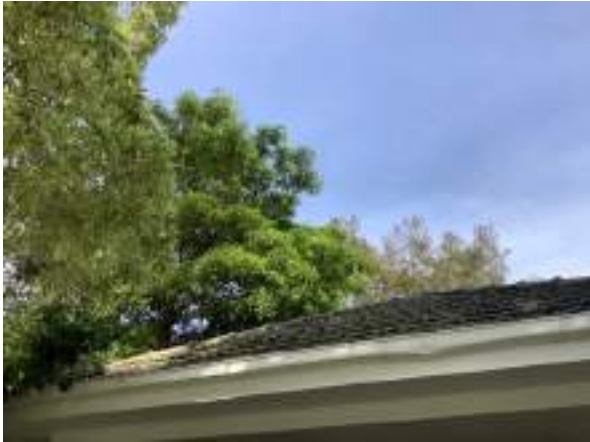
Minor Defect 3.29

Location: Garden Areas - All Areas

Finding: Garden trees - Overhanging and filling gutters
PLEASE NOTICE THE ATTACHMENT PICTURES TO THIS DEFECT STATEMENT;
H = the height of the tree at its full potential height, not its height today.
D = the distance from the tree to the building at the trees full potential height.
D = varies pending on one tree to 4 trees or more.

Gutters are a critical part of the building's management of storm water and rain. It is therefore important that they be kept clear to prevent secondary damage to associated building elements, including exterior and interior walls, ceiling linings and any adjoining building elements. Where gutters are blocked, pooling of rainwater is likely to occur, fast-tracking rust and corrosion of the roof plumbing elements.

It is highly advised that all overhanging tree branches be removed as soon as possible to prevent any further damage. Repair and/or replacement of sections of damaged guttering may also be required where the extent of the damage necessitates.

Such works should be performed by the homeowner; however, appointment of a landscape contractor or an arborist may be required. Consultation with a licensed roof plumber is required where guttering has been damaged.

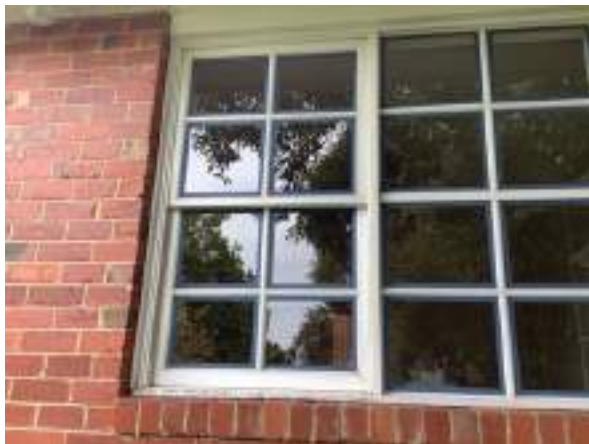
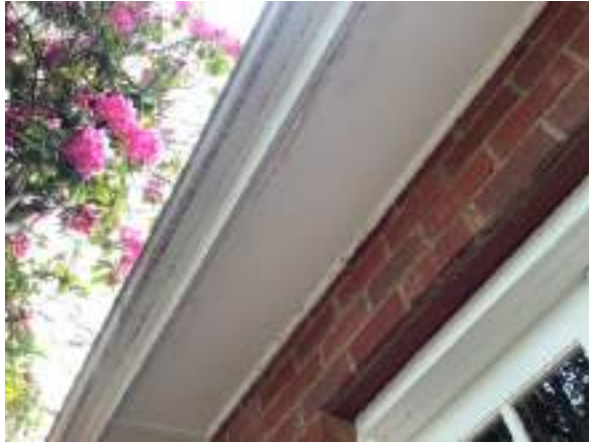
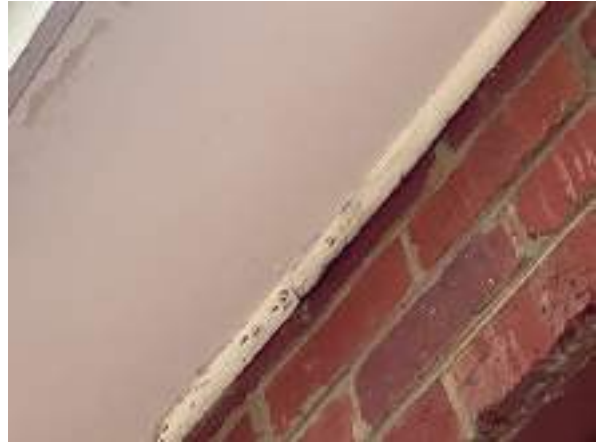
Minor Defect 3.30

Location: Timber Work - All External Areas

Finding: Timber, exposed to weather / External painting deteriorated
Much of the external paint work including but not limited to windows, fascias, guttering, veranda and other external fitments have been neglected and require attention to prepare and re paint.
External timbers that are frequently exposed to harsh weather conditions require adequate protection (paint) in order to maintain their condition. Where timbers have not been painted or treated adequately, general deterioration is likely to occur at an accelerated rate.

Whilst incomplete or missing paint finish is generally an appearance defect, it can also lead to the development of secondary building defects over time. Incomplete areas of paint finish exposes the area to moisture, potentially accelerating the deterioration of underlying building materials.

Degraded paint finishes should be sanded back, filled, leveled and painted, as applicable. Where inadequate or missing paint protection has led to the deterioration of the associated building element, repair and/or replacement of this building element may be required.

If left unattended, replacement of these timbers is likely to be necessary in the short-term future. Adequate treatment of these timbers is required as soon as possible by a painting contractor should be appointed as soon as possible to perform necessary works to aid the appearance of the affected area and to ensure the area is protected against further deterioration. Alternatively, the homeowner following manufacturer instructions may perform these works.

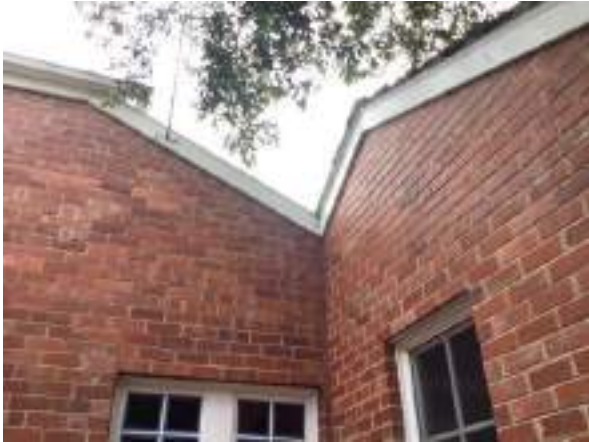
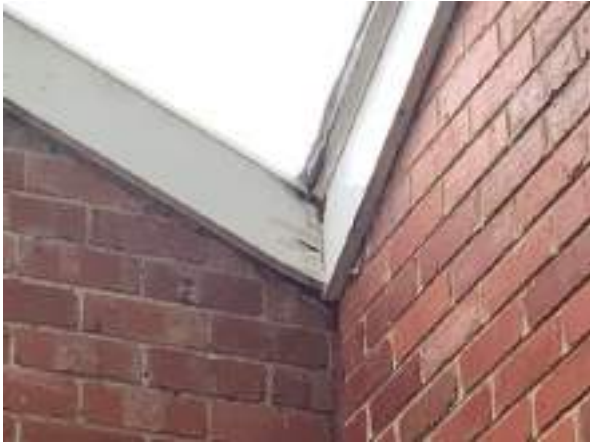
Minor Defect 3.31

Location: Timber Work - All External Areas

Finding: Fascias - Wood rot

Wood rot was found to be affecting fascias and barges in this area, evidenced by the presence of mould on the surface in some areas.

Wood rot, also known as Fungal Decay, occurs when timbers and other cellulose building materials are exposed to damp conditions on an ongoing basis.

It is likely that this wood rot has developed as a result of faults in the roof plumbing, creating excessive moisture in this areas.

Frequent exposure to rain and other weather conditions also make fascias and barges susceptible to accelerated deterioration.

Early intervention and regular maintenance will prolong the useful life of these building elements. Prior to any works being performed, the cause of the moisture that has created the visible wood rot should be identified and addressed in a suitable manner.

Replacement of affected fascias and barges may then be a necessary step in protecting surrounding building elements from such deterioration.

A qualified plumber may be appointed to assess the cause of excessive moisture and to provide advice on any remedial works as required. A qualified carpenter or registered builder may also be required to replace affected building materials.

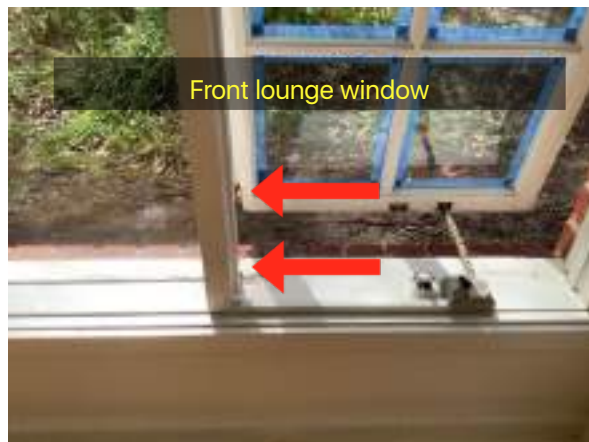
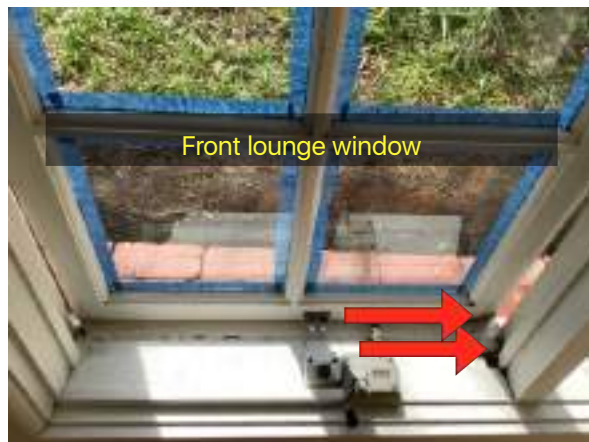
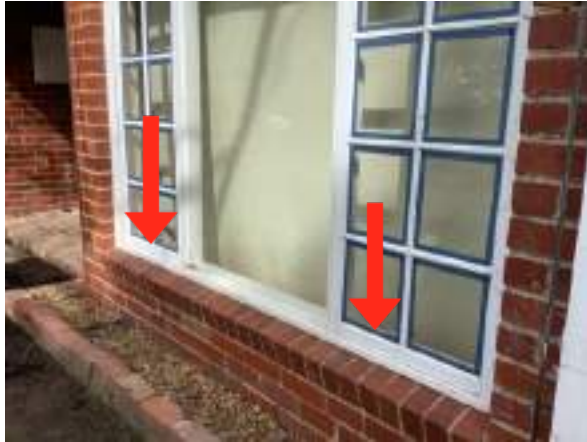
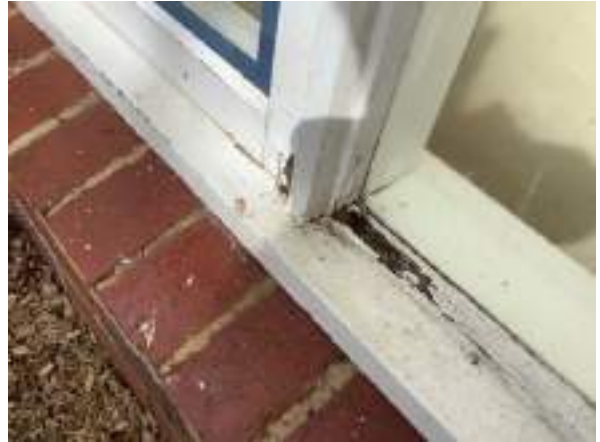
Minor Defect 3.32

Location: Windows - External

Finding: Windows - Wood Rot

Repair and/or replacement of affected window frames may be a necessary step in protecting surrounding building elements from such deterioration. Remedial works should be performed by a qualified carpenter or registered builder as soon as possible to prevent any further damage.

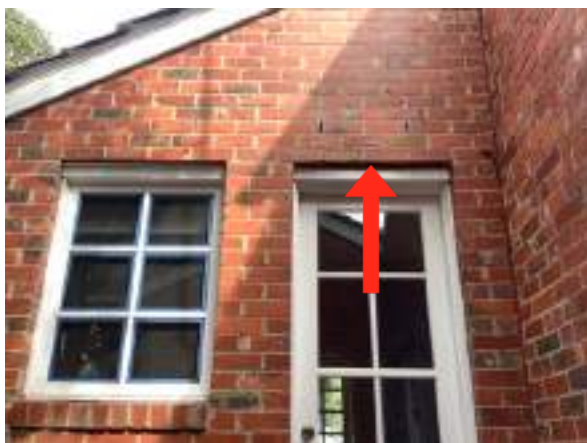
Minor Defect 3.33

Location: Lintels - Above All Exterior Openings.

Rusting and corrosion should be managed by ideally removing or limiting the affected surface from exposure to moisture.

A registered builder may be appointed to replace any building elements that have been severely affected by rust or water damage.

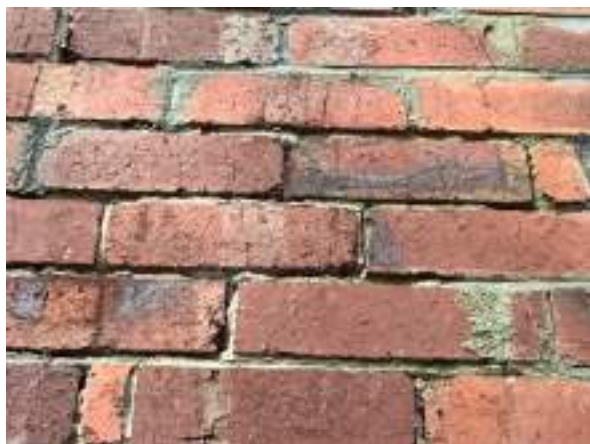
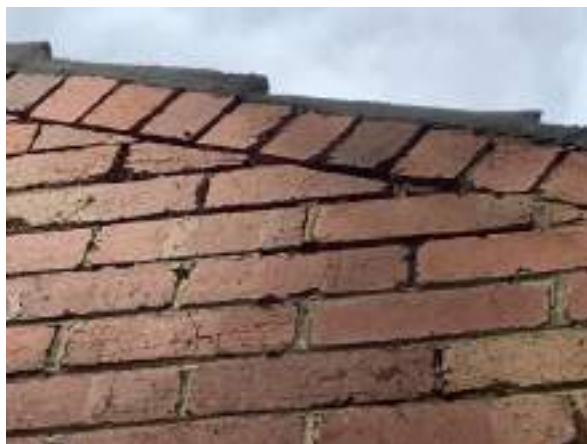
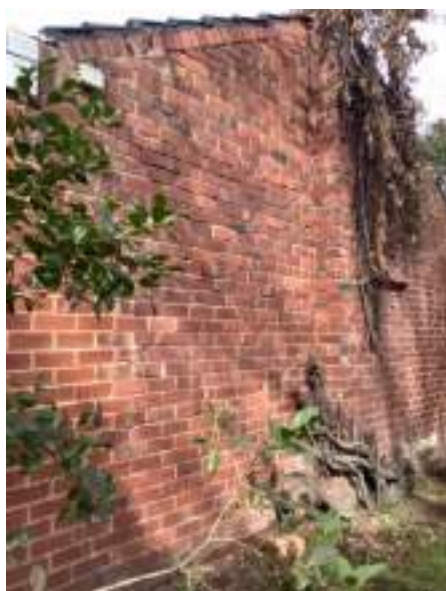
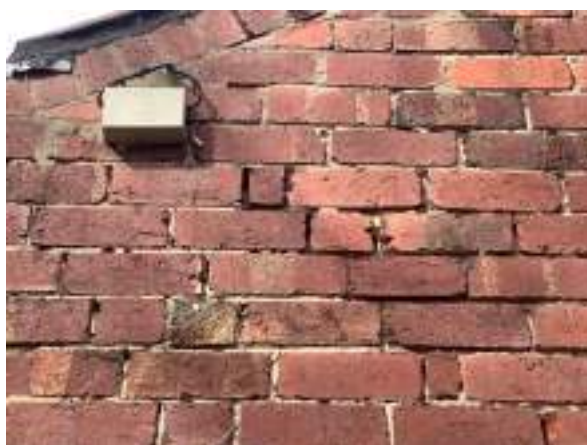
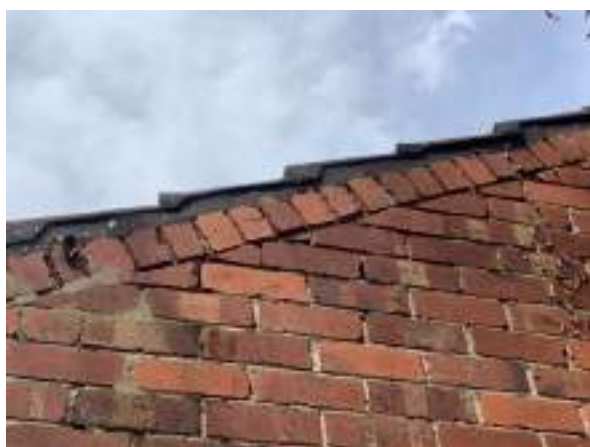
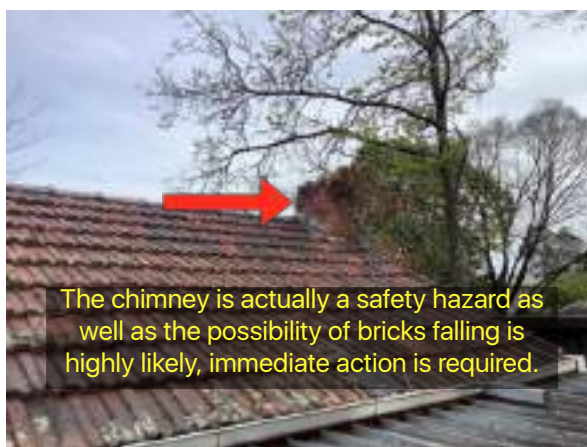
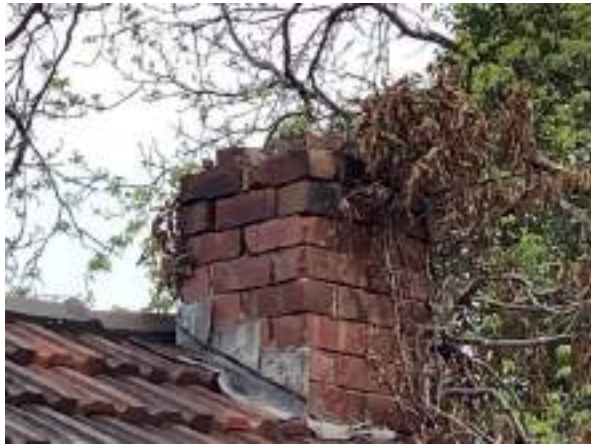
Minor Defect 3.36

Location: Side Of Building

Finding: Brickwork - Deteriorated mortar - Minor

The mortar is deteriorating, into the brick mortar joints, however at this stage, it does not appear to be deteriorated at a level that is a structural concern.

This generally occurs as when the building was built, the bricklayers used to put a special chemical adhesive into the brick mortar mix as a waterproof, however it is now become apparent that over time on some homes the chemicals are eating into the brick mortar and this will continue in some cases, so I highly recommend that this item be monitored over time by an appropriate and competent person.

Mortar, or 'bedding', is the material which fills joins and intersections between bricks in masonry walls and structures. Sections of mortar in this brickwork were identified as having deteriorated, which is generally expected for a property of this age and condition.

Mortar may deteriorate as a result of age of building materials, minor movement of bricks, or frequent exposure to weathering. Mortar should be replaced to ensure that bricks remain in their intended location and to prevent gaps, which would allow water or moisture ingress and secondary damage as a result.

Mortar deterioration can be addressed by a bricklayer where areas of deterioration are localised and easily accessible. Alternatively, appointment of a registered builder is advised, to repoint large areas of decaying mortar.

Where secondary structural defects have become evident, consultation with a structural engineer may be required.

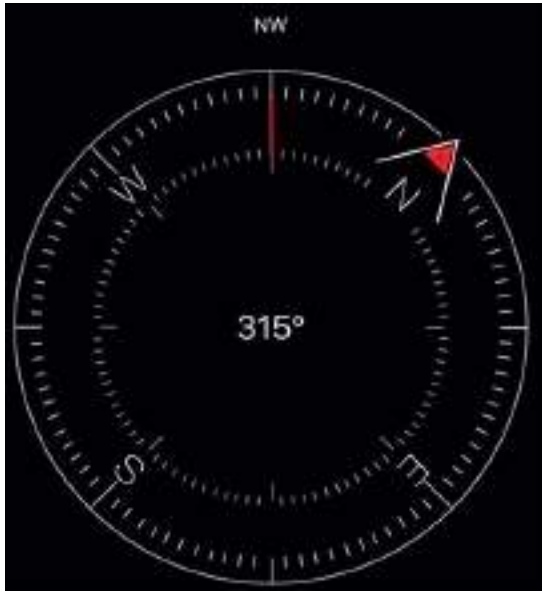
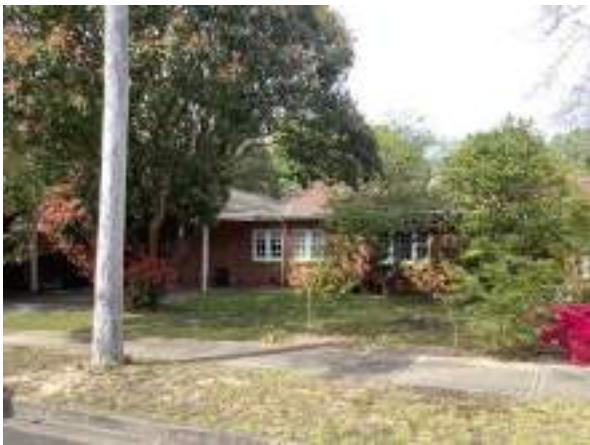
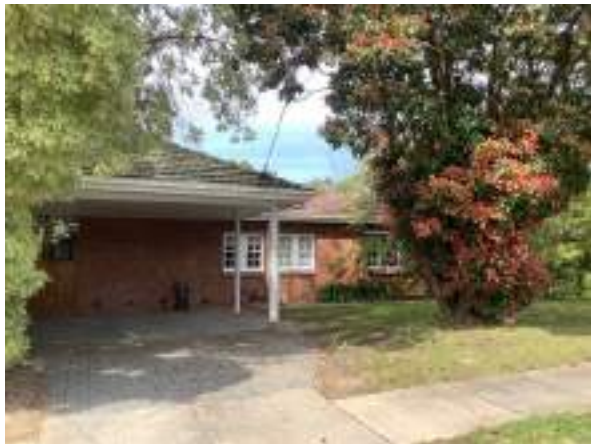
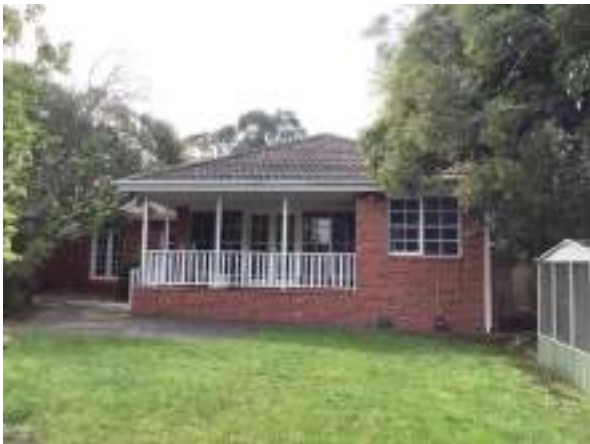
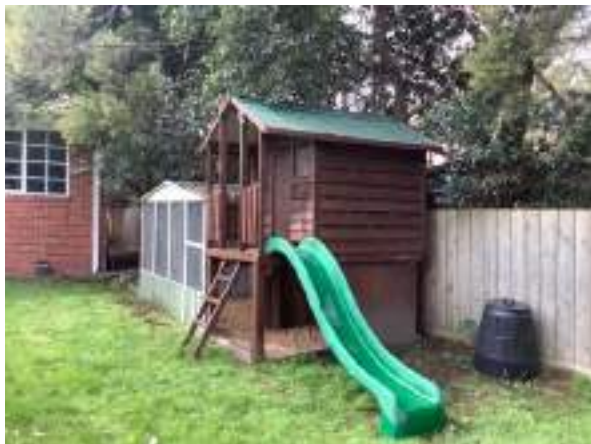
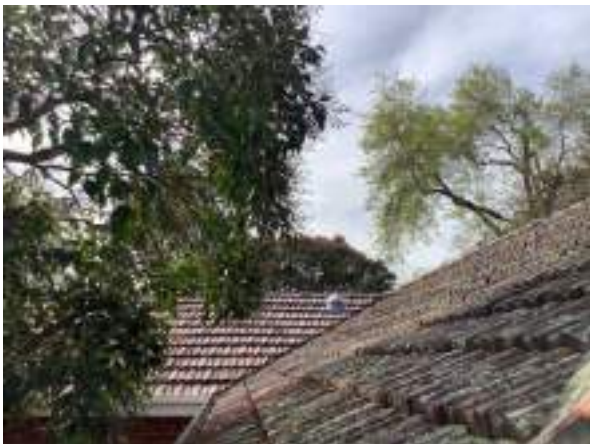
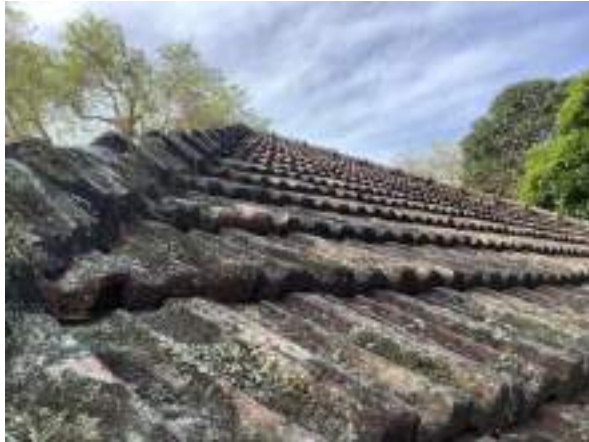
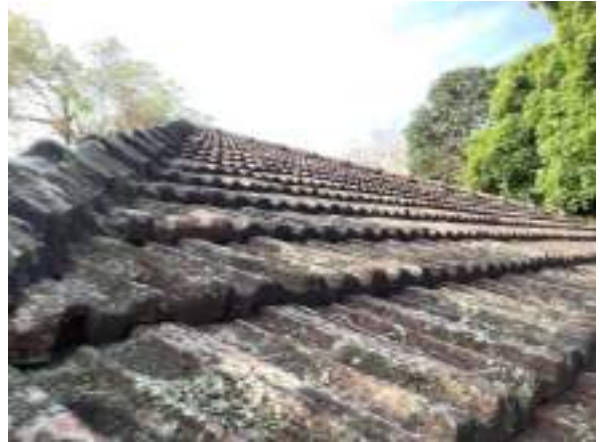
Location: For Your Information

Finding: General Site Photos
General site photos and other areas of interest are provided for your general reference.

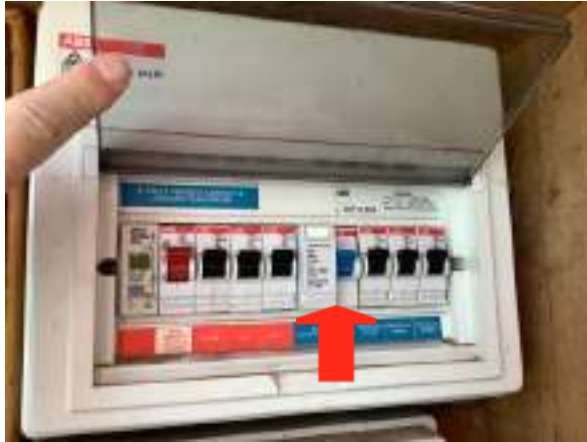
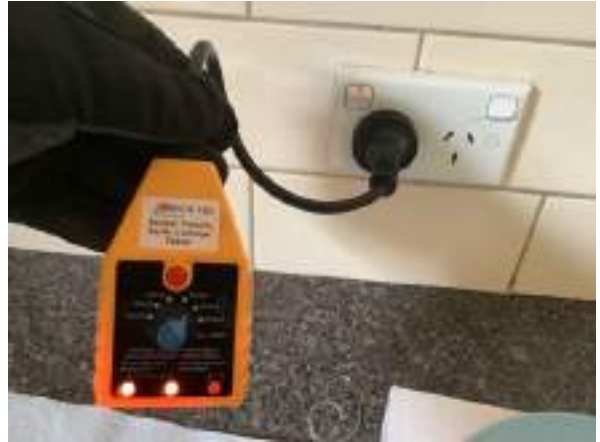
For your information 4.42

Location: The Site

These tests all passed the AS 3000 requirement and exceptance level.

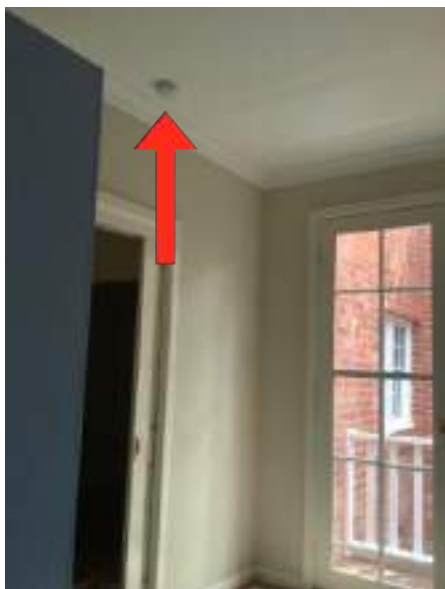
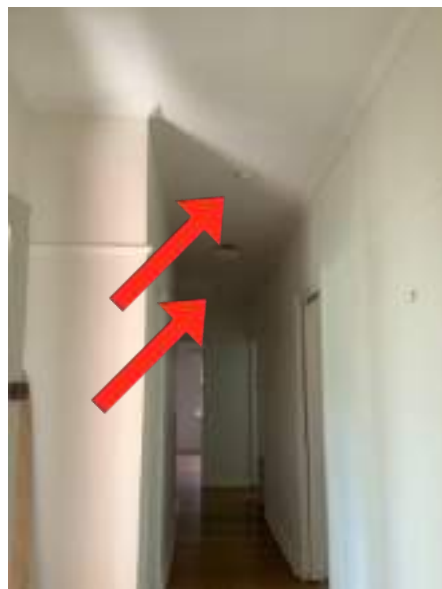
For your information 4.43

Location: The Site

Testing of smoke detectors is required monthly.

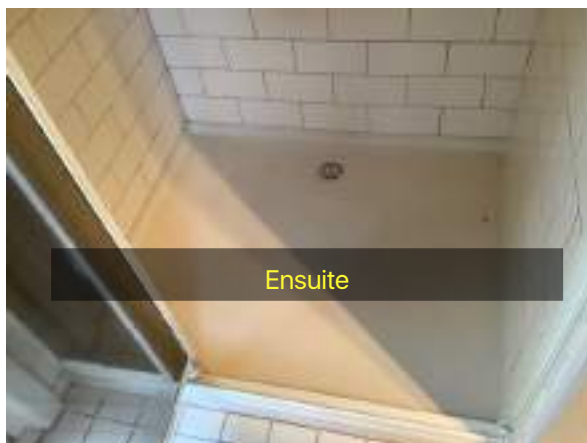
For your information 4.44

Location: Shower Base - Drummy

Specialist trades are available for these types of services.

A registered builder may be required to undertake works if damage is extensive or if secondary building defects have resulted. Otherwise, it is advised that a suitable trade be appointed to perform works as necessary. Immediate action is recommended to ensure that no further damage is sustained in the affected area.

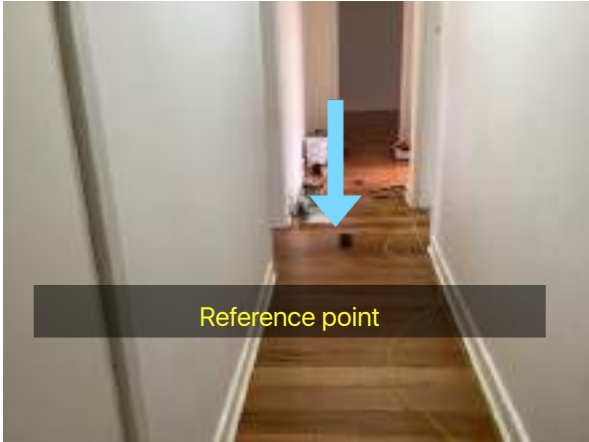
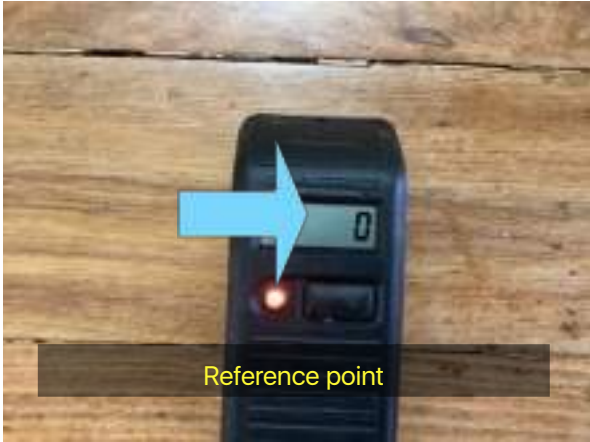
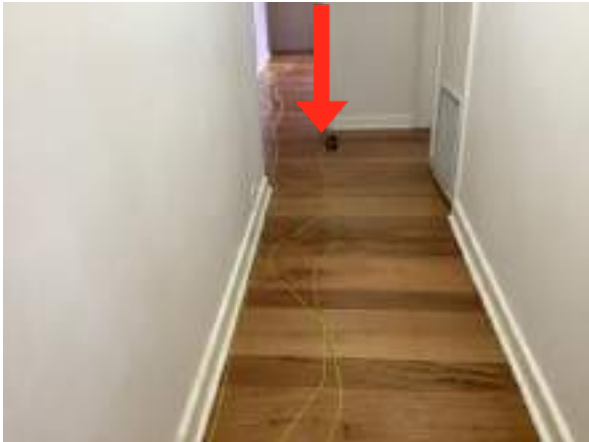
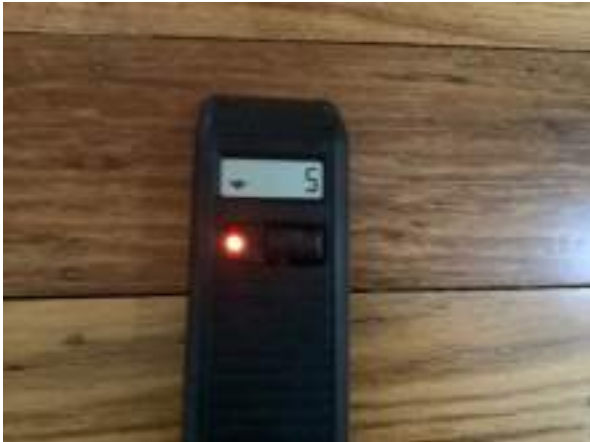
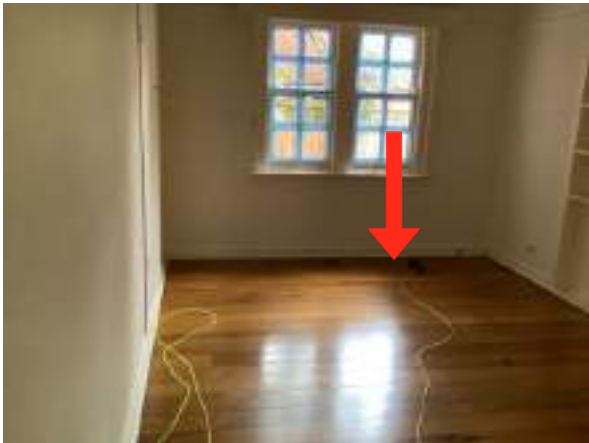
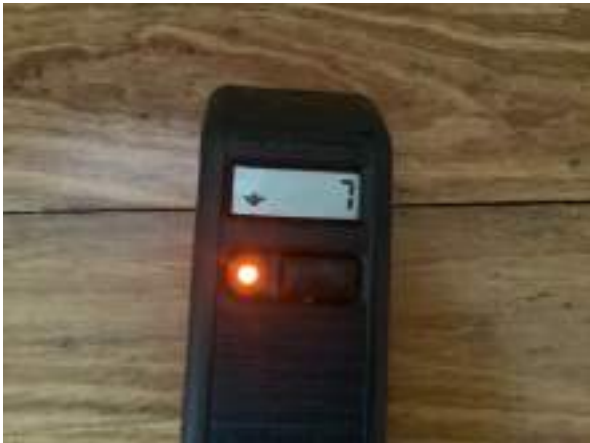
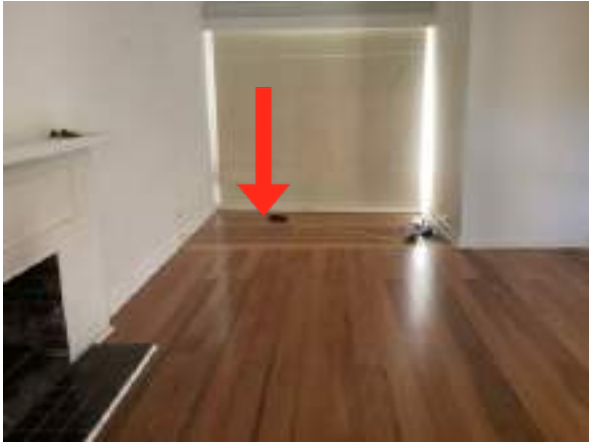
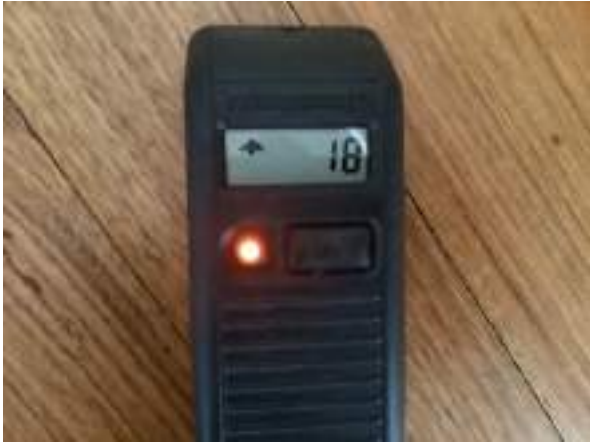
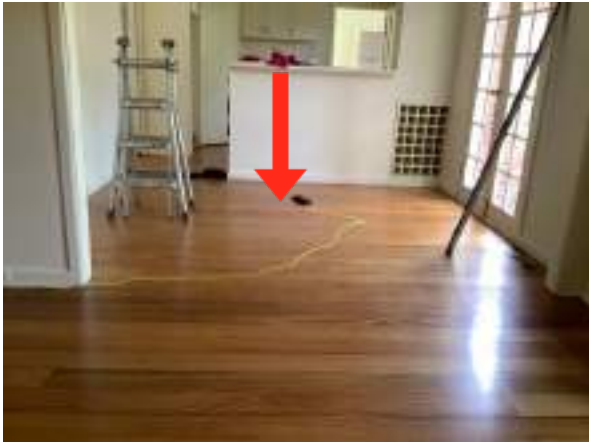
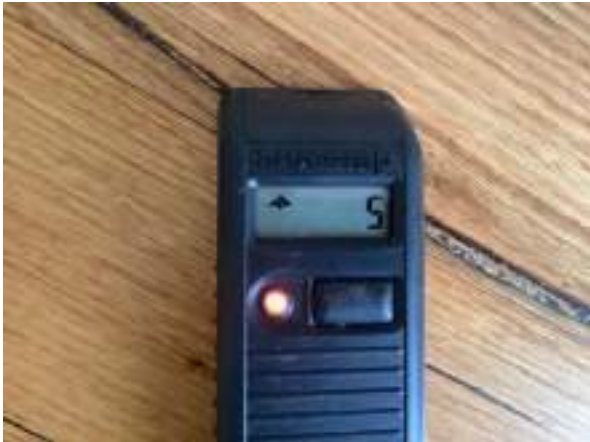
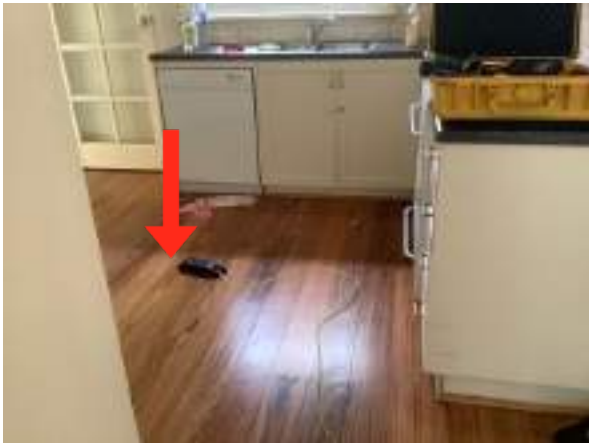
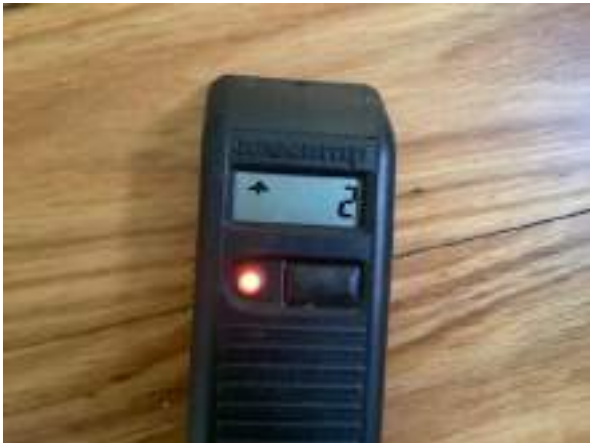
For your information 4.45

Location: Flooring - All Areas
Finding: Flooring Levels—Acceptable
DIGITAL ELECTRONIC FLOOR LEVELLING ASSESSMENT.

Whilst there are some areas that are close to the levels that are not acceptable, generally older homes do have these type of levels, which are due to ground movement, ground change and timber shrinkage.

We advise that the flooring be closely monitored to identify any movement over time. Where flooring remains relatively unchanged for an extended period of time (i.e. several months or seasons) it is likely that the flooring is relatively stable, however unexpected movement of the foundations of the property can happen at any time.
