Vendors Report (Building & Termite/ Timber Pest)

Inspection Date: 1 Oct 2020

Property Address: Bundoora

Report Type: Property and Timber Pest Report

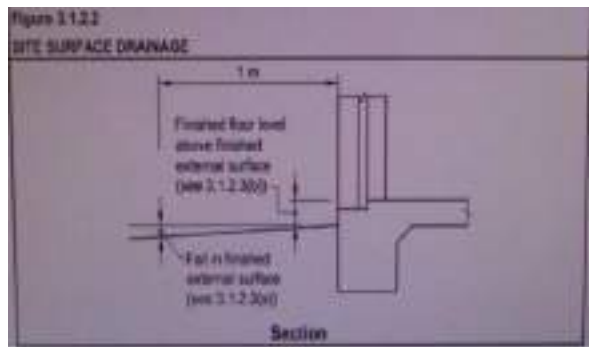
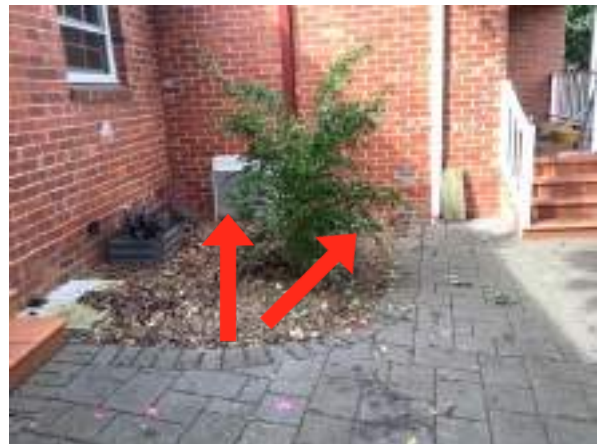
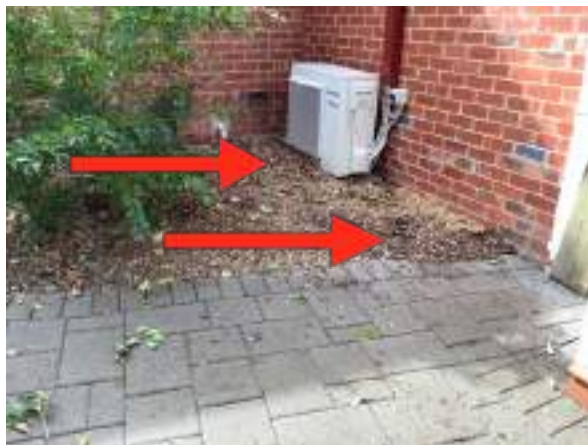
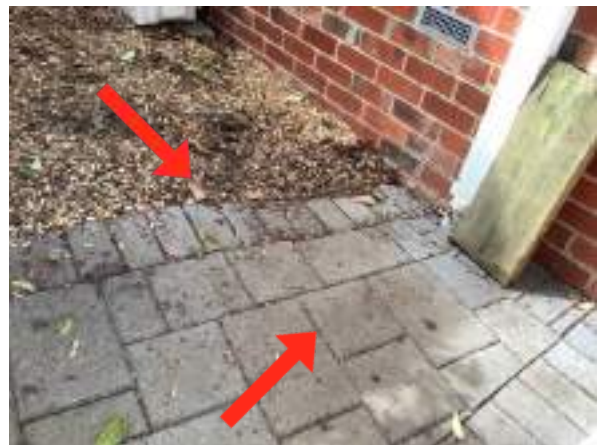
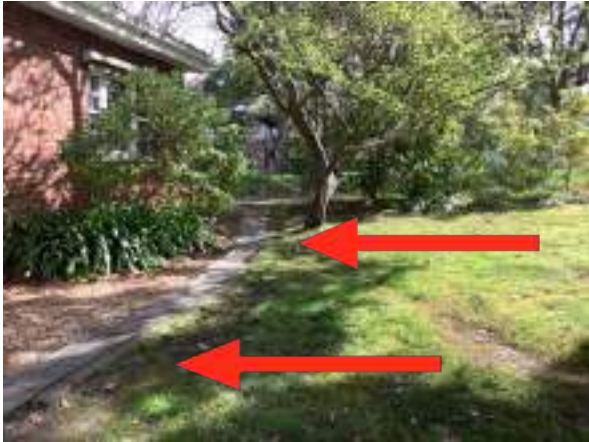
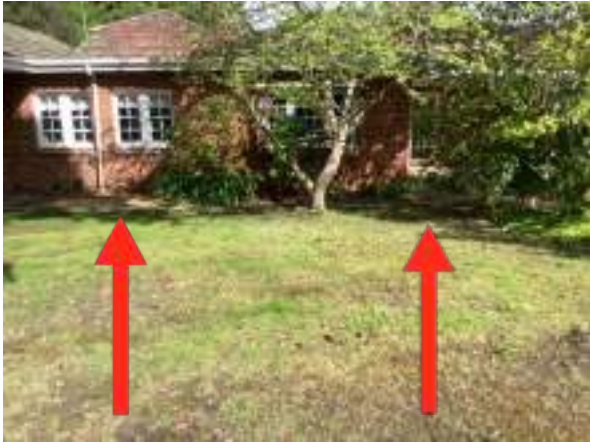
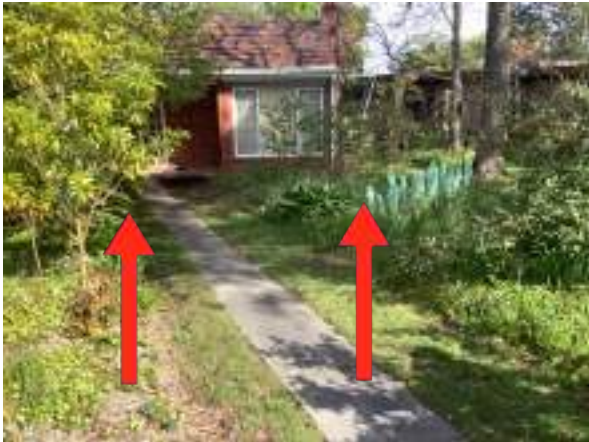
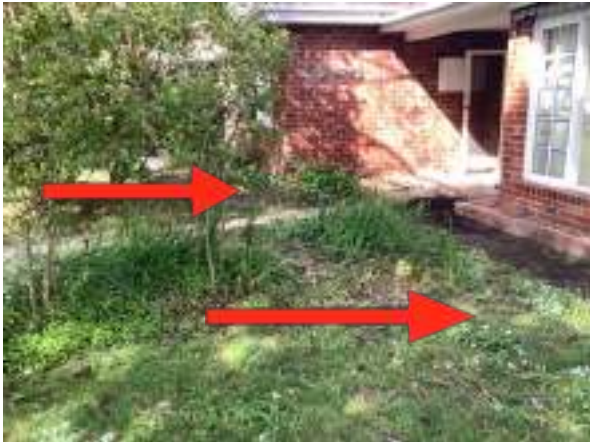
For your information 4.46

Location: Perimeter Of Building - Exterior

Finding: Drainage - Inadequate and/or Perimeter Building Ground Fall Defective.
At the time of the inspection it was noted that the surrounding perimeter soil does not fall away from the slab / building.

Water pooling near foundations and footings is a serious concern with the potential to adversely impact on the longevity of the dwelling. The Building Code of Australia (BCA) outlines that the soil or concrete must be graded away from the dwelling at a minimum of 50mm over 1m (1:50 fall).

The site drainage in this report was found to be inadequate at the time of inspection, creating potential for subsequent water damage to associated building elements, such as foundation subsidence, brickwork cracking, windows and doors moving, concrete paths cracking, etc.

These drainage concerns in this report can have grave potential for foundation subsidence and/or secondary damages such as structural defects such as brick movement / cracking as already mentioned above.

In relation to termites Defective drainage and falls create high water and moisture which creates a very high risk for termites as the environments to the property are very conducive with many susceptible areas.

Where site drainage is inadequate, another option can be installation of an Agricultural (Aggie) Drain may be required or more serious remedial works.

It is highly recommended that a plumber, builder and other forms of professionals be appointed to further inspect the area and to install / repair adequate drainage equipment where necessary.

If secondary damages have ALREADY accrued we highly recommend that you engage a structural engineer, geotechnical engineer to start with to then engage a registered builder, qualified plumber to further inspect the property and perform any remedial works as necessary.

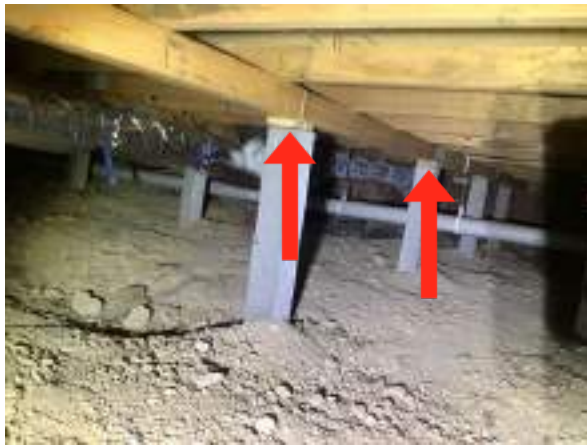
For your information 4.47

Location: Subfloor
Finding: Subfloor stumps – defective installation

The packers on top of the stumps to the subfloor area do not comply with current building codes. Any Packers should be a non-compressible material.

I highly recommend that you engage A registered builder to determine the works that are required In relation to this matter.

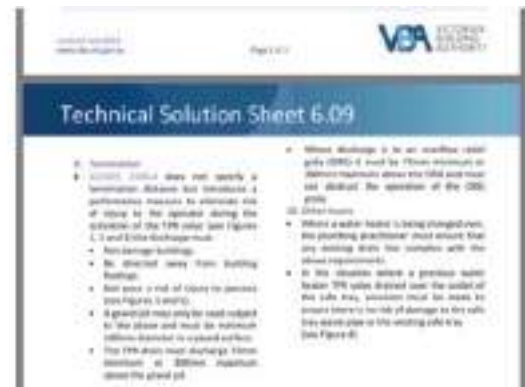
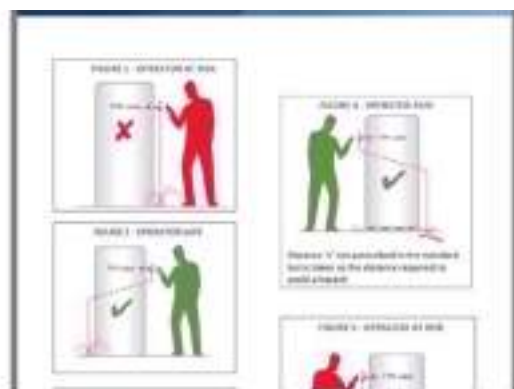
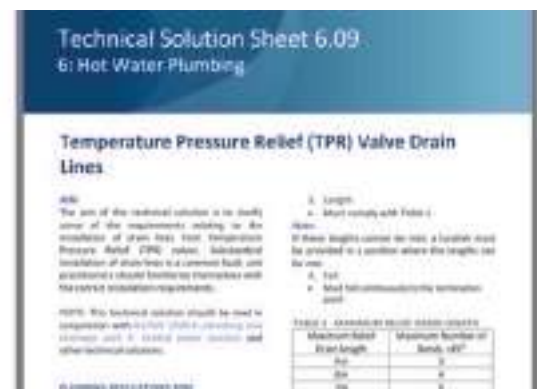
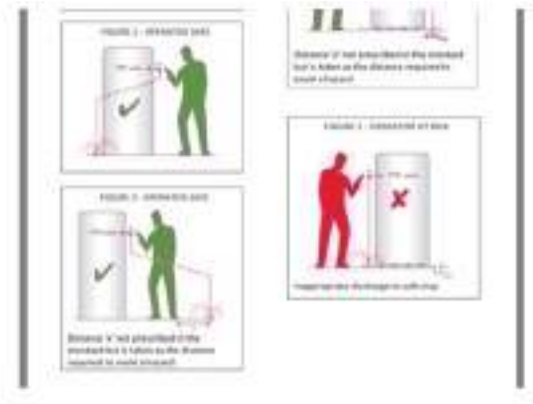
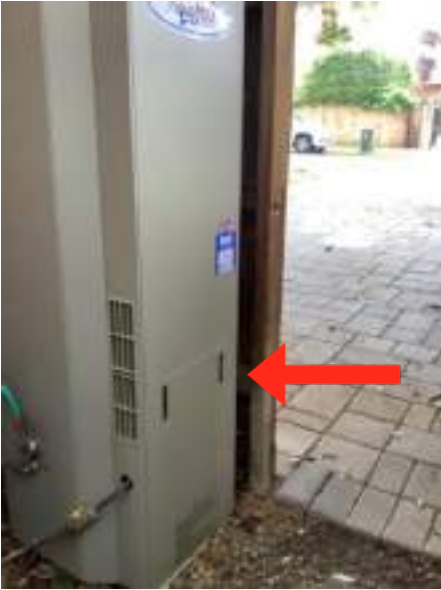
Item 2.03

Location: Perimeter Of Building - Exterior

These damp conditions can lead to secondary defects such as rot, rust or corrosion of associated building elements, the formation of fungal decay, or even the creation of potential slip hazards. When coupled with poor site drainage, pooling of water may also attract termite activity to this area.

It is highly recommended that a licensed plumber be appointed to connect the HWS overflow in order to prevent such an environment from being created. These minor works should be carried out as soon as possible.

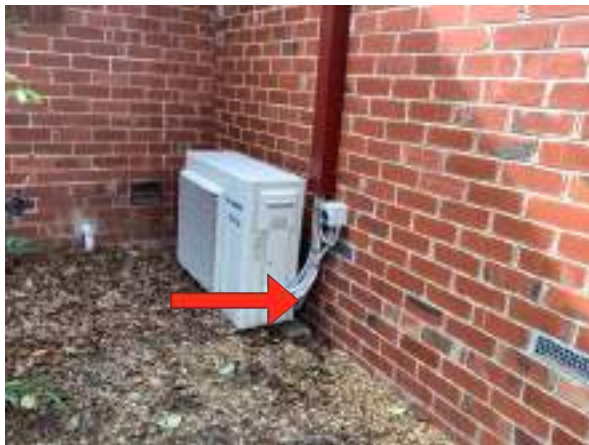
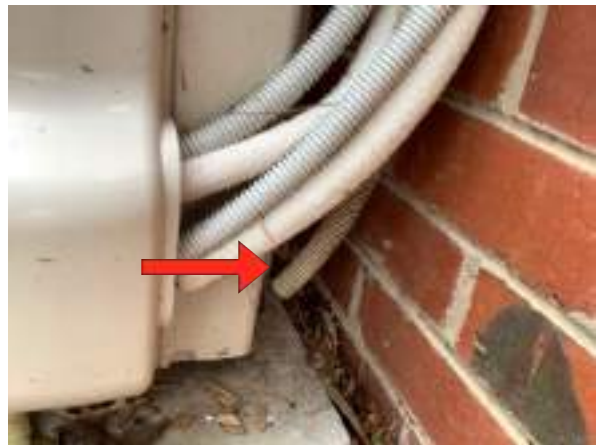
Item 2.04

Location: Perimeter Of Building - Exterior

This excessive water creates a much more conducive environment for termites as well.

These minor works should be carried out as soon as possible.

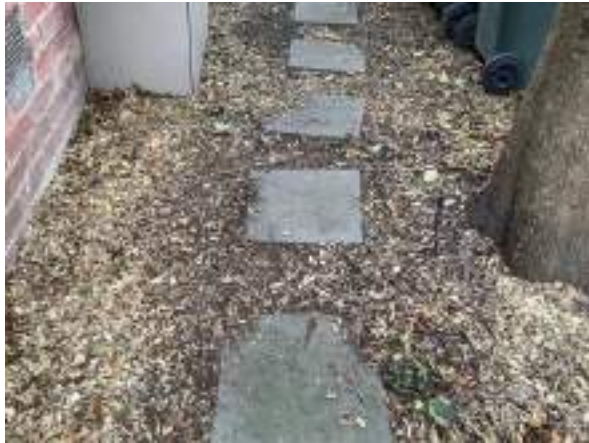
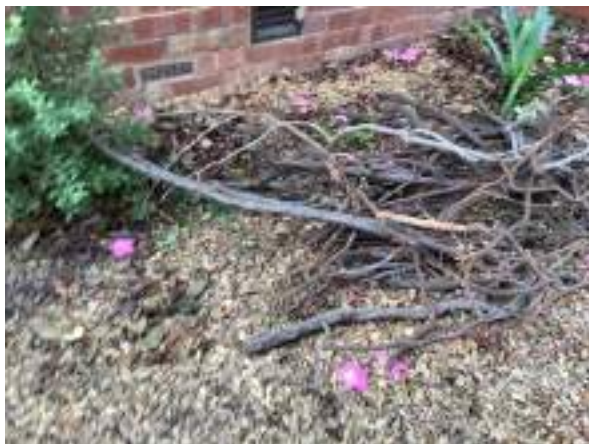
Item 2.05

Location: Garden Areas - All Areas

Finding: Garden Beds - Conditions Conducive to Termites
Garden beds were found to be evident in areas of garden areas. These garden beds can include untreated timber, bark, excessive old vegetation and with a combination of moisture from watering hosing can make conditions very conducive to termite activity and termite ingress. It is always important to keep the garden beds as clean as possible and take out excess old bark from the trees, leaves and keep bark mulch to a minimum or better introduce rocks or some item that does not create an conducive environment for termites and hold excess moisture.

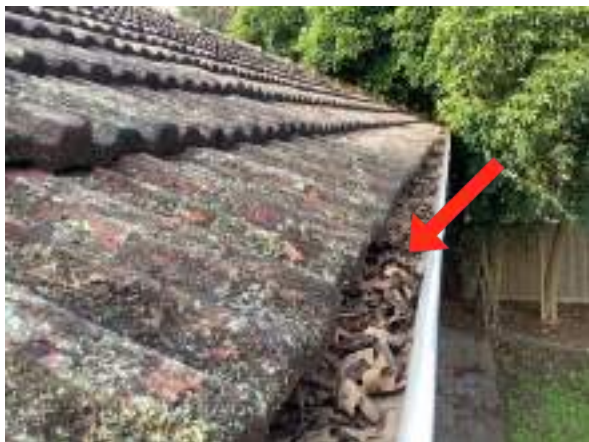
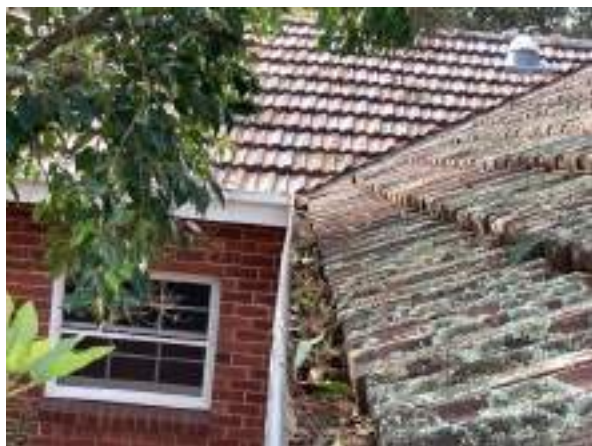
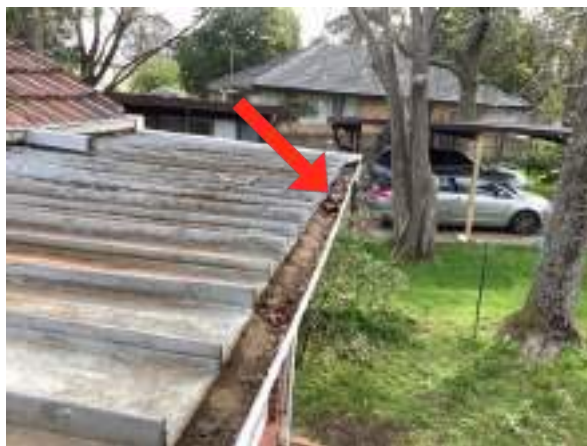
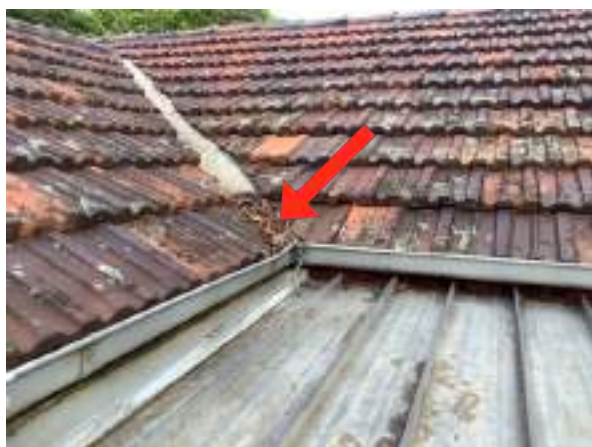
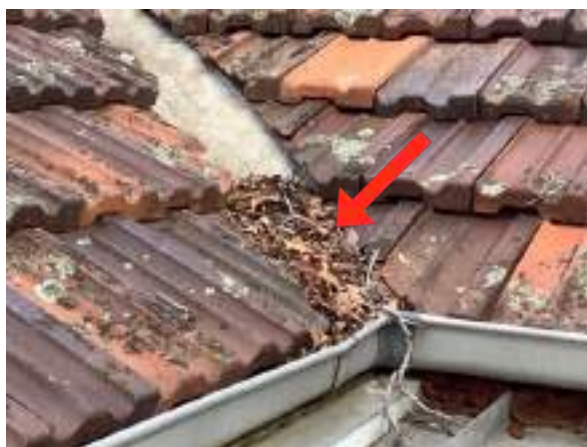
Blockages should be removed and addressed promptly, as they will lead to the development of secondary building defects. The blockage should be removed as the primary rectification works. Secondly, check for any secondary or concealed damage, and then attempt to address the cause of the blockage to prevent recurrence or any water damage to associated structures.

ALL AREAS should be checked carefully for this defect and attached are a few PHOTO EXAMPLES as a GUIDE.

Immediate clean up is required.

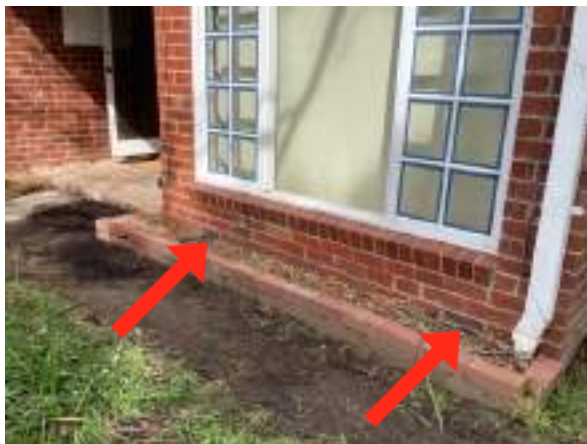
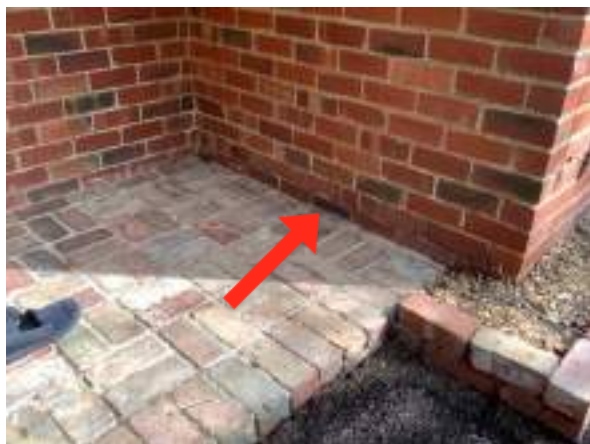
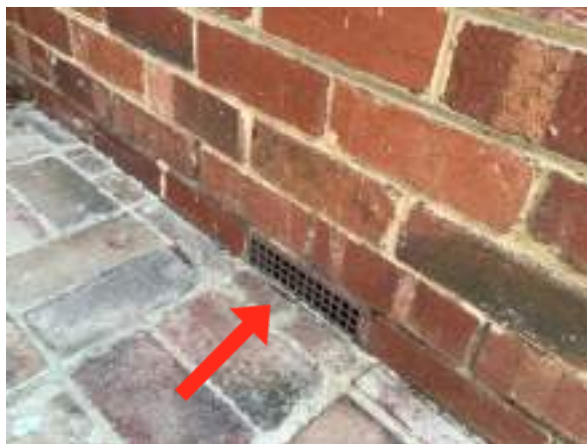
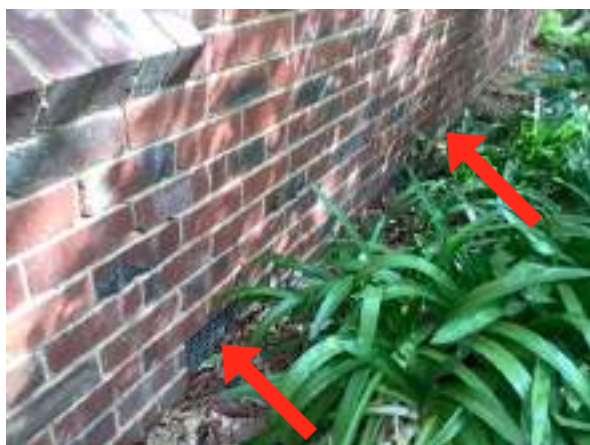
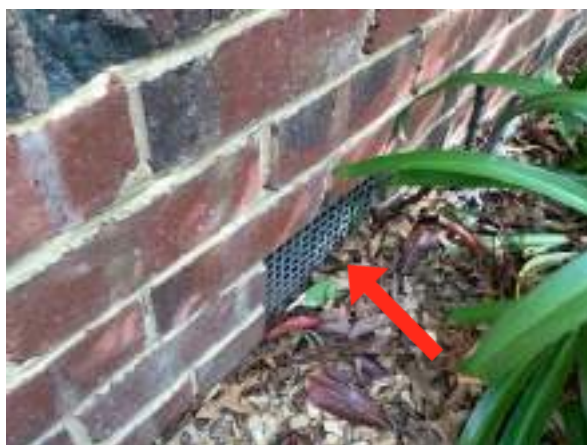
Item 2.07

Finding: Weep Holes - Bridging Or Breaching Of Termite Barriers Defective.
Bridging is the spanning of a termite barrier or inspection zone so that subterranean termites are provided with passage over or around that barrier.

Weep holes in the exterior brickwork of the property are designed to allow condensation that may build up between the brickwork and subsequent timber framework to drain from within the wall hence preventing any deterioration of the timber building elements.

Additionally build-up of moisture is likely to occur if weep holes are covered further attracting termite activity to these areas.

ALL AREAS should be checked carefully for this defect and attached are a few PHOTO EXAMPLES as a GUIDE.

It is highly recommended that weep holes are left exposed 150mm from the bottom of the weep hole to the ground level and 75mm from the bottom of the weep hole to the top off concrete paving in all areas throughout the external property.

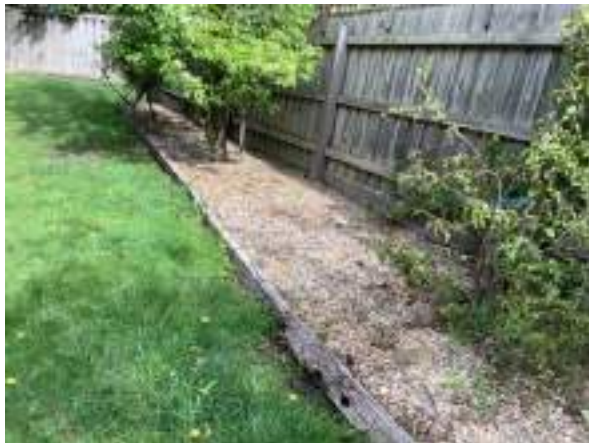
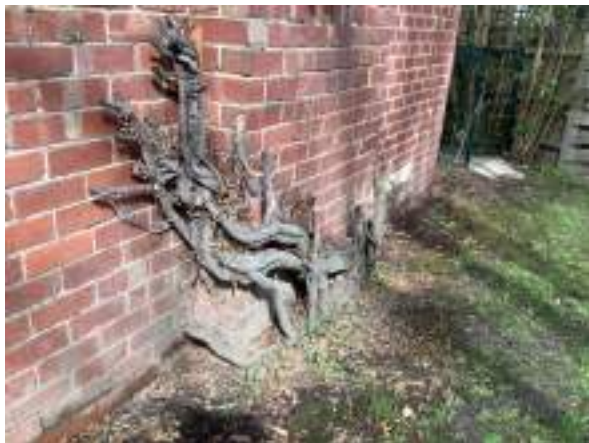
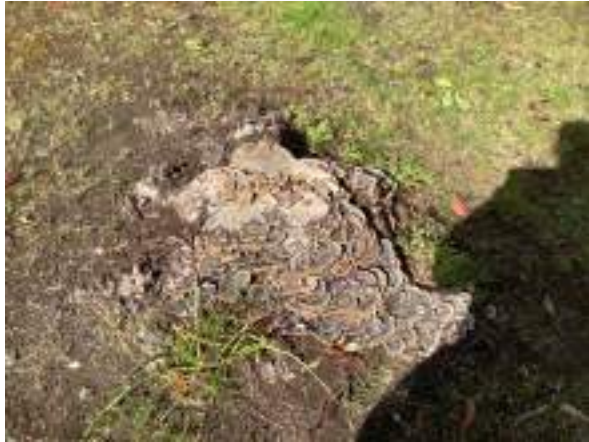
Item 2.08

Any timbers in direct ground contact provide opportunity for concealed termite entry and are likely to be subject to premature rot and decay as the soil retains moisture or damp conditions against the timbers.

When met with excessive moisture timber begins to decay and develop wood rot. Any timbers that are in direct contact with external grounds especially if left untreated or non-durable also provide ingress for subterranean termites into that particular element.

Remove untreated timber that is in direct contact with external grounds. Consider replacement with more durable materials i.e. treated timber or non timber elements.

Frequent pest inspections are advised to readily identify any termite activity in these areas.

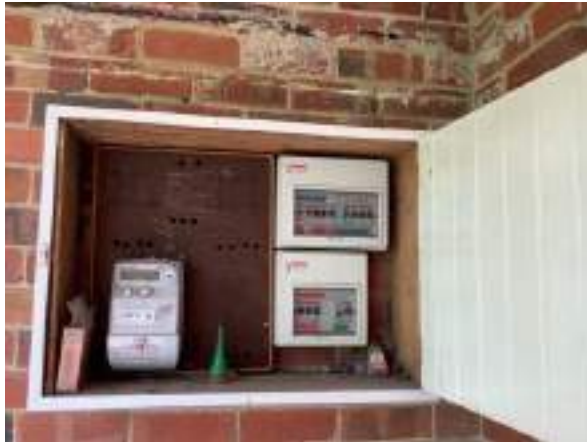
Finding: Termite Management System - NO evidence of installation
The application of a post-construction chemical termite barrier and/or baiting stations or the like is highly recommended for all properties, particularly if live termite activity has been found on the site previously. Such barriers are highly effective in preventing termite attack on any timber building elements throughout the property.

At the time of inspection, it appeared as though no termite management system has been installed, with no evidence to suggest preventative works taking place.

The client may consider gaining further advice from a pest controller as to the costs and procedures involved with this application. It is recommended that obtaining such advice be a short-term priority.

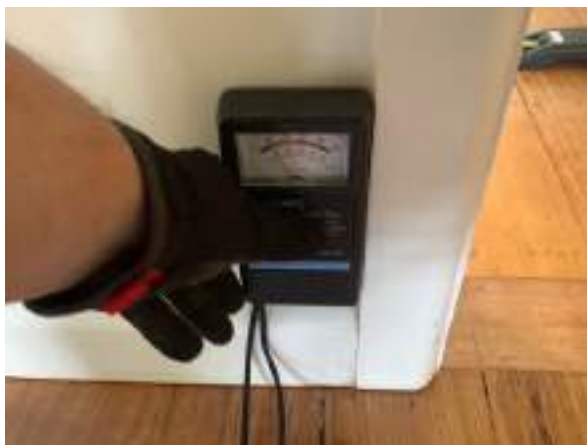
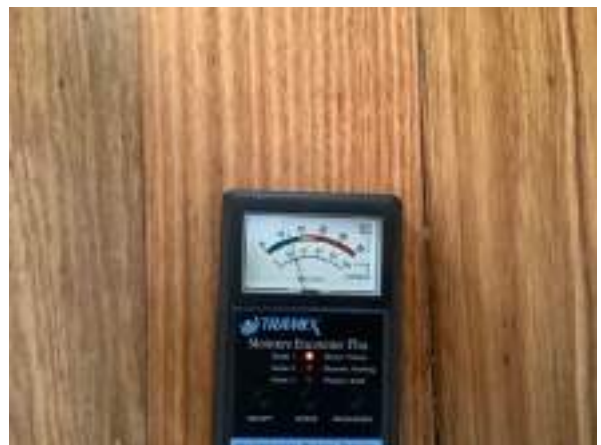
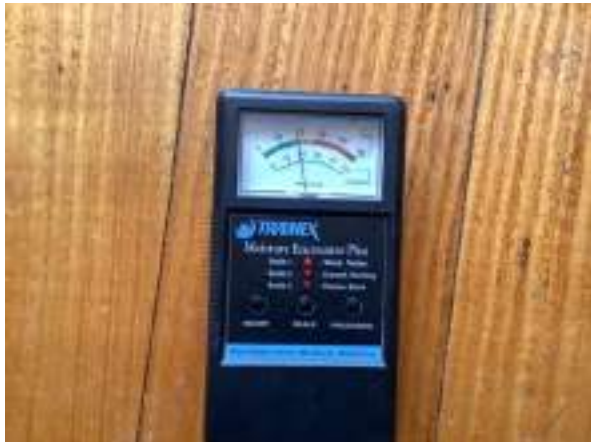
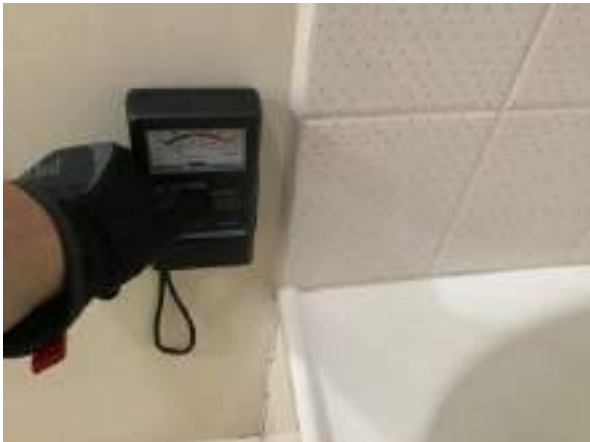
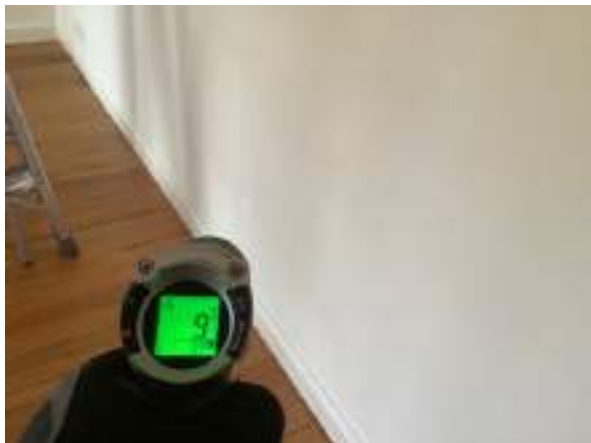
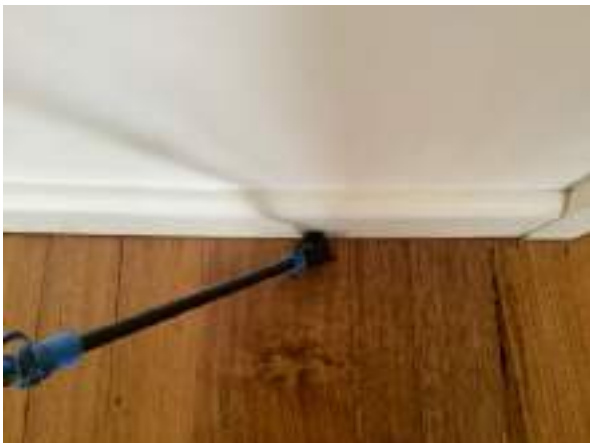
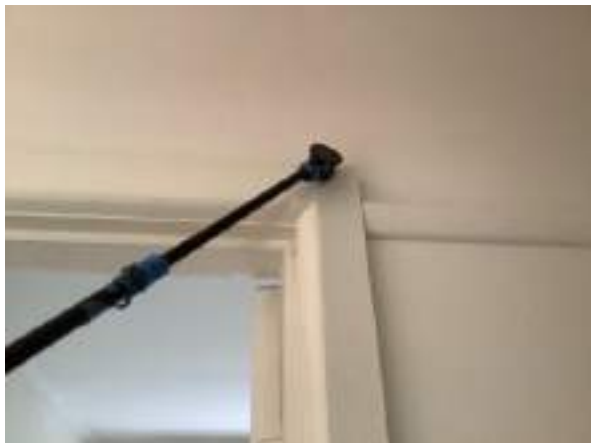
Item 4.10

All areas accessible of the dwelling are checked with particular attention paid to the wet areas which were closely assessed to check for excessive levels of moisture and temperature anomalies.

In attempt to identify the presence of hidden timber pest activity , a variety of techniques are adopted to identify irregularities including, a moisture meter and temperature digital meter assessments for comparison analysis , sounding of timber elements using a device called a " donga" visual assessments of materials affected by moisture or signs of deformity , trails and bridging constructed by termites , irregular and regular shaped holes in timber elements indicating pest destruction.

The moisture content variation was within the acceptable range of 5% to 20%.

Temperature variations were all identified under 25 degrees which is consistent with normal range for building elements in these conditions.

At the time of the inspection there was evidence of (timber pest) damage / activity and visually accessible timber damage caused by termites and / or timber pest.

The levels of moisture in all areas were found to be in the normal range.
