(Vendors Report)- Building & Termite/ Timber Pest Report

Inspection Date: 5 Feb 2021

Property Address: Yarraville Area

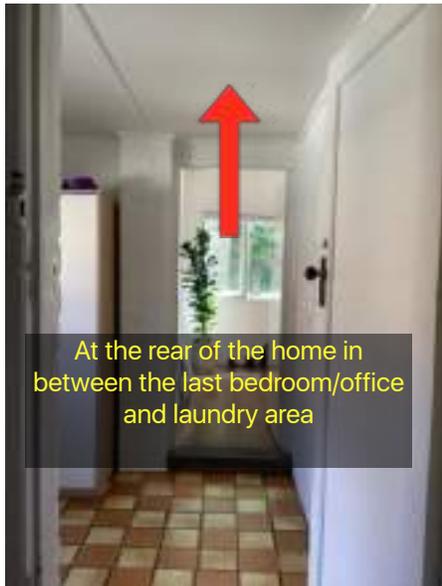
A qualified electrician is required do these works for hard wiring.

Upon completion a safety certificate is required to be supplied to the owner of the building.

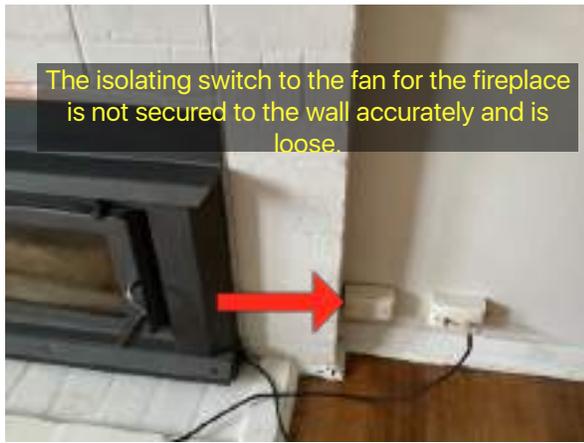
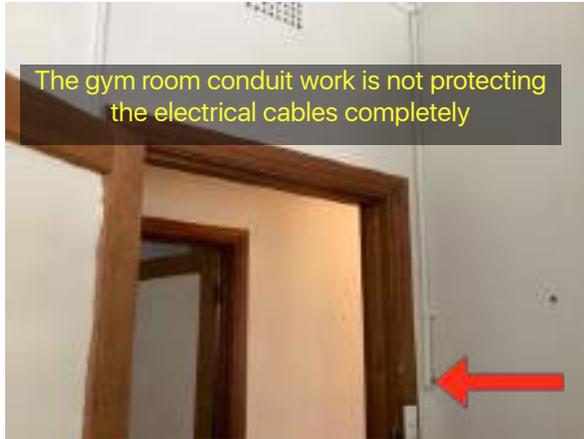
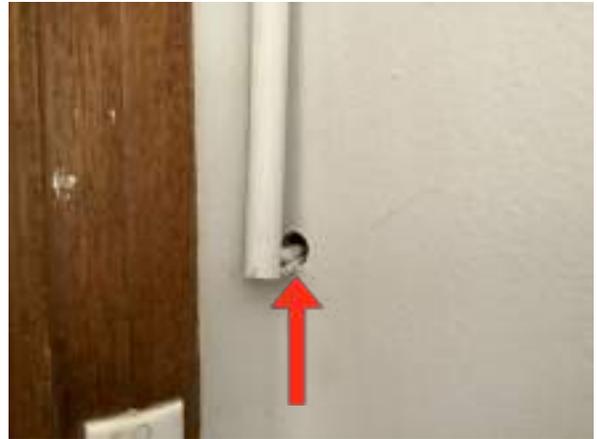
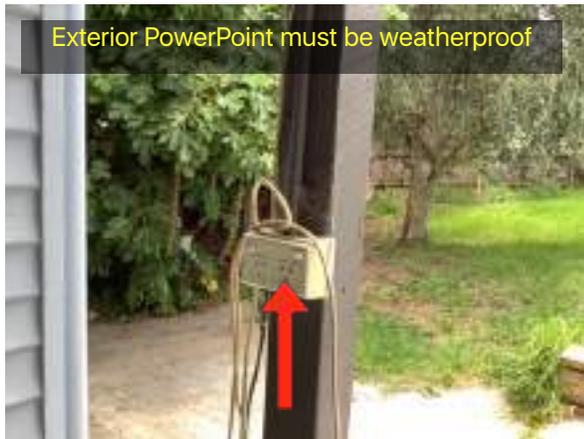
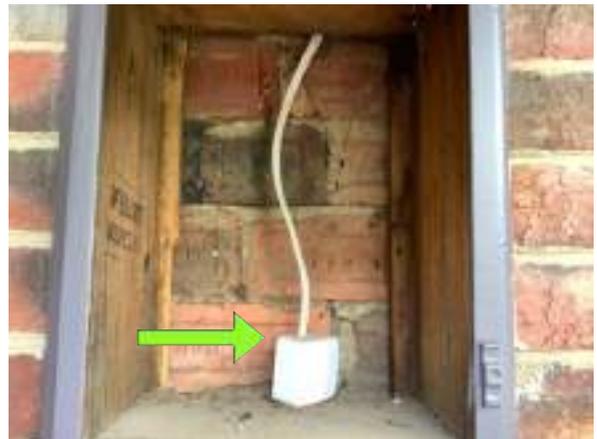
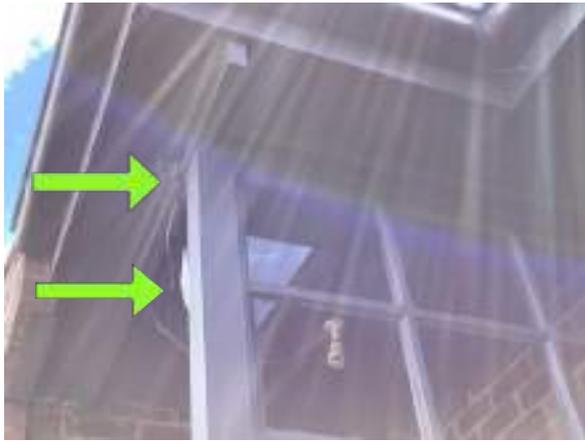
Serious Safety Hazard 1.02

Location: Electrical - All Areas

Finding: Isolating switch for the fan fire place / Kitchen power point / Gym room conduit work / Exterior Power Point / Wiring in old meter box - Defective / Unsafe / Exterior Front Light - Non Compliant - Electrical Wiring Installation

It appears that the electrical wiring to the Isolating switch for the fan fire place / Kitchen power point / Gym room conduit work / Exterior Power Point / Wiring in old meter box - Defective / Unsafe / Exterior Front Light, does not comply with today's electrical safety standards and electrical regulation codes of AS3000-2007.

We HIGHLY RECOMMEND that the purchaser engage a licensed electrical contractor to check compliance and make good any defective wiring or unsafe items throughout the entire property including the outbuildings, garden, etc, where applicable.

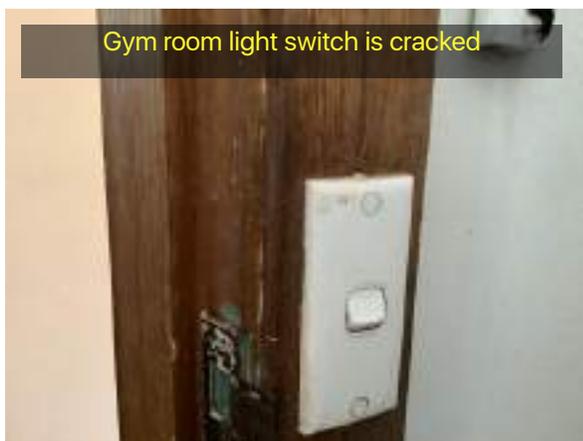
Serious Safety Hazard 1.03

Location: Electrical - All Areas

Finding: Electrical Switch - Damaged/Faulty

The switches in areas were found to be damaged or faulty at the time of inspection.

This occurs generally when the switch plate or the switch itself have either worn, decayed or burnt out as a result of electrical arching.

Repair and/or replacement of the switch is advised to ensure the fixture and it's associated structures are safe and fully operational.

A licensed electrician should be appointed to repair/replace the light switch or switches as soon as possible.

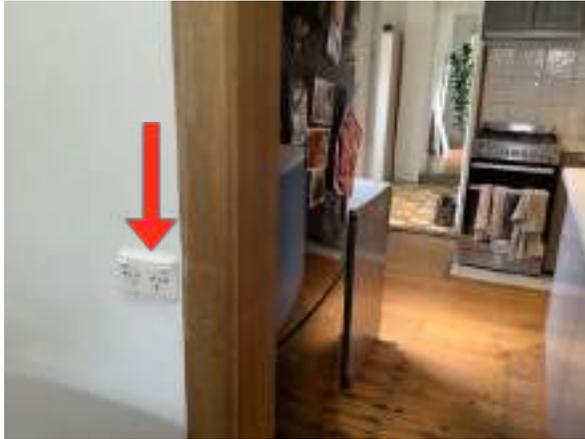
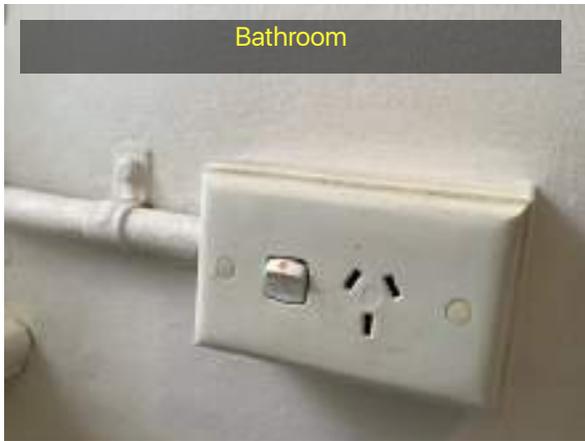
Serious Safety Hazard 1.04

Location: Electrical - All Areas

Finding: Electrical Power Points - Damaged/Faulty

Repair and/or replacement of the power points is advised to ensure the fixture and it's associated structures are safe and fully operational.

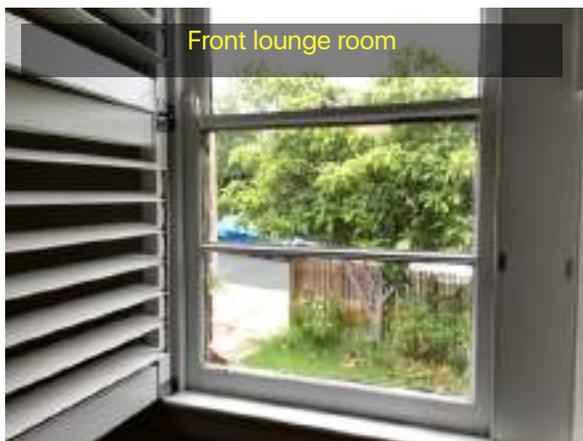
Serious Safety Hazard 1.05

Location: Windows - Internal Areas

Windows MUST function as a safety requirement and we HIGHLY RECOMMEND that you engage an appropriate professional as soon as possible to check all windows to the property.

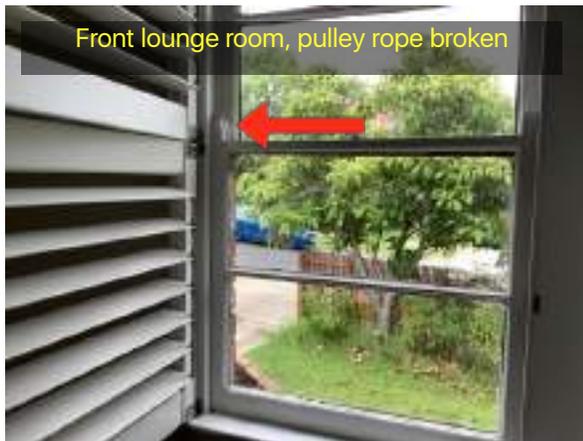
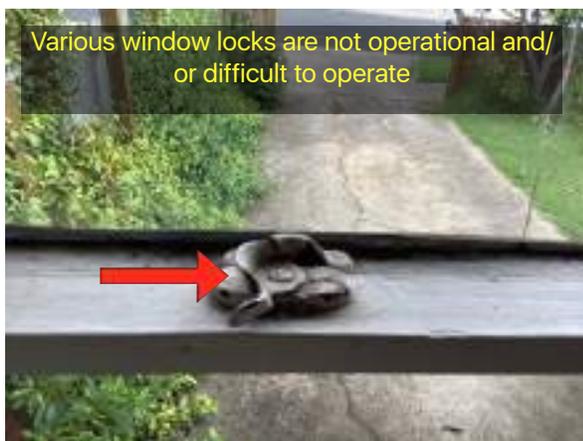
Serious Safety Hazard 1.06

Location: Windows - Internal Areas
Finding: Window - Handles / Locks / Accessories- Broken

Replacement of the handle /locks should be conducted as soon as possible. A general handy person, window manufacturer and/or service technician should be appointed to perform these works to improve the operational state of the affected window and improve the safety of the internal area.

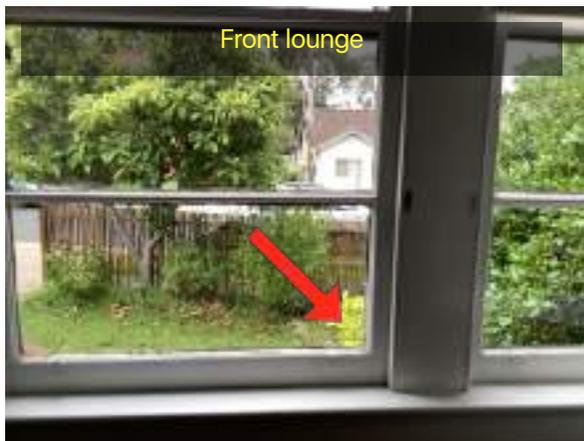
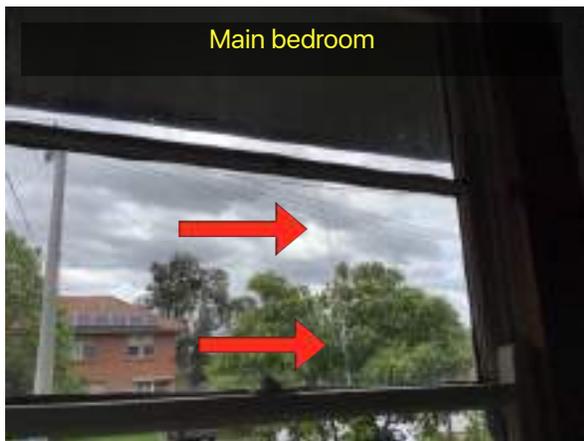
Serious Safety Hazard 1.07

Location: Windows - Internal Areas

Please be advised that any persons coming into contact with the cracked window should do so with due caution to avoid any personal injury that may ensue.

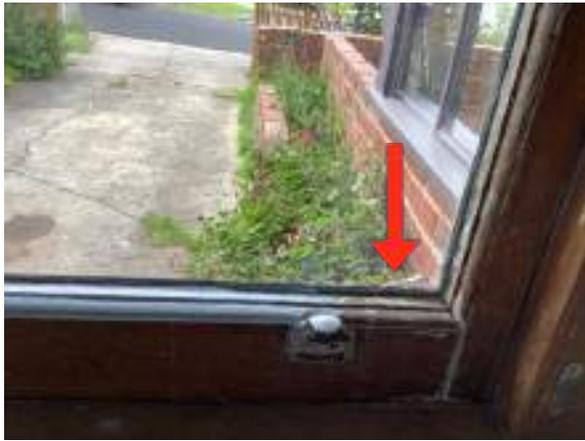
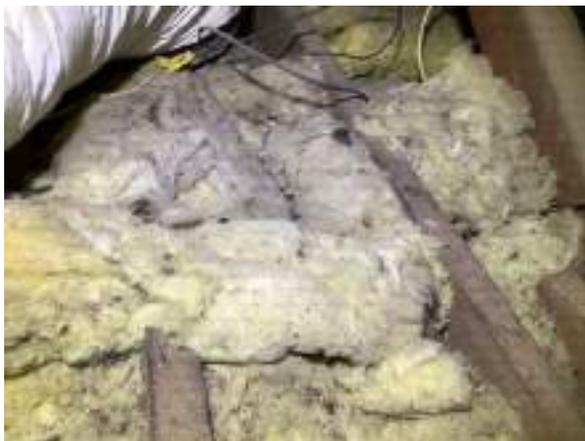
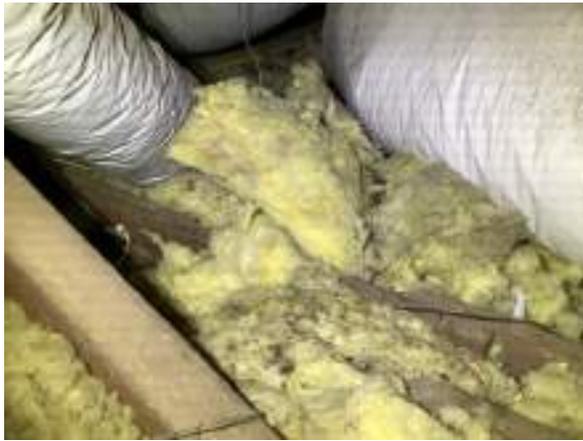
Serious Safety Hazard 1.08

Location: Roof Space
Finding: Animal Faeces - Roof Space

This roof space should all be cleaned for health and hygienic reasons by an appropriate professional.

To ensure no such infestation occurs any holes should be adequately covered. Holes such as these are also likely to attract rain penetration which may lead to subsequent water damage to associated structures if left unmanaged.

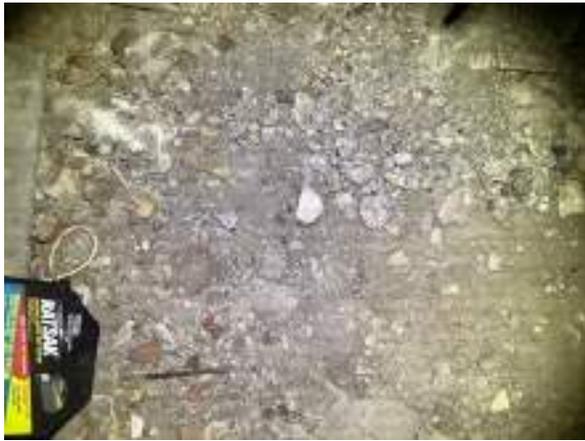
Serious Safety Hazard 1.09

Location: Subfloor

Finally the cause or source of the mould **MUST BE TAKEN CARE OF URGENTLY.**

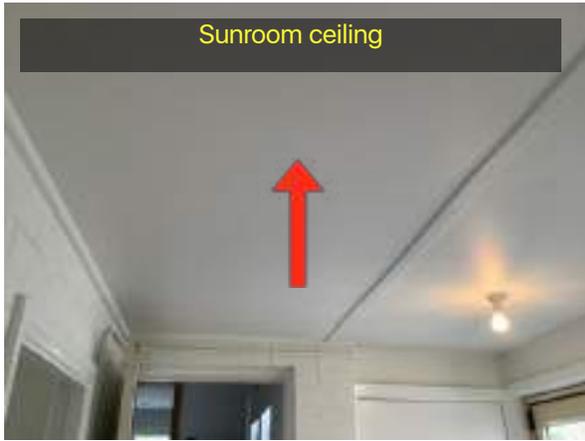
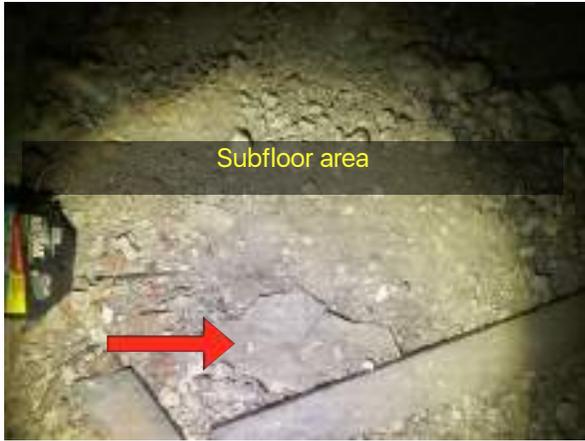
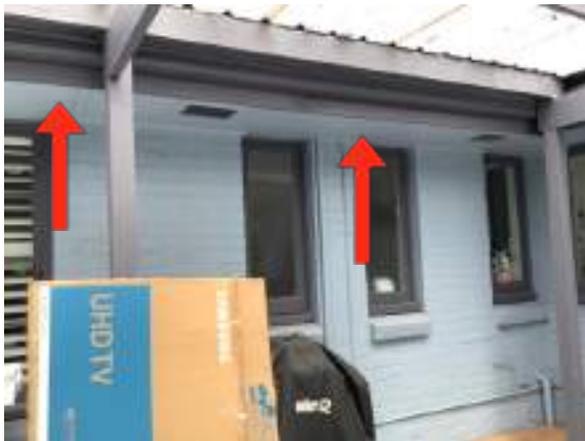
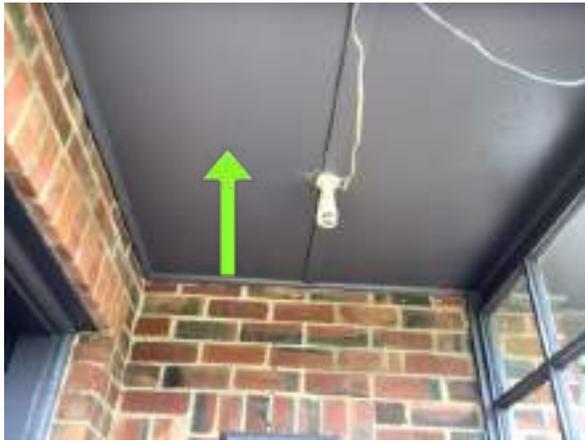
Serious Safety Hazard 1.10

Location: Asbestos - Various Areas

In the interim, the client is advised to act with caution, especially when considering any damage to building materials general wear and tear renovations extensions demolition and general maintenance activities due to the suspected presence of Asbestos.

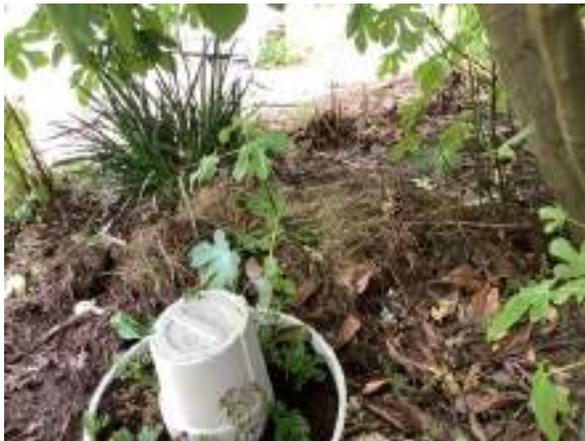
Serious Safety Hazard 1.11

Location: Garden Areas - All Areas

This type of environment also creates a very conducive environment for termites as well.

I highly recommend as a matter of urgency the entire area be cleaned up by a handyman, gardener or competent similar persons and in addition the possibility of Vermin/Rodents/Snakes/Etc maybe of high risk as these conditions would be perfect.

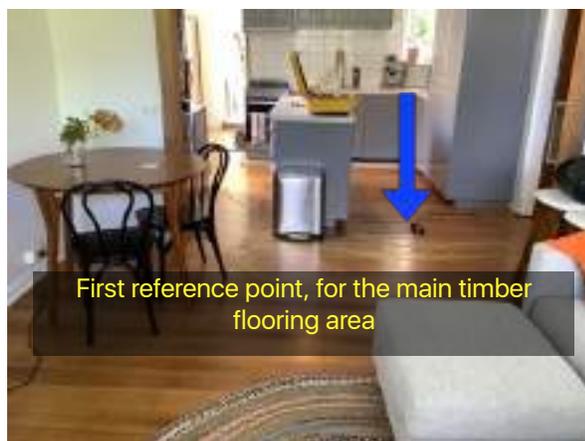
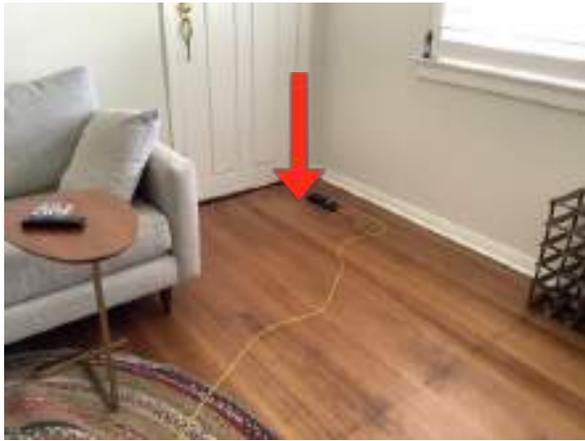
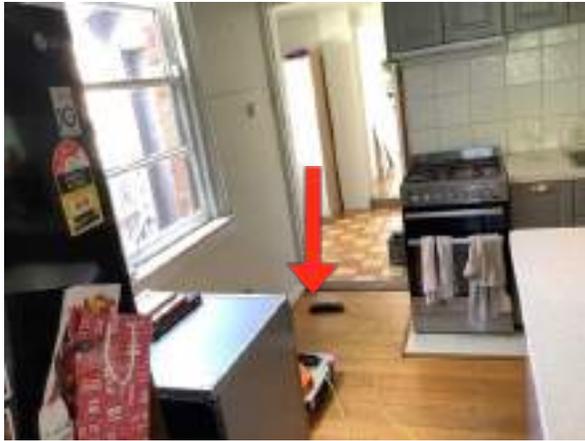
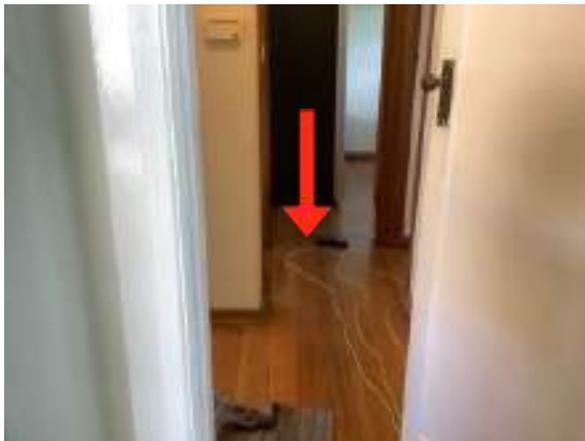
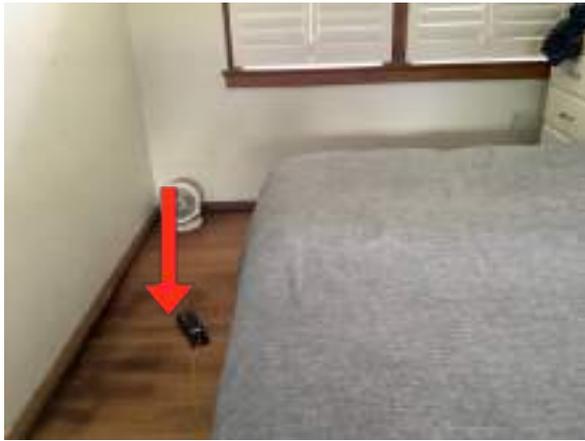
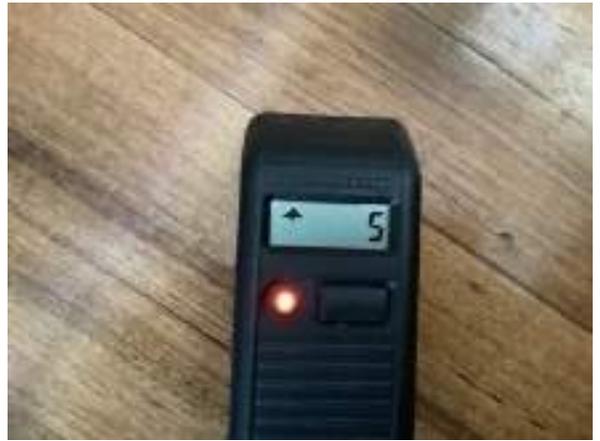
Major Defect 2.01

IMPORTANT TO NOTE : It will be important to note that the likelihood of cracking and movement to plaster, floor and wall tiles, doors requiring re-working, windows requiring re-working, kitchen cupboards, etc will be high once the home is jacked up and re-leveled to the correct height, the amount of repairs can be nothing to many areas. There will more then likely be the repairs of plaster, paint and the other repair concerns mentioned.

A Registered Builder who is experienced in flooring, stumps and re-stumping would then generally carry out works or be associated with re-stumpers as advised by a Structural Engineer and/or a geotechnical engineer, if required.

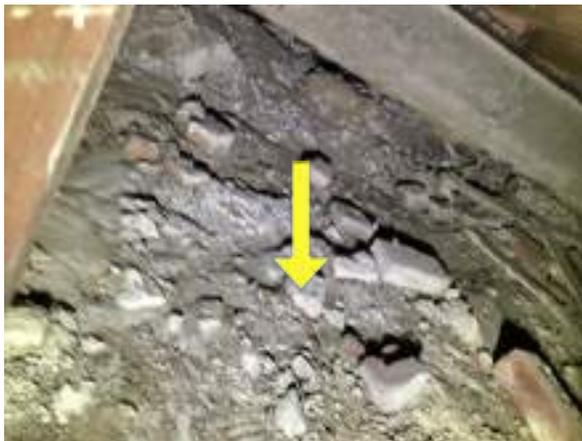
Major Defect 2.04

Location: Subfloor
 Finding: Damp - Rising

The first step in addressing rising damp is to diagnose the cause. The identified cause should be addressed first before addressing the appearance and other defects which have resulted from the rising damp. If the original cause is not resolved, further cases of damp are likely to ensue, resulting in secondary defects.

Consultation with a PLUMBER, BUILDER AND OR STRUCTURAL ENGINEER AND SOMETIMES A GEOTECHNICAL ENGINEER, and also more then likely a structural engineer is advised immediately to identify the cause of the damp and perform remedial works as required.

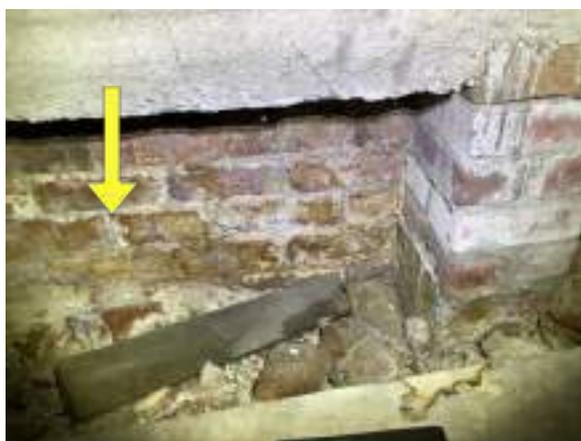
Major Defect 2.05

It was noted at the time of inspection that the subfloor area lacks adequate ventilation. Ventilation can be restricted by a variety of minor defects, including obstructions in the subfloor space, a lack of vents or a low clearance.

The initial step in improving ventilation is to ensure that the subfloor area is free of any debris or stored items. Where ventilation is still inadequate, it is advised to ensure that all vents are clear of blockages, and additional vents may be installed.

The client may also consider adding additional ventilation to the perimeter of the subfloor area and/or mechanical ventilation (powered fans) to improve subfloor airflow. This can be a complicated problem that may require various solutions and remedial works should be conducted as a matter of urgency to protect against the development of potentially harmful subfloor conditions and/or further damage the subfloor area.

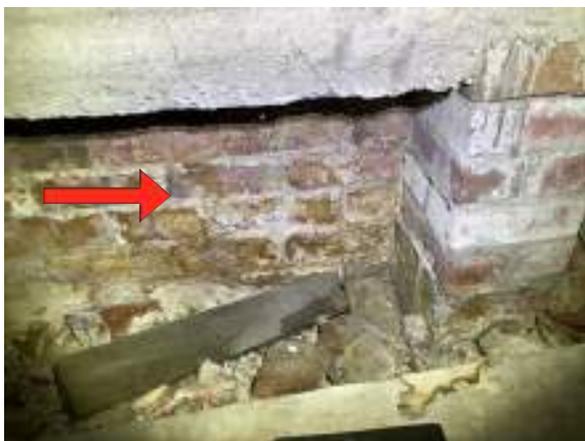
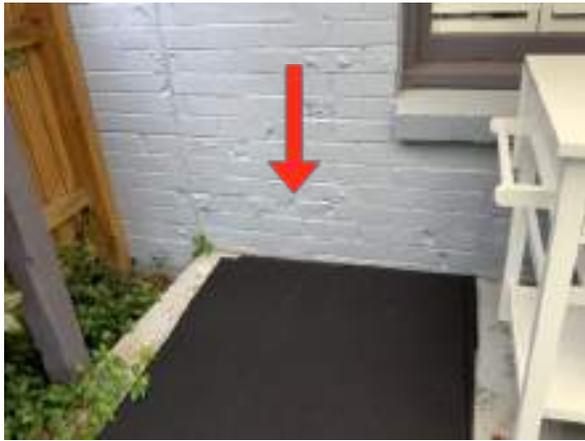
Major Defect 2.06

Location: Brickwork

I believe that the building warrants a structural engineer to determine the structural integrity of the foundations.

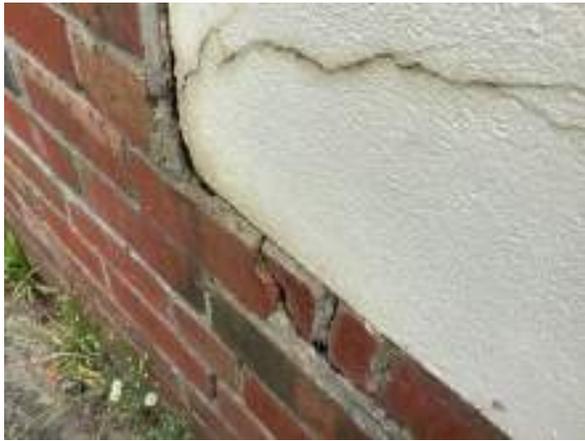
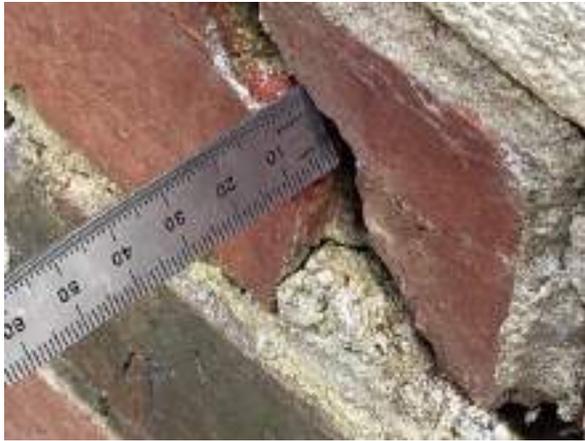
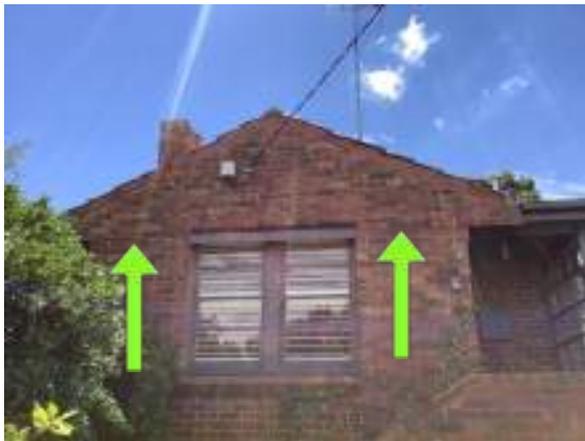
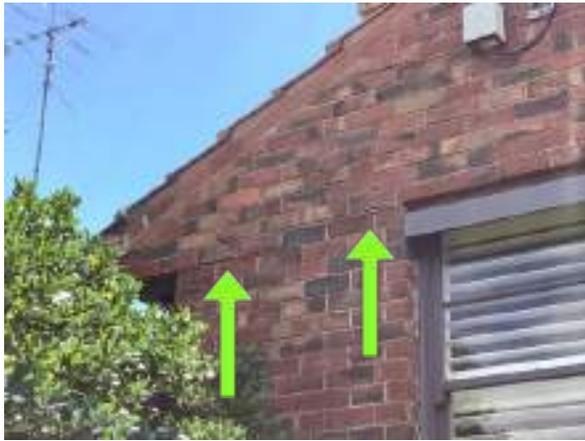
Minor Defect 3.01

If left unmanaged, water penetration to these areas may lead to subsequent water damage, which is likely necessitate repair work to affected building elements.

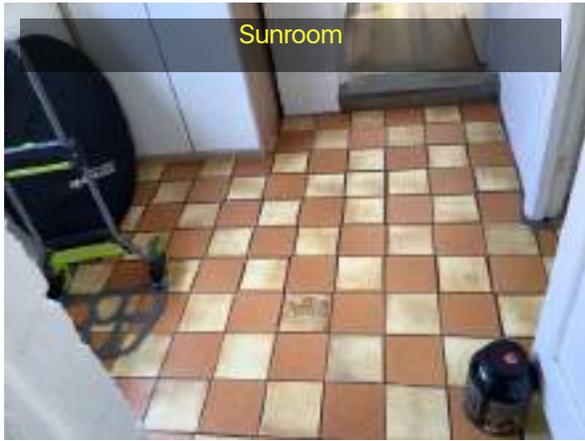
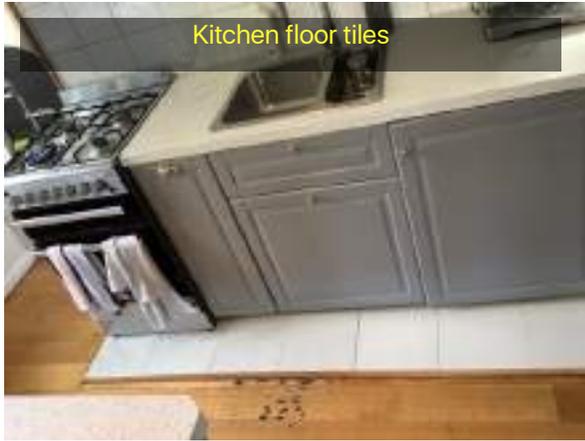
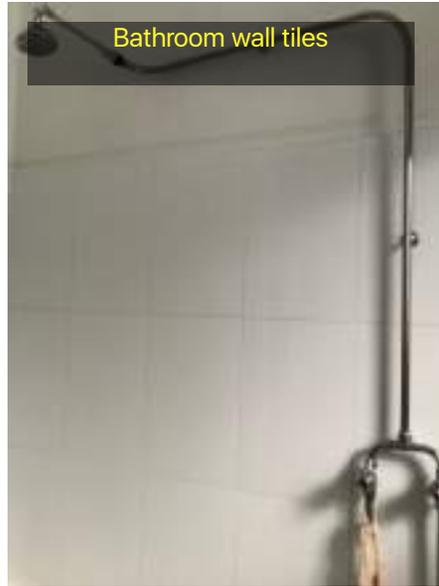
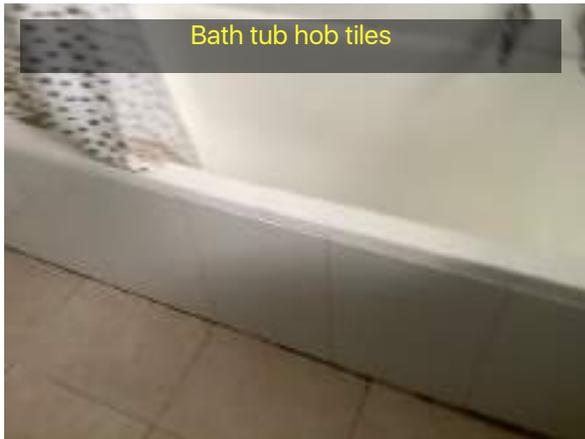
Minor Defect 3.02

Location: Tiled Areas

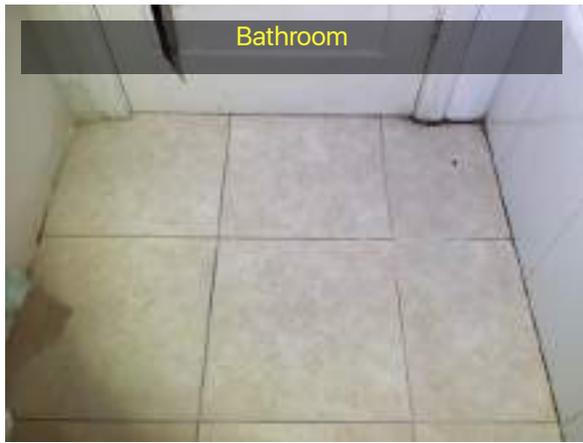
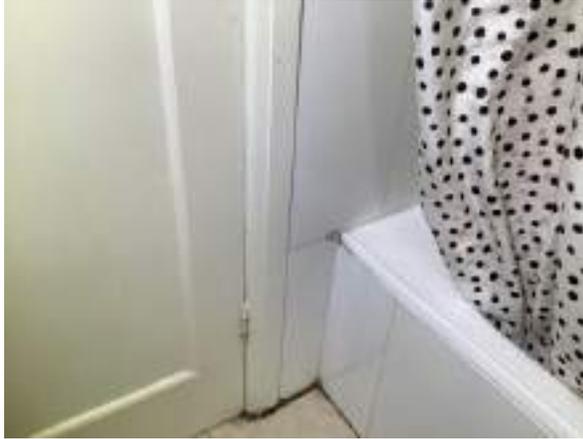
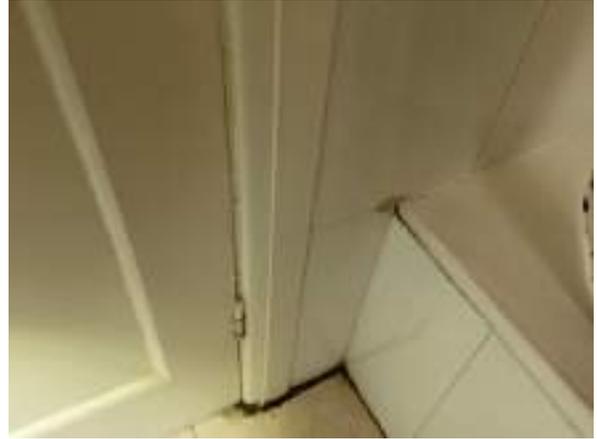
Minor Defect 3.03

Location: Flooring - All Areas

The client is advised to seek quotations for required repairs from a Registered Builder specialising in re-stumping. The potential resolution may range from packing gaps in subfloor structures through to replacement of subfloors stumps and refixing of flooring.

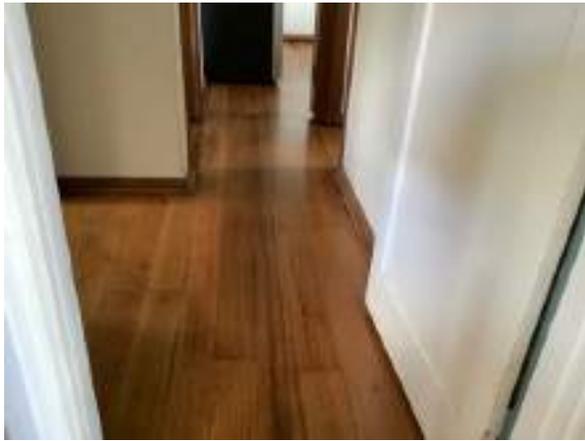
Minor Defect 3.04

Location: Worn/Aged and/or Damaged-All Areas
Finding: Worn/Aged and/or Damaged.

It is IMPERATIVE that you engage registered and qualified trades and at the end of there works they must supply certificates, such as an electrical safety certificate, plumbing and gas certificate if the works are electrical or plumbing, but for items such as damaged door handles, painting an experienced carpenter or handyman can sometimes be engaged.

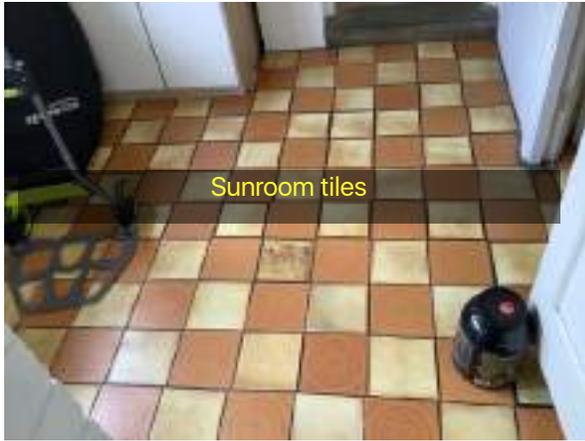
Sunroom tiles

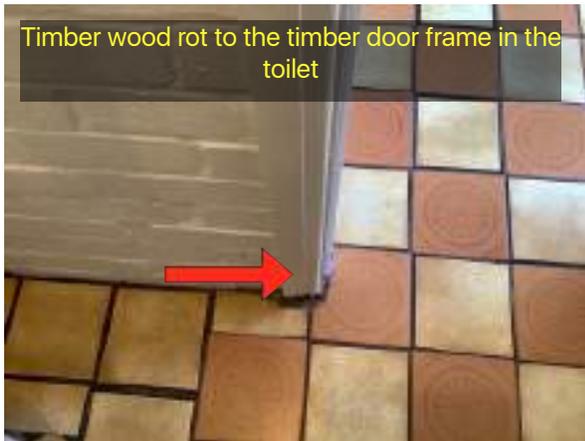
Timber wood rot to the timber door frame in the toilet

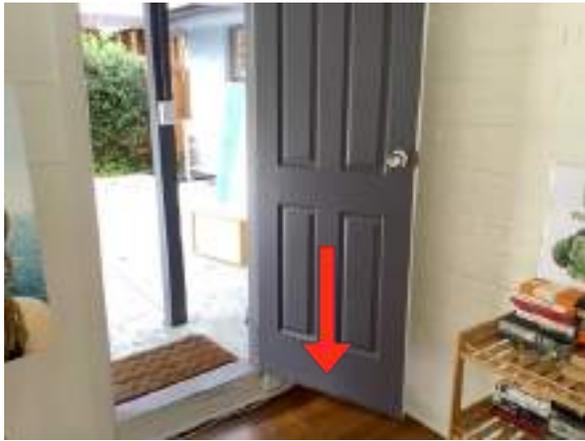
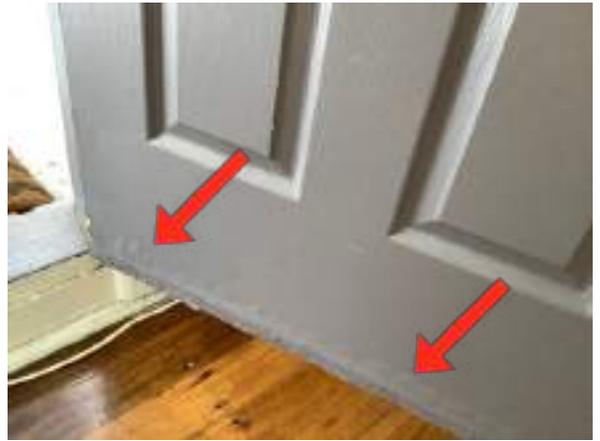
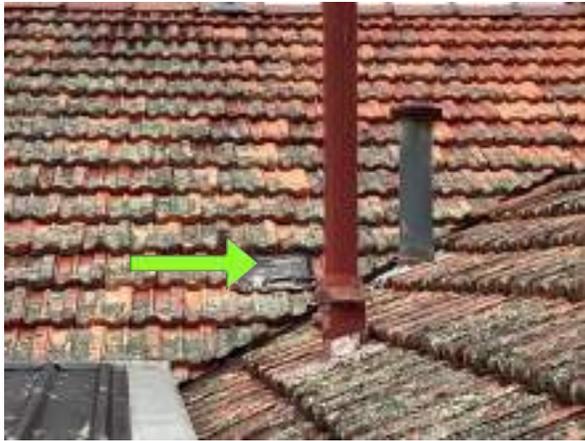
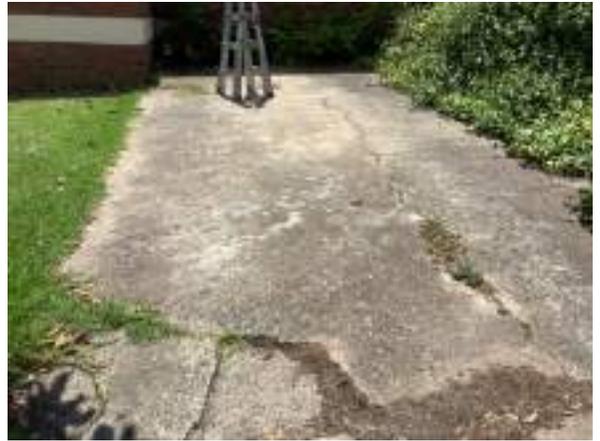
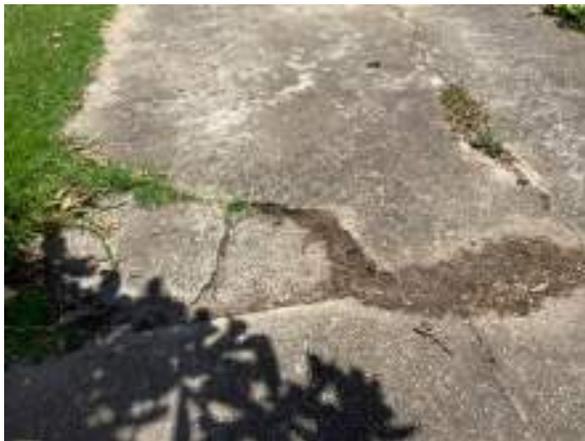
Minor Defect 3.05

Location: Sub Standard Workmanship or Incomplete-All Areas

Where installation is substandard and/or incomplete, the client should contact the responsible trade to undertake rectification works.

The appropriate tradesperson, specialist or handyman should be appointed to complete the various items for repair and organise the appropriate QUALIFIED trades (or not pending on job) to repair and complete the works to illiminate or reduce further deterioration / disfunction.

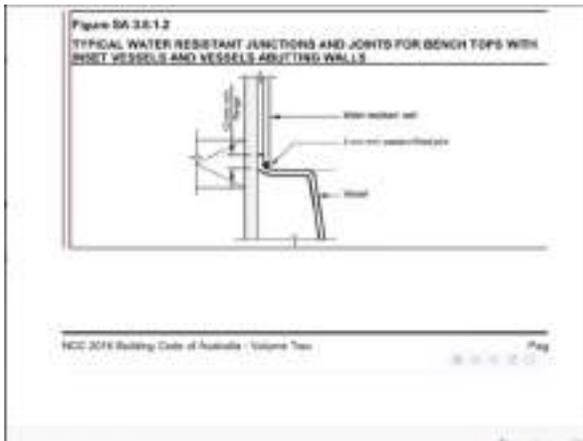
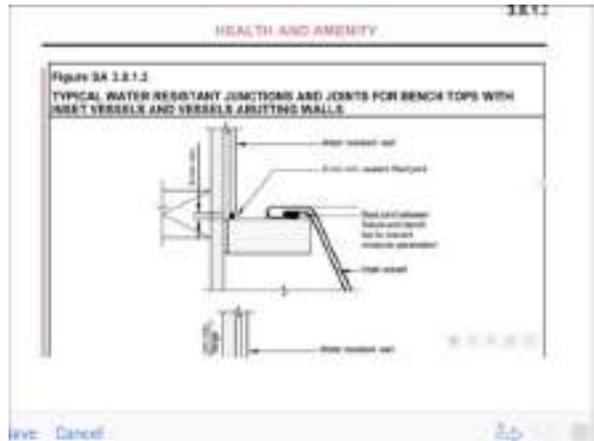
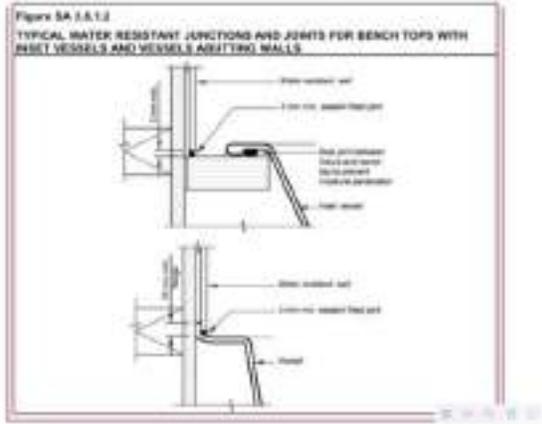
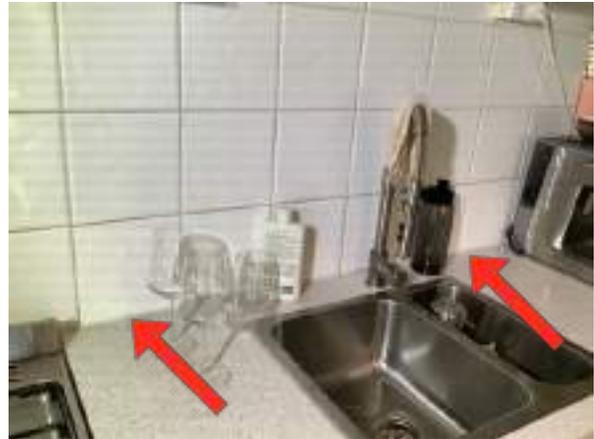
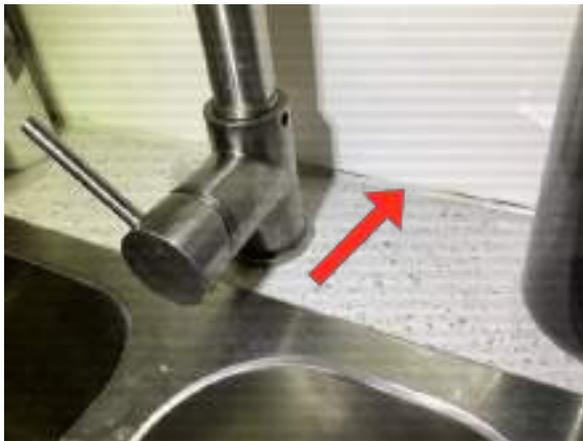
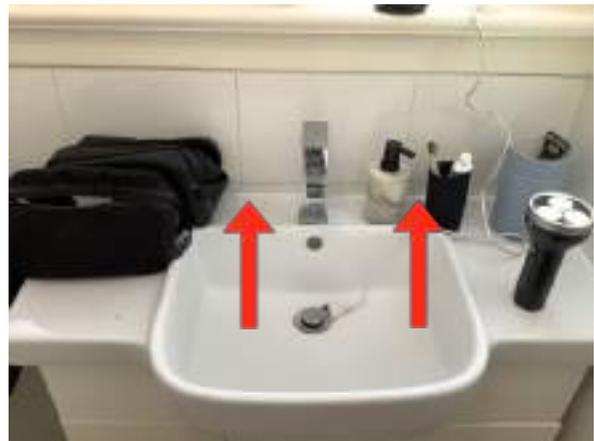
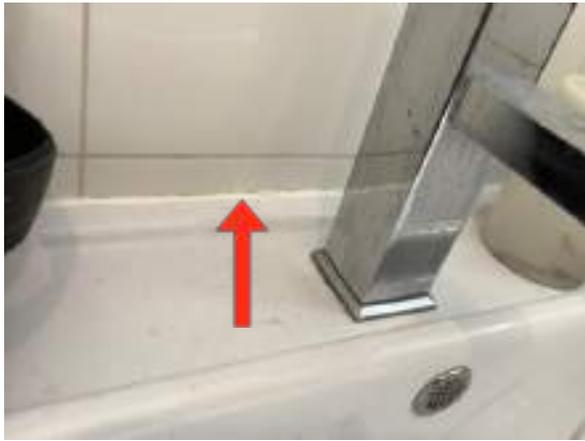
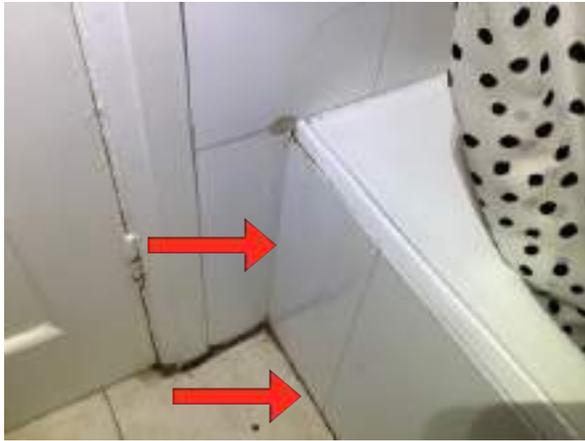
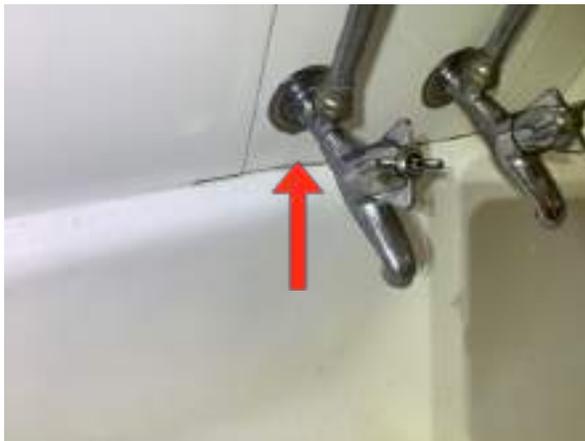
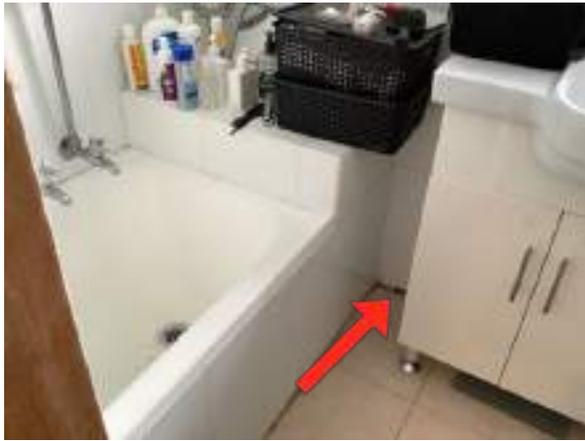
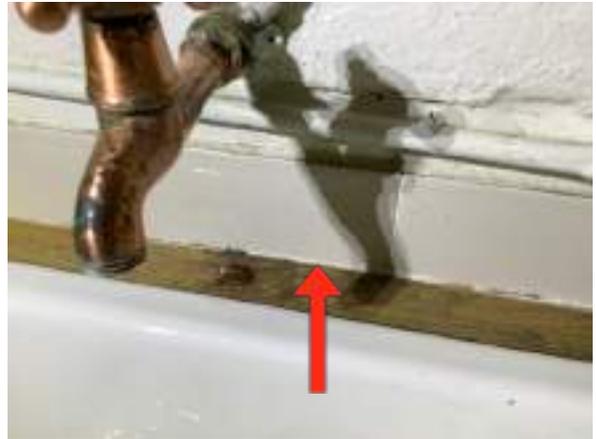
◆ ALL AREAS should be checked carefully, for the Silicone / Caulking To All Wet Area Junctions and Tile Grouting, that is Missing/Damaged or just installed poorly.

A sealant specialist, tiling contractor and/or registered builder in some serious cases, should be appointed to assess any damage caused by water to the entire internal, sub-floor where applicable, walls, etc of the building and clean, take off old sealant and tile mortar, then re-seal and re-mortar these areas as soon as possible.

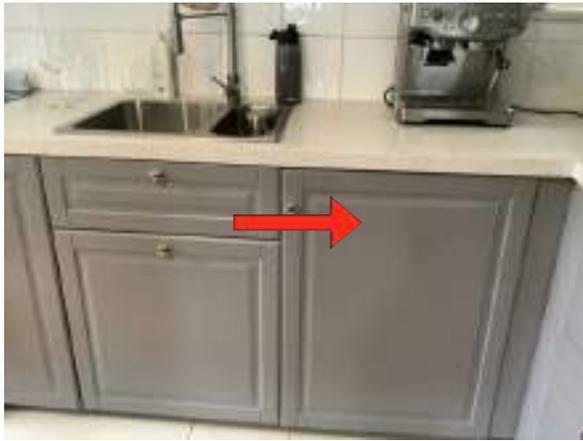
Minor Defect 3.07

Location: Cabinetry / Wardrobe Doors Internal Areas

Finding: Cabinetry - Loose hinges / Re-adjustment

Upon further inspection, it was noted that the hinges to the cupboard doors have deteriorated or just need adjustment.

This is a result over time, where the hinges have come loose from their original fixings, or the hinges need adjustments and/or the hinges are damaged/worn and require replacement.

To improve operation of the affected doors, a general handyman / cabinetmaker/ carpenter may be appointed to replace the faulty hinges and/or adjust .

Such works should be completed at the discretion of the client, but we do recommend repairs so that there is no further damages to the existing cabinets or cupboards.

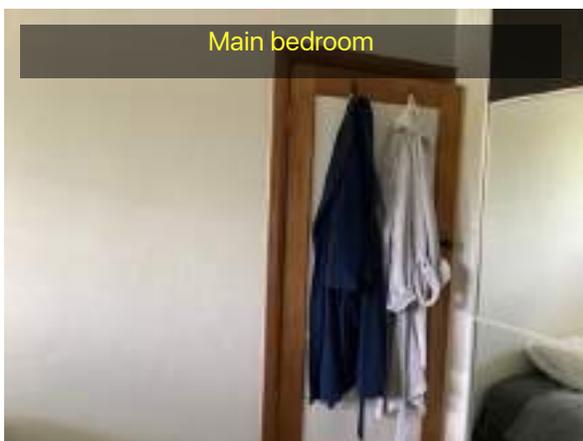
Minor Defect 3.08

Location: Doors - All Areas

This defect inhibits the functionality of the affected door as well as creating potential for secondary defects to associated building elements, such as damage to the floor covering.

A door that binds to flooring or to the associated door frame may have several causes, ranging from minor defects, such as poor installation of the door or deteriorated hinges, through to major structural issues, such as damage and/or subsidence (sinking) to subfloor structures or concrete slabs.

For minor causes, a qualified carpenter or general handyperson should be appointed to perform minor rectification works at the clients discretion.

ALL AREAS should be checked carefully for this defect.

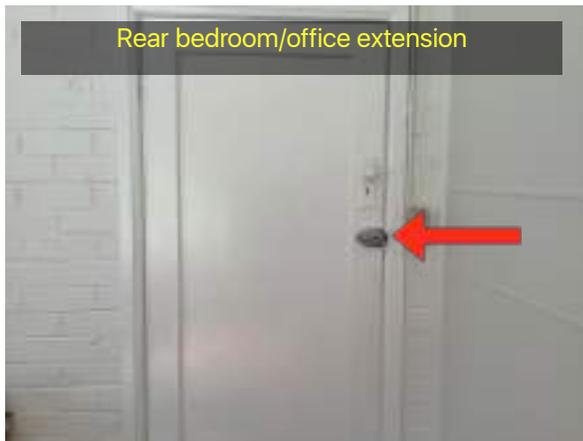
Minor Defect 3.09

Location: Doors - All Areas

This is a common defect and is expected in a property of this age, whether being due to substandard installation or general deterioration of the door hardware and sometimes also the associated hinges

If left unattended, further functional impairment is likely to occur.

Readjustment of the striker plate and/or hinges is recommended at client discretion.

A qualified carpenter or general handyperson may be appointed to perform rectification works as necessary, at client discretion.

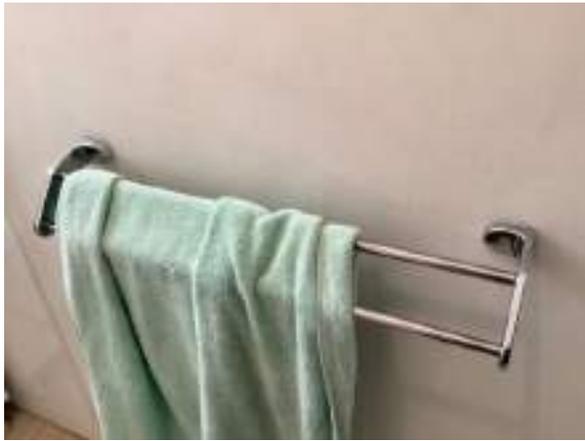
Minor Defect 3.10

Location: Bathroom

Finding: Towel Rail - Loose

The Towel Rail was found to be loose at the time of inspection. While not a major operational defect, function can deteriorate and cause further damage to the plaster/tiles if the problem is left unmanaged.

It is advised that the homeowner performs remedial works to re-attach the towel rail to its original fixing.

A general handyperson may be required to perform these works.

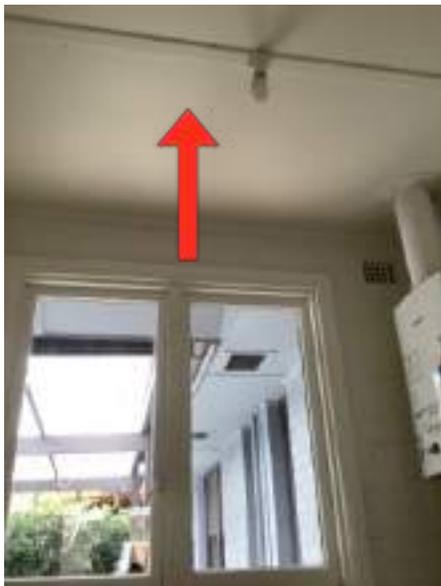
Minor Defect 3.11

Location: Laundry

By not having an exhaust fan in this area, you increase the chance of mould growth, paint damage or blistering or even plaster damage.

Also new air is generated in the area and illiminates the room fogging up.

A Licensed electrician should be appointed to wire and install the fan at the client's discretion, however where there is no window access an exhaust fan may be required by council regulations.

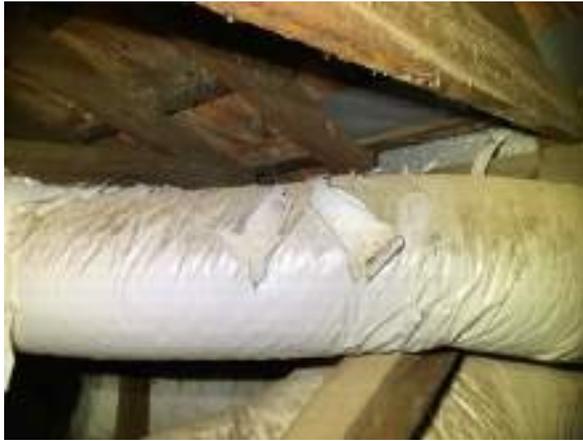
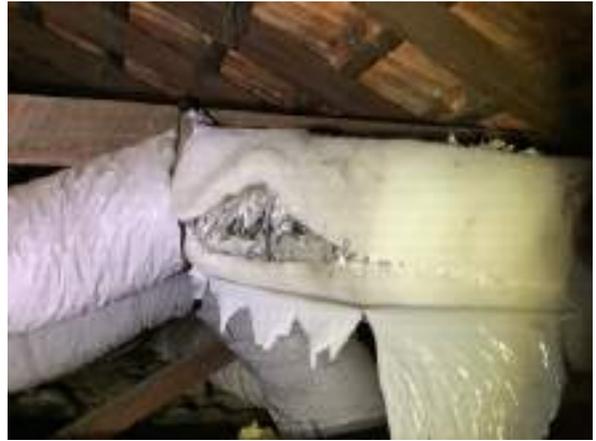
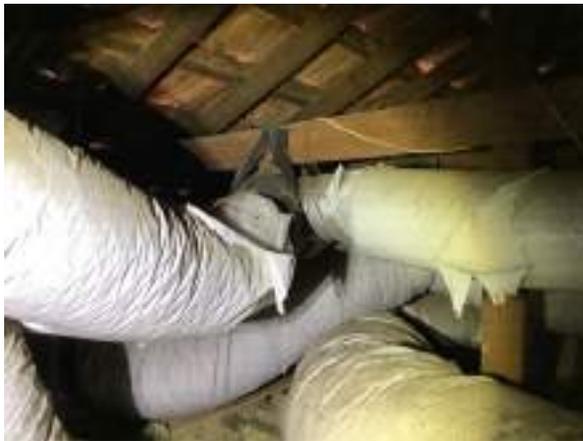
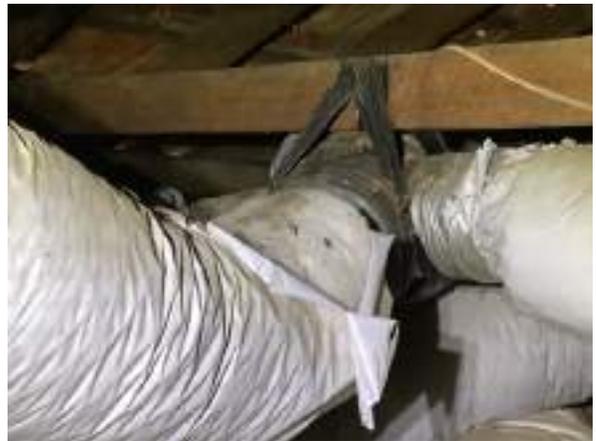
Minor Defect 3.12

Location: Roof Space

Finding: Heating / Cooling Ducts - damaged

The heating/cooling ducts were found to be damaged and not at a fully operational level. Generally, damage to ducts occurs as a result of ageing and material deterioration, but impact damage or pest damage may also be the underlying cause.

The damage sustained by the ducts detracts from the energy efficiency of the property. The airflow within the property is likely to be restricted, particularly in areas where ducting shows signs of major damage.

A heating/cooling specialist should be appointed to provide further advice on remedial work options and to perform any works deemed necessary.
