(Vendors Report)- Building & Termite/ Timber Pest Report

Inspection Date: 5 Feb 2021

Property Address: Yarraville Area

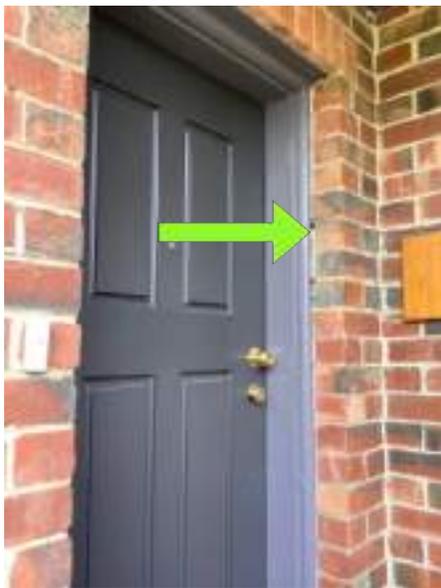
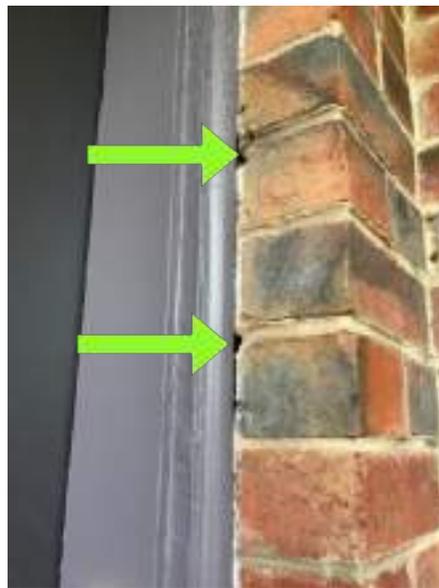
Minor Defect 3.13

Location: Perimeter Of Building - Exterior

Finding: Water Leaking & Water Ingress - External Areas

Water leaks were found to be present to the exterior sides, tops and or bottoms of the windows and/or doors and other areas as per the photos attached, such as brick expansion joints and timber and cement sheet junctions above windows , eaves and other areas.

Leaks are generally caused by deterioration of silicon or rubber seals or sometimes just defective workmanship when no caulking as ever been used .

With gaps like these that can be only a few millimeters to be exposed to weather conditions, can cause wood rott internally to the walls create a conducive environment for termites or possibly cause secondary defects the have the potential for structural damage the can be seen or in the walls internally.

Such leaking creates damp conditions in the affected area, causing potential for water pooling and subsequent water damage if left unattended. These conditions may also attract termite attack as already mentioned above, particularly if the area is subject to minimal levels of sun throughout daylight hours.

It is highly advised that a licensed plumber, handyman, builder be appointed to rectify any water leaks that may be present.

It is important to note once caulking these areas if water damage is noticeable to windows, timbers, etc, such as wood rott, it is imperative to engage the appropriate trades for replacement or repairs.

ALL AREAS should be checked carefully for this defect and attached are a few PHOTO EXAMPLES as a GUIDE.

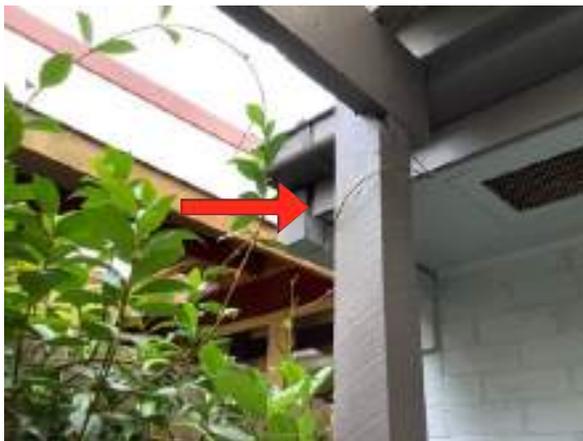
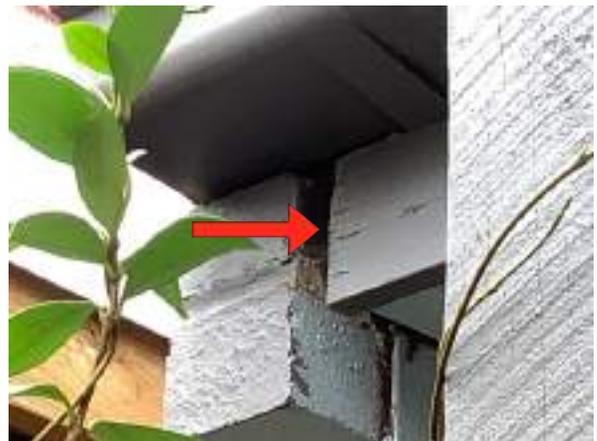
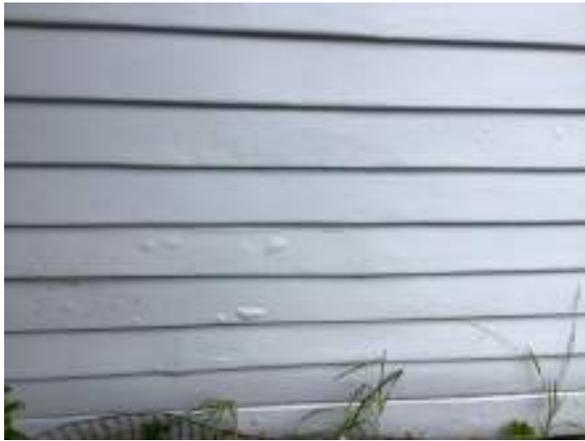
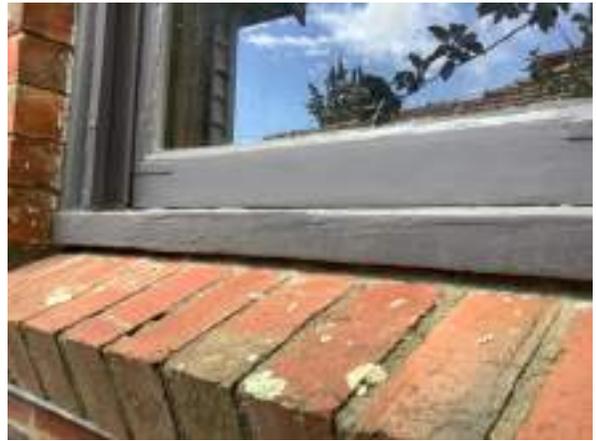
Minor Defect 3.14

Location: Timber Work - All External Areas

Finding: Timber, exposed to weather / External painting deteriorated

External timbers that are frequently exposed to harsh weather conditions require adequate protection (paint) in order to maintain their condition. Where timbers have not been painted or treated adequately, general deterioration is likely to occur at an accelerated rate.

Incomplete or missing paint finish NOT ONLY an appearance defect, it can in most cases lead to the development of secondary building defects over time. Incomplete areas of paint finish exposes the area to moisture, potentially accelerating the deterioration of underlying building materials.

It is important to note that when people are selling a home it can be common for them to cover the wood rot (decay) by means of using wood putty and paint over the existing timber wood rot (decay), not realising how dangerous this can be as covering up timber wood rot (decay) could be structurally compromising the building, or even more concerning is putting a persons life at risk.

Degraded paint finishes should be sanded back, filled, leveled and painted, as applicable. Where inadequate or missing paint protection has led to the deterioration of the associated building elements, meaning WOOD ROT (Decay) repair and/or replacement of this building element may be required, As if the wood rot is too severe repair of decayed timbers is generally too late.

If left unattended, replacement of these timbers is likely to be necessary in the short-term future. Adequate treatment of these timbers is required as soon as possible by a painting contractor should be appointed as soon as possible to perform necessary works to aid the appearance of the affected area and to ensure the area is protected against further deterioration. Alternatively, the homeowner following manufacturer instructions may perform these works.

Please read the report carefully and Maintenance to all susceptible and conducive timber areas is a MUST to minimise the risk of termite and timber pest existence and timber damage.

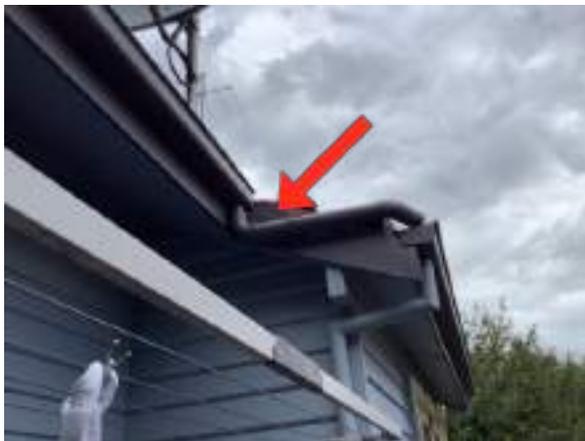
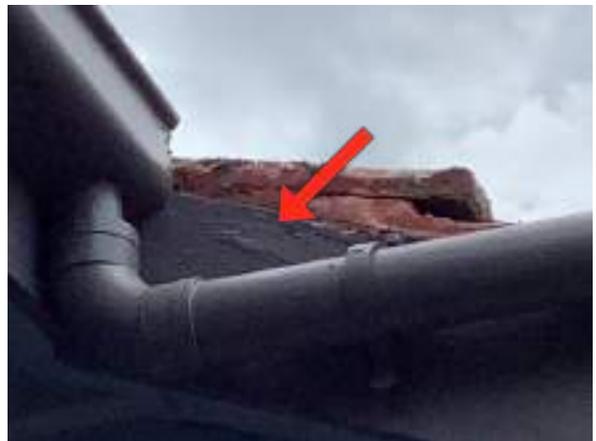
Minor Defect 3.15

Location: Timber Work - All External Areas

Finding: Fascias - Wood rot

Wood rot was found to be affecting fascias and barges in this area, evidenced by the presence of mould on the surface in some areas.

Wood rot, also known as Fungal Decay, occurs when timbers and other cellulose building materials are exposed to damp conditions on an ongoing basis.

It is likely that this wood rot has developed as a result of faults in the roof plumbing, creating excessive moisture in this areas.

Frequent exposure to rain and other weather conditions also make fascias and barges susceptible to accelerated deterioration.

Early intervention and regular maintenance will prolong the useful life of these building elements. Prior to any works being performed, the cause of the moisture that has created the visible wood rot should be identified and addressed in a suitable manner.

It is advised that a roof plumber be appointed to inspect all roof plumbing and subsequently identify the cause of the wood rot, which may have been caused by blocked gutters, broken roof tiles, deteriorated tile mortar and/or just deteriorated paint.

Replacement of affected fascias and barges may then be a necessary step in protecting surrounding building elements from such deterioration.

A qualified plumber may be appointed to assess the cause of excessive moisture and to provide advice on any remedial works as required. A qualified carpenter or registered builder may also be required to replace affected building materials.

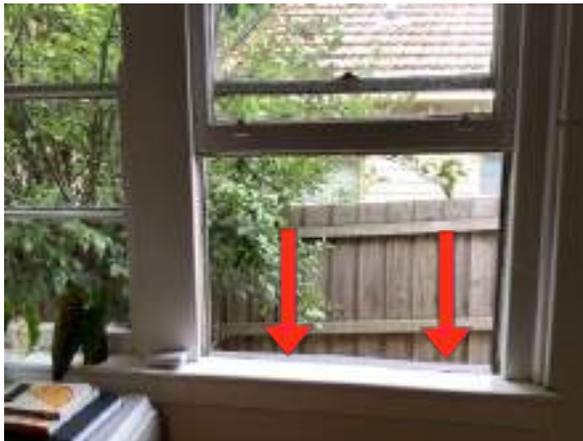
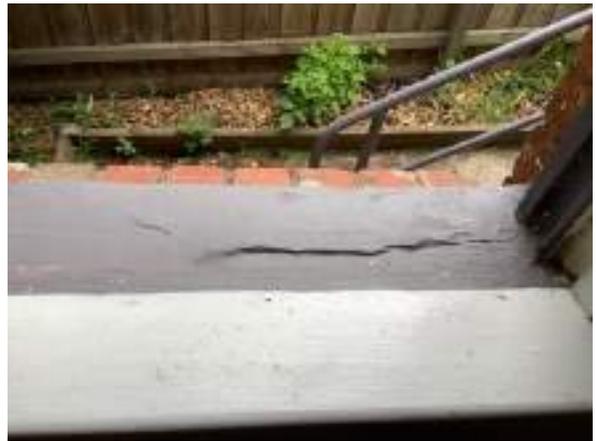
Minor Defect 3.16

Location: Timber Work - All External Areas

Finding: Windows - Wood Rot

Wood rot was found to be affecting external windows. Wood rot, also known as Fungal Decay, occurs when timbers and other cellulose building materials are exposed to damp conditions on an ongoing basis.

Early intervention and regular maintenance will prolong the useful life of these building elements. Prior to any works being performed, any associated pipework or roof plumbing should be inspected by a licensed plumber for faults or leaks.

Repair and/or replacement of affected window frames may be a necessary step in protecting surrounding building elements from such deterioration. Remedial works should be performed by a qualified carpenter or registered builder as soon as possible to prevent any further damage.

ALL AREAS should be checked carefully for this defect and attached are a few PHOTO EXAMPLES as a GUIDE.

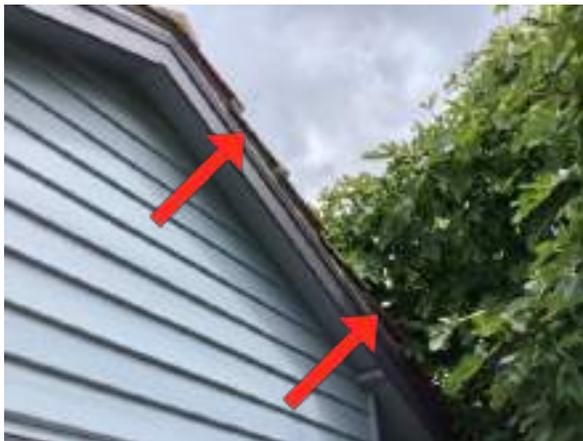
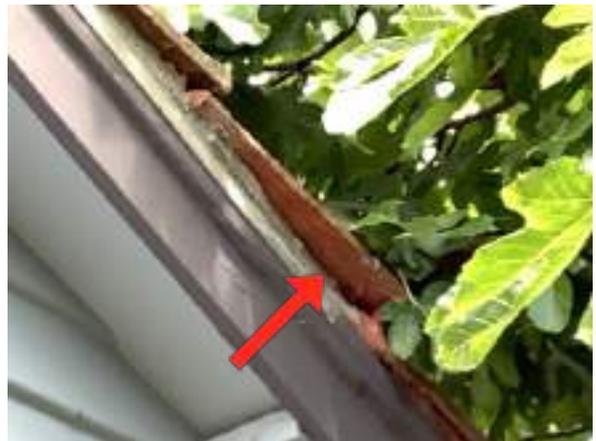
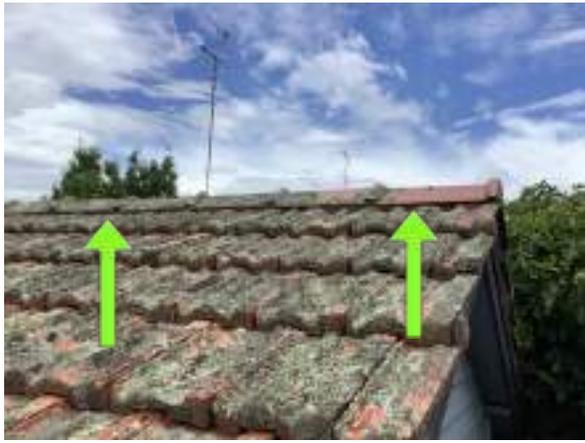
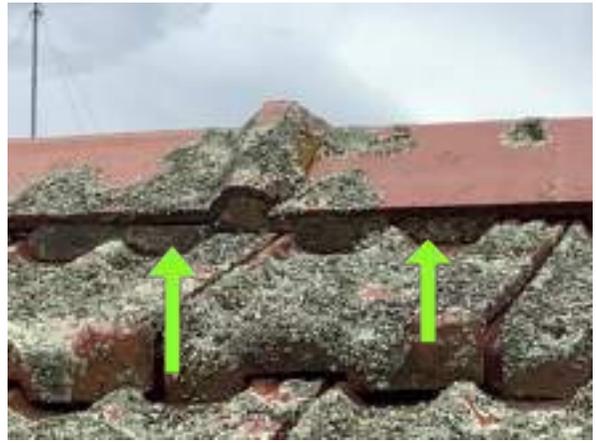
Minor Defect 3.17

Location: Roof Areas & Stormwater

Remedial works are likely to increase the longevity of the exterior roofing structure.

ALL AREAS should be checked carefully for this defect and attached are a few PHOTO EXAMPLES as a GUIDE.

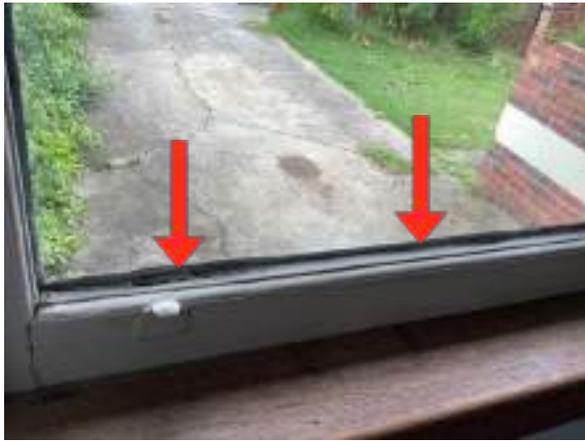
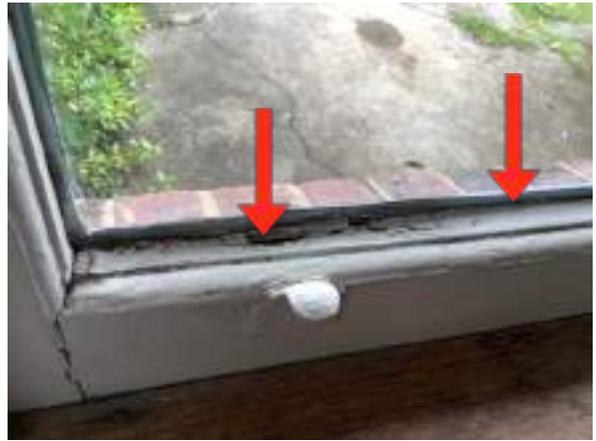
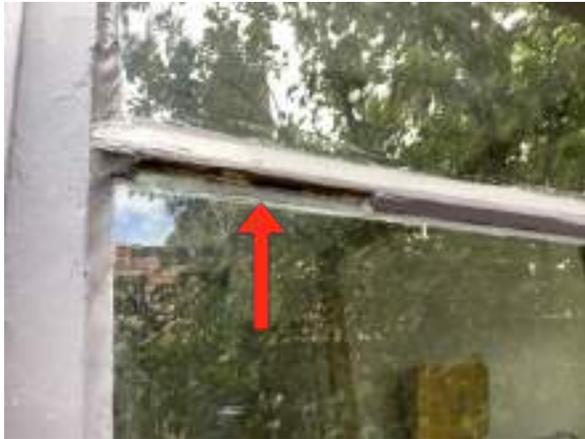
Minor Defect 3.19

Location: Window Seals - Interior / Exterior

Finding: Window Seals - Deteriorated

In the case of window seals that may have also deteriorated on this building, then window seals that have deteriorated and/or are in a generally poor condition, due to frequent exposure to weather conditions and subsequent moisture, deterioration of window seals is expected in a property of this condition and age.

Where window seals have deteriorated, the window is no longer weather-tight; rain penetration and subsequent water damage is therefore likely to ensue. Insulation of the area against external weather conditions will also be compromised.

ALL AREAS should be checked carefully for this defect and attached are a few PHOTO EXAMPLES as a GUIDE.

It is recommended that all deteriorated window seals be replaced by a general handyman, window technician, glazier, builder or sealant expert to prevent any further damage and to restore the window to a fully functional level. Damaged window seals can be rubber, silicon or with the old windows a special type window putty.

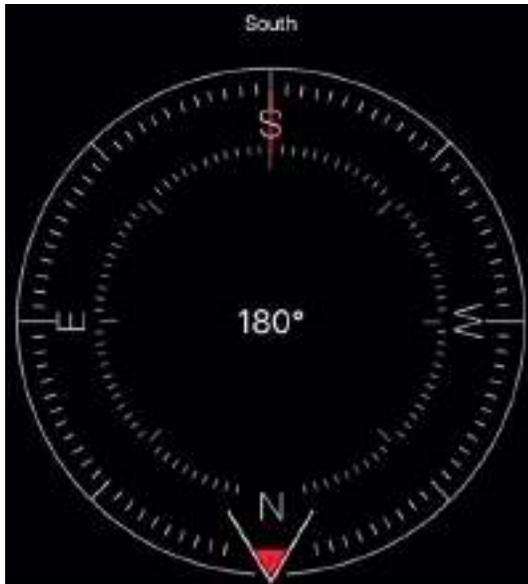
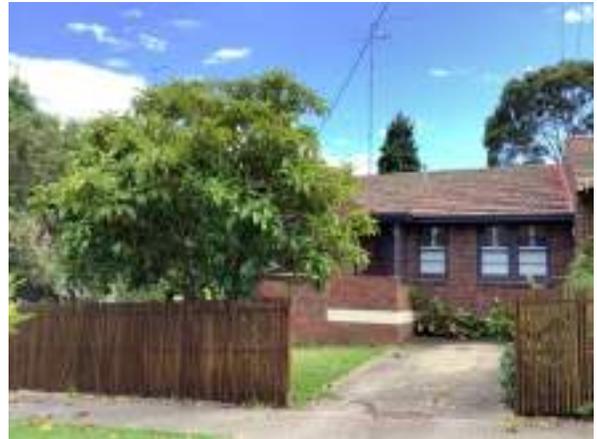
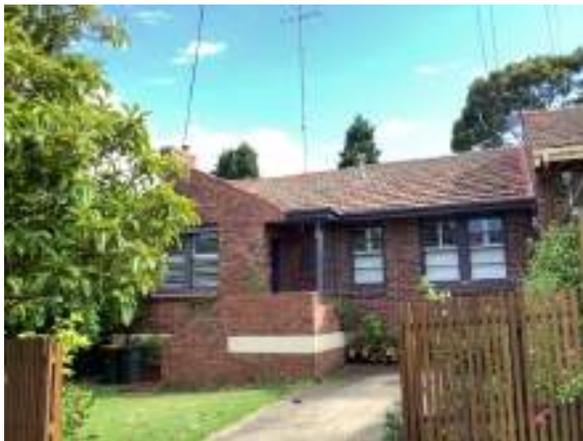
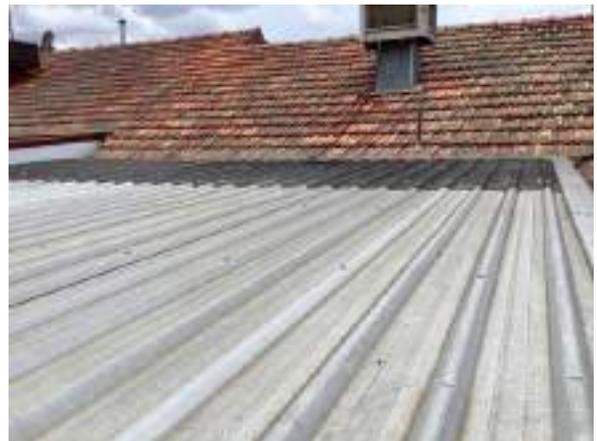
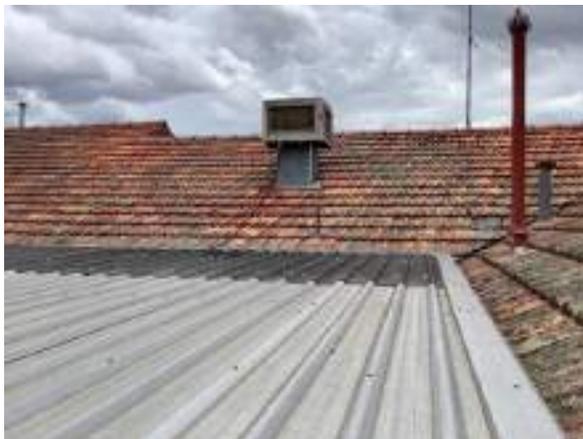
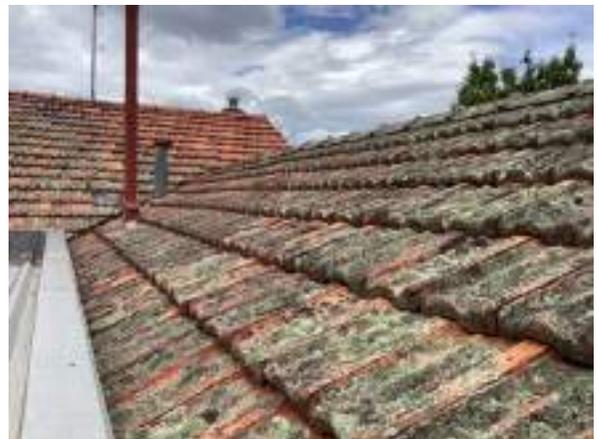
Finding: General Site Photos

General site photos and other areas of interest are provided for your general reference.

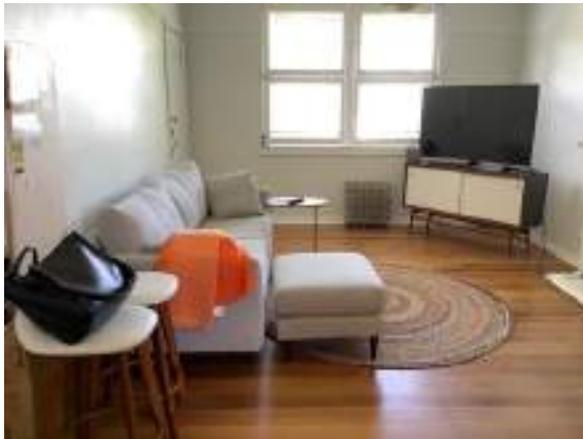
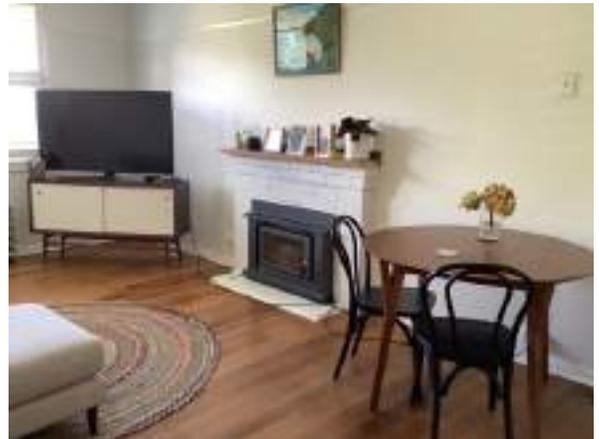
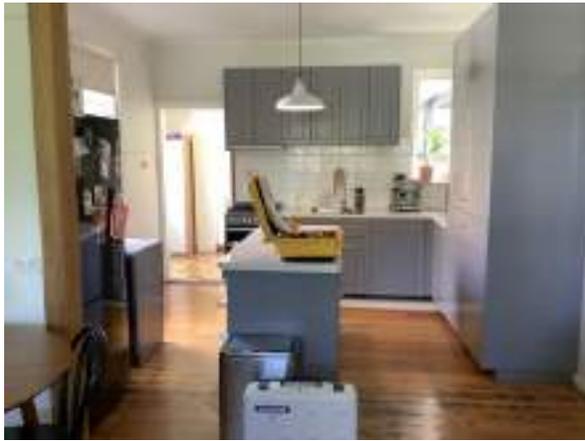
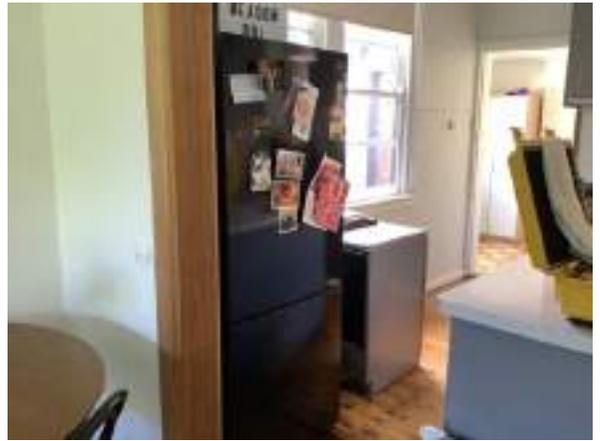
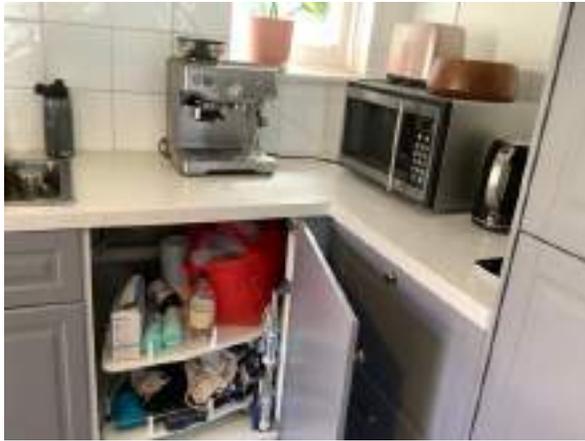
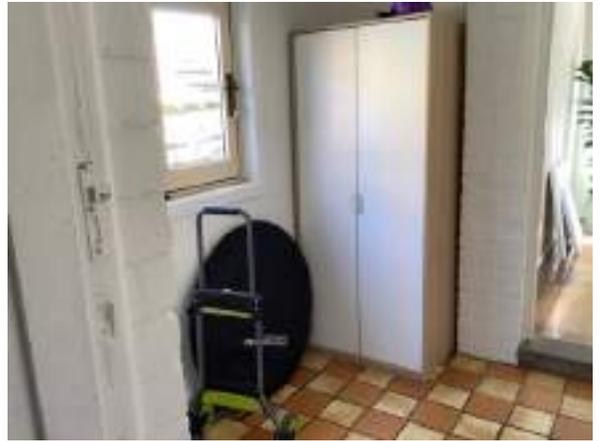
For your information 4.05

Location: The Site

These obstructions can hide an array of defects such as minor defects , major defects , safety hazards , termite activity and conducive environments for termites but not limited to.

These photos in the report are for you to understand the type of obstructions and limitations on site, that restricted our inspection process.

Once the property is emptied, a re-inspection is at the client's discretion.

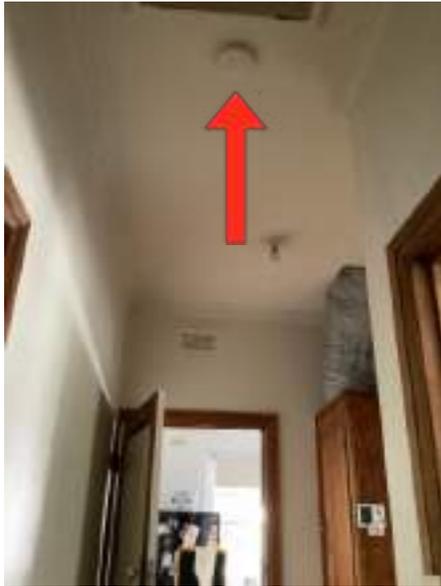
For your information 4.06

◆ Smoke Detectors Battery Replacement.

Upon moving into a new property, it is highly recommended that the batteries to the smoke detectors all get replaced instantly.

Smoke detector batteries should be replaced every 12 months at a minimum.

It is highly recommended that replacement dates of the batteries be kept in a log book.

Testing of smoke detectors is required monthly.

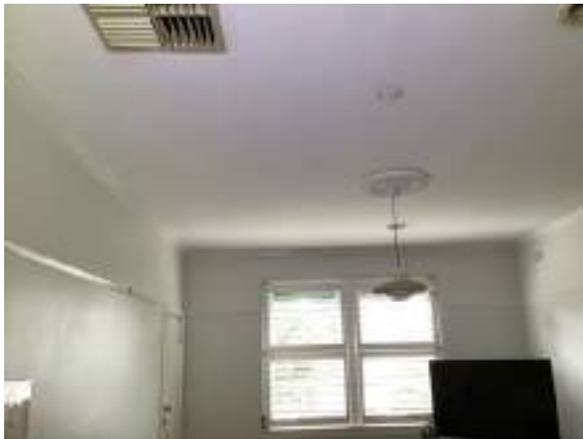
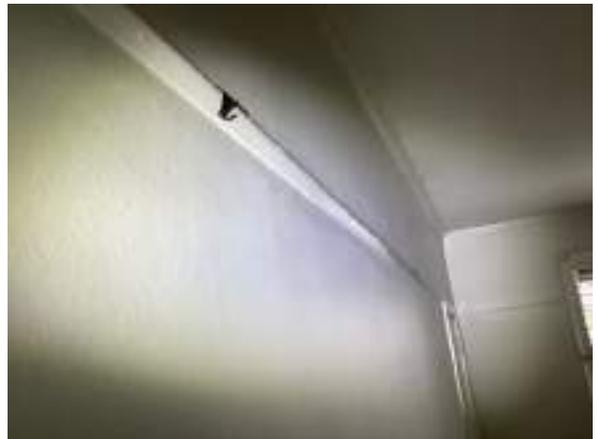
For your information 4.07

Location: Paint & Plaster-Various Areas

Please note that some cracks in the plaster work and/or solid plaster work have been repaired, so it is unknown how severe the cracks in the plaster work and/or solid plaster work really were, before they were repaired.

Superficial scuff marks, damaged plaster, holes in walls,missing paint,sub-standard paint work were noted to the internal walls / ceilings and/or architraves as per the photos attached at the time of inspection.

While these minor defects are detracting from the overall appearance of the affected building element, they do not indicate any operational or structural damage.

This degree of surface damage is consistent with general damage, accidents, movement and wear and tear.

These type of minor defects are appearance cosmetics but they can also lead to the development of secondary building defects over time.

Incomplete areas of paint finish, holes in plaster, exposes the area to moisture, potentially accelerating the deterioration of underlying building materials especially in wet areas such as laundrys and bathrooms.

Superficial scuff marks, damaged plaster, holes in walls,missing paint,sub-standard paint work should be sanded back, filled, levelled and painted, as applicable. Where inadequate or missing protection has led to the deterioration of the associated building element, repair and/or replacement of this building element may be required.

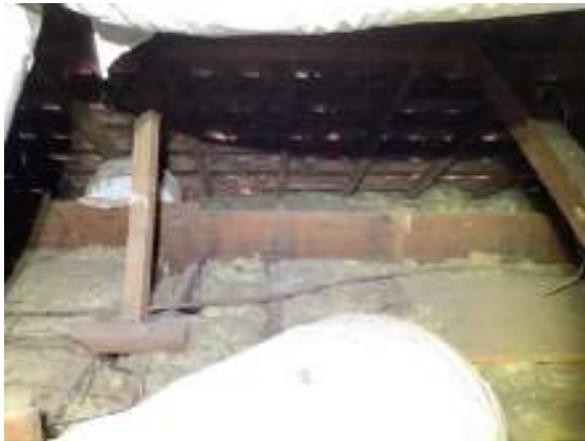
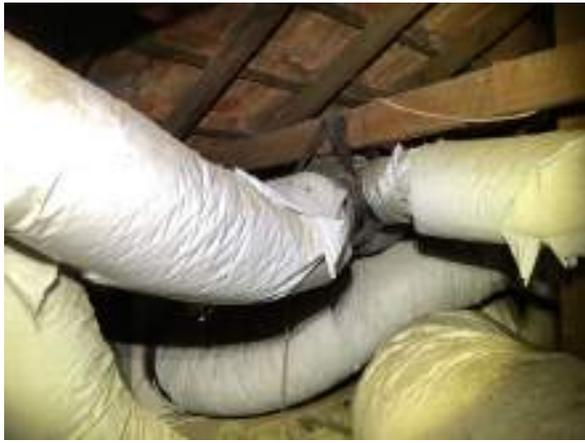
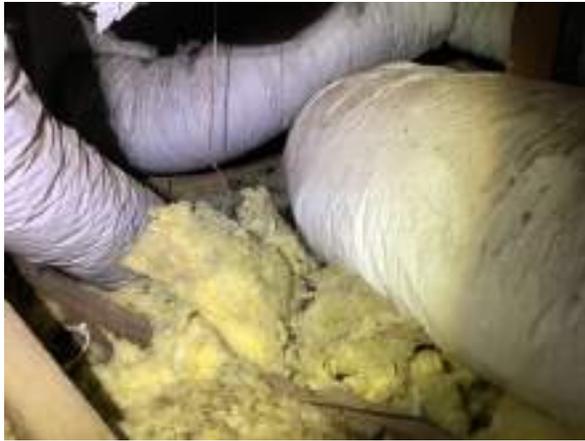
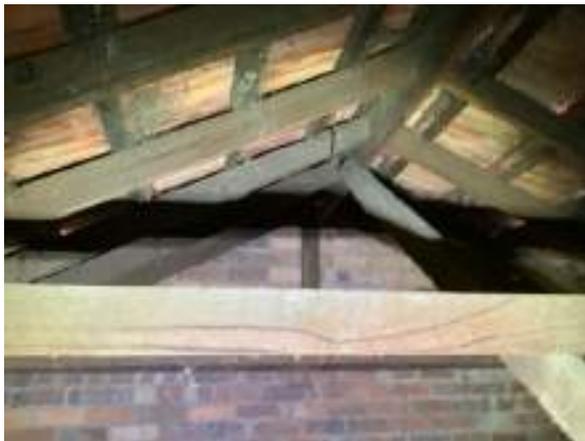
For your information 4.08

Location: Roof Space

These obstructions can hide an array of defects, without removing the insulation it is impossible to rule out termite activity and/or termite damage and other undetectable issues.

The property is a very high risk for termites as the environments to the property are very conducive with many susceptible areas.

Please read the report carefully and Maintenance to all susceptible and conducive areas is a MUST to minimise the risk of termite and timber pest existence and timber damage.

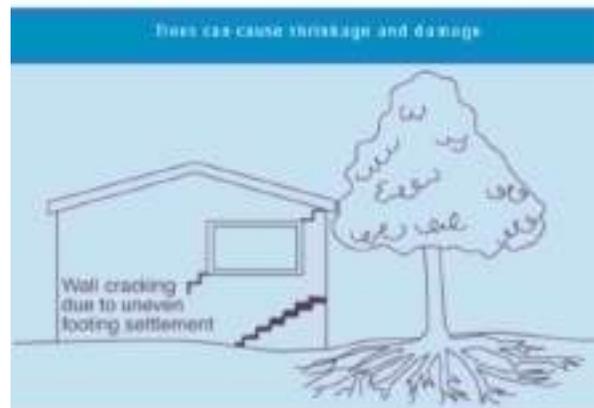
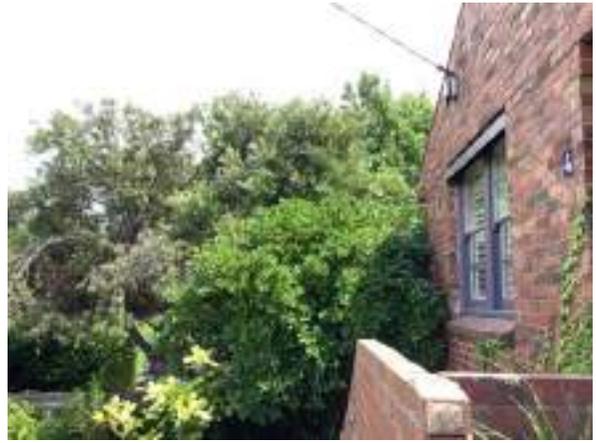
For your information 4.09

Location: Garden Areas - All Areas

Trees and other vegetation can have a significant local effect on drying of soils. Over a number of years, especially during drought conditions, adjacent trees and vegetation may draw excessive moisture from the soils. The opposite may also occur, where swelling of the soil results when the trees decline or are removed.

As the cumulative moisture deficient is reversed, the surface level around the tree (and adjoining subfloor or concrete slab) will rise and expand laterally. This is often damaging to buildings unless the foundations have been strengthened or designed to cope with the effect.

Subsidence can have complex and varying causes, which will influence the required remedial works. It is advised to begin by consulting a structural engineer to determine the required scope of works. This generally includes some form of underpinning, as well as addressing the underlying cause. Consultation with a geotechnical engineer may also be necessary.

A registered builder specialising in re-stumping / structural damage such as major brick cracking would then generally carry out works as advised by an Engineer and/or Geotechnical Engineer.

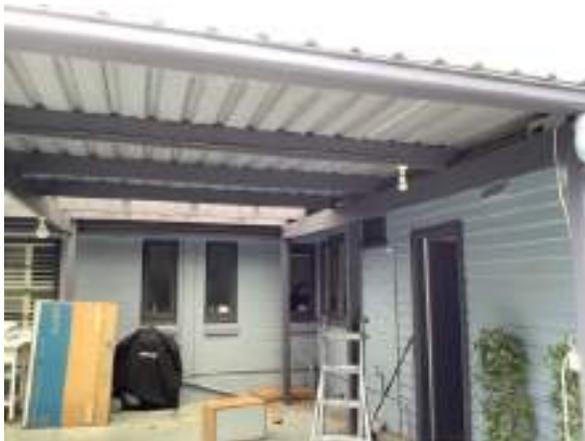
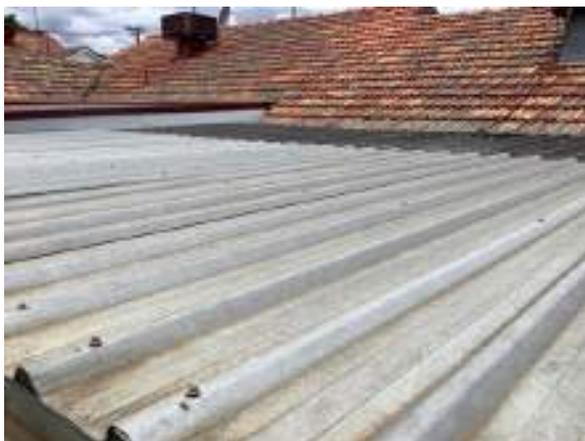
For your information 4.10

Location: Pergola
 Finding: Pergola - Non Compliant & Additional Structure Suspected To Be Built Without A Permit

I highly recommend that you further investigate this home as the Pergola may or may not have the correct permits / paperwork through the council, architects, engineers, etc regardless if the works have been done to a quality tradesmens like manner or not.

The Pergola also has various elements that do not appear to comply and more importantly it also has had modifications that appear unsafe.

I HIGHLY RECOMMEND that you engage the professionals as stated above. I also highly recommend that persons keep clear of the areas until further investigations are made , repaired and cleared by the appropriate people.

It is highly advised to request that the current owner provide a Defect report (Owner Builder/ Section 137b) for this structure. This would involve a structural engineer or a licenced building surveyor conducting an inspection of the structure and advising of any defects and/or areas of non-compliance in accordance with the current building codes. The current owner should then attend to any issues on this report prior to settlement.

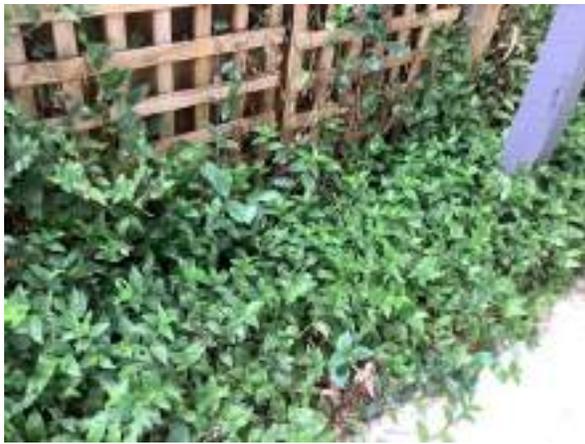
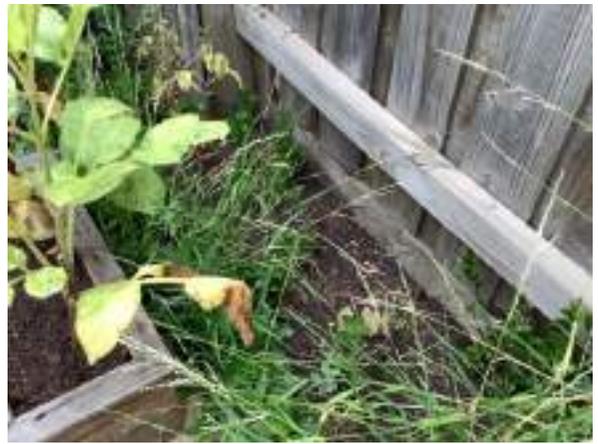
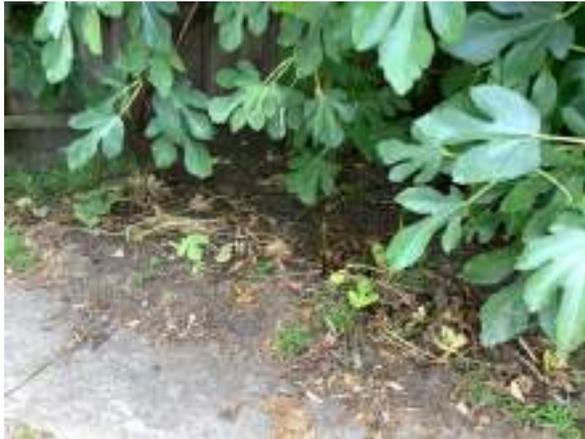
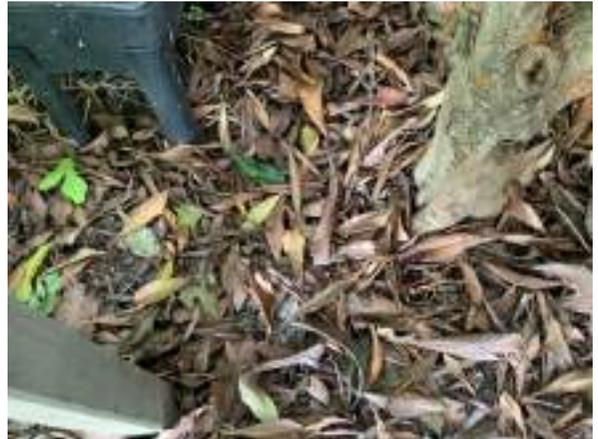
Conditions conducive to timber pest attack 4.13

Location: Garden Areas - All Areas

It is always important to keep the garden beds as clean as possible and take out excess old bark from the trees, leaves and keep bark mulch to a minimum or better introduce rocks or some item that does not create an conducive environment for termites and hold excess moisture.

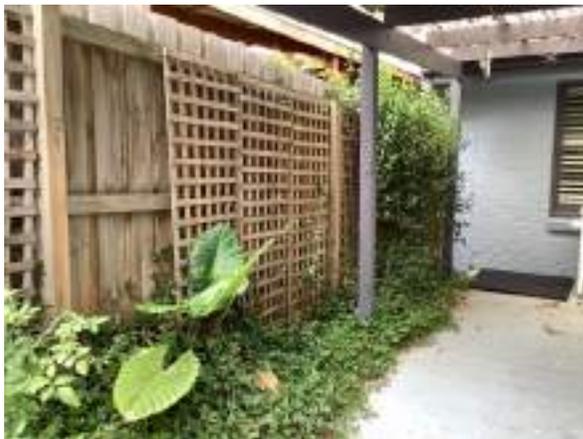
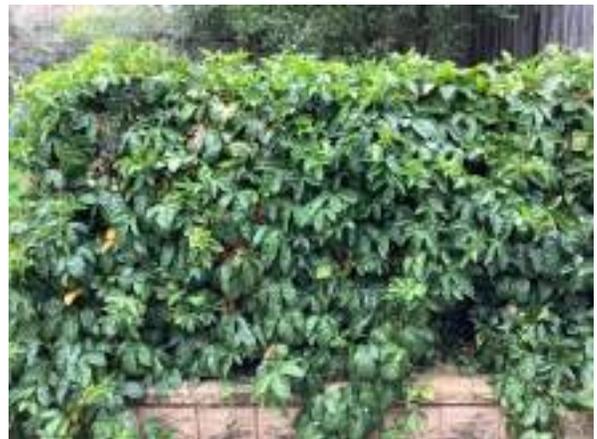
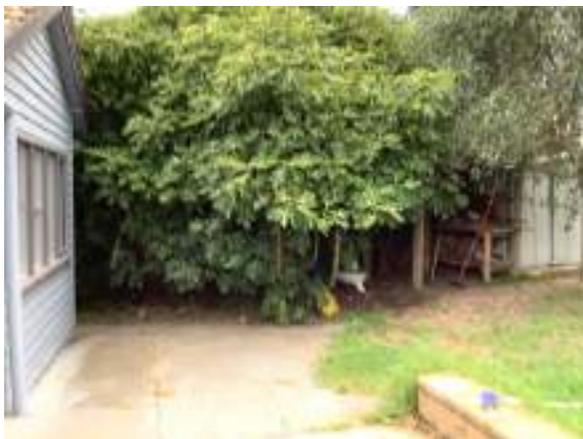
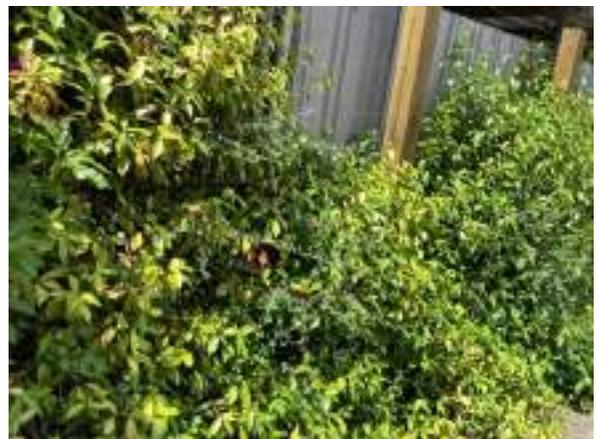
Conditions conducive to timber pest attack 4.14

Location: Garden Areas - All Areas

It is impossible to identify all areas for termites, timber pest and timber pest damage.

Please read the report carefully and Maintenance to all susceptible and conducive areas is a MUST to minimise the risk of termite and timber pest existence and timber damage.

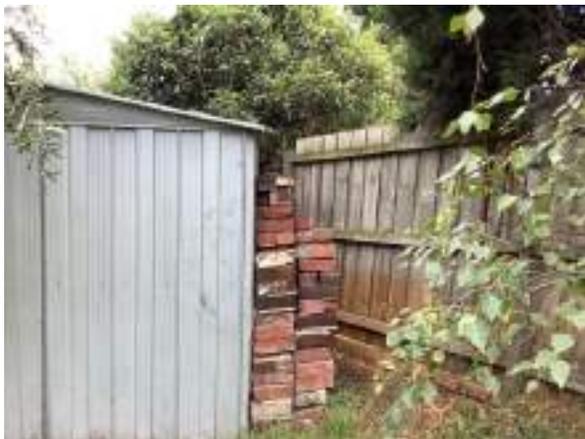
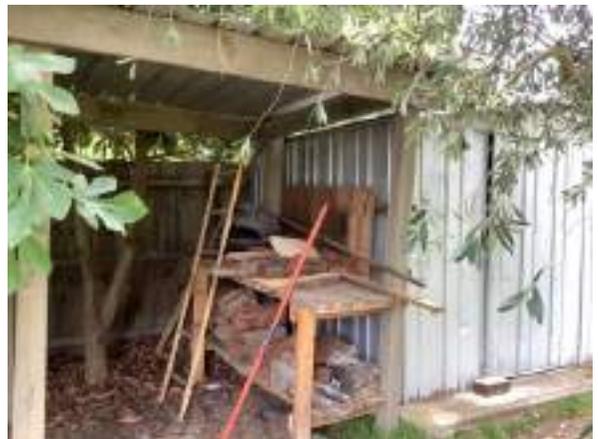
Conditions conducive to timber pest attack 4.16

OTHER CONDITIONS CONDUCTIVE TO TIMBER PEST ATTACK

It is highly recommended that any stored building materials or other materials be immediately removed from areas in which they may attract any termite / timber pest attack around the perimeter and/or sub floor areas of the dwelling and a re-inspection is carried out.

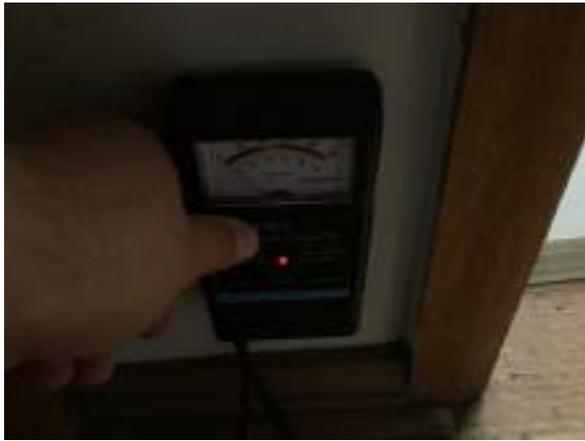
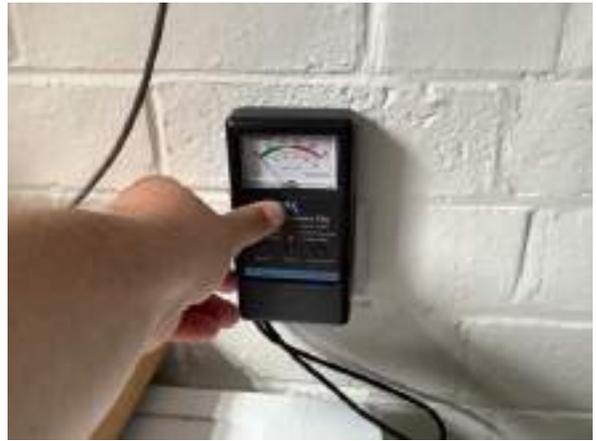
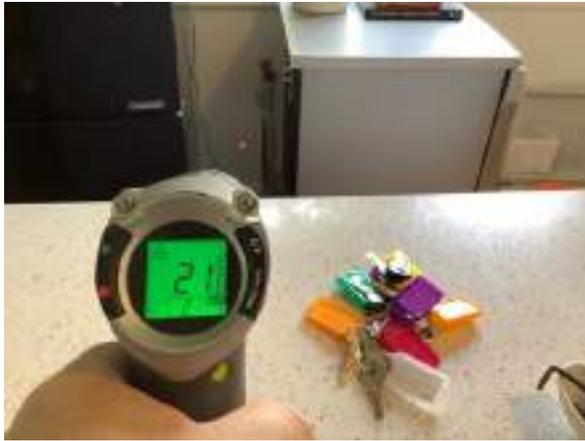
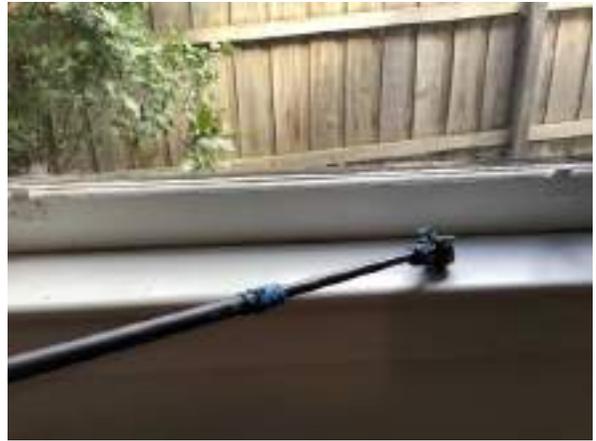
For your information 4.18

Location: The Site

As all areas are not able to be inspected due obstructions and limitations, we therefore can not rule out the possibility of concealed timber pest activity.

Wall paneling, wall paper, carpet and fixed cabinetry can obscure termite activity.
