Structural report related to concrete slab movement.

Inspection Date: 10 Mar 2021

Property Address: Werribee Area, Victoria.

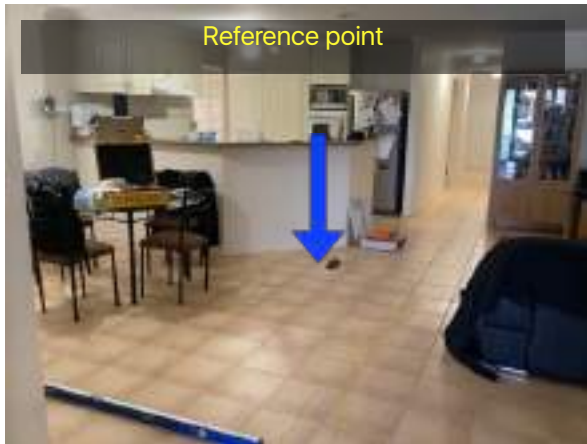
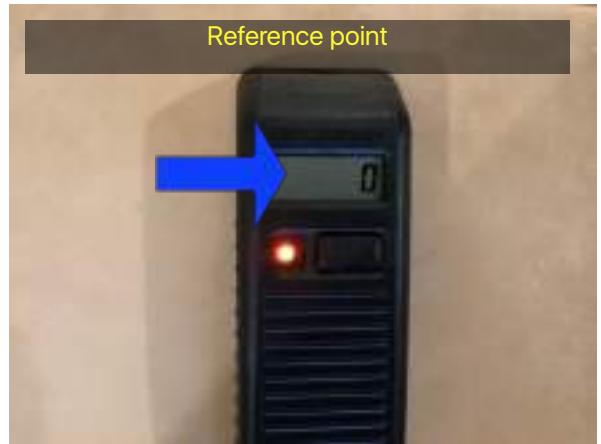
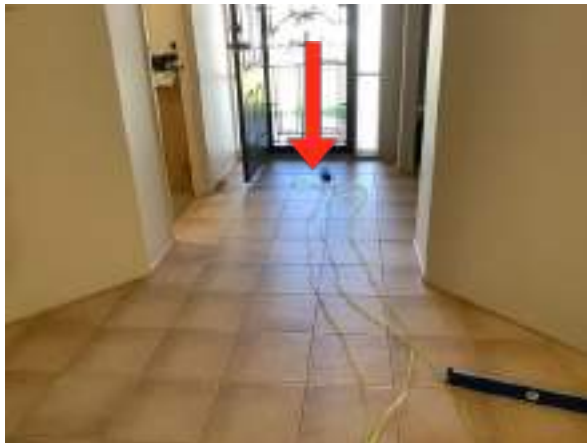
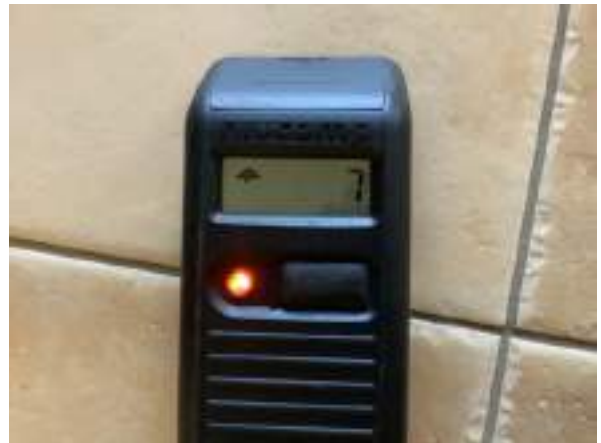
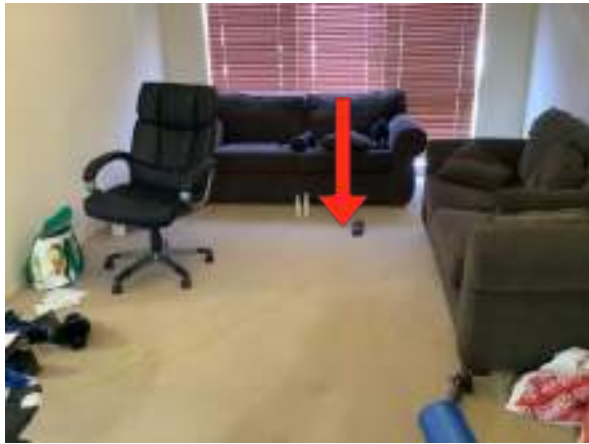
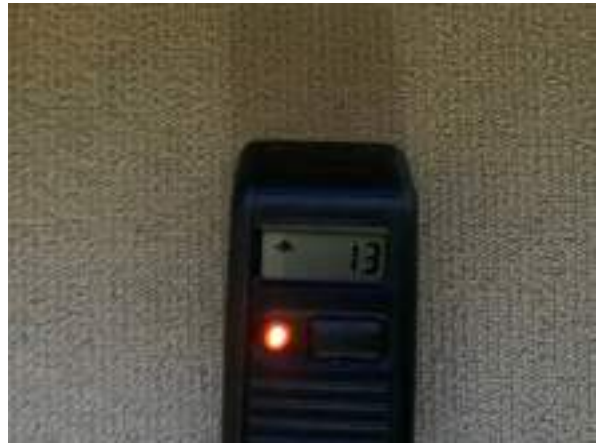
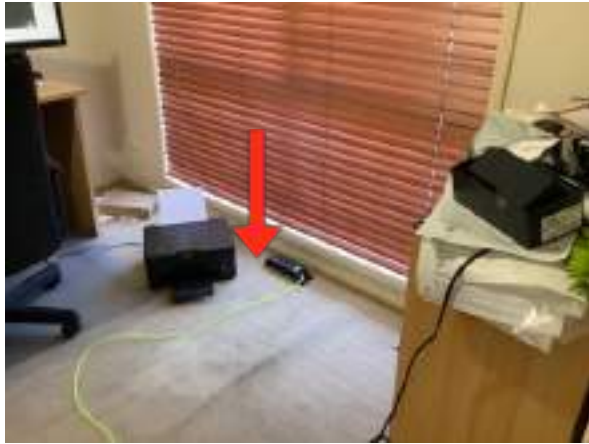
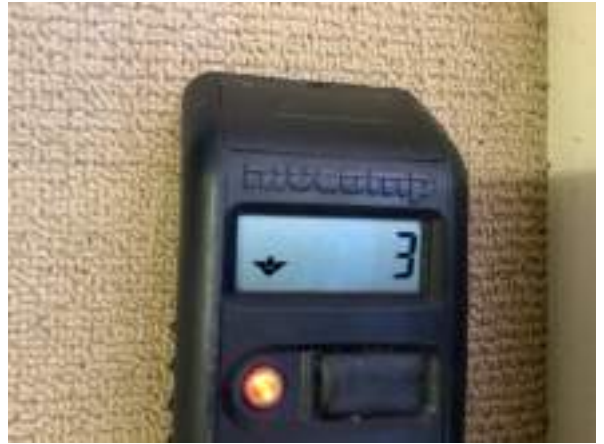
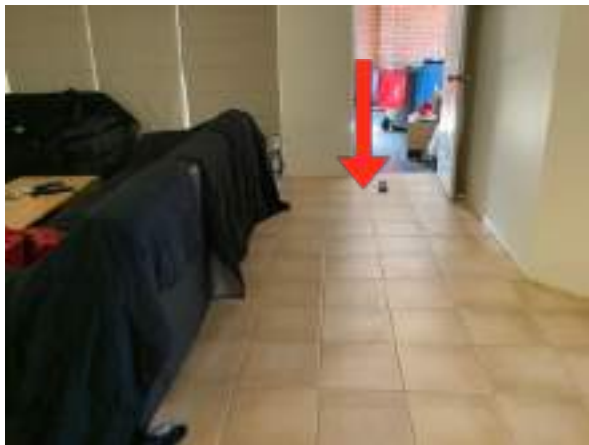
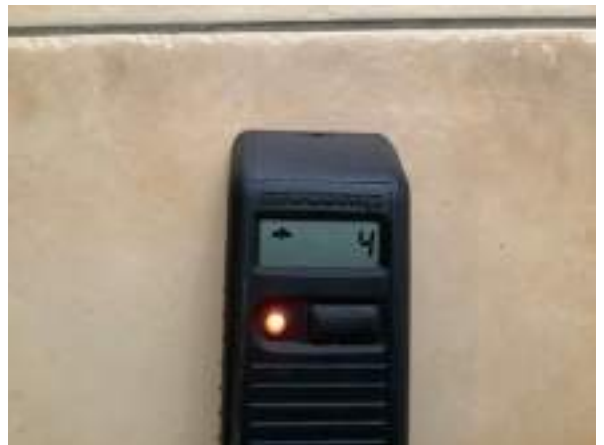
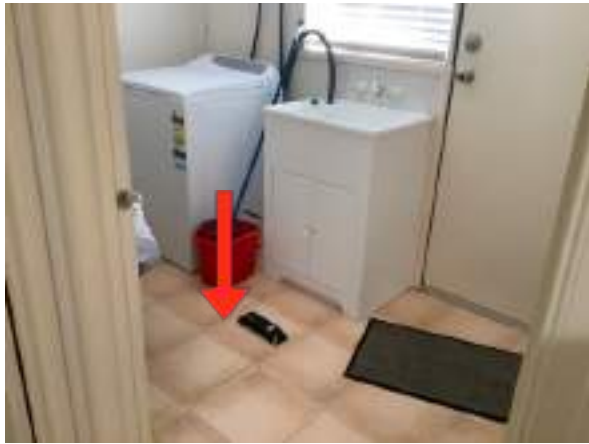
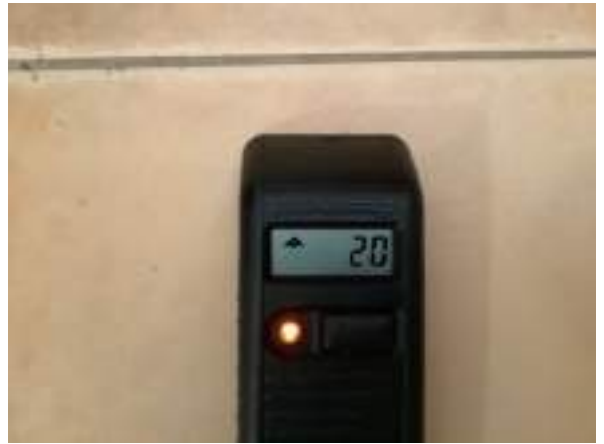
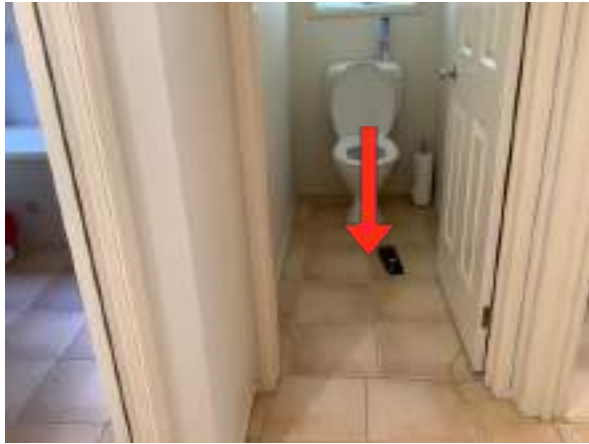
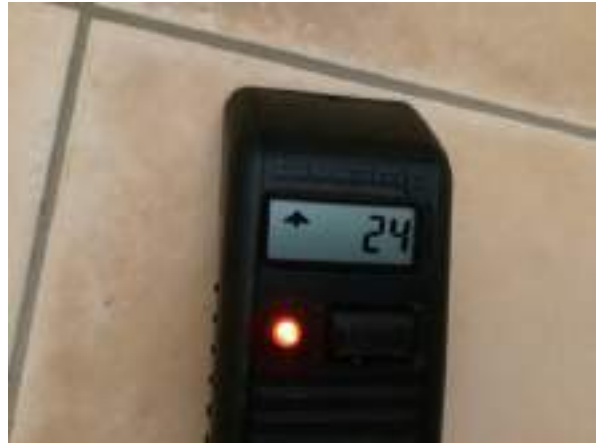
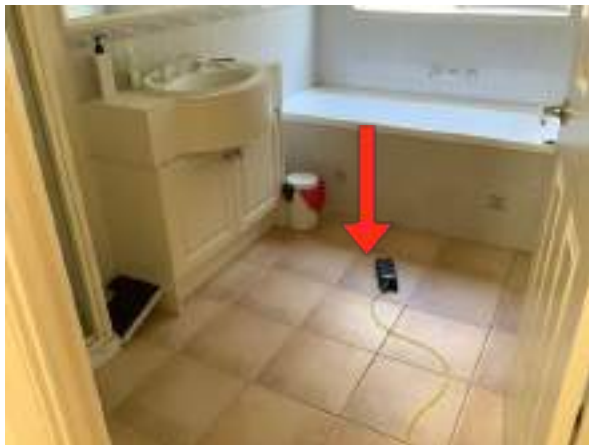
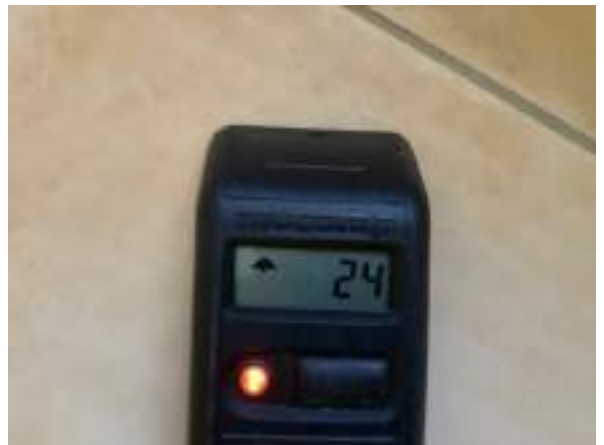
Major Defect 2.01

Concrete - Slab Heave & Foundation Subsidence

It appears that the subfloor structure (concrete slab) has been affected by movement of the foundations, often referred to as sinking or subsidence, now a degree of movement is expected in subfloors over time, but generally not with concrete slabs of a home and not to this degree, where the brickwork in areas, the floors and the walls are all consistent with signs of serious movement.

General subsidence is usually initiated by changes in soil moisture content clauses by various reasons. The most critical factor is identifying the specific causes, and identifying if this is a recurring or ongoing problem, or one that has been resolved by previous works in the past.

This significant type of movement in a concrete slab that shifts the floors, walls and brickwork may be caused by an under engineered concrete slab, soil moisture changes, broken water pipes and others forms of causes.

Subsidence can have complex and varying causes, which will influence the required remedial works. It is advised to begin by consulting a structural engineer , geotechnical engineer to determine the required scope of works. This generally includes some form of underpinning, in part or full, that is if the concrete slab can be repaired and/or even saved ??

A geotechnical engineer will be necessary where changes to soil moisture content is apparent caused by large trees or tree may be in the area or inadequate drainage, fall of the land, damaged plumbing above ground or below ground.

Once the stormwater/sewage/drain pipe invasive inspection has been performed, the next step would be to engage A geotechnical engineer and/or a structural engineer to make their further assessments, however it would be the preferred order that all the camera detection be completed to the underground pipes first.

The geotechnical engineer and structural engineer will then make further assessments and determine the scope and procedure of works that will be required.

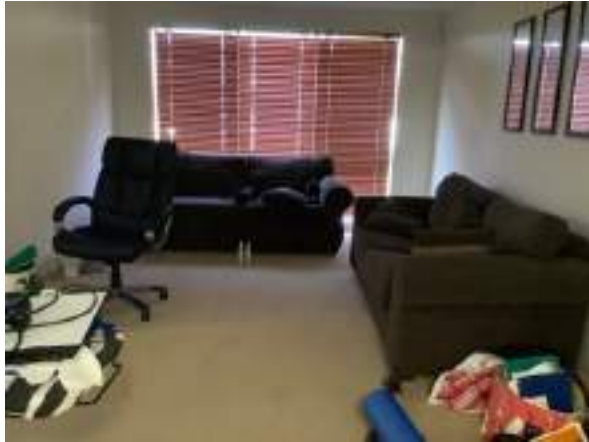
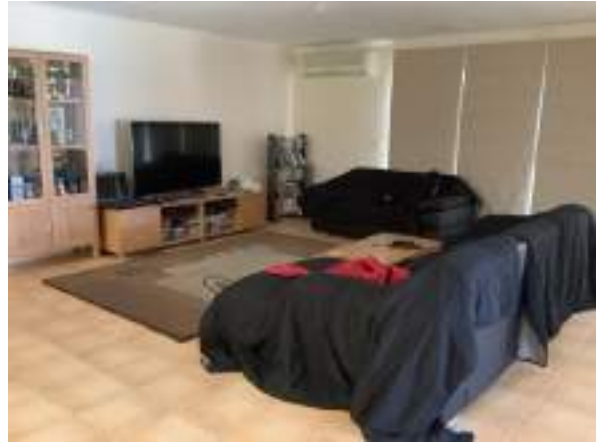
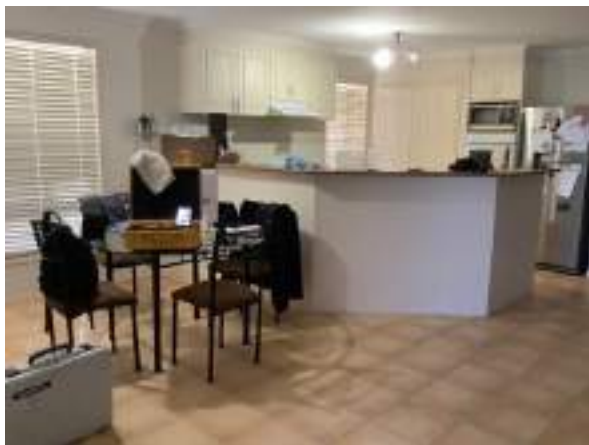
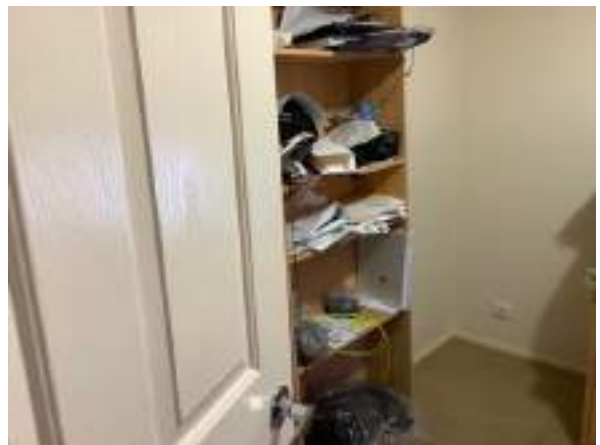
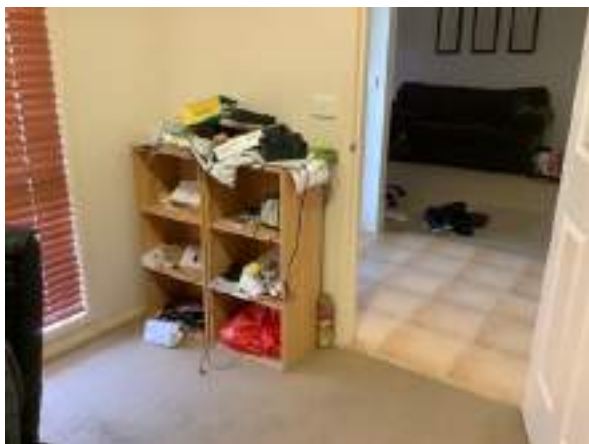
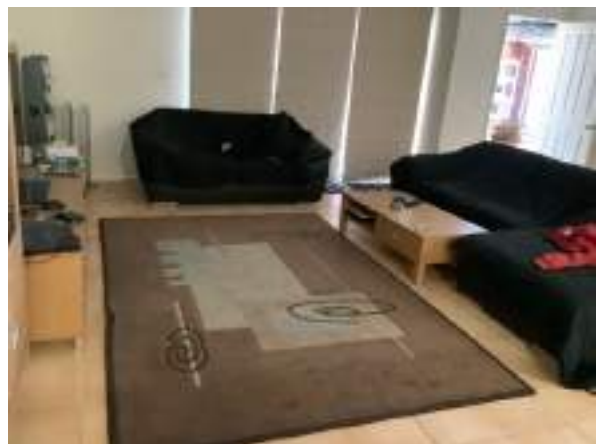
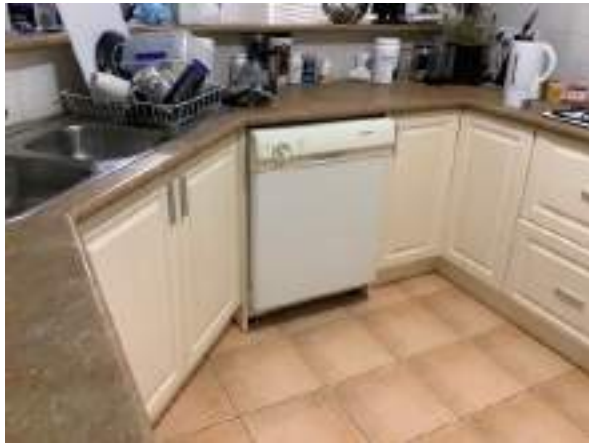
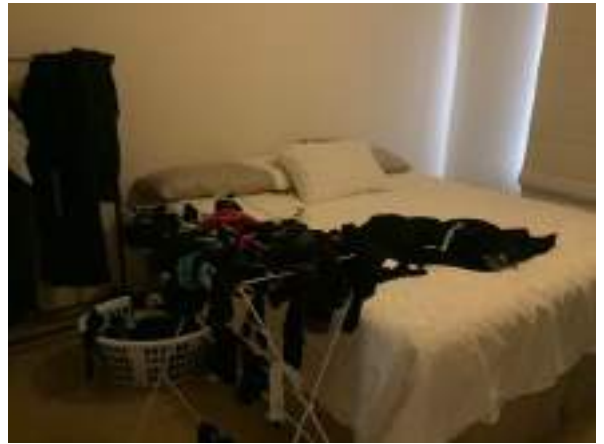
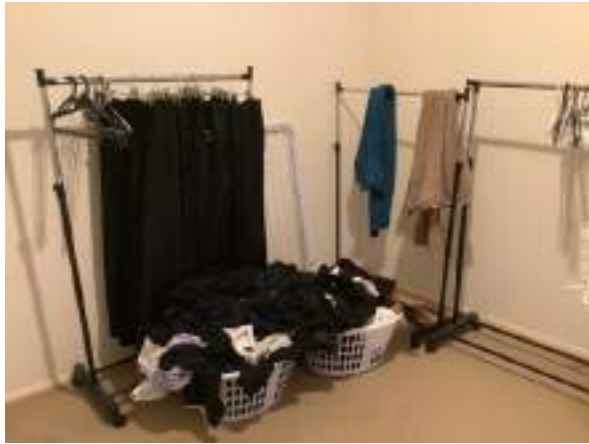
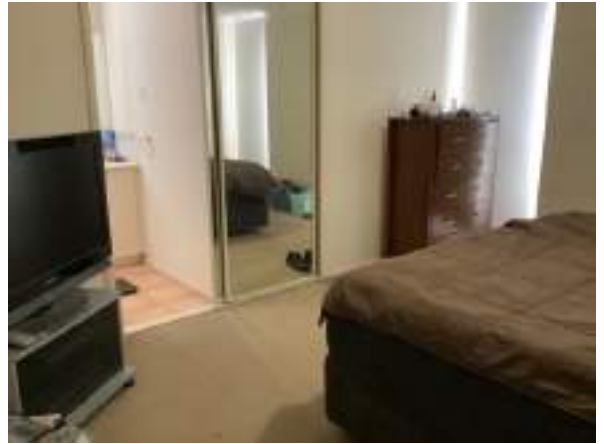
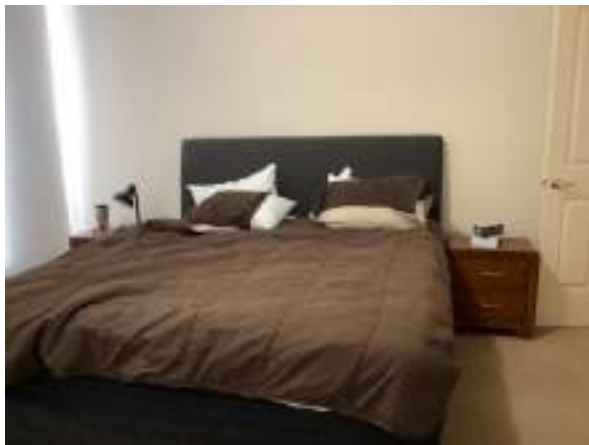
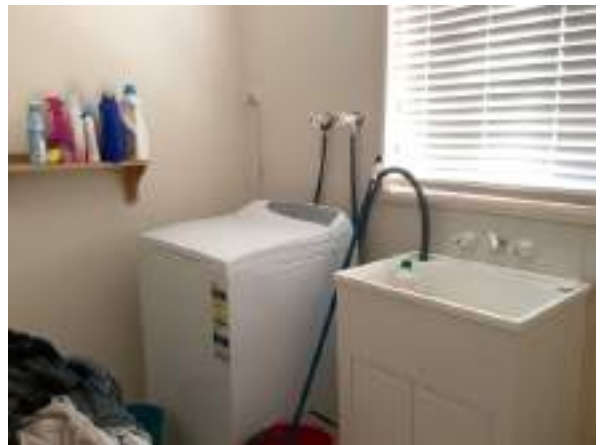
These photographs are an indication of the obstructions and limitations which impeded full inspection of the property at the time of inspection. These obstructions can hide an array of defects such as minor defects , major defects , safety hazards , termite activity and conducive environments for termites but not limited to.

These photos in the report are for you to understand the type of obstructions and limitations on site, that restricted our inspection process.

Once the property is emptied, a re-inspection is at the client's discretion.

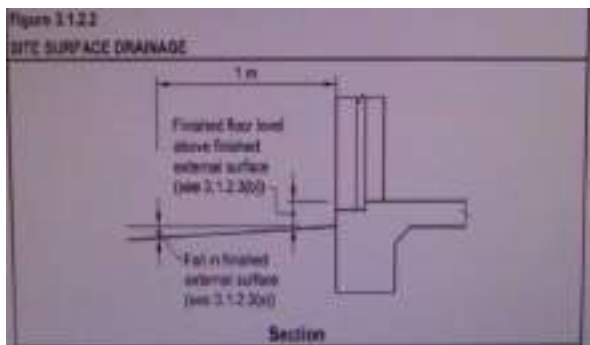
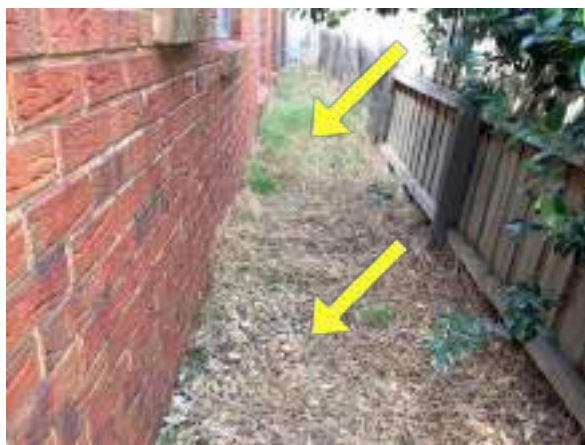
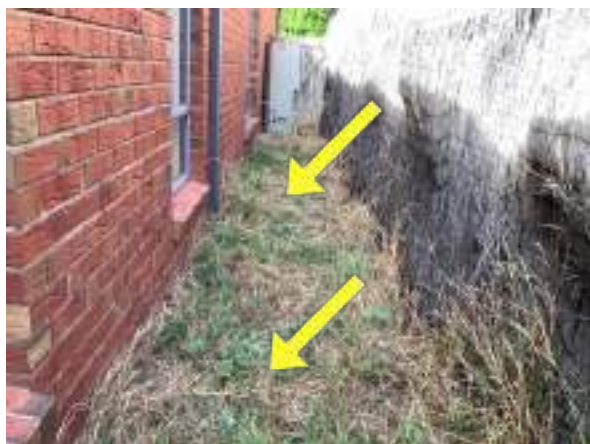
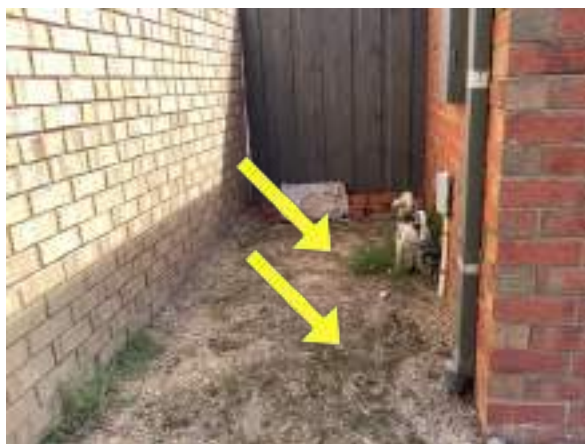
Observation 4.13

Location: Perimeter Of Building - Exterior
 Finding: Drainage - Inadequate and/or Perimeter Building Ground Fall Defective.

Water pooling near foundations and footings is a serious concern with the potential to adversely impact on the longevity of the dwelling. The Building Code of Australia (BCA) outlines that the soil or concrete must be graded away from the dwelling at a minimum of 50mm over 1m (1:50 fall).

The site drainage in this report was found to be inadequate at the time of inspection, creating potential for subsequent water damage to associated building elements, such as foundation subsidence, brickwork cracking, windows and doors moving, concrete paths cracking, etc.

These drainage concerns in this report can have grave potential for foundation subsidence and/or secondary damages such as structural defects such as brick movement / cracking as already mentioned above.

In relation to termites, Defective drainage and falls create high water and moisture which creates a very high risk for termites as the environments to the property are very conducive with many susceptible areas.

Where site drainage is inadequate, another option can be installation of an Agricultural (Aggie) Drain may be required or more serious remedial works.

It is highly recommended that a plumber and/or builder and then pending on the outcome, other forms of professionals be appointed to further inspect the area and to install / repair adequate drainage equipment where necessary. If secondary damages have ALREADY accrued we highly recommend that you engage a structural engineer, geotechnical engineer to start with then engage a registered builder, qualified plumber to further inspect the property and perform any remedial works as necessary. Note, this is only if there is any building damages that have occurred.

Please read the report carefully and Maintenance to all susceptible and conducive areas is a MUST to minimise the risk of termite and timber pest existence and timber damage.

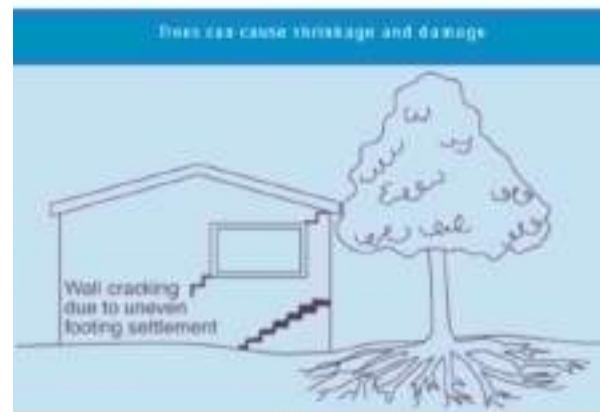
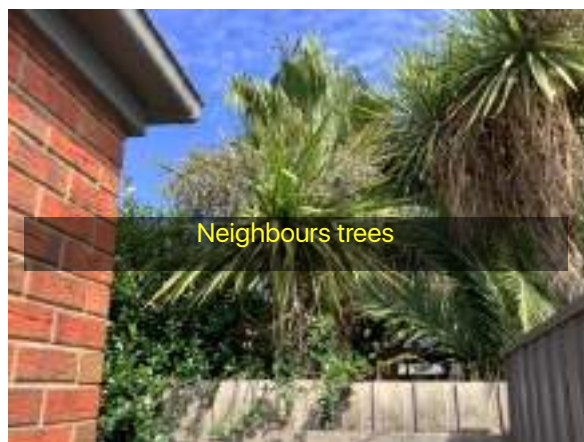
Observation 4.14

Location: Garden Areas - All Areas

Trees and other vegetation can have a significant local effect on drying of soils. Over a number of years, especially during drought conditions, adjacent trees and vegetation may draw excessive moisture from the soils. The opposite may also occur, where swelling of the soil results when the trees decline or are removed.

As the cumulative moisture deficient is reversed, the surface level around the tree (and adjoining subfloor or concrete slab) will rise and expand laterally. This is often damaging to buildings unless the foundations have been strengthened or designed to cope with the effect.

Subsidence can have complex and varying causes, which will influence the required remedial works. It is advised to begin by consulting a structural engineer to determine the required scope of works. This generally includes some form of underpinning, as well as addressing the underlying cause. Consultation with a geotechnical engineer may also be necessary.

A registered builder specialising in re-stumping / structural damage such as major brick cracking would then generally carry out works as advised by an Engineer and/or Geotechnical Engineer.
