Building & Termite/Timber Pest Report (3 Star)

Inspection Date: 16 Jun 2021 Property Address: Northcote Area

Complies with Australian Standard AS 4349.1 – 2007 Inspection of Buildings Part 1: Pre-Purchase Inspections – Residential Buildings and AS 4349.3 – 2010 Inspection of buildings - Timber Pest Inspections.

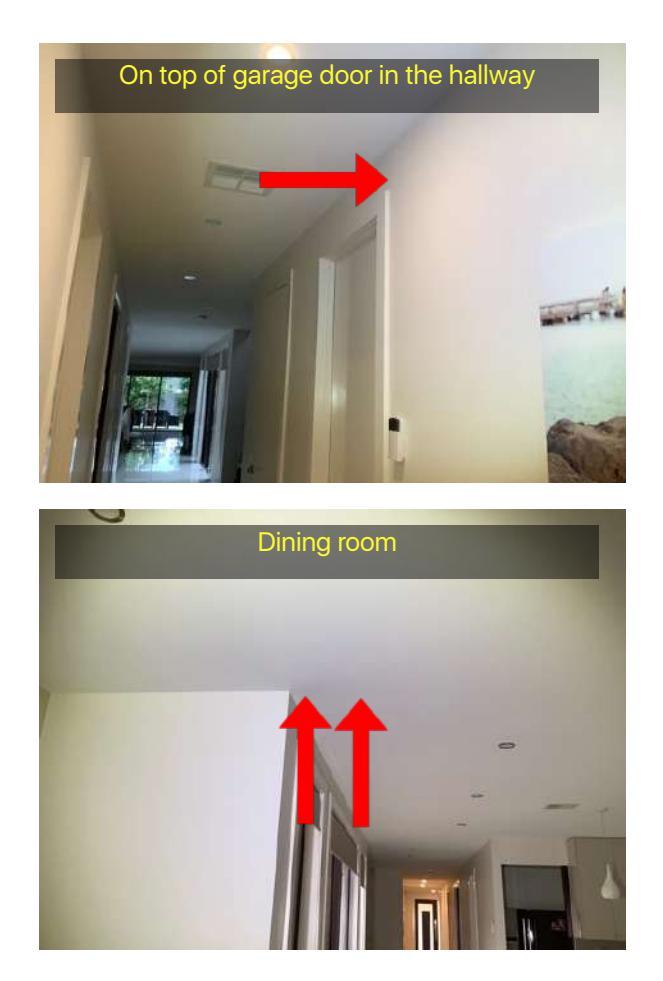
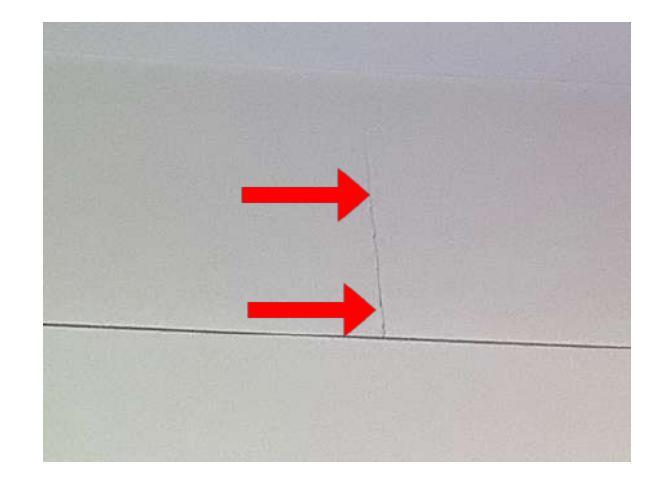
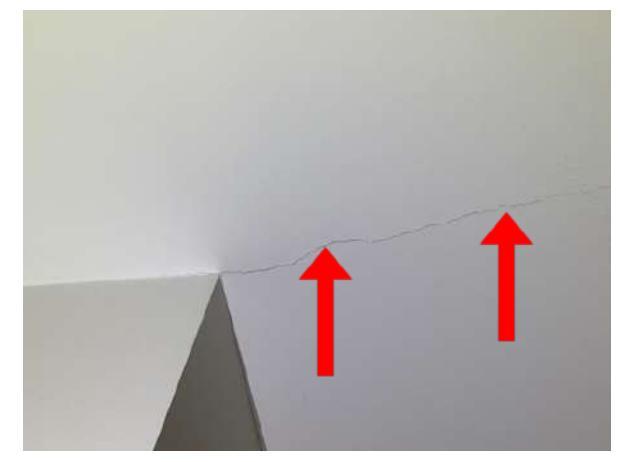
Location: Finding: Worn/Aged and/or Damaged-All Areas

Worn/Aged and/or Damaged.

Plaster damage caused from wardrobe sliding door

Relevant tradespeople, such as carpenters, painters and plasterers, should be appointed to perform remedial works, as deemed necessary.

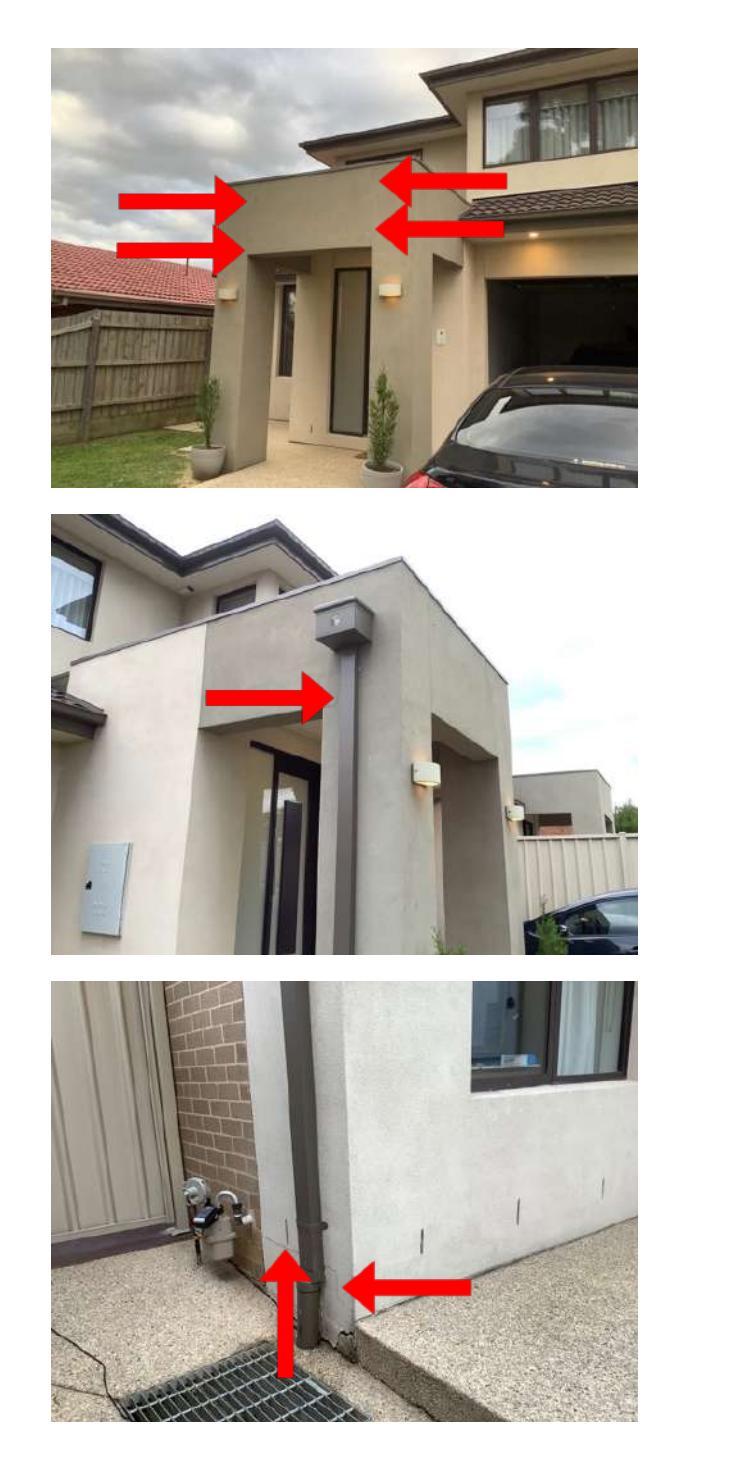
These types of cracks are generally hard to get rid of as the light weight sheeting is not flexible.

Generally these types of cracks must be prepared by a professional in this area, as typical repairs and filling will generally crack again in a short to medium time frame again.

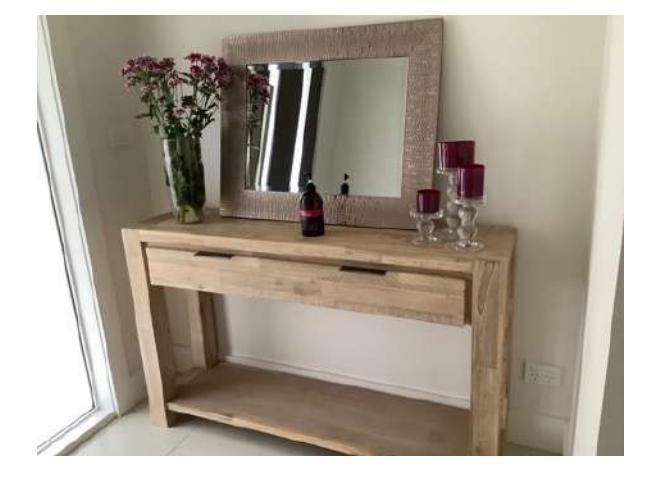
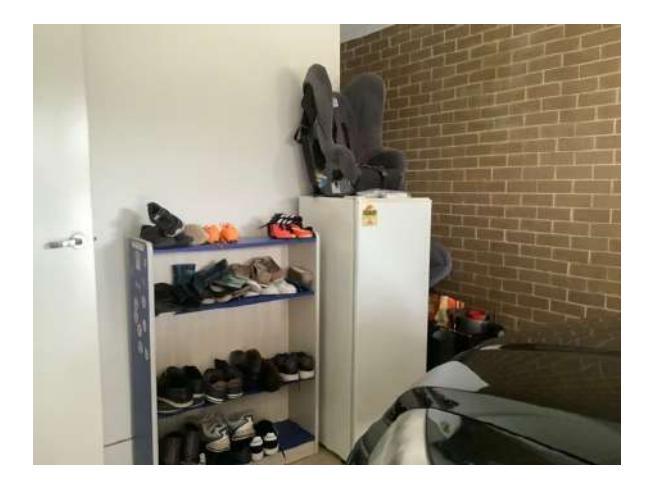
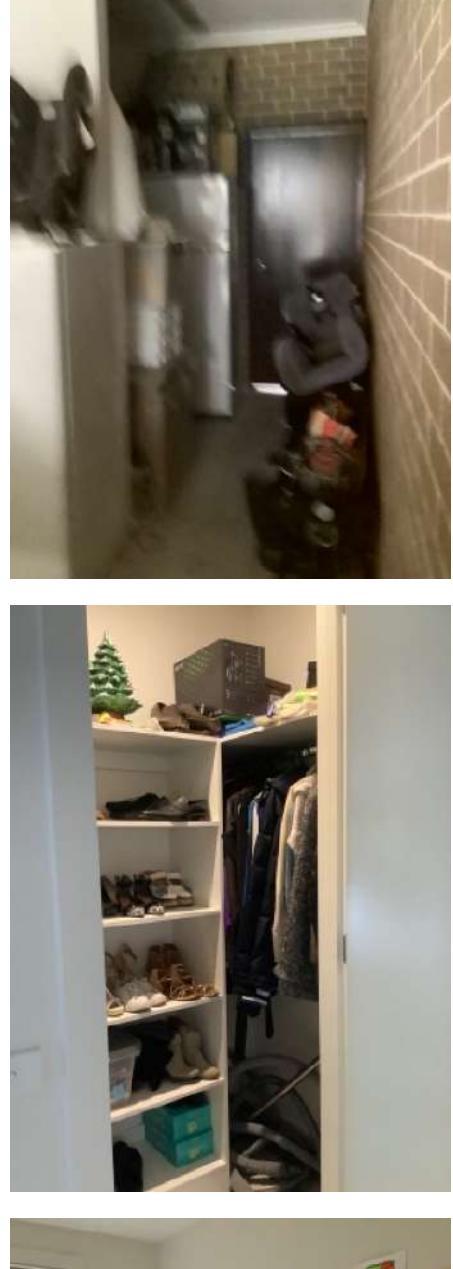
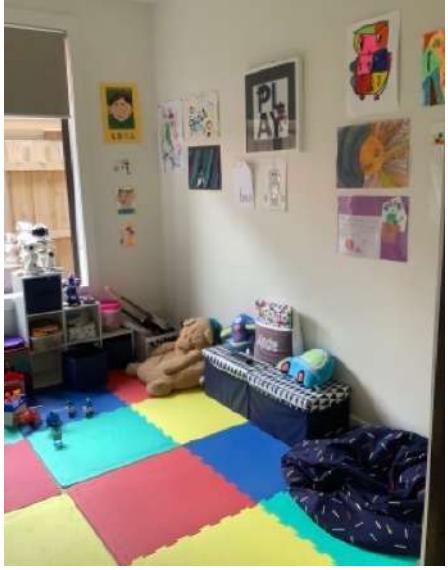
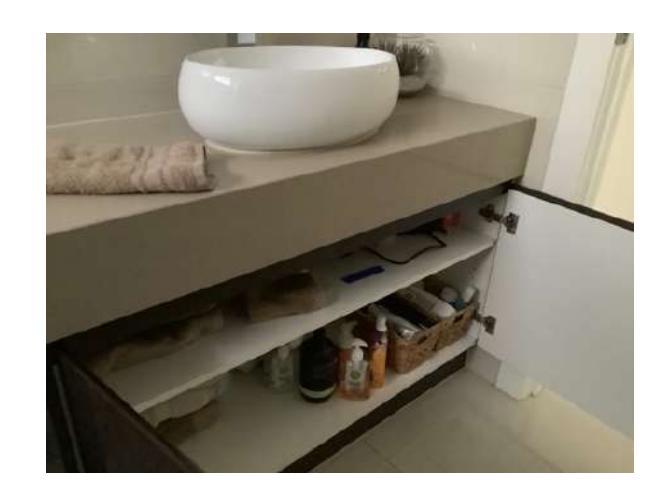
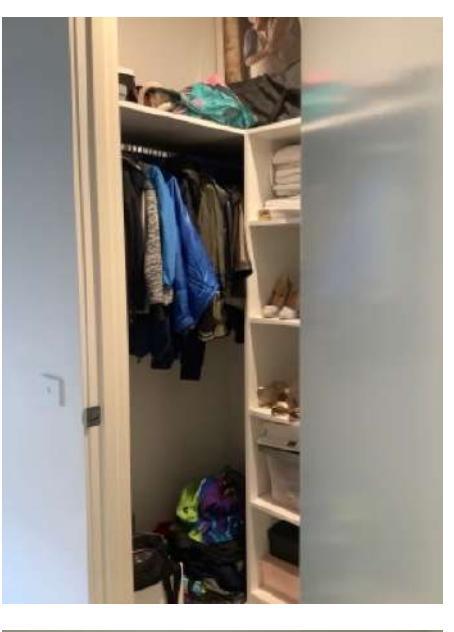
These photos in the report are for you to understand the type of obstructions and limitations on site, that restricted our inspection process.

Once the property is emptied, a re-inspection is at the client's discretion.

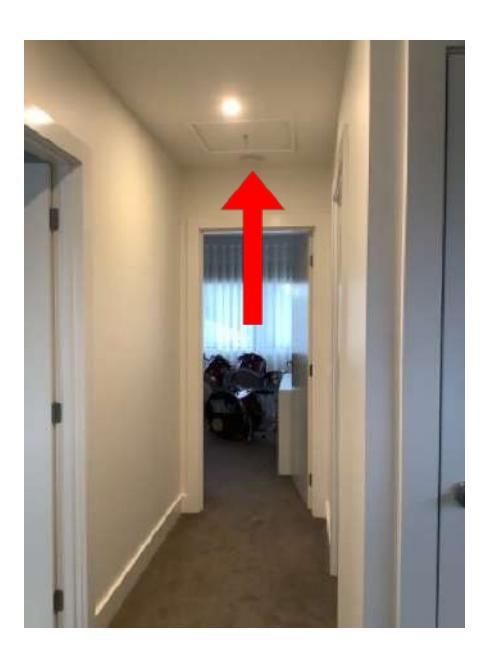
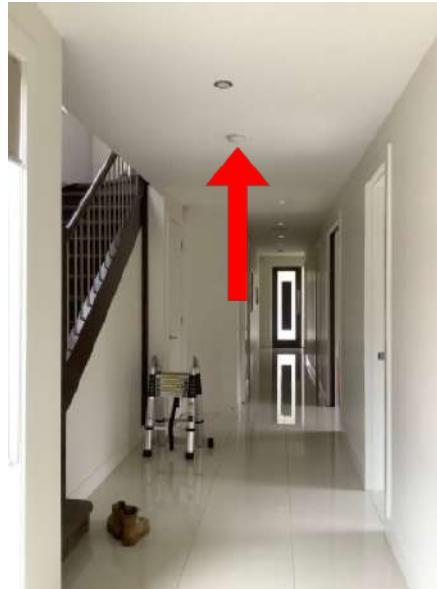
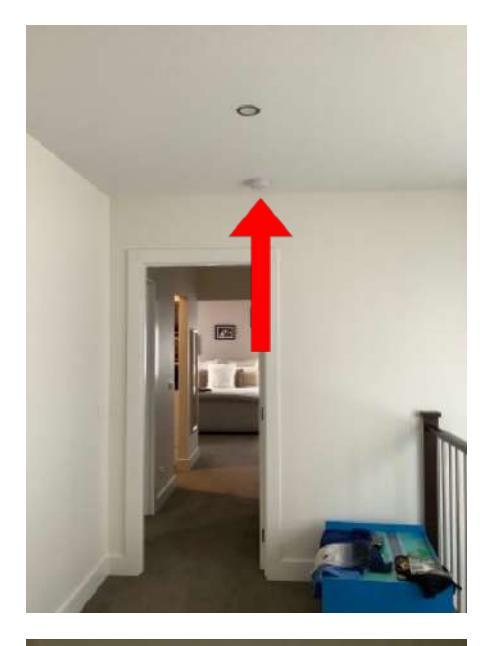
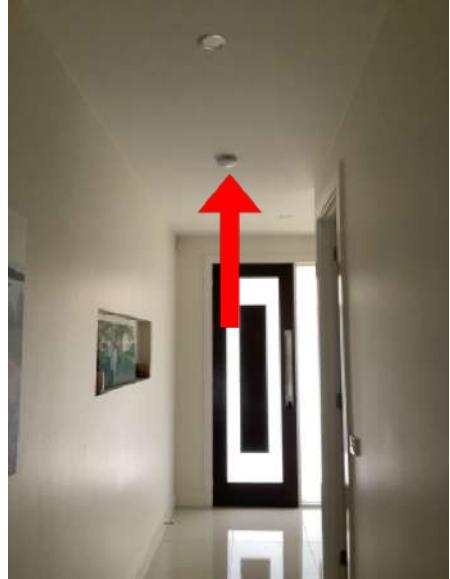
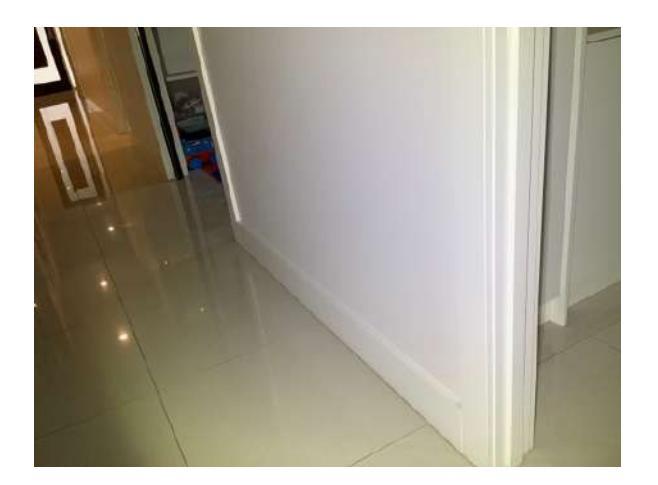
Paint & Plaster-Various Areas

Superficial scuff marks, damaged plaster, holes in walls, missing paint, sub-standard paint work were noted to the internal walls / ceilings and/or architraves as per the photos attached at the time of inspection.

While these minor defects are detracting from the overall appearance of the affected building element, they do not indicate any operational or structural damage.

This degree of surface damage is consistent with general damage, accidents, movement and wear and tear.

These type of minor defects are appearance cosmetics but they can also lead to the development of secondary building defects over time.

Incomplete areas of paint finish, holes in plaster, exposes the area to moisture, potentially accelerating the deterioration of underlying building materials especially in wet areas such as laundrys and bathrooms.

Superficial scuff marks, damaged plaster, holes in walls, missing paint, sub-standard paint work should be sanded back, filled, levelled and painted, as applicable. Where inadequate or missing protection has led to the deterioration of the associated building element, repair and/or replacement of this building element may be required.

A painting contractor, builder, plasterer and/or suitable handy person may be appointed to perform necessary works to aid the appearance of the affected area and to ensure the area is protected against further deterioration.

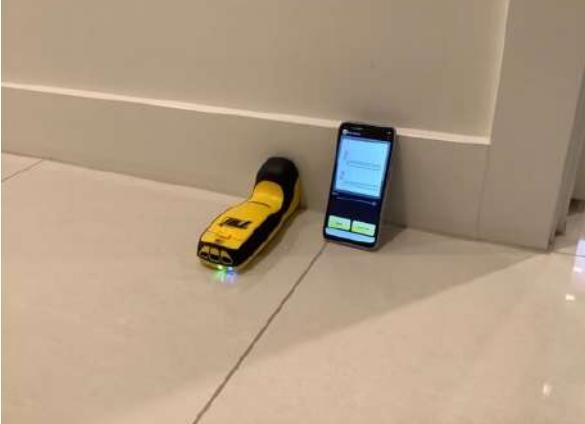
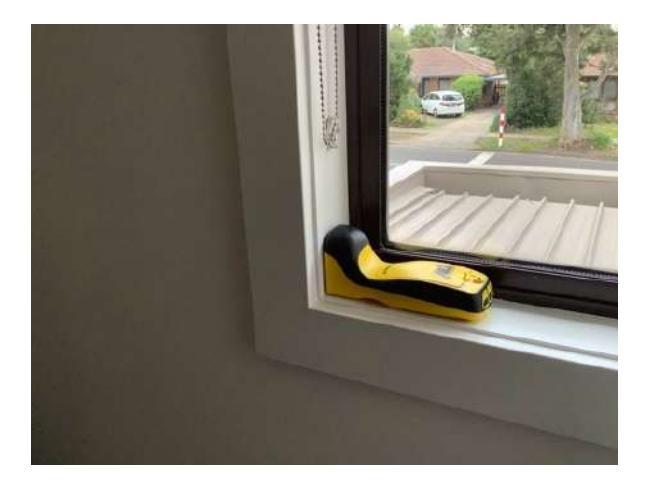
Location: Finding: The Site

◆ Termite Management System - NO evidence of installation

The application of a post-construction chemical termite barrier and/or baiting stations or the like is highly recommended for all properties, particularly if live termite activity has been found on the site previously. Such barriers are highly effective in preventing termite attack on any timber building elements throughout the property.

The client may consider gaining further advice from a pest controller as to the costs and procedures involved with this application. It is recommended that obtaining such advice be a short-term priority.

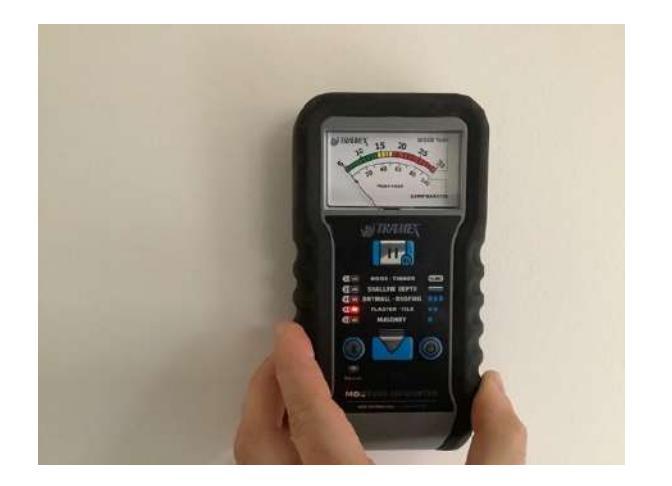
At the time of the inspection there was no evidence of termite (timber pest) activity and no visually accessible timber damage caused by termites and timber pest. The levels of moisture in all areas were found to be in the normal range. As all areas are not able to be inspected due obstructions and limitations, we therefore can not rule out the possibility of concealed timber pest activity.

Wall paneling, wall paper, carpet and fixed cabinetry can obscure termite activity.

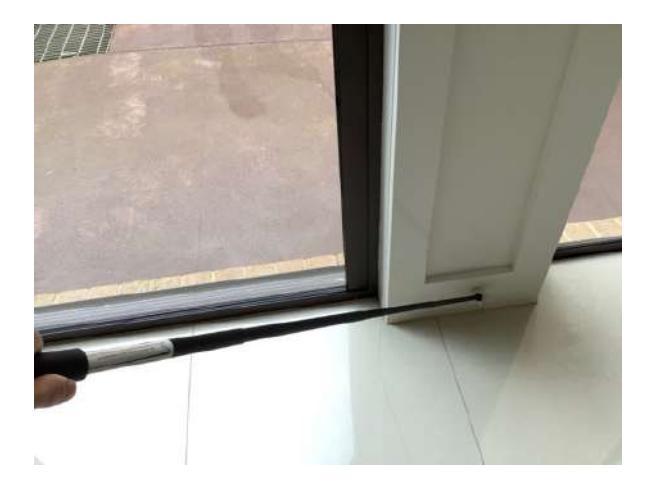
PREVIOUS TERMITE MANAGEMENT PROGRAM

No evidence was found
