# Building & Termite/Timber Pest Report ( 4 Star )

Inspection Date: 9 Jul 2021

Property Address: Sunshine Area

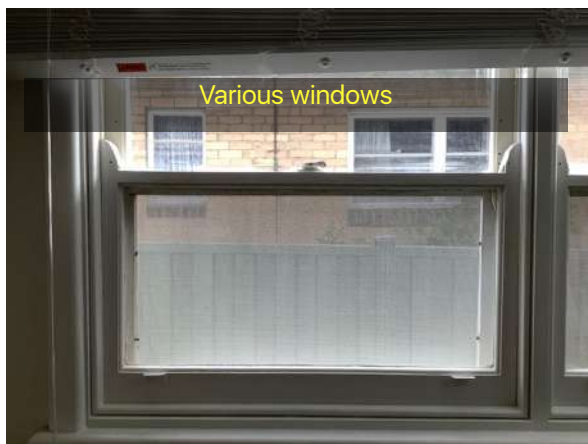
Windows MUST function as a safety requirement and we HIGHLY RECOMMEND that you engage an appropriate professional as soon as possible to check all windows to the property.

♦ IMPORTANT ; ALL AREAS should be checked carefully for Binding / Jamming / Out Of Level windows and attached are a few PHOTO EXAMPLES as a GUIDE.

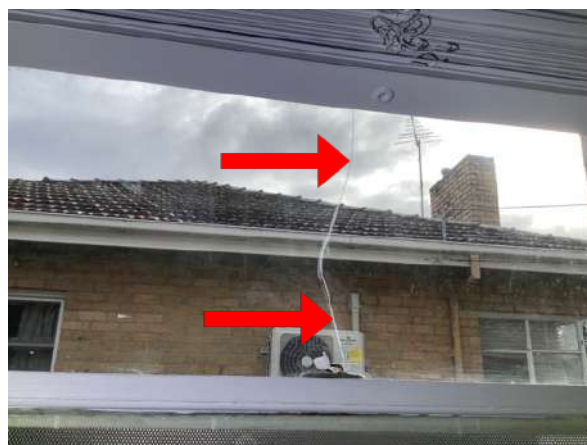
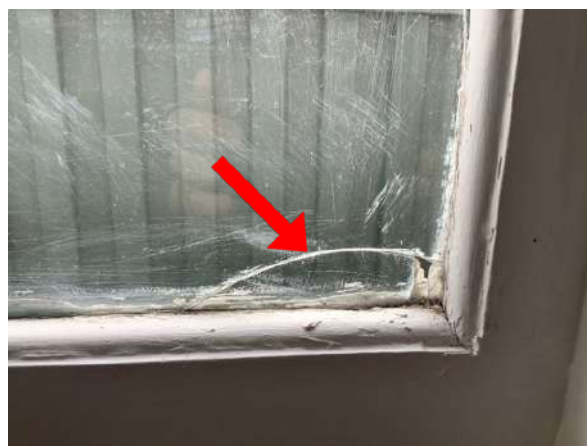
Location: Windows - Internal Areas

Please be advised that any persons coming into contact with the cracked window should do so with due caution to avoid any personal injury that may ensue.

ALL AREAS should be checked carefully for this defect and attached are a few PHOTO EXAMPLES as a GUIDE.

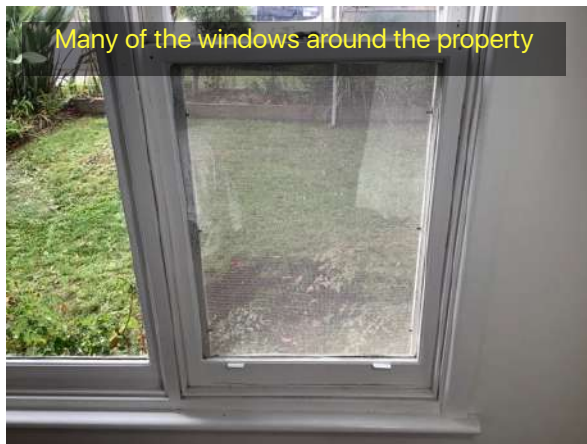
Location: Windows - Internal Areas

ALL AREAS should be checked carefully for this defect and attached are a few PHOTO EXAMPLES as a GUIDE.

Replacement and/or adjustment of the springs, ropes, etc should be conducted as soon as possible. A general handy person, window manufacturer and/or service technician should be appointed to perform these works to improve the operational state of the affected window and improve the safety of the internal area.

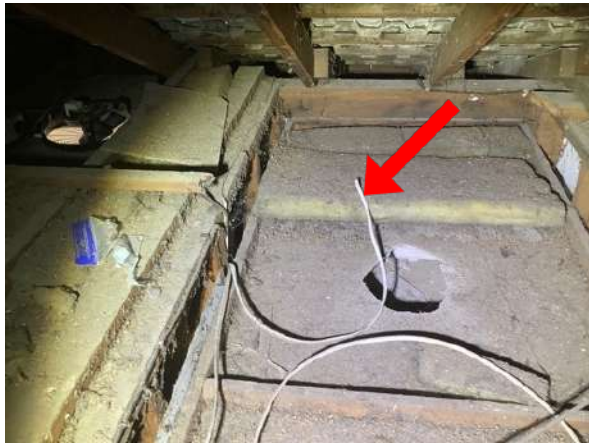
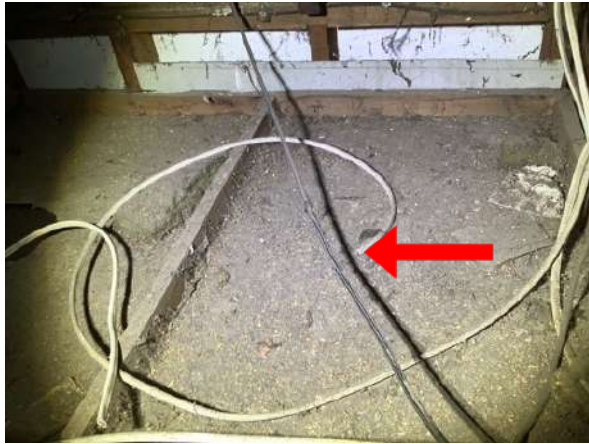
Location: Roof Space

Exposed electrical wiring was identified. Exposed electrical wiring represents a potential safety hazard including for fire and personal contact. Contact a licensed electrician urgently for further inspection investigation and rectification.

ALL AREAS should be checked carefully for this defect and attached are a few PHOTO EXAMPLES as a GUIDE.

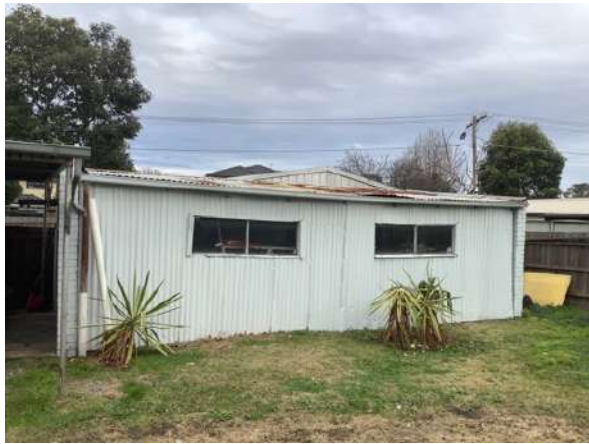
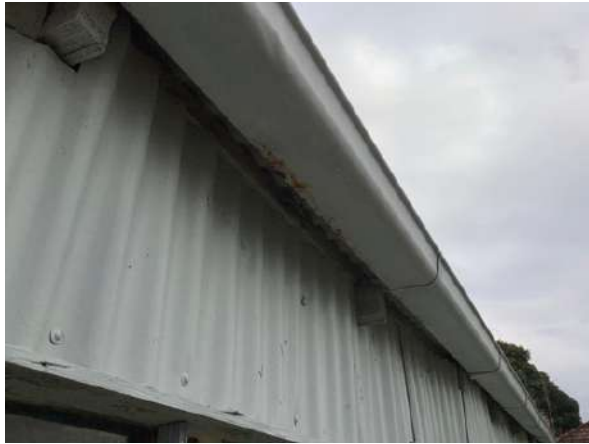
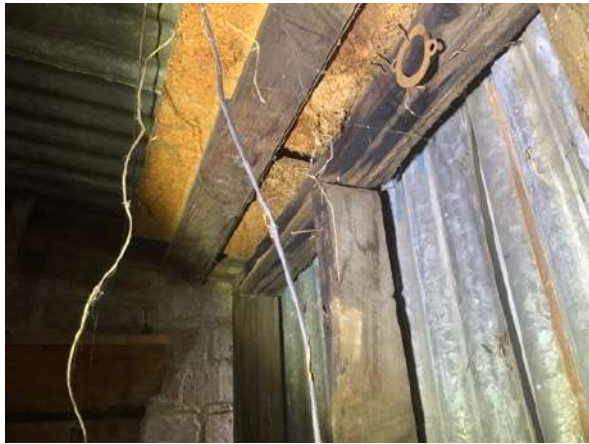
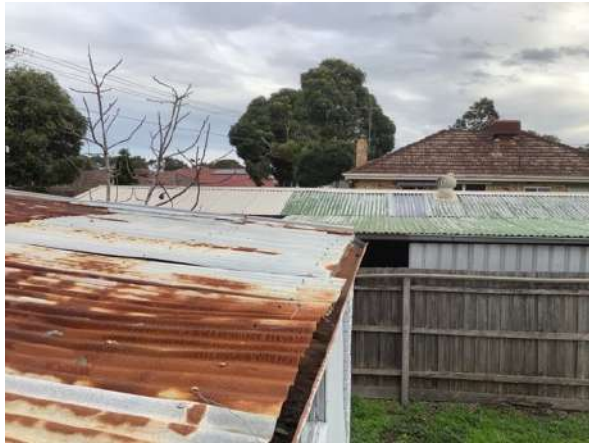
Location: External Areas

The structure is in a dilapidated state, that requires urgent attention of repairs or demolition in a safe manner.  
It is highly recommended that the repairs or demolition be performed by professional services or at a minimum a person that is handy.

The client should exercise care when coming into the immediate vicinity of the area.  
Works are advised as soon as possible by the appropriate trades.

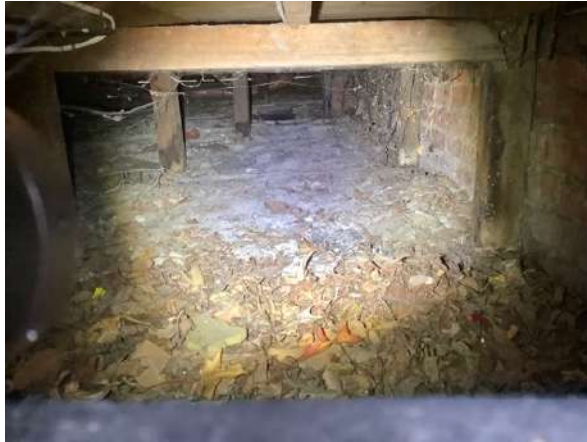
Location: Subfloor

ALL AREAS should be checked carefully for this defect and attached are a few PHOTO EXAMPLES as a GUIDE.

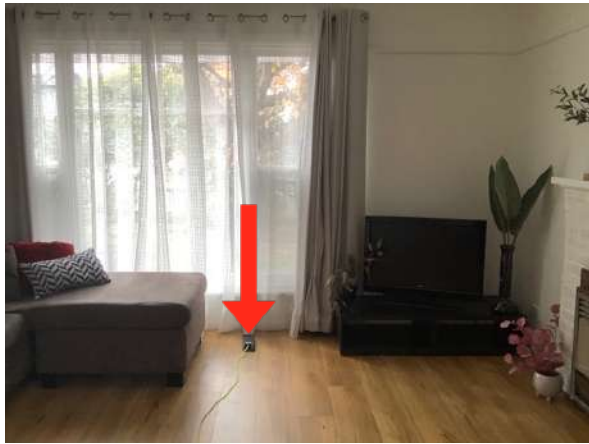
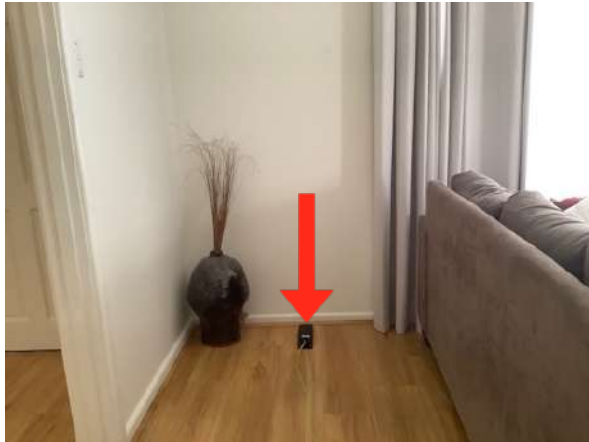
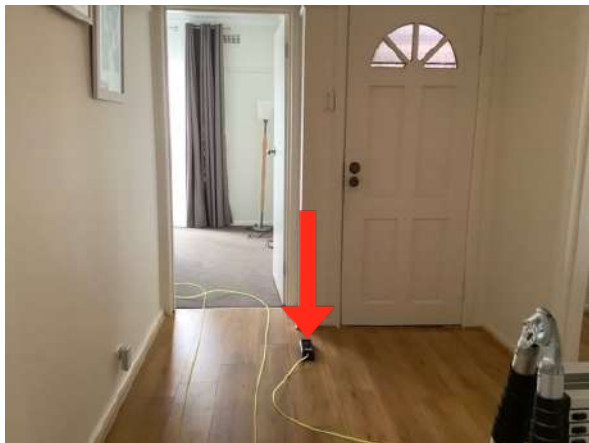
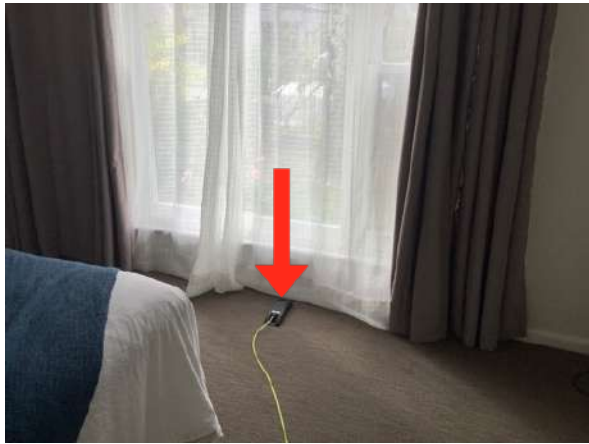
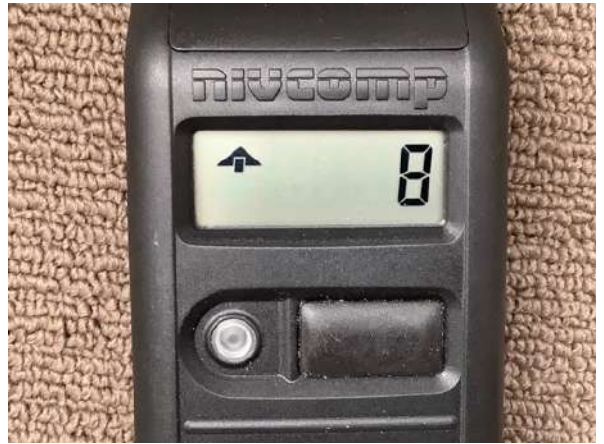
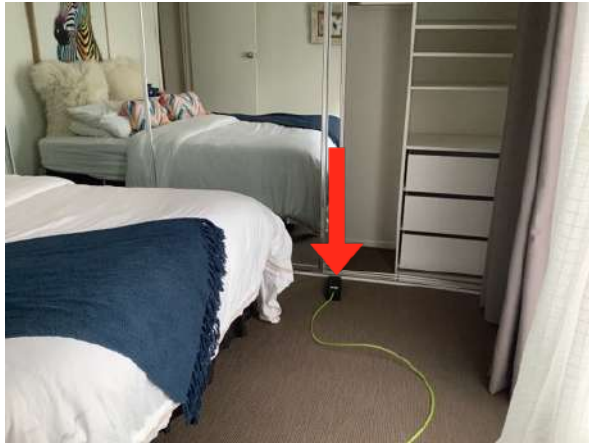
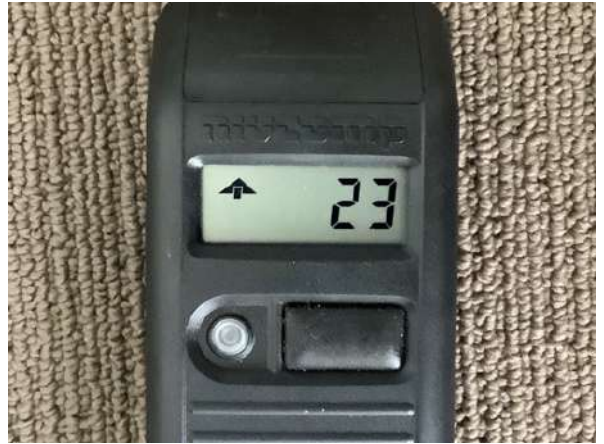
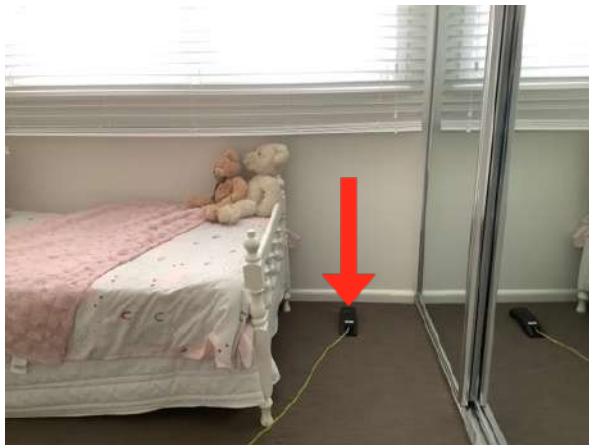
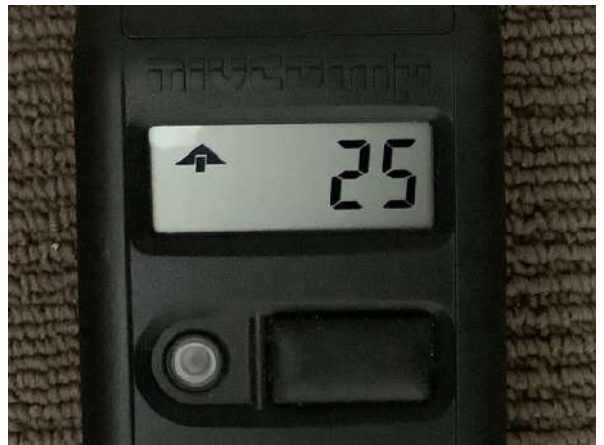
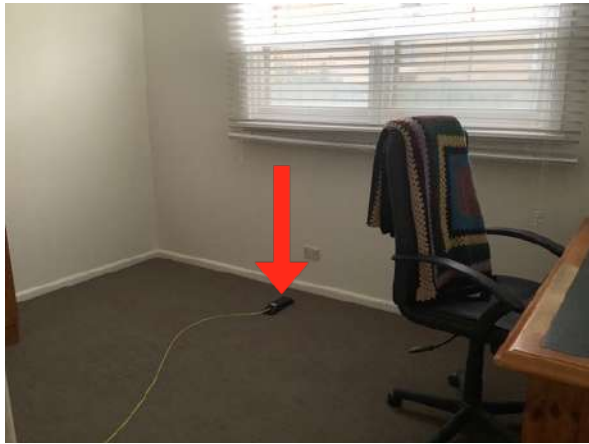
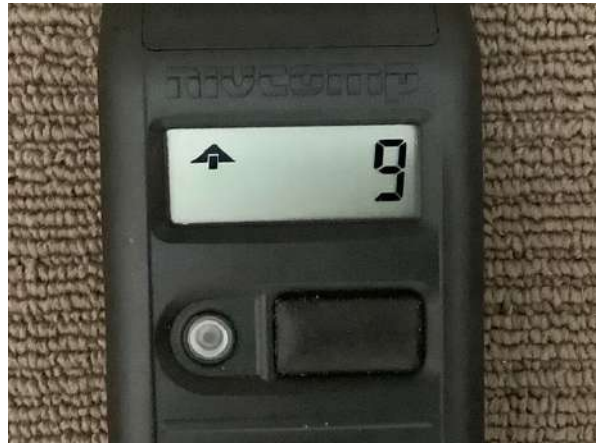
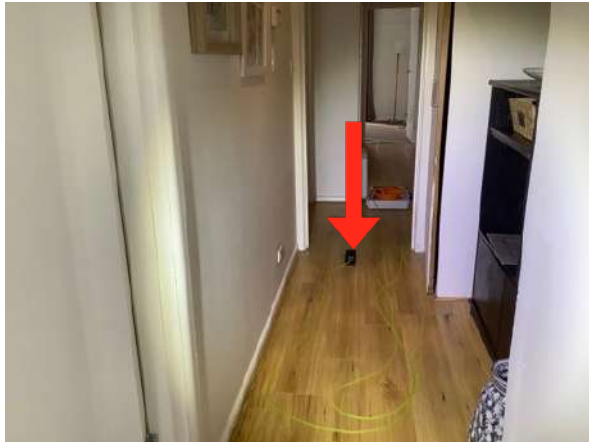
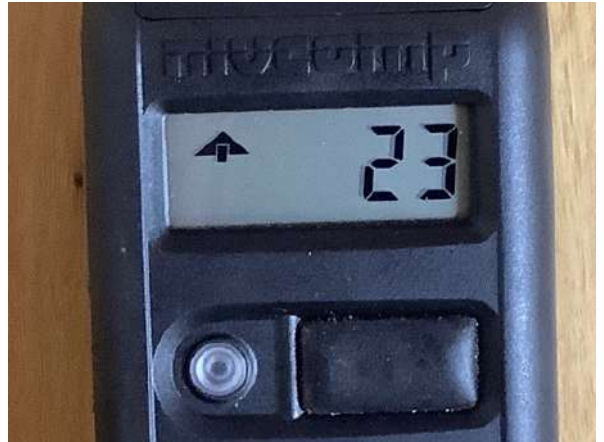
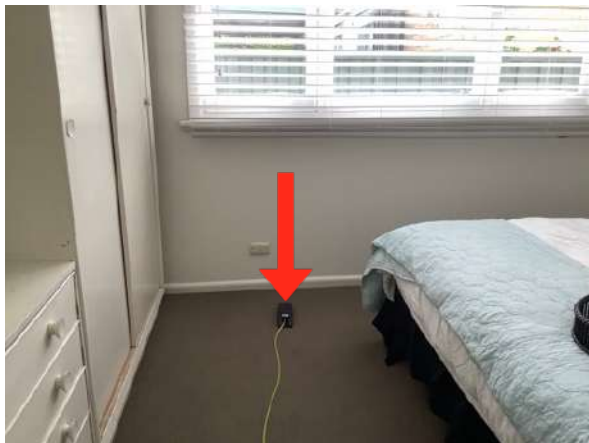
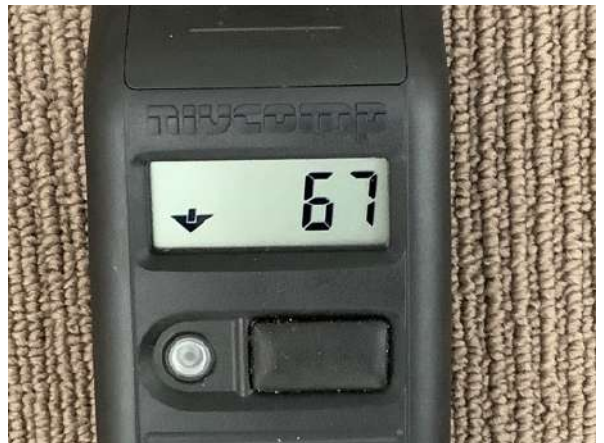
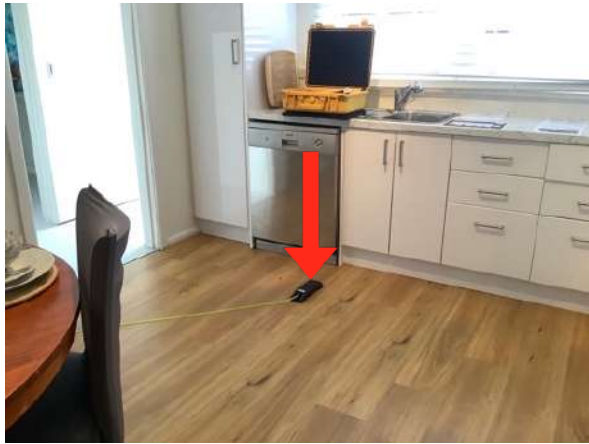
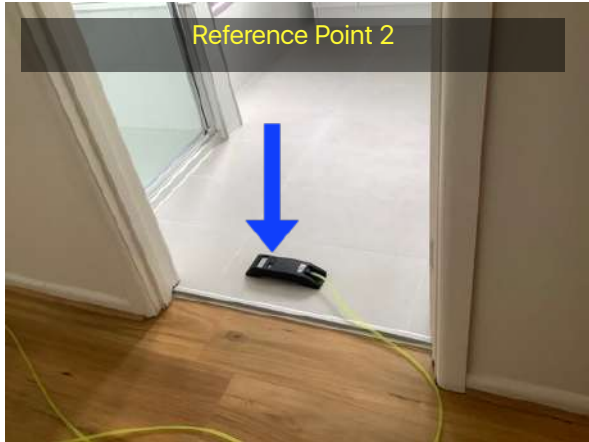
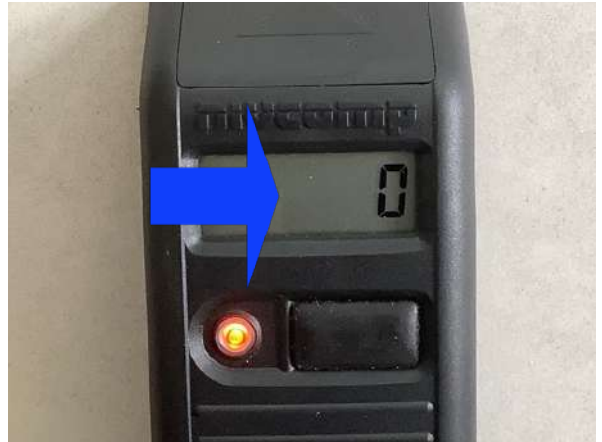
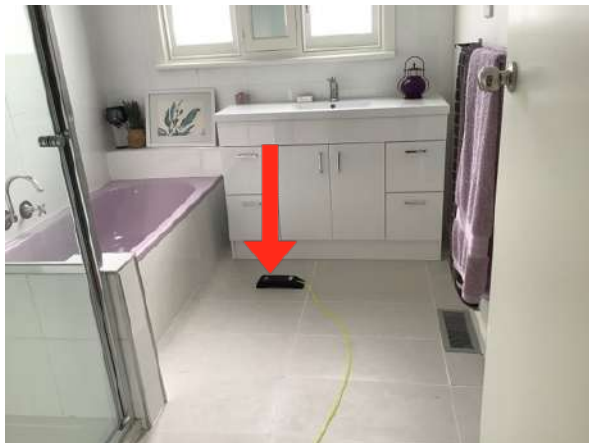
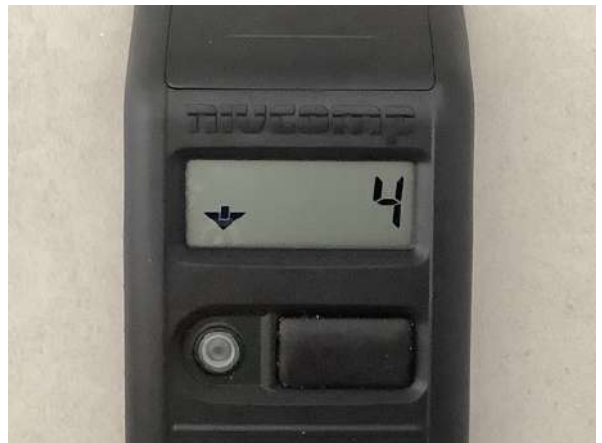
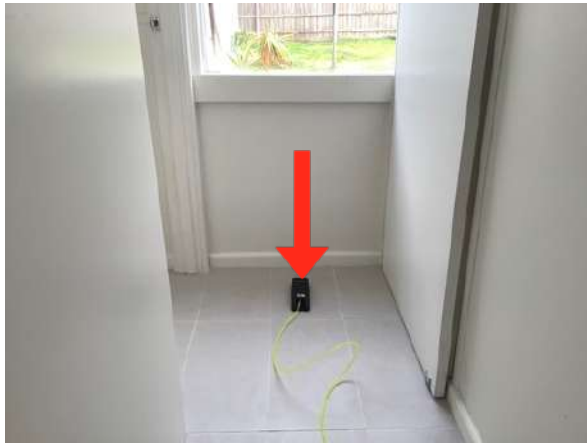
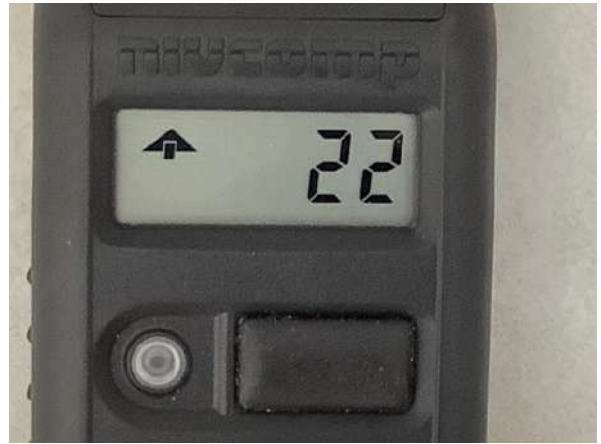
## Major Defect 2.01

IMPORTANT TO NOTE : It will be important to note that the likelihood of cracking and movement to plaster, floor and wall tiles, doors requiring re-working, windows requiring re-working, kitchen cupboards, etc will be high once the home is jacked up and re-leveled to the correct height, the amount of repairs can be nothing to many areas. There will more then likely be the repairs of plaster, paint and the other repair concerns mentioned.

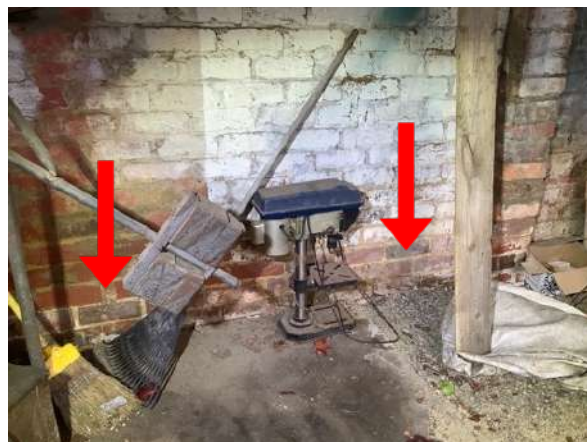
ALL AREAS should be checked carefully for this defect and attached are a few PHOTO EXAMPLES as a GUIDE.

Consultation with a PLUMBER, BUILDER AND OR STRUCTURAL ENGINEER AND SOMETIMES A GEOTECHNICAL ENGINEER, and also more then likely a structural engineer is advised immediately to identify the cause of the damp and perform remedial works as required.

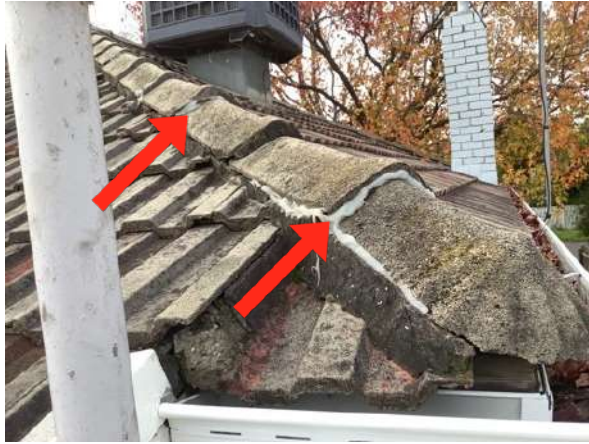
### Minor Defect 3.01

These Defects are of Sub Standard Workmanship or Incomplete and not finished to a tradesmens like manner.

The installation of these building elements appear to have been completed to a substandard level of workmanship or is incomplete and does not comply with regular building practices. Unfinished and substandard building works are likely to degrade more quickly and may create potential for secondary defects to associated building elements and surrounding structures.

Generally substandard repairs or installation are related to poor workmanship, the use of inappropriate materials, or a failure to complete installation to a suitable standard.

The appropriate tradesperson, specialist or handyman should be appointed to complete the various items for repair and organise the appropriate QUALIFIED trades ( or not pending on job ) to repair and complete the works to illiminate or reduce further deterioration / disfunction.

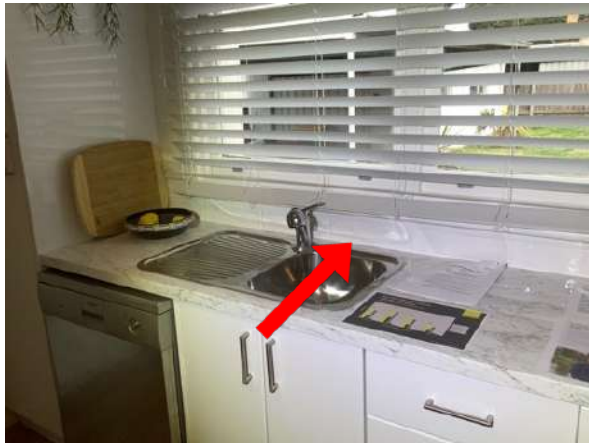
## Minor Defect 3.02

Location: Caulking / Silicone / Tile Grout-All Wet Areas

Finding: Silicone / Caulking To All Wet Area Junctions & Tile Grouting - Missing/Damaged or Poorly Installed

It was noted on inspection that sealant and/or tile grout is missing/damaged or inadequate to the tiled wet areas.

Sealant and/or tile grout where missing, damaged or inadequate to the tiled wet areas allows the water to penetrate into the walls and floors which can cause much damage, to the affect were the damage may become a secondary defect and create a conducive environment for termites due to the excessive moisture and/or cause rotting to the timber studs, floor joists and bearers or plaster, etc, especially in showers, baths, laundry and the like

Whilst in some of the areas there is sealant/silicon , it has become apparent that the sealant has deteriorated and/or is just missing or just installed defectively/messy.

Whilst in some of the tile mortar is perfect , it has become apparent that the tile mortar has deteriorated and/or is just missing in other areas.

A flexible sealant/silicon and tile mortar should be applied to affected areas to prevent any subsequent water damage that is likely to occur.

A sealant specialist, tiling contractor and/or registered builder in some serious cases, should be appointed to assess any damage caused by water to the entire internal, sub-floor where applicable, walls, etc of the building and clean, take off old sealant and tile mortar, then re-seal and re-mortar these areas as soon as possible.

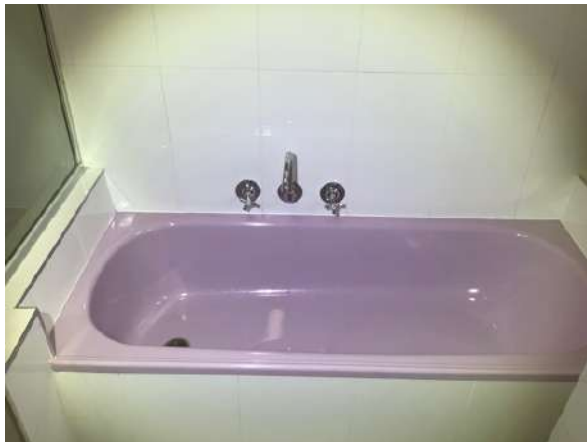
## Minor Defect 3.04

Location: Bathroom  
Finding: Bath tub installation – damaged

The bath tub has been damaged.

If this does not get repaired, It will only get worse in time and create secondary building defects, such as wood rott, to the frame or subfloor and can create a very conducive environment for termites.

I highly recommended you engage a builder to repair or replace the bath tub installation and provide all certificates required such as the plumbers certificate for installation and the waterproofing certificate for waterproofing.

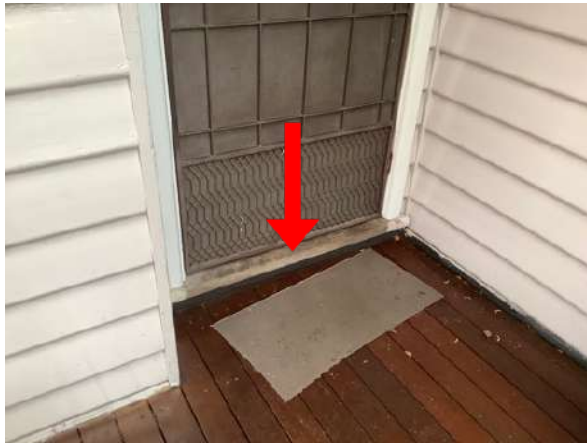
## Minor Defect 3.07

Finding: Timber, exposed to weather / External painting deteriorated

External timbers that are frequently exposed to harsh weather conditions require adequate protection ( paint ) in order to maintain their condition. Where timbers have not been painted or treated adequately, general deterioration is likely to occur at an accelerated rate.

Incomplete or missing paint finish IS NOT ALWAYS ONLY an appearance defect, it can in most cases lead to the development of secondary building defects over time. Incomplete areas of paint finish exposes the area to moisture, potentially accelerating the deterioration of underlying building materials.

If left unattended, replacement of these timbers is likely to be necessary in the short-term future. Adequate treatment of these timbers is required as soon as possible by a painting contractor should be appointed as soon as possible to perform necessary works to aid the appearance of the affected area and to ensure the area is protected against further deterioration. Alternatively, the homeowner following manufacturer instructions may perform these works.

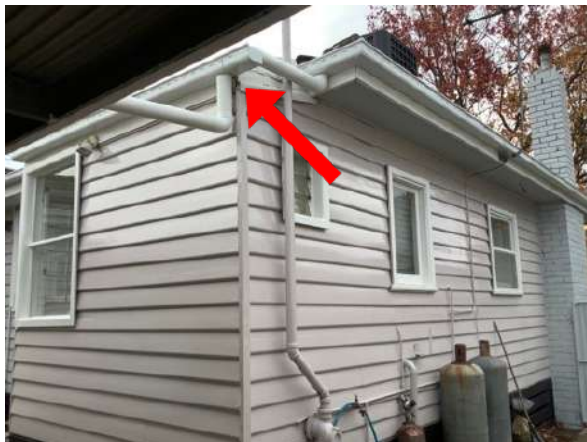
### Minor Defect 3.08

Location: Timber Work - All External Areas

Finding: Fascias - Wood rot

Frequent exposure to rain and other weather conditions also make fascias and barges susceptible to accelerated deterioration.

Replacement of affected fascias and barges may then be a necessary step in protecting surrounding building elements from such deterioration.

A qualified plumber may be appointed to assess the cause of excessive moisture and to provide advice on any remedial works as required. A qualified carpenter or registered builder may also be required to replace affected building materials.

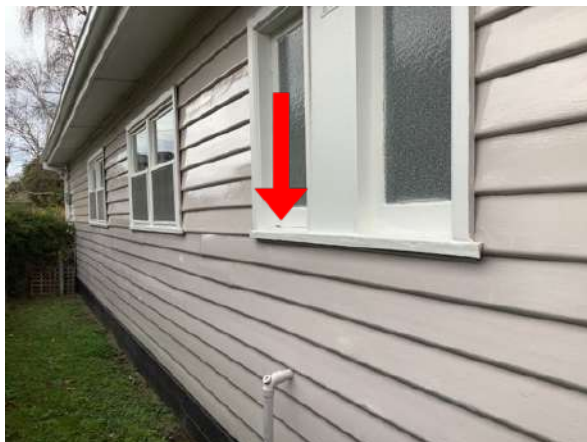
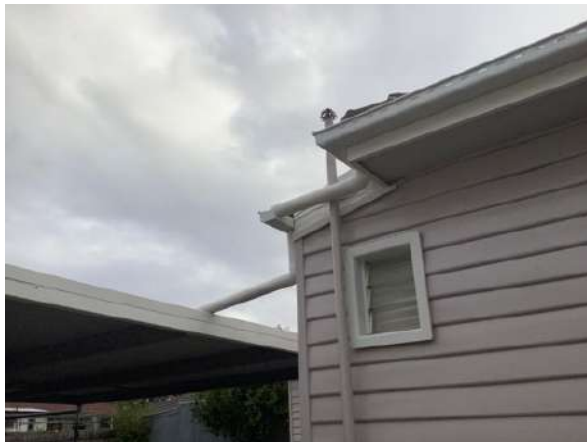
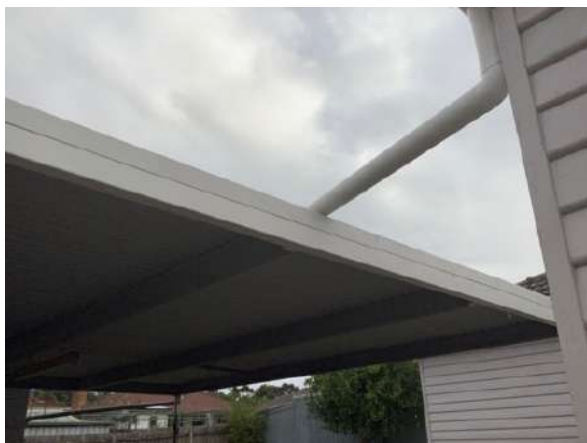
## Minor Defect 3.11

Location: Exterior Roof & Stormwater Areas

If secondary damages have accrued we highly recommend that you engage a structural engineer and/or a registered builder for remedial works.

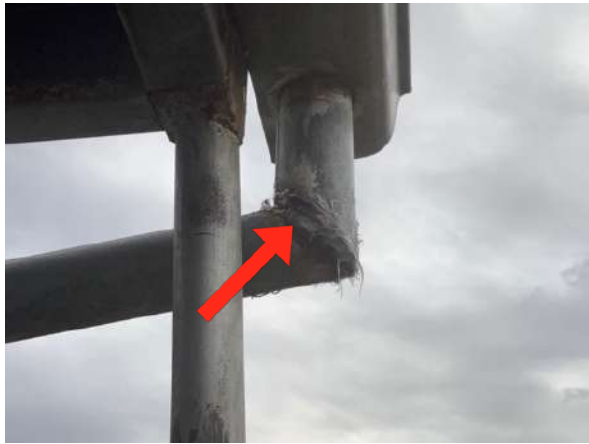
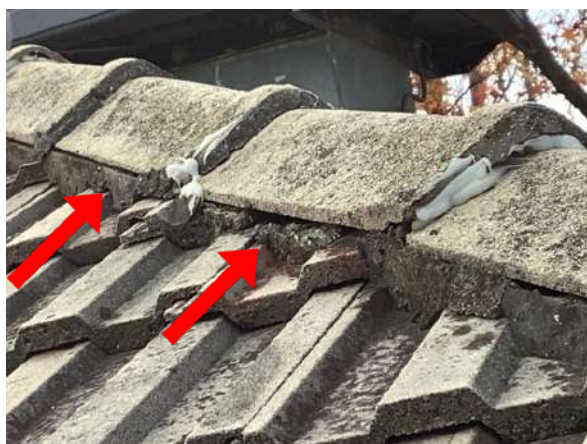
## Minor Defect 3.12

Location: Exterior Roof & Stormwater Areas

Remedial works are likely to increase the longevity of the exterior roofing structure.

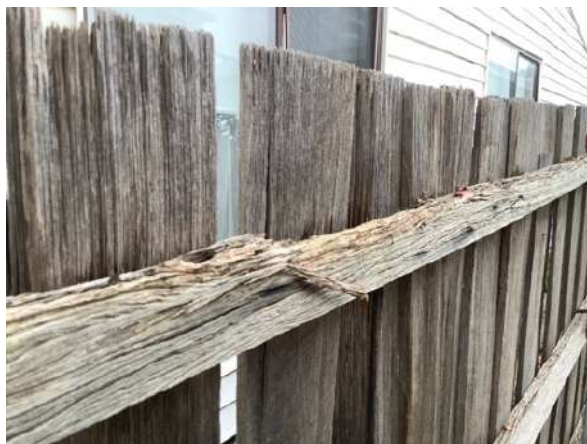
### Minor Defect 3.13

Location: Fencing

Finding: Timber Fencing - Deteriorated

It was noted at the time of inspection that sections of the fencing throughout the property have deteriorated. Typically fencing deteriorates due to age or rot which is generally expected for a structure of this age, due to prolonged exposure to weather conditions. A licensed fencing contractor should be appointed to provide further advice and perform rectification works as necessary.

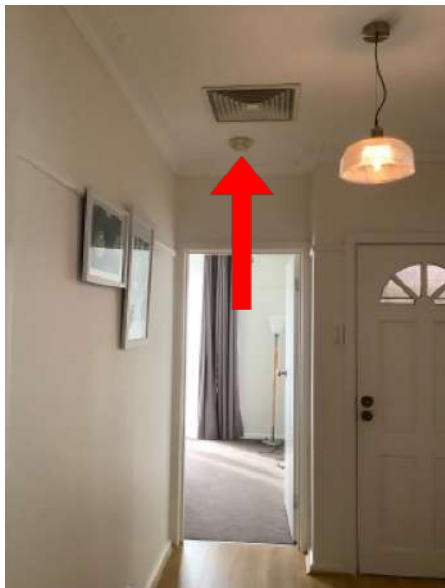
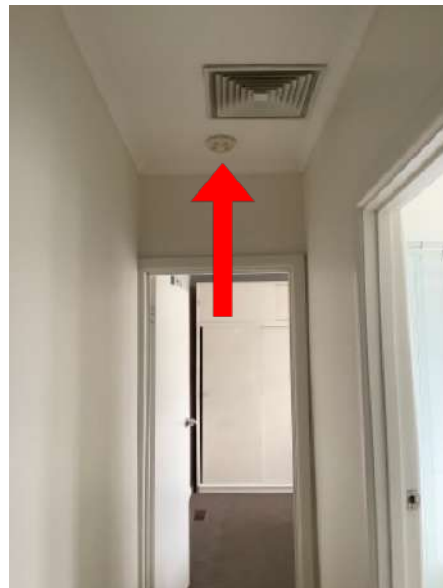
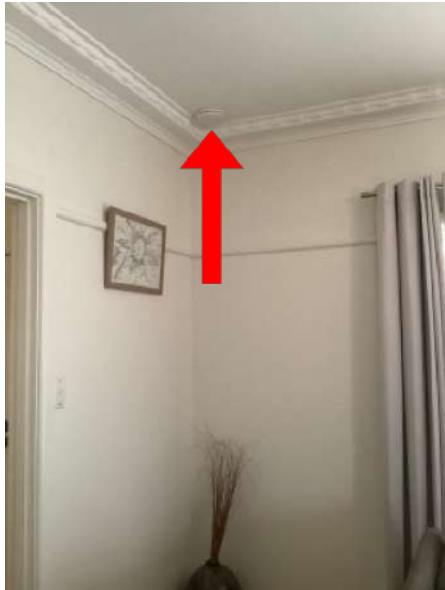
Finding: ♦ Smoke Detectors Battery Replacement.

Upon moving into a new property, it is highly recommended that the batteries to the smoke detectors all get replaced instantly.

Smoke detector batteries should be replaced every 12 months at a minimum.

Testing of smoke detectors is required monthly.

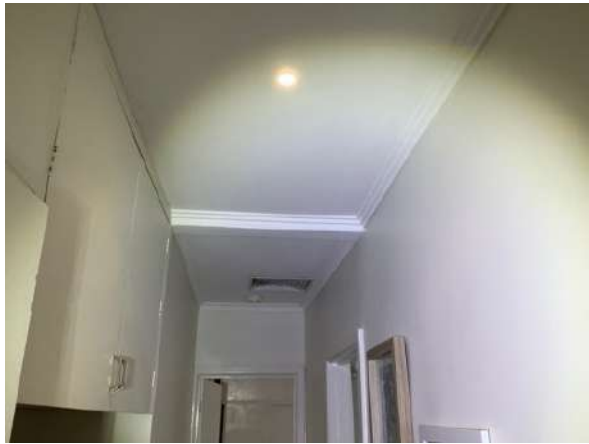
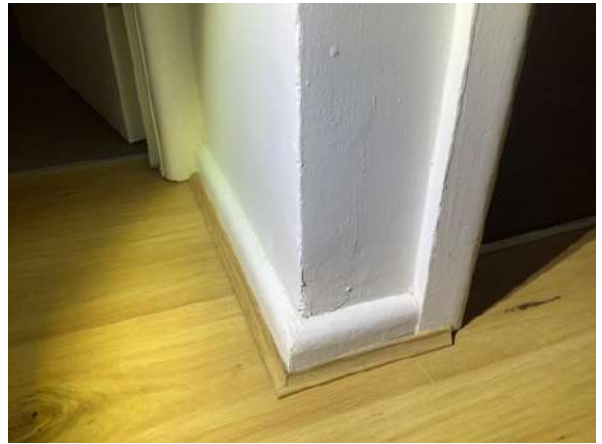
Location: Paint & Plaster-Various Areas

It appears that the property has had plaster work repairs to various areas of the property.

Superficial scuff marks, damaged plaster, holes in walls,missing paint,sub-standard paint work were noted to the internal walls / ceilings and/or architraves as per the photos attached at the time of inspection.

While these minor defects are detracting from the overall appearance of the affected building element, they do not indicate any operational or structural damage.

This degree of surface damage is consistent with general damage, accidents, movement and wear and tear.

Superficial scuff marks, damaged plaster, holes in walls,missing paint,sub-standard paint work should be sanded back, filled, levelled and painted, as applicable. Where inadequate or missing protection has led to the deterioration of the associated building element, repair and/or replacement of this building element may be required.

A painting contractor,builder, plasterer and/or suitable handy person may be appointed to perform necessary works to aid the appearance of the affected area and to ensure the area is protected against further deterioration.

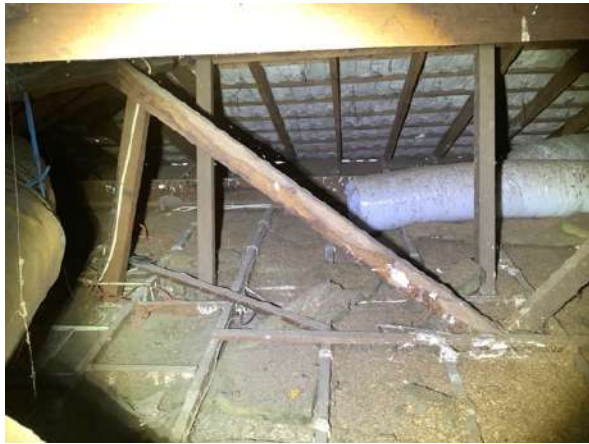
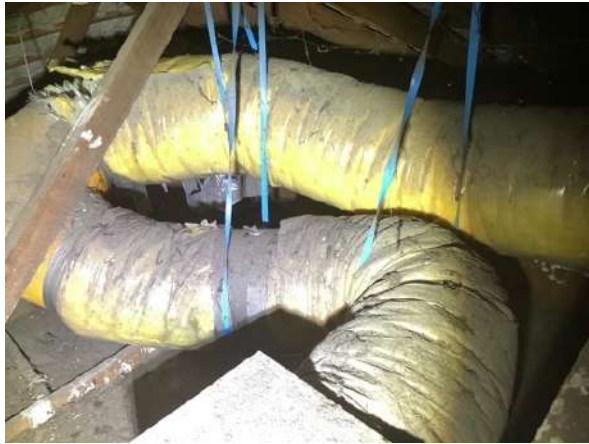
Location: Roof Space

These obstructions can hide an array of defects, without removing the insulation it is impossible to rule out termite activity and/or termite damage and other undetectable issues.

Please read the report carefully and Maintenance to all susceptible and conducive areas is a MUST to minimise the risk of termite and timber pest existence and timber damage.

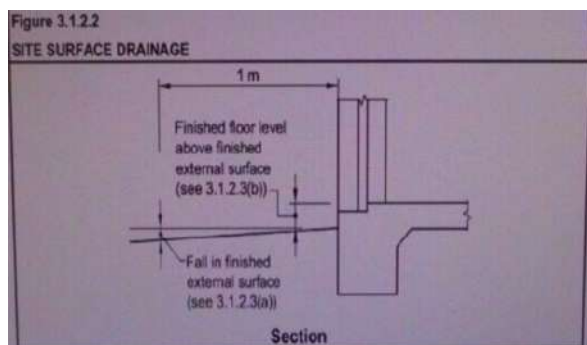
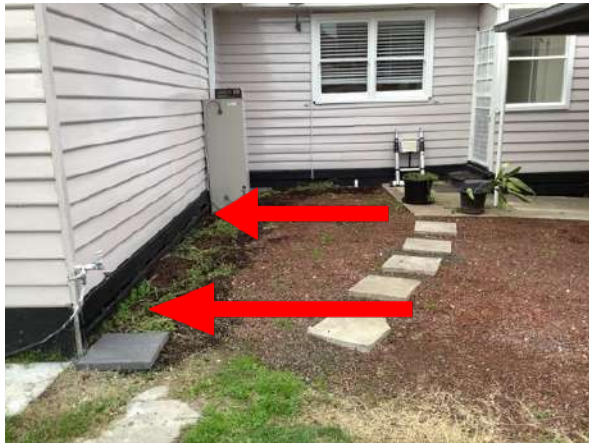
Location: Perimeter Of Building - Exterior

Finding: Drainage - Inadequate and/or Perimeter Building Ground Fall Defective.

◆ One of the reasons ( but not limited to ) we have stated the drainage as defective and as a major structural defect is because we have found structural movement to the property as detailed in this report.

In addition, we have stated the drainage as defective and as a major structural defect is because we have found Mould to the sub floor area.

Water pooling near foundations and footings is a serious concern with the potential to adversely impact on the longevity of the dwelling. The Building Code of Australia (BCA) outlines that the soil or concrete must be graded away from the dwelling at a minimum of 50mm over 1m (1:50 fall).

The site drainage in this report was found to be inadequate at the time of inspection, creating potential for subsequent water damage to associated building elements, such as foundation subsidence, brickwork cracking, windows and doors moving, concrete paths cracking, etc.

◆ **IMPORTANT INFORMATION** - The soil levels around several footings need to be adjusted to ensure that footings and foundations are protected from excessive moisture. It is critical that good site drainage is maintained at all times around the building. At no time should water be allowed to pond on the surface near or against the footings or flow towards the perimeter of the building. As a minimum these works should comply with Clauses 5.2.1 and 5.6.3 of AS 2870-2011. Generally, the surrounding ground surface must be permanently graded away from the footing and building works with a slope of at least 50 mm over the first 1.0 metre. All runoff water should be collected via a drain in the ground level and/or run away from the building, not allowing the run off water to remain near the building or neighbouring buildings as well. It is preferably that the grading is achieved by excavation rather than top soil type filling. If soil filling is to be used to grade the ground surface away, granular filling must be avoided and the area back filled with clean well compacted clay filling placed at the appropriate moisture content.

Where site drainage is inadequate, another option can be installation of an Agricultural (Aggie) Drain may be required or more serious remedial works.

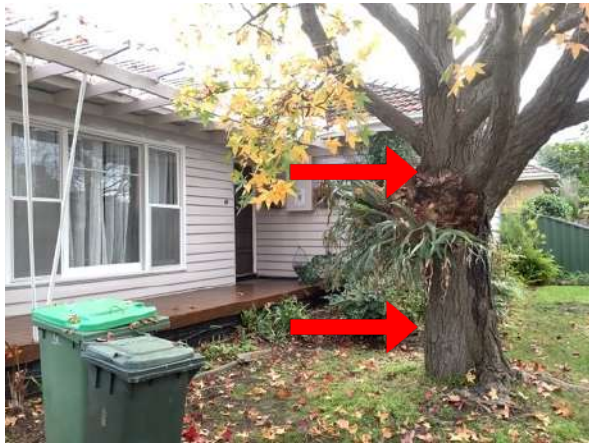
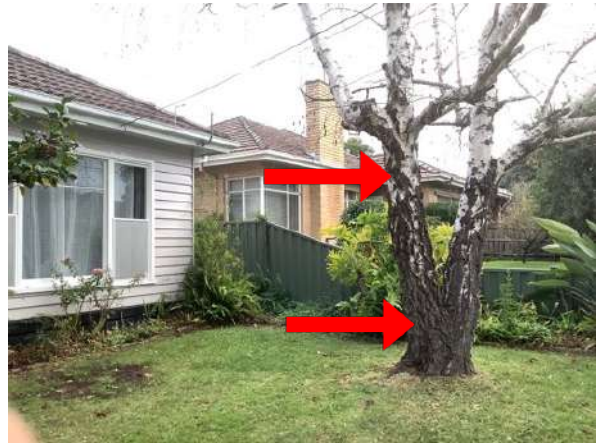
Location: Garden Areas - All Areas

Trees can cause shrinkage and damage

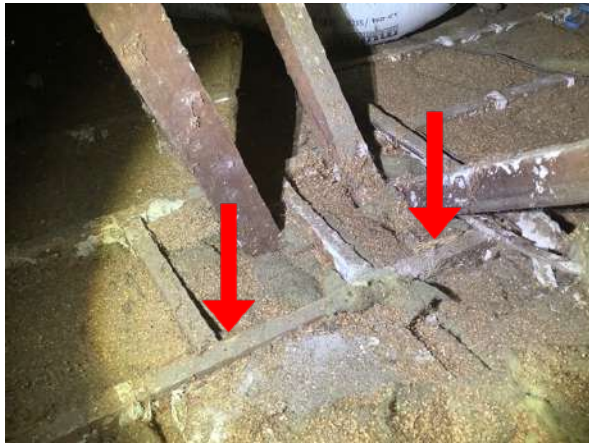
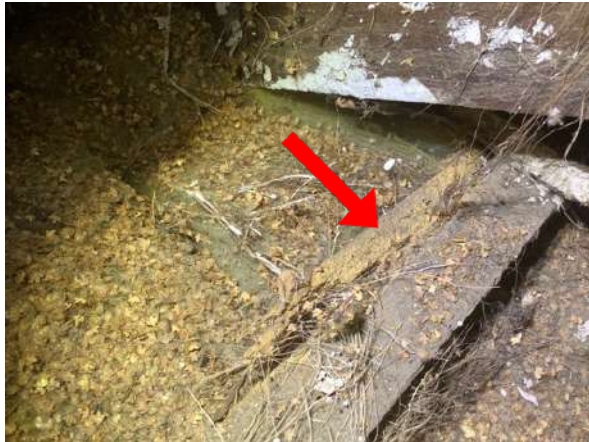
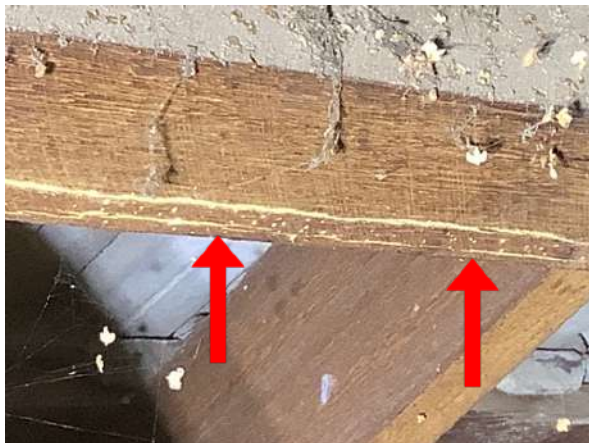
Location: Roof Space

ALL AREAS should be checked carefully for this defect and attached are a few PHOTO EXAMPLES as a GUIDE.

It is recommended that obtaining such advice be a short-term priority.

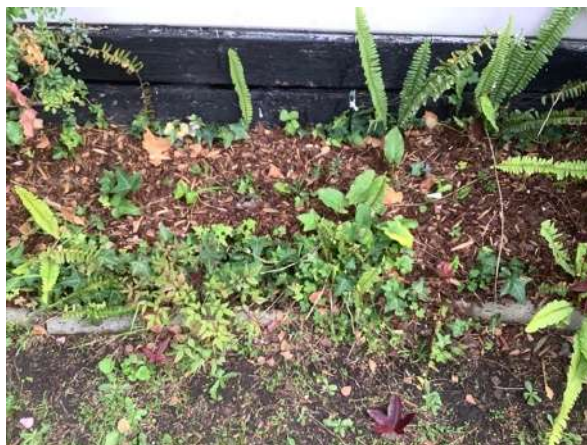
Location: Garden Areas - All Areas

It is impossible to identify all areas for termites, timber pest and timber pest damage.

Please read the report carefully and Maintenance to all susceptible and conducive areas is a MUST to minimise the risk of termite and timber pest existence and timber damage.

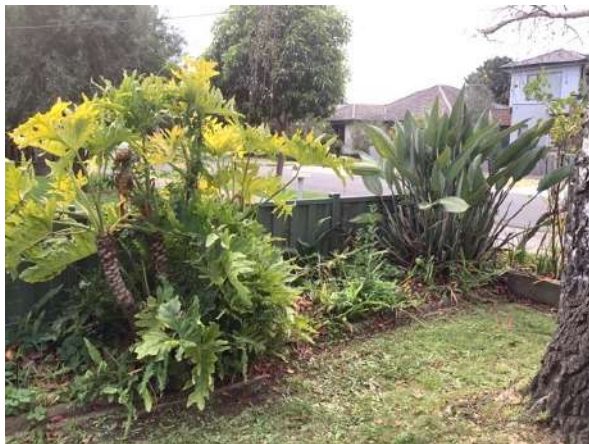
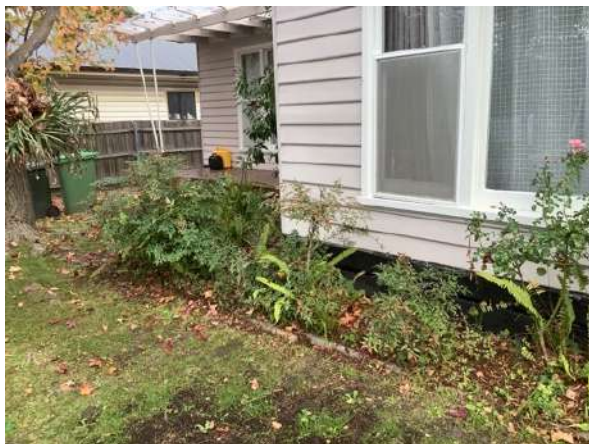
## Conditions conducive to timber pest attack 4.16

Tree stumps by far in my career has been the highest location, where I have found live termite activity or termite damage in a property, without any doubt whatsoever.

I highly recommend you seek further professional advice from a licensed pest controller and termite management system controller in relation to any trees that have been cut on the property and what can be done overall from just the typical termite management systems to a property.

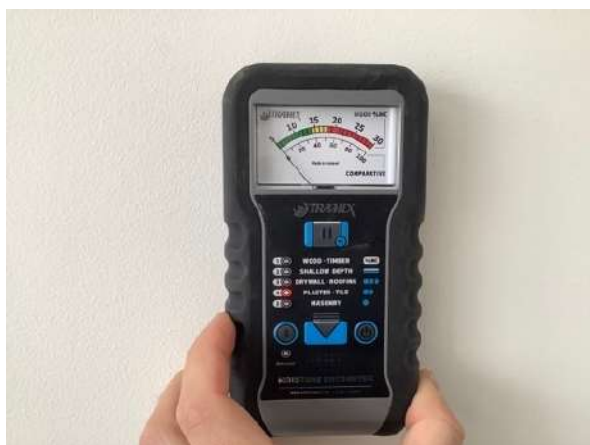
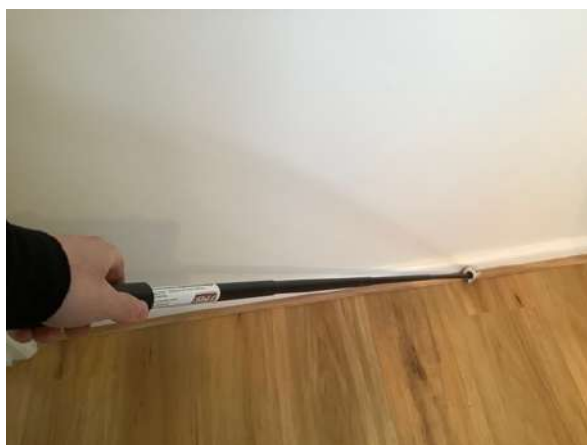
Location: The Site

As all areas are not able to be inspected due obstructions and limitations, we therefore can not rule out the possibility of concealed timber pest activity.

Wall paneling, wall paper, carpet and fixed cabinetry can obscure termite activity.
