Asbestos Sampling Report

Inspection Date: 30 Apr 2020

Property Address: Nothern Country Area

Report Type: Asbestos Inspection and Condition Report

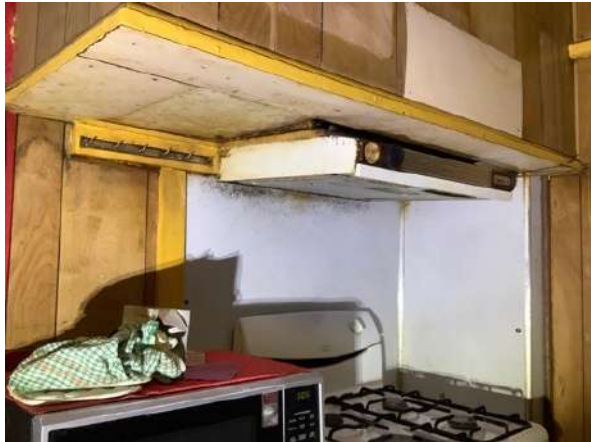
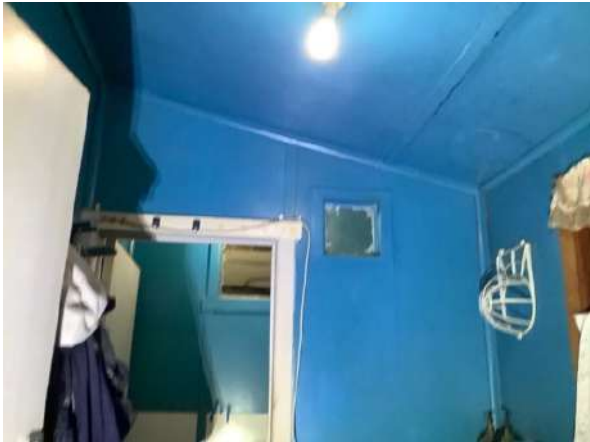
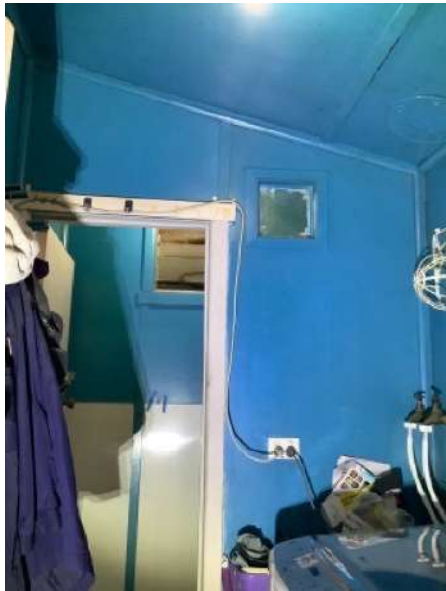
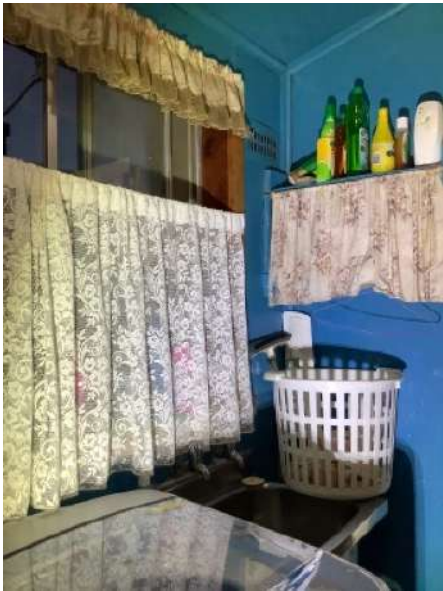
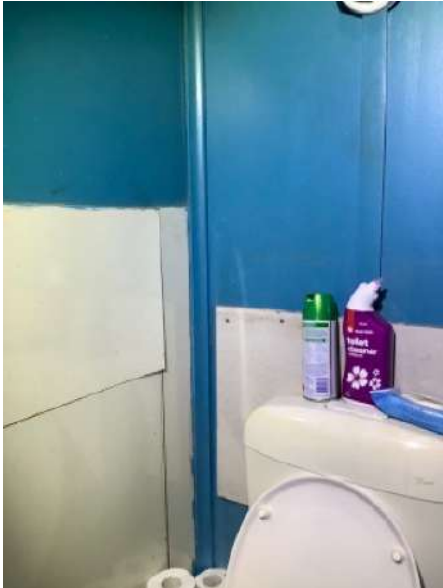
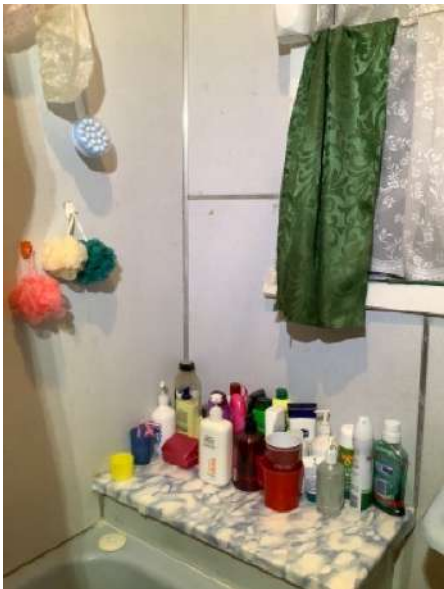
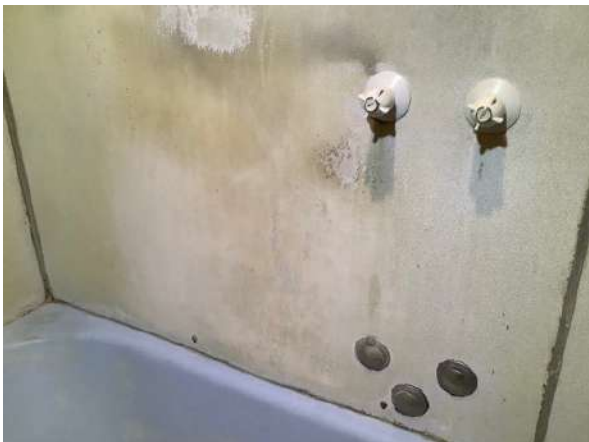
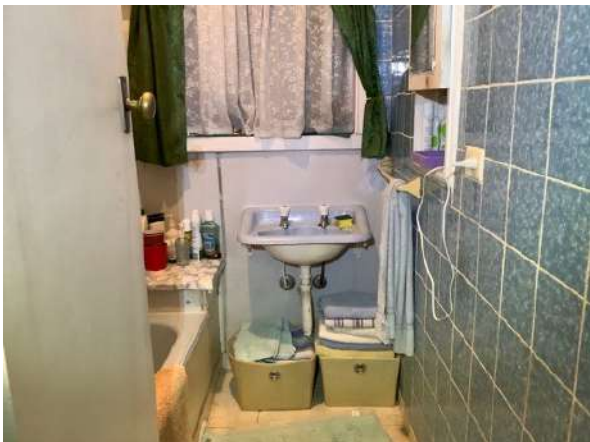
These photographs are an indication of the obstructions and limitations which impeded full inspection of the property at the time of inspection. These obstructions can hide an array of defects and should be removed to allow full inspection to be carried out.

A re-inspection is recommended once the areas are made accessible, if you require a further detailed inspection and report, which we do recommend.

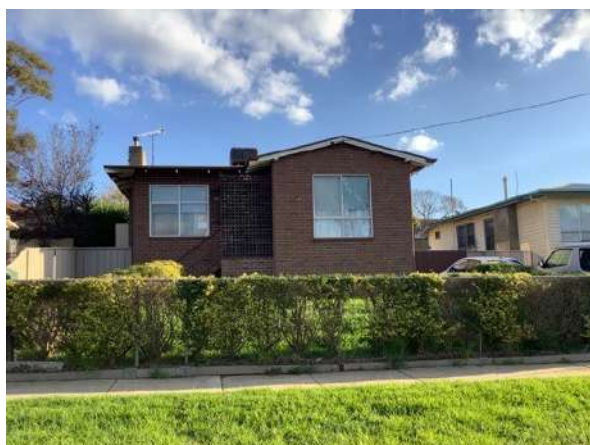
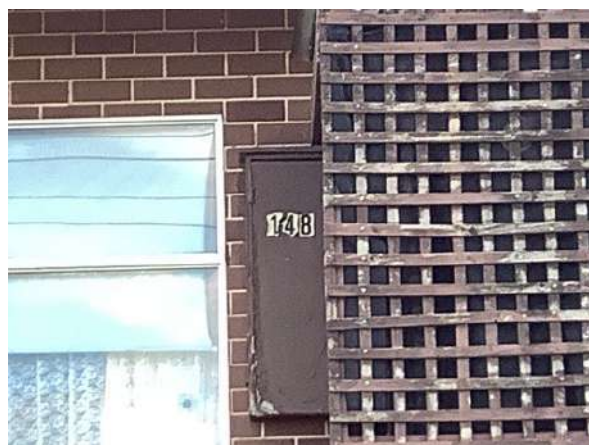
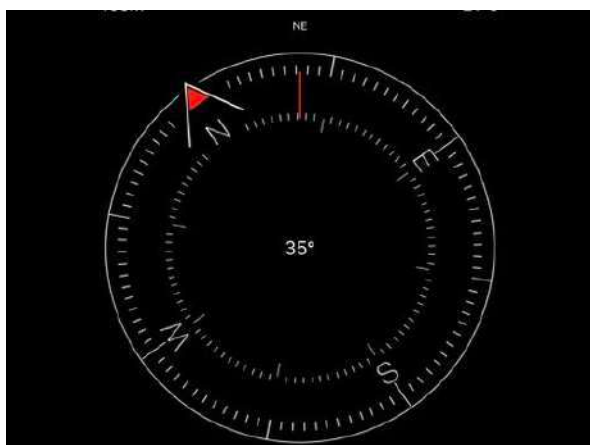
For your information 5.11

Location: The Site
Finding: Site Photos Added
Additional photos are provided for your general reference.

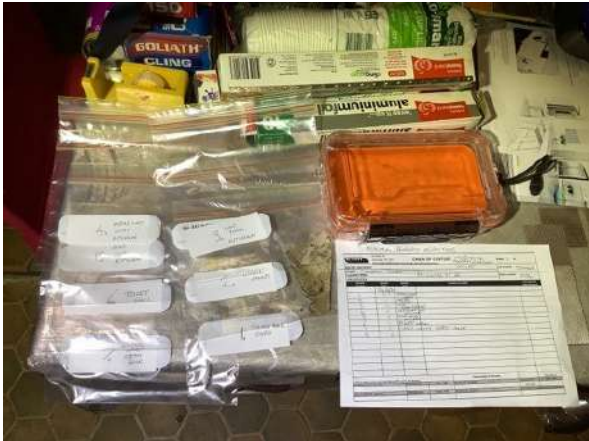
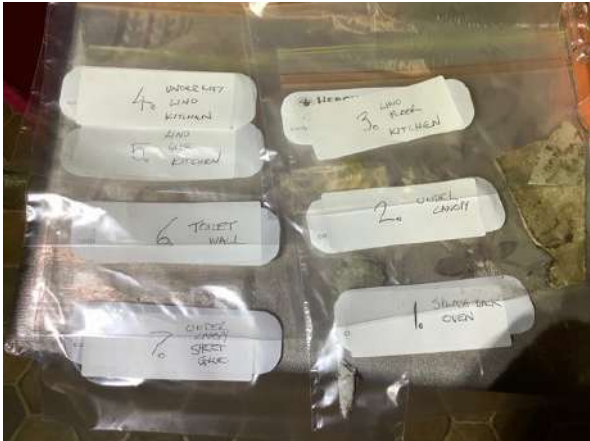
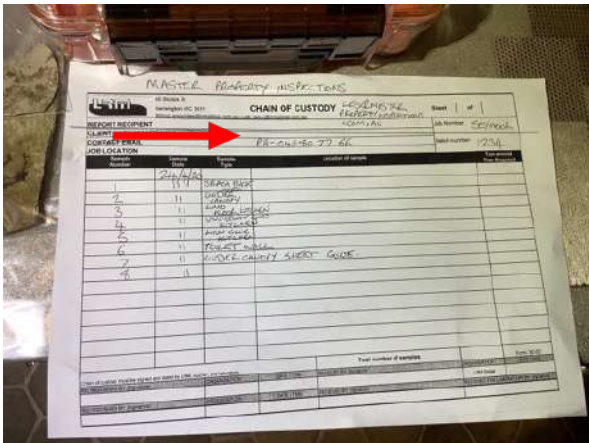
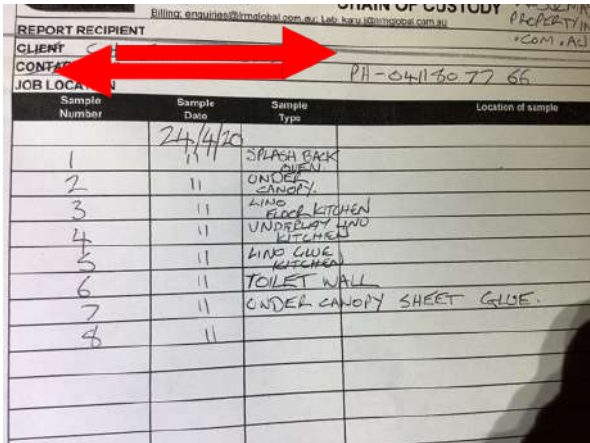
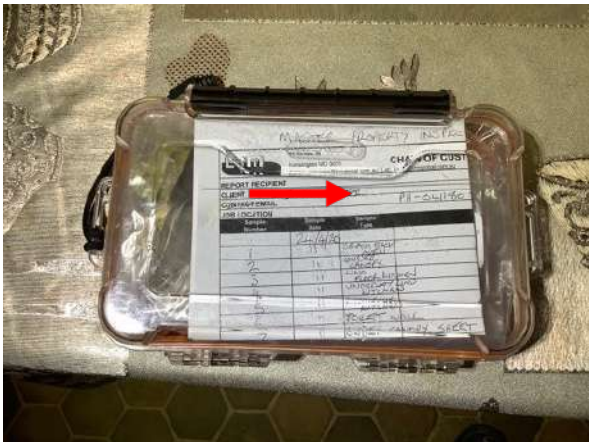
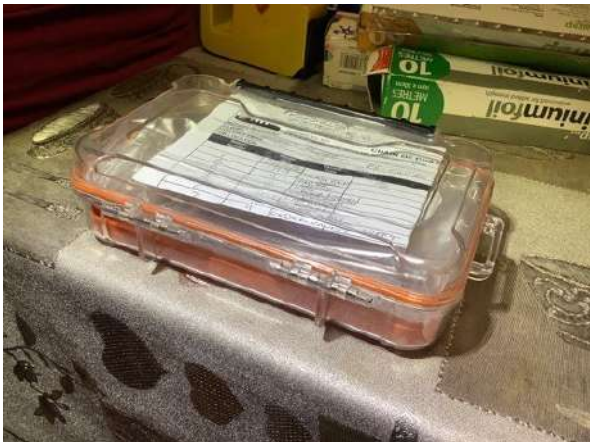
For your information 5.12

Finding: Copy of Chain Of Custody & Materials To Be Taken Away - For Your Information
Copy of Chain Of Custody and Asbestos in sealed bags and container, to be taken away for laboratory results.
