Building & Electrical Report

Inspection Date: 6 Jul 2021 Property Address: Footscray area

Complies with Australian Standard AS 4349.1 - 2007 Inspection of Buildings Part 1: Pre-Purchase Inspections - Residential Buildings

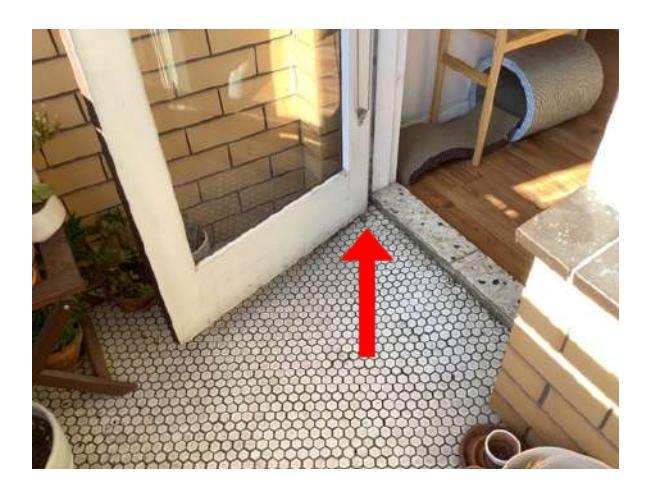
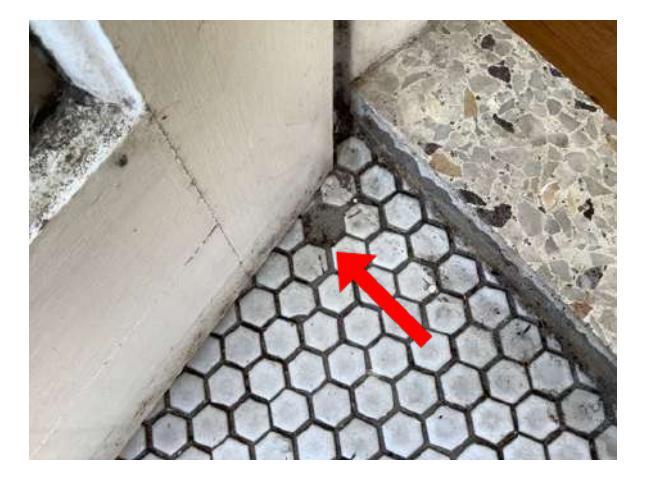
Whilst in some of the tile mortar is perfect, it has become apparent that the tile mortar has deteriorated and/or is just missing in other areas.

A sealant specialist, tiling contractor and/or registered builder should be appointed to assess any damage caused by water to the entire internal, sub-floor, walls etc of the building and clean, take off old sealant and tile mortar, then re-seal and re-mortar these works as soon as possible.

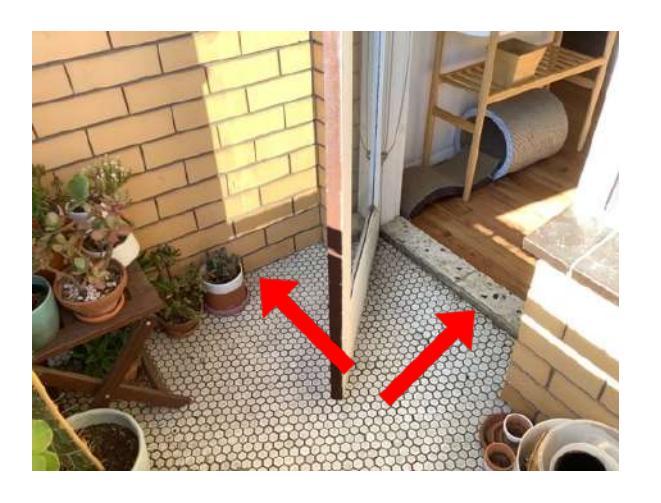
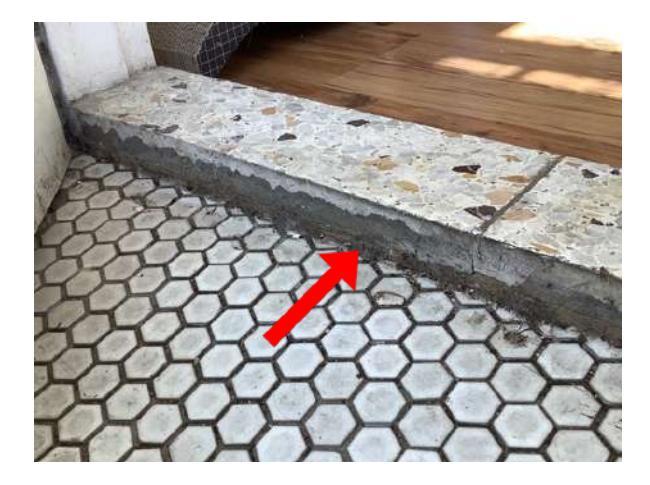
If left unmanaged, water penetration to these areas may lead to subsequent water damage, which is likely necessitate repair work to affected building elements.

Specialist trades are available for these types of services. A registered builder may be required to undertake works if damage is extensive or if secondary building defects have resulted. Otherwise, it is advised that a tiling contractor be appointed to perform works as necessary. Immediate action is recommended to ensure that no further damage is sustained in the affected area.

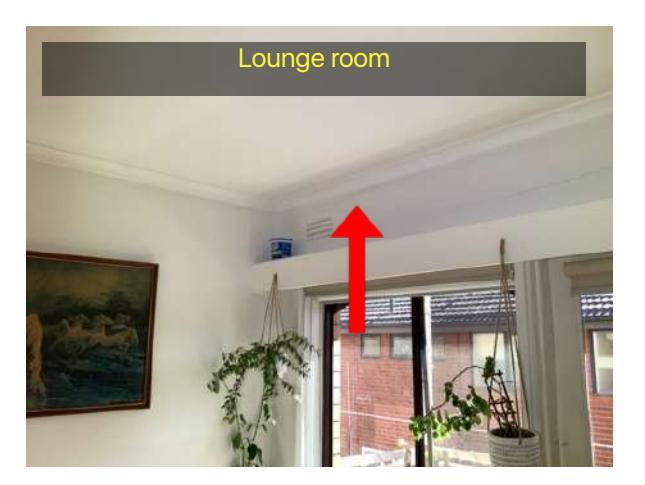
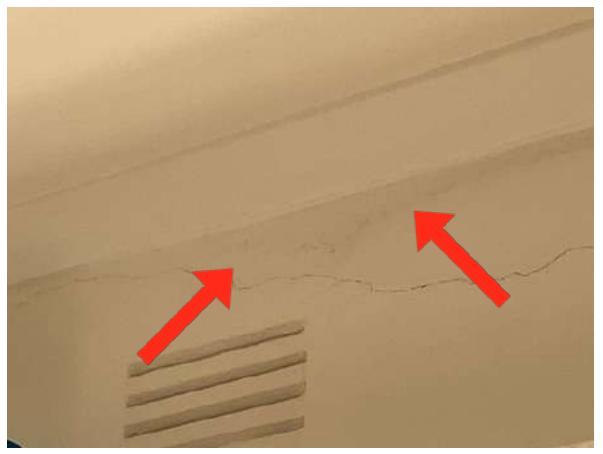
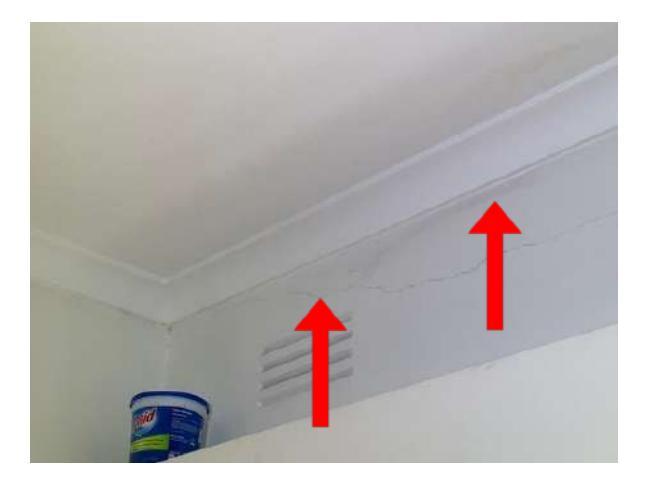
Minor Defect 3.05

Location: Sub Standard Workmanship or Incomplete-All Areas

Where installation is substandard and/or incomplete, the client should contact the responsible trade to undertake rectification works.

The appropriate tradesperson, specialist or handyman should be appointed to complete the various items for repair and organise the appropriate QUALIFIED trades (or not pending on job) to repair and complete the works to illiminate or reduce further deterioration / disfunction.

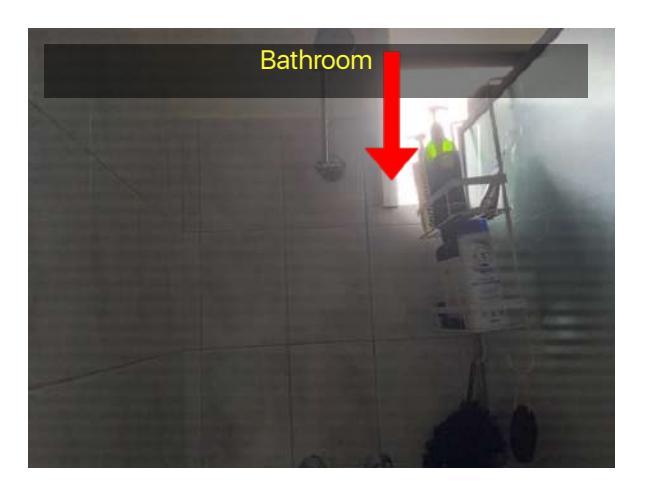
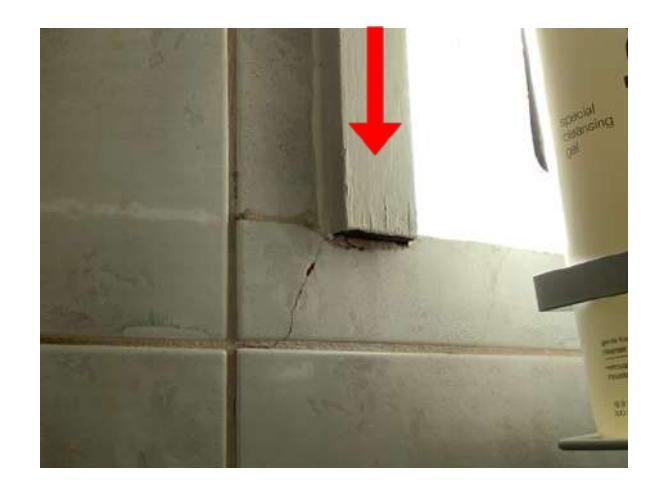
Location: Caulking / Silicone / Tile Grout-All Wet Areas

Finding: Silicone / Caulking Wet Area Junctions & Tile Grouting - Missing/Damaged or Poorly Installed

A sealant specialist, tiling contractor and/or registered builder in some serious cases, should be appointed to assess any damage caused by water to the entire internal, sub-floor where applicable, walls, etc of the building and clean, take off old sealant and tile mortar, then re-seal and re-mortar these areas as soon as possible.

♦ ALL AREAS should be checked carefully, for the Silicone / Caulking To All Wet Area Junctions and Tile Grouting, that is Missing/Damaged or just installed poorly.

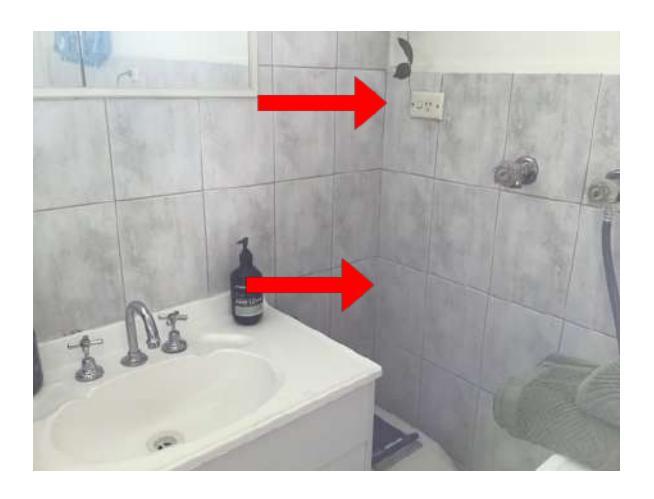
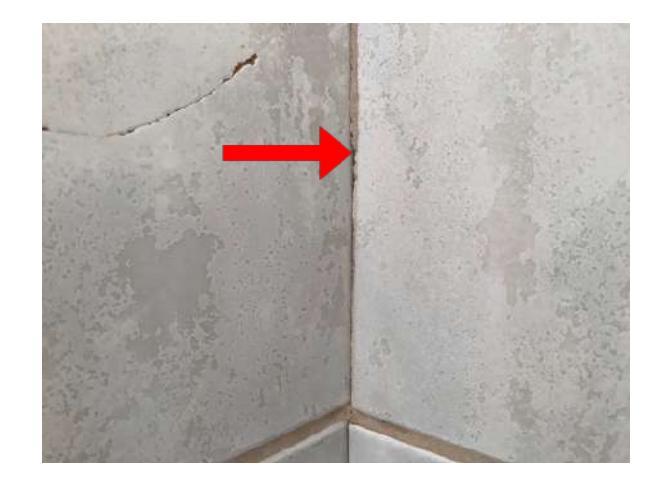
Cracking - Damage Category 1 - Fine (up to 1mm) Although fine cracks are quite noticeable, they are often only considered to be an appearance defect, and usually do not indicate any structural damage. Generally, the cause of a fine crack is indicative of a separation between building materials and finishes (e.g. paint, plaster, etc.) along joins.

Cracking of this nature can generally be repaired with minor sanding, filling and/or repainting. Such works should be performed by a qualified painter or a general handyman. Monitoring of all cracking should be conducted frequently. Always contact a building inspector should cracks widen, lengthen, or become more numerous.

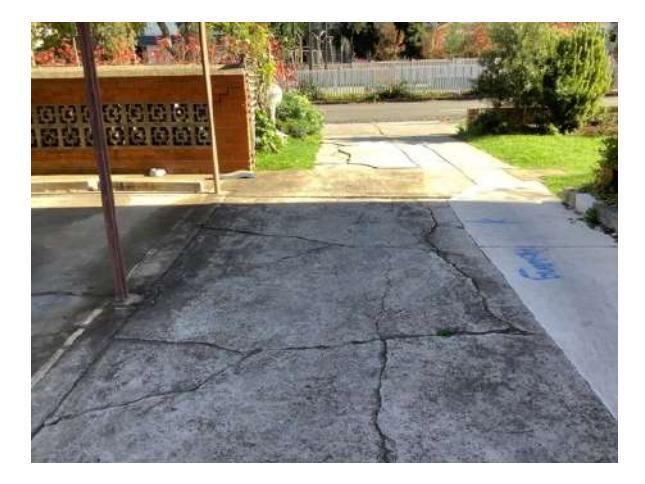
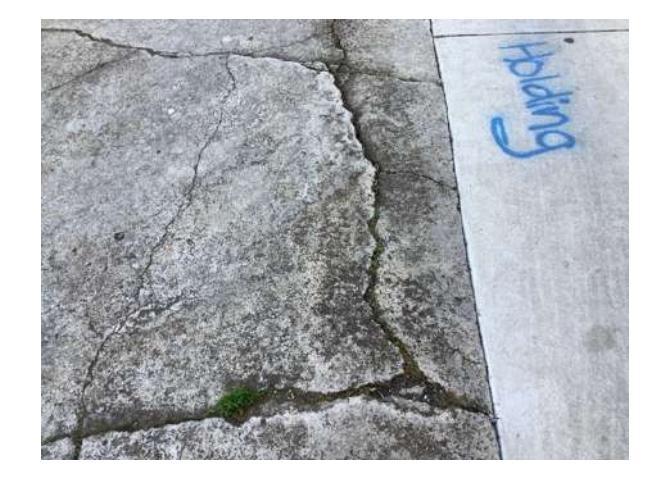
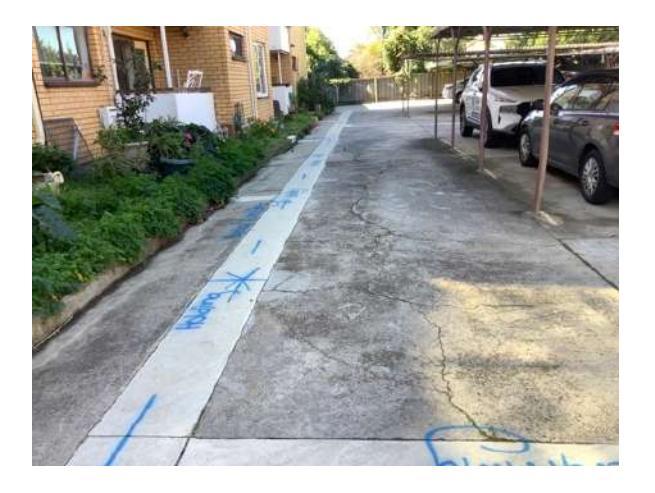
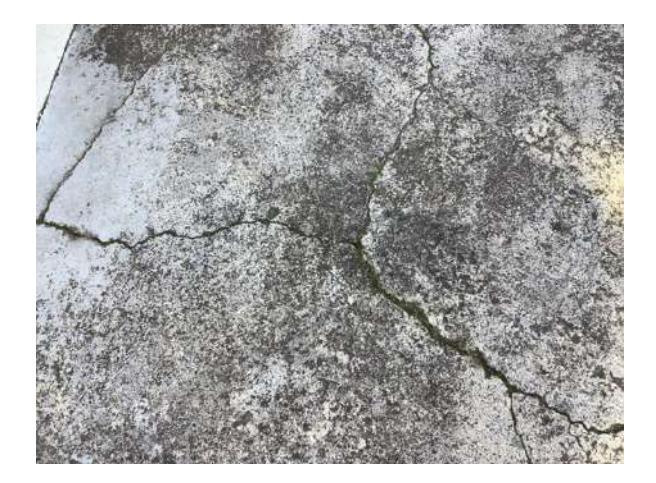
Cracking - External Concrete Paving Damage Category 3 - Wide Cracks (Over 3 to 5mm) Wide cracks were identified in external concrete paving Wide cracks are significant and are likely to lead to the development of safety hazards and secondary defects if left unmanaged.

General age and expected deterioration of the paved areas is a common cause of this type of cracking. However, expansion and contraction of the slab may also have occurred due to environmental factors. Such factors include variable moisture and weather conditions, the presence of trees and their roots having a settling or lifting affect on the soil, or the effect of load bearing, e.g. heavy vehicles over a sustained period of time.

Cracking to this degree may also be due to poor original installation of the concrete. Factors such as poor compaction of the sub surface and/or inadequate reinforcing of the slab may create cracking and other secondary defects. Wide cracks may also have a more significant structural cause, such as subsidence of soils.

Where the crack is located adjacent to structural elements of the building, the advice of a Structural Engineer is advisable before undertaking repairs. Significant repair and likely replacement of the concrete paving is probable.

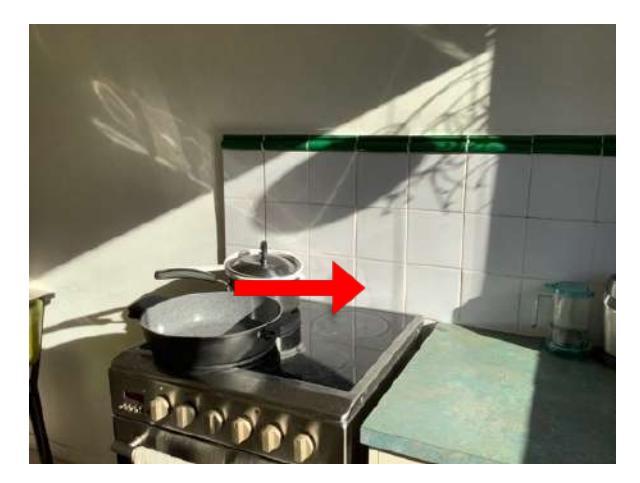
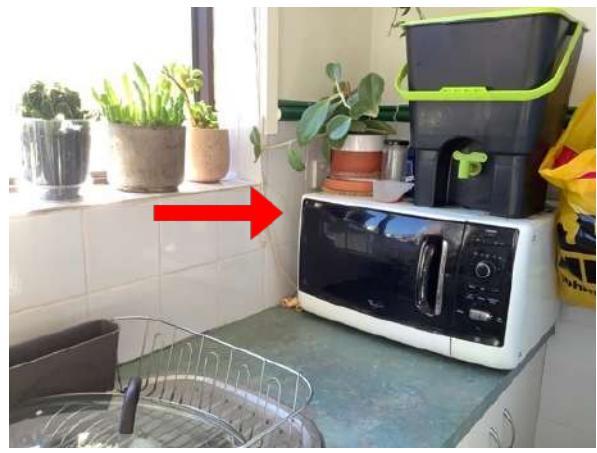
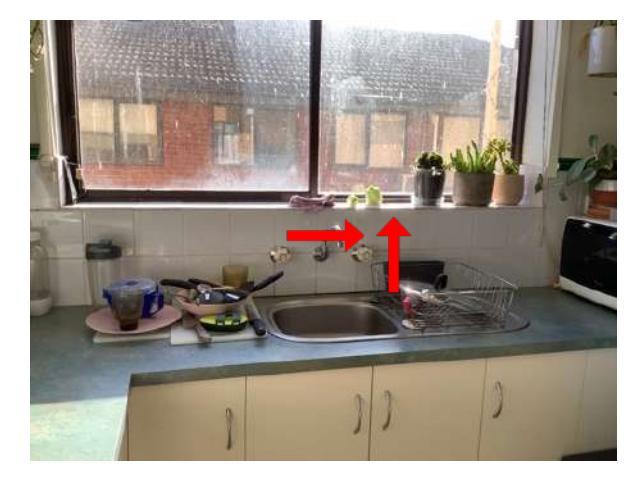
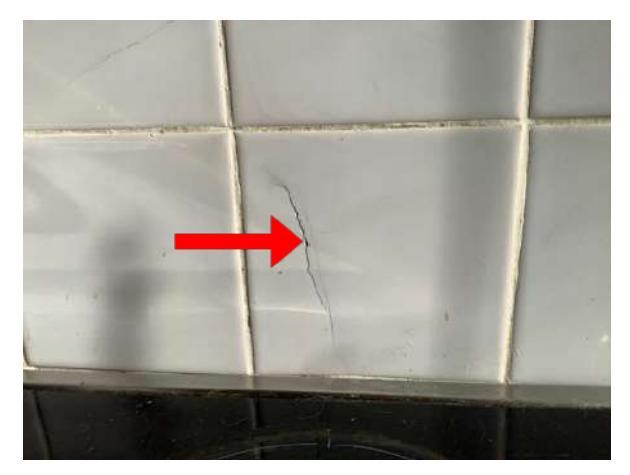
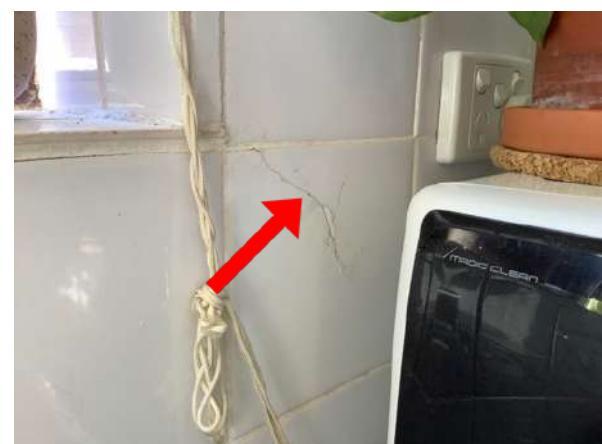
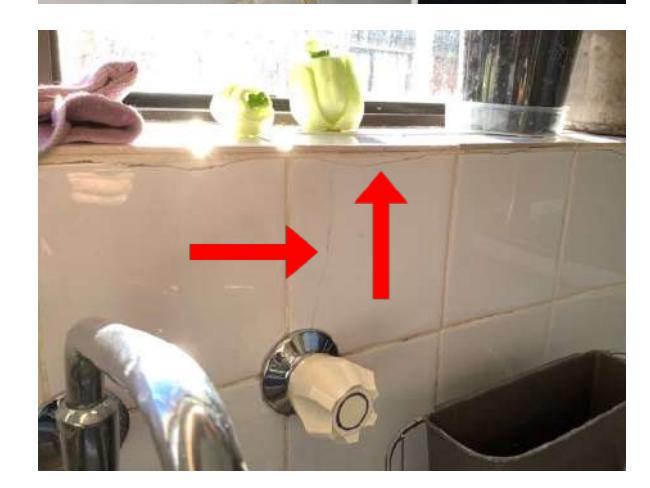
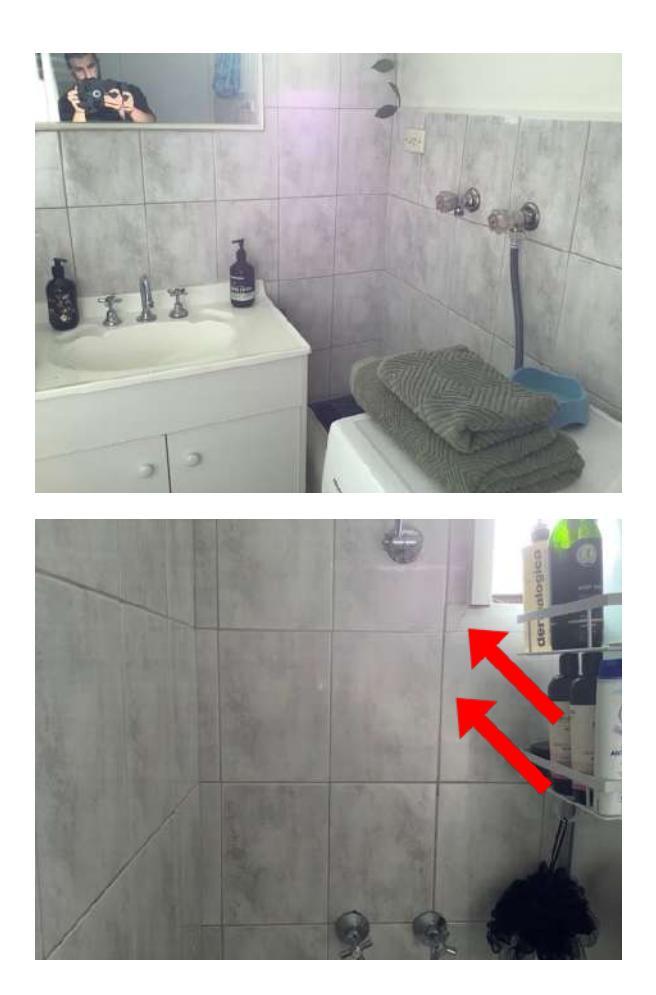
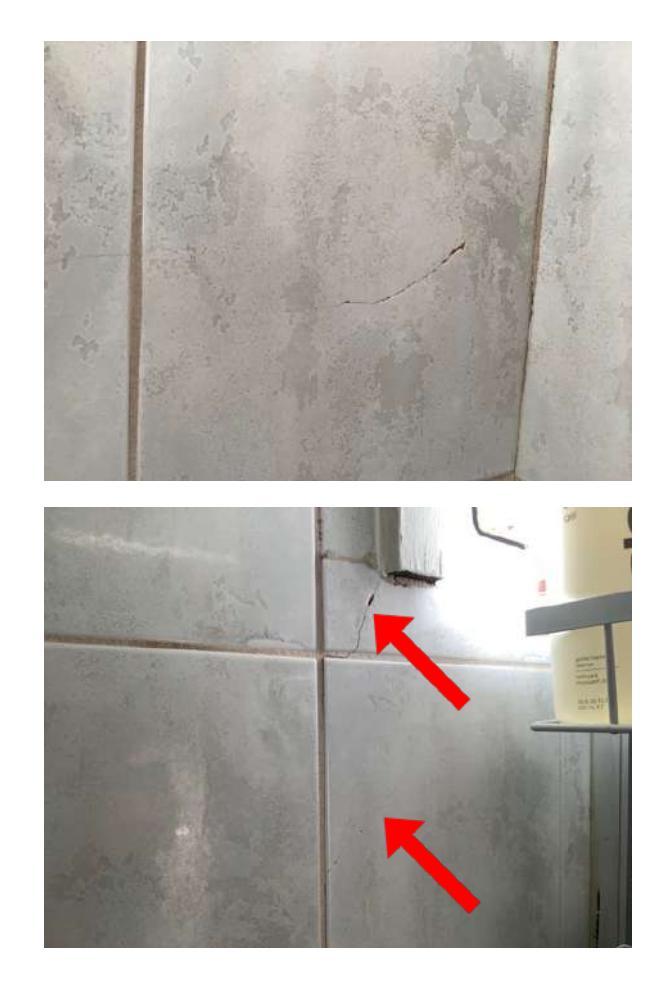
Tiles - Cracked or damaged

Cracking was evident to the tiling at the time of inspection. While the cracking appears to be minor, these areas are frequently exposed to water, allowing potential for water penetration into adjoining sections of walls or flooring.

If left unmanaged, water penetration to these areas may lead to subsequent water damage, which is likely necessitate repair work to affected building elements.

What is important when tiles are cracking is to determine the cause of the cracking, which may be related to the subfloor structure, typical wear and tear and/or poor workmanship The cause of the tiles cracking must be determined and repaired otherwise the same defect will occur.

A tiling contractor should be appointed to ensure that no further water damage occurs. The reapplication of silicone and grouting throughout remaining tile work is also advised, to further protect the area against water penetration.

Where water penetration has led to water damage, appointment of a relevant tradesperson may be required to repair damaged building elements.

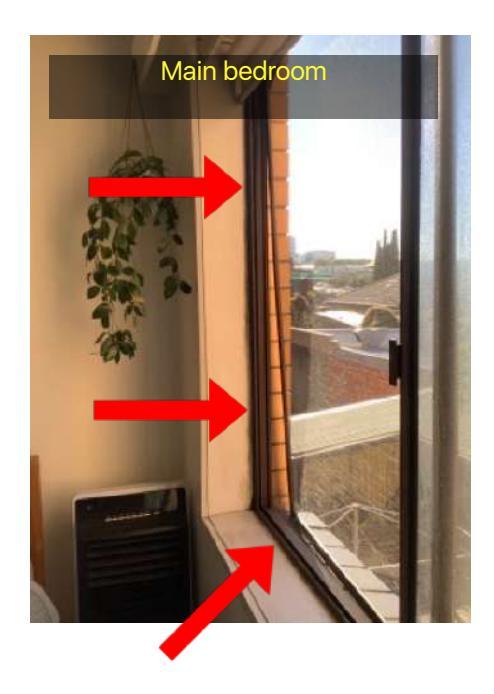
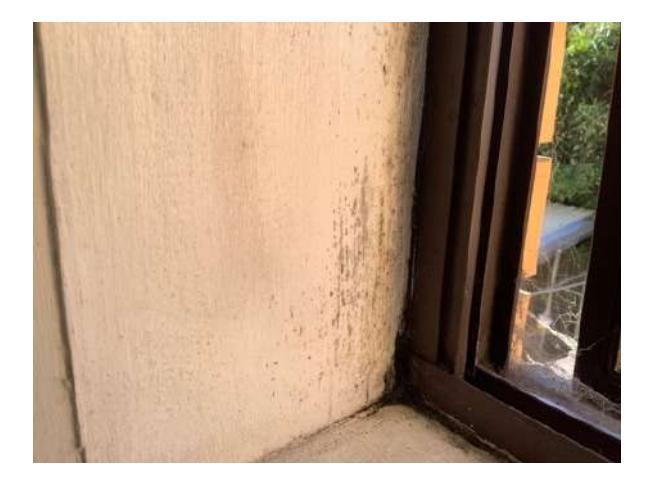
Location:	Windows - Internal
Finding:	Windows - Water Staining
	Water staining was evident to various window frames.

Generally water staining to window frames, may be due to the window seals to the perimeter of the glass edges, have deteriorated. This may be due to damaged rubbers, particularly to metal window frames or may be due to deteriorated silicon and/or may be due to timber rott. In addition water staining may be a combination of damaged silicon, damaged rubber seals and wood rott.

Water staining indicates that surfaces have been exposed to excessive moisture / water over time. The minerals and other elements in the water lead to staining, which may graduate to corrosion and deterioration if left unmanaged.

Water staining can be indicative of more serious defects, such as plaster damage that has become detached from its fixings and become dangerous not just cosmetic, wood rot, mould, conducive environment for termites and damage to other types of building materials that are concealed or not concealed by other building elements.

Water staining can cause minor damages such as paint staining, timber discolouration, etc or water staining can lead to more serious major structural defects.

It is important to identify the cause of water staining and STOP FURTHER DETERIORATION by the appropriate tradesperson.

Replacement of any broken or damaged structures is advised in particular if the damage has caused secondary defects that have compromised the building structure or safety of any persons.

It is important to identify the correct proffesional to perform these works, pending on each situation on how minor or major it has become.

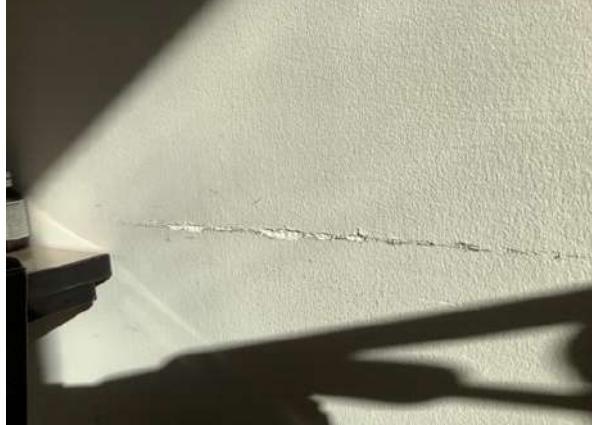
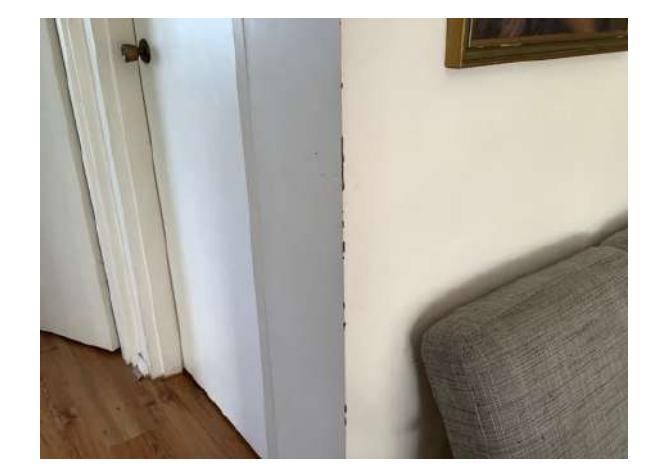
Location:	Paint & Plaster-Various Areas
Finding:	Paint & Plaster To The Doors, Various Timber's, Plaster Walls & Ceilings, ETC.
	It appears that the property has had plaster work repairs to various areas of the property.
	It appears that the property has been painted in some areas in recent times.
	There is the possibility that various plaster/solid plaster cracks may have been covered up and/ or repaired, so there is always the possibility that the cracks in part or full will come back if the repairs have not been professionally completed AND/OR the property has movement and/or continuing subsidence to the property. It is unknown how severe the cracks in the plaster work and/or solid plaster work really were, before the plaster & paint work was performed.
	Superficial scuff marks, damaged plaster, holes in walls,missing paint,sub-standard paint work were noted to the internal walls / ceilings and/or architraves as per the photos attached at the time of inspection.

While these minor defects are detracting from the overall appearance of the affected building element, they do not indicate any operational or structural damage. This degree of surface damage is consistent with general damage, accidents, movement and wear and tear.
	These type of minor defects are appearance cosmetics but they can also lead to the development of secondary building defects over time.
	Incomplete areas of paint finish, holes in plaster, exposes the area to moisture, potentially accelerating the deterioration of underlying building materials especially in wet areas such as laundrys and bathrooms.
	Superficial scuff marks, damaged plaster, holes in walls, missing paint, sub-standard paint work should be sanded back, filled, levelled and painted, as applicable. Where inadequate or missing protection has led to the deterioration of the associated building element, repair and/or replacement of this building element may be required.

A painting contractor, builder, plasterer and/or suitable handy person may be appointed to perform necessary works to aid the appearance of the affected area and to ensure the area is protected against further deterioration.
	Wet areas are the main areas that MUST have SUFFICIENT paint coverage to the walls, ceilings and timber work as moisture can deteriorate the areas.
	ALL AREAS should be checked carefully, attached are a some PHOTO EXAMPLES as a GUIDE.

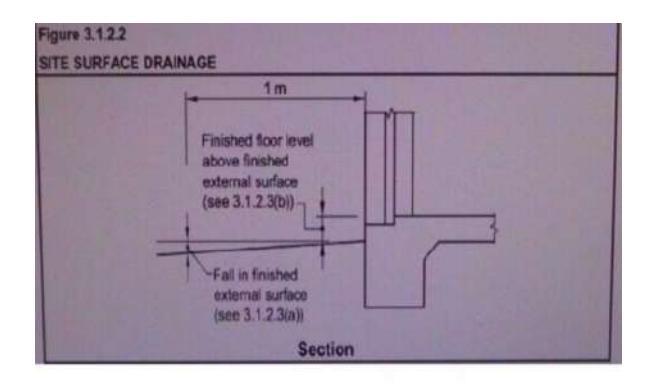
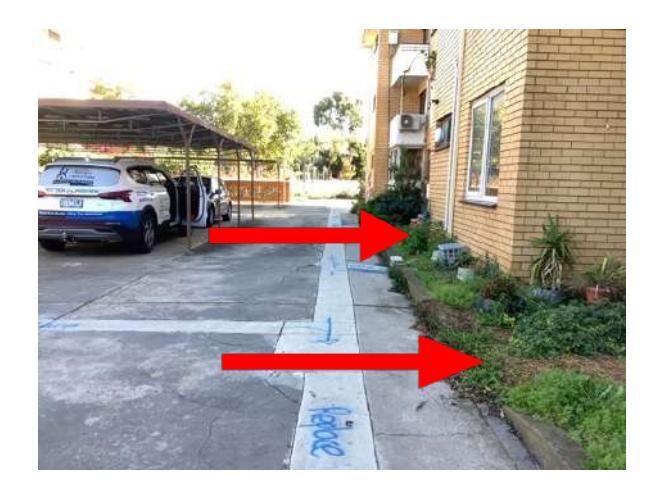
Location: Finding: Perimeter Of Building - Exterior

Drainage - Inadequate and/or Perimeter Building Ground Fall Defective.

Water pooling near foundations and footings is a serious concern with the potential to adversely impact on the longevity of the dwelling. The Building Code of Australia (BCA) outlines that the soil or concrete must be graded away from the dwelling at a minimum of 50mm over 1m (1:50 fall).

The site drainage in this report was found to be inadequate at the time of inspection, creating potential for subsequent water damage to associated building elements, such as foundation subsidence, brickwork cracking, windows and doors moving, concrete paths cracking, etc.

These drainage concerns in this report can have grave potential for foundation subsidence and/ or secondary damages such as structural defects such as brick movement / cracking as already mentioned above.

Where site drainage is inadequate, another option can be installation of an Agricultural (Aggie) Drain may be required or more serious remedial works.

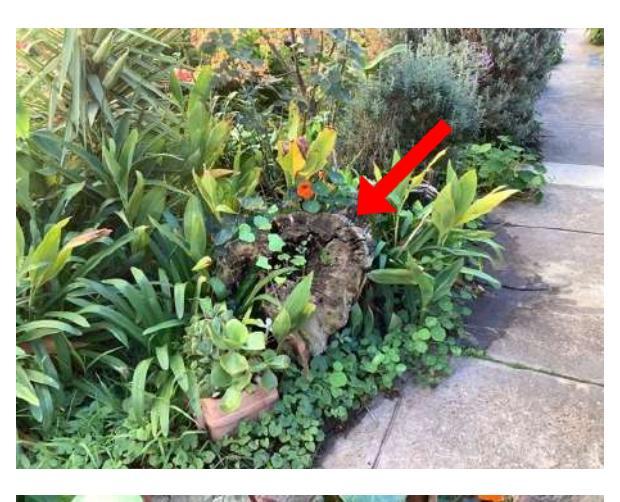
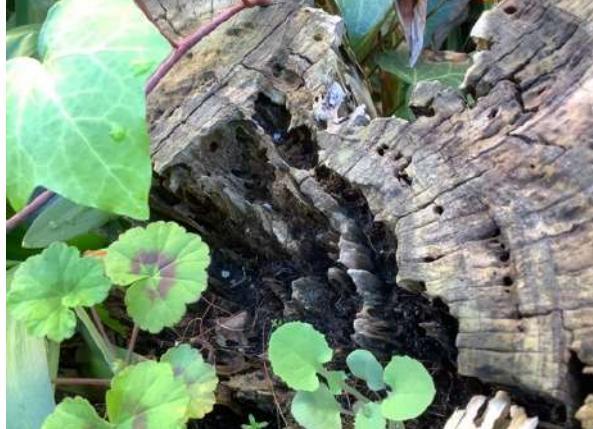
Location:	Termite - Damage Identified.
Finding:	Termite - Damage Identified.
-	It is suspected that termite activity is occurring or has occurred as there is evidence of termite damage.
	Damage caused by termites found in termite areas is considered a defect if the termite management system is not installed in accordance with the BCA / NCC and relevant Australian Standards.
	Such damage creates a potential safety hazard, and is likely to worsen and cause further damage to adjoining building materials.
	If left unattended, this damage creates an unsafe environment and is likely to lead to the need for major structural works.
	A building contractor should be appointed immediately to advise on options to prevent further damage and repair on all affected building materials, if any areas of damage are noticeable.
	The application of a post-construction chemical termite barrier or other termite treatments is ALWAYS highly recommended for all properties, particularly if live termite activity has been found on the site previously. Such barriers are highly effective in preventing termite attack on any timber building elements throughout the property.

We HIGHLY RECOMMEND the client may consider gaining further advice from a pest controller as to the costs and procedures involved with this application.
	It is recommended that obtaining such advice be treated as HIGH PRIORITY.
	ALL AREAS should be checked carefully for this defect and attached are a few PHOTO EXAMPLES as a GUIDE.
	Please Note :
	Timber pest damage WAS FOUND on the property and further information is in the report.
	The property is a HIGH risk for termites as the environments to the property are very conducive with many susceptible areas as noted in this report.
	I can not stress how important it is to reduce and keep clean the trees, vegetation, timber and/ or all other debri and all other items not only around the home but to the entire property as a matter of urgency to reduce the very high risk for termite activity and to keep the environment as low risk as possible for a conducive and susceptible area or areas for termites and timber pests.

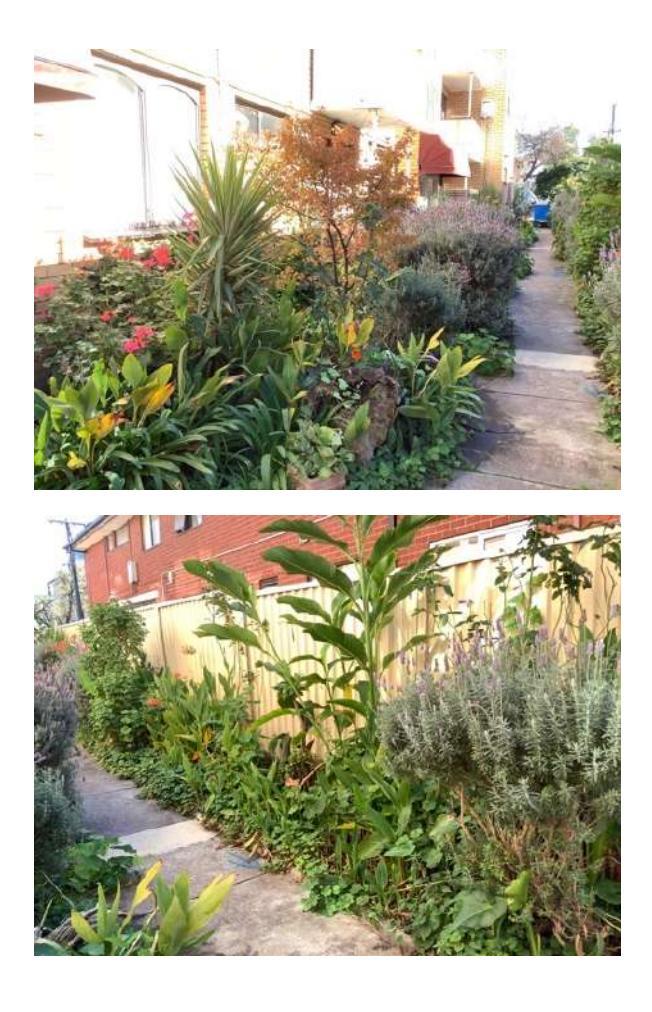
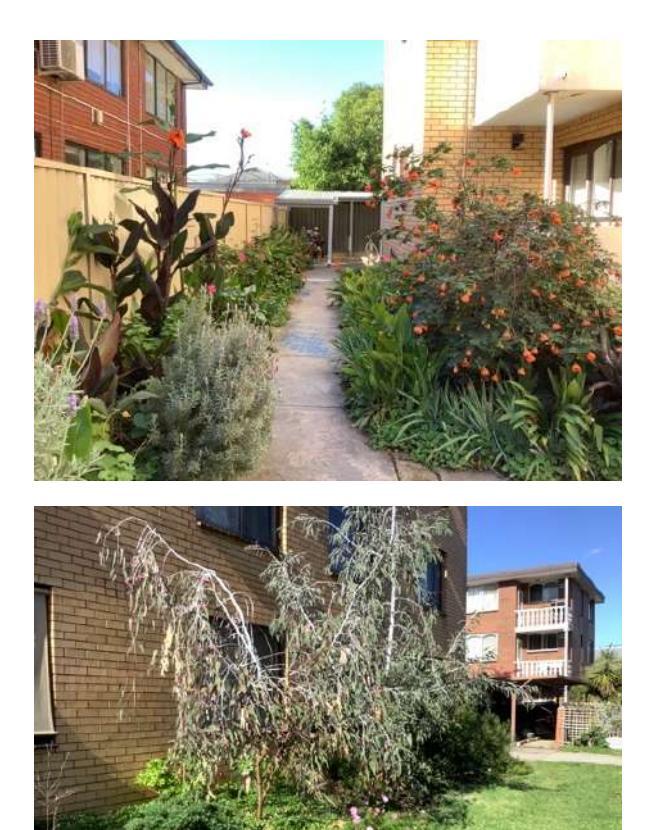
At the time of the inspection it was found that the plants are overgrown and close to the exterior building.

It is highly recommended that the plants be trimmed and/or moved away from the immediate area of the perimeter building...

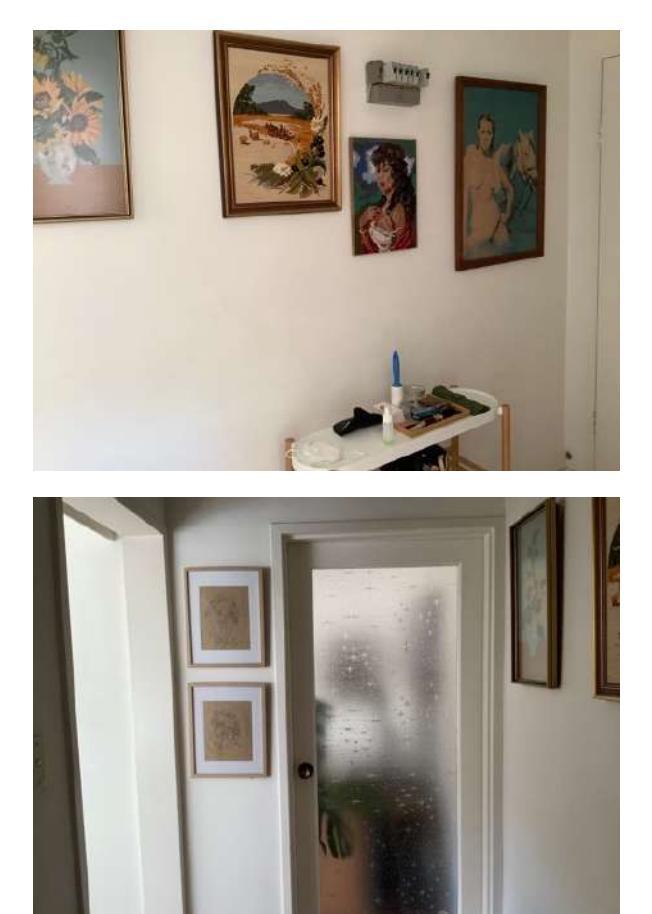
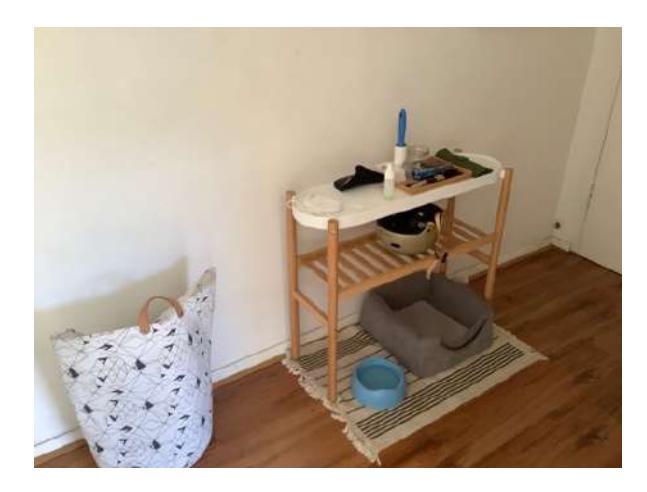
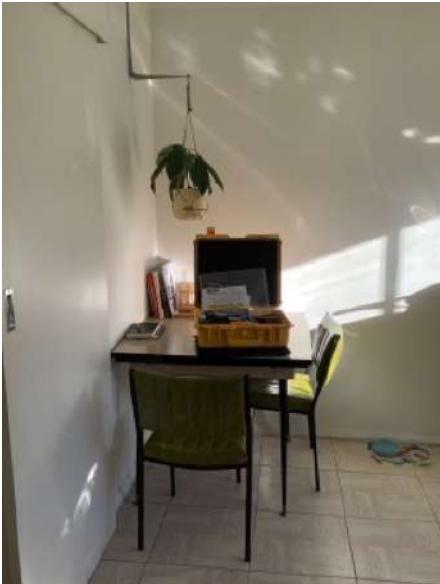
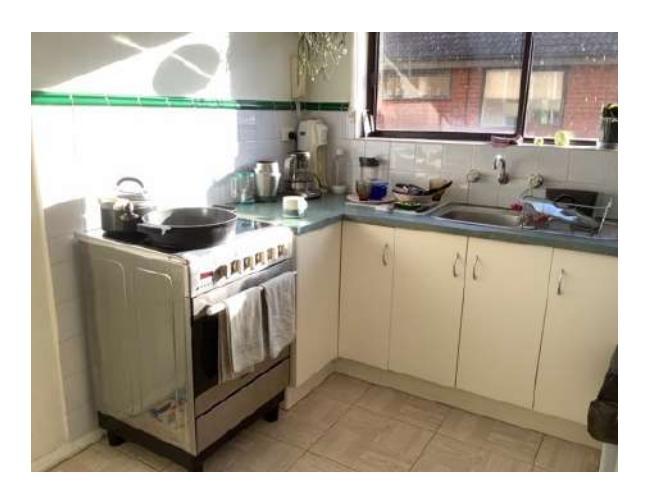
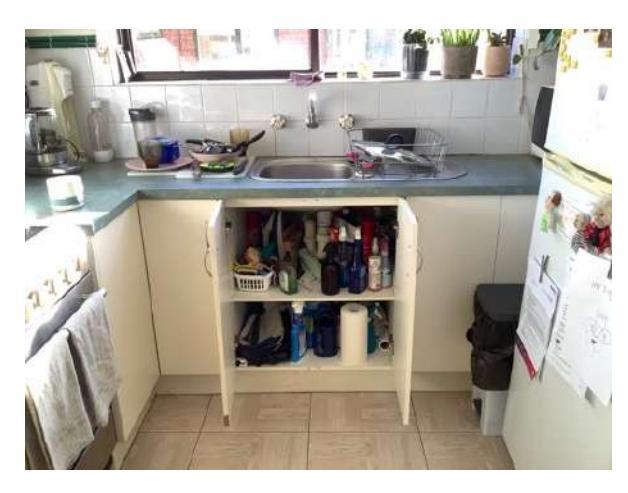
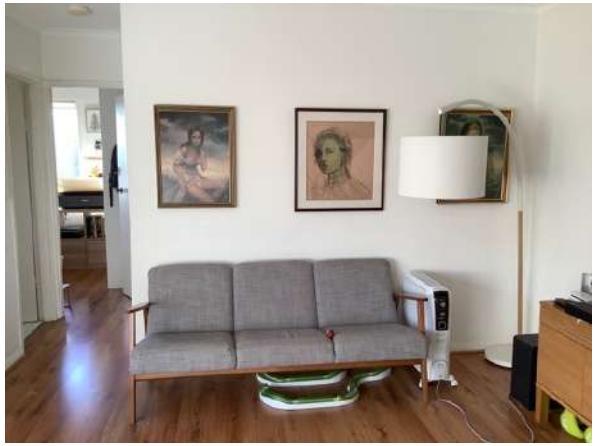
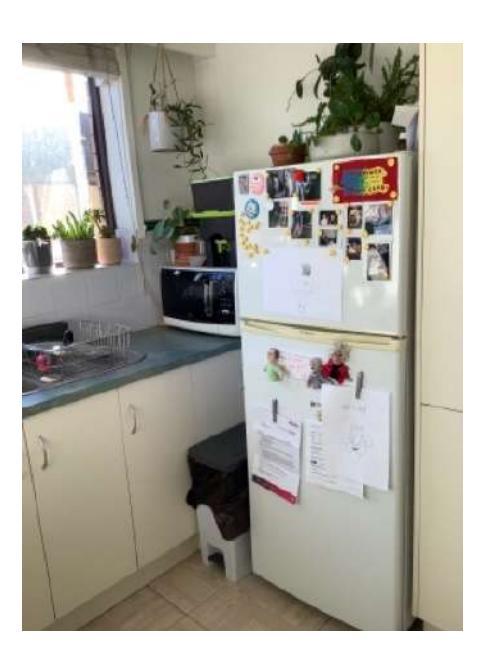
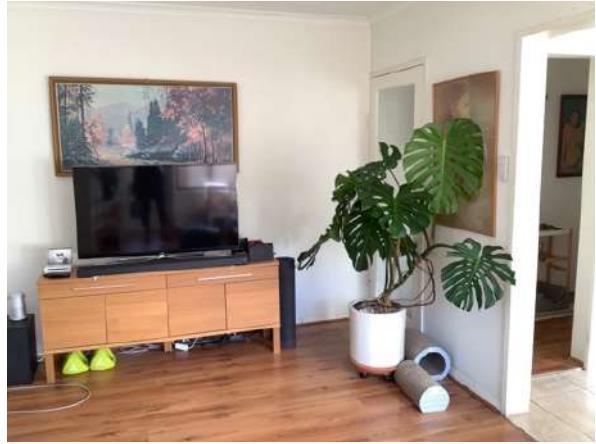
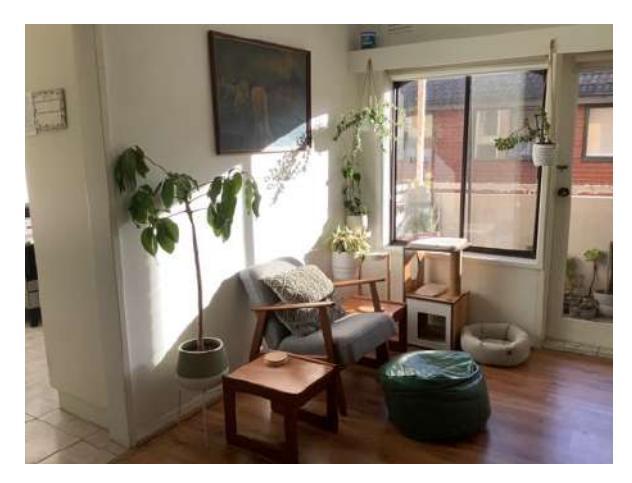
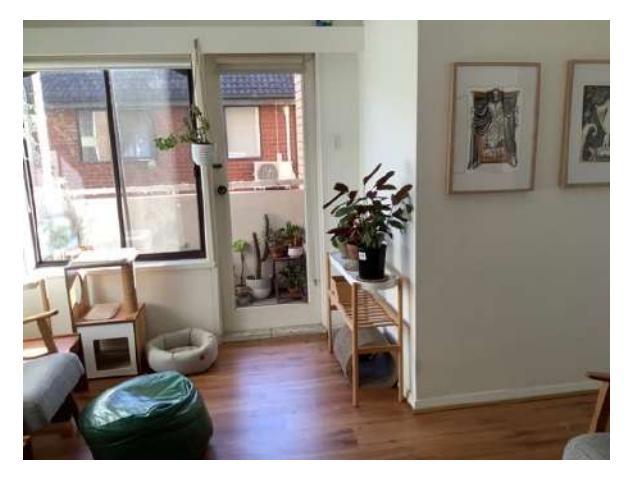
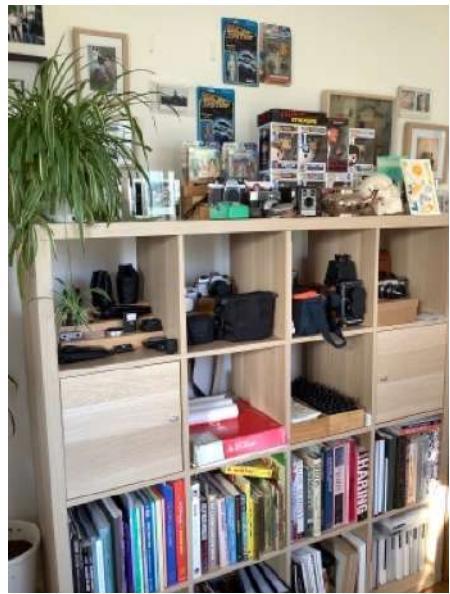
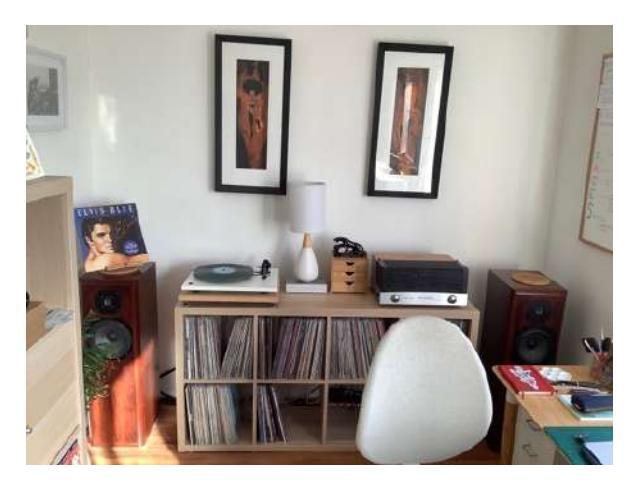
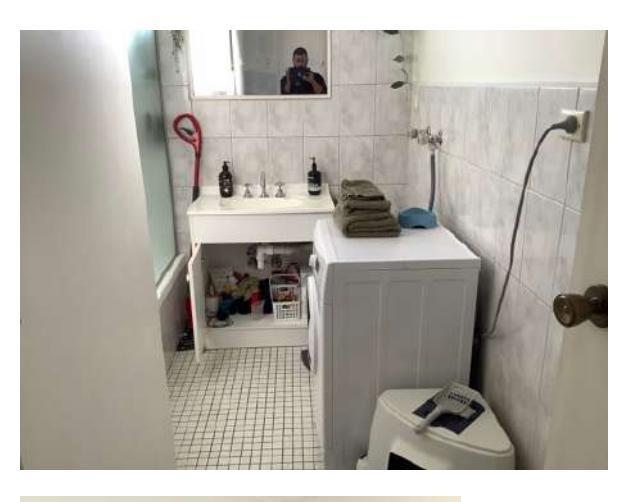
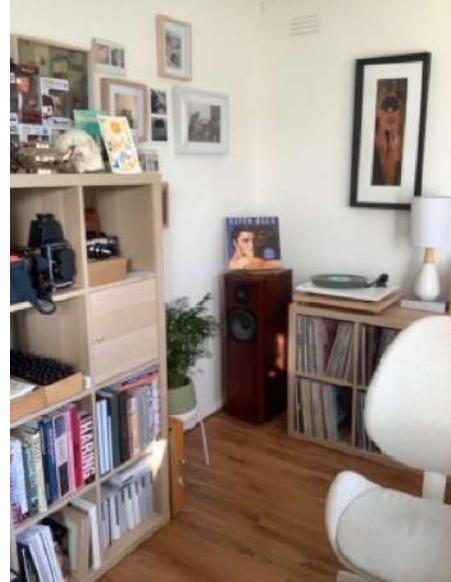
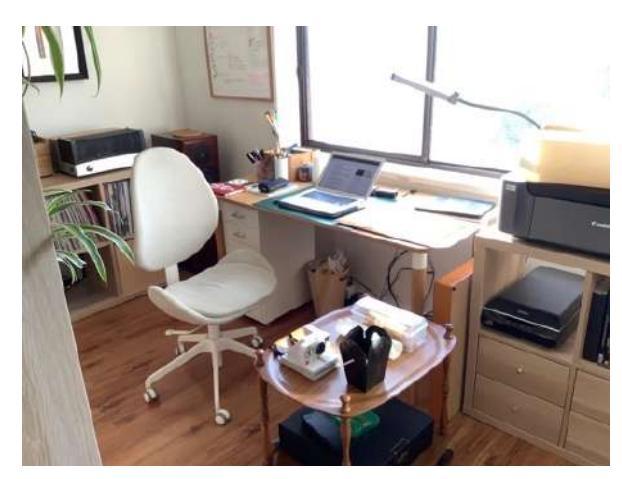
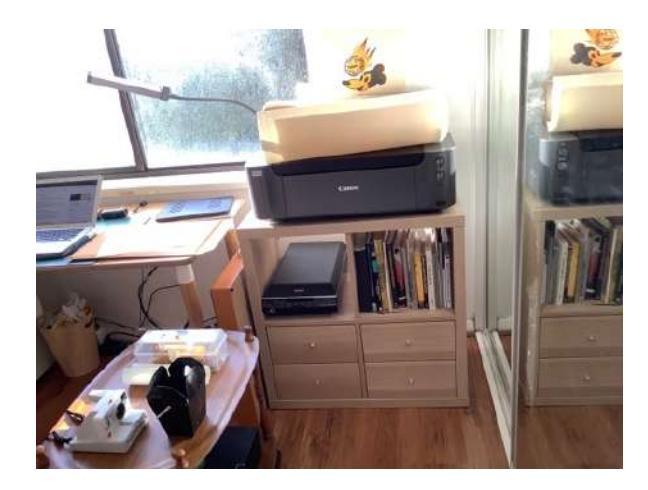
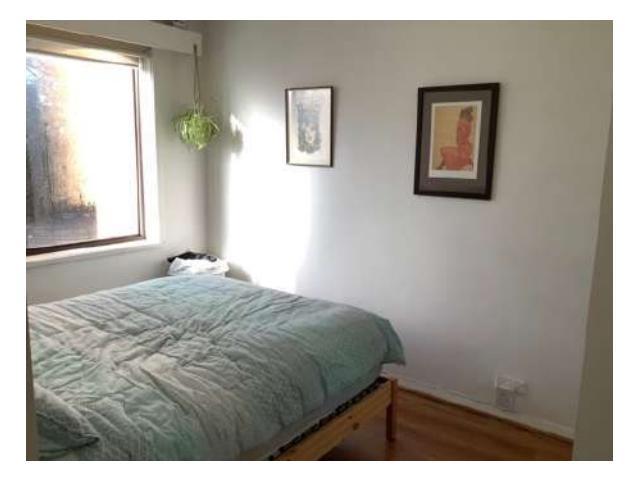
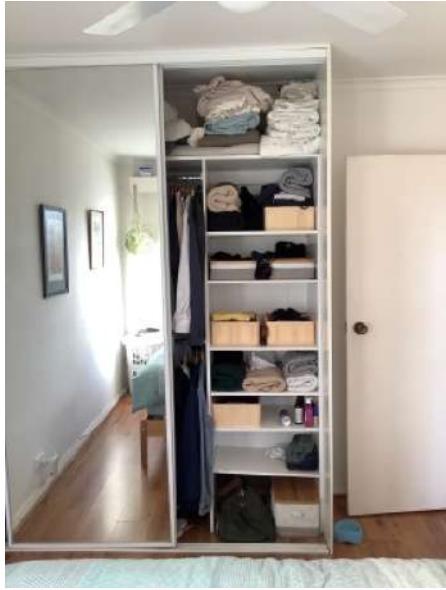
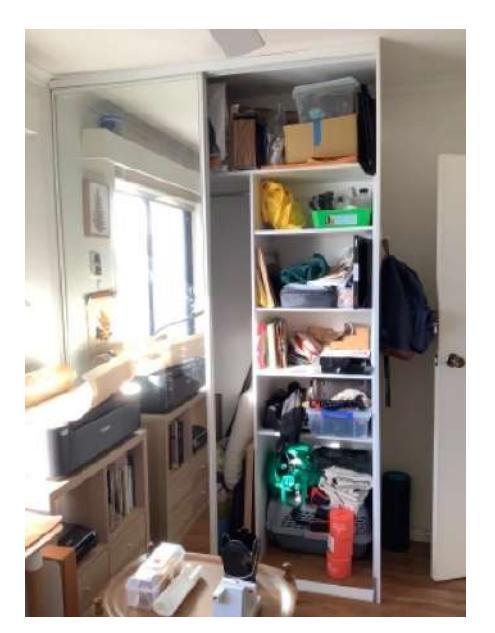
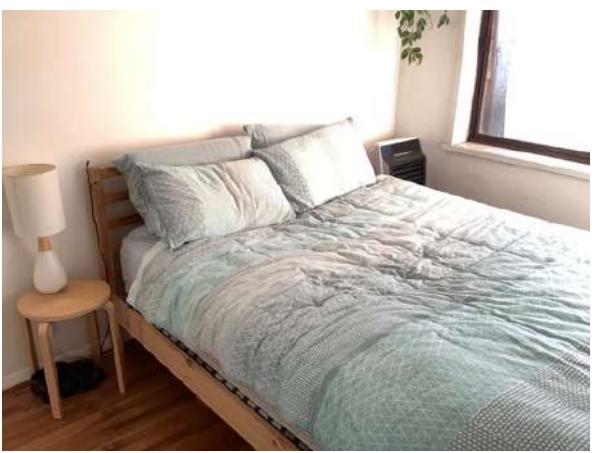
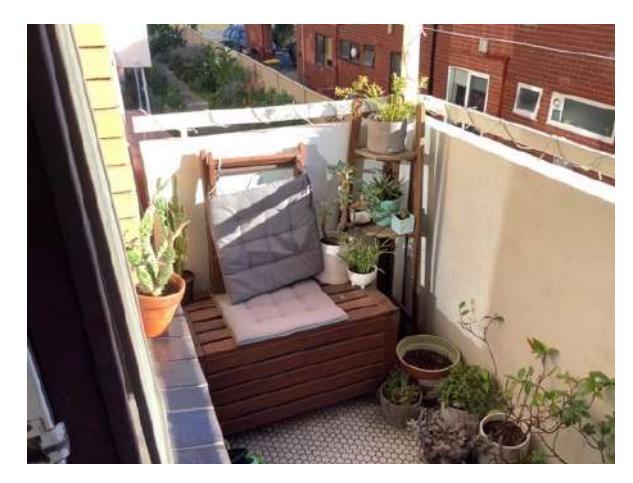
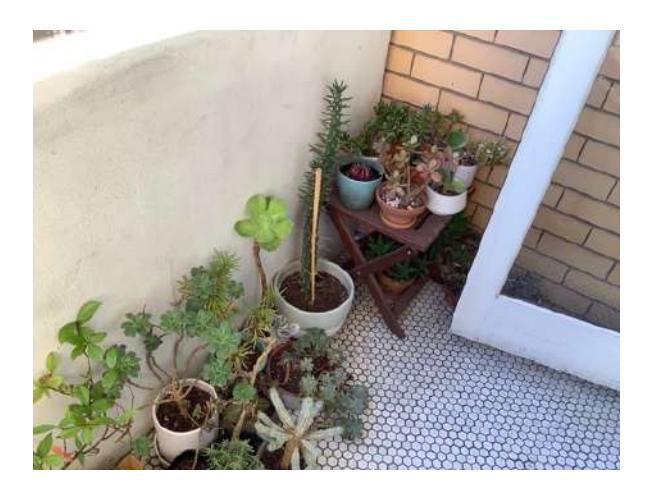
Location: Finding: The Site

Obstructions and Limitations

These photographs are an indication of the obstructions and limitations which impeded full inspection of the property at the time of inspection. These obstructions can hide an array of defects such as minor defects , major defects , safety

hazards, termite activity and conducive environments for termites but not limited to.

These photos in the report are for you to understand the type of obstructions and limitations on site, that restricted our inspection process.

Once the property is emptied, a re-inspection is at the client's discretion.
